# Durability Evaluation of Florida's Fiber-Reinforced Polymer (FRP) Composite Reinforcement for Concrete Structures

**Final Report**

**March 2017**

UF Project No. 106074 & 107174  
FDOT Contract No. BDV31-977-01

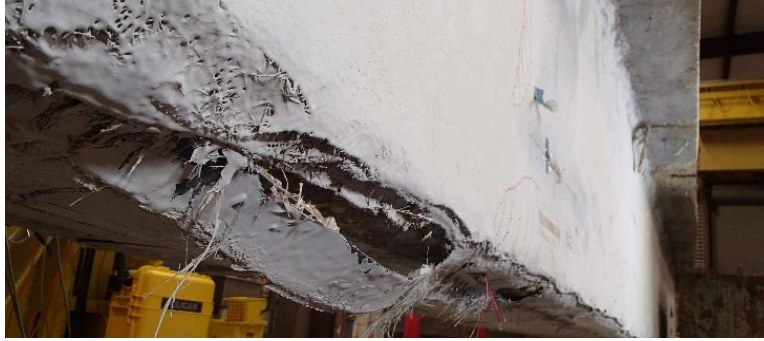
Girder 3-4 had the highest ductility of all four exterior girders, which was also the only girder with FRP to have a higher ductility than a girder without FRP. This may be the case because Girder 3-4 was the only girder to have the CFRP strips debond and rupture prior to the GFRP rupture, before any crushing of concrete in the compression zone had occurred. The other two girders with FRP had the GFRP rupture first, which may have resulted in a sudden increase in strain for the CFRP strip that may have led to the CFRP strip rupture and debond earlier than anticipated.

Figure 173—CFRP debonding (Girder 3-4)

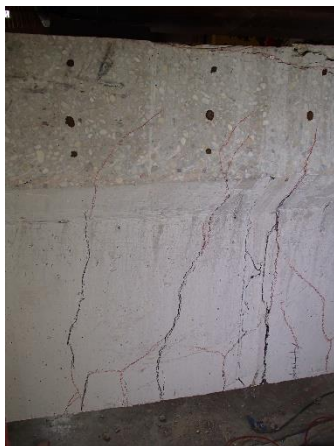
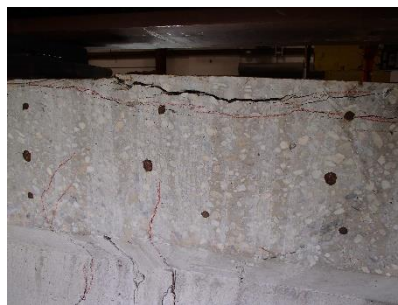
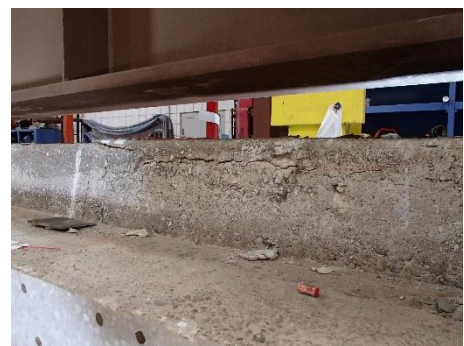
During flexural testing of 3-4, FSG3 indicated approximately 1000 microstrain more than FSG4. This difference in strain increased to approximately 3000 microstrain as the CFRP strips as the load approached ultimate strength. This difference in strain may be an indicator that lateral deformations were occurring since GFRP was only applied to the west face. Another possibility is that strain gages may have been in varying proximity to flexural cracks, which produced differing strains near ultimate strength. While the west CFRP strip debonded at a load of 217 kip, there was no indication on the load-displacement plot (Figure 172). The east CFRP debonded at ultimate strength (223 kip), which resulted in a small loss in load. The GFRP ruptured at 218.3 kip. At this point, both CFRP strips had debonded (Figure 173), and the GFRP had ruptured (Figure 174), resulting in a load decrease to approximately 200 kip residual strength. The GFRP rupture occurred simultaneously with a crack that formed in a formwork joint on the opposite face (east elevation) (Figure 175). The crack then lengthened into the compression zone (Figure 175b) where crushing occurred (Figure 175c).

Figure 175—Concrete damage to Girder 3-4 including (a) cracking near formwork joint (b) concrete crushing in compression zone in east elevation (c) crushing of concrete in west elevation

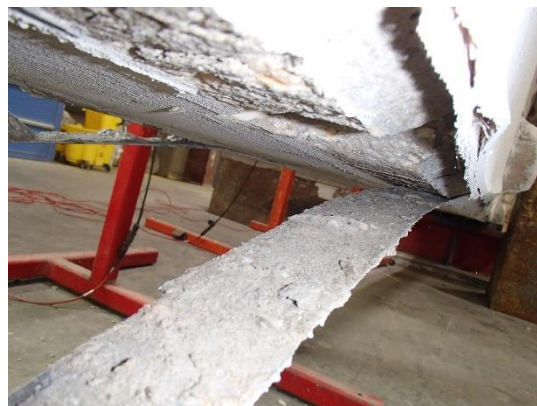
The cross-section of Girder 4-1 was slightly asymmetric. During testing of the CFRP strips, the strain gage readings on the CFRP strip on the west half of the girder (FSG3) varied from a few hundred to 1000 microstrain from the readings on the CFRP strip on the east half of the girder (FSG4). The GFRP ruptured first at the ultimate strength (222 kip), which resulted in a decrease in load to 195.7 kip (Figure 176). The CFRP strips debonded shortly after the GFRP ruptured. FSG3 indicated that a strain release occurred at 198 kip, followed by another strain release detected by FSG4 at 194.3 kip, indicated CFRP debonding. CFRP debonding was also detected by FSG3 at a load of 189.1 kip. Following CFRP debonding (Figure 177) and rupture (Figure 178), and GFRP rupture (Figure 179) the beam resisted a residual load of 181 kip. The debonding crack front was visible on the west CFRP strip (Figure 180). Crushing of concrete in the compression zone had also occurred at failure (Figure 181).

Figure 177—Debonded CFRP strips (Girder 4-1)

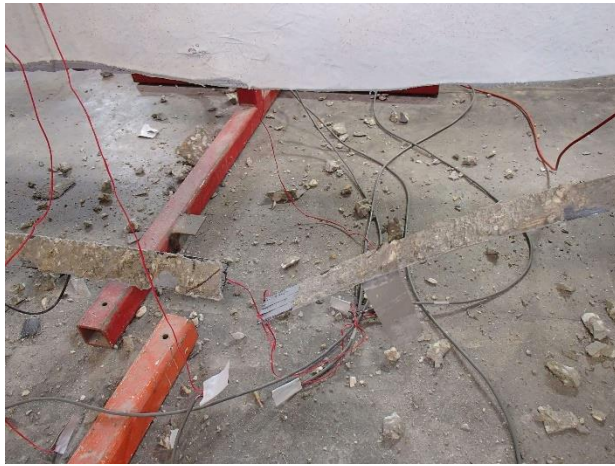
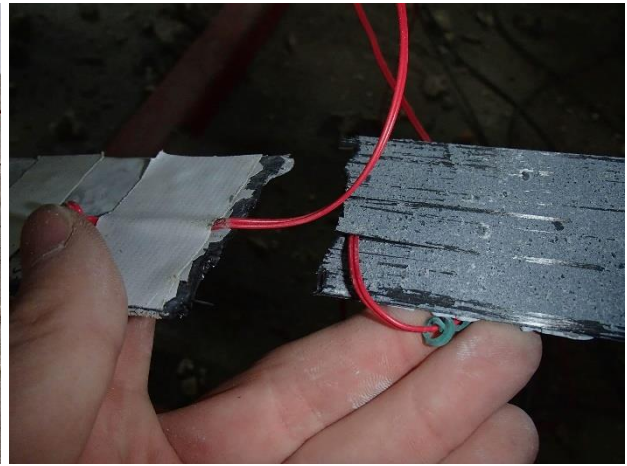
Figure 178—CFRP rupture (Girder 4-1): (a) one strip breaks apart (b) close-up image

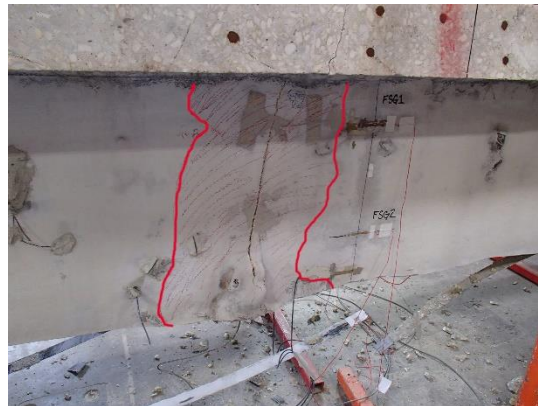
Figure 179—GFRP rupture (Girder 4-1) with debonded GFRP region outlined in red

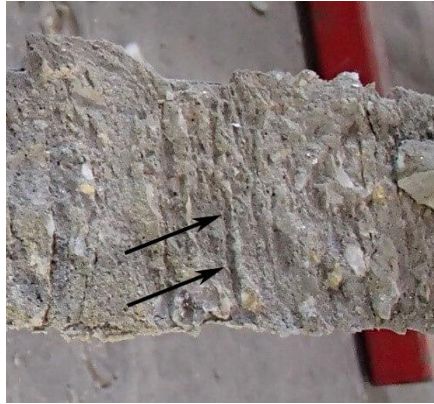
Figure 180—Crack front appearing on concrete substrate of debonded CFRP (Girder 4-1)

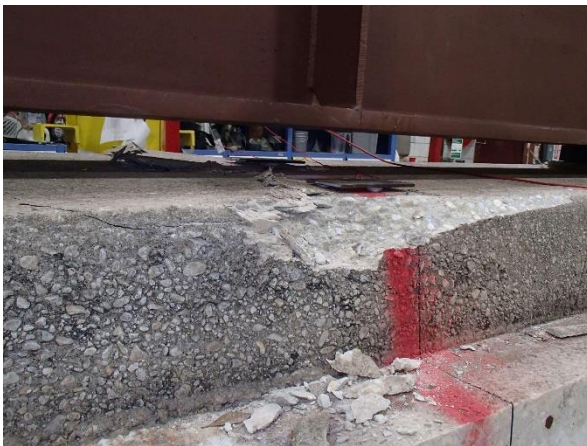
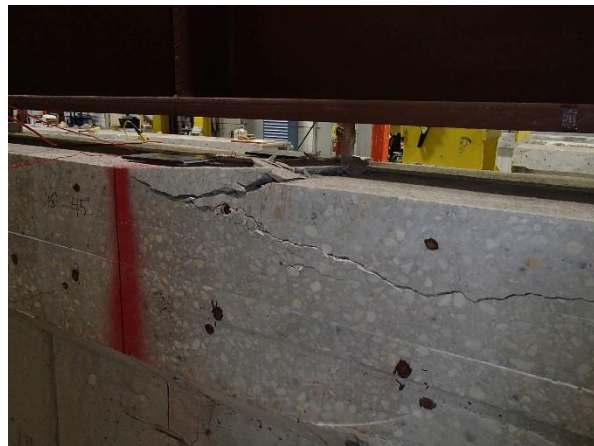
Figure 181—Damage to Girder 4-1 including (a) compression failure on east elevation (b) compression failure on west elevation

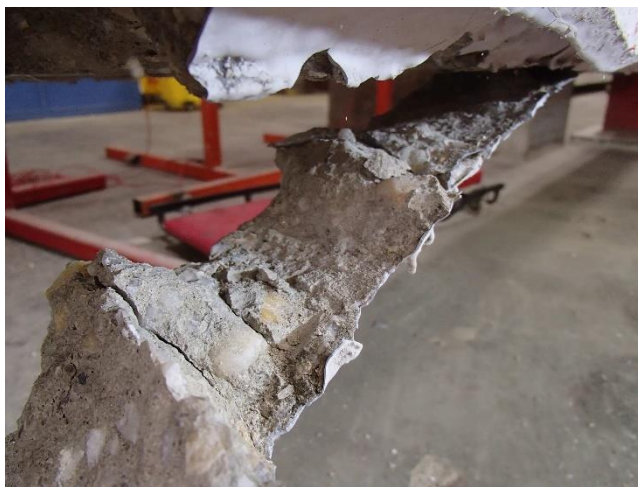
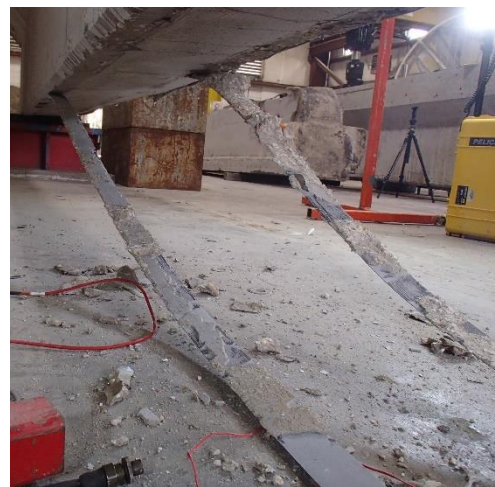
During flexural testing of 4-4, FSG3 indicated approximately 1000 microstrain more than FSG4. This difference in strain grew to approximately 3000 microstrain as the load approached ultimate strength. This difference in strain may be an indicator that lateral deformations were occurring since GFRP was only applied to the west face. GFRP ruptured first at the ultimate strength (226 kip), which resulted in a slight loss in load Figure 182. FSG4 indicated that a strain release occurred at 217.2 kip, followed by another strain release detected by FSG3 at 212.3 kip, then resulting in debonding detected by FSG4 at 210.7 kip, and by FSG3 at 206 kip. The residual strength was 202 kip following FRP rupture and debonding. Both CFRP strips have debonded (Figure 183) and GFRP rupture occurred on the west elevation (Figure 184) as well. Similar to Girder 3-4, cracking formed at a formwork joint on the east elevation (Figure 185). The crack

Figure 183—CFRP strip debonded (Girder 4-4): (a) single strip up close (b) both strips from a distance

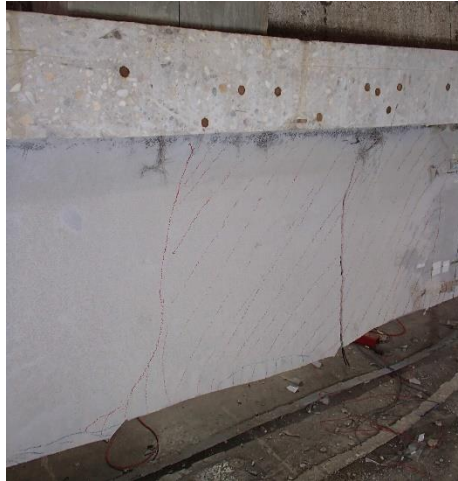
Figure 184—GFRP rupture (Girder 4-4)

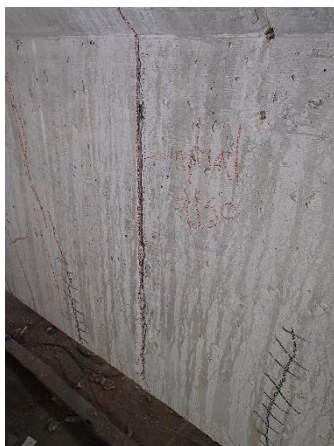
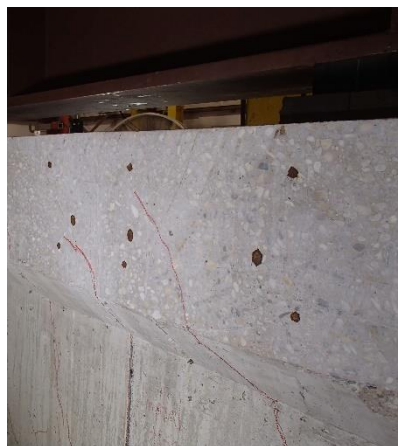
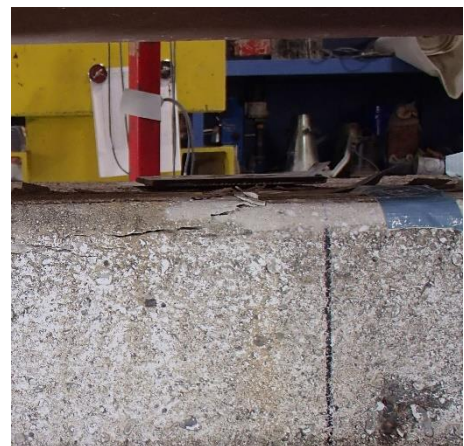
then expanded into the compression zone (Figure 185b). Crushing of concrete in the compression zone in the west elevation also occurred (Figure 185c).

Figure 185—Damage to Girder 4-4 including (a) cracking at formwork joint (b) crack at formwork joint extended to compression zone in east elevation (c) crushing of concrete in west elevation

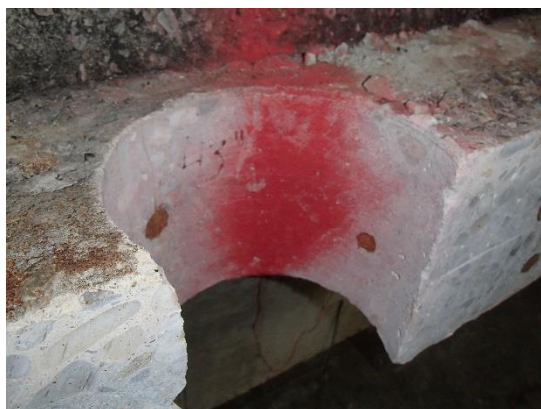
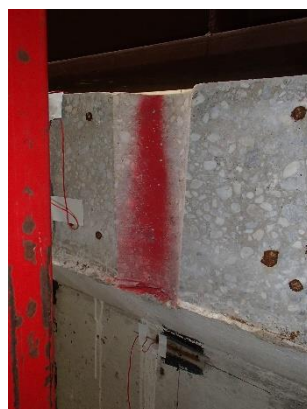
Girder 5-1 had a reduced cross-section at the midspan (Figure 186) with initial cracks located at about 12 in. away from the midspan. The contractors that extracted the girders from the University Boulevard bridge had attempted to ease removing girders 5-1 and 5-2 by coring both sides of the flange, which resulted in a reduced cross-section. During load testing, the service load cycles caused cracks to develop closer to the midspan. At ultimate strength, the girder failed by crushing of concrete in the compression zone (Figure 187). The failure occurred once the beam cracked at a formwork joint on the east elevation (Figure 188), after cracks developed in the compression zone and expanded to the joint.

Figure 186—Reduced cross-section at the midspan (Girder 5-1): (a) west elevation (b) east elevation

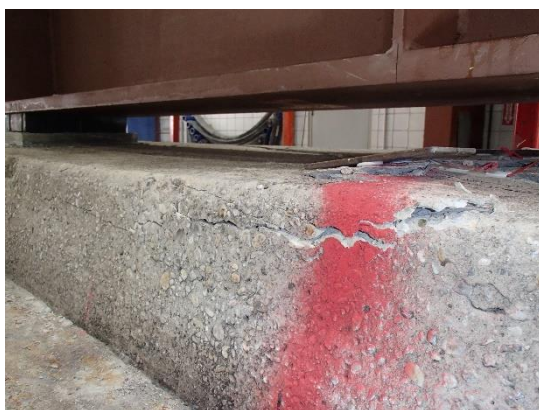
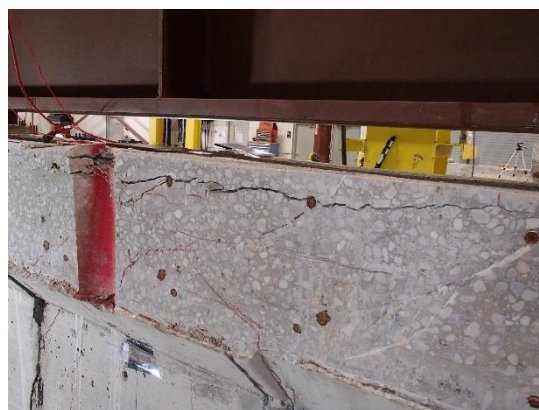
Figure 187—Crushing of concrete in compression zone (Girder 5-1): (a) west elevation (b) east elevation

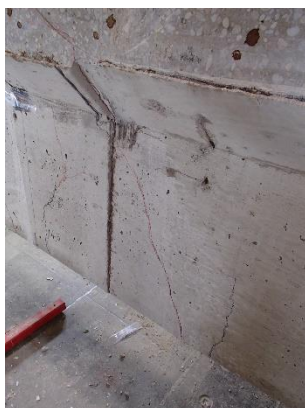
Figure 188—Formwork joint on the east elevation (Girder 5-1)

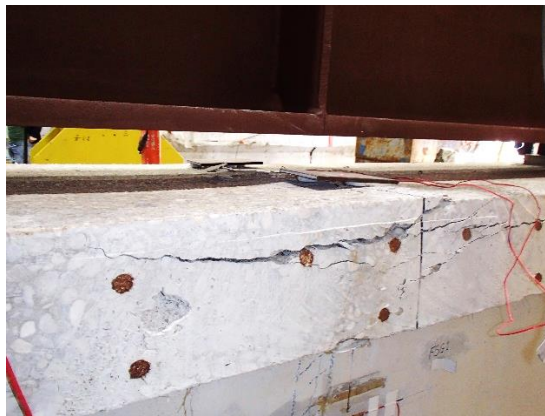
Girder 3-2 had considerable audible GFRP cracking at midspan when the load reached approximately 220 kip. This was likely the result of nearing the yield point, which was at approximately 229 kip. The girder reached ultimate strength when the GFRP ruptured; crushing of concrete in compression was observed as well (Figure 190). Debonding of CFRP closest to the east face occurred around midspan. The span of the debonded CFRP strip is indicated by red arrows (Figure 191) and the GFRP on the midspan of the east face has blue hatching to indicate the debonded region around the GFRP rupture (Figure 192).

Figure 190—Crushing of concrete in compression (east elevation view of Girder 3-2)

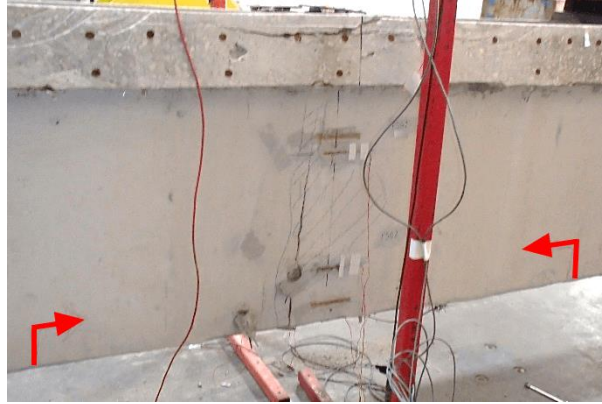
Figure 191—Red arrows indicate the span of debonded CFRP strip (Girder 3-2)

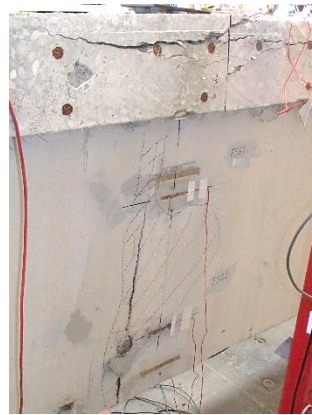
Figure 192—GFRP rupture and GFRP debonding indicated in hatch (Girder 3-2)

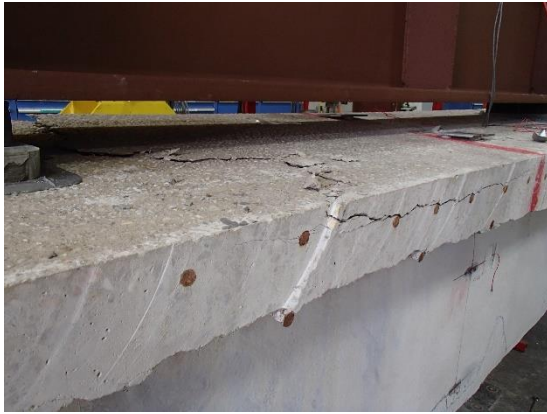
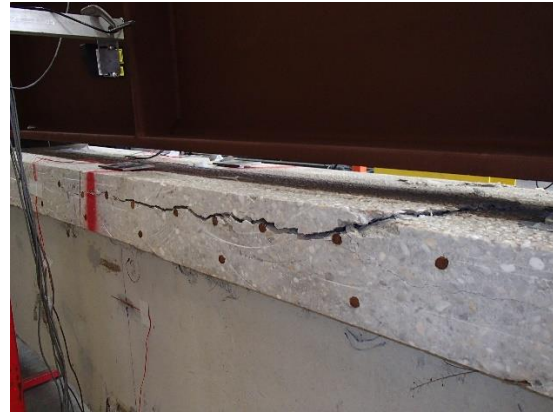
Girder 4-2 had considerable audible GFRP cracking at midspan when the load reached approximately 200 kip, which is approximately 27 kip before a change in stiffness occurred. At ultimate strength, the girder failed by crushing of concrete in compression (Figure 193). Although cracks formed in the web near midspan (Figure 194), they did not seem to expand (Figure 195), or appear to affect the failure mode. Although some debonding occurred at midspan on the west face (Figure 195), the debonding did not result in GFRP rupture.

Figure 193—Crushing of concrete in compression (Girder 4-2): (a) west elevation (b) east elevation

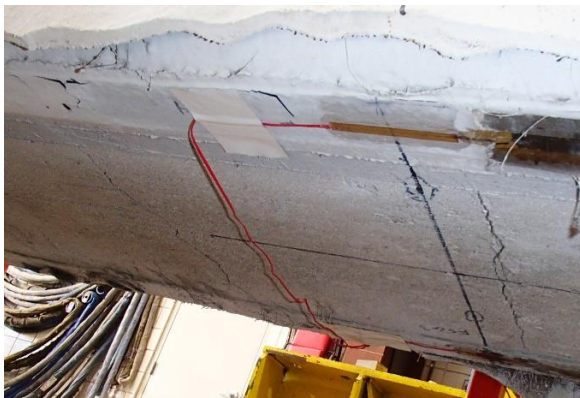
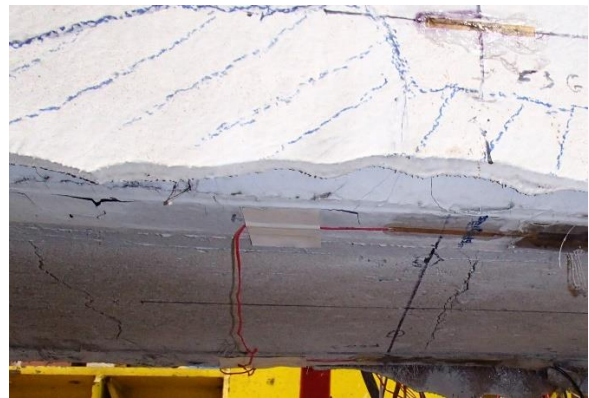
Figure 194—Girder 4-2 cracking on bottom and side (a) at initial and (b) after failure

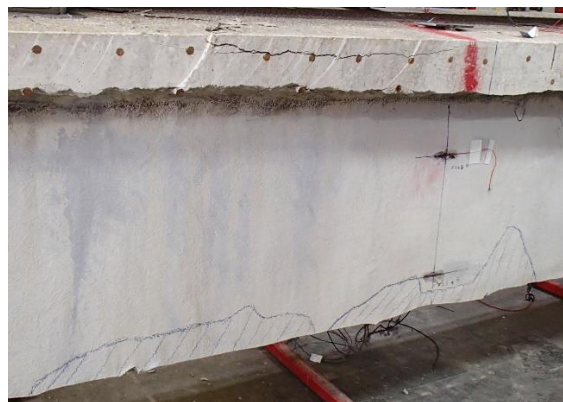
Figure 195—GFRP debonding by midspan on west elevation (Girder 4-2)

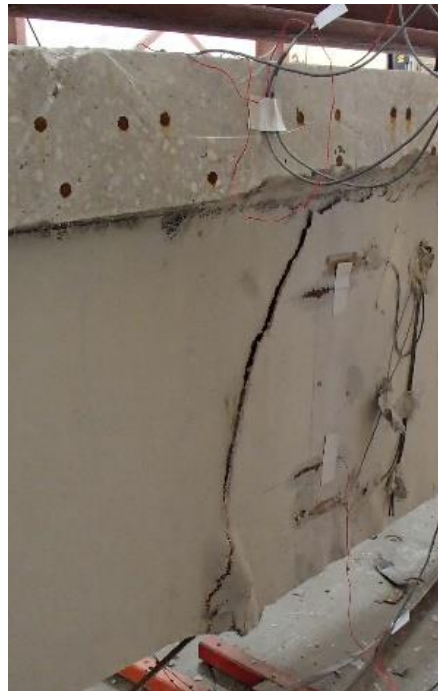
(Figure 196) followed the FRP rupture. GFRP rupture occurred on the east elevation (Figure 197), followed by debonding (Figure 198b) and rupture (Figure 198a) of the CFRP strip on the beam web closest to the east elevation. Longitudinal cracking found on the bottom face of the web may have been due to corrosion (Figure 199).

Figure 197—GFRP rupture on east elevation (Girder 4-3)

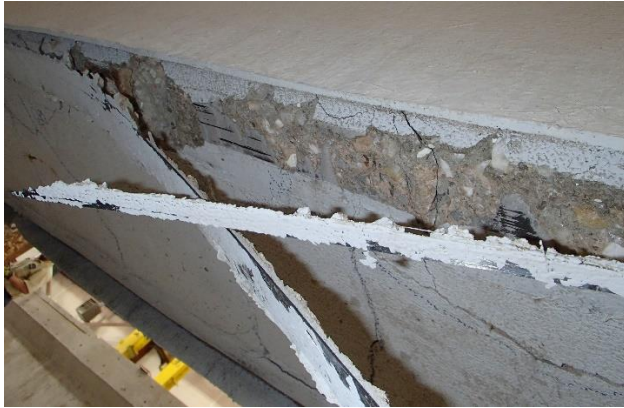
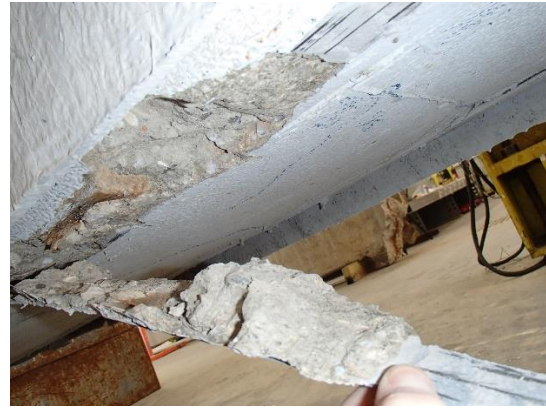
Figure 198—CFRP on east elevation (Girder 4-3): (a) ruptured (b) debonded

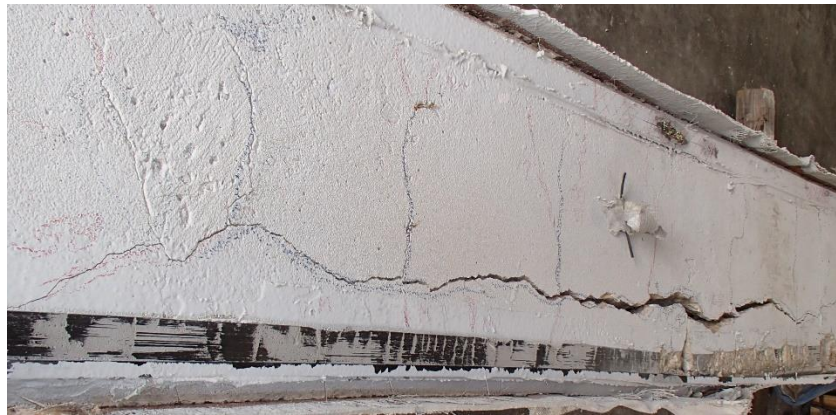
Figure 199—Longitudinal cracking on the tension face of Girder 4-3

1). Girder 4-3 was chosen due to a horizontal crack noticed on the bottom face of the web after failing in flexure.

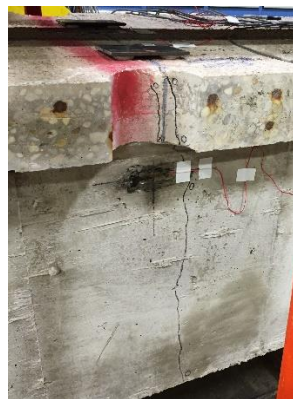
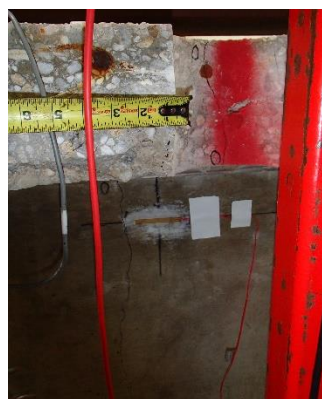
Girder 5-2 had a reduced cross-section at the midspan (Figure 200) with initial cracks on the reduced cross-section and nearby regions. At ultimate strength, the girder failed by crushing of concrete in compression (Figure 201).

Figure 200—Reduced cross-section at midspan (Girder 5-2): (a) west elevation (b) east elevation

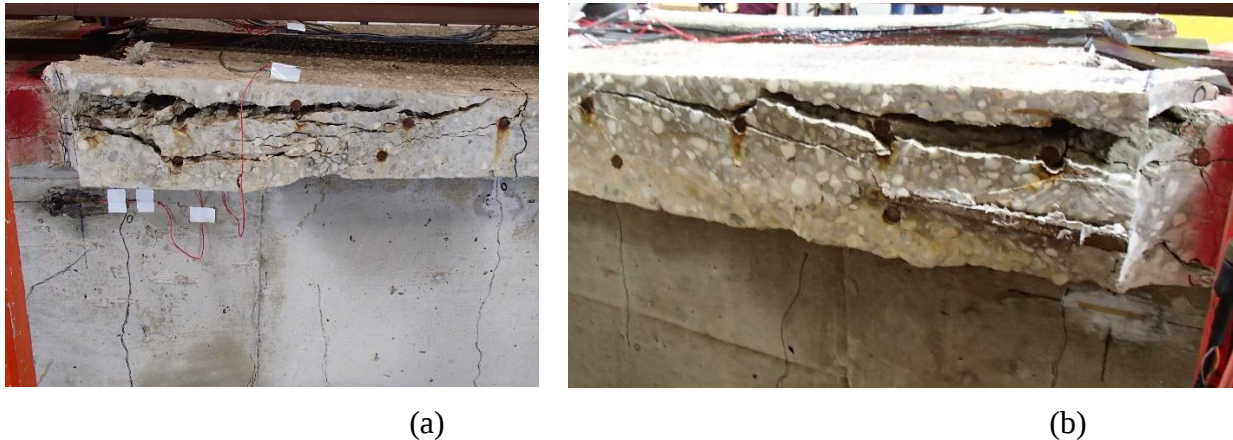
Figure 201—Crushing of concrete (Girder 5-2): (a) west elevation and (b) east elevation

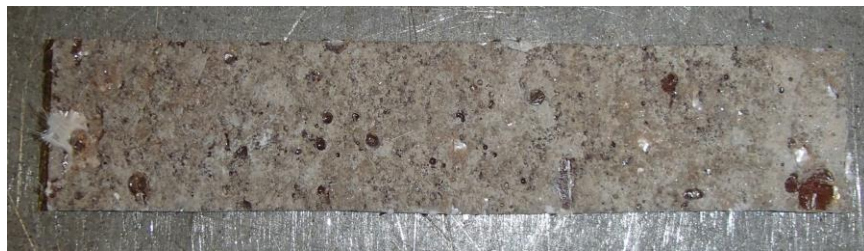
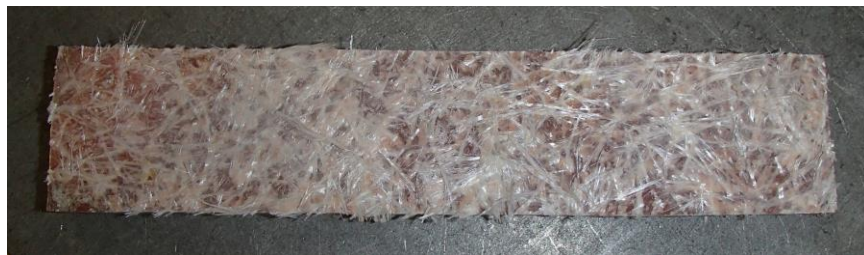
GFRP coupons were saw cut from the east face approximately 3 feet from the south end of four beams, and manually peeled from the concrete surface. In some cases, concrete remained adhered to the surface (Figure 214a) and in other cases the sample came away clean (Figure 214b) Prior to sanding the GFRP samples to uniform dimensions, the surface condition of each sample was characterized as having a light, medium, or heavy concrete concentration. This was done to determine the effect of the residual concrete on the flexural strength of the samples (Figure 215). Although there may be a slight indication of a higher than average flexural strength on the cohesively debonded samples, no firm conclusions can be drawn.

Figure 214—GFRP samples with (a) residual concrete adhered and (b) free of concrete

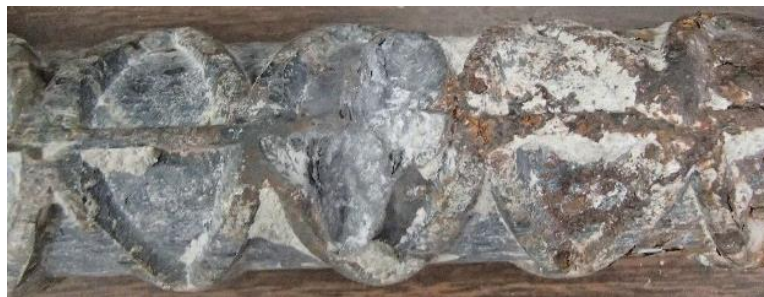
Figure 218—Corroded reinforcement samples from (a) Girder 3-1 and (b) Girder 4-1

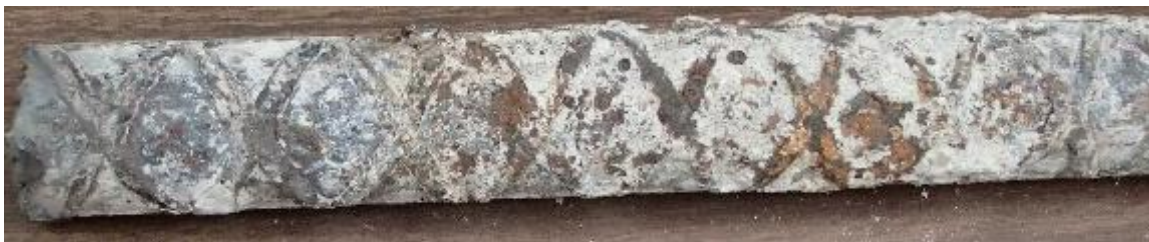
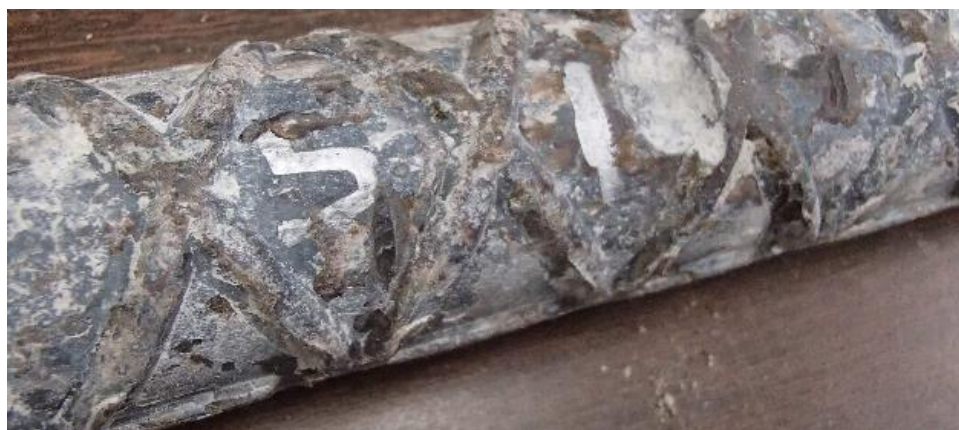
Figure 219—Corroded reinforcement samples from (a) Girder 4-3 and (b) Girder 5-1

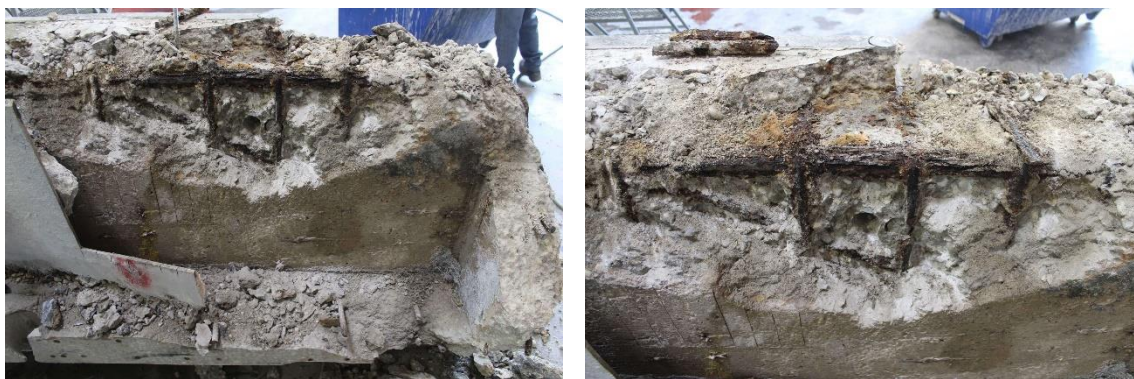
The steel reinforcement at the north end of Girder 3-1 was uncovered due to the swelling and cracking noted there (Figure 220). This location was the most severe, with reinforcement section losses of up to 34% (Table 29). The severe corrosion uncovered at this location had likely occurred prior to FRP application. Furthermore, GFRP was applied to the inside face, but not the outside face of Girder 3-1. Consequently, it is not possible to determine if the corrosion was deterred by the presence of the FRP.

Figure 220—Corroded steel reinforcement in the north end of Girder 3-1

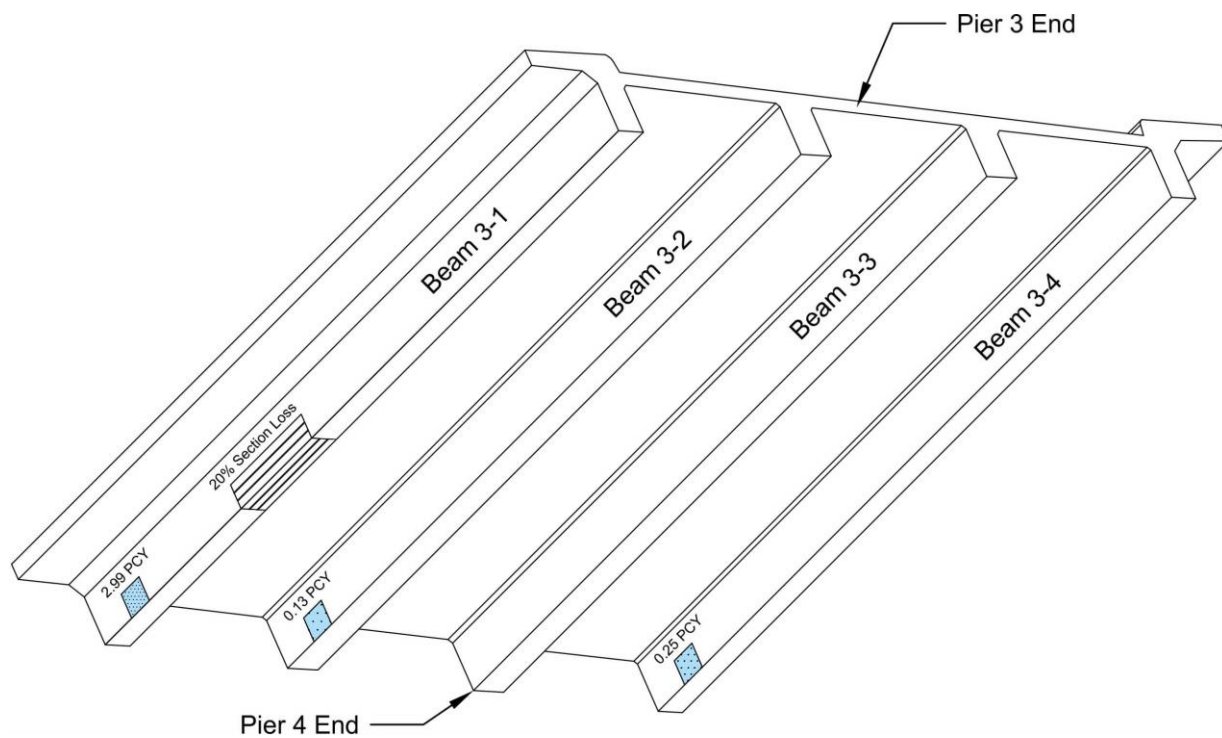
Steel reinforcement section loss was higher in Span 3 than the other two spans, which was expected since Span 3 was the lowest elevation and was inundated during high tide (Figure 222). Span 4 had more section loss on the exterior girder (Girder 4-1) than the interior girder (Girder 4-3). It is not clear why the  $\text{Cl}^-$  concentration does not relate to the levels of section loss due to corrosion

Figure 223—Chloride ion contamination levels and section loss in steel reinforcement in Span 3

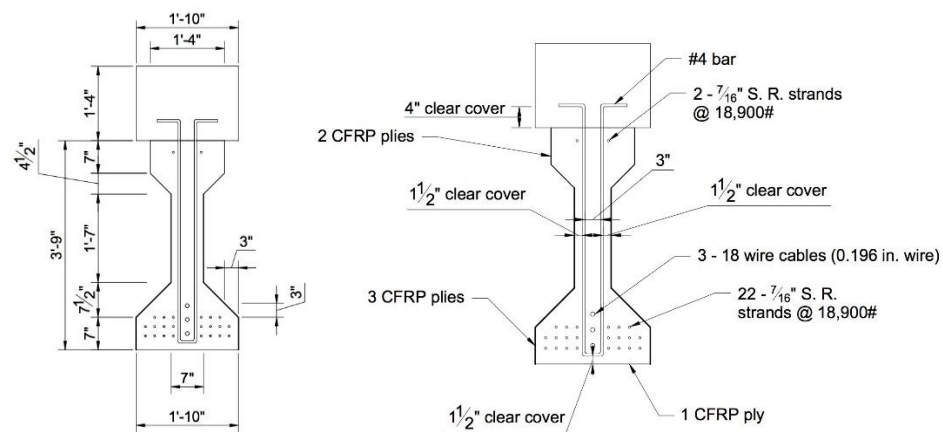
Figure 228—Typical beam section (a) original and (b) with CFRP repair

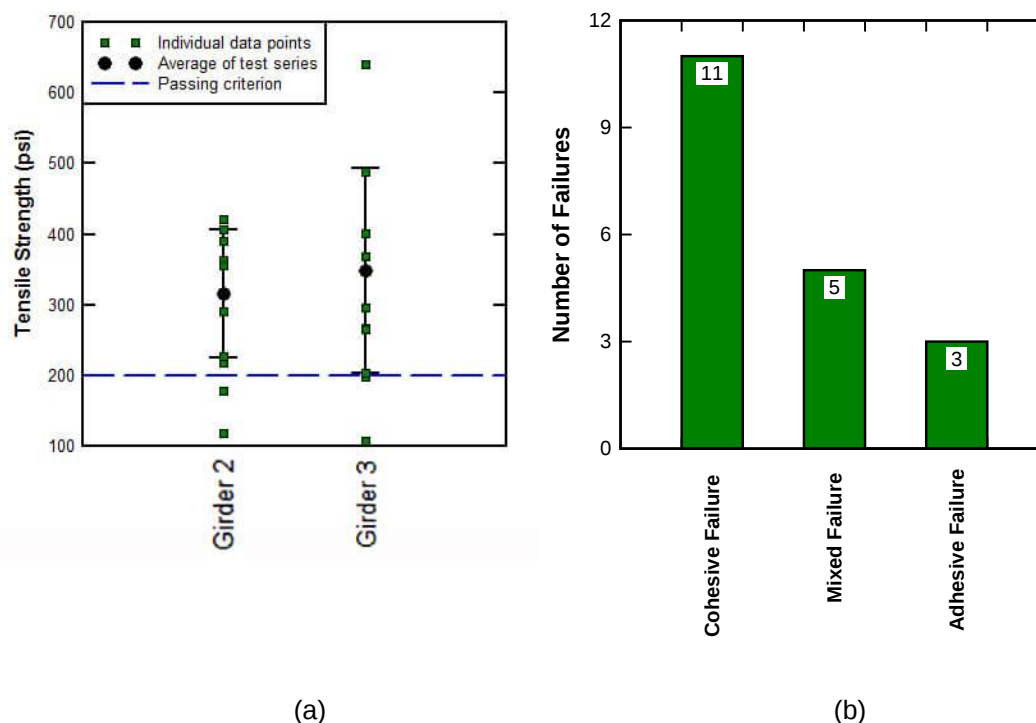
Overall, direct tension pull-off tests between Girder 2 and 3, showed that all of the samples (excluding samples which had failure mode A) met the specified strength of over 200 psi (Figure 237). Over 42% did show an adhesive or mixed failure mode, however, indicating that there may have been some bond degradation.

Figure 237—Direct pull-off testing: (a) tensile strength comparison and (b) failure modes

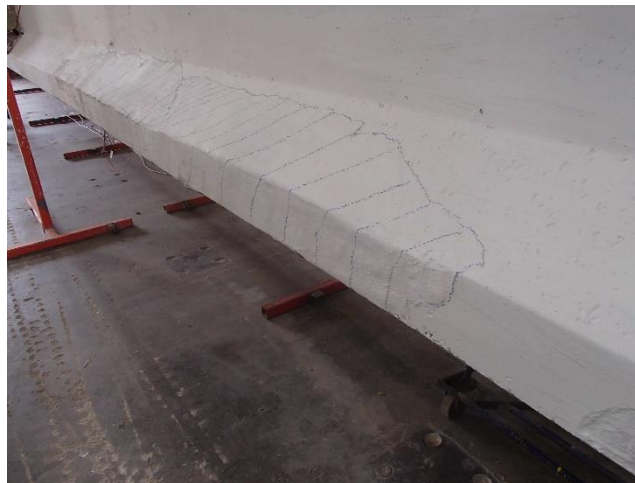
Figure 245—Region of concrete repair indicated in hatched area

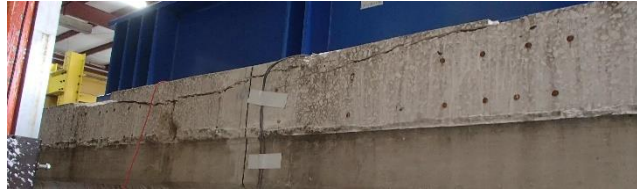
Figure 246—Concrete crushing in compression zone

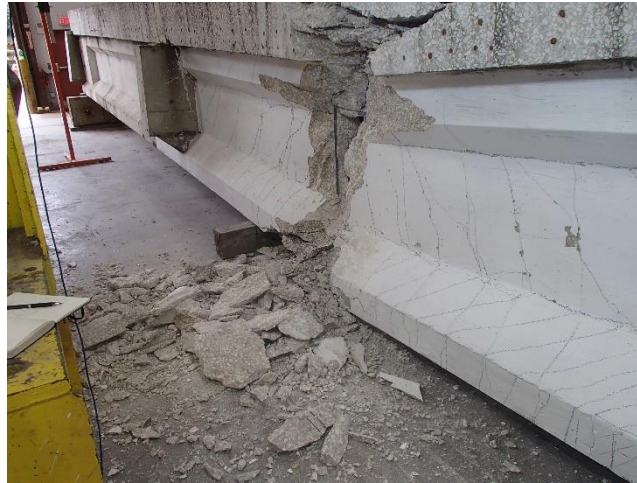
Girder 1 was the easternmost exterior girder over the eastbound lane, and its repair did not include FRP (Figure 245). This was most likely the case because the damage may have not been as severe as Girder 2 and Girder 3. Girder 1 and Girder 2 had identical cross-section geometry. The failure mode only consisted of the concrete crushing in the compression zone (Figure 246), as expected. When loading the girder past its ultimate strength, Girder 1 failed at the end of the repaired region (Figure 247), which may indicate that the repair had a minor effect on the ultimate strength.

Figure 247—Girder 1 failed at the end of the repaired region

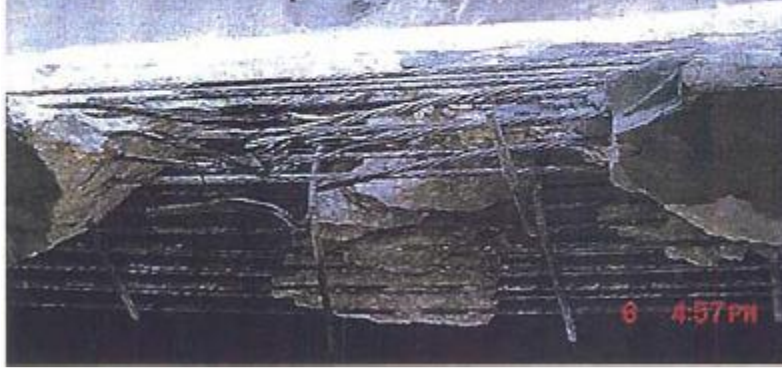
An FDOT inspection report by Cheshire (2001) indicates that Girder 2 (Beam 3-5) had the most severe damage in Span 3, because of four severed strands from an impact (Figure 248). This girder was the easternmost exterior girder over the westbound lane, which is why it had the most severe damage. Girder 2 failed at the center of the repaired region that had only repair mortar without FRP, which was likely due to multiple repairs to multiple impacts (Figure 249). The repair originally had FRP in this location, but it was removed during a more recent impact event and the section was restored without application of FRP; FRP, however, was still on the web. Although Girder 1 and Girder 2 had an identical cross-section (Figure 228), Girder 2 had four severed strands. The location of failure may indicate that the repair had affected the ultimate strength, resulting in Girder 2 having a lower ultimate strength than the other exterior girder. The failure mode consisted of the concrete crushing in the compression zone (Figure 250), instead of FRP rupture prior to a concrete crushing failure mode. This may indicate that the FRP was not able to provide as much supplemental reinforcement as intended when designed.

Figure 248—Severed strands on Girder 2 after impact in 2001 (Green et al., 2004)

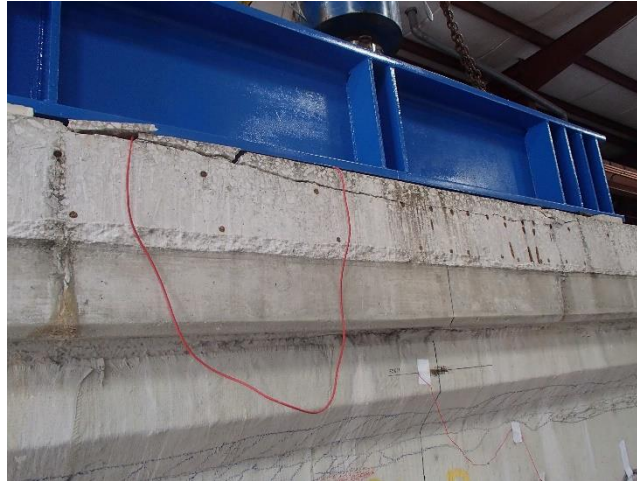
Figure 250—Concrete crushing in the compression zone

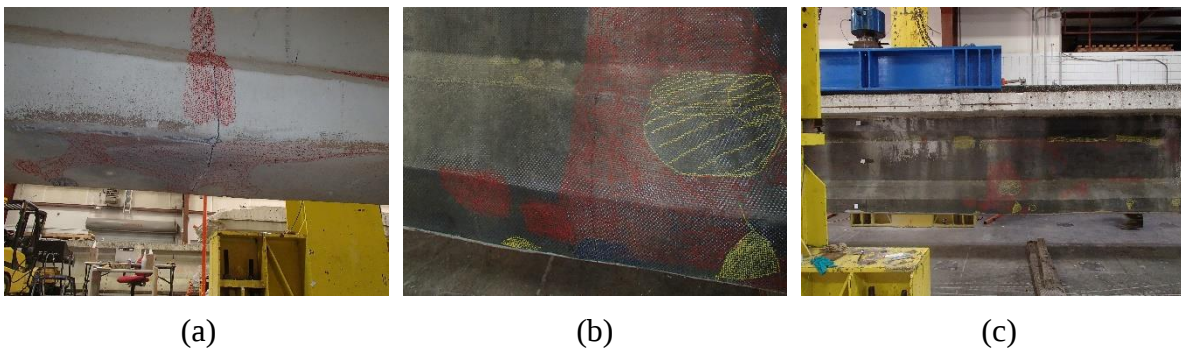
Girder 3 was the westernmost exterior girder over the westbound lane. At failure, the FRP ruptured on the west elevation (Figure 251a) and on the east elevation (Figure 251b), which was in a highly debonded region directly below the north end of the spreader beam bearing pad (Figure 251c). The cross-section for Girder 3 was different from Girder 1 and Girder 2. Additional depth was provided by the deck in Girder 1 and Girder 2, which may explain why Girder 1 had a higher ultimate strength than Girder 3. Although Girder 3 had a number of debonded regions after loading, Girder 2 had larger amounts of debonded regions and the FRP may have not been as effective in increasing the ultimate strength and ductility because of the repaired region without FRP, which included four severed prestressing strands.

Figure 251—FRP damage on Girder 3: (a) close-up of rupture on east face (b) close-up of rupture on west face (c) rupture location on west face

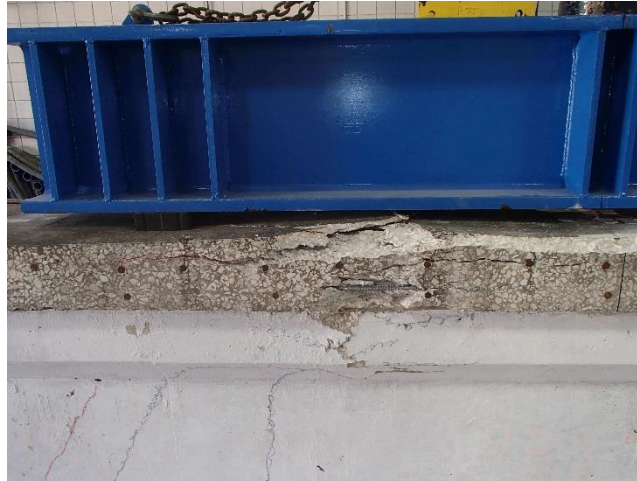
Girder 4 was a westernmost interior girder facing eastbound traffic, which did not have any apparent repairs in the midspan region. This girder had a shallower overall depth than the exterior girders due to the smaller deck thickness than that of the exterior girders. This resulted in the girder having the lowest ultimate strength of the tested girders. The failure mode consisted of the concrete crushing in the compression zone (Figure 252).

Figure 252—Concrete crushing in the compression zone

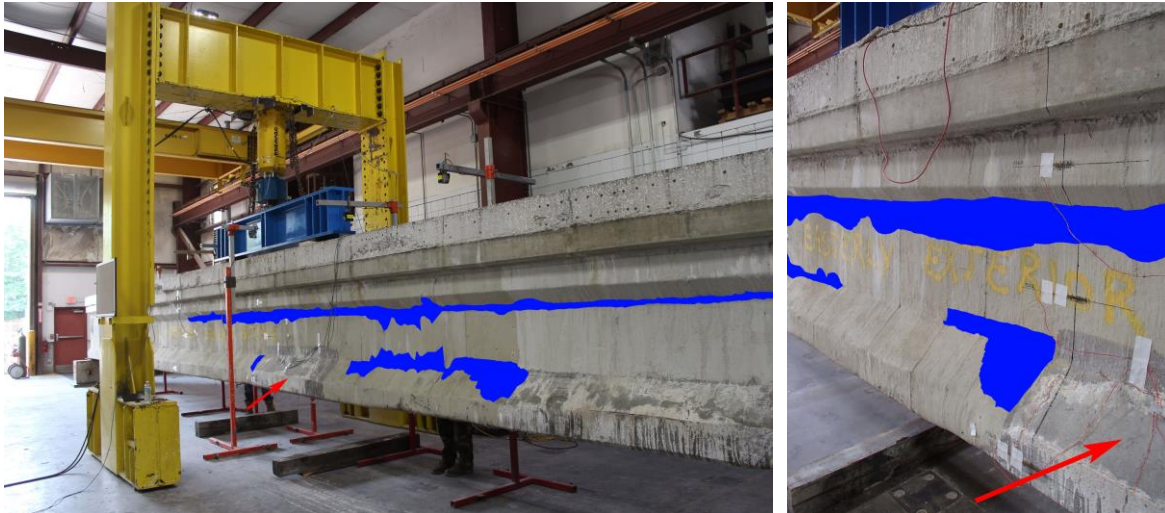
Prior to loading Girder 2 in flexure, debonded regions were identified through coin tap inspection (Figure 257a). Some additional debonding had occurred when loading the girder to 90 kips, primarily in areas within the constant moment region that most likely did not have a critical effect on the ultimate capacity, with the exception of the debonded region near the repair. Figure 257b shows the proximity of the repaired region to the constant moment region. Failure had occurred in this repaired region, which most likely was the cause of failure at a load notably lower than the theoretical ultimate capacity.

Figure 257—FRP debonding on Girder 2; repaired region is identified with a red arrow, and debonding is identified in blue: (a) prior to loading in flexure (b) after loading Girder 2 to 90 kips

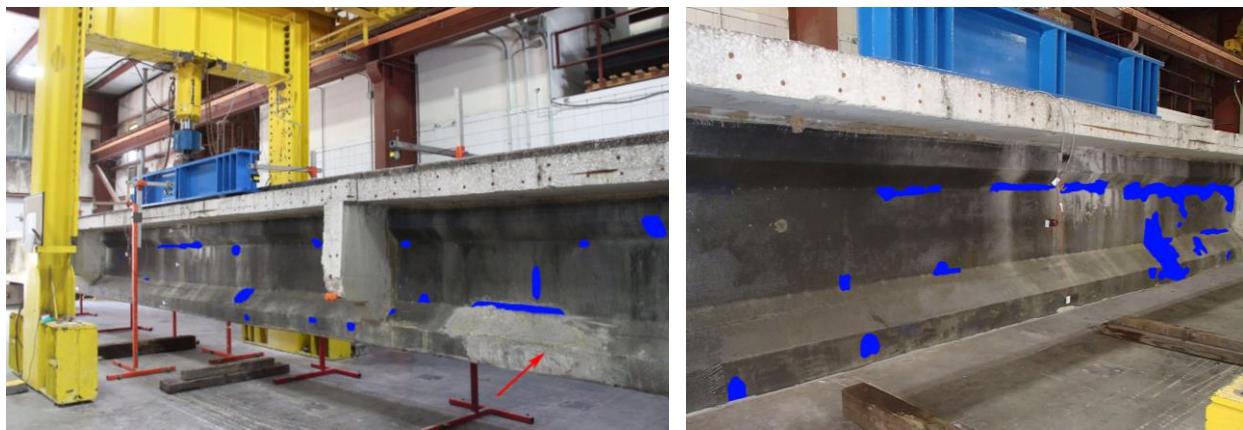
Based on inspection through coin tap prior to testing the girders in flexure, the total debonded area on Girder 3 was less than that of Girder 2 prior to loading (Figure 258a) and after loading the girder to 90 kips in flexure (Figure 258b). Girder 3, however, did not have a repair region within the constant moment region, which most likely was the reason why Girder 3 had a much higher ultimate capacity than Girder 2.

Figure 258—FRP debonding on Girder 3; repaired region is identified with a red arrow, and debonding is identified in blue: (a) prior to loading in flexure (b) after loading Girder 3 to 90 kips

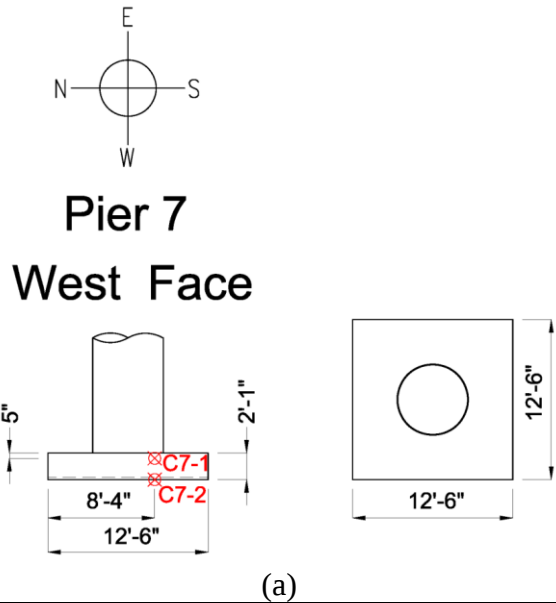
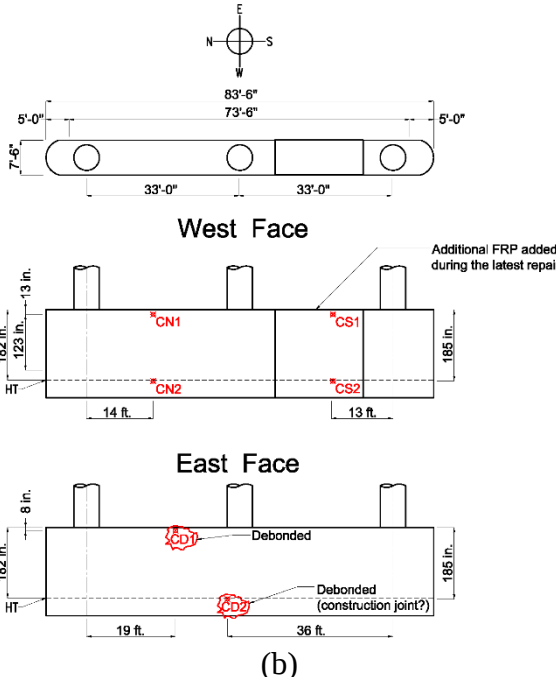
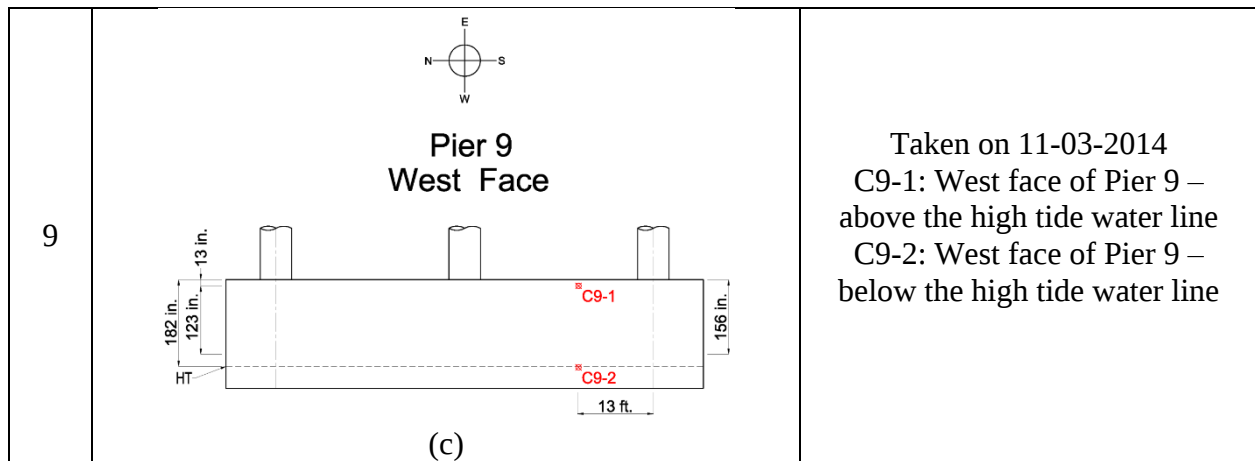
Figure 276—Grenada Bridge coring locations: (a) Pier 7 (b) Pier 8 (c) Pier 9

| Pier | Pier figure | Core Locations |
|---|---|---|
| 7 | <p style="text-align: center;">(a)</p> | <p>Taken on 11-03-2014</p> <p>C7-1: West face of Pier 7 (middle foundation) – above the high tide water line</p> <p>C7-2: West face of Pier 7 (middle foundation) – below the high tide water line</p> |
| 8 | <p style="text-align: center;">(b)</p> | <p>Taken on 11-03-2014</p> <p>CN1: North side of Pier 8 – West face – above the high tide (HT) water line</p> <p>CN2: North side of Pier 8 – West face – below the high tide (HT) water line</p> <p>CS1: South side of Pier 8 – West face – above the high tide (HT) water line</p> <p>CS2: South side of Pier 8 – West face – below the high tide (HT) water line</p> <p>CD1: east face – debanded region – above the high tide (HT) water line</p> <p>CD2: east face – debanded region – below the high tide (HT) water line</p> |

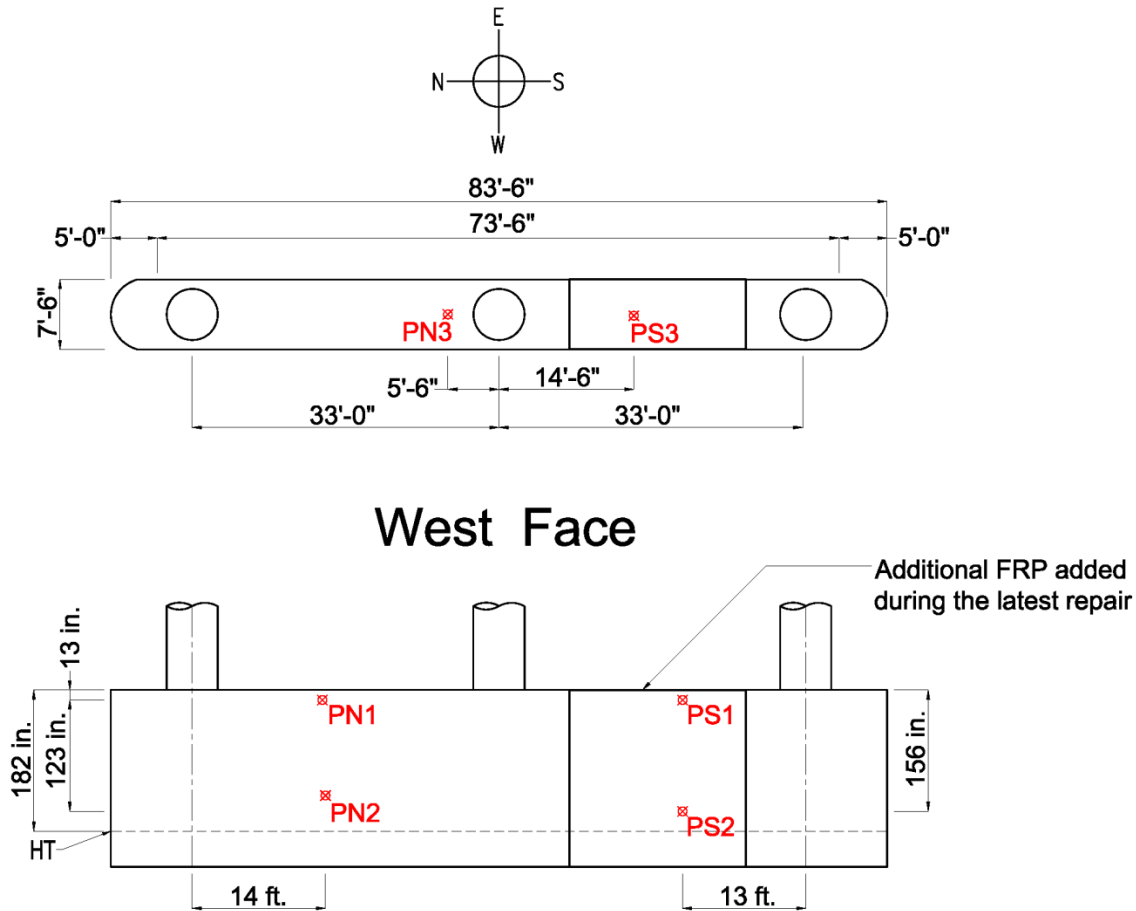
Figure 277—Pull-off test locations on Pier 8

A total of six pull-off tests were performed on Pier 8 crash wall, as per ASTM D7522. Test disks were installed on Monday, November 3<sup>rd</sup> 2014; the testing was performed on Tuesday, November 4<sup>th</sup> 2014. Tests were executed at the following locations:
