Final Report

July 2018

Use of Small Unmanned Aerial Vehicles (sUAV) for Structural Inspection

Florida Department of Transportation (FDOT)
Office of Maintenance
Richard I. Kerr, P.E. – Project Manager

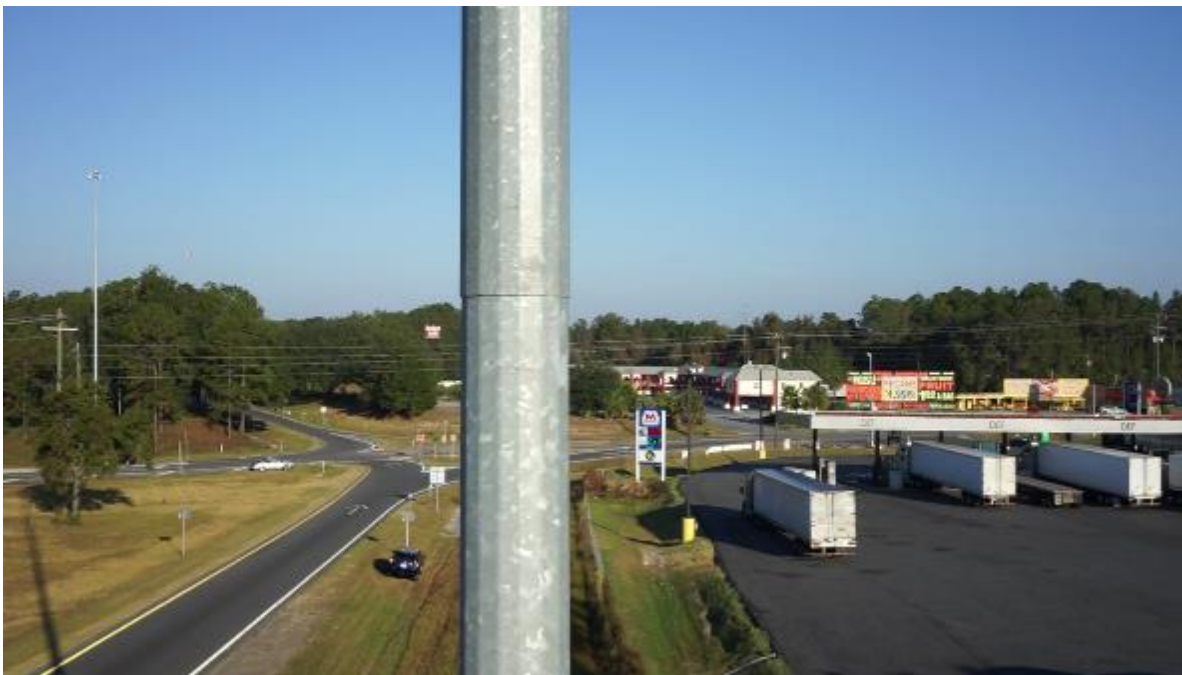
Figure 3-4. View of southeast face of first slip joint of 32P049

During this inspection, the sun was behind the HMLP. The brightness of the background caused portions of the video to be underexposed, so the HMLP was too dark. Later, it was determined that by pointing the camera downward, this effect is reduced. Tear down time was about five minutes. No deficiencies were detected on this HMLP.

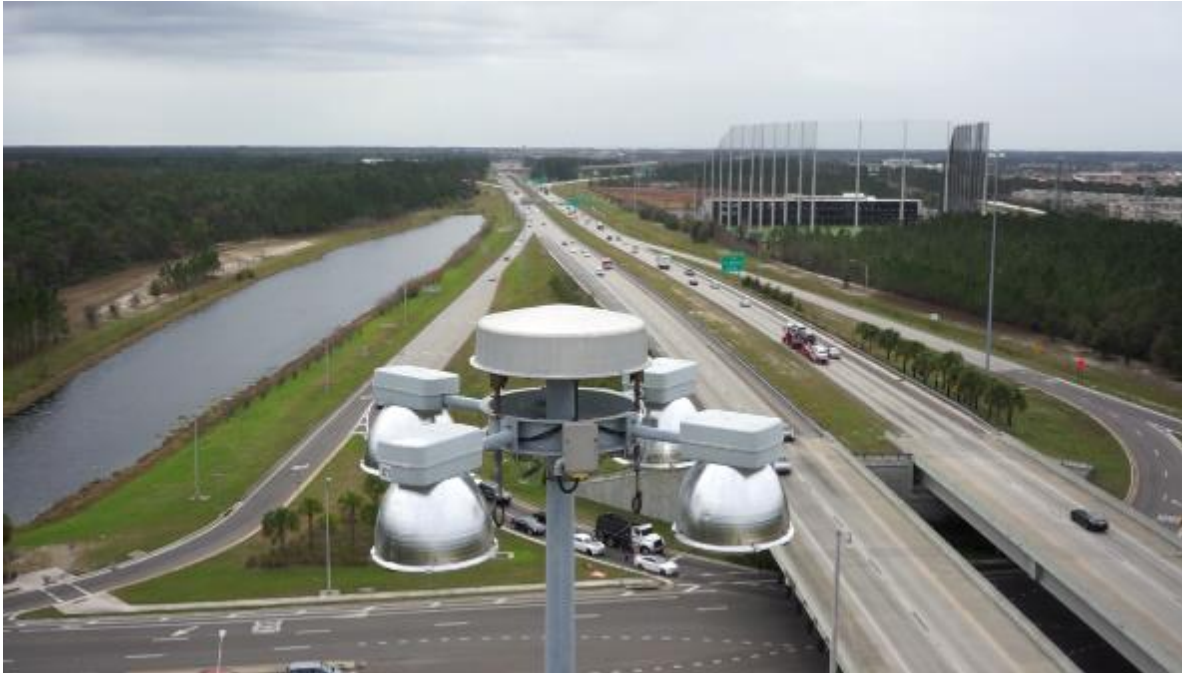
This inspection began at the east face of the pole. The inspection then proceeded according to the method described in Section 2.3.2. The duration of this flight was just over three minutes, and tear down of the ground station took about six minutes. No deficiencies were detected on this HMLP, which is consistent with the inspection report provided by the FDOT. A typical image pulled from the video inspection of this structure is shown in Figure 3-8. This image shows a view of the luminaire from the north.

Figure 3-8. View of luminaire of 72P741 from north

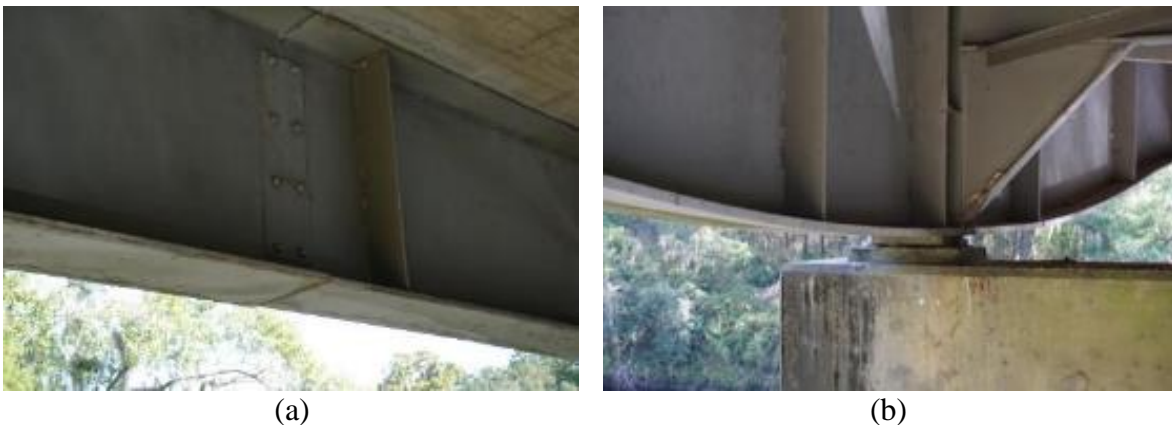
Figure 4-16. Sample images taken during inspection of 320016: (a) splices in the girders, and (b) bearing over Pier Cap 5.

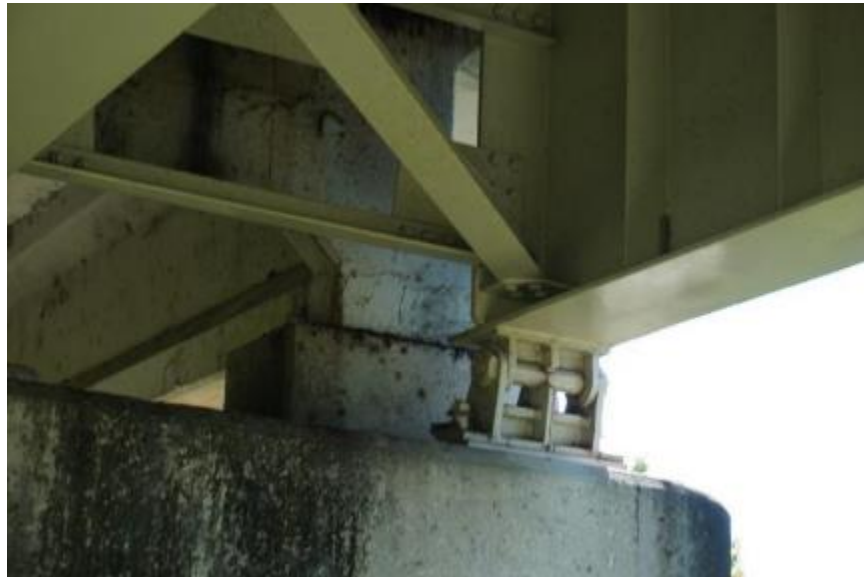
Figure 4-18. Bearing 17-5 over Pier 18

The fourth flight took place underneath steel girder spans. The inspection method used for the steel span was more thorough than the method used for the prestressed concrete spans. The process involved looking at bearings 1 and 2 at the beginning of the span, flying down the bay between Beam 1 and Beam 2 while focusing on connections and diaphragms, looking at bearings 1 and 2 at the end of the span, flying back down the same bay, and then moving to the next bay and repeating. The fifth and final flight was a special inspection of bearing 17-5 over Pier 18, which had nearly reached its maximum range of movement (see Figure 4-18).

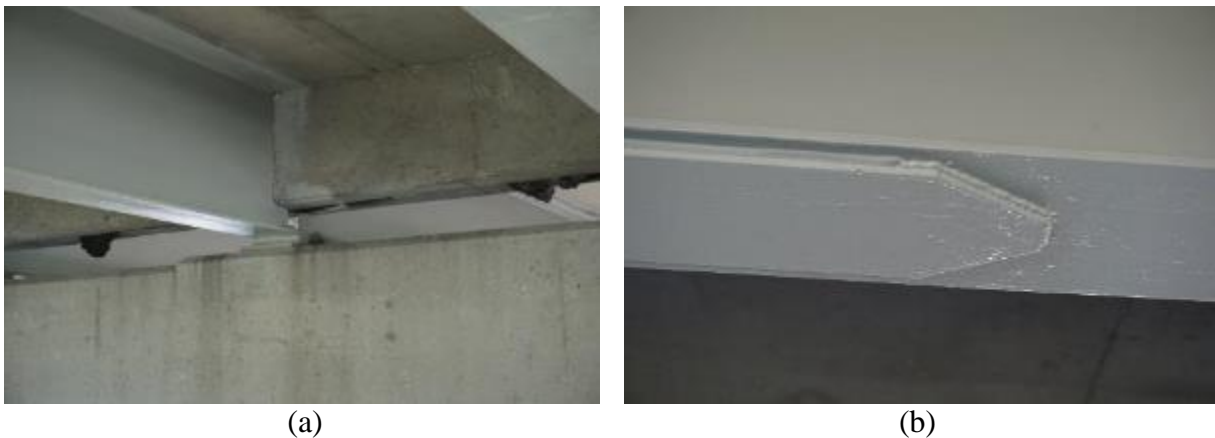
stand-off was set back to 1.5 meters to be safe. The second flight under Span 7 was an inspection of the bearings and beam ends in Span 7 over Bent 7 (see Figure 4-20.a).

The final flight was an inspection of the mid-span diaphragms and the cover plate ends (see Figure 4-20.b) in Span 5. Initially, the sUAV had trouble stabilizing, but its stability improved later on. The sUAV was not flown in the bays next to the exterior beams.

Figure 4-20. Sample images from inspection of 290032: (a) bearings and beam ends in Span 7 over Pier Cap 7, and (b) cover plate end in Span 5.

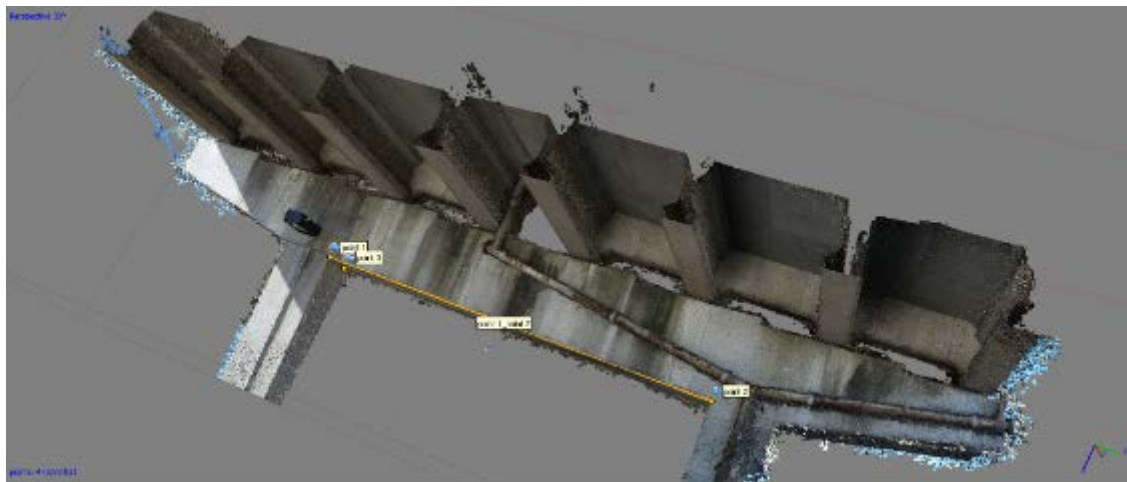
Figure 5-19. Reconstruction of Pier Cap 34 of 720114

Because 3D reconstruction requires significant computational resources, it can take hours to complete for large models. A large scale reconstruction was created from more than 180 images of Pier Cap 34 of 720114. The reconstructed pier cap is shown in Figure 5-19. The file size of this reconstructed Pier Cap is about 0.65 GB, in addition to the 1.06 GB from the photos. A discussion of data storage options is provided in Section 6.1.

Based on these sample reconstructed models, if 3D reconstruction methods are adopted for processing images taken during inspections, it is recommended to create 3D reconstructions of specific deficiencies, rather than large scale 3D reconstructions. Reconstructions of specific deficiencies require fewer images. They can be made with at least three images, but more still images will result in models that are more accurate. Because they require fewer images, they will require less storage than large scale reconstructions, which will be discussed in more detail in Section 6.1. Deficiency reconstructions will also require less time to create than large scale reconstructions. The model of the spall shown in Figure 5-17 and Figure 5-18 took about ten minutes to process on a typical desktop computer. If specific deficiencies are reconstructed, this would align well with recommended practices for sUAV special or damage bridge inspections given in Section 4.9, and models can be directly be compared over time.

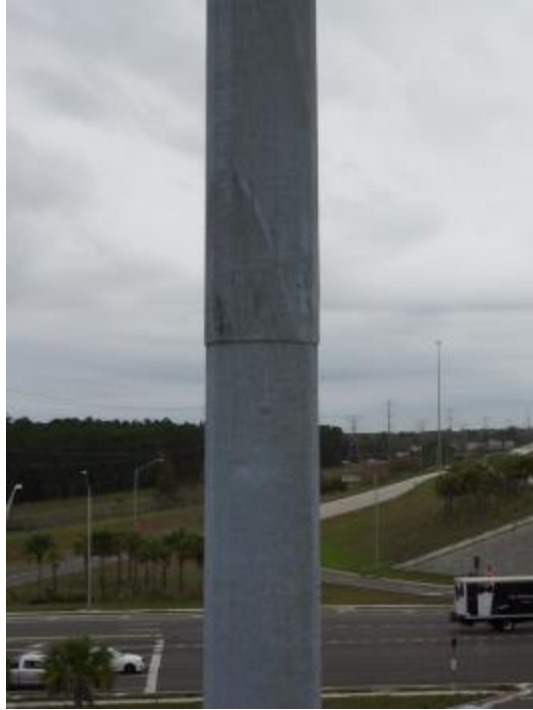
Figure A2-22. 72P740 - View of Lower Slip Joint from South

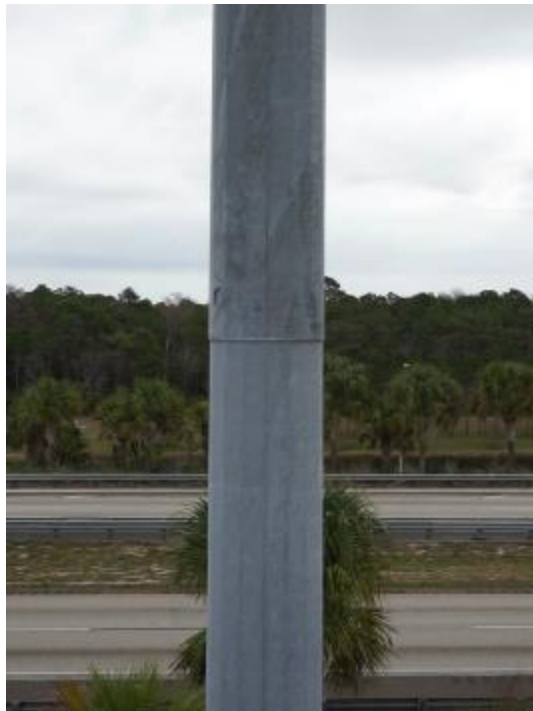
Figure A2-23. 72P740 - View of Lower Slip Joint from West

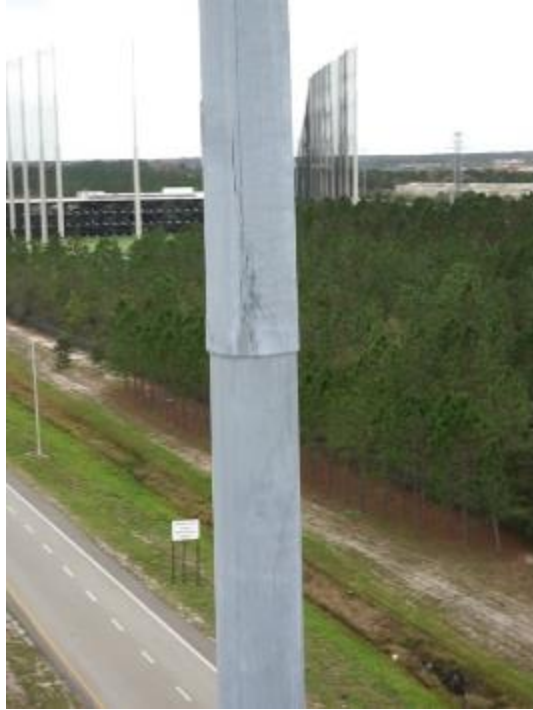
Figure A2-24. 72P740 - View of Second Slip Joint from North

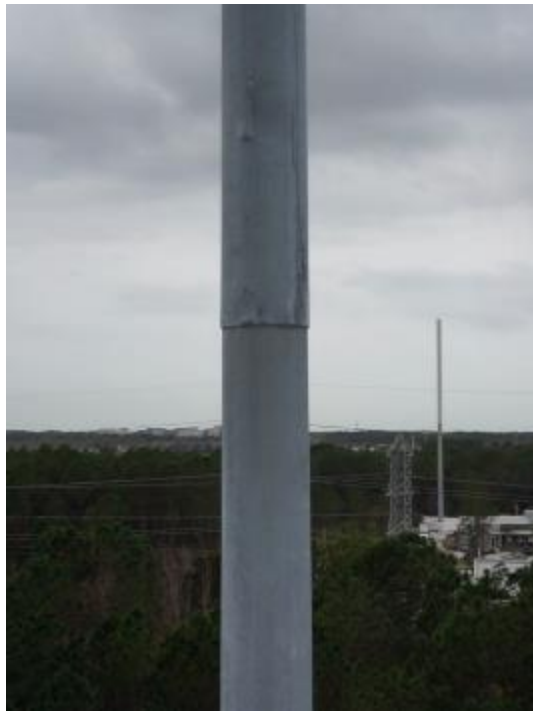
Figure A2-25. 72P740 - View of Second Slip Joint from East

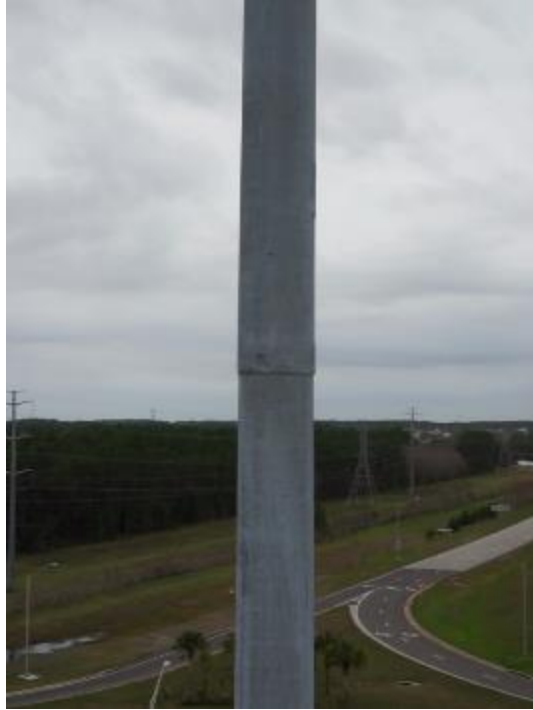
Figure A2-26. 72P740 - View of Second Slip Joint from South

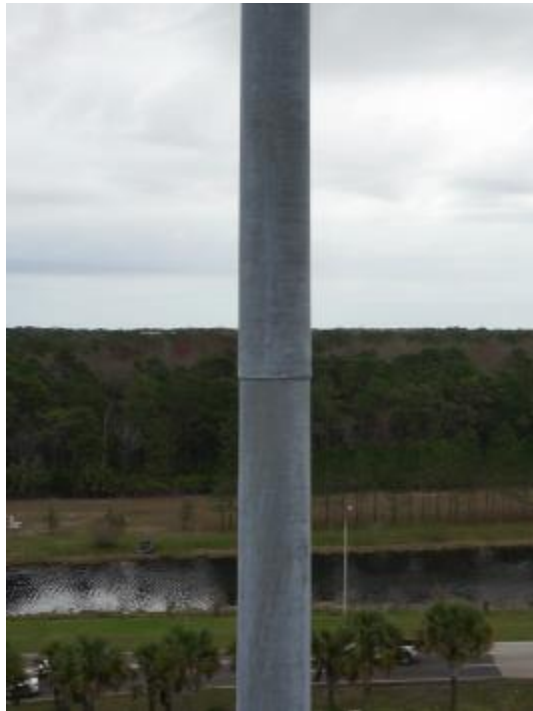
Figure A2-27. 72P740 - View of Second Slip Joint from West

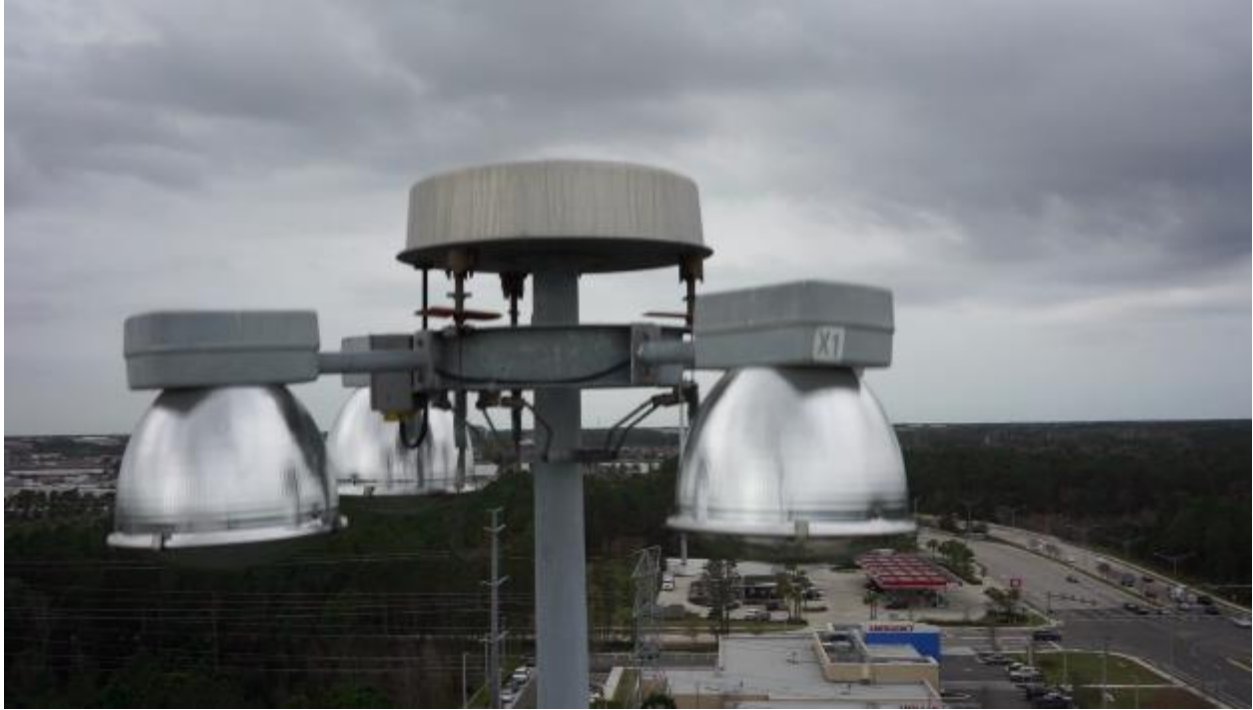
Figure A2-28. 72P740 - View of Lights from East

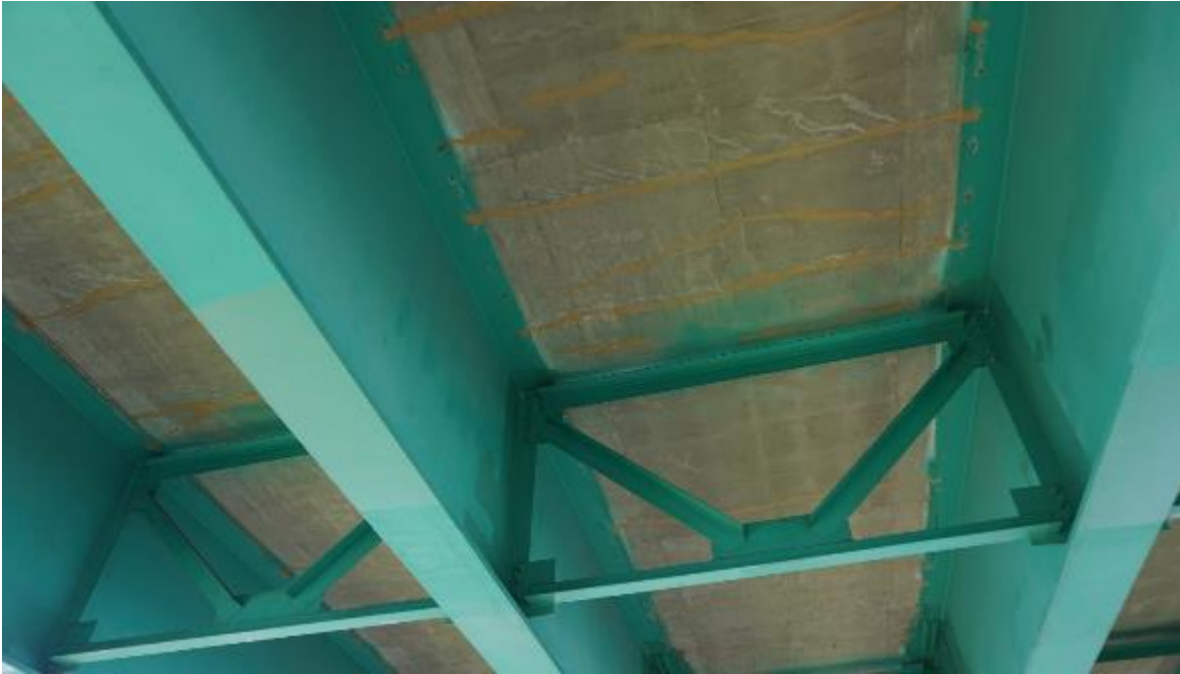
Figure A2-50. 720690 – Typical view of diaphragm between steel girders

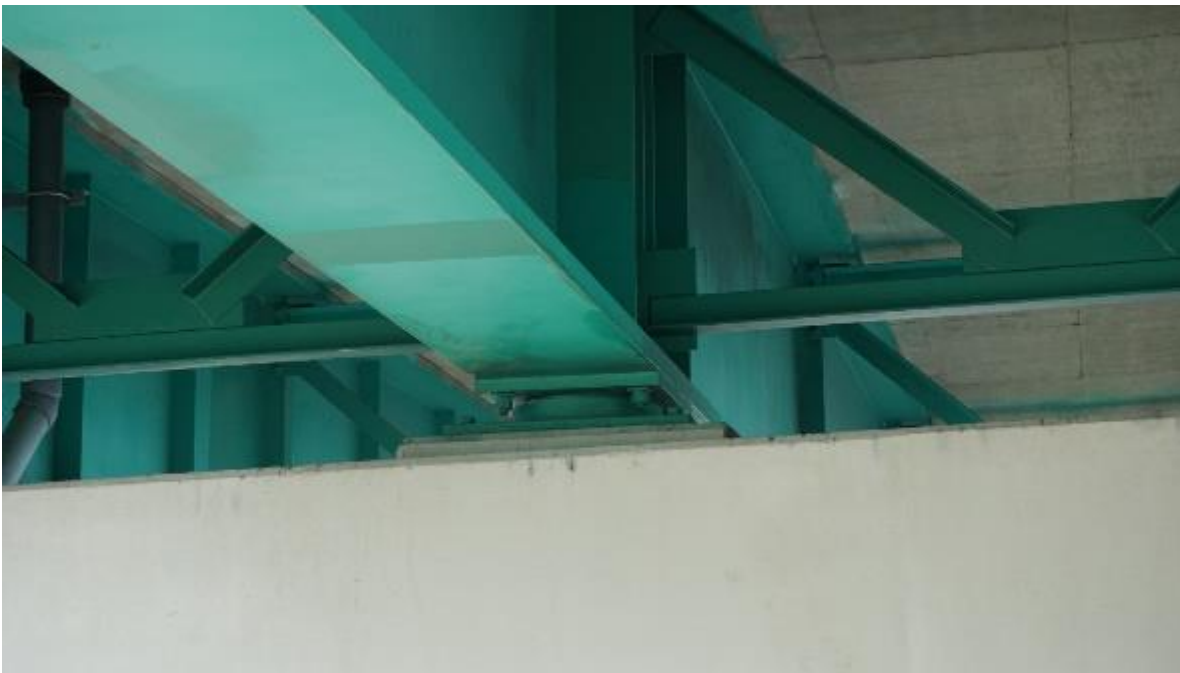
Figure A2-51. 720690 – Typical view of bearing under steel girder

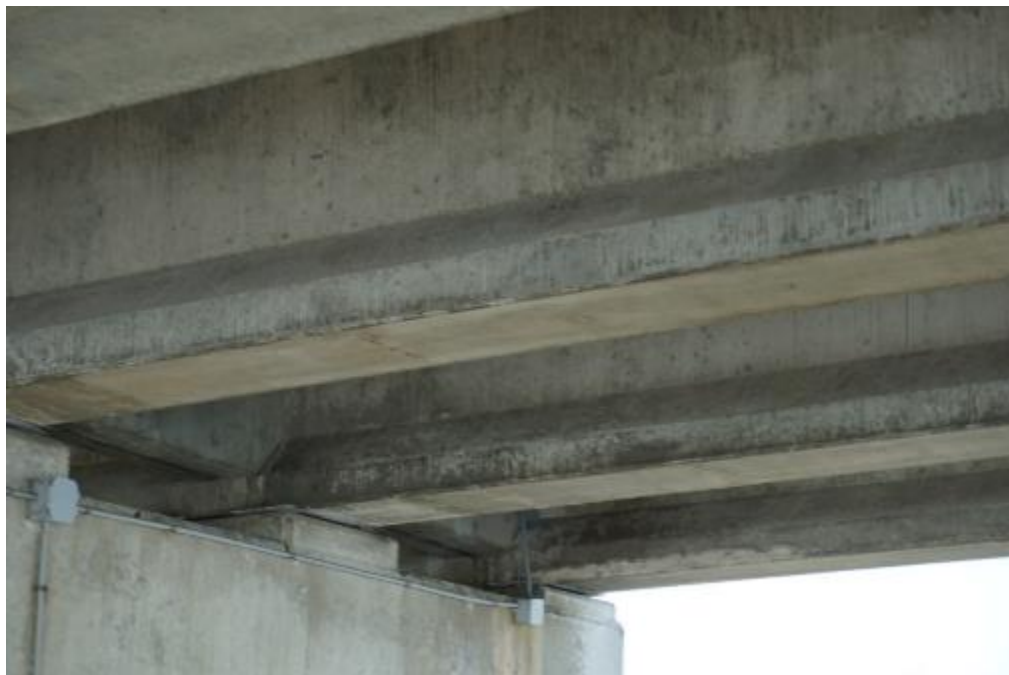
Figure A2-58. 790148 – Typical view of pier cap

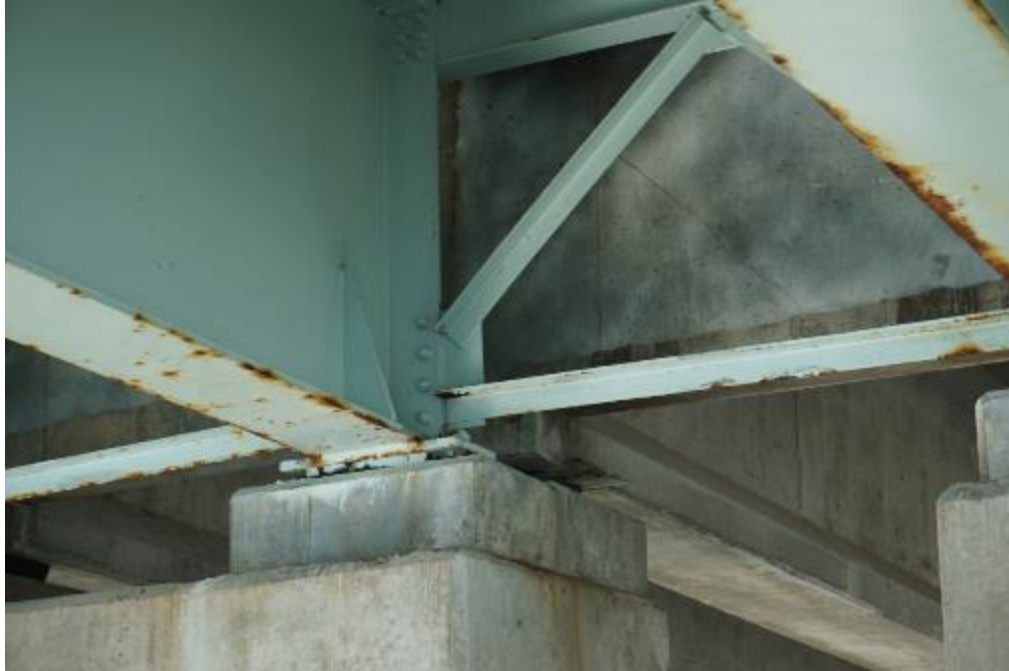
Figure A2-63. 790148 – Typical view of bearing under steel girder

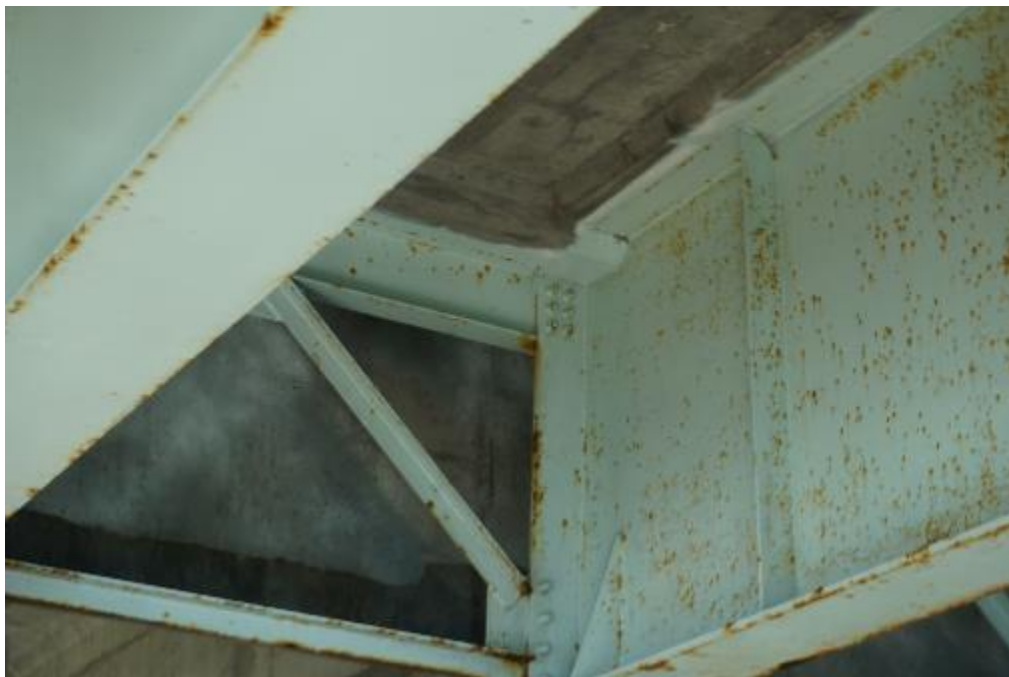
Figure A2-64. 790148 – Typical view of diaphragm connection to steel girder at beam end

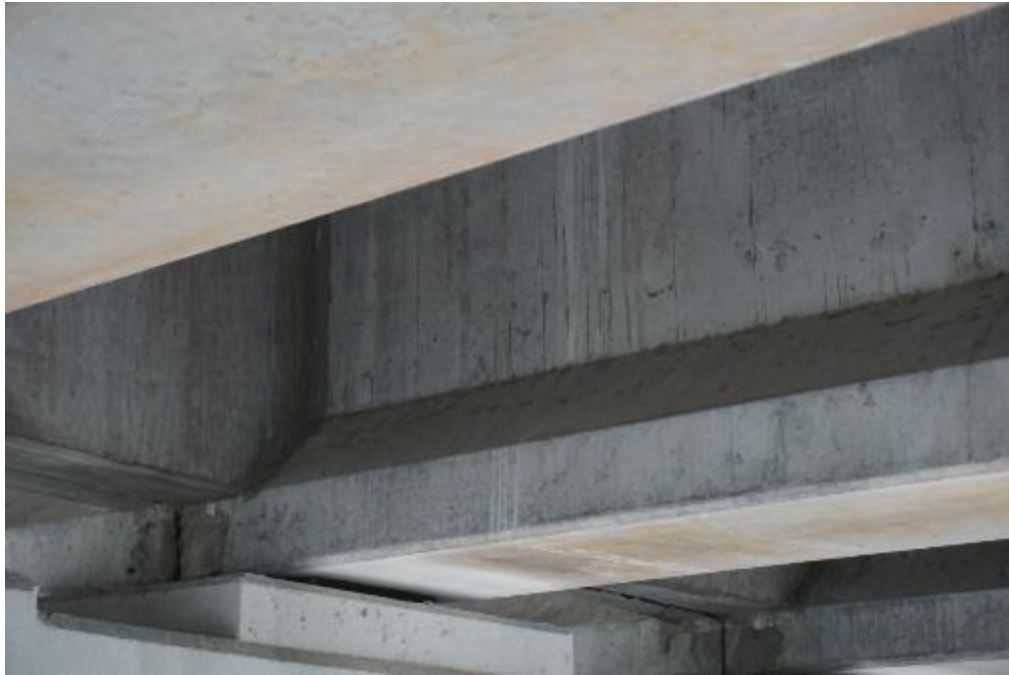
Figure A2-66. 790152 – Typical view of bearing under prestressed concrete girders

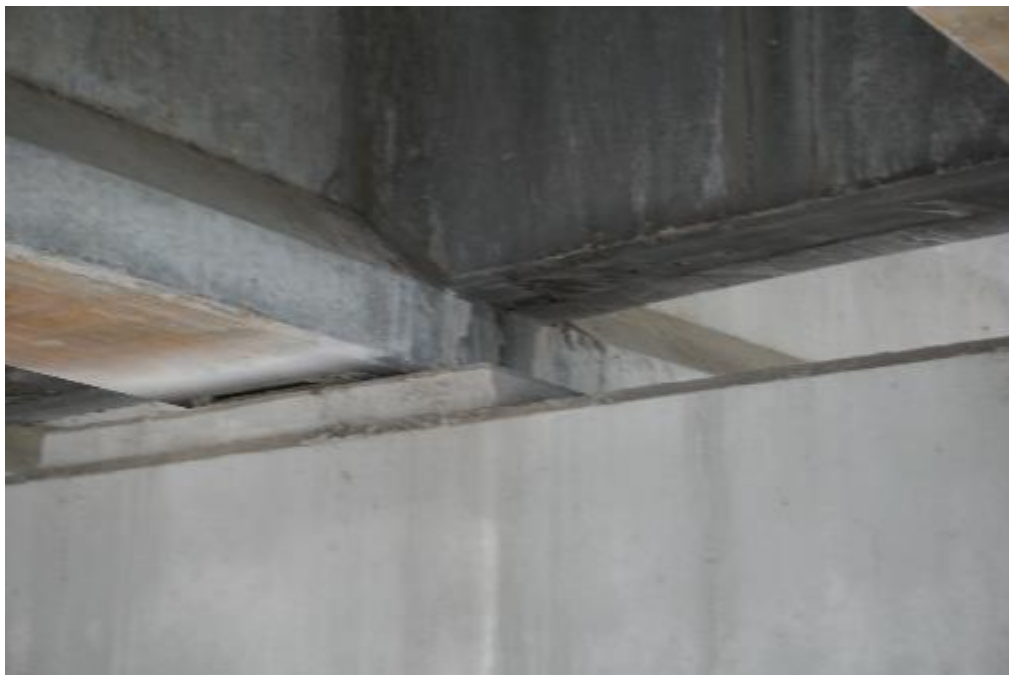
Figure A2-67. 790152 – Typical view of bearing under prestressed concrete girders

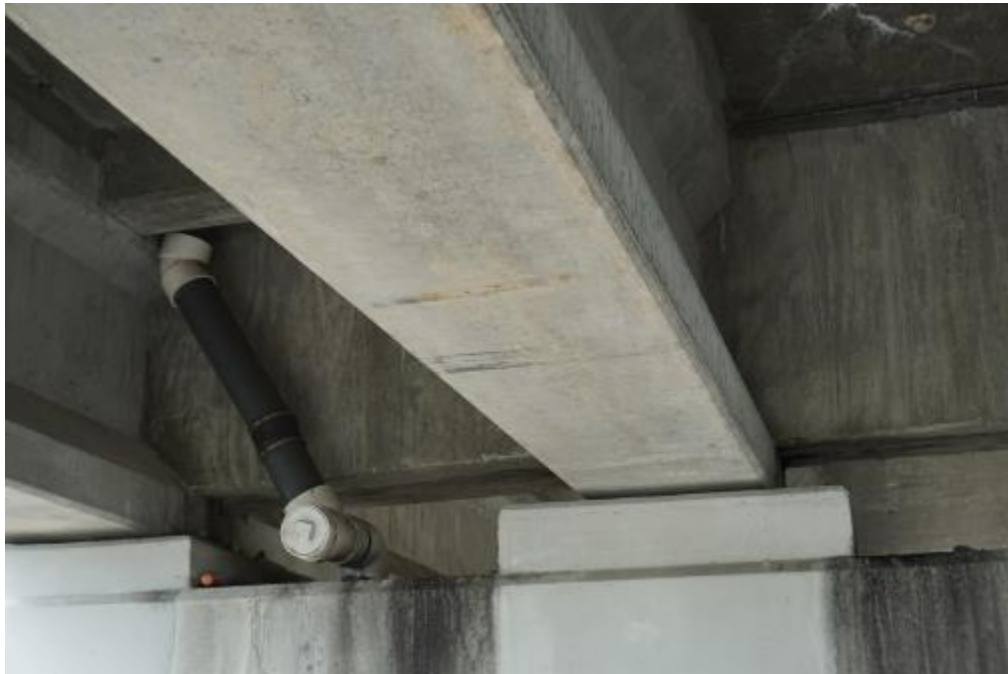
Figure A2-71. 790152 – Typical view of pipe above pier cap

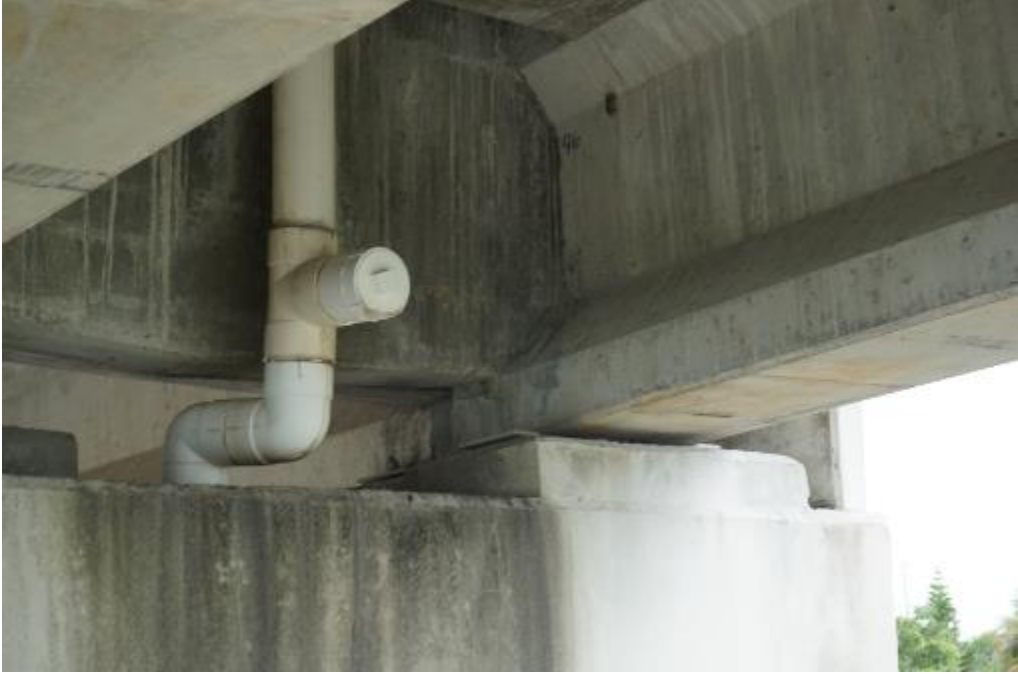
Figure A2-72. 790152 – Typical view of pipe above pier cap

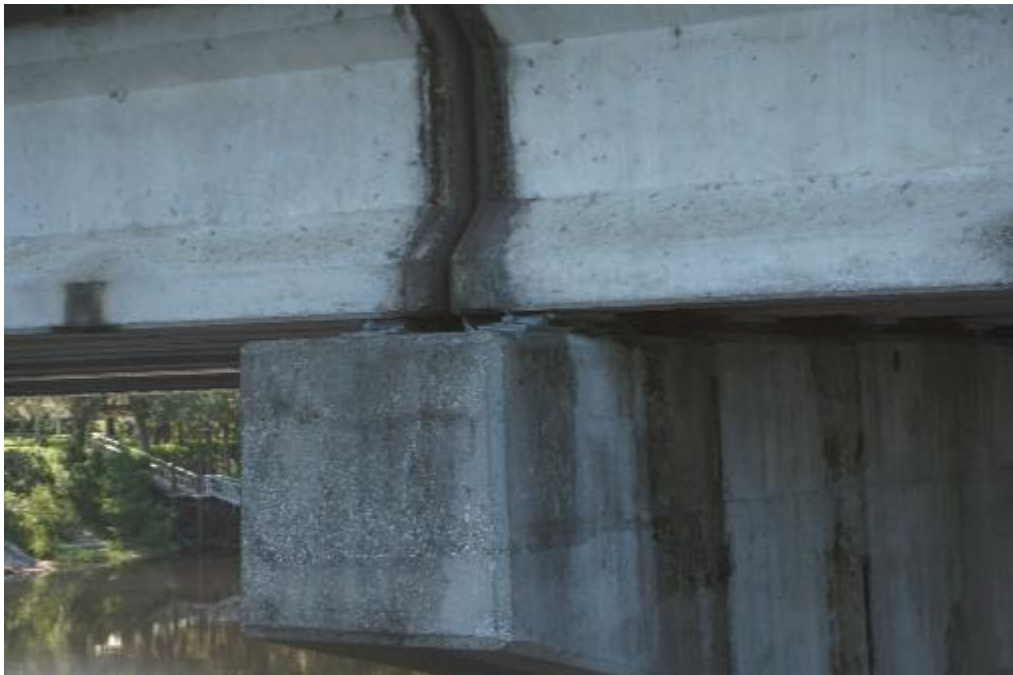
Figure A2-75. 300031 – Typical view of exterior bearings above pier cap

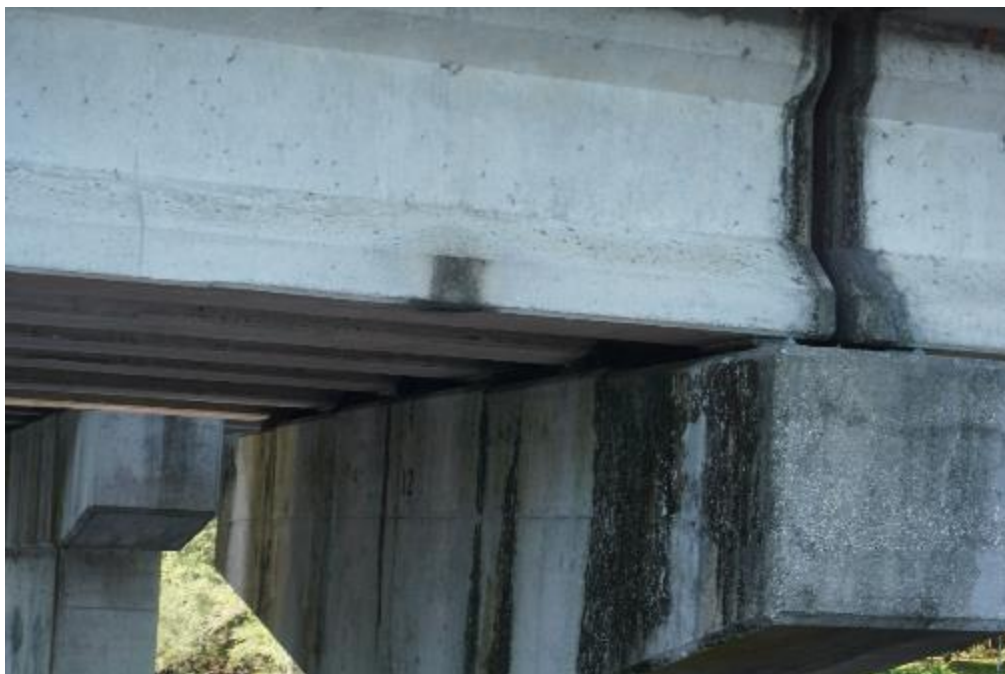
Figure A2-76. 300031 – Typical view of pier cap taken from outside of bridge

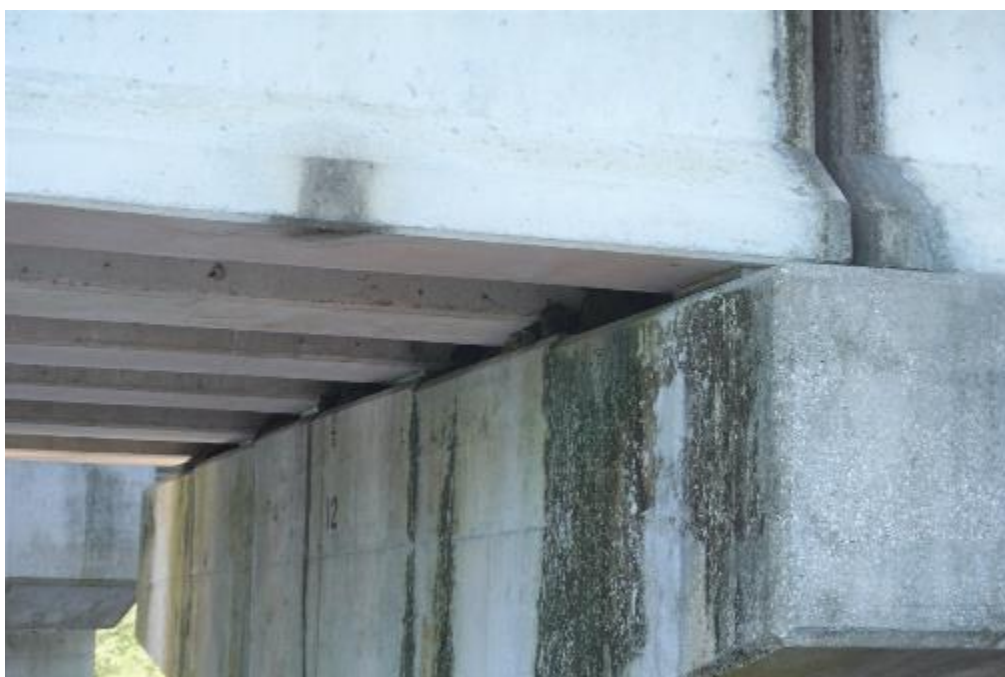
Figure A2-77. 300031 – Typical view of pier cap taken from outside of bridge

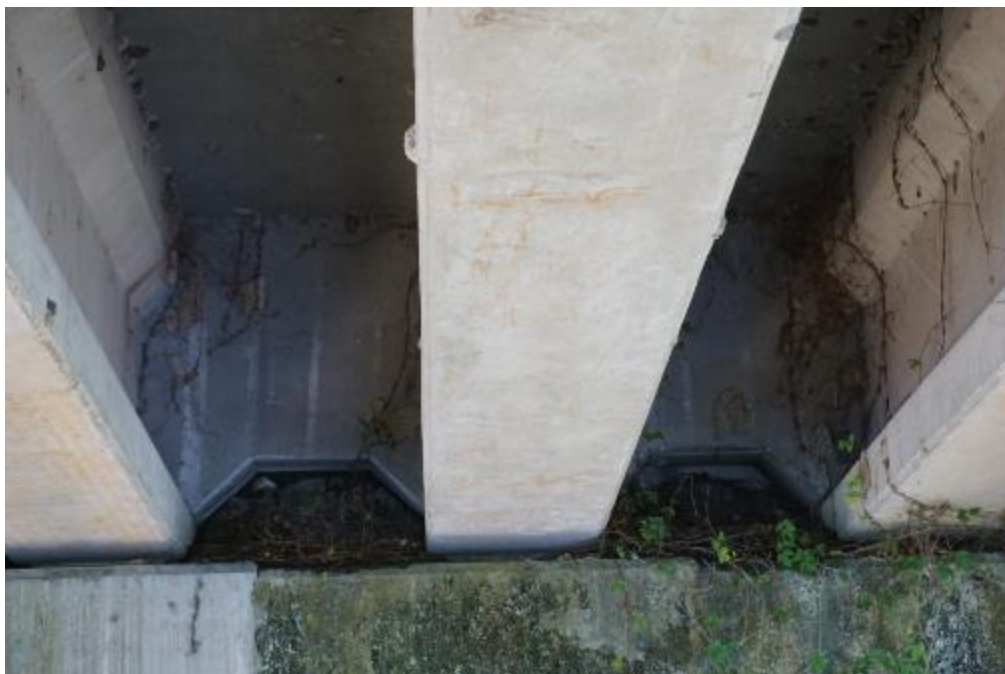
Figure A2-78. 300061 – Typical view of vegetation growth and debris on top of pier cap

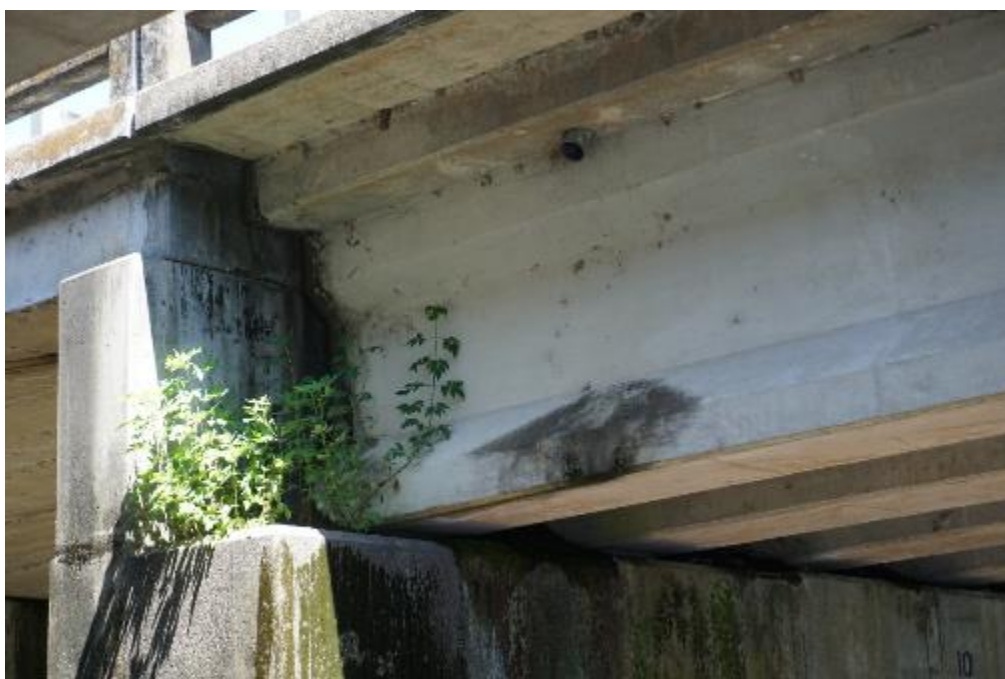
Figure A2-79. 300031 – Typical view of debris growth on pier cap

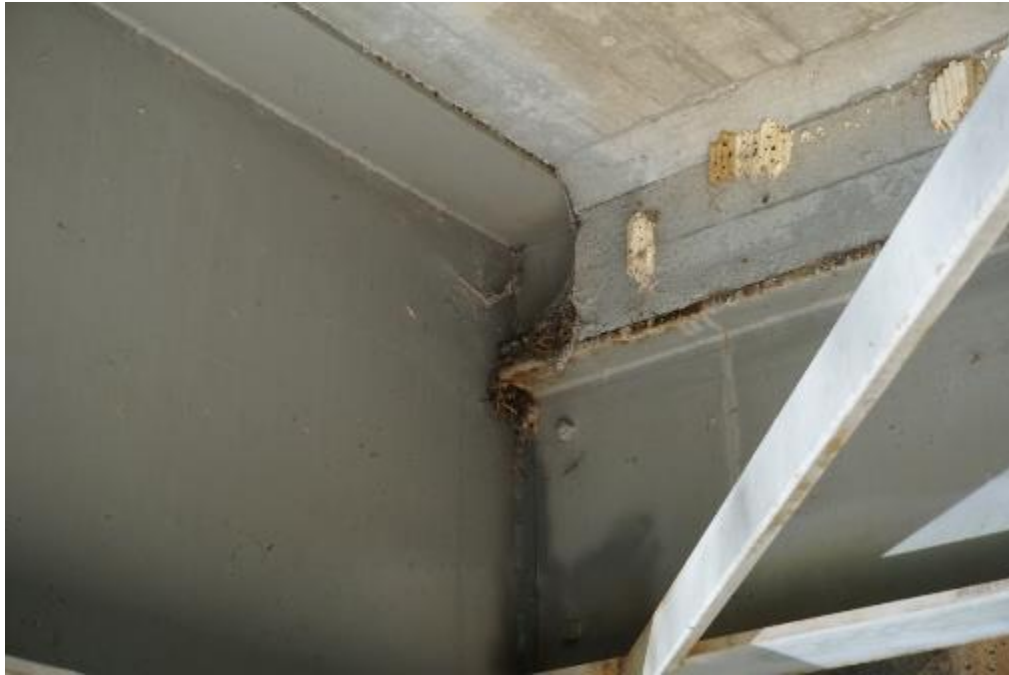
Figure A2-80. 320061 – Typical view of floorbeam connection to girder

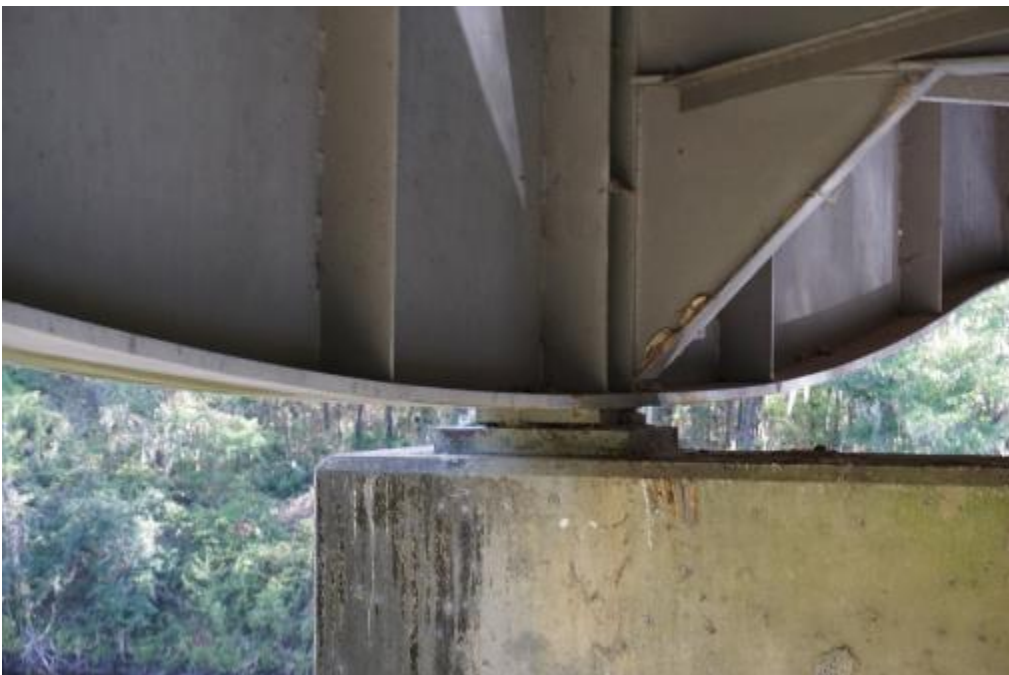
Figure A2-81. 320061 – Typical view of floorbeam connection to girder

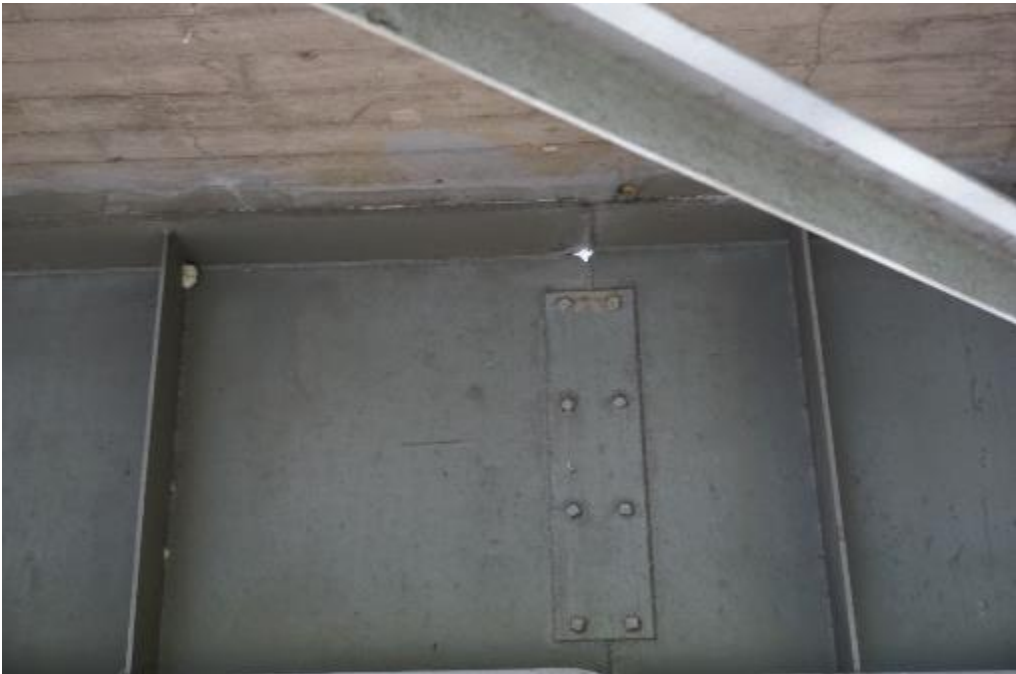
Figure A2-83. 320061 – Typical view of girder splice connection

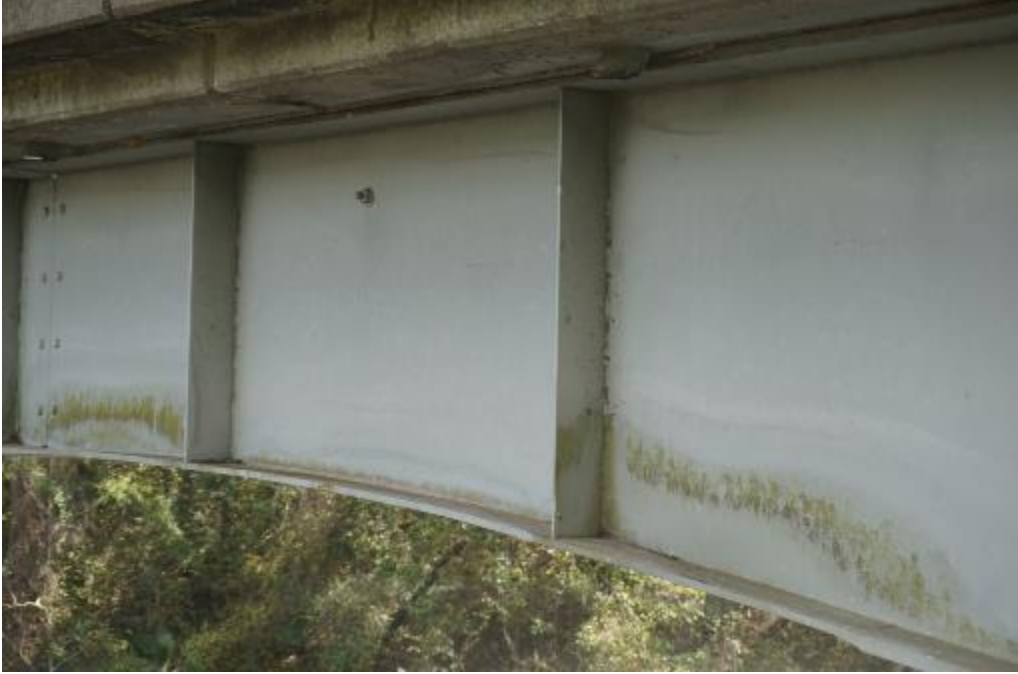
Figure A2-84. 320061 – Typical view of exterior of girder

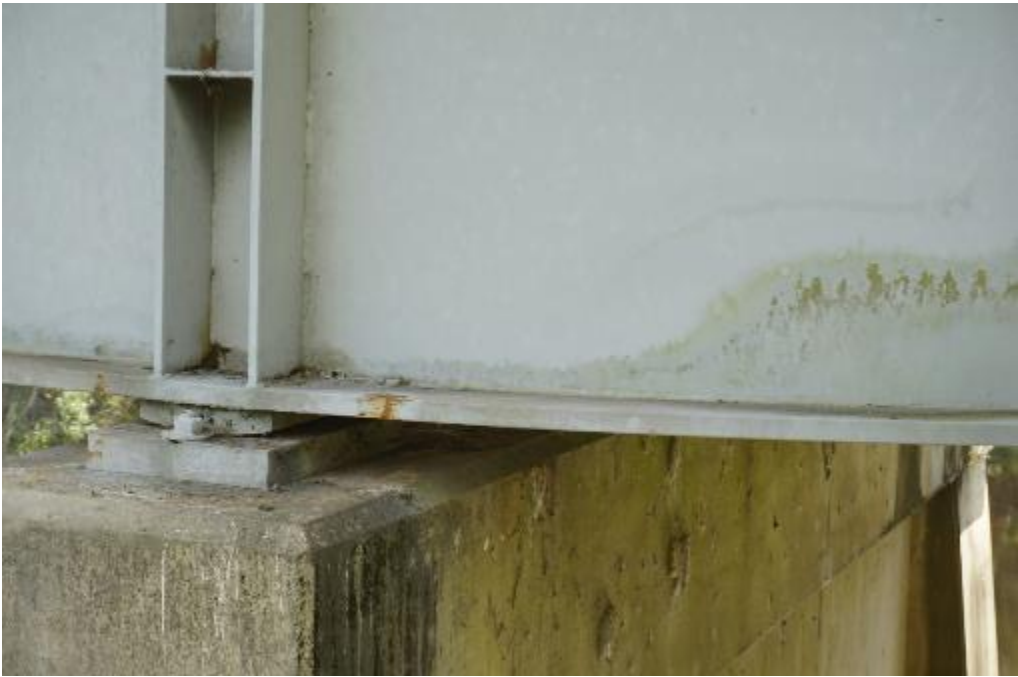
Figure A2-85. 320061 – Typical exterior view of bearing under girder

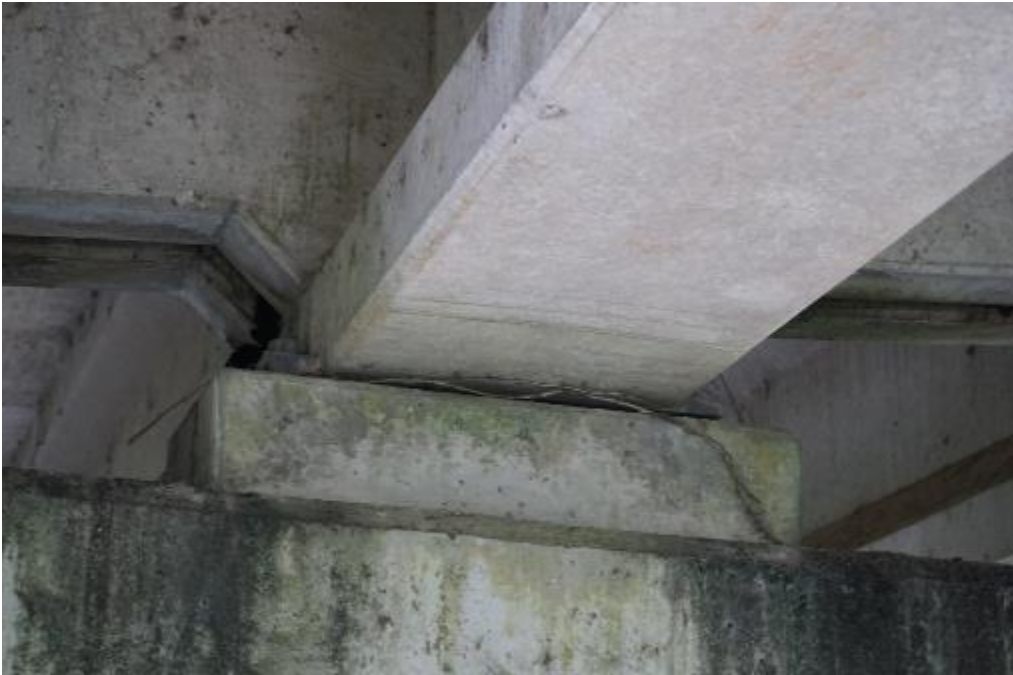
Figure A2-86. 360055 – Typical view of bearing under prestressed concrete girder

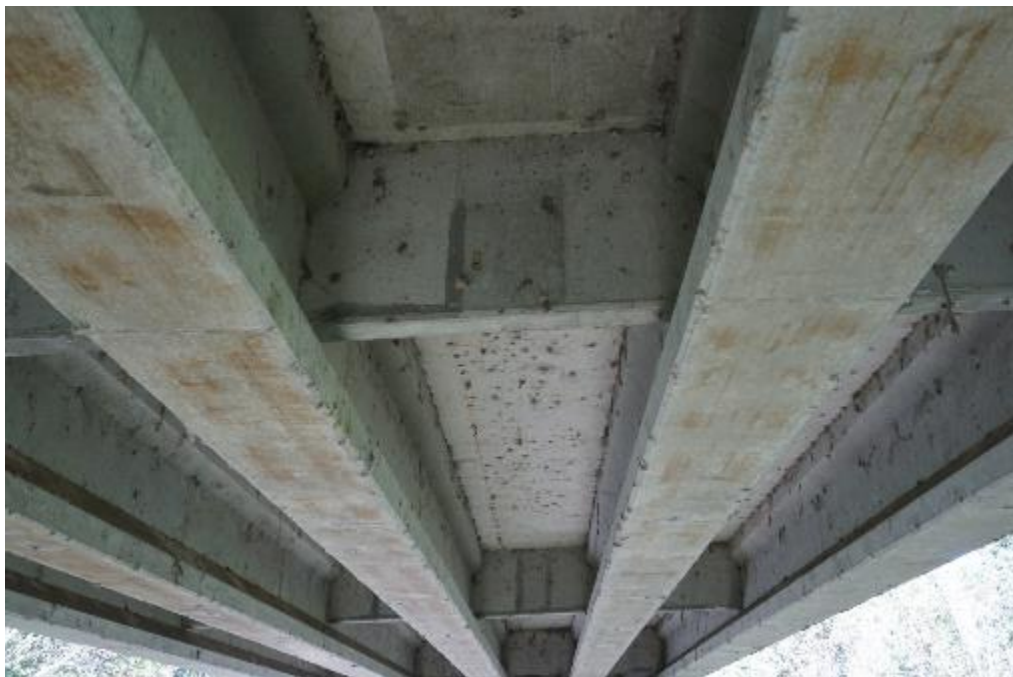
Figure A2-87. 320055 – Typical view down bay between prestressed concrete girders
