Final Report

July 2018

Use of Small Unmanned Aerial Vehicles (sUAV) for Structural Inspection

Florida Department of Transportation (FDOT)
Office of Maintenance
Richard I. Kerr, P.E. – Project Manager

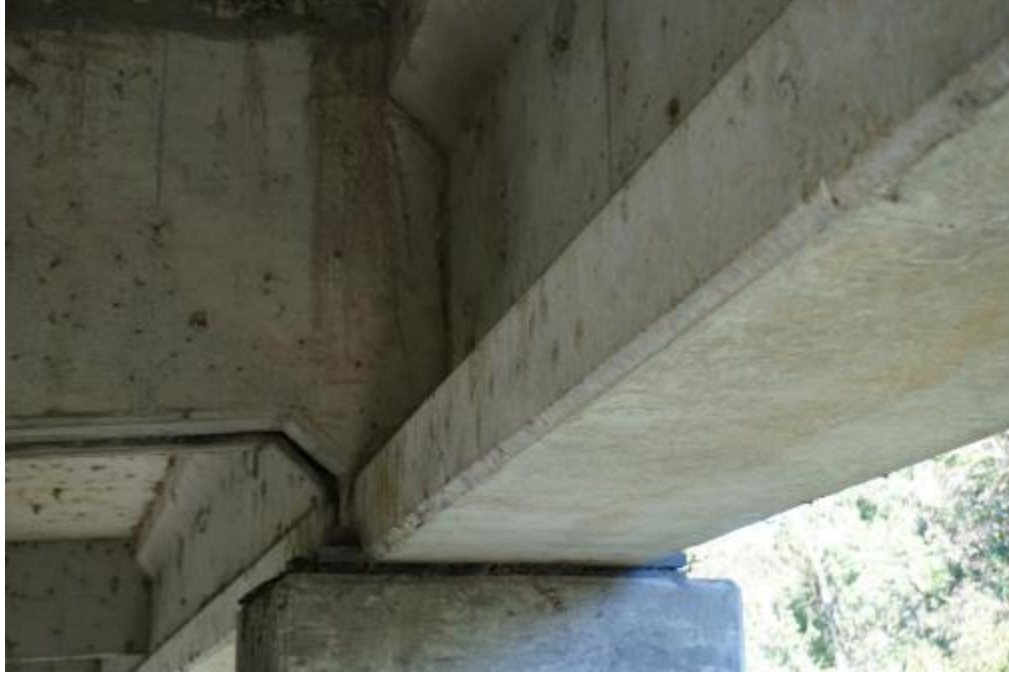
Figure A2-88. 360055 – Typical view of bearing under prestressed concrete girder

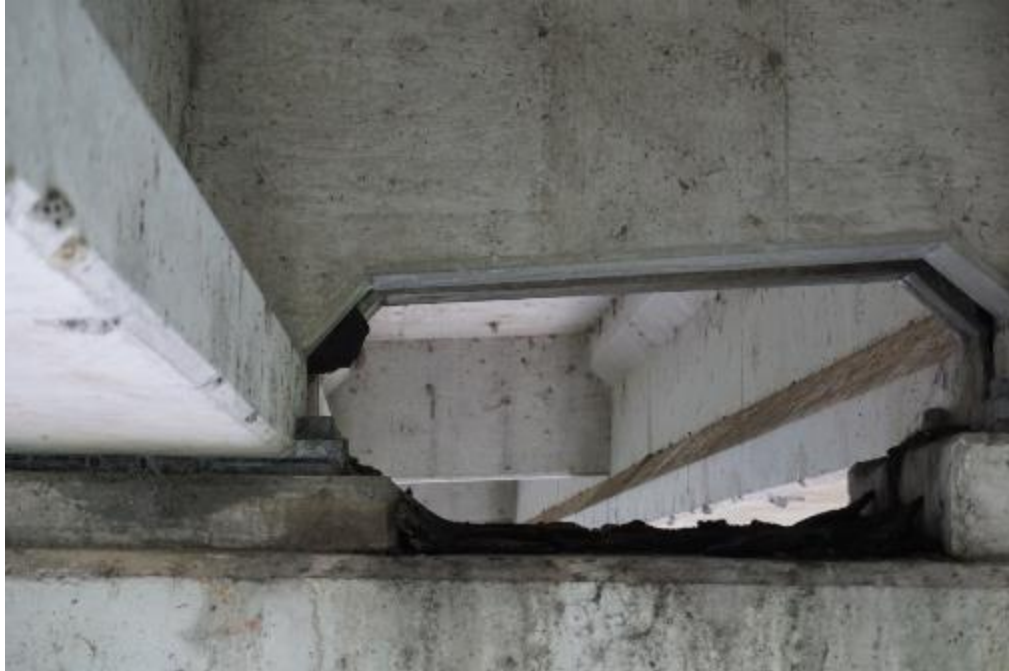
Figure A2-90. 360055 – Typical view of bearing under prestressed concrete girder

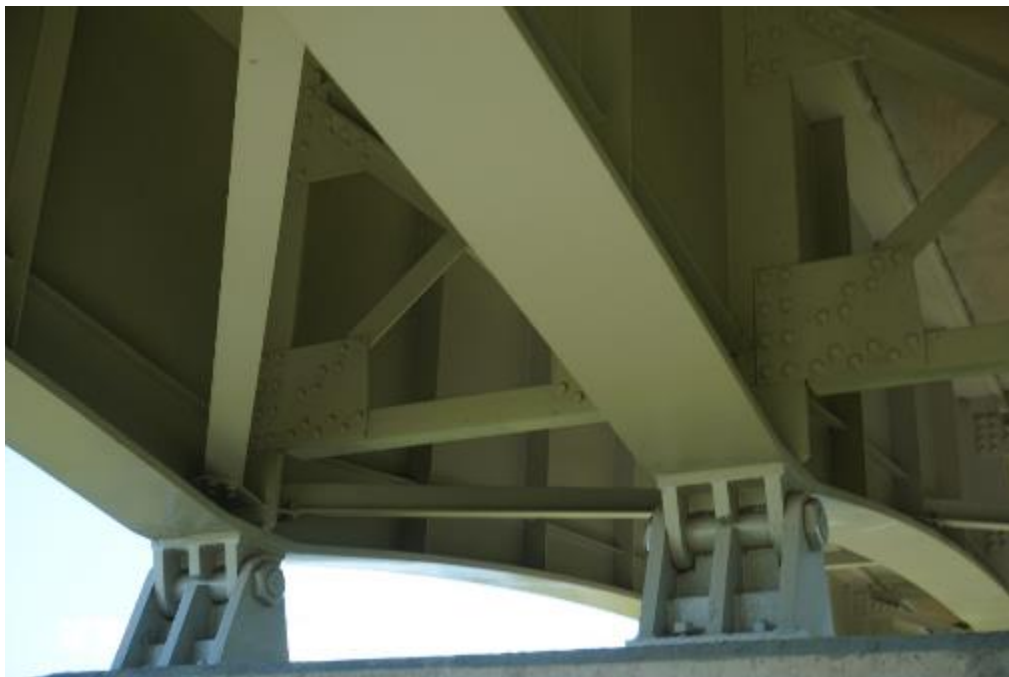
Figure A2-91. 360055 – Typical view of bearing under steel girder

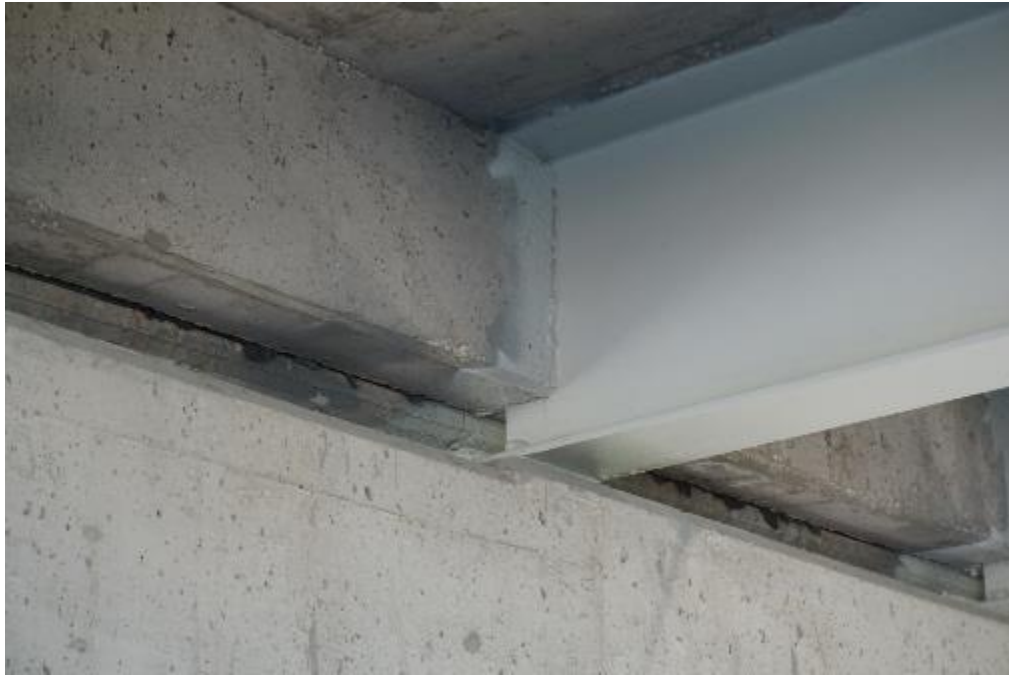
Figure A2-93. 290032 – Typical view of steel beam end

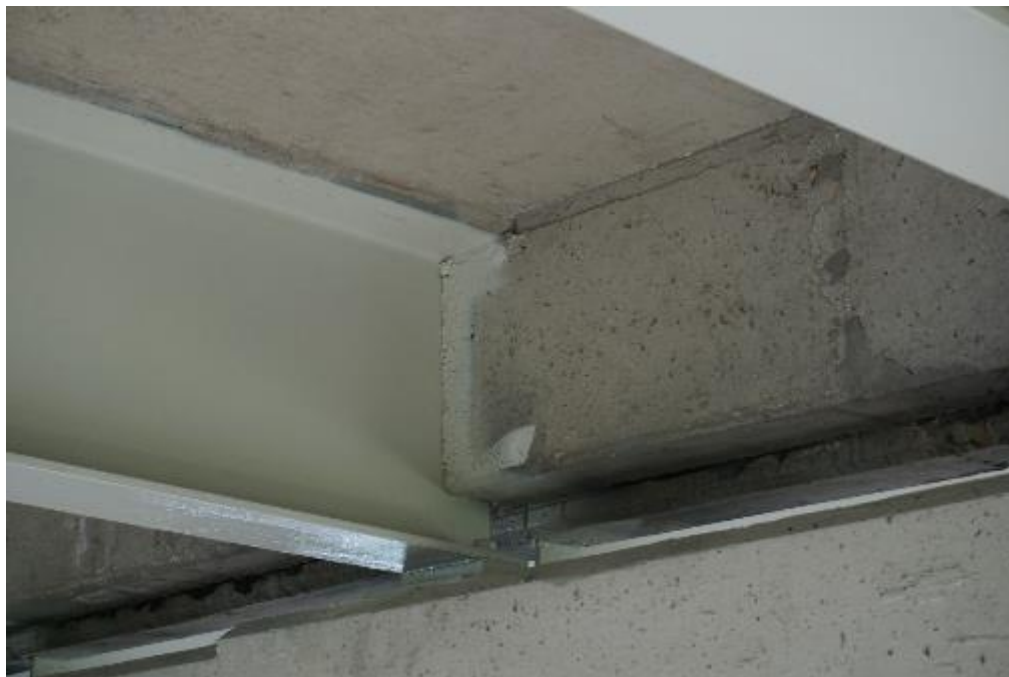
Figure A2-94. 290032 – Typical view of steel beam ends

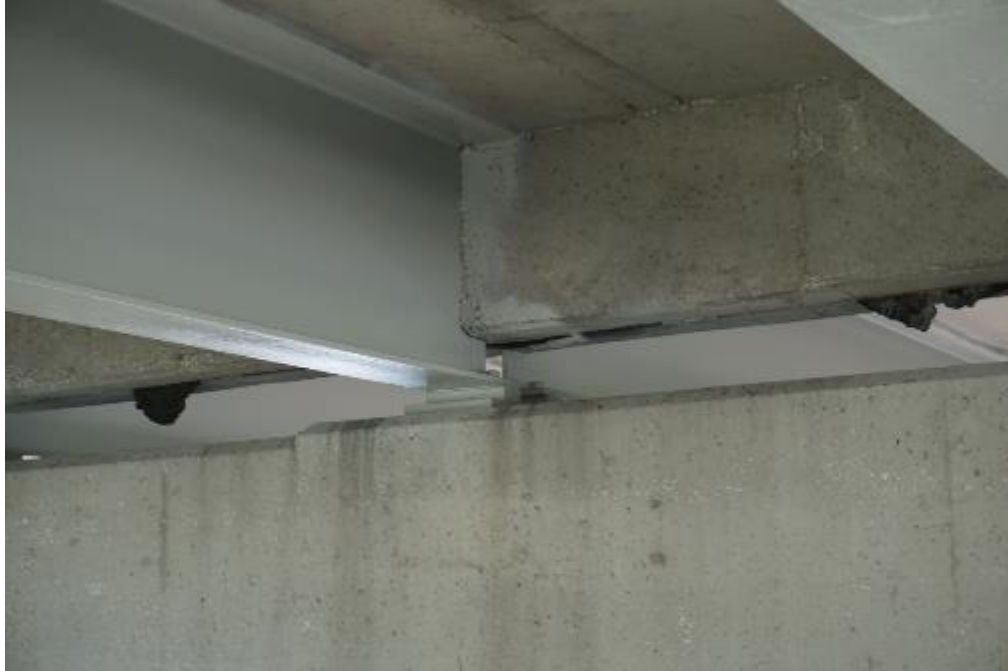
Figure A2-95. 290032 – Typical view of bearing under steel beam and steel beam ends

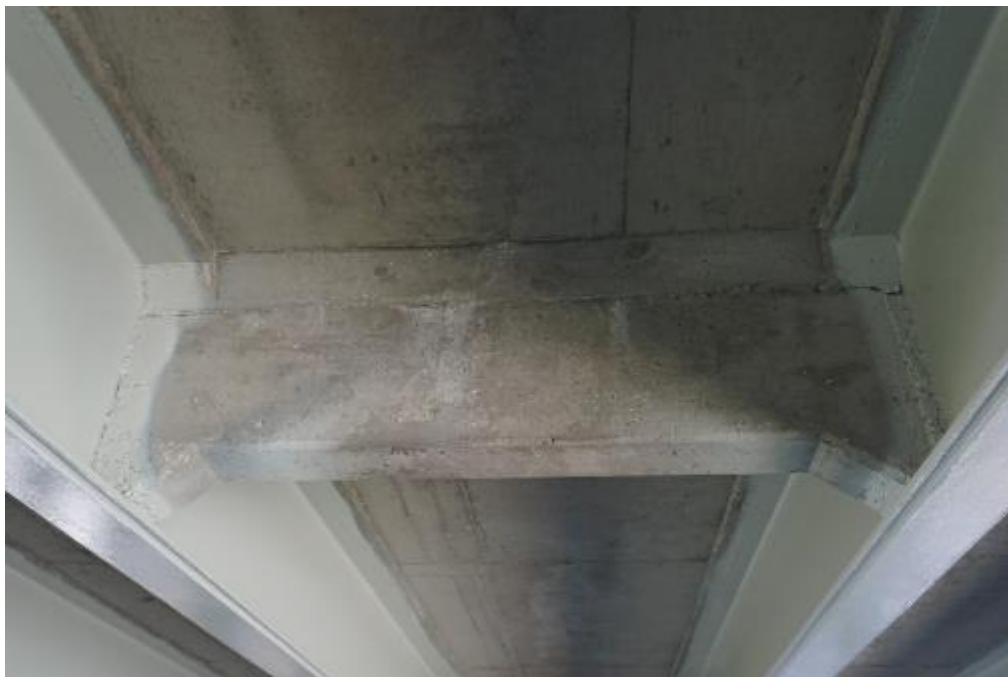
Figure A2-96. 290032 – Typical view of diaphragm between steel beams

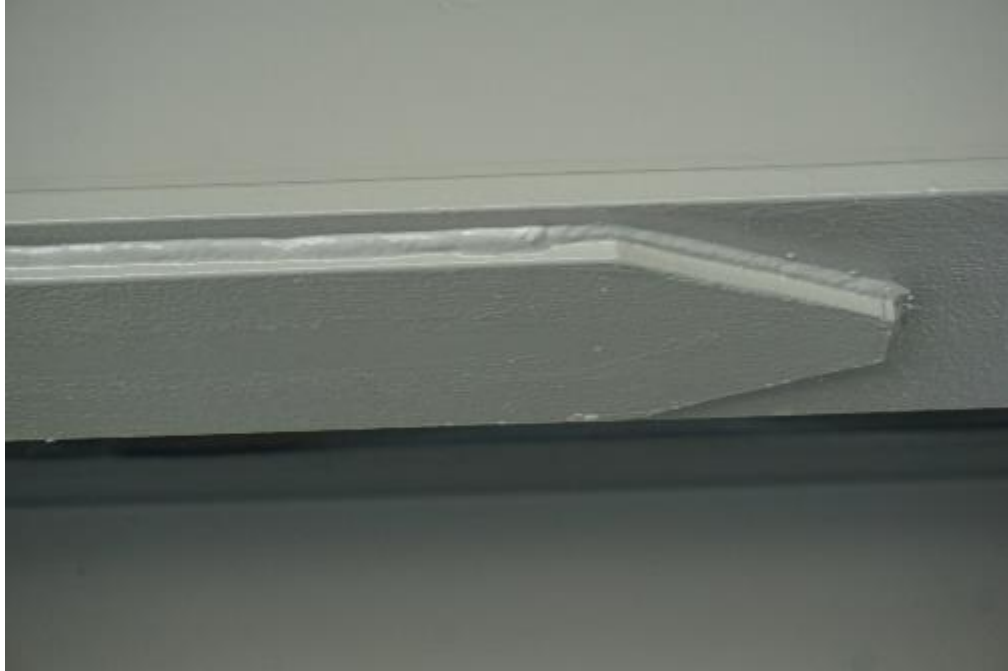
Figure A2-97. 290032 – Typical view of terminal of cover plate

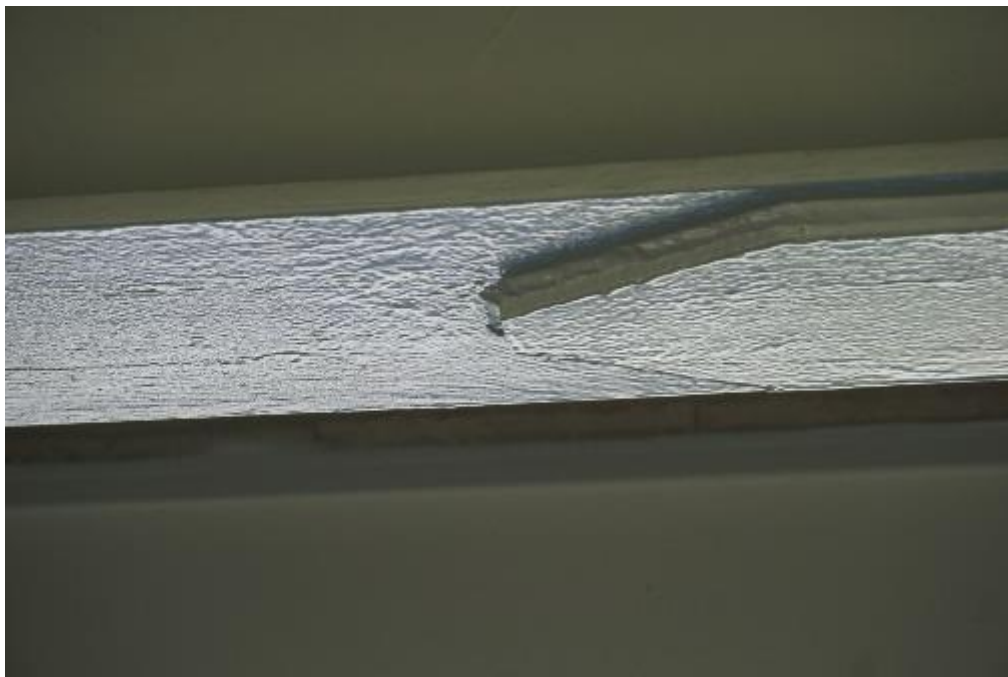
Figure A2-98. 290032 – Typical view of terminal of cover plate

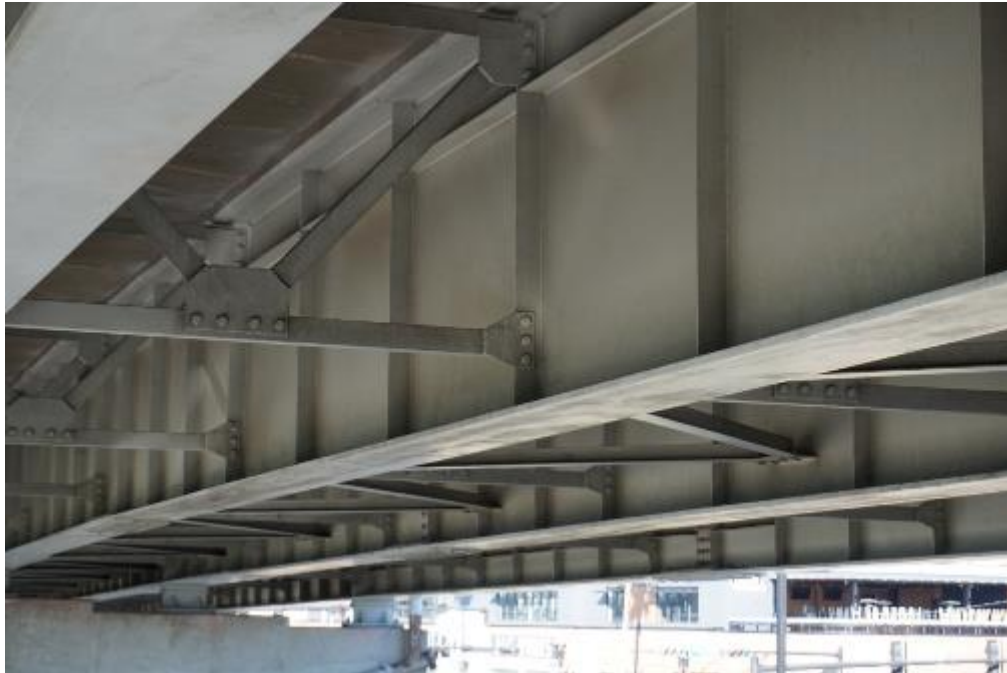
Figure A2-99. 720114 – Typical view of diaphragm between steel girders

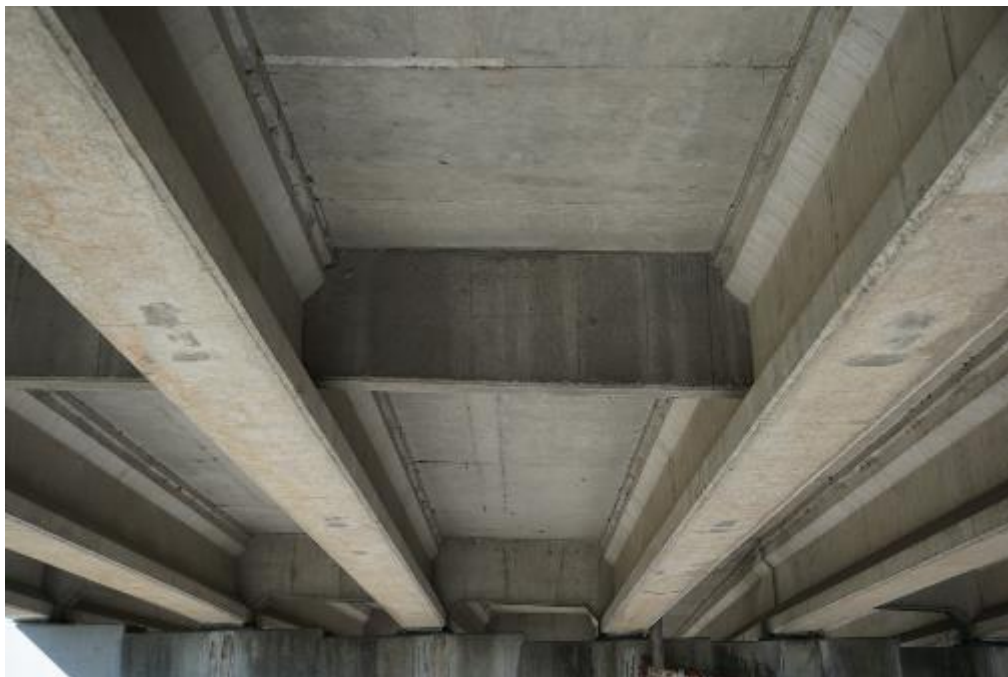
Figure A2-102. 720114 – Typical view down bay between prestressed concrete girders

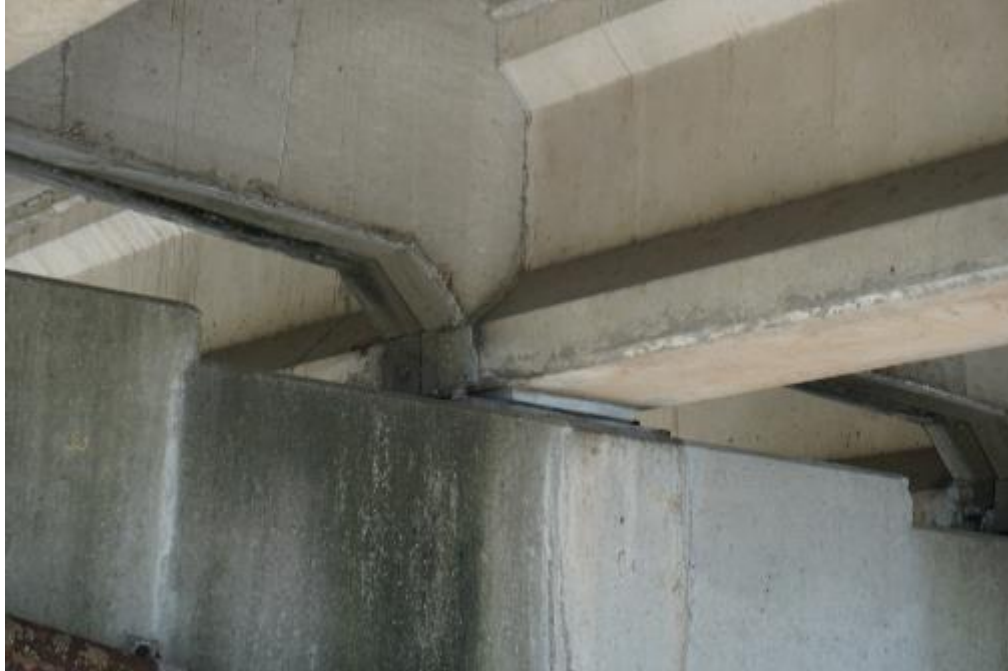
Figure A2-103. 720114 – Typical view of bearing under prestressed concrete girder

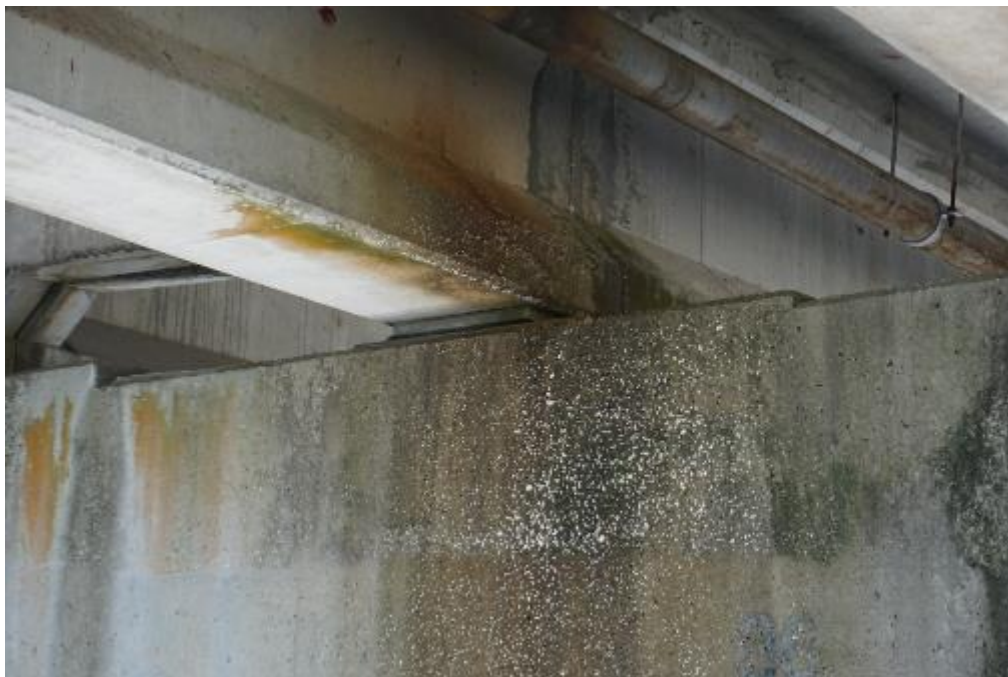
Figure A2-104. 720114 – Typical view of bearing under prestressed concrete girder
