Evaluation of Roadway Worms/Distortions

Final Report

Prepared by:
Applied Research Associates, Inc.
430 W 5th Street, Suite #700
Panama City, Florida 32401
850-914-3188 / 850-914-3189 Fax

Contract No. BE491

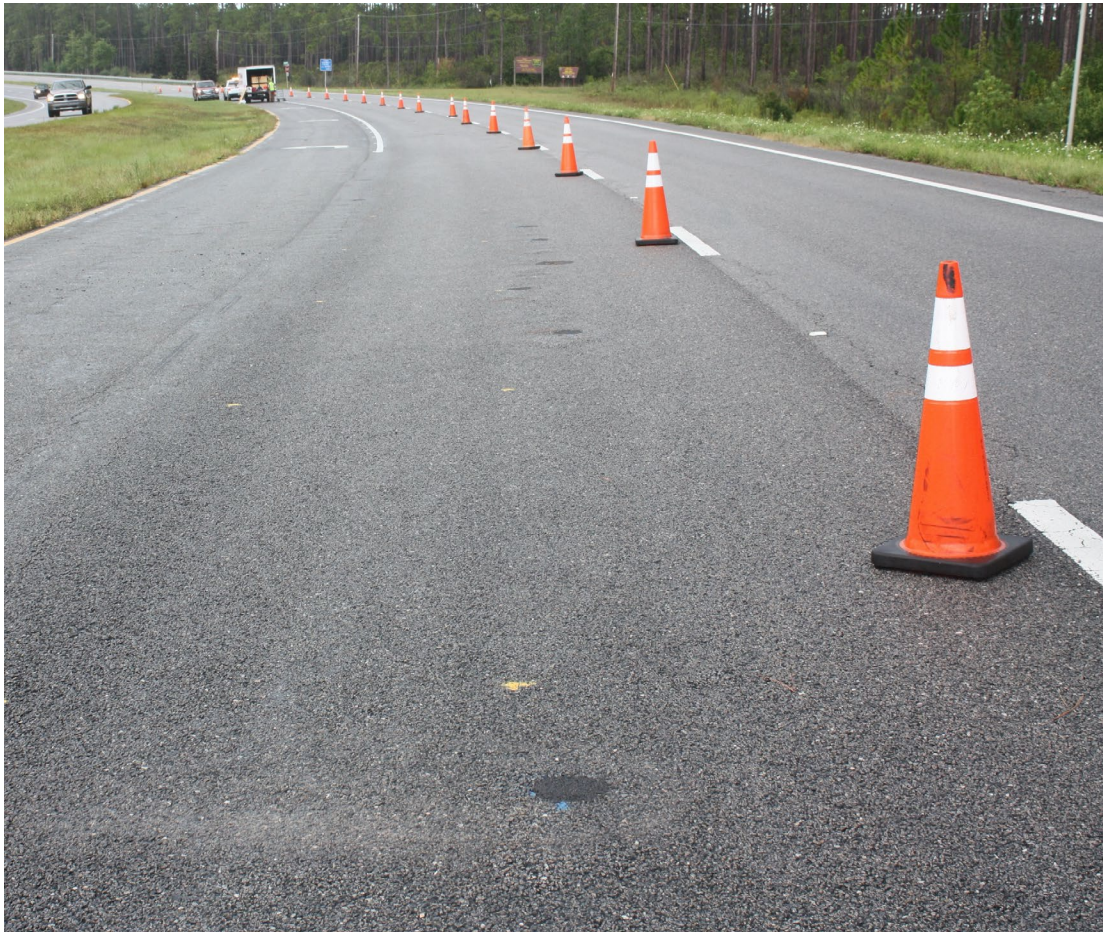
Figure 3-3. SR 79 Roadway Overview

No separate, discrete area was available for a control section. The selected control section with no visible surface worm distress was limited to a 310-ft segment that begins 243 ft south of the northern test section boundary and ends 553-ft south of the northern test section boundary. The worm distresses are prominent in magnitude and density, occurring as both round and roughly rectangular in shape (Figure 3-4). The roadway surface is an open-graded friction course (OGFC). The worm distresses ranged in height from approximately 0.25 to 0.5 in. The area of the project studied is composed of a superelevated section of roadway where worm distresses increase in density with lanes at lower elevation. The most severe worm distresses were observed in the turning lane at the lowest elevation point. No standing water or drainage issues were observed.

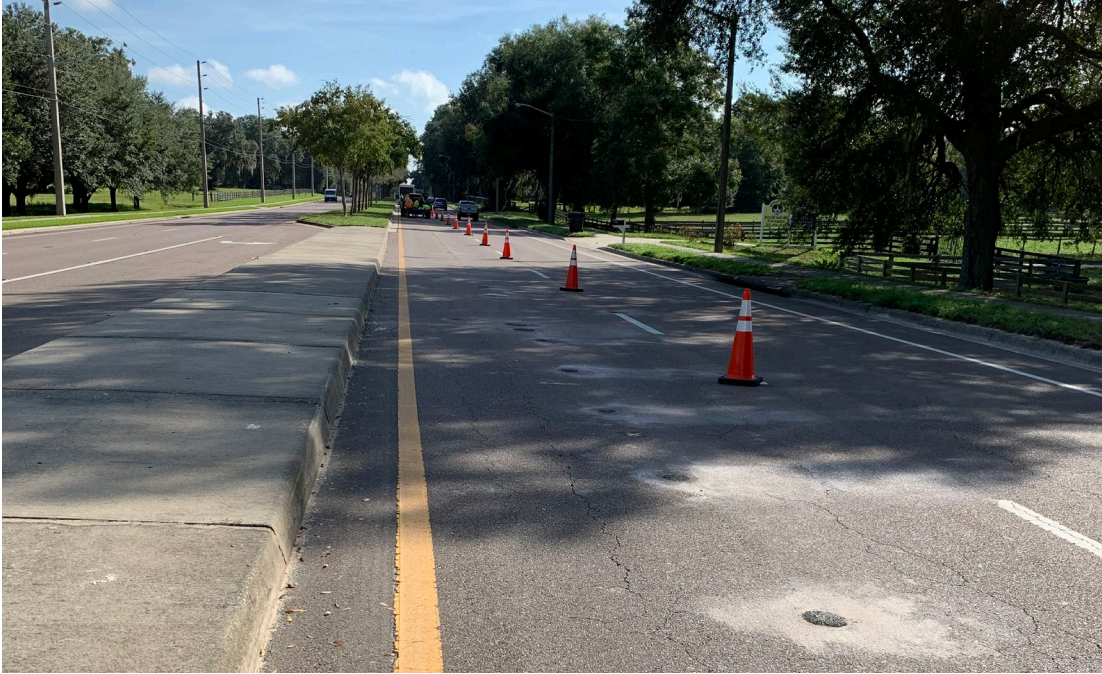
Figure 3-5. SR 26 Roadway Overview

Worms are present in un-trafficked areas of the lane but primarily between the wheel paths. A greater density of the worm distress is present where the longitudinal crack component of block cracking occurs (Figure 3-6). The research team originally assumed the presence of cracking would provide relief for the mechanism causing worms; however, this does not appear to be the case. Worms occur on the site despite there being a substantial amount of age-related cracking on the pavement surface. The roadway consists of 12-ft lanes and a divided median. Curb and gutter are present throughout. A cross-slope drains water from the inside lanes to the outside lanes. The cross-slope ranges from 1.3% to 2.3% in the worm section and 0.8% to 2.9% in the control section. No standing water or drainage issues were observed.

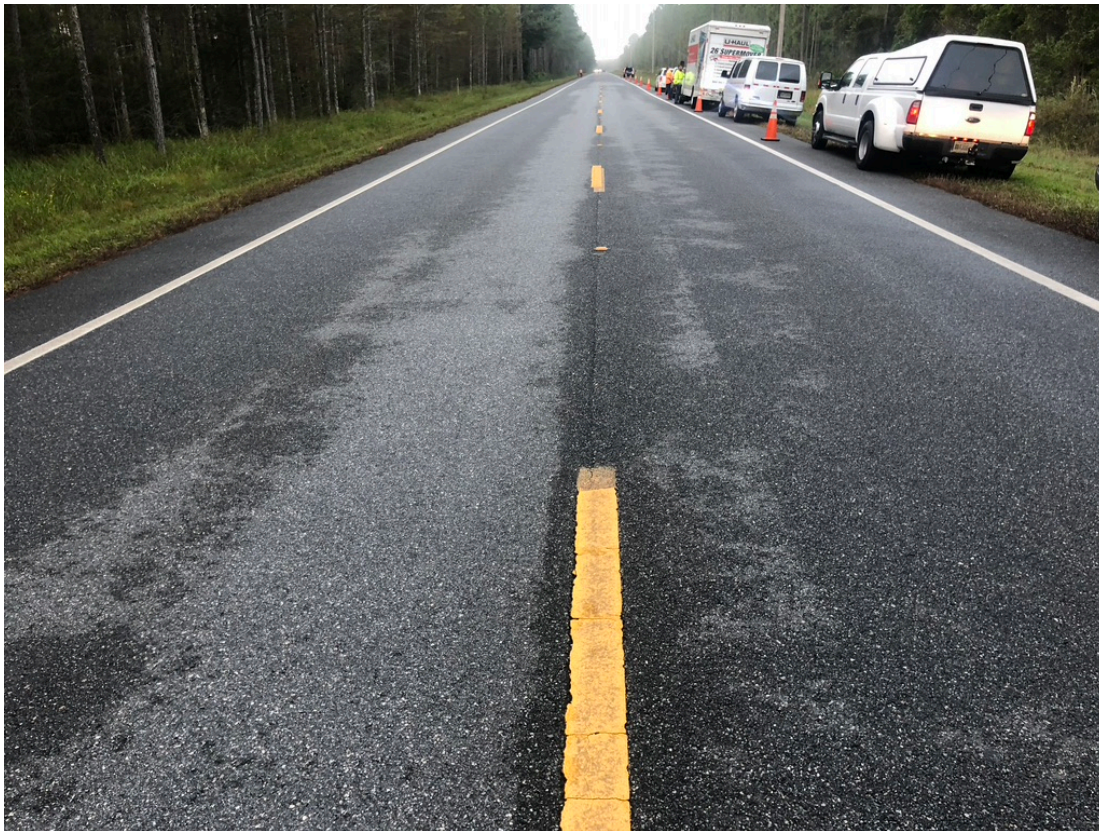
Figure 3-7. SR 24 Roadway Overview

The worm distress uplift height observed on SR 24 was approximately 0.25 in. The majority of the worm distress did not accompany cracking and was difficult to photograph. Figure 3-8 presents a worm occurrence that caused a fracture in the wearing course. The worm distresses occurring on the test section are relatively small in size (footprint), low in frequency of occurrence, and low in severity (height), making them difficult to detect visually on the ground. The distresses are more easily detected in early morning/late evening lighting conditions or by driving the road in an automobile to feel intermittent roughness that occurs due to worms between wheel paths. The roadway consists of two 12-ft lanes. The centerline is crowned. The longitudinal paving joint at the crown of the roadway has opened to form a crack for approximately 50% of the length of the worm section; however, the control section did not have cracking at the paving joint. Cross slopes range from 1.4% to 2.4% in the worm section and 1.9% to 2.0% in the control section. No standing water or drainage issues were observed.

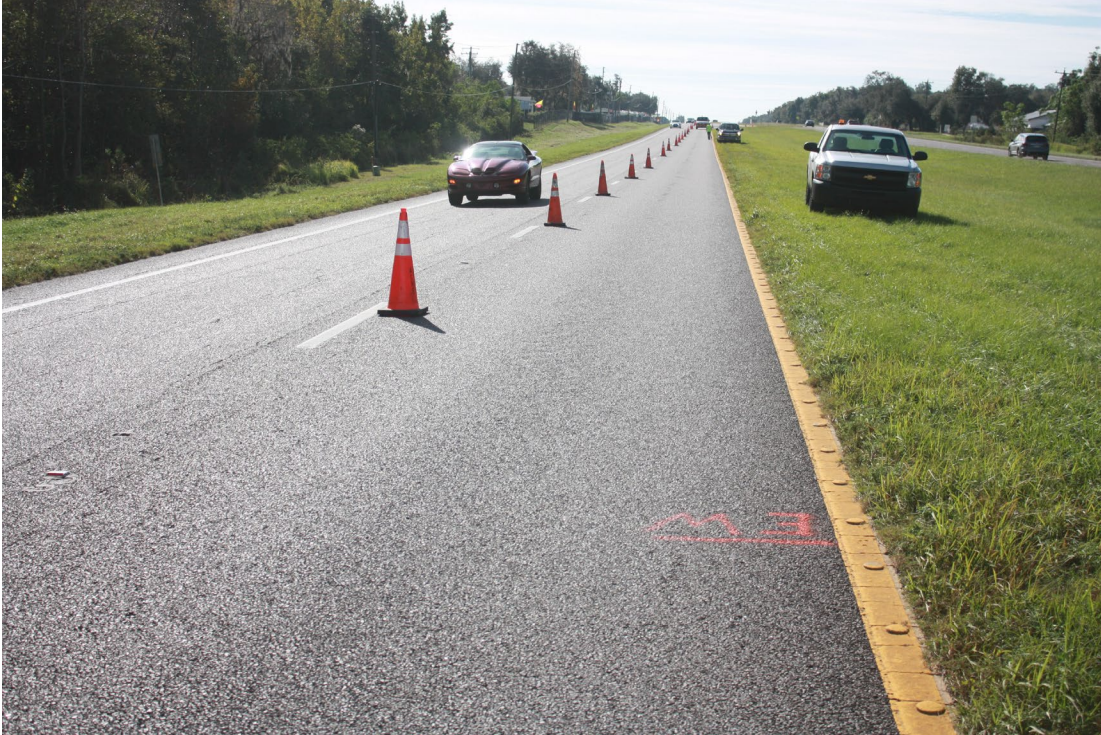
Figure 3-9. US 17 Roadway Overview

The worm distresses occur both as round and roughly rectangular in shape (Figure 3-10). The roadway surface is an OGFC. The worm distresses ranged in height from approximately 0.25 to 0.5 in. The control section is at a higher elevation on a vertical curve. The severity of worm distress increases in areas of lower elevation. The roadway consists of two 12-ft lanes. The centerline is crowned. Cross slopes range from 1.1% to 3.1% in the worm section and 1.2% to 2.6% in the control section. No standing water or drainage issues were observed.

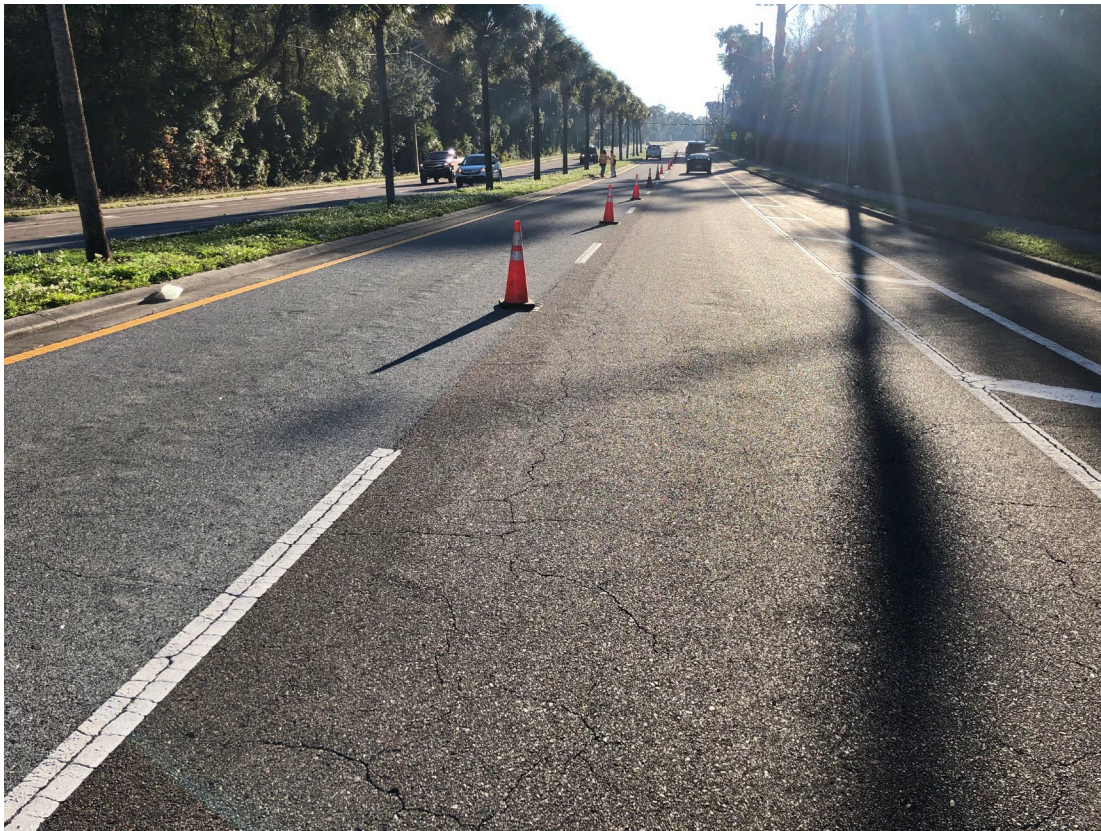
Figure 3-11. SR 20 Roadway Overview

This roadway features two different dense-graded asphalt (DGA) surface mixes. Both lanes exhibit worm distresses, indicating worm distress may not necessarily be being associated with factors related to the top AC lift. Worm distresses are not considerably severe (< 0.25 in tall) and occur infrequently. No worm distresses were observed over 390 ft of the 581-ft test section. Figure 3-12 presents a close-up of a worm distortion on the left edge of the worm section. The roadway consists of 12-ft travel lanes, with a 5-ft gore area separating the mainline from a 6-ft parking lane. Curb and gutter are present throughout. A cross-slope drains water from the inside lanes to the outside lanes. The cross-slope ranges from 1.6% to 2.7% in the worm section and 1.9% to 2.8% in the control section. No standing water or drainage issues were observed.

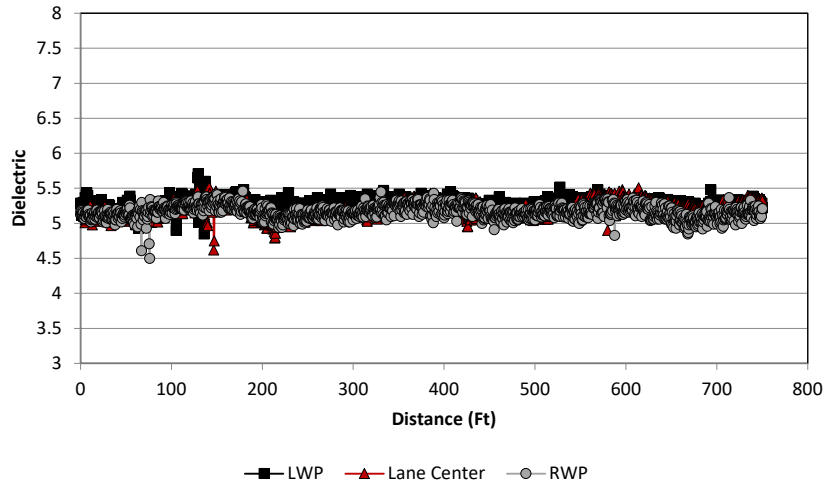
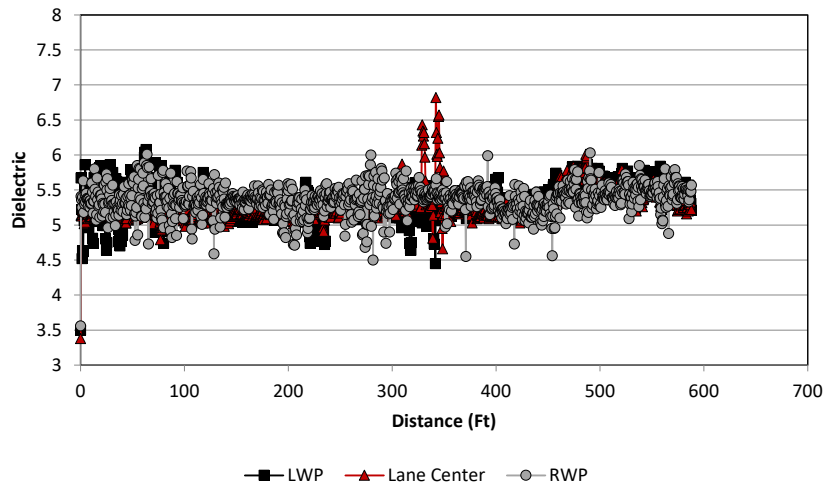
Figure 4-1. Dielectric Profiles from SR 24 (a) Control and (b) Worm Sections

With the exception of SR 79, the PaveScan GPR data was collected from both the control and the worm sections of all field sites. The PaveScan data was collected with a total of three GPR antennas located at both wheel paths (outside antennas were positioned four feet from pavement edge lines) and at the lane center. Figure 4-1 through Figure 4-4 show the dielectric profiles collected from the respective sections using PaveScan. These figures clearly show that the dielectrics from worm sections exhibit higher variability (i.e., inconsistency) compared to the control sections. Moreover, these figures generally indicate that the highest variability within the worm sections is observed from the lane center. This indicates that the wheel paths of worm sections may have been compacted by the driving traffic, leaving more inconsistency in the lane center where lower density may exist. The variability or inconsistency in the SR 20 worm section was less pronounced than the other three roadways; however, this observation was consistent across all sites.

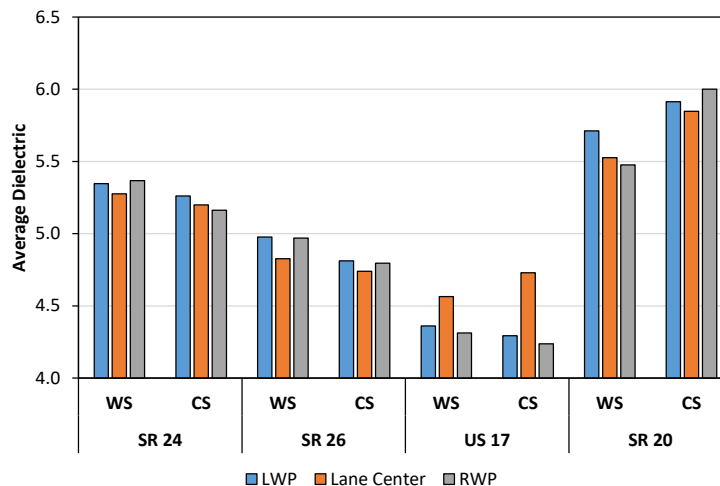
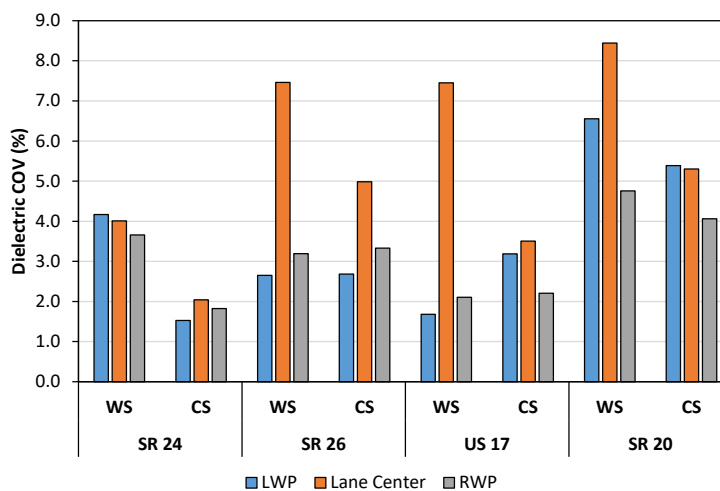
Figure 4-5. Dielectric Summaries: (a) Mean and (b) COV

Figure 4-5 shows a summary (i.e., mean and coefficient of variation [COV]) of the dielectrics obtained from the respective field sites. Figure 4-5(a) shows that higher mean dielectric values are seen in the worm sections of SR 24 and SR 26, while the trend is reversed for US 17 and SR 20. As such, the trend of the mean dielectric values is not quite conclusive. However, Figure 4-5(b) clearly shows that the worm sections generally exhibit higher variability, especially within the lane center where the asphalt was not compacted by traffic.

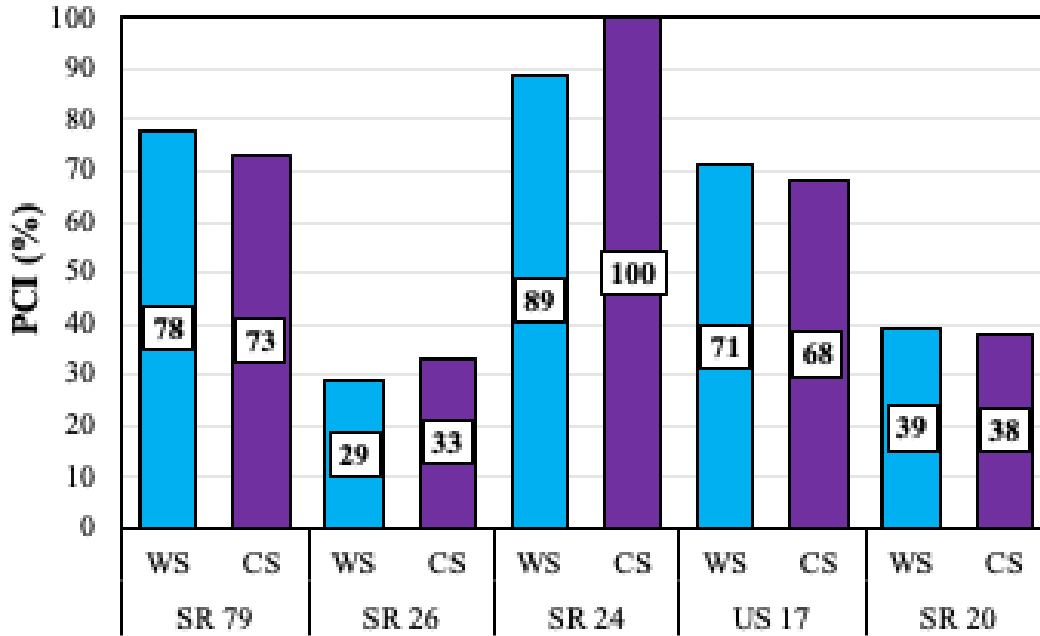
Figure 4-6. Overall PCI

The overall PCI values for the five roadway sections evaluated in this study are presented in Figure 4-6 and range from 29 to 100. Contrary to expectations, three of the five worm sections (SR 79, US 17, and SR 20) exhibited higher PCI values than the control sections. The difference in PCI between worm and control sections was minimal and ranged from 1 to 5 PCI points on SR 79, SR 26, US 17 and SR 20. The largest difference in condition was observed between worm and control sections of SR 24, where the control section carried a PCI of 11 points greater than the worm section. The SR 24 roadway was also in the best overall condition of the five projects, according to PCI. The only distress observed in the SR 24 control section was 16 ft of low-severity longitudinal and transverse (L&T) cracking. In contrast, there was 375-ft of L&T cracking in the worm section. A total of four distress types were observed across all the projects: L&T cracking, alligator cracking, rutting, and block cracking. All block cracking and rutting observed was of low severity. Low-severity and medium-severity L&T cracking and

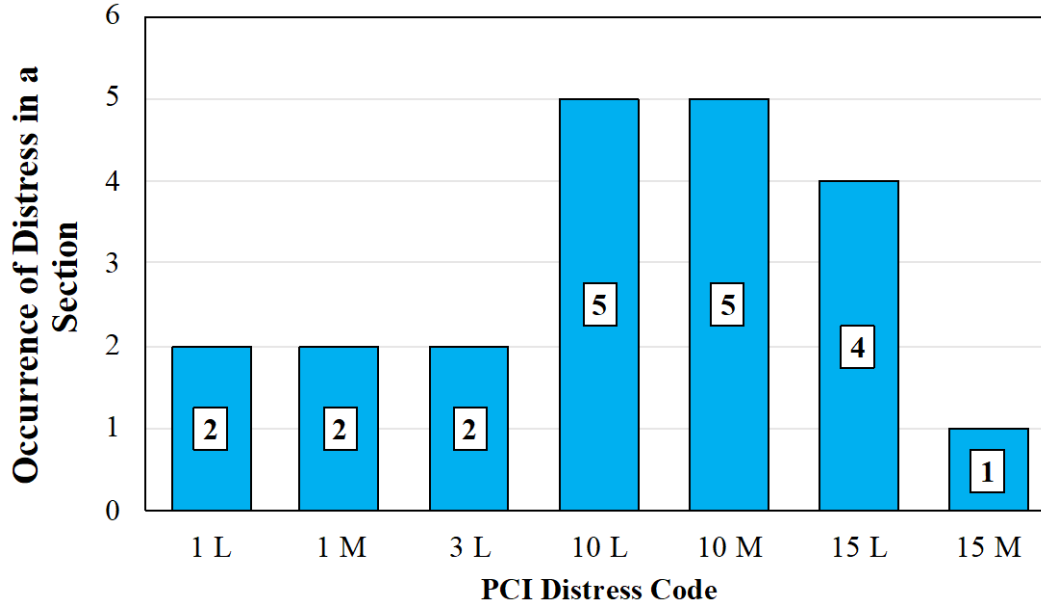
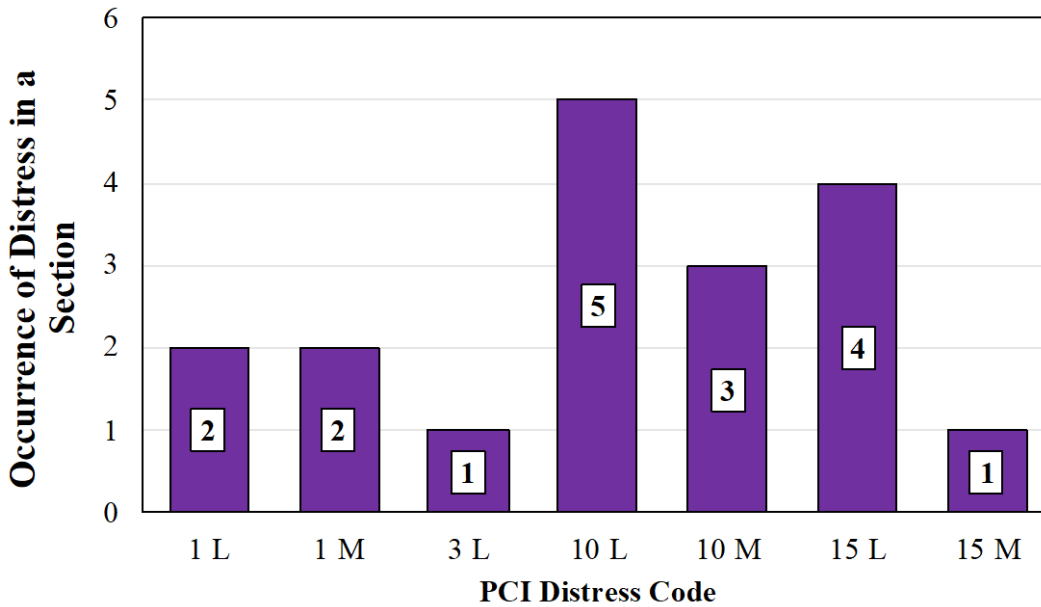
alligator cracking were also observed on each roadway. Histograms provided in Figure 4-7 and Figure 4-8 show the occurrence of distress types and severity over worm and control sections, respectively. Low, medium and high distress severities are indicated by “L”, “M”, and “H” designations on the x-axis. Table 4-1 provides a key for referencing distress codes. These data show that the same distresses generally occurred in both worm and control sections. Two exceptions were the occurrence of low-severity block cracking in the SR 26 worm section, where the control section did not exhibit block cracking, and the occurrence of medium-severity L&T cracking in worm sections on SR 24 and US 17, where the control sections only exhibited low-severity L&T cracks.

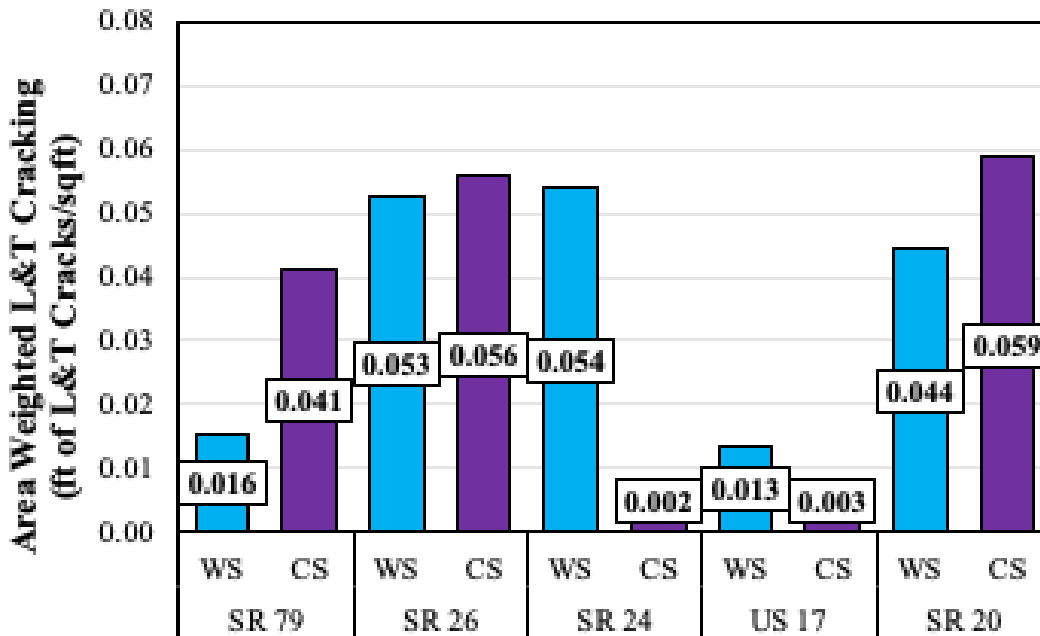
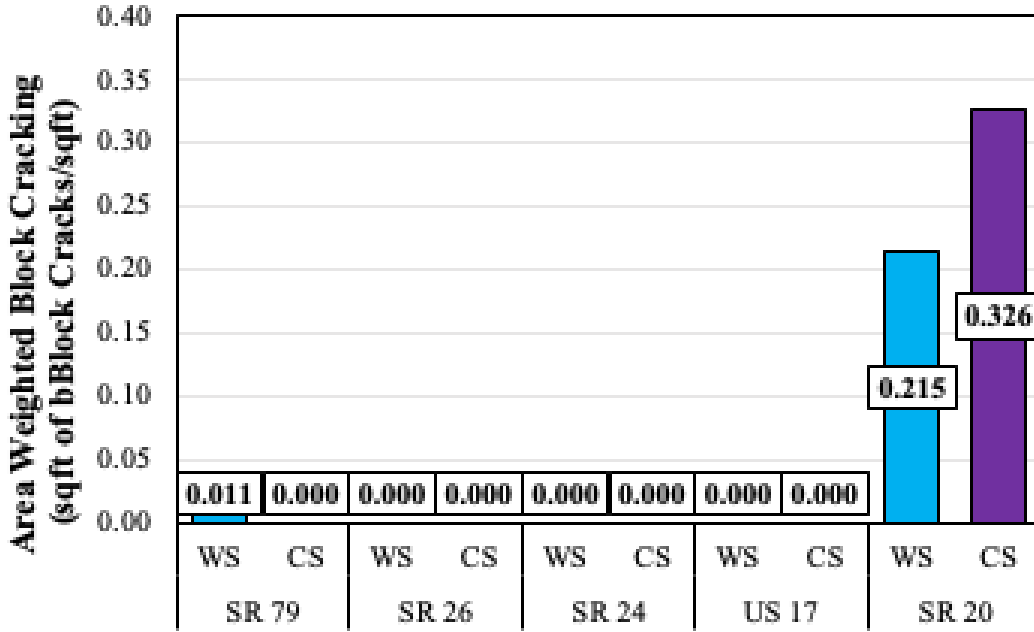
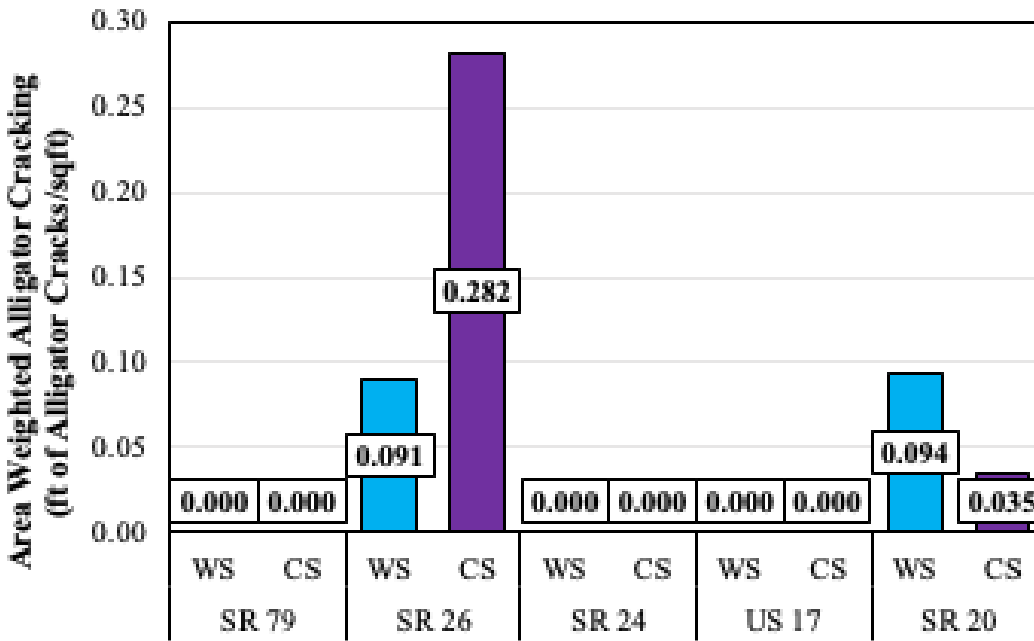
Area weighted averages for L&T cracking, block cracking, and alligator cracking are provided in Figure 4-9, Figure 4-10, and Figure 4-11, respectively. Low- and medium-severity distress quantities were combined for these computations. These figures show the occurrence of block cracking and alligator cracking was not consistent across each site and may not be a major contributing factor to the occurrence of worm distress. The rate of L&T cracking observed on the control sections of SR 24 and US 17 was considerably minimal. Taken together, the absence of worm distress in the control sections of SR 24 and US 17 may have an association with the absence of surface cracking. A possible interpretation of this finding is that cracking may be a prerequisite for the mechanism(s) causing worm distress. Control sections for SR 79, SR 26, and SR 20 all exhibit as much or more cracking than the worm sections; therefore, L&T cracking is not sufficient to cause blistering but may be necessary.

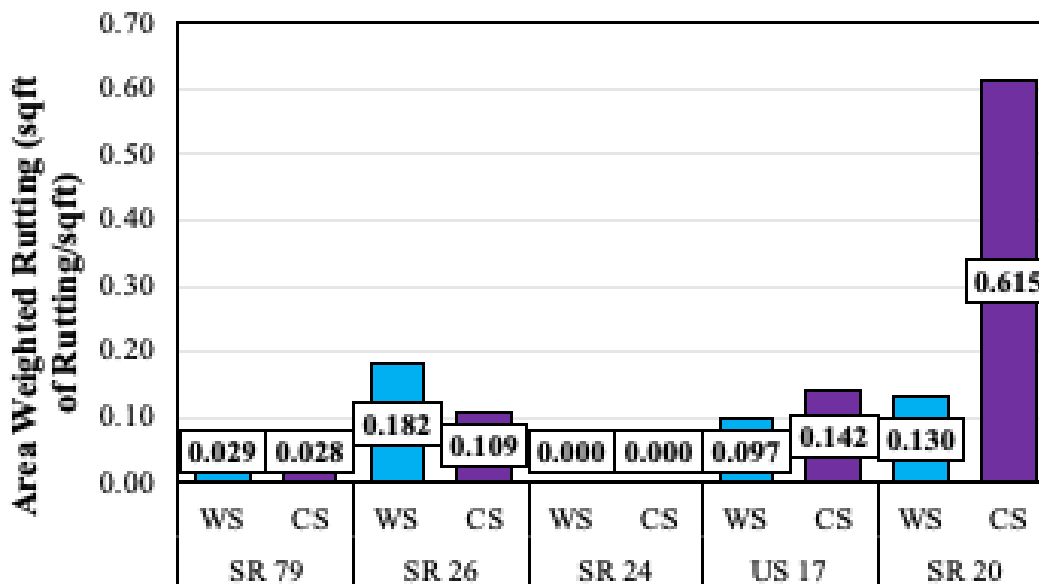
Figure 4-12. Area Weighted Rutting

Rutting was also computed as an area weighted average and is provided in Figure 4-12. No rutting occurred on SR 24. Rutting was considerably greater in the control section of SR 20, which is supported by higher air voids measured and presented in Section 4.2.3. Rutting was not consistently higher or lower in worm sections on the remaining three projects and does not appear to be associated with worm distress.

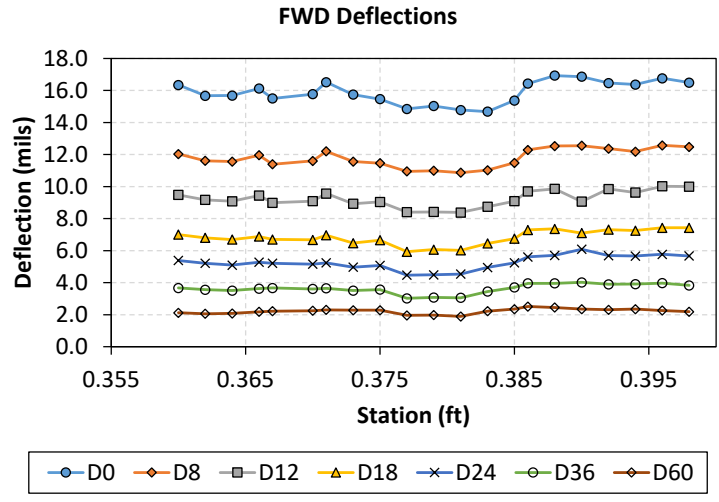
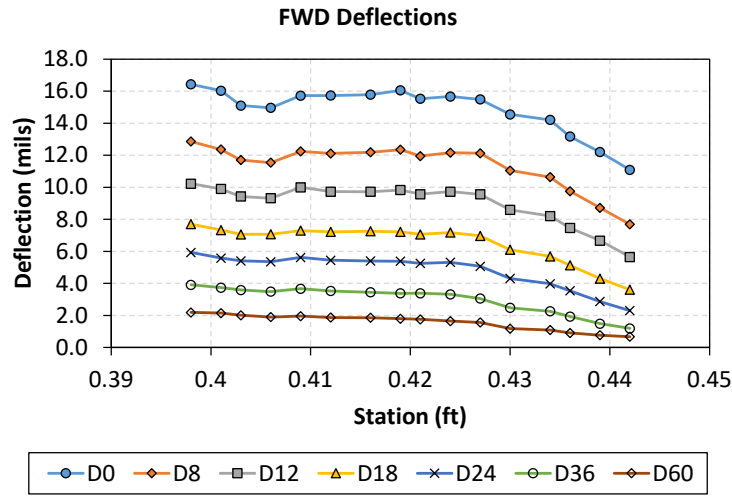
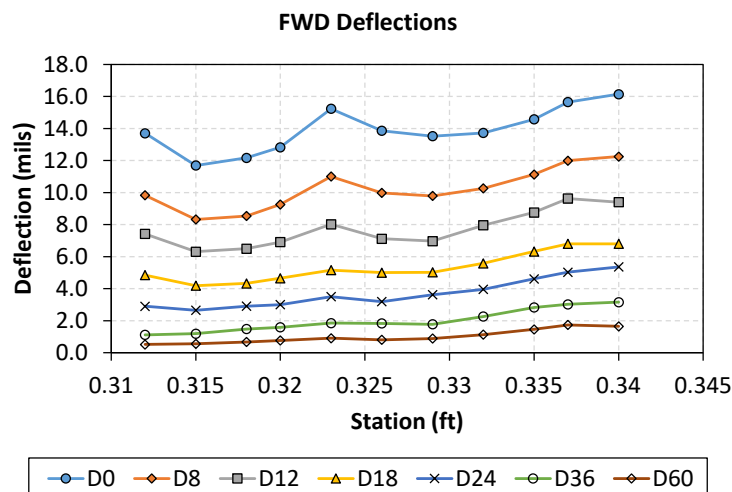
Figure 4-14, Figure 4-15, and Figure 4-16 show the raw FWD deflections under the 9,000-lb target load, collected from the control, worm section no. 1, and worm section no. 2, respectively. These figures generally show the deflections follow relatively consistent trends within each section, indicating that no subsurface anomalies (or an abrupt pavement change) exist within these sections.

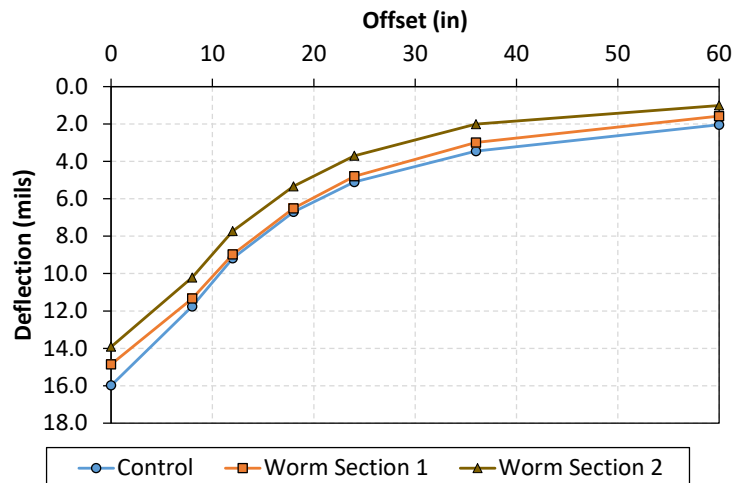
Figure 4-17. Average FWD Deflection Basins from SR 79

Figure 4-17 shows the average deflection basins obtained from each section, with the summary statistics of the deflections, provided in Table 4-2. The figure shows that the shape of the deflection basins is relatively consistent among all three sections. Table 4-2 shows that despite the comparable average deflection basins, both worm sections exhibit higher variability as indicated by the standard deviation and COV. Worm section no. 2 showing the lowest average deflections may be attributed to a stiffer subgrade or embankment material below this particular section.

The control section also shows the highest deflections, especially for the FWD sensor directly below the load plate (D0). While such higher D0 may be attributed to a weaker AC layer, it is also possible that the pavement temperature in the control section was higher than the worm sections during the FWD testing. Higher D0 within the control section may also be attributed to weaker foundation layers (i.e., base and subgrade). Although backcalculating the dynamic modulus master curve of the AC layer and shifting the master curve to a reference temperature may allow for a fair assessment of the AC modulus, the FWD temperature sensor malfunctioned at the time of FWD testing on SR 79 and, hence, backcalculation was not conducted for the FWD data from SR 79. Instead, the AC dynamic modulus needed for the pavement performance assessment was obtained from laboratory testing of field-retrieved cores.

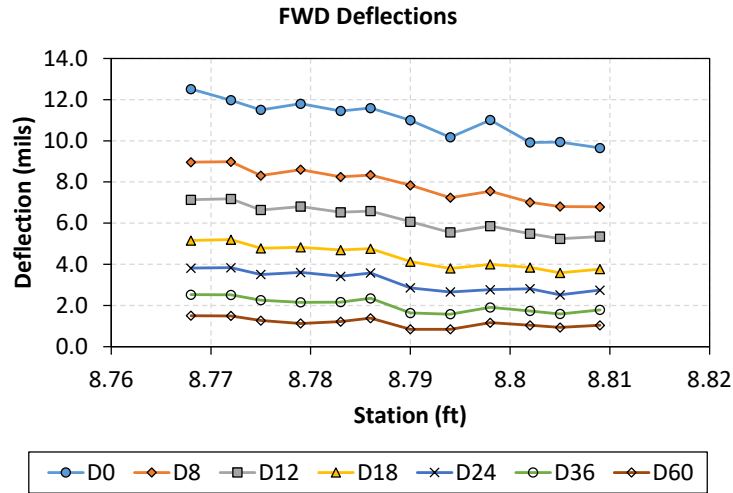
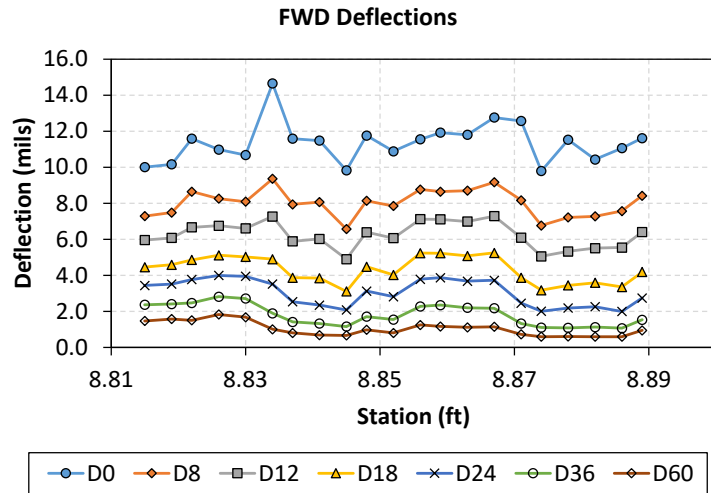
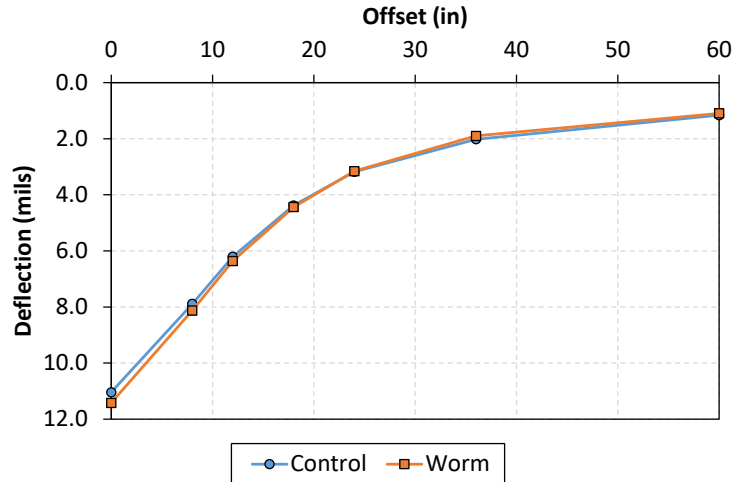
Figure 4-18 and Figure 4-19 show the raw FWD deflections under the 9,000-lb target load, collected from the control and worm sections of SR 26, respectively. Figure 4-20 shows the average deflection basins, with the summary statistics of the deflections provided in Table 4-3. Figure 4-20 and Table 4-3 show that the average deflections from the control and the worm sections were comparable, with the worm section showing slightly higher deflections. The deflections from the worm section also show slightly higher variability (Table 4-3).

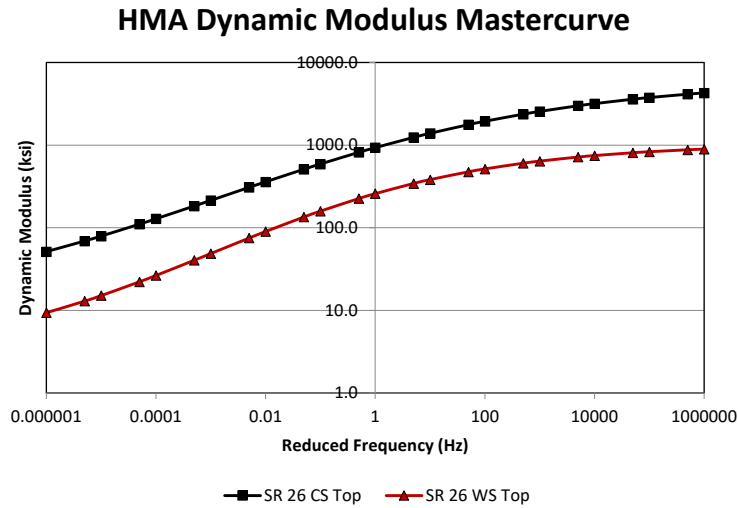
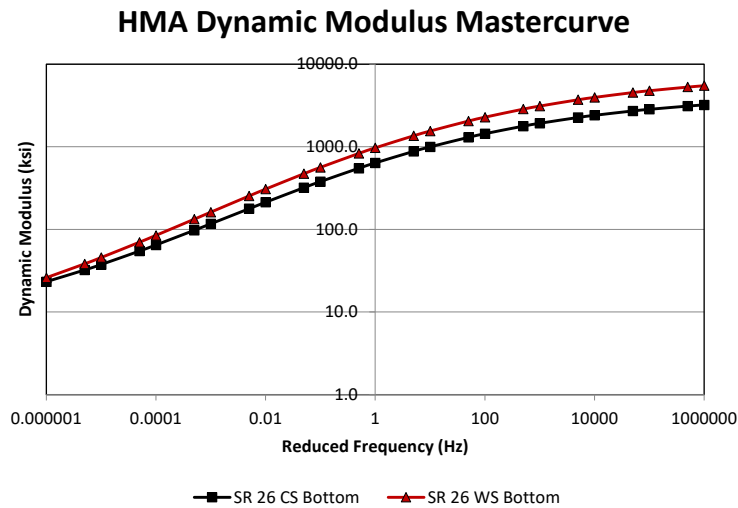
Figure 4-21 and Figure 4-22 show the backcalculated AC dynamic modulus master curve shifted to a reference temperature of 50 °F (10 °C) for the top and the bottom AC lifts, respectively. The backcalculated dynamic modulus values of the AC layer at 10 Hz as well as the backcalculated modulus of the interface bond and the unbound layers (i.e., base and subgrade) are summarized in Table 4-5. The table clearly shows that when the AC modulus was shifted to a common reference temperature, the top AC lift within the worm section showed significantly lower modulus compared to the control section. This trend is reversed for the lower AC lift. The table also shows that the control section has a slightly stronger bond between the top and the bottom AC lifts.

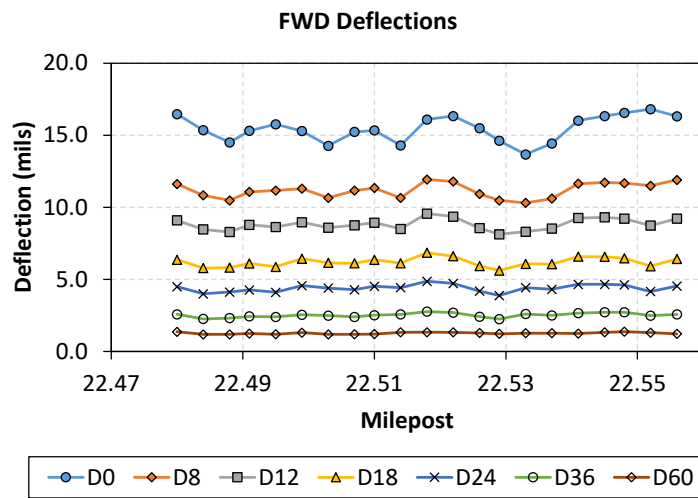
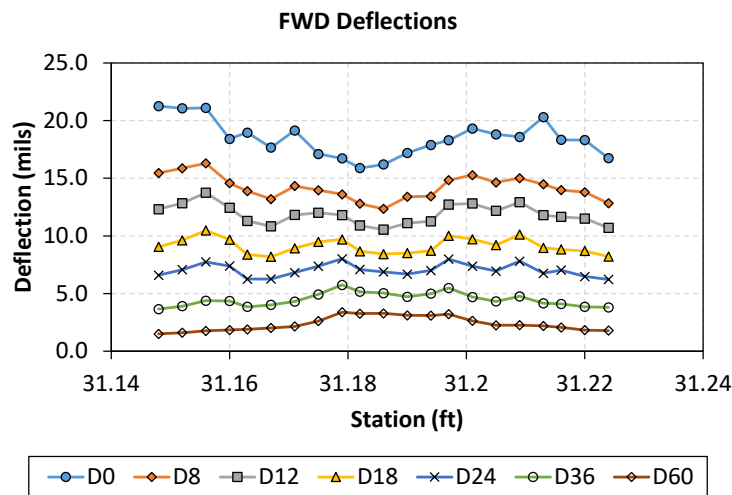
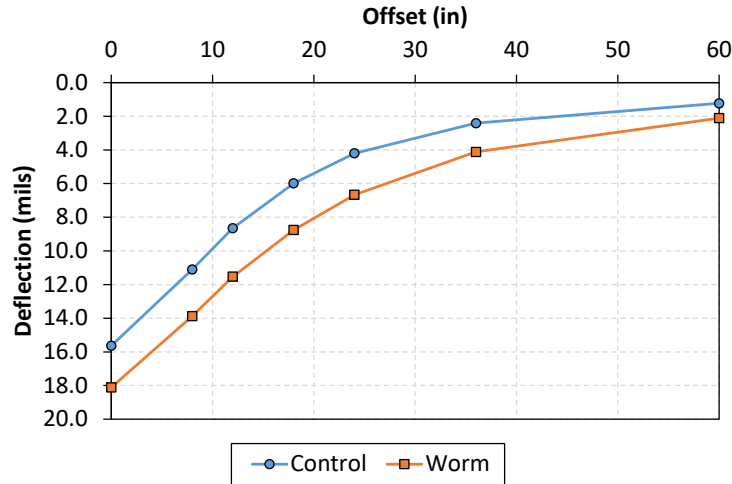
Figure 4-23 and Figure 4-24 show the raw FWD deflections under the 9,000-lb target load, collected from the control and worm sections of SR 24, respectively. Figure 4-25 shows the average deflection basins, with the summary statistics of the deflections provided in Table 4-6. Figure 4-25 and Table 4-6 indicate that the worm section shows not only higher deflections, but also higher variability within the measured deflections.

Table 4-7 summarizes the pavement surface temperature during FWD testing. As seen from the table, the control section temperature was significantly higher (i.e., approximately 24 °F higher) than the worm section temperature. In other words, the worm section showed higher deflections, despite the lower temperature. This indicates that the AC layer in the worm section may show significantly lower modulus when the AC dynamic modulus from both sections are evaluated at the same temperature.

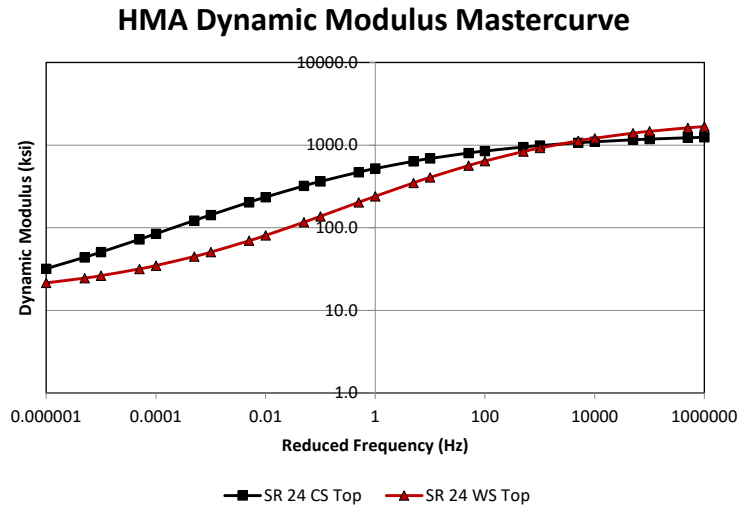
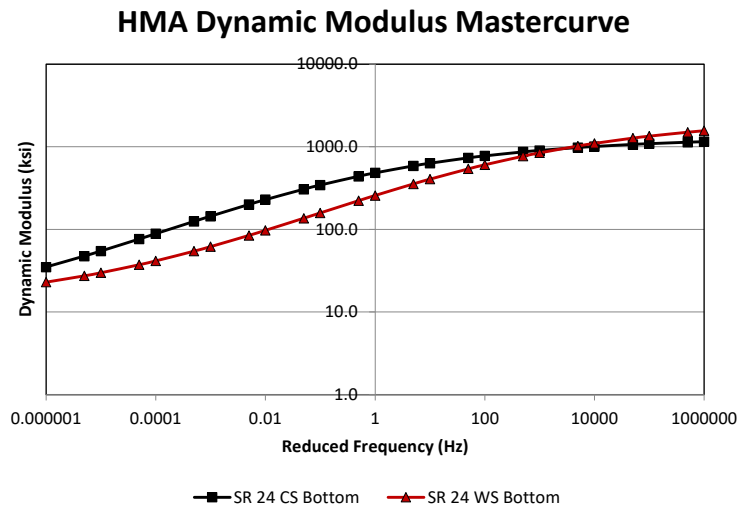
Figure 4-26 and Figure 4-27 show the backcalculated AC dynamic modulus master curve shifted to a reference temperature of 50 °F (10 °C) for the top and the bottom AC lifts, respectively. The backcalculated dynamic modulus values of the AC layer at 10 Hz as well as the backcalculated modulus of the interface bond and the unbound layers (i.e., base and subgrade) are summarized in Table 4-8. The table clearly shows that at the respective FWD testing temperature, the AC within the worm section showed higher modulus. Nonetheless, when the AC modulus was shifted to a common reference temperature, the AC within the worm section showed significantly lower modulus. The table also shows that the control section has a significantly stronger bond between the top and the bottom AC lifts.

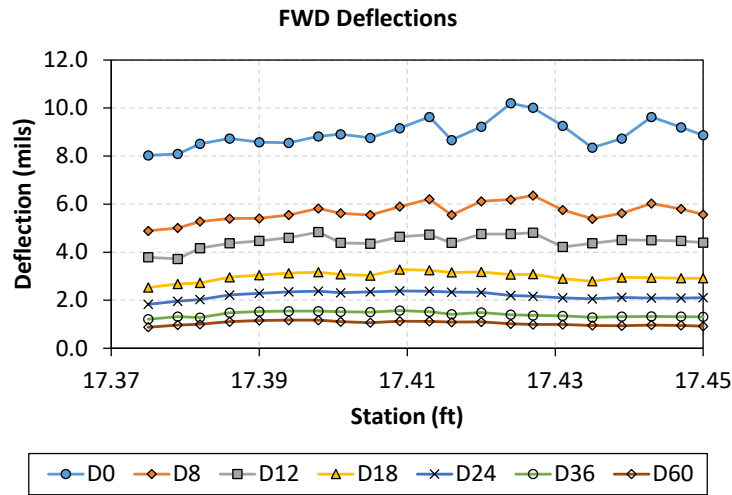
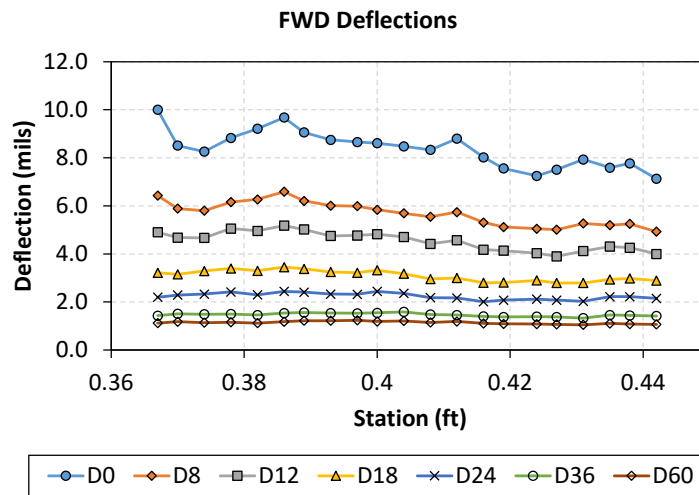
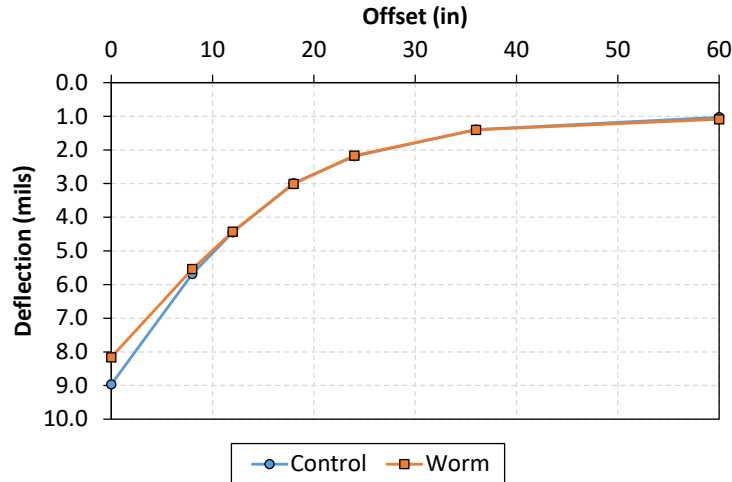
Figure 4-28 and Figure 4-29 show the raw FWD deflections under the 9,000-lb target load collected from the control and worm sections of US 17, respectively. Figure 4-30 shows the average deflection basins, with the summary statistics of the deflections provided in Table 4-9. Figure 4-30 and Table 4-9 show that the average deflections from the control and the worm sections were comparable, with the worm section showing higher variability within the deflections.

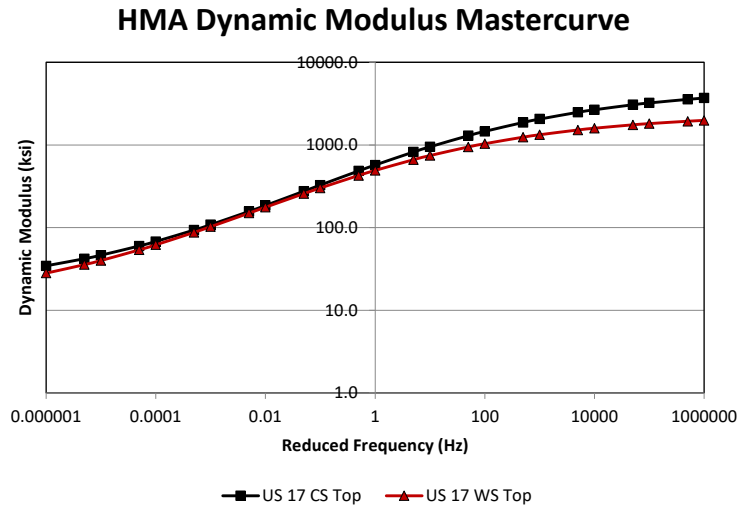
Figure 4-31. Backcalculated Dynamic Modulus Master Curves for US 17 Top Lift AC Layer

Figure 4-31 and Figure 4-32 show the backcalculated AC dynamic modulus master curve shifted to a reference temperature of 50 °F (10 °C) for the top and the bottom AC lifts, respectively. The backcalculated dynamic modulus values of the AC layer at 10 Hz as well as the backcalculated modulus of the interface bond and the unbound layers (i.e., base and subgrade) are summarized in Table 4-11. The table clearly shows that when the AC modulus was shifted to a common reference temperature, both the top and bottom AC lifts within the worm section showed lower modulus compared to the control section. The modulus of the interface bond and the unbound layers were comparable to each other.

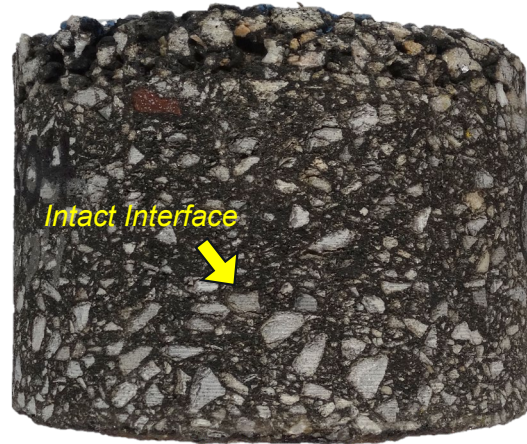
Figure 4-48. SR 79 MP 0.391 Control Section Core – Typical Core

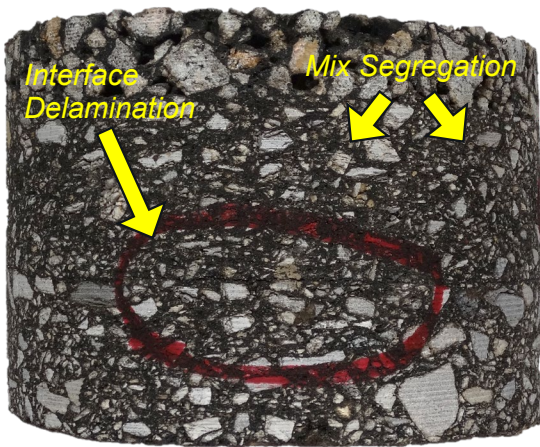
All cores collected from SR 79 were intact. Typical field cores are presented in Figure 4-47 through Figure 4-50. Delamination between the bottom two structural asphalt layers was observed more frequently in worm section cores. Some segregation of aggregate was evident on the bottom AC lift. AC layer thicknesses were consistent between the worm and control sections. The overall AC layer thickness and individual lift thicknesses are presented in Figure 4-51.

Figure 4-49. SR 79 MP 0.321 Worm Section Core – Structural AC Layer Delamination and Segregation

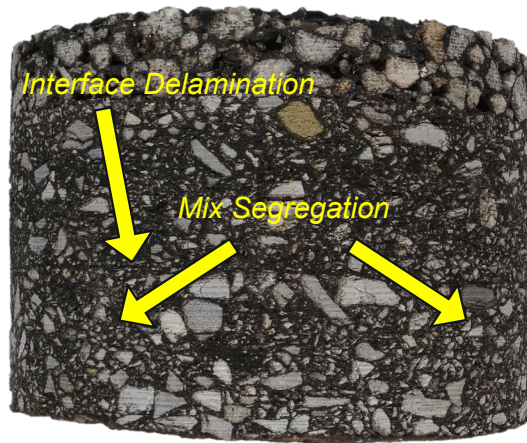
Figure 4-50. SR 79 MP 0.357 Control Section – Structural AC Layer Delamination and Segregation

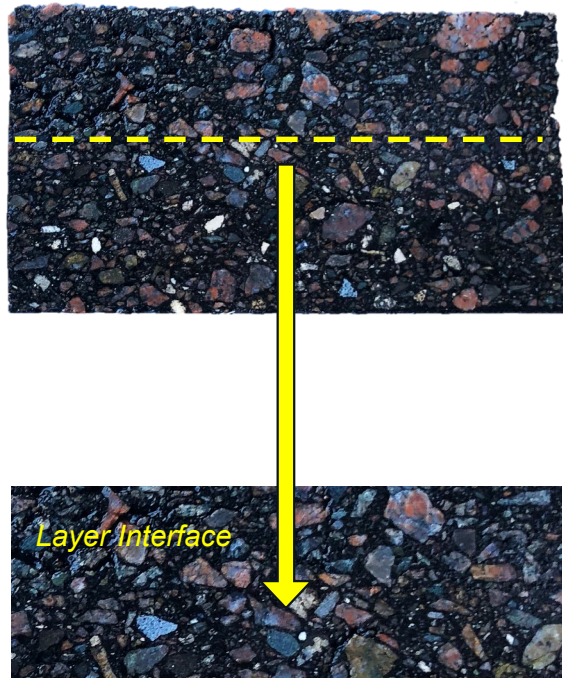
Figure 4-53. SR 26 MP 8.809 Control Core Cross-Section – Typical Core
