Evaluation of Roadway Worms/Distortions

Final Report

Prepared by:
Applied Research Associates, Inc.
430 W 5th Street, Suite #700
Panama City, Florida 32401
850-914-3188 / 850-914-3189 Fax

Contract No. BE491

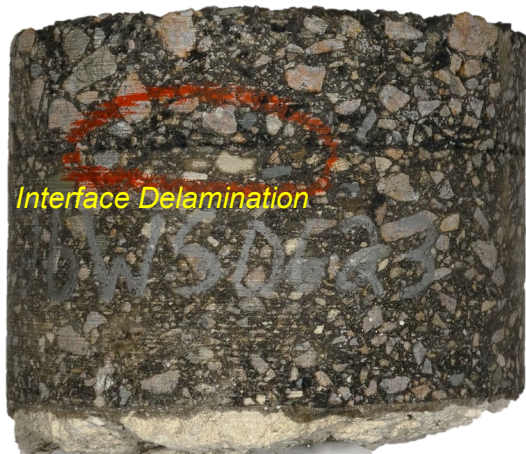
All cores collected from SR 26 were intact. Typical field cores are presented in Figure 4-52 through Figure 4-55. Voids in the pavement structure were noted in both the top two DGA layers for control and worm section cores. The greatest concentration of voids was at the interface of these two layers in the worm section, especially at the bottom of the surface course. The stripped aggregate at this subject interface, shown in Figure 4-52, could be indicative of water traveling along the interface. SR 26 AC layer thicknesses are presented in Figure 4-56. Surface mix lift thicknesses were within 0.1-in agreement on average. The bottom lift AC was 0.6-in thicker in the worm section.

Figure 4-54. SR 26 MP 8.879 Worm Section Core – Upper Layer Delamination

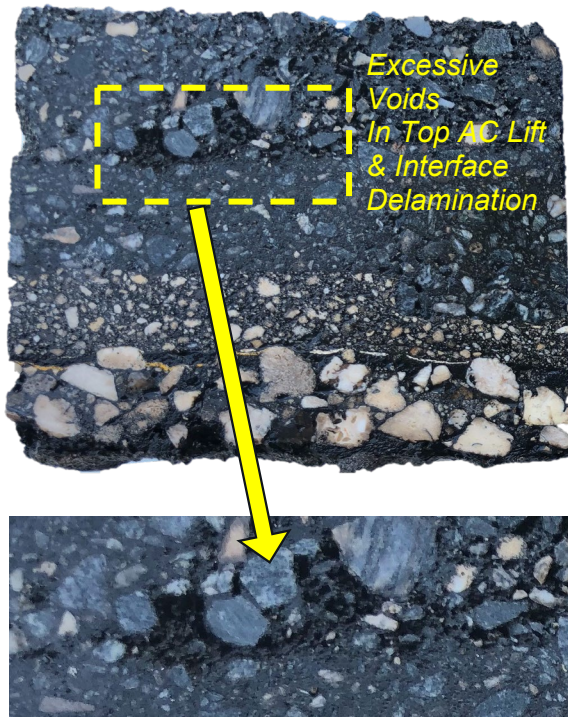
All cores collected from SR 24 were intact. Typical field cores are presented in Figure 4-57 through Figure 4-60. Like the SR 26 cores, the SR 24 cores exhibit considerable voids at the interface of the surface course and underlying layer. These voids are primarily at the bottom of the top layer, but it appears water may have entered the pavement structure and weathered material on both sides of the interface over time. SR 26 AC layer thicknesses are presented in Figure 4-61. Layer thicknesses between worm and control groups are in good agreement.

Figure 4-57. SR 24 MP 31.207 Worm Core Cross Section – Paving Lane Joint with Voids at Bottom of Friction Course

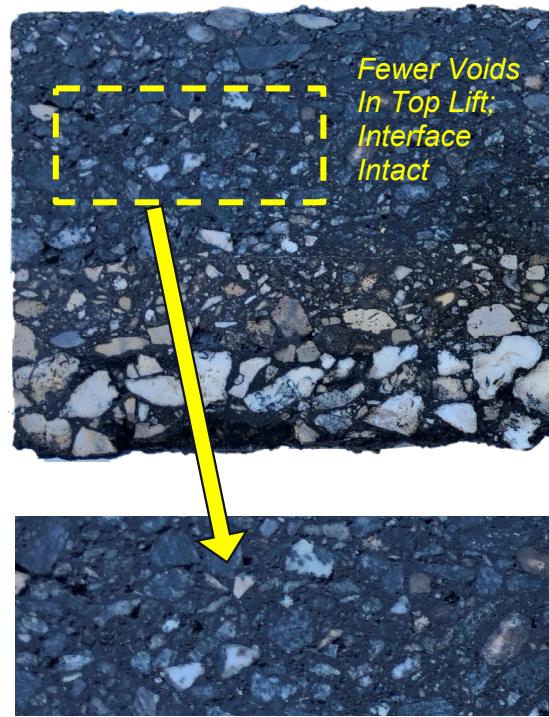
Figure 4-58. SR 24 MP 22.473 – Typical Control Core Cross-Section

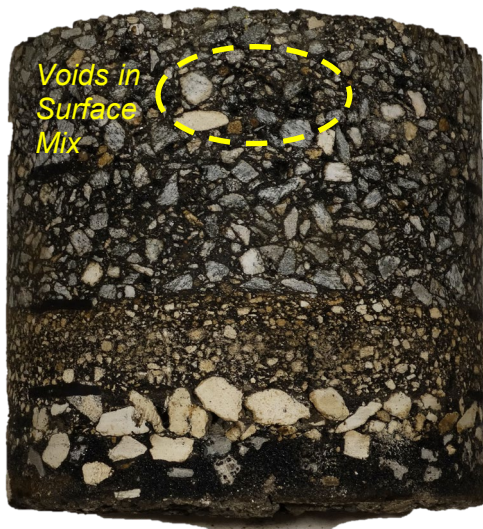
Figure 4-59. SR 24 Typical Worm Section Core at MP 31.185

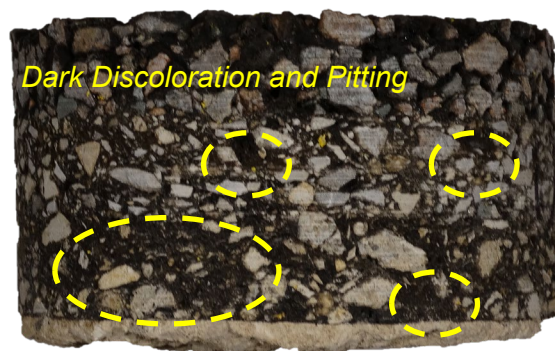
Figure 4-65. US 17 Control Core at MP 17.432 – High Air Voids in All Layers

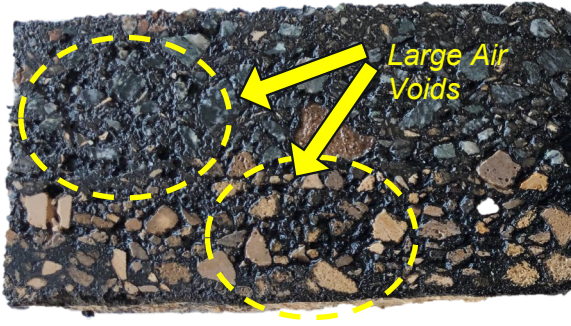
One worm section core broke at the interface during drilling/extraction in the field. The remainder of the 59 cores were collected intact. Typical field cores are presented Figure 4-67 through Figure 4-70. Voids were concentrated around the layer interface in both worm and control sections; however, these voids were more severe in the worm cores. The overall AC layer thickness and individual lift thicknesses are similar for the worm and control cores and are presented in Figure 4-71.

Figure 4-67. SR 20 MP 2.511 Worm Section Paving Lane Joint Cross-Section Showing Large Air Voids in Both AC Layers

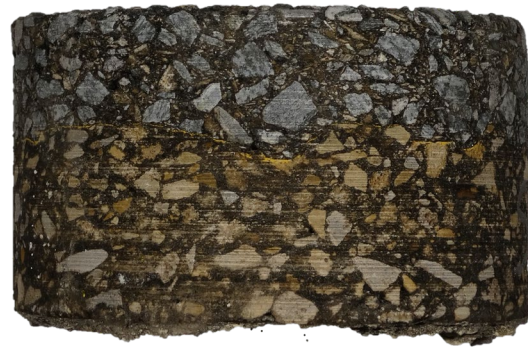
Figure 4-70. SR 24 Typical Control Section Core at MP 2.931

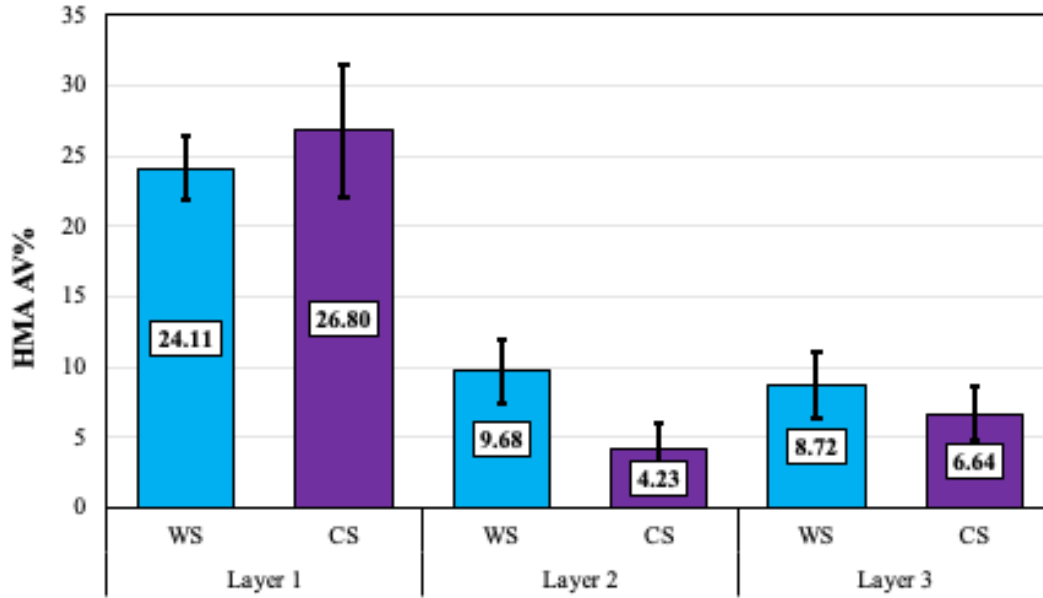
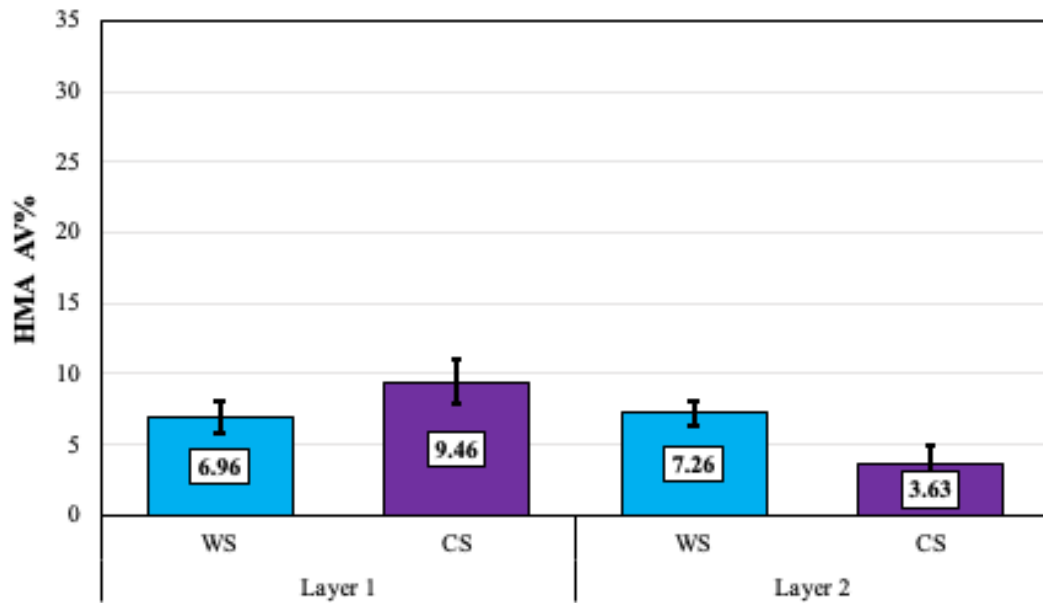
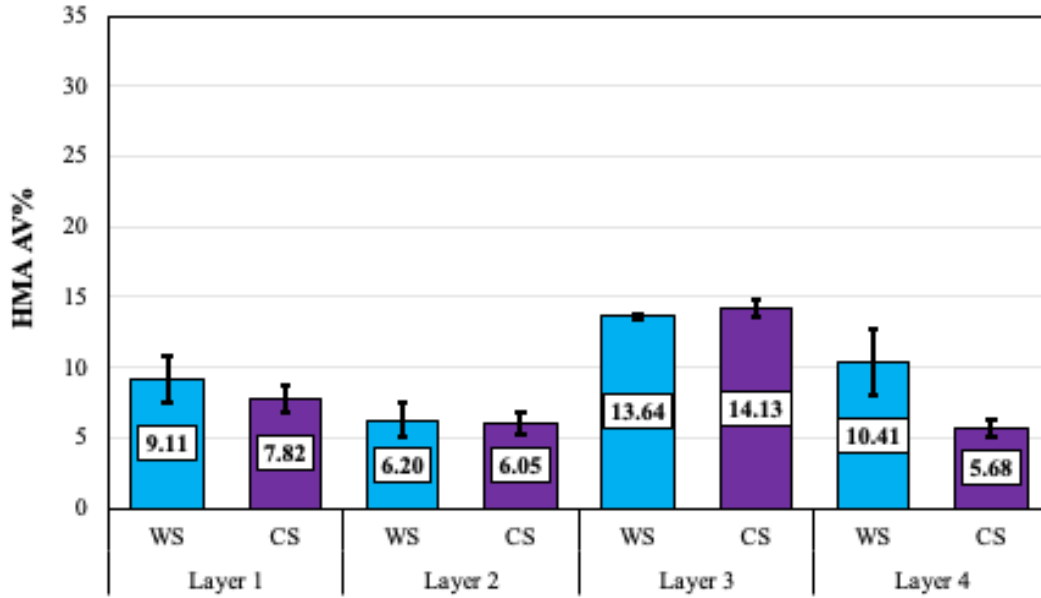
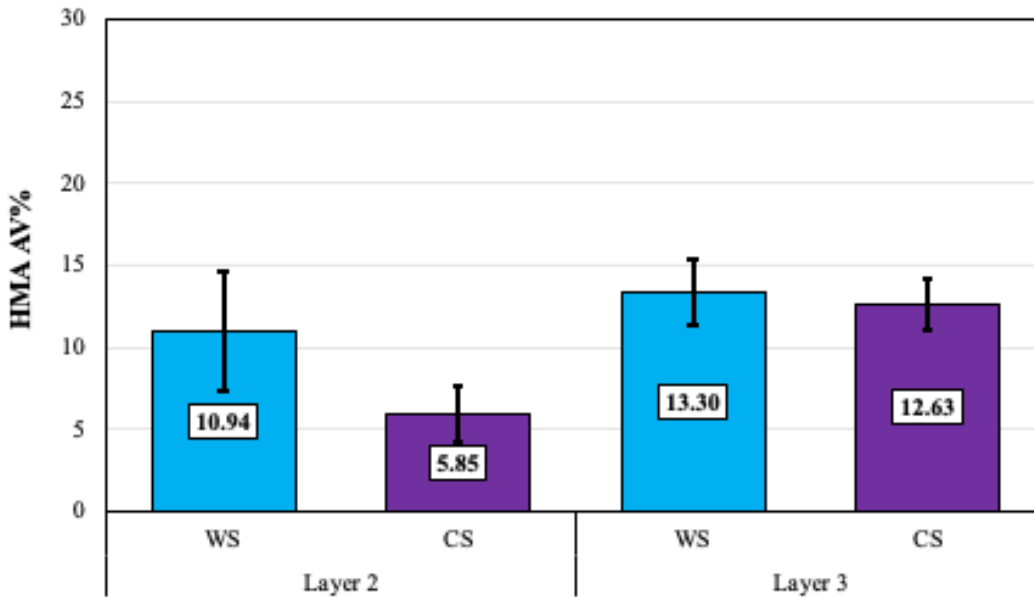
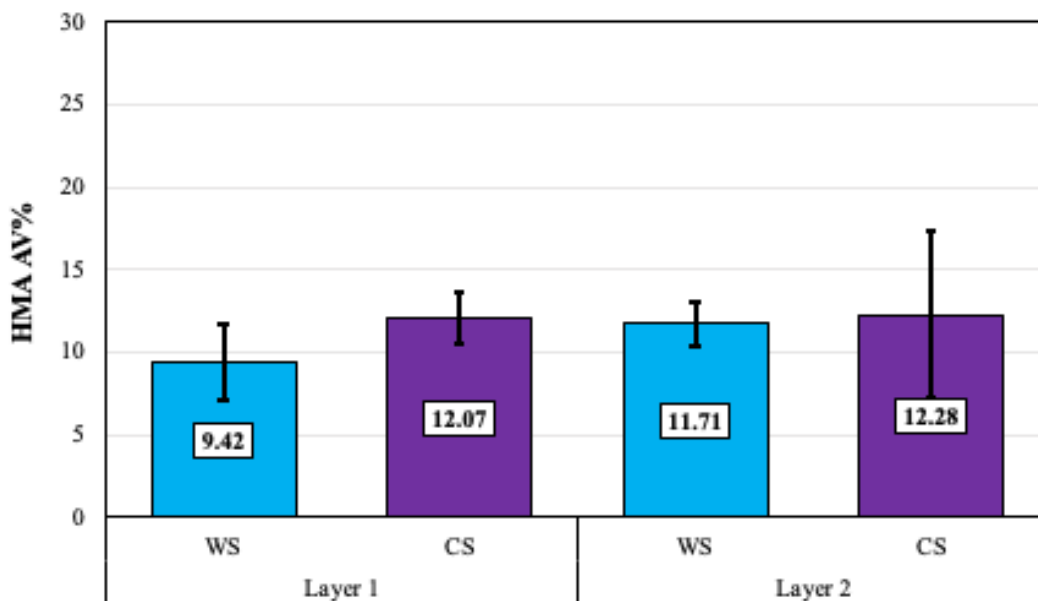
Figure 4-83 through Figure 4-87 present the average air void content for field cores. It was determined after testing the first site (SR 79) that OGFC was likely not a contributing factor to the development of worm distresses; therefore, the US 17 OGFC was not tested. The air void content of DGA materials ranged from 3.63% to 14.13%. In the upper two DGA layers of each project, 90% of the AC tested on the five projects exhibited air voids in excess of the 4% target. The worm section AC contained greater air voids than the control section in 7 of the 10 subject layers.

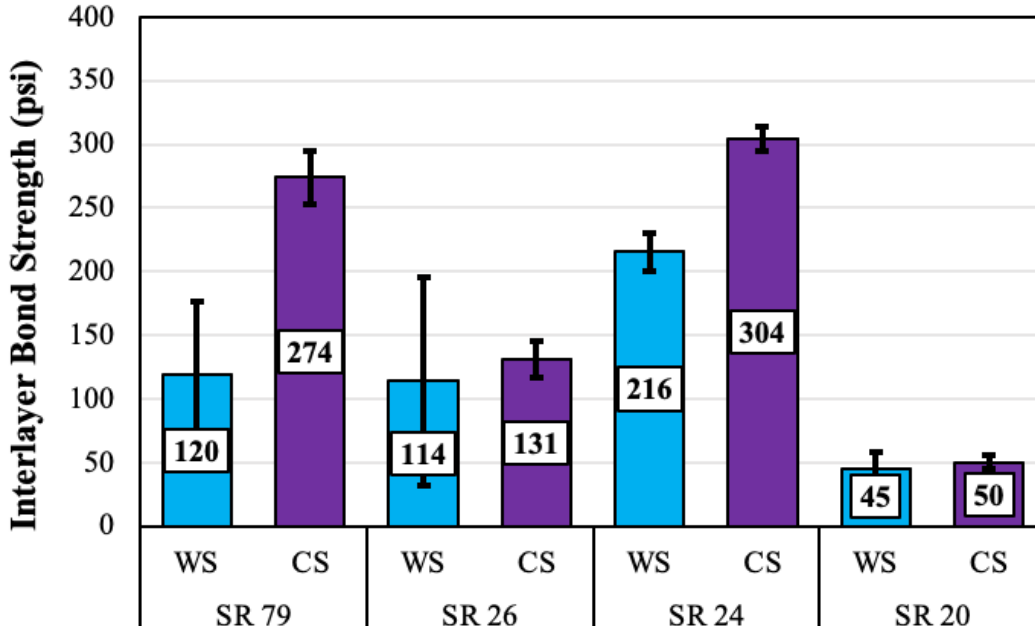
Figure 4-88. Interlayer Bond Strength Results

A total of 58 bond strength tests were performed to assess the interlayer bond strength of the top two dense-graded AC layers of each project. Bond test results are presented in Figure 4-88. The test results show the presence of worm distress is consistent with a reduction in interlayer bond strength. Overall, a total of 31 cores could not be tested due to material failure and not necessarily bond failure. During the initial testing of cores retrieved from SR 79, five consecutive cores failed in the AC material outside of the interface (within the AC mixture itself), resulting in invalid tests. The material failures occurred both in cores sampled from the control and worm-distressed sections. It was observed that the cores did not have interfaces that were truly in plane with the surface of the roadway. To account for this skew, the gap between the shear and reaction frames was increased from 0.25 to 0.375 in to promote better layer interface alignment within the gap. The 0.375-in gap spacing was maintained for all interlayer bond strength tests. Failures in the AC mix continued to occur on cores sampled from all five sites,

possibly indicating a loss of durability, stiffness, and strength of the AC at the subject interface. Of the 58 tests performed, 14 failures were observed in the top AC layer, 8 failures were observed in the bottom layer, 30 cores sheared at the interface, and 5 cores exhibited fractures in both the upper and lower AC layers. No core samples from US 17 fractured along the interface. Both AC layers at the interface were considerably deteriorated; however, the lower layer exhibited the most severe pitting and voids. A close-up of these distresses along the interface are shown on a typical worm section core in Figure 4-89.

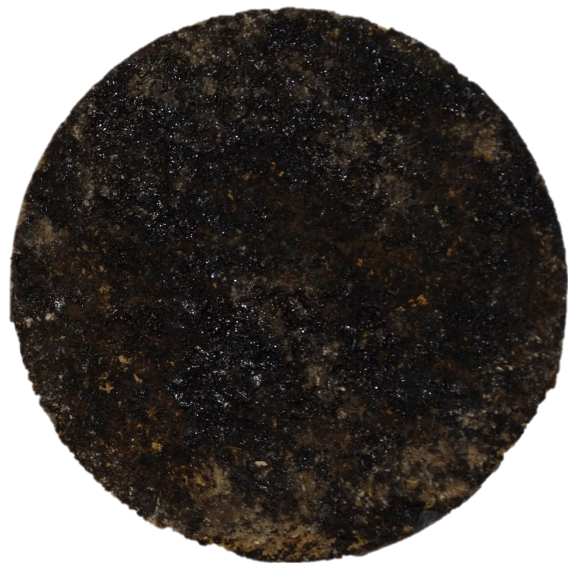
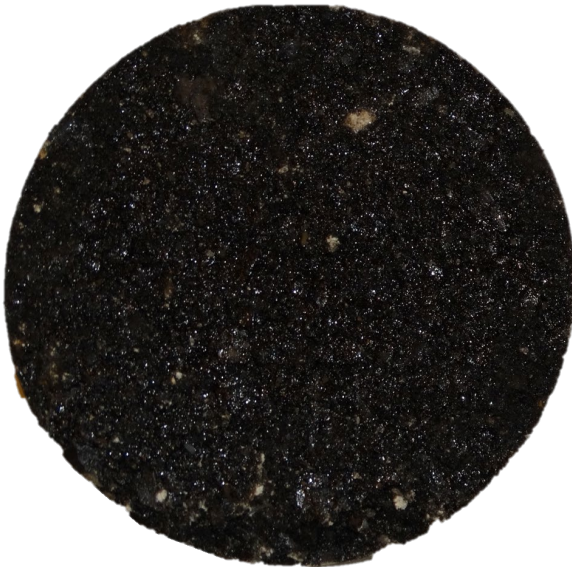
Figure 4-90. SR 79 Example AC Layer Interfaces

- SR 79
 - Control Section: Uniform tack coat on interfaces.
 - Worm Section: Inconsistent tack coat coverage; approximately 30% to 40% of tack material missing or has brown color that resembles an unbroken or re-emulsified tack coat.

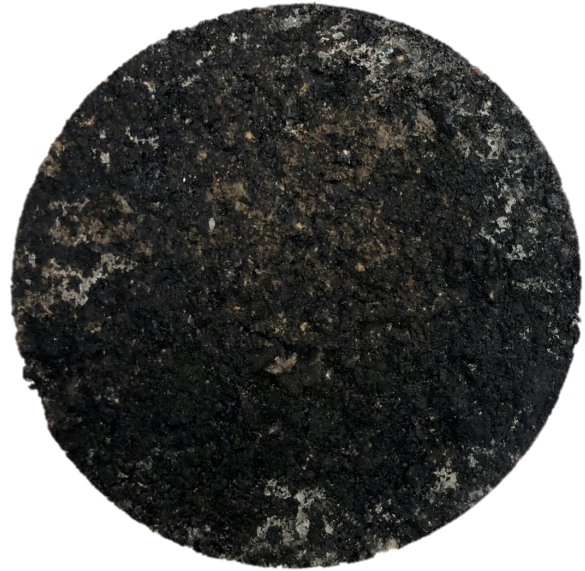
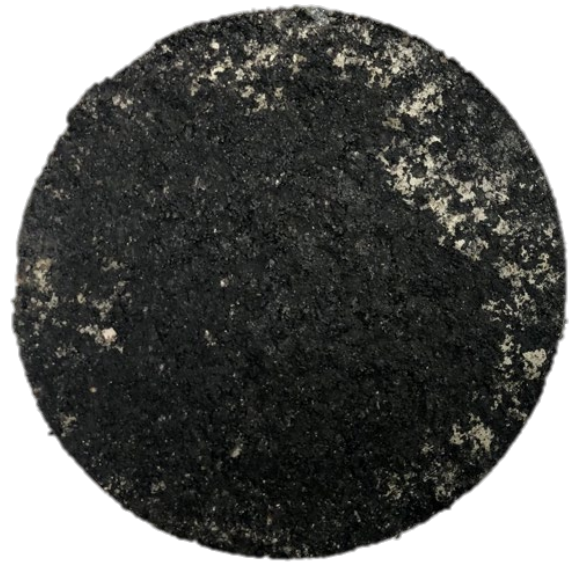
Figure 4-92. SR 24 Example AC Layer Interfaces

- SR 24
 - Control Section: Uniform tack coat on interfaces.
 - Worm Section: Missing tack coat; appearance may indicate trapped water between layers has stripped tack in areas and left behind white stains.

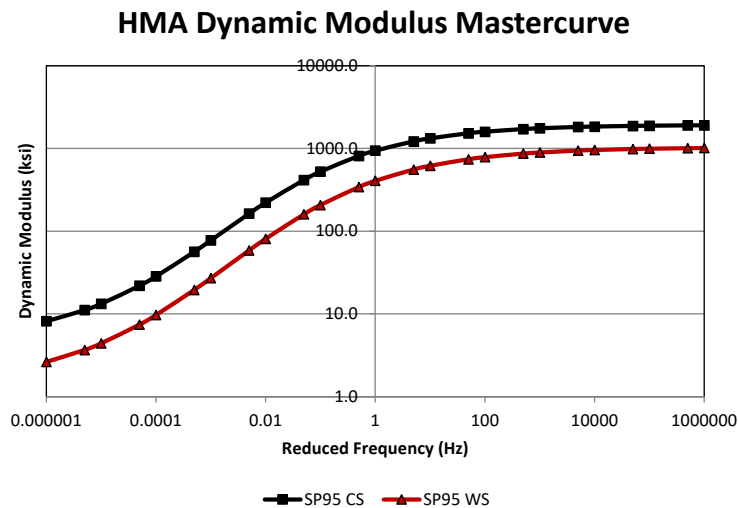
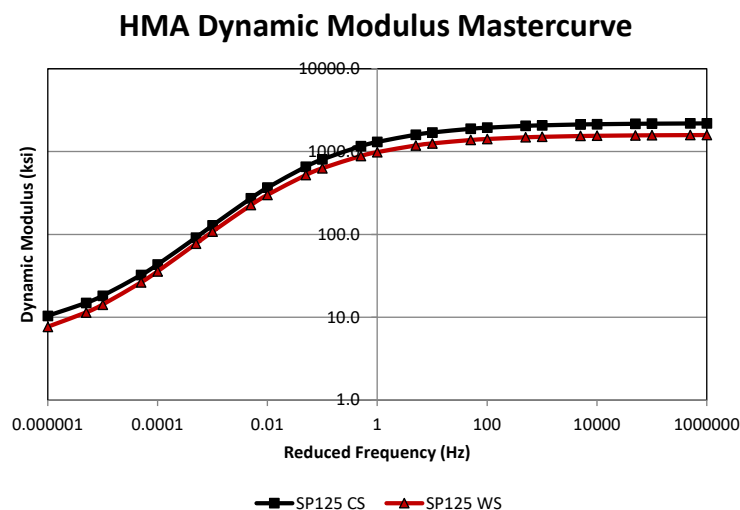
Figure 4-104 and Figure 4-105 show the AC dynamic modulus master curves for SR 79 at a reference temperature of 50°F (10°C) for the top and the bottom AC lifts, respectively. Similar to the trends of the FWD backcalculated dynamic modulus master curves, the worm section shows significantly lower modulus for the top lift AC (Figure 4-104). More specifically, the top lift AC modulus was found to be 1,323 ksi and 618 ksi for the control and worm sections, respectively. This corresponds to a 53% reduction in AC modulus for the worm section, which is in agreement with the PSPA data discussed previously (Figure 4-46). The bottom lift AC from the worm section is also showing lower modulus compared to the control section (Figure 4-105), although the difference is not as significant—approximately 26% reduction from control section modulus of 1,703 ksi to worm section modulus of 1,257 ksi.

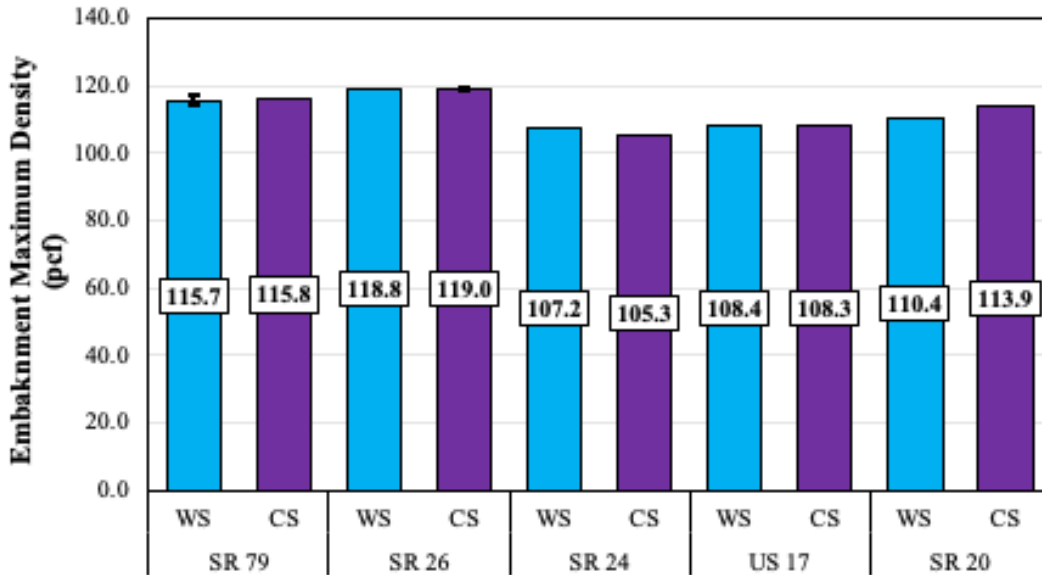
Figure 4-114. Laboratory Embankment Maximum Density Results

Maximum density of embankment materials from the proctor test are presented in Figure 4-114. The average maximum density of all materials ranged from 105.3 pcf to 119.3 pcf. No bias in the data was observed between worm and control groups.

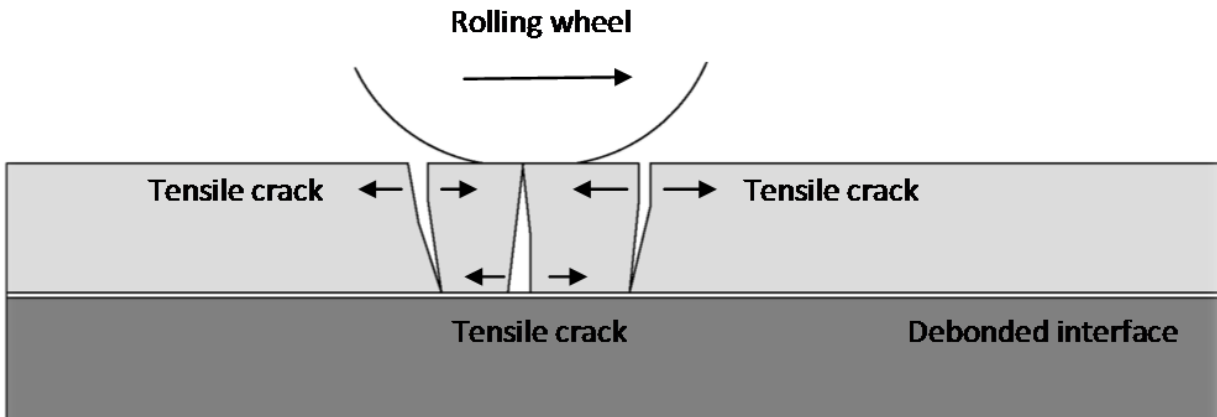
Figure 4-115. Illustration of Tensile Cracks in the Debonded Surface Layer [32]

If the top lift/layer of AC is debonded from the lower layers, it is possible for cracks to initiate at the bottom of the top AC lift and propagate upwards. An illustration of tensile cracks due to debonding of the upper AC is shown in Figure 4-115 [32]. Since the top lift is relatively thin (typically 1.0 to 1.5 in), these cracks may appear at the pavement surface much sooner than the traditional bottom-up cracking from intact pavements. As such, these cracks are frequently categorized as top-down cracking by the time they become visible at the pavement surface.

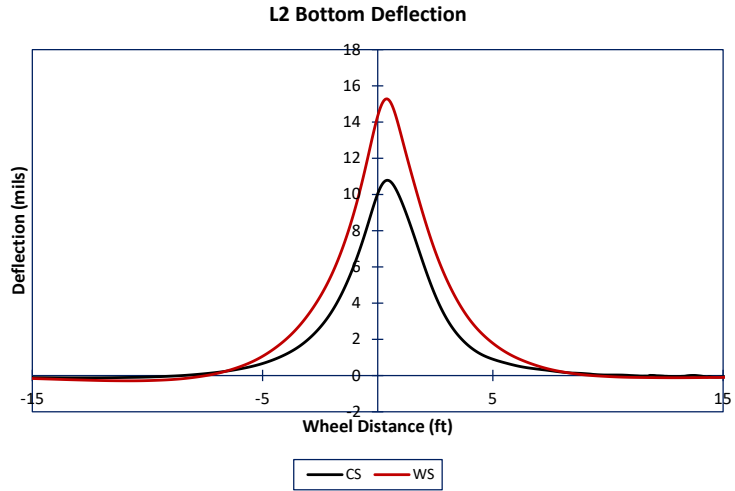
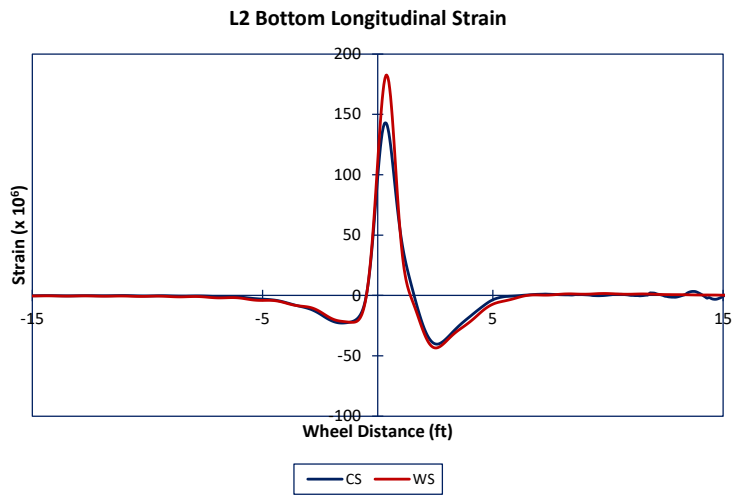
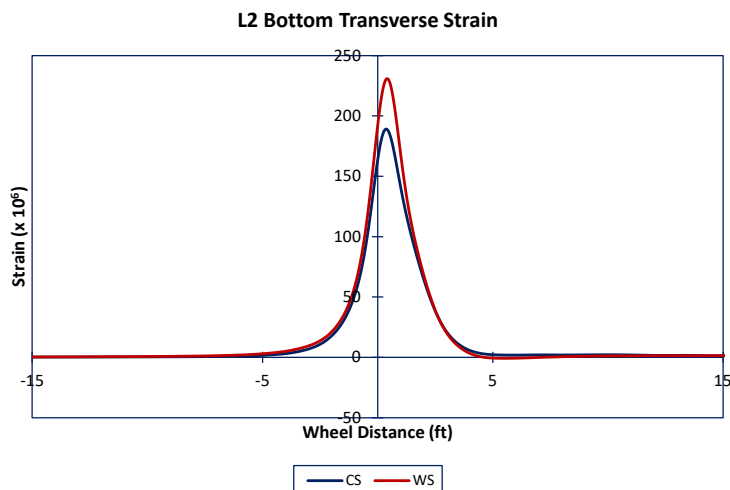
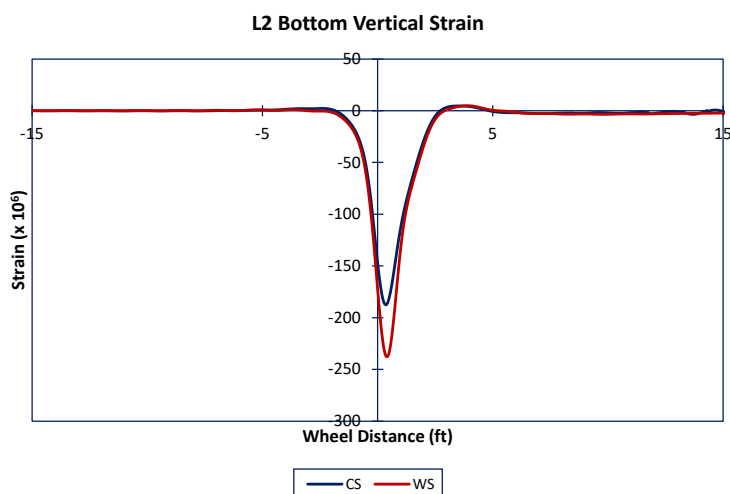
The same pavement structures used for FWD backcalculation (see Section 4.1.3) were used for simulating the pavement response under a moving load with ViscoWave. The load was modeled as a single tire with 9,000 lbs uniformly distributed over a circular, 8-in diameter contact area. The speed of the moving load was fixed at 50 mph. As an example of the ViscoWave simulation results, Figure 4-116 shows the pavement deflection simulated at the bottom of SR 24 AC. Similarly, Figure 4-117, Figure 4-118, and Figure 4-119 show the longitudinal, transverse, and vertical strains simulated at the bottom of the AC layer, respectively. Clearly, these figures show that the lower AC modulus and the lower bond modulus in the worm section contributed to the increased pavement response (deflection and strains).

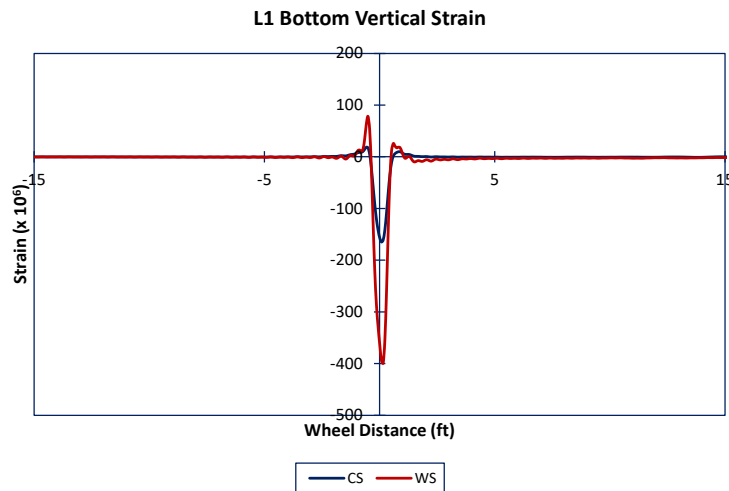
Figure 4-120. ViscoWave Simulated SR 26 Vertical Strain at Bottom of Top Lift AC

the bottom lift AC compared to the control section. Furthermore, the SR 26 worm section was the only section in which the top lift AC exhibited significantly lower (i.e., almost five times lower) modulus compared to the bottom lift (see Figure 4-38 and Figure 4-39). The outcome of such a drastic difference in AC modulus is that the bottom lift AC does not undergo a significant amount of “bending” and most of the strains occur within the weaker, top lift AC. As an example, Figure 4-120 and Figure 4-121 show the simulated vertical and transverse (i.e., horizontal) strains for the bottom of the SR 26 top lift AC. For all three strains, tension is positive and compression is negative in the charts. These figures clearly show that while the vertical, compressive strain increased significantly, the tensile strain almost diminished within the worm section (i.e., no bending).

As seen from the above, the negligible amount of tensile strain observed within the top lift AC of the SR 26 worm section is responsible for the higher amount of N_f value shown in Table 4-24. On the other hand, it is believed that the increased vertical strain within the top lift AC may cause increased rutting within the AC layer. As such, the vertical strain at the mid-depth of each AC lift was simulated and the rut depth progression was predicted using the MEPDG methodology. Figure 4-122 and Figure 4-123 show, as an example, the predicted rut depth for the SR 26 control and worm sections, respectively. Figure 4-122 shows that the rutting within the control section is relatively minimal and most of the rutting is contributed to the bottom lift AC. Conversely, Figure 4-123 shows that the rut depth within the worm section grows relatively rapidly, and the rutting is mostly confined to the top lift AC (i.e., the weaker AC layer).

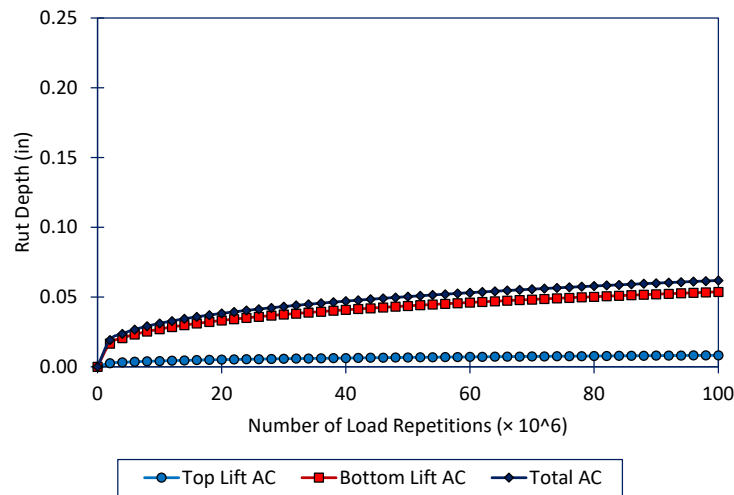
Figure 4-122. Rut Depth Predicted for SR 26 Control Section

From the rut depth progression curves (such as those shown above), the pavement life under rutting was obtained for each of the sites. The rutting pavement life was defined as the number of load repetitions (N_f) until a total AC rut depth of 0.25 in is achieved. Table 4-25 summarizes these N_f values as well as the estimated life reduction for the worm sections.

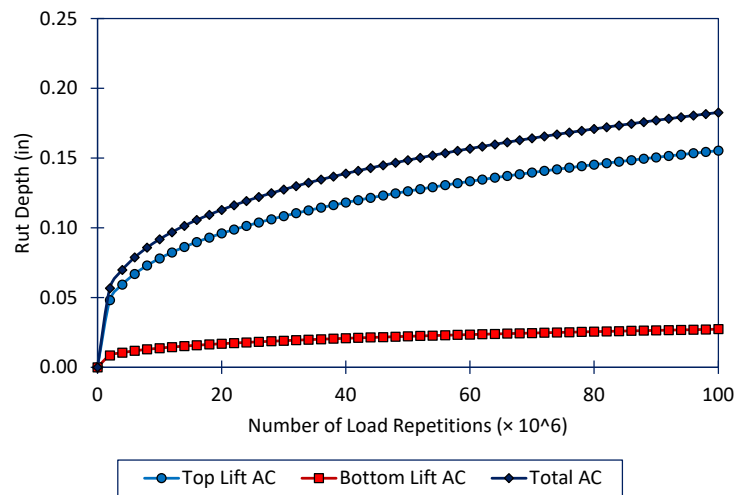
Figure 4-123. Rut Depth Predicted for SR 26 Worm Section

The above table clearly shows that the worm distress may have a significant effect on pavement life based on rutting, which ranges from a 7% to 97% reduction. The most significant life reduction was observed from SR 26.
