Evaluation of FDOT Corrosion Prevention and Control Programs

DOT-RFP-19-9059-GH

FINAL REPORT

Wiss, Janney, Elstner Associates, Inc.

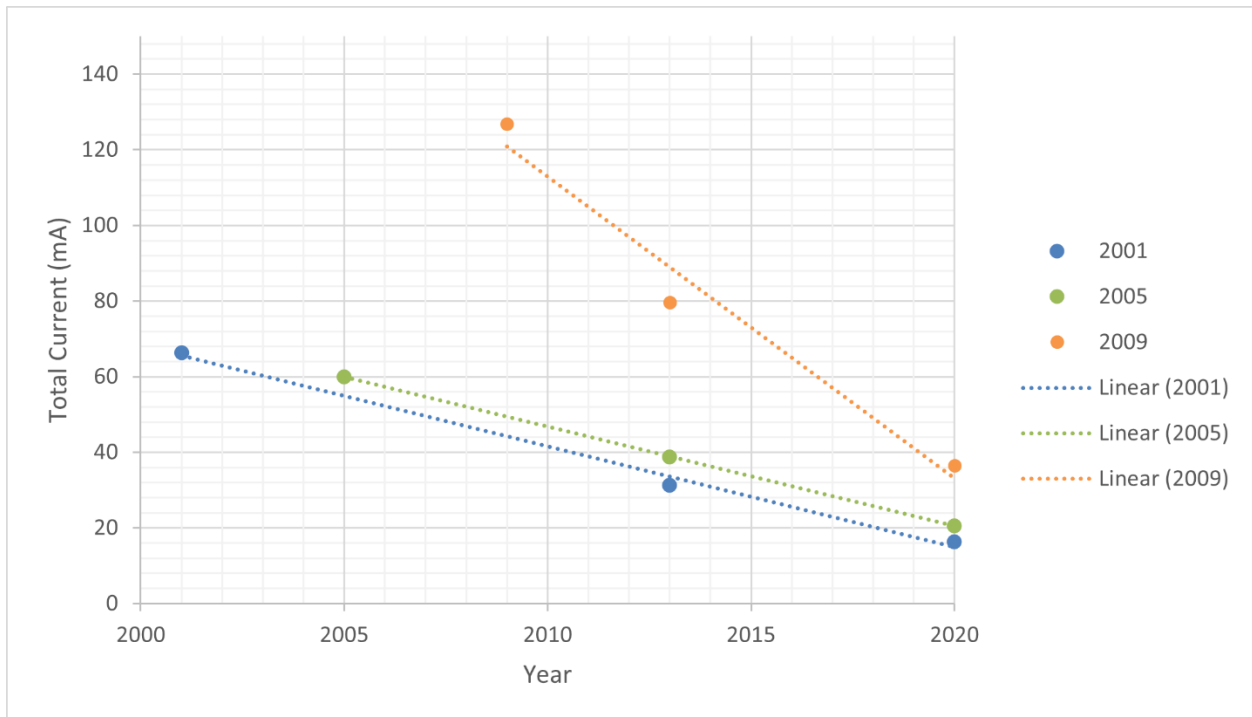
Current– A review of total current output data for the three generations of jackets indicated a clear downward trend between commissioning and 2020. Although the average total current measured for the 2009 CP pile jacket installations was measured approximately double the 2001 and 2005 installations, average total current outputs have lessened at approximately a linear rate since initial installation, as

shown in Figure 10. While there are no direct criteria for the minimum total current required to provide adequate CP within pile jackets, higher current flows are generally associated with greater levels of protection and larger polarization decays, if similar system resistances are present. As such, lower current can be indicative of lower CP; however, polarization development and/or decay are not directly proportional to the total current.

Figure 10. Overview of total current as a function of time.

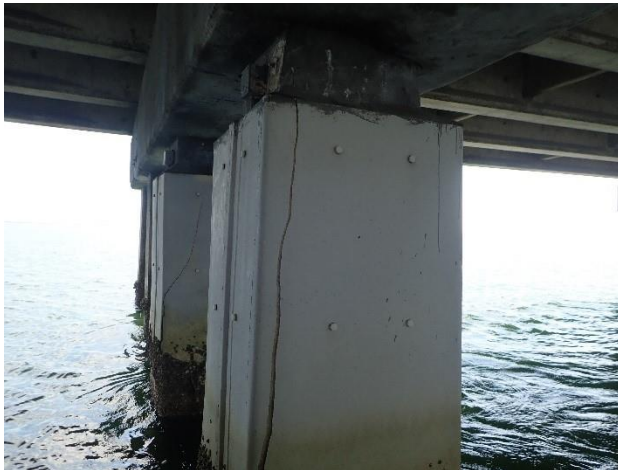
Fiberglass Jacket Distress – Approximately 55 percent of the 38 observed fiberglass jackets exhibited some form of distress with variable degrees of severity. The most commonly observed distress was cracking of the fiberglass, which was observed on 12 jackets, ranging from minor corner cracks to vertical cracking extending the entire length of the jacket (Figure 14). In worse cases, entire sections of the jackets had been broken off, exposing the fill grout, as observed in 9 jackets (Figure 15). When entire sections of fiberglass were missing, cracking appeared to initiate at the bottom portion of the jacket and extend upwards. The exact mechanism of the jacket failures was unable to be determined. However, a likely assumption is that cracking initiates first, allowing water and marine growth to penetrate between the jacket and the grout, eventually breaking off.

Figure 14. Full-height cracking of fiberglass jacket (Pile 289-5 shown).

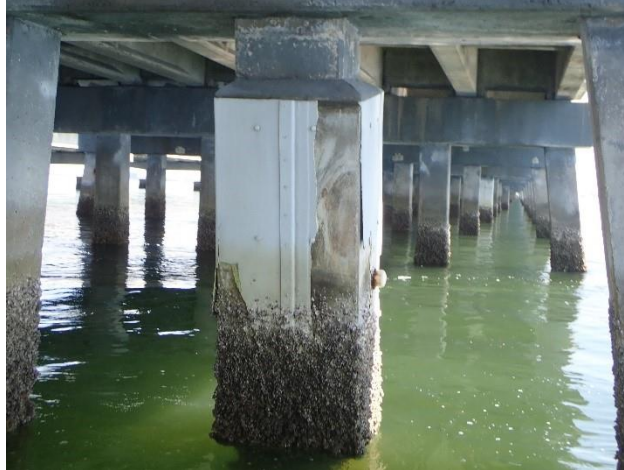
Figure 15. Sections of fiberglass jacket broken off entirely (Pile 105-9 shown)

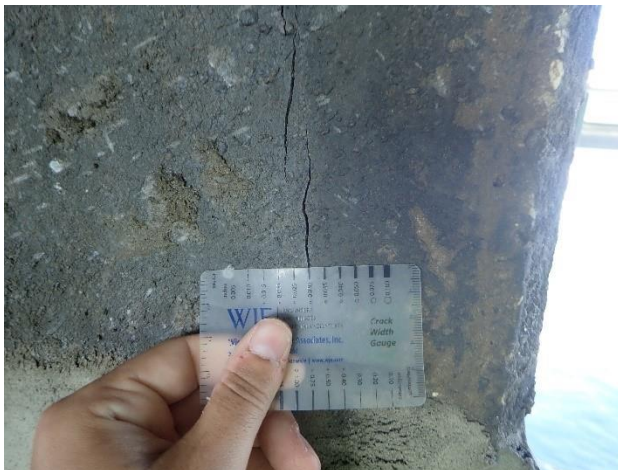
Pile Distress –Twentyone of the 38 piles observed in this investigation exhibited distress such as cracking or spalling. Cracking typically propagated upward from the top of the jackets and ranged in width from 5 to 50 mil, likely indicative of underlying corrosion of the embedded steel (Figure 16). In some cases, reddish-brown staining was visibly discharging from the crack, further evidence of likely corrosion of the reinforcing steel (Figure 17). In most cases, the cracking was observed two to four inches from the corner(s) of the pile, suggesting that the corner prestressing strands are experiencing ongoing corrosion, as would be expected due to the two-sided exposure. In isolated cases, the cracking resulted in delamination and/or spalling at the corners of the piles.

Figure 16. Typical vertical cracking propagating upward from top of pile at corner (Pile 198-1 shown)

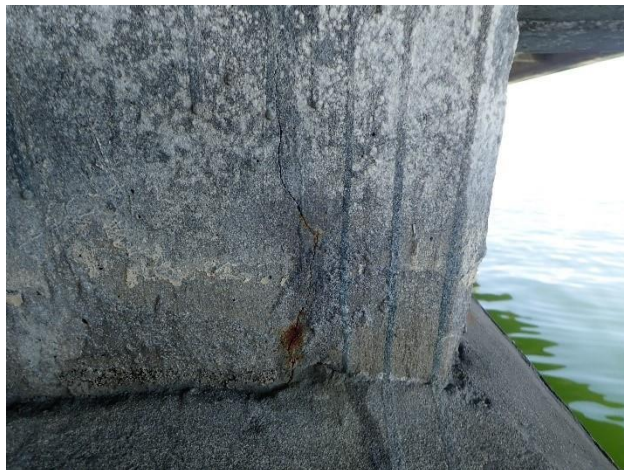
Figure 17. Example of vertical cracking exhibiting minor rust staining (Pile 236-7 shown)

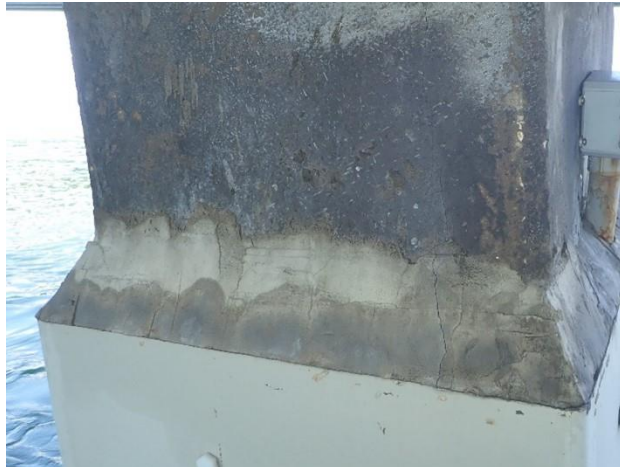
Miscellaneous Observations – Separation between the top portion of the grout material and/or cracking of grout material was commonly observed. The separation was between either the fiberglass jacket and grout interface, the grout and pile interface, or both. The jacket to grout interface separation is of minor consequence, as is transverse cracking within the grout. Separation of the grout-to-concrete pile interface may negatively affect CP performance depending on severity due to the increased resistance disruption of the ionic current path. However, it is likely that the observed separation is limited to the sloped portion of

Figure 18. Cracking of sloped grout material above jacket (Pile 198-1 shown).

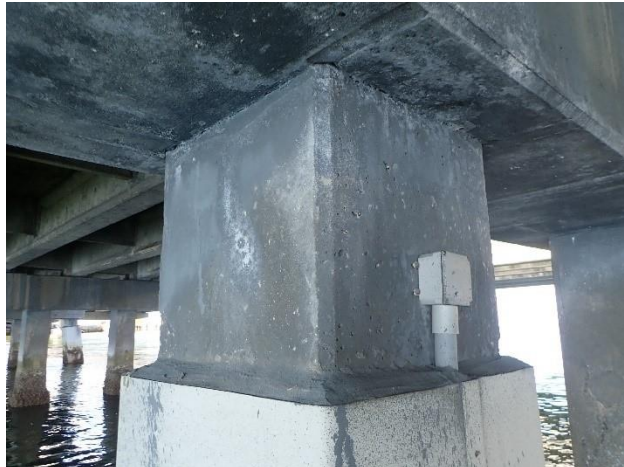
Multiple pile caps had been coated with arc-spray metalizing, and several piles below had received some level of coating due to overspray (Figure 18 and Figure 19). While it did not appear the intent was for the metalizing to protect the top of the piles, they may be receiving some residual protection if reinforcing steel from the piles and pile caps are continuous.

Figure 19. Metalizing overspray observed on pile (Pile 14-4 shown)

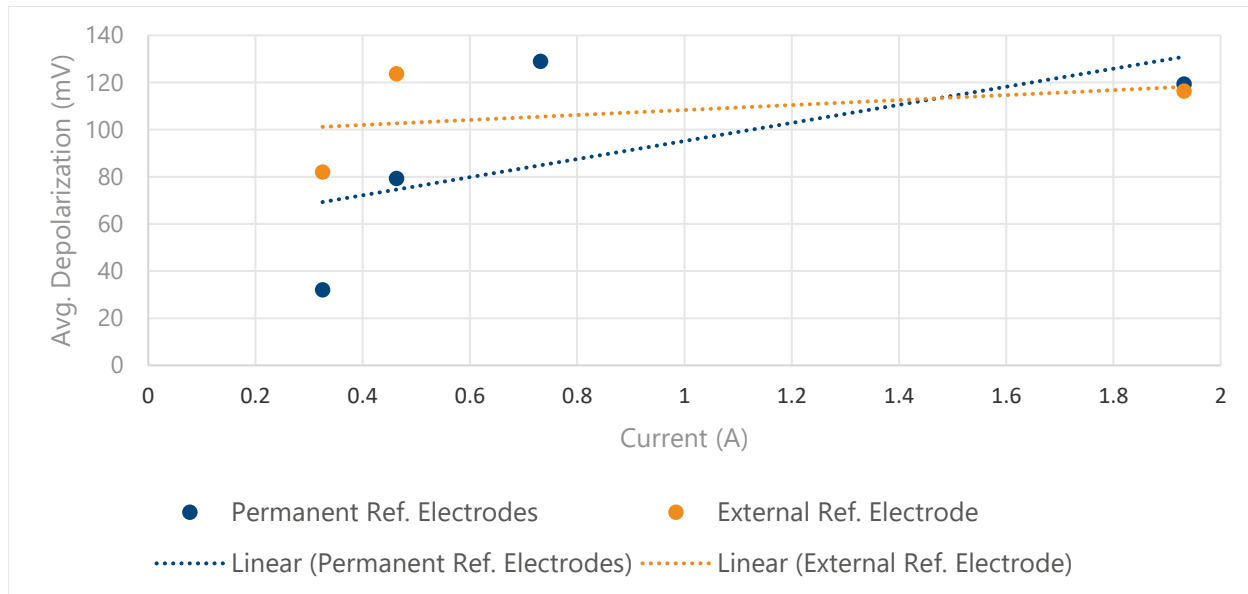
Further review of obtained data shows that increased current output appears to correspond with higher average depolarization measurements at the respective piers, as shown in Figure 24. However, with such a limited amount of applicable data, it is difficult to thoroughly compare the current output with depolarization measurements and substantiate a given conclusion.

Figure 24. Current versus average depolarization measurements for the Gandy Bridge.

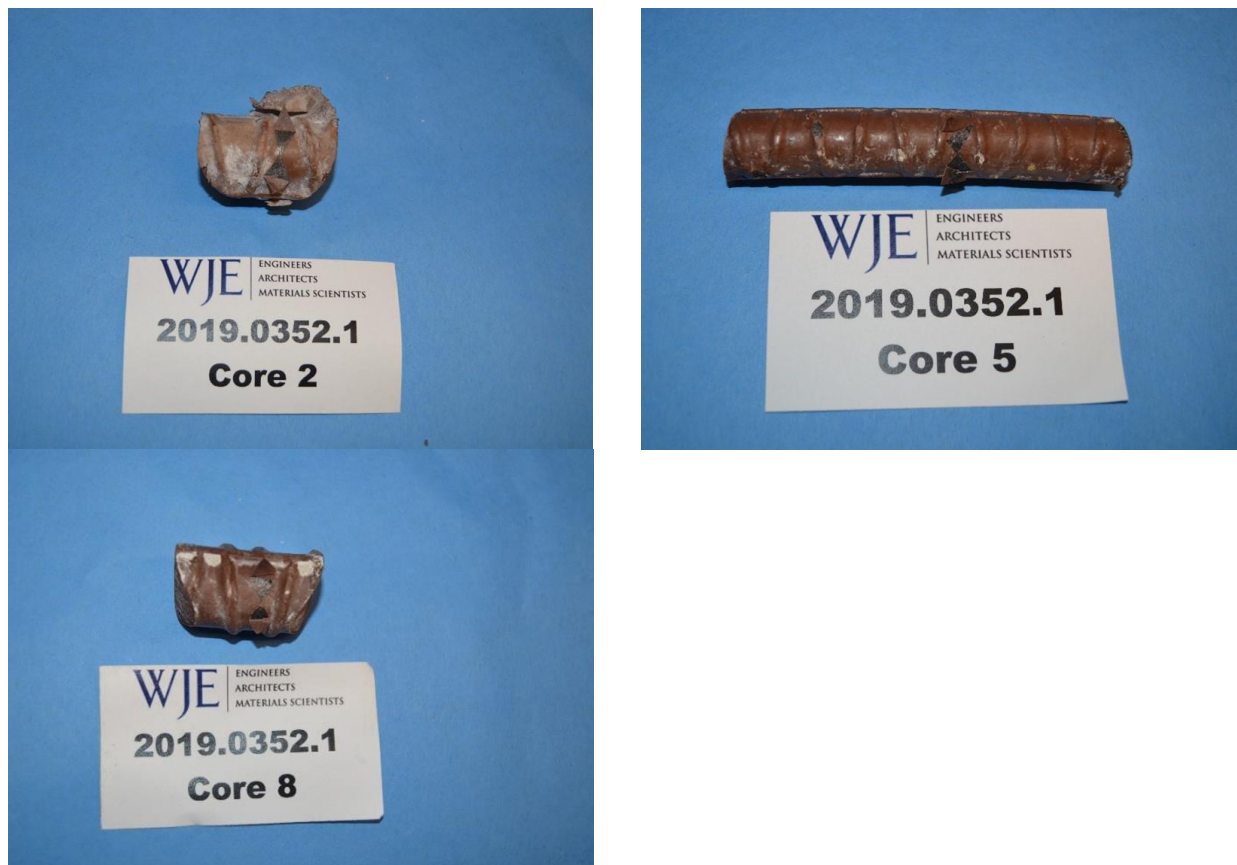
epoxy coated bars were included within the collected cores, as shown in Figure 26. Brown epoxy coating was used. Laboratory evaluation of the ECR found that the coating thickness averaged between 8 to 12 mils. No corrosion (rated 1) is observed in one of the bars. Minor corrosion (rated 2) is present in the other two bars, with corrosion observed to be active in one. The knife adhesion rating for the epoxy coating ranged from a rating of 3, moderate adhesion (epoxy peels from bars in 1/4" sections), to a rating of 4 (epoxy peels from bars in 3/8" sections). The backside contamination rating for the epoxy coating is less than 5% for the three bars.

Figure 26. Photographs of evaluated ECR samples from Bridge No. 700181.

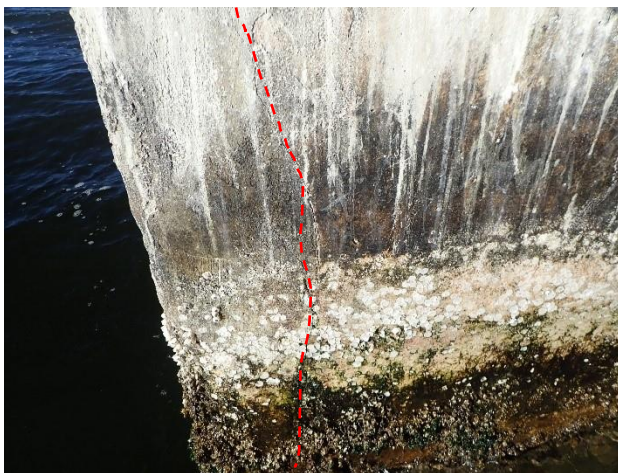
Pile Caps – Pile caps exhibited cracking on the vertical faces with crack widths ranging from approximately 10 to 40 mil in width. With the exception of one 15 mil crack observed within the face of the north pile cap, cracking was observed to be located within six inches of an outside corner, presumably caused by corrosion of the vertical bars placed in the corners. Lengths of these cracks varied, but most of them extended upward from the mean growth line (MGL) (Figure 27 and Figure 28). Sounding of these areas did not identify any concrete surfaces that were delaminated.

Figure 27. Representative vertical cracking extending upward from the MGL.

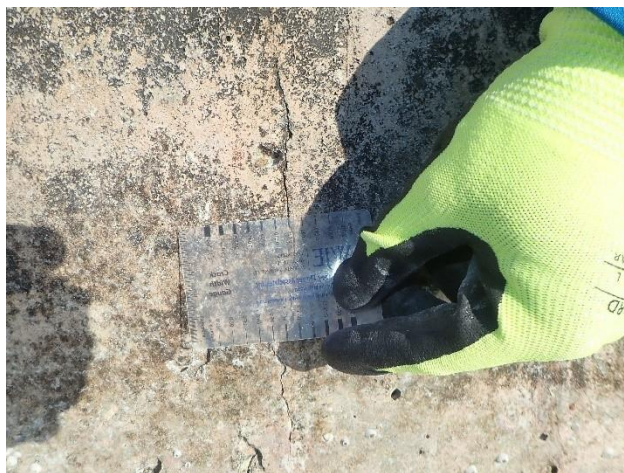
Figure 28. Crack width gauge indicating an approximate crack width of 25 mil.

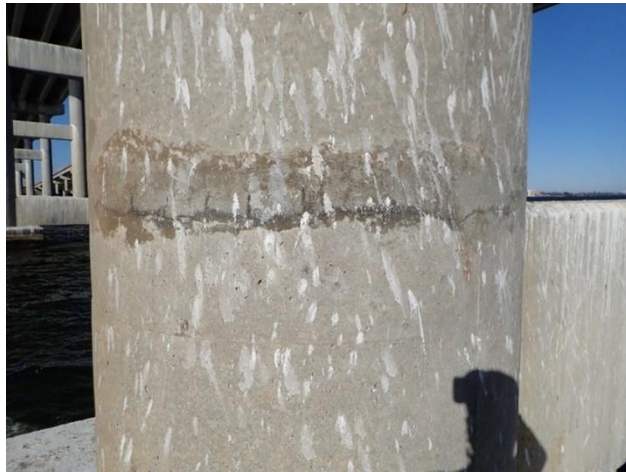
Figure 29. Typical cracking of column at elevation of top of strut.

Columns – Columns exhibited minimal distress except for circumferential cracking adjacent to the top of the strut. This cracking exhibited minor efflorescence and appeared to have had parge coat repairs at some time in the past. With the elevation of this cracking matching the top of the strut, this cracking is assumed to be flexural cracking as the columns sway above the struts that provide lateral constraint. Because this cracking is not believed to be a result of corrosion activity, it is omitted from the quantitative summary of distress provided later in this section.

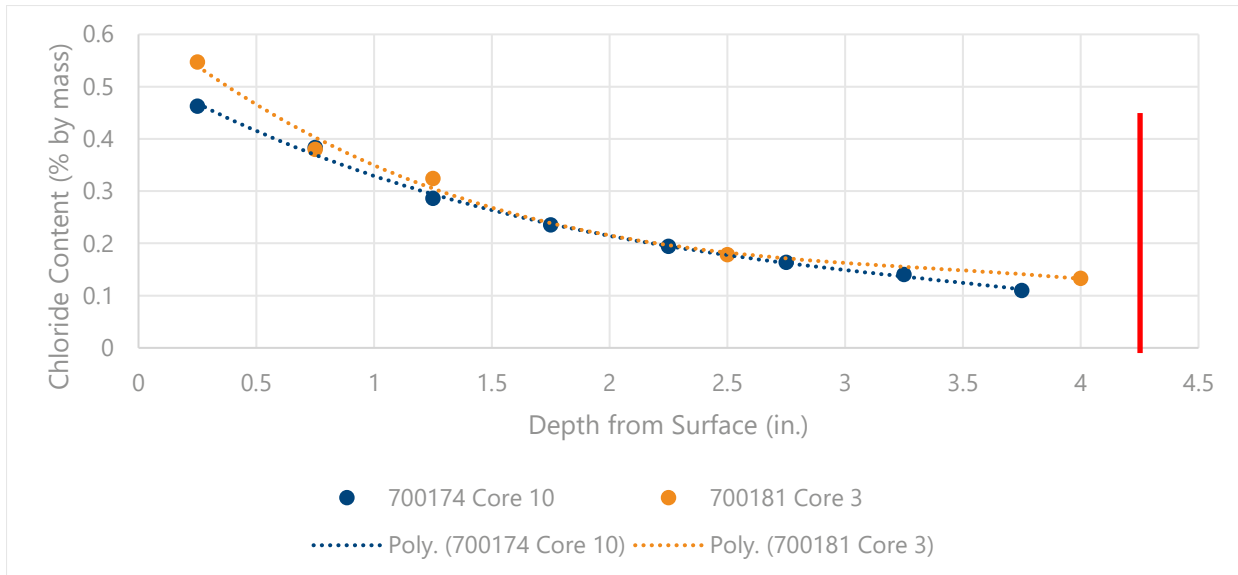
In 2011, Bridge No. 700181 had seven fewer years of exposure than Bridge No. 700174, and as expected, chloride contents were measured to be less in Bridge No. 700181. The primary purpose of chloride content testing in this investigation is to determine if the chloride profiles, and specifically the chloride

Figure 30. Chloride profiles for pile cap core samples. Cores shown are Core 10 (Bridge No. 700174, 2011) and Core 3 (Bridge No. 700181, 2021). The red line indicates an approximate depth of the reinforcing steel (4.25 in.)

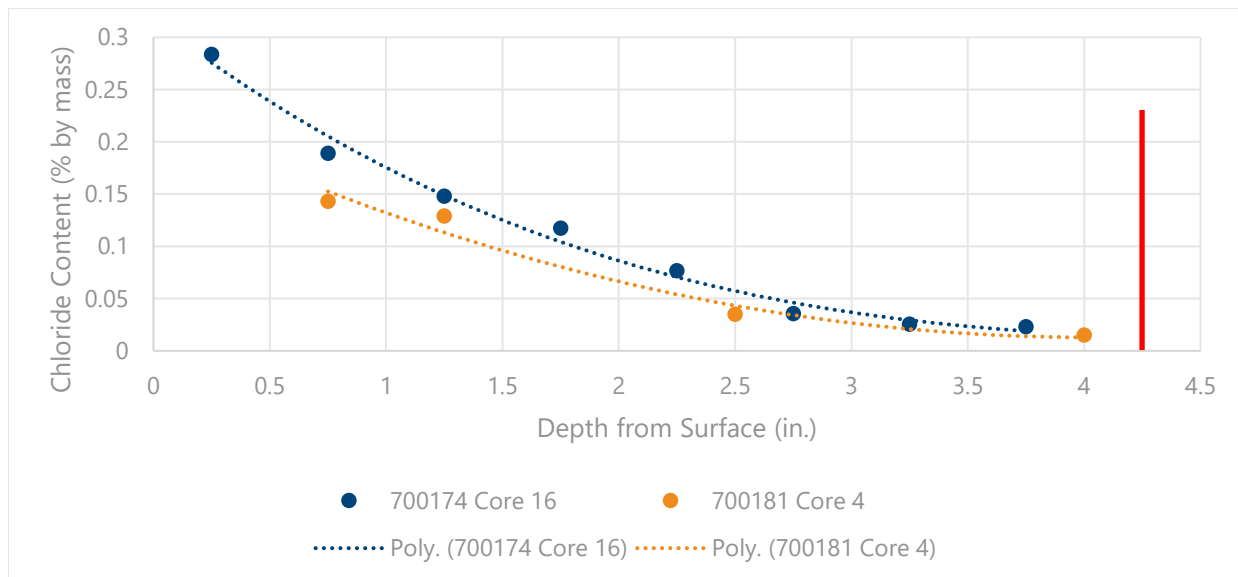
Figure 32. Chloride profiles for strut core samples. Cores shown are Core 16 (Bridge No. 700174, 2011) and Core 4 (Bridge No. 700181, 2021). The red line indicates an approximate depth of the reinforcing steel (4.25 in.)

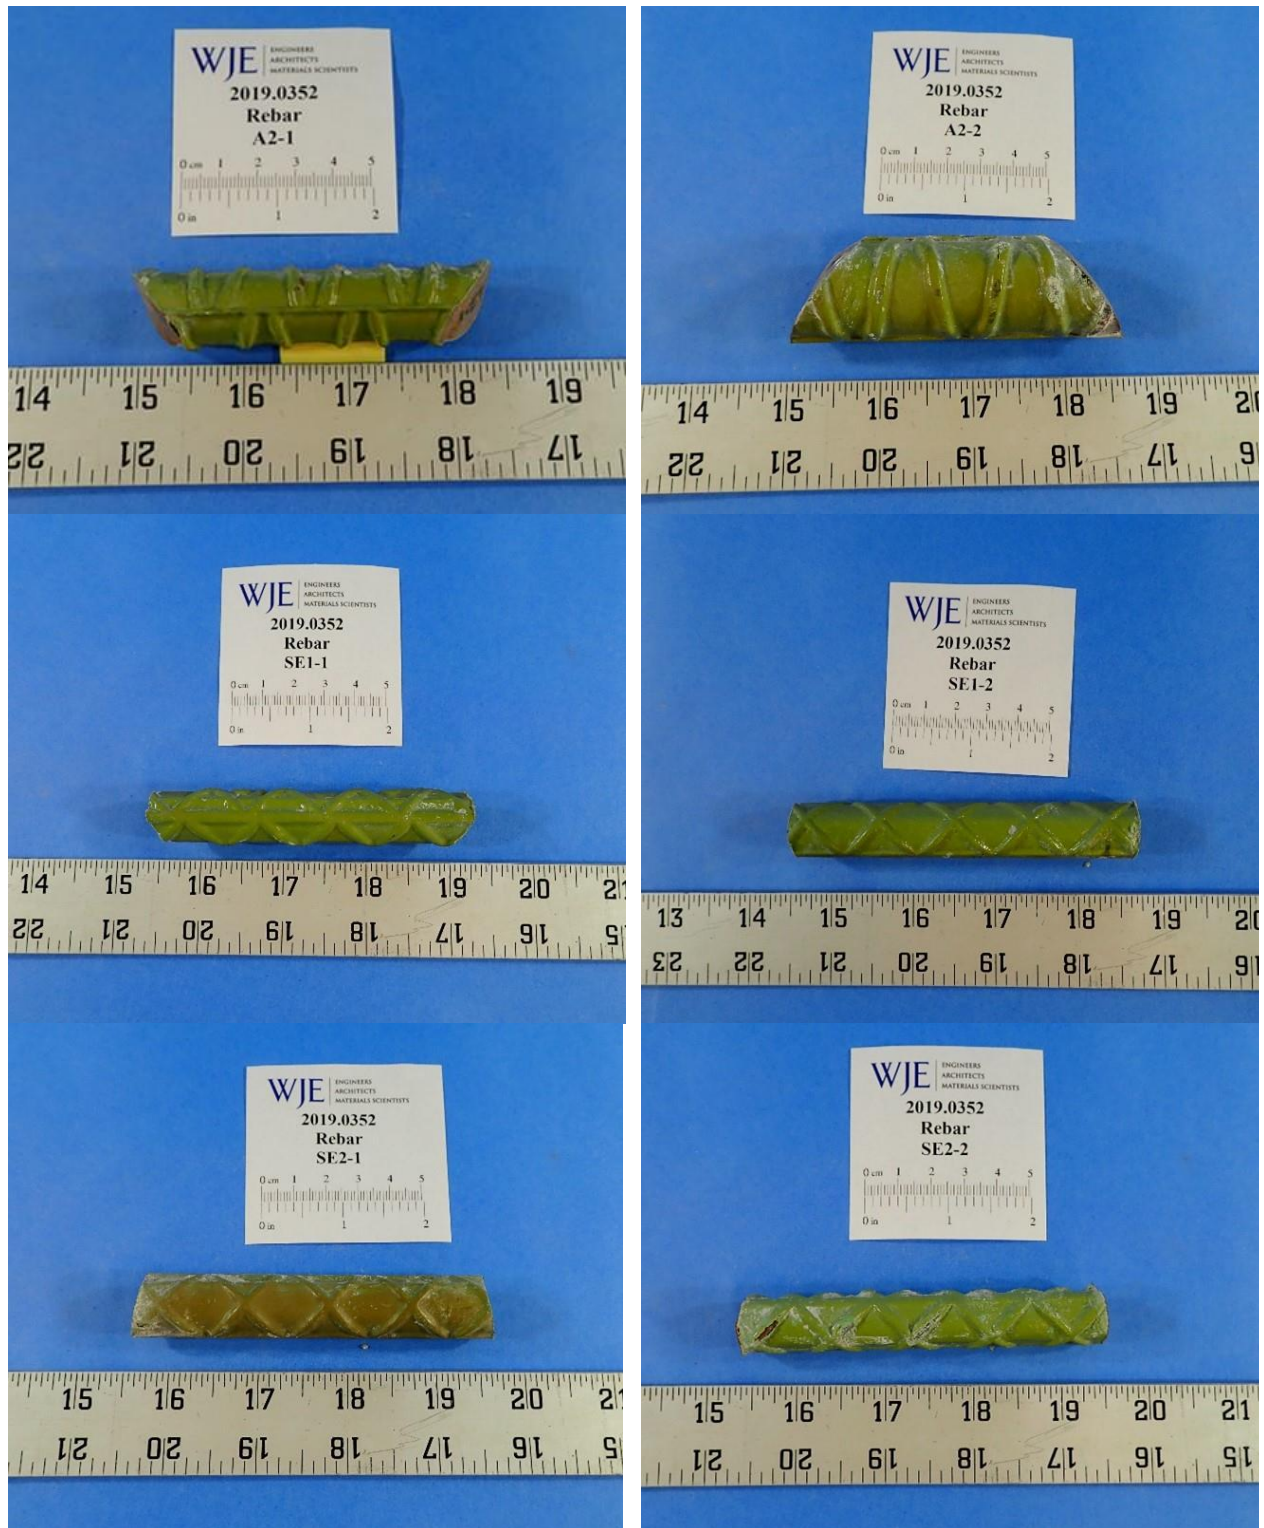
Epoxy-Coated Reinforcement (Bridge No. 860466, 860467, and 860319) – As mentioned in the section above, exact detailing and material specifications are unknown for the three bridges, including ECR specifications. However, laboratory evaluation of the ECR for the 860466 and 860319 bridges indicated that the coating thickness averaged between 6.7 to 12.4 mils. The results of the ECR evaluation are presented in Table 42, and the bar samples are illustrated in Figure 36. No corrosion (rated 1) was observed on three bars (A2-2, SE1-1, and SE1-2); minor corrosion (rated 2) was observed on three bars (A2-1, SE2-1, and SE2-2). The knife adhesion rating for the epoxy coating was 5 (poor adhesion as epoxy peeled from bars in 1/2inch sections) for the majority of the samples and 1 (excellent adhesion) for sample SE1-1. The backside contamination for the epoxy coating was less than 5% for four bars (A2-2, SE1-2, SE2-1, and SE2-2) and 30-40% for one bar (A2-1) as seen in Figure 37.

Figure 36. Photographs of evaluated ECR samples.

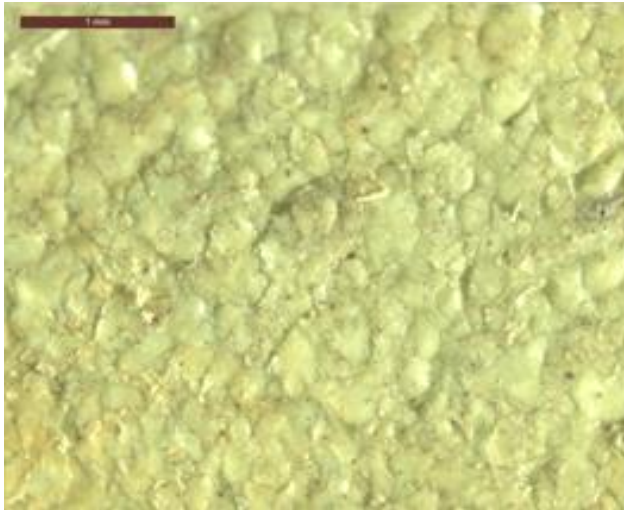
Figure 37. A2-1 30-40% Backside Contamination.

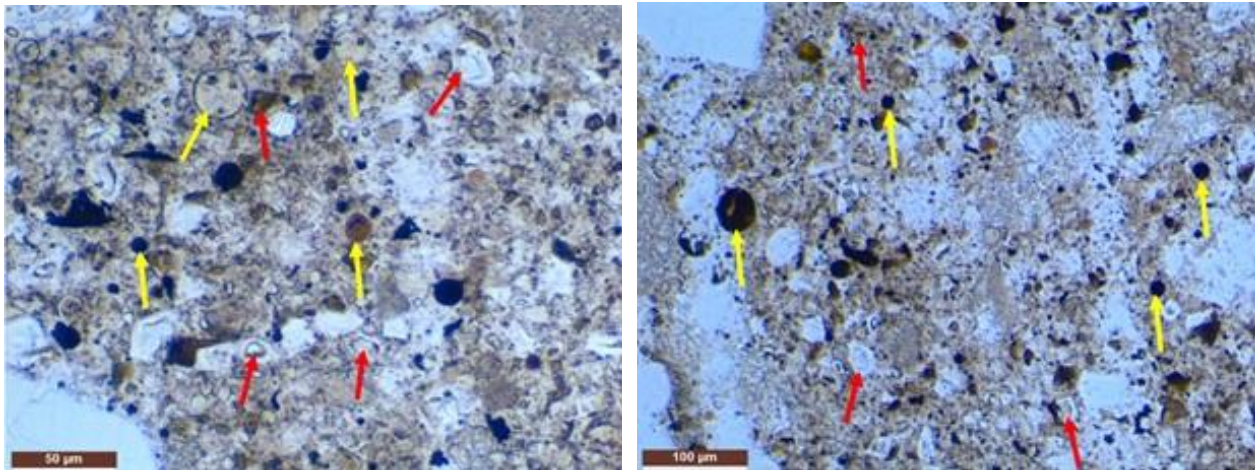
Figure 38. Core SE3. Thin section photographs show the cement paste composition and micro texture. Portland cement (red arrows) appeared to be well hydrated. Fly ash was observed (yellow arrows) and estimated at 15 to 25 percent by mass of total cementitious materials. Plane-polarized light for both.

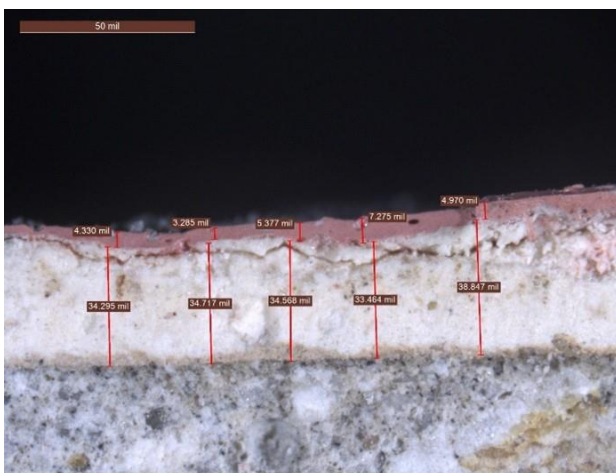
- The coating system for Bridge No. 860319 (A2) appeared to have two layers, a red top coat and a white base coat. The layers were consistent with a reference spectrum of styrenated acrylic copolymer. A micrograph showing the cross-section and some thickness measurements is presented in Figure 39.
 - On average the thickness of the red topcoat measured 4.2 mils. Measurements ranged from 1.7 to 7.3 mils.
 - The thickness of the white base layer averaged 42.9 mils and ranged from 33.5 to 53.8 mils.
- The coating system for Bridge No. 860466 (SW2) appeared to have only one layer consistent with a reference spectrum of styrenated acrylic copolymer. A micrograph showing the cross-section and some thickness measurements is presented in Figure 40.
 - On average the coating thickness measured 13.3 mils, and the measurements ranged from 5.4 to 20 mils.

Figure 39. Micrograph of Core A2 cross-section with coating thickness measurements.

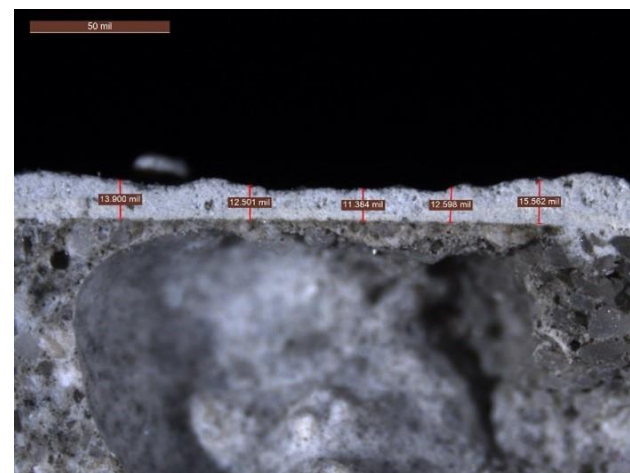
Figure 40. Micrograph of Core SW2 cross-section with coating thickness measurements.

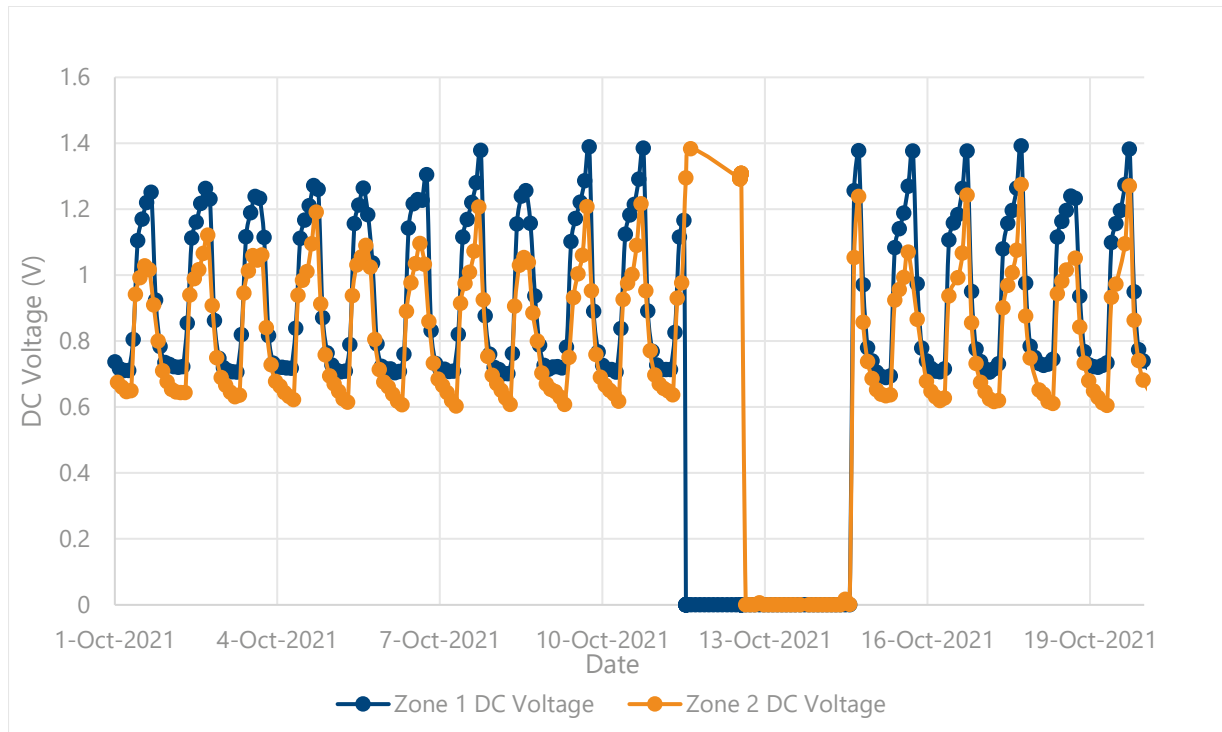
Figure 44. Measured output DC voltage data from RMU.

Review of data showed that output voltages dropped between 0.6 and 0.8 volts overnight, presumably as a result of lack of sunlight exposure to the solar panels reducing current output. Furthermore, recorded potentials typically shifted more positive during similar time frames, particularly for the Zone 1 (Upper) system primarily above the water line. While potentials in reinforced concrete structures in marine environments may shift dependent on environmental factors (tidal conditions, temperature, etc.), the consistent positive shift during the night hours provides significant evidence that the reduced current output of the solar panels does affect potentials of the structure and associated level of cathodic protection.

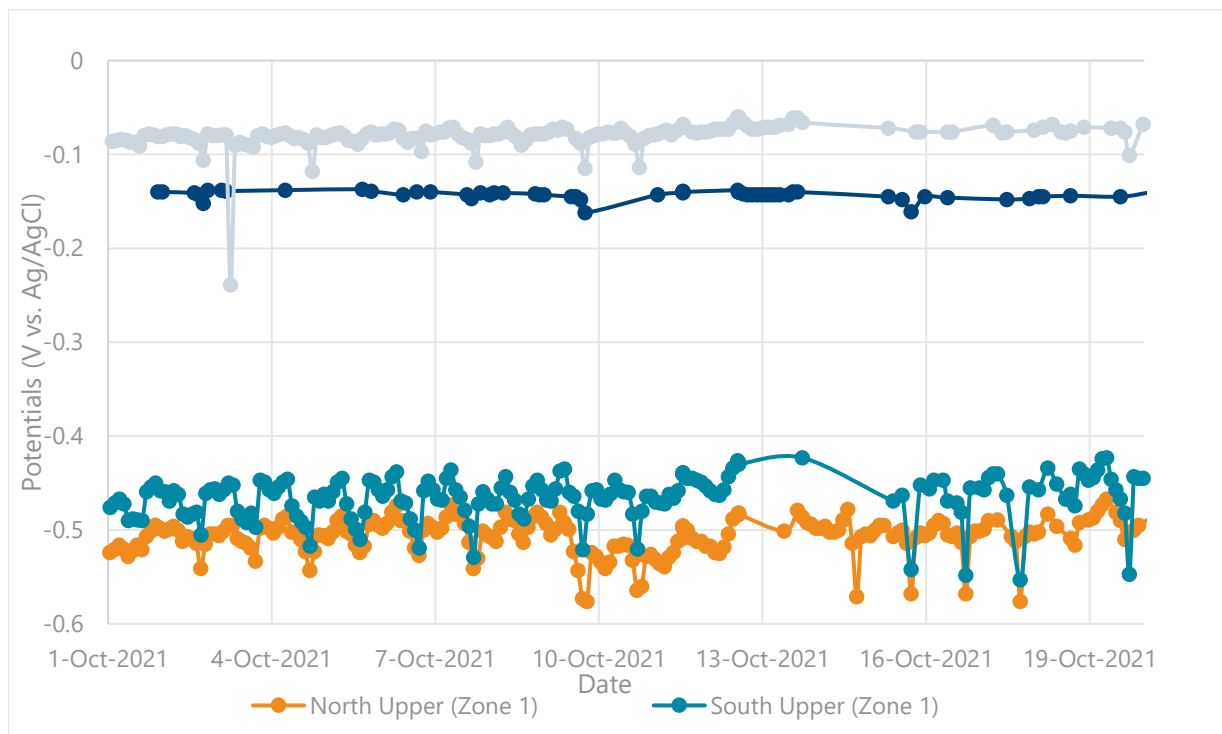
Figure 45. Measured potential data from RMU for Zone 1 and Zone 2.

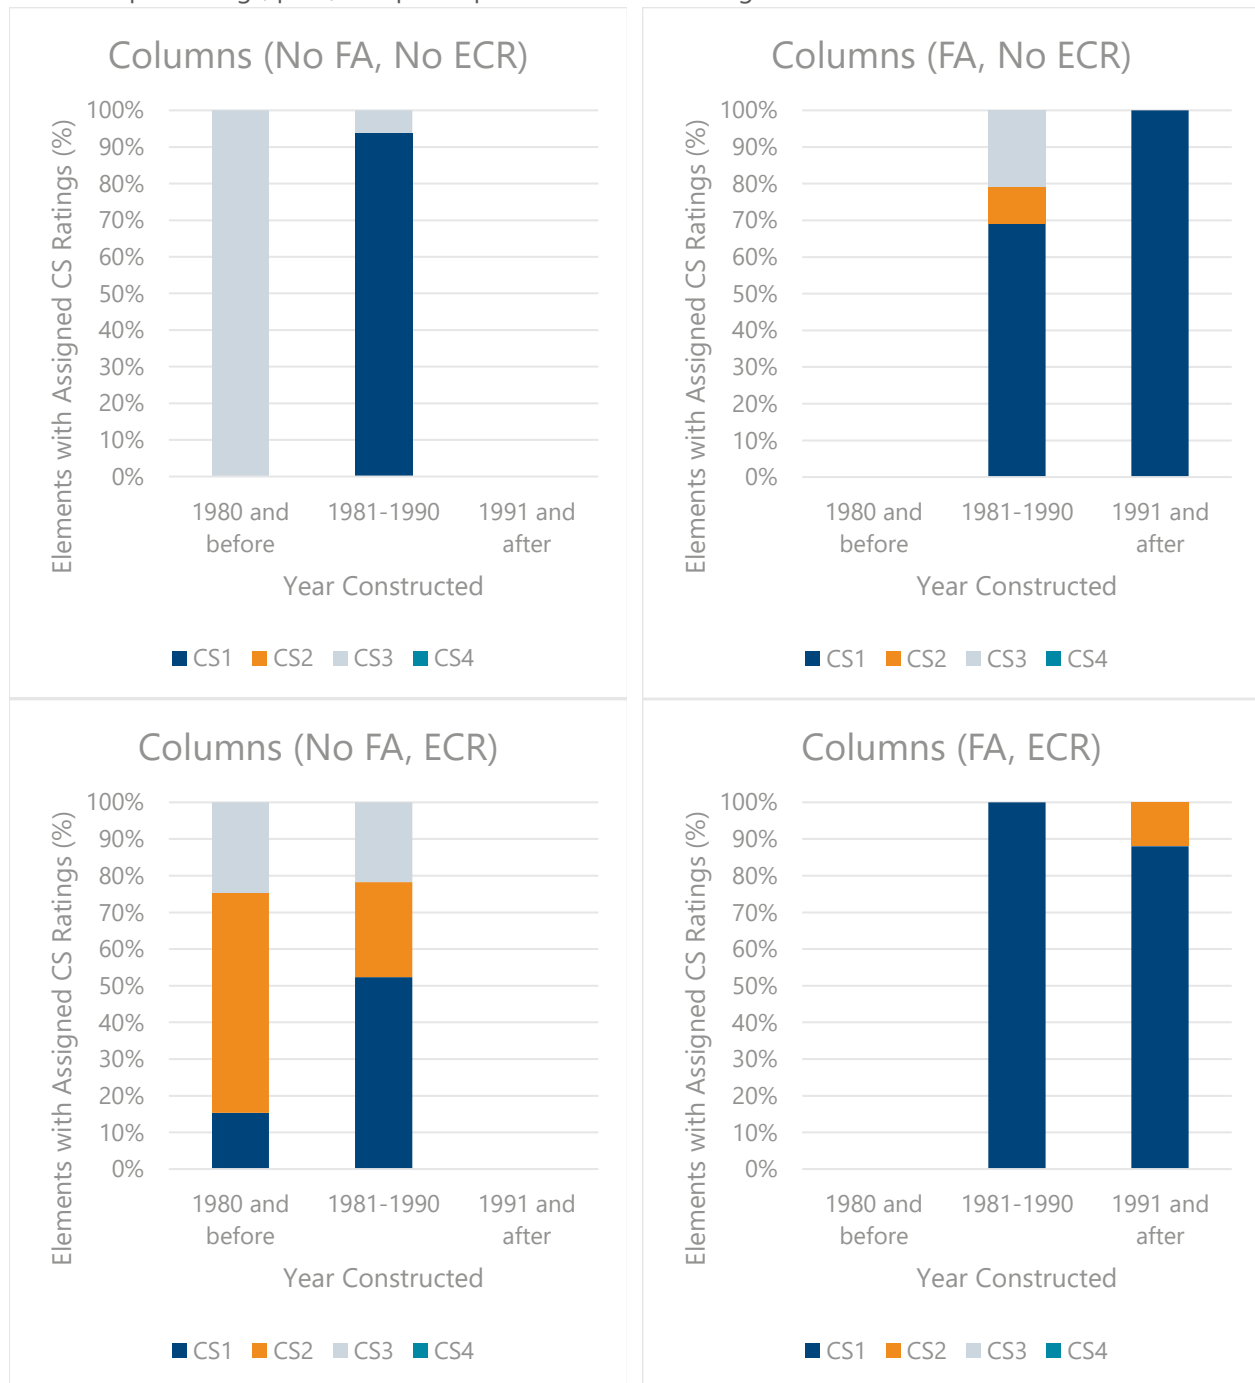
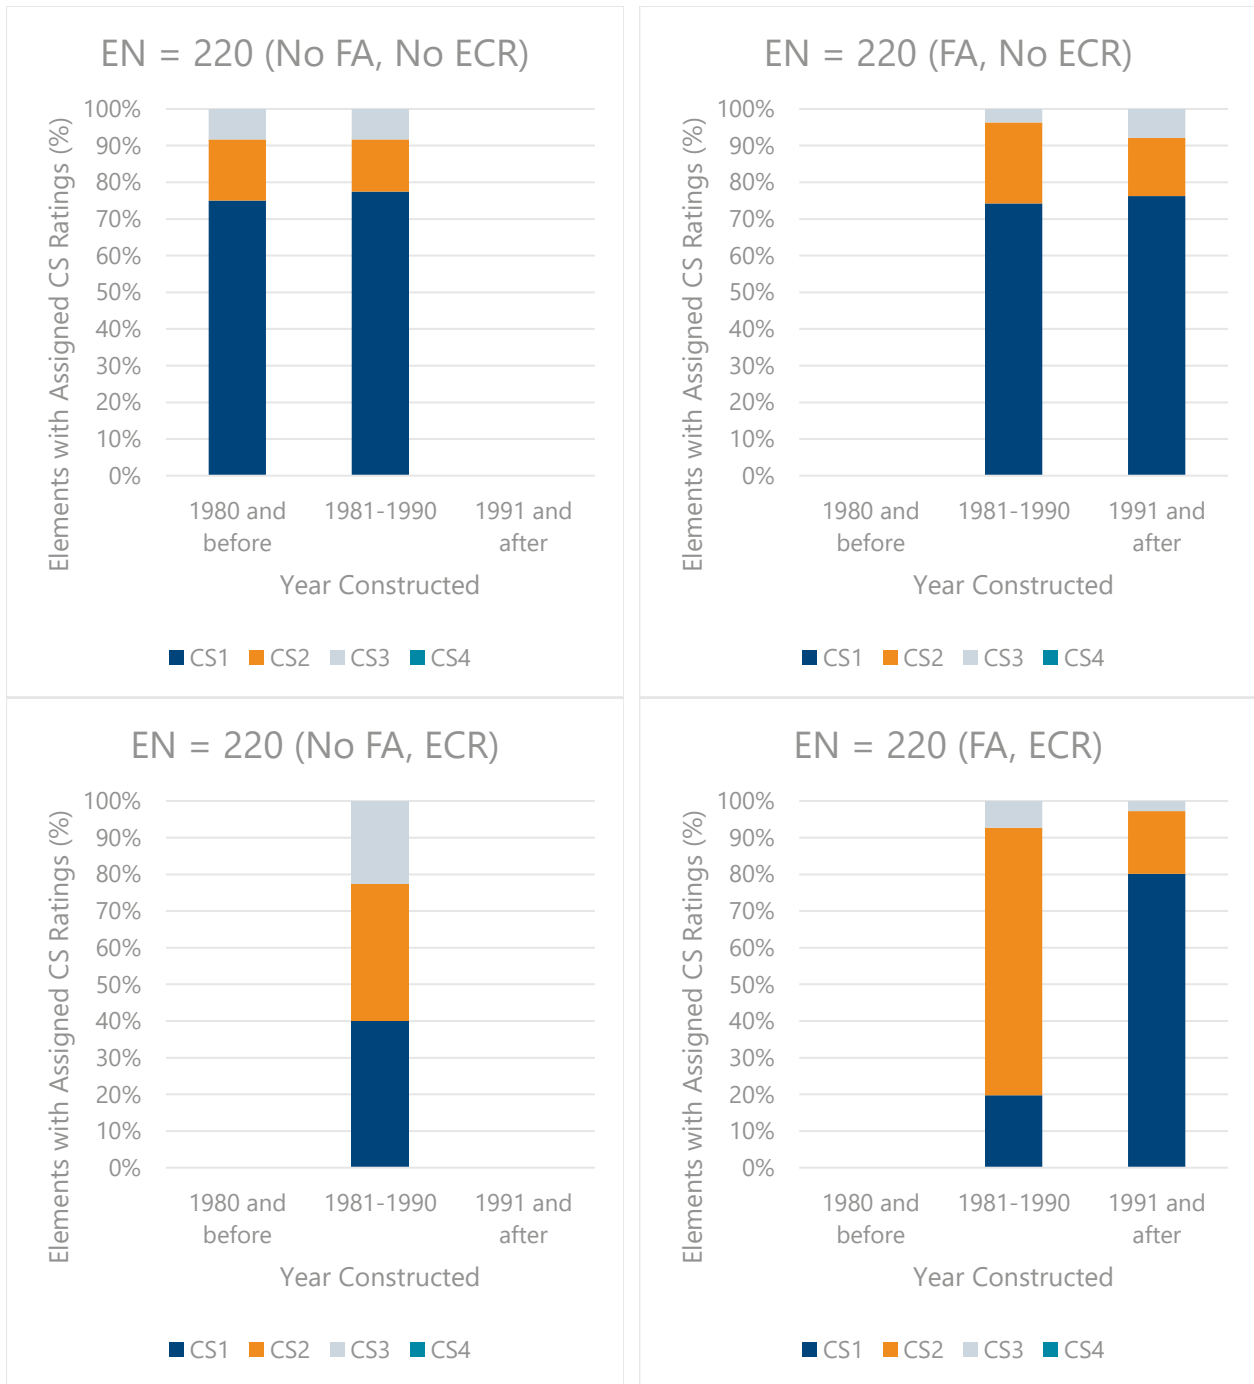
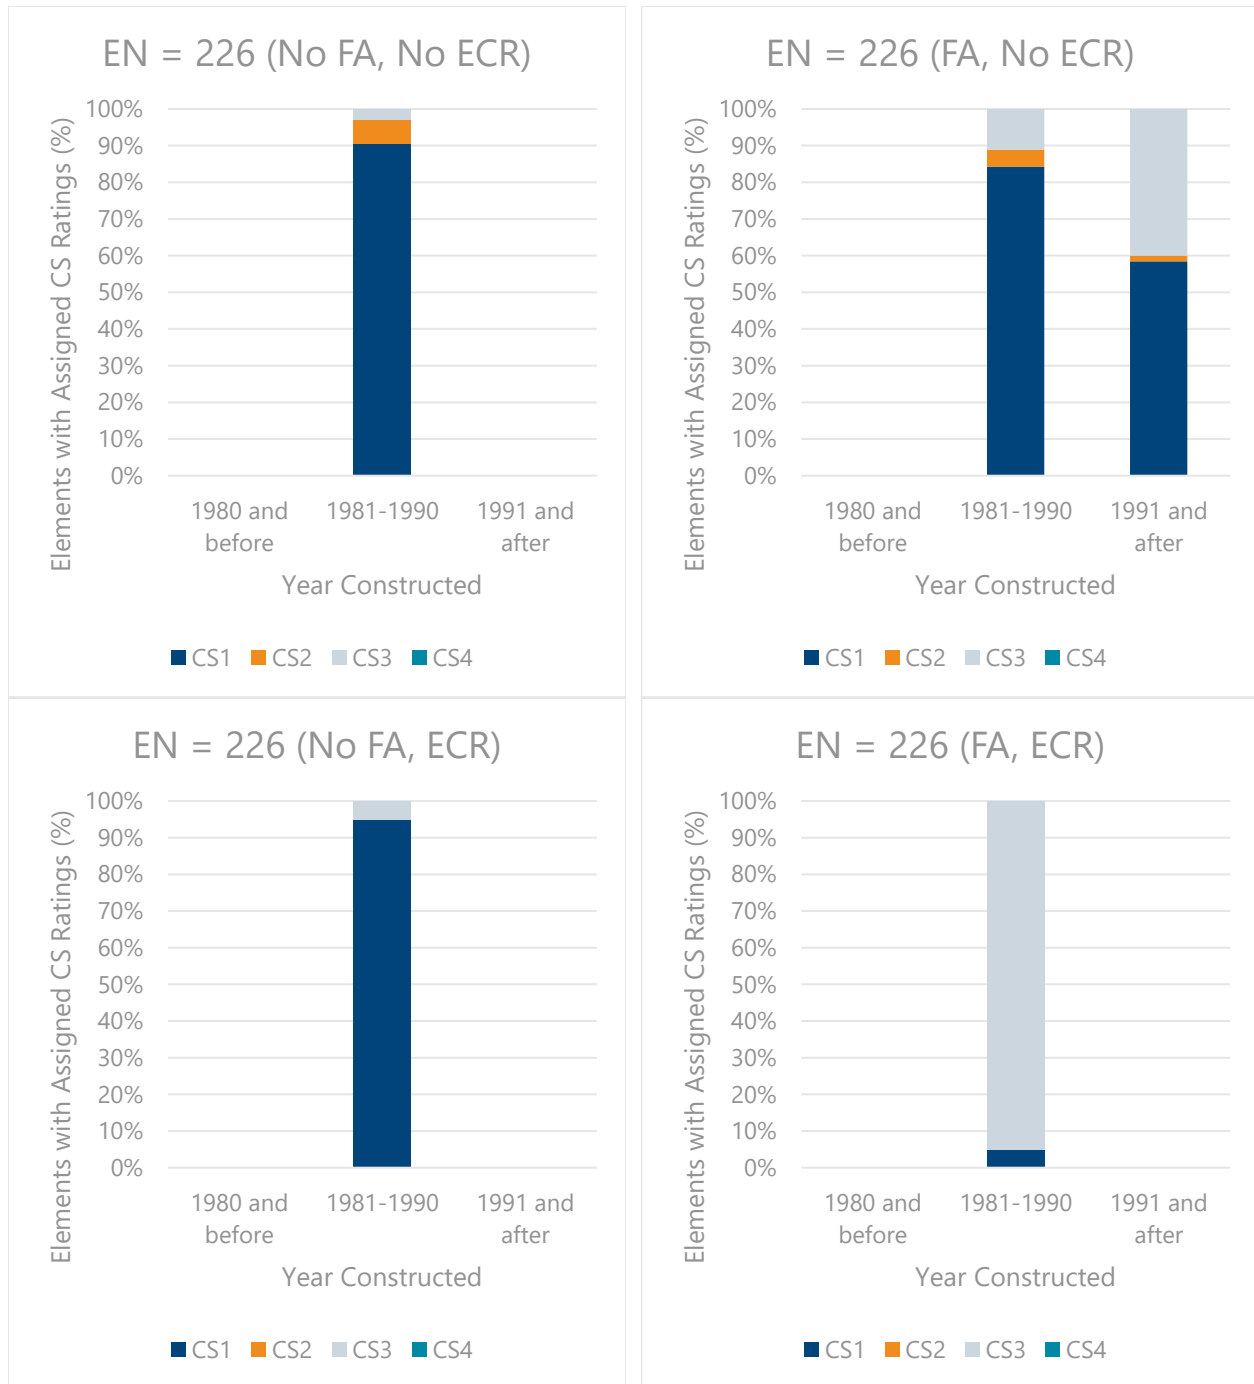
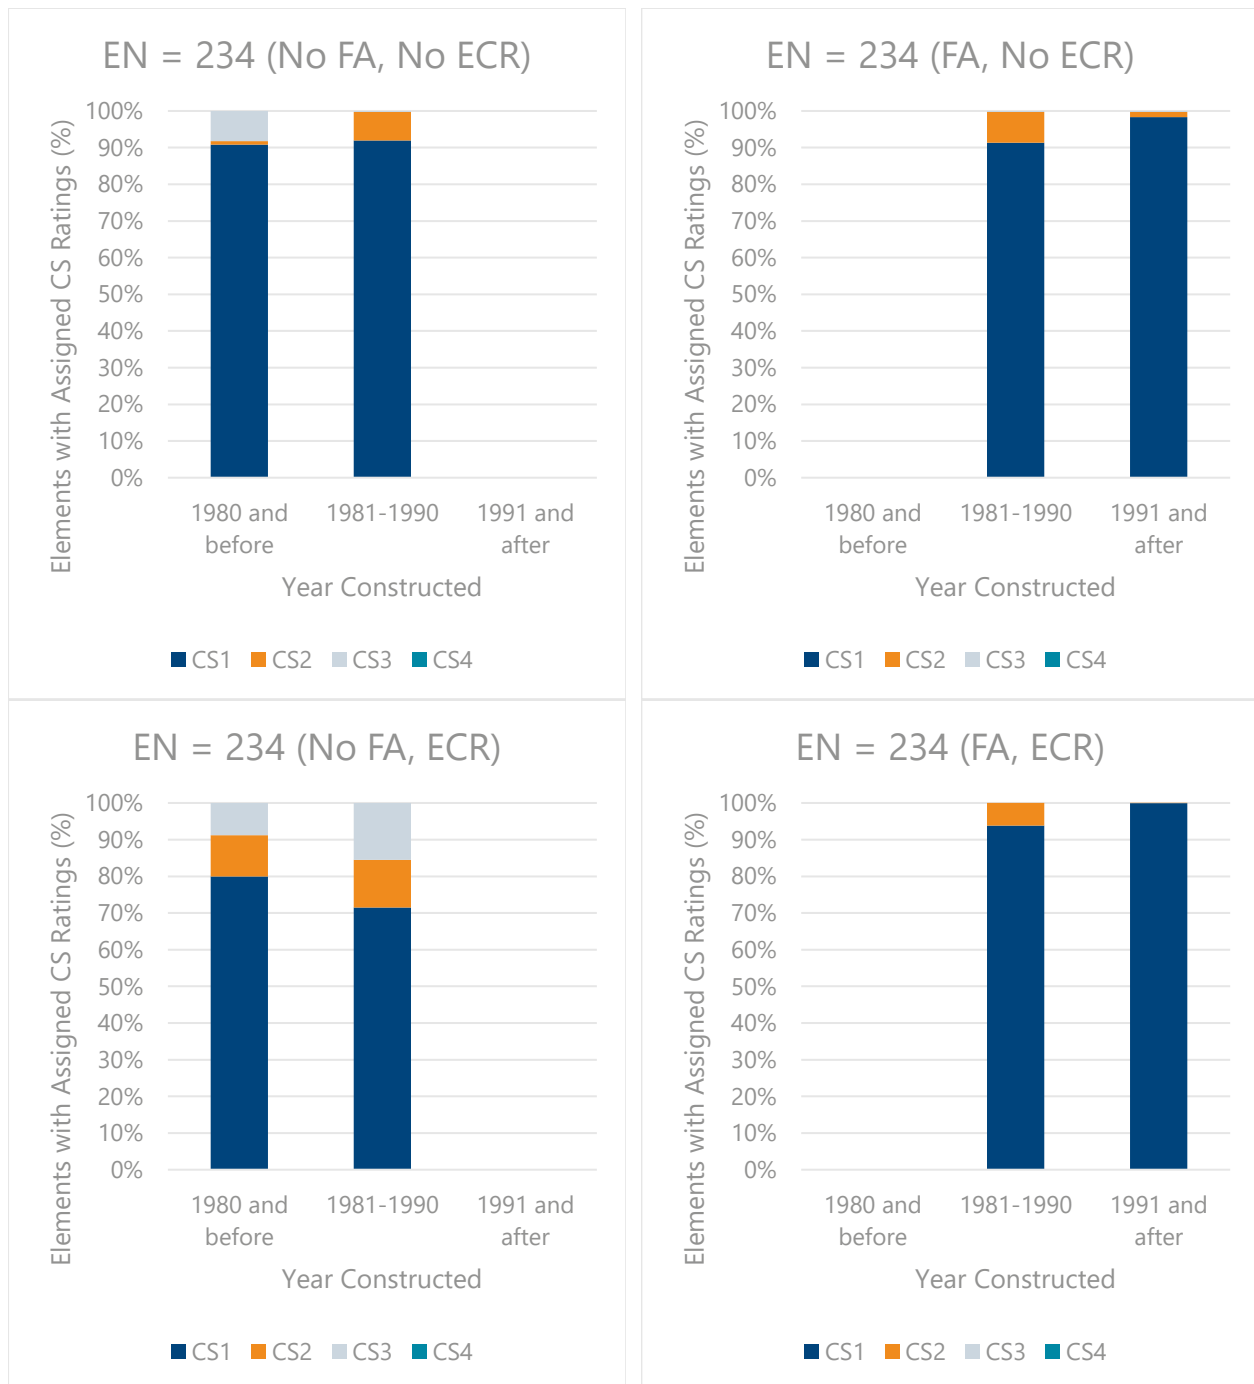
In order to quantify the amount of failed corrosion repairs and the effect of the failed repairs on the service life of select bridges, data was mined from publicly available National Bridge Institute (NBI) element data published by the FHWA. Figure 50, Figure 51, Figure 52, and Figure 53 below provide a statistical comparison of elemental distress as a function of bridge age and construction practice for columns (Element Number [EN] = 205), pile caps/footings (EN = 220), piles (EN = 226), and pier caps (EN = 234), respectively.

- Columns and pier caps with FA and ECR showed less distress than that without FA and ECR.
- Pile caps/footings and piles with FA and ECR showed higher distress than that without FA and ECR.
- Columns, pile caps/footings, and pier caps with FA and without ECR showed less distress than that without FA and with ECR.
- Piles with FA and without ECR showed higher distress than that without FA and with ECR.
- Columns and pier caps with FA showed less distress than that without FA.
- Piles with FA showed higher distress than that without FA.

- Pile caps/footings with FA showed similar distress to that without FA.
- Columns with ECR showed less distress than that without ECR.
- Pile caps/footings, piles, and pier caps with ECR showed higher distress than that without ECR.
