Evaluation of FDOT Corrosion Prevention and Control Programs

DOT-RFP-19-9059-GH

FINAL REPORT

Wiss, Janney, Elstner Associates, Inc.

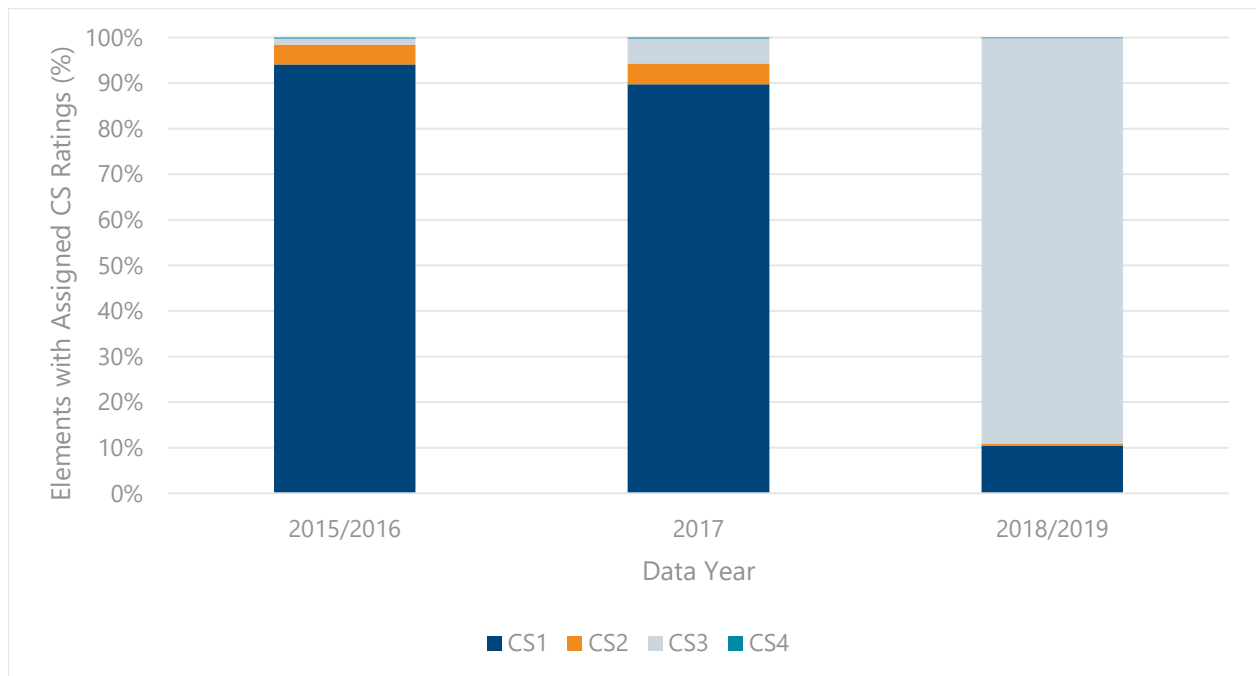
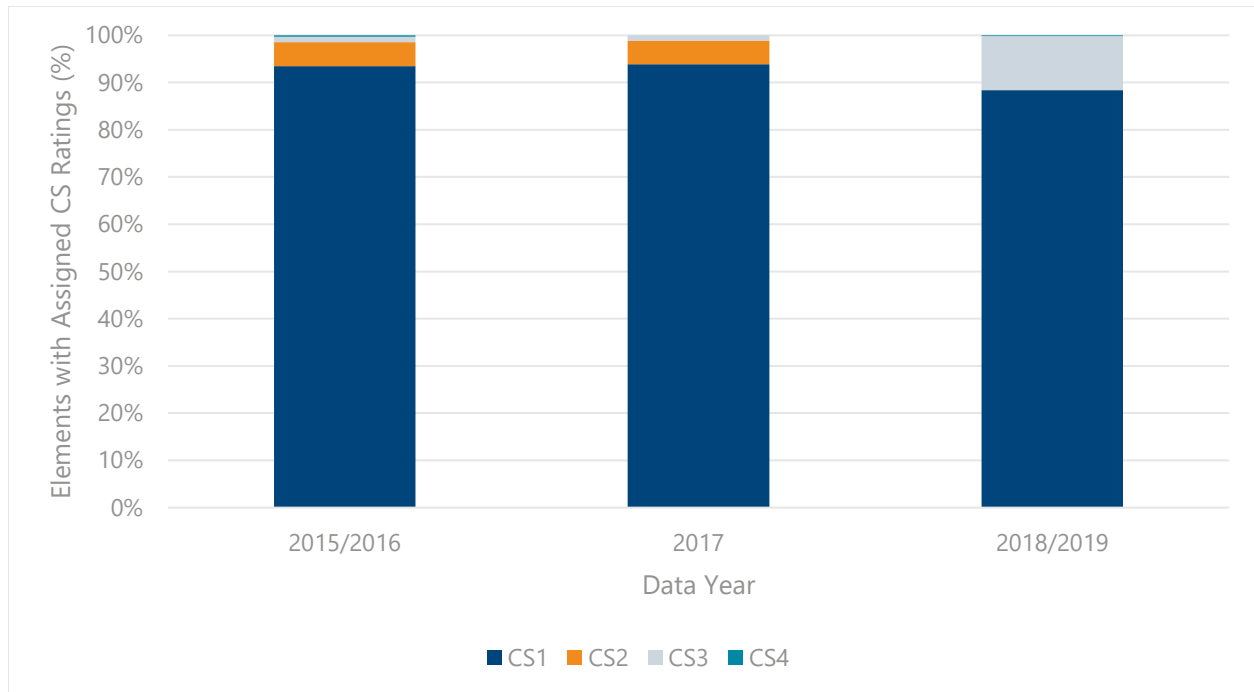
Distress trends below show that pile cap/footing elements are showing an apparent linear downward trend over the past 5 years in terms of distress (Figure 54). However, only approximately 30 percent of the element exhibited any distress, and approximately two-thirds of that would be considered as minor CS2 damage. Similarly, pile jacket data showed a similar trend over the same time span (Figure 56), with less than 8 percent of pile jackets exhibiting any distress in 2015 to over 10 percent exhibiting significant distress, primarily rated as a CS3. The data for pile elements, however, shows a drastic decline in condition between 2017 and 2018/2019 (Figure 55), with less than 20 percent of piles exhibiting any distress in 2017 to over 80 percent of piles exhibiting significant distress deemed CS3, primarily due to delamination/spall/patched areas. The reason(s) for this large discrepancy over less than a 24-month time frame is difficult to determine using bridge inspection records alone. While some amount of decline in condition is expected, it is likely not at the rate determined between the two inspection records. It should be noted that different consultants performed the two inspections, and while the NBI program intends to train inspectors to use similar criteria for assigning condition states and ratings, it is impossible to eliminate all subjectivity from these inspections, and this subjectivity likely played some role in variable conditions.

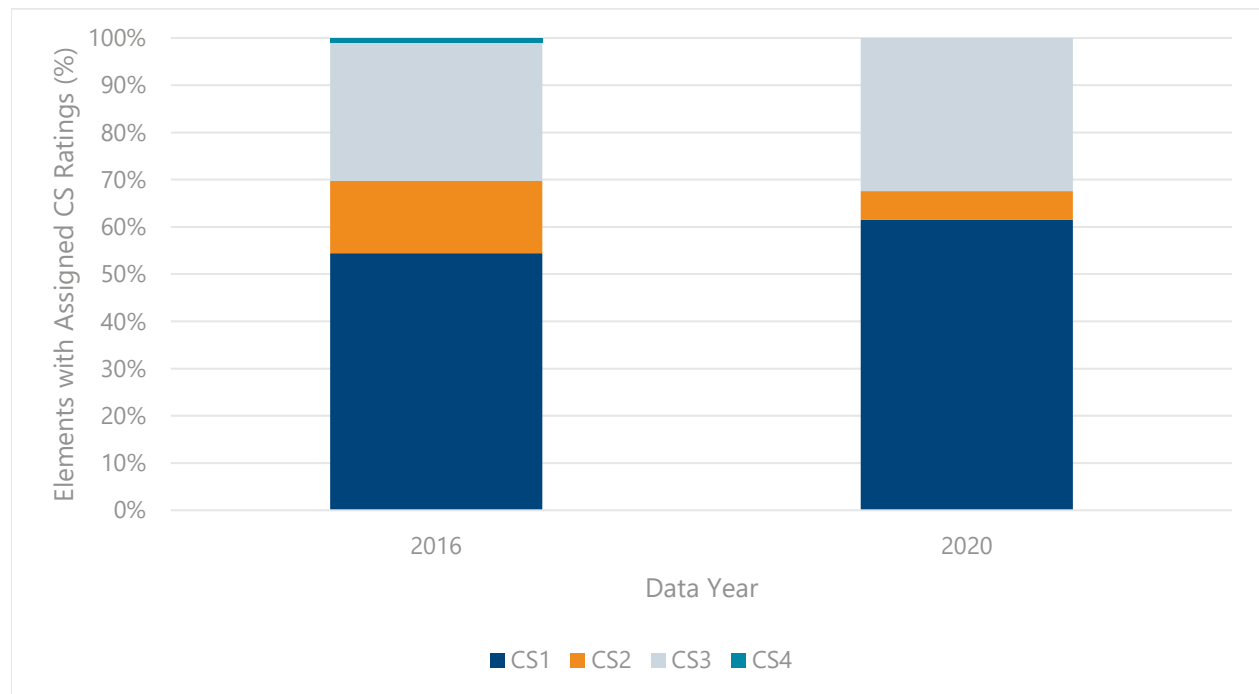
Table 53 below presents the bridges selected for this analysis for galvanic CP pile jackets, including their year of construction, the year the CP system was installed, and a brief description of the systems. This analysis did not differentiate between system detailing and intends to provide a cumulative data summary showing improved trends in elemental data based on the installation of a select system, as shown in Figure 57. For the four bridges with data available for comparison, the installation of galvanic pile jackets reduced the percentage of piles distributing distress by approximately 10 percent and eliminated all CS4 condition state ratings. However, it can be seen that almost 40 percent of piles on the subject bridges still exhibit some amount of distress, mostly that qualifying as a CS3 condition state rating.

Figure 57. Statistical comparison of elemental distress as a function of cumulative data and installation system for piles (EN = 226/227).

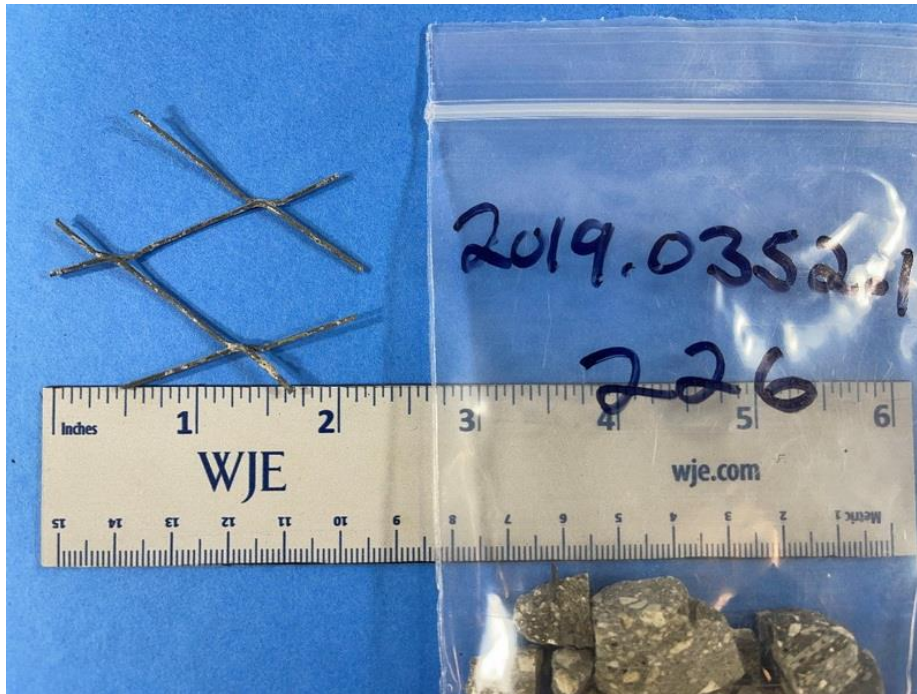
Titanium Mesh – Embedded titanium mesh within core samples obtained from the Gandy 226, Gandy 231, and HF 158 piers (Figure 67). Mesh samples were examined using both optical stereomicroscope and SEM/EDX. Each of the three laths was similar in composition and composed of pure titanium with only trace amounts of other elements. The thickness of the original titanium sheet used to manufacture the lath was 1 millimeter (40 mils), and no evidence of corrosion or alteration, other than that expected as a result of obtaining and preparing the samples, was observed (Figure 68 and Figure 69). On the exterior surface, Nickel and Phosphorus were detected locally, which are likely a result of surface treatment of the lath. In summary, titanium mesh samples between the three samples appeared similar in composition. Nothing was noted from a material standpoint that would indicate the titanium mesh itself affected the performance of the ICCP systems.

Figure 67. Representative titanium mesh sample (Gandy 226)

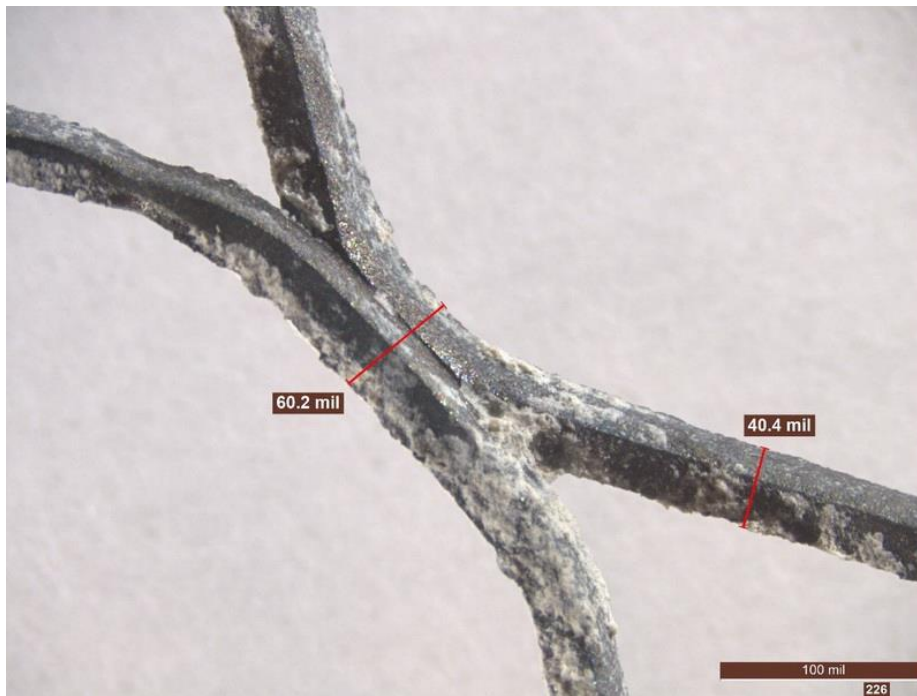
Figure 68. Microscopic view of titanium mesh, including thickness measurements (Gandy 226)

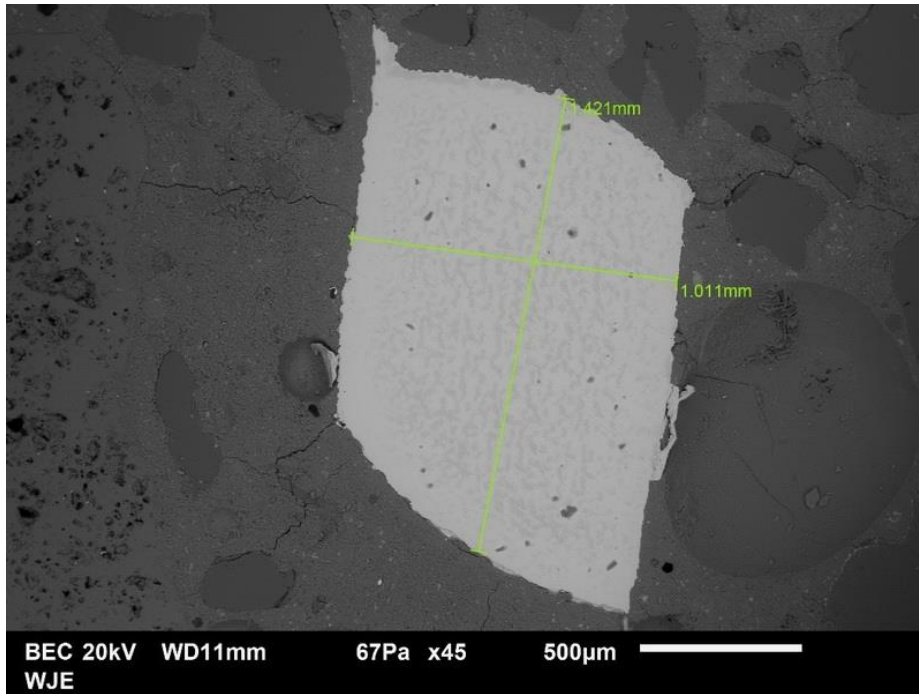
Figure 69. Microscopic view of titanium mesh cross section, including thickness measurements (HF 158)

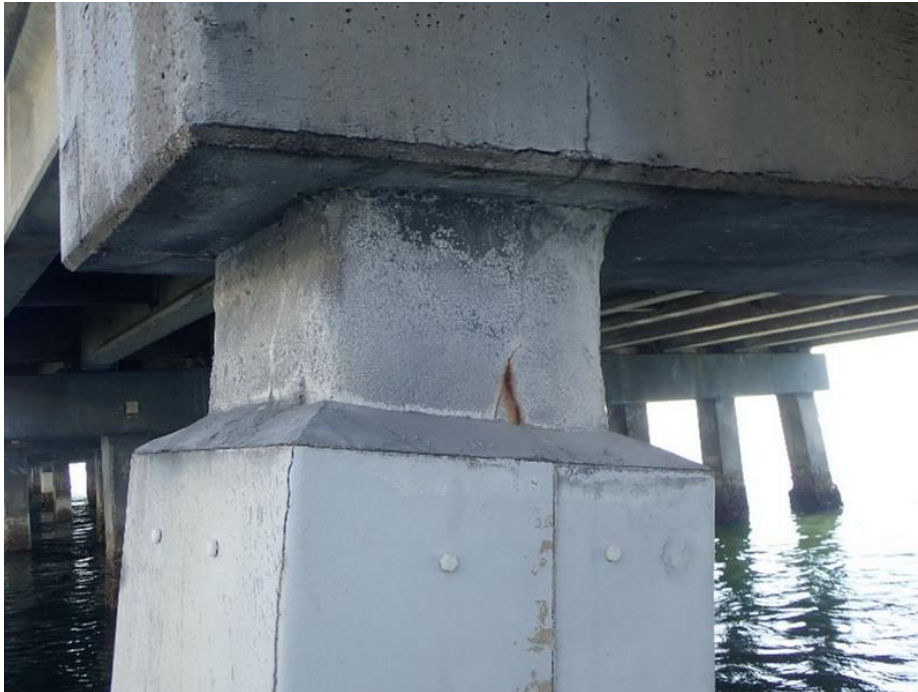
Figure 71. Vertical cracking with rust staining extending upward from top of pile (Pile 12-1)

File ID	CP Pile Jacket Observations	Pile Observations	Miscellaneous Observations	Figures
12-1	Splitting at top of jacket in NW corner and missing portion below	Vertical cracking extending upward from top of jacket on W face, also exhibiting rust staining	Apparent repair material at top of pile	Figure 70 Figure 71
14-4	Jacket splitting at bottom SE corner	None	Limited metalizing overspray on pile	Figure 72
44-5	Jacket broken off at bottom S face and split at top NE corner	Vertical cracking extending above top of jacket, measured up to 50 mil wide	Cracking of grout	Figure 73 Figure 74
53-3	Jacket splitting at NE corner and missing lower section	None	None	Figure 75
65-8	None	None	None	Figure 76
73-5	Jacket splitting and broken off around lower perimeter of pile	None	None	Figure 77
80-6	Apparent jacket extension on top, no distress noted	None	None	Figure 78
99-9	None	None	None	Figure 79
105-9	Jacket in poor condition	None	None	Figure 80

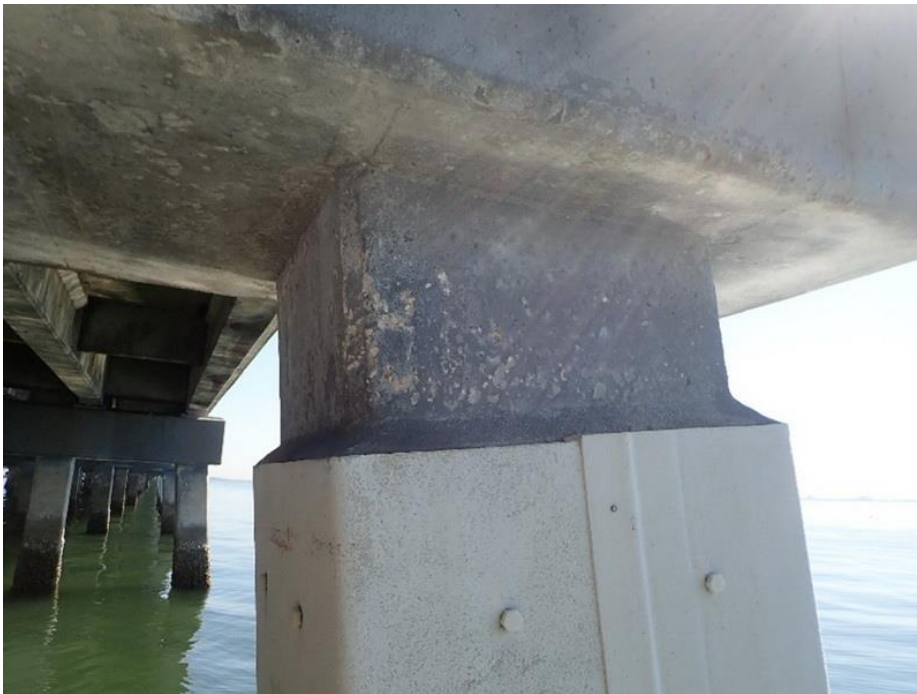
Figure 76. Overview photograph of pile and jacket with no noted distress (Pile 65-8)

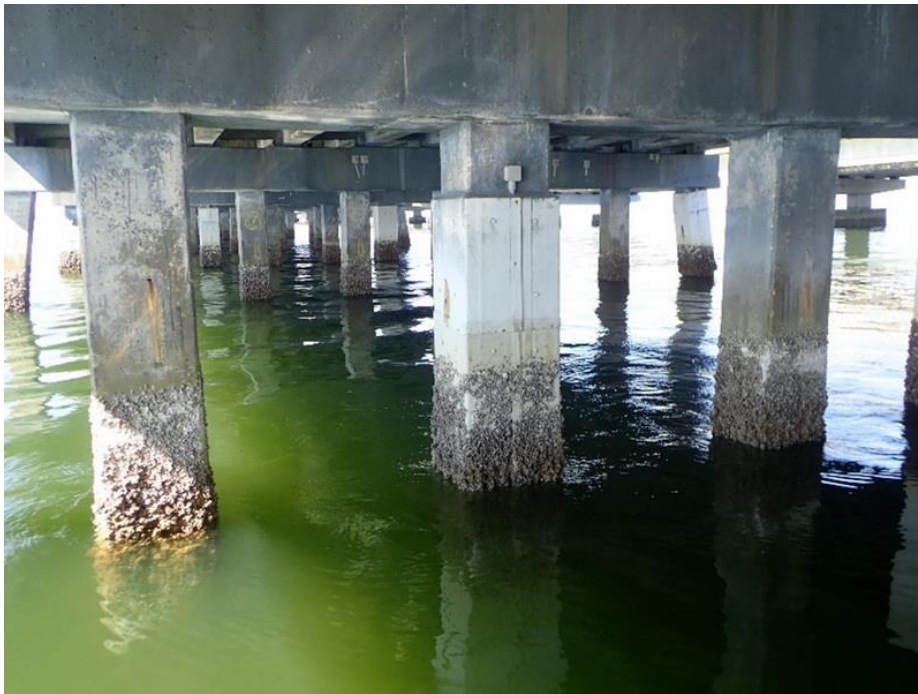
Figure 78. Overview photograph of apparent jacket extension on top (Pile 80-6)

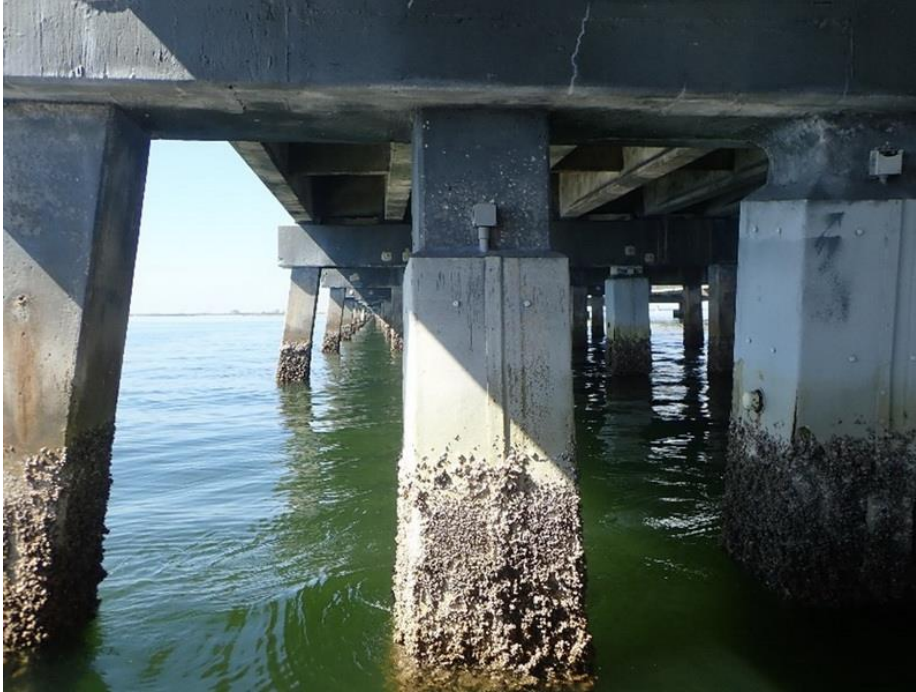
Figure 79. Overview photograph of pile and jacket with no noted distress (Pile 99-9)

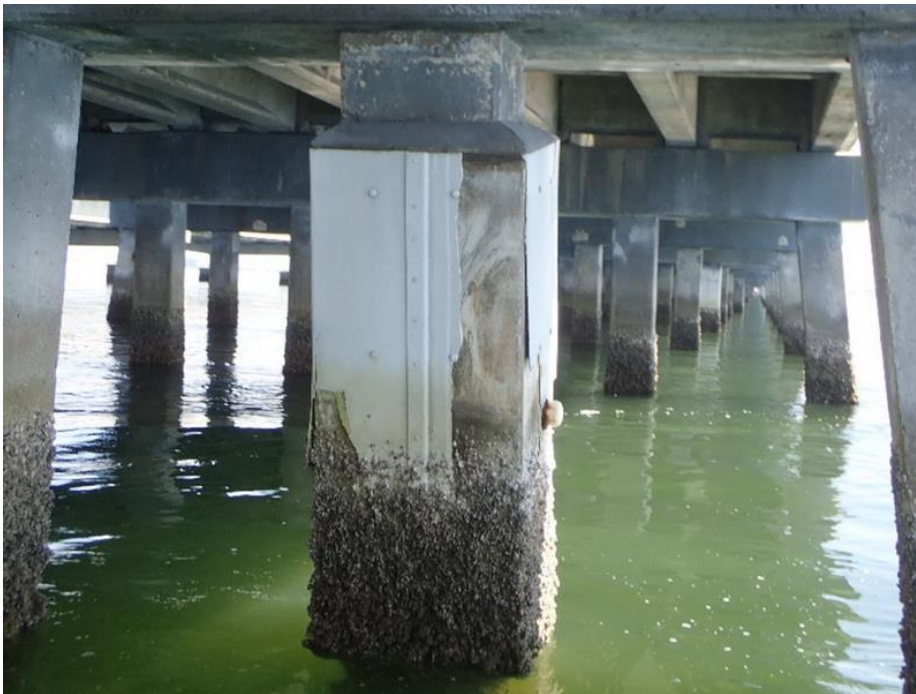
Figure 80. Significant distress of jacket (Pile 105-9)

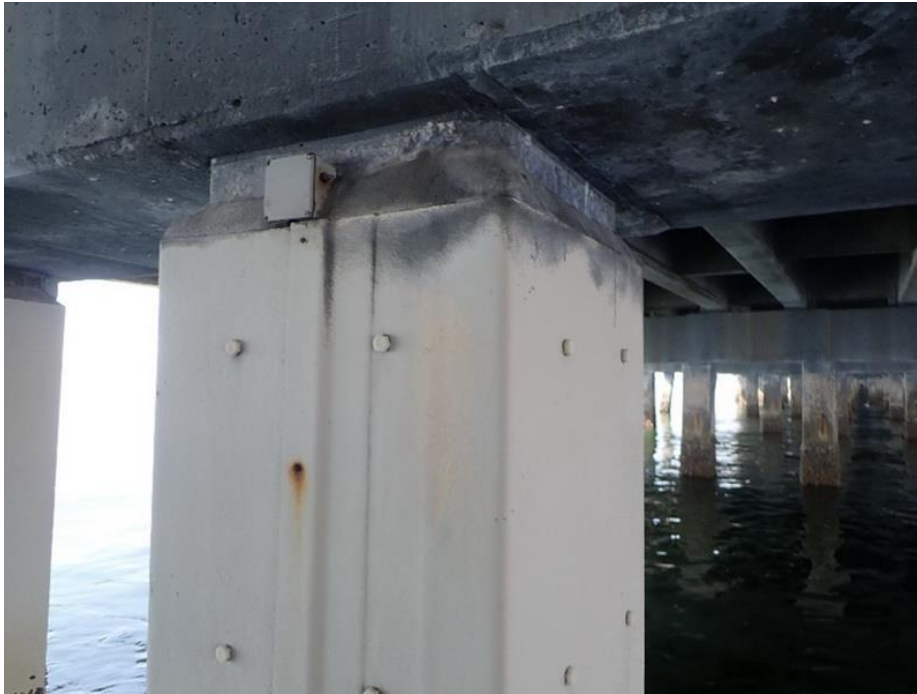
Figure 81. Overview photograph of pile and jacket with no noted distress (Pile 116-4)

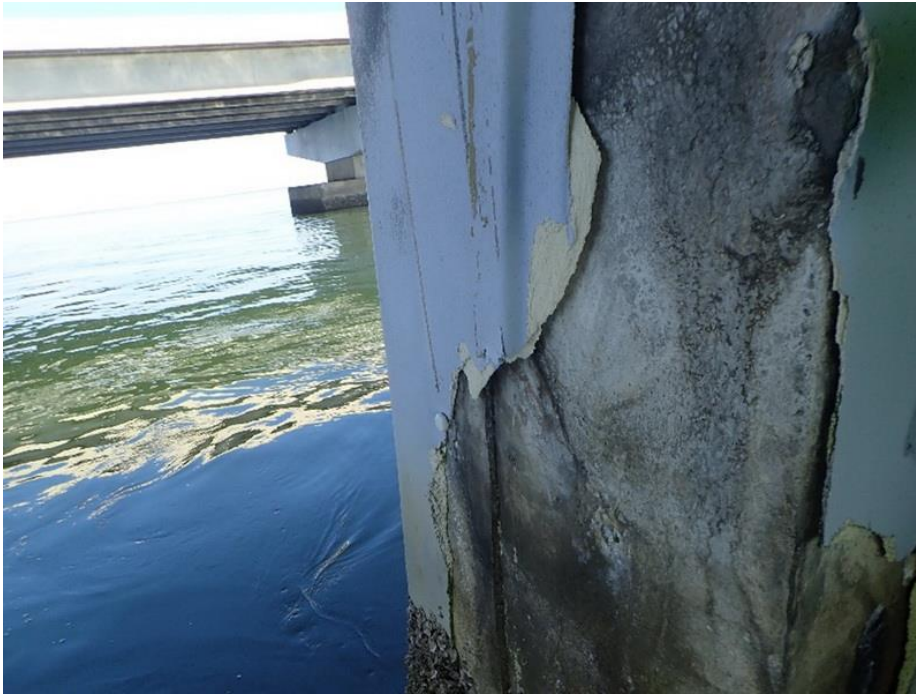
Figure 83. Exposed grout exhibiting staining and cracking (Pile 120-1)

116-4	None	None	None	Figure 81
120-1	Jacket in poor condition	None	None	Figure 82 Figure 83
123-8	None	Minor spall on SW corner top, metalized over	None	Figure 84
129-6	Jacket extension on top, no distress noted	None	None	Figure 85
133-5	Jacket splitting and missing all around	Exposed steel with corrosion on S face	None	Figure 86
138-7	None	Repair on NW corner	None	Figure 87
138-8	Jacket splitting	Repair on NW corner	None	Figure 88
177-4	Jacket splitting right above water line at SE corner	None	None	Figure 89
182-3	Jacket cracking on N face	Spall repair on SE and SW corners	None	Figure 90
190-6	None	Cracking and spalling at NE corner	None	Figure 91

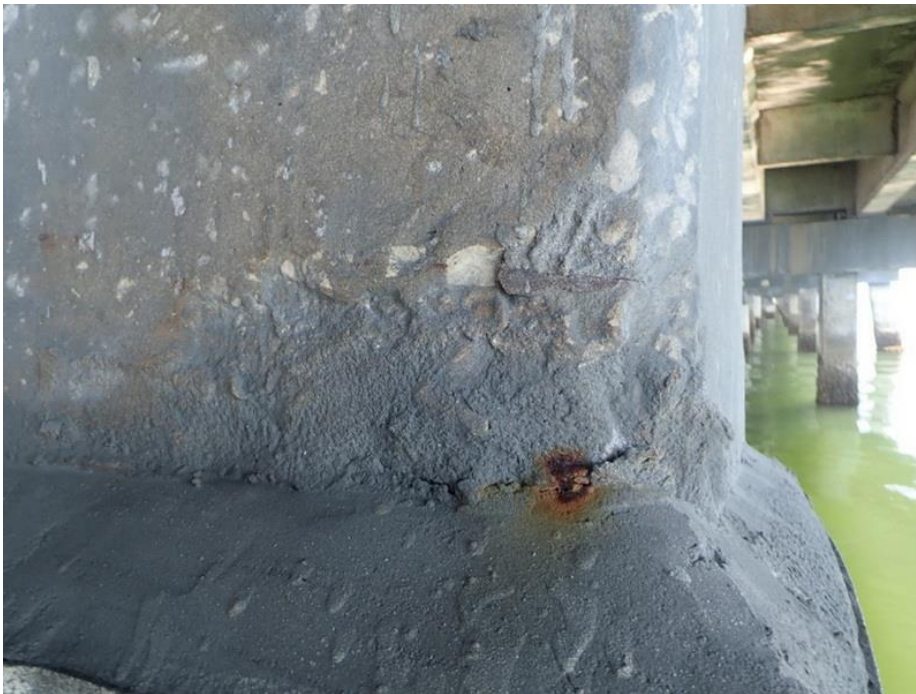
Figure 84. Minor spall on the SW corner top that was metalized over (Pile 123-8)

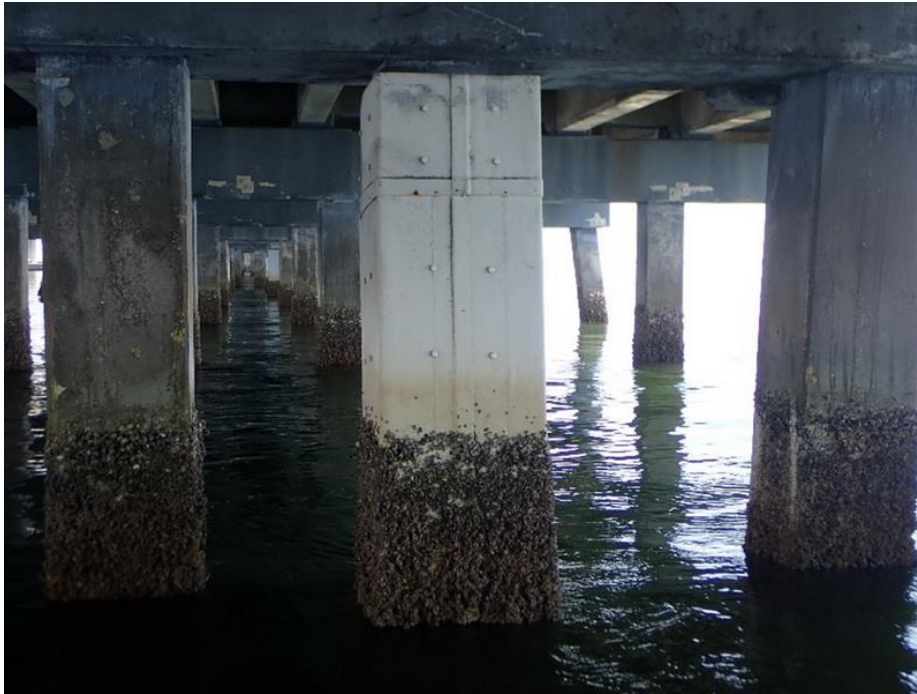
Figure 85. Jacket extension on top, no distress noted (Pile 129-6)

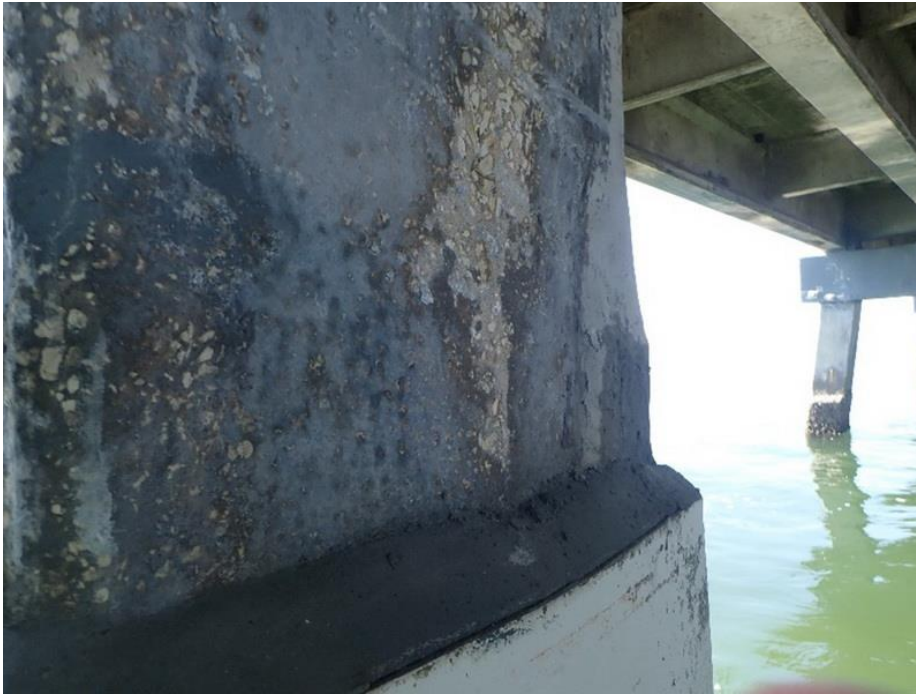
Figure 87. Repair on NW corner of the pile (Pile 138-7)

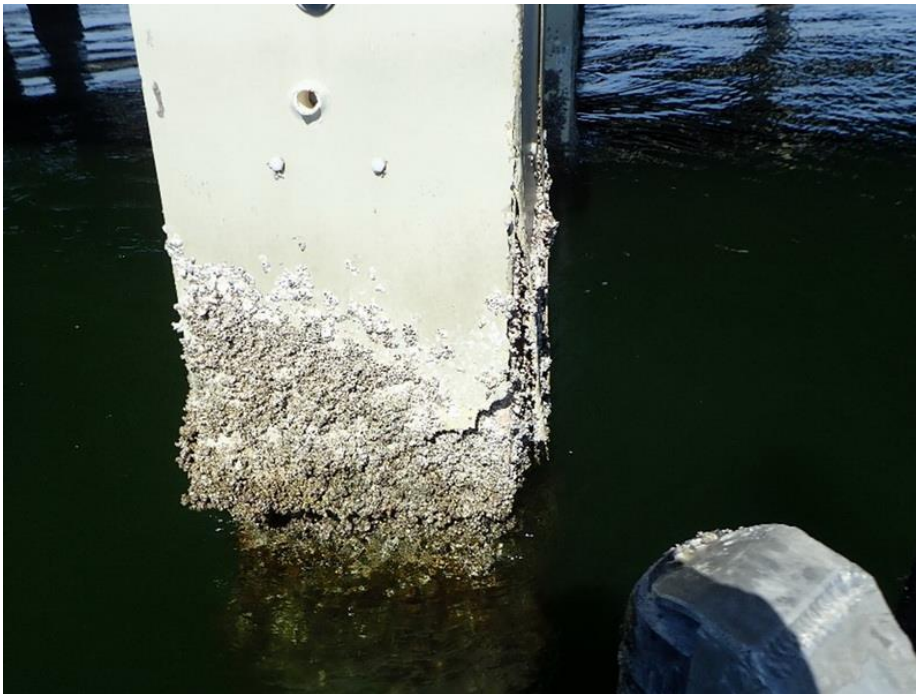
82-6 ²	2009	3	2.3	4.0	Significant corrosion and section loss at the corner; less severe corrosion and section loss along edges.	Figure 64
106-7 ²	2009	1	1.6	3.3	Appeared to be the most corroded sample among examined; widespread corrosion and significant section loss.	Figure 65
138-8	2009	2	1.2	3.0	Minor corrosion along edges; more severe at the corner with minor section loss.	Figure 66

Figure 88. Vertical splitting of jacket (Pile 138-8)

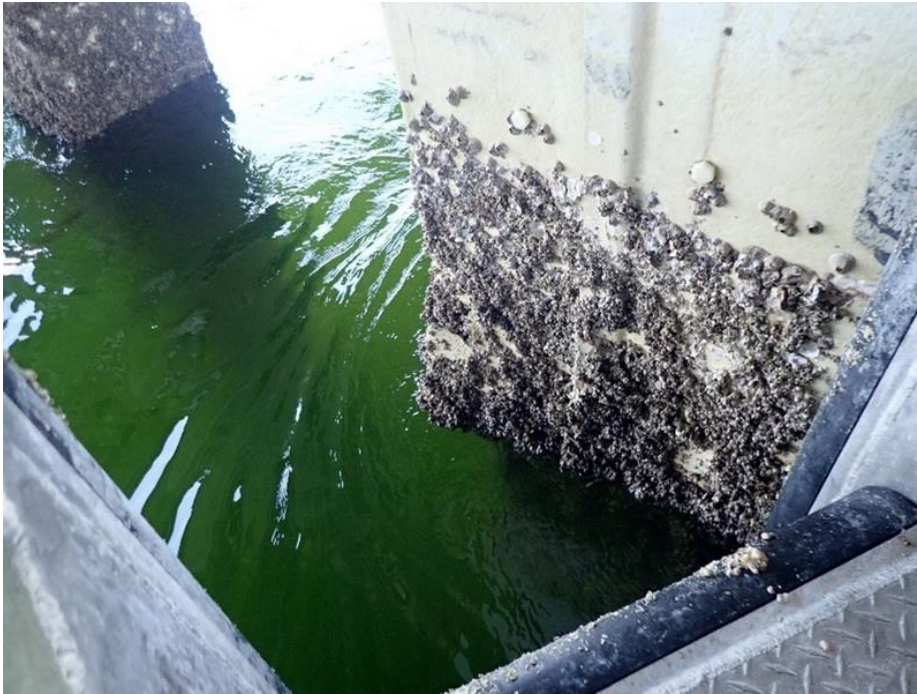
Figure 89. Horizontal splitting of jacket (Pile 177-4)

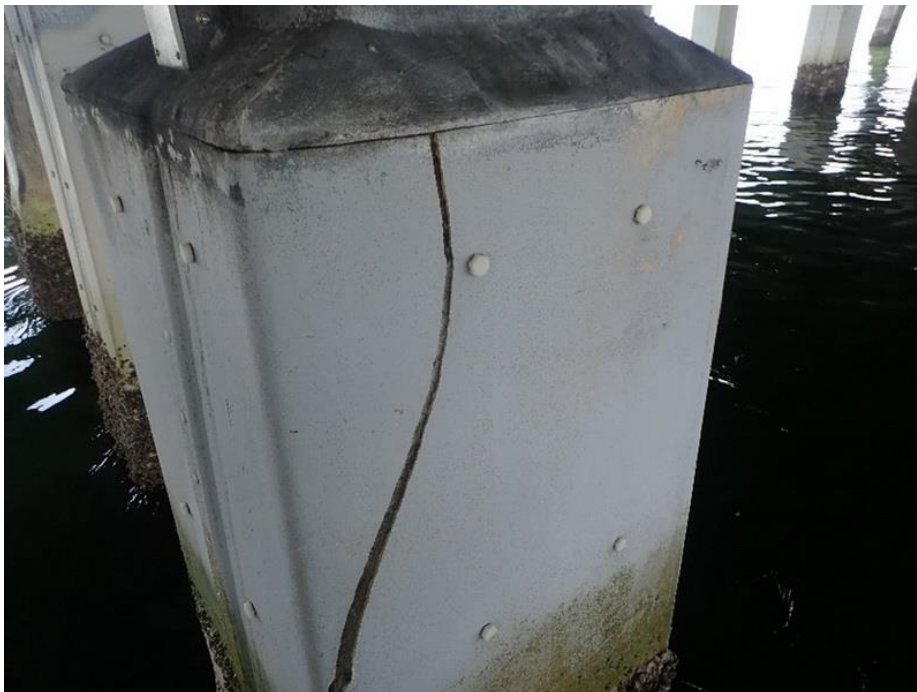
Figure 92. Vertical cracking of jacket (Pile 191-3)

File ID	CP Pile Jacket Observations	Pile Observations	Miscellaneous Observations	Figures
191-3	Jacket splitting on N face	Failed repair of the bent cap underside	None	Figure 92
198-1	None	Vertical cracking on S face, repair on NE corner	None	Figure 93
214-3	None	None	None	Figure 94
214-6	None	Previous repairs with corroded anchors	None	Figure 95
236-7	Jacket splitting on NE corner	Cracking on NW, SE, and SW faces	None	Figure 96
263-1	None	Two cracks on N face	None	Figure 97
270-2	Jacket splitting on NE corner	Cracking on N face with corrosion staining, cracking on all faces	None	Figure 98
289-2	None	None	None	Figure 99
289-5	Jacket splitting on N face	Piles repair in all faces, cracking in previous repair	None	Figure 100
304-4	None	Cracking in repair on SE corner and S face	None	Figure 101
308-5	None	Cracking in repair at top of the pile	None	Figure 102
316-8	None	Repair on SE corner	None	Figure 103
46-3	Missing jacket at the bottom	Several cracks on E face, repairs on E and S face with cracking, cracking on W face	None	Figure 104

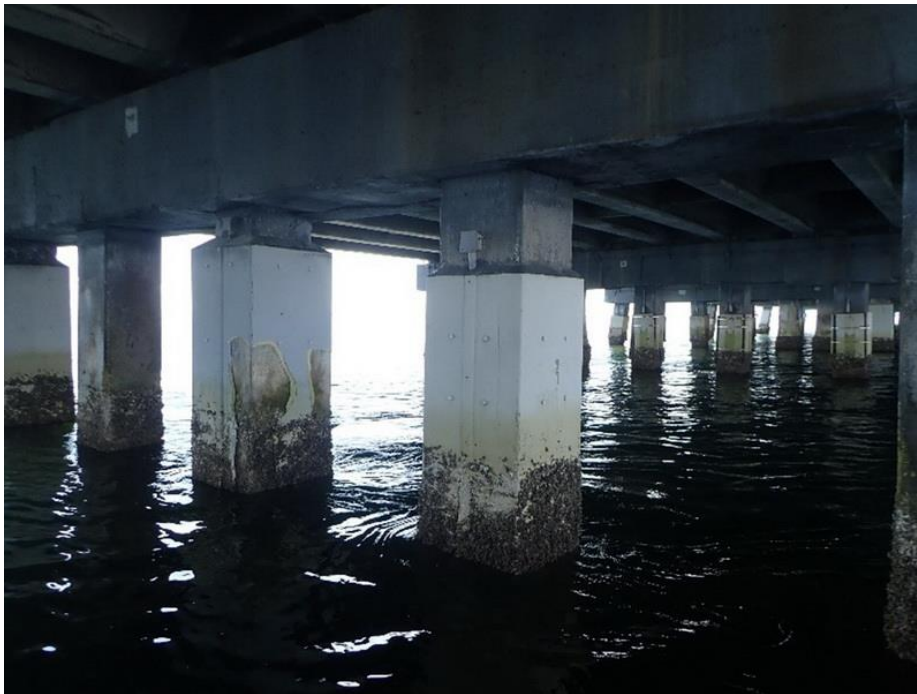
Figure 94. Overview photograph of pile and jacket with no noted distress (Pile 214-3)

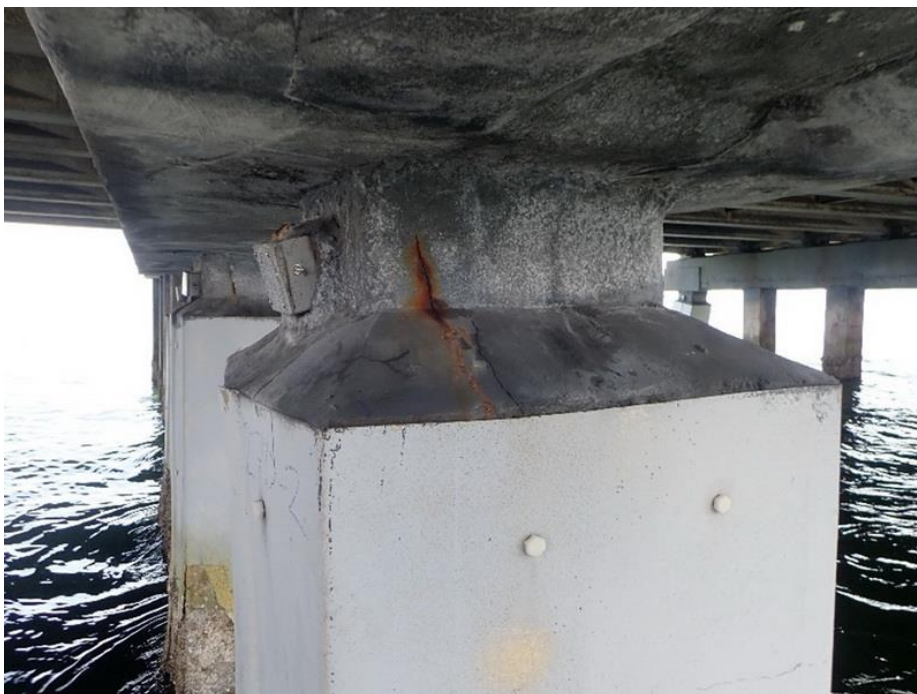
Figure 98. Cracking measured up to approximately 50 mil wide with corrosion staining (Pile 270-2)

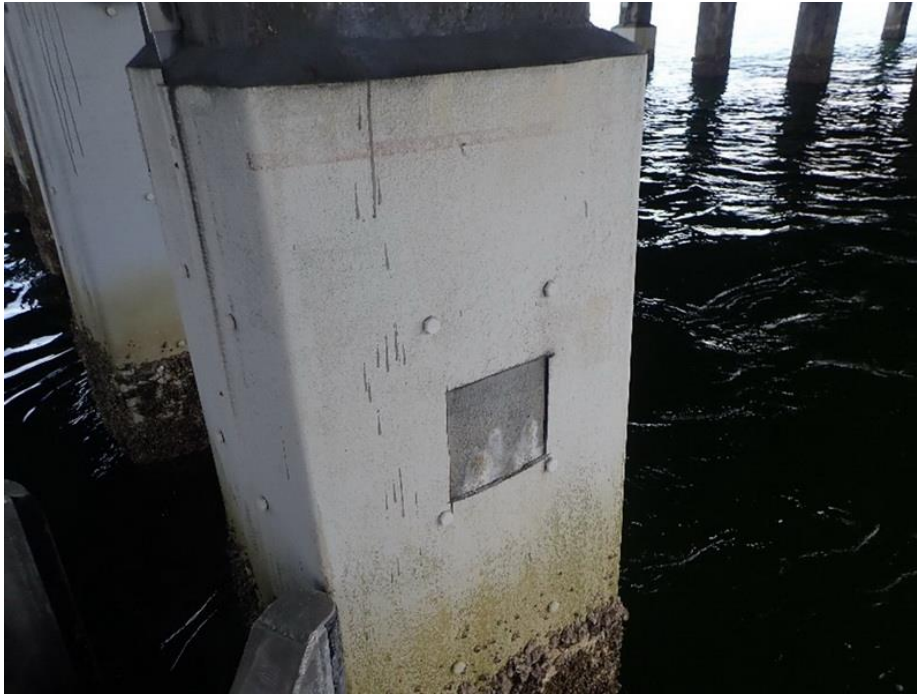
Figure 99. Overview photograph of pile and jacket with no noted distress (Pile 289-2)

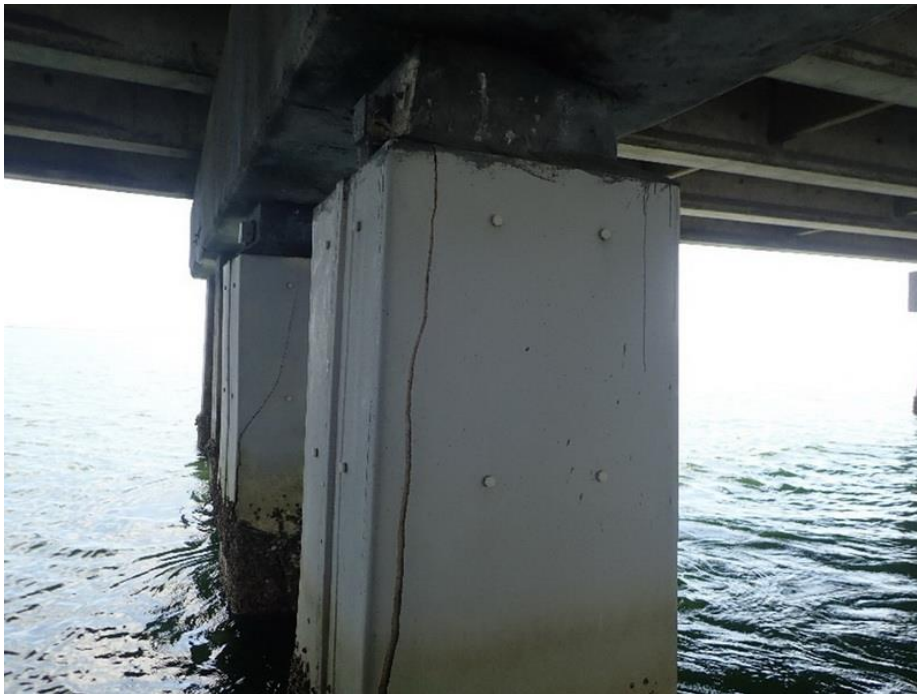
Figure 100. Vertical full length splitting of the jacket (Pile 289-5)

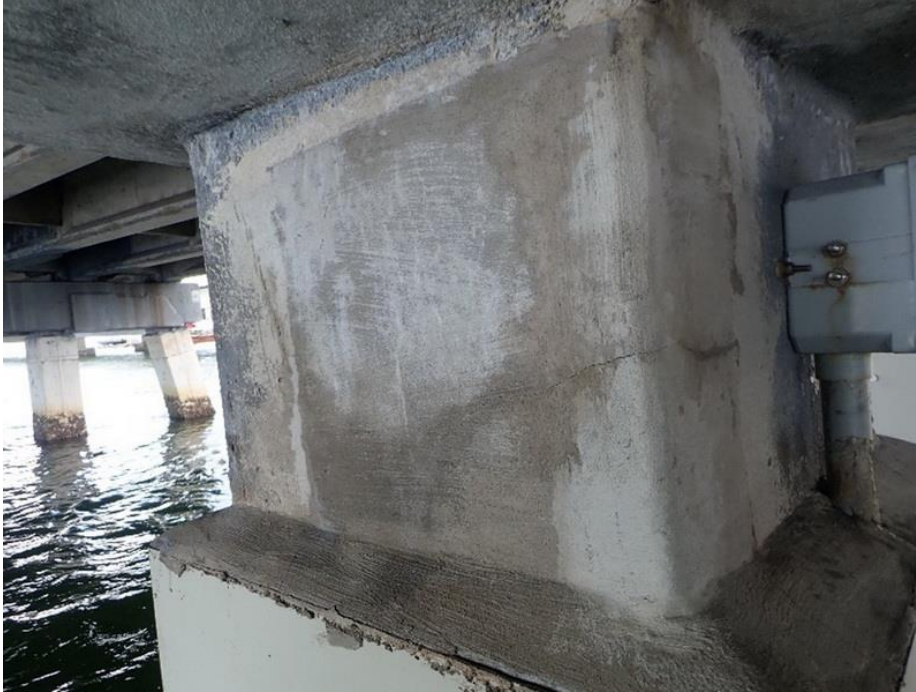
Figure 101. Cracking in repair of pile (Pile 304-4)

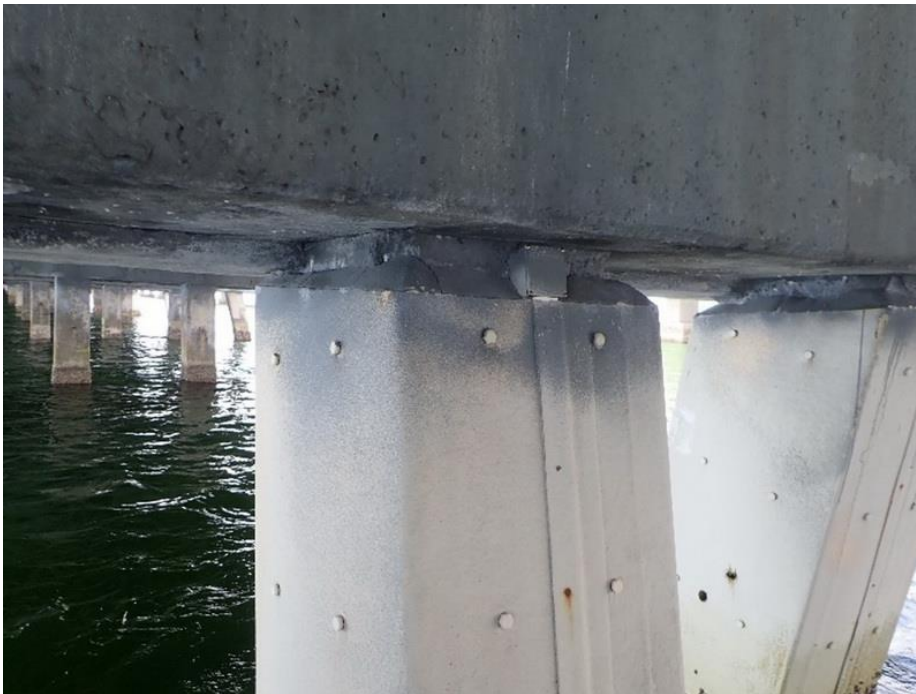
Figure 102. Cracking in repair on top of pile (Pile 308-5)

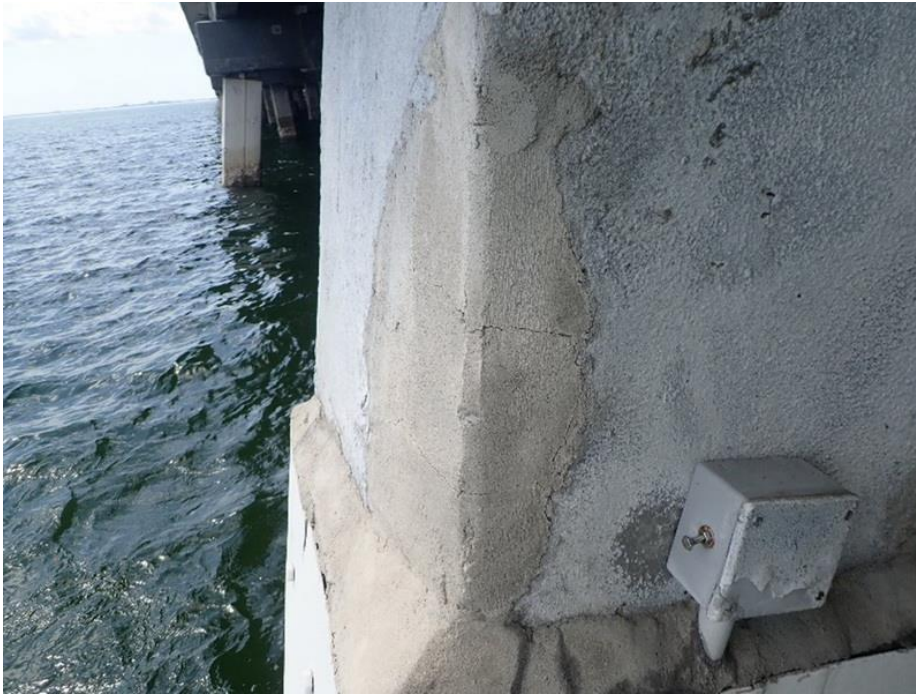
Figure 103. Repair on pile corner (Pile 316-8)

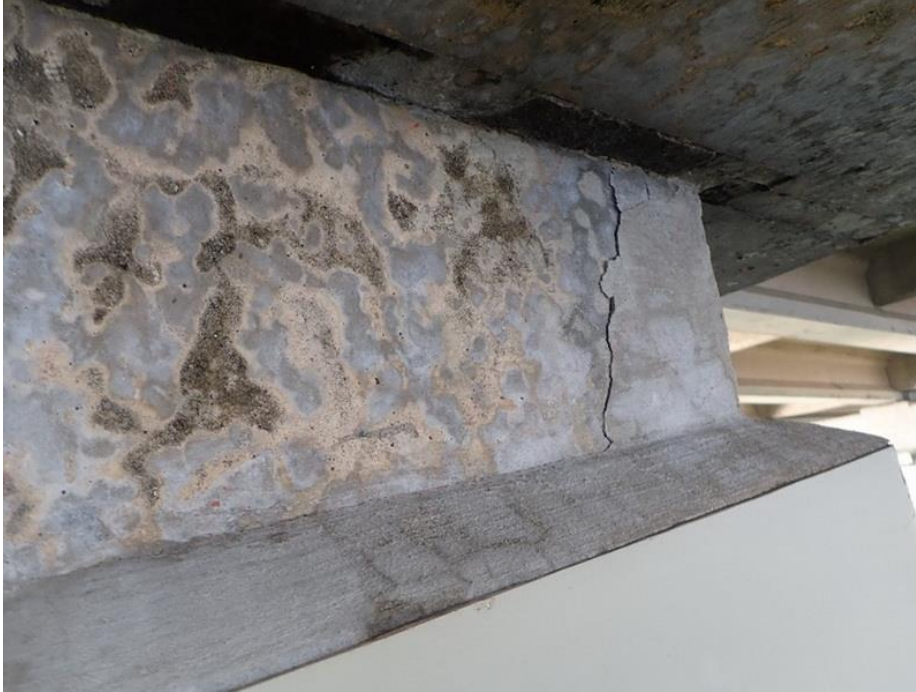
Figure 109. Cracking of pile (Pile 94-3)

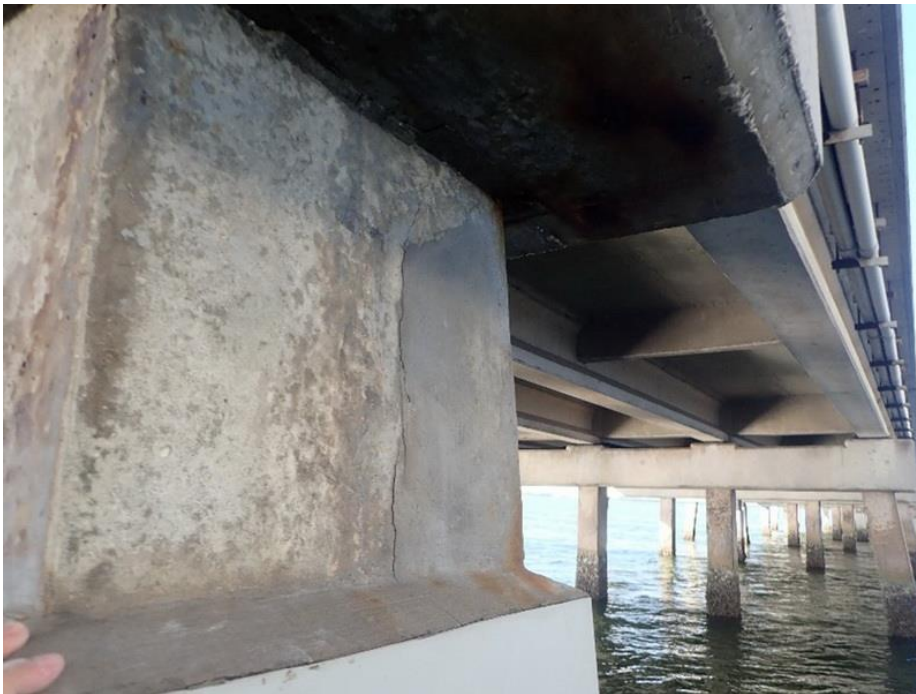
Figure 110. Cracking on repair of pile (Pile 104-1)

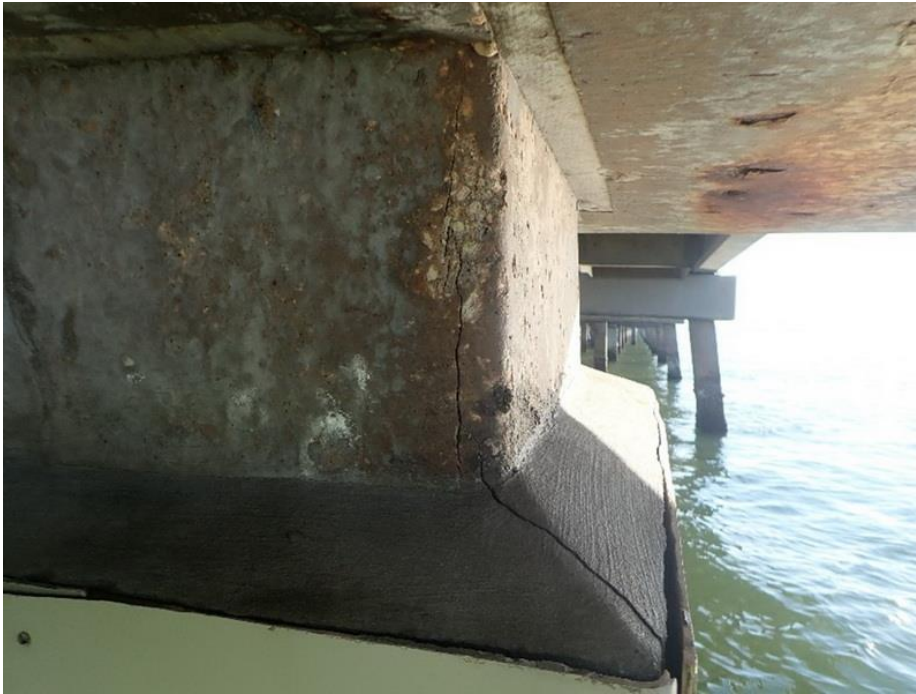
Figure 111. Corner cracking of pile (Pile 106-7)

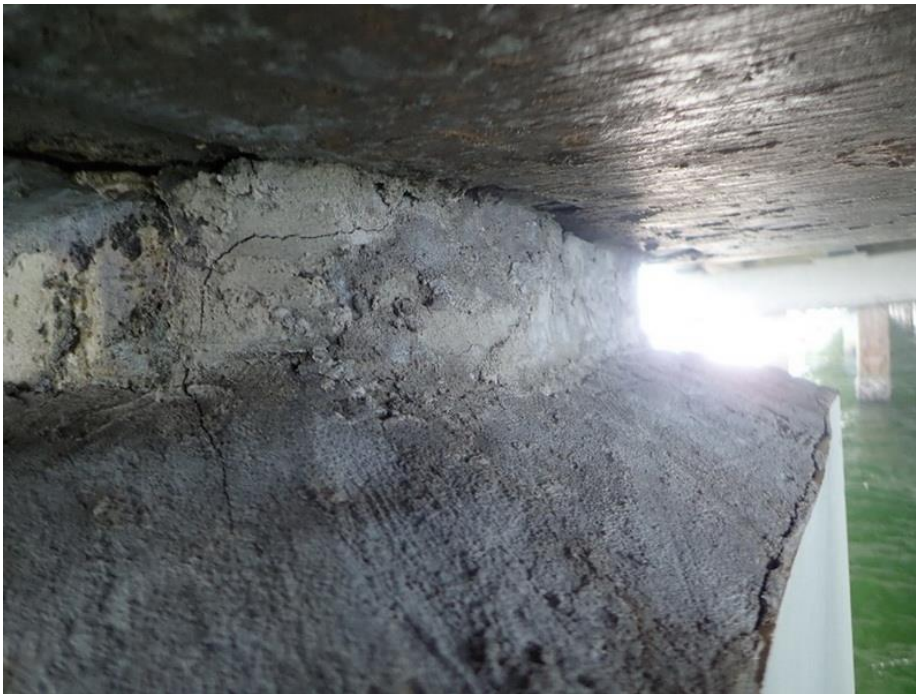
Figure 112. Parge coat cracking, no pile cracking noted (Pile 137-4)
