Evaluation of FDOT Corrosion Prevention and Control Programs

DOT-RFP-19-9059-GH

FINAL REPORT

Wiss, Janney, Elstner Associates, Inc.

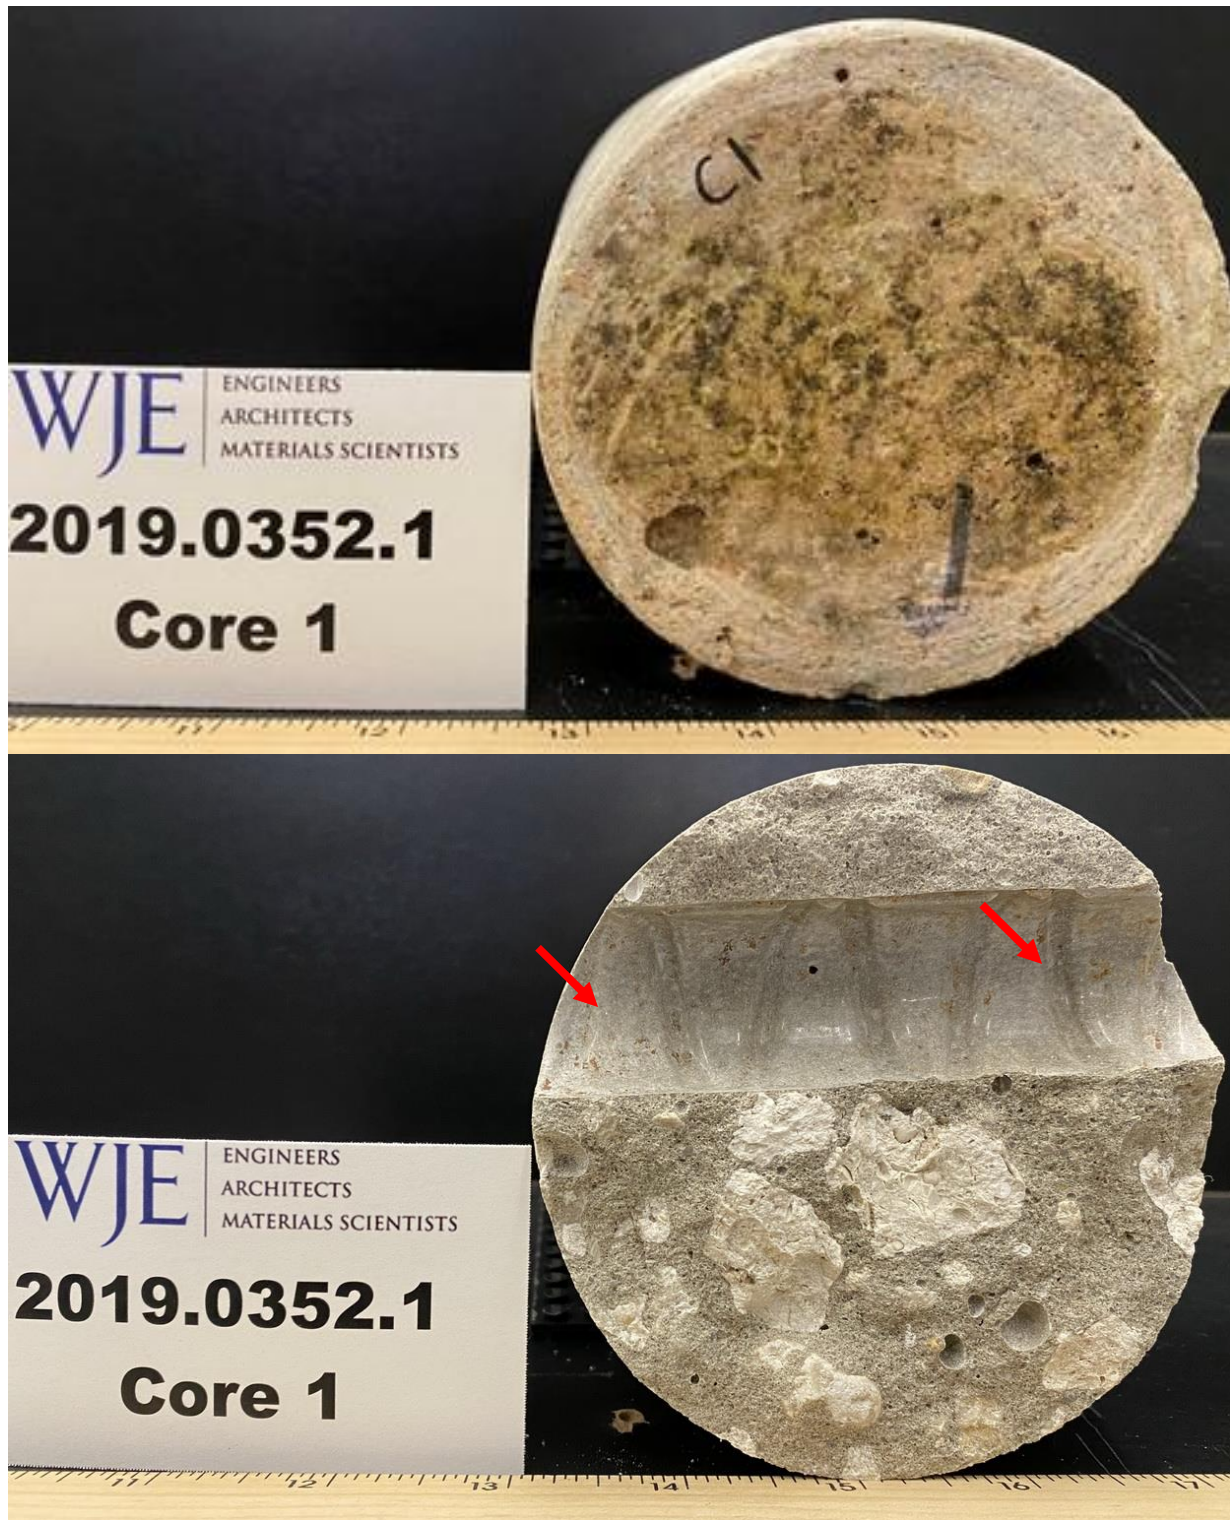
4. **Distress Related to Seawater Exposure:** Minimal in Core 10; None observed in Core 1.
5. **Reinforcement:** Core 1 contained an imprint of No. 8 epoxy-coated steel reinforcing bar. The imprint is free of significant rust or staining, suggesting the bar is likely in good condition. No radiating cracking was observed surrounding the bar. No reinforcement bars or imprints were observed in Core 10.

Figure 114. Core 1. Exterior (exposed) surface (top photo) and interior surface (bottom photo). Arrows indicate imprint of coated deformed steel reinforcing bar, with essentially no to minimal stains or corrosion rust. The fractured surface extended mainly through coarse aggregate particles, consistent with a tight paste-aggregate bond. As-received.

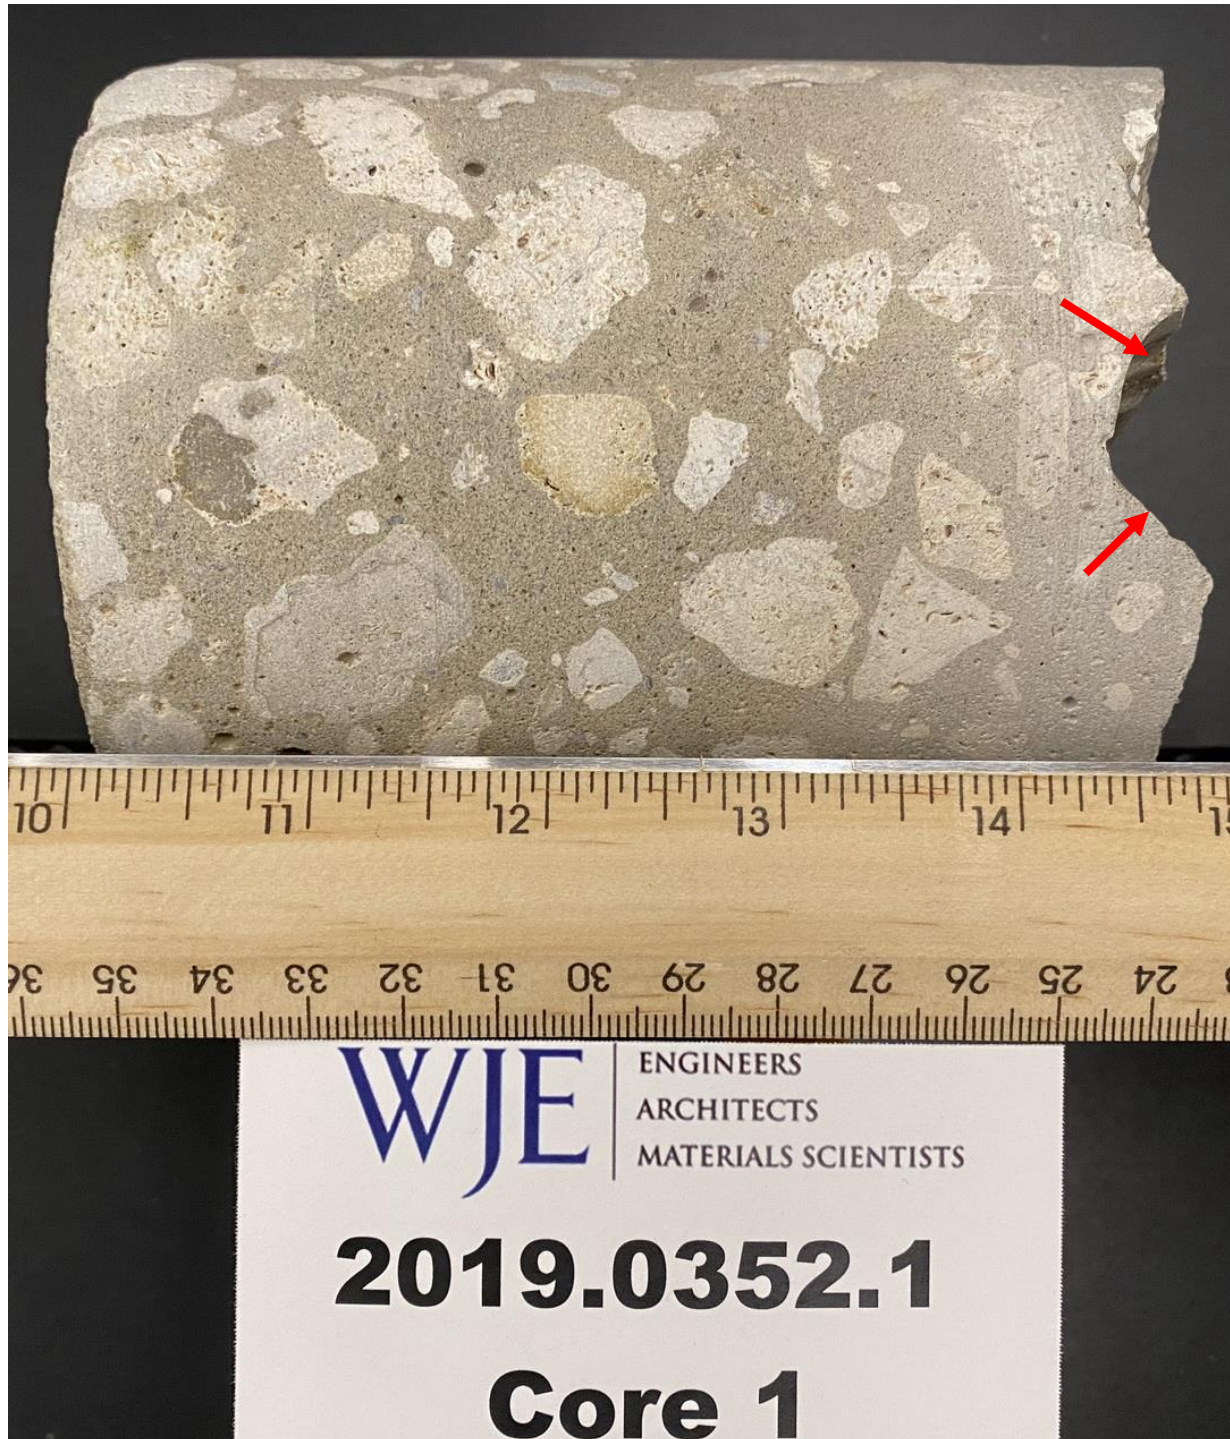
Figure 115. Core 1. Side view. Exterior end of the core is on the left. Arrows indicate the imprint of the rebar.

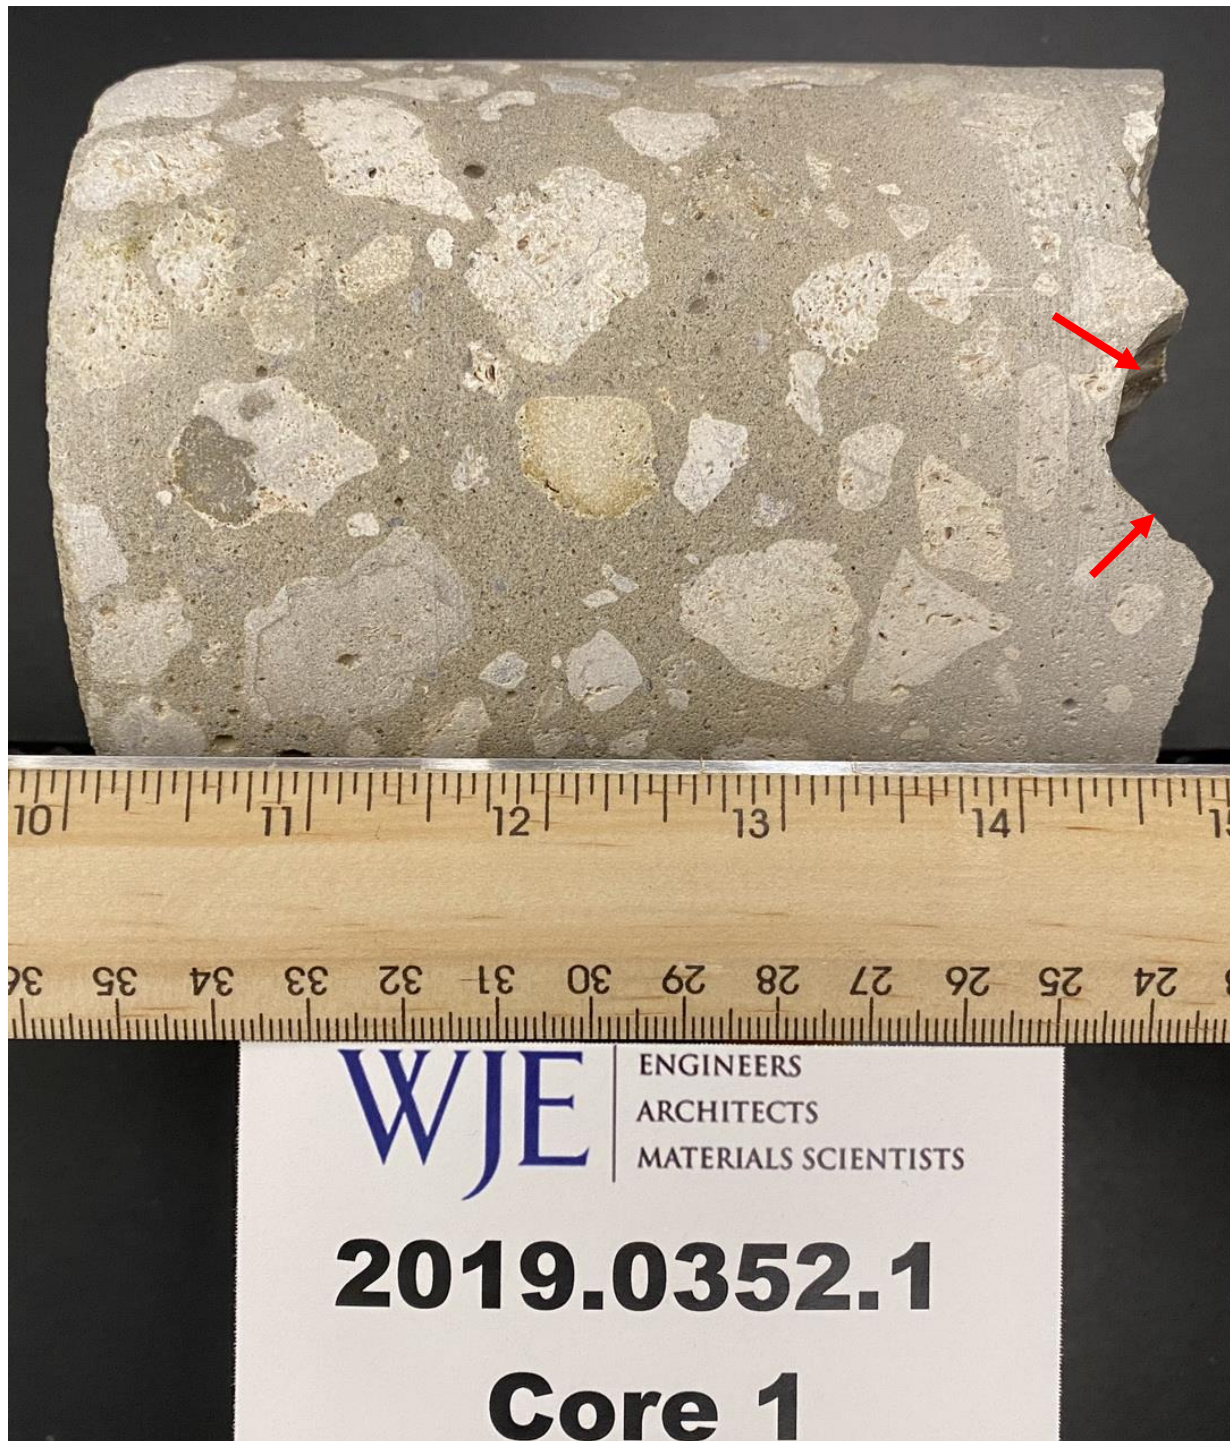
Figure 117. Core 1. Side view. Exterior end of the core is on the left. Arrows indicate the imprint of the rebar.

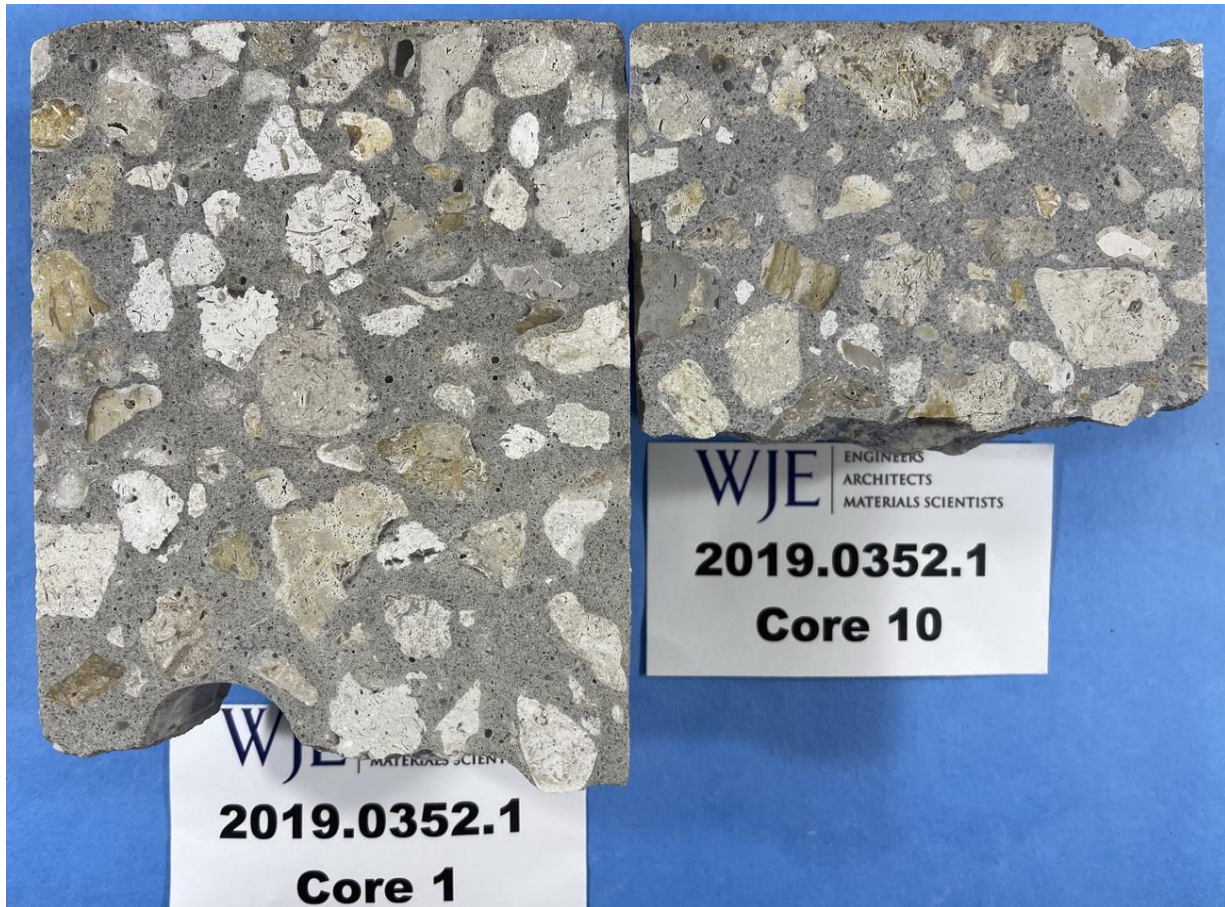
Figure 120. Core 1 and Core 10. Lapped cross sections show the overall similarity between the two cores.

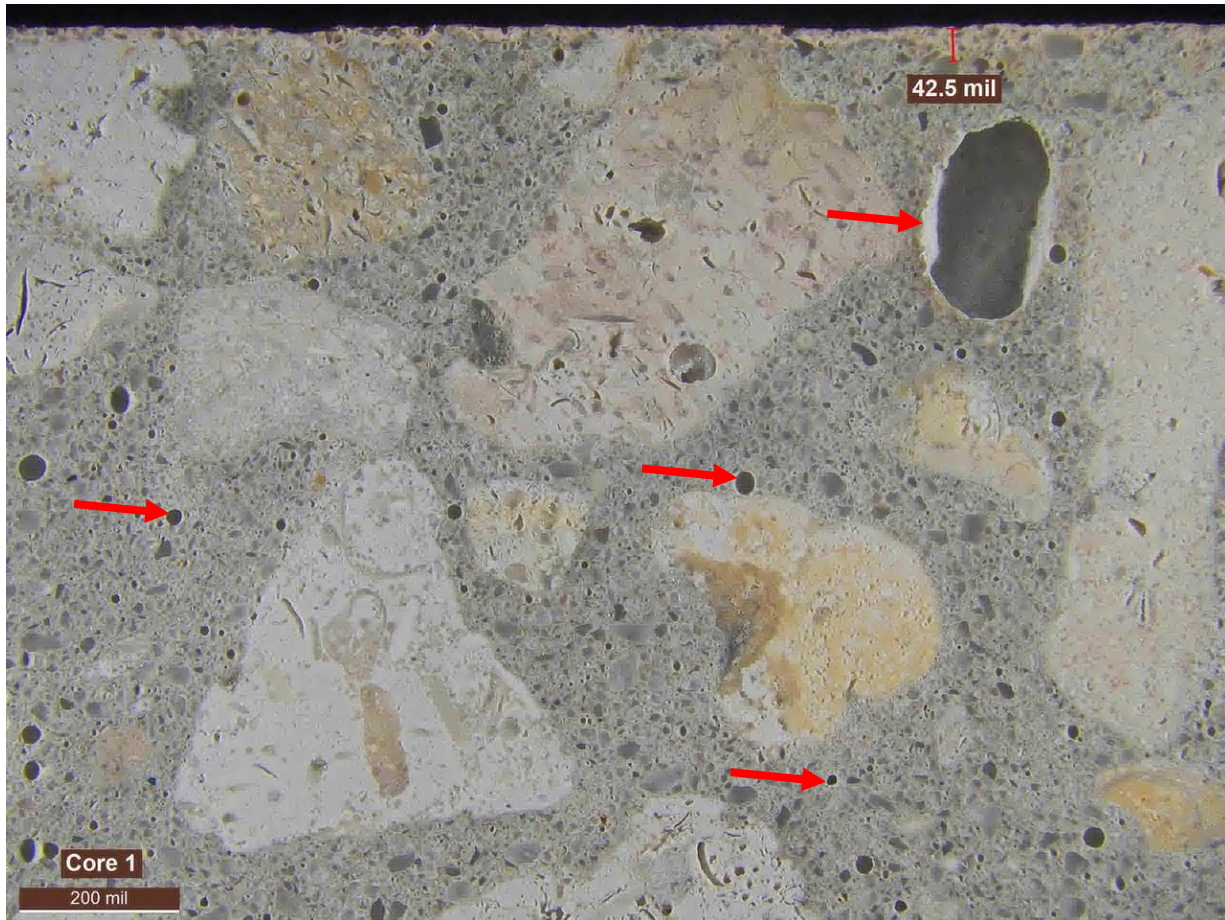
Figure 121. Core 1. Closeup view of the exterior region shows the appearance of aggregate, paste, air voids, and a discolored, carbonated top layer measuring 42.5 mils (0.043 inch). Arrows indicate air voids of varying size.

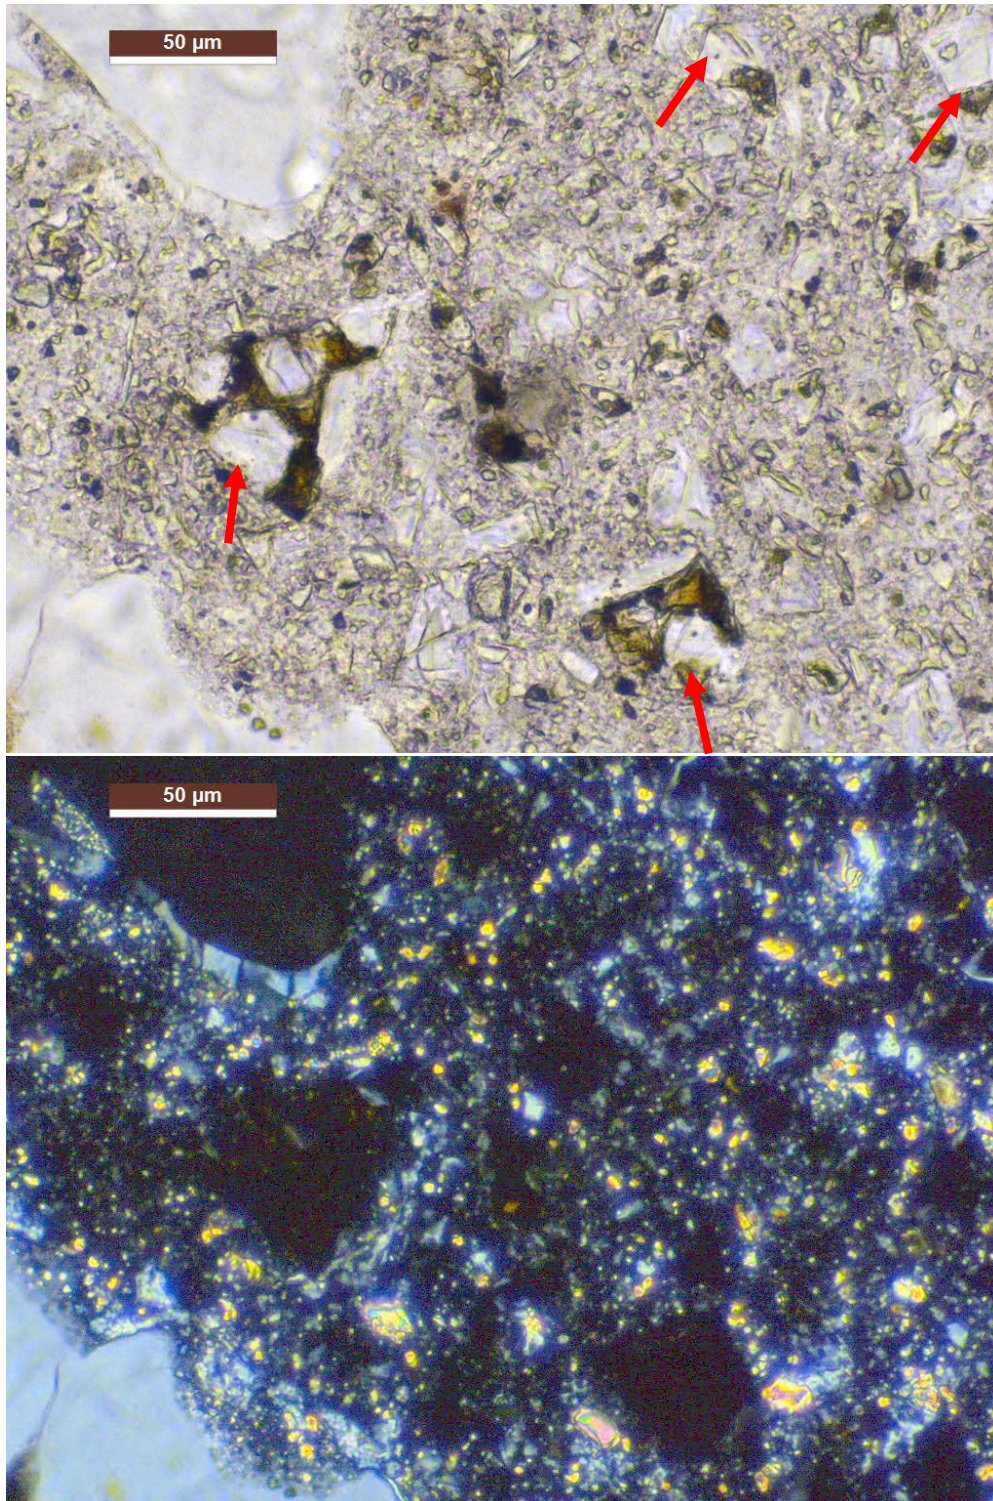
Figure 123. Core 1. Thin section photographs show the cement paste composition and micro texture. Portland cement (arrows) appeared to be well hydrated. No supplementary cementitious materials were observed. Top photo: plane-polarized light. Bottom photo: cross-polarized light.

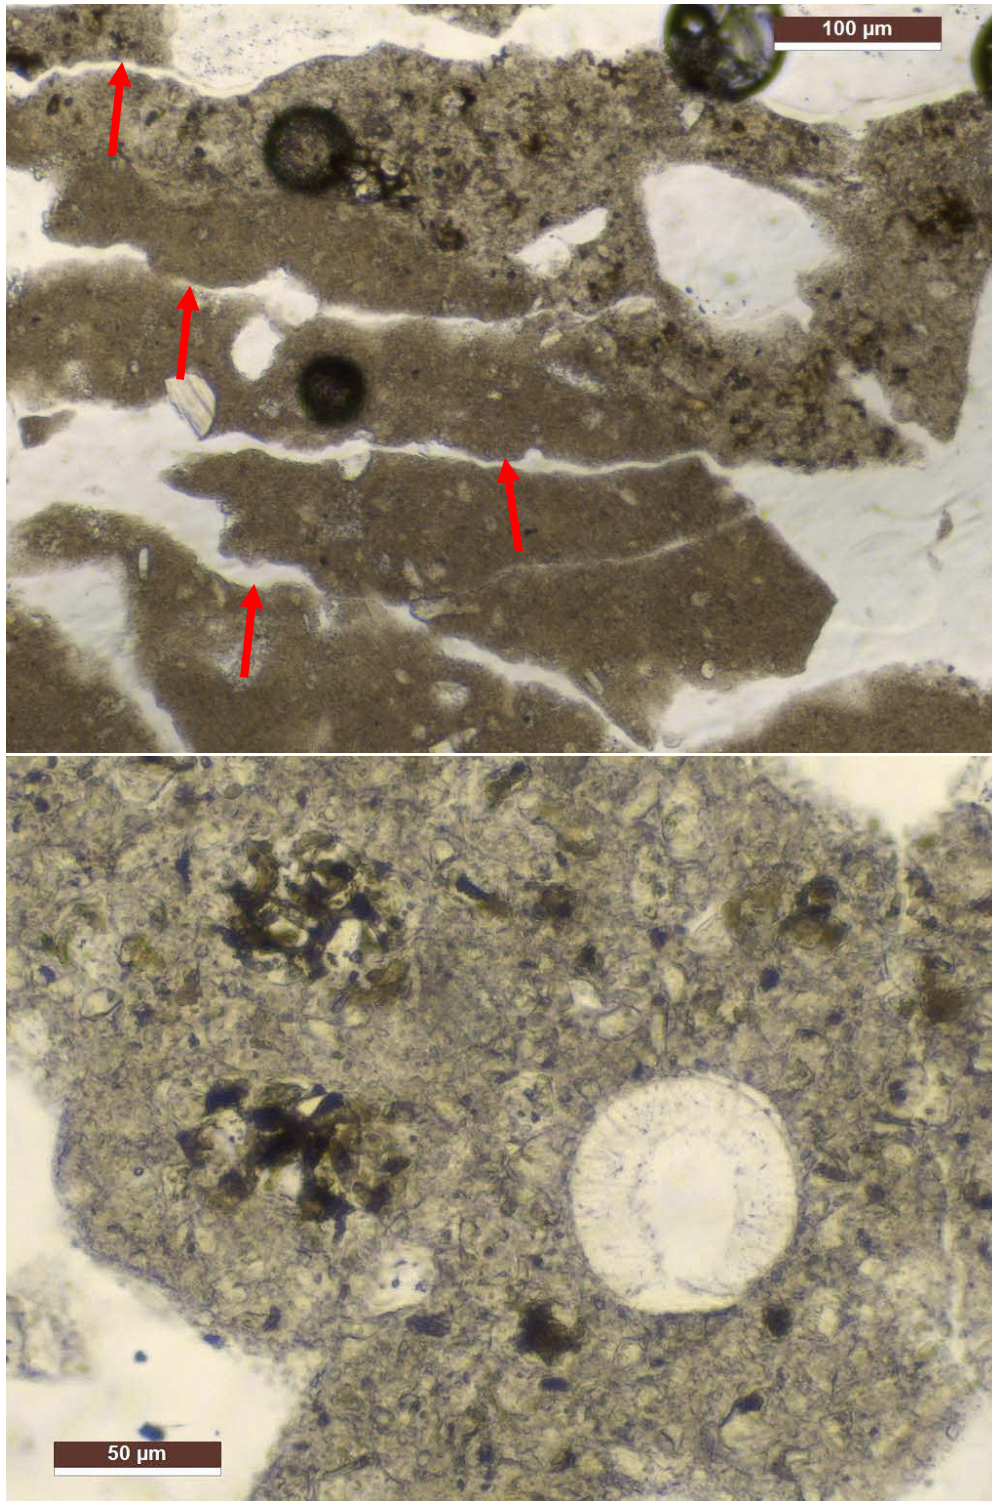
Figure 124. Core 1. Thin section photographs show the cement paste composition and micro texture. Portland cement (arrows) appeared to be well hydrated. No supplementary cementitious materials were observed. Top photo: plane-polarized light. Bottom photo: cross-polarized light.

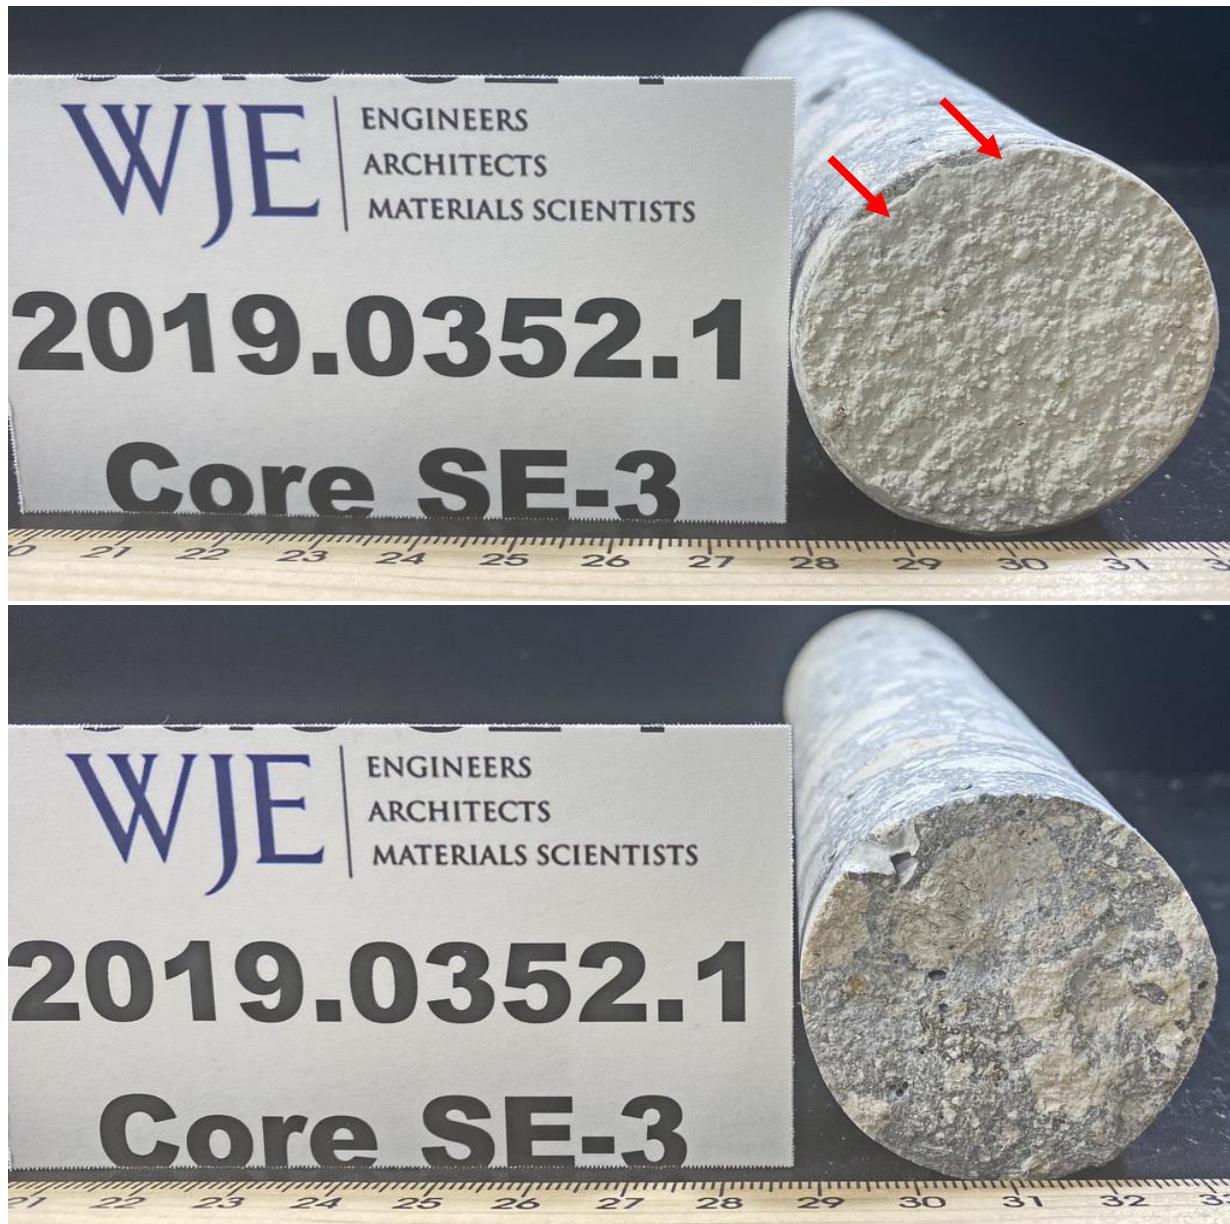
Figure 125. Core SE-3. Exterior (exposed) surface (top photo) and interior surface (bottom photo). Arrows indicate a thin layer of light-gray coating. The interior fractured surface extended mainly through coarse aggregate particles, consistent with a tight paste-aggregate bond. As-received for examination.

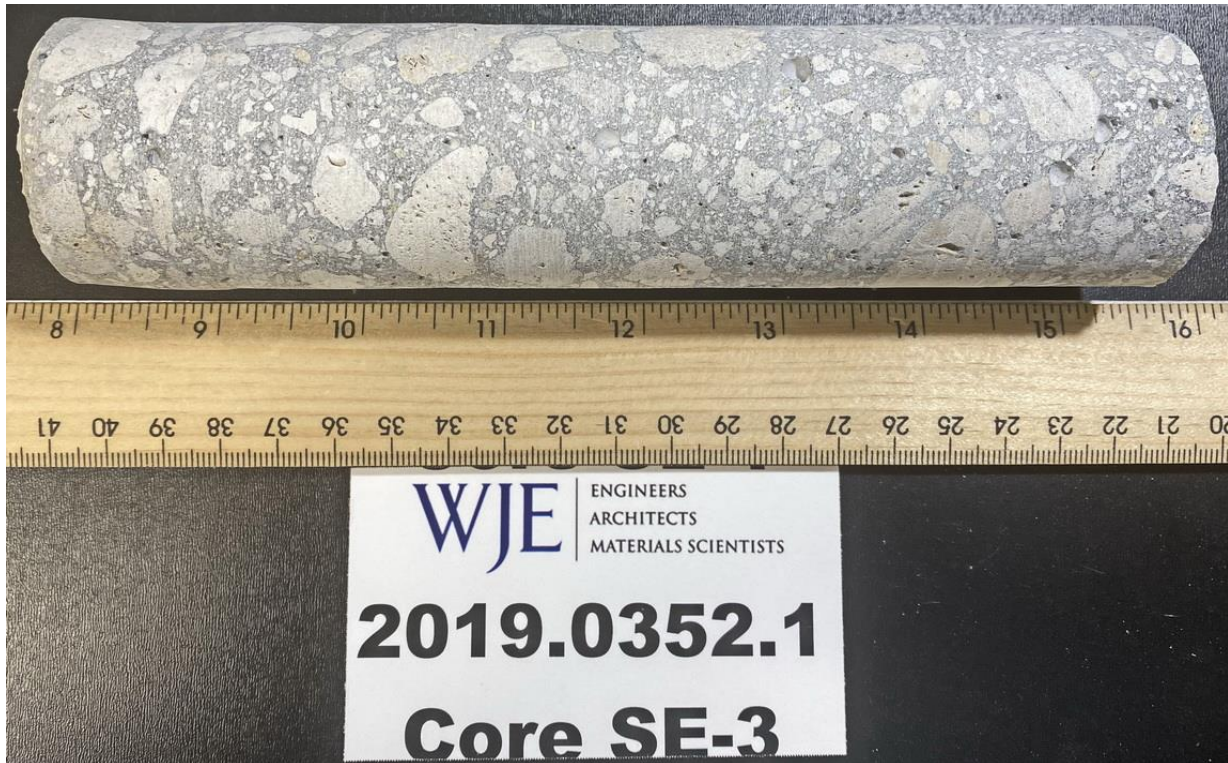
Figure 126. Core SE-3. Side view. Exterior end of the core is on the left.

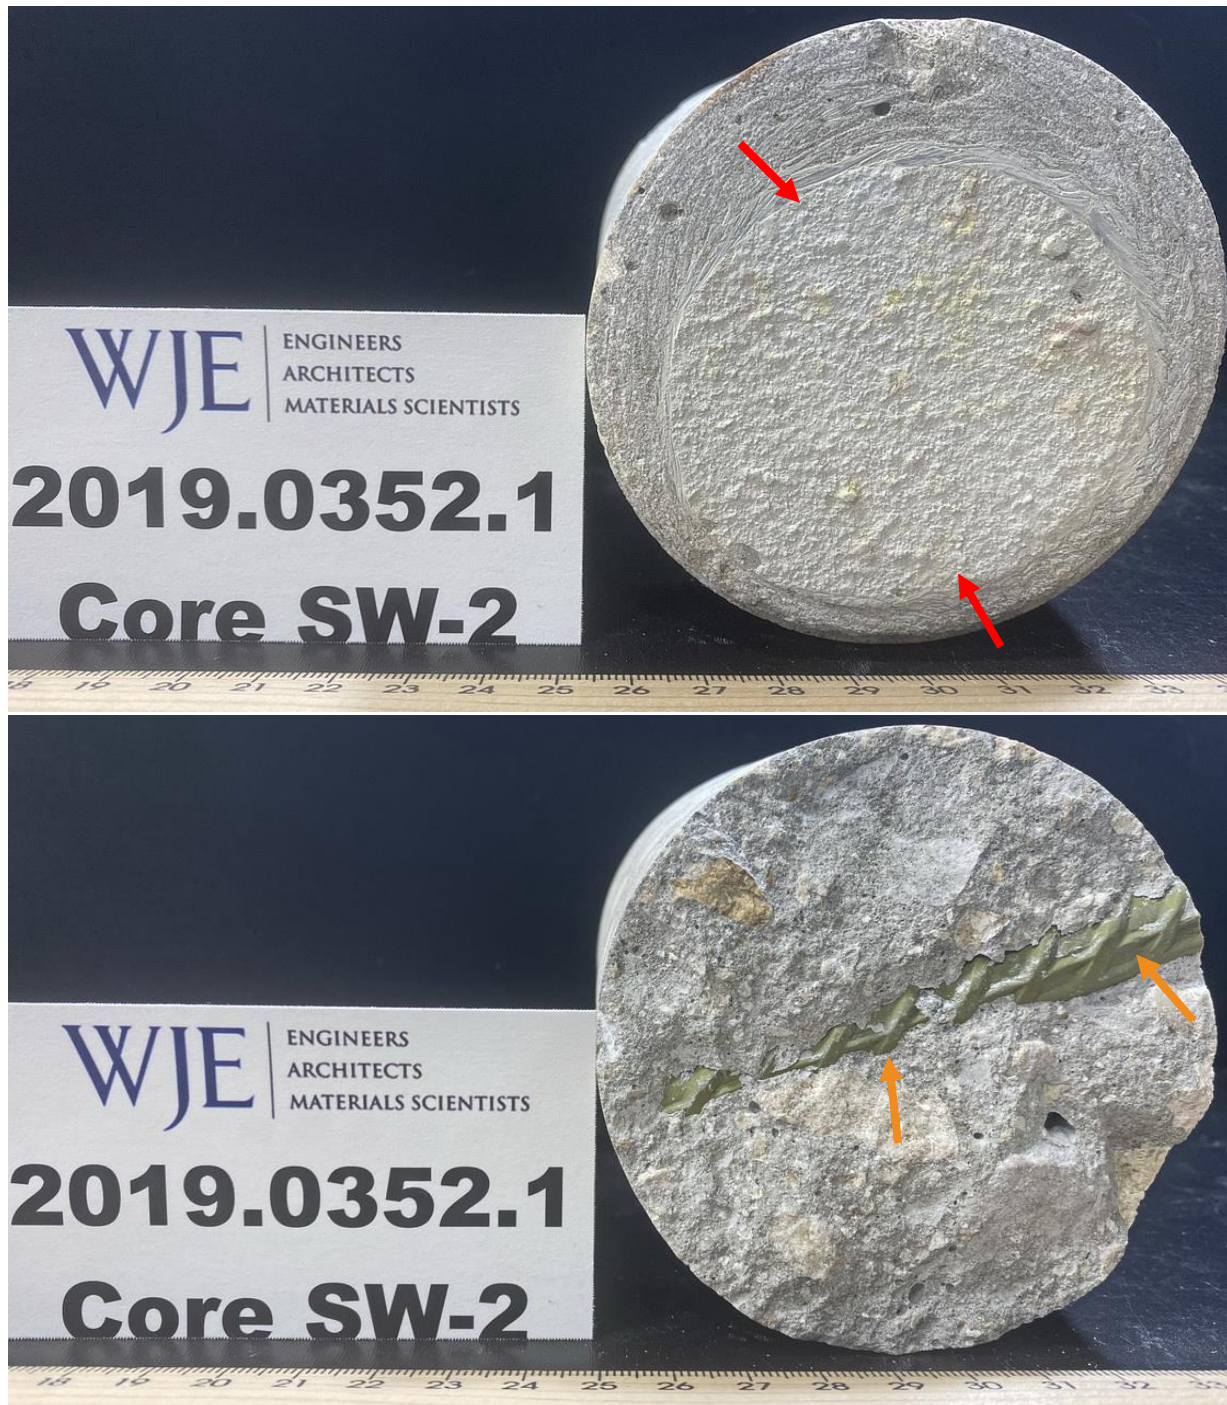
Figure 127. Core SW-2. Exterior (exposed) surface (top photo) and interior surface (bottom). The interior fractured surface extended mainly through coarse aggregate particles, consistent with a tight paste-aggregate bond. Orange arrows indicate a partially exposed No. 5 reinforcing steel bar.

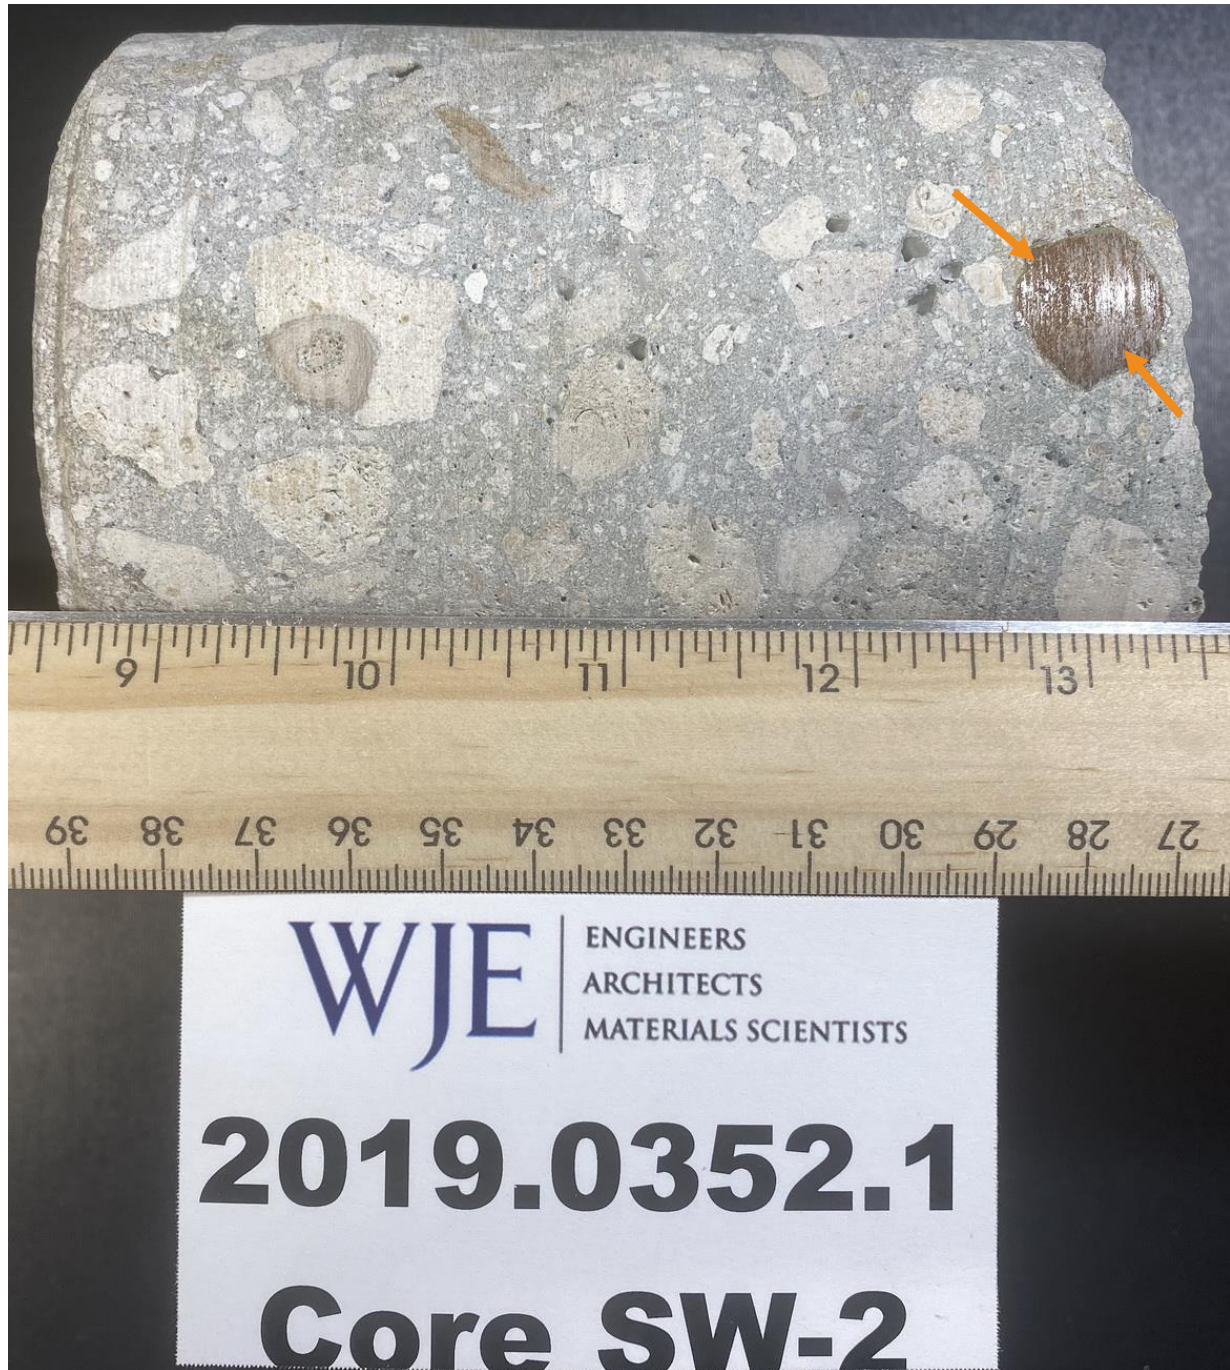
Figure 128. Core SW-2. Side view. Exterior end of the core is on the left. Arrows indicate the reinforcing steel bar.

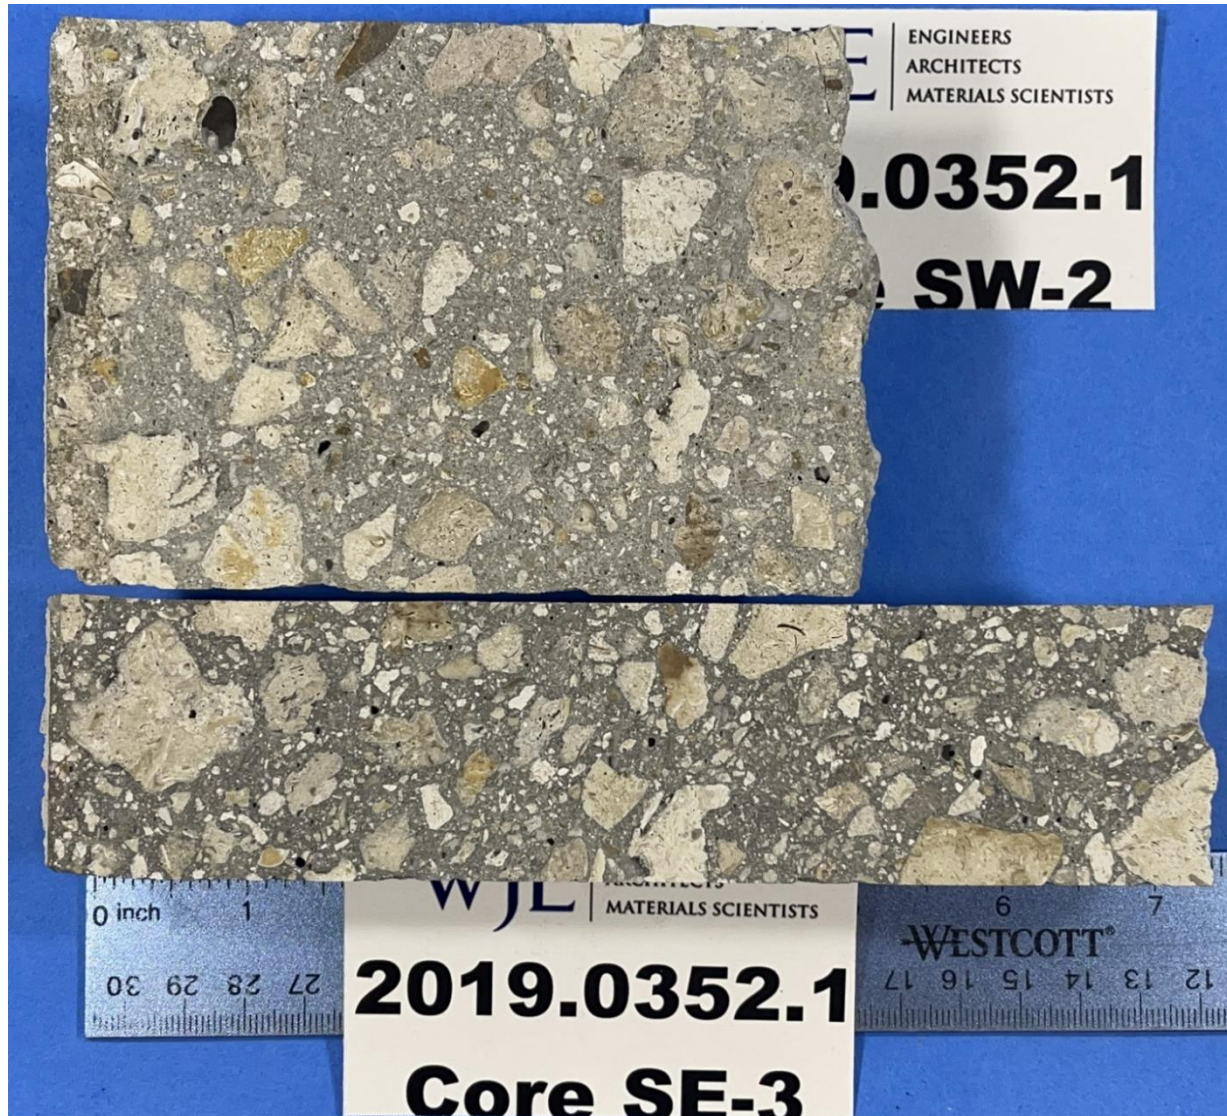
Figure 129. Lapped cross sections of the two cores show the overall appearance and condition of the concrete in each core. Distribution of paste and aggregate appears to be uniform and the concrete in each core is overall well consolidated. The exterior ends are on the left.

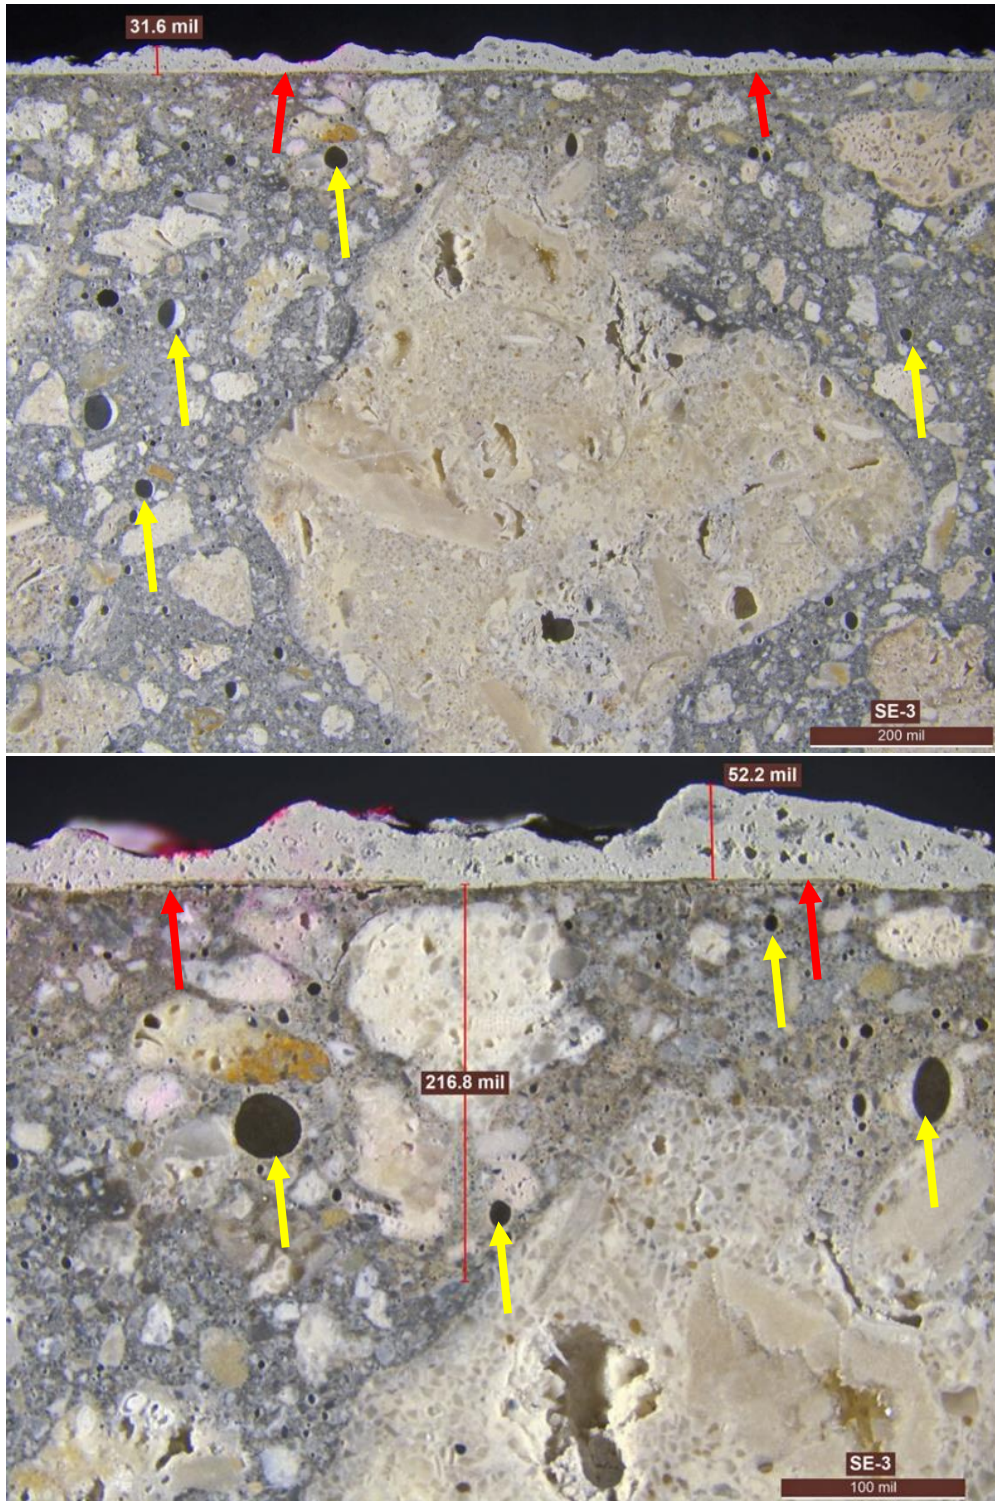
- Depth of carbonation was approximately 0.2 to 0.3 inch in Core SE-3 and 0.4 to 0.5 inch in Core SW-2 (Figure 130, Table 59).
- Each core contains a thin layer of light-gray coating that appeared to be well bonded to the concrete (Figure 131 and Figure 132).

Figure 131. Core SE-3. Closeup views of the exterior region show the appearance of aggregate, paste, air voids, a marginally discolored, carbonated top layer measuring 216.8 mils (0.22 inch), and a light-gray coating layer (red arrows). Yellow arrows indicate air voids.

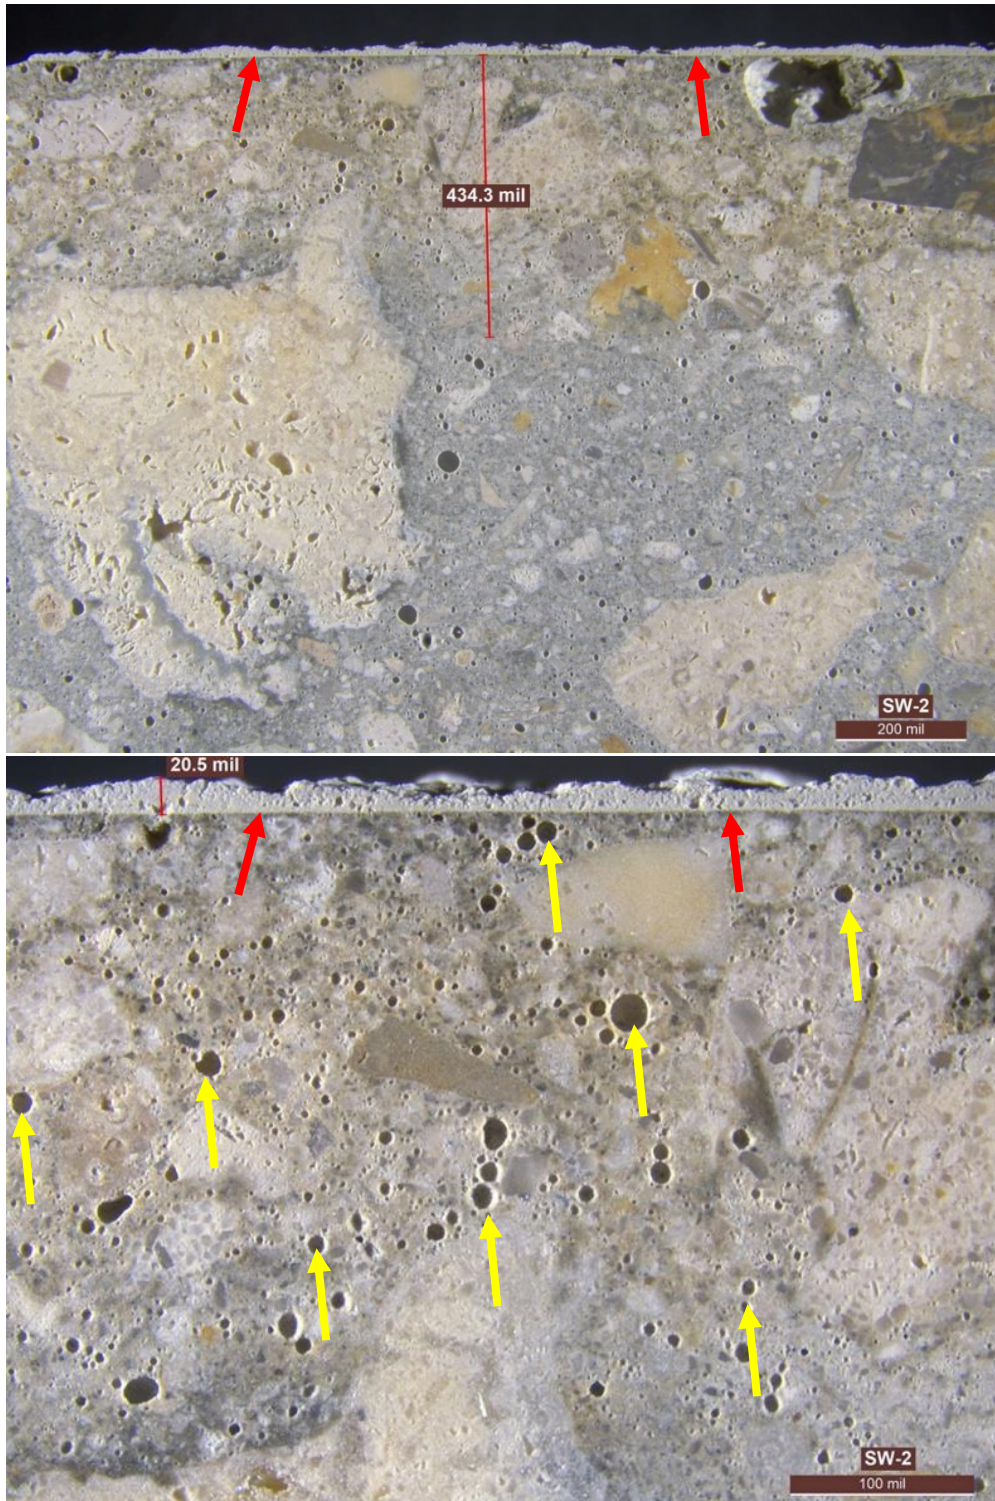
- Concrete in Core SE-3 is air entrained. Abundant small spherical air voids were observed in the core (Figure 132). Estimated air content was 4 to 6 percent. Concrete in Core SW-2 appeared to be air entrained. Small spherical air voids were observed in the core but much less frequently than in Core SE-3. The air content was estimated at 3 to 4 in Core SW-2.

Figure 132. Core SW-2. Closeup views of the exterior region show the appearance of aggregate, paste, air voids, a marginally discolored, carbonated top layer measuring 432.3 mils (0.43 inch), and a light-gray coating layer (red arrows). Abundant small spherical air voids were observed (yellow arrows), consistent with air-entrainment.
