Evaluation of FDOT Corrosion Prevention and Control Programs

DOT-RFP-19-9059-GH

FINAL REPORT

Wiss, Janney, Elstner Associates, Inc.

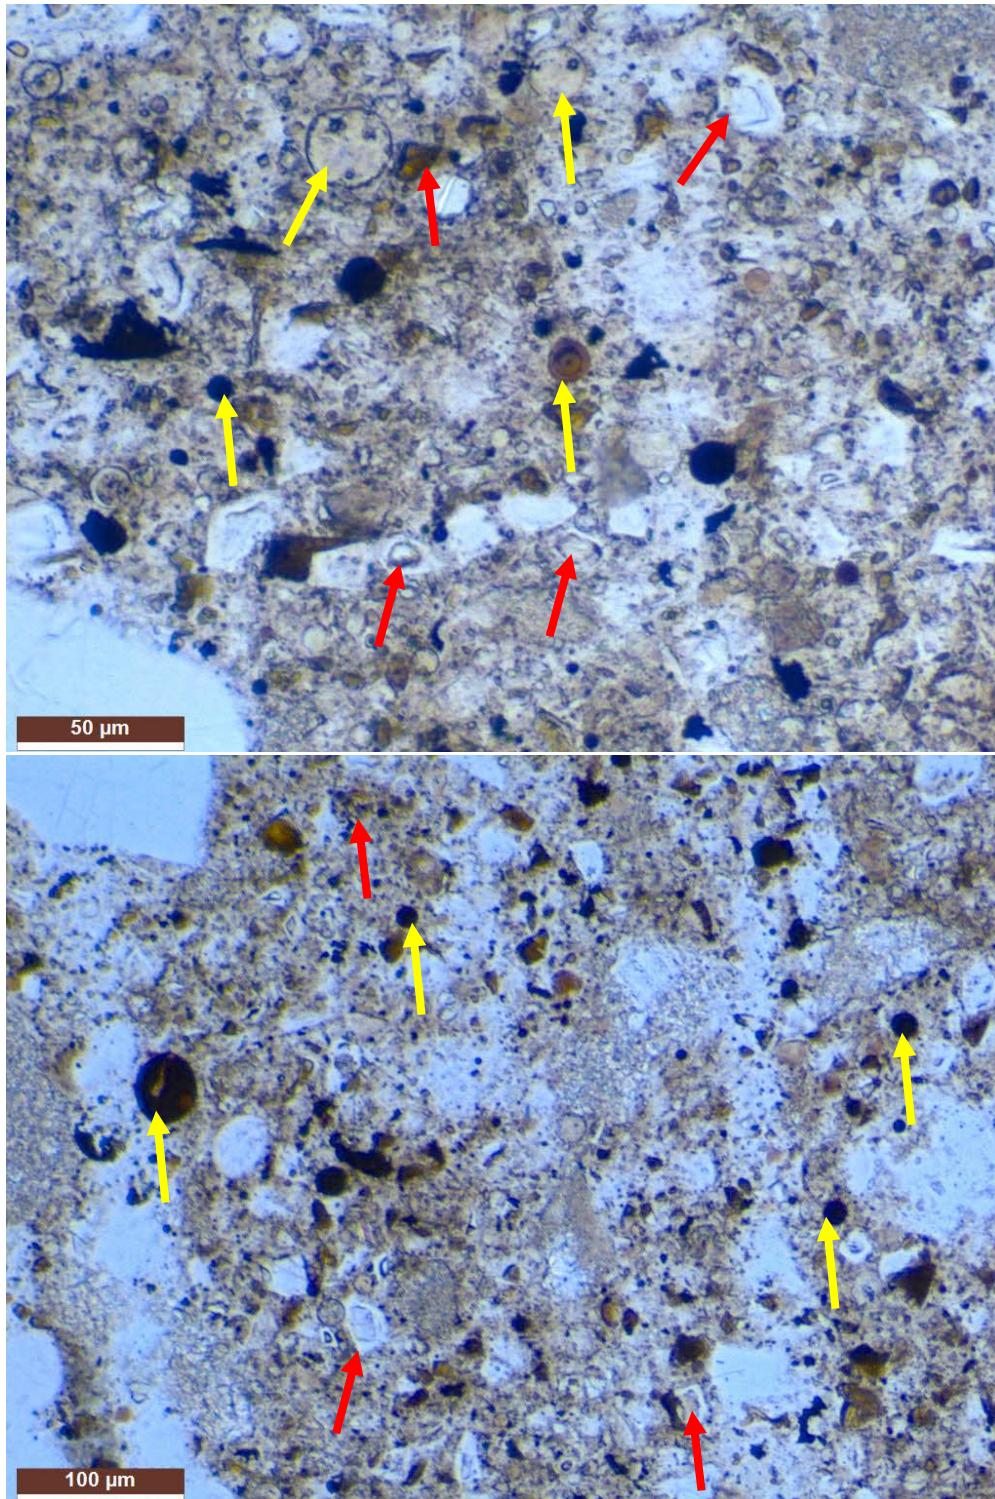
- Fly ash was observed in Core SE-3 but not in Core SW-2. Fly ash was estimated at 15 to 25 percent of total cementitious materials in Core SE-3.
- Estimated w/cm is 0.39 to 0.44 in Core SE-3 and 0.40 to 0.45 in Core SW-2. Paste in Core SE-3 is darker and marginally harder than Core SW-2 (Figure 118), likely due to presence of fly ash and a lower w/cm.

Figure 133. Core SE-3. Thin section photographs show the cement paste composition and micro texture. Portland cement (red arrows) appeared to be well hydrated. Fly ash was observed (yellow arrows) and estimated at 15 to 25 percent by mass of total cementitious materials. Plane-polarized light for both.
