*Final Report: Submitted to*  
**State of Florida**  
**Department of Transportation**

*Submitted by the*  
**Texas A&M Transportation Institute**

**Green Bike Lane Evaluation for Florida Pavements**

**Final Report**

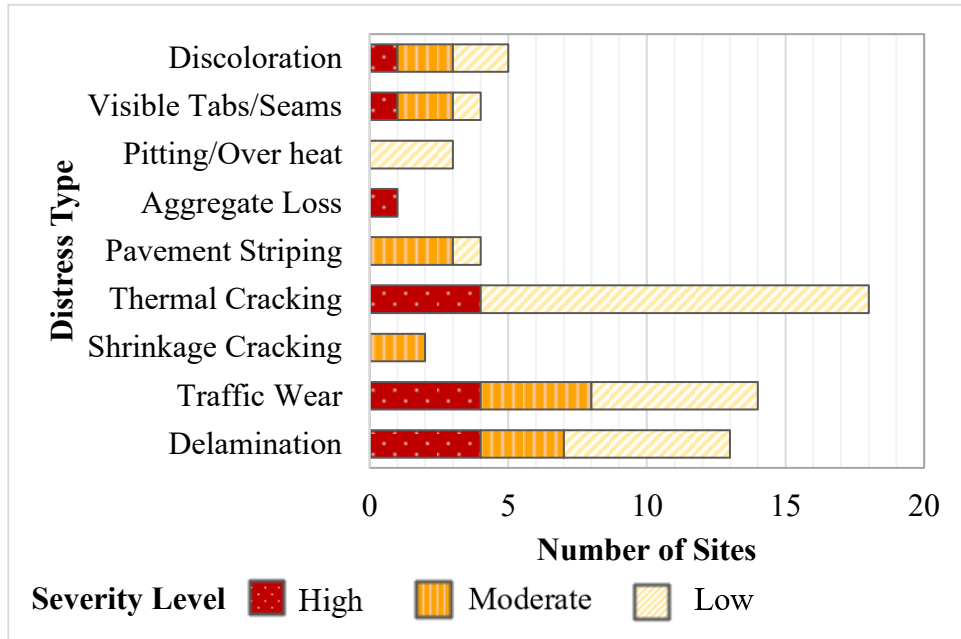
**Figure 3-2. Number of GCPM Installations versus Distress Type.**

A summary of distresses observed for each site is shown in Table 3-2. Severity is marked as low (L), moderate (M), or high (H). An overall qualitative rating of ‘good,’ ‘fair,’ or ‘poor’ was also made. In general, the researchers found that thermal cracking, delamination, and wear were the three most common distresses in Florida’s bike lanes (Figure 3-2).

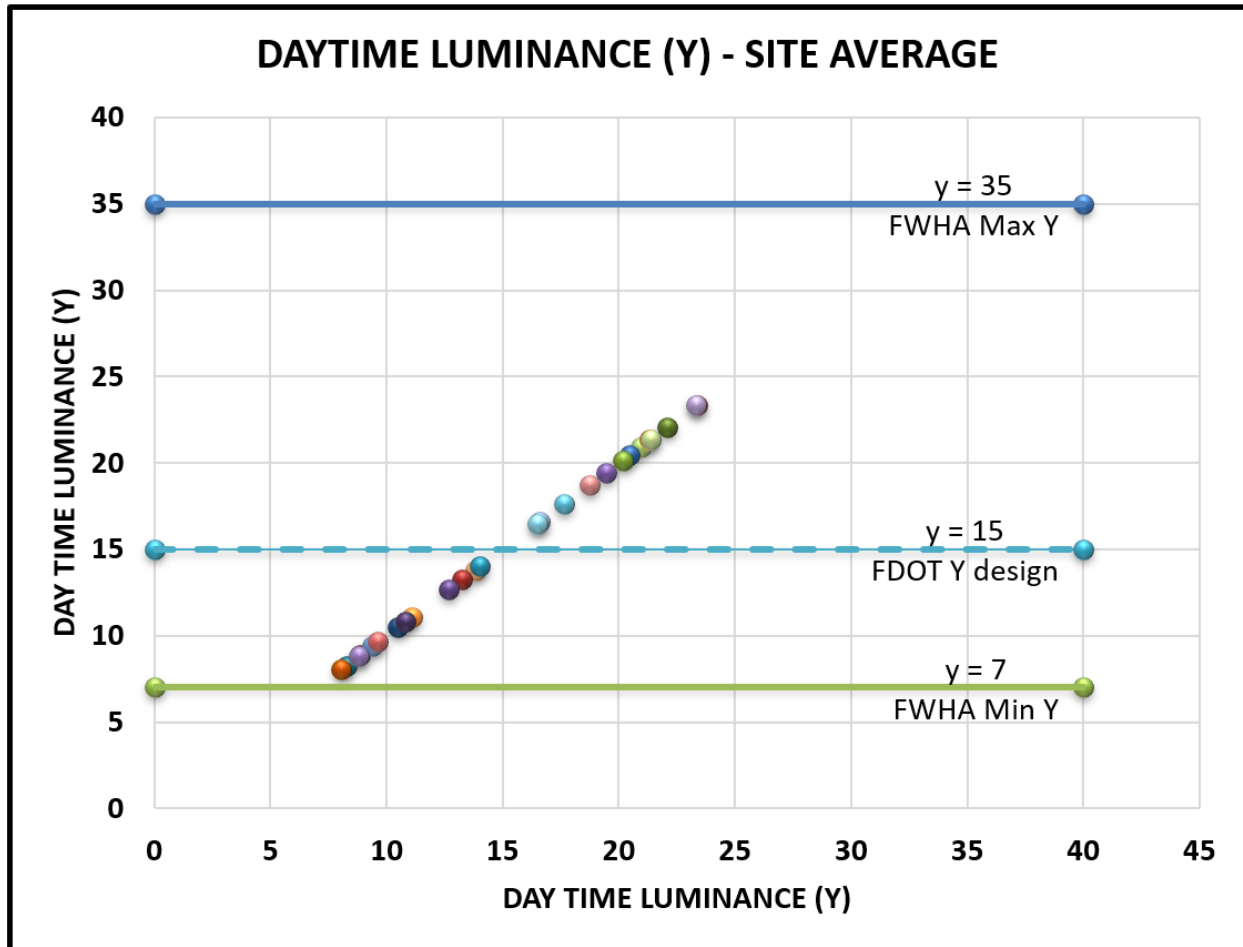
Figure 3-6. Daytime Luminance (Y) Field Test Results.

Furthermore, the research team measured the luminance (Y) of the GCPMs. The average luminance of different sites is shown in Figure 3-6. All areas passed the Y criterion (between 7 and 35). To be precise, all sites 'Y' lies between 7 and 25, and over 50 percent of the site's Y values are above 15.

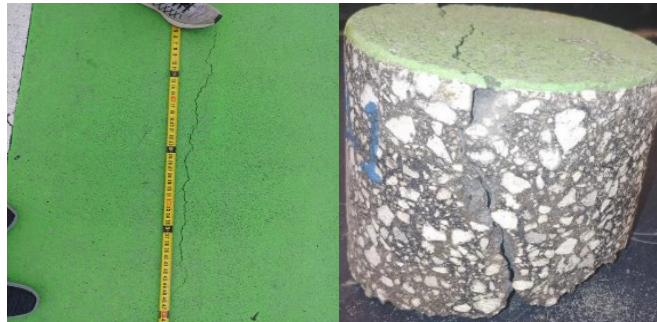
**Figure 3-7. Core Showing Extent of a Crack Observed in the Field.**

The research team collected cores from the different GCPM installations in Florida and performed a lab investigation at the Texas A&M Transportation Institute headquarters. The purpose was to investigate the extent and possible cause of distress in the pavements. Distresses limited to the surface could be indicative of the problems related to the GCPMs. For example, on site 8, the researchers observed a crack in the field but could not determine its extent until after lab investigation (Figure 3-7). The results of the core investigation were used to supplement the

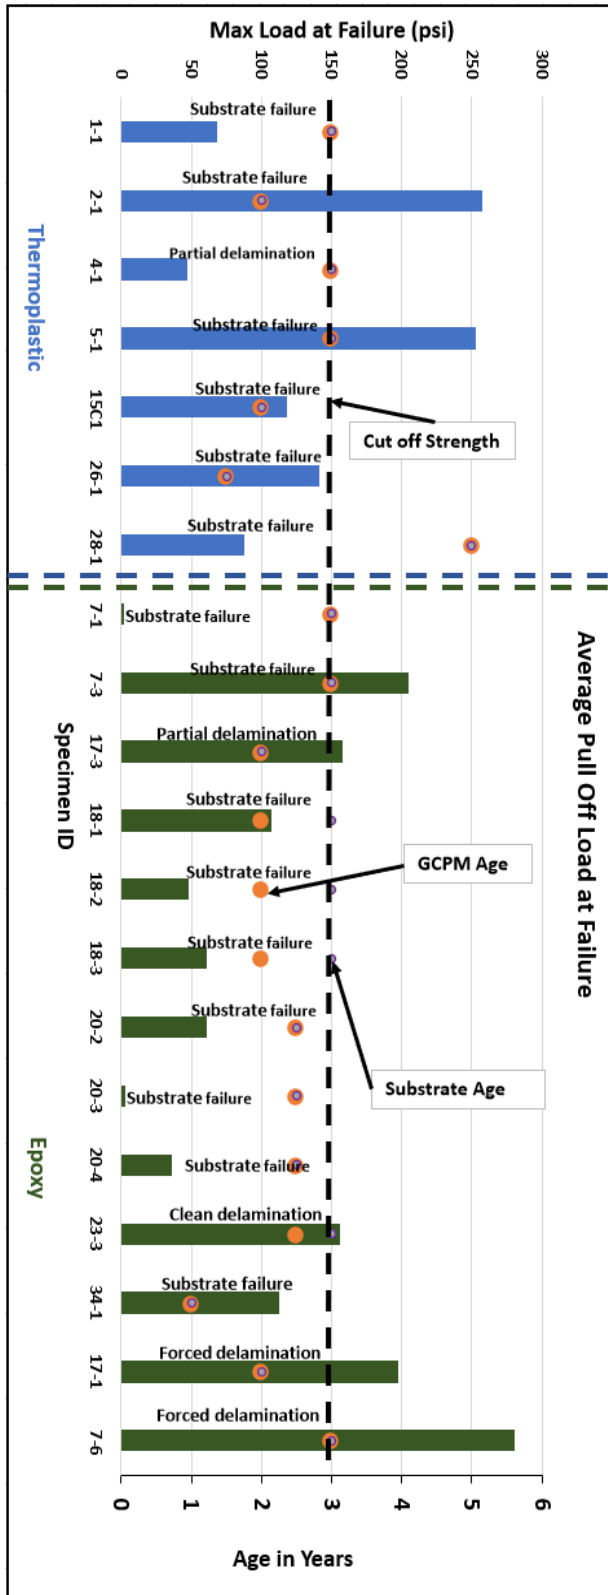
Figure 3-14. Pull-Off Test Results.

Figure 3-14 shows the pull-off test results for 19 specimens (7 thermoplastic and 12 epoxy-modified acrylic). The results indicate that a little more than 50 percent of thermoplastic specimens failed or needed more testing to determine GCPM to HMA bonding strength. Likewise, over 60 percent of the epoxy-modified acrylic specimens fall in the same category. The research team assessed the relationship between age and the GCPMs' performance. Almost all GCPMs were equal to or less than three years and could not show a correlation between age and performance. The extended results of the pull-off tests are shown in Appendix B.

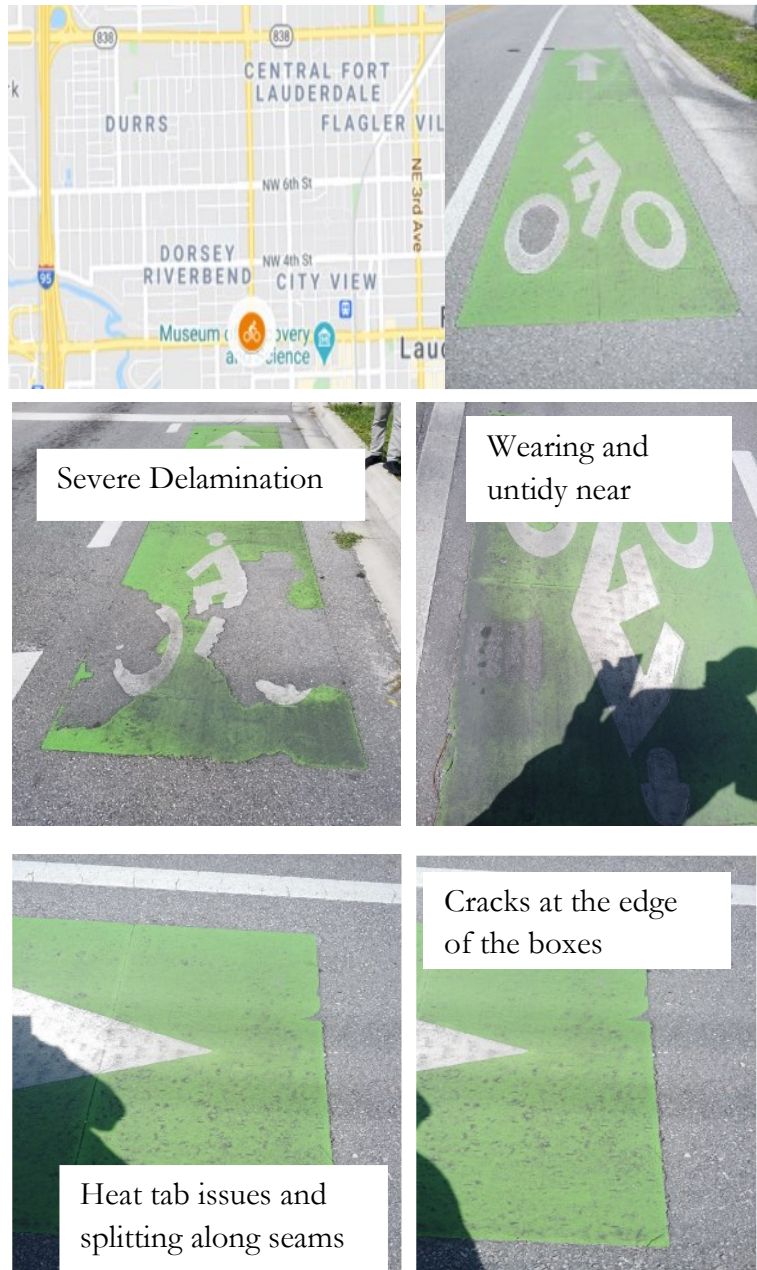
**Figure A-6. Site 24-Location and Distresses.**

- Construction and Materials
  - This site was constructed in June 2017 on a DGFC substrate. The thermoplastic was applied to the pavement immediately after construction (Figure A-6). The Bike lane is in District 4, Broward County.
- Observation
  - Overall poor condition.
  - Skid marks, especially on turning.
  - GCPM on the shoulder was severely delaminated.
  - Thermoplastic is worn out and very dirty near gutters.
  - Heat tab issues and splitting along seams.
  - Cracks were observed at the edges of the boxes.

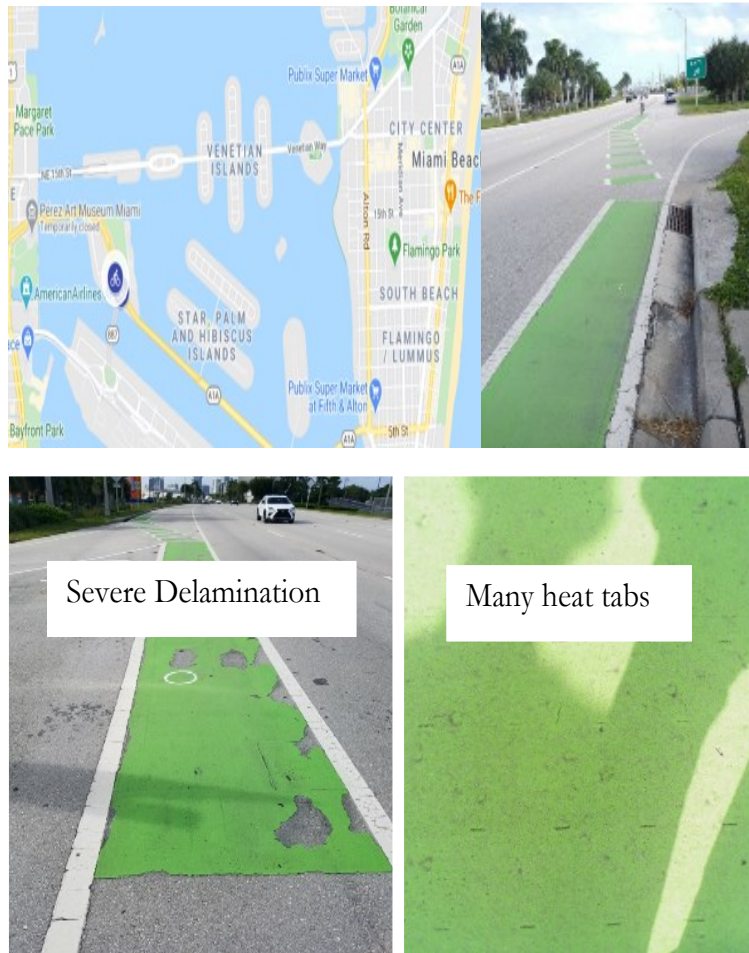
**Figure A-7. Site 28 and 29-Location and Distresses.**

- Construction and Materials
  - Site 28 and 29 fall in the same lane, split into two parts, 28 and 29, before and after exit (Figure A-7)
- The site was constructed in 2015 on a DGFC substrate. The substrate was built during the same period. The bike lane is in District 6, Dade County.
- Observation
  - Overall poor condition.
  - Severe delamination was observed on both sites 28 and 29.
  - Many heat tabs issues, probably due to poor construction.

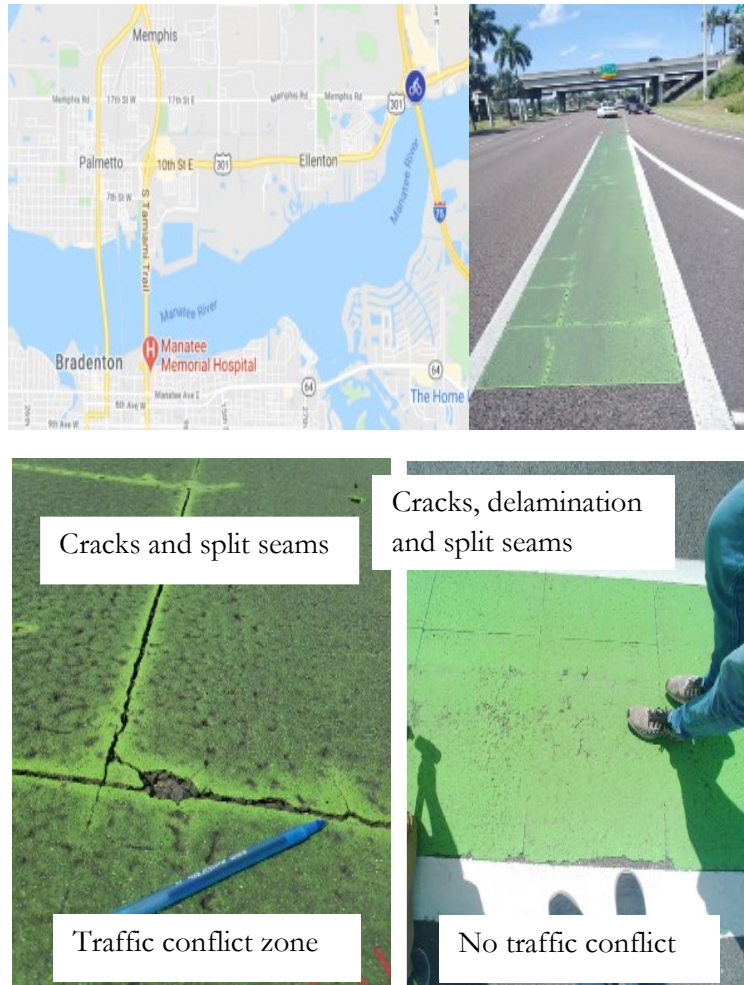
**Figure A-8. Site 1-Location and Distresses.**

- Construction and Materials
  - By the time of the survey, the thermoplastic and its substrate (OGFC) clocked 3.25 years. They were both built in June 2017. Traffic entering and exiting I75 crosses the green bike lane. The lane is on SR43/US301, in district 1, Manatee County. Figure A-8 shows observed distresses.
- Observation
  - Overall, the thermoplastic treatment is in poor condition.
  - Seams are splitting, both in trafficked and un-trafficked locations.
  - Cracks were observed within sheets, both in trafficked and un-trafficked locations.
  - Thermal compatibility may be a factor. But fatigue from traffic load could be another reason.
  - Sections conflicting with traffic are dull.

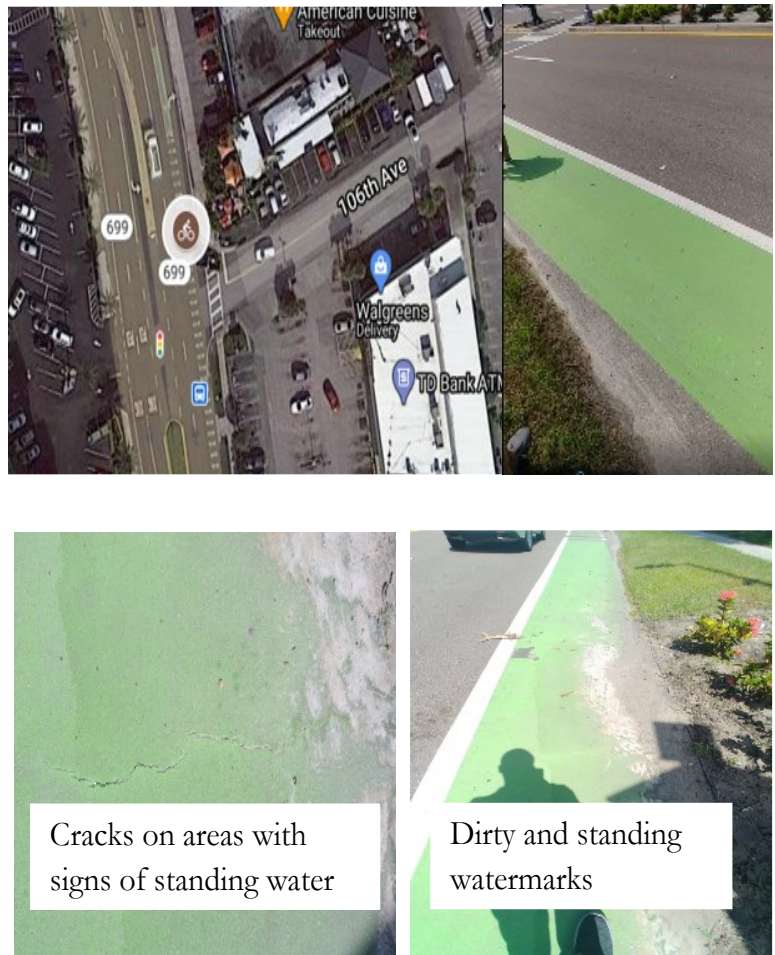
**Figure A-9. Site 3-Location and Distresses.**

- Construction and Materials
  - By the time the field survey was conducted, the thermoplastic and its substrate (DGFC) were three years old. They were both built in October 2017. The lane is on SR699 (Gulf Blvd/106th Ave.) in District 7, Pinellas County.
- Observation
  - Overall the thermoplastic treatment is in relatively good condition.
  - The survey found limited delamination and cracks in areas of poor drainage (Figure A-9).

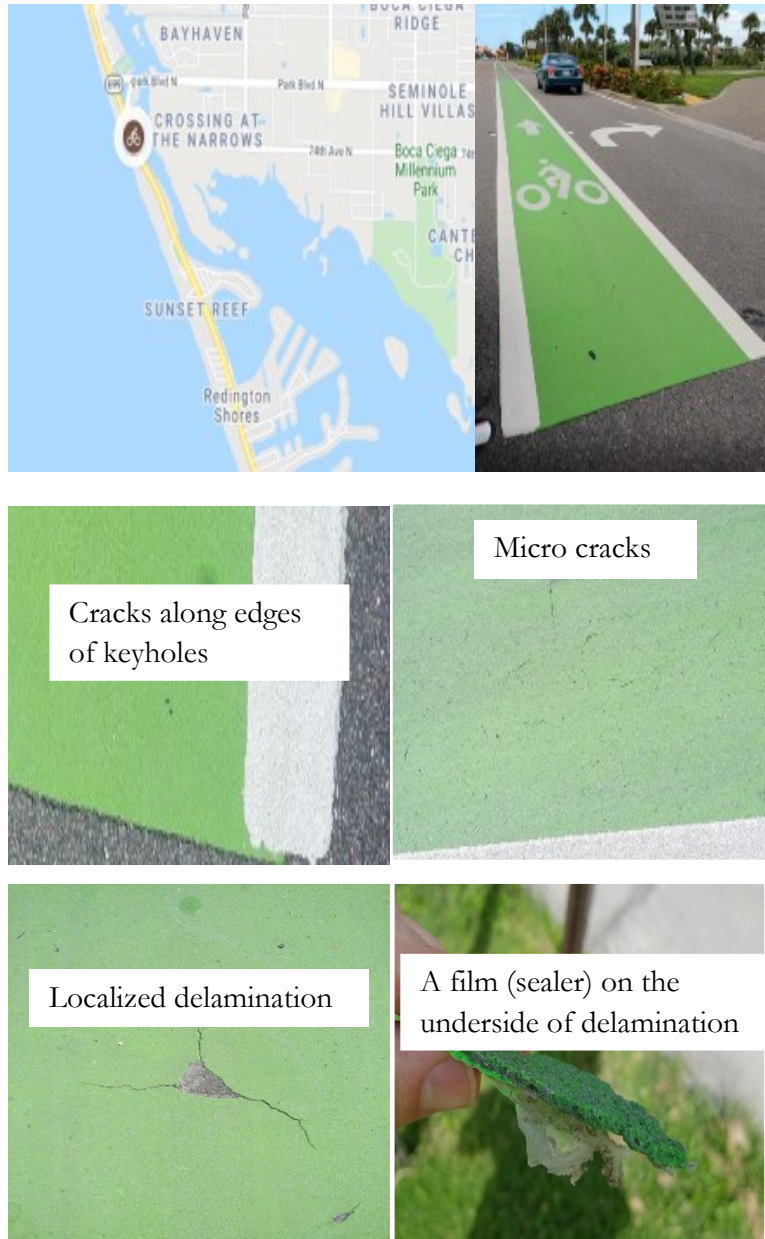
**Figure A-10. Site 4-Location and Distresses.**

- Construction and Materials
  - By the time the field survey was conducted, the thermoplastic and its substrate (DGFC) were three years old. They were both built in October 2017. The lane is on SR699 (Gulf Blvd/CR694), in District 7, Pinellas County.
- Observation
  - Overall the thermoplastic treatment is in relatively good condition.
  - Localized cracks and delamination were observed (Figure A-10).
  - Microcracks within boxes.
  - A sealer was used, as was seen on the underside of the delamination (Figure A-10).

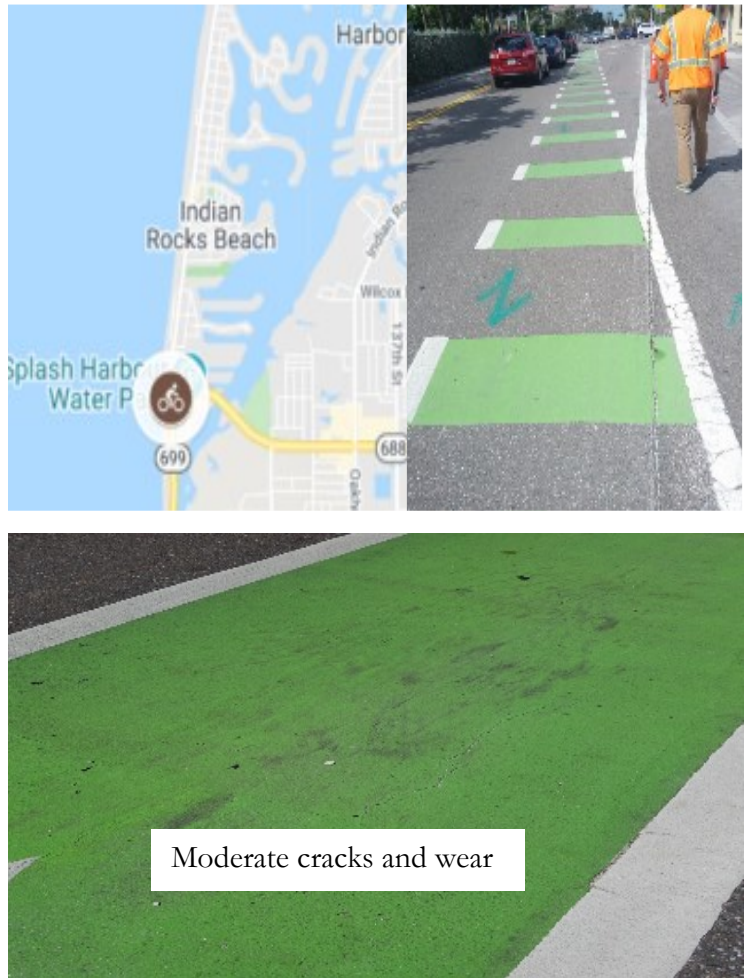
**Figure A-11. Site 5-Location and Distresses.**

- Construction and Materials
  - By the time the field survey was conducted, the thermoplastic and its substrate (DGFC) were three years old. They were both built in October 2017. The lane is on SR699 (Walsingham Rd/Gulf Blvd), in District 7, Pinellas County.
- Observation
  - Overall good condition.
  - Moderate cracks are probably related to traffic and thermal (Figure A-11). It may also be structural/asphalt related.
  - Slight wearing.

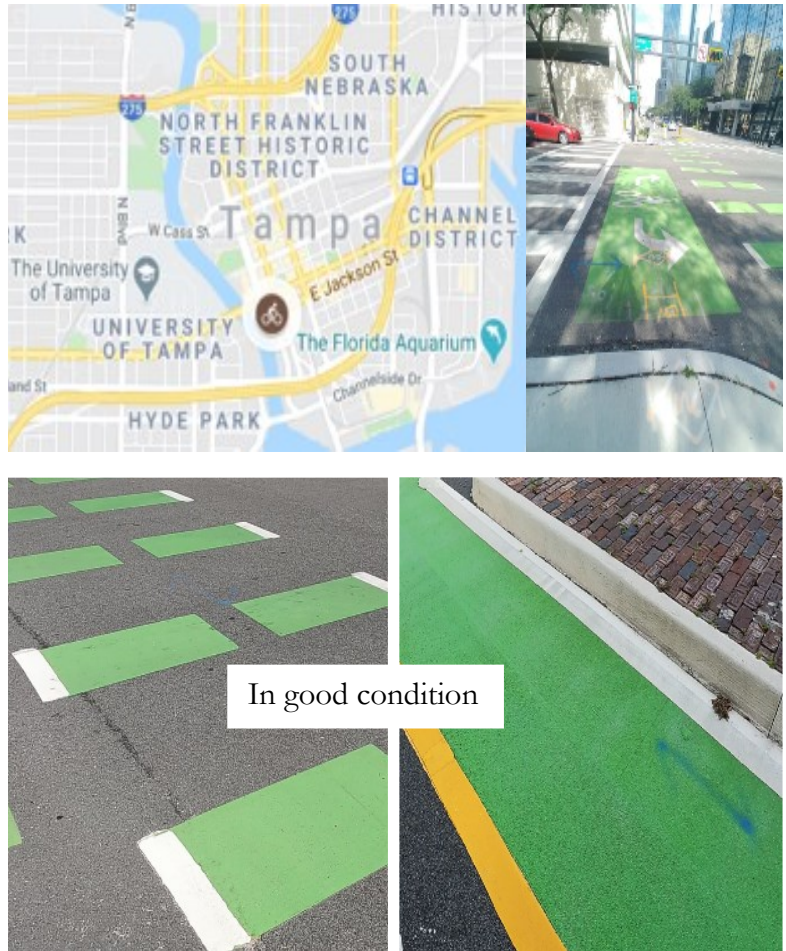
**Figure A-12. Site 2-Location and Distresses.**

- Construction and Materials
  - By the time the field survey was conducted, the thermoplastic and its substrate (DGFC) were two years old. They were both built in September 2018. The lane is on SR60, in District 7, Hillsborough County.
- Observation
  - Overall good condition (Figure A-12).
  - It's a lengthy application in a busy downtown.

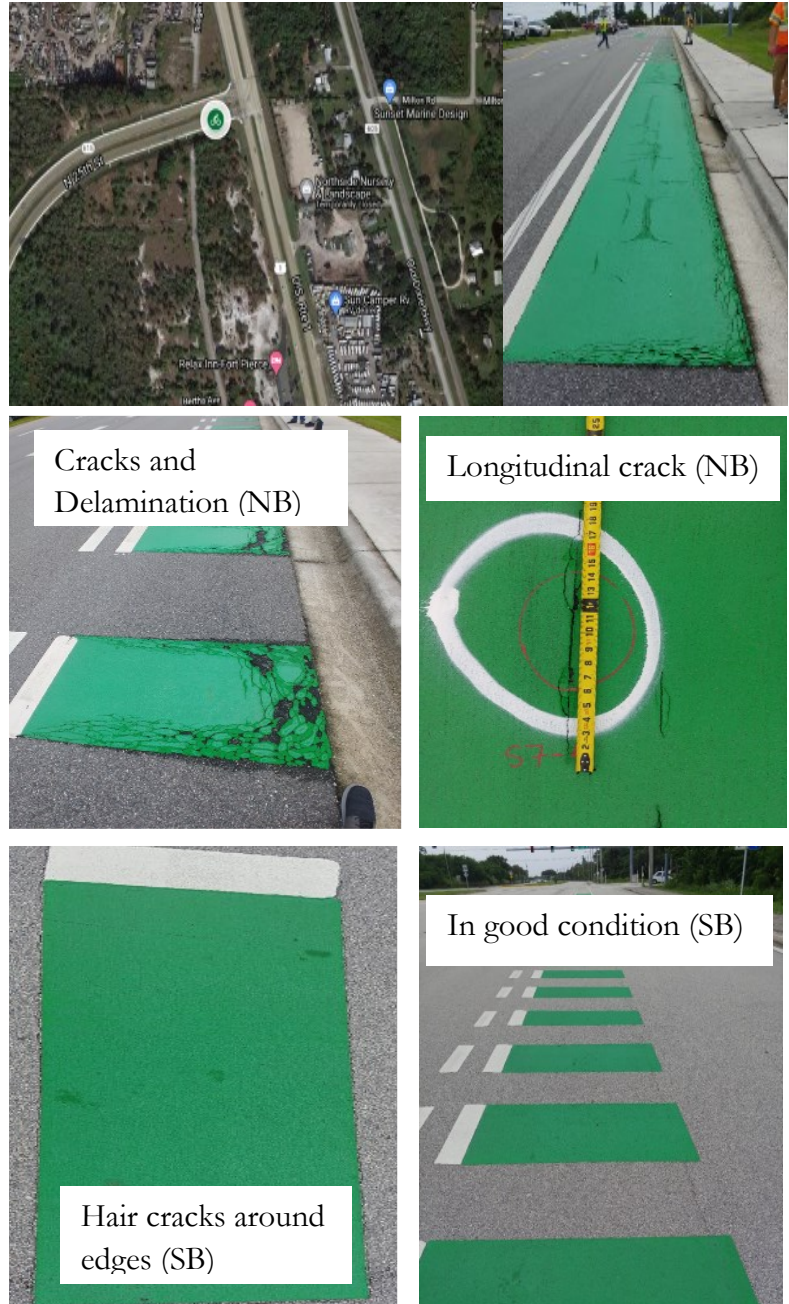
**Figure A-13. Site 7-Location and Distresses.**

- Construction and Materials
  - The epoxy-acrylic treated lane and its substrate (DGFC) were three years old during the survey. Both were built in October 2017. The bike lane is on SR 615 from St. Lucie Blvd to SR-5, in district 4, St. Lucie County.
- Observation
  - The northbound (NB) bike lane, located adjacent to the gutters, was in poor condition.
  - The southbound (SB) lane, constructed off-gutters, is in relatively good condition.
  - Significant cracking on shoulder lanes (Figure A-13).
  - Epoxy-acrylic peeling off with HMA.
  - Skips edges badly cracked.
  - Longitudinal cracks were observed at the center turning box lane.
  - Since the damages are mainly on the gutter's proximity, less compacted substrates and perhaps water infiltration could be the primary sources of the problems.

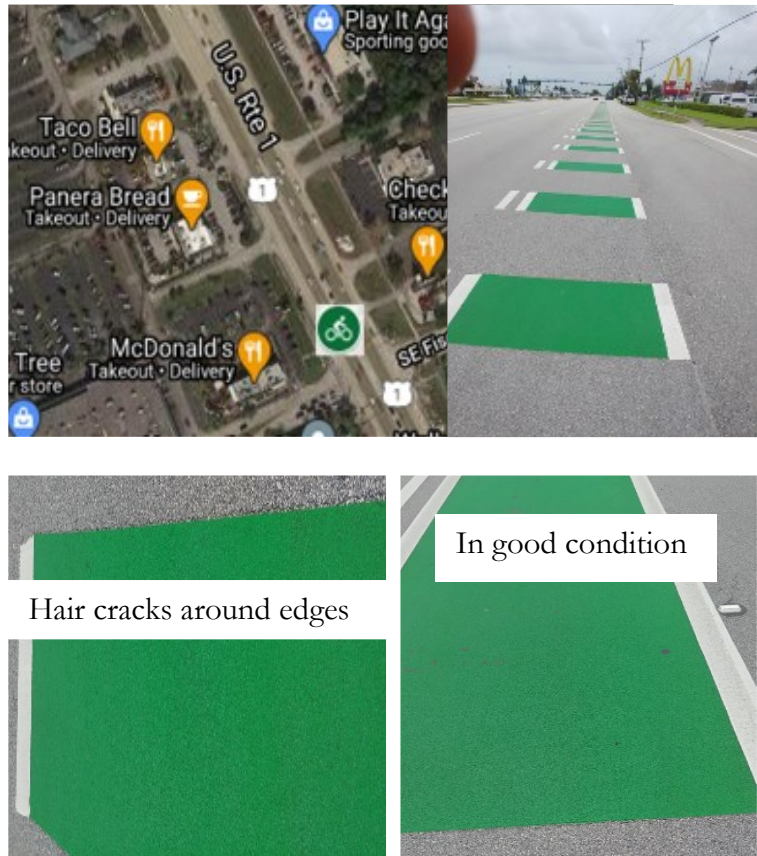
**Figure A-14. Site 16-Location and Distresses.**

- Construction and Materials
  - This epoxy-acrylic treated lane and its substrate (DGFC) were 1.5 years old during the survey. Both were built in April 2019. The bike lane is on US1 and SE Gran Park Way, in District 4, Martin.
- Observation
  - Good condition (Figure A-14).
  - The survey observed a few hairline cracks around the edges of skips.

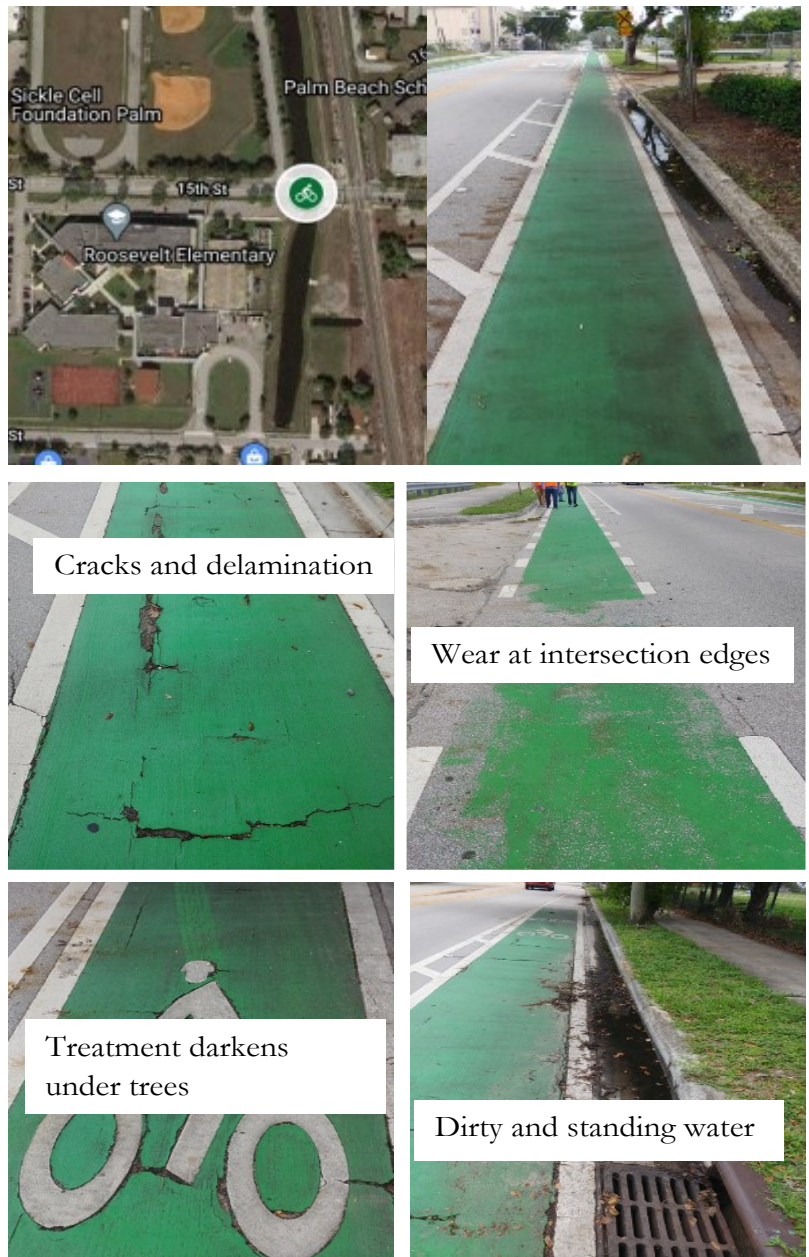
**Figure A-15. Site 17-Location and Distresses.**

- West of the railroad—poor condition. East of the railroad—fair condition (Figure A-15).
- The epoxy-acrylic treatment is badly cracked and delaminated with chunks of HMA. The distresses are more pronounced in the westbound direction.
- The epoxy-acrylic treatment has badly worn out at the intersection .
- Areas, under trees and along the gutters, are darkened. Some areas seemed to have been underwater.

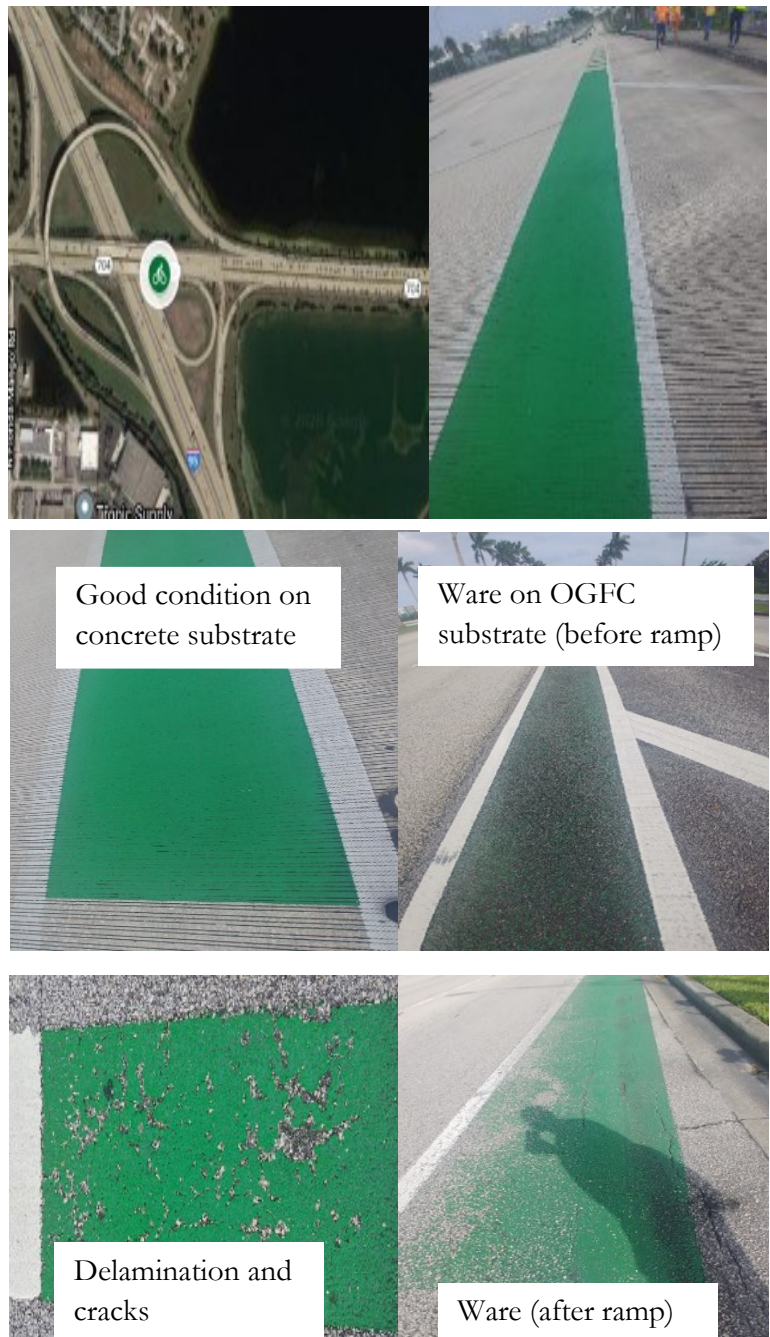
**Figure A-16. Site 18-Location and Distresses.**

- Construction and Materials
  - Site 18 is an Epoxy-acrylic treated bike lane laid on OGFC substrate and extends into a concrete bridge substrate. By the time this field survey was conducted, the Epoxy-acrylic-treated lane was two years old (built in August 2018). Meanwhile, the age of the substrate is not known. The green bike lane is on EB Okeechobee Blvd at I-95, in District 4, Palm Beach.
- Observation (Figure A-16)
  - Poor condition on OGFC substrate.
  - Good condition on concrete substrate.
  - On the OGFC substrate, the epoxy-acrylic is worn out. More Epoxy-acrylic application could be needed for the OGFC substrate.
  - Skips on OGFC substrate were cracked and delaminated.

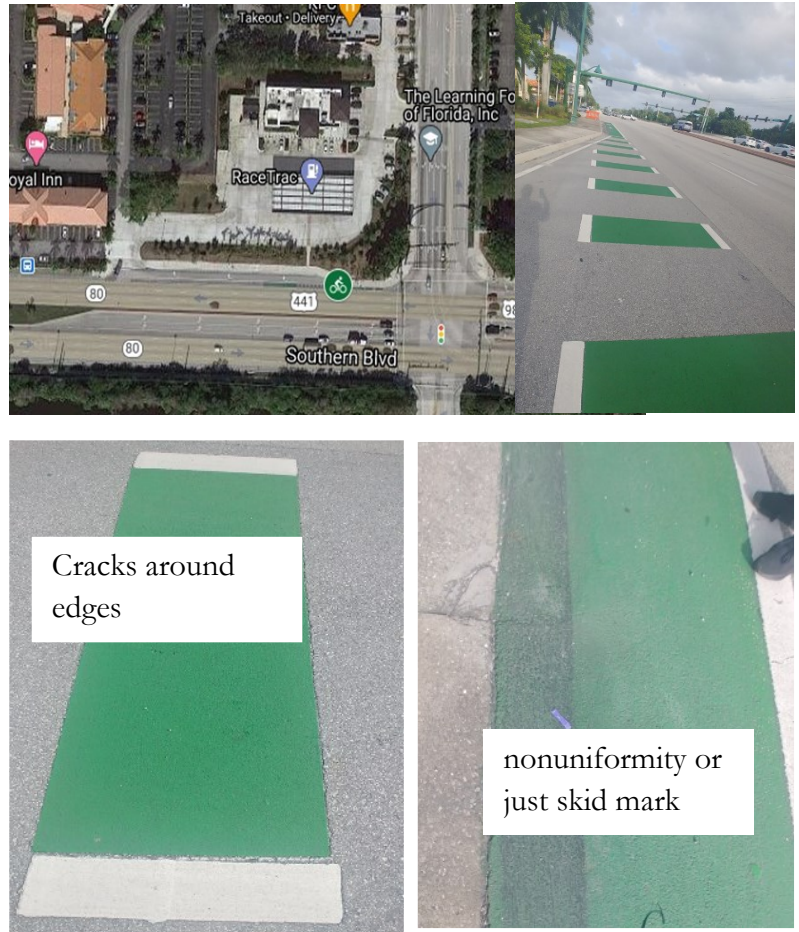
**Figure A-17. Site 34-Location and Distresses.**

- Construction and Materials
  - The substrate (DGFC) and the epoxy-acrylic treatment were relatively new during the survey period. The green bike lane is on SR80 at Royal Palm Beach Blvd, in District 4, Palm Beach.
- Observation
  - Overall in good condition.
  - Some cracks around the edges of the epoxy-acrylic treatment (Figure A-17).
  - Slight application nonuniformity. Maybe skid mark.

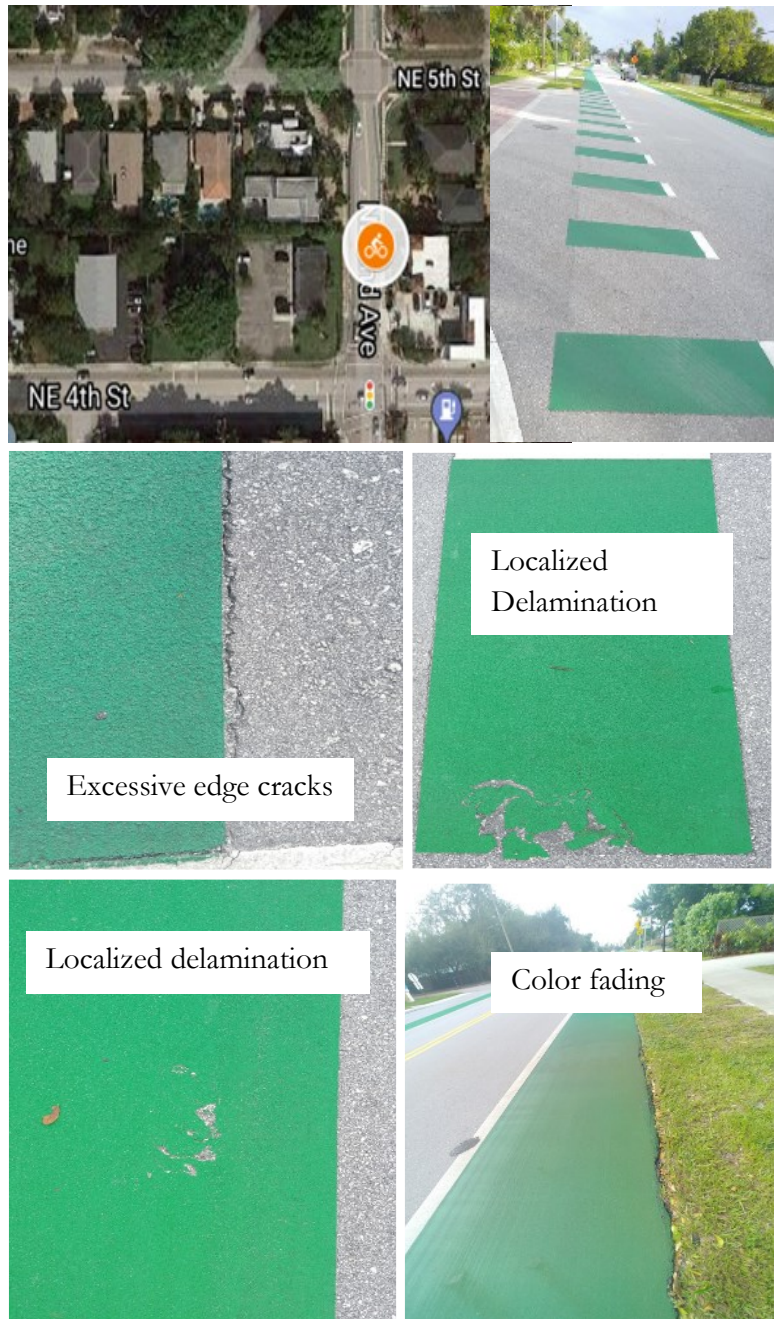
**Figure A-18. Site 19-Location and Distresses.**

- Construction and Materials
  - This is an Epoxy-acrylic treated bike lane laid on a DGFC substrate in May 2017. The substrate and the epoxy-acrylic treatment were constructed at the same period. When the survey was conducted, the treated lane was about 3.25 years old. The green bike lane is on NE 2nd Ave from NE 4th St to George Bush Blvd, in District 4, Palm Beach.
- Observation (Figure A-18)
  - Overall, in good condition.
  - Excessive edge on a few keyholes
  - Localized delamination; could be a construction issue.
  - Color fading in some locations.

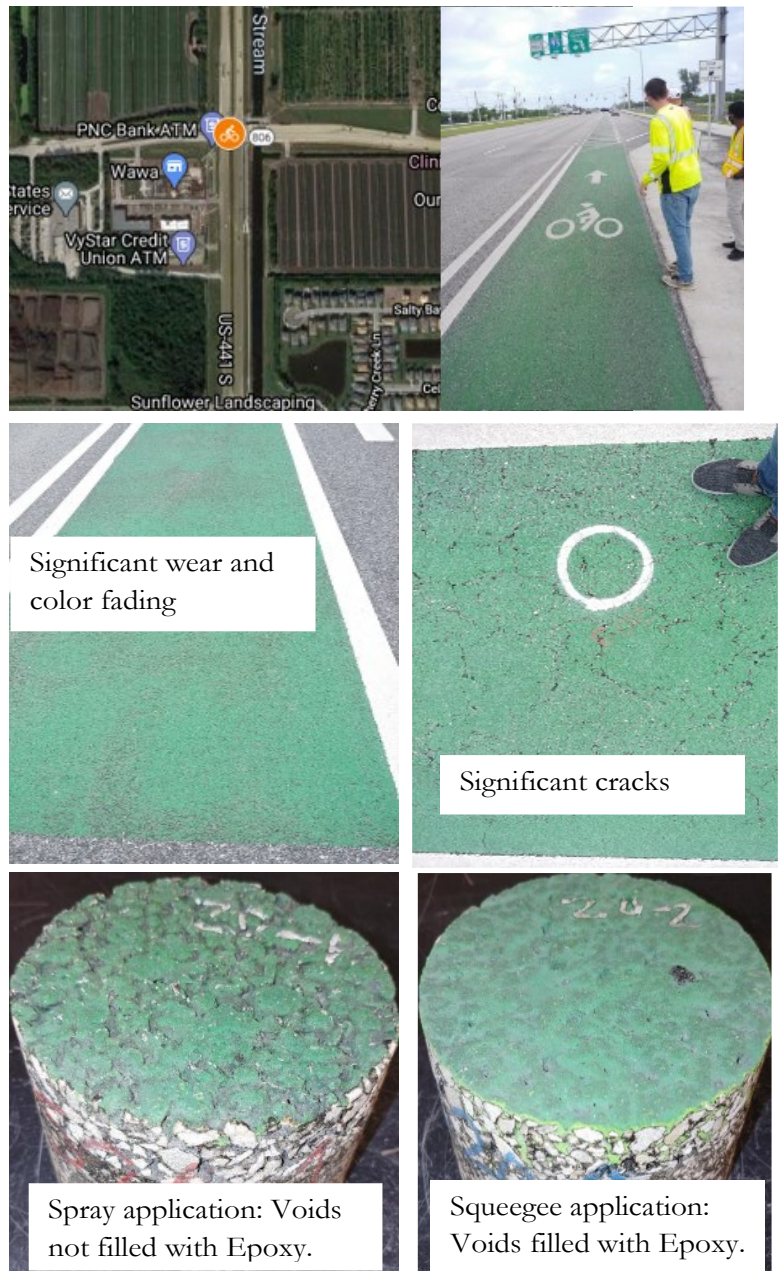
**Figure A-19. Site 20-Location and Distresses.**

- Observation (Figure A-19)
  - Color fades into OGFC.
  - Significant wear near WAWA gas station (NB). It seems the NB application was by spraying, whereby the SB application was by the squeegee.

- Significant cracking. Maybe due to differential movements.
  - The NB was sprayed, and SB was squeegeed. Lab investigation showed voids filled with epoxy-acrylic for squeegeed sections and open pores for sprayed areas.

- The spray application does not cover the OGFC aggregates uniformly. On the other hand, squeegee takes a lot of materials to fill in voids.

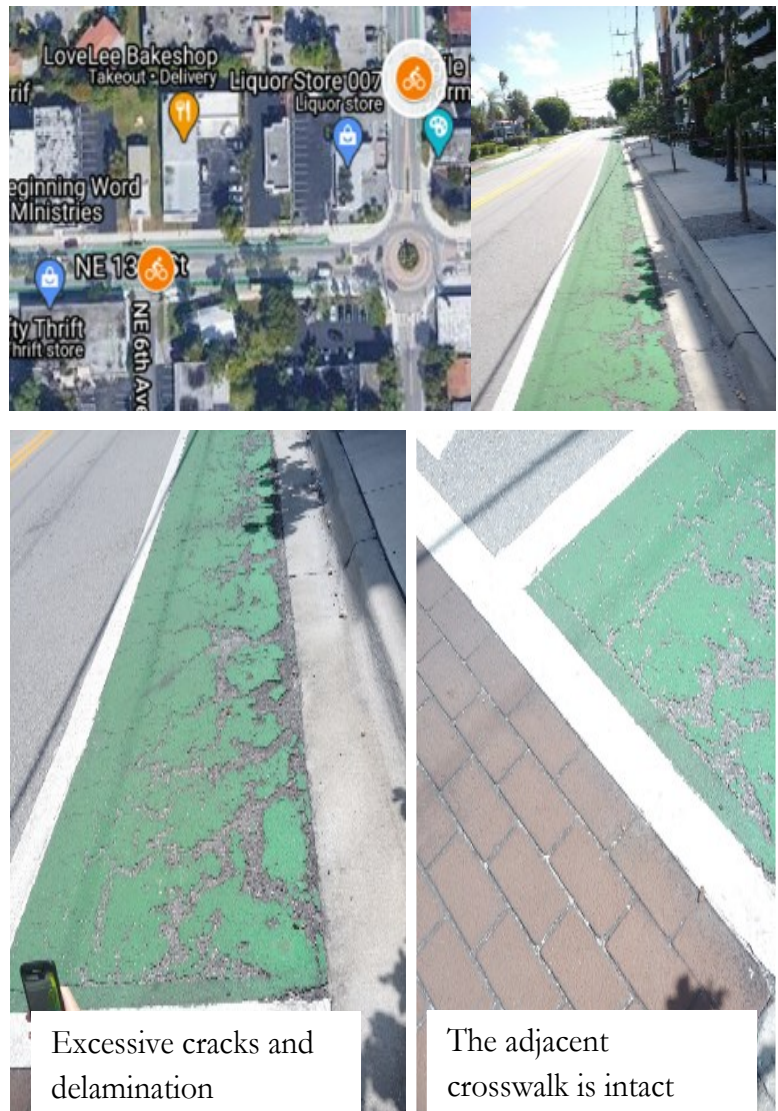
**Figure A-21. Site 23 and 55-Location and Distresses.**

- Construction and Materials
  - These are 2.5 years old, two epoxy-acrylic-treated sites separated by a roundabout. The lanes were constructed at the same time in April 2018 on a DGFC substrate. The substrate is slightly older than the epoxy-acrylic treatment. The green bike lanes are on NE 13th St. to Middle River (site 23) and Dixie Hwy from NE 17th CT to Middle River Bridge (site 55), in District 4, Broward County.
- Observation (Figure A-21)
  - Overall poor condition.
  - Excessive cracking and delamination.
  - Constructed adjacent to the gutter. Water could be one of the destruction factors. Another factor could be thermal cracking and low-density substrate.
  - The adjacent crosswalk was intact though it was made of epoxy-acrylic as well. The observed difference was the construction pattern.
  - Most problems were observed on site 55 on dixie highway.

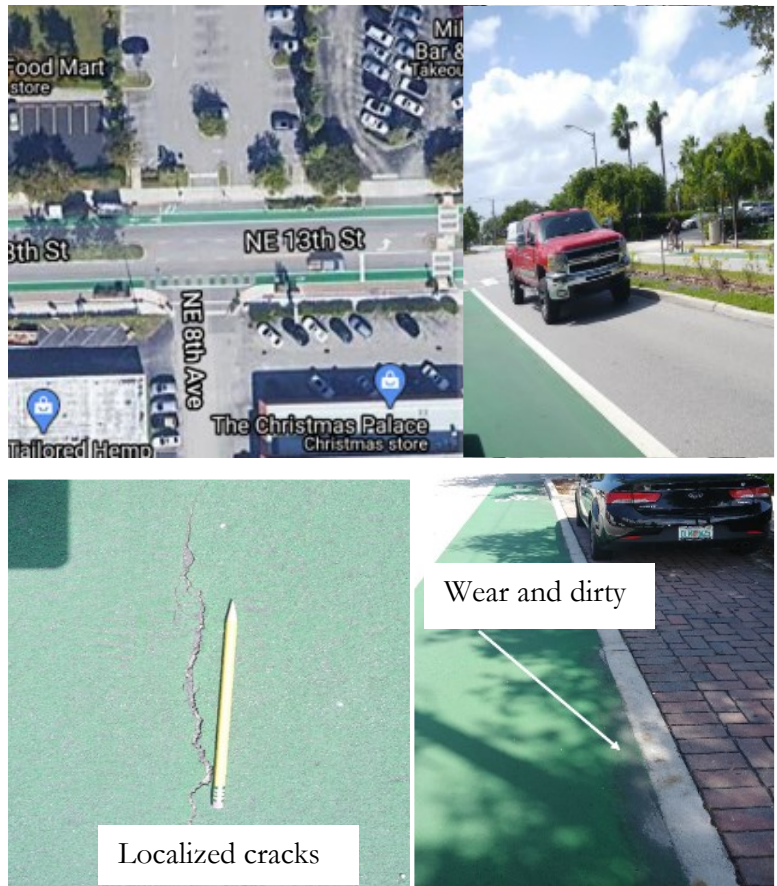
**Figure A-22. Site 56-Location and Distresses.**

- Construction and Materials
  - This is 205 years old epoxy-acrylic treated green bike constructed in April 2018 on a DGFC substrate. The lane was built at the same time as sites 23 and 55. However, it is in excellent condition compared to the other two lanes. The green bike lane is on NE 13th Street from NE 4th Ave to NE 9th Ave, in District 4, Broward County.
- Observation (Figure A-22)
  - The survey observed a few localized cracks.
  - Wear and dirt under tree shades and roadside parking.
  - The lanes are in good condition.

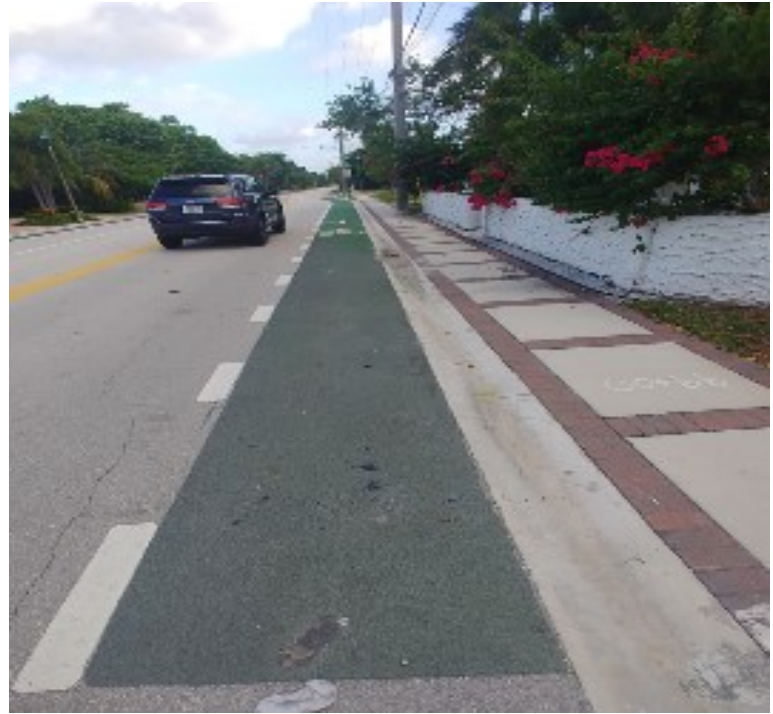
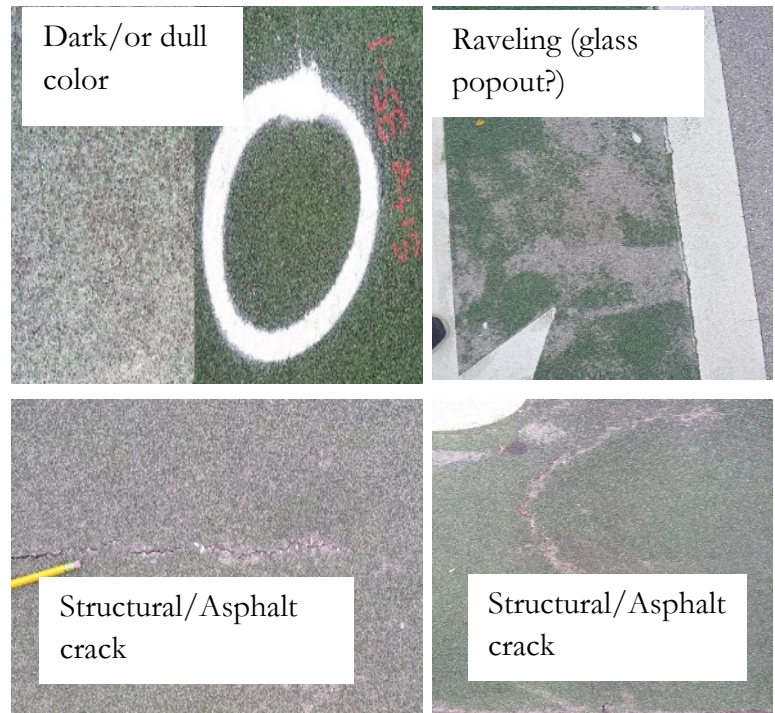
**Figure A-25. Site 35-Location and Distresses.**

- Construction and Materials
  - This is an Epoxy-glass-mixed treated bike lane laid on a DGFC substrate in January 2017. The substrate and the epoxy treatment were constructed at the same period. When the survey was conducted, the treated lane was about 3.5 years old. The green bike lane is on NE 2nd Ave from NE 4th St to George Bush Blvd, in District 4, Palm Beach.
- Observation (Figure A-25)
  - Overall condition is fair.
  - Raveling throughout the bike lane. Maybe due to glass popping out of the mix/treatment.
  - Nonuniform color, in some places very dull.
  - Some areas have cracks, but these cracks are structural/asphalt.

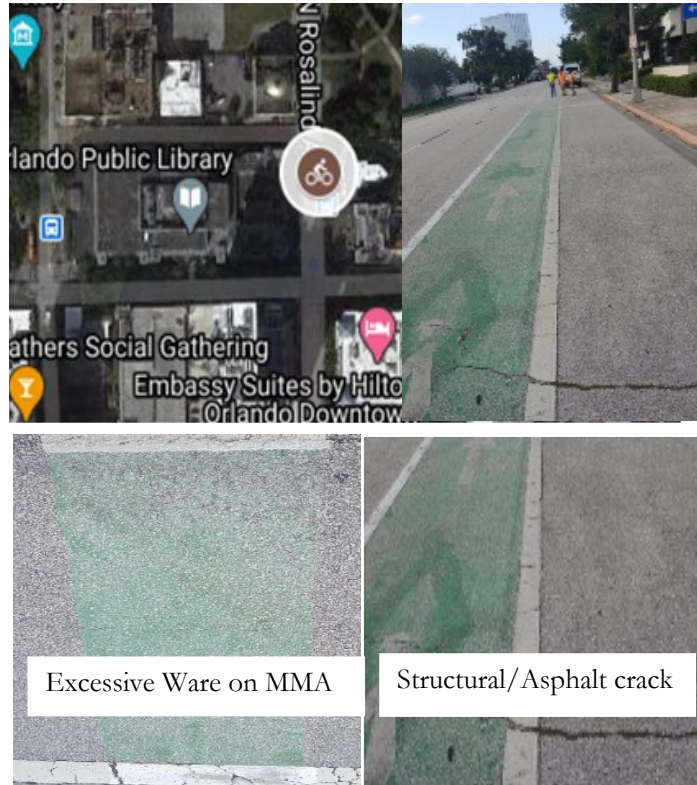
**Figure A-26. Site 58 and 27-Location and Distresses.**

- Construction and Materials
  - These sites are MMA treated bike lanes covering N. Rosalind and N. Magnolia streets in District 5, Orange County. The age of the MMA and a DGFC substrate are currently not known to the researchers.
- Observation (Figure A-26)
  - The MMA is completely worn out from traffic exposure.
  - We observed structural/Asphalt related cracks.
  - In general, the MMA treated lanes are in poor condition.

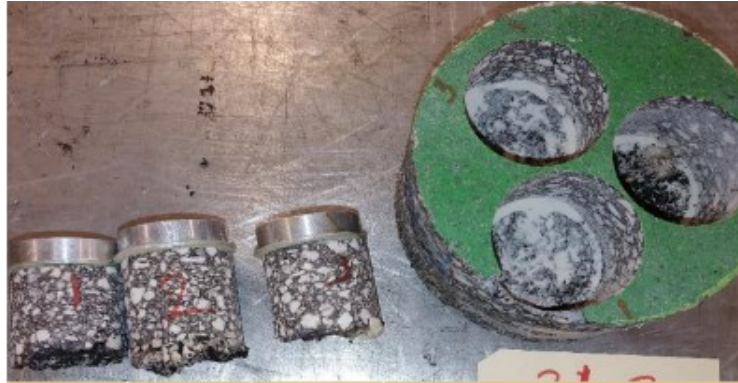
**Figure B-1. Pull-Off Test for Specimen 21-1.**

The research team determined that the failure mechanism for this specimen was 100% Substrate (HMA to HMA bond) failure (Figure B-1). However, the strength achieved (129.5 psi) was relatively low (<150 psi). Therefore, an additional surface pull-off test is needed (with a shallow cut). At the current state, the Epoxy to DGFC bond strength is inconclusive.

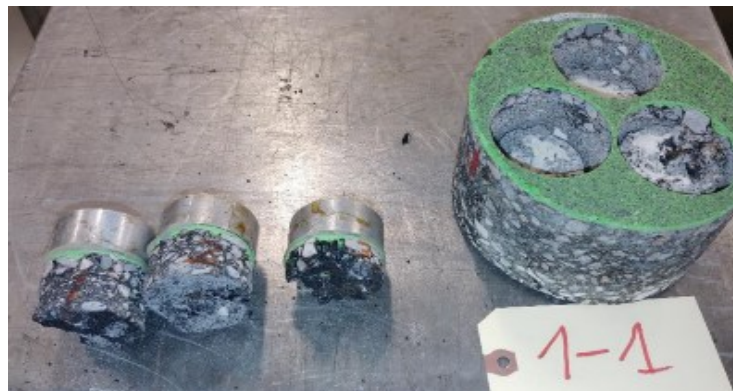
**Figure B-2. Pull-Off Test for Specimen 1-1.**

The research team determined that the failure mechanism for this thermoplastic-treated specimen was 100% substrate failure (Figure B-2). However, the achieved Pull off strength (64.8 psi) was relatively very low (<<150 psi). At this failure mechanism and low strength, deciding on the thermoplastic-to-substrate bond is challenging. Therefore, an additional surface pull-off test on a shallow-cut specimen is needed.
