*Final Report: Submitted to*  
**State of Florida**  
**Department of Transportation**

*Submitted by the*  
**Texas A&M Transportation Institute**

**Green Bike Lane Evaluation for Florida Pavements**

**Final Report**

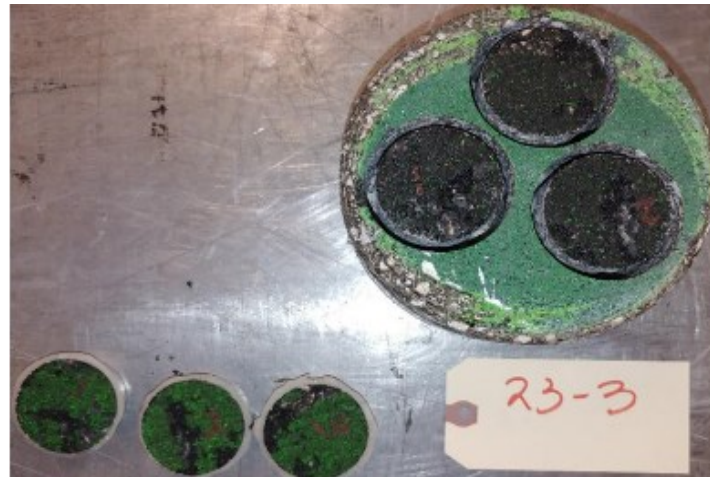
**Figure B-3. Pull-Off Test for Specimen 23-3.**

The research team determined that the failure mechanism for this specimen was a clean delamination/debond of epoxy from the Substrate (Figure B-3). The average pull-off strength was 155.7 psi (>150). The Epoxy treatment meets the minimum bond strength.

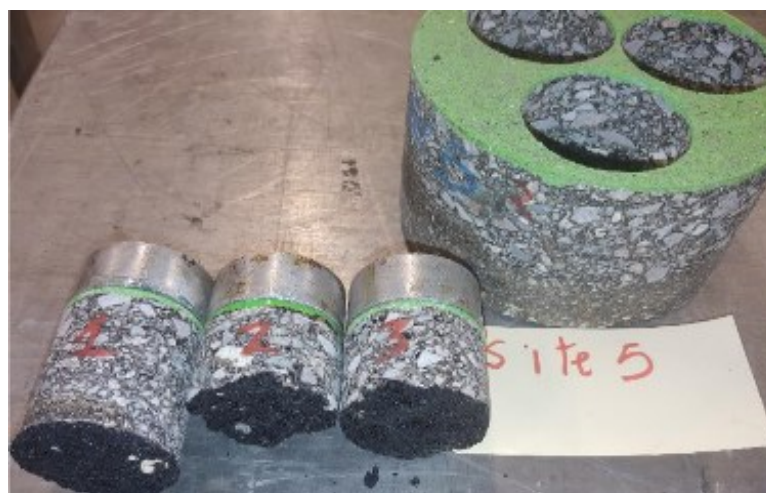
**Figure B-4. Pull-Off Test for Specimen 5-1.**

The research team determined that the failure mechanism for this specimen was 100% substrate failure (Figure B-4). The average pull-off strength (253.1 psi) was relatively high (<<150 psi). The thermoplastic bond did not fail, implying that the thermoplastic-substrate bond is strong (>253.1 psi).

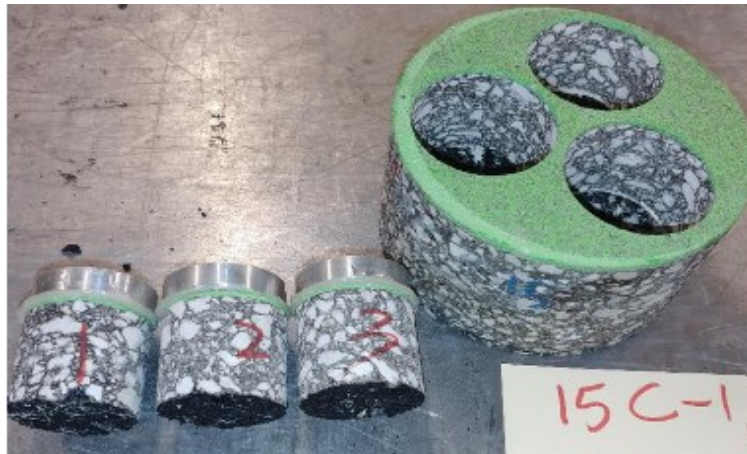
**Figure B-5. Pull-Off Test for Specimen 15-C1.**

The research team determined that the failure mechanism for this specimen was 100% substrate failure (HMA to HMA bond) (Figure B-5). However, the strength at failure (117.8 psi) was relatively low (<150 psi). Therefore, an additional surface pull-off test is needed (with a shallow groove). At the current state, the thermoplastic/DGFC bond strength is inconclusive.

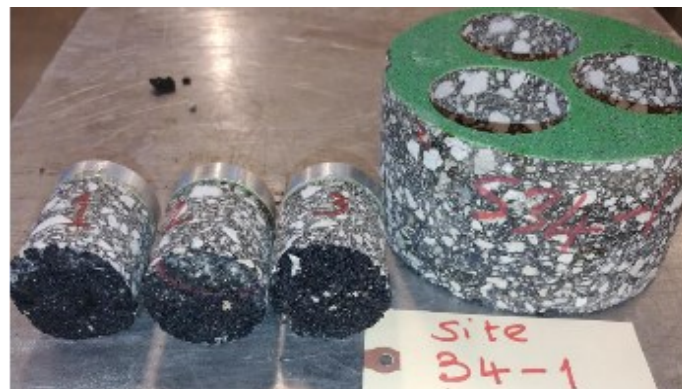
**Figure B-6. Pull-Off Test for Specimen 34-1.**

The research team determined that the failure mechanism for this specimen was 100% substrate failure (HMA to HMA bond). Maybe due to the ingress of water, the bond was already partially de-bonded. The average strength (113 psi) was relatively low (<150 psi) (Figure B-6). The failure mechanism and low strength imply that an additional surface pull-off test is needed (with a shallow cut). At the current state, the thermoplastic to substrate bond strength is inconclusive.

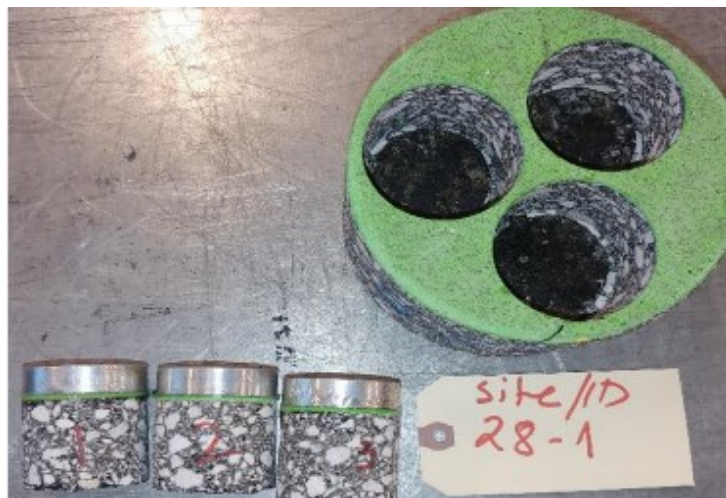
**Figure B-8. Pull-Off Test for Specimen 28-1.**

The research team determined that the failure mechanism for this specimen was 100% substrate failure(HMA to HMA bond) (Figure B-8). The average strength at failure (87.4 psi) was relatively very low (<150 psi). Because of the failure mechanism and low strength, an additional surface pull-off test is needed (on a sample with a shallow groove). At the current state, the thermoplastic-substrate bond strength is inconclusive.

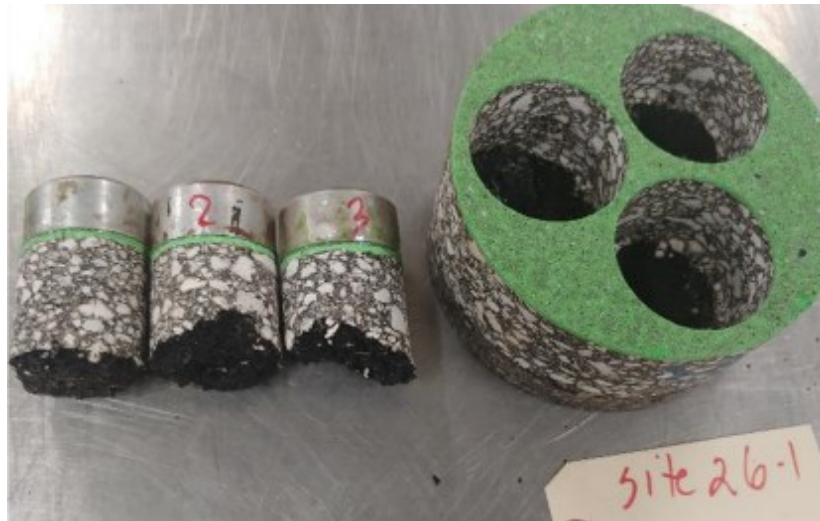
**Figure B-17. Pull-Off Test for Specimen 26-1.**

Figure B-17 shows core-1 collected from site 26. During the pull-off test, the researchers observed a failure at the very bottom of the DGFC substrate. And the pull-off force that failed the specimen was below 150 psi. Because of this failure mechanism, the research team determined that the GCPM bond strength is inconclusive, pending additional tests on shallow cut surface to specify GCPM bond strength separately.

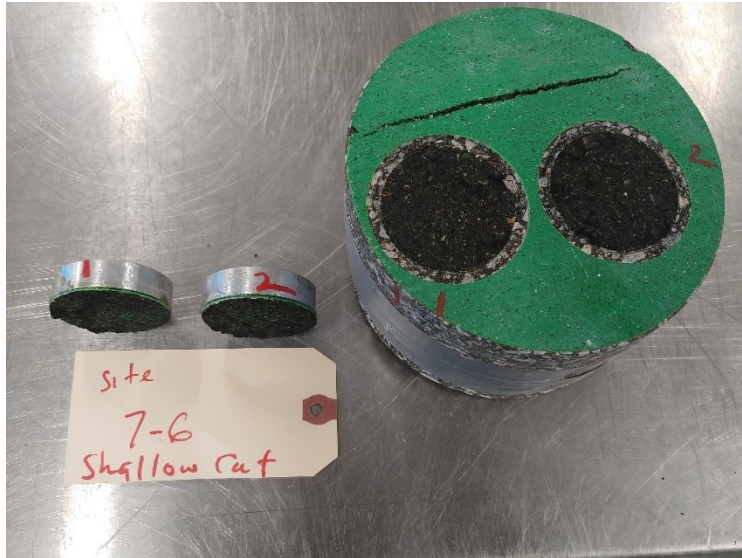
**Figure B-18. Pull-Off Test for Specimen 7-6.**

By predetermining the failure location (on shallowly grooved specimens), the research team demonstrated that one could force surface delamination to determine the GCPM-Substrate bond strength without worrying about failure at different locations—nevertheless, the technique sacrifices the assessment of substrate strength. Figure B-18 shows core-6 collected from site 7.

The specimen is an Epoxy-treated-DGFC core. Based on the pull-off test, the average strength of the epoxy DGFC bond was 280.85psi. It passed the minimum cut-off value (150 psi).

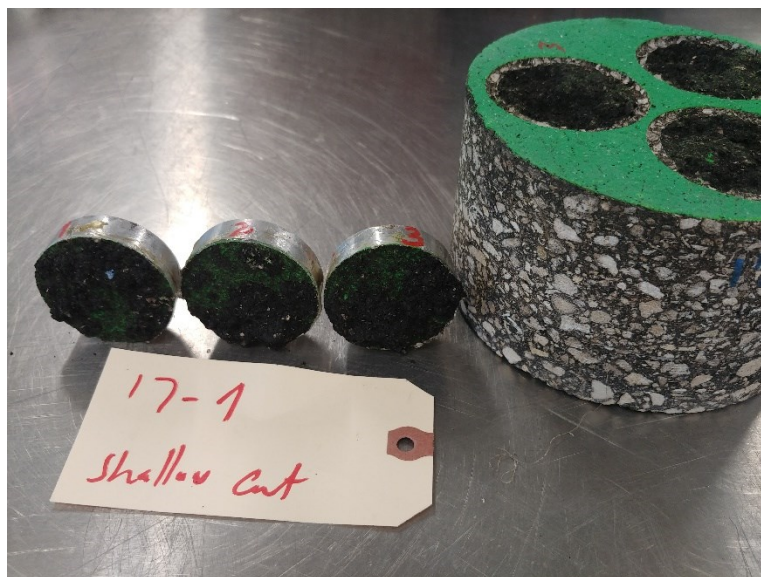
**Figure B-19. Pull-Off Test for Specimen 17-1.**

Site 17 – Core 1: Epoxy Treatment Age: 2 years; DGFC Substrate Age: Slightly older

The forced delamination was also demonstrated on Site 17 cores. Figure B-19 shows core-1 collected from site 17. The specimen is an Epoxy-treated-DGFC core. Based on the pull-off test, the average strength of the epoxy to DGFC bond was 197.4 psi. It passed the minimum cut-off value (150 psi).
