Report Prepared by:  
Dr. Francisco J. Presuel–Moreno  
With  
Samantha Mavrak  
David Anguelov

## **Final Report**

Evaluation of Concrete Specimens Prepared with Corrosion Resistant  
Reinforcement after Long Term, Greater than 15 years, Outdoor and  
Laboratory Exposures

Contract Number – FDOT (BED27-977-04)  
FAU (AWD003253)

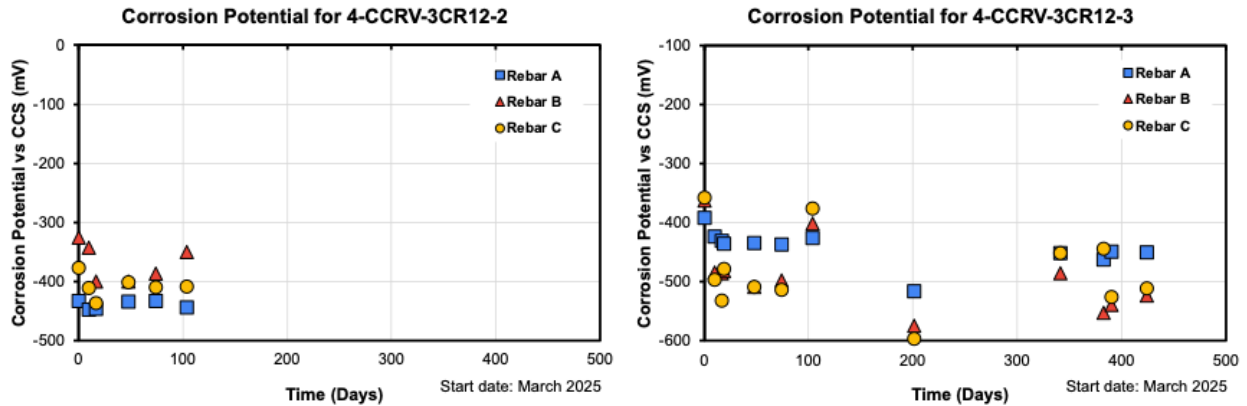
Figure 3-1. Potential vs. time for terminated 4-CCRV-3CR12-2 and non-terminated companion 4-CCRV-3CR12-3.

For samples with high corrosion activity, plots showing the corrosion potentials measured with the Gecor 8 are shown in Figure 3-1 through Figure 3-5. Plots of samples that were terminated are presented next to their non-terminated counterpart. Corroding samples generally showed potentials more negative than  $-350 \text{ mV}_{\text{CSE}}$ , though some samples showed a wide range of variability between individual rebars. For example, rebar C of terminated BCCD-CT2-1 (Figure 3-3) measured potentials in the range that would suggest no active corrosion, while rebar A of the same sample measured significantly more negative potentials.

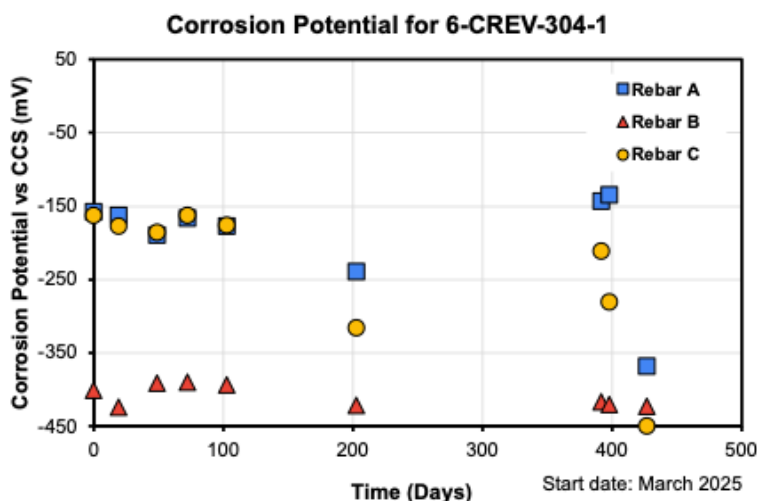
Figure 3-6. Potential vs. time for 6-CREV-304-1.

Plots of corrosion potential over time for selected samples with all rebars showing moderate corrosion activity are shown in Figure 3-6 through Figure 3-8. With the exception of rebar B of sample 6-CREV-304-1 (Figure 3-6), potentials for each rebar from the selected samples measured more positive than  $-250 \text{ mV}_{\text{CSE}}$  on average. Rebar B of 6-CREV-304-1 had an average potential of approximately  $-410 \text{ mV}_{\text{CSE}}$  over the monitoring period, indicating a high likelihood of active corrosion. Upon visual examination of this sample, a concrete crack in the reservoir directly above rebar B was observed.

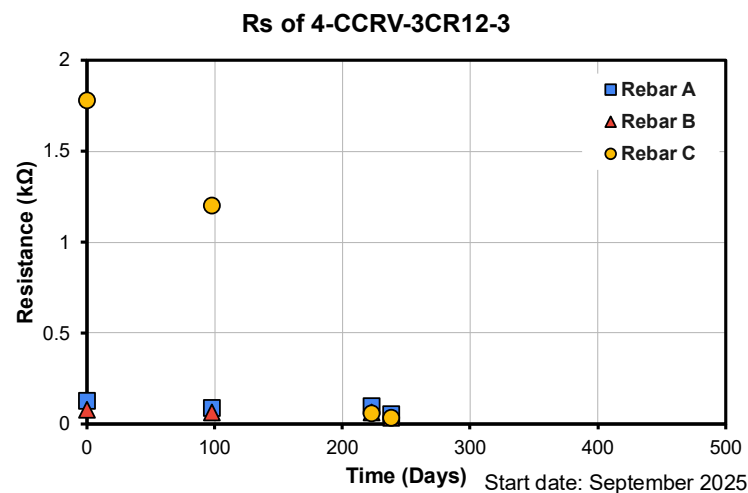
Figure 3-53. Solution resistance vs. time for non-terminated 4-CCRV-3CR12-3.

Due to bad electrical contact on rebar C of 4-CCRV-3CR12-3 (Figure 3-53), solution resistance was higher on this rebar compared to A and B until the rebar was sanded. After good contact was made, solution resistance values lowered and were comparable to the other rebars in the

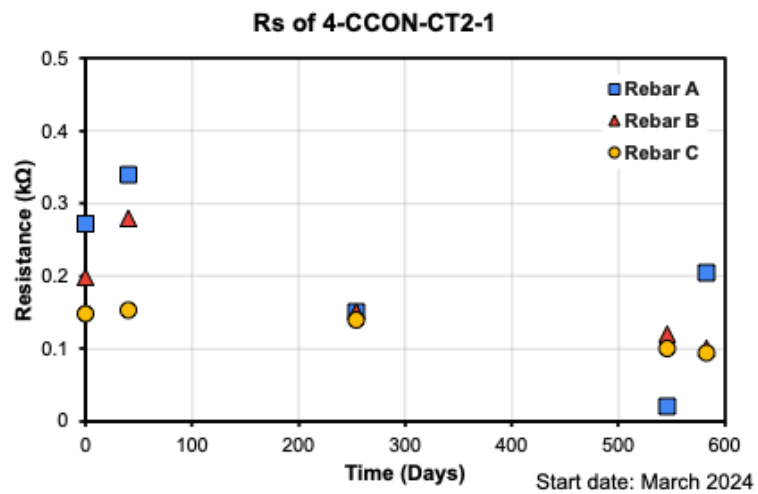
Figure 3-57. Solution resistance vs. time for 4-CCON-CT2-1. Rebar C was terminated.

specimen. The terminated rebar C of 4-CCON-CT2-1 (Figure 3-57) consistently showed solution resistances lower than the non-terminated rebars A and B, possibly evidencing more localized chloride penetration over rebar C.

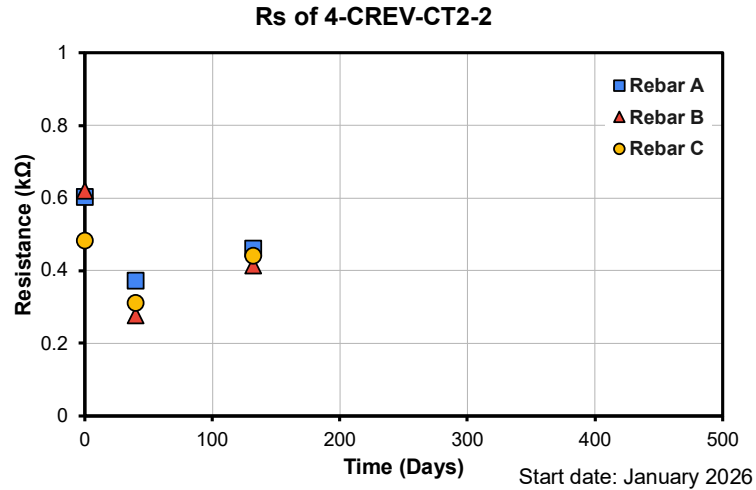
Figure 3-59. Solution resistance vs. time for 4-CREV-CT2-2.

Plots of solution resistance over time for selected samples showing moderate  $I_{corr}$  values are shown Figure 3-59 and Figure 3-60. Samples 4-CREV-CT2-2 (Figure 3-59) and 6-STD2-304-2 (Figure 3-60) had solution resistances that averaged between 0.1 kΩ and 0.6 kΩ, which is comparable to the values measured with the Gecor 8. Although the concrete quality of 6-STD2-304-2 was higher than that of 4-CREV-CT2-2 (which was composed of STD1 concrete), solution resistances calculated for the STD2 sample were slightly lower on average than those calculated for 4-CREV-CT2-2.

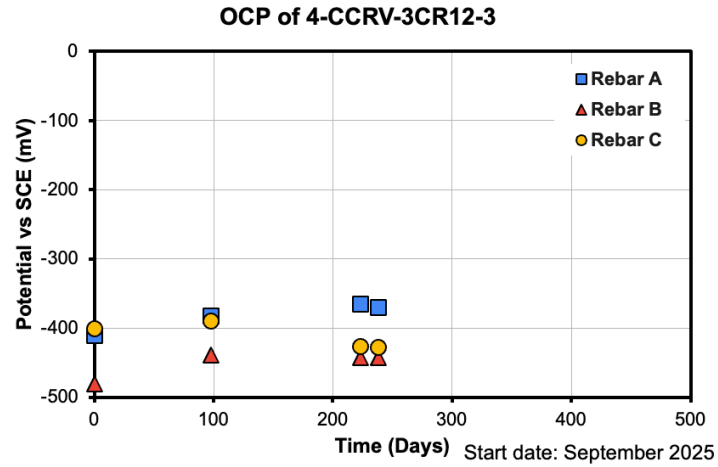
Figure 3-66. Open circuit potential vs. time for 4-CCRV-3CR12-3.

Two examples of open circuit potentials (i.e. corrosion potentials) vs. time as measured by the GP method are shown in Figure 3-66 and Figure 3-67. Sample 4-CCRV-3CR12-3 is presented first, demonstrating active corrosion with open circuit potentials averaging more negative than -380 mV<sub>SCE</sub> (-453 mV<sub>CSE</sub>). Sample 6-STD2-304-2 is presented next, with open circuit potentials ranging between about -120 mV<sub>SCE</sub> (-193 mV<sub>CSE</sub>) and -10 mV<sub>SCE</sub> (-83 mV<sub>CSE</sub>). The open circuit potentials of most samples as measured with the GP method are comparable to their corrosion potentials as measured with the Gecor 8, after converting SCE to CSE.

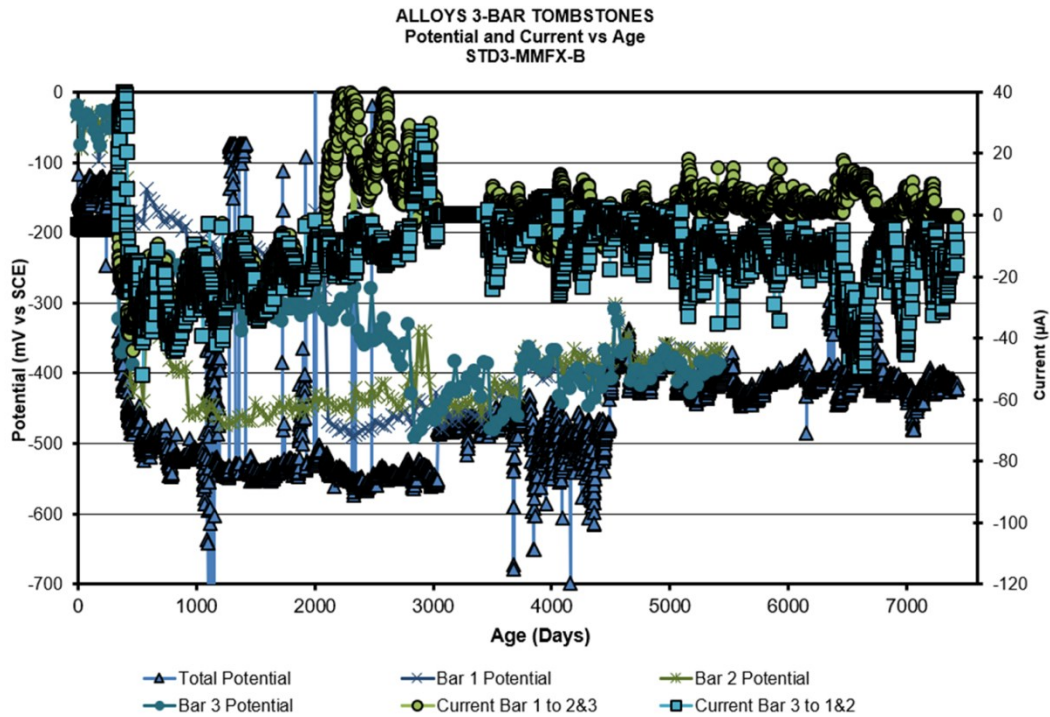
Figure 4-4. Potential and current vs. age measured on sample STD3-MMFX-B up to Fall 2025.

One Tombstone STD3-MMFX sample continued to be monitored (the other five had been terminated), the average rebar potential of this Tombstone sample is  $-411 \text{ mV}_{\text{SCE}}$ , with macro-cell current around  $-10 \text{ } \mu\text{A}$  for rebar 3 to rebar 1&2. There were several excursions to values as negative as  $-50 \text{ } \mu\text{A}$ . Figure 4-4 shows the total potential and currents measured on STD3-MMFX-B. STD3-MMF-B was chosen to be terminated.

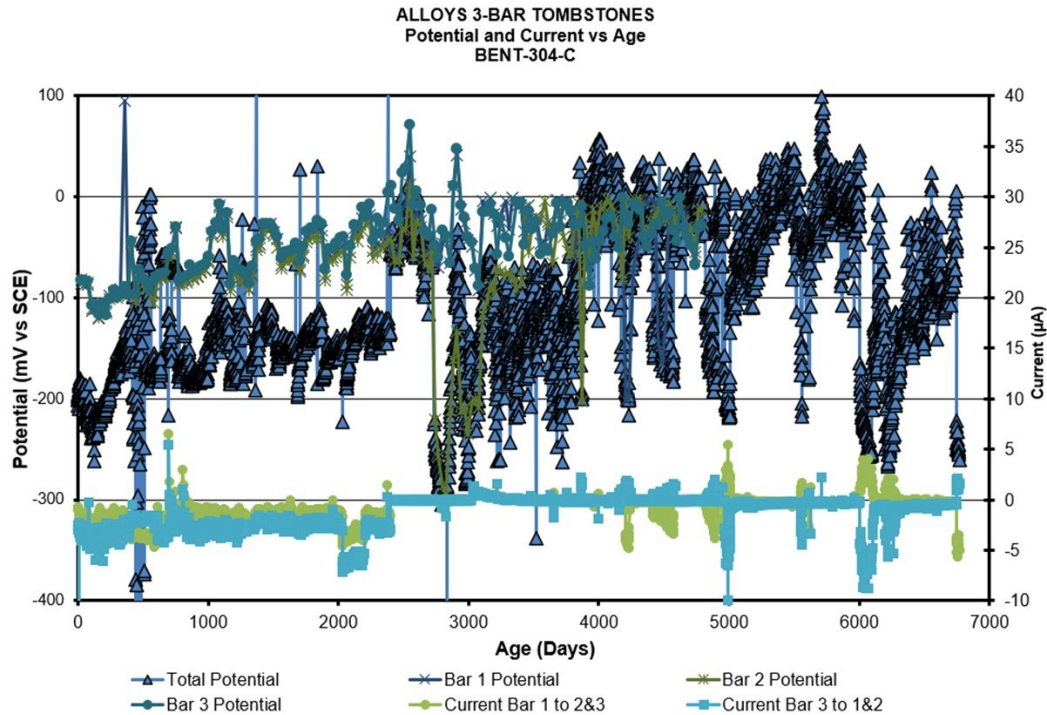
Figure 4-5. Potential and current vs. age measured on sample BENT-304-C up to Fall 2025.

For Tombstone samples with 304 rebars, at least one rebar per sample appears to have experienced a transient to more active rebar potential values. In many cases this was rebar 2. No Tombstone sample with 304 rebar had been terminated. Sample BENT-304-C Tombstone was chosen for termination as part of this project. Figure 4-5 shows the potential vs. time and current vs. time for this sample. The total potential seems to indicate that there were more potential transients than what each individual rebar (manually measured) experienced. The manually measured rebar values stopped being measured at around day 4800 of monitoring. The total potential transients observed might be indicative of repassivation taking place when the total potential reached noble values (more positive than  $-100 \text{ mV}_{\text{SCE}}$ ), but the transients in the opposite direction indicate that a new corroding or that a dormant site became active. The macro-cell current magnitude seems to indicate low activity. The positive macro-cell current reached  $5 \text{ } \mu\text{A}$ , whereas the negative macro-cell current reached values as negative as  $-10 \text{ } \mu\text{A}$ , but many readings were close to zero  $\mu\text{A}$ .

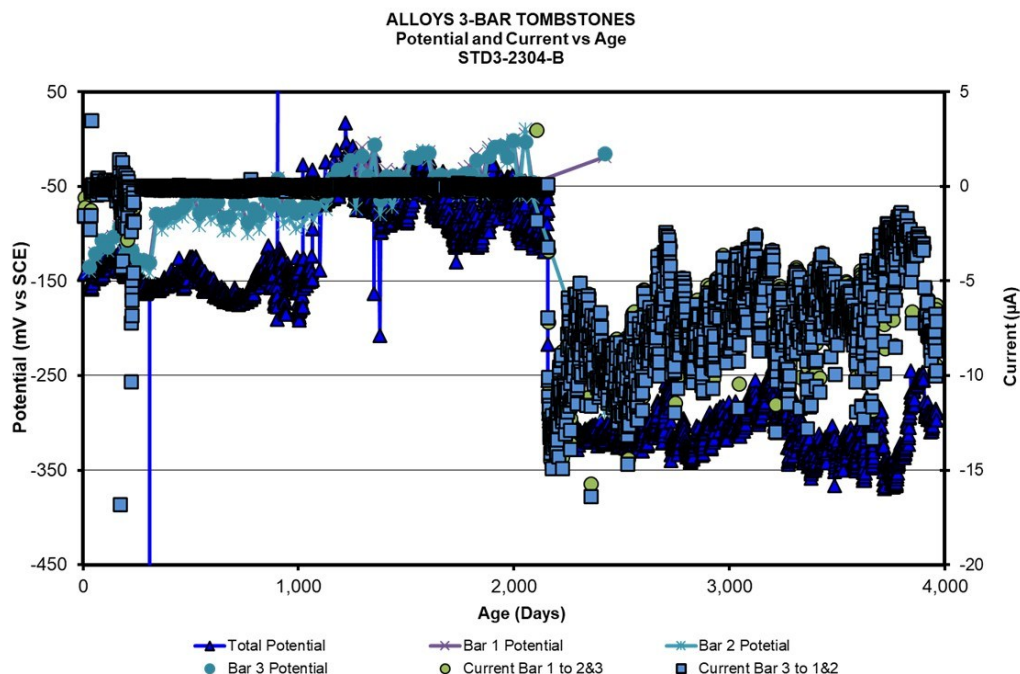
Figure 4-7. Potential and current vs. Age measured on Tombstone sample STD3-2304-B.

For the more recently prepared Tombstone samples with duplex stainless steel rebars. Figure 4-7 shows the total rebar potential and current vs. time for sample STD3-2304-B. Tombstone sample STD3-2304-B with 2304 rebar has an average total rebar potential of  $-325 \text{ mV}_{\text{SCE}}$ , and modest macro-cell current values. The transition to more negative total rebar potential values on this sample took place after 2000 days of exposure. The other four Tombstone samples with 2304 rebars do not seem to be corroding based on the total rebar potential.

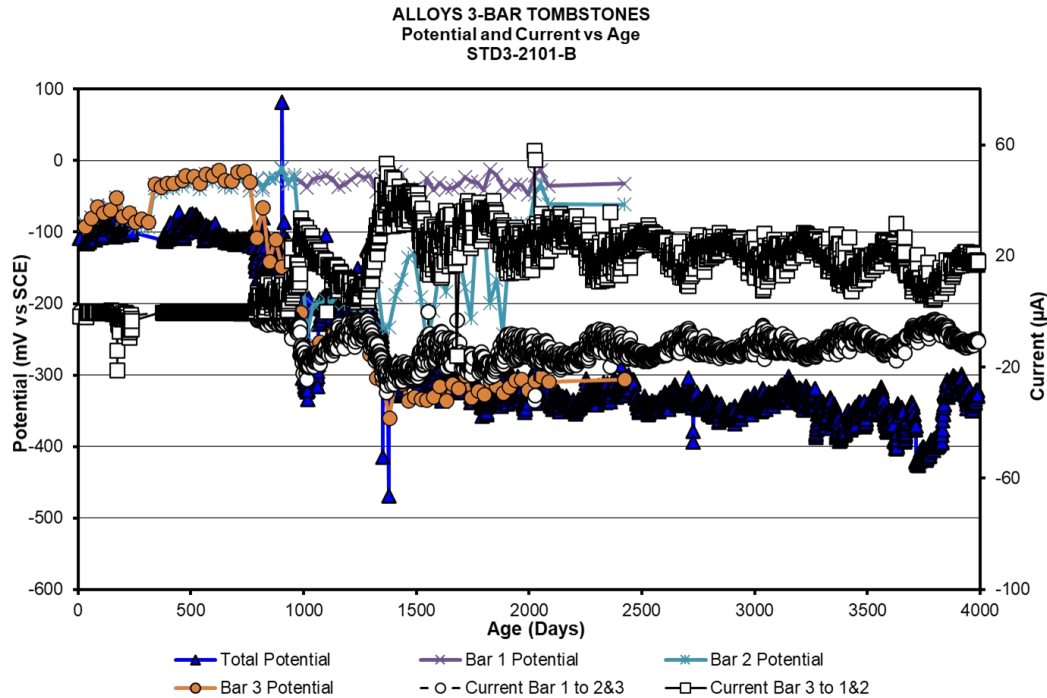
Figure 4-8. Potential and current vs. Age measured on Tombstone sample STD3-2101-B.

All new set Tombstone samples with 2101LDX rebar have total average rebar potential more negative than  $-350 \text{ mV}_{\text{SCE}}$ . For the new set of Tombstone samples with 2101LDX rebars, the total potential transitioned to  $-300 \text{ mV}_{\text{SCE}}$  (total/interconnected) or more negative between 1000 and 1400 days for samples A, B and E. The rebars in sample 2101-C transitioned to  $\sim -300 \text{ mV}_{\text{SCE}}$  after 3000 days and rebars in sample D transitioned to active values at around 200 days. All samples have reached total rebar potential of around  $-400 \text{ mV}_{\text{SCE}}$ . The measured macro-cell current values are less than  $50 \text{ } \mu\text{A}$  for most rebars (except sample E rebar 3 to 1&2 with a value of  $-70 \text{ } \mu\text{A}$ ). Figure 4-8 shows the total rebar potential and current measured on sample STD3-2101-B. In this sample, Bar 3 is the rebar that seems to drive the total potential value after Bar 3 transitioned to more negative rebar potential values. Before all rebars contributed to the total potential value (i.e., all rebars had similar noble potential), Rebar 3 activated first for samples A and B, Rebar 2 activated first for samples C and D and Rebar 1 for sample E (but Rebar 2 became active soon after). Sample STD3-2101-B was the sample selected for termination.

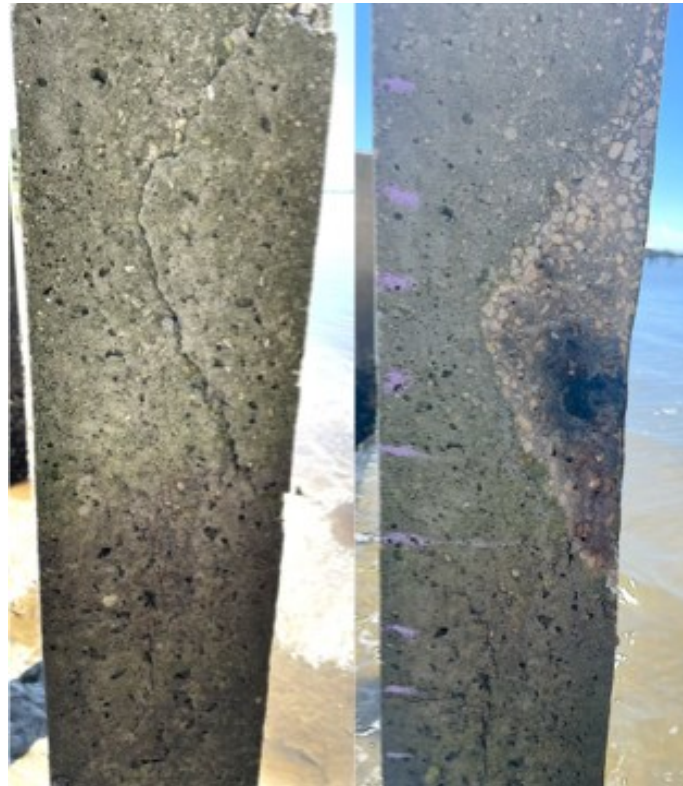
Figure 5-10. Picture showing north face of 2101-C in October 2024 (left) and September 2025 (right).

Column 2101-C north face experienced spalling due to corrosion of the reinforcement between the October 2024 and September 2025 visits. A large crack was visible in October 2024, as shown in Figure 5-10 on the left. By September 2025, the concrete had spalled in the same location, exposing corrosion products from the embedded rebar, as seen in Figure 5-10 on the right.

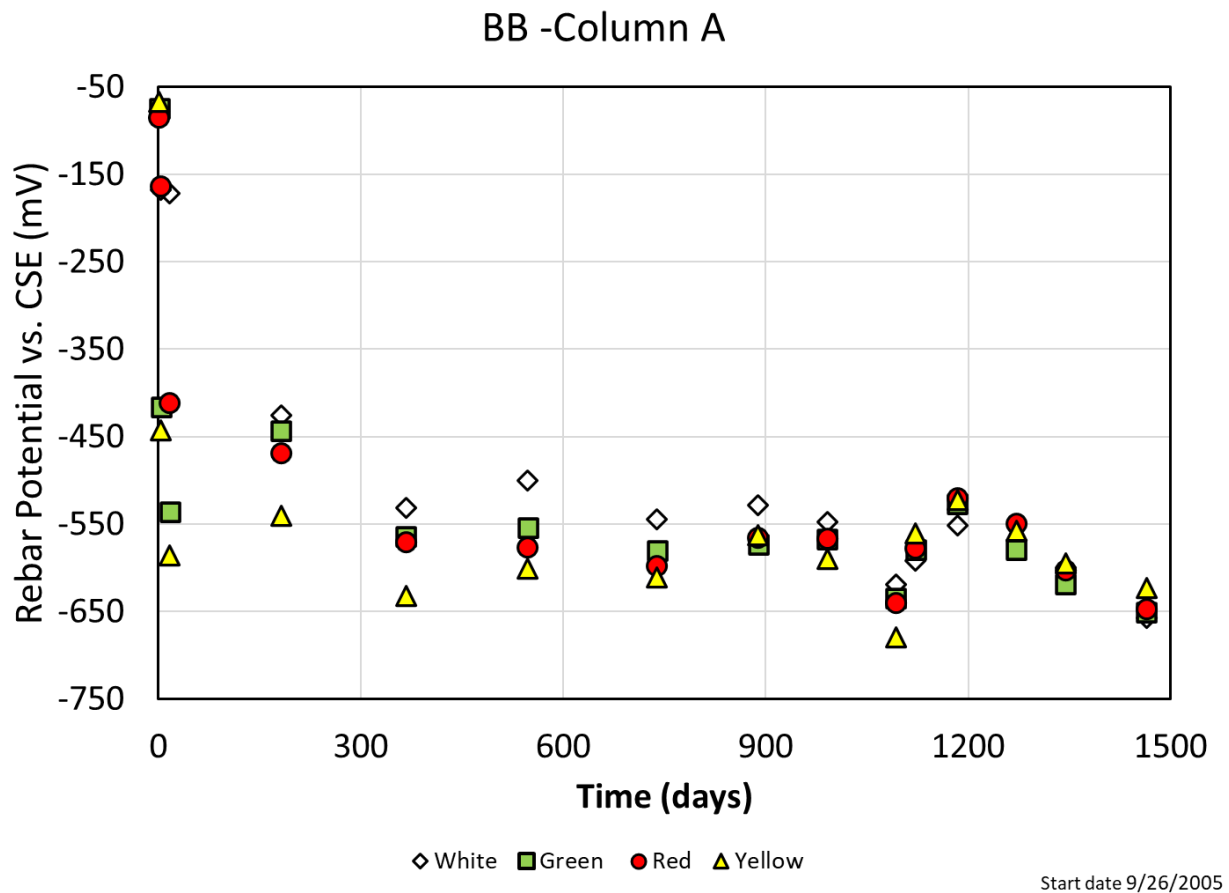
Figure 5-11. Plot showing the potential evolution for black bars embedded in BB column A.

This section presents rebar potential vs. time for selected columns. The plots were prepared from the data provided by FDOT-SMO. Figure 5-11 shows column BB-A, with conventional black rebar. All rebars show potential values more negative than  $-400 \text{ mV}_{\text{CSE}}$ , this in part could be due to the low oxygen availability for the section on the ground that likely is wet most of the time. Figure 5-12 shows the rebar potential evolution for column MMFX-Column A. Similar transition to values more negative than  $-400 \text{ mV}_{\text{CSE}}$  are also observed. Figure 5-13 shows how the 2101 rebar potential evolved, in this case the transition to values more negative than  $-400 \text{ mV}_{\text{CSE}}$  were observed after 500 days. Figure 5-14 shows how the 3CR12 rebars embedded in column C evolved with time. The rebar potential reach values as negative as  $-500 \text{ mV}_{\text{CSE}}$  within a short period of time. LPR measurements not included in here indicated that the corrosion rate was moderate during the period shown. Figure 5-15 shows column A with 304 rebars, the rebar potential in this column ranged between  $-200 \text{ mV}_{\text{CSE}}$  and  $-100 \text{ mV}_{\text{CSE}}$ . Figure 5-16 (Column A)

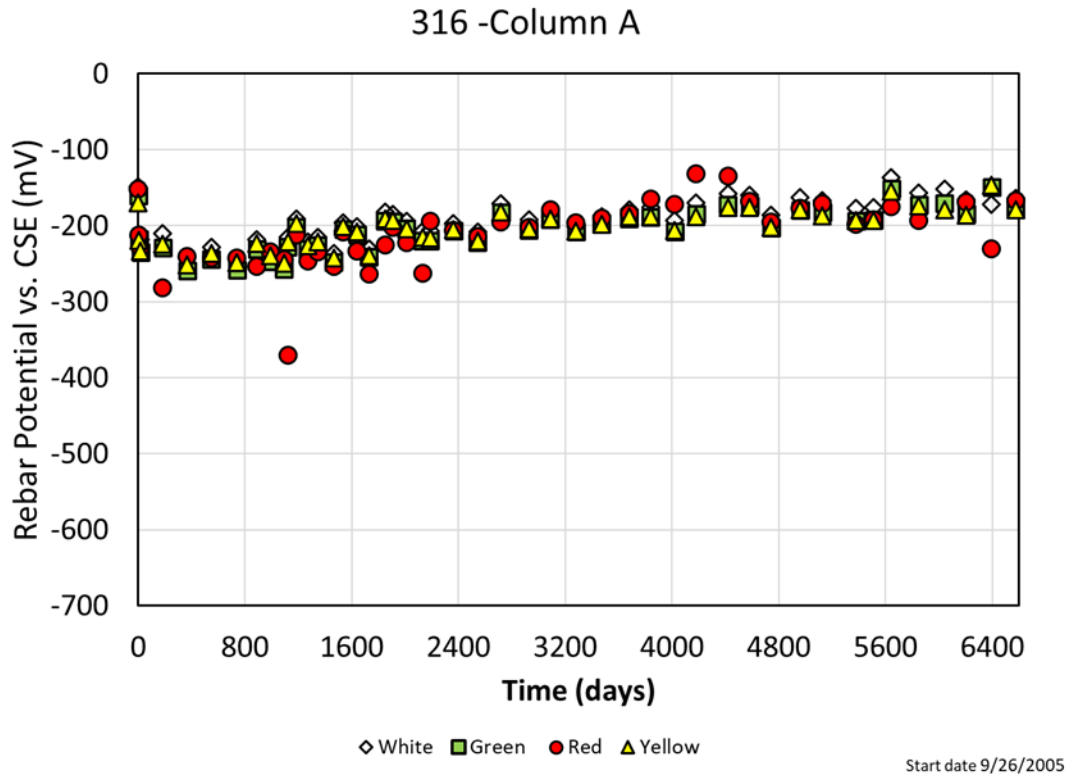
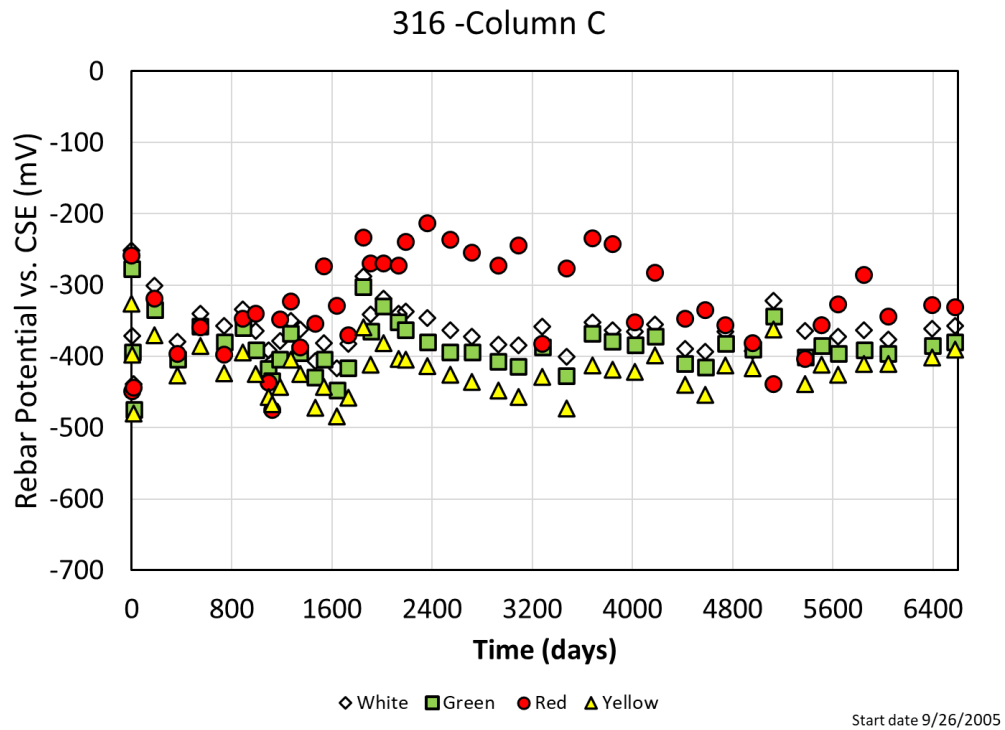
and Figure 5-17 (Column C) show plots on how the rebar potential evolved for columns with 316 rebars. In column A the rebar potential ranged between  $-300 \text{ mV}_{\text{CSE}}$  and  $-150 \text{ mV}_{\text{CSE}}$ , whereas the rebar potential values in column C transition to values that ranged between  $-300 \text{ mV}_{\text{CSE}}$  and  $-500 \text{ mV}_{\text{CSE}}$ . Column C with 316 was damaged during placement at the site and the measured values are likely due to the rebars becoming in contact with seawater shortly after deployment. It is known that 316 suffers pitting corrosion when immersed in seawater.

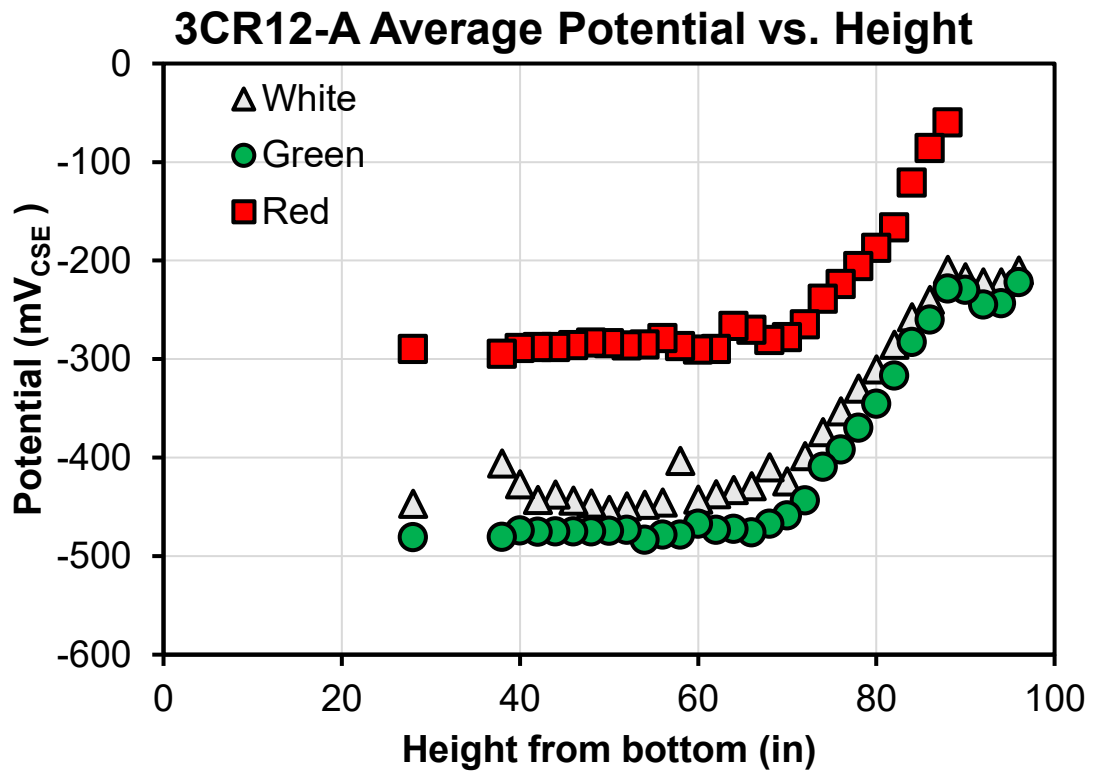
Figure 5-18. Avg. rebar potential vs height measured in column 3CR12-A.

Figure 5-18 shows the rebar potential measured in Column 3CR12-A. In column 3CR12-A, the rebar connected to the red wire had the more positive rebar potential values (when compared to the other rebars in this column), with a ~24 inches section of the rebar at a potential around -300 mV<sub>CSE</sub>. Rebar potential measurements for the rebar connected to the yellow wire were not made due to lack of good contact. The rebar potential in the other rebars reached values as negative as -500 mV<sub>CSE</sub>. Figure 5-19 shows that two rebars in column 3CR12-B reached values more negative than -550 mV<sub>CSE</sub>. For column 3CR12-B, the rebar connected to the white wire displayed a more positive values when compared to the other rebars. A portion of the rebar connected to the white wire showed values close to -420 mV<sub>CSE</sub>, but the rebar section closest to the ground and on the water had a rebar potential of -400 mV<sub>CSE</sub>. This suggests a section of the rebar being more active above the ground.

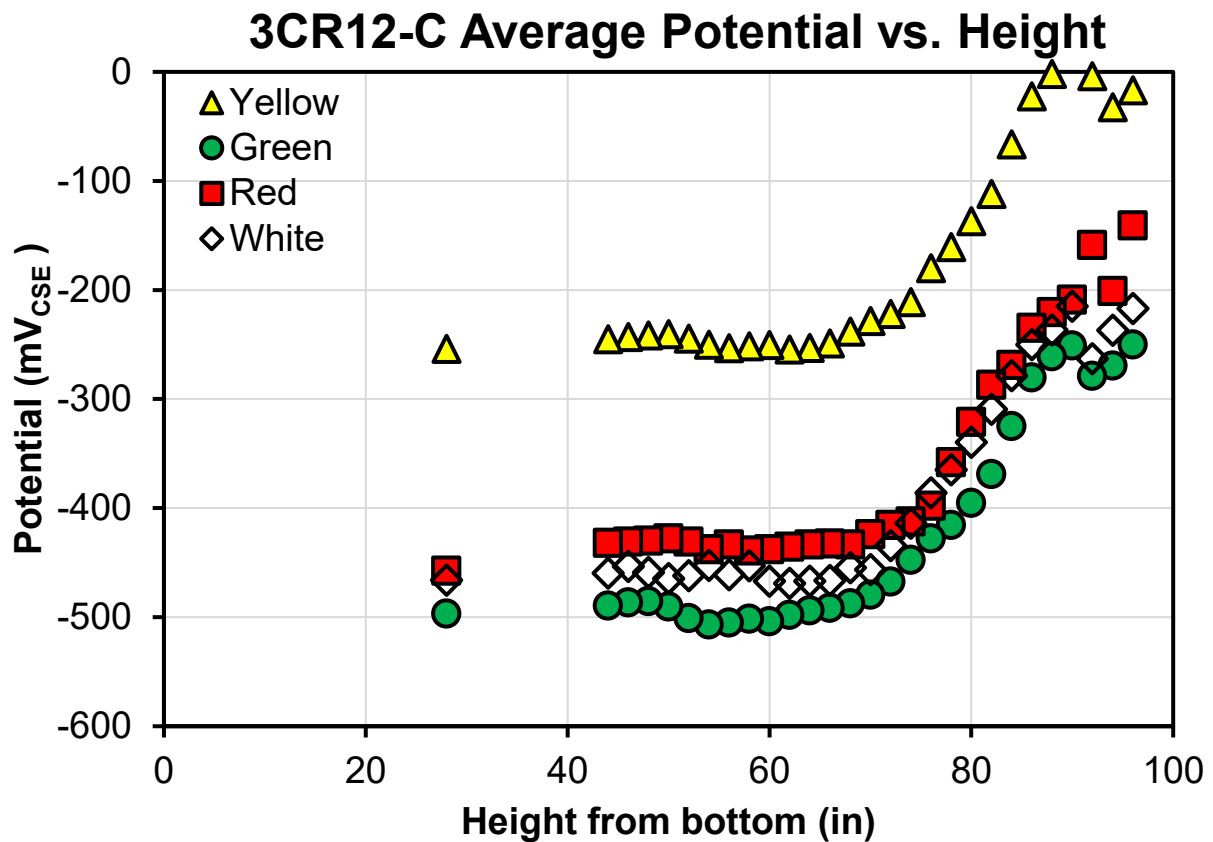
Figure 5-20. Avg. rebar potential vs height measured in column 3CR12-C.

Figure 5-20 shows rebar values vs. height for the four rebars embedded in column 3CR12-C. In this column, the rebar connected to the yellow wire had more positive rebar potential values compared to the other three rebars. The rebar connected to the green lead had the most negative rebar potential values. All rebars show a section that has more negative potential values. All columns showed sections with cracks during the October 2024 visit.

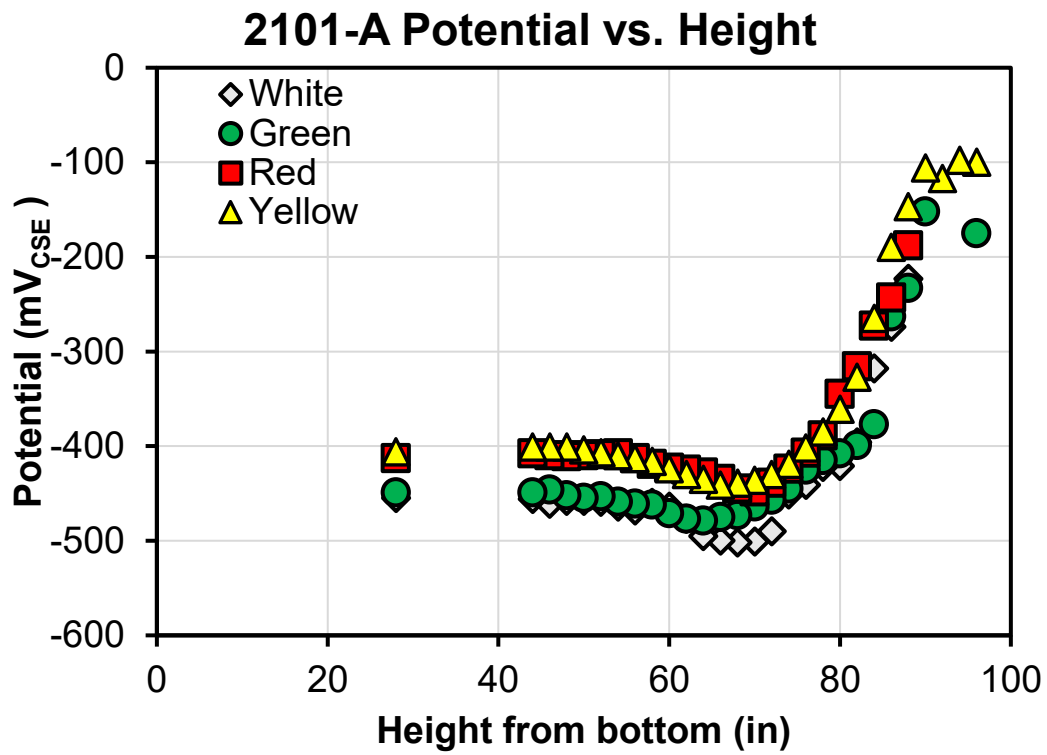
Figure 5-21. Avg. rebar potential vs height measured in column 2101-A.

This section shows the plots for rebar potential vs. height measured on the columns with 2101 rebars. These rebars are believed to have mill-scale upon casting. The mill-scale presence likely lowered the chloride threshold. In column 2101-A all rebars showed similar rebar potential vs. height, this can be observed in Figure 5-21. The rebar in contact with the white wire appears to have a section between 60 and 75 inches that is more negative than the rest. In all rebars, the section above 80 had rebar potential that increased steeply toward more positive values. For example, rebar connected to the yellow wire had values as high as -100 mV<sub>CSE</sub>. Similar trends were observed on columns 2101-B and 2101-C. Figure 5-22 shows the potential vs. height measured on the rebars in column 2101-B and Figure 5-23 shows the potential vs. height plots obtained on rebars embedded in Column 2101-C. All rebars in these three columns show a section that is indicative of active corrosion.

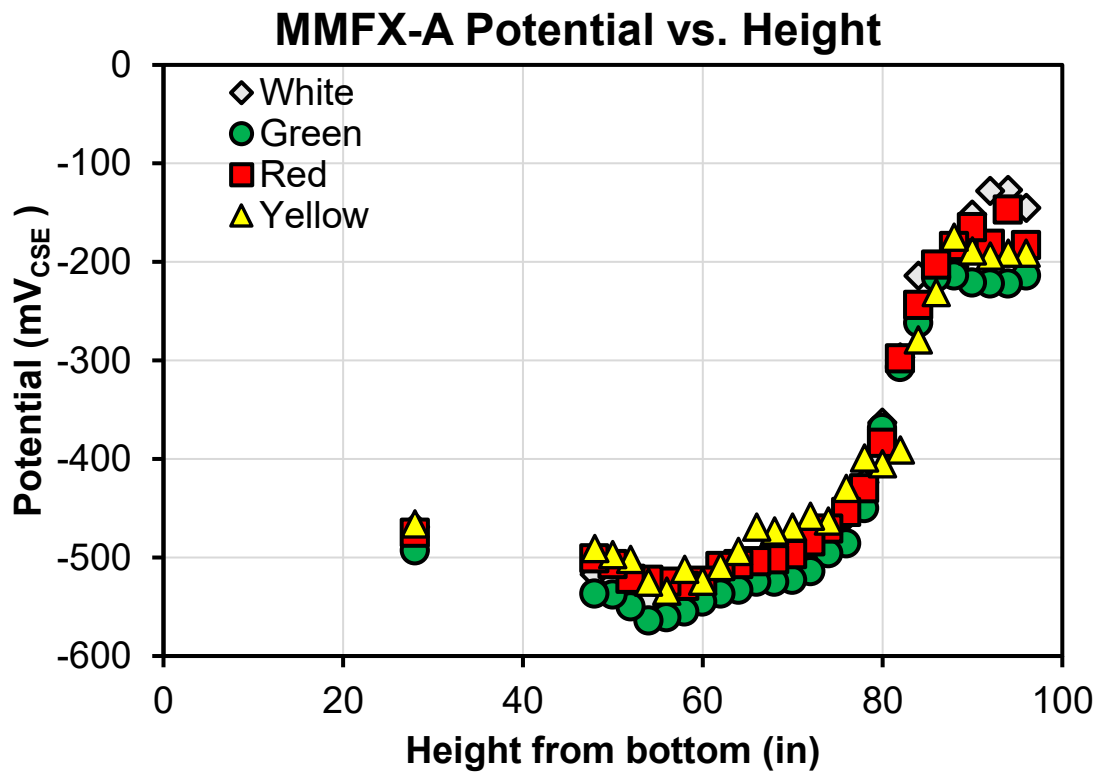
Figure 5-24. Avg. rebar potential vs height measured in column MMFX-A.

Figure 5-24, Figure 5-25 and Figure 5-26 show the potential vs. height measured on the rebars for Columns MMFX-A, MMFX-B and MMFX-C, respectively. Two columns MMFX-A and MMFX-C showed rebars that reach potential values more negative than  $-520 \text{ mV}_{\text{CSE}}$ , with column MMFX-C having the rebar with the more negative potentials. Two of the rebars in column MMFX-B (Figure 5-25) also showed rebar values close to  $-600 \text{ mV}_{\text{CSE}}$ . The rebar connected to the white wire in Column MMFX-B showed the most positive values from all 12 MMFX rebars.

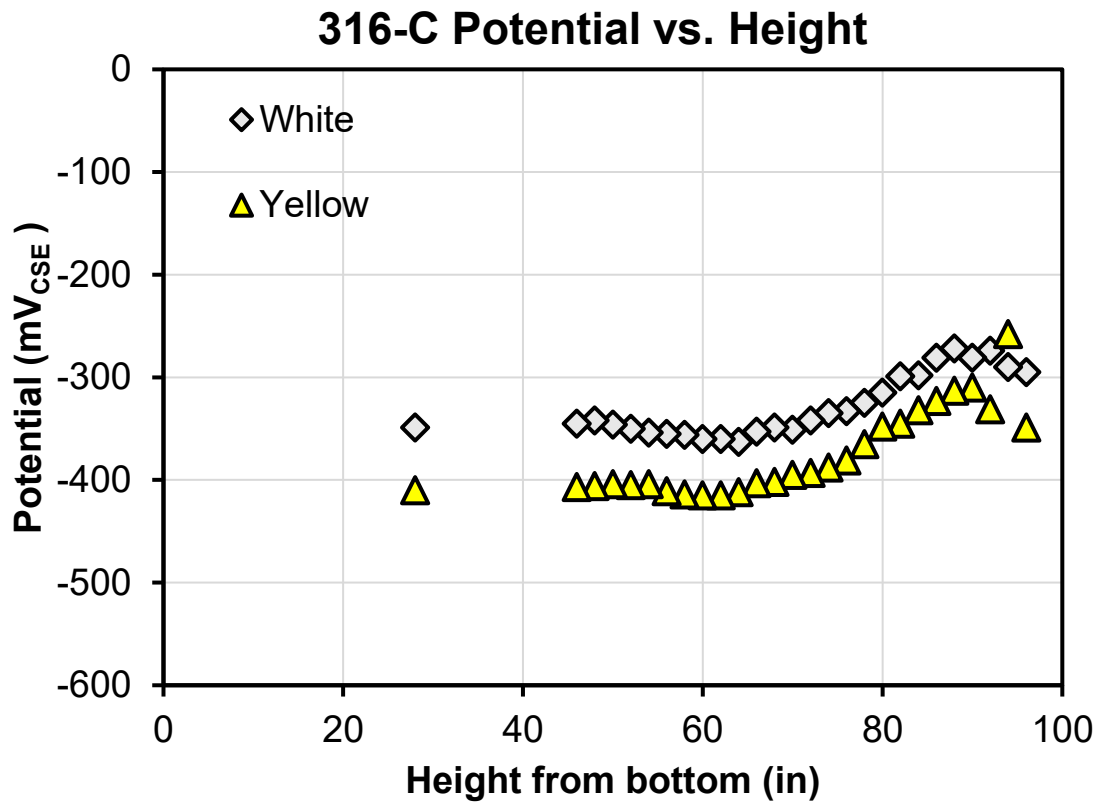
Figure 5-27. Avg. Rebar Potential vs height measured in column 316-C.

Column 316-C was damaged while driving them into place. It is likely that the rebar corrosion is taking place on section below the column region that was damaged. The two rebars measured seem to indicate that there is active corrosion taking place. Figure 5-27 shows the two wires' rebar potential vs. height measurements from Column 316-C. The rebar potential ranged between  $-420 \text{ mV}_{\text{CSE}}$  and slightly more positive than  $-300 \text{ mV}_{\text{CSE}}$ .

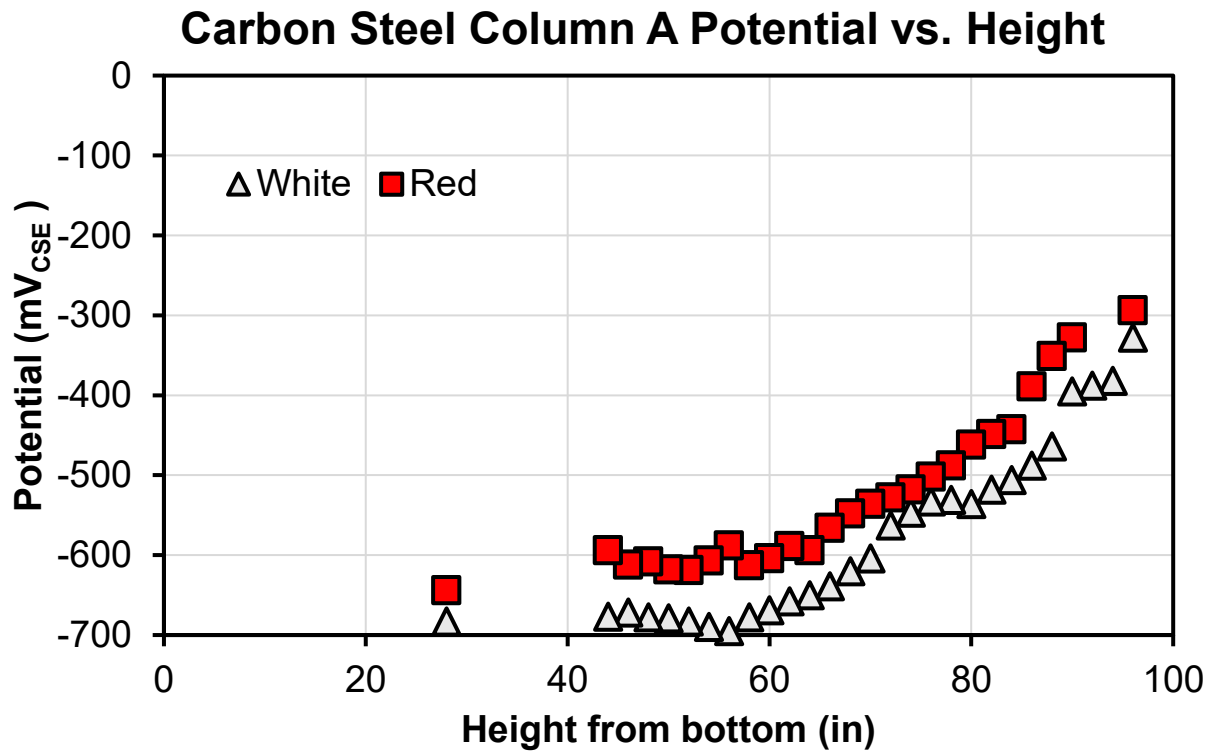
Figure 5-28. Avg. rebar potential vs height measured in column A (with carbon steel rebar).

The columns with carbon steel rebars show significantly wider cracks than the columns with MMFX, 3CR12 or 2101 rebars. Figure 5-28 shows the potential vs. height measured on two rebars of column A.

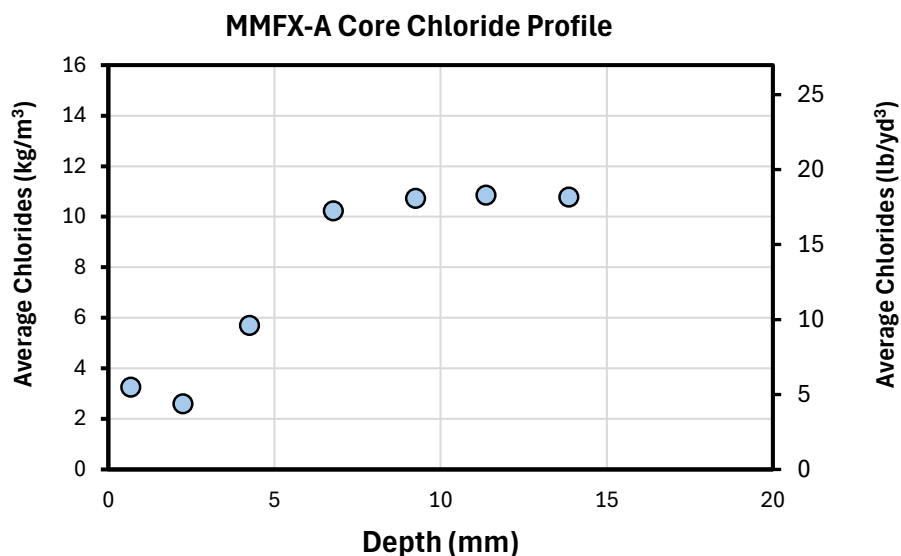
Figure 5-34. MMFX-A Core Chloride Profile.

Figure 5-34 and Figure 5-35 depict chloride profiles for one of the MMFX columns. Both profiles correspond to millings obtained from a concrete core. Figure 5-34 shows the profile from the column surface, whereas Figure 5-35 shows how the chloride evolved behind the rebar (rebar trace). Note that the chloride concentration at the rebar depth is two to three times the  $C_T$  reported by Trejo [15].

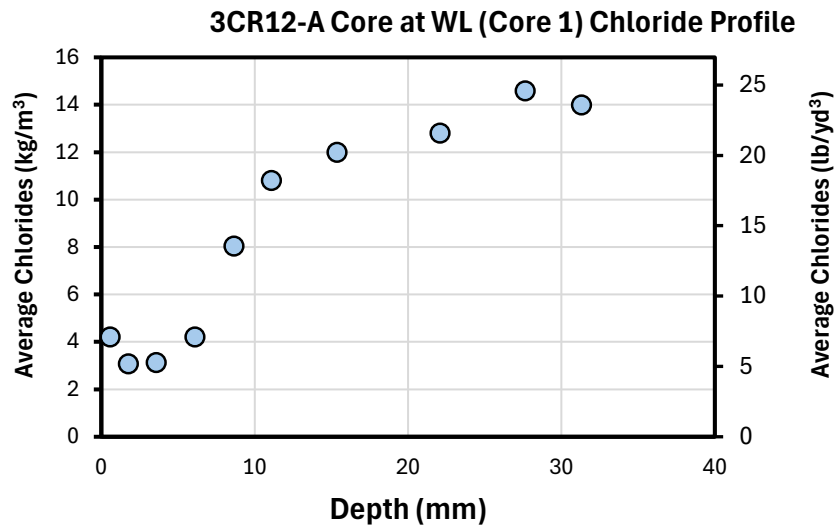
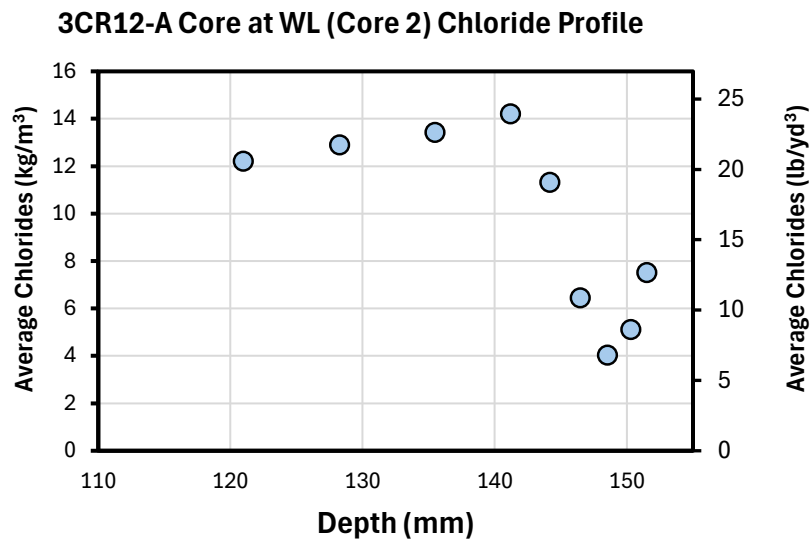
Figure 5-40. 3CR12-A @ WL(both sides) Chloride Profile.

One of the cores obtained from column 3CR12-A penetrated the whole column and did not touch any rebar. Figure 5-40 shows the profiles from both ends of the column. The concentration at the rebar depth appears to be between  $12.5 \text{ kg/m}^3$  and  $14 \text{ kg/m}^3$  (no counting increase in chloride concentration build up due to the rebar presence [16] [17] [1]).

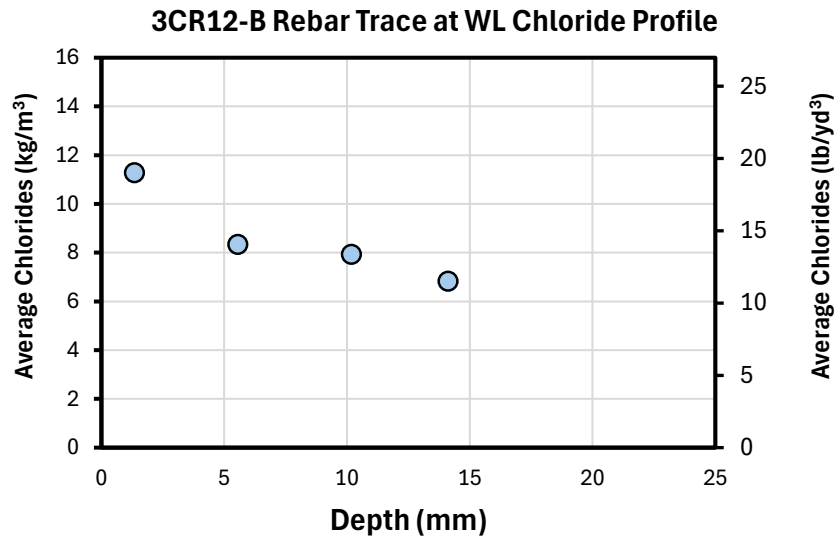
Figure 5-42. 3CR12-B Rebar Trace at WL Chloride Profile.

Figure 5-42 shows the rebar trace chloride concentration, in this case the layers were obtained toward the column surface, i.e., concrete in front of the rebar. Recall that no rebar segment was obtained from 3CR12 columns.

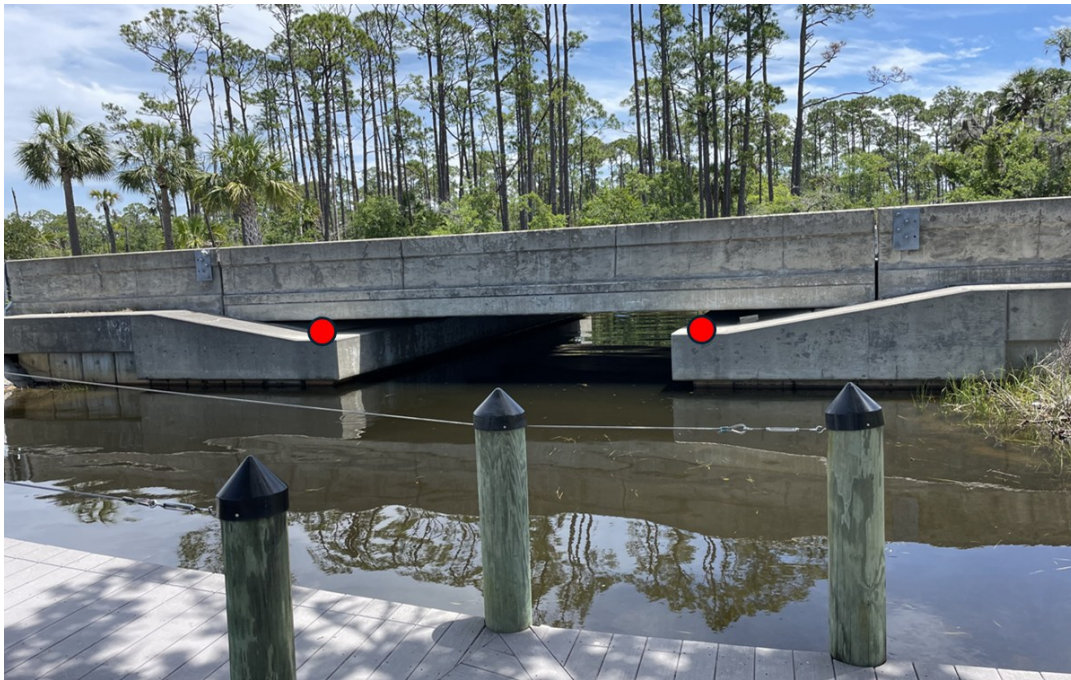
Figure 6-1. Picture of SR30A Bridge (510072) taken from the marina, left dot location 1, right dot is location 2.

The visit to SR30A bridge (#510072) took place during May 2025. Figure 6-1 below shows an image of the bridge and the bulk-head on each side. The red circles show the approximate locations where drilling took place to locate the reinforcement. Figure 6-2 shows a picture of the hole made at site one, a crack is also visible, but it is believed not to be due to corrosion.

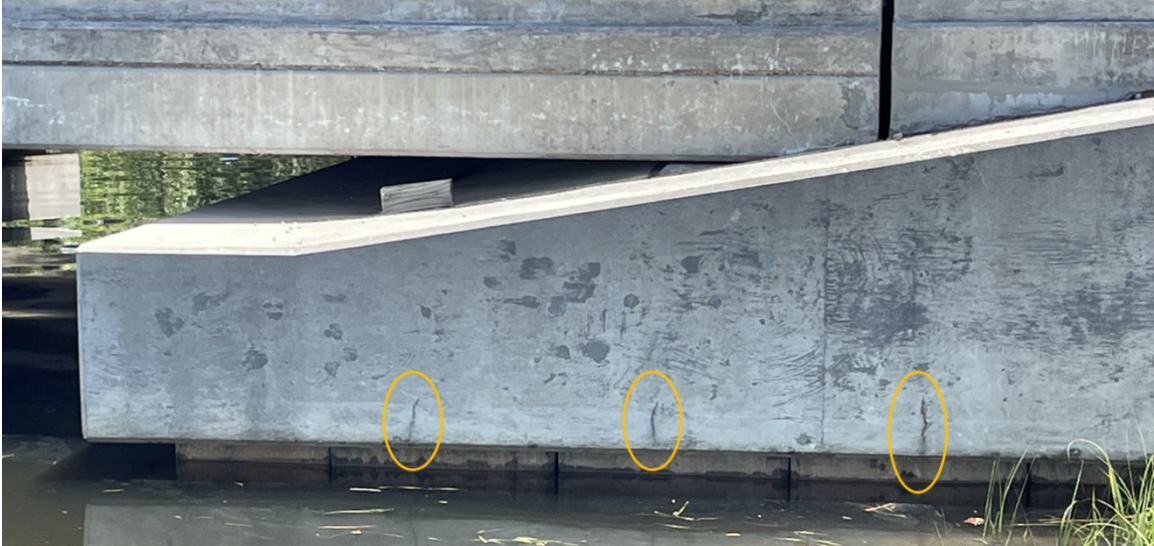
Several cracks were observed on the bulk-heads and documented with photographs. Figure 6-3, Figure 6-4 and Figure 6-5 show images of where the cracks are located. These are not believed to be due to corrosion of the reinforcement.

Figure 6-3. South side of the bridge, showing several cracks (moisture allows for observation).

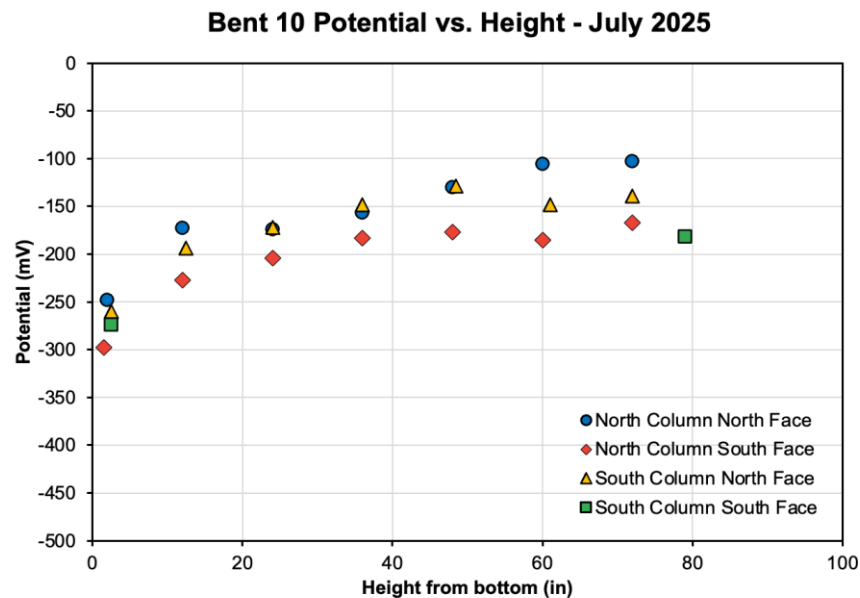
Figure 6-8. Bent 10 rebar potential vs. height.

During the visit on July 8, 2025, the FDOT field team brought one of its boats and measurements were made on the columns in Bent 10. The column in Bent 10 has carbon steel rebars, and except for the lowest elevation, all other rebar potential values were more positive than -250 mVcse. This can be observed from the plots in Figure 6-8. Figure 6-8 shows that at the lowest elevation the rebar ranged between -300 and -250 mVcse. It is known that carbon steel rebars require more current to be polarized when compared to stainless steels.

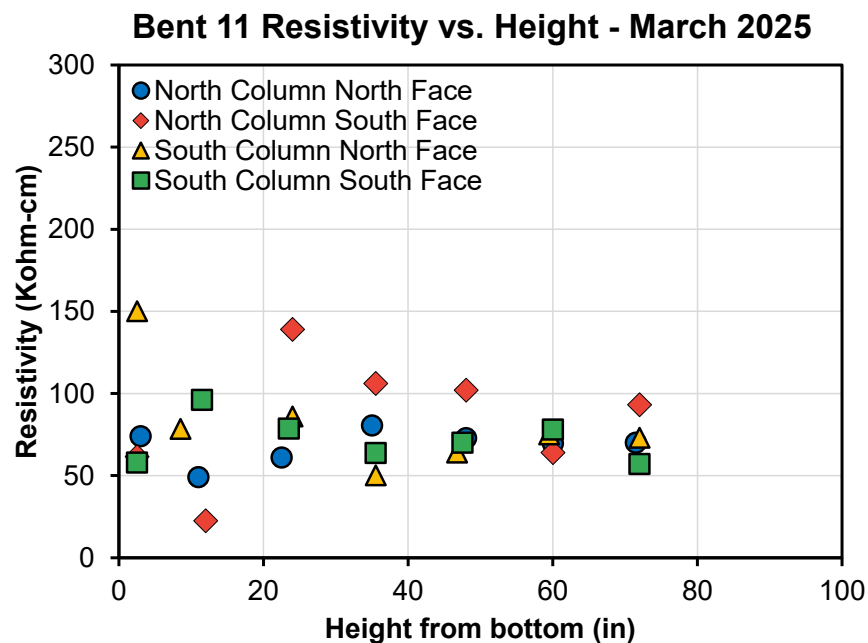
Figure 6-11. Bent 11 concrete resistivity vs. height.

Figure 6-11 and Figure 6-12 show the concrete resistivity vs. height measured on the columns of Bent 11 and Bent 12, respectively. The values in most cases were greater than 50 K $\Omega$ -cm. The exception was the concrete on the North column North face from Bent 12, which displayed values ranging from 15 K $\Omega$ -cm to 72 K $\Omega$ -cm.
