Report Prepared by:  
Dr. Francisco J. Presuel–Moreno  
With  
Samantha Mavrak  
David Anguelov

## **Final Report**

Evaluation of Concrete Specimens Prepared with Corrosion Resistant  
Reinforcement after Long Term, Greater than 15 years, Outdoor and  
Laboratory Exposures

Contract Number – FDOT (BED27-977-04)  
FAU (AWD003253)

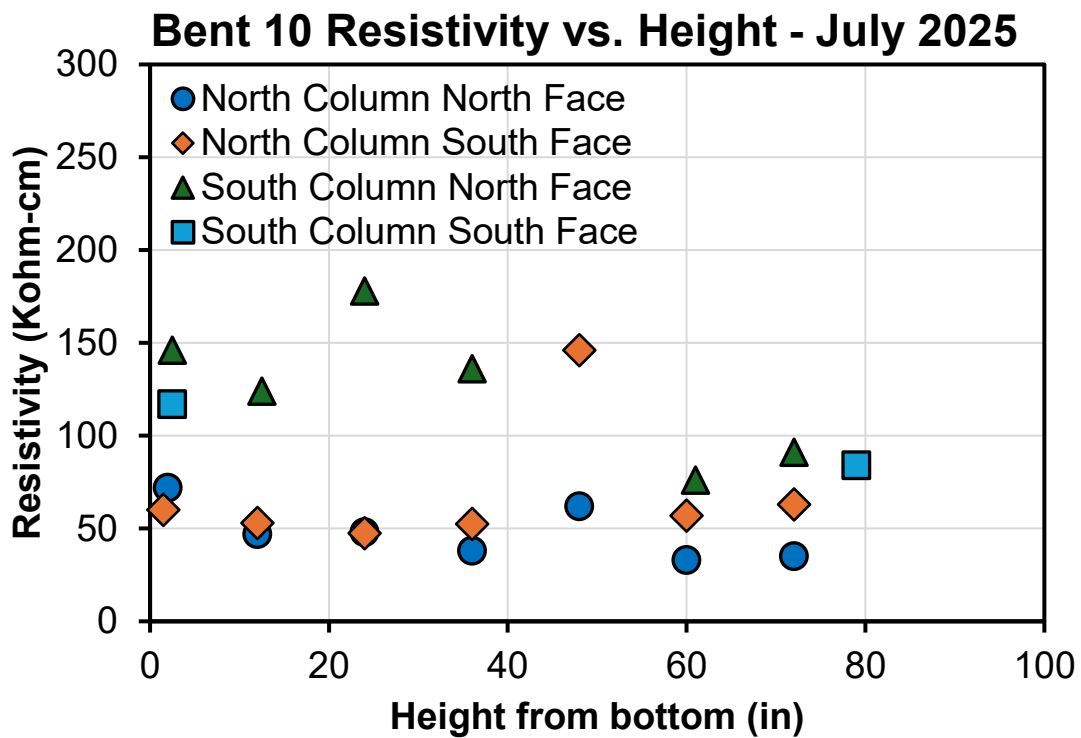
Figure 6-13. Bent 10 concrete resistivity vs. height.

Figure 6-13 shows the concrete resistivity measured on the columns with carbon steel rebar located on Bent 10. The smallest value was measured on the North Column North face at 60 inch elevation was 33 KΩ-cm. Most values were greater than 50 Kohm-cm and in some cases were as high as 150 KΩ-cm. The range of values suggest that the moisture content varies greatly from column to column, and also with elevation. Figure 6-14 and Figure 6-15 shows the concrete resistivity values measured on the columns of Bent 11 and Bent 12, respectively. The concrete resistivity values tended to be somewhat higher at some elevations during the July visit compared to the values measured during the March visit. During the July visit, the Bent 12 North Column North Face showed values close to 100 KΩ-cm.

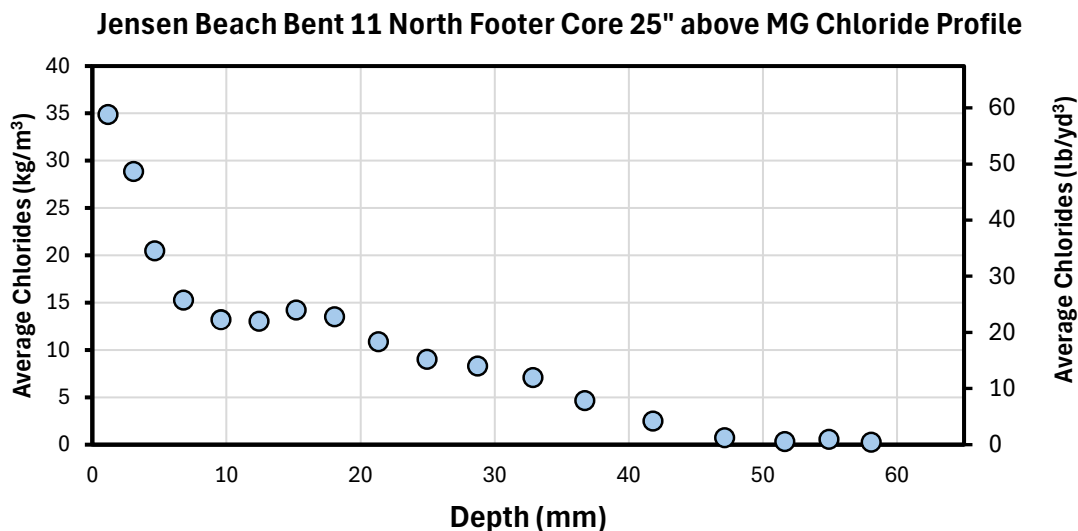
Figure 6-16. Chloride profile of Jensen Beach bent 11 north footer core (25" above marine growth).

Figure 6-16 and Figure 6-17 reveal that the chloride concentration decreased significantly faster with depth for the north footer core 25 inches above the marine growth compared to the core from the same footer 5 inches above the marine growth. As Figure 6-17 demonstrates, the chloride concentration for the core 5 inches above the marine growth hovers consistently near 30 kg/m<sup>3</sup> for the first 10 mm. This is likely because the area closer to the marine growth remains submerged or wet for longer periods of time, resulting in a higher chloride surface concentration that then appears to have penetrated about 10 mm. On the other hand, because the area at the

higher elevation experiences more wetting and drying cycles, the chloride surface concentration is higher, and thus Figure 6-16 shows that the concentration decreases by over half in the same depth range of 0 mm to 10 mm. There appears to be a local maximum at 15 mm depth.

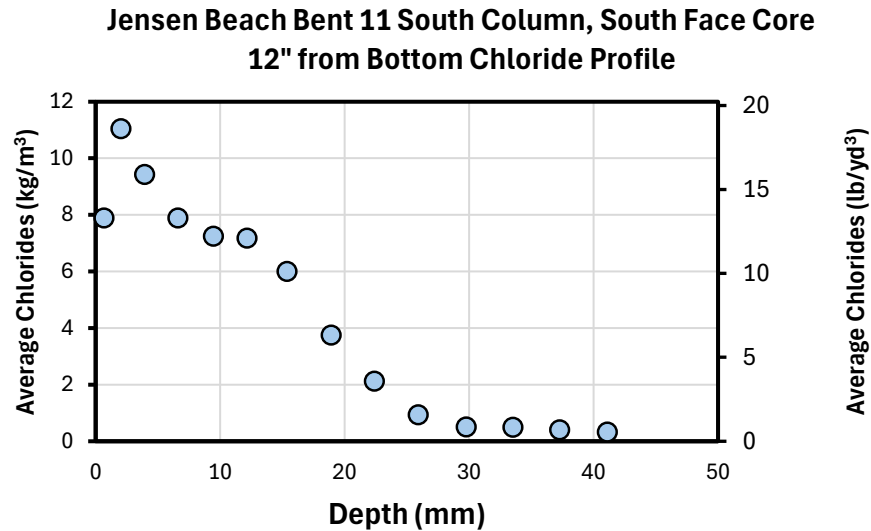
Figure 6-18. Chloride profile of Jensen Beach bent 11 south column, south face core (12" above bottom).

The chloride profile from the core obtained on the column is a few feet above the footer and the chlorides likely reach the surface from ocean spray (breaking of the waves on the footer). The columns have a paint coating that might have slowed the chloride penetration, but it can be observed in Figure 6-18 that there is a considerable chloride amount that has penetrated the first

20 mm of the concrete. If the rebar depth is 75 mm (i.e. 3 inches), then the chloride at the rebar depth is expected to be very low currently. The Dapp (apparent diffusion coefficient) was calculated assuming 21 years of exposure, a Co of 0.2 kg/m<sup>3</sup>. Table 6-1 shows the calculated Cs, Dapp in cm<sup>2</sup>/s and in in<sup>2</sup>/year, as well as the residual and the number of layers removed (#LaRem – Number of Layers Removed) to obtain a good fit.

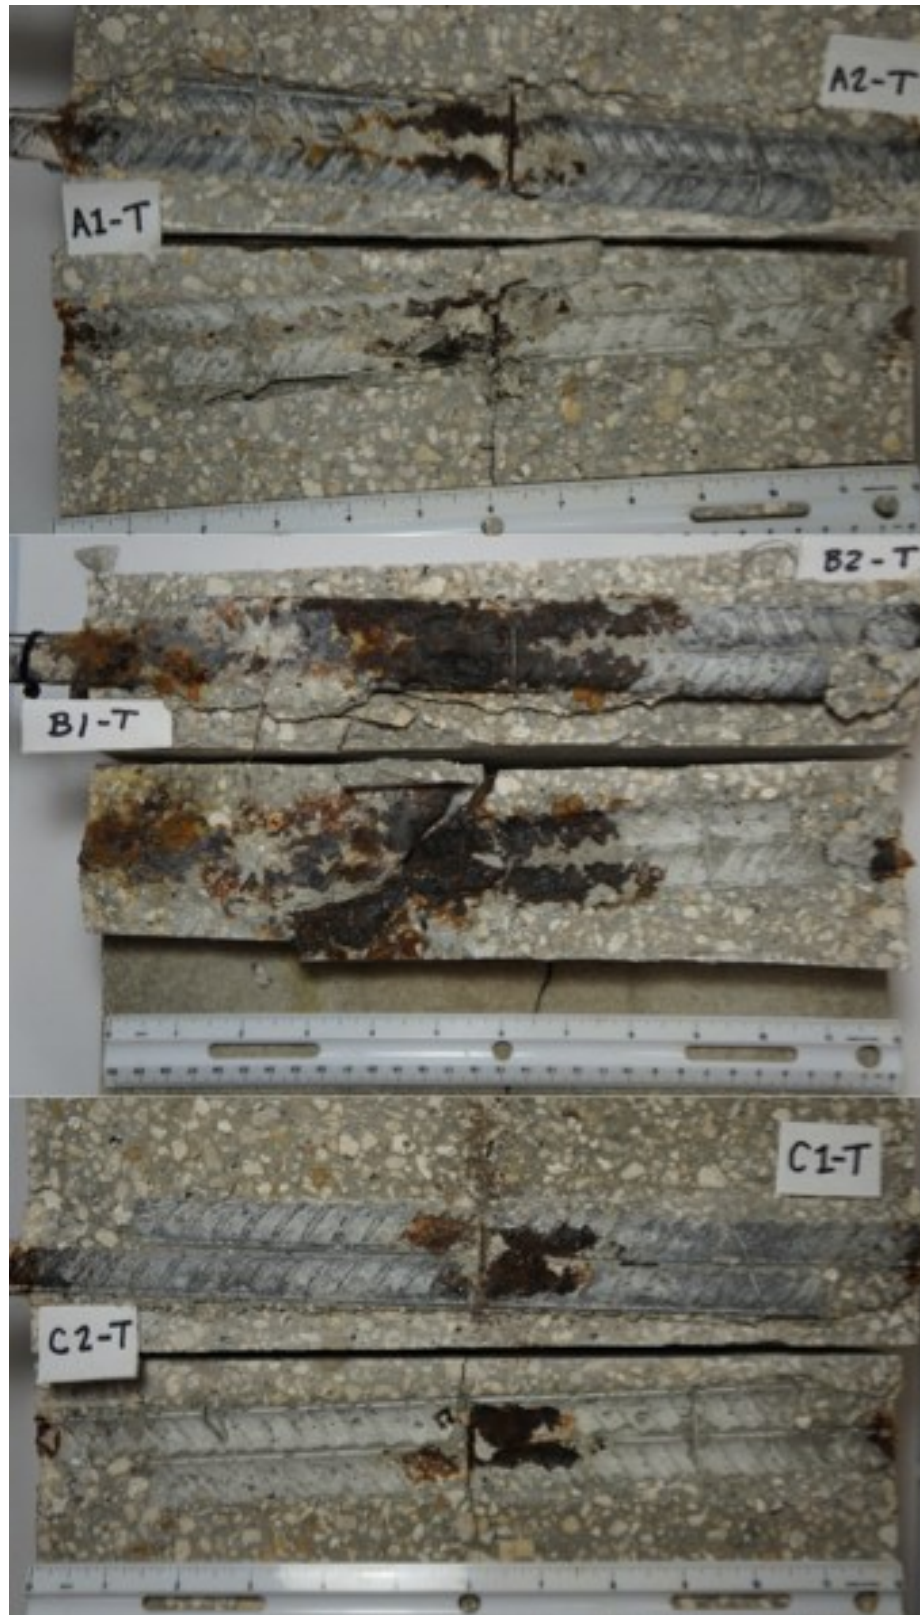
Figure 7-1. 4-CCRV-3CR12-2 top row, top-facing rebars and concrete rebar traces.

This section presents photos of sample 4-CCRV-3CR12-2 immediately after termination, including each rebar and its rebar trace in the concrete. Figure 7-1 presents the top-facing side of the top row of rebars while Figure 7-2 shows the bottom-facing side of the top row. Because this sample had a simulated crevice, there are 6 rebars in the top row instead of 3. The top-facing side displayed the most severe corrosion, concentrated near the midpoint of the rebars. This is because the sample also had a simulated crack, which helped facilitate the initial chloride ingress. Red rust stains appear on both the concrete and the rebars. Extensive pitting and cross-section loss is present on the top-facing side of all the rebars in the top row, with rebars B1 and B2 having the most severe pits. As Figure 7-1 shows, the corrosion products that accumulated on rebars B1 and B2 caused a large crack inside the concrete. Figure 7-2 shows that no or very little corrosion is apparent on the bottom-facing sides of the rebars. As expected, corrosion was present at the exposed ends of each rebar (outside the concrete) in both the top and bottom rows.

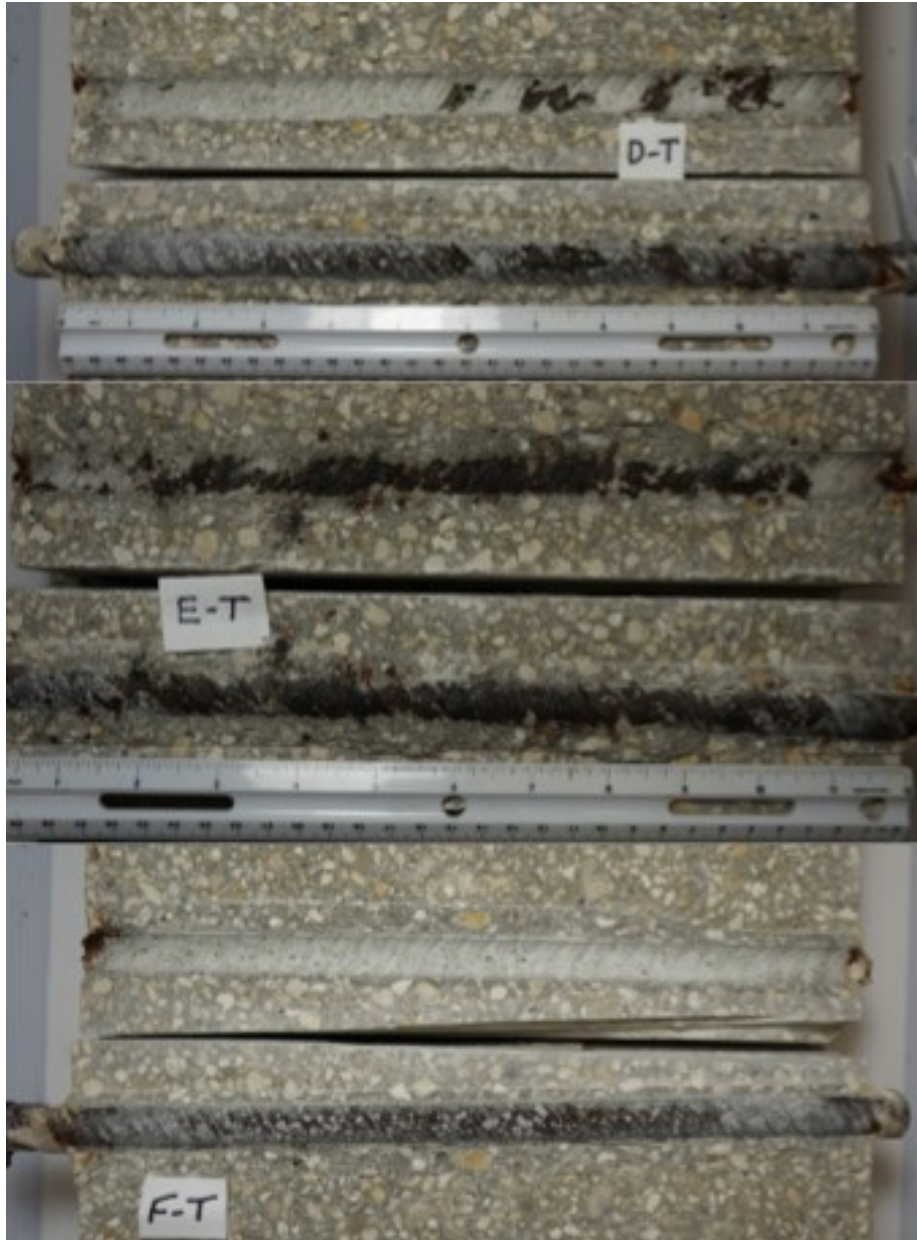
Figure 7-3. 4-CCRV-3CR12-2 bottom row, top-facing rebars and concrete rebar traces.

Figure 7-3 shows the top-facing side of the bottom row of rebars while Figure 7-4 shows the bottom-facing side of the bottom row. Similar to the top row, the top-facing rebar side of the bottom row displayed significantly more corrosion than the bottom-facing side. Red rust stains appear on the top faces of rebars D and E and their rebar traces. Rebars D and E displayed several pits on their top faces. Figure 7-3 shows that rebar E showed the most severe corrosion out of the three rebars in the bottom row likely because it was directly under rebars B1 and B2. Figure 7-4 shows that the bottom-facing side of rebar E had one area with red rust stain in the rebar close to the concrete end. The bottom side of rebar D showed little to no corrosion. Similarly, rebar F showed not to very little corrosion, both on its top face and bottom face.

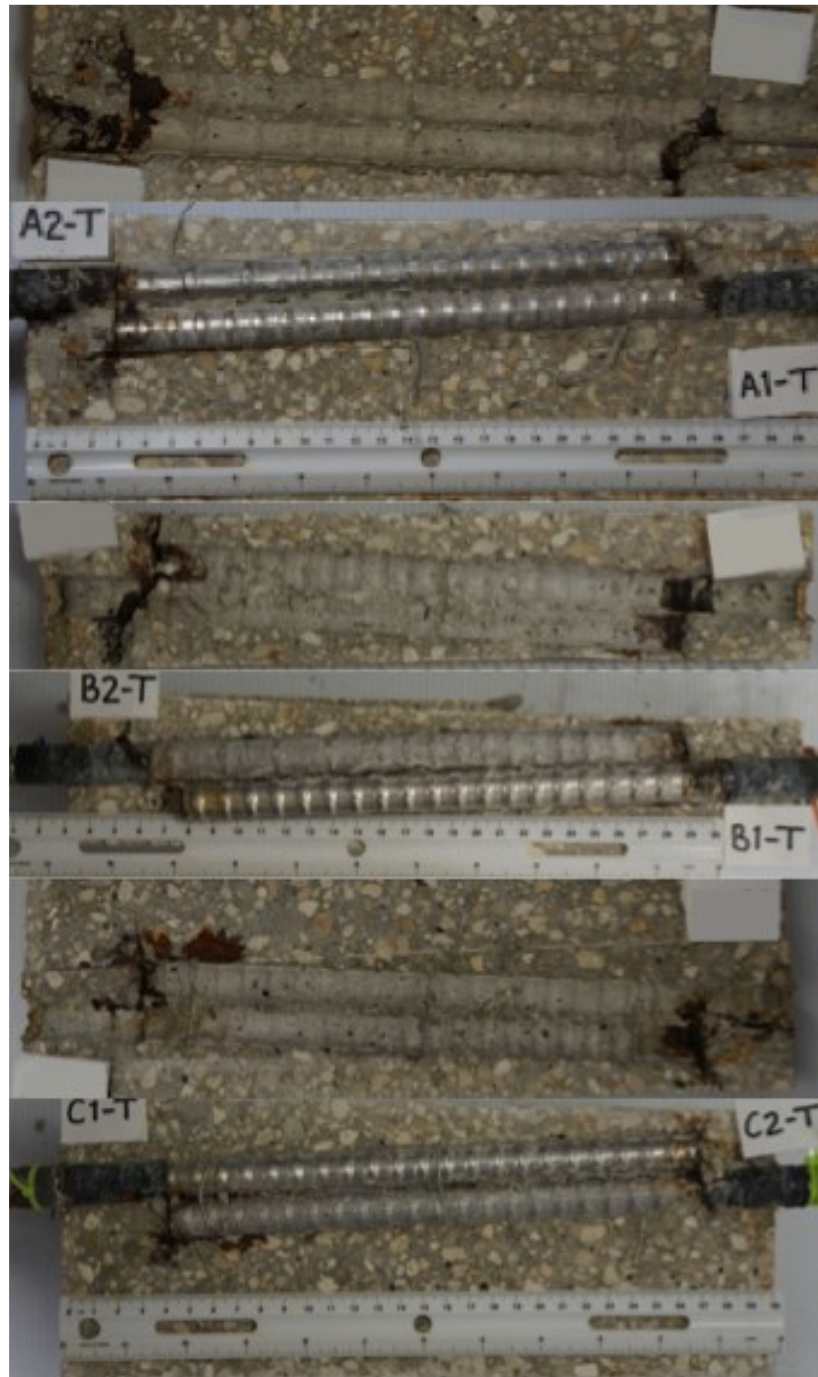
Figure 7-5. CREV-CT2-2 top row, top-facing rebars and concrete rebar traces.

This section presents photos of sample CREV-CT2-2 immediately after termination, including each rebar and its rebar trace in the concrete. Figure 7-5 presents the top-facing side of the top row of rebars while Figure 7-6 shows the bottom-facing side of the top row. This sample also had a simulated crevice. Rust stains on the rebars and cracks in the concrete are evident on both the top-facing and bottom-facing sides, concentrated near the ends of the rebar. Because the 316 cladding did not cover the ends of the rebars (i.e., no end-caps were used), the carbon steel core was exposed and began corroding, both inside and outside of the concrete. The end of rebar B1

that was embedded in the concrete within the solution reservoir showed evidence of corrosion and corrosion product buildup, which likely caused the crack in the concrete seen in Figure 7-5. The rebar ends embedded in the concrete were within the solution reservoir above. Rust stains in the concrete are evident from the bottom faces of the rebars in Figure 7-6 but are not as severe as the top faces. Figure 7-5 and Figure 7-6 both show that the clad portions of the rebars remained in good condition and did not show any evidence of corrosion.

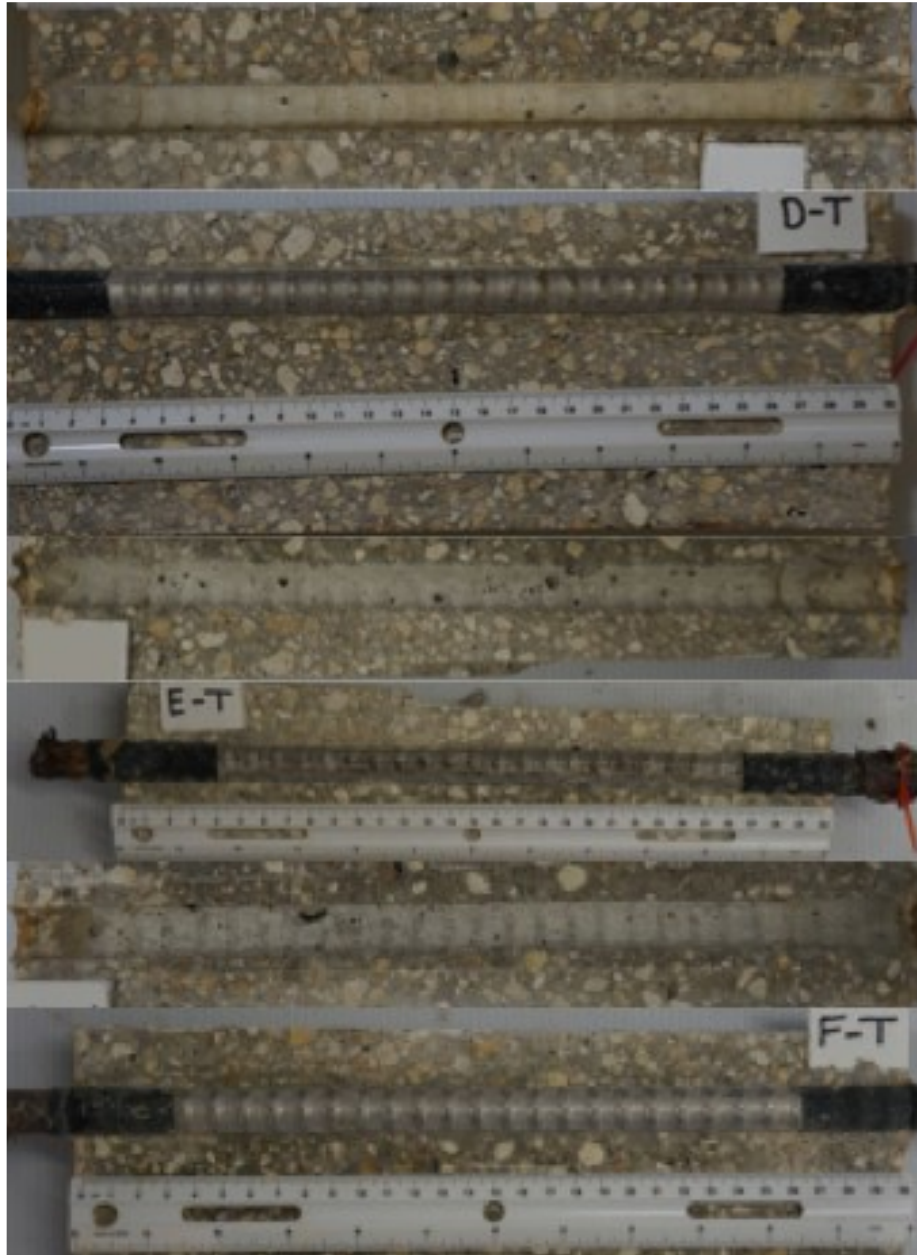
Figure 7-7. CREV-CT2-2 bottom row, top-facing rebars and concrete rebar traces.

Figure 7-7 presents the top-facing side of the bottom row of rebars while Figure 7-8 shows the bottom-facing side of the bottom row. The uncovered ends of the rebars showed evidence of corrosion, which is expected given their exposure to the environment. The portions of rebar inside the concrete showed no corrosion. The rebars had shrinkage sleeves on each end.

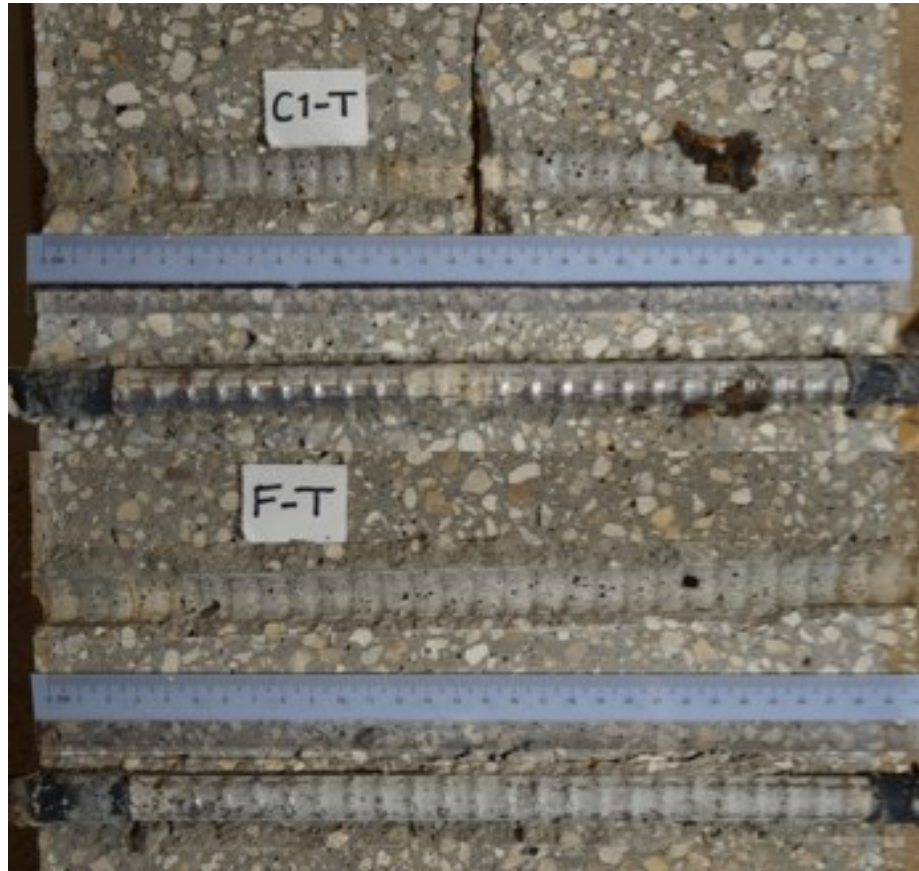
Figure 7-9. 4-CCON-CT2-1 top-facing, top and bottom rebars and concrete rebar traces.

This section presents photos of sample 4-CCON-CT2-1 immediately after termination, including each rebar and its rebar trace in the concrete. In this sample, only rebars C and consequently F were terminated. Rebar C showed consistently more negative corrosion potential values and corrosion rates than the other two rebars in the top row. Figure 7-9 shows the top-facing sides of rebars C and F as well as their concrete rebar traces. The simulated crack in the concrete surface is visible in rebar C's rebar trace. Rust stains are also apparent in this sample as shown in the concrete rebar trace of C in Figure 7-9 about 3 inches (7.6 cm) away from the simulated crack in

the center. The top-facing side of rebar C shows a corrosion spot on the cladding, which caused the rust stain on the concrete. The crack in the concrete facilitated chloride ingress, however the rust spot is away from the simulated crack. It is hypothesized that a defect in the clad allowed corrosion to initiate at that location. No signs of corrosion are visible on the top-facing side of rebar F.

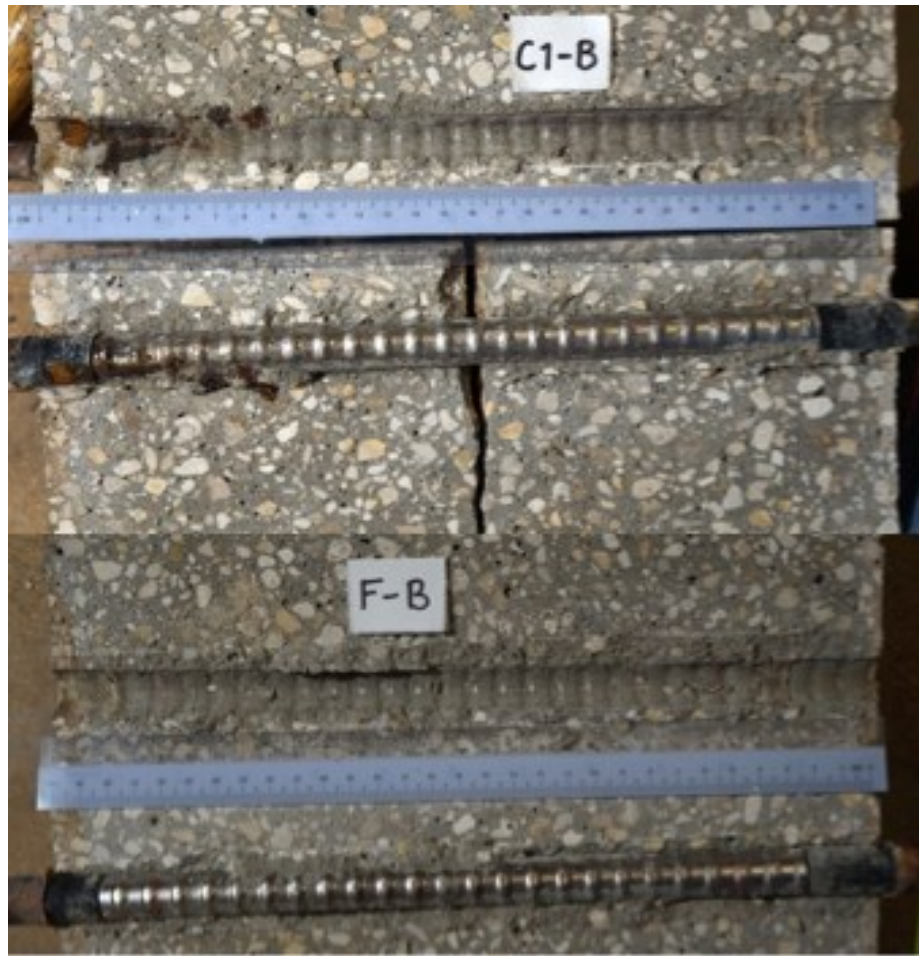
Figure 7-10. 4-CCON-CT2-1 bottom-facing, top and bottom rebars and concrete rebar traces.

Figure 7-10 shows the bottom-facing sides of rebars C and F as well as their concrete rebar traces. The simulated crack in the concrete surface is again visible under rebar C. More rust stains are apparent in the concrete rebar trace of C, close to the shrinkage sleeve. The bottom-facing side of rebar C shows corrosion on the end of the rebar. It is possible that the corrosion stain close to the shrinkage wrap was due to crevice corrosion. Outside of the concrete, corrosion on the uncoated rebar ends likely initiated because the carbon steel core was exposed. No signs of corrosion are visible on the bottom-facing side of rebar F.

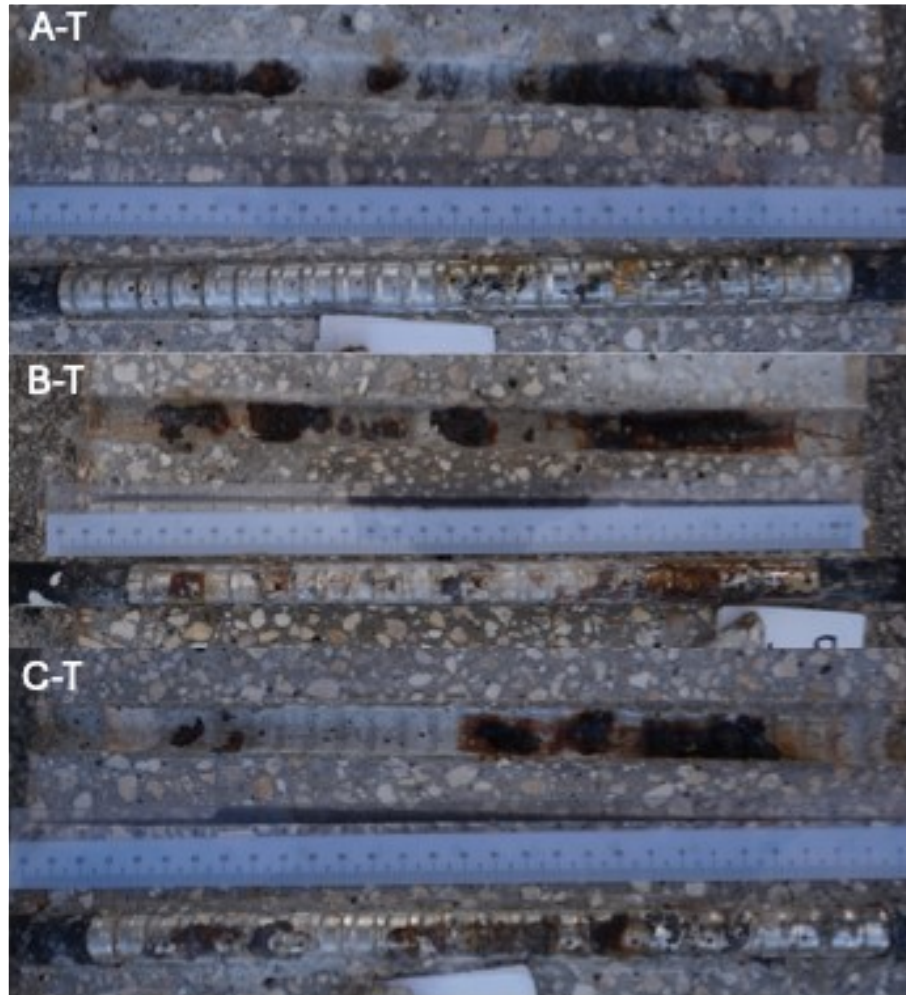
Figure 7-11. BCCD-CT2-1 top-facing, top rebars and concrete rebar traces.

This section presents photos of sample BCCD-CT2-1 after termination, including each rebar and its rebar trace in the concrete. During the preparation of this sample, holes of 3 mm diameter were drilled in the cladding 25 mm apart. The rebars in the bottom row are black steel with no cladding. Figure 7-11 and Figure 7-12 show the top-facing and bottom-facing sides, respectively, of the top row of rebars. Figure 7-11 shows that corrosion appears to be concentrated around the drilled holes, where chlorides were able to reach the carbon steel core. There are several rust stains on the concrete, stemming from the corrosion on the rebar. Corrosion stains are observed on the 316 cladding surrounding the holes. The bottom faces also showed corrosion around the holes, but they were less severe than the top side. The exception to this is the bottom of rebar B, under which a large crack formed, as Figure 7-12 shows. The crack was likely caused by corrosion of the carbon steel rebar E, from the bottom row.

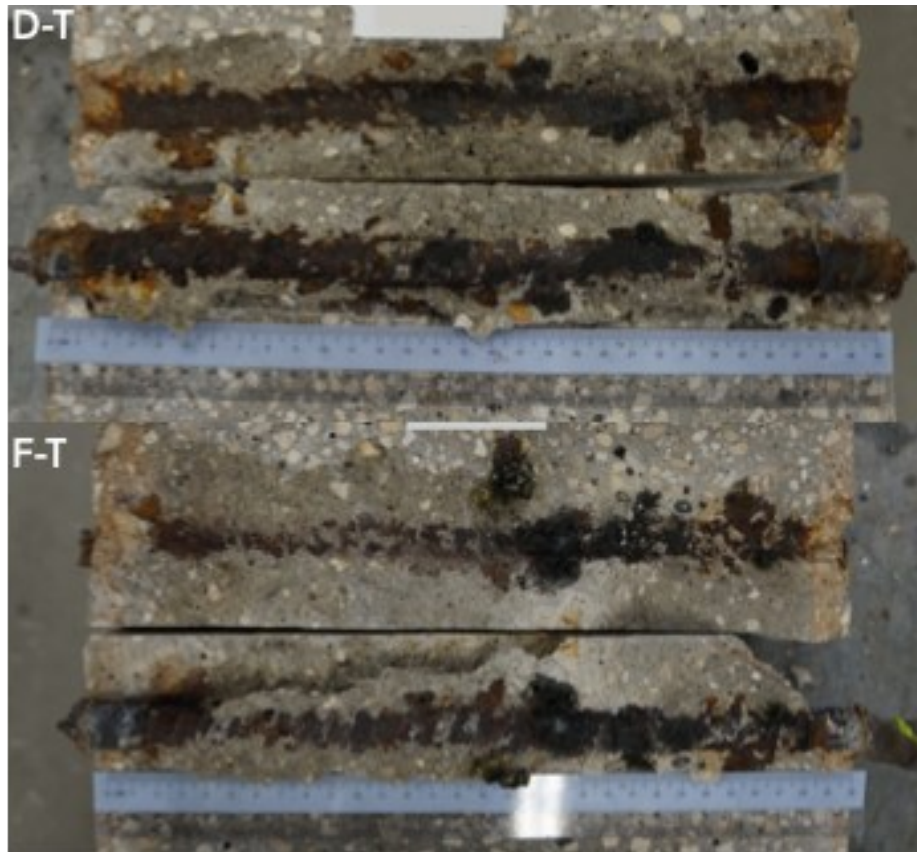
Figure 7-13. BCCD-CT2-1 top-facing, bottom rebars and concrete rebar traces.

Figure 7-13 and Figure 7-14 show the top-facing and bottom-facing sides, respectively, of the bottom row of carbon (black) steel rebars. Extensive corrosion is evident in these photos. Each rebar showed severe mass loss on the exposed ends and substantial corrosion product accumulation along the entire length of each rebar. The concrete trace of each rebar was thoroughly stained with rust. Several sections with cross-section loss were apparent on each rebar. Rebar E appeared to experience the most severe damage, which probably caused the previously mentioned crack above it (caused by Rebar E).

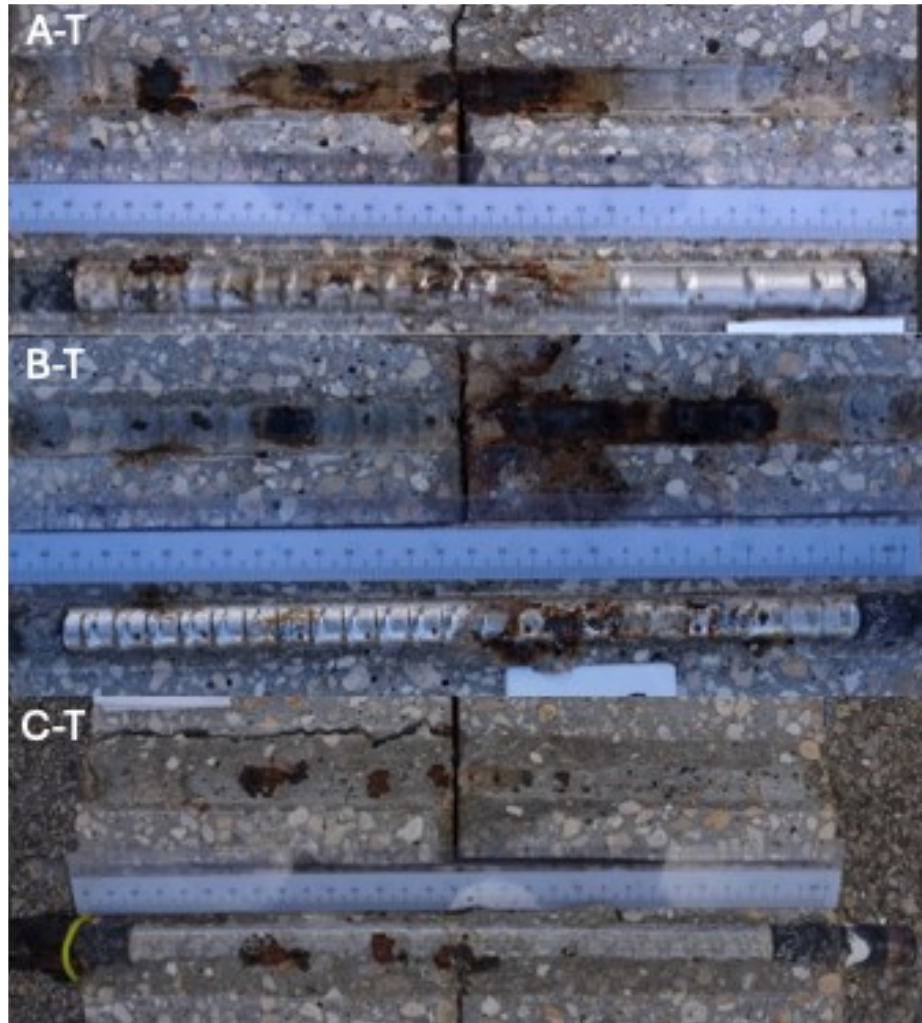
Figure 7-15. CSDB-CT2-1 top-facing, top rebars and concrete rebar traces.

This section presents photos of sample CSDB-CT2-1 after termination, including each rebar and its rebar trace in the concrete. This sample was also prepared with drilled holes of 3 mm diameter in the cladding 25 mm apart, with a simulated crack in the concrete. In this sample all rebars in both rows are clad type 2. Figure 7-15 and Figure 7-16 show the top-facing and bottom-facing sides, respectively, of the top row of rebars. Figure 7-15 shows rust stains on the concrete that stemmed from the corrosion in the drilled holes. The corrosion on the rebars is most severe near the concrete crack, where the chlorides would have most easily penetrated and accumulated. Some of the cladding surrounding the holes was stained by the corrosion, as seen in Figure 7-15.

The longitudinal crack in the concrete rebar trace of top-facing rebar C formed during the termination process while trying to open the sample. The bottom faces exhibited less severe corrosion, but the carbon steel beneath the drilled holes still exhibited some corrosion and rust stains were present on the concrete surrounding the drilled holes. It is also apparent that not all drilled holes had bleeding of corrosion products.

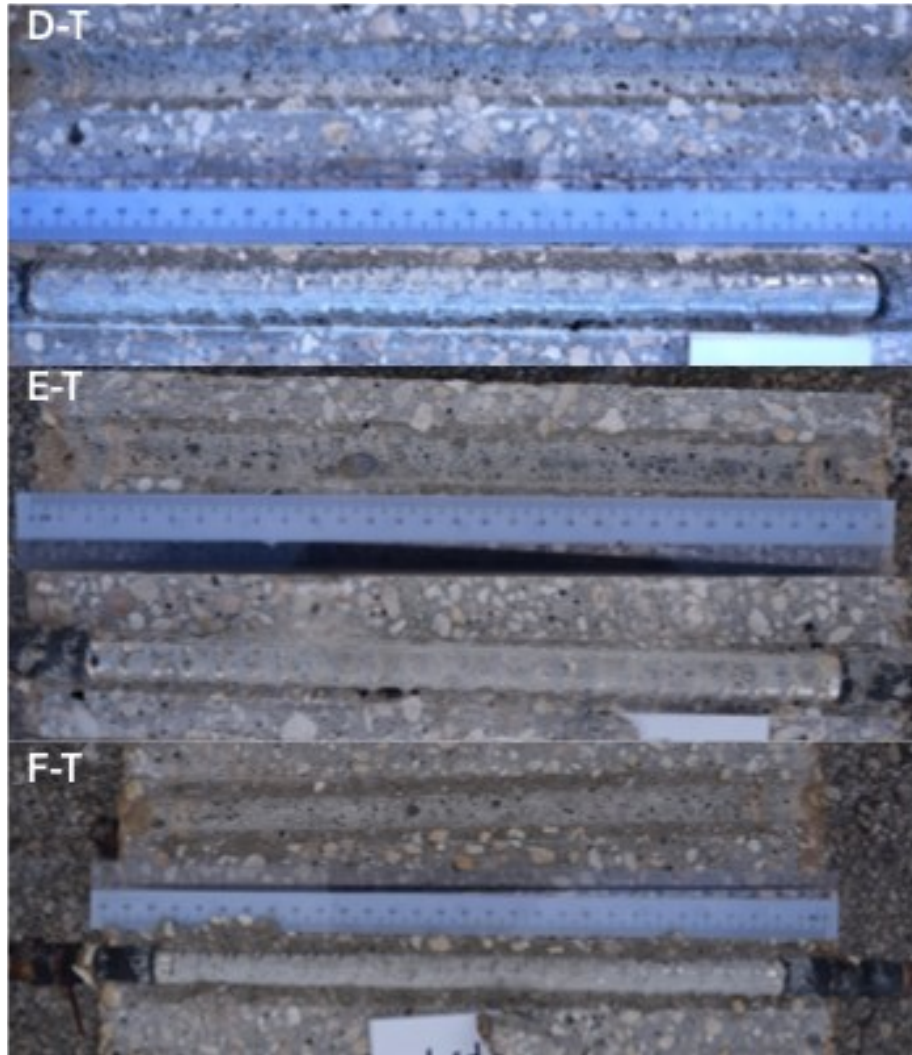
Figure 7-17. CSDB-CT2-1 top-facing, bottom rebars and concrete rebar traces.

Figure 7-17 presents the top-facing side of the bottom row of rebars while Figure 7-18 shows the bottom-facing side of the bottom row. The uncovered ends of the rebars showed evidence of corrosion, which is expected given their exposure to the environment. The portions of rebar inside the concrete showed no corrosion and the cladding remained in good condition.

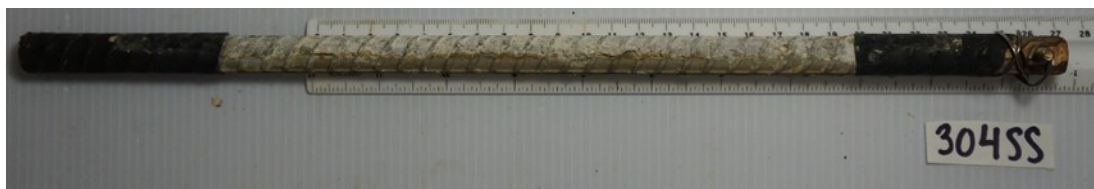
Figure 7-20. Bottom-facing side of 304SS rebar before cleaning, showing some corrosion.

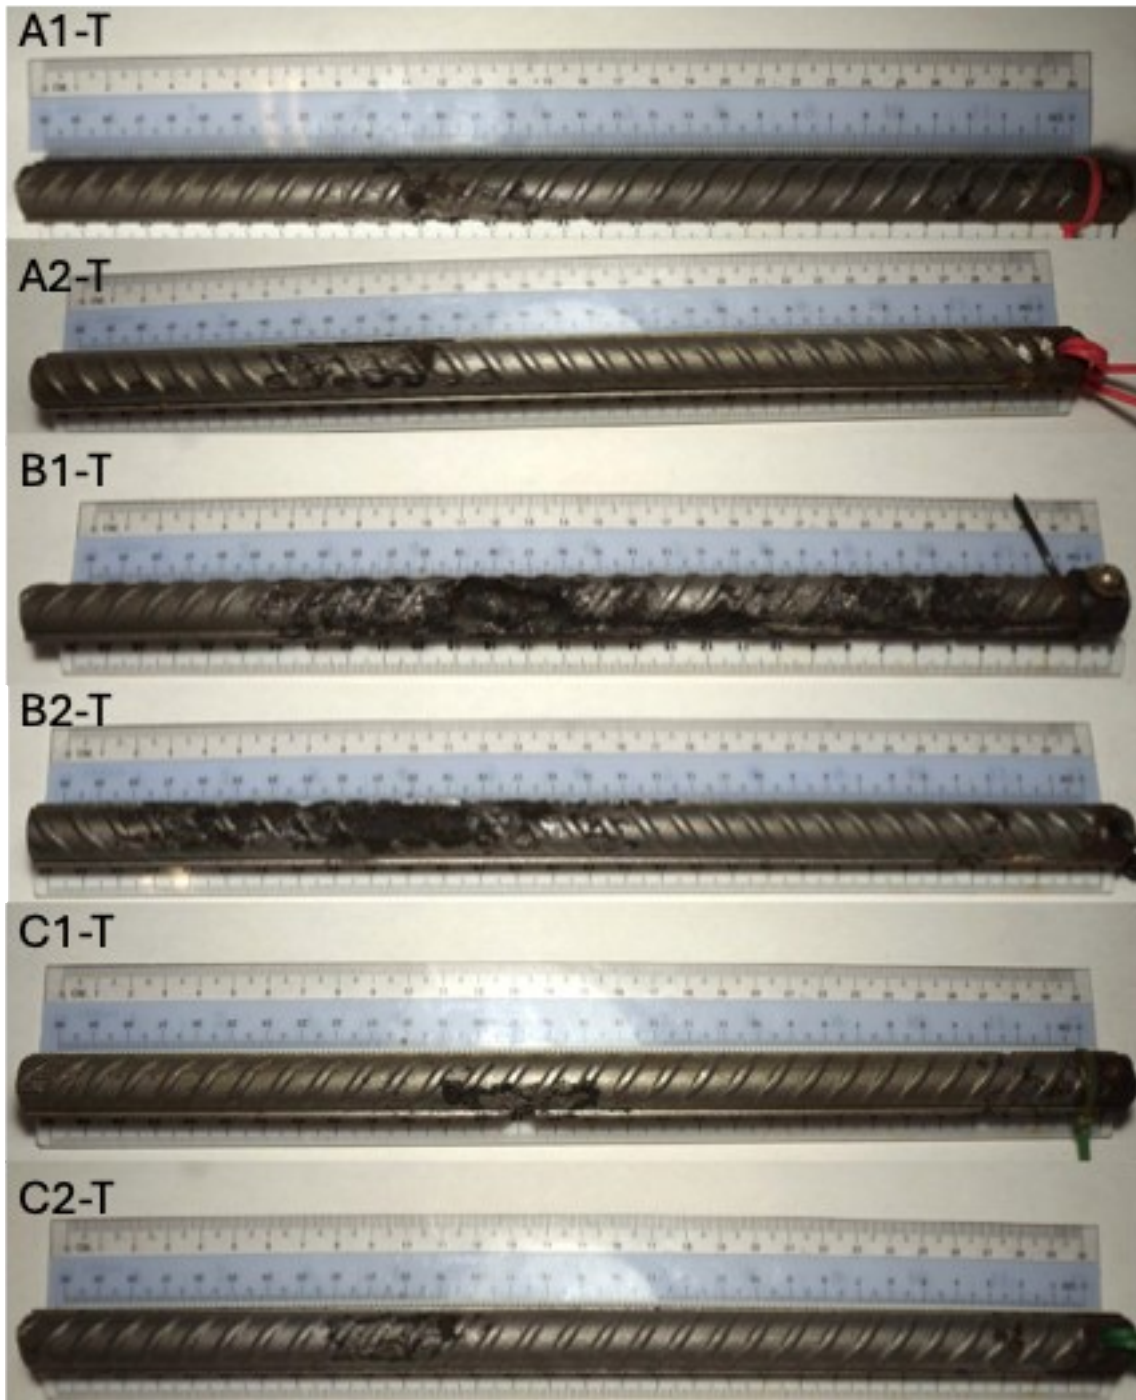
Figure 7-23. 4-CCRV-3CR12-2 top row, top-facing rebars after cleaning.

This section presents photos of the rebars from sample 4-CCRV-3CR12-2 after cleaning. Figure 7-23 presents the top-facing side of the top row of rebars while Figure 7-24 shows the bottom-facing side of the top row. Because the top-facing side was closest to the simulated crack and the NaCl reservoir, this side displayed the most severe corrosion, concentrated near the midpoint of the rebars. Extensive pitting and cross-section loss is present on the top-facing side of all the rebars in the top row, with rebars B1 and B2 having the most severe cross-section loss. Table 11-3 through Table 11-11 in Section 11.3.1 of APPENDIX C: QUANTITATIVE MEASUREMENTS OF CORROSION DAMAGE TO SDS SAMPLES lists the diameter loss experienced by the most prominent corrosion site/pits in each rebar. Figure 7-24 shows that very little corrosion is apparent on the bottom-facing sides of the rebars, with the exception of some pits near the exposed ends of each rebar.

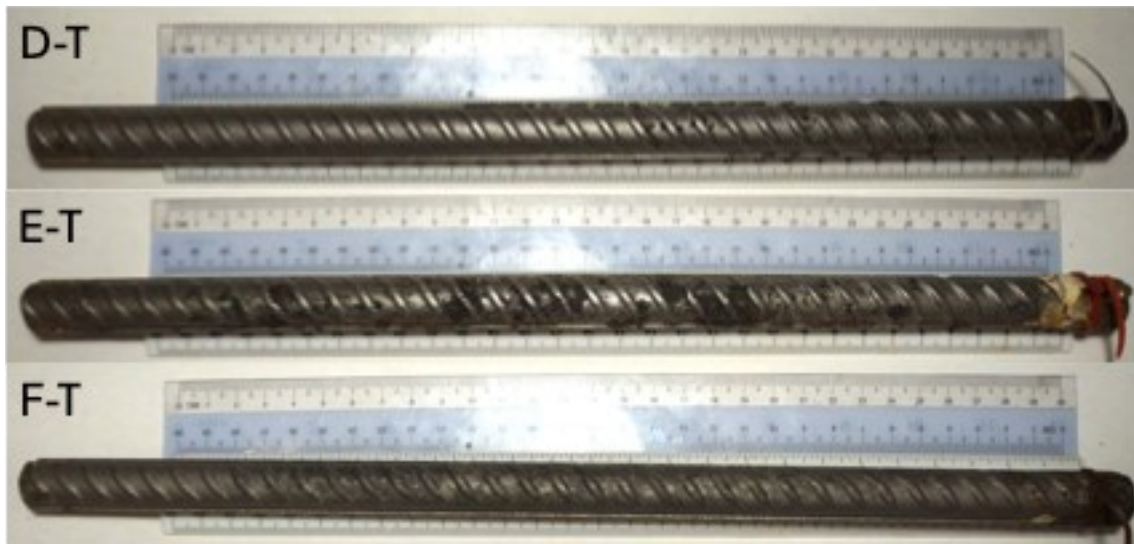
Figure 7-25. 4-CCRV-3CR12-2 bottom row, top-facing rebars after cleaning.

Figure 7-25 shows the top-facing side of the bottom row of rebars and Figure 7-26 shows the bottom-facing side of the bottom row. Again, the top-facing side displayed the most severe corrosion, concentrated near the midpoint of the rebars. The top faces of rebars D and E had extensive corrosion sites, with rebar E being the more severe of the two. Rebar E was likely the worst because it was directly under rebars B1 and B2, which were the most damaged rebars of the top row. Rebar F had little corrosion on either side. The cross-section loss observed on rebars

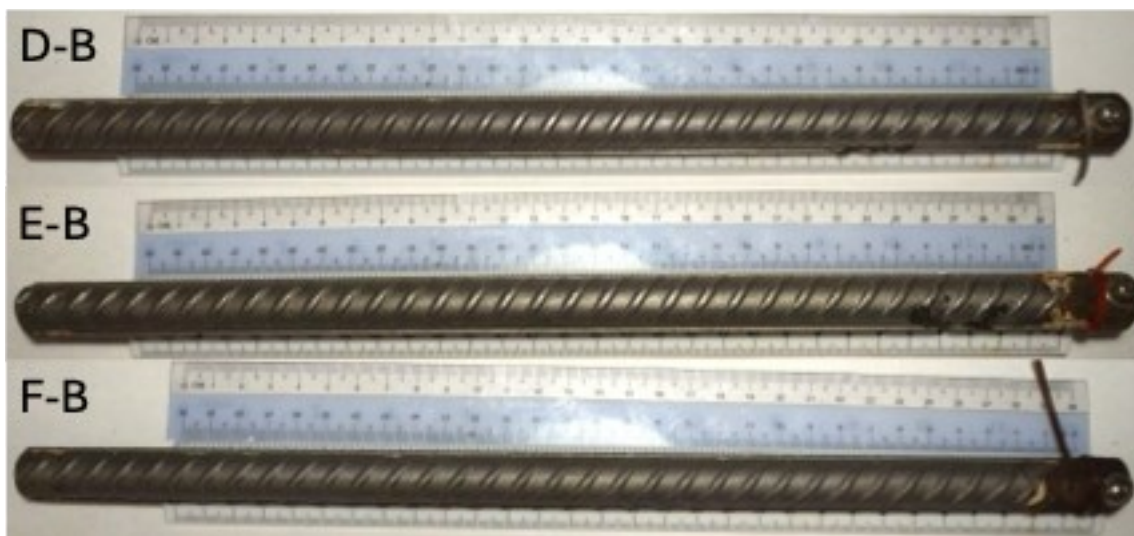
Figure 7-26. 4-CCRV-3CR12-2 bottom row, bottom-facing rebars after cleaning.

D and E is significantly less than what was observed on the rebars on the top row. The bottom faces of rebars D and E showed little corrosion, except for some pits (small corrosion sites) near one of the ends of rebar E, as Figure 7-26 shows.

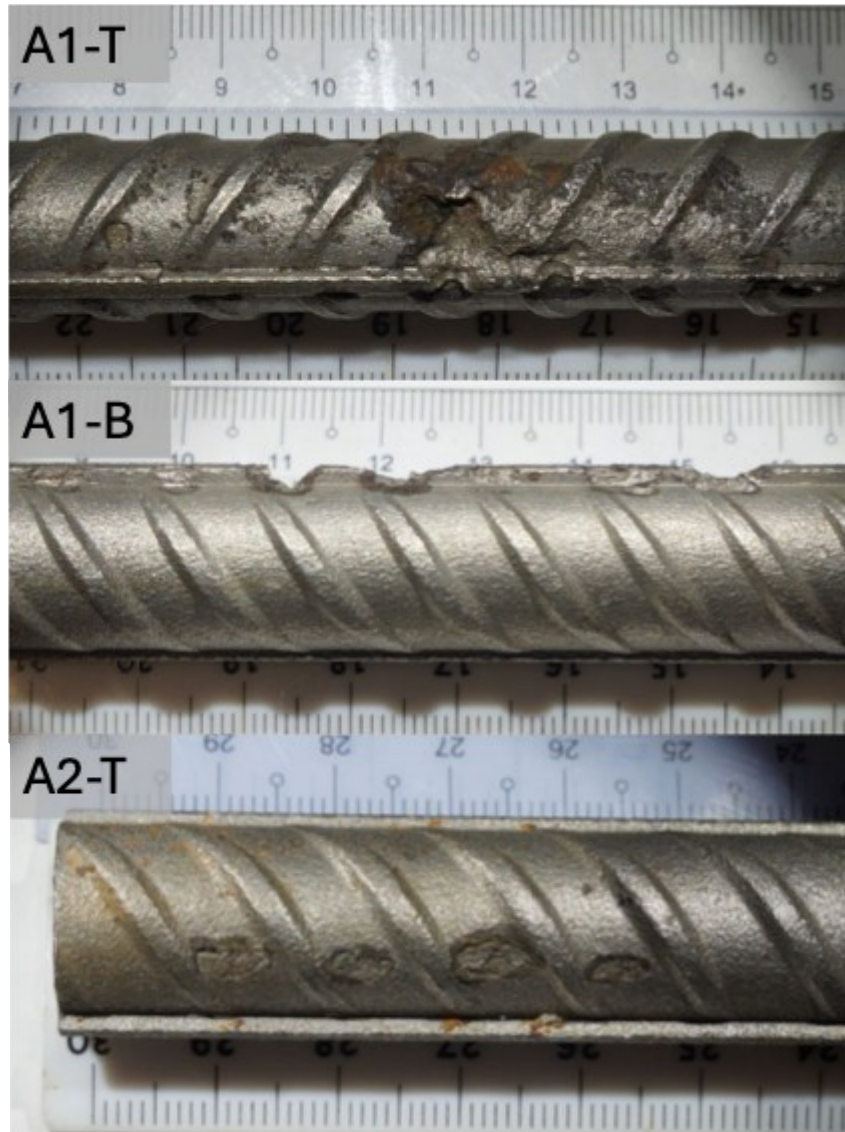
Figure 7-27. Rebars A1 and A2 closeups (top and bottom).

The following section presents closeup photos of the corrosion experienced by the rebars from sample 4-CCRV-3CR12-2. Figure 7-27 shows the pits present on rebars A1 and A2. Out of the two rebars, most cross-section loss was experienced by the top-facing side of rebar A1. Several pits are present on the top face of rebar A2 as well.

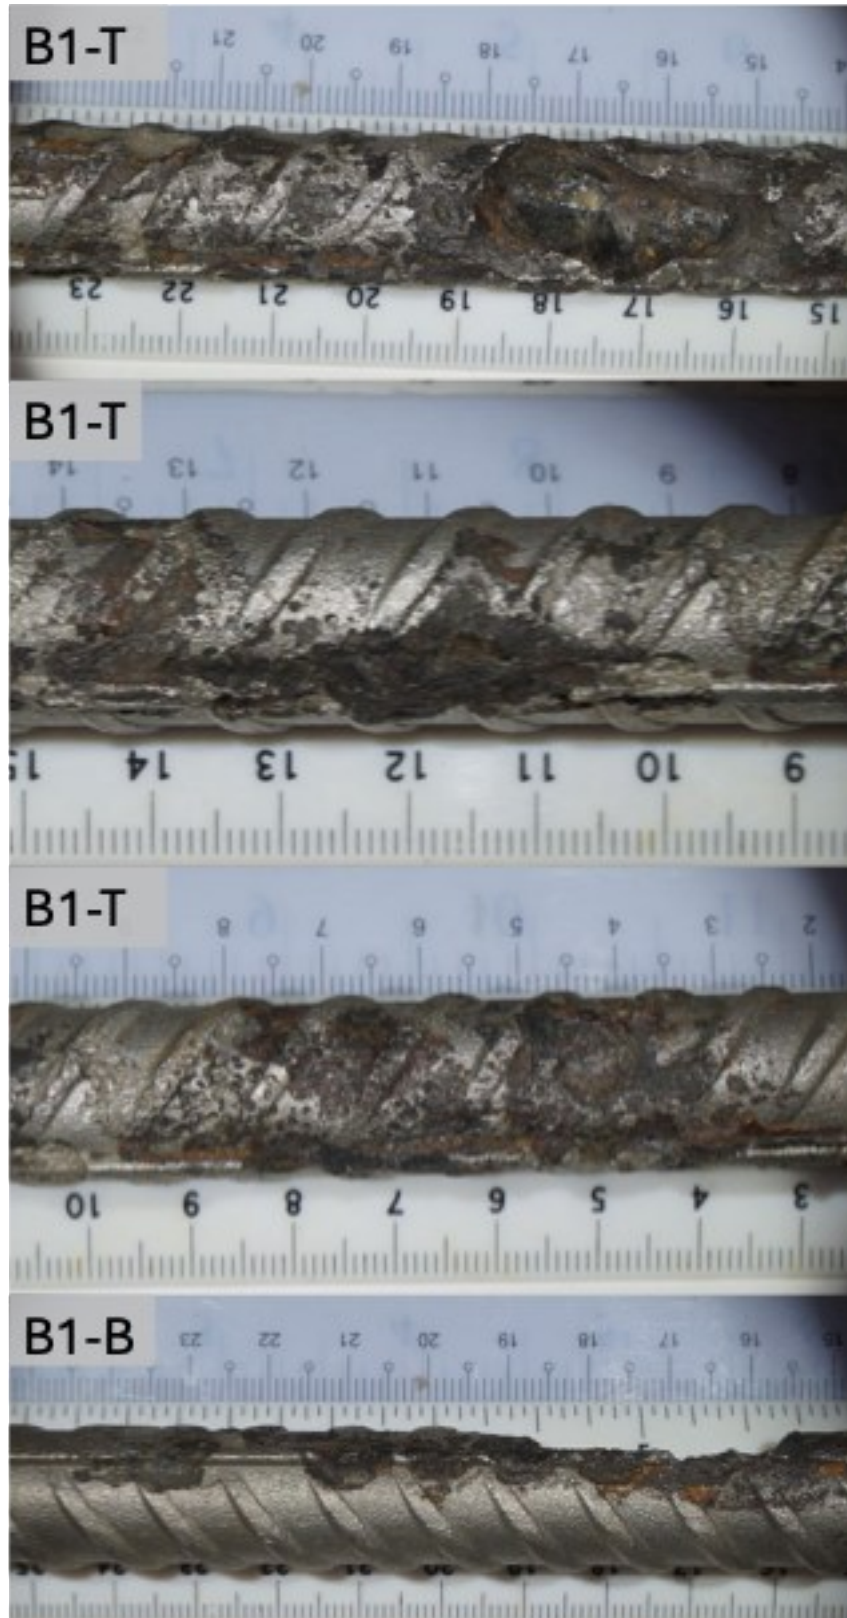
Figure 7-28. Rebar B1 closeups (top and bottom or side image).

Figure 7-28 shows the corrosion extent present on rebar B1 while Figure 7-29 shows the corrosion extent on rebar B2. Rebar B1 experienced the most cross-section loss out of all rebars in the sample, mainly on the top face. The deepest corrosion spot is shown in the first image of Figure 7-28. Rebar B1 suffered a loss of almost half its diameter in a few locations due to corrosion (see Table 11-5 for pit depths of this rebar). The top side of rebar B2 also showed extensive number of corrosion sites, albeit less severe than rebar B1.

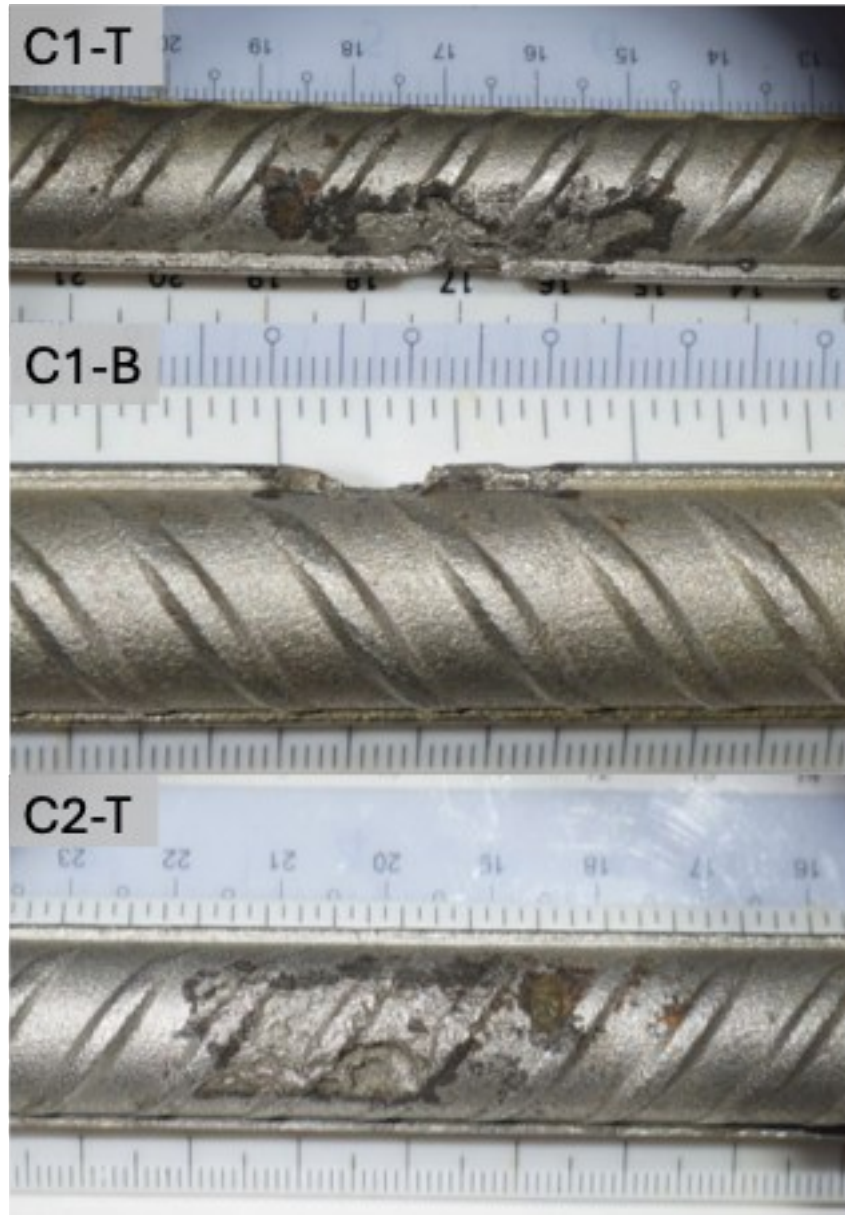
Figure 7-30. Rebars C1 and C2 closeups.

Figure 7-30 shows the corrosion present on rebars C1 and C2. Corrosion was less severe on these rebars than the rest of the rebars in the top row of this sample. Areas of pitting (small corrosion sites) extended about 5.5 cm on the top faces of each rebar, but the diameter loss was not as significant as the A or B rebar pairs.
