Report Prepared by:  
Dr. Francisco J. Presuel–Moreno  
With  
Samantha Mavrak  
David Anguelov

## **Final Report**

Evaluation of Concrete Specimens Prepared with Corrosion Resistant  
Reinforcement after Long Term, Greater than 15 years, Outdoor and  
Laboratory Exposures

Contract Number – FDOT (BED27-977-04)  
FAU (AWD003253)

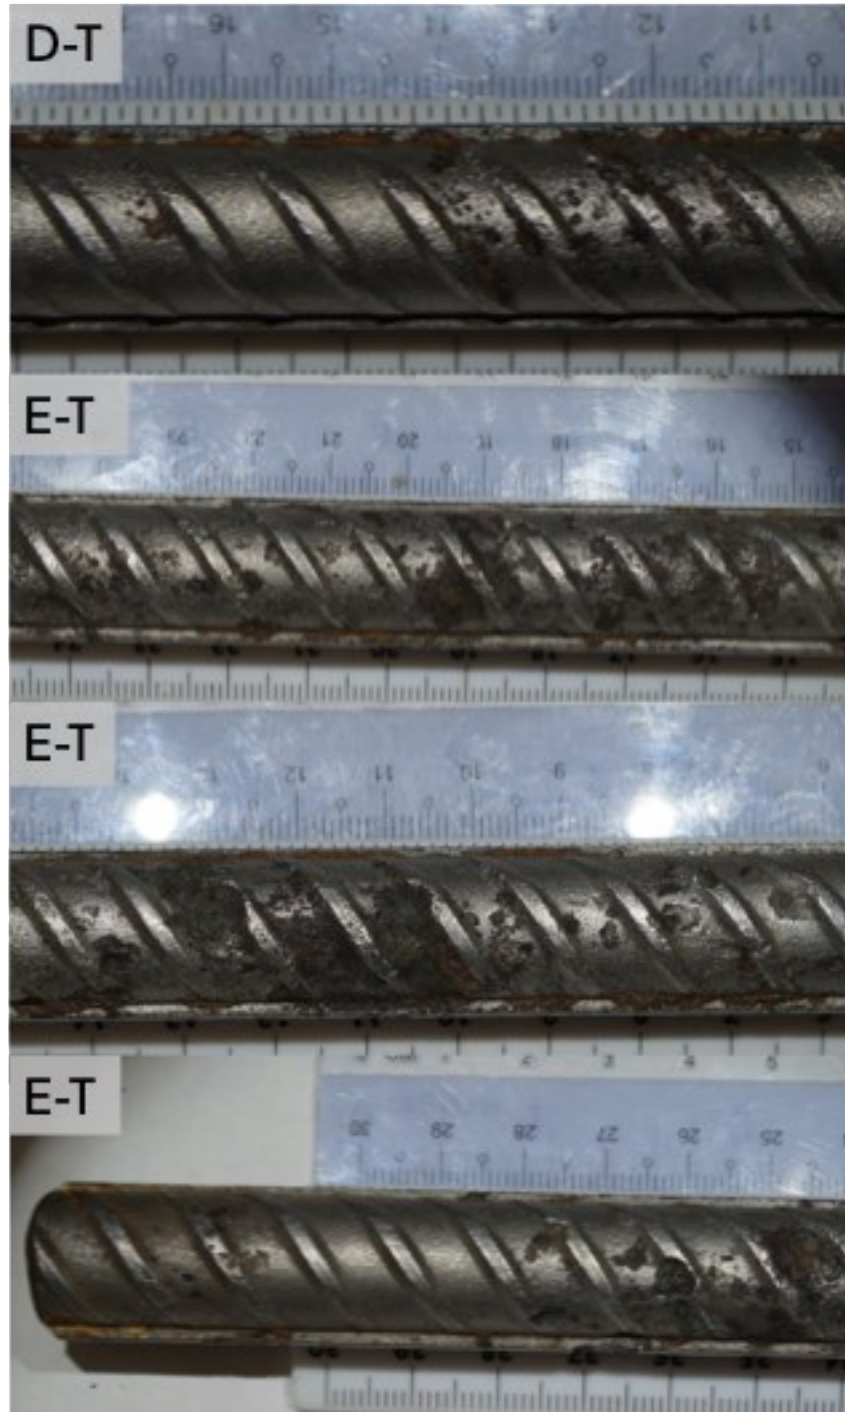
Figure 7-31. Notable closeups of 3CR12 bottom row rebars.

Figure 7-31 shows the corrosion present on rebars D and E. Several small pits can be seen on the top face of rebar D, however rebar E experienced the most extensive corrosion and cross-sectional loss from the rebars in the bottom row. As previously mentioned, this is likely due to rebar E's position under rebars B1 and B2. The concentration of chlorides was probably highest near rebars B1 and B2 due to cracks caused by the corrosion products accumulated in these two rebars, giving rebar E the shortest and most direct diffusion path from that region.

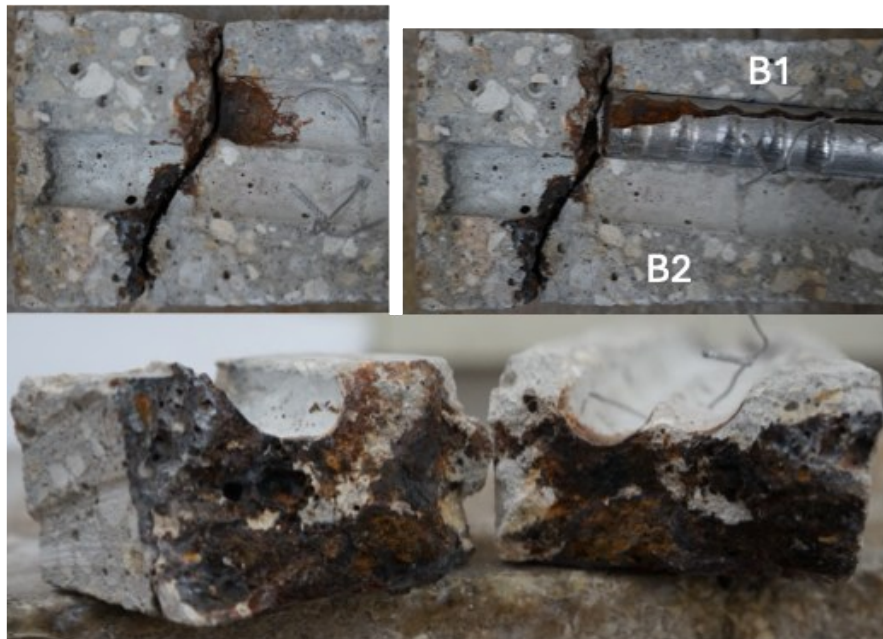
penetration depth at the rebar ends due to pitting (followed by more general corrosion) is recorded in Table 11-12, which can be found in Section 11.3.2 of APPENDIX C: QUANTITATIVE MEASUREMENTS OF CORROSION DAMAGE TO SDS SAMPLES. The rebar ends that were embedded in the concrete to simulate a crevice began corroding likely due to chloride ingress, as they were within the reservoir. The corrosion products accumulated and expanded within the concrete, causing several cracks inside the sample. Rust stains were evident on both the concrete and the cladding. The most significant crack was caused by the corrosion from the embedded unclad end of rebar B1. Figure 7-32 shows a large crack formed from rebar B1's embedded end. In Figure 7-33, a crack formed near the exposed end of rebar A2. This crack likely stemmed from the corrosion that leached out from the embedded end of rebar B1, which was directly next to A2.

Figure 7-32. Concrete fracture caused by corrosion from rebar B1.

Figure 7-35 and Figure 7-36 show closeups of the rebar ends, after cleaning, that caused the cracks. Figure 7-35 shows the embedded, unclad end of rebar B1 which caused the crack shown in Figure 7-32 and likely caused the crack near rebar A2 in Figure 7-33. The loss of cross section due to corrosion at the end of rebar B1 extended 6 mm deep, as noted in Table 11-12. Figure 7-36 shows the embedded, unclad end of rebar C1 which caused the crack shown in Figure 7-35. The loss of cross section due to corrosion at the end of rebar C1 was less extensive than that of B1; the penetration depth was approximately 3.5 mm, as noted in Table 11-12.

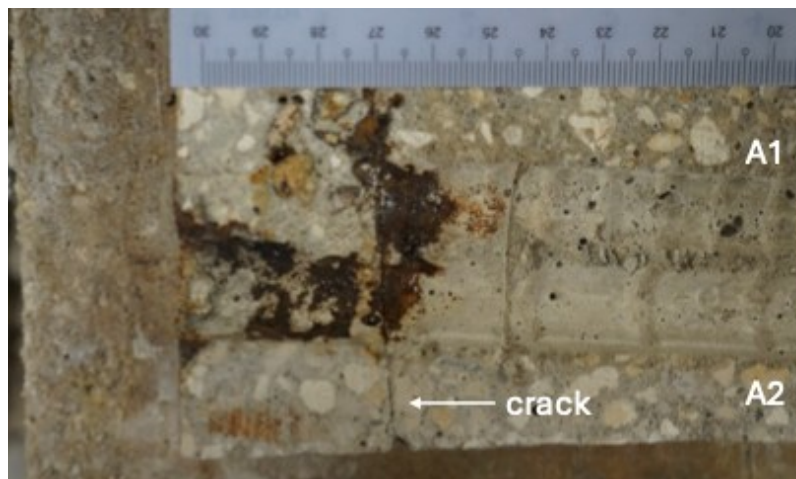
Figure 7-33. Concrete crack near rebar A2, likely caused by corrosion from rebar B1.

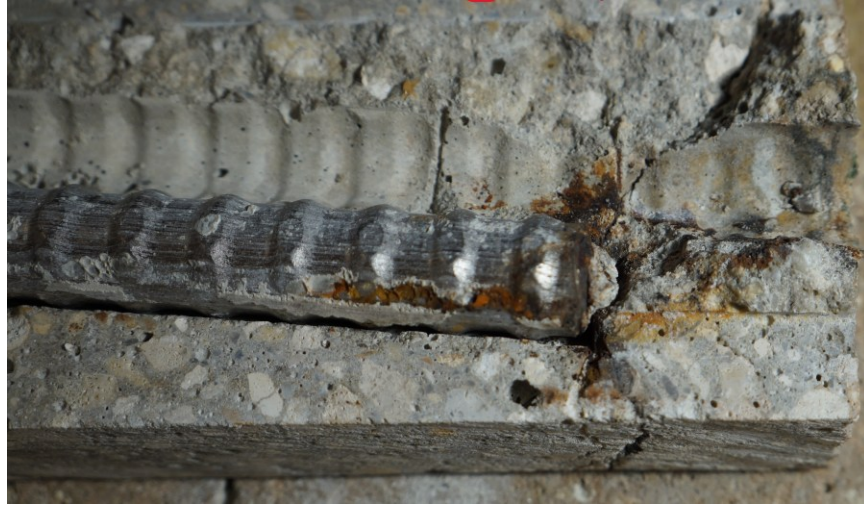
Figure 7-34 shows the concrete crack formed above the top face of rebars C1 and C2. The crack likely propagated from the corrosion of the embedded end of rebar C1.

Figure 7-34. Concrete crack caused by corrosion from rebar C1.

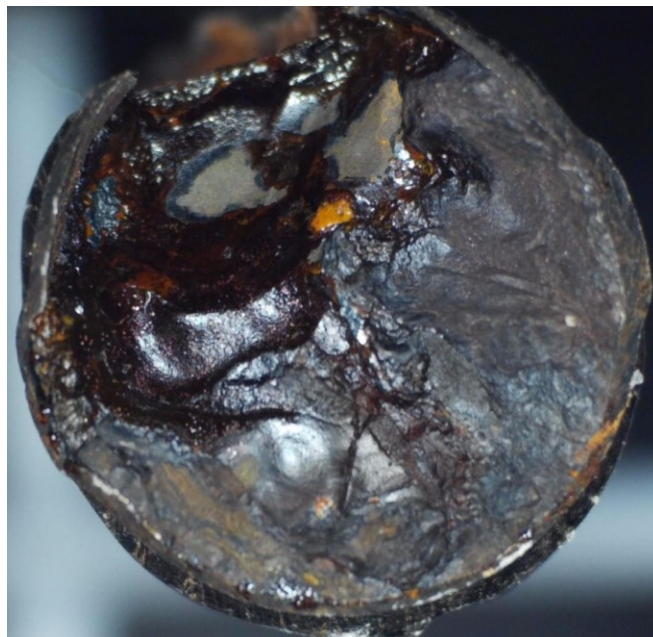
Figure 7-35. Corrosion of unclad, embedded rebar end of rebar B1 after cleaning.

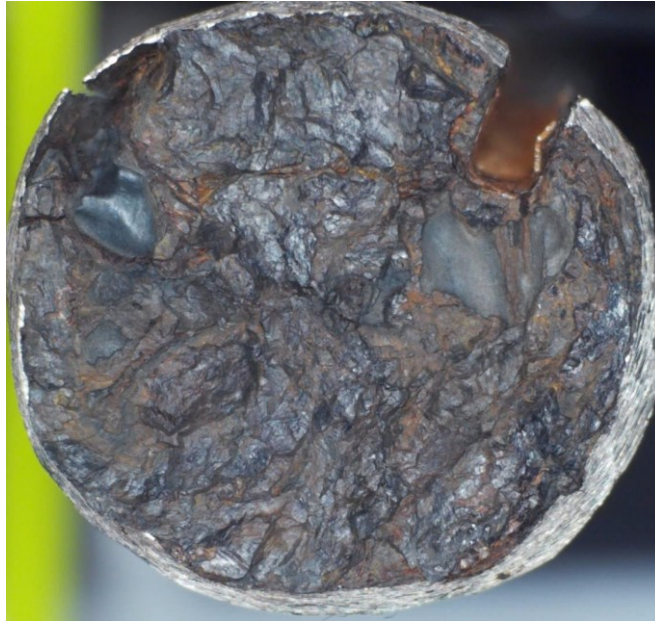
Figure 7-36. Corrosion of unclad, embedded rebar end of rebar C1 after cleaning.

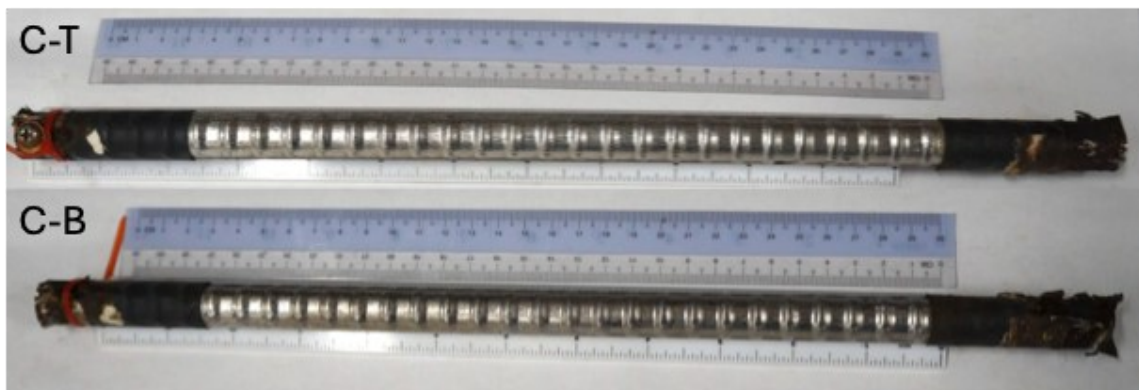
This section presents photos of rebar C from sample 4-CCON-CT2-1 after cleaning. The rebars (rebar F not shown) were cleaned using the same way explained in the methodology. Figure 7-37 presents both sides of rebar C while Figure 7-38 depicts a closeup photo of several shallow red rust pits in the cladding in top face of rebar C. The original damage to the rebar likely occurred during the preparation of the rebar when the cladding was being clamped on around the carbon steel core of the rebar. It is likely there was a small holiday. Residual stresses from this process likely resulted in weak spots in the cladding, possibly facilitating the mild corrosion depicted in Figure 7-38 during the sample's exposure period. The damage extends about 1.5 cm along the length of the rebar, with a maximum diameter loss of approximately 0.19 mm.

Figure 7-37. Both sides of 4-CCON-CT2-1 rebar C.

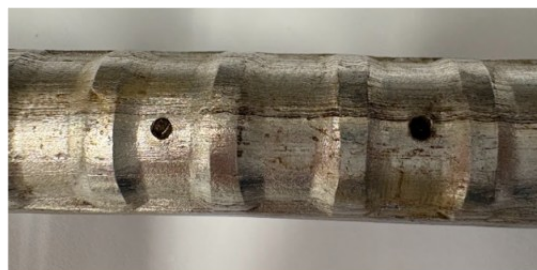
Holes 6 (left) and 7 (right)

The top sides of rebars A, B, and C were examined first. Rebar A, shown in Figure 7-39, did not show significant signs of corrosion along the top side after cleaning. The two deepest holes on the top side of rebar A were holes 1 at 3 millimeters and hole 9 at 5.2 millimeters, which are shown in Figure 7-40 and Figure 7-41. Hole 9 shows an initial smaller diameter closer to the surface, and it becomes larger towards the bottom of the hole, while hole 1 was uniform in diameter throughout.

Figure 7-39. Top side of rebar A and select segments of sample BCCD-CT2-1.

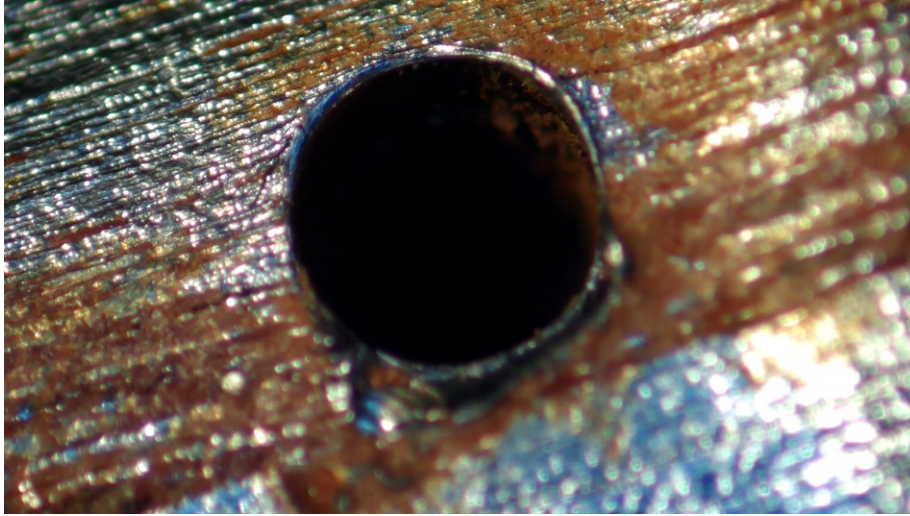
Figure 7-40. Hole 1 on top side of rebar A of sample BCCD-CT2-1.

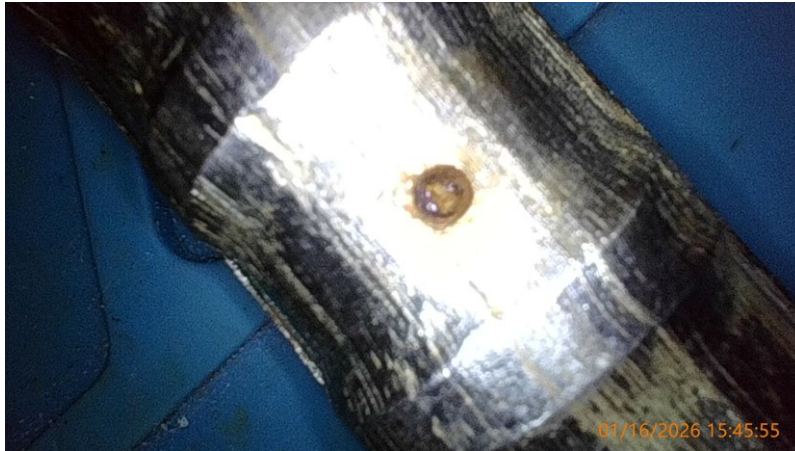
Figure 7-41. Hole 9 on top side of rebar A of sample BCCD-CT2-1.

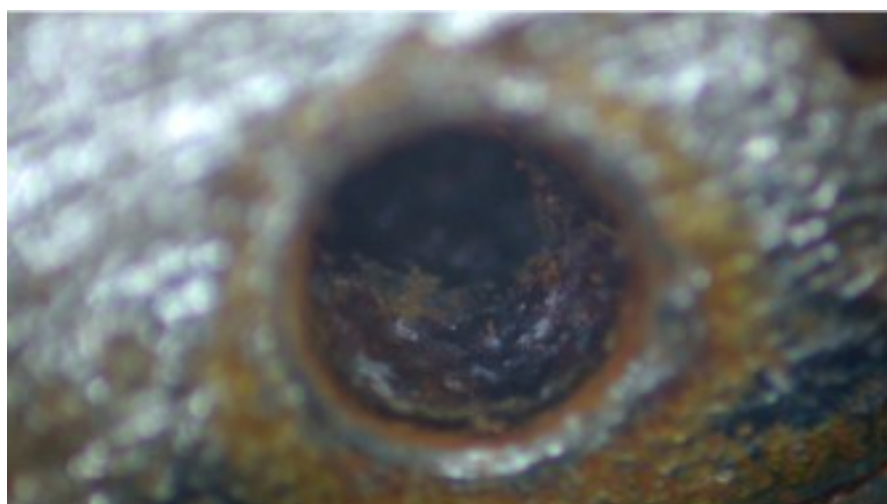
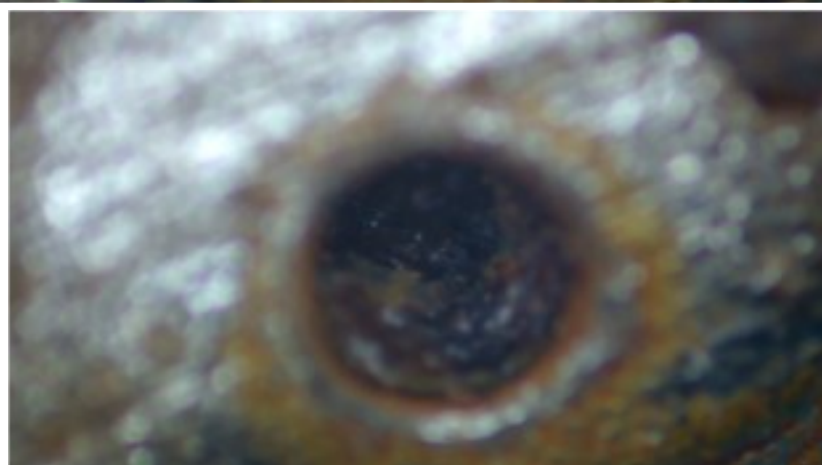
Rebar B in Figure 7-42 showed significantly more amounts of corrosion left over on the top side after cleaning compared to rebar A and C. Holes 7 and 9 were the deepest holes at 1.5 millimeters and 2.3 millimeters respectively. As depicted in Figure 7-43, hole 9 also shows evidence of pitting corrosion, as the hole diameter is not uniform at each depth, and appears to be smaller towards the surface compared to the deeper parts. This side of rebar B had two bumps beneath hole 7 and hole 10. There was a crack in the bump of hole 10 that was filled with corrosion products as well. Hole 10 is depicted in Figure 7-44.

Figure 7-43. Hole 9 on top side of rebar B of sample BCCD-CT2-1.

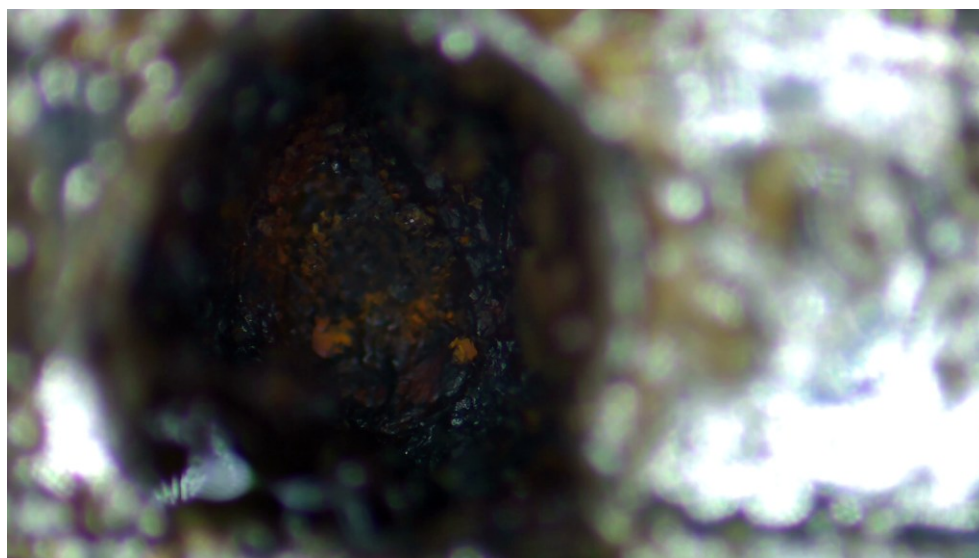
Figure 7-45 shows the top side of rebar C. There was some corrosion throughout the middle of the surface from holes 1 to 7. Holes 1 and 2 were also slightly deformed. The holes on the top side of rebar C did not have large depths, and the largest one was hole 2 at 1.2 millimeters, which is shown in Figure 7-46. This side had several bumps with cracks in them along the holes. Hole 3 is an example shown in Figure 7-47.

Figure 7-46. Hole 2 on top side of rebar C of sample BCCD-CT2-1.

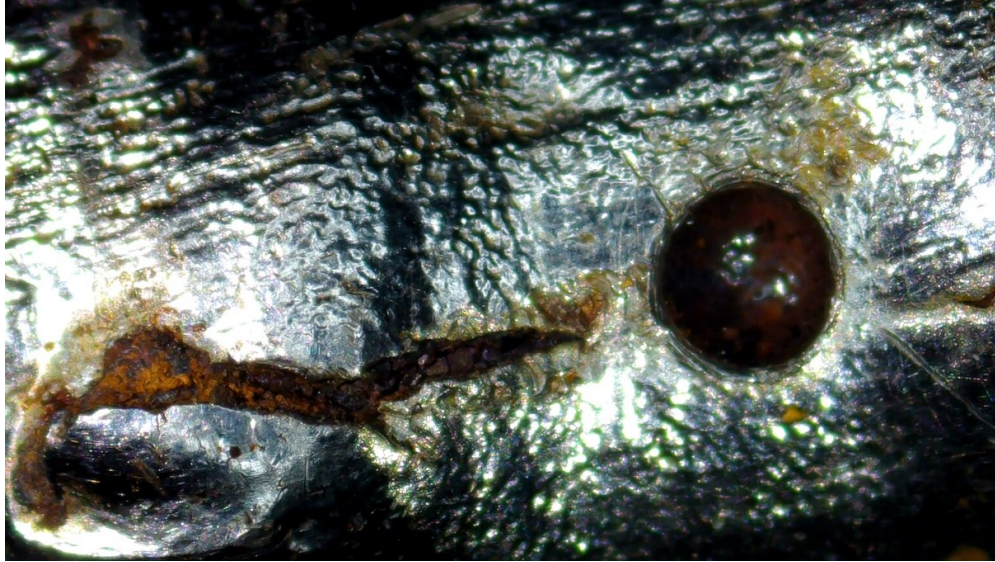
Figure 7-47. Bump with crack in hole 3 on top side of rebar C of sample BCCD-CT2-1.

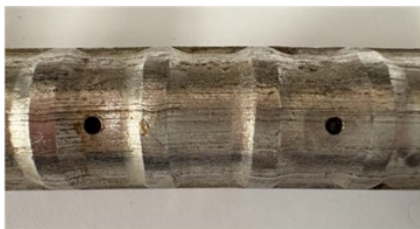
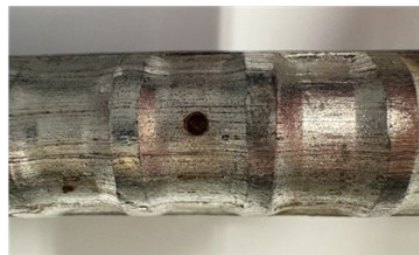
The bottom sides of each top rebar in sample BCCD-CT2-1 are analyzed in the following section. Overall, the amount of corrosion products on these sides was less than the top sides after cleaning. The bottom side of rebar A in Figure 7-48 did not show major signs of corrosion after it was cleaned, with only some spots left over. The only hole that had a major depth was hole 5 at 3.3 millimeters, which is shown in Figure 7-49. It is important to note that this hole had a relatively uniform diameter throughout, unlike some other rebars. Hole 9 had a slight bump beneath the hole as well, which is visible in Figure 7-48.

Figure 7-48. Bottom side of rebar A and select segments of sample BCCD-CT2-1.

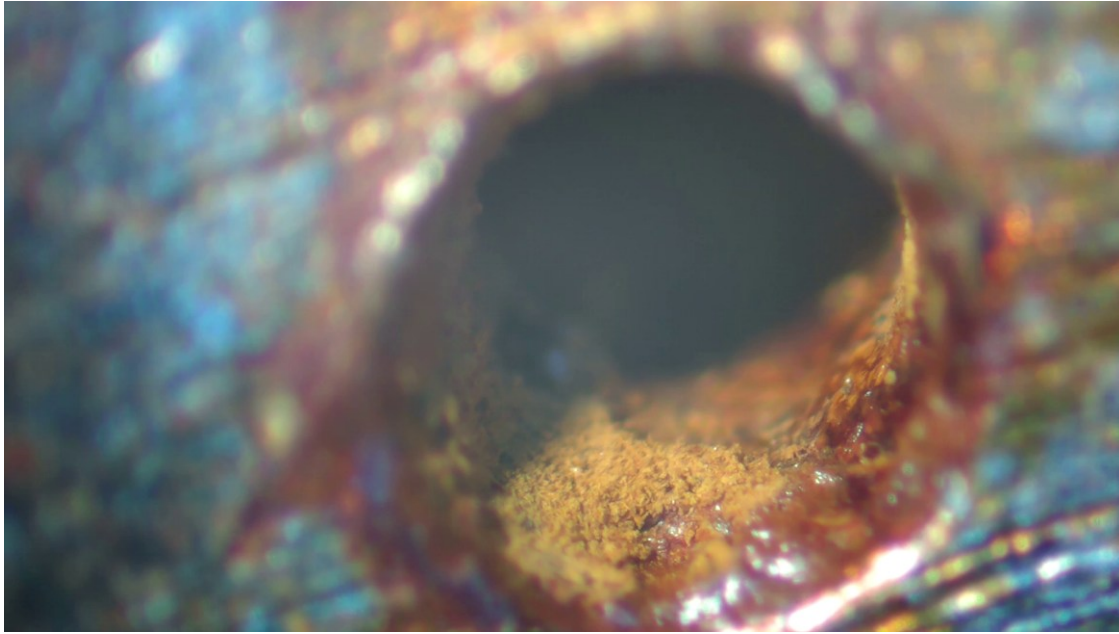
Figure 7-49. Hole 5 on bottom side of rebar A of sample BCCD-CT2-1.

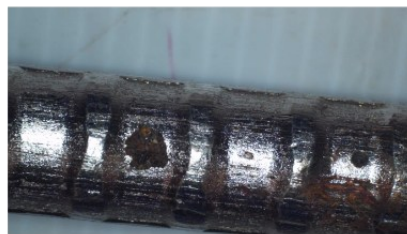
Holes 7 (left) and 8 (right) (before cleaning)

The bottom side of rebar B in Figure 7-50 showed some notable stains and leftover corrosion product after cleaning, although not as much as the top side. Hole 7 is an example of a hole that was clogged with corrosion product that was unable to be fully cleaned. A picture before the full cleaning of the rebar shows the corrosion product above hole 7. The deepest hole was hole 2 at 3.9 millimeters, followed by hole 3 at 2.5 millimeters. Hole 2 was very narrow due to a buildup of corrosion product along the edges. Hole 3 is depicted in Figure 7-51. This side also had some bumps beneath the holes, but none of them had cracks going through them.

Figure 7-50. Bottom side of rebar B and select segments of sample BCCD-CT2-1.

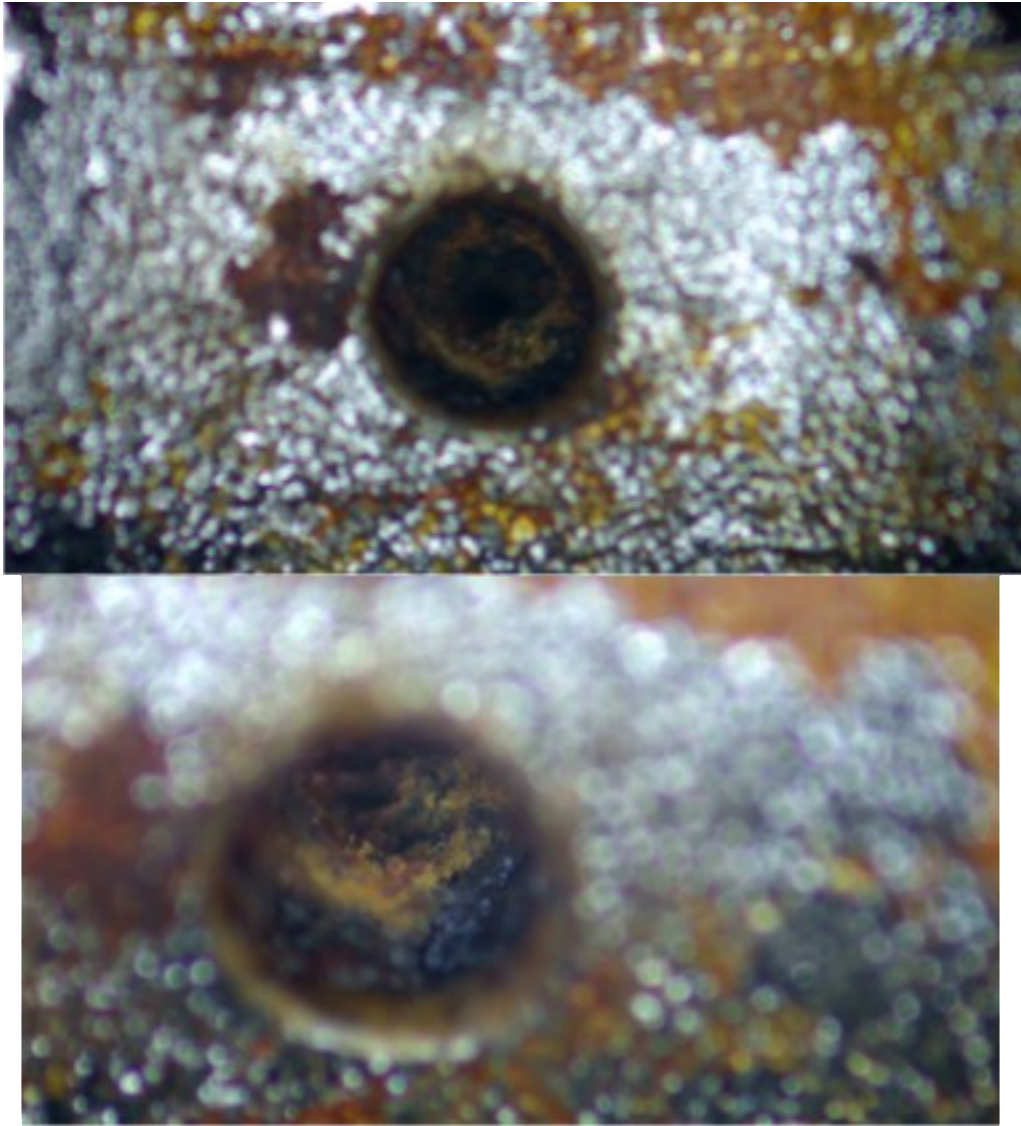
Figure 7-51. Hole 3 on bottom side of rebar B of sample BCCD-CT2-1.

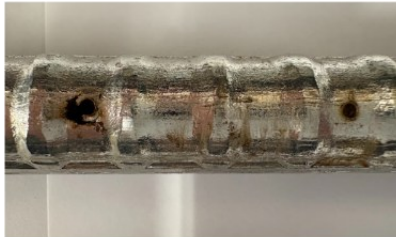
Holes 6 (left) and 7 (right)

The bottom side of rebar C in Figure 7-52 had a hole deformation that occurred on hole 6 and slightly on hole 7. This side also had relatively shallow holes. The two deepest holes were 4 and 6 both at 2.2 millimeters. Figure 7-53 and Figure 7-54 show that holes 4 and 6 could also be subject to pitting corrosion, as the hole shape is irregular and changes at different depths. There were slight bumps beneath a few holes, and remnants of a bump around hole 6, which seemed to have broken from corrosion that occurred inside of it.

Figure 7-52. Bottom side of rebar C and select segments of sample BCCD-CT2-1.

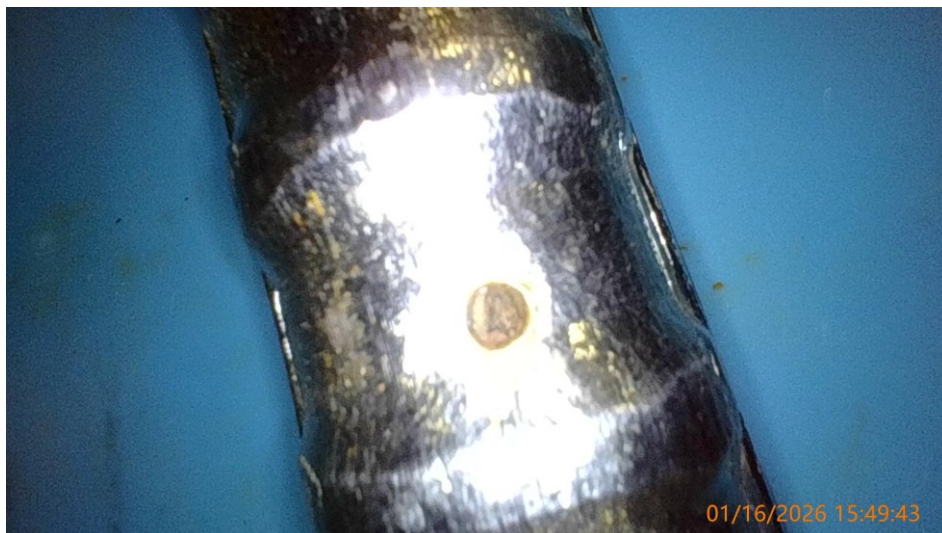
Figure 7-53. Hole 4 on bottom side of rebar C of sample BCCD-CT2-1.

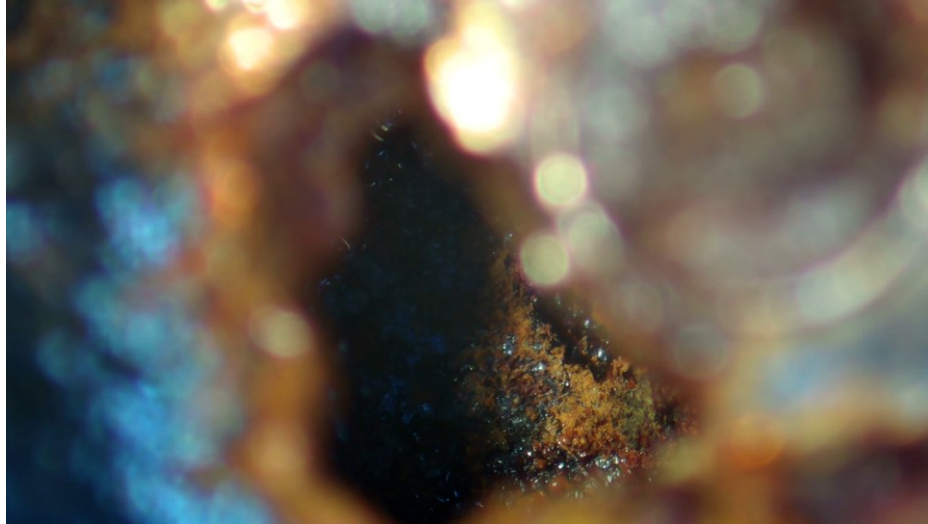
Figure 7-54. Hole 6 on bottom side of rebar C of sample BCCD-CT2-1.

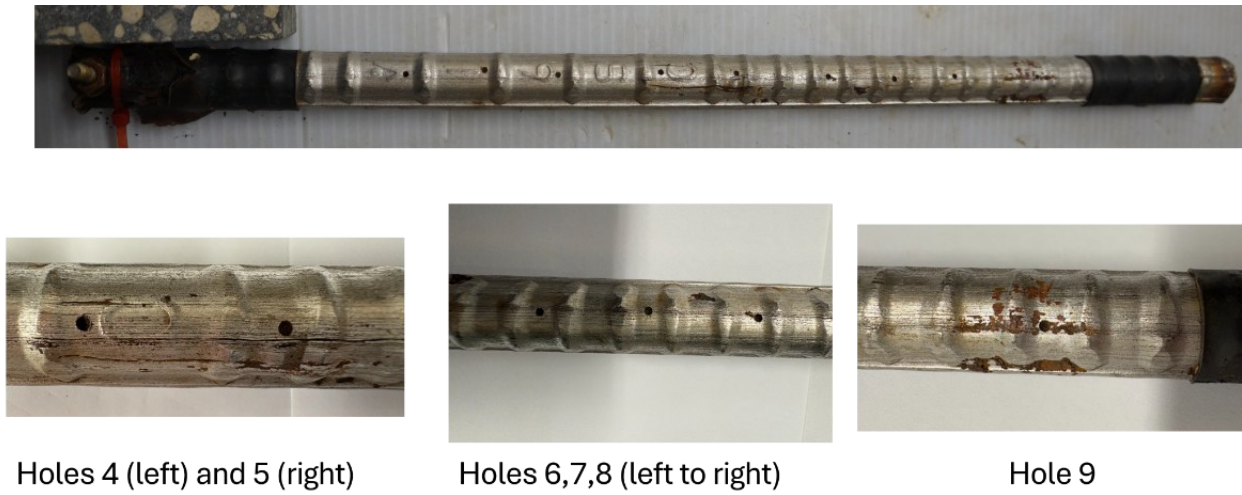
The top sides of each rebar in CSDB-CT2-1 are presented and analyzed below. Figure 7-55 shows the top side of rebar A, with corrosion still present along holes 4, 5 and 6-9 after the full cleaning. A large crack in the rebar formed along holes 4 and 5, which allowed a crevice suitable for corrosion to take place. The corrosion around hole 9 was the most pronounced and persistent after cleaning. These images are consistent with the images taken right after termination, as most of the corrosion in the concrete and the rebar were found around these holes. Only hole 1 had a large depth of 4 millimeters and is depicted in Figure 7-56. The two images in the figure show that the diameter of the hole slightly changed at greater depths of the hole as corrosion penetrated through.

Figure 7-55. Top side of rebar A and select segments of sample CSDB-CT2-1.

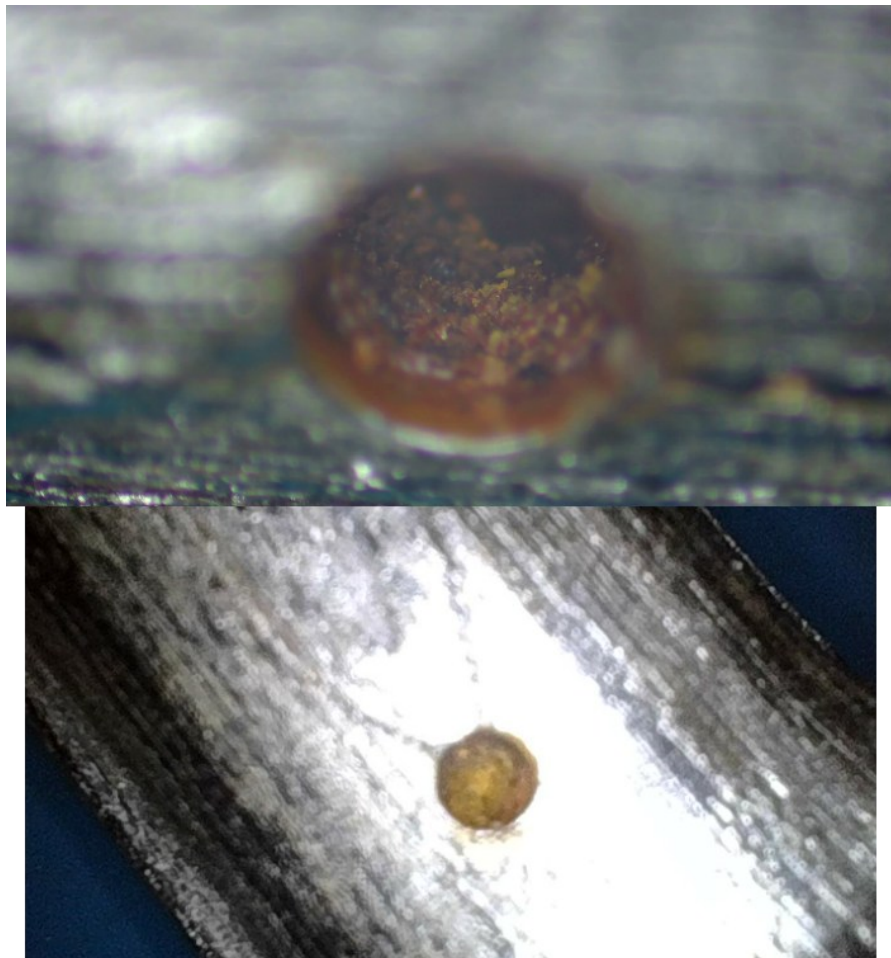
Figure 7-56. Hole 1 on top side of rebar A of sample CSDB-CT2-1.

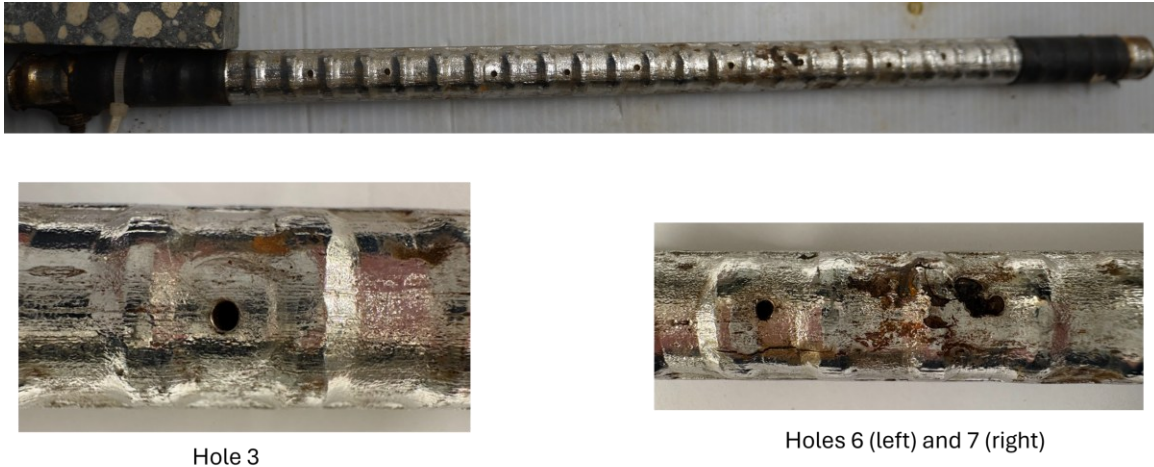
Figure 7-57 shows the top side of rebar B. It shows remnants of corrosion mainly around hole 7, with the remaining holes showing very little corrosion after cleaning. The damage caused by corrosion penetrated past the circumference of hole 7, indicating that there was significant corrosion that may have originated from this area and spread out, which is consistent with the images after termination. The rest of the holes looked quite similar to holes 2 and 3. None of the holes, including hole 7, had very large depths, as none of them surpassed 1 millimeter. Figure 7-58 depicts hole 2, which had a depth of 1 millimeter. This rebar was the only one from sample CSDB-CT2-1 that had bumps protruding right beneath the holes. There were several bumps present on the top and the bottom side of rebar B in this sample.

Figure 7-57. Top side of rebar B and select segments of sample CSDB-CT2-1.

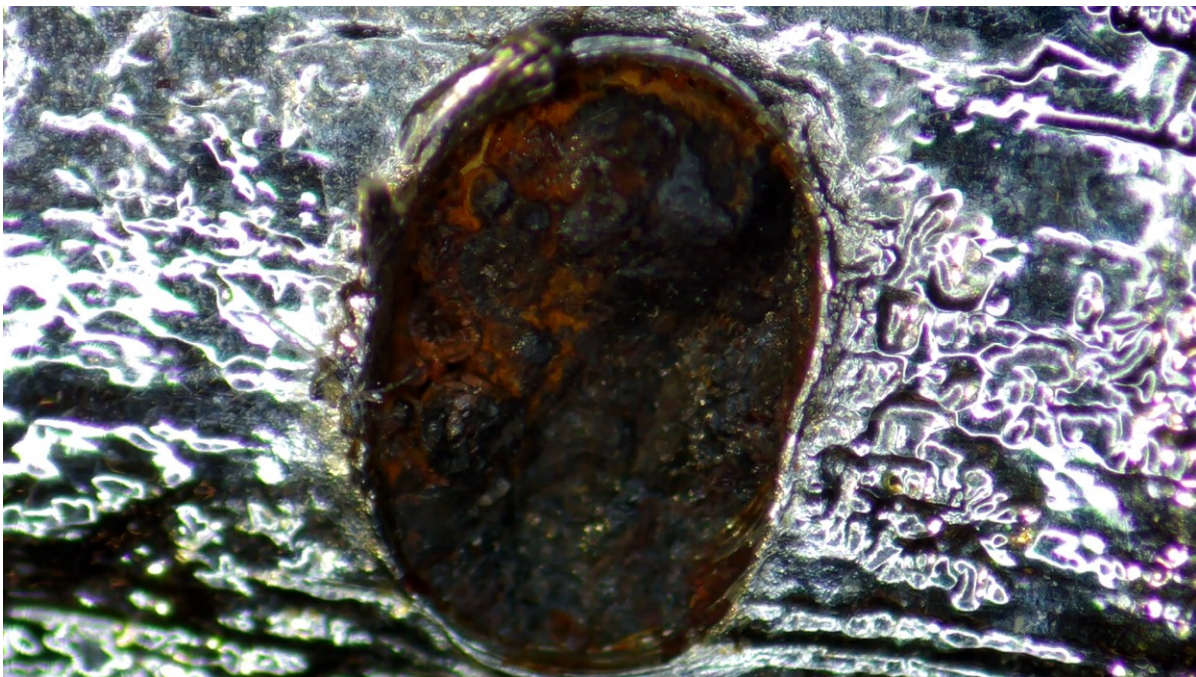
Figure 7-58. Hole 2 on the top side of rebar B of sample CSDB-CT2-1.

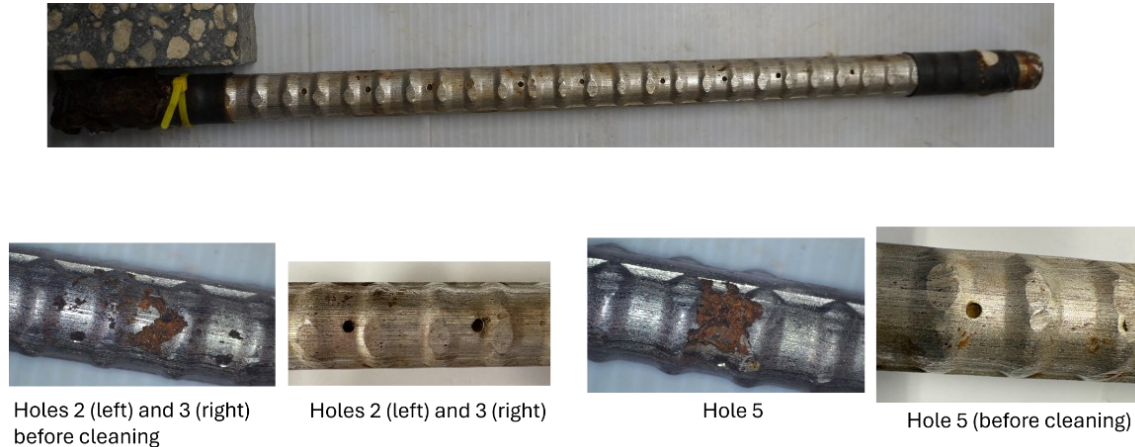
Figure 7-59 shows the top part of rebar C, which did not have signs of significant corrosion after cleaning. Some spots were visible around holes 2, 3, and 5 after initial cleanings, but they were removed after. After all the cleanings were done, this side of the rebar did not show significant signs of corrosion and showed much less compared to the top sides of rebar A and B of this sample. The only hole on the top side of rebar C that had a relatively large depth was hole 8 at 2.5 millimeters, which is depicted in Figure 7-60. This hole also shows changes in shape at different depths.

Figure 7-59. Top side of rebar C and select segments of sample CSDB-CT2-1.

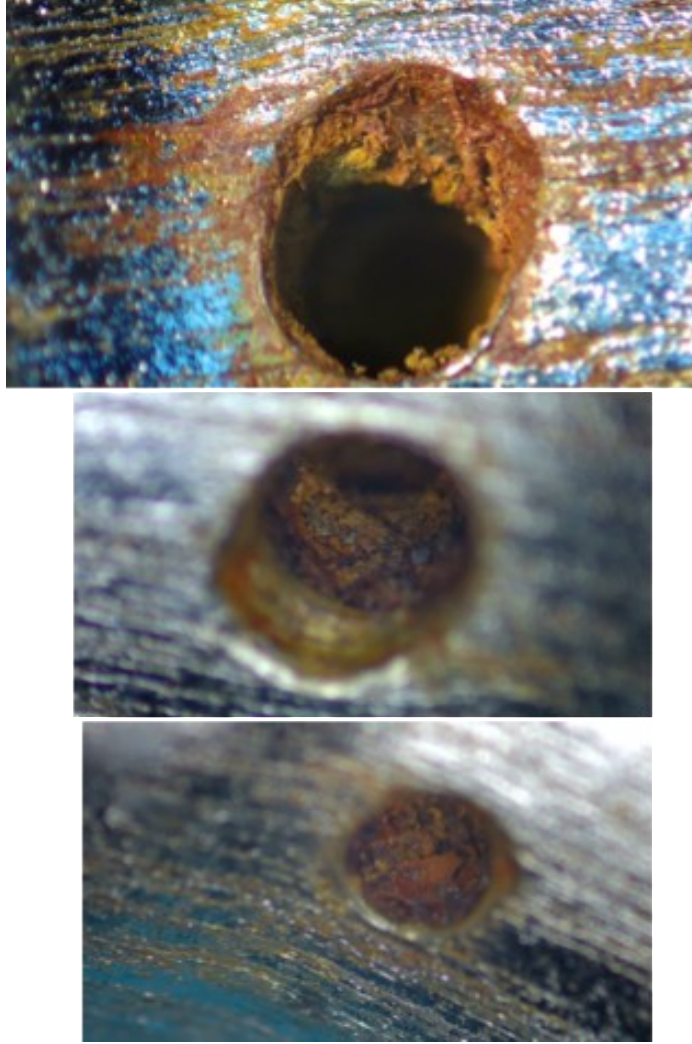
Figure 7-60. Hole 8 on top side of rebar C of sample CSDB-CT2-1.

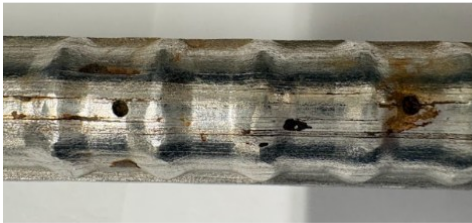
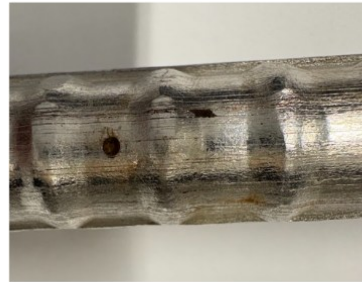
The next set of figures shows the bottom sides of each top rebar in sample CSDB-CT2-1. Figure 7-61 shows the bottom side of rebar A. This rebar did have notable hole depths of 3.5 millimeters for hole 1 and 2 millimeters for hole 7. Both also showed a change in diameter at varying hole depths. This can be seen with the outer, darker ring of corrosion product in the photo that surrounds the deeper, more illuminated section at the bottom. This suggests evidence of pitting corrosion. These holes are depicted in Figure 7-62 and Figure 7-63.

Figure 7-61. Bottom side of rebar A and select segments of sample CSDB-CT2-1.

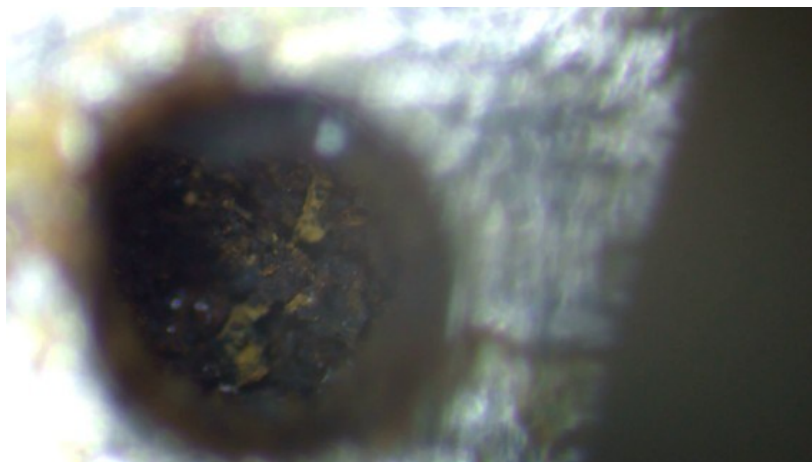
Figure 7-63. Hole 7 on bottom side of rebar A of sample CSDB-CT2-1.

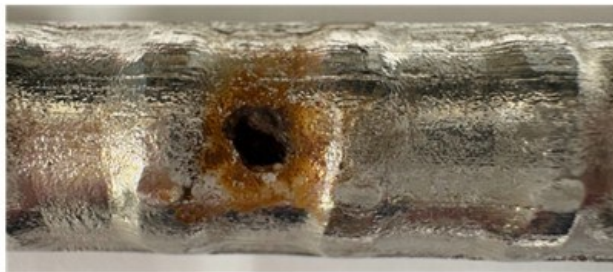
There were prominent stains on the bottom side of rebar B after cleaning, and some remnants of corrosion product as well, albeit less than the top side. Hole 1 on the bottom of rebar B was damaged and expanded due to corrosion. It also had significant staining around it as well. This is consistent with the corrosion exhibited by the images of the concrete right after the sample was terminated. Rebar B and selected segments are shown in Figure 7-64, where other examples of persistent corrosion can be seen. Hole 1 had a depth of 2 millimeters, and hole 5 had a depth of 2.3 millimeters, and they are displayed in Figure 7-65 and Figure 7-66. These holes also had changes in shape at different depths. As mentioned with the top side of rebar B of this sample, there were several bumps on this side beneath the holes. This side also had a bump to the side of hole 6. The bump had a large crack going through it with corrosion product inside. The crack is displayed below in Figure 7-67.

Figure 7-64. Bottom side of rebar B and select segments of sample CSDB-CT2-1.

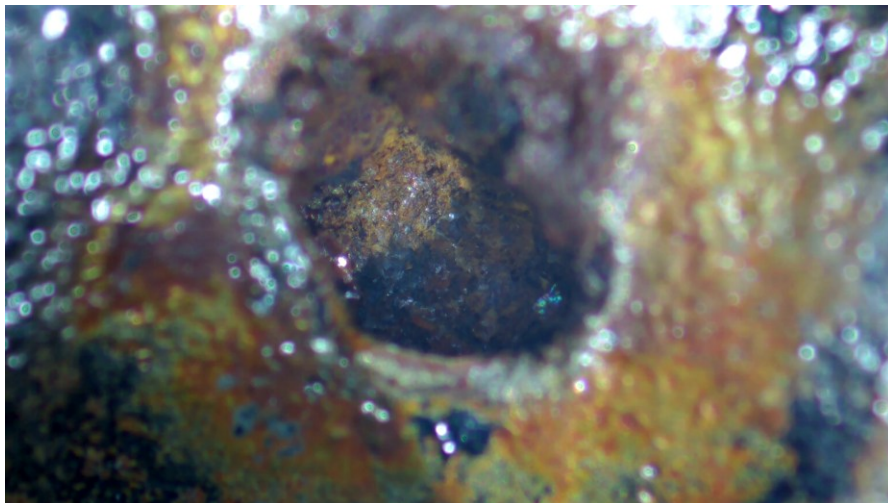
Figure 7-65. Hole 1 on bottom side of rebar B of sample CSDB-CT2-1.

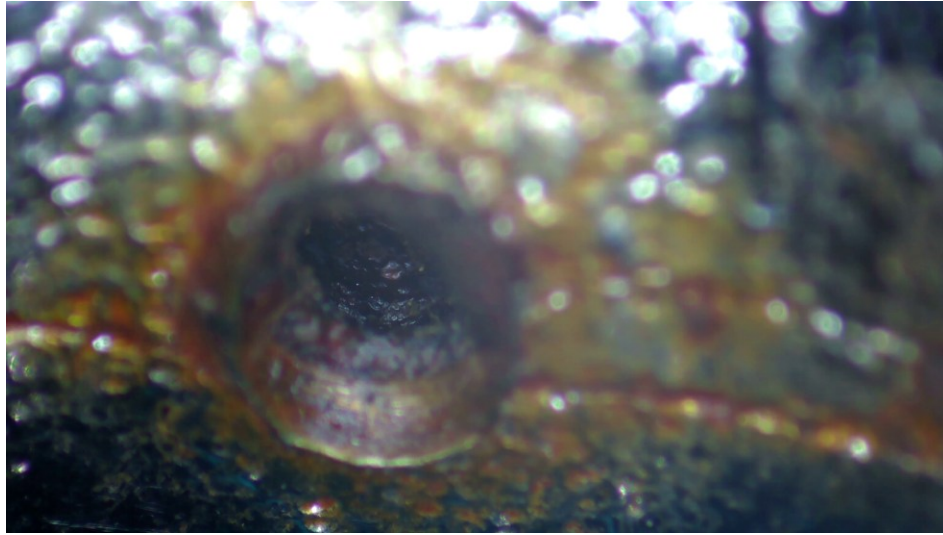
Figure 7-66. Hole 5 on bottom side of rebar B of sample CSDB-CT2-1.

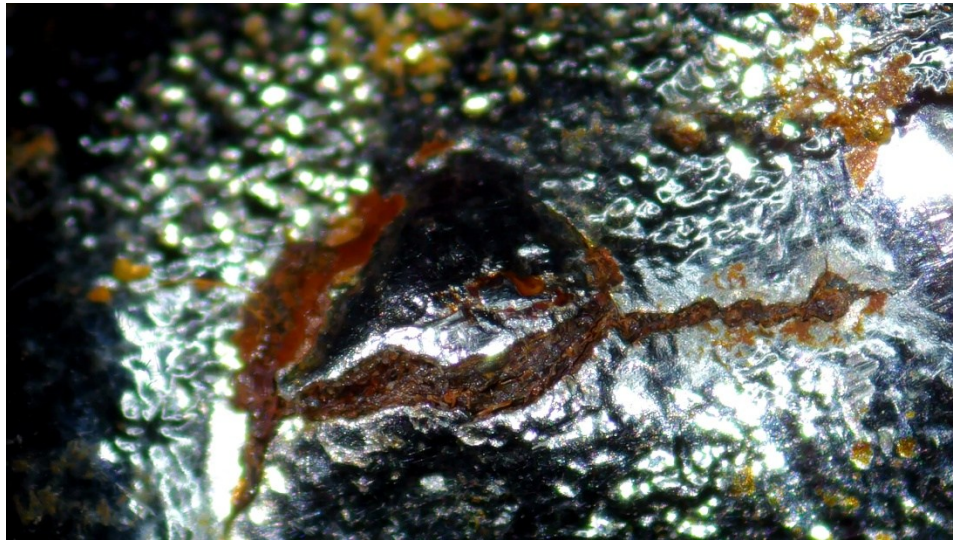
Figure 7-67. Bump with crack next to Hole 6 on bottom side of rebar B of sample CSDB-CT2-1.

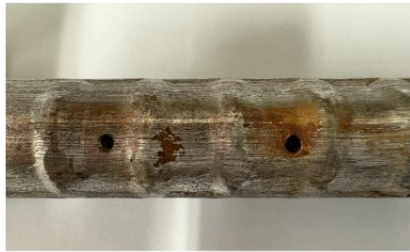
Holes 1 (left) and 2 (right)

Figure 7-68 shows the bottom side of rebar C. This side also had stains after the rebar was fully cleaned with trace amounts of corrosion product as seen around holes 1 and 2 in the figure. This side of the rebar also had multiple holes of significant depth. Hole 3 was 3 millimeters deep, Hole 5 was 2 millimeters deep, Hole 6 was 2.8 millimeters, hole 8 was 4.5 millimeters, and hole 9 was 3.6 millimeters deep. Figure 7-69, Figure 7-70, and Figure 7-71 show holes 3, 8, and 9, which were the three deepest ones. They all showed varying hole diameters along the hole depth.

Figure 7-68. Hole 3 on bottom side of rebar C of sample CSDB-CT2-1.

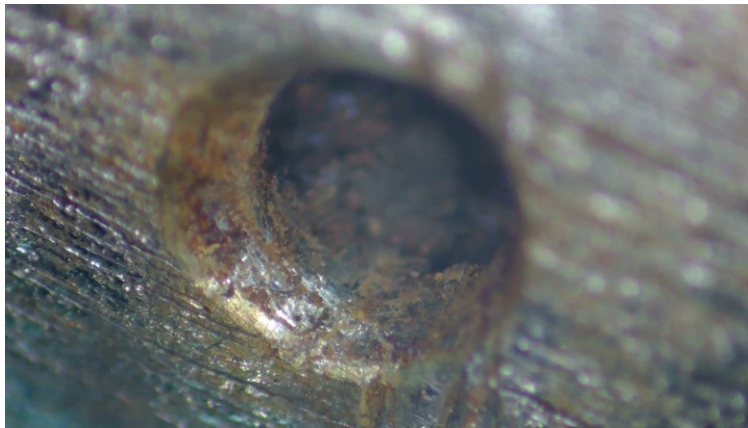
Figure 7-69. Hole 3 on bottom side of rebar C of sample CSDB-CT2-1.

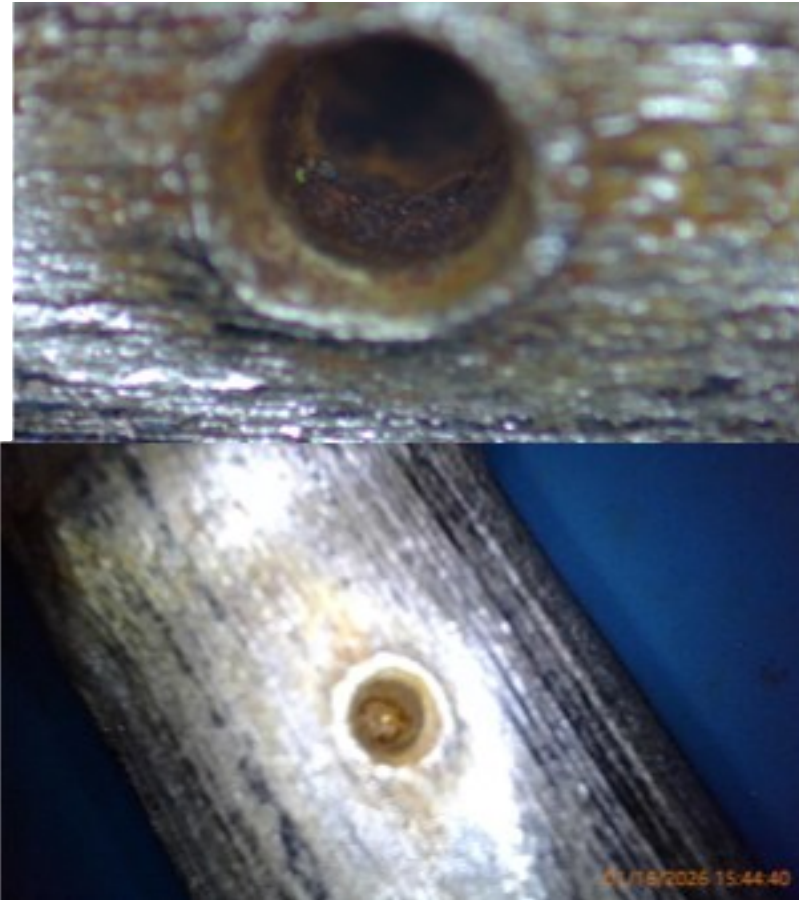
Figure 7-70. Hole 8 on bottom side of rebar C of sample CSDB-CT2-1.

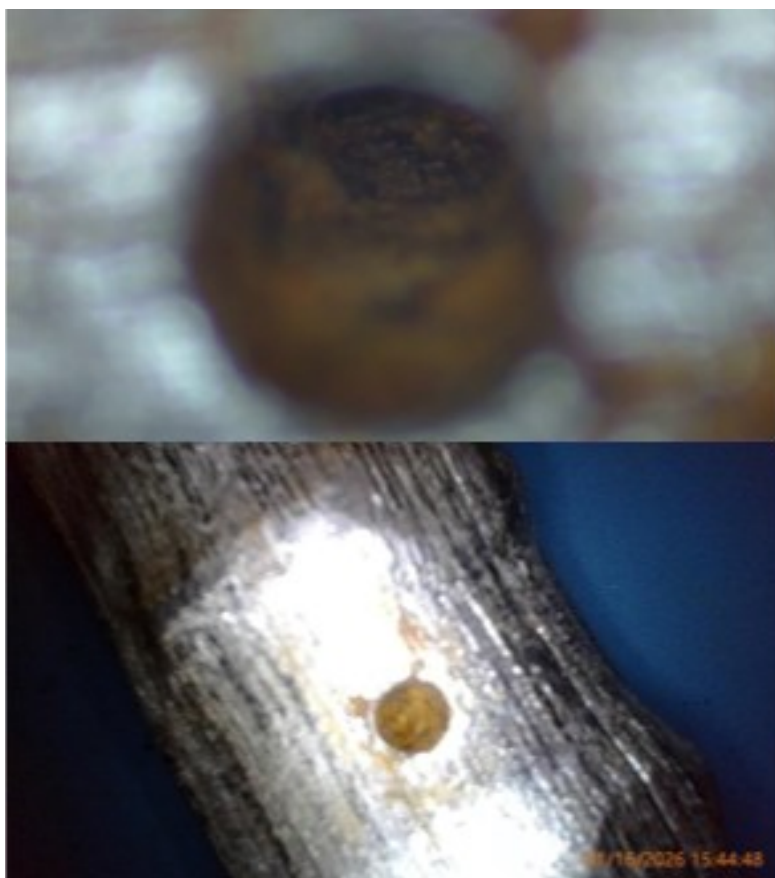
Figure 7-71. Hole 9 on bottom side of rebar C of sample CSDB-CT2-1.

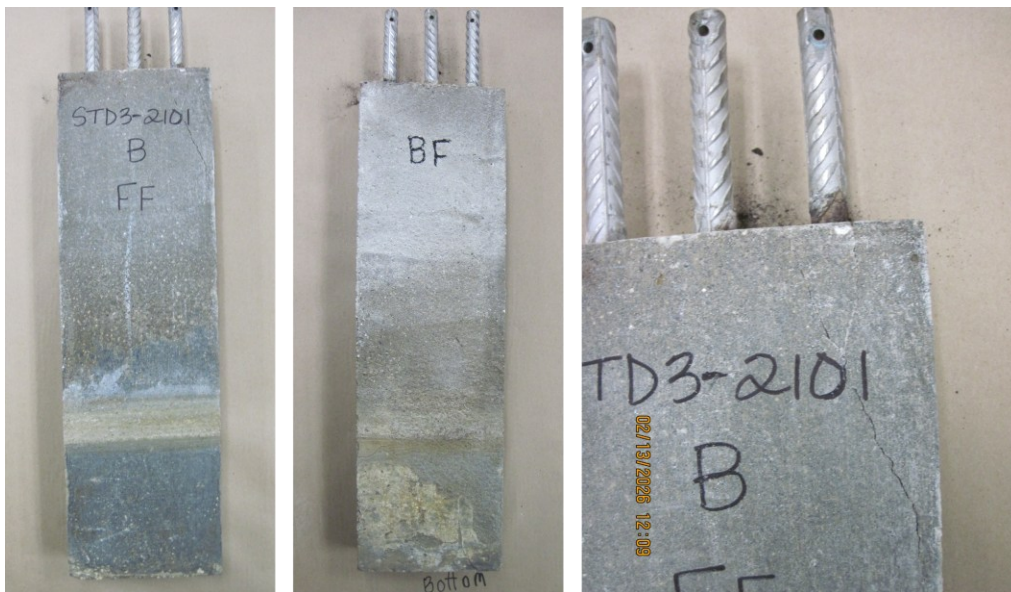
Figure 8-1 shows the front and back side of sample STD3-2101-B. A crack without visible corrosion formed on the front face over bar 3 at the top of the sample extending down about 5 5/8" toward the right face. There was also a crack on the right face from the top of the sample with corrosion extending about 2.5" and then extending diagonally down towards the front face by about 3.5." This is shown in Figure 8-2.

Figure 8-1. Front and back side of sample STD3-2101-B before termination.
