Report Prepared by:  
Dr. Francisco J. Presuel–Moreno  
With  
Samantha Mavrak  
David Anguelov

## **Final Report**

Evaluation of Concrete Specimens Prepared with Corrosion Resistant  
Reinforcement after Long Term, Greater than 15 years, Outdoor and  
Laboratory Exposures

Contract Number – FDOT (BED27-977-04)  
FAU (AWD003253)

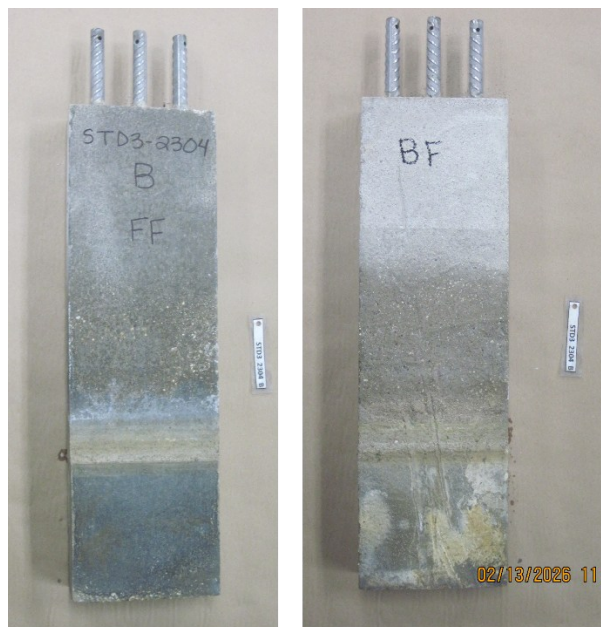
Figure 8-3 shows the front and back side of sample STD3-2304-B. There was a crack with a bleed out on the back side below where the waterline was.

Figure 8-3. Front and back side of sample STD3-2304-B before termination.

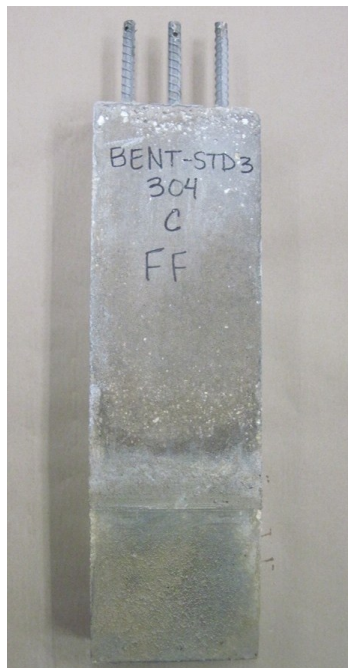
Figure 8-4 and Figure 8-5 show the back and front side of sample BENT-STD3-304-C, respectively. There were cracks with white bleed out on all sides of the sample above the waterline.

Figure 8-5. Front side of sample BENT-STD3-304-C before termination.

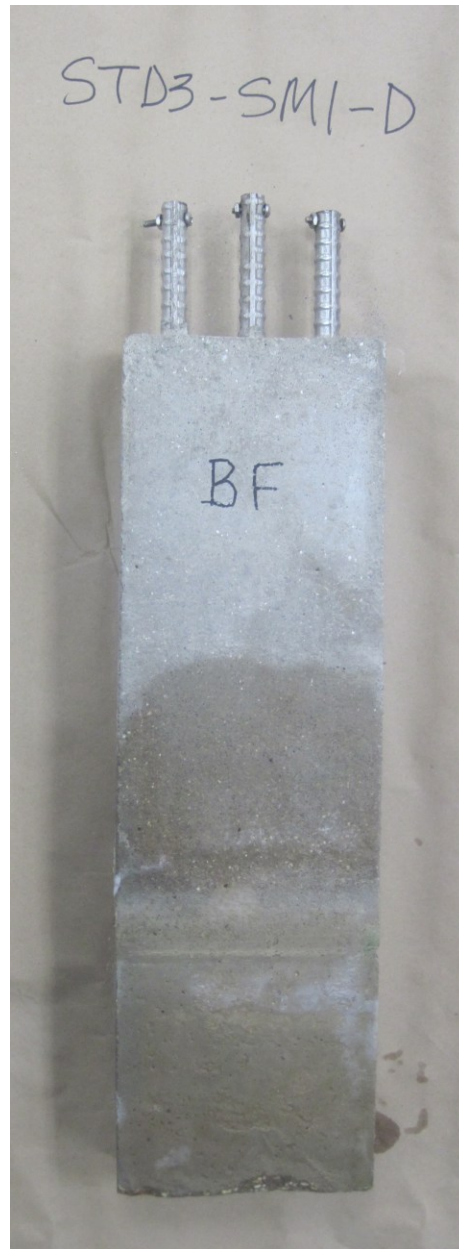
Figure 8-6. Back side of sample STD3-SMI-D before termination.

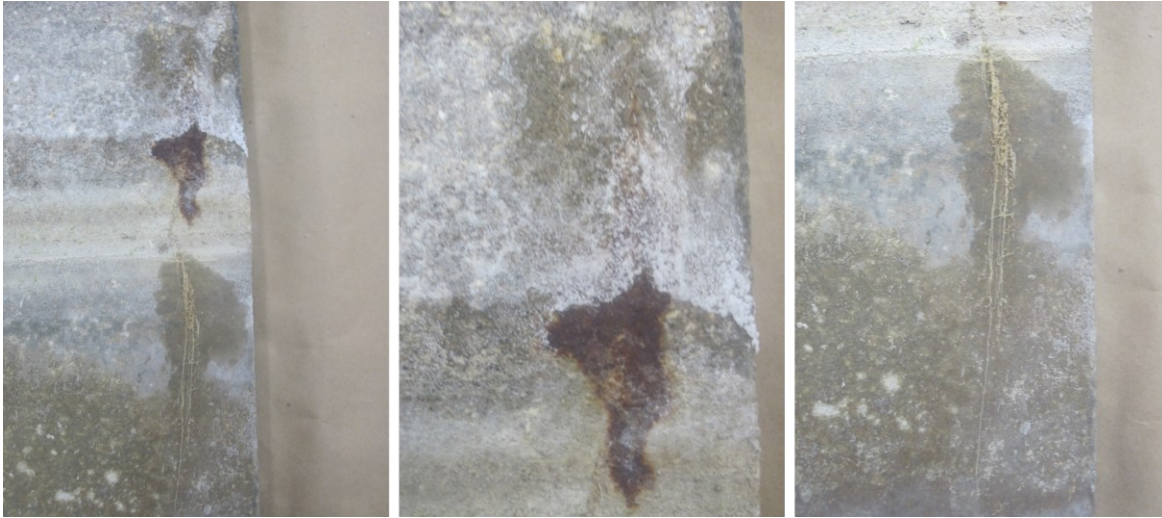
Figure 8-6 shows the back side of sample STD3-SMI-D and Figure 8-7 shows multiple images of the front side. There was a crack with white bleed out on the front face below the waterline over bar 3. The front side also had a big spot of corrosion with bleed out over bar 3 above the waterline. The crack there had a length of about 6.0" and width of 0.012". There were corrosion spots at a width of 1.0" and a length about 3.0", and small spots of corrosion on the bottom over bar 3.

Figure 8-7. Front side of sample STD3-SMI-D before termination.

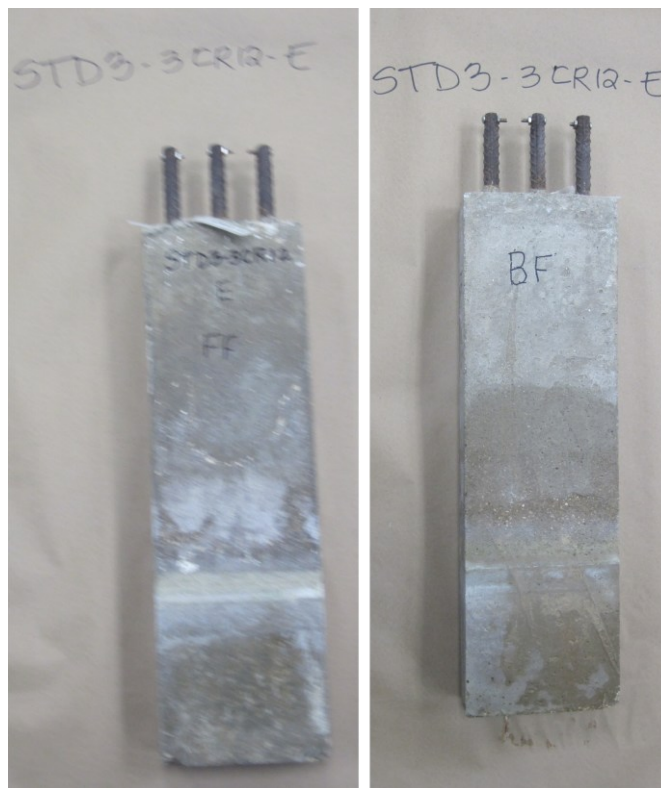
Figure 8-8 shows the front and back of sample STD3-3CR12-E. There was a crack with white bleed out on the bottom left corner of the front side below the waterline extending to the left face, which is shown in Figure 8-9. There was no corrosion in this crack.

Figure 8-8. Front and back side of sample STD3-3CR12-E before termination.

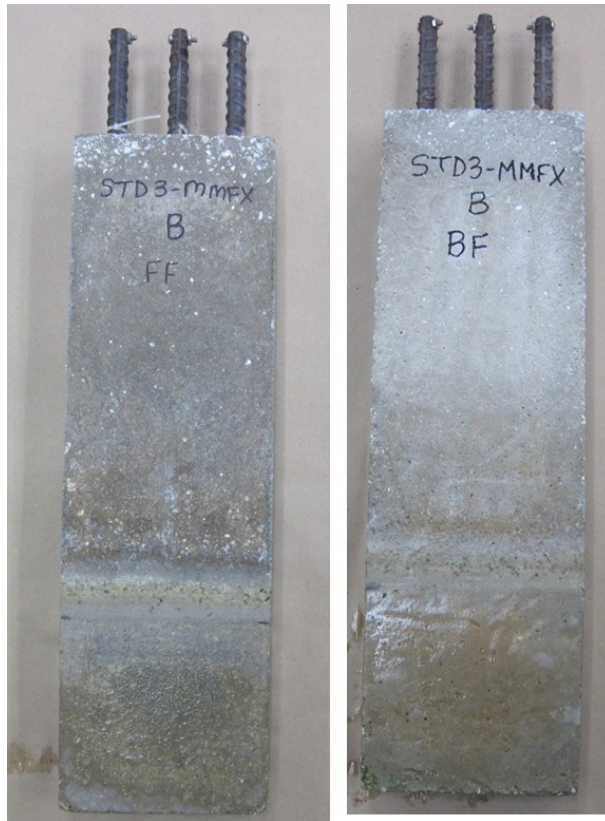
Figure 8-10. Front and back side of sample STD3-MMFX-B before termination.

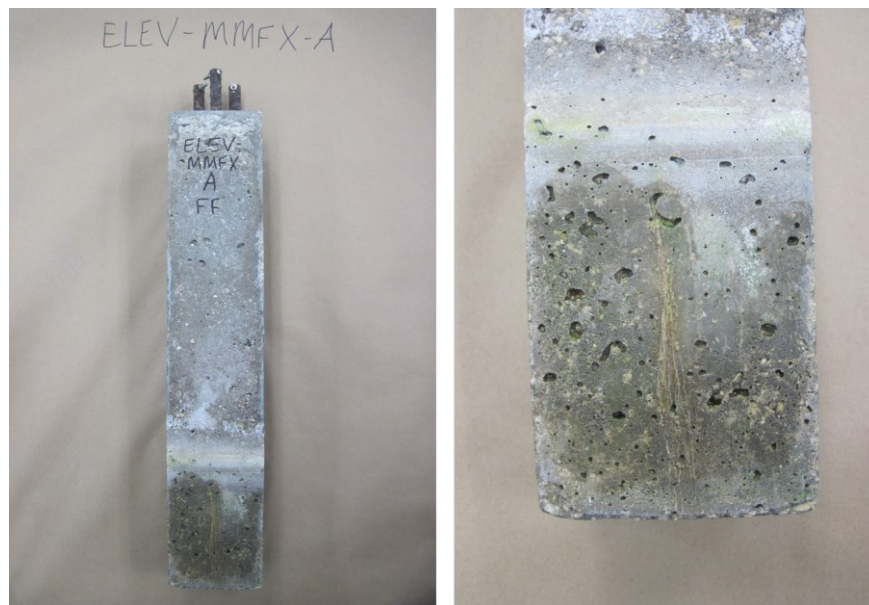
Figure 8-12 shows the front side of sample ELEV-MMFX-A with a bleed out evident on the bottom area. Figure 8-13 shows the back side. No noticeable corrosion took place, and there were no visible cracks.

Figure 8-12. Front side of sample ELEV-MMFX-A before termination.

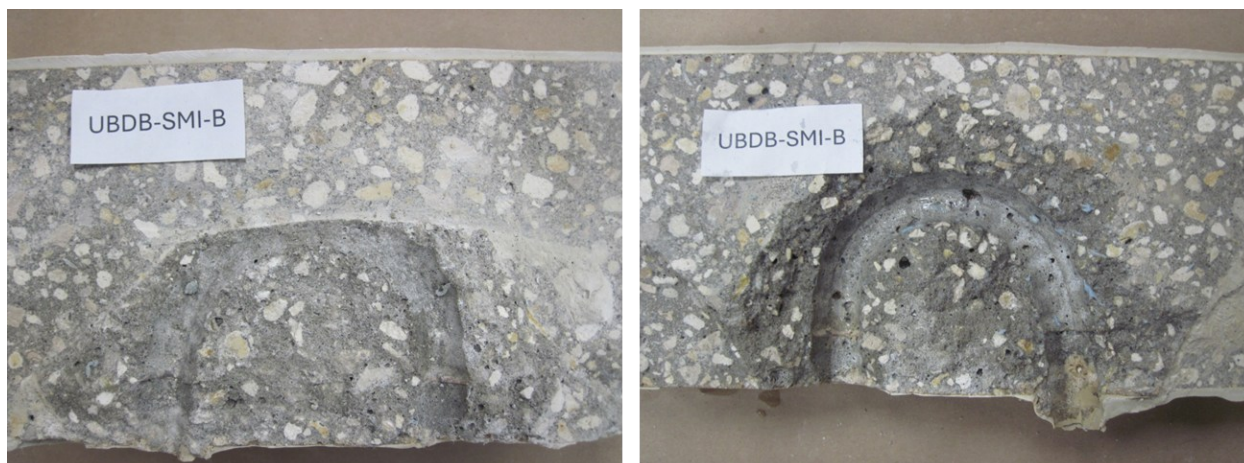
Figure 8-14 shows the top and bottom trace left by the u-bar in sample UBDB-SMI-B. An up-close image of the top side is shown in Figure 8-15, which shows slight marks of corrosion in the middle of the U.

Figure 8-14. Top (left) and bottom (right) trace of sample UBDB-SMI-B (G109).

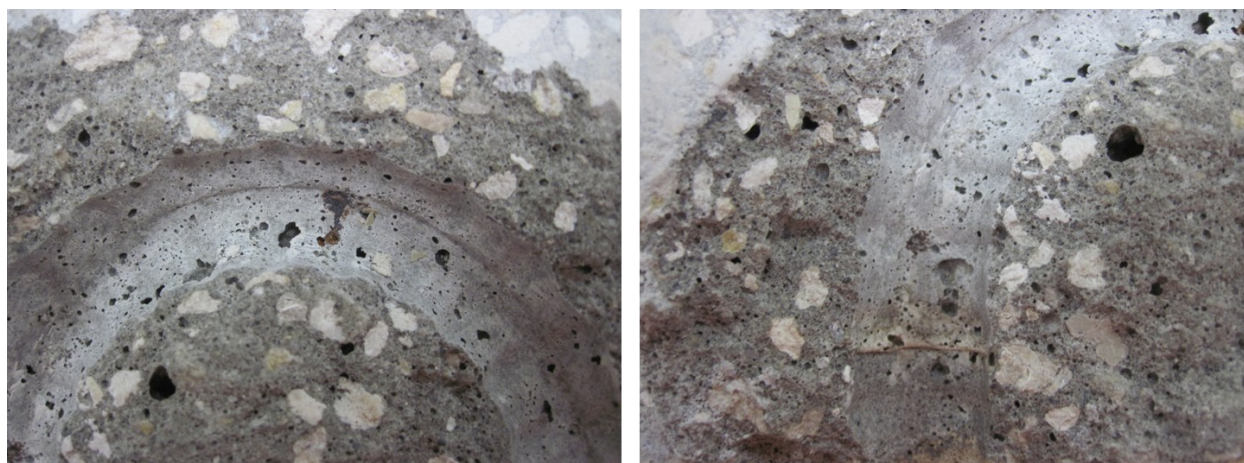
Figure 8-15. Top trace and close-up of sample UBDB-SMI-B (G109).

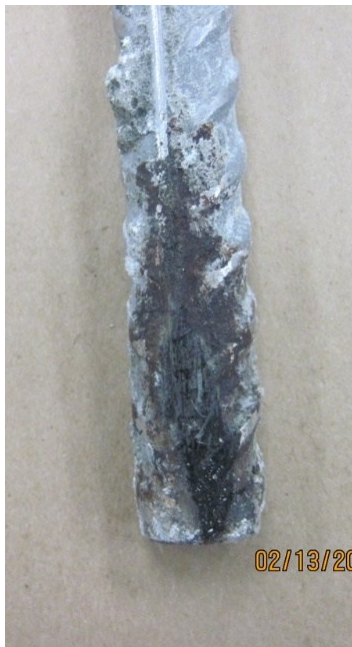
Figure 8-19 shows all the rebars from sample STD3-2304-B. Rebar 2, shown in Figure 8-20, had notable corrosion at the bottom of the bar extending 2" up from the bottom of the bar and the spot itself is about 1/2" wide. Rebars 1 and 3 had no corrosion.

Figure 8-20. Close up corrosion spot on rebar 2 of sample STD-2304-B.

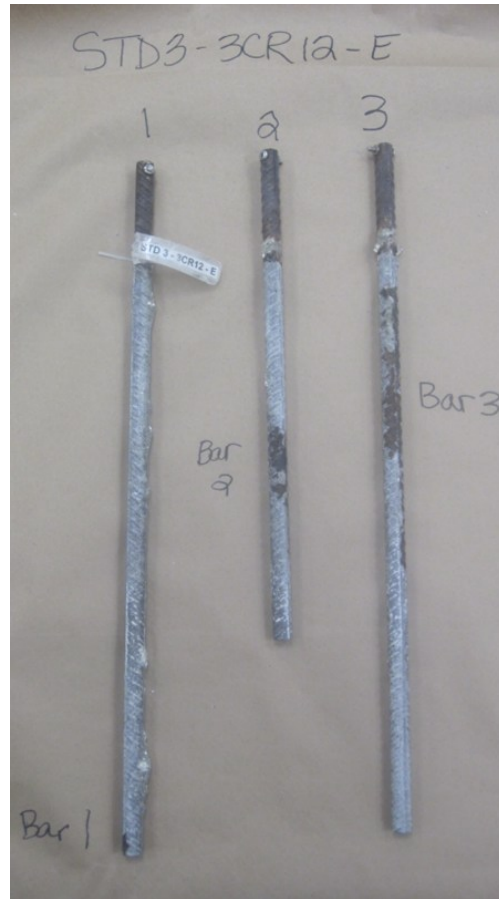
Figure 8-26 shows all rebars of sample STD3-3CR12-E. Figure 8-27 shows corrosion spots on rebars 1 and 2. Rebar 1 had a spot of corrosion at the bottom of the bar extending about 7/8" up from the bottom and covering about 1/3 of the bar at that location. There was corrosion on rebar 2 starting approximately 2.75" up from the bottom of the bar and extending up to about 7.25" from the bottom of the bar; corrosion covers approximately 3/4 of the bar at that location. Figure 8-28 shows multiple large corrosion spots on rebar 3.

Figure 8-26. All rebars of sample STD3-3CR12-E.

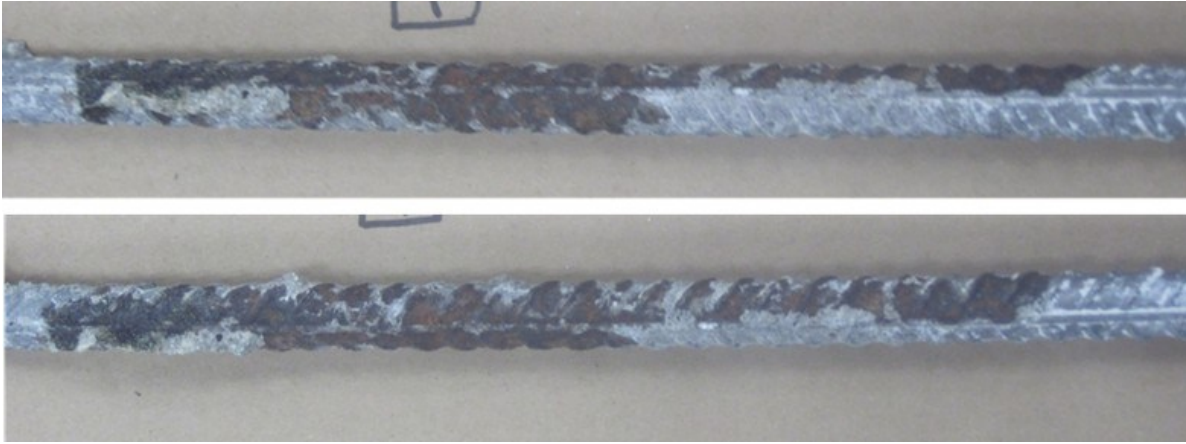
Figure 8-28. Corrosion spots on rebar 3 of sample STD3-3CR12-E.

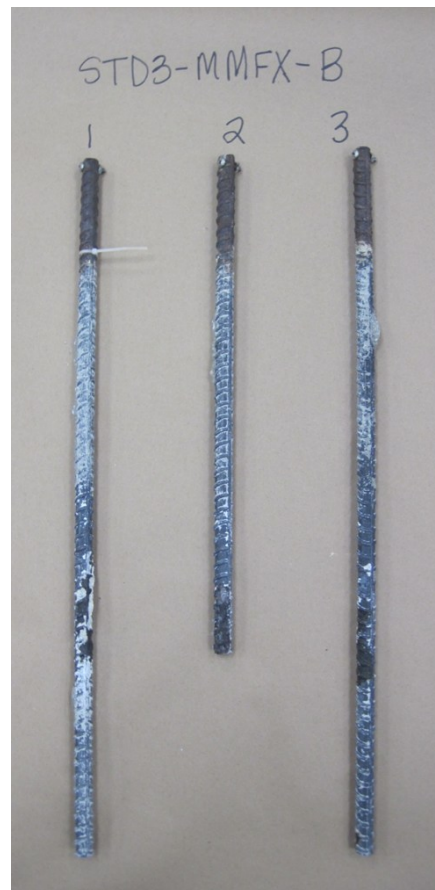
Figure 8-29 shows all rebars of sample STD3-MMFX-B. Figure 8-30 shows corrosion spots on rebars 1, Figure 8-31 shows the corrosion spots observed on rebar 2 (bottom of the rebar), and. Figure 8-32 shows the corrosion spots observed on rebar 3.

Figure 8-29. All rebars of sample STD3-MMFX-B.

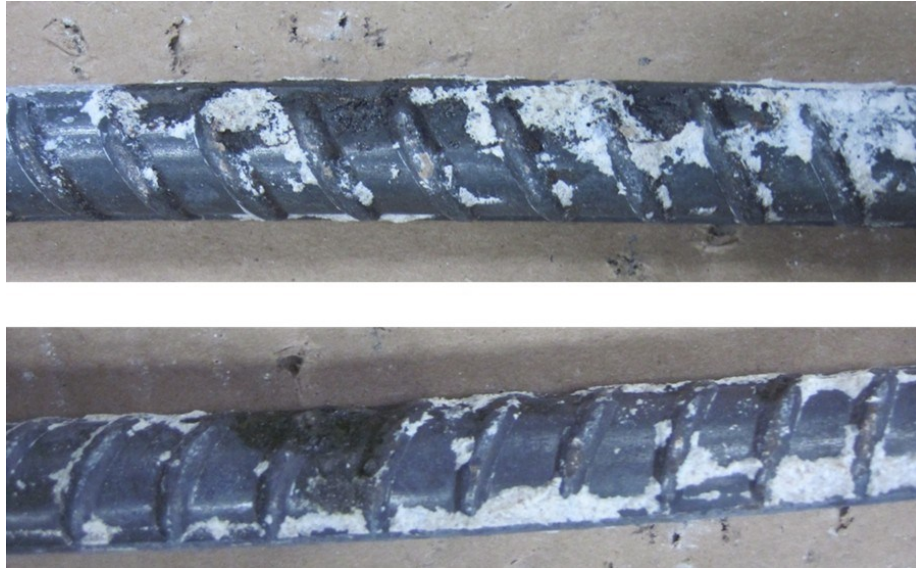
Figure 8-30. Corrosion spots observed on rebar 1 of sample STD3-MMFX-B.

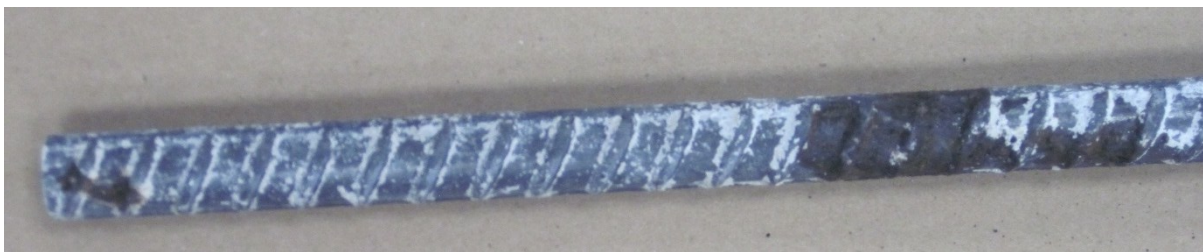
Figure 8-32. Corrosion spots observed on rebar 3 of sample STD3-MMFX-B.

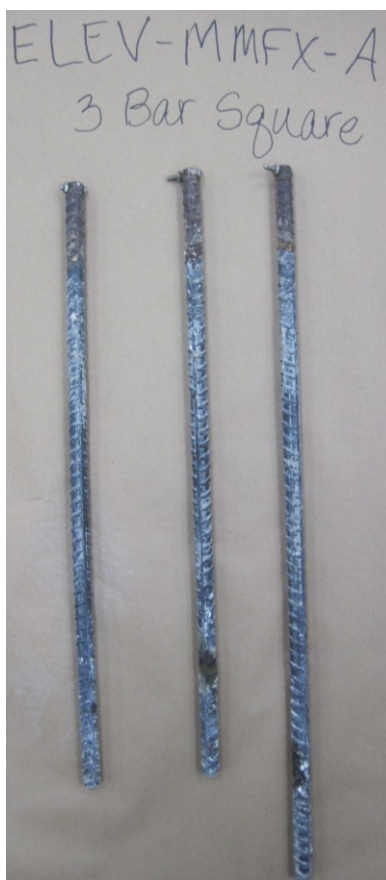
Figure 8-33 shows the rebars from sample ELEV-MMFX-A. Each rebar in this sample had corrosion. Figure 8-34 shows corrosion on rebar 1. There was corrosion on the bar about 3.25" up from the bottom of the bar which extended to  $\frac{3}{8}$ " up from the bottom with a width of  $\frac{1}{2}$ ". Figure 8-35 shows the corrosion on rebar 2. There was corrosion on the bar about 3.5" up from the bottom of the bar extending to about  $\frac{2}{3}$ " around the bar at that location. Figure 8-36 shows the corrosion spots on rebar 3, which was about  $\frac{1}{8}$ " up from the bottom extending to approximately  $\frac{3}{4}$ " and 1" up from the bottom. There was also a spot of corrosion about 3.5" up from the bottom of the bar extending 1" up on the bar. Corrosion covered approximately  $\frac{3}{4}$  of the bar at that location.

Figure 8-33. All rebars of sample ELEV-MMFX-A.

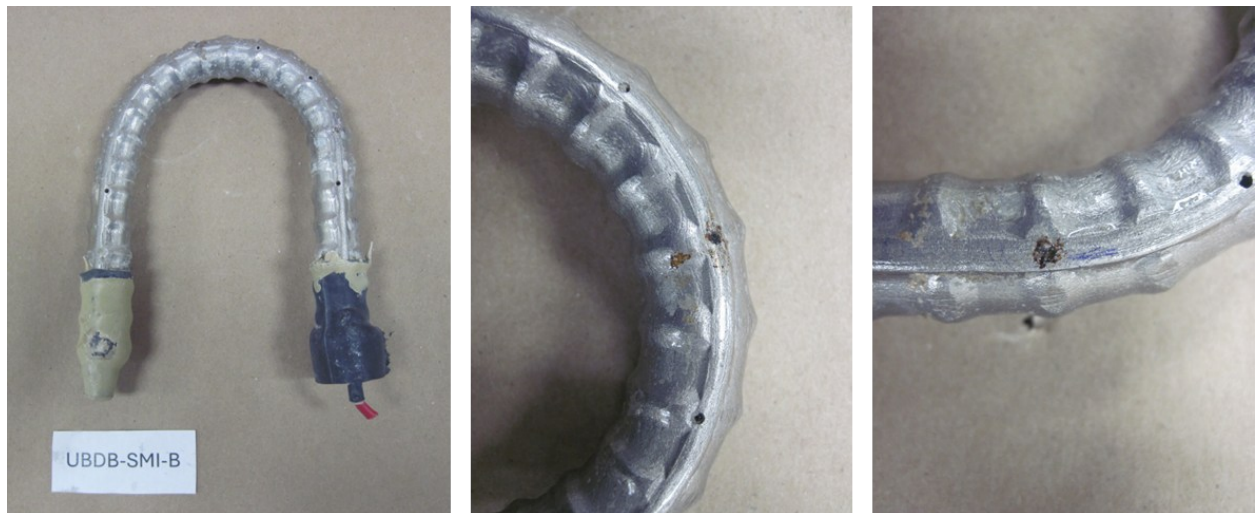
Figure 8-37 and Figure 8-38 show the top and bottom sides of the u-bar in sample UBDB-SMI-B, respectively. There was corrosion on the left arm of the bar on the bottom side at about 3/4" length and about 1/2" wide. The top side had tiny spots of corrosion in one of the pin holes on the bent part of the bar and a tiny spot of corrosion 1/8" away.

Figure 8-37. Corrosion spots on top side of sample UBDB-SMI-B (G109).

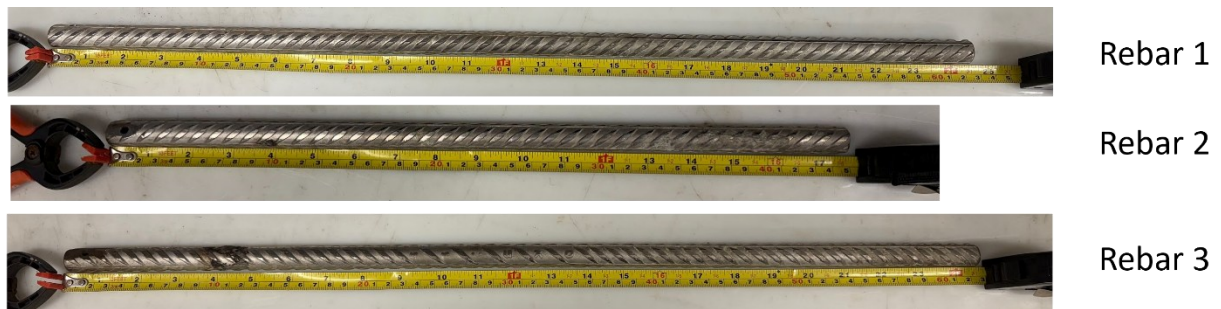
Figure 8-39. All rebars of sample STD3-2101-B after cleaning.

Rebars 2 and 3 showed corrosion sites, and rebar 3 showed the largest surface area affected. There was also one smaller affected area on rebar 2. Figure 8-40 and Figure 8-41 show rebar 2 and 3 respectively. Rebar 1 did not have any major areas of pitting or corrosion damage.

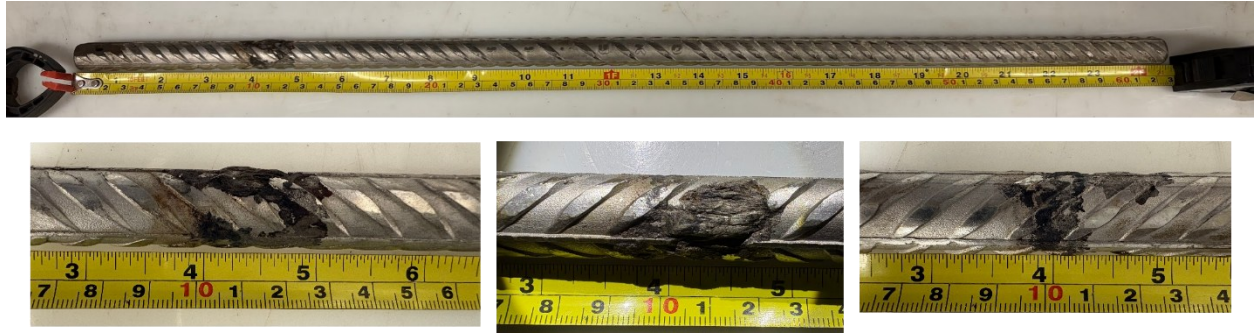
Rebar 3 (Figure 8-41) had a larger area of corrosion damage that spanned from around 3.5 inches to just over 5 inches on the length scale. The affected area spanned around the entire circumference of the rebar, and it varied in length around the circumference as seen in the images. The rebar cross section loss was much deeper compared to the damage on rebar 2. The corrosion products at rebar 3 caused the concrete to crack as described in Section 8.1.1.

Figure 8-41. Full length of rebar 3 and notable areas of corrosion damage of sample STD3-2101-B.

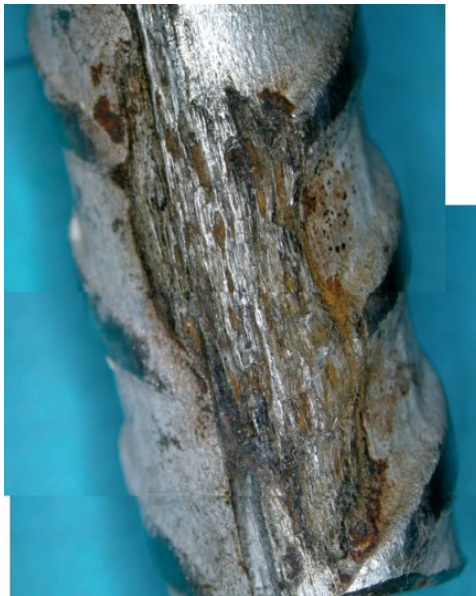
Figure 8-42 and Figure 8-43 show images of rebars 2 and 3, respectively after cleaning the rebars removed from sample STD-2304-B. Figure 8-42 shows that Rebar 2 had one major corroding area at the rebar end. The corrosion site length is a little longer than the spacing between three rebar ribs. The corrosion site covered a small fraction of the rebar circumference. The corrosion site was about  $1/10^{\text{th}}$  of an inch in depth. Figure 8-43 shows the full length and close-up of the shallow corroding sites observed on Rebar 3.

Figure 8-42. Corrosion spot observed on rebar 2 of sample STD3-2304-B.

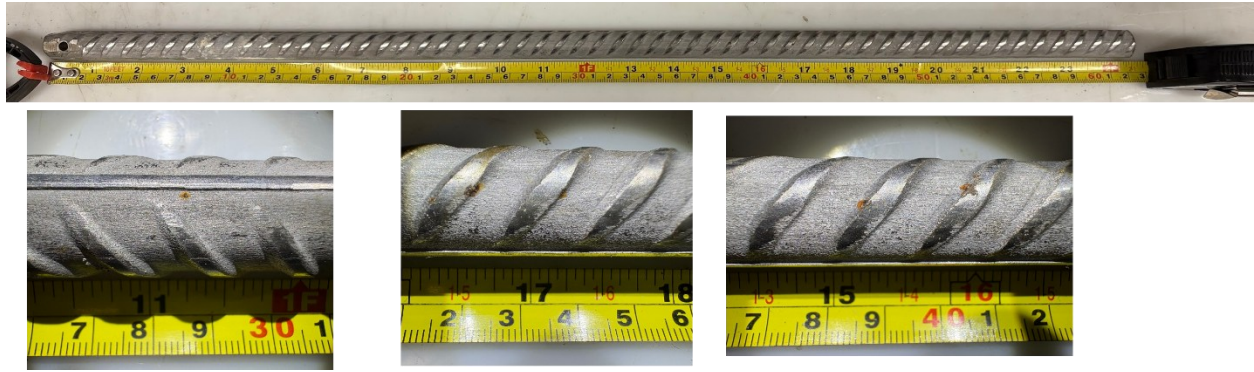
Figure 8-43. Sample STD3-2304-B - full length of rebar 3 and corrosion sites.

Rebar 3 did not have any major areas of corrosion, and it only had very little corrosion spots scattered throughout the rebar, which are documented in Figure 8-43. The spots had very shallow depths and did not result in significant damage to the rebar.

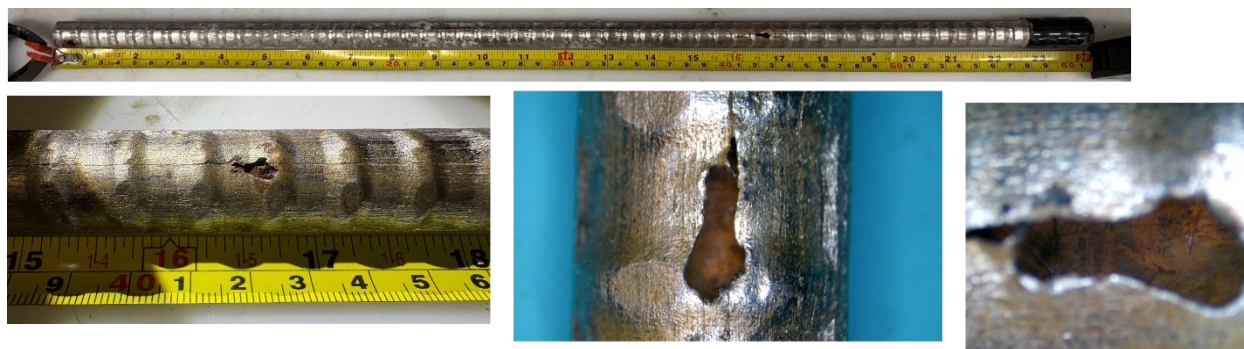
Figure 8-46 and Figure 8-47 show rebars 1 and 3, respectively from sample STD3-SMI-D. Rebar 1 did not show any major signs of corrosion apart from one very large pit that spanned from roughly 16.3 inches to 16.7 inches on the length scale. The pit was about 0.25 inches in depth.

Figure 8-46. STD3-SMI-D - full length of rebar 1 and notable corroding site after cleaning.

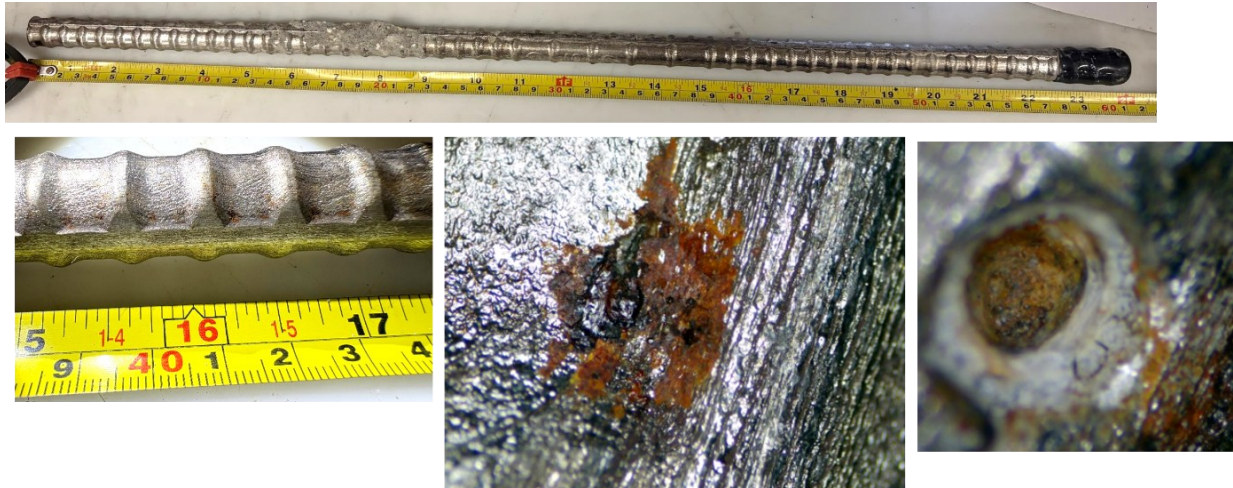
Rebar 3 had a few minor damage sites from corrosion, and one small, but deep pit that occurred 20 inches on the length scale, which is shown on the bottom left of Figure 8-47. The rest of the damage was minor and did not result in any deep pits, as shown with an example on the bottom middle of Figure 8-47.

Figure 8-47. STD3-SMI-D - full length of rebar 3 and notable areas of corrosion damage.

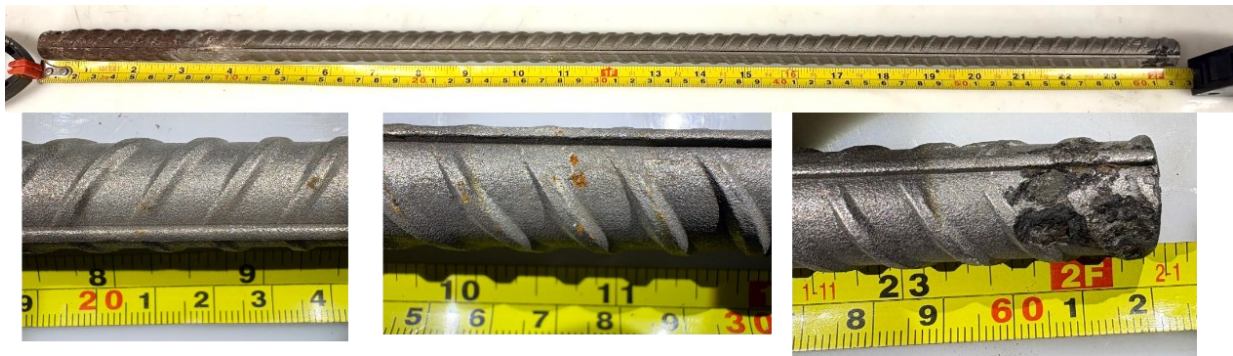
Below are notable areas of corrosion damage on rebars 1 and 3 from sample STD3-3CR12-E. Rebar 2 did not show any major damage. Figure 8-48 shows rebar 1, which had minor specs of damage in a few places along its length. The only major area of damage occurred at the end of the rebar at around 2 feet on the length scale, as seen below. The damage did not span around the rebar and stayed on the displayed side.

Figure 8-48. STD3-3CR12-E - full length of rebar 1 and notable areas of corrosion damage.

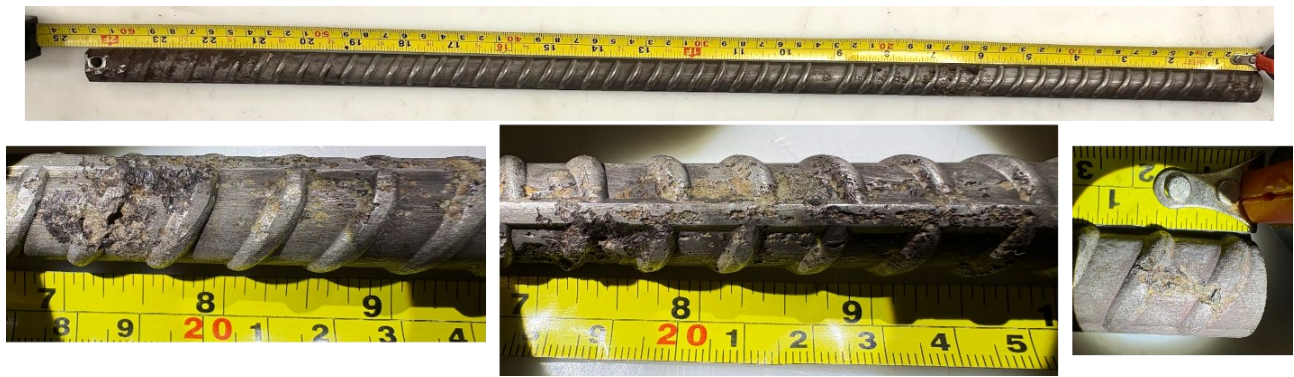
The following figures show rebars 1, 2, and 3 from the STD3-MMFX-B. The measuring tape was located in the opposite end for the rebars on this sample. Each of the rebars showed significant corrosion damage along large sections of them. Figure 8-50 shows rebar 1, which had two major corroded areas that occurred at the rebar end and from about 6 inches to 10 inches on the length scale shown. The site between 6 and 10 inches extended most of the rebar circumference. Major corrosion sites occurred at the very beginning, and at the end of this damaged region.

Figure 8-50. STD3-MMFX-B - full length of rebar 1 and notable areas of corrosion damage.

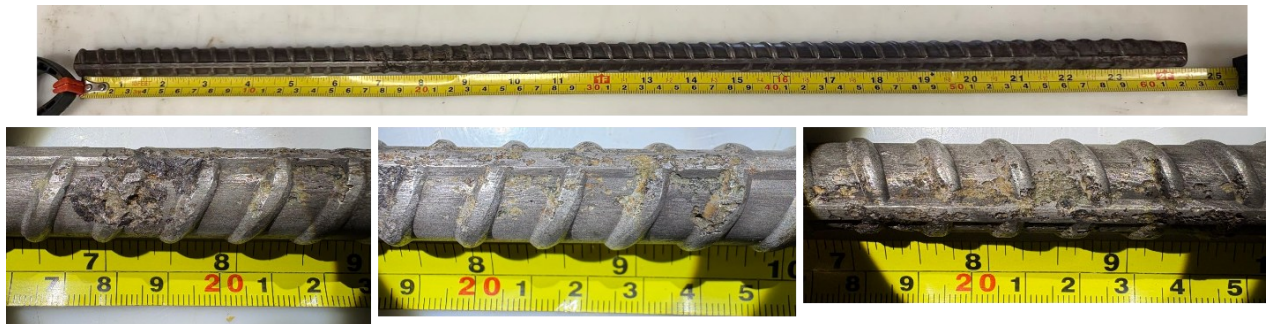
Figure 8-52 shows rebar 3, which had one large section with corrosion damage, located 19 inches from the side with the drilled hole. The corrosion site extended about two inches in length. The damaged area was somewhat deep as can be observed on the close-up. It cover most of the rebar circumference.

Figure 8-52. STD3-MMFX-B - full length of rebar 3 and notable areas of corrosion damage.

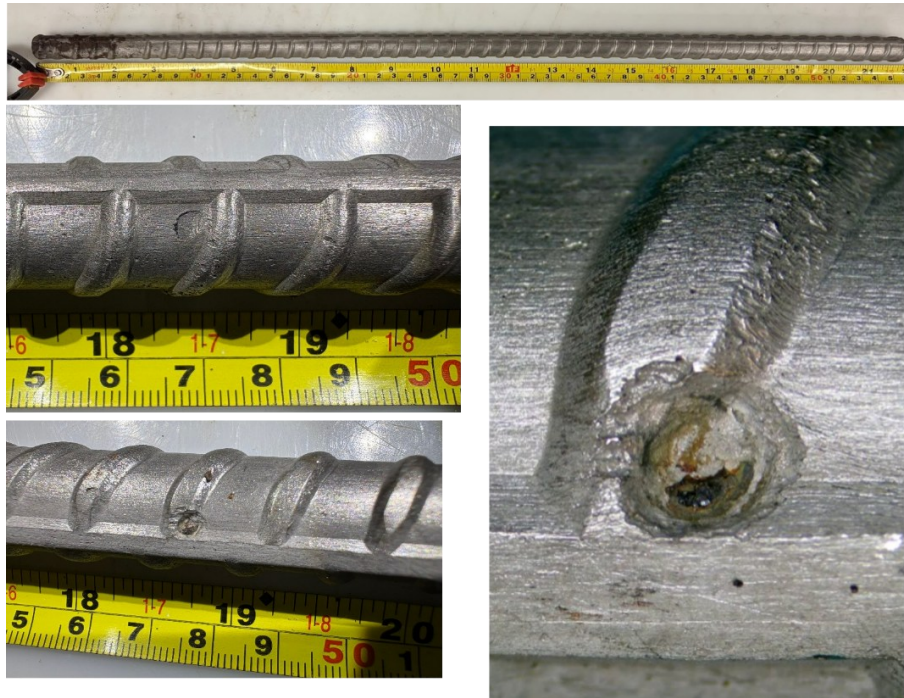
The following rebar images after cleaning the rebar removed from ELEV-MMFX-A 3-Bar Square sample. Each of the three rebars of this sample had some corrosion damage. Figure 8-53 shows rebar 1, which had very little damage, and only contained one small corrosion site, a deep pit occurred at around 18.8 inches on the length scale.

Figure 8-53. ELEV-MMFX-A - full length of rebar 1 and notable areas of corrosion damage.

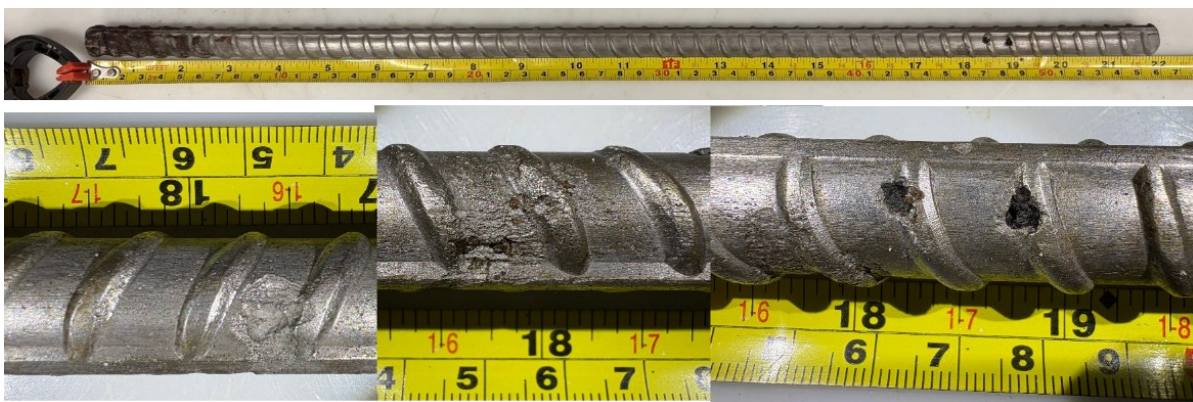
Figure 8-54. ELEV-MMFX-A - full length of rebar 2 and notable areas of corrosion damage.

Figure 8-54 shows rebar 2. Rebar 2 had more significant damage at around 18.5 inches on the length scale. The rebar had two deep corrosion sites in that location, and other wider areas of damage on the other side around the same area on the length scale. Figure 8-55 shows rebar 3, which had the most severe damage out of all three rebars. It had multiple deep sites around 21 to 22 inches on the length scale, as well as a wide section of cross-section loss around that area as well. It also had damage at the end that spread unevenly to about an inch long.

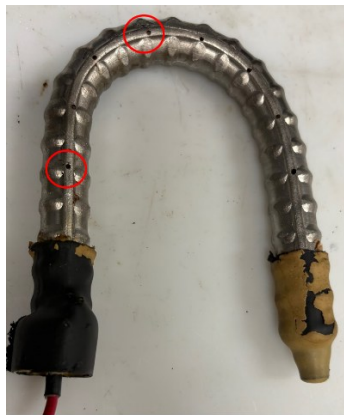
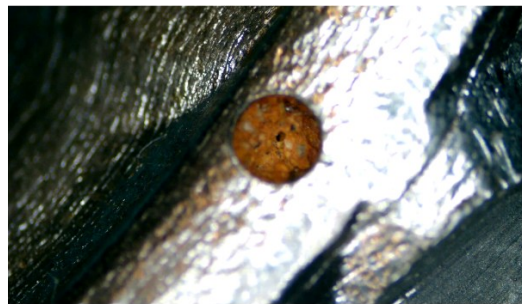
Figure 8-56. Rebar removed from UBDB-SMI-B sample: left top side full U rebar view and two close-up of the drilled holes.

Figure 8-56 shows the bottom side of the U-bar from sample UBDB-SMI-B. Before the rebar was cleaned, there was corrosion build-up on the left side of this rebar face. This section was the only area of major corrosion build-up on the entire rebar. After this rebar area was cleaned, the hole drilled below this area was photographed and shown on the very right side of the figure. The hole resembled the others, and some of them were clogged with corrosion products and some were not. The two holes depicted below are representative of how the holes throughout the rebar looked.

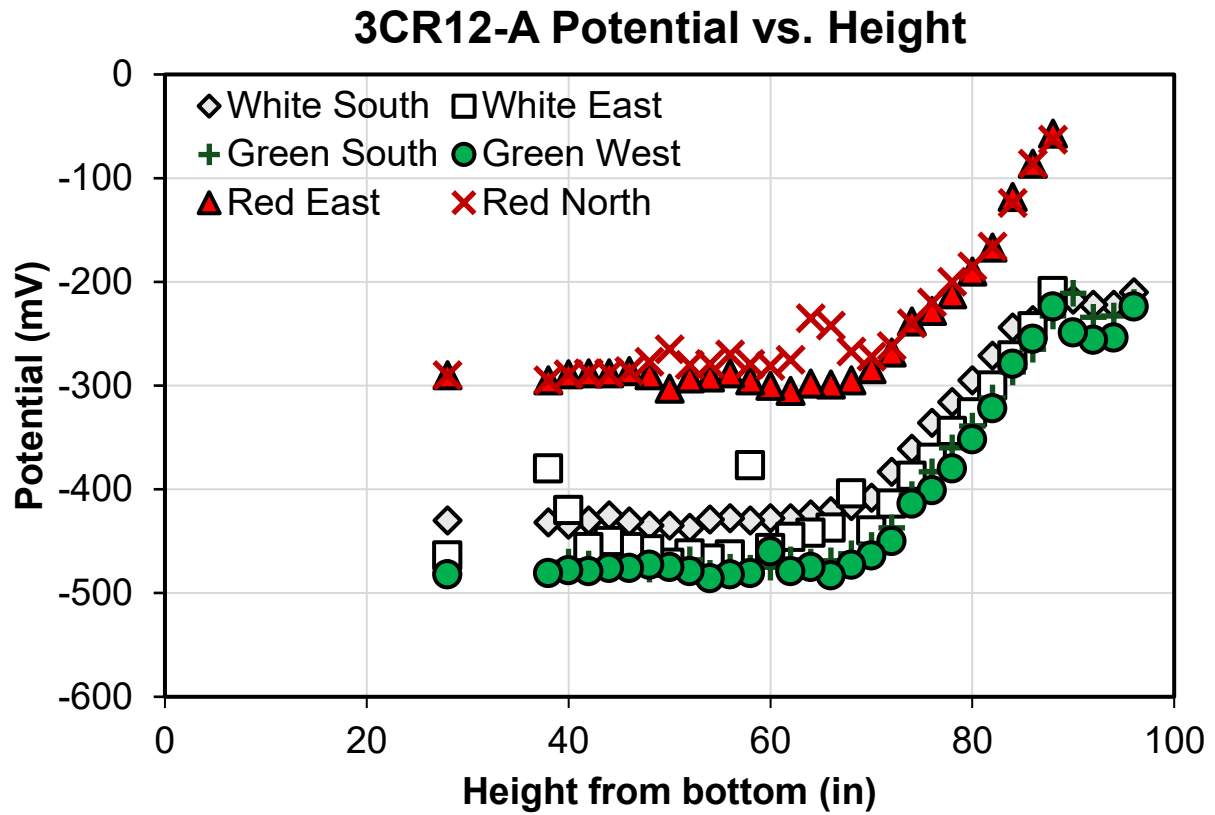
Figure 11-1. Rebar potential vs. height measured in column 3CR12-A. Two column faces per wire were measured and plotted.

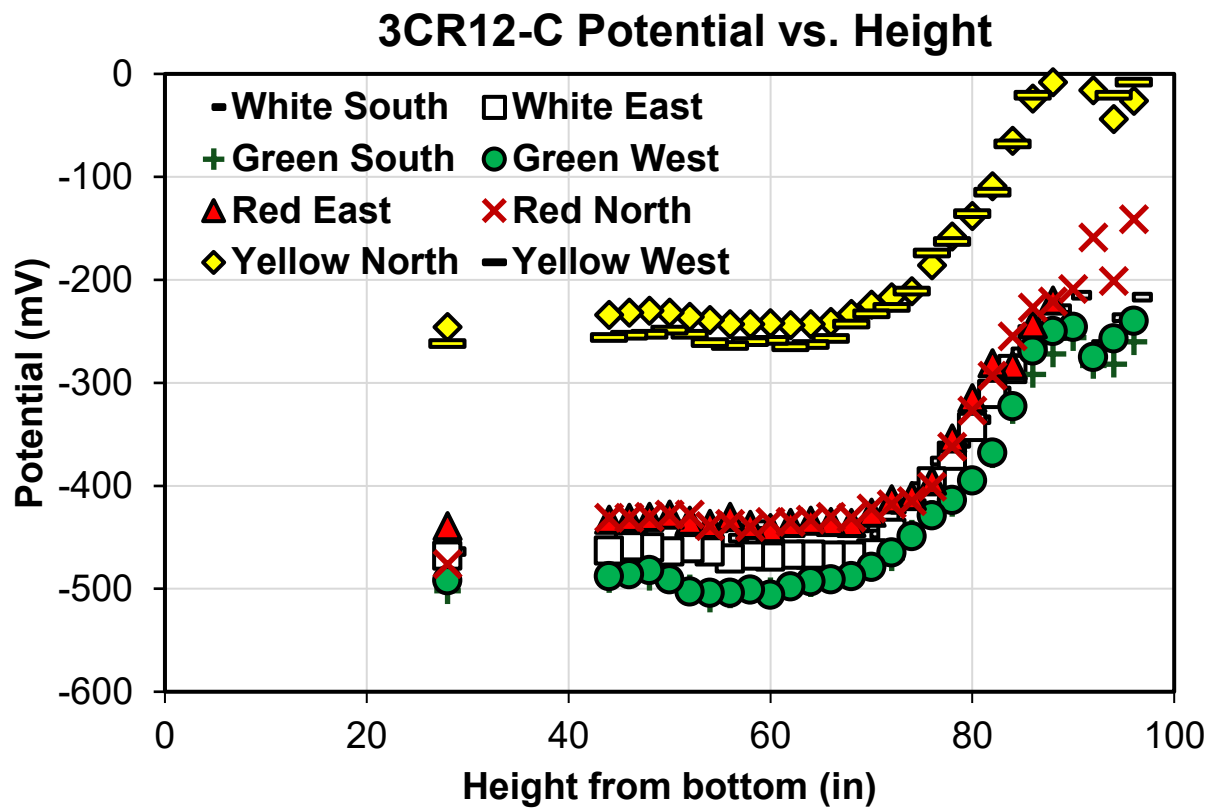
Figure 11-2. Rebar potential vs. height measured in column 3CR12-C. Two column faces per wire were measured and plotted.
