SUBJECT: Temporary Design Bulletins C00-5 and C01-01 (Post-Tensioning Issues)
Dated September 29, 2000 and February 7, 2001, Respectively

Florida Department of Transportation
District 3

Final Report

This report summarizes inspections, tests, analyses, and repairs of the Mid-Bay Bridge post-tensioning system.

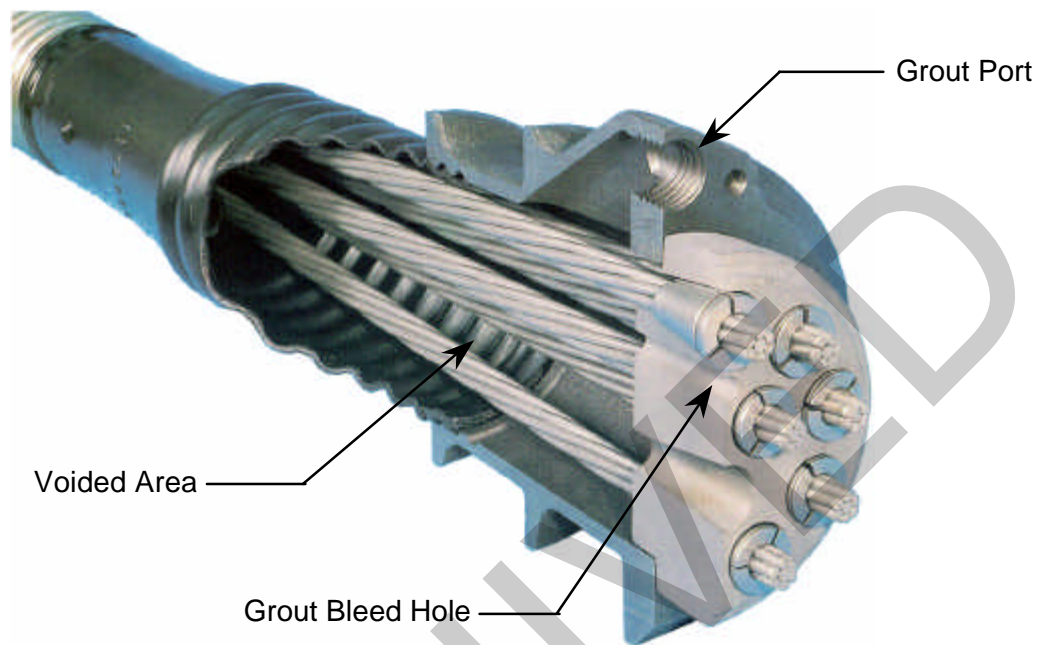
Figure 2.2 – Typical Post-tensioning tendon anchor.

The failure of Tendon 57-1 (Section 3.1) resulted from the corrosion of the prestressing strands inside the post-tensioning anchorage assembly. It was observed during removal of this tendon that there was no grout inside the anchor. At the time of inspection, the anchorage components and exposed strands were found to be dry. It was therefore concluded, that water present at the time of construction had caused the corrosion. As a result of this finding, an inspection procedure was developed using flexible borescopes to video record the conditions inside all anchors that contained voids. The inspection would determine whether sufficient grout was present in each anchor and the extent of corrosion on exposed prestressing strands.

completely filled with good grout. Voids found in the Mid-Bay Bridge were inside the anchor, just behind the anchor plate, extending variable distances along the length of the tendon.

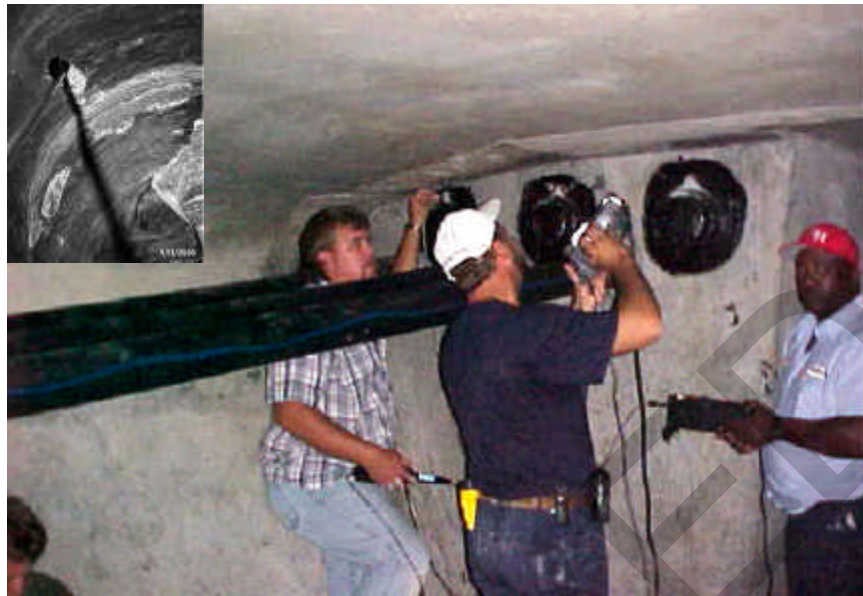
Figure 2.3 – Borescope Inspection of a Post-Tensioning Tendon Anchor.

Four, four-person inspection crews conducted borescope inspections of the post-tensioning anchors of the Mid-Bay Bridge. The borescope was inserted into the grout port after grout, if present in the port, was removed with a drill. Drilling was typically required for 2" to 3" before the clear access was available to a voided trumpet. If grout was found after drilling 4" then the anchorage was typically full. One inspector manipulated the borescope inside of the anchorage while another inspector controlled the video recording equipment. The other two members of each team provided support services to the two inspectors, including keeping a hand written log documenting the number of strands viewed, depth of void, extent of corrosion and whether or not a second borescope inspection was in order. For consistency in interpreting the borescope findings, the lead inspector reviewed all tendons that were recommended for a second inspection. Figure 2.3 shows a borescope team inspecting an anchorage of the Mid-Bay Bridge. The inset photograph in Figure 2.3 shows the borescope as it is inserted into the grout port.

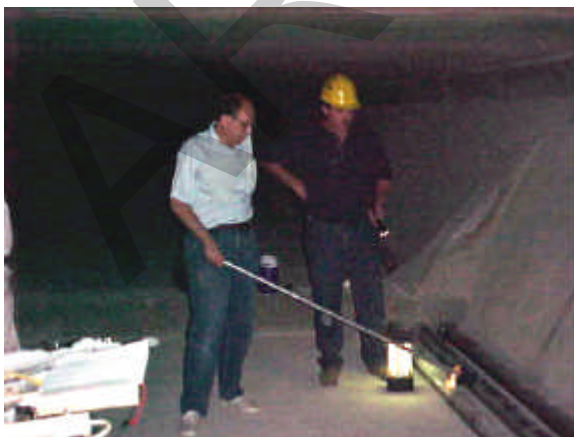
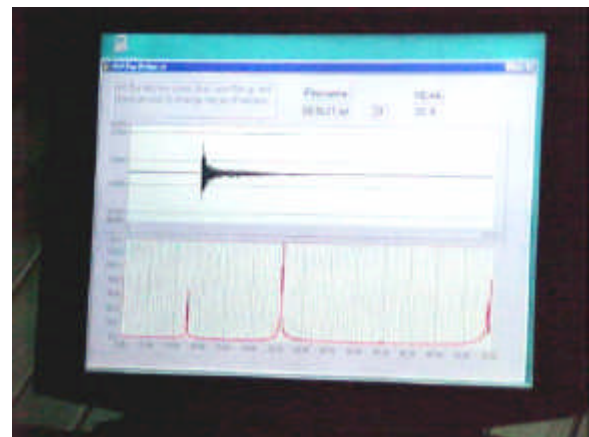
Figure 2.5 – Vibration Testing

Complete vibration testing of all tendons was conducted from October 2, 2000 to October 9, 2000. This testing consisted of measuring the vibrational response of tendons to mechanical excitation, and using the results to estimate forces in the tendons. Comparison of results for the various tendons in the bridge can be used as a possible indicator that a tendon may be in distress. Figure 2.5 shows photographs of the vibration testing and the visual display of a tendon test.

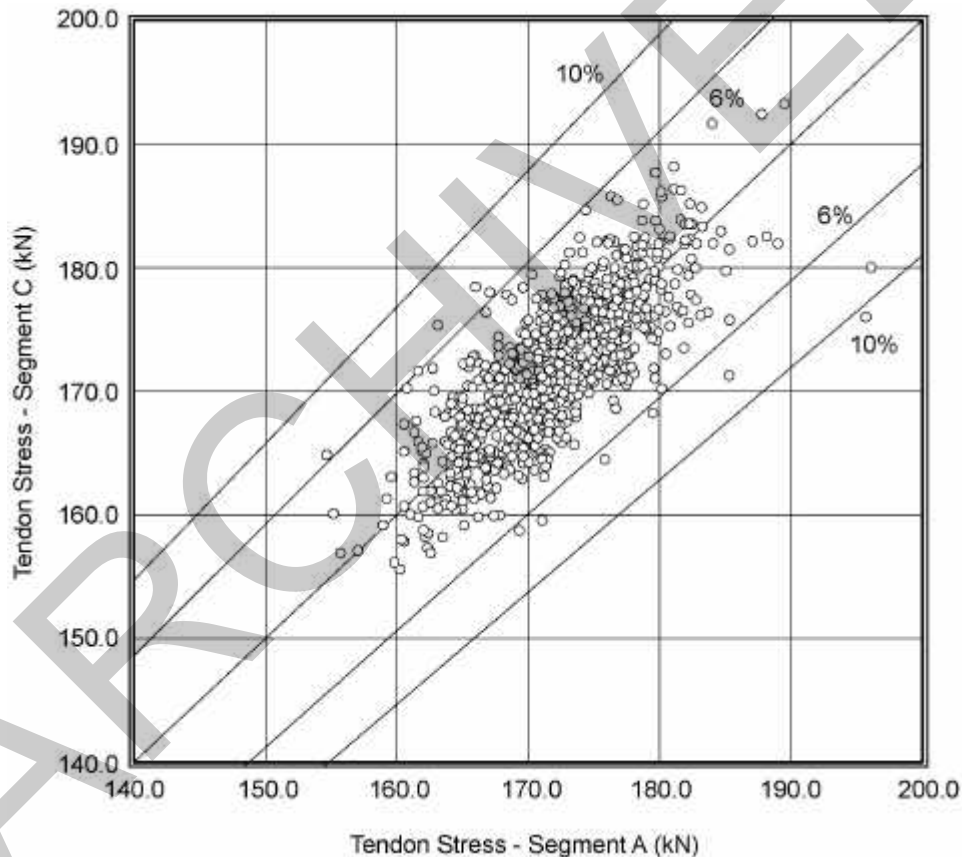
Figure 2.6 – Comparative tendons forces from vibration testing.

The raw data, synthesized results, and Final Report of the vibration testing for the Mid-Bay Bridge post-tensioning tendons is presented in Appendix C of this report. Figure 2.6 shows a summary plot comparing the stresses in Zone A and Zone C of the tendons. Equal forces in the two zones would result in a point plotted on the 45° line. The variations of all of the tendons are essentially within a +/-6% variation from equal values, indicating no significant loss in forces along the length of the tendon. Some variation is expected to exist as a result of friction developed during stressing of the tendons.

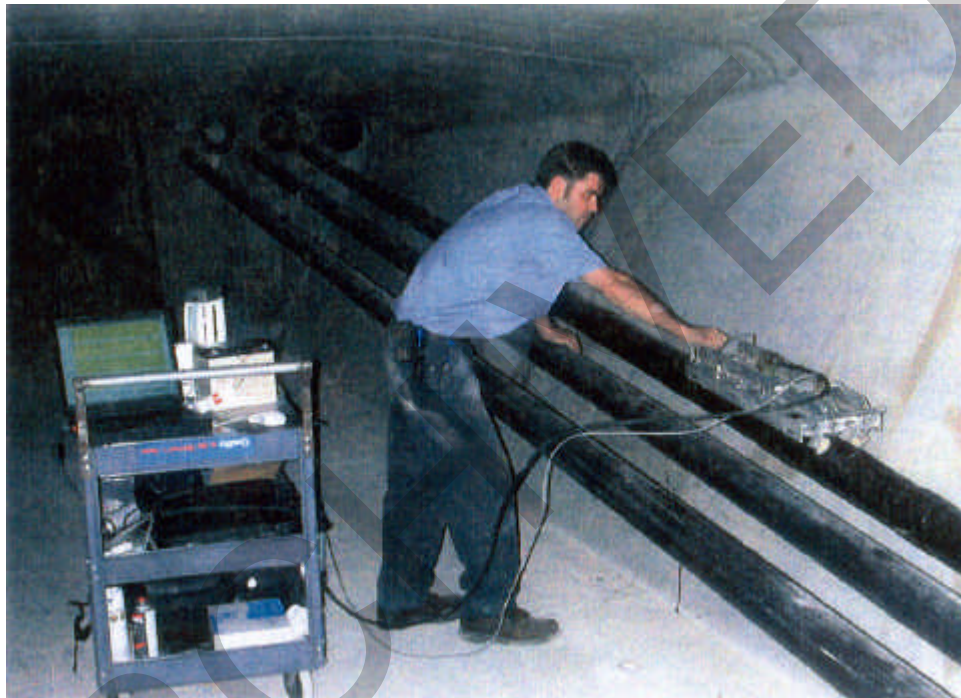
Figure 2.9 – Mag-Flux Testing

Mag-Flux Testing at the Mid-Bay Bridge resulted in identifying two locations on the post-tensioning tendons where corrosion and section loss had occurred. These locations and the findings were:

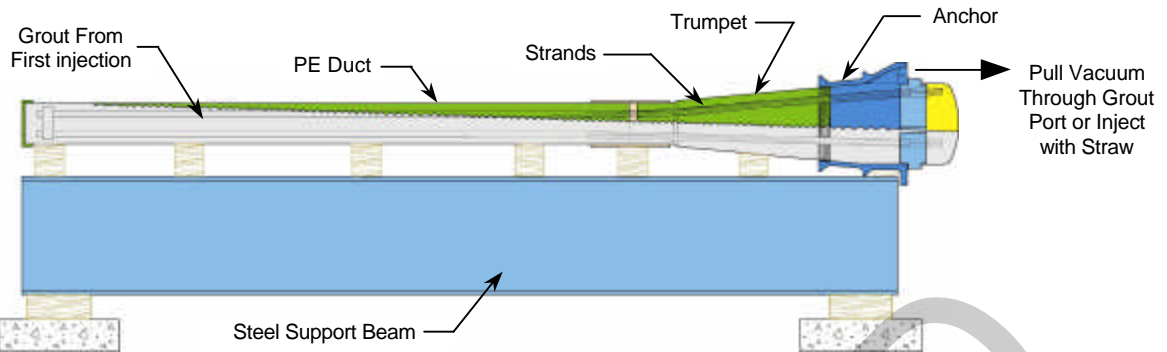
Figure 2.10 – Mock-up test specimen

Mock-up testing using the two proposed methods of grout injection was conducted to determine which produced the most effective repair of the anchor. The mock-up tests were performed using the same components of the post-tensioning system used in the bridge. Post-tensioning strands were placed inside the anchor and a length of duct and then partially filled with grout. The mock-up tests were slightly inclined to replicate voided conditions similar to those found during the borescope inspections. Figure 2.10 shows a sketch of the mock-up test specimen.

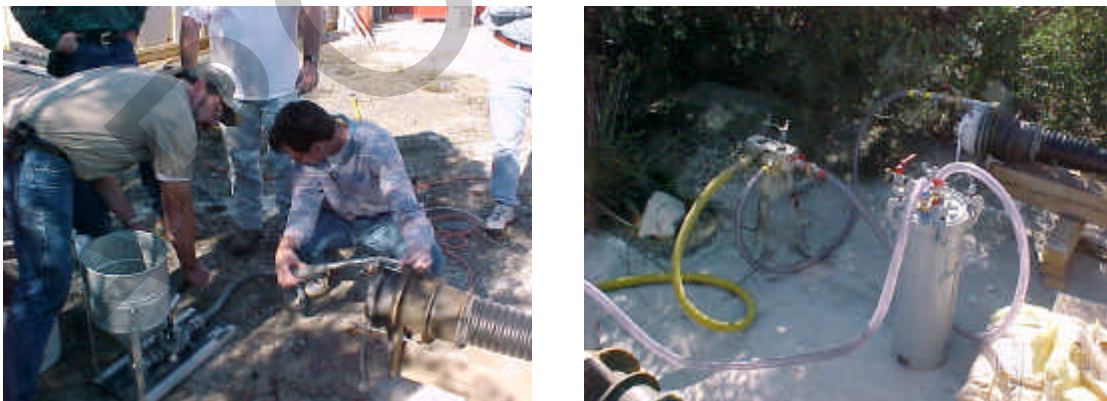
Figure 2.11 – Injection methods: Positive Pressure (left), Vacuum Injection (right).

After the first grout placed in the test specimen hardened, the two different methods of injection, positive pressure and vacuum injection, were used to fill the voids in the anchors. Figure 2.11 shows the two injection methods in progress. The positive pressure method is shown on the left with the straw inserted into the grout port of the anchor and a hand pump being used to force the grout into the voids. The vacuum injection method is shown at the right in Figure 2.11. One end of the grout injection tube is connected to the grout port. The other end is attached to a switchable manifold. The air is first removed under vacuum, being drawn out by the grout-metering pump. The volume is measured on the vacuum and therefore provides an estimate and degree of confidence in the amount of grout to be placed. Generally the amount of grout placed in the Mid-Bay Bridge was slightly higher in volume than what the vacuum indicated. In the second stage of work the manifold controls are switched, causing the vacuum to pull the grout into the void.

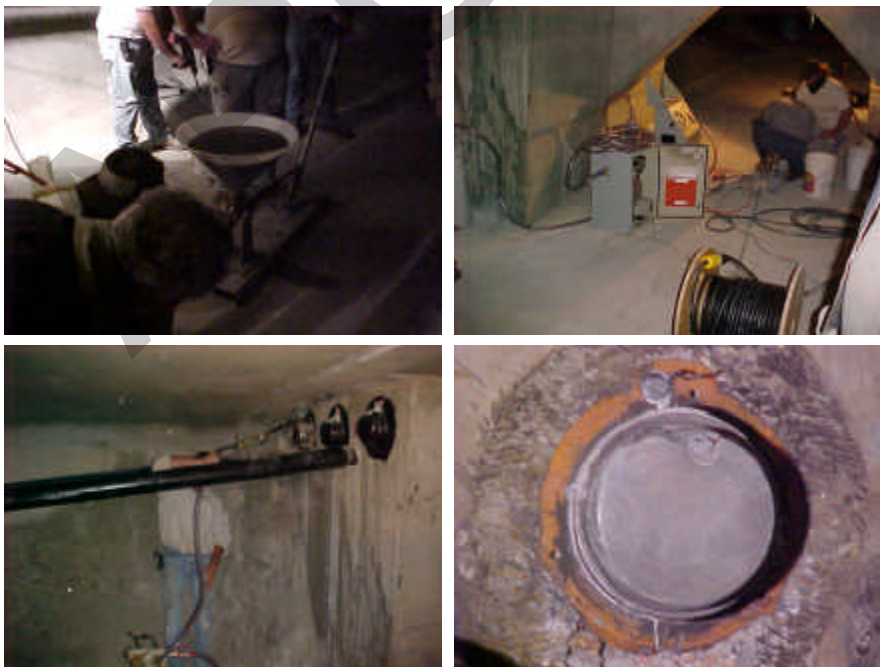
Figure 2.13 – Field trial of the vacuum injection method.

Following the mock-up testing, a field trial was conducted to determine procedures for using the vacuum method of injection in the rehabilitation of the Mid-Bay Bridge. The photographs in Figure 2.13 show different aspects of the field trial. The photograph at the bottom right of Figure 2.13 shows the finished grout cap for this tendon. Based on the mock-up testing and field trial, the vacuum method of injection was selected for filling the voids in the anchors of the Mid-Bay Bridge.

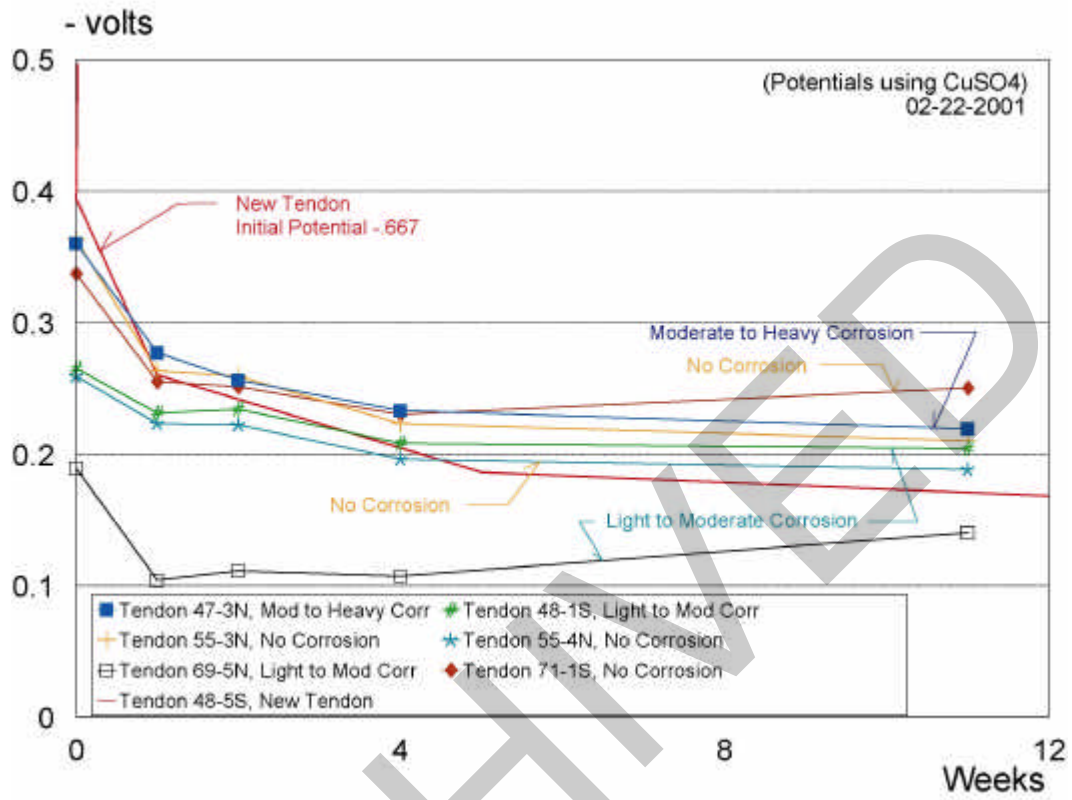
Figure 2.14 – Variation in electrical potential with time.

Figure 2.14 shows a plot of the variation in electrical potential within the grout over the eleven-week test period. Test results indicated that potentials reached a passive state, as defined by ASTM standards, shortly after re-grouting. Also, the potentials of the re-grouted tendons were similar to those of the newly grouted replacement tendon. Based on these findings, secondary vacuum grouting of tendons was incorporated into the repair procedures of the post-tensioning tendons. Complete results of these tendon potential tests are provided in Appendix F of this report.

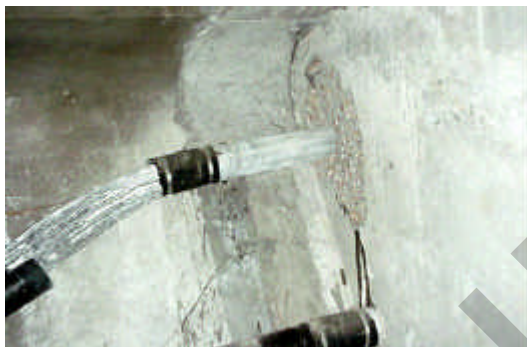
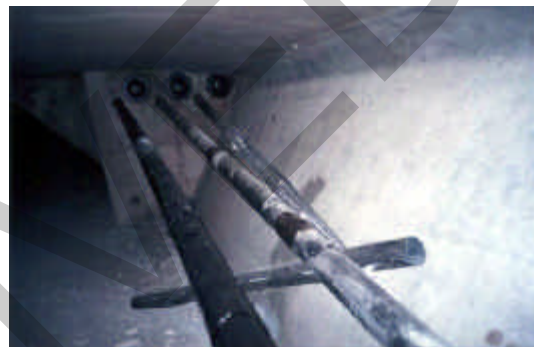
This tendon was one of two failed post-tensioning tendons that were discovered during the annual inspection on August 28, 2000. A description of this tendon is found in Section 3.1. The tendon was replaced before the borescope inspections.

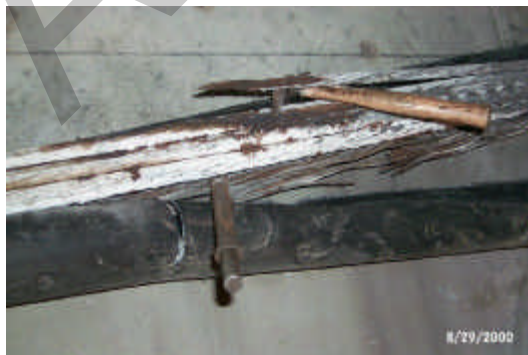
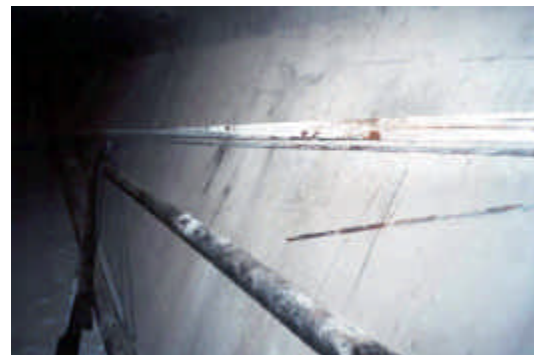
4.2.2 Tendon 28-6

Like Tendon 57-2, this tendon was one of the post-tensioning tendons that had failed and was discovered during the annual inspection. A description of this tendon is found in Section 3.1. The tendon was replaced before the borescope inspections.

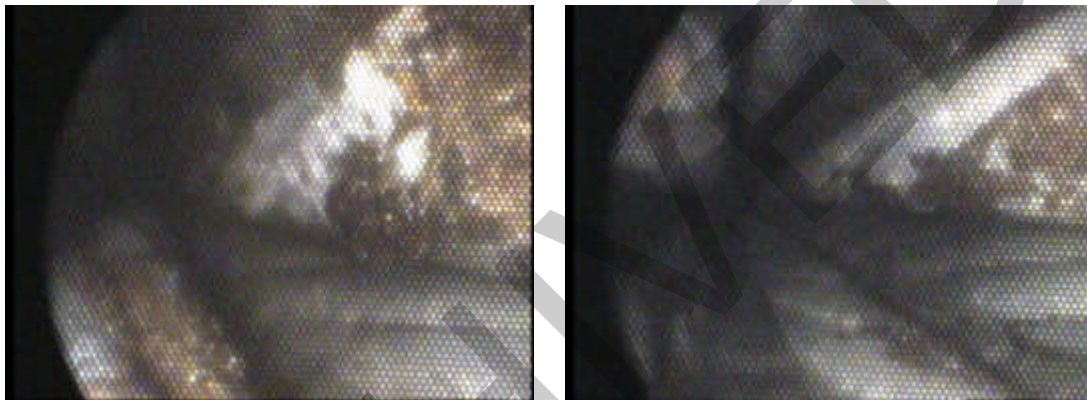
4.2.3 Tendon 57-2

North Anchor – 6 strands visible with deep pits, 18” to 28” of penetration, bright copper, orange corrosion on tendons, active corrosion on side of trumpet

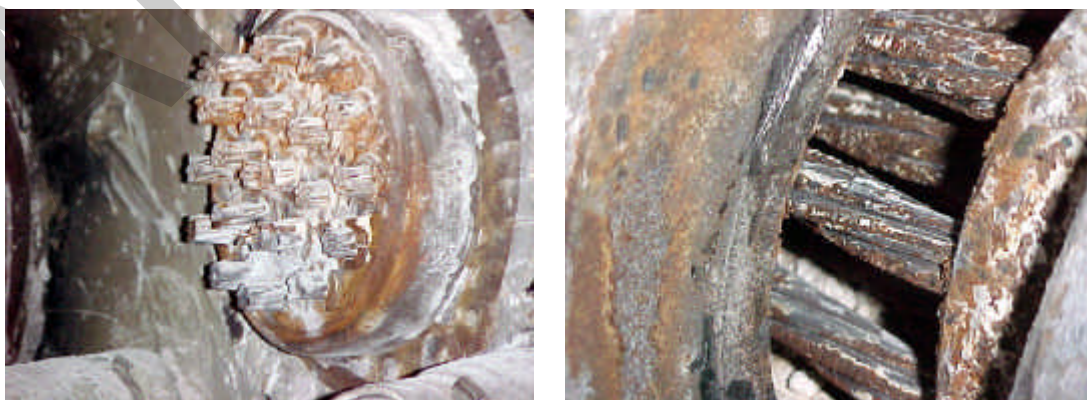
Photographs of removed tendon:

South Anchor – 2 ½” void then solid grout, no video

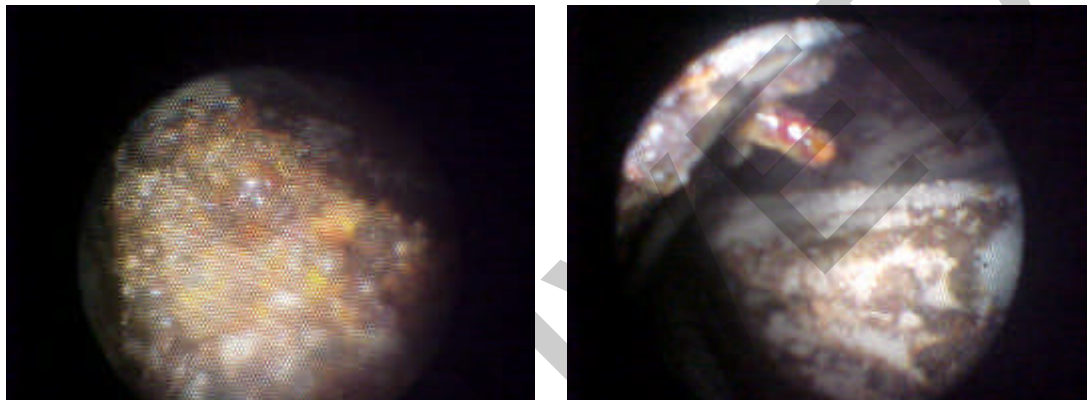
Borescope Photographs:

North Anchor – 3 to 4 strands visible, black and gray heavy corrosion on bottom of strands, broken grout, red and black (active) corrosion.

South Anchor - Tendon under replacement at time of inspection, no video or notes.

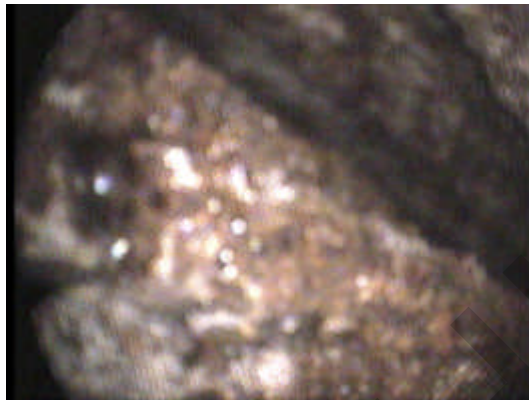
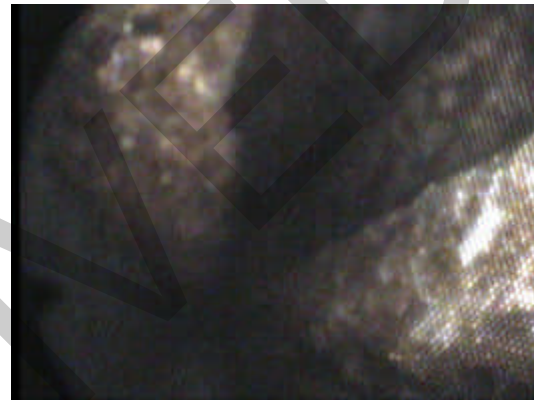
Borescope Photographs:

North Anchor – no corrosion, white grout

South Anchor – no grout present, 8 to 10 strands visible, severe corrosion, active corrosion cells, wires on strands could not be distinguished due to corrosion for approximately 4" to 6"

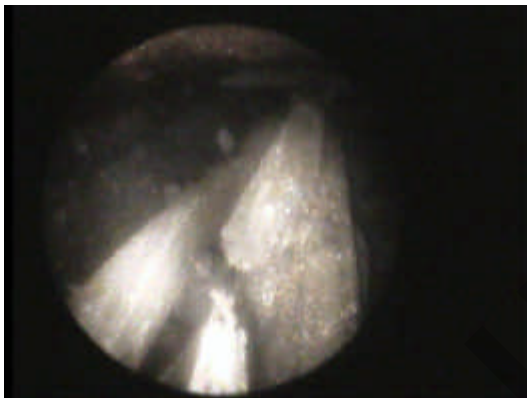
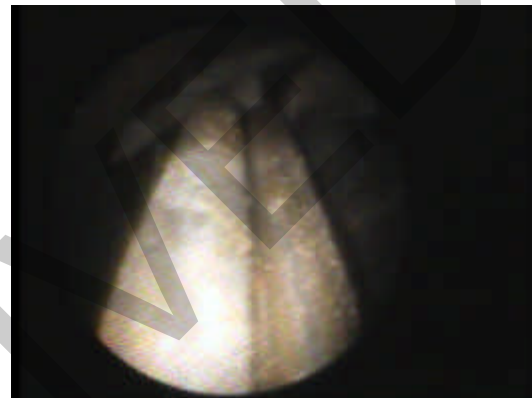
Borescope Photographs:

North Anchor – 5' void, 5 strands visible, trumpet has advanced corrosion with pitting, several strands with advanced corrosion and what appears to be pitting.

South Anchor – 3 strands visible with light orange spotty corrosion, moderate corrosion on trumpet, white grout, and 2' penetration.

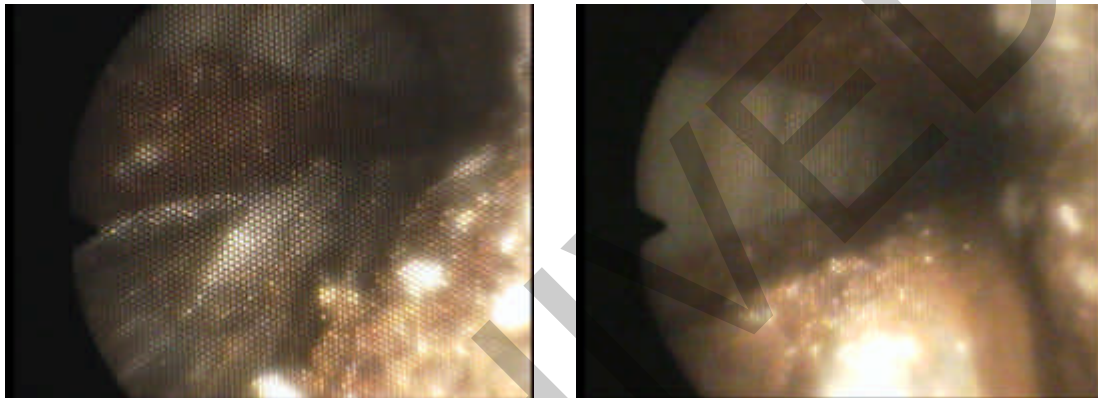
Borescope Photographs:

North Anchor – 3' void, 5 to 7 strands visible, appears to be necking
South Anchor – small void, black corrosion on trumpet, 8" void

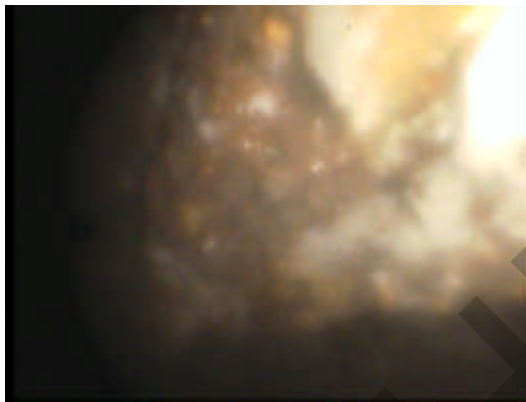
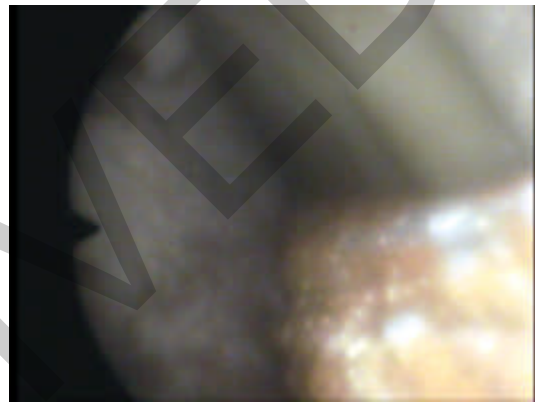
Borescope Photographs:

North Anchor – 18" void, 5 strands visible, extremely heavy corrosion, active corrosion cells on strands

South Anchor – good white grout, 6" void

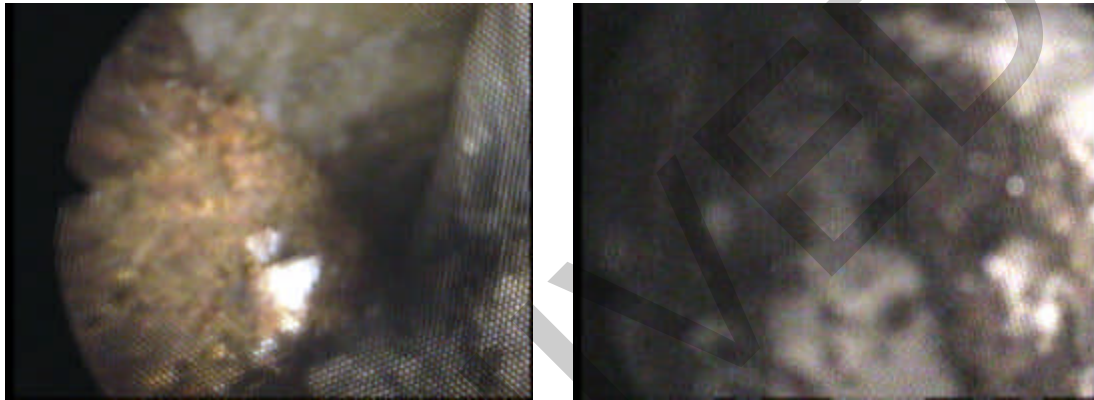
Borescope Photographs:

North Anchor – moderate corrosion on trumpet, no strands visible, white grout, 1'-6" void

South Anchor – 3' void plus, 5 strands visible, wires on strands cannot be distinguished, severe corrosion present, active corrosion cells. Face of diaphragm at pier 64 has three diagonal cracks adjacent to all of the ducts, effervescence present at the top of deck underside adjacent to duct 64-1.

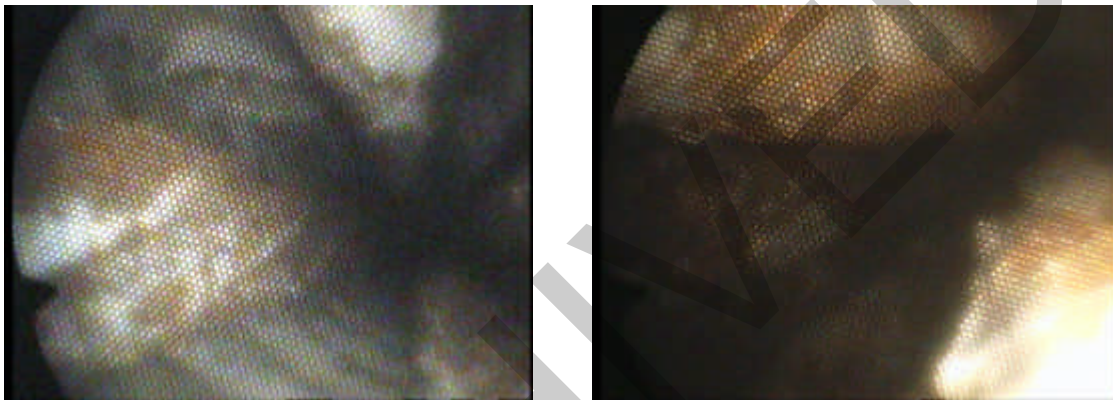
Borescope Photographs:

North Anchor – no corrosion, white grout
South Anchor – 3'-6" void, 8 to 9 strands visible, severe corrosion, active corrosion cells, wires on strands could not be distinguished due to corrosion for approximately 12"

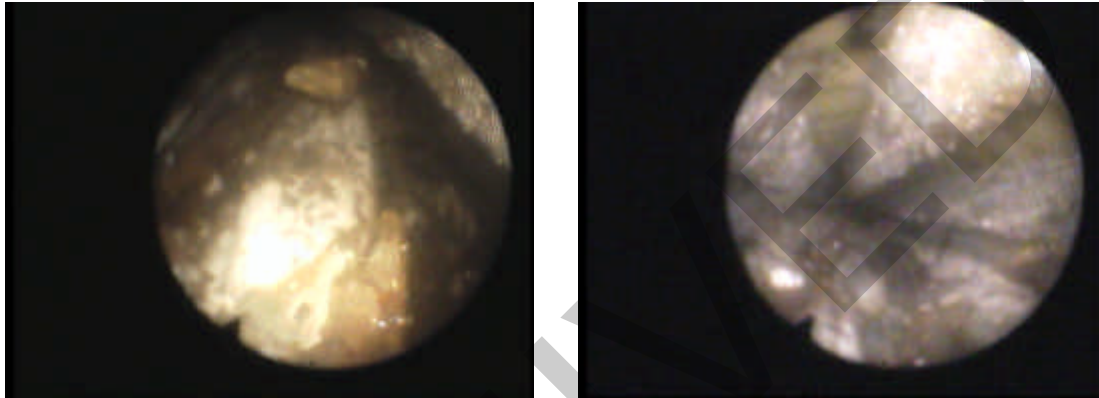
Borescope Photographs:

North Anchor – 12" void, white grout, light red corrosion on trumpet
South Anchor – 5 to 6 visible strands, 1 strand has a broken wire, moderate to heavy corrosion on all strands with pitting and blistering, moderate to heavy corrosion on trumpet, white grout
