SUBJECT: Temporary Design Bulletin DB-C01-1 and Commentary

Draft Report

This report summarizes inspections, tests, analyses, and repairs of the Mid-Bay Bridge post-tensioning system

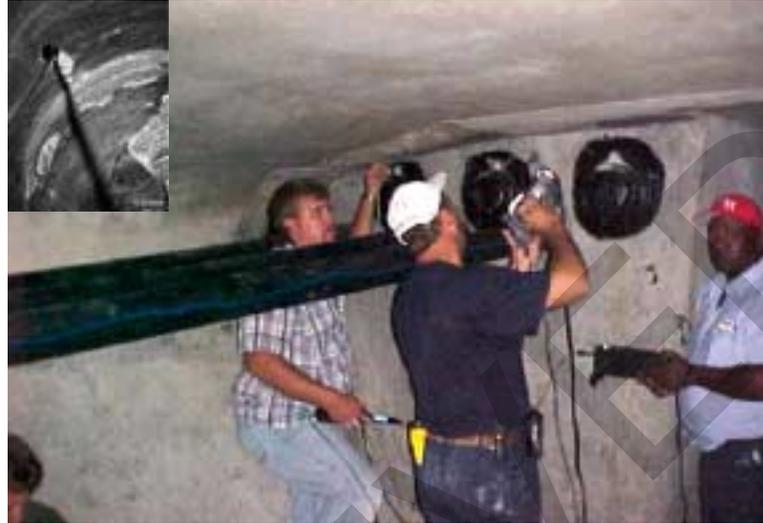
Figure 2.3 – Bore Scoping a Post-Tensioning Tendon Anchor Head

Four, four-person crews were used to inspect post-tensioning anchorages throughout the bridge. The bore scope is inserted in to the grout port after the grout filling the port is drilled out. Drilling is required for 2" to 3" before the clear access is available into a voided trumpet. If grout was found after drilling 4" then the anchorage was generally full. One inspector manipulates the bore scope inside of the anchorage while another inspector controls the video equipment. The other two members of the team provide support services to the two inspectors, including a hand written log documenting the number of strands viewed, depth of void, extent of corrosion and whether or not a second bore scope inspection was in order. All tendons that received a second inspection were reviewed by the lead inspector to have a consistent perspective as the extent of corrosion. Figure 2.3 shows a bore scope team inspecting an anchorage of the Mid-Bay Bridge. The inset photograph in Figure 2.3 shows the bore scope as it is inserted into the grout port.

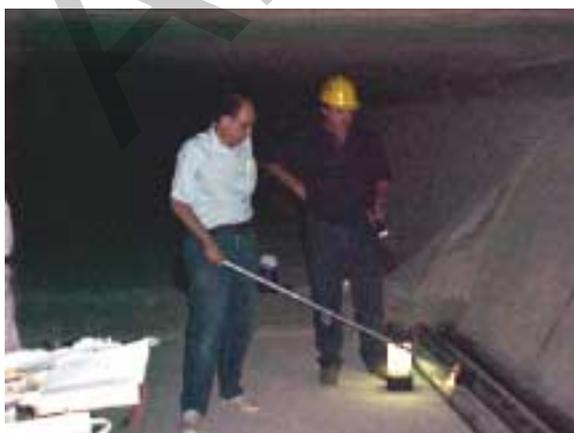
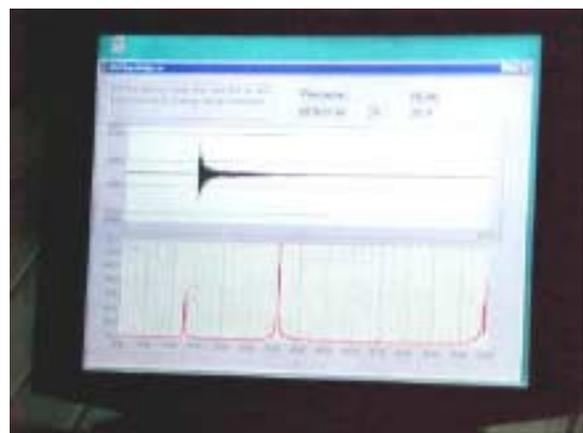
Figure 2.5 – Vibration Testing

Signal recording was performed using a laptop computer and proprietary software to acquire stereo audio input. The software creates an audio file (*.wav) of the recording that is stored in the computer hard drive, and provides visual indication of the waveform and spectral distribution obtained, allowing for immediate feedback in case a test needed to be repeated. Another proprietary computer program is used to compute the tension in the tendon. Figure 2.5 shows photographs of the vibration testing and the visual display of a tendon test.

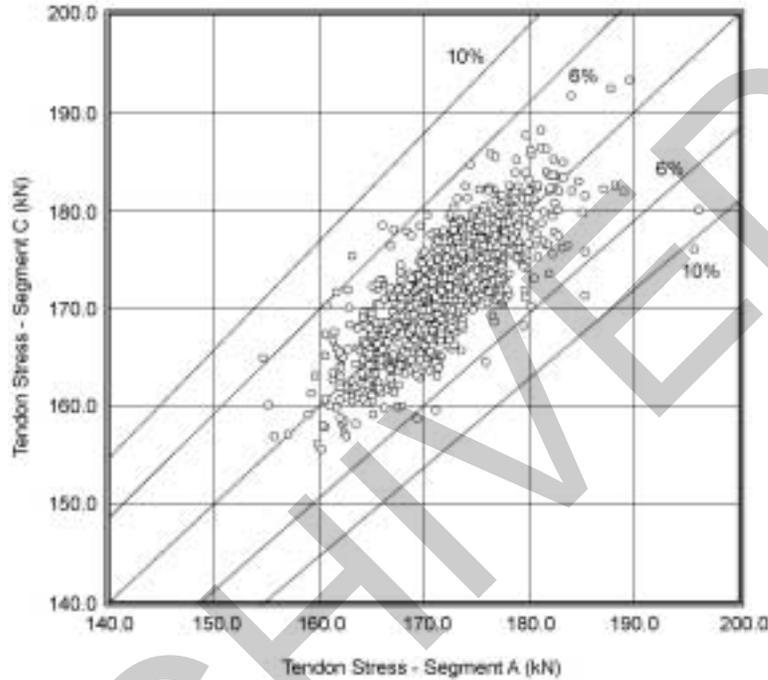
Figure 2.6 – Comparative tendons forces from vibration testing.

The raw data and synthesized results of the vibration testing for the Mid-Bay Bridge post-tensioning tendons is presented in Appendix C to this report. Figure 2.6 shows a summary plot comparing the stresses in Zone A and Zone C of the tendons. Equal forces in the two zones would result in a point plotted on the 45° line. The variations of all of the tendons are essentially within a +/-6% variation from equal values, indicating no significant loss in forces along the length of the tendon. Some variation is expected to exist as a result of friction developed during the stressing of the tendons.

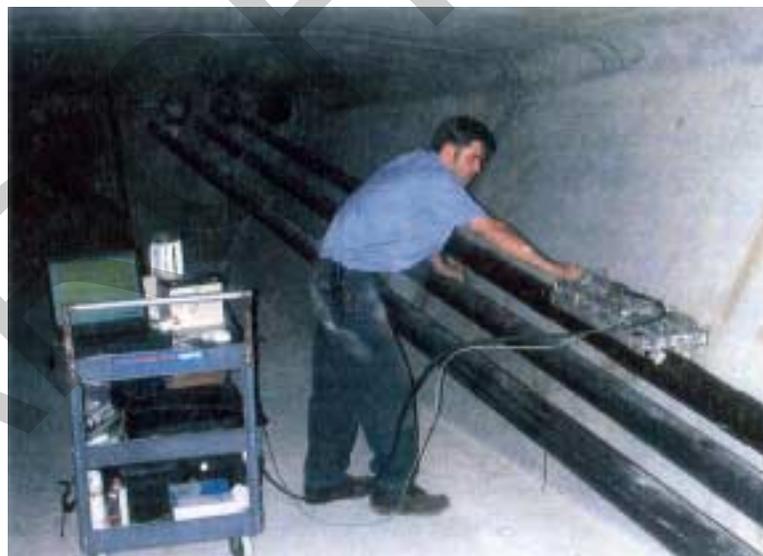
Figure 2.9 – Mag-Flux Testing

Mag-Flux Testing of the Mid-Bay Bridge found two locations along the lengths of two post-tensioning tendons where the results indicated corrosion and section loss had occurred. These locations and the findings were:

- Tendon 71-1 produced a positive test result for possible section loss in Segment A of the tendon, 30' from the start of the test. Physical examination of this location found a small hole present in the polyethylene duct. A small window was cut in the duct to further

In general, the number of tendon corrosion locations detected by Mag-Flux testing, was very low considering the number of tendons in the bridge. However, many of the ducts that had already been sealed by heat wrapping could not be successfully tested for reasons stated above.

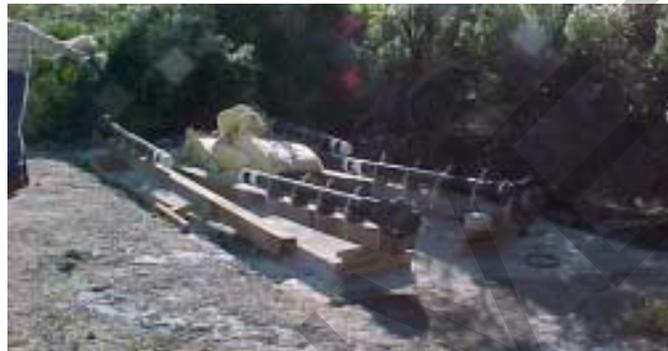
Figure 2.10 – Mock-up test specimen

Mock-up testing using the two proposed methods of grout injection was conducted to determine which produced the most effective repair of the anchor head. The mock-up tests were performed using the same components of the post-tensioning system used in the Mid-Bay Bridge. Post-tensioning strands were placed inside of anchor head and duct and partially filled with grout. The mock-up tests were slightly inclined to replicate voided conditions similar to those found during the bore scope inspections. Figure 2.10 shows the mock-up test specimens.

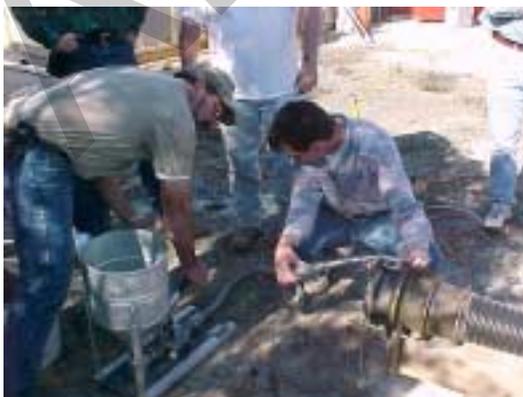
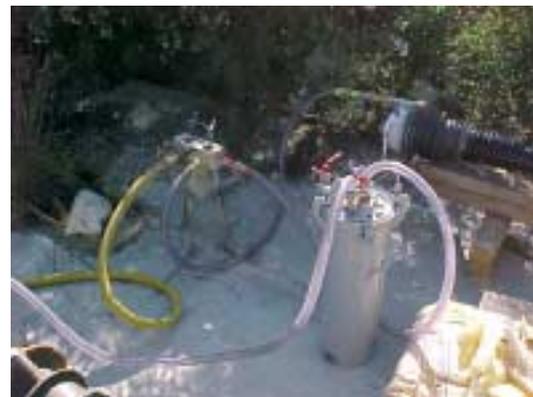
Figure 2.11 – Injection methods: Positive Pressure (left), Vacuum Injection (right).

After the grout in the test specimen hardened, the two different methods of injection, positive pressure and vacuum injection, were used to fill the voids in the anchor heads. Figure 2.11 shows the two injection methods in progress. The positive pressure method is shown on the left with the straw inserted into the grout port of the anchor head and a hand pump being used to force the grout into the voids. The vacuum injection method is shown at the right in Figure 2.11. One end of the grout injection tube is connected to the grout port. The other end is attached to a switchable manifold. The air is first removed under vacuum, being drawn out by the grout-metering pump. The volume is measured on the vacuum and therefore provides an estimate and degree of confidence in the amount of grout to be placed. Generally the amount of grout placed in the Mid-Bay Bridge has been slightly higher volume than the vacuum indicated. In the second stage of work the manifold controls are switched, locking off the vacuum and allowing the grout to be pulled into the void.

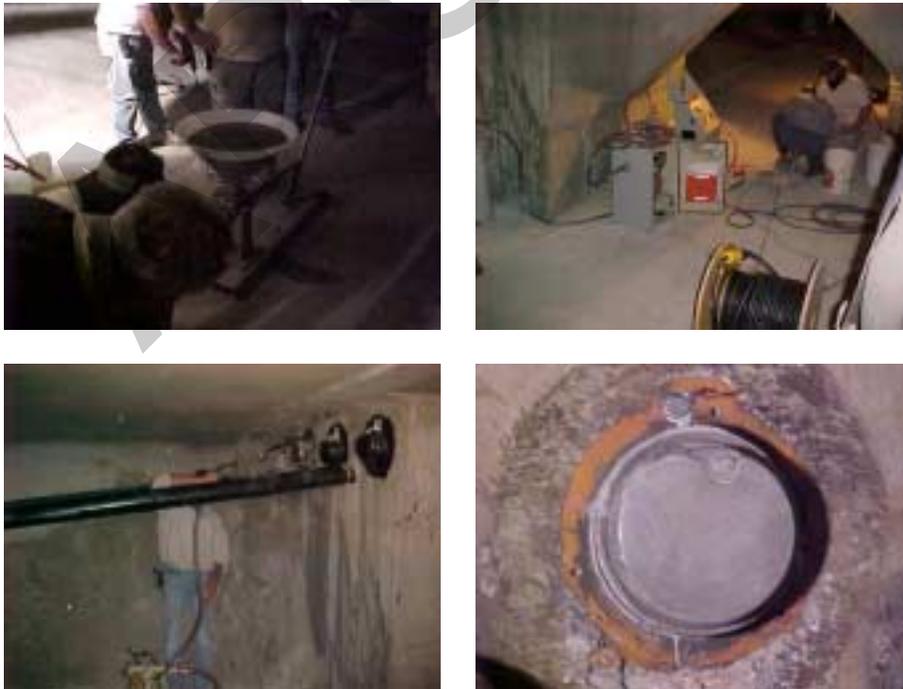
Figure 2.13 – Field trial of the vacuum injection method.

Following the mock-up testing a field trial was conducted to determine how to use the vacuum method of injection in the rehabilitation of the Mid-Bay Bridge. The photographs in Figure 2.13 show different scenes during the field trial. The photograph on at the bottom right of Figure 2.13 shows the finished grout cap this tendon. Based on the mock-up testing and field trials, the vacuum method of injecting the voids behind the anchors in the Mid-Bay Bridge is being used.

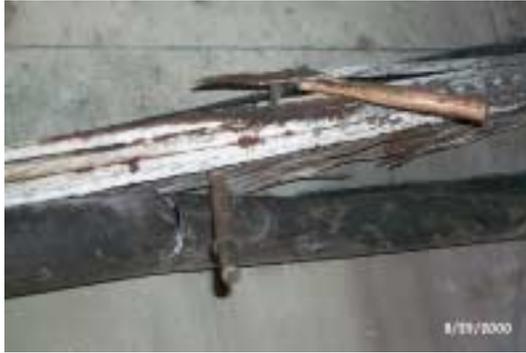
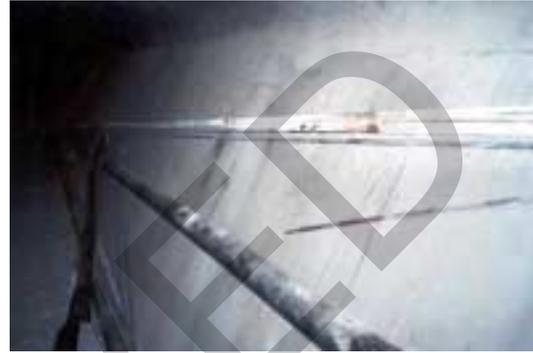
This tendon was one of the two failed post-tensioning tendons that were originally discovered during the annual inspection on August 28, 2000. A description of this tendon is found in Section 1 of Chapter 3. The tendon had already been replaced when the bore scope inspections were started.

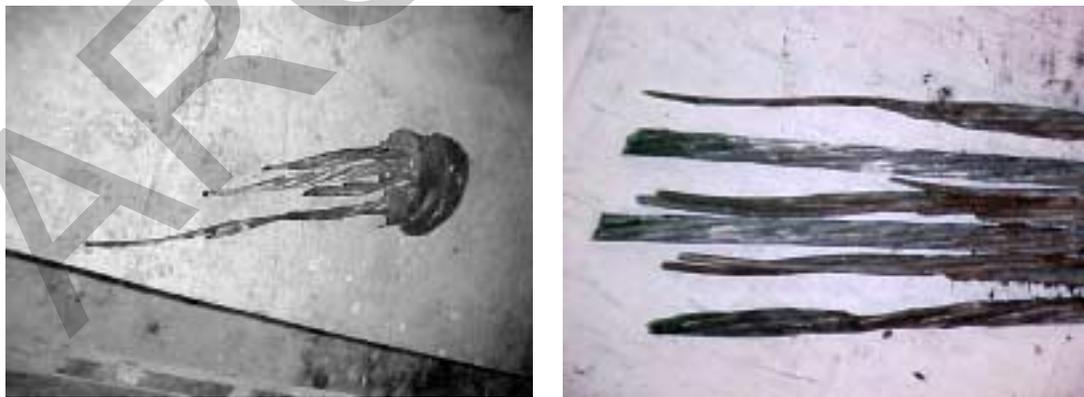
Photographs of removed tendon:

North Anchor – 3 to 4 strands visible, black and gray heavy corrosion on bottom of strands, broken grout, red and black (active) corrosion.
South Anchor - Information to be provided

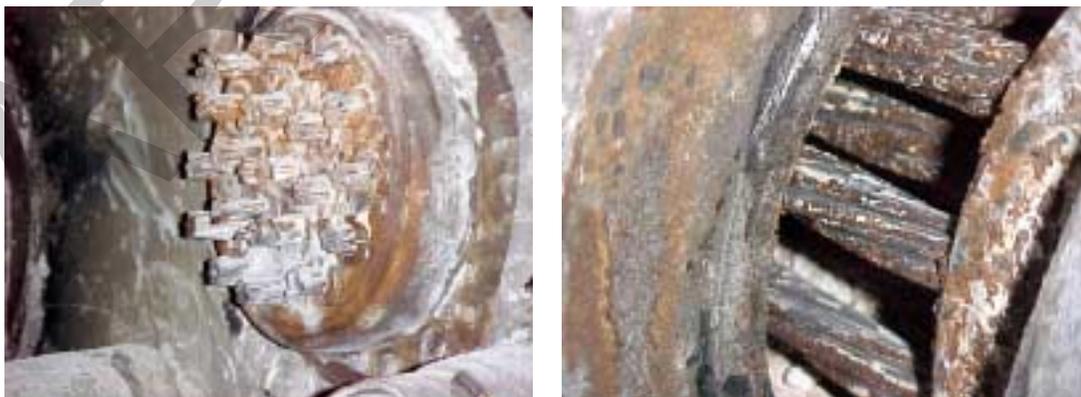
Photographs of removed tendon:

North Anchor – 6 strands visible with deep pits, 18" to 28" of penetration, bright copper, orange corrosion on tendons, active corrosion on side of trumpet
South Anchor – 2 1/2" void then solid grout, no video

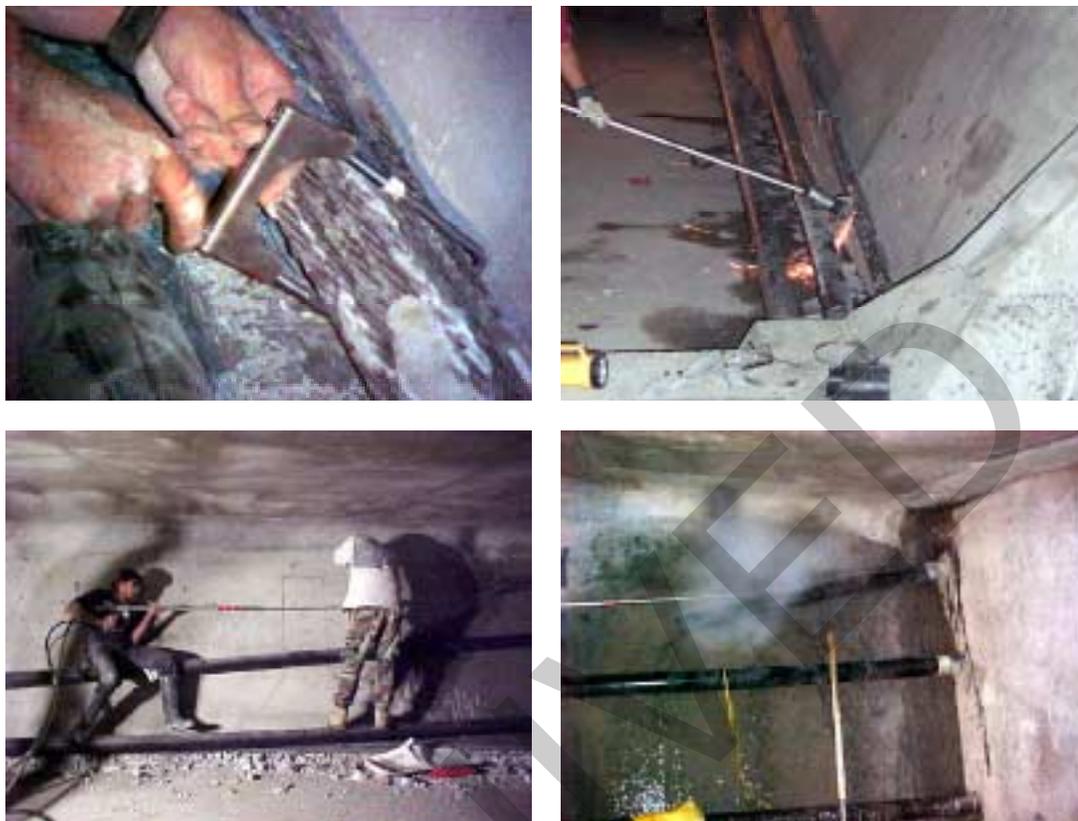
Figure 4.1 – Details of the Removal of External Tendons (Clockwise from upper left: clamping strands, cutting cable, hydro-blasting at pier segment diaphragm, and hydro-blasting operator)

The following are the steps taken by the Contractor to remove an external tendon from the Mid-Bay Bridge.

10. Check that cut strands are shortening by the appropriate amount to relieve their stress. If not, loosen U-bolt clamps to allow cut strands to slide along their length.
