Inspection and Monitoring of Fabrication and Construction for the West Halls River Road Bridge Replacement

Contract Number BDV30-706-01

TASK 1 Deliverable: End of Construction Report
(Part A – Fabrication and Construction)

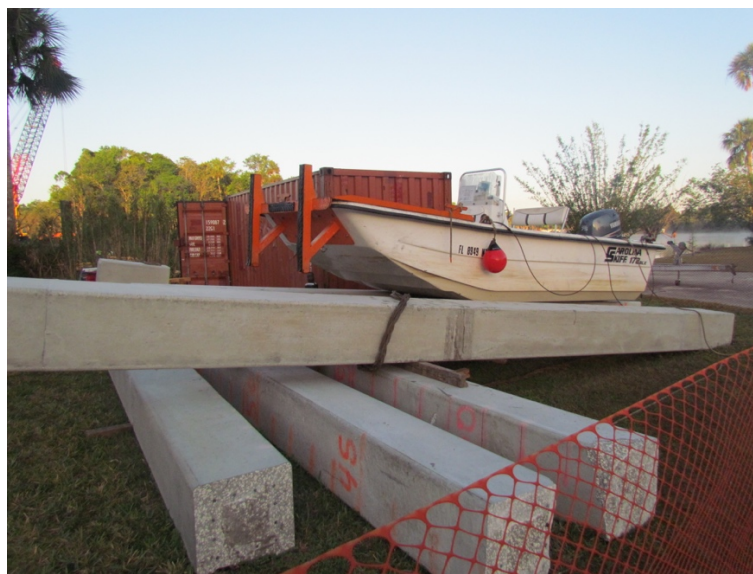
On March 22, 2017, the piles at bent 2 were driven on fuel setting 2 to within a foot of pile cutoff, without reaching pile bearing capacity. Astaldi had proposed to use pile cutoffs as splice piles for bent 2, due to the lead time required to order CFCC material and produce additional piles, as stated in RFI 0030. Pile R5 (bent 6 pile 3), pile R17 (bent 6 pile 1), and pile R2 (bent 4 pile 2) were selected due to the length and condition of the cutoffs. Although Pile R2 did not have any excessive spalling, there were cracks within the CFCC strands on the cutoff end of the pile, and a hairline crack extended approximately 2 ft longitudinally along the pile. The pile cutoffs were stored on-site but were not treated as usable piles. Some piles were stacked on each other, and the piles were used as a platform for boat storage, as shown in **Figure 6**. The use of cutoff piles was later rejected as a feasible option, and splice piles were fabricated at Gate Precast Company for Bent 2.

Figure 6: Stored pile cutoffs

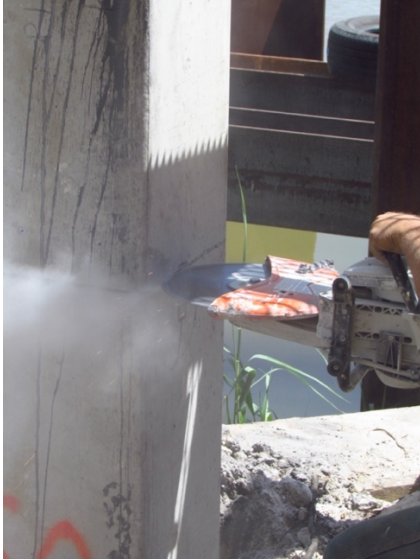
Figure 14: Cutting Bent 1 Pile 1

Piles 2 and 3 at bent 1 were cut on April 19 and 20, 2017 (**Figures 14 and 15**). The piles were prepared for cutting by removing the pile driving form and surveying and marking a pile cutoff line. Using a hand-held concrete saw, the piles were cut one side at a time, slowly moving around the pile. A loop was positioned over the pile head, and as the pile was cut free it was lifted using the crane.

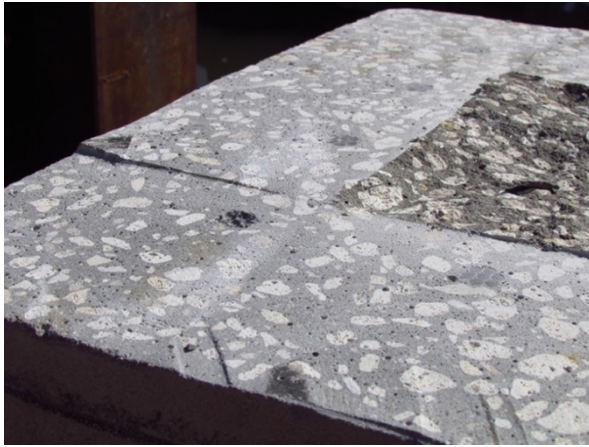
Bent 1 pile 2 exhibited cracking between the CFCC strands from the west to the east on the northern row of strands, and a few of the strands recessed slightly. The north-western edge of the pile spalled, and one of the CFCC strands tore, as shown in **Figures 16-18**. In bent 1 pile 3, one strand recessed slightly, as shown in **Figure 19**.

Figure 18: Tearing of CFCC (Bent 1 Pile 2)

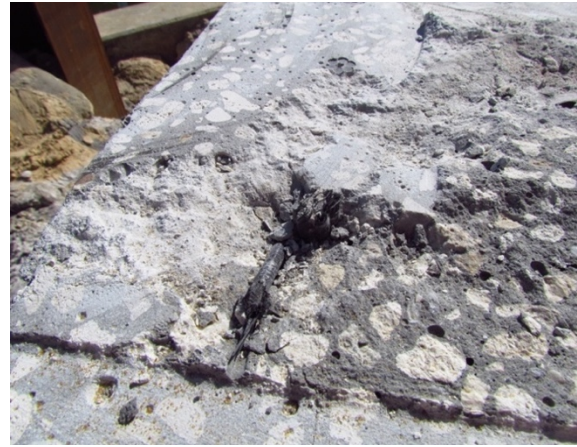
Figure 19: Recessing of CFCC (Bent 1 Pile 3)

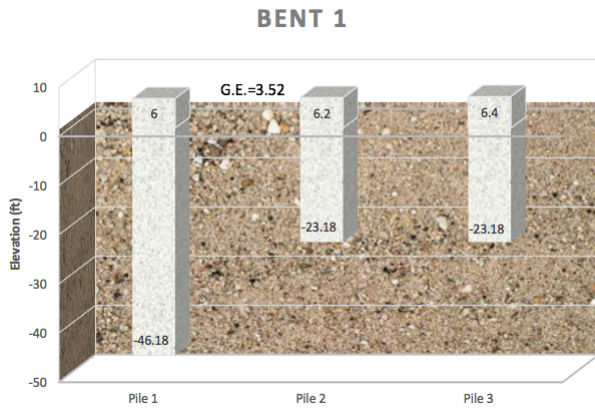
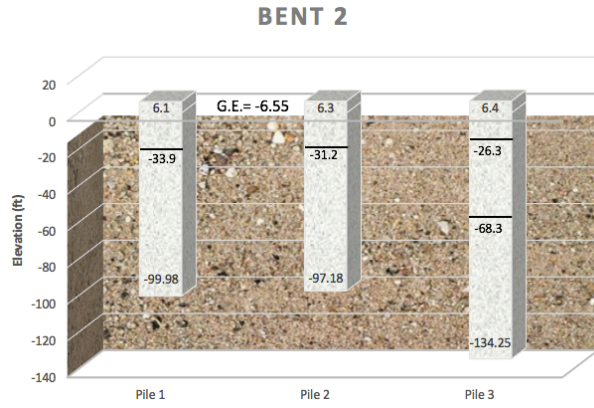
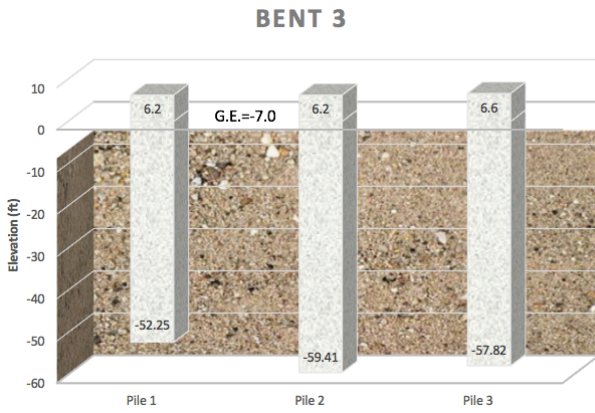
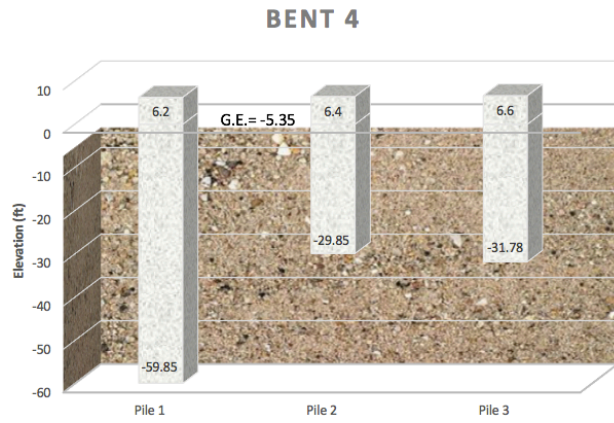
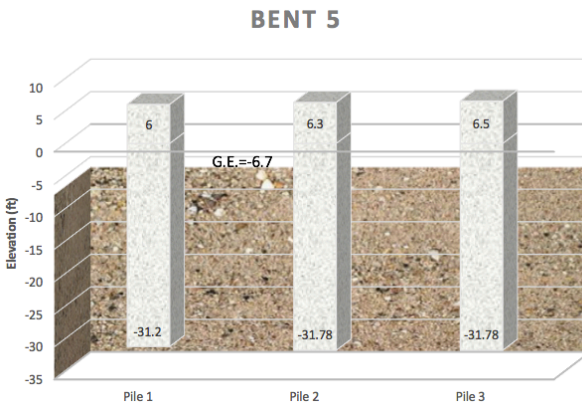
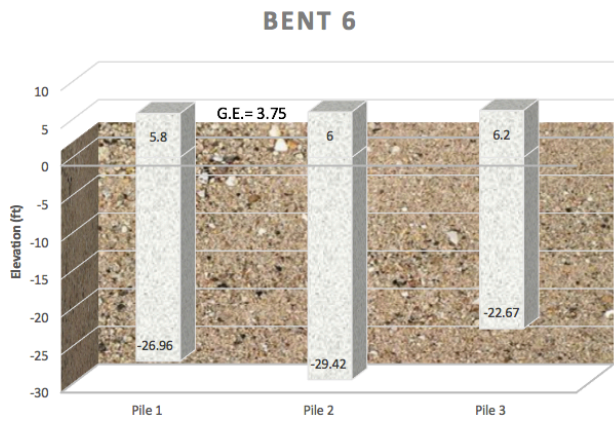
Figure 51: Phase II pile diagrams

Shown in **Table 4** is a summary of the pile data for Phase II, including the four splice piles required at Bent 2. A graphical representation of the pile data is shown in **Figure 51**, where the tip elevations, cut off elevations, and ground elevations (G.E.) of the piles are provided.

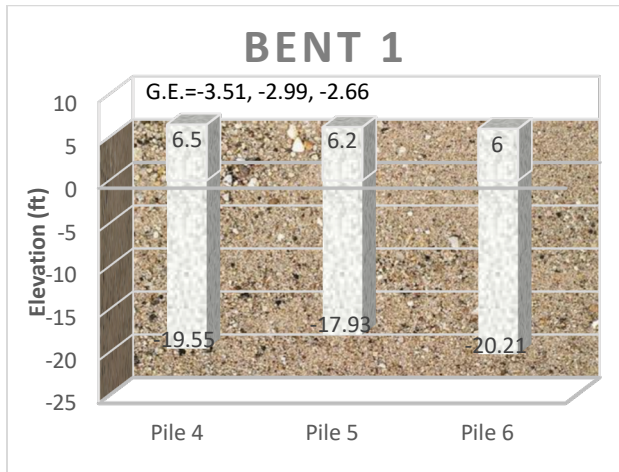
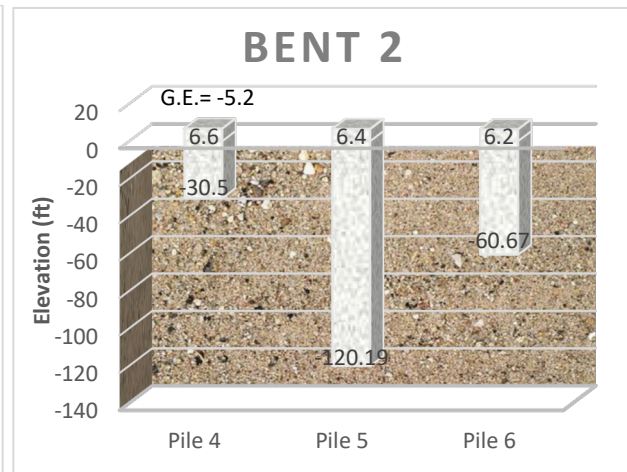
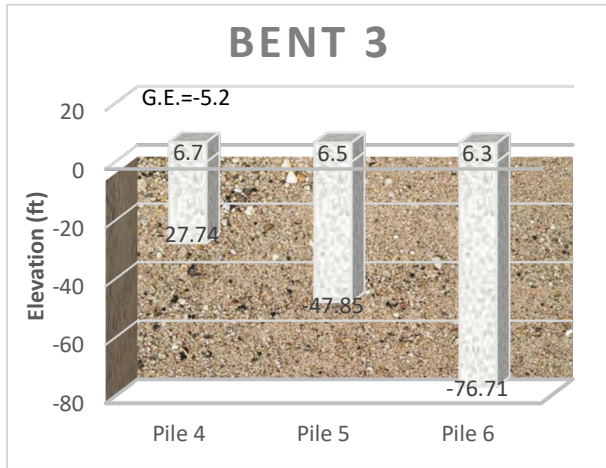
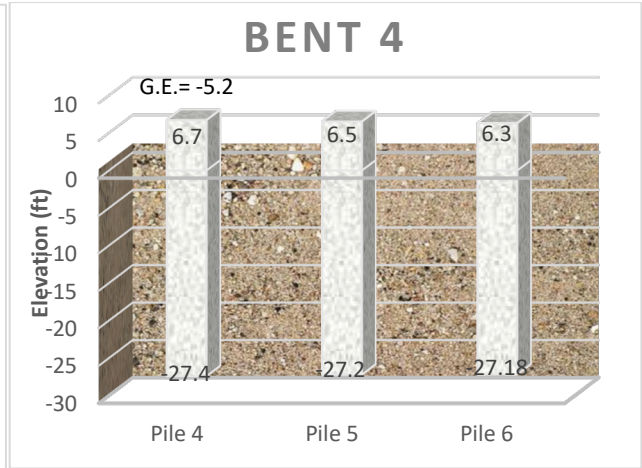
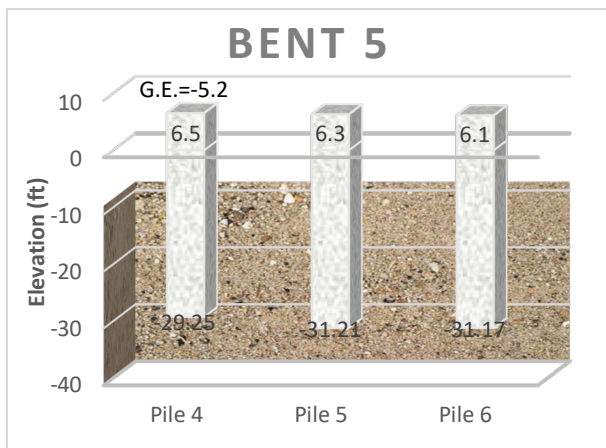
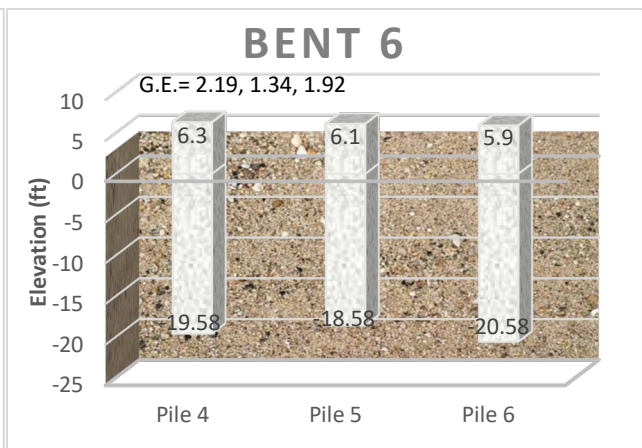
Figure 52: Phase III pile diagrams

elevation. As shown in **Figure 52**, there is a large variation between the driven pile lengths on bents 2 and 3 due to the varying soil conditions. Piles at bent 1, 2, 3, 4, and 5 are displayed in **Figures 53, 54, 55, 56, and 57** respectively. As shown, the pictures are prior to splice pile installation. Piles stored on site for bent 6 displayed cracks between the CFCC strands on all three piles, shown in **Figure 58**.

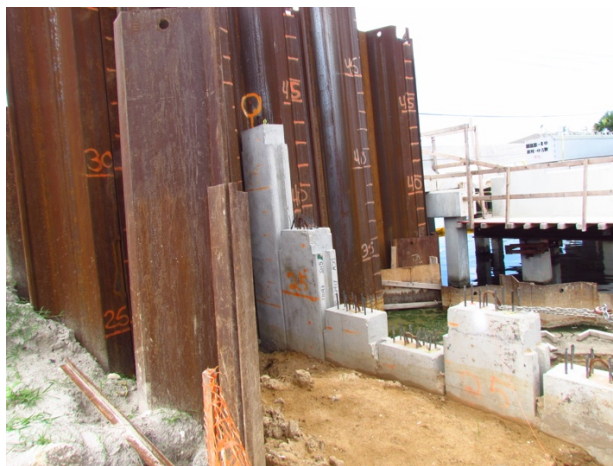
Figure 76: Installed CFCC sheet piles

Astaldi installed nine (9) CFCC sheet piles (**Figure 76**) by trenching on the east sea wall as of June 30, 2017. The sheet piles were installed to the lowest elevation possible, but they did not reach the required depth. Astaldi was able to trench through the first layer of dense soil, but they were unable to excavate soil after encountering a harder rock layer. A 42-in.-wide hydraulic drum cutter was ordered to excavate the solid rock layer. Trenching on the west side of the

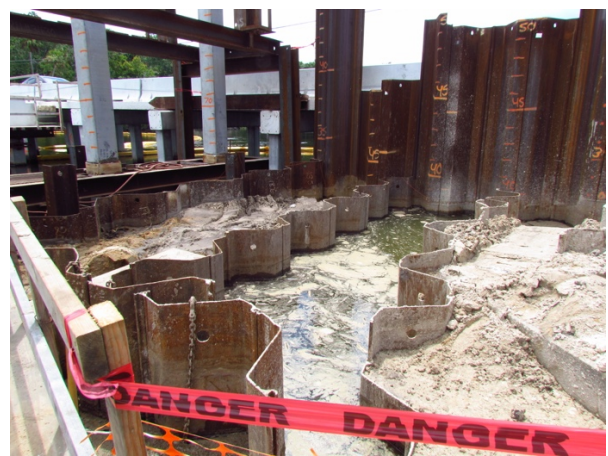
Figure 77: Double layer of metal sheet piles

bridge encountered the same dense rock layer. A double layer of metal sheet piles has been used on the west side to contain soil during trenching operations (**Figure 77**).

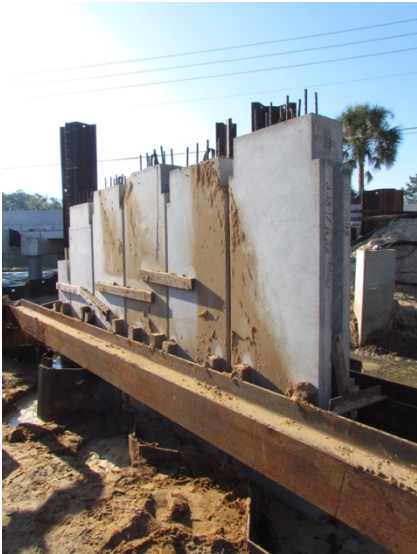
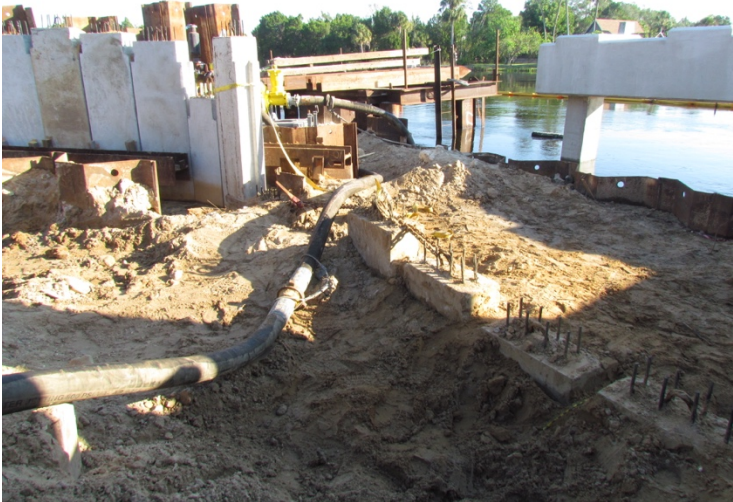
Figures 78: Sheet piles (West HRB)

As of September 28, 2017, fifteen (15) CFCC sheet piles were installed on the west side of Halls River Bridge (**Figures 78** and **79**). The soil conditions prevented timely sheet pile installation, and according to RFI 0040 all concrete sheet piles must be installed to plan elevations.

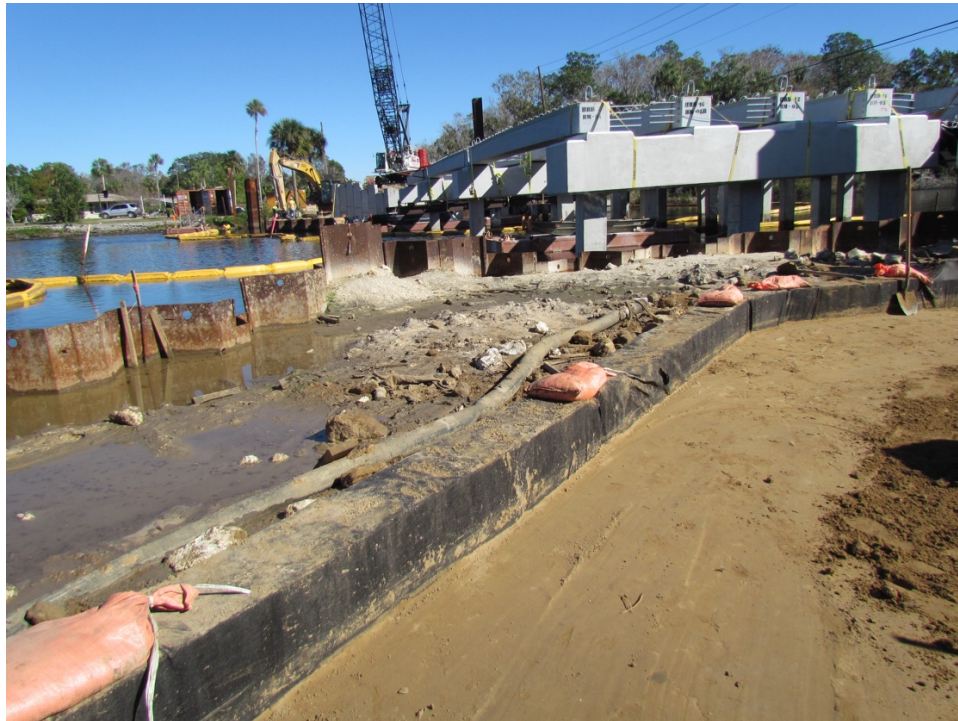
Figure 81: West side sheet pile walls (1A, 2A, and 3A)

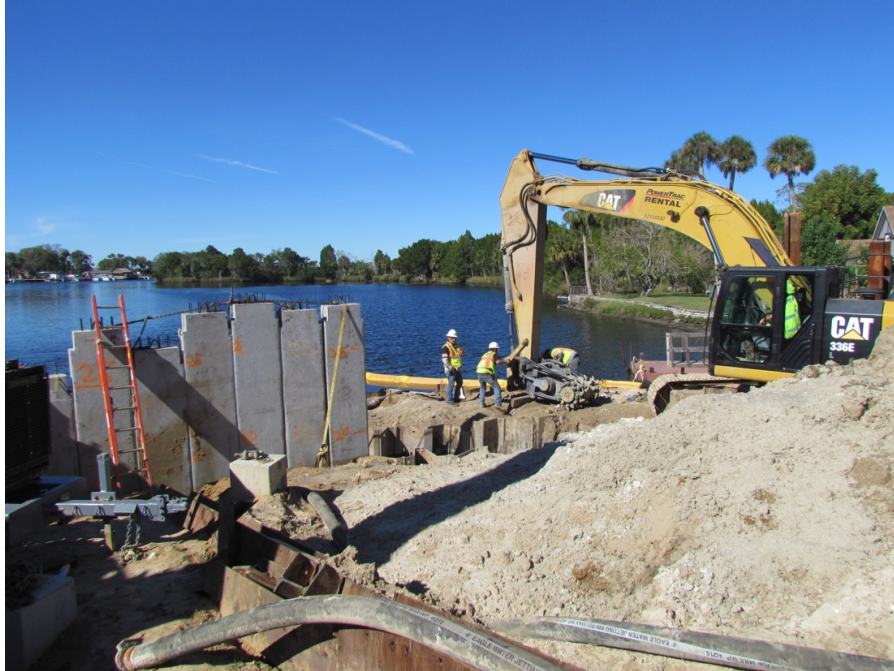
Figure 82: East side sheet pile walls

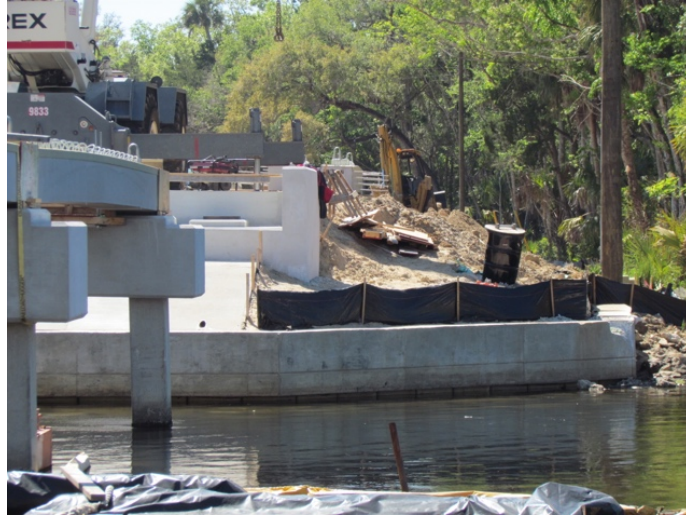
Figure 83: Sheet pile walls 1A, 2A, and 3A

The soil conditions encountered when installing the prestressed concrete sheet piles caused setbacks in construction. The sheet piles were installed by trenching using a CAT 336E with a rotor trenching attachment, shown in **Figure 79**. The minimum tip elevation was unreachable due to the soil conditions, leading Astaldi to propose a new sheet pile design with deadman anchors, as shown in **Figure 80**. The Phase II sheet pile walls on the west side of the bridge (sheet pile walls 1A, 2A, and 3A) have been installed using the proposed deadman design; the same method was used for the sheet piles on the east side of the bridge for Phase II (sheet pile walls 1B, 2B, and 3B). Sheet pile installation progress is shown in **Figures 81** and **82**. The updated design uses #5 stainless steel deadman anchors with a 6-in. perforated PVC sleeve. The sheet piles were to be installed to the minimum tip elevations listed in **Table 8**. After reaching approved elevation, the sheet piles were cut using a concrete saw and covered with an approved geosynthetic material. The sheet piles on the west side were backfilled and tamped to prepare for bulkhead cap formwork. The completed sheet pile walls 1A, 2A, and 3A are shown in **Figure 83**.

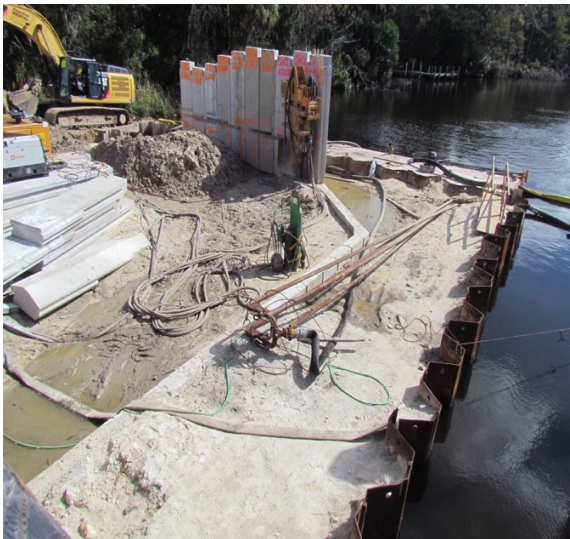
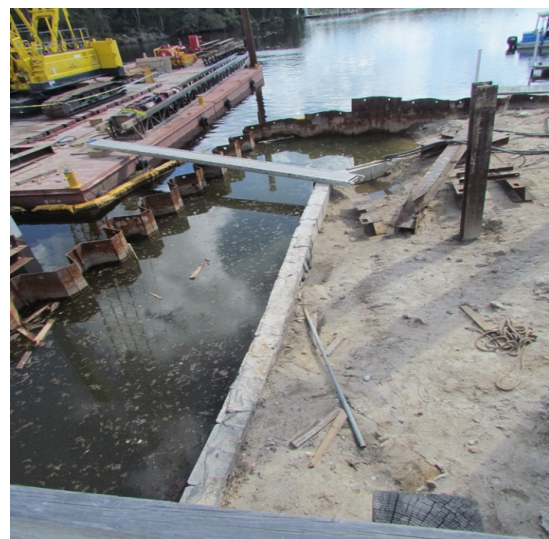
As of November 07, 2018, the east side seawall walls 4B and 5B were complete and construction was progressing on walls 6B, 7B, and 8B. Shown in **Figure 88**, the east side seawall 6B was under construction where temporary steel sheet piles were used to contain the soil during sheet pile driving. On the west side, walls 4A and 5A of the seawall were complete and wall 6A was under construction. **Figure 89** displays the completed seawalls 4A and 5A along with the installed temporary steel sheet piles. After construction of wall 6A, shown in **Figure 90**, walls 7A and 8A were to be constructed on the west side.

Figure 88: East side seawall (walls 4B, 5B, & 6B) Figure 89: West side seawall (walls 4A & 5A)

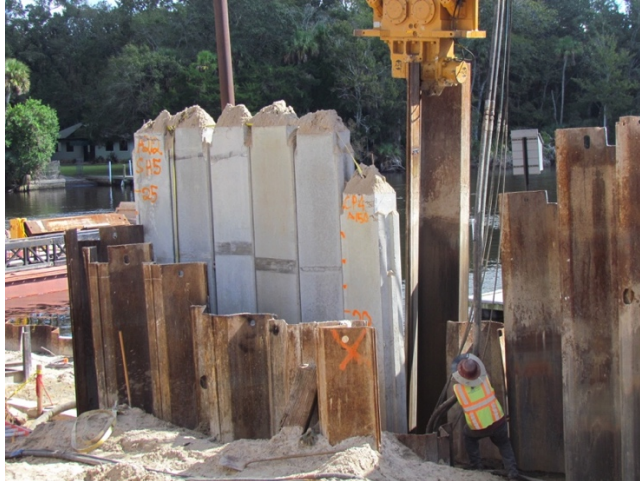
Figure 90: West side seawall (wall 6A)

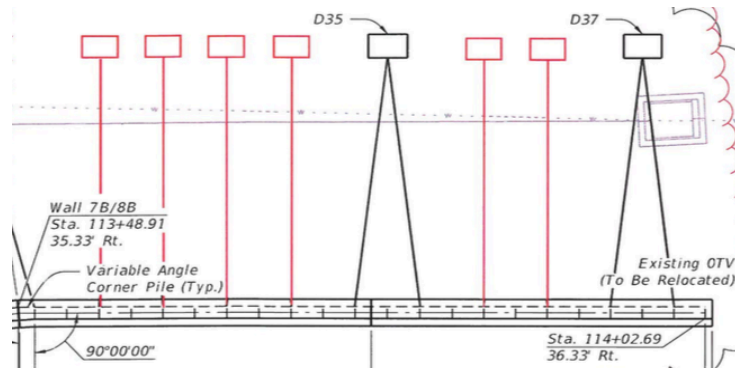
Sheet pile wall 8B is composed of twenty-one (21) sheet piles, of which twelve (12) of them did not meet minimum tip elevation, as shown in **Figure 91**. A2B Engineering LLC performed an independent analysis using Support IT to determine the sufficiency of the sheet pile walls. The analysis yielded an increased tie-back force from 1.523 kips/ft to 2.013 kips/ft. To account for the increase in tie-back force it was proposed to add additional deadmen anchors (with one stainless steel bar) every 5 ft where the sheet piles did not meet minimum tip elevation, as shown in **Figure 92**.

Figure 92: Wall 8B deadmen anchor design

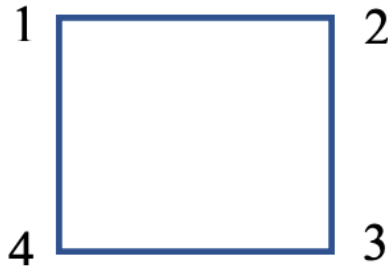
After performing an as-built survey on bents 3 and 5, it was noted that both of the bents were out of tolerance, as stated in RFC 0001 Rev.1. The error was caused by a surveying inaccuracy when forming the pedestals; the four corners of each pedestal were surveyed to determine the difference in elevations. At bent 5, the difference in elevations vary from 0.8 to 1.8 in. above plan elevations, while at bent 3 the elevations vary from 0.8 to 1.6 in. below plan elevations. The elevations at the four corners of each pedestal are shown in **Table 13**, with the point locations shown in **Figure 101**. At bent 3, a non-shrink grout NC FL GROUT (APL 934-000-019) was used to reach plan elevation, and at bent 5 the pedestals were ground down to reach the plan elevation.

Figure 101: Location of surveyed points

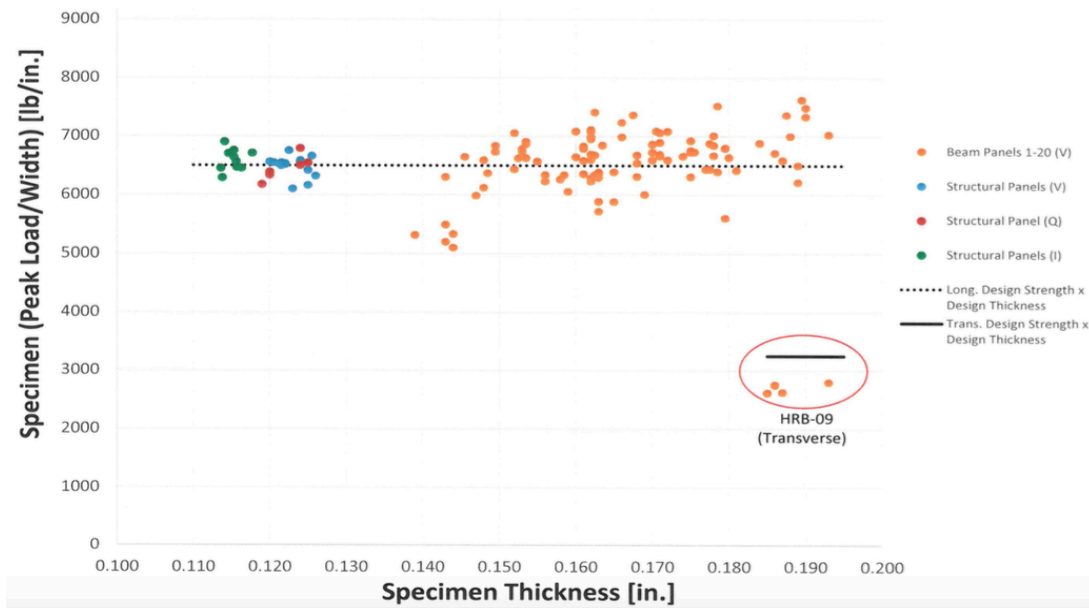
According to RFI 0039, witness panels tested by FDOT Materials Office resulted in a longitudinal tensile strength and longitudinal tensile modulus below the values shown in TSP-T-450. The values obtained from the test results are a longitudinal tensile strength of 33 ksi and a longitudinal tensile modulus of 2,300 ksi.

including the CFM layer and tested by FDOT State Materials Office for beams 1 through 20. The panels were tested based on ASTM D3039 Tensile Properties of Polymer Matrix Composite Materials in the longitudinal (0 degree) direction. **Figure 136**, provided by FDOT State Materials Office, displays both sets of tested panel data. As shown in the figure, there is no significant increase in longitudinal or transverse capacity due to the presence of the CFM layer.

Figure 136: HCB panels without CFM layer

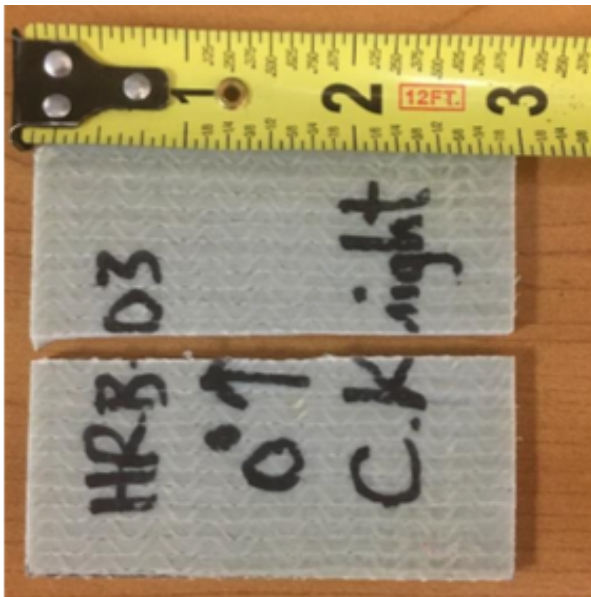
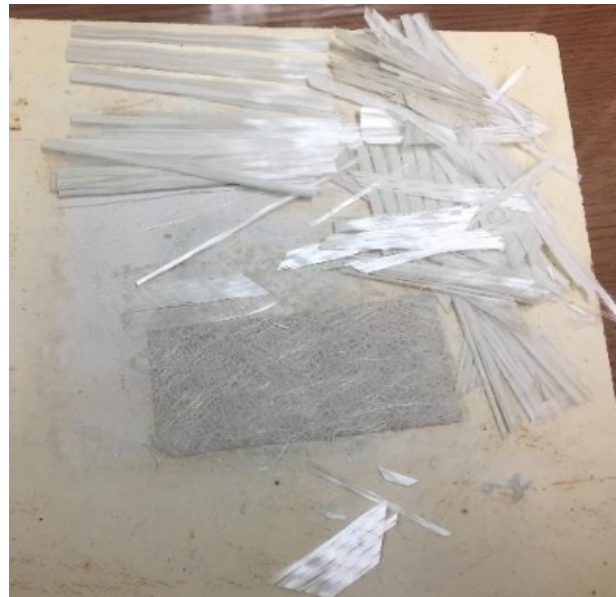
Kenway Corporation believed the reduced strength of HRB-03 was due to a missing fiberglass layer. Beam 9 (HRB-09) low values could be due to incorrect labeling of the panel fiber direction thus the results for HRB-09 correspond to transverse tensile properties. FDOT State Materials Office and Kenway Corporation performed burn-off tests to determine the fiberglass structure of the witness panels for beams HRB-03 and HRB-09. Kenway performed the burn-off test by placing the 2 ¾ in. x 3 in. samples into a muffle furnace set to a temperature of 1050°F, removing the samples after four hours, and allowing them to cool overnight, as shown in **Figures 137** and **138**. Kenway reported that the burn-off test of HRB-03 witness panel revealed the 24 oz biaxial E-BX-2400 layer was missing. A summary of the thickness and weights of the specimens tested by Kenway Corporation are shown in **Table 18**.

Figure 137: Samples cut for testing (Kenway Corp.)

Figure 138: Samples deconstructed after testing (Kenway Corp.)

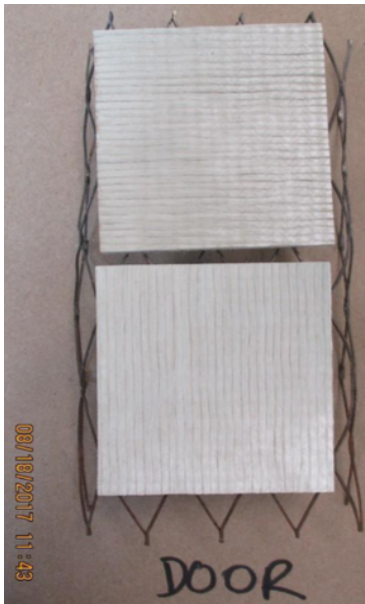
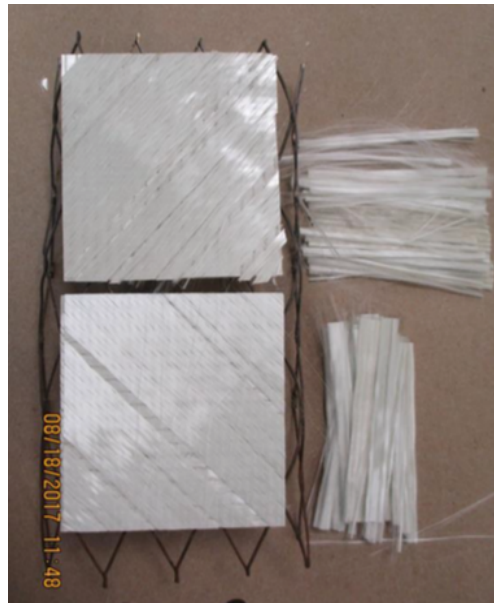
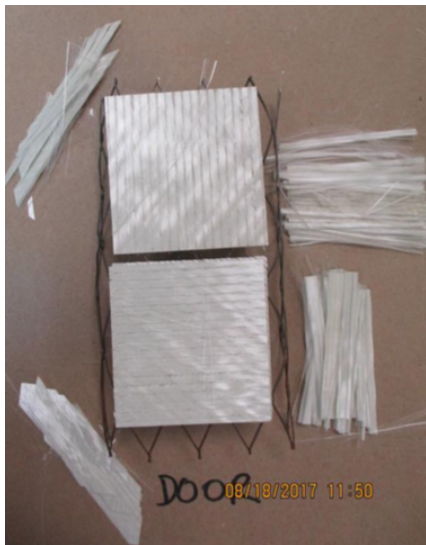
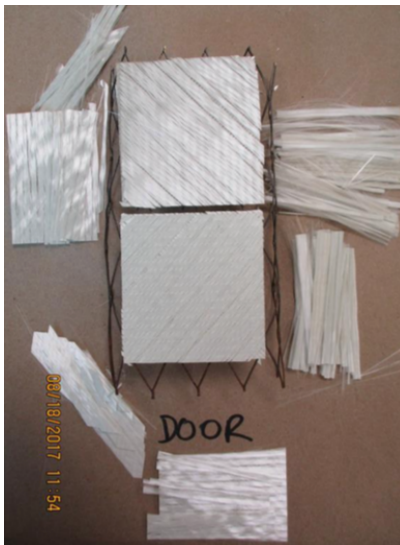
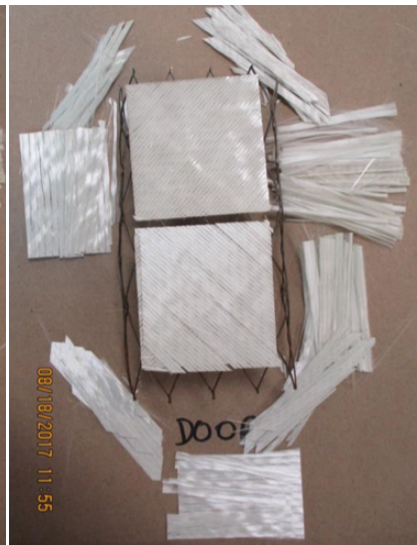
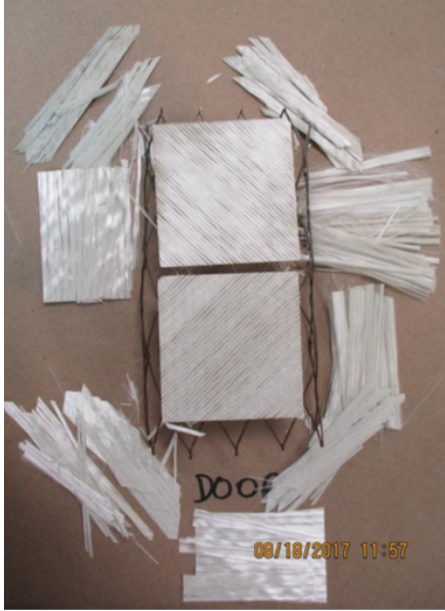
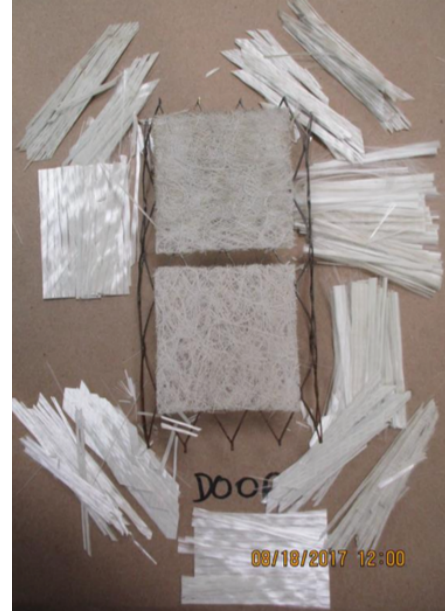
FDOT placed samples in a muffle furnace set to 550°C (1022°F) for two hours to burn off the resin. FDOT's results of the burn-off test for beams HRB-03 and HRB-09 were fiberglass layers consistent with the shop drawings (HRB-03 was not missing a 24 oz layer) and confirmation that HRB-09 primary fiber direction was perpendicular to the marked direction, as shown in **Figures 139-145**.

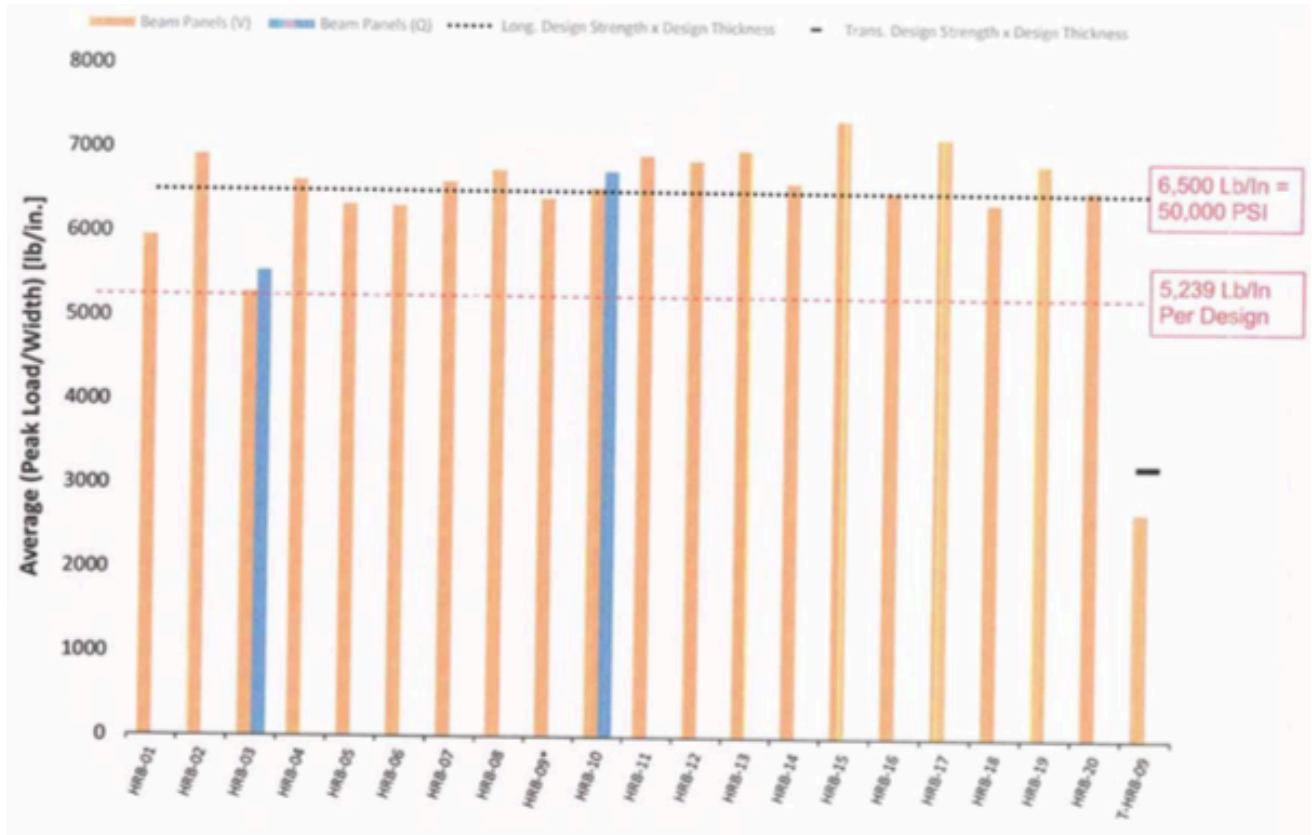
When considering the ultimate tensile stress per unit width, HRB-01 through HRB-20 meet the minimum strength requirements, as shown in **Figure 146**. According to Garcia Bridge

Engineers P.A. the beam laminate exceeds the design requirements and should perform as designed.

Figure 146: Average load per unit width of HRB-01 through HRB-20

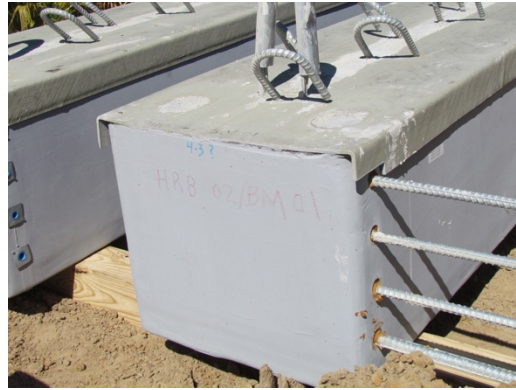
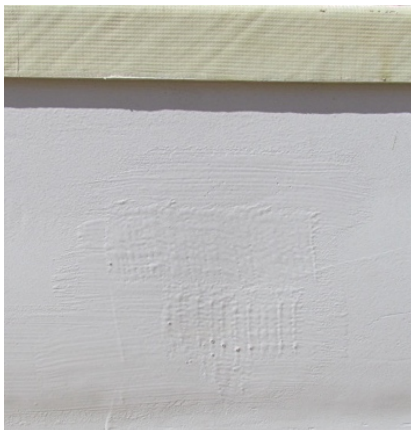
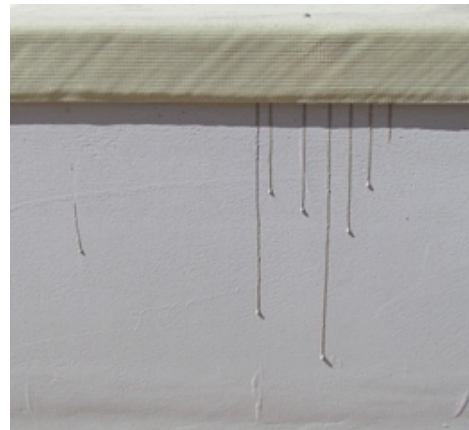
Upon inspection, one beam (HRB-02, BM-01) displayed surface flaws including an abrasive surface patch, dripping lid sealant, and unpainted beam labels (**Figures 151-153**).

Figure 151: Unpainted beam labels on HRB-02

Figure 152: Abrasive patch on HRB-02

Figure 153: Dripping sealant on HRB-02

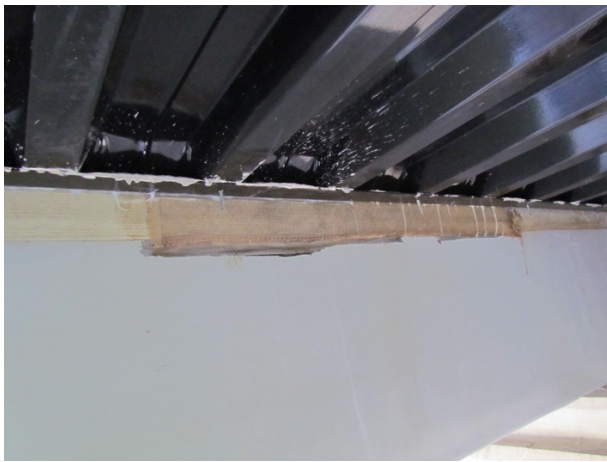
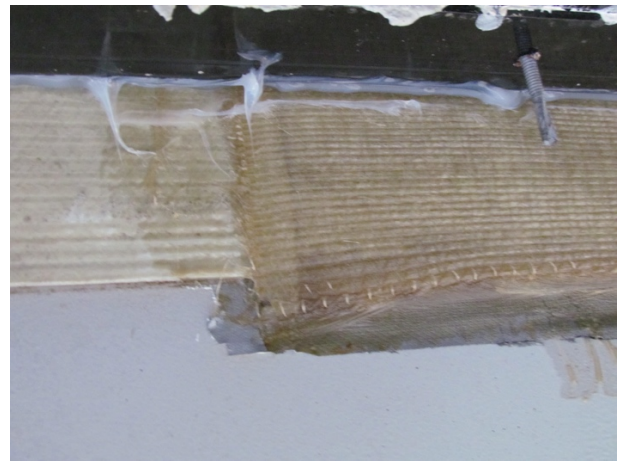
Figure 160: HC Beam patch

Figure 161: HC Beam patch

Since the repair, the black plastic covering the repair patch has been removed; the patch is shown in **Figures 160** and **161**.

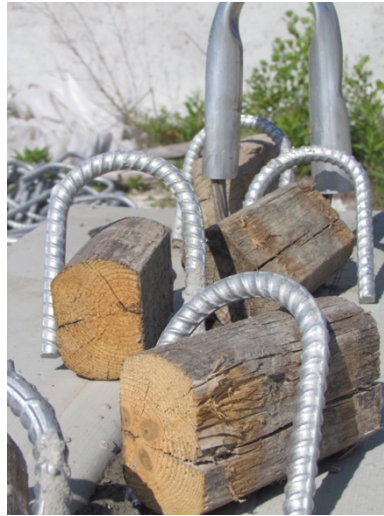
Unlike the first HC beam pour where rebar was used to hold the shear connectors at a height of 5 in., wooden blocks were used to position the shear connectors. As shown in **Figure 163**, some of the shear connectors were positioned above the wooden blocks resulting in non-uniform height and position of the shear connectors.

Figure 163: Uneven shear connectors

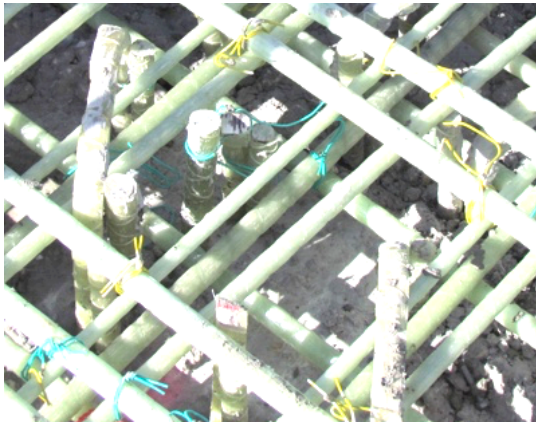
Figure 171: Top of diaphragm reinforcement removed

When casting the diaphragms, site inspectors mentioned the instability of the 6D1 GFRP stirrups; the stirrups were attempting to float during concrete placement. Upon inspection, some of the GFRP stirrups were too high to provide the minimum required concrete cover of 2.5 in. According to RFM 0013, select stirrups were required to be ground down to maintain a clear cover of 1.5 in., and other stirrups were cut off to maintain a minimum cover of 1.75 in. and a maximum of 2.5 in. The location, elevation, and action required to maintain minimum cover of the stirrups are listed in **Table 28**. **Figures 171** and **172** show the removed GFRP stirrups.

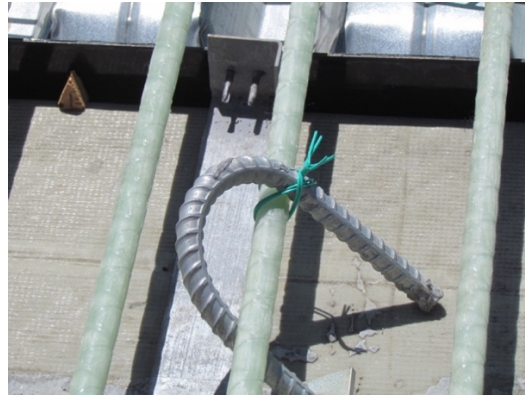
Figure 182: GFRP bars tied to shear connector

A few issues were encountered when tying the GFRP reinforcement including the angle and height of the shear connectors, the spacing of the SIP (stay-in-place) deck form anchors, and the height of the GFRP diaphragm stirrups. The angle of some of the shear connectors was causing issues with the spacing of the longitudinal GFRP bars. The contract plans require a 4.5-in. bar spacing, but the location of the shear connectors was allowing for a 3 in. or 6 in. spacing for

longitudinal bars. A few of the shear connectors were too high to provide minimum concrete cover; the shear connectors were bent to accommodate bar spacing and height requirements. GFRP bars tied to shear connectors are shown in **Figure 182**.

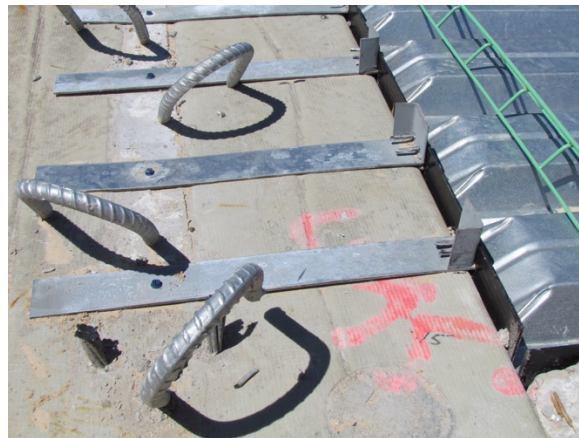
Figure 183: SIP deck form support bars

The original plan was to install stay-in-place (SIP) deck form galvanized support bars spaced every 18 in., but after installation the stability of the forms was a concern. To increase the stability of the forms, support bars were installed every 9 in. on the interior beams and every 18 in. on the exterior beams (**Figure 183**). Four Tapcon screws per anchor were used to secure the forms to the HC beams.

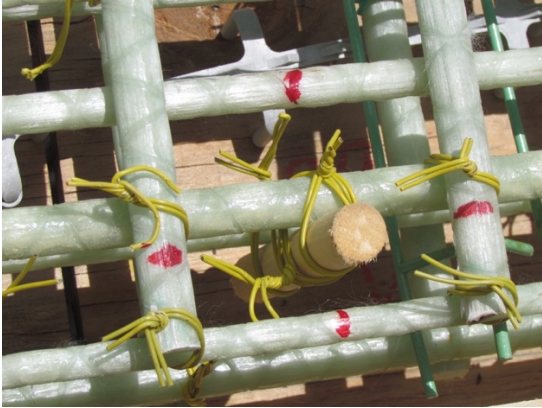
Figure 186: Wooden dowel installation

To mark the future drilling location for pedestrian handrail installation, wooden dowels were installed, as shown in **Figure 186**. Upon inspection, the wooden dowels were not stable and continued to shift when workers walked across the GFRP reinforcement bars. It was decided to remove the wooden dowels, and the GFRP bars were marked in red to indicate the point of intersection for future handrail installation, as shown in **Figure 187**. During concrete placement, the GFRP bars shifted, resulting in unknown alignment of the GFRP bars in comparison to future drilling locations.

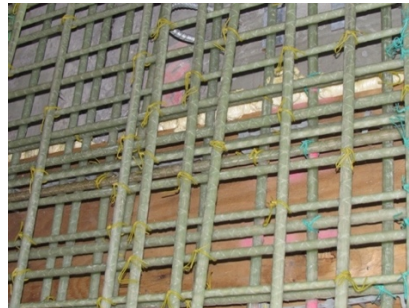
Figure 188: Spray foam in deck form

On the morning of the deck pour, inspectors noticed spray foam next to the exterior beams on the deck forms (shown in **Figure 188**); workers were required to remove the foam before the deck pour.

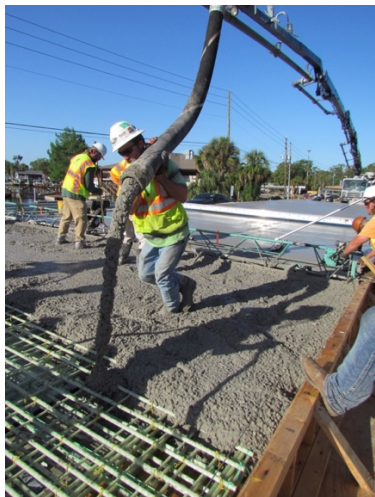
Figure 196: Pumping of deck concrete

As the concrete was pumped onto the deck reinforcement, the GFRP bars were visibly shifting. Bar movement was especially noticeable when the pump hose was angled, as shown in **Figure 196**. As shown in **Figure 197**, the GFRP bars were tied at multiple locations along the length of the bars. Using a GFRP bar with larger deformations or using a stronger tie wire could reduce bar movement. After screeding the deck, the screed was removed, and the deck end was smoothed using hand trowels (**Figure 198**). The deck was then smoothed with a bull float, and a broom finish was applied, as shown in **Figure 199**. The deck was wet cured for seven (7) days and forms were pulled after approximately three (3) days; no heavy equipment was allowed on the deck for 14 days.

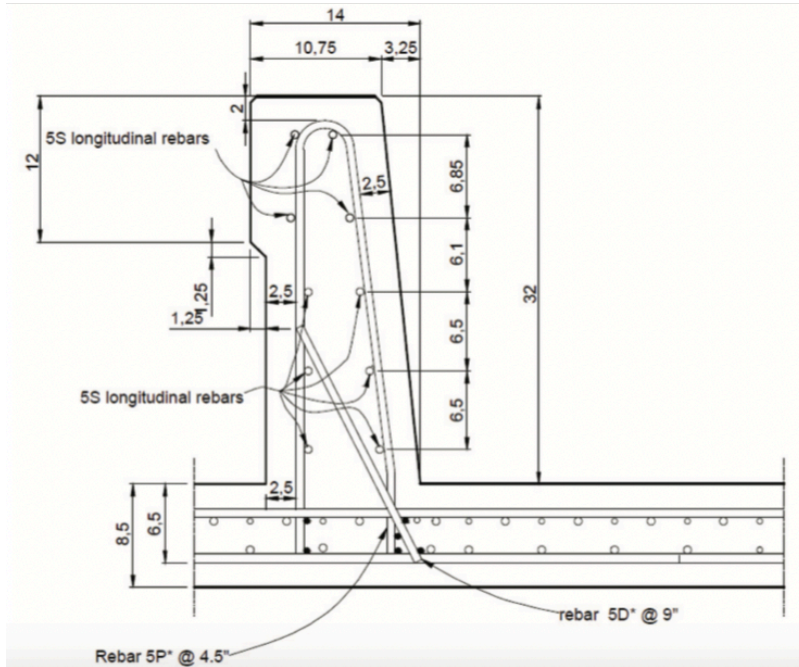
Figure 203: North side traffic barrier (FDOT)

As shown in **Figure 203**, the north side traffic barrier 5D and 5P bars were designed to extend into the deck 6.5 in. Because of the construction phasing, the 5D and 5P bars will be epoxy embedded into the deck. While the design calls for an embedment of 6.5 in., the maximum embedment depth possible is 4.5 in. Astaldi Construction tasked the University of Miami with performing pull out tests of GFRP bars using the sheet pile cutoffs. FDOT Section 416-6, on the field testing of post-installed anchors systems and dowels, will be adhered to during pullout testing. A potential cause for the lack of achievable embedment depth was the failure to block-out or mark the location for future drilling of the post-installed bars during the deck pour. Astaldi Construction attempted to install wooden dowels to mark the drilling location, but installation of the dowels was too time consuming. As a result, the location for future drilling was marked on the deck GFRP bars with the intent to monitor the marks during the deck pour to ensure the bars had not shifted. Unfortunately, the GFRP bars were moving more than anticipated during the pour, especially when the concrete pump was angled at the GFRP bars.

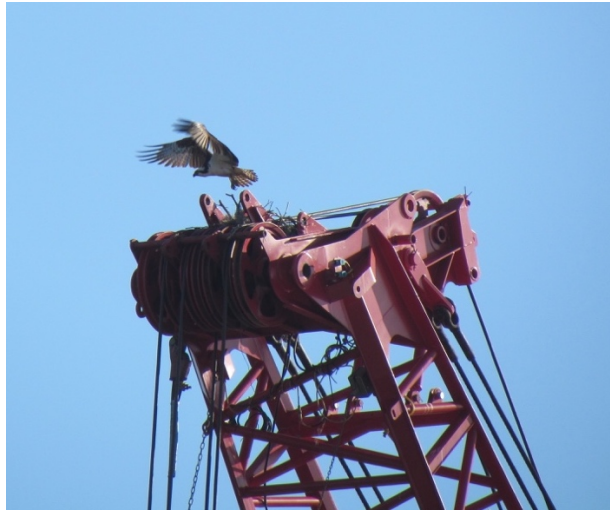
Figure 206: Osprey nest on crane

On March 27, 2017, the crane boom was lowered to begin pile driving operations, and an Osprey nest was discovered on the end of the boom. The crane had been raised over the weekend, allowing time for an Osprey to create a nest (**Figure 206**). Osprey (*Pandion haliaetus*) are a raptor species that typically nest between December and February. Protected by the U.S. Migratory Bird Treaty Act, Osprey nests cannot be moved without a permit. On April 17, 2017, the Osprey nest was relocated, under the supervision of Florida Fish and Wildlife Conservation Commission, to a post installed on Margarita Grill property. The nest was brought down the

crane in a box with a heated compartment for the eggs. After relocation, crows took over the nest, and it is believed that the eggs were eaten by the crows. Strobe lights and flags have been placed on each crane to prevent future bird nesting incidents. Although the eggs were not preserved, the Osprey have been spotted returning to the relocated nest.

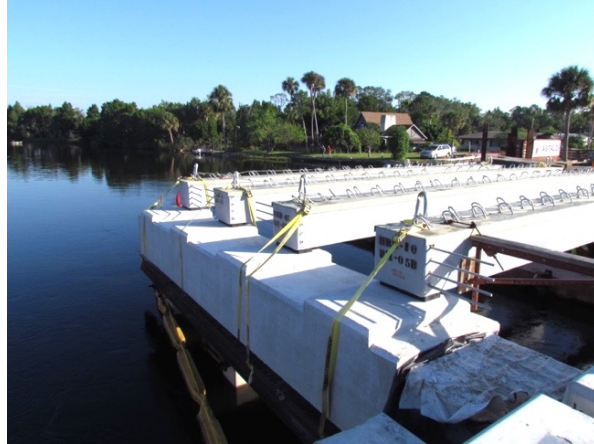
On September 11, 2017, Hurricane Irma passed through Citrus County, Florida. Astaldi prepared for Hurricane Irma by securing the jobsite, moving and securing the crane, removing barges from Halls River, and stacking and securing wooden platforms. The HCB beams were secured, as shown in **Figure 207**. The only disturbance to the bridge site was to the storm water control structures, which were easily put back into position. Due to the large number of Florida residents evacuating from Hurricane Irma, FDOT requested Astaldi to stop construction until September 18, 2017.

Figure 207: HCB beams strapped for Hurricane Irma
