Inspection and Monitoring of Fabrication and Construction for the West Halls River Road Bridge Replacement

Contract Number BDV30-706-01
FSU Project ID 038971

**TASK 2 Deliverable: Six-Month Report
(Part A – Visual inspection of bridge)**

Draft 1 Submitted June 14, 2020

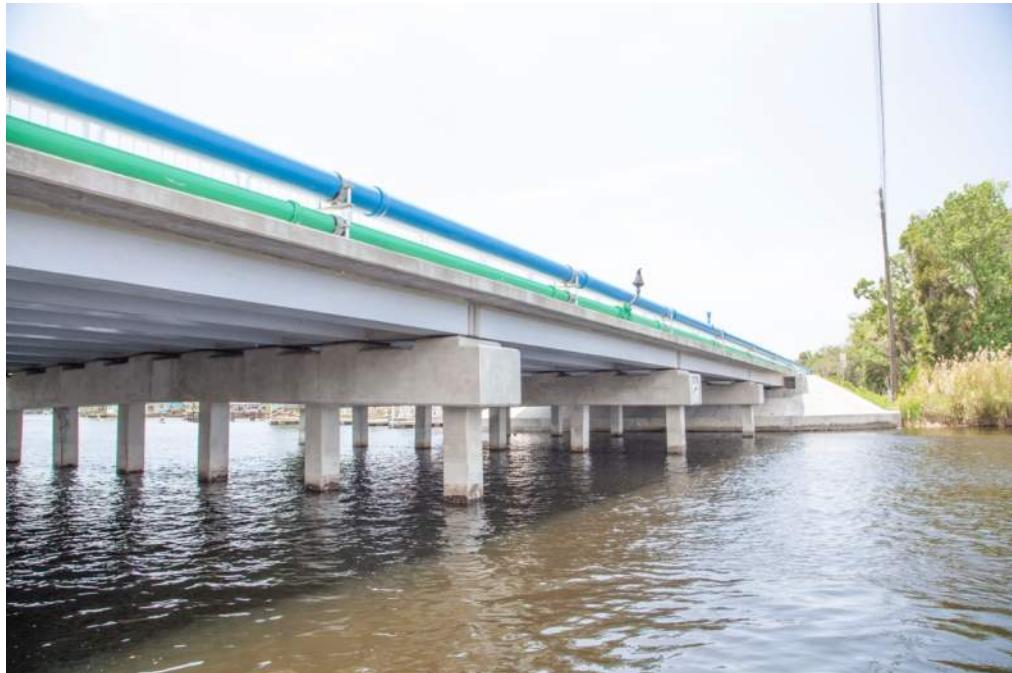
Figure 10: Spans 1-4, looking southwest, view from north side

Figure 10 shows a view from the north side of the bridge, looking southwest towards Spans 1-4. Photos of the end bents are shown in **Figures 11-15**. Intermediate bents are shown in **Figures 16-23**. Photos of the underside of the beams are in **Figures 24-28**.

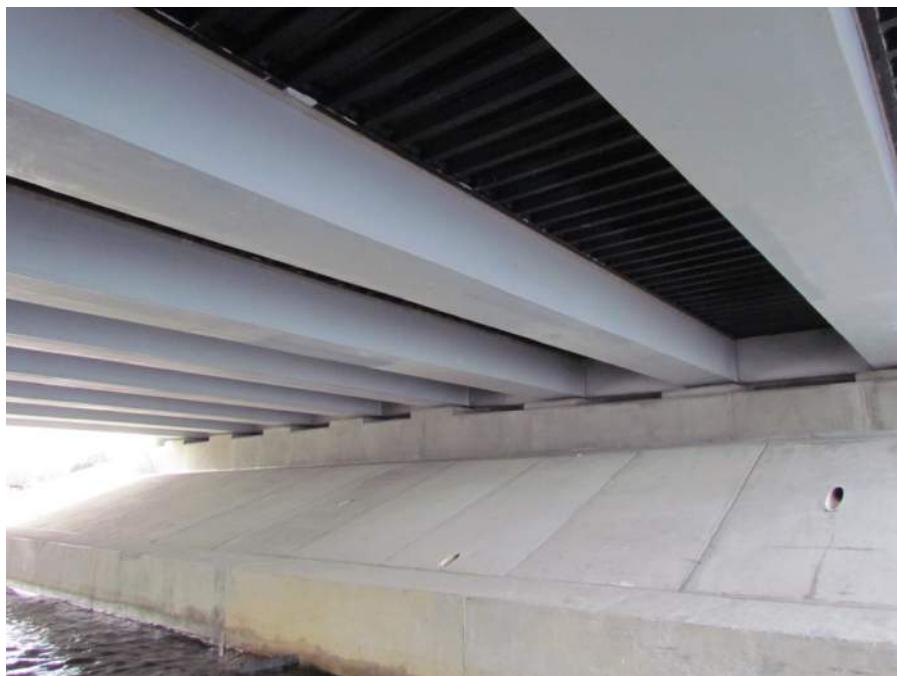
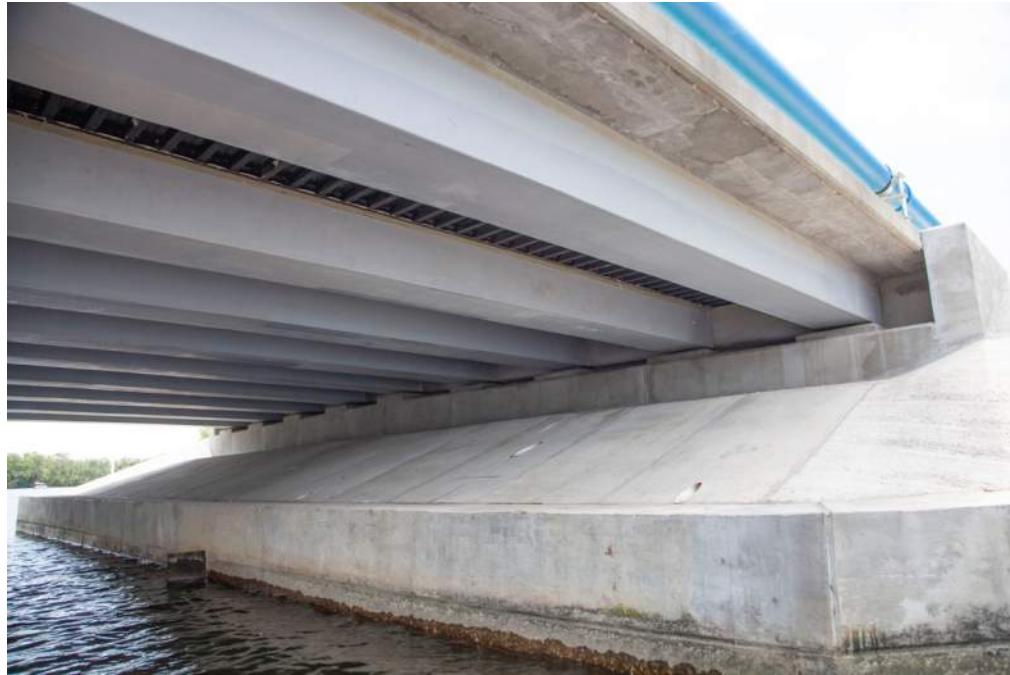
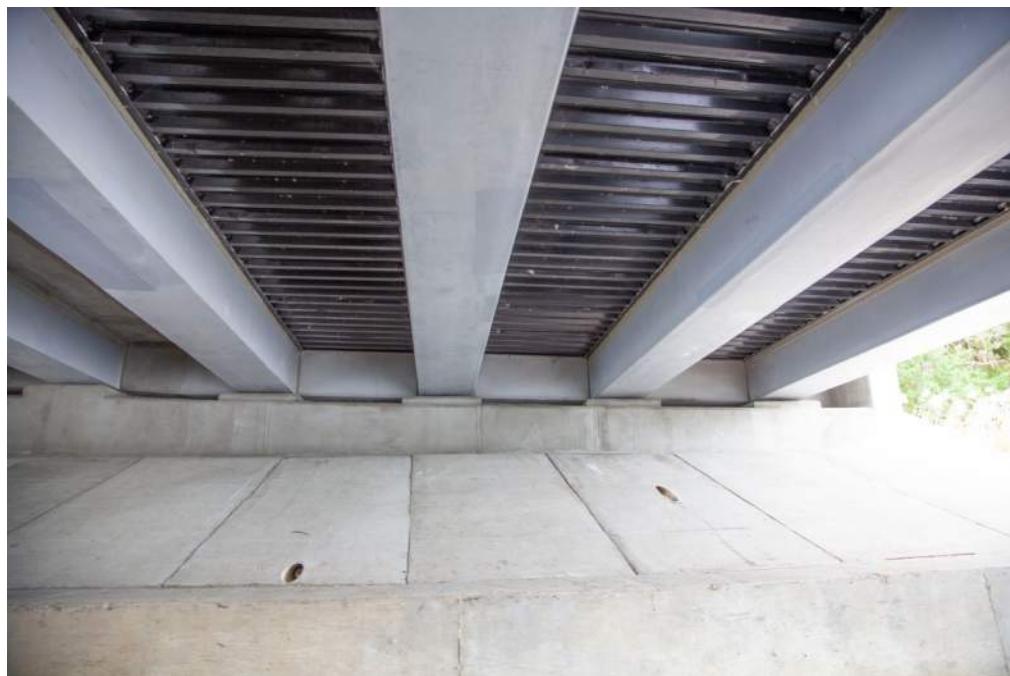
End Bent 1 ([Figures 29-31](#)):

In both the three- and six-month inspections, there were no signs of distress visible to the naked eye. No noticeable deterioration was noticed between the two inspections. Particular areas of interest were the ripples on the bottom of the fiberglass shell ([Figure 4](#)) and the gel coat patched areas ([Figure 5](#)) that were noticed at the 3-month visit; those areas had not visibly changed at the 6-month visit.
