Inspection and Monitoring of Fabrication and Construction for the West Halls River Road Bridge Replacement

Contract Number BDV30-706-01

TASK 4 Deliverable: Two-Year Report
(Visual inspection of bridge)

Draft 1 Submitted December 27, 2021

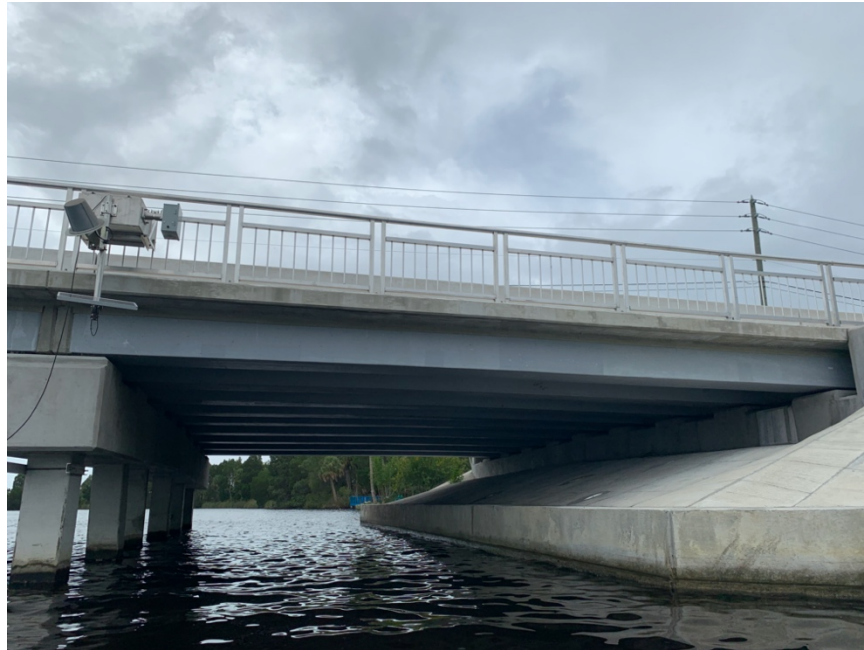
Figure 11: Span 5, looking north

Additional photos showing the overall condition of the bridge are in **Figures 11 and 12**.
