**Materials Research Report  
Final Report**

**UNF Project  
Contract No. BDK82 977-03**

# **The Repair of Damaged Bridge Girders with Carbon-Fiber-Reinforced Polymer “CFRP” Laminates**

**Principal Investigator: Adel ElSafty, P.E., Ph.D.**

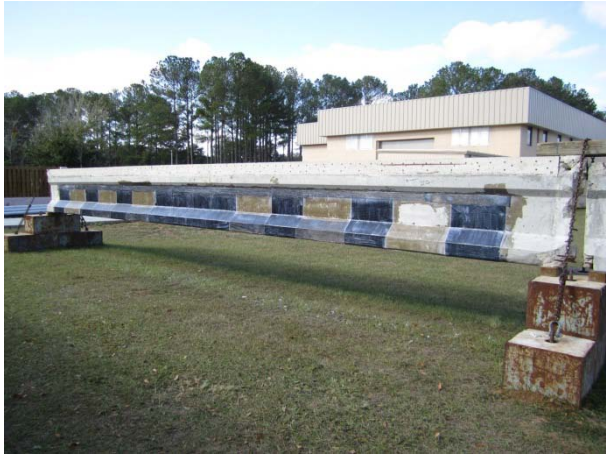
**Figure 4-42: CFRP pattern**

The failure modes for tested girders are presented in Figures 4-42 through 4-45.

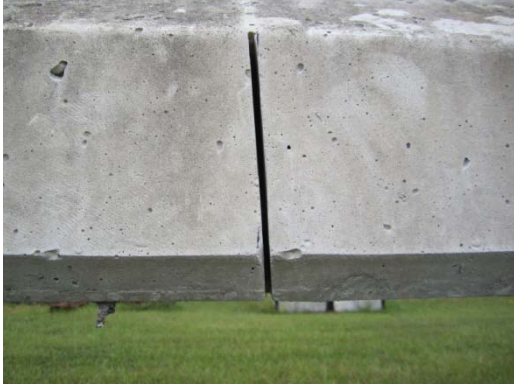
**Figure 9-1: Sawing in actual PSC girder**

Figure 9-1 shows the sawing to simulate the concrete damage for the girder. Figure 9-2 shows the repaired concrete. Figures 9-3 and 9-4 show the girder preparation and CFRP wrapping application.

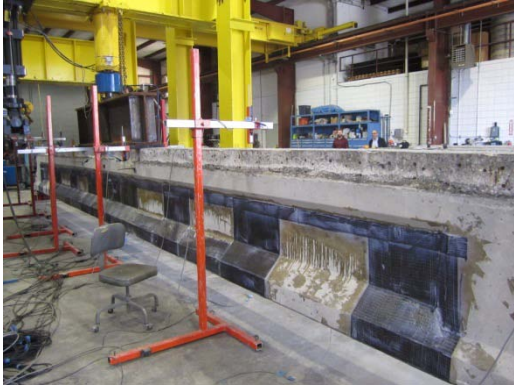
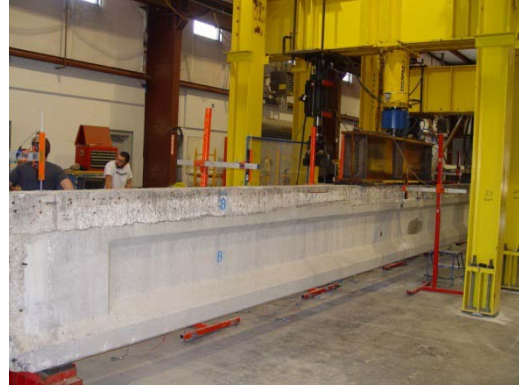
**Figure 9-5: Testing preparation and set-up**

Figure 9-5 shows testing preparation and girder set-up. Figure 9-6 shows girder failure under loading.
