Precast Element Evaluation for the US 90 Bridges over Little River and Hurricane Creek

Contract Number BDV30-307-01
FSU Project ID 032819

July 2019
FINAL REPORT

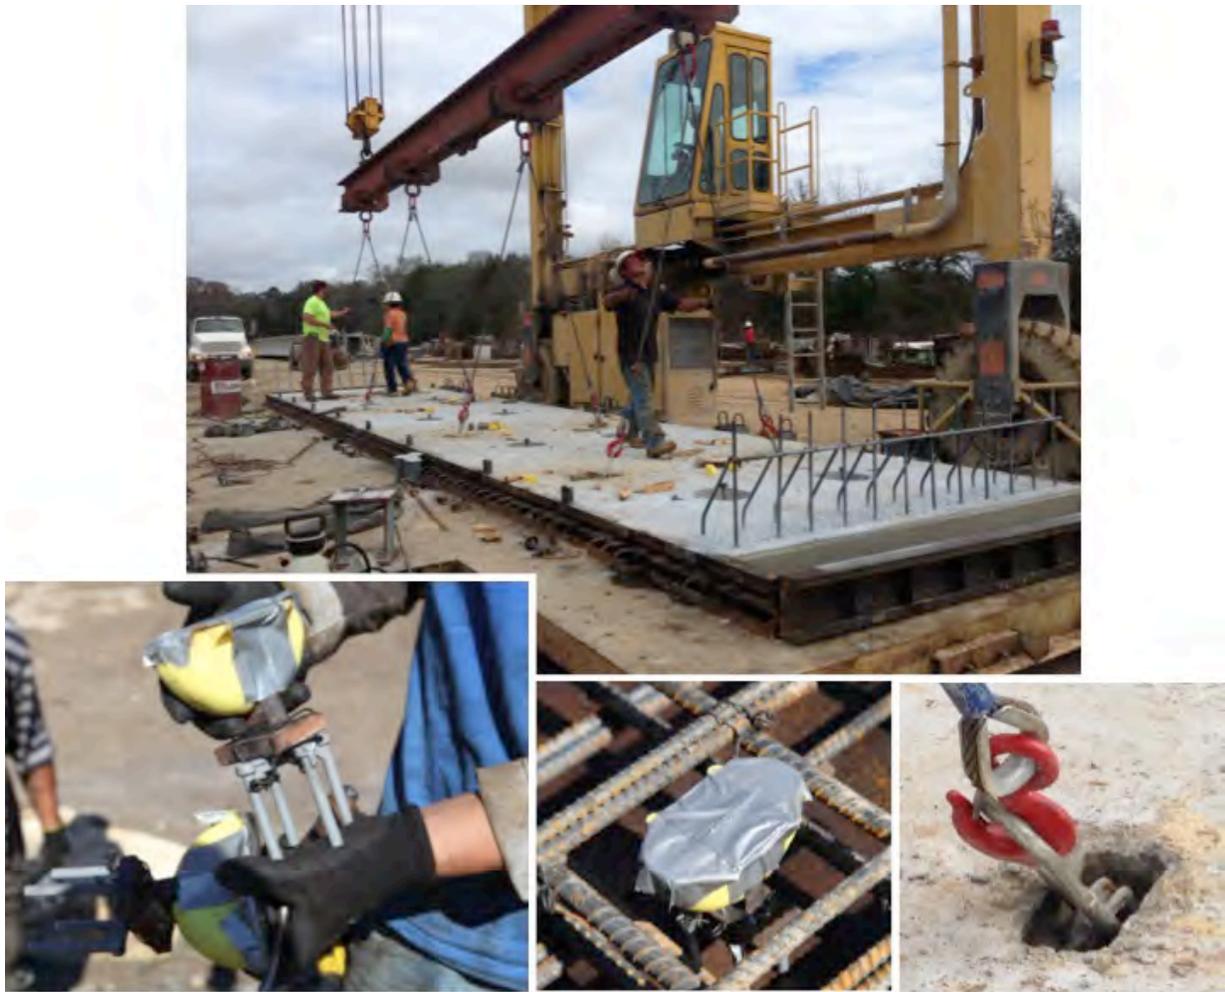
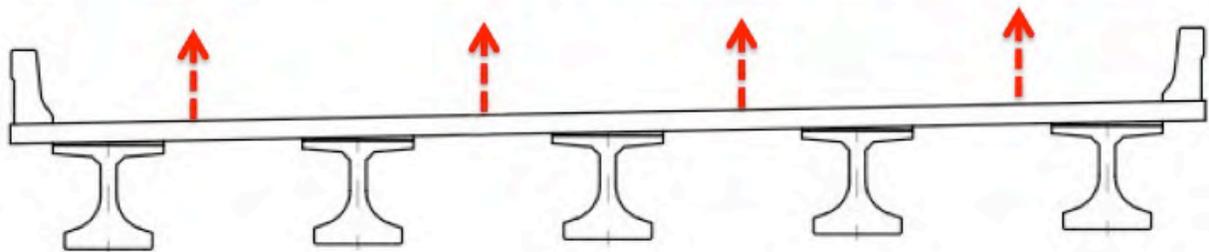
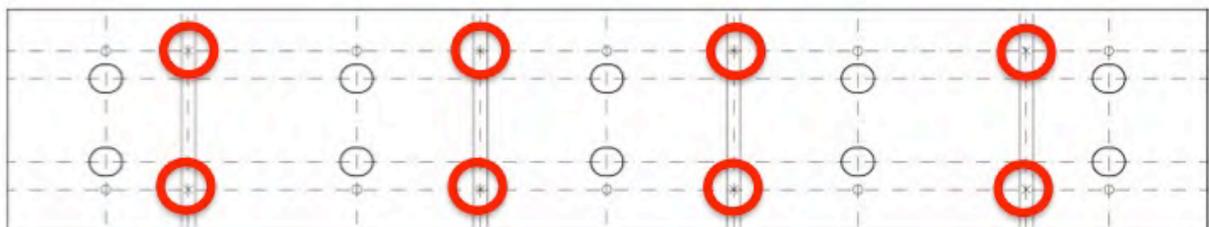
Fig. 3-17. Precast Deck Panel Lifting Devices

Spalls around lifting eye blockouts:

Some areas around the lifting eye blockouts had small spalls. For Hurricane Creek EB Bridge, after the panels were erected, the inspector directed the contractor to saw around the blockouts to remove the spalled areas, and to fill the area with grout. For Little River

EB Bridge, repairs were made to the lifting eye blockouts in the casting yard, before the panels were shipped to the site.

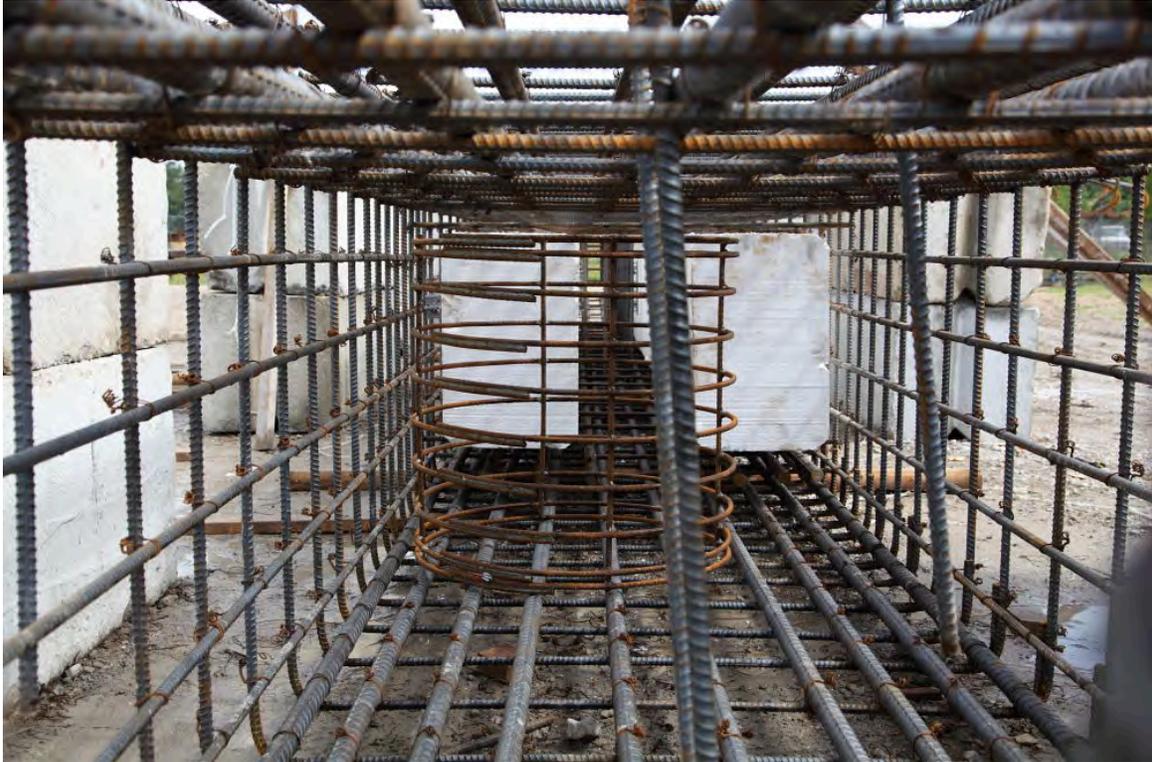
Fig. 6-18. Precast Bent Cap, Photo of Cross Section, Showing Hoop Ties (in Foreground) and EPS Blockout (in Background)

Reinforcing steel details per the design plans are provided in **Figure 6-16**. **Figure 6-17** is a cross section at the drilled shaft/column location, where the dowel bars extend. The design called for a spiral that surrounds the dowel bars; however, the precaster substituted the spirals with hoop ties (**Figures 6-18 and 6-19**), with permission from the Engineer. Also notice the EPS blockouts shown in the background of **Figure 6-18** and in **Figure 6-20**.

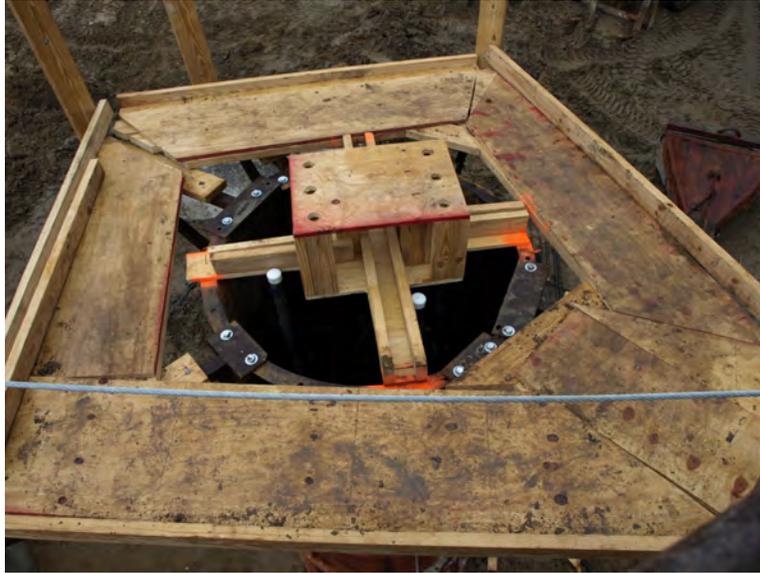
Fig. 6-25. Original Wooden Template Used to Position Drilled Shaft Dowel Bars that Will Extend into Precast Bent Cap (Drilled Shaft Steel Casing Shown Underneath)

The contractor used a wooden template to position the dowel bars (**Figure 6-25**). However, the template did not sufficiently secure the dowels while the concrete was placed in the drilled shaft extension on Bent 4 (the easternmost bent) of Little River EB Bridge. The dowel bars were out of position, to a condition in which the holes in the bent cap (as designed) would not be able to fit. **Figure 6-26** shows the constructed locations of these dowel bars. This misalignment was realized *before* the bent cap was cast, so the precaster was able to adjust the dowel hole ducts and reinforcing steel (bends and positions) in the bent cap.

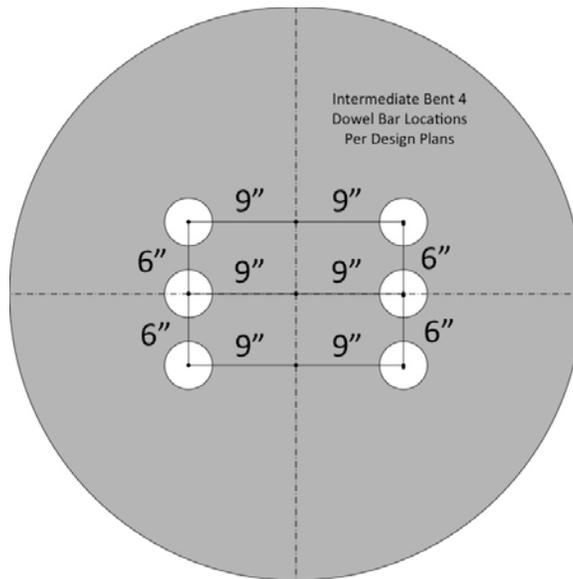
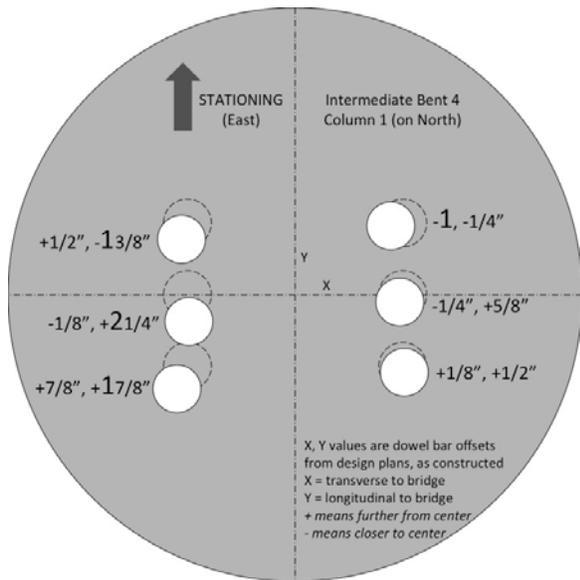
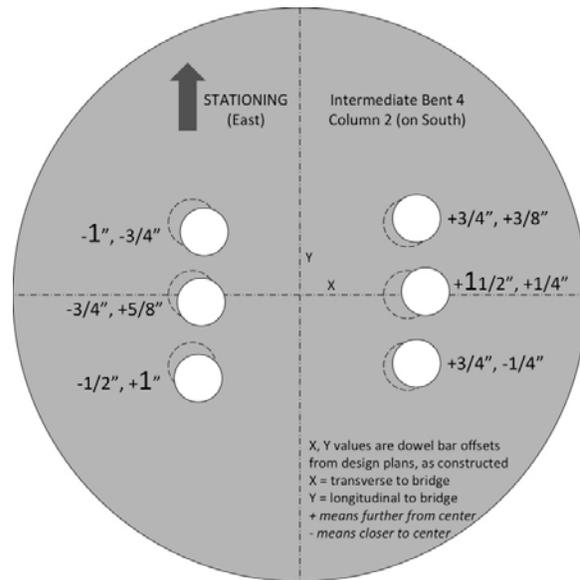
Fig. 6-26. Constructed Locations of Dowel Bars on Little River EB Bridge, Intermediate Bent 4 (Diameters Are Drawn Larger for Clarity)

On Little River EB bridge, the #9 dowel bars were misaligned in both drilled shafts for Bent 4. This would have caused the dowel bars to not fit up with the preformed holes in the bent cap. Fortunately, the bent cap had not yet been cast, so adjustments could be made to the bent cap details. More details are discussed in the following section.

- For Little River EB Bent 4, the #9 dowel bars were misaligned in both shafts. Because it had not yet been cast, the precast bent cap was revised for the as-built condition of the dowel bars. The as-built locations of the dowel bars are provided in Report 2, as are figures of the reinforcing steel adjustments that were made in the bent cap. In addition, several of the preformed dowel-bar holes in the bent cap were shifted by 0.5 in. (relative to the design condition) in one or both directions, longitudinally and/or transversely. The maximum amount that any bar was shifted was 1.25 in.

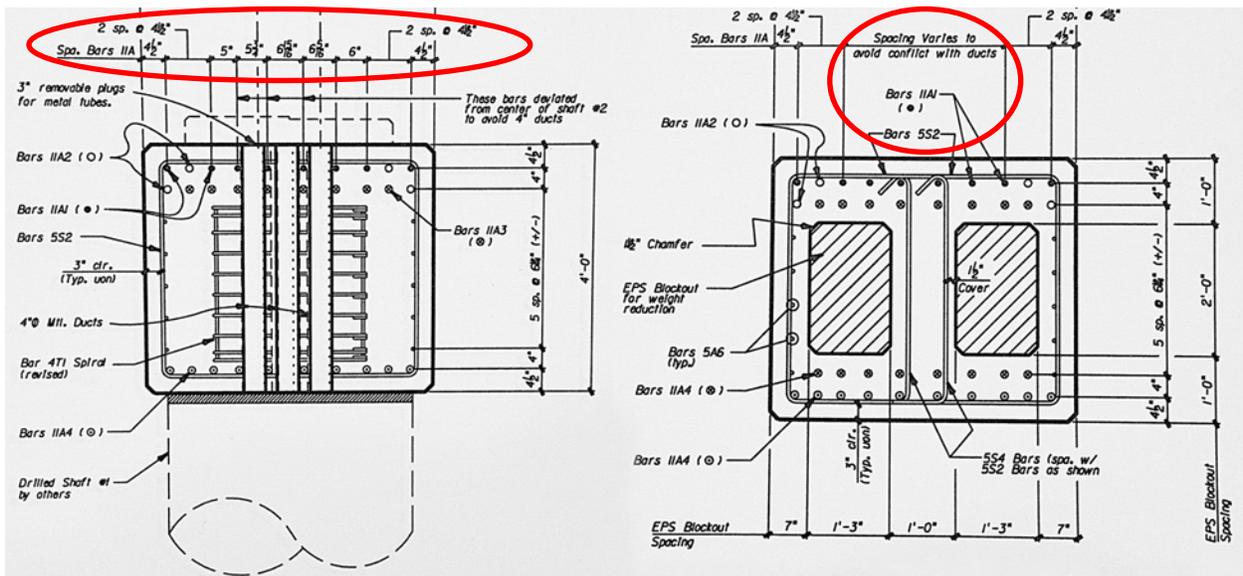
Fig. 6-28. Adjustment to Bent Cap 4EB (Reinforcing Steel Bars 11A, 5S2 and 5S4)

Figure 6-27 shows the original shop drawings for the reinforcing steel in the bent cap cross section, and **Figure 6-28** shows the changes that were made to Bent 4EB (longitudinal bars 11A were shifted horizontally to avoid the shifted dowel ducts, and the stirrups were changed from two rectangular hoops to one large hoop and two single legs with hooks/bends at their ends. (See also information on RFI #12 below). For the remaining bents, the contractor made the holes smaller in the dowel bar template to better secure the bars. Later, the dowel bars for Bent 2 of Little River WB Bridge were out of position, but the bent cap had not yet been cast. The precaster was able to shift longitudinal bars 11A, along with the dowel holes; also, some of the stirrups were made 1.5 in. wider so that bars 11A would fit in the stirrup corners (**Figure 6-29**).

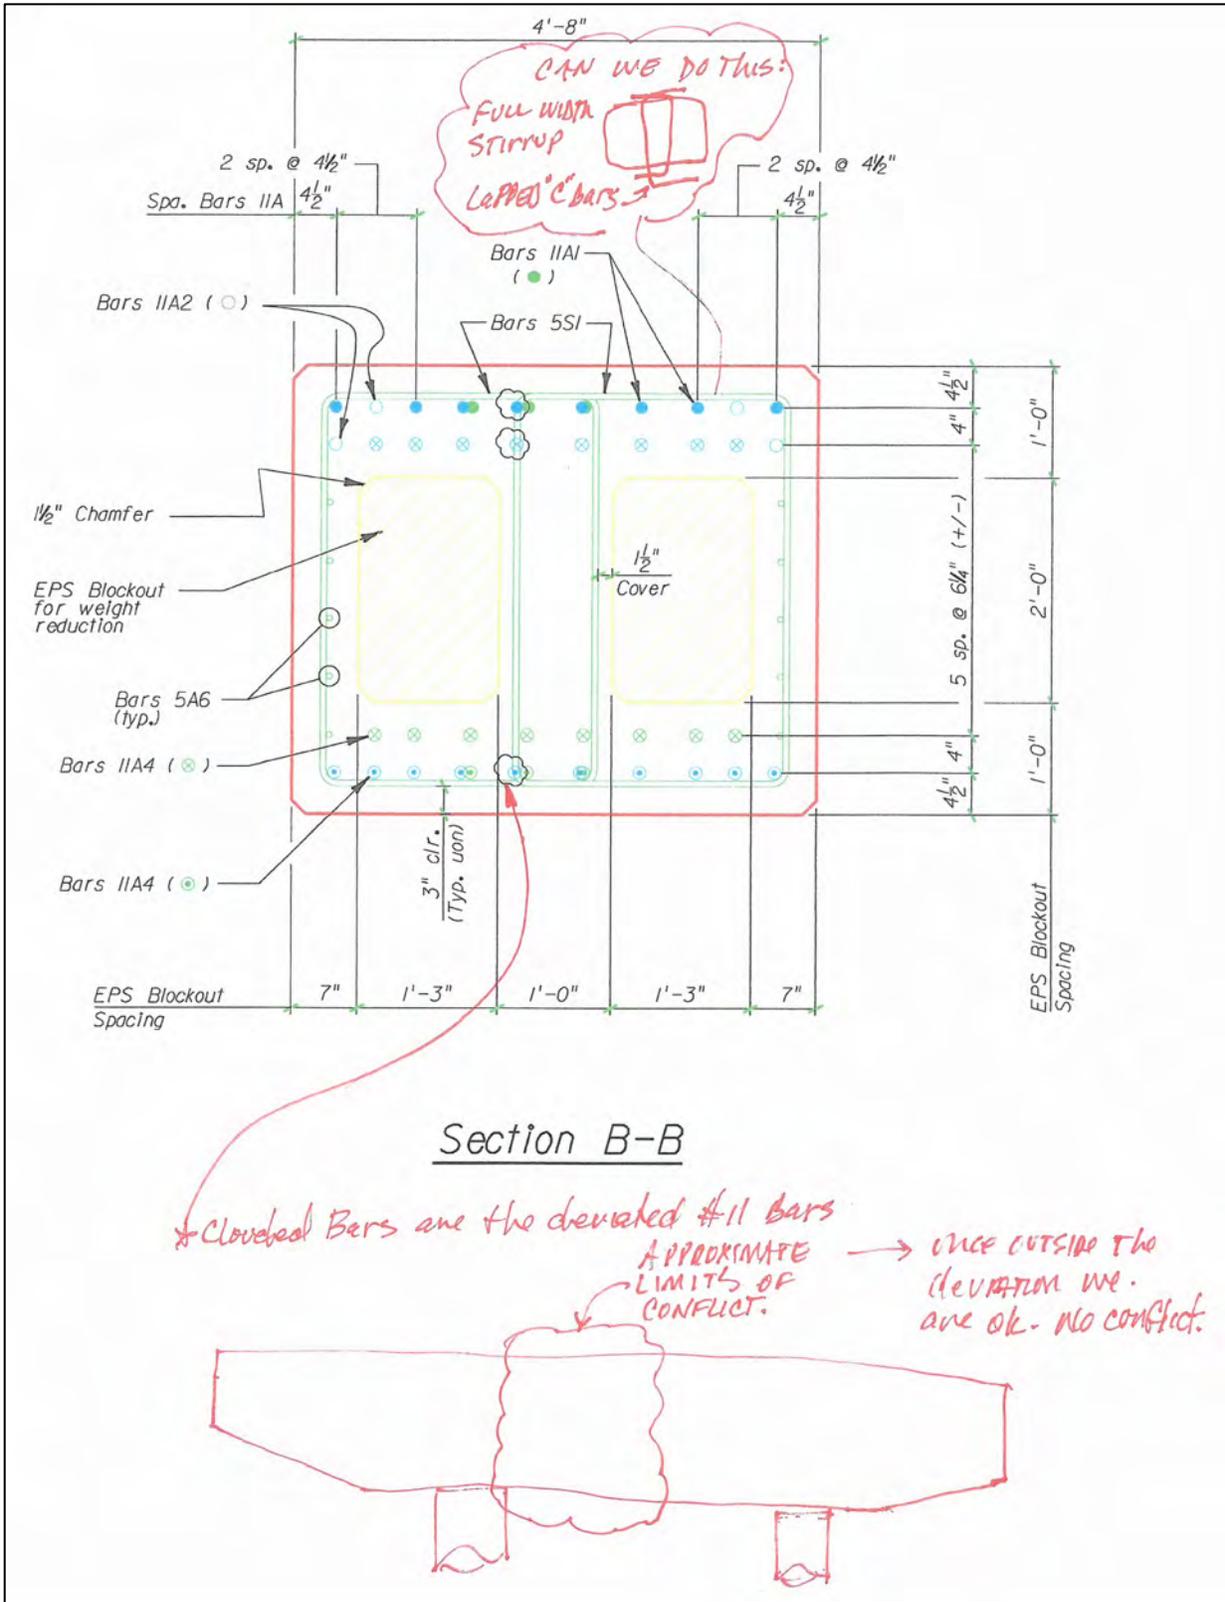
Fig. 6-30. Hand Sketch of Adjustments Made to Intermediate Bent 4 Reinforcing Steel

Figure 6-30 shows hand sketches of the changes that were made to the reinforcing steel as a result of RFI #12. (See also **Figures 6-26 to 6-28.**)

Response: Using the Bars C as substitutes for the internal legs of the shear stirrups (Bars 5S1) and reconfiguring Bars 5S1 as perimeter reinforcing only is acceptable. The bottom and top bar bend legs of the Bars C with Bars 5S1 should be at least 10" long. The Contractor will need to resubmit revised shop drawings detailing these stirrup bars, and to add to what I said below, the bars should be positioned so that there is a longitudinal bar in each corner of each single leg stirrup. That means the single leg stirrups could be positioned as [] or [|. And, the single leg stirrups should have one 90 degree hook and one 135 degree hook.

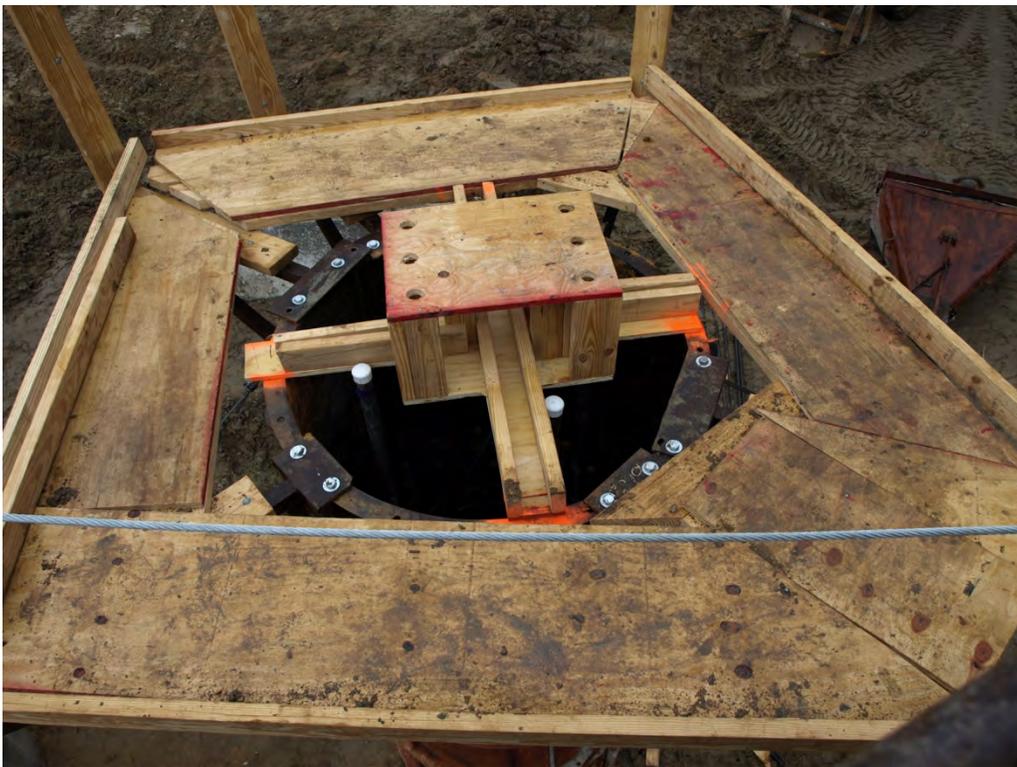
Six (6) #9 dowel bars extended from the top of each column, so that they could protrude into preformed holes in the precast bent cap when it was erected. Placement of the dowel bars was somewhat challenging for the contractor at first. A plywood template (**Figure 2-13**) was used to align the bars, but inspectors noted the difficulty of determining whether or not the dowel bars were in the correct position at their top ends. For two (2) of the 12 columns, the dowel bar positions did not meet tolerance. After having this problem on the first bent (Little River EB Bent 4), a remedy was made for EB Bents 2 and 3 and all WB bents: the template was moved upward towards the ends of the bars, to provide better lateral stability for the bars.

Fig. 2-13. Original Template on Column for Setting Dowel Bars for Little River EB (February 6, 2014)

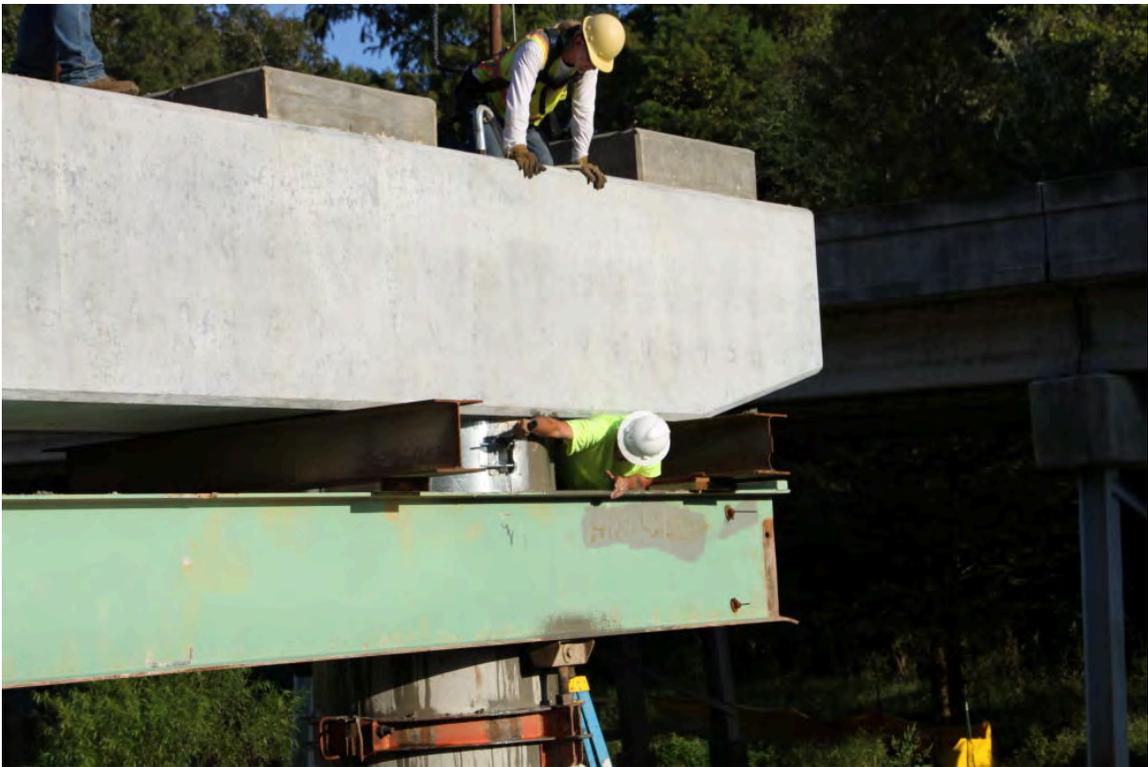
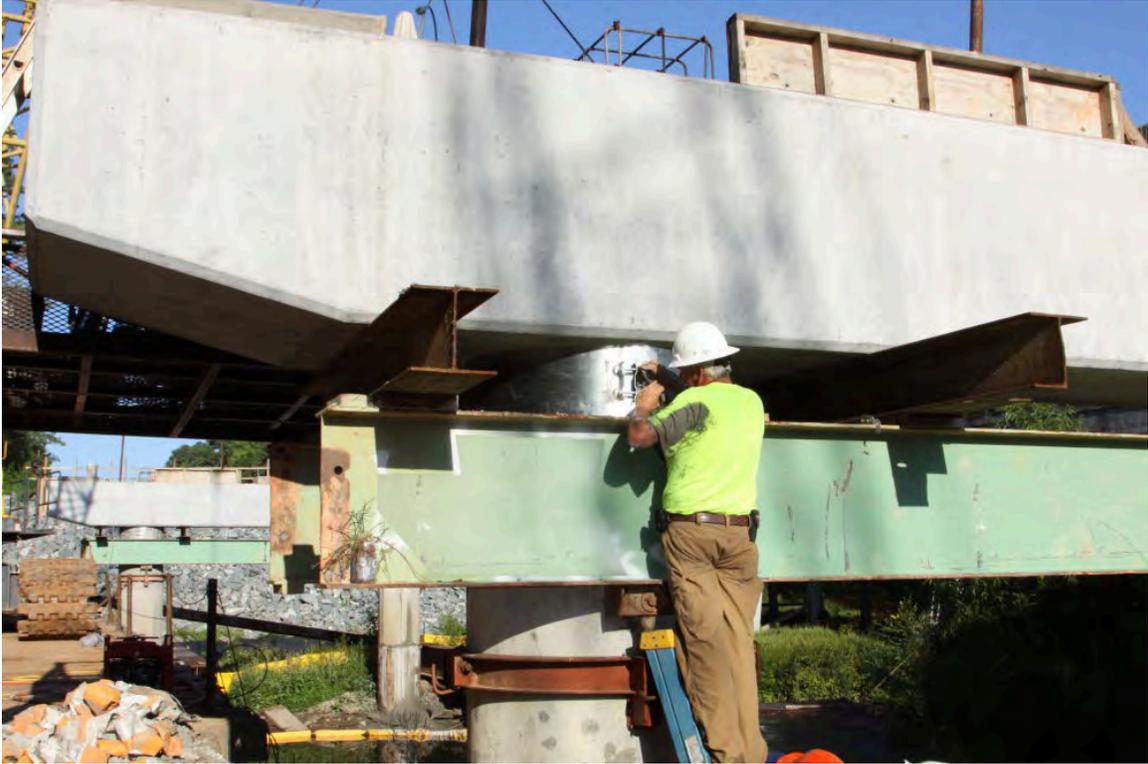
Getting a good seal on the forms was difficult. The forms often leaked (**Figure 2-35**) and had to be tightened “on the fly”, as shown in **Figures 2-36 and 2-37**. Sonotube forms were originally used, but they blew out. Then sonotubes with metal collars were used, but the metal leaked. The contractor ended up using sonotube – cut into two pieces to get it around the column – and clamped a two-piece sheet metal around it. They also caulked the top and bottom of the sonotube to help with the seal. The WB bridges had far less leakage than EB because of the improvements made in the process. The ability to freely tighten the forms, to stop leaks that occurred while grouting, was important.

Fig. 2-36. Tightening Forms while Grouting Bent Cap on Little River EB (September 14, 2014)

Fig. 2-37. Tightening Forms while Grouting Bent Cap on Little River EB (September 14, 2014)

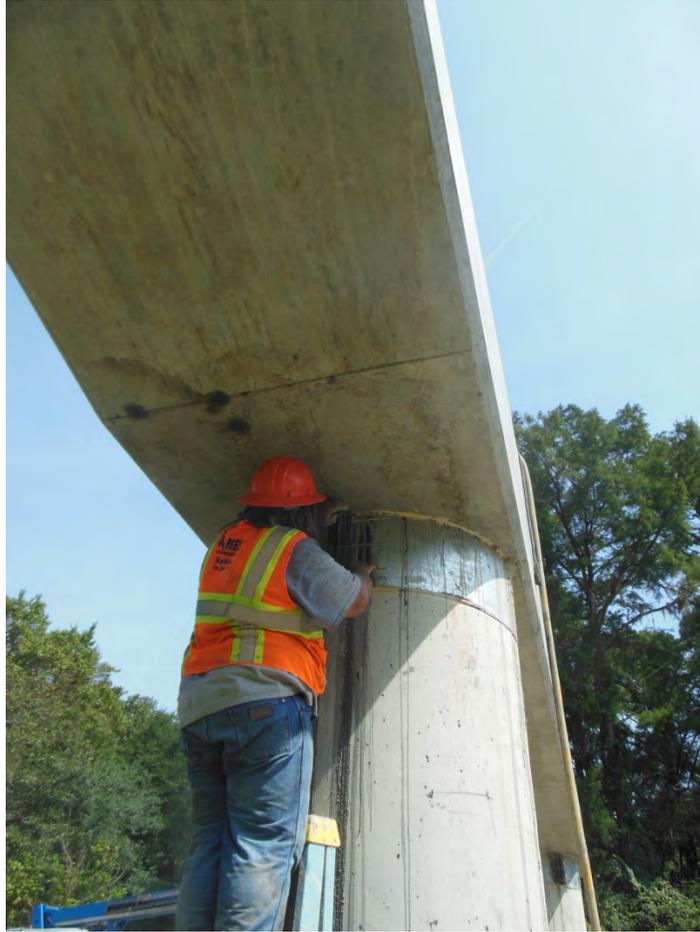
Fig. 2-40. Inspecting Cap-Column Connection on Little River WB (August 2015)

Some voids occurred between the column and cap, where grout leaked out around the form during grouting. The voids were inspected (**Figure 2-40**) and then repaired by epoxy injection using the previously-approved Dayton Superior Pro-Poxy 100, an epoxy injection resin. This is a high-strength adhesive that is used for concrete repair, and it has low viscosity for deep penetration.

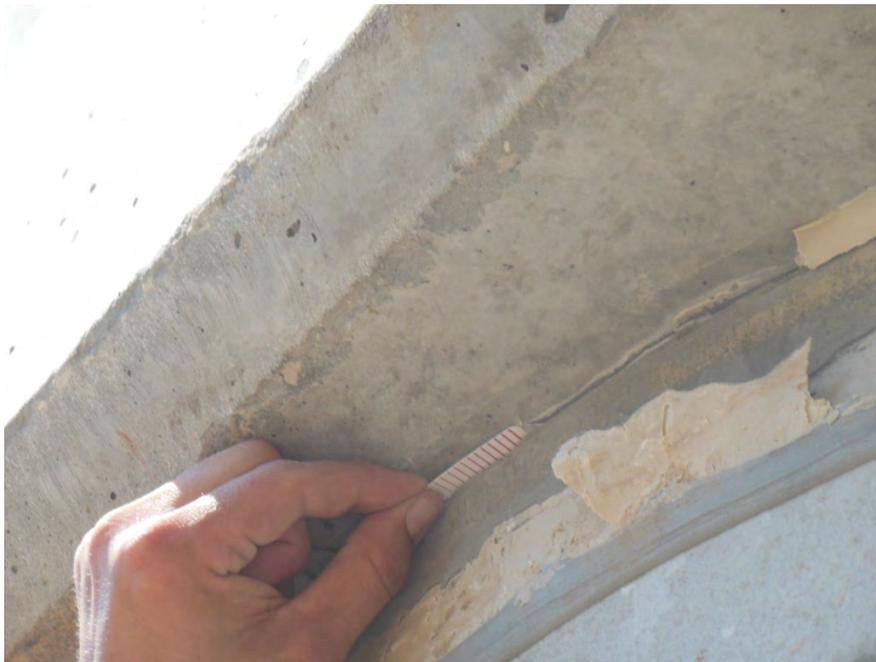
Fig. 2-41. Measuring Gap in Cap-Column Connection on Little River WB (August 2015)

The non-shrink grout did shrink a little bit, causing a gap between the grouted area and the bottom of the bent cap. **Figure 2-41** shows this gap being measured. Voids were documented, as shown in **Figure 2-42**, but only one (1) of the 12 column-to-cap connections needed to be repaired. The contractor submitted a repair procedure: the

outside of the gap was caulked, and the gap was pressure grouted with Dayton Superior Pro-Poxy 100, which is good for voids less than 0.25 in.

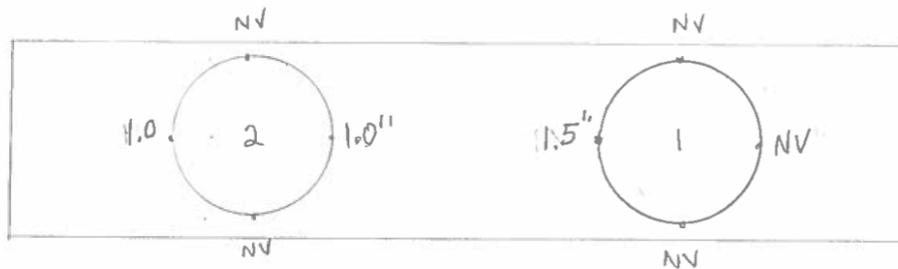
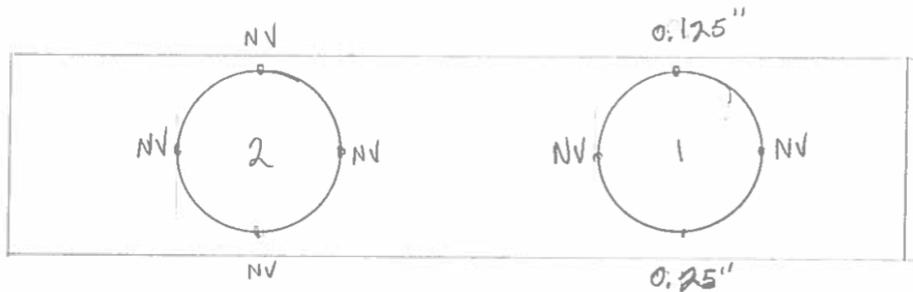
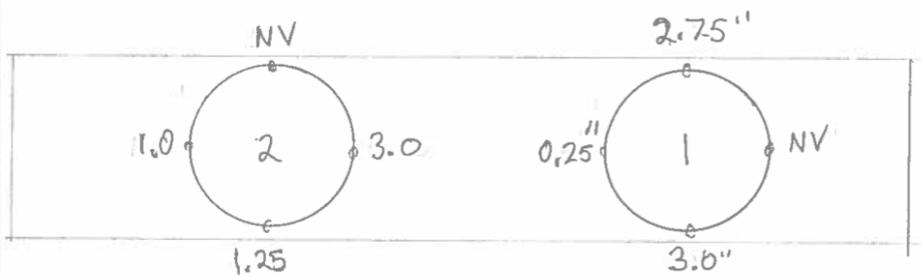
Fig. 2-42. Documentation of Voids in Column-Cap Connection for Little River WB (August 2015)

MEASUREMENTS OF VOID DEPTH AT LITTLE RIVER

* NOTE: ALL VOIDS LESS THAN 0.25" HEIGHT,
NV = NO VOID

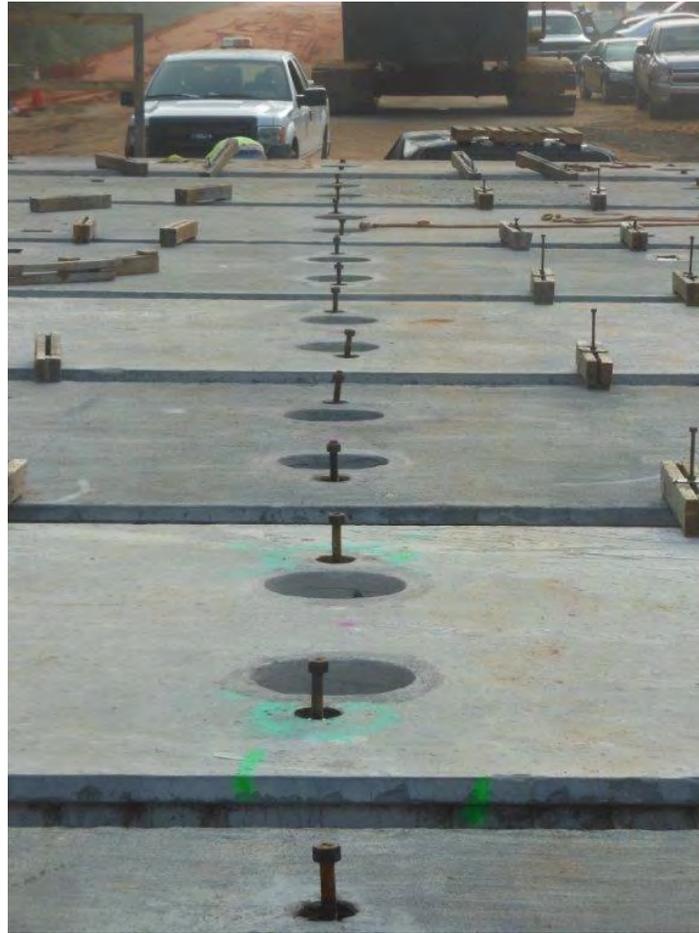
In the casting yard, the blockouts for the leveling bolts were anchored at the top, but they were not anchored at the bottom. It appears that the blockouts shifted at the bottom during panel casting, because some of the bolts were misaligned, as shown in **Figures 3-42 and 3-43**, and therefore did not make contact with the 6" x 6" Embedded Plate Assemblies in the FIB top flange (**Figure 3-44**). These steel plates were embedded during girder casting operations, specifically for the purpose of providing an area on which the panel could rest until the haunches were grouted. Tolerances, the sweep of the FIB, and shortening of the beam caused by creep and shrinkage could contribute to a condition in which the bolts do not contact the plates.

Fig. 3-42. Leveling Bolts Slightly Misaligned

The inspectors could not easily see the misaligned bolts, because they were underneath the panels in the haunch region. Inspectors used a smartphone (set on video mode) to look underneath the panels at the bolts, to check if they were making contact with the steel plates. The inspectors did this constantly as the panels were being set. To resolve the immediate issue, the panel was shifted so that the bolt would make contact; this slightly changed the adjacent closure joints' dimensions. Where the panel could not be shifted enough, the inspectors made notes of the misalignments. A retrofit was made at the location where the leveling bolt made contact with the girder – usually the next day. The panel had to be picked up, the girder top flange was grinded, and a new plate was epoxied onto the beam. This issue is also discussed in Report 2, Fabrication of Precast Elements.

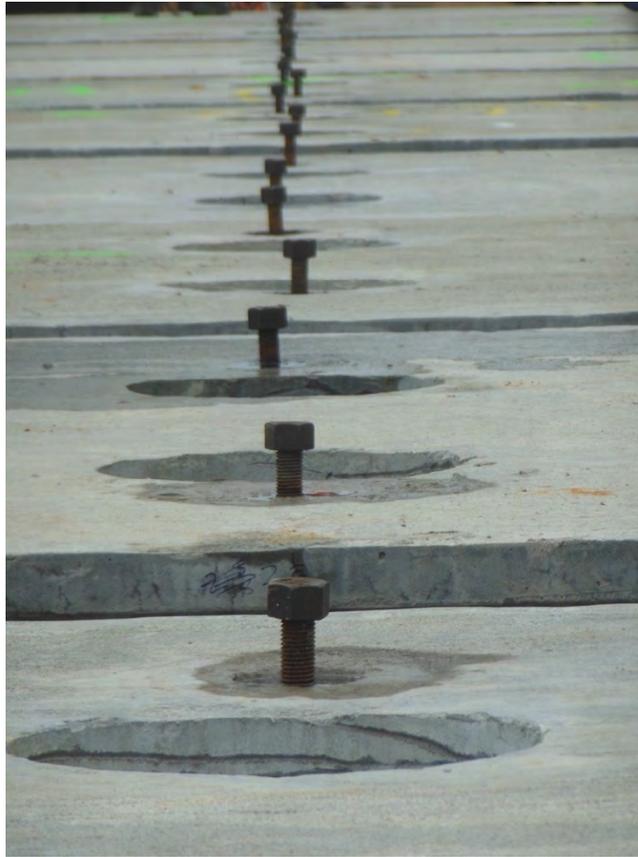
Fig. 3-43. Close-up of Misaligned Leveling Bolts

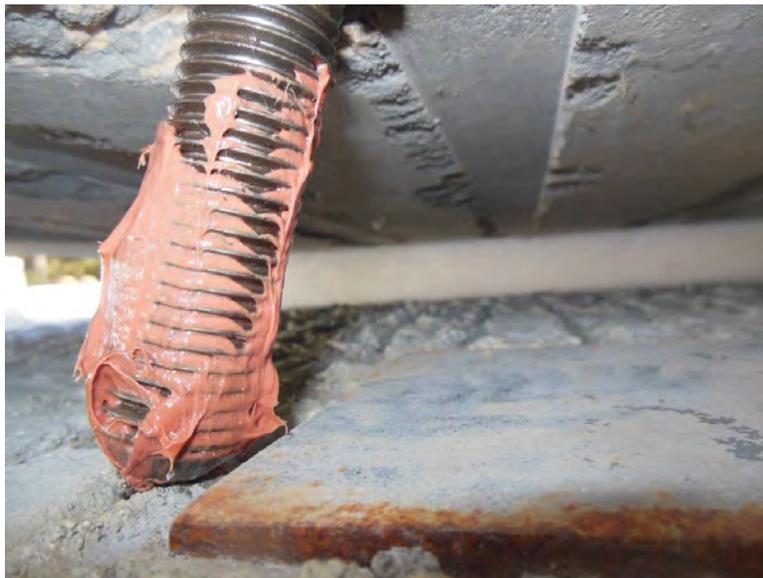
Fig. 3-44. Leveling Bolt Misaligned and Not in Contact with Steel Plate on Girder Top Flange

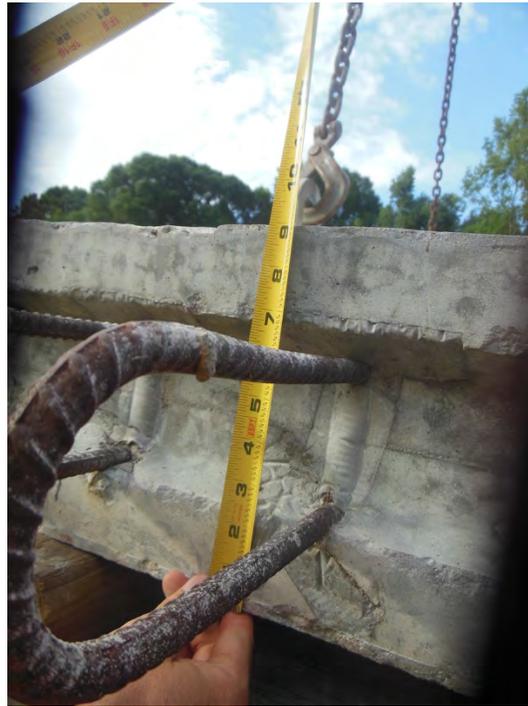
Fig. 3-49. Some Panels Were Cast as Much as 9 in. Thick

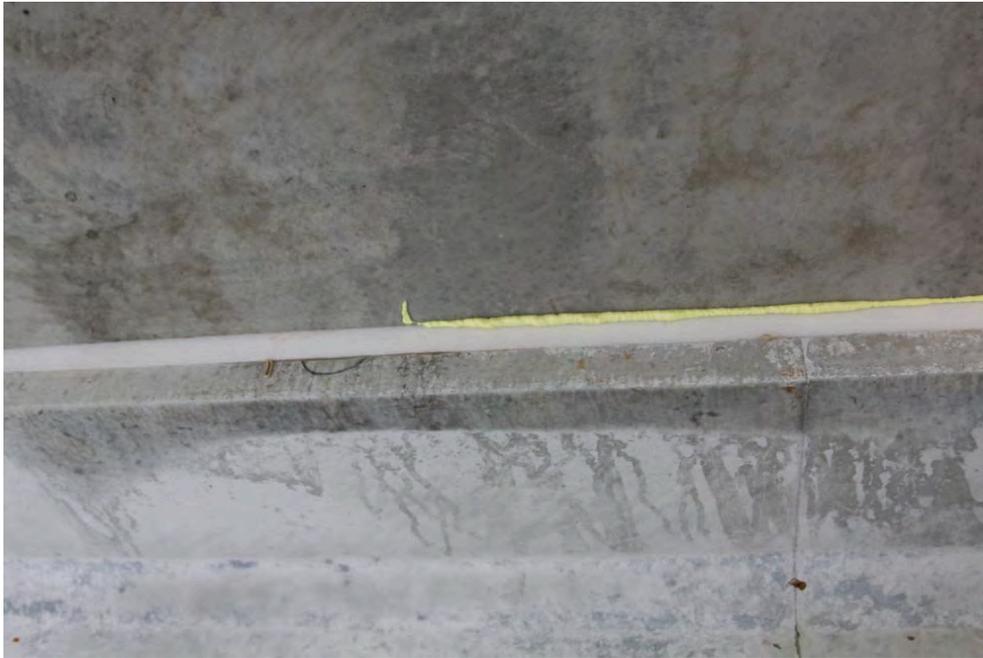
Fig. 3-58. Polystyrene Forms (white) and Spray Foam Sealant (yellow) for Haunch

Before grouting commenced, the perimeter of the shear pocket was sprayed with an epoxy bonding agent (**Figure 4-13**). The grout is a very fluid material, so it easily leaked if the forms between the panel and girder top flange were not very tightly sealed. A tarp was placed underneath the bridge to prevent grout from leaking into the creek or river below (**Figure 4-14**). Where the polystyrene form did not provide a good enough seal, sprayed foam sealant was added (**Figure 4-15**). This was problematic later on, though, when the forms were removed. In some locations, the sealant had expanded excessively into the haunch, so it left voids in the haunch where the grout did not flow.

Because voids were found where the spray foam was used on Hurricane Creek EB bridge, the contractor was directed to remove the polyethylene forms and spray foam from *all* girders and spans. (Specification 404-5.3 required removal at only a few representative locations.) Removal of all forms was also required for the other three bridges constructed later.

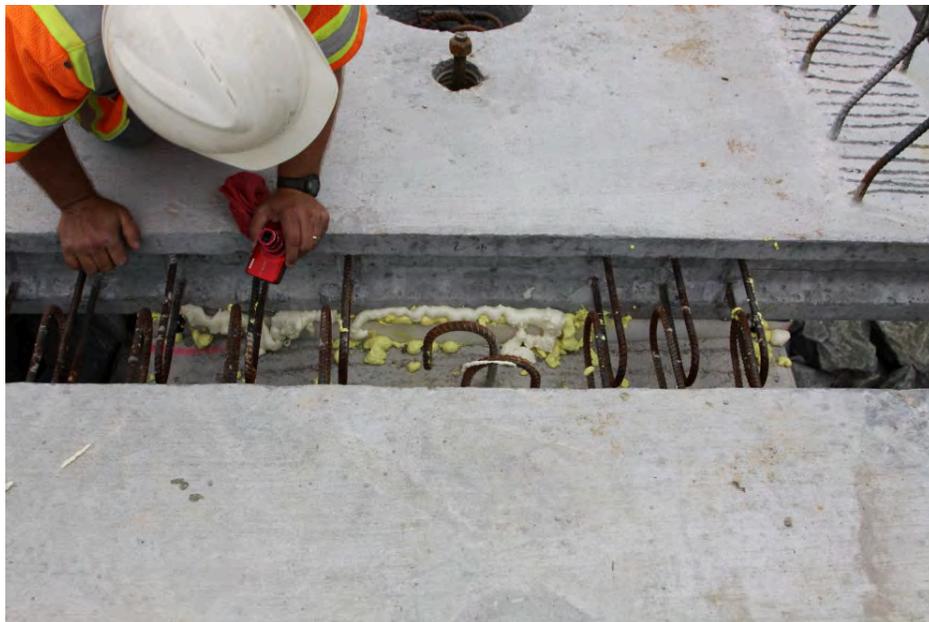
Transverse direction (perpendicular to girders): Initially, polyethylene form strips were used to seal the gap between the precast panel and girder top flange in the direction perpendicular to the girders, as shown in **Figures 3-50 and 3-51**. However, leaks occurred, partly because the top of the girder was intentionally roughened in the casting yard with a rake. Also, the forms needed to be removed so that the closure joints could be cast, but removal was difficult. The reinforcing steel that protruded from the sides of the precast panels and into the closure joint region (**Figure 3-62**) made it difficult to get in a crowbar to pry out the strips. (For this reason, inspectors noted that the *additional* reinforcing steel, as detailed in the design plans, should be placed in the closure joint *after* the forms are removed so that it does not make form removal even more difficult.) The process was later improved by using – instead of polyethylene – wooden forms and caulk perpendicular to the girders (**Figure 3-63**). However, the wood did not seal well because of the irregular rough surface of the girder top flange. Ultimately, the contractor improved the method further by using a dry pack to form the gap; this formed a good seal for grouting (**Figure 3-64**).

Fig. 3-62. Original Forming Method Using Polystyrene to Grout Shear Pockets on Hurricane Creek EB

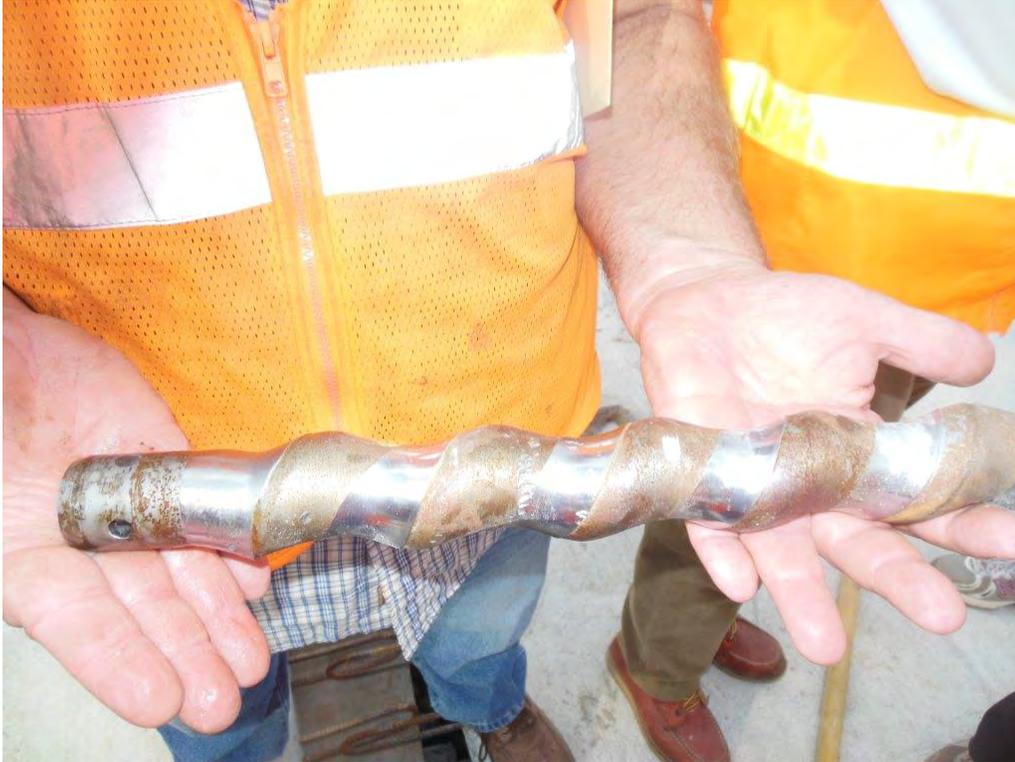
There were a few problems with the equipment. The air compressor sometimes broke and needed to be repaired. The lines got plugged, and the hose got dry packed. The auger (**Figure 4-11**) wore out and had to be replaced each time after mixing about 500 bags of grout. (This repair was expensive.)

Fig. 4-11. Auger from Grout Mixing Equipment

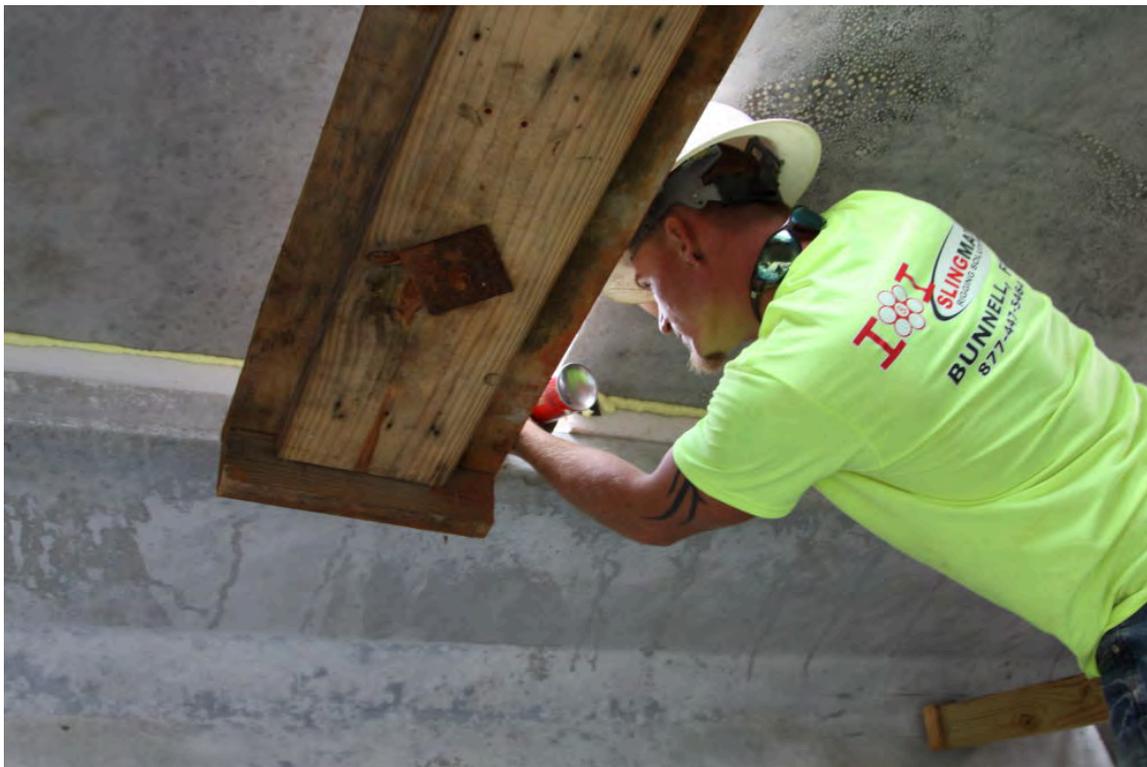
Fig. 4-15. Spray Foam Sealant Being Added to Haunch Forms to Prevent Leaks While Grouting Shear Pockets on Hurricane Creek EB

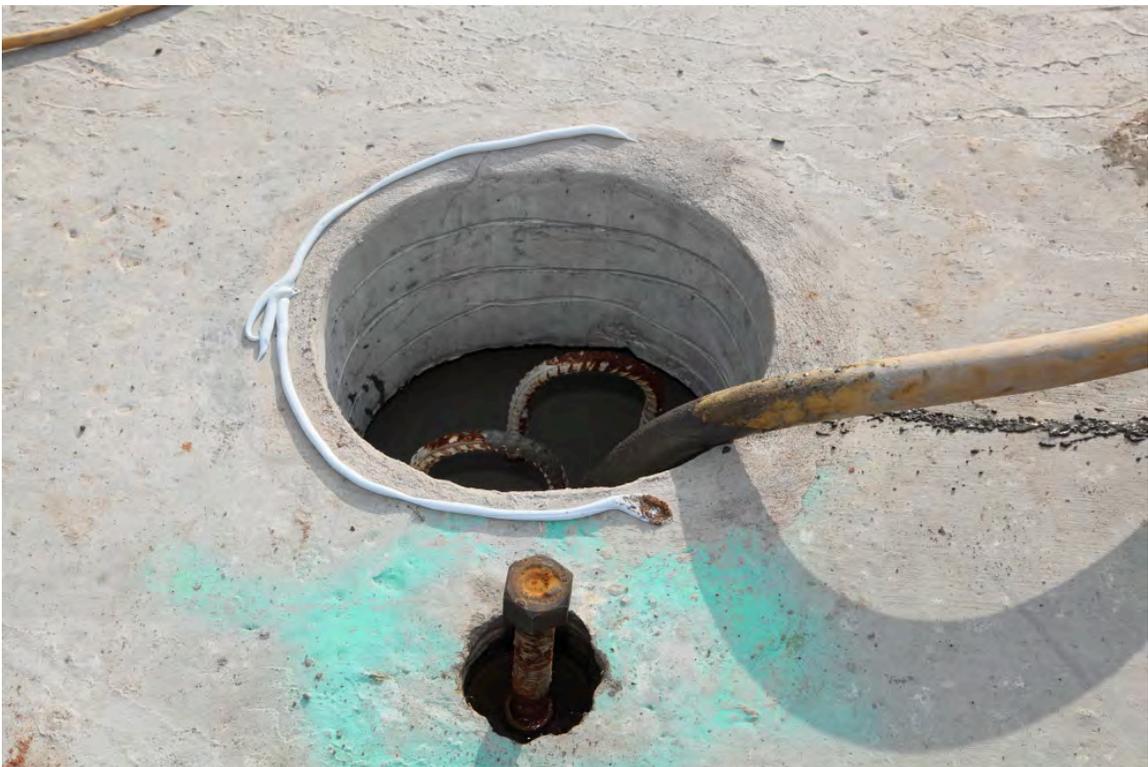
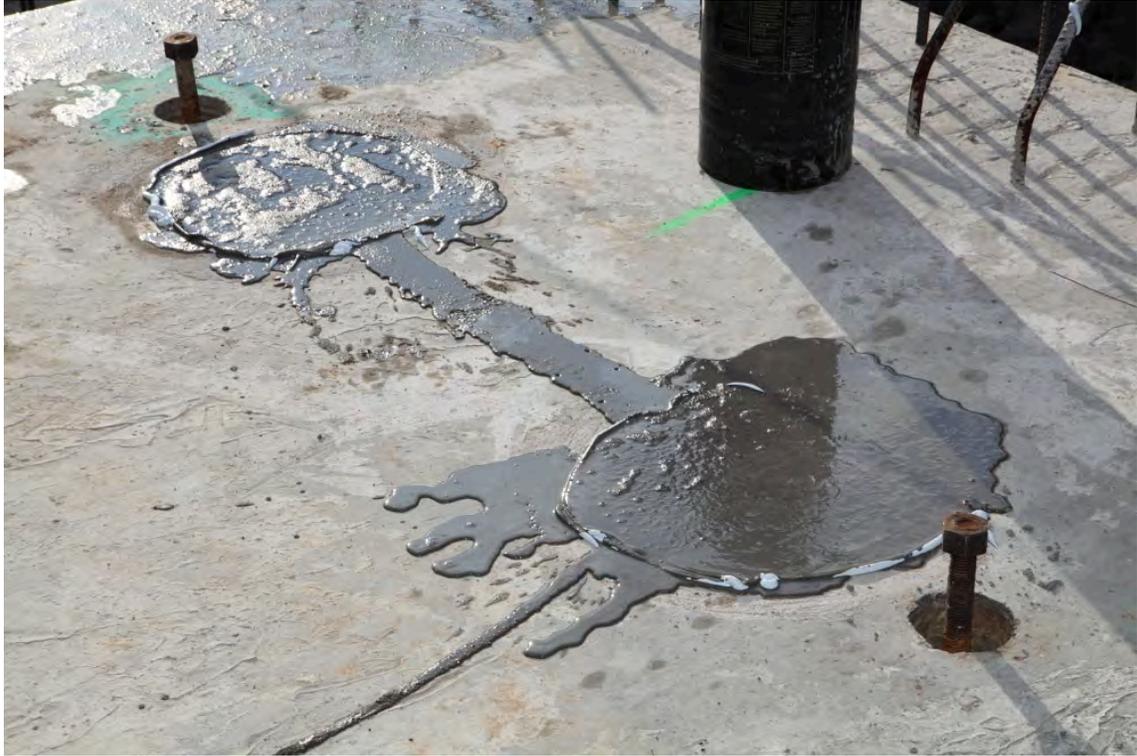
Ports were placed protruding from the polystyrene forms. **Figure 4-16** shows the ports before the panels were placed, and **Figure 4-17** shows a port that has been plugged (see the plug in **Figure 4-18**). The process was later improved by using small pipes that extended into the closure joints. They were placed on both sides of the panel (**Figures 4-19 and 4-20**), so that grout could either be fed into them (**Figures 4-21 and 4-22**), or could flow out once the haunch and pockets were filled. After it appeared that the haunch was filled, and the grout began to rise into the shear pocket, then grout was placed directly into the pocket until filled (**Figure 4-23**). The grout was very fluid and tended to flow across the panel once the pocket was full. The contractor prevented the grout from flowing by placing a bead of caulk around the low side of the shear pocket (**Figures 4-24 and 4-25**).

Fig. 4-24. Bead of Caulk Around Low Side of Shear Pocket to Stop Grout on Little River WB

Fig. 4-25. Grouting Shear Pockets on Little River WB – Caulk Prevented Flow

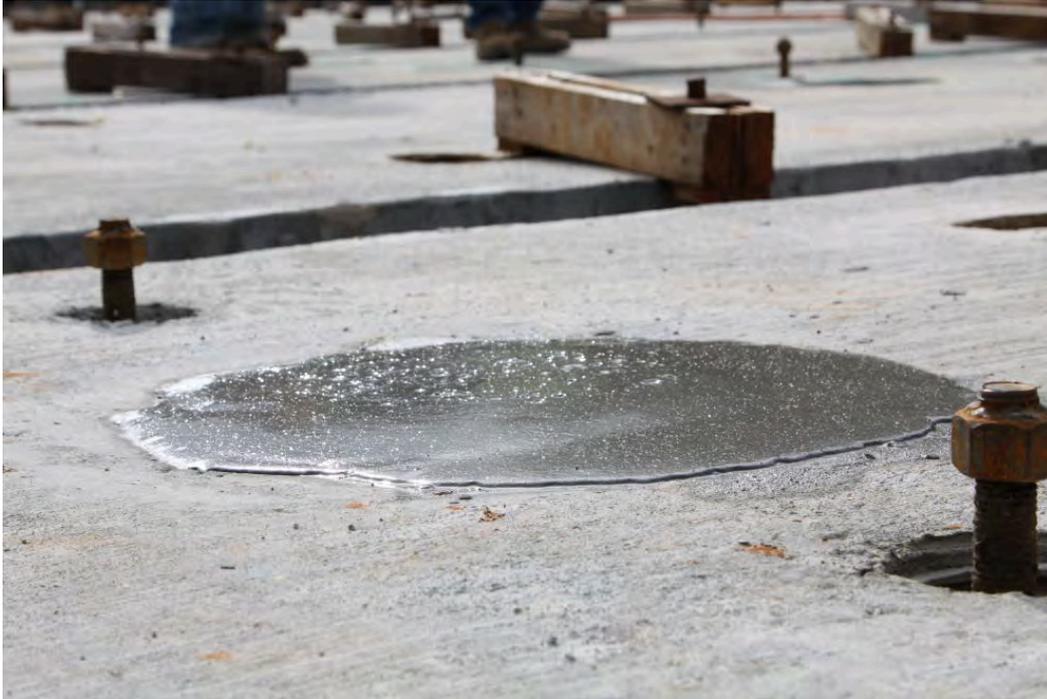
After the grout was placed, it was left alone for a few minutes, and then a crew member would return to add grout if it had sunk any. Then the grout was smoothed until level with the surface of the precast deck panel. The grout tended to swell as it set, leaving small “humps” on the bridge deck (**Figures 4-27 and 4-28**). The finisher on the construction crew would sometimes let the grout set for a little while longer and would then go back and smooth out the humps. (The final grinding and grooving of the deck would ensure a flat surface for the final traveled roadway.) After initial set, wet burlap was placed over the pocket to facilitate curing (**Figure 4-29**).

Fig. 4-28. Slightly Raised Grout, After Setting

The shear pockets on the WB bridges ended up with more cracks in them. Inspectors opined that not enough attention was paid to the finishing while the grout was wet. This resulted in “humps” once the grout cured. The milling machine had difficulty planing the deck, so the contractor had to chip down the pockets so that the milling machine could go over them. Perhaps the specifications could address this, by specifying an allowable amount of swelling of the finished shear pocket above the precast panel concrete (e.g., any swelling shall be no more than 0.25 in. higher than the surrounding panel concrete.)
