Precast Element Evaluation for the US 90 Bridges over Little River and Hurricane Creek

Contract Number BDV30-307-01
FSU Project ID 032819

July 2019
FINAL REPORT

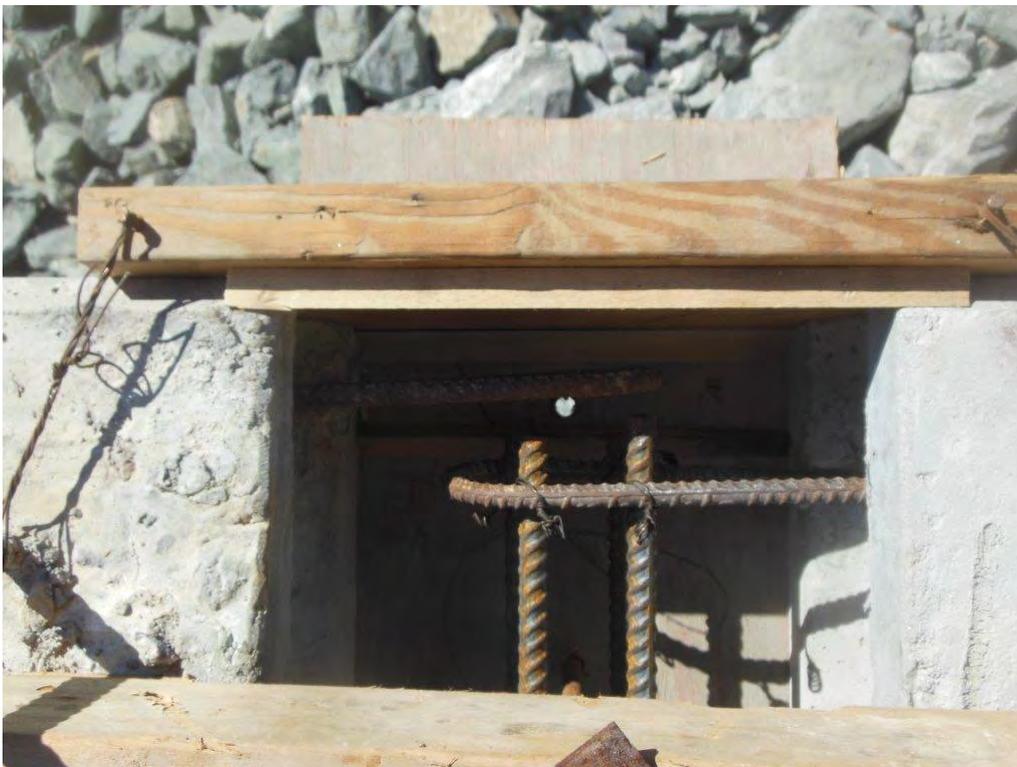
side.) As shown in **Figure 4-40**, the bars were not quite long enough to span the width of the bridge (there would be too much cover), so short bars were added at the ends. For future, inspectors recommended making the splice a little longer than required, as a precaution.

Fig. 4-40. Closure Joint Reinforcing Steel (Horizontal Bars in Photo are Protruding from Panel, and Vertical Bars Were Added per the Design Plans)

The hooked bar that protruded from the precast panel, at the end, was set to 2 in. from the bar's center to the panel's edge. This left a cover of only 1.75 in. to the hooked bar – less than the 2 in. that was required.

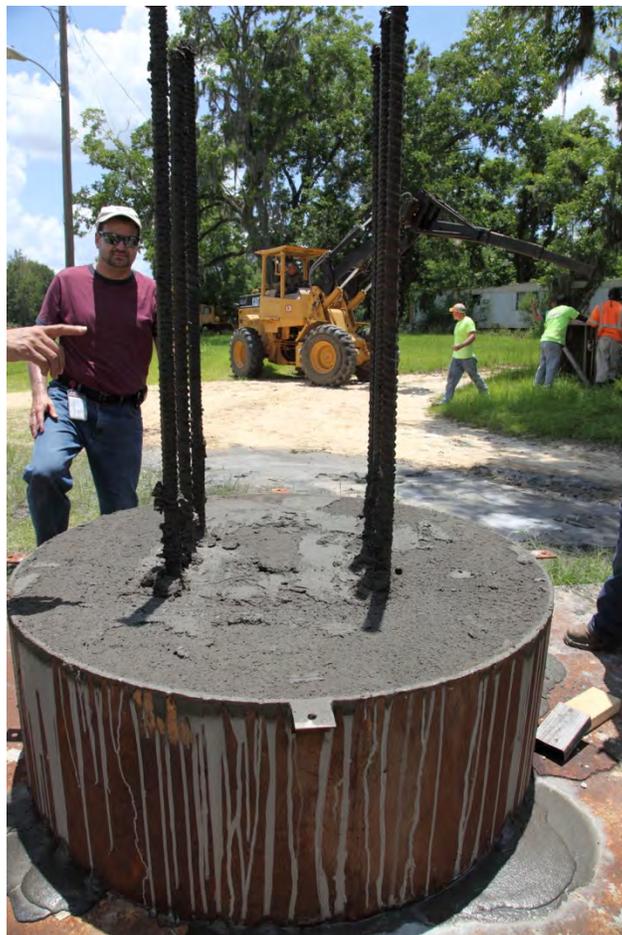
Fig. 5-10. Grout Mock-up for Precast Bent Cap, after Casting and Removal of Forms

temperature, and making compression-test specimens). The next day, the wooden “bent cap” forms were removed, and the top of the “shaft” was inspected (Figure 5-10). The grout surface was very smooth, and there were no voids.

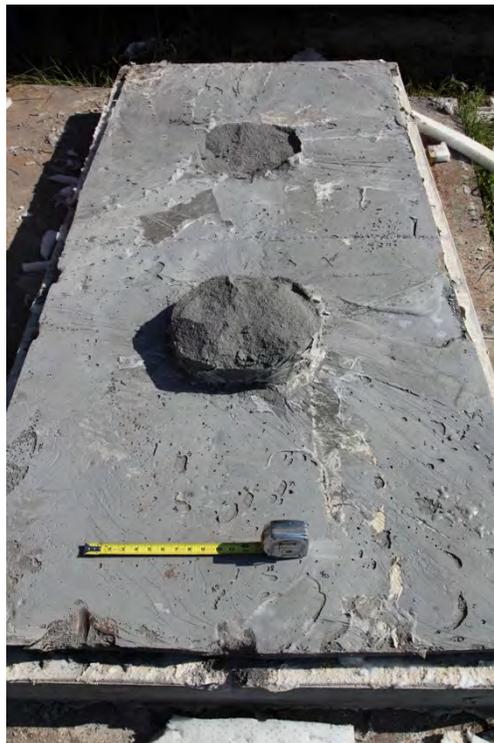
Fig. 5-20. Grout Mock-up for Precast Deck Panel, Grout Surface

The next day, the “panel” was removed (**Figure 5-19**), and the grouted surface was inspected (**Figure 5-20**). **Figures 5-21 to 5-28** are close-up photos of the voids, which were measured and recorded (see **Table 5-1**). The total area of voids was about 6.1% of the total grouted area (calculated in **Table 5-2**).

The Engineer of Record (EOR) recommends that, on future projects, the mockup schematic clarify that the bedding layer sealing system be formed similar to that proposed in the contractor’s Grouting Plan, to verify the efficacy and facilitate better evaluation of the mockup sample to reveal any voids on the column face after form removal.

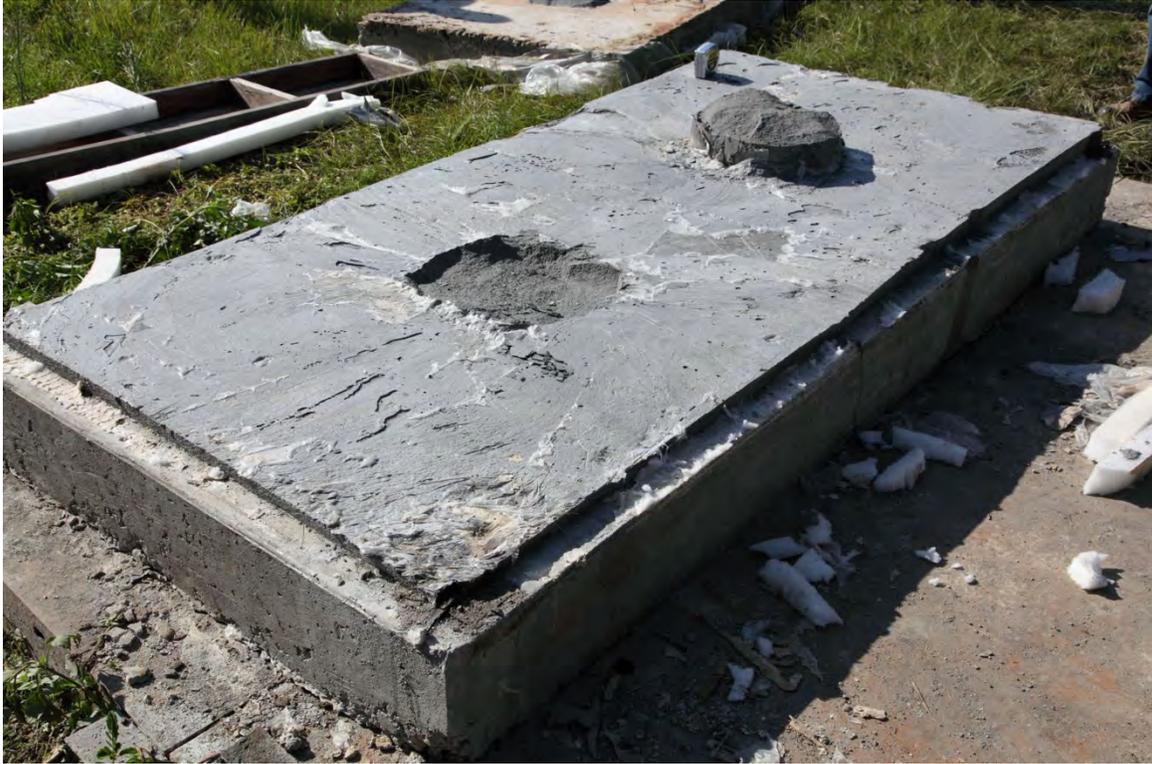
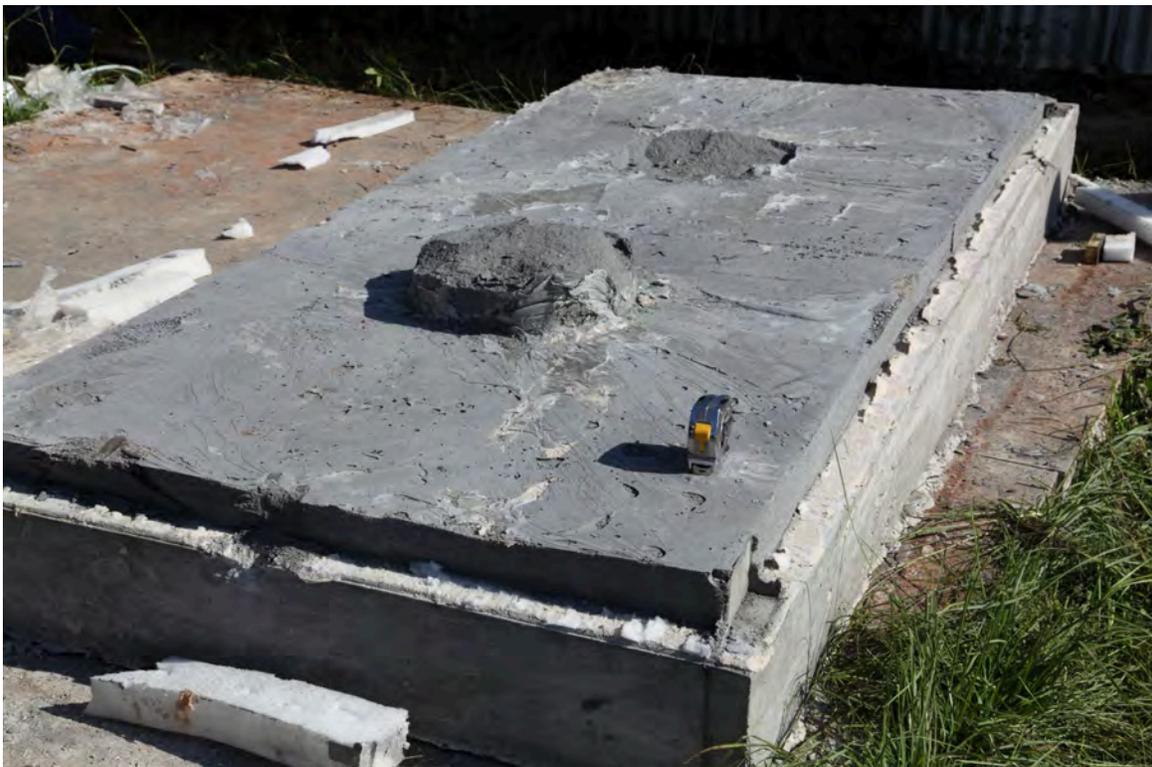
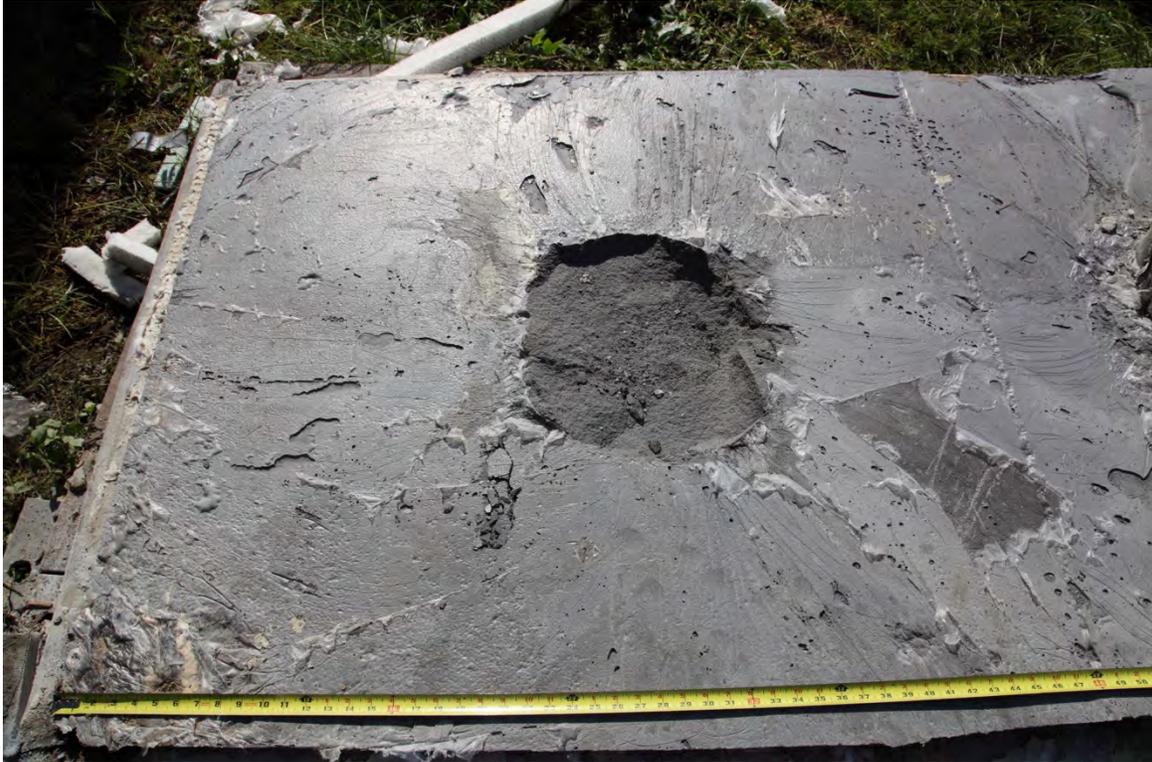
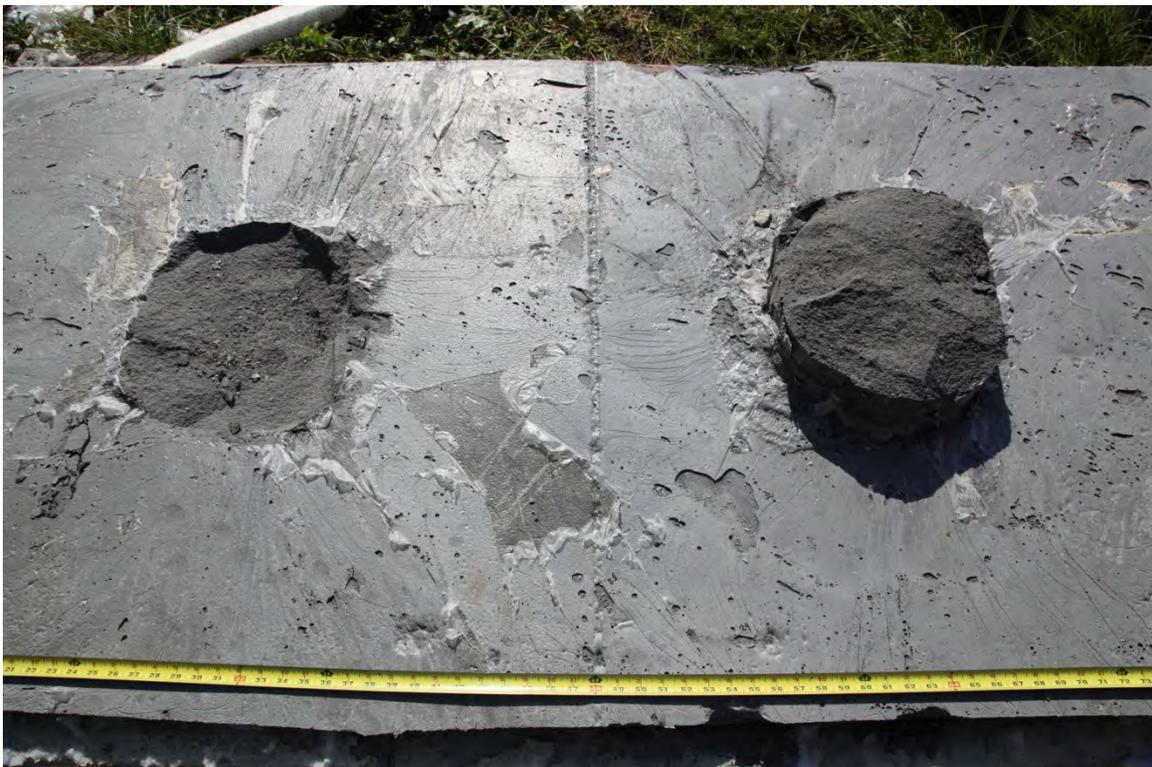
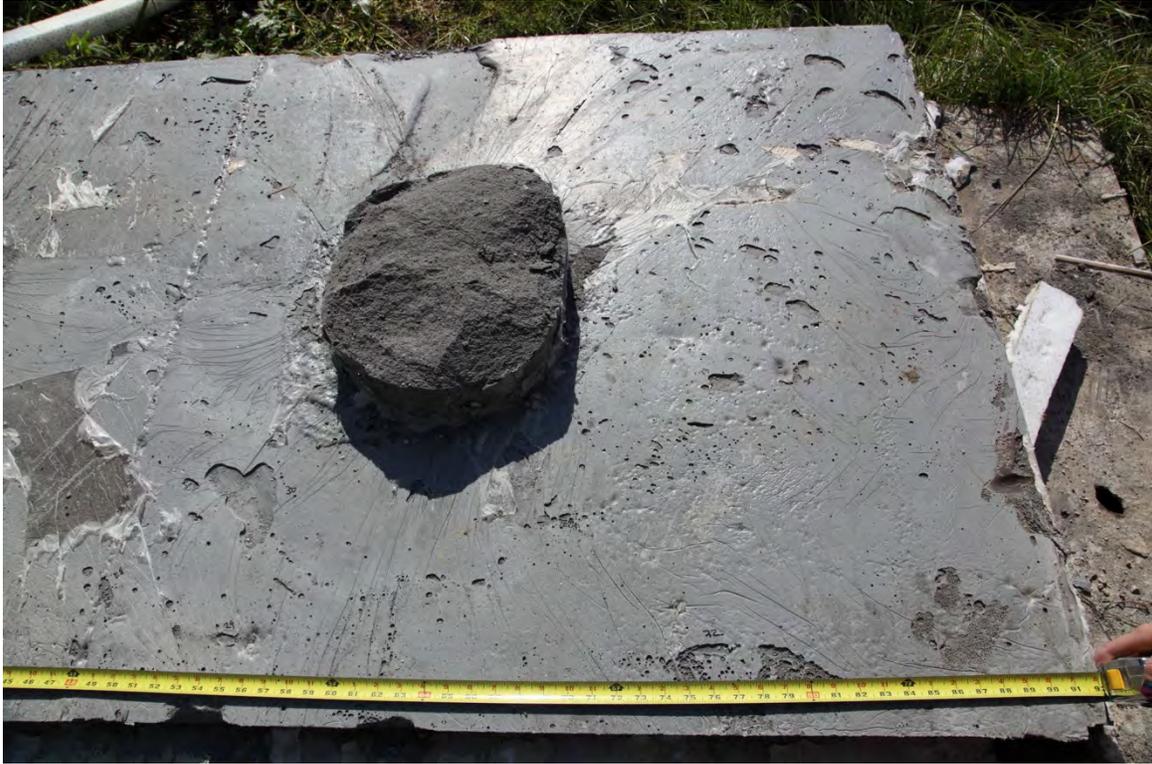
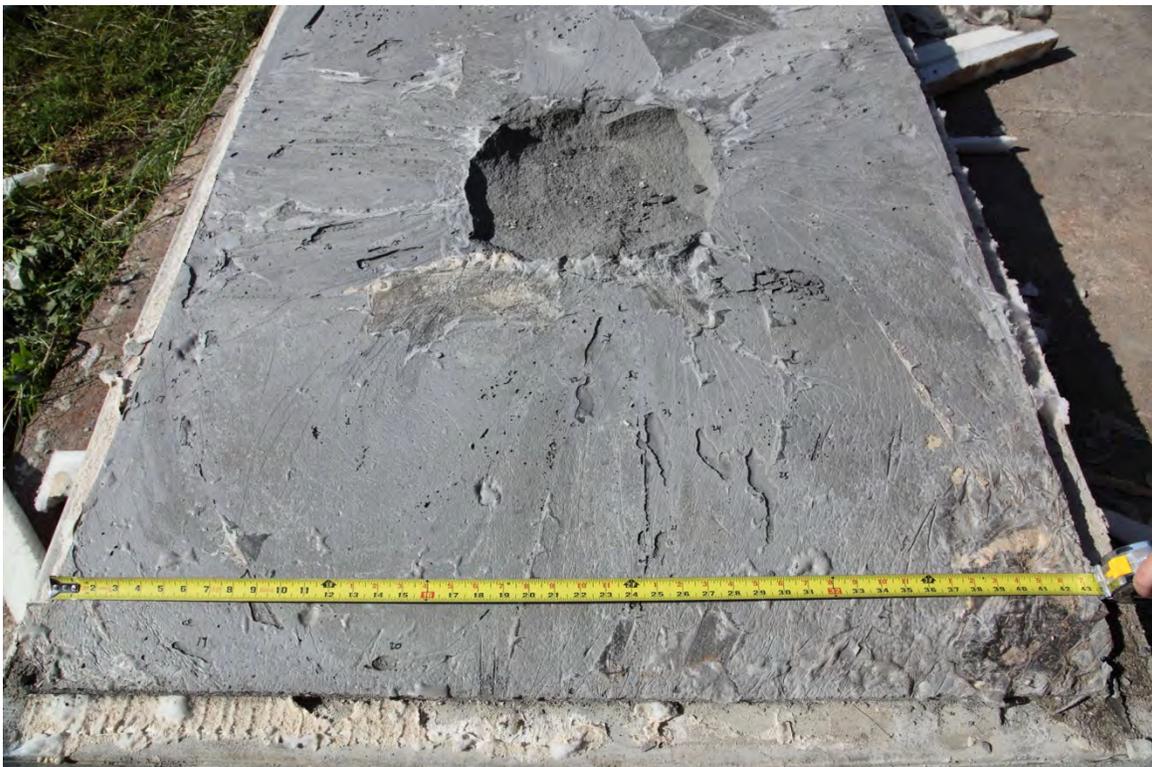
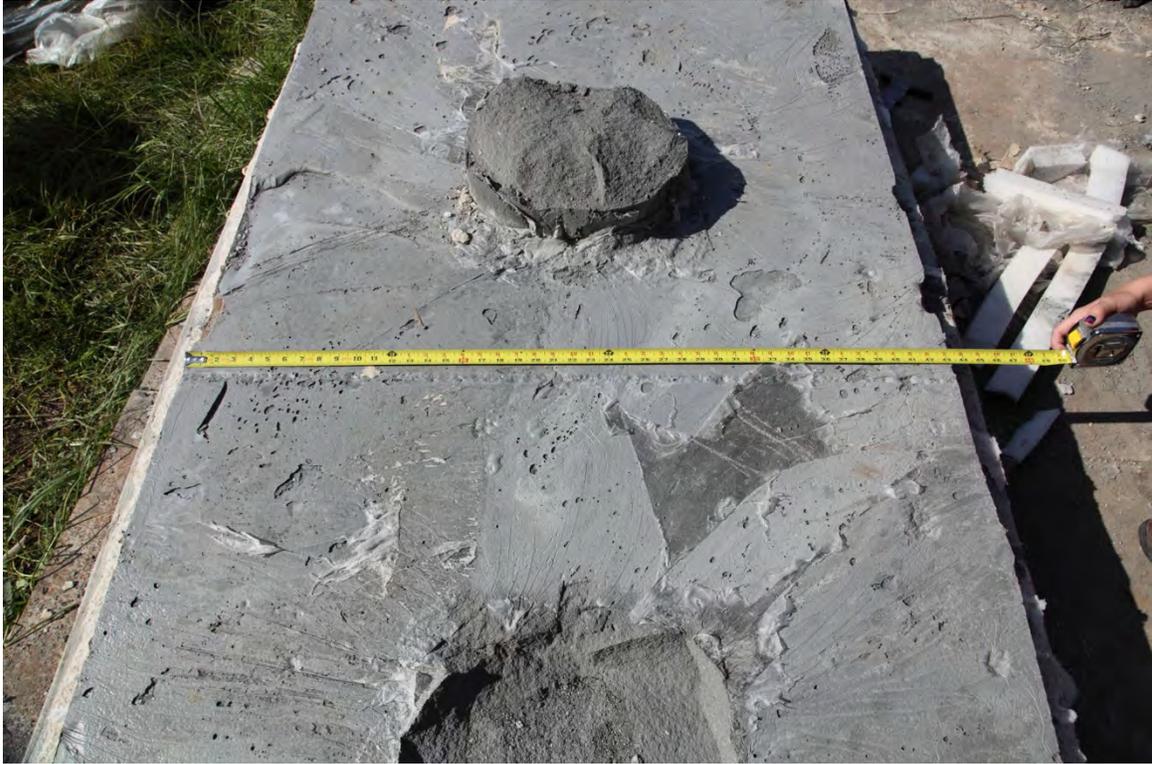
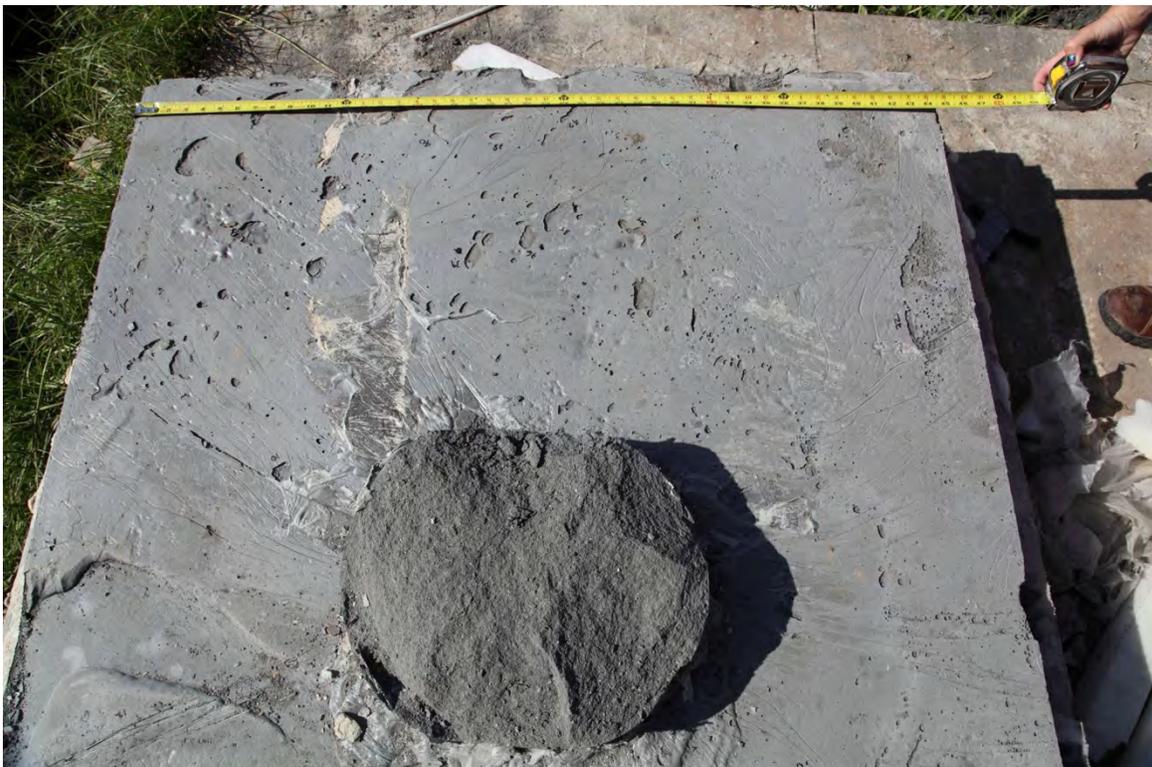
Fig. 5-21. Grout Mock-up for Precast Deck Panel, End 1

Fig. 5-22. Grout Mock-up for Precast Deck Panel, End 2

Fig. 5-23. Grout Mock-up for Precast Deck Panel, End 1 Close-up

Fig. 5-24. Grout Mock-up for Precast Deck Panel, Area between Shear Pockets

Fig. 5-25. Grout Mock-up for Precast Deck Panel, End 2 Close-Up

Fig. 5-26. Grout Mock-up for Precast Deck Panel, End 1

Fig. 5-27. Grout Mock-up for Precast Deck Panel, Middle Region

Fig. 5-28. Grout Mock-up for Precast Deck Panel, End 2

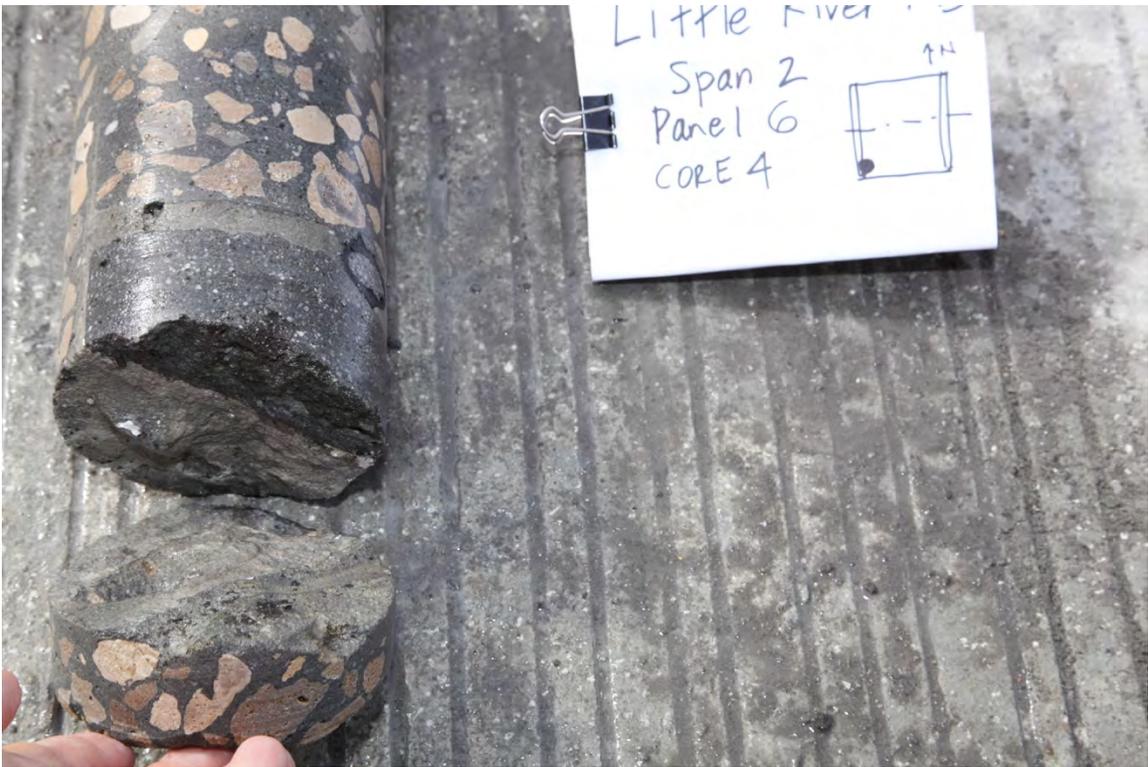
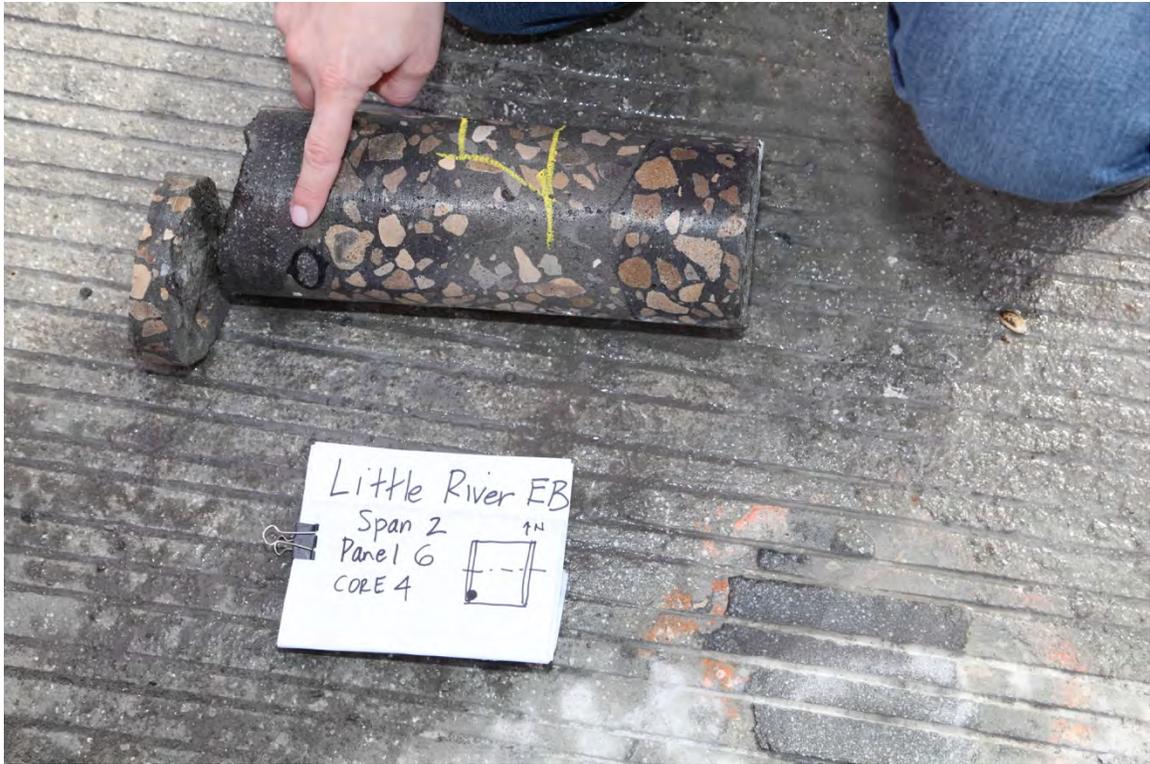
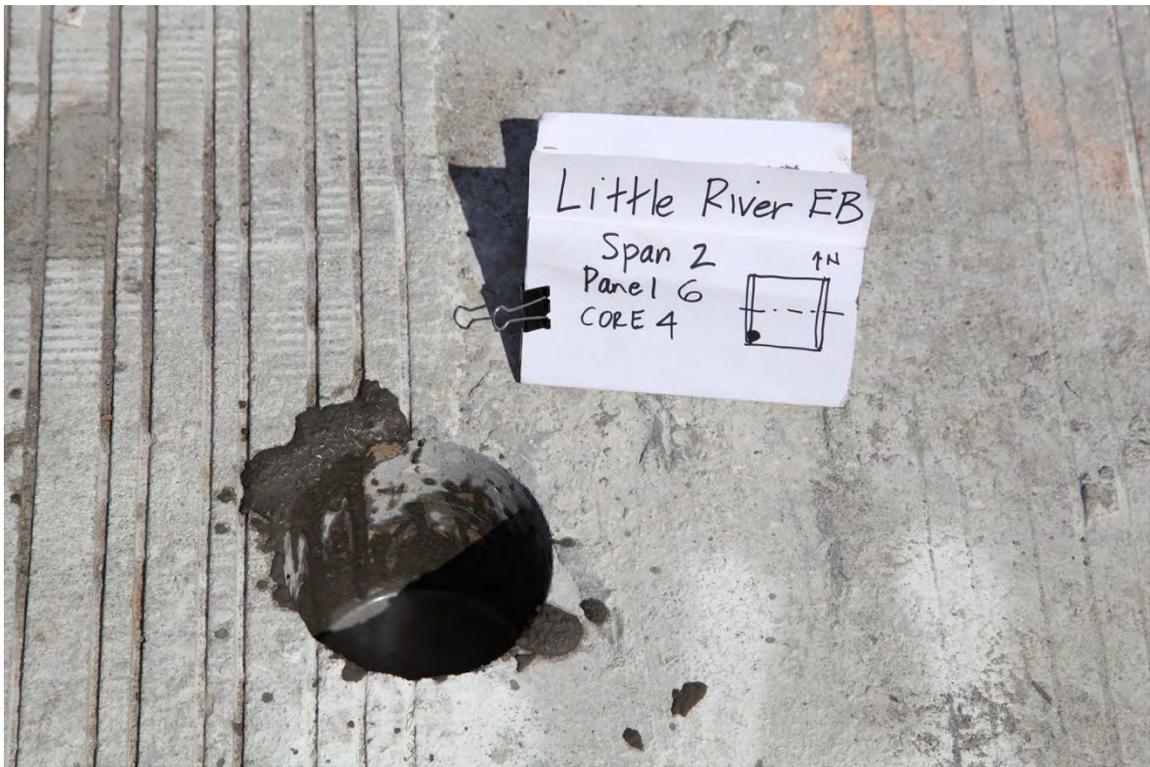
- Core 4 (**Figures 6-12 to 6-14**) was cut through an area where the grout in the haunch had been repaired, and good consistency was apparent.
- The panel-to-closure pour surfaces were tightly bonded on almost all cores. Some surfaces had minor gaps, probably from air getting trapped on the underside of the panel joint (see **Figure 6-28**).
- The surfaces between the girder and closure pour were rough, but they fit together well and seemed to provide good interlock and friction bond.
- **Figure 6-29** is of a core through the panel and shear pocket, extending into the girder top flange; it shows good bond between the three elements.
- Cores that were made through areas with grout repairs showed that the repairs had good fit with the concrete, meaning that the grout flowed well into the repaired areas.

Fig. 6-12. Core 4, Little River EB, Span 2, Panel 6 (Closure Joint-to-Panel Interface) (1)

Fig. 6-13. Core 4, Little River EB, Span 2, Panel 6 (Closure Joint-to-Panel Interface) (2)

Fig. 6-14. Core 4, Little River EB, Span 2, Panel 6 (Closure Joint-to-Panel Interface) (3)

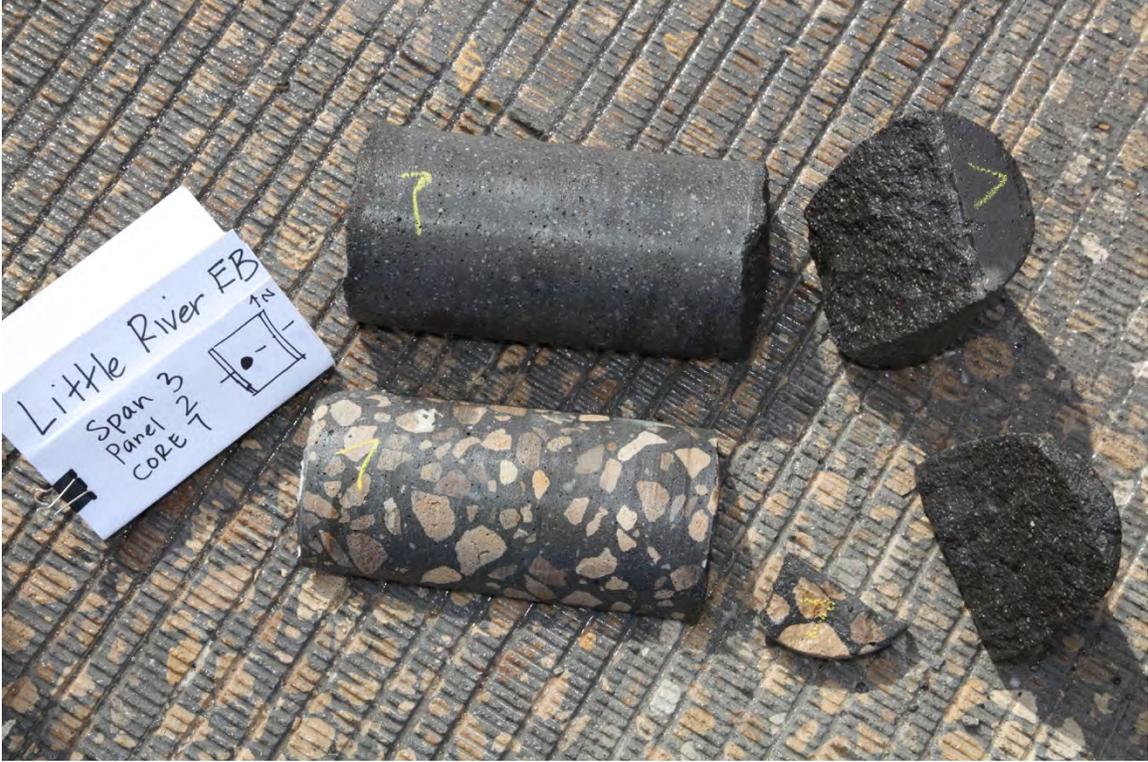
Fig. 6-16. Core 7, Little River EB, Span 3, Panel 2 (in Panel, at Edge of the Shear Pocket) (2)

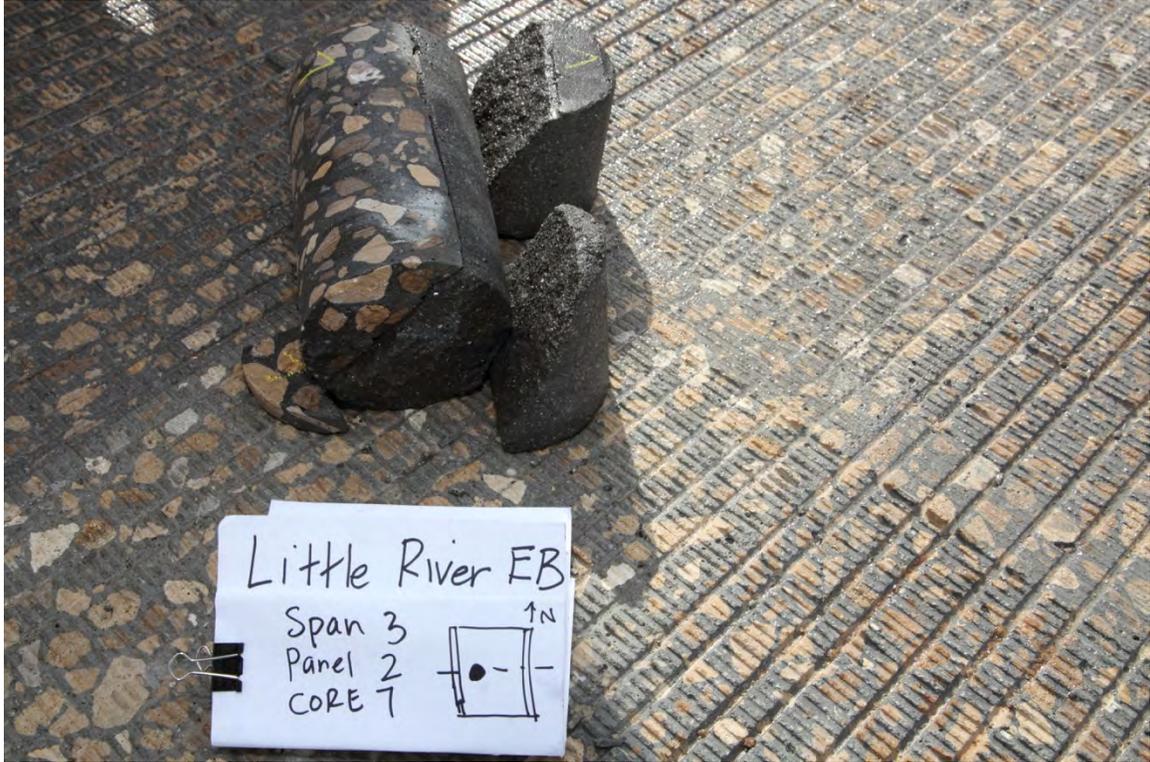
Fig. 6-17. Core 7, Little River EB, Span 3, Panel 2 (in Panel, at Edge of the Shear Pocket) (3)

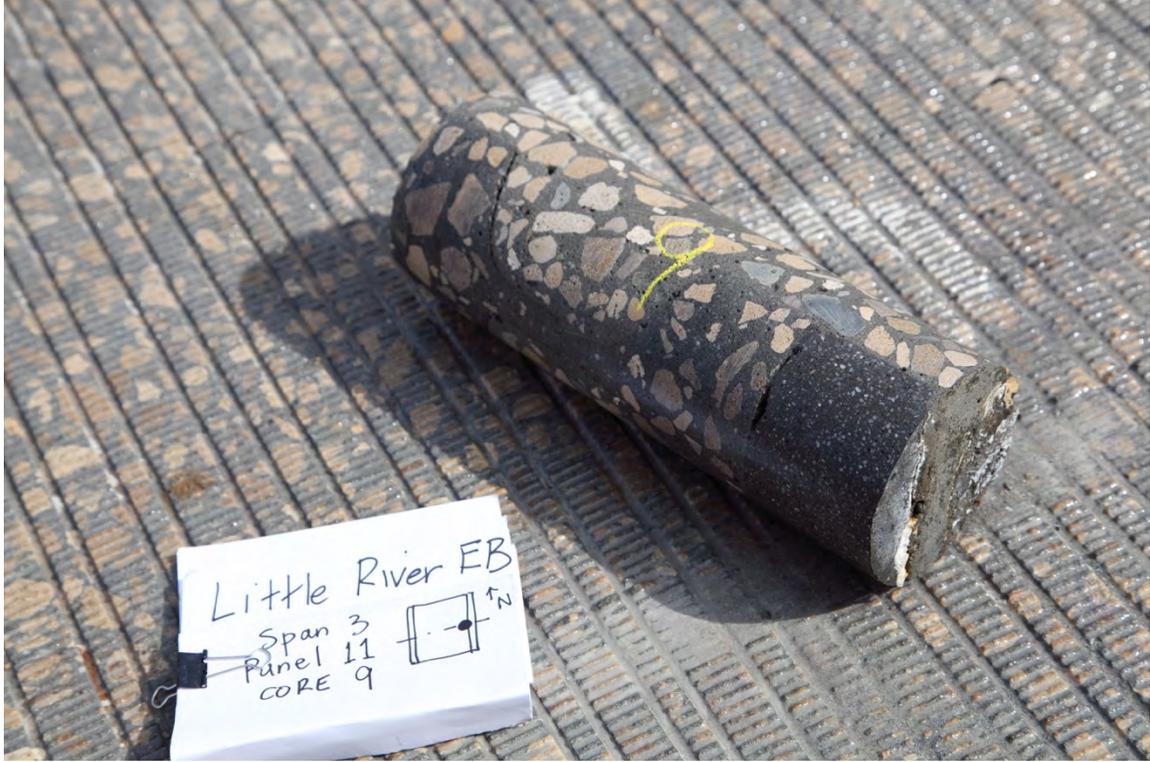
Fig. 6-18. Core 9, Little River EB, Span 3, Panel 11 (Closure Joint-to-Panel Interface) (1)

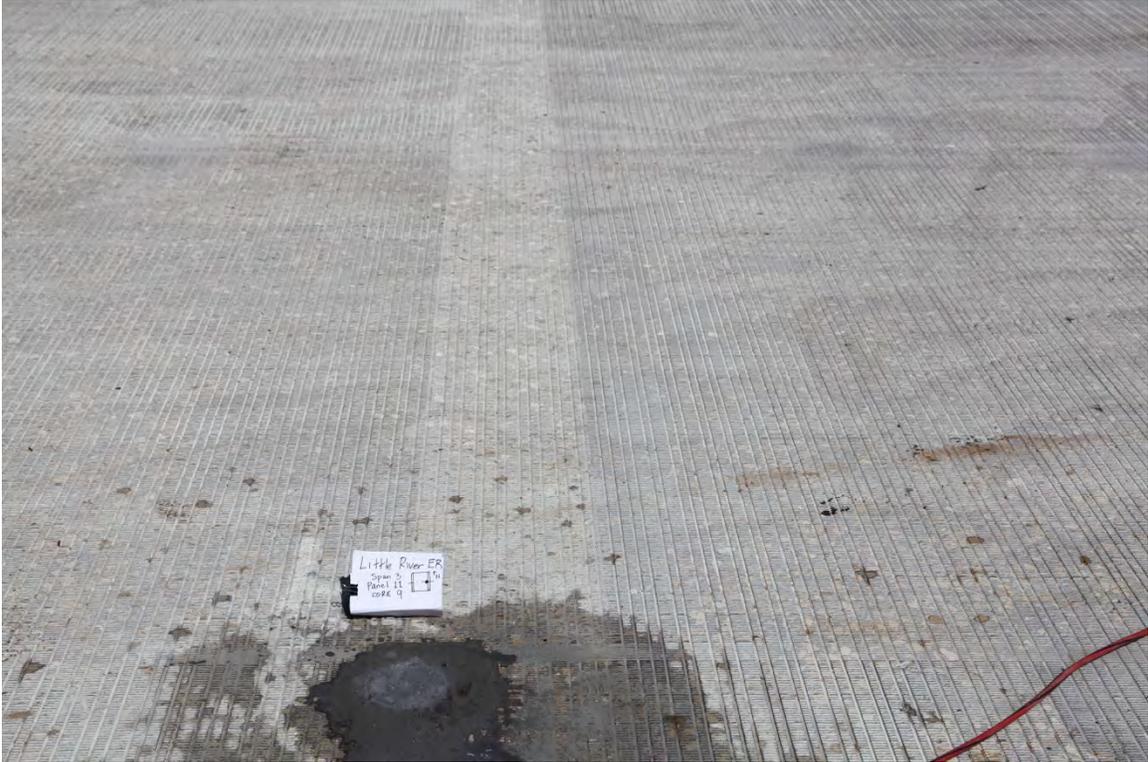
Fig. 6-19. Core 9, Little River EB, Span 3, Panel 11 (Closure Joint-to-Panel Interface) (2)

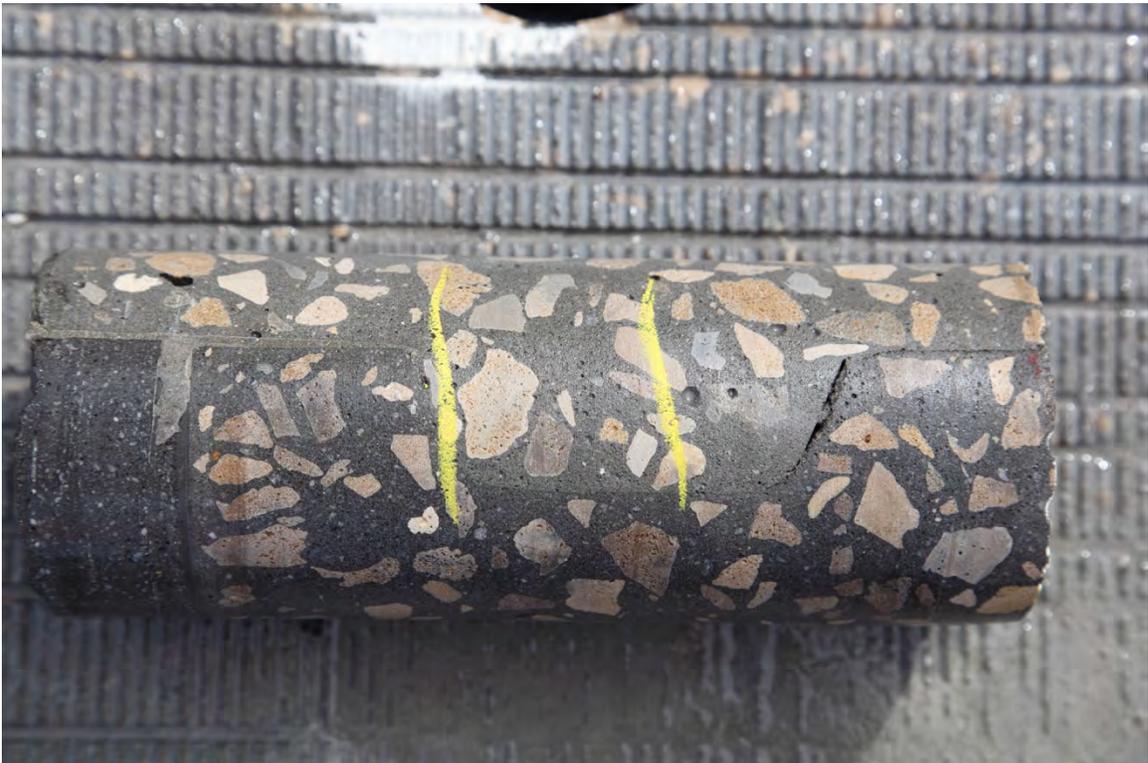
Fig. 6-20. Core 11, Little River EB, Span 4, Panel 4 (Closure Joint-to-Panel Interface) (1)

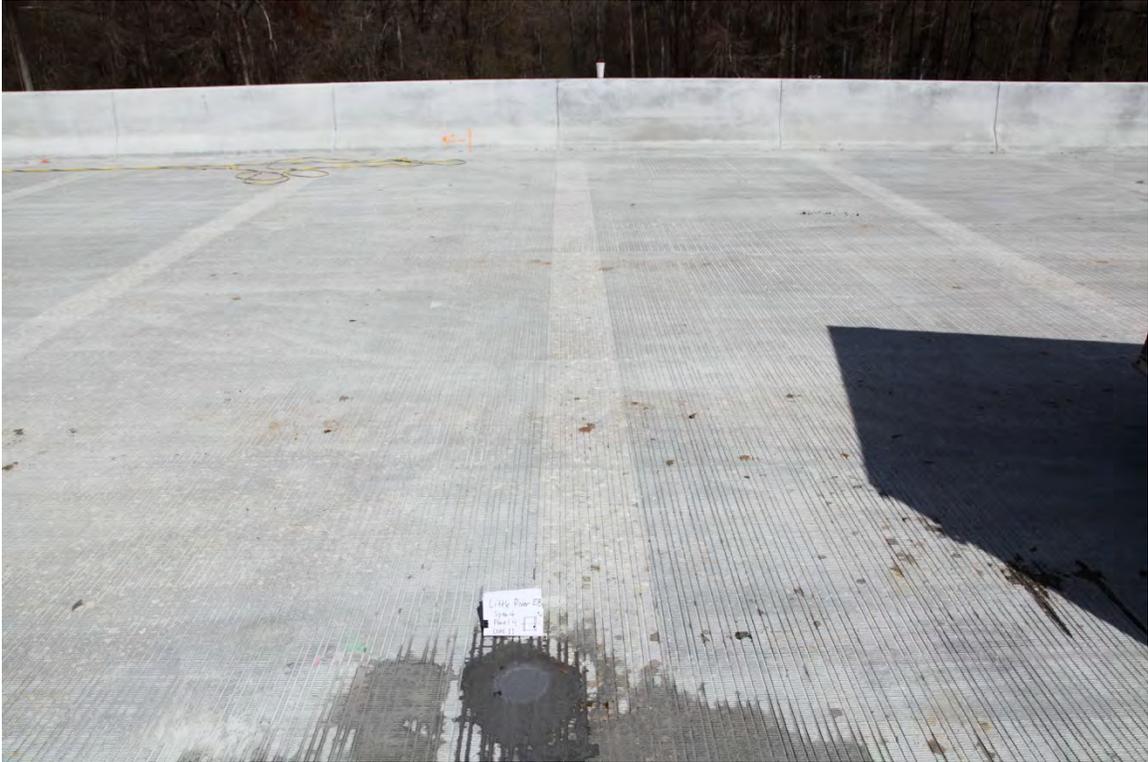
Fig. 6-21. Core 11, Little River EB, Span 4, Panel 4 (Closure Joint-to-Panel Interface) (2)

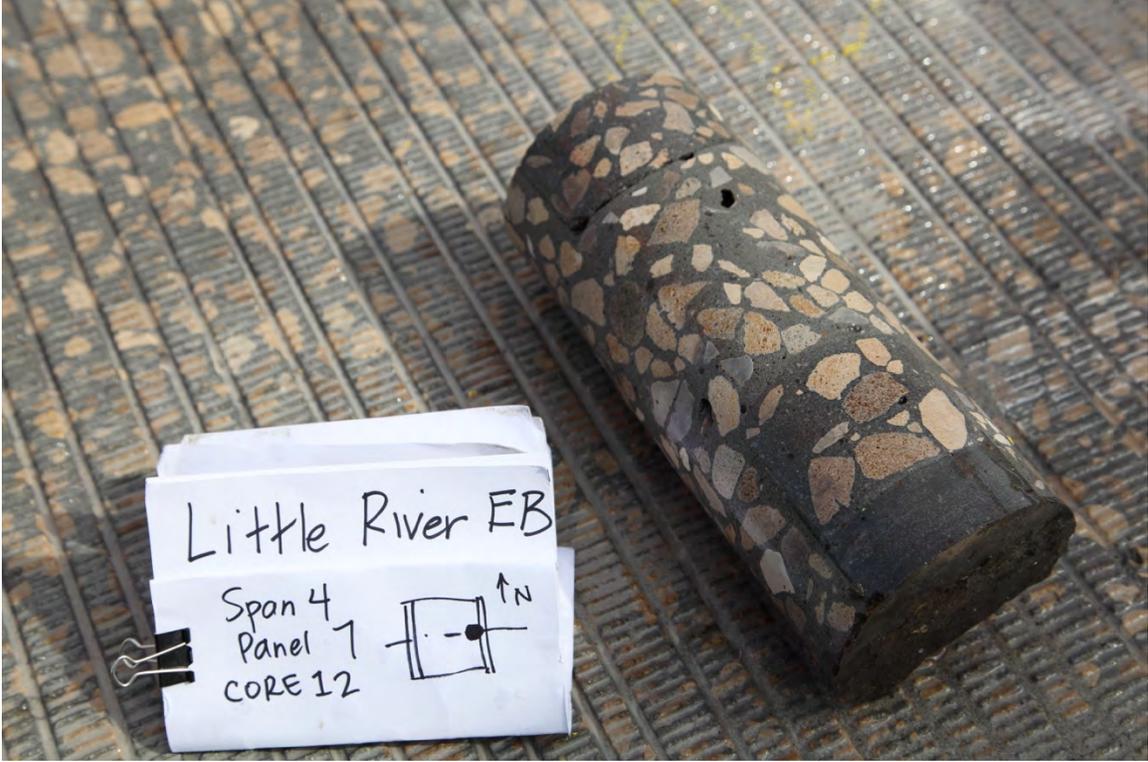
Fig. 6-22. Core 12, Little River EB, Span 4, Panel 7 (Closure Joint-to-Panel Interface) (1)

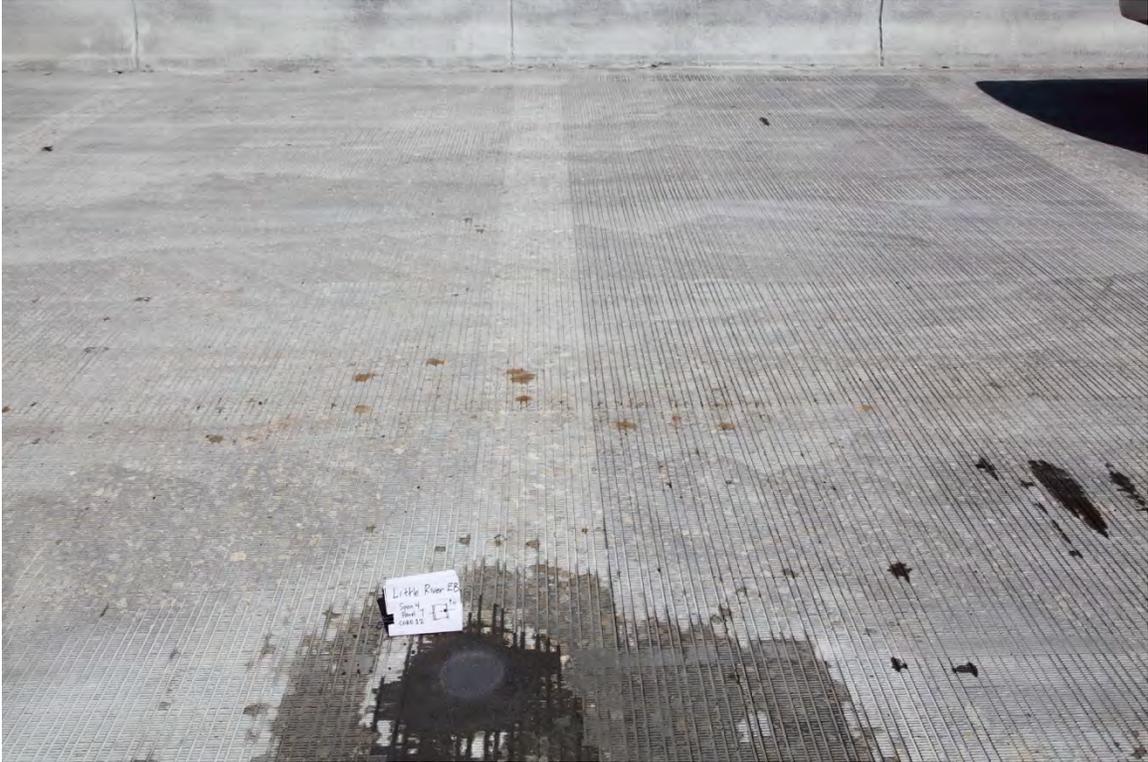
Fig. 6-23. Core 12, Little River EB, Span 4, Panel 7 (Closure Joint-to-Panel Interface) (2)

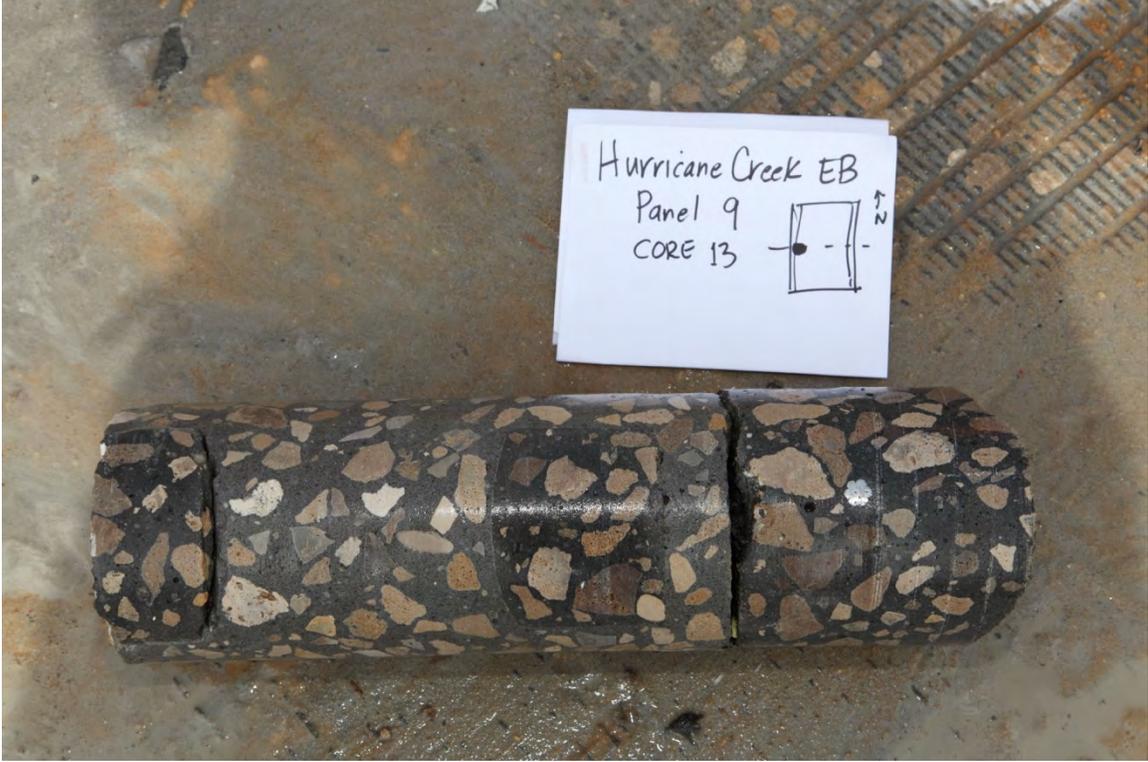
Fig. 6-24. Core 13, Hurricane Creek EB, Panel 9 (Closure Joint-to-Panel Interface) (1)

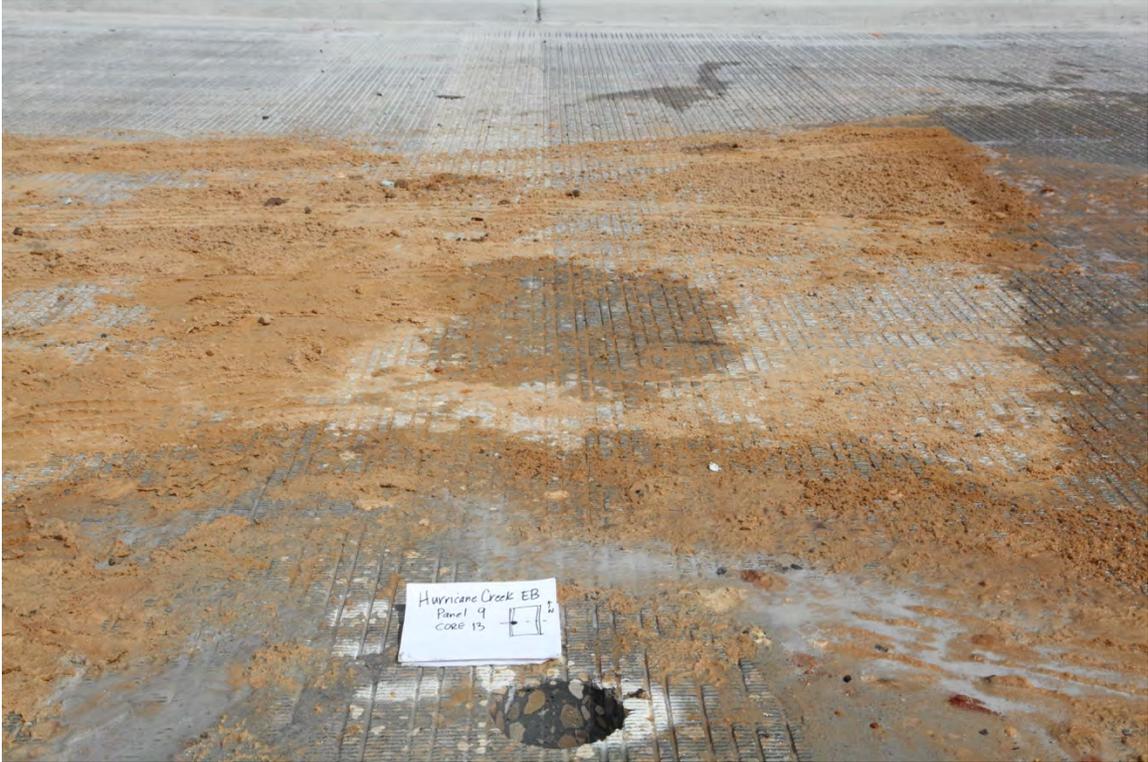
Fig. 6-25. Core 13, Hurricane Creek EB, Panel 9 (Closure Joint-to-Panel Interface) (2)

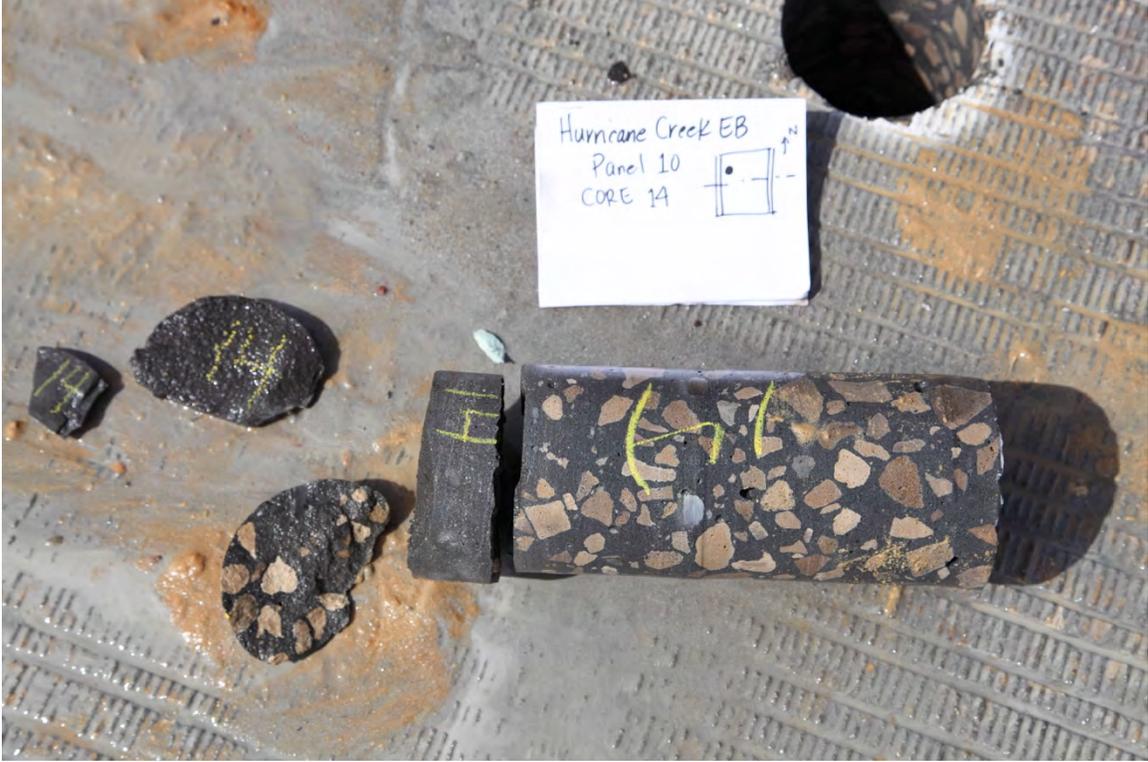
Fig. 6-26. Core 14, Hurricane Creek EB, Panel 10 (in Panel) (1)

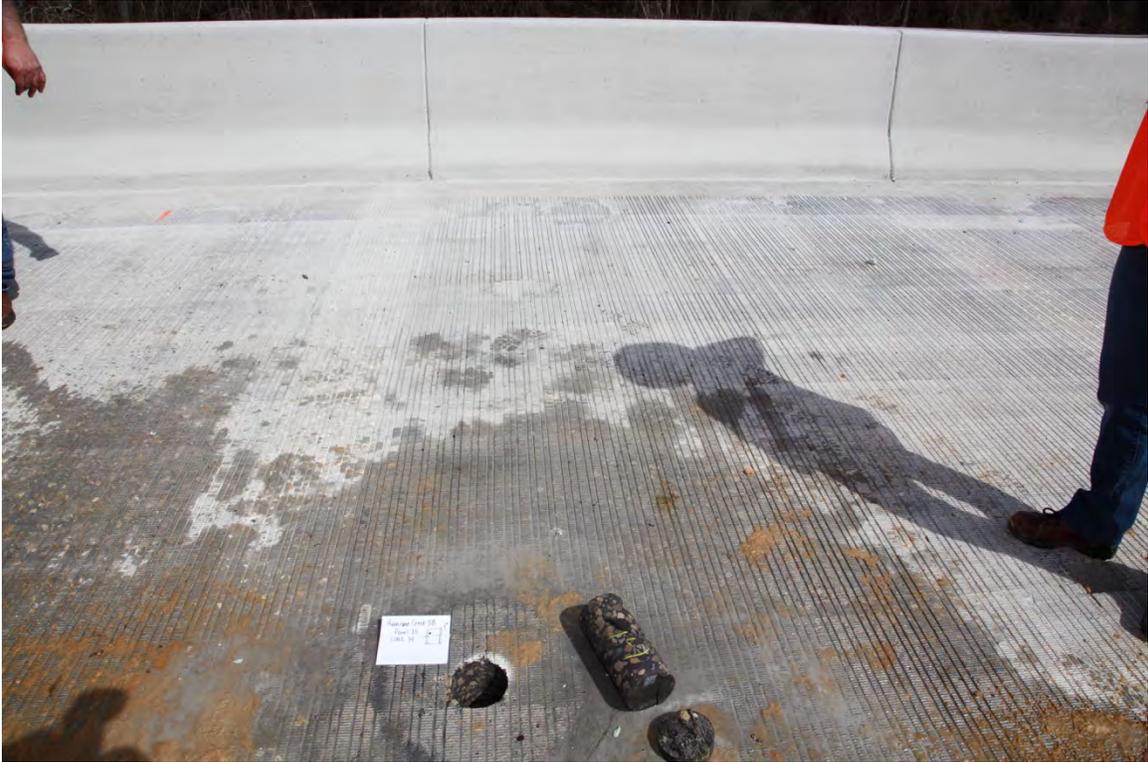
Fig. 6-27. Core 14, Hurricane Creek EB, Panel 10 (in Panel) (2)
