Precast Element Evaluation for the US 90 Bridges over Little River and Hurricane Creek

Contract Number BDV30-307-01
FSU Project ID 032819

July 2019
FINAL REPORT

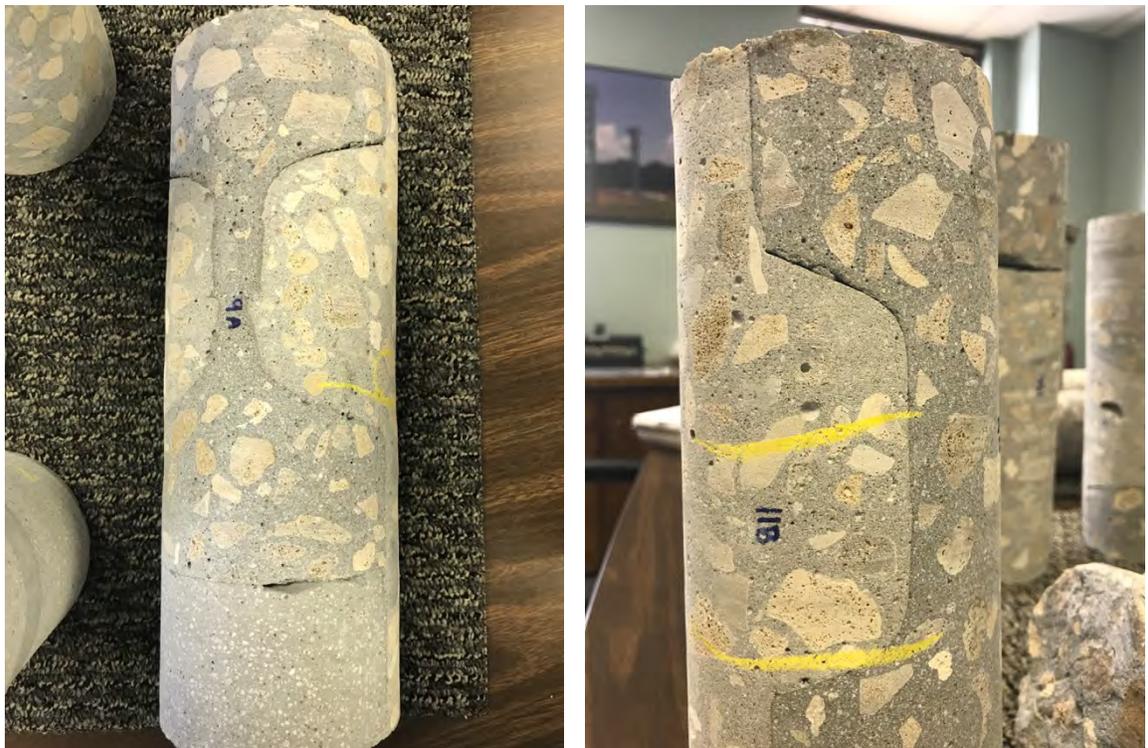
- Core 4 (**Figures 6-12 to 6-14**) was cut through an area where the grout in the haunch had been repaired, and good consistency was apparent.
- The panel-to-closure pour surfaces were tightly bonded on almost all cores. Some surfaces had minor gaps, probably from air getting trapped on the underside of the panel joint (see **Figure 6-28**).
- The surfaces between the girder and closure pour were rough, but they fit together well and seemed to provide good interlock and friction bond.
- **Figure 6-29** is of a core through the panel and shear pocket, extending into the girder top flange; it shows good bond between the three elements.
- Cores that were made through areas with grout repairs showed that the repairs had good fit with the concrete, meaning that the grout flowed well into the repaired areas.

Fig. 6-28. Core 9 (left) and 11 (right), Showing Minor Gaps Between Panel and Closure Joint

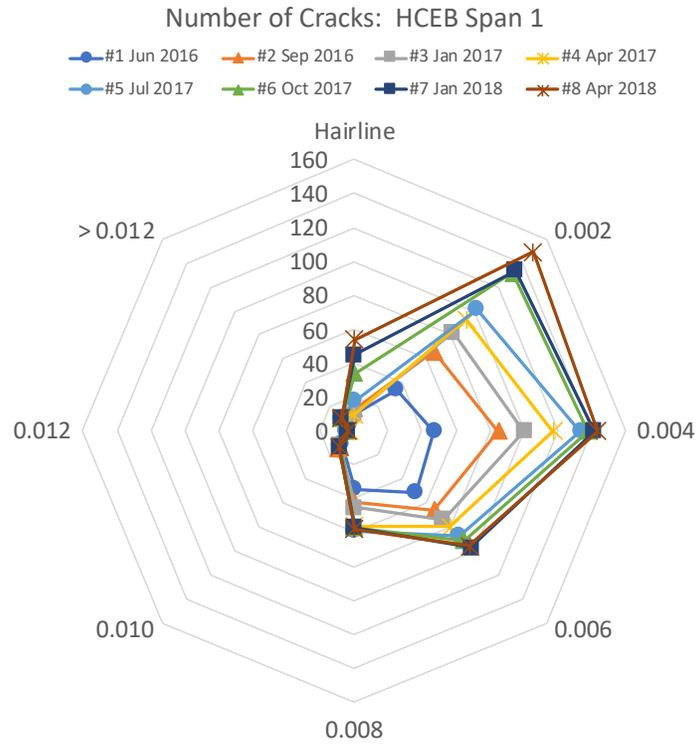
Fig. 3-1. Number of Cracks for Each Width: Hurricane Creek Eastbound Bridge

The subtotals are shown in radar-type plots in **Figures 3-1 to 3-10**. As shown in the figures, all spans had an increase in the number of recorded cracks over time, from mapping #1 through mapping #8. However, there are clear differences in cracking between the eastbound and westbound bridges. The differences are summarized as follows:

- The radar plots indicate more considerable cracking in the *eastbound* bridges, with the plots skewed to the 0.002, 0.004, and 0.006 in. widths.
- For the *westbound* bridges, the radar plots are skewed mostly to the 0.002 in. width.
- A typical *eastbound* bridge span has around 80 – 140 cracks that are 0.002 in. wide, 100 – 140 cracks that are 0.004 in. wide, and 60 cracks that are 0.006 in. wide.
- A typical *westbound* bridge span has around 100 – 120 cracks that are 0.002 in. wide, 40 – 60 cracks that are 0.004 in. wide, and 20 cracks that are 0.006 in. wide.
- Westbound spans had fewer and narrower cracks than eastbound spans.

Based on the radar plots in **Figures 3-1 to 3-10**, Hurricane Creek EB Bridge had the most cracking in the panels. A crack disposition analysis was performed on the April 2017 (fourth) mapping. The analysis was done per FDOT Specification 400-21 Disposition of Cracked Concrete. The bridge superstructure is classified in the Environment Category of Slightly Aggressive, and it is more than 12 feet above mean high water (MHW). Panels 1 through 9 were analyzed, and a summary is provided in **Table 4-1**. Cracks in the adjacent joints were not included in the analysis; only cracks in the panels were included.

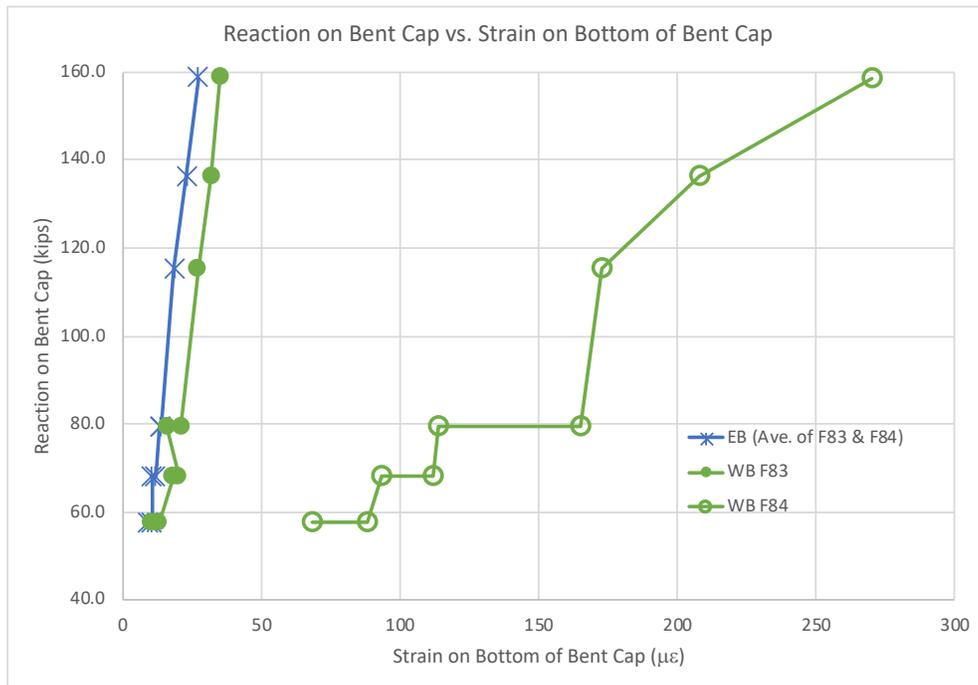
Fig. 4-63. Reaction on Bent Cap vs. Strain on Bottom of Bent Cap

Similar linearity was observed in the raw data for the 12 and 18 block cases for Load Position 4 (see **Table 4-3** and **Figure 4-63**), as well as for the 12, 18, and 24 block cases for Load Position 5.

- The bent cap strains were erratic. Based on the mismatch between the strains on the right and left faces, the bent cap likely behaved as a cracked section. One face may be cracked more than the other. However, overall the bent caps responded well to load.

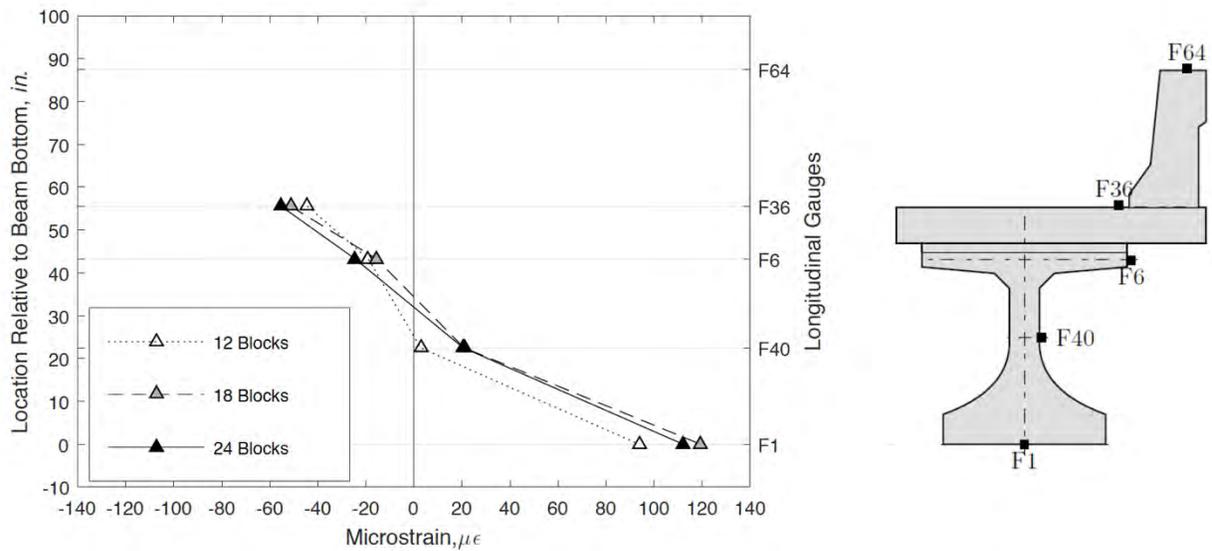
Fig. 5-1. Composite Action – HCEB – FIB5 – LS2

Figure 5-1 shows longitudinal strains on HCEB FIB5, measured with gauges F36, F6, F40, and F1, which are located on top of the deck panel, top flange of the girder, on the web of the girder, and below the bottom flange of the girder, respectively. Gauge F64 on top of the barrier malfunctioned during the load test, therefore it was excluded from this analysis. The graph shows that the strains vary approximately linearly with the depth, which confirms composite action was achieved. Generally, as the number of blocks increased from 12 to 24, the compression at the top and the tension at the bottom both increased.

However, there was an exception as in gauge F1 (below the bottom flange of the girder), where more tensile strain was recorded for 18 blocks than the 24 block case. This could be attributed to the drift in F1 gauge readings that was observed; there was also some drift in F6 gauge readings. The average neutral axis position was approximately 31 in. measured from the bottom of the composite section, as shown in Figure 5-1. The neutral axis is the location where zero strain occurs in the cross section, as determined from interpolation. For the pre-service tests, the neutral axis was approximately 36 in. from the bottom of the section.

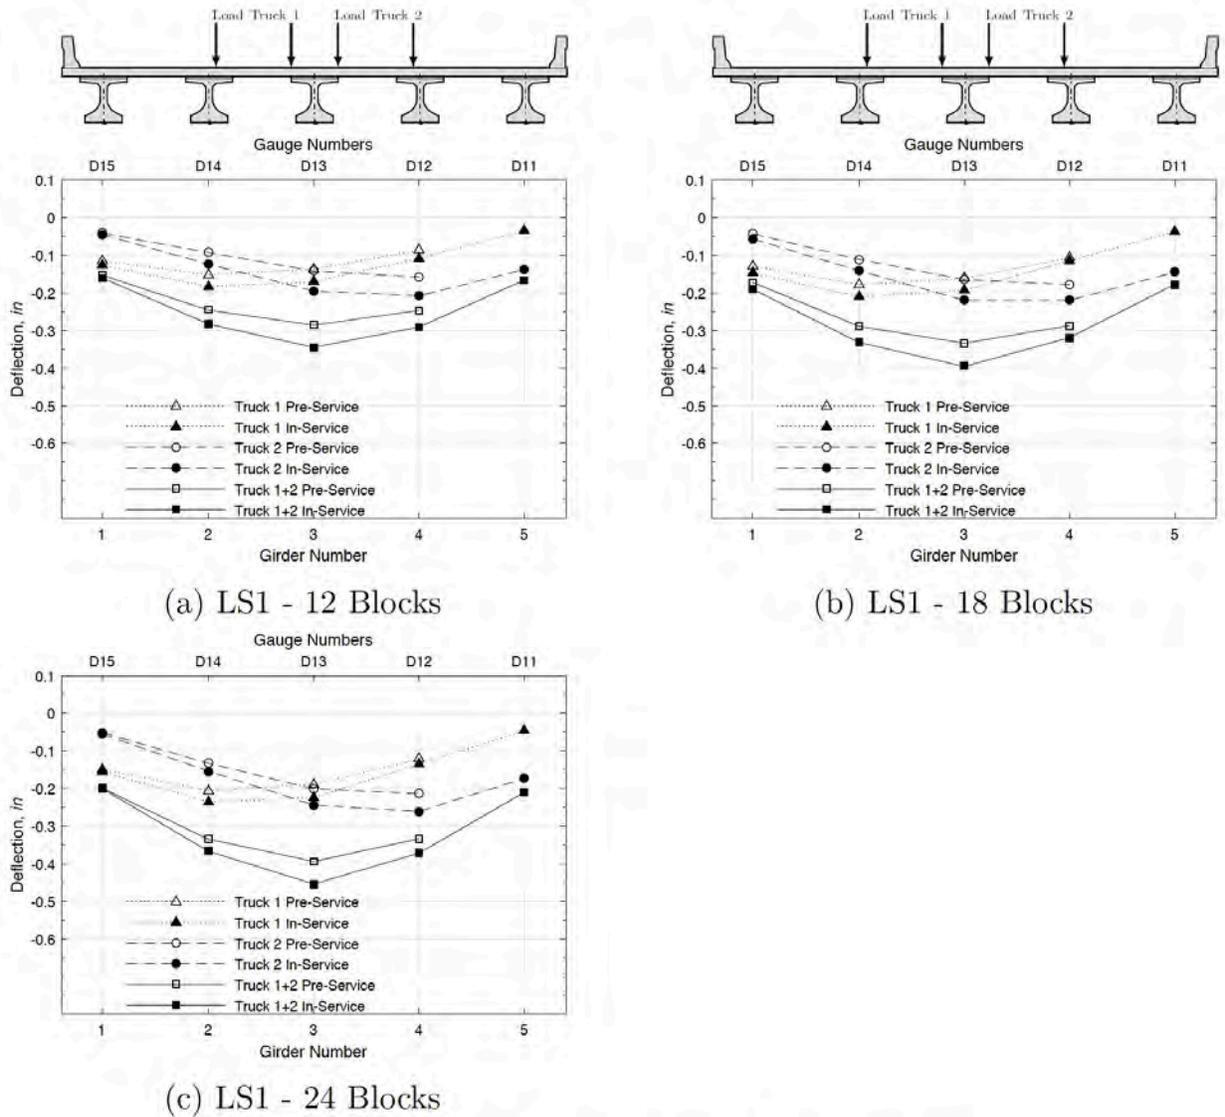
Fig. 5-3. Deflection Mid Span – HCEB – LS1

From the pre-service and in-service plots for HCEB (Figure 5-3), the maximum deflection (at FIB3) was 0.29", 0.33", and 0.39" for 12, 18 and 24 blocks, respectively, for the pre-service test. The in-service test shows maximum deflections to be 0.35", 0.40", and 0.45" for those block cases. This is an average increase of 18.1% from pre-service to in-service.

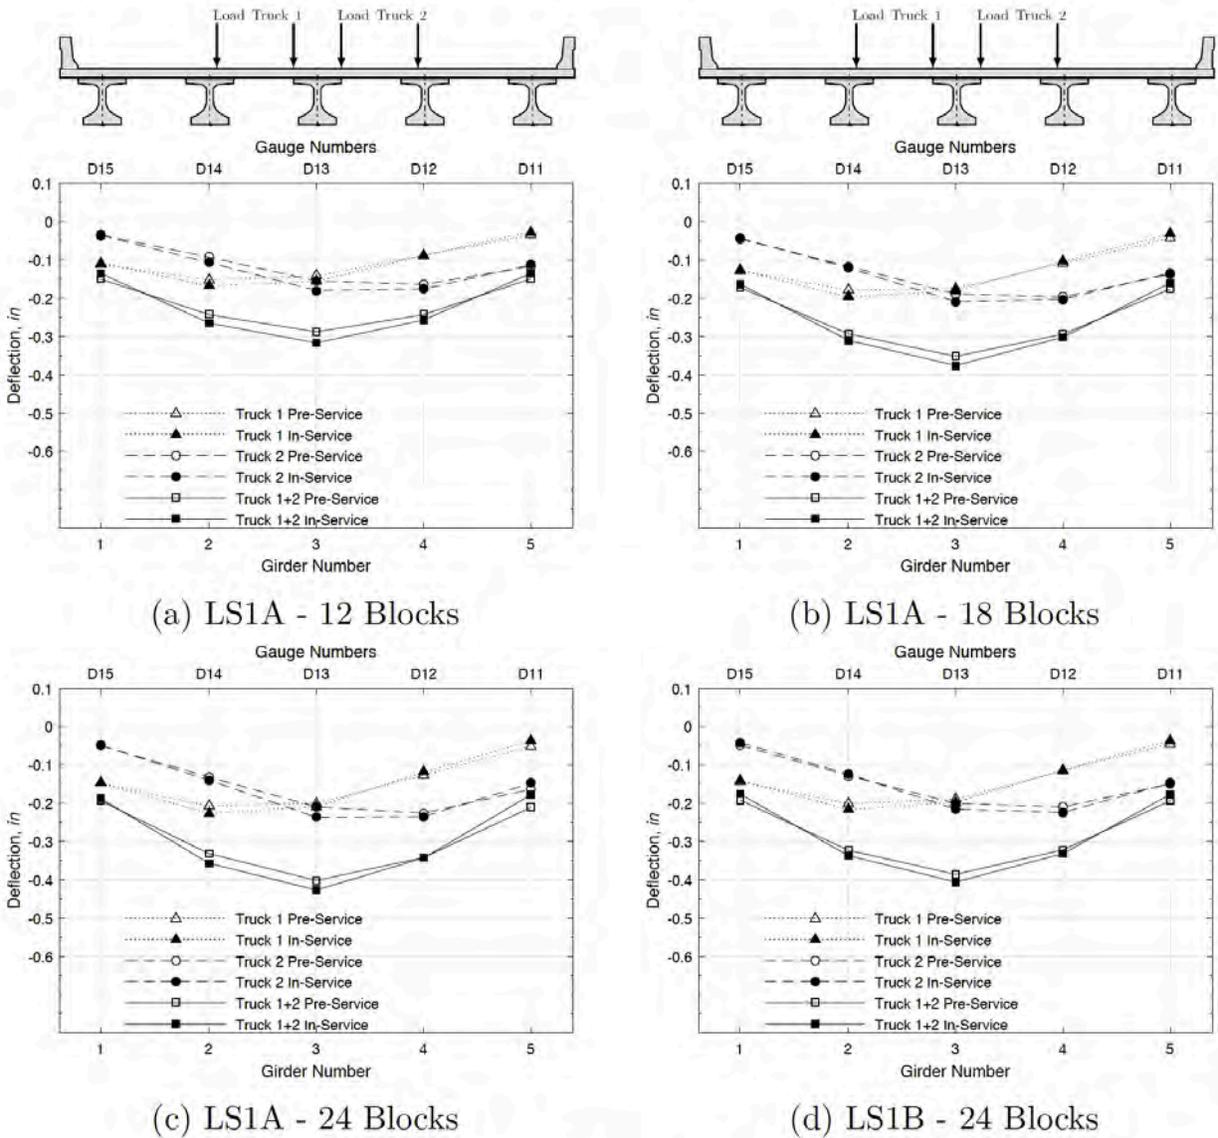
Fig. 5-4. Deflection Mid Span – LREB – LS1A/1B

Figure 5-4 shows the pre-service and in-service plots for LREB, for load position 1A/1B. For position 1A (Figures 5-4a, b and c), the maximum deflection (at FIB3) was 0.29", 0.35", and 0.40" for 12, 18, and 24 blocks, respectively, for the pre-service test. The in-service

test shows maximum deflection to be 0.32", 0.38", and 0.43" for those block cases. This is an average increase of 7.7% from pre-service to in-service. **Figure 5-4d** shows that deflection increased from 0.39" to 0.41" for load position 1B, which is a 5.1% increase.

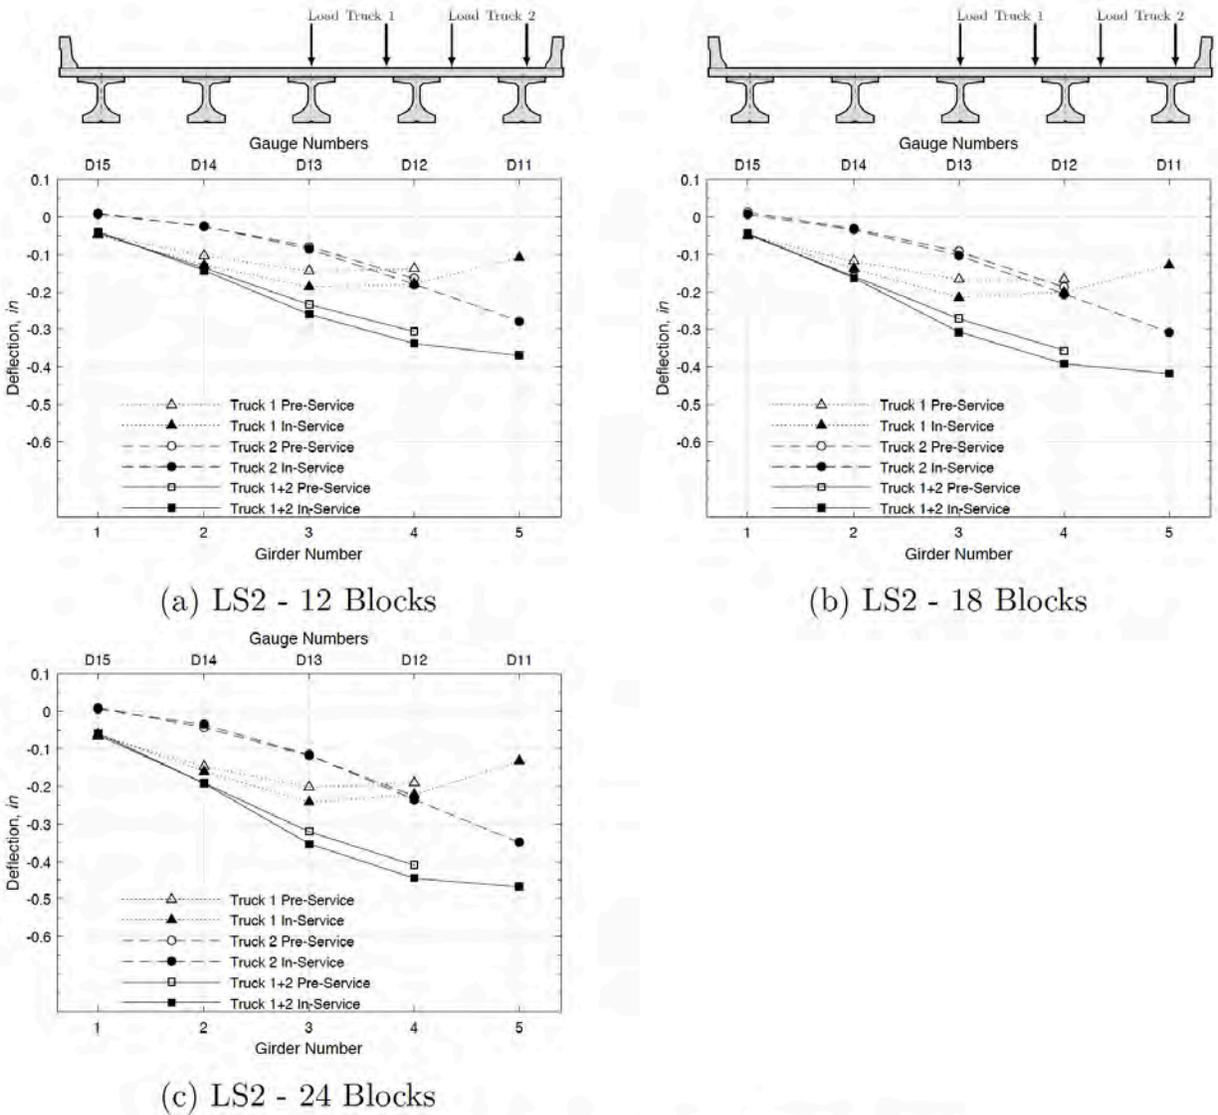
Fig. 5-5. Deflection Mid Span – HCEB – LS2

The pre-service and in-service plots for HCEB, load position 2, are shown in Figure 5-5. Gauge D11 was faulty during the pre-service test, hence its data is not included in the results. Maximum deflections (at FIB5) were 0.37", 0.42", and 0.47" for 12, 18, and 24 blocks, respectively, for the in-service test.

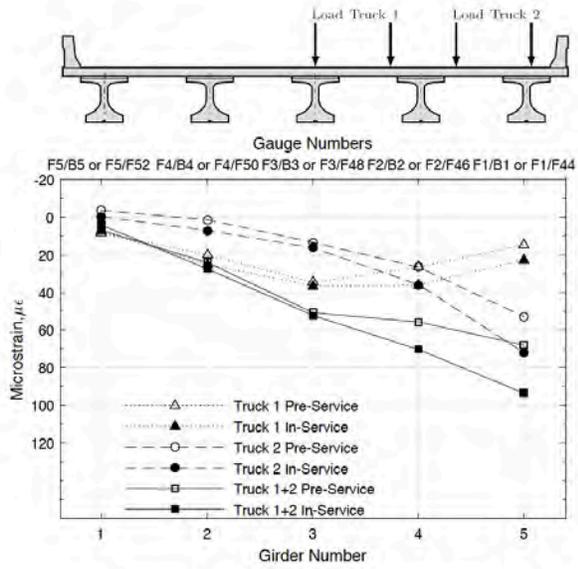
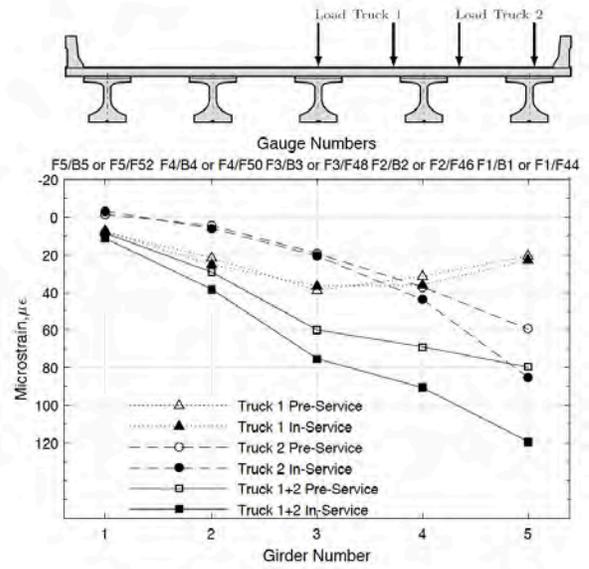
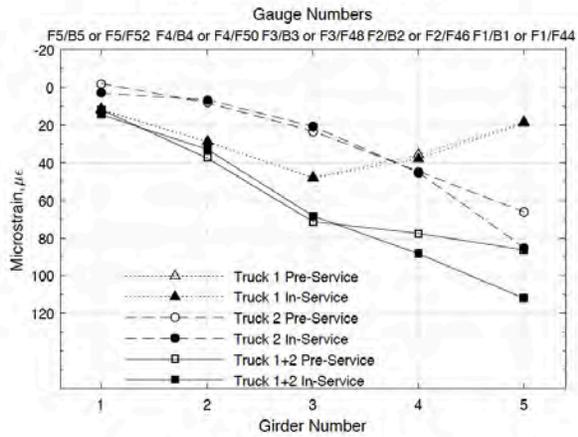
Fig. 5-9. Longitudinal Strain – Section B – HCEB – LS2

Load Position 2: Maximum strains recorded on HCEB - FIB5 increased progressively after being in service. Pre-service, the maximum strains were 68 $\mu\epsilon$, 80 $\mu\epsilon$, and 86 $\mu\epsilon$ for 12, 18, and 24 blocks, respectively. The in-service strains, however, were 94 $\mu\epsilon$, 119 $\mu\epsilon$, and 112 $\mu\epsilon$. This is an average increase of 39% (**Figure 5-9**).

- The response of the bridges from the pre-service tests to the in-service tests was different in some cases. This could be due to changes in stiffness or boundary conditions. The highest strain increase was noticed on HCEB FIB5.

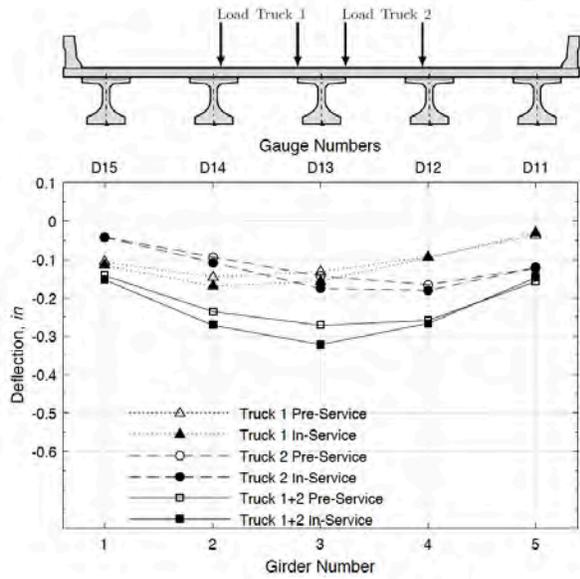
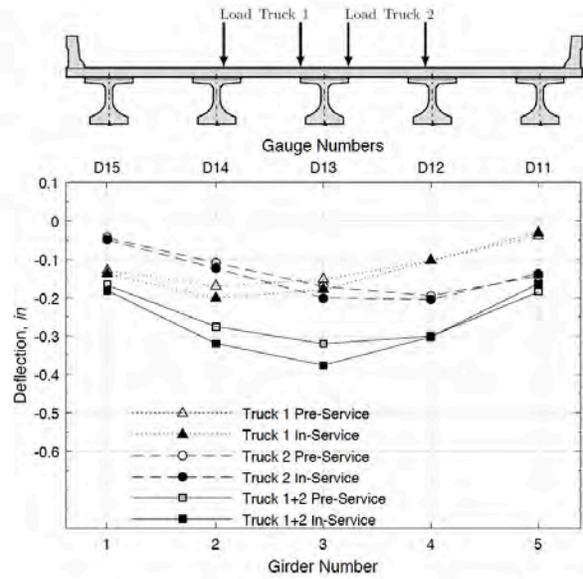
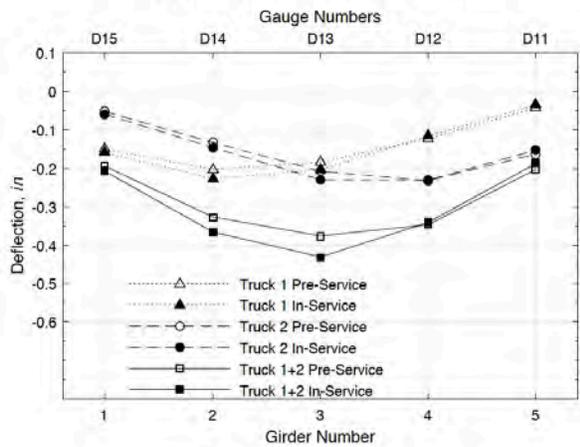
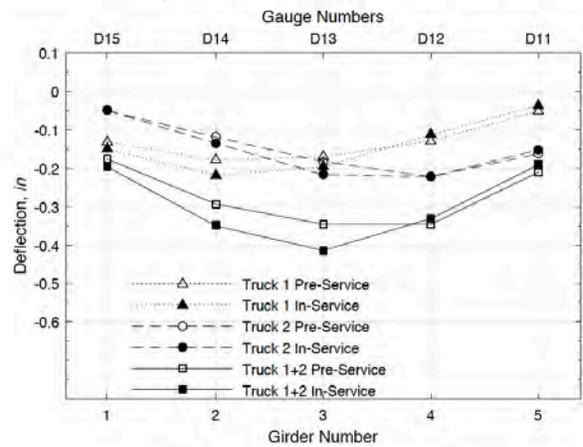
Fig. 5-14. Deflection Mid Span – LRWB – LS1A/1B

Figure 5-14 shows the pre-service and in-service plots for LRWB, for load position 1A/1B. For position 1A (**Figures 5-14a, b and c**), maximum deflection (at FIB3) was 0.27", 0.32" and 0.38" for 12, 18 and 24 blocks, respectively, for the pre-service test. The in-service test showed maximum deflection of 0.32", 0.38" and 0.43" for those block cases. This reflected an average increase of 17% between the pre-service and in-service results. **Figure 5-14d** shows that deflection increased from 0.35" to 0.41" which is also a 17% increase for load position 1B.

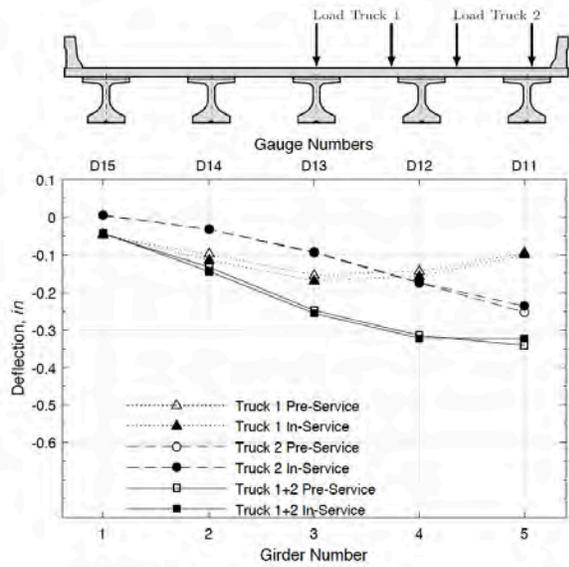
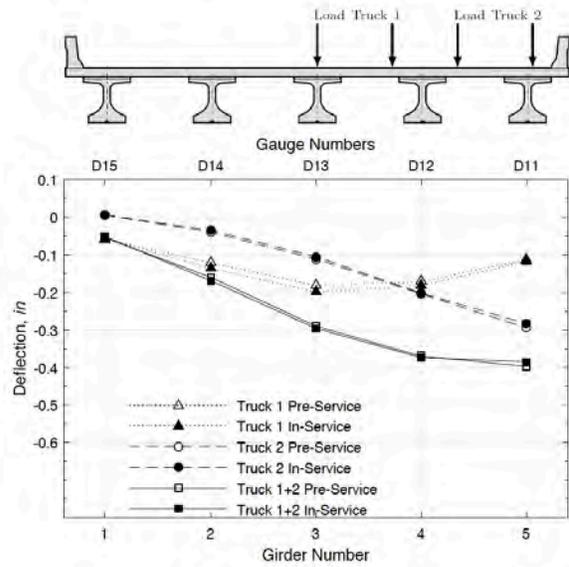
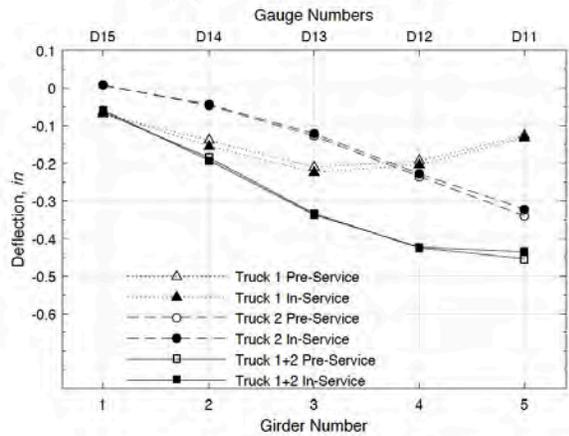
Fig. 5-15. Deflection Mid Span – HCWB – LS2

The pre-service and in-service plots for HCWB, load position 2, are shown in **Figure 5-15**. Maximum deflections (at FIB5) were 0.34", 0.40", and 0.45" for 12, 18, and 24 blocks, respectively, for the pre-service test. The in-service test produced maximum deflections of 0.32", 0.39" and 0.44", for an average decrease of 4%.

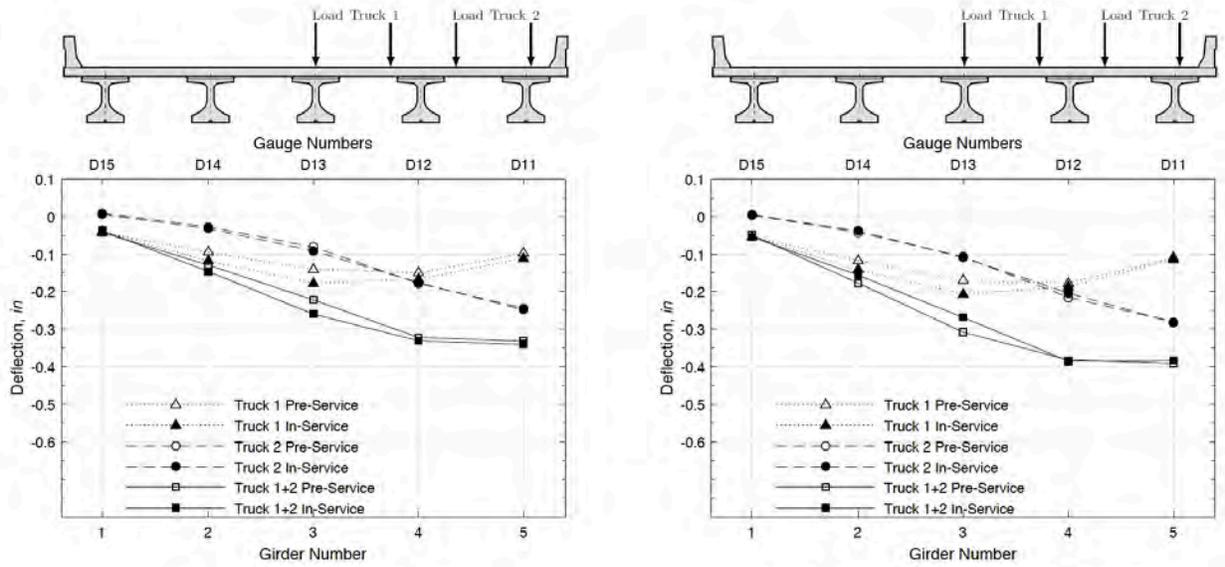
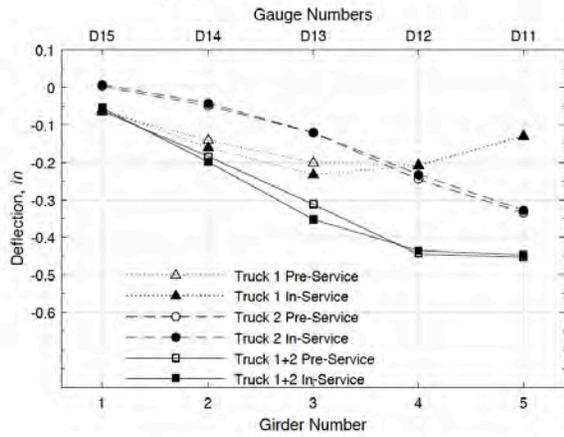
Fig. 5-16. Deflection Mid Span – LRWB – LS2

Figure 5-16 shows the pre-service and in-service plots for LRWB, load position 2. When the plots of the two tests were compared, the change in maximum deflection was very small for each of the block cases. Values for the pre-service test were 0.33", 0.39", and 0.45" for 12, 18, and 24 blocks, respectively. For the pre-service test, they were 0.34", 0.38", and 0.44", which is a slight decrease.

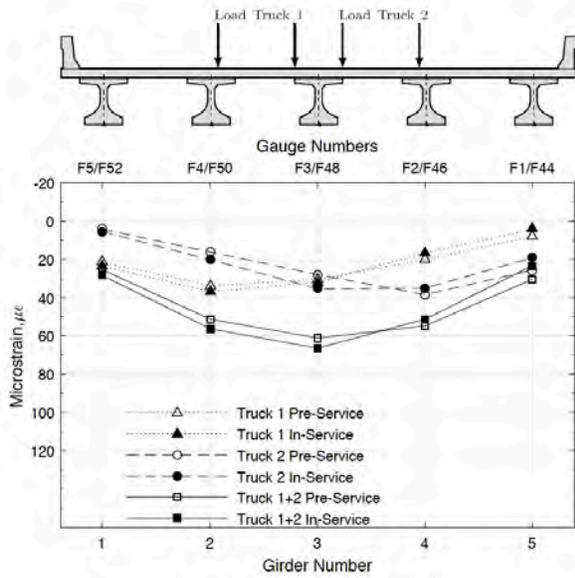
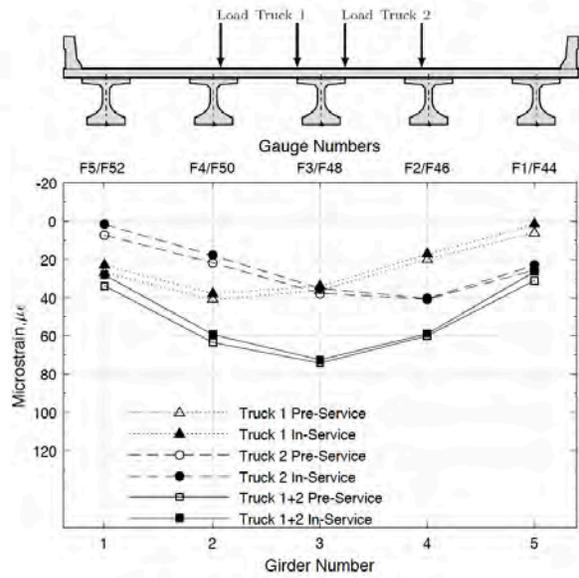
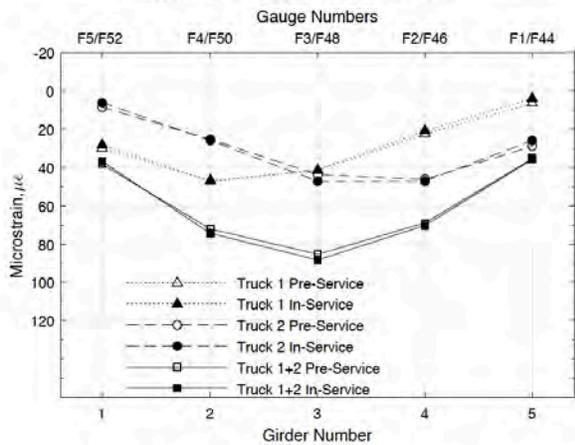
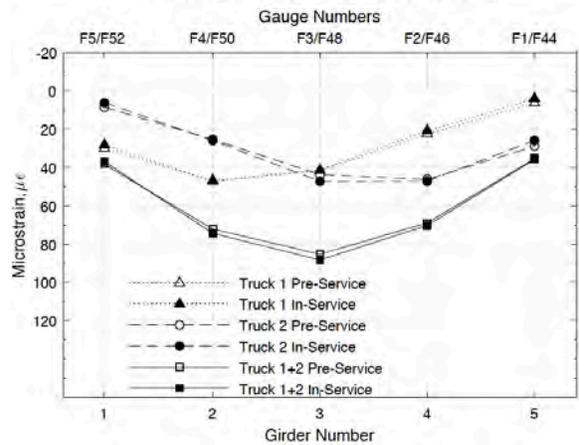
Fig. 5-17. Longitudinal Strain – Section B – HCWB – LS1A/1B

Load Position 1A/1B: Maximum strains recorded on FIB3 for HCWB, load position 1A, were 61 $\mu\epsilon$, 74 $\mu\epsilon$, and 85 $\mu\epsilon$ for 12, 18, and 24 blocks, respectively, for the pre-service test. The in-service test shows maximum strains to be 66 $\mu\epsilon$, 73 $\mu\epsilon$, and 88 $\mu\epsilon$ for those block cases. This was an average increase of 3.3% (**Figure 5-17a, b, and c**). For HCWB, load position 1B, the maximum strain increased slightly as well (**Figure 5-17d**).

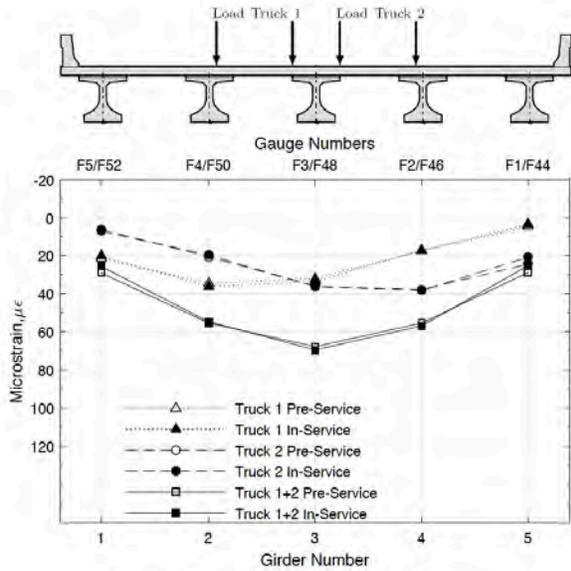
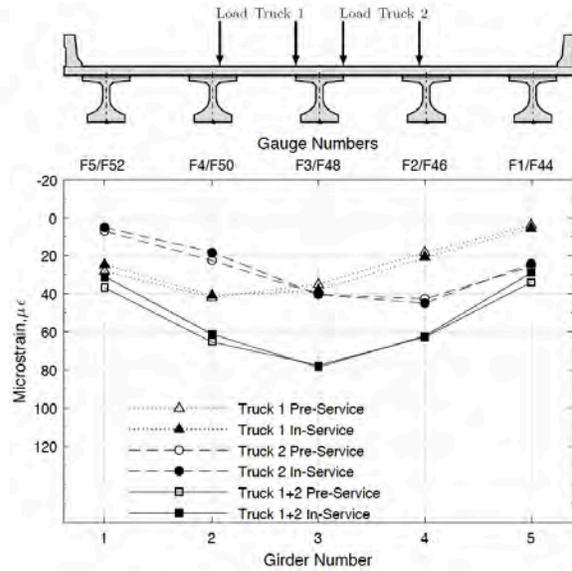
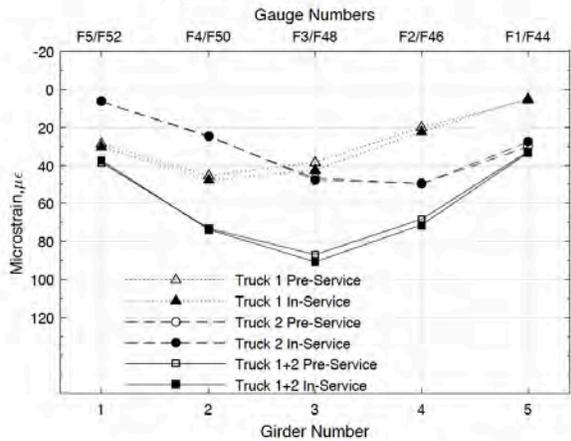
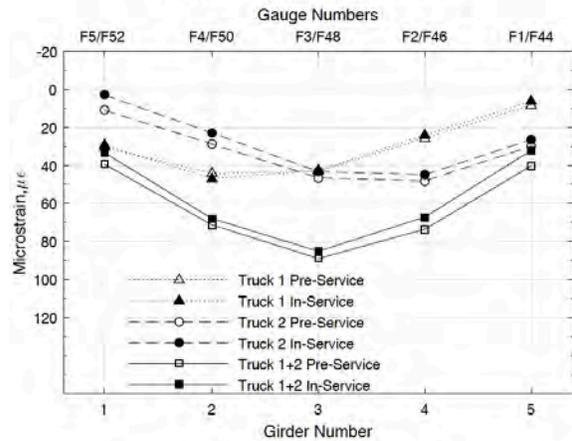
Fig. 5-18. Longitudinal Strain – Section B – LRWB – LS1A/1B

LRWB, load position 1A had maximum strains of 68 $\mu\epsilon$, 78 $\mu\epsilon$, and 87 $\mu\epsilon$ for 12, 18 and 24 block in the pre-service test, and 69 $\mu\epsilon$, 79 $\mu\epsilon$, and 91 $\mu\epsilon$ in the in-service test (**Figures 5-18a, b and c**). This is an average increase of 2.7%. For LRWB, load position 1B, the maximum strain went from 89 $\mu\epsilon$ to 85 $\mu\epsilon$ (**Figure 5-18d**).

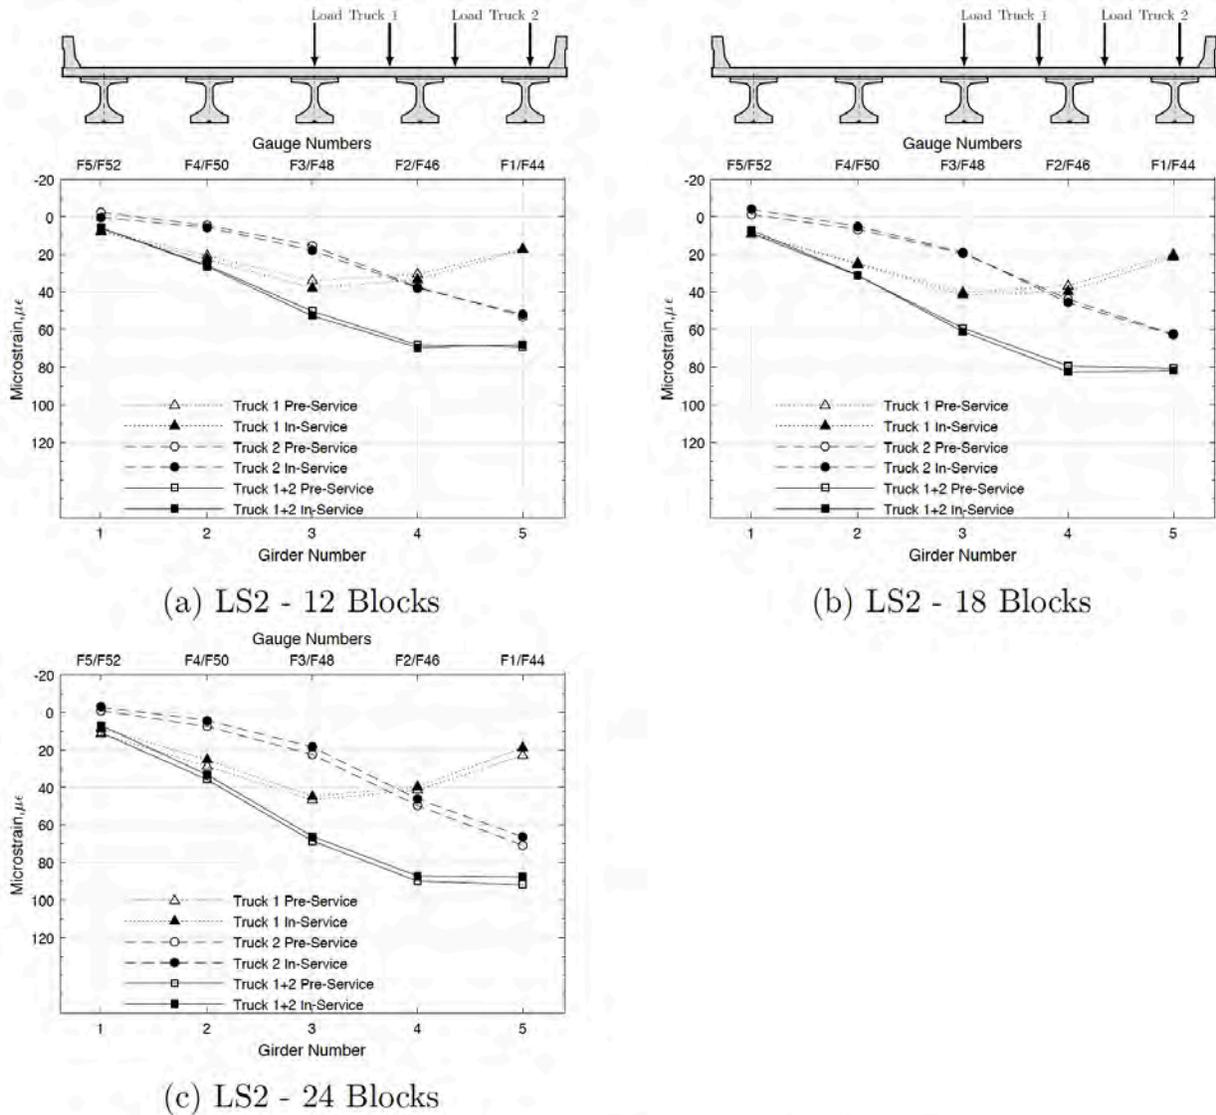
Fig. 5-19. Longitudinal Strain – Section B – HCWB – LS2

Load Position 2: Maximum strains recorded on HCWB FIB5 pre-service results were 69 $\mu\epsilon$, 81 $\mu\epsilon$, and 92 $\mu\epsilon$ for 12, 18, and 24 blocks, respectively. The in-service results, however, gave 68 $\mu\epsilon$, 82 $\mu\epsilon$, and 88 $\mu\epsilon$. This is an average decrease of 1.6% (**Figure 5-19**).

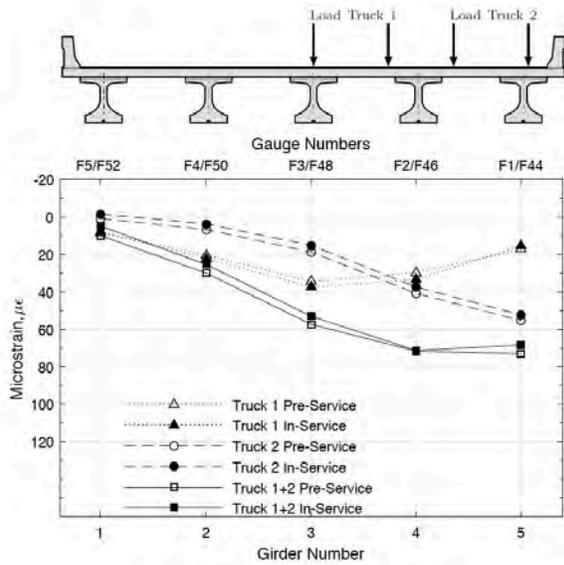
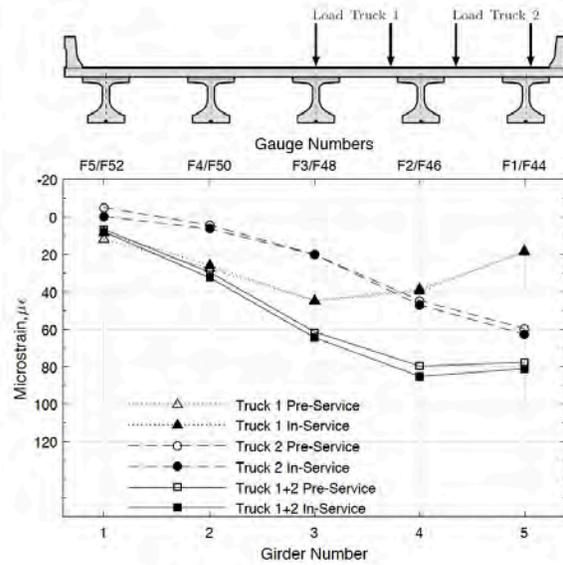
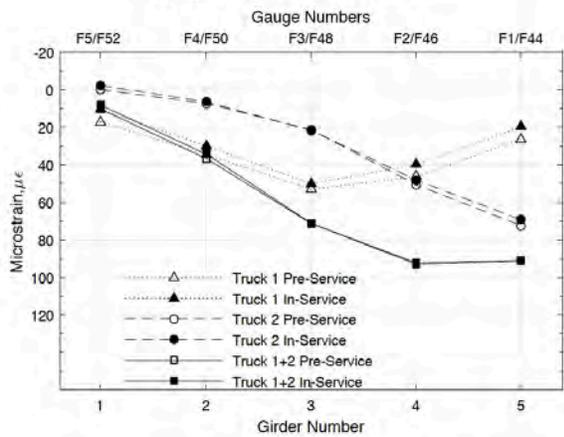
Fig. 5-20. Longitudinal Strain – Section B – LRWB – LS2

For LRWB, load position 2, maximum strains were 73 $\mu\epsilon$, 78 $\mu\epsilon$, and 91 $\mu\epsilon$ for the pre-service test and 68 $\mu\epsilon$, 81 $\mu\epsilon$, and 91 $\mu\epsilon$ for the in-service test. This is an average decrease of 0.56% (**Figure 5-20**).

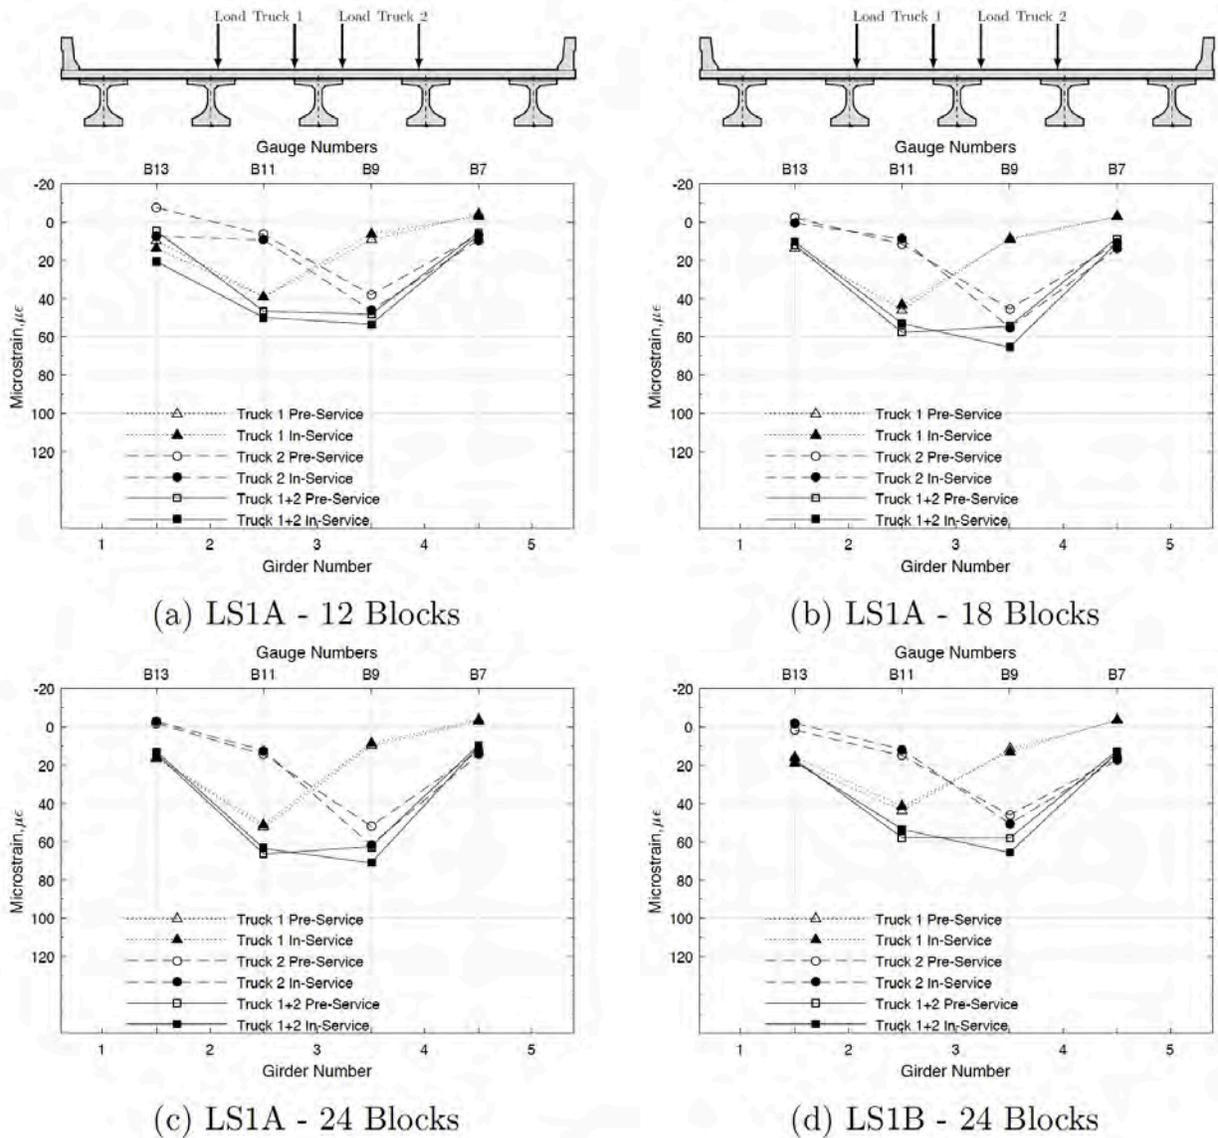
Fig. 5-21. Transverse Strain – Section B – HCWB – LS1A/1B

Figure 5-21 shows transverse strain results at Section B for HCWB load position 1A/1B. As shown, the pre-service results are similar to in-service strain results, with the most change generally occurring in gauge B9, which is between FIB3 and FIB4. The trend also

shows that B11 (between FIB2 and FIB3) had higher maximum strains for the pre-service test, whereas, gauge B9 recorded higher maximum strains for the in-service test. This could be attributed to a slight variation in the placement of the wheel loads, transversely.

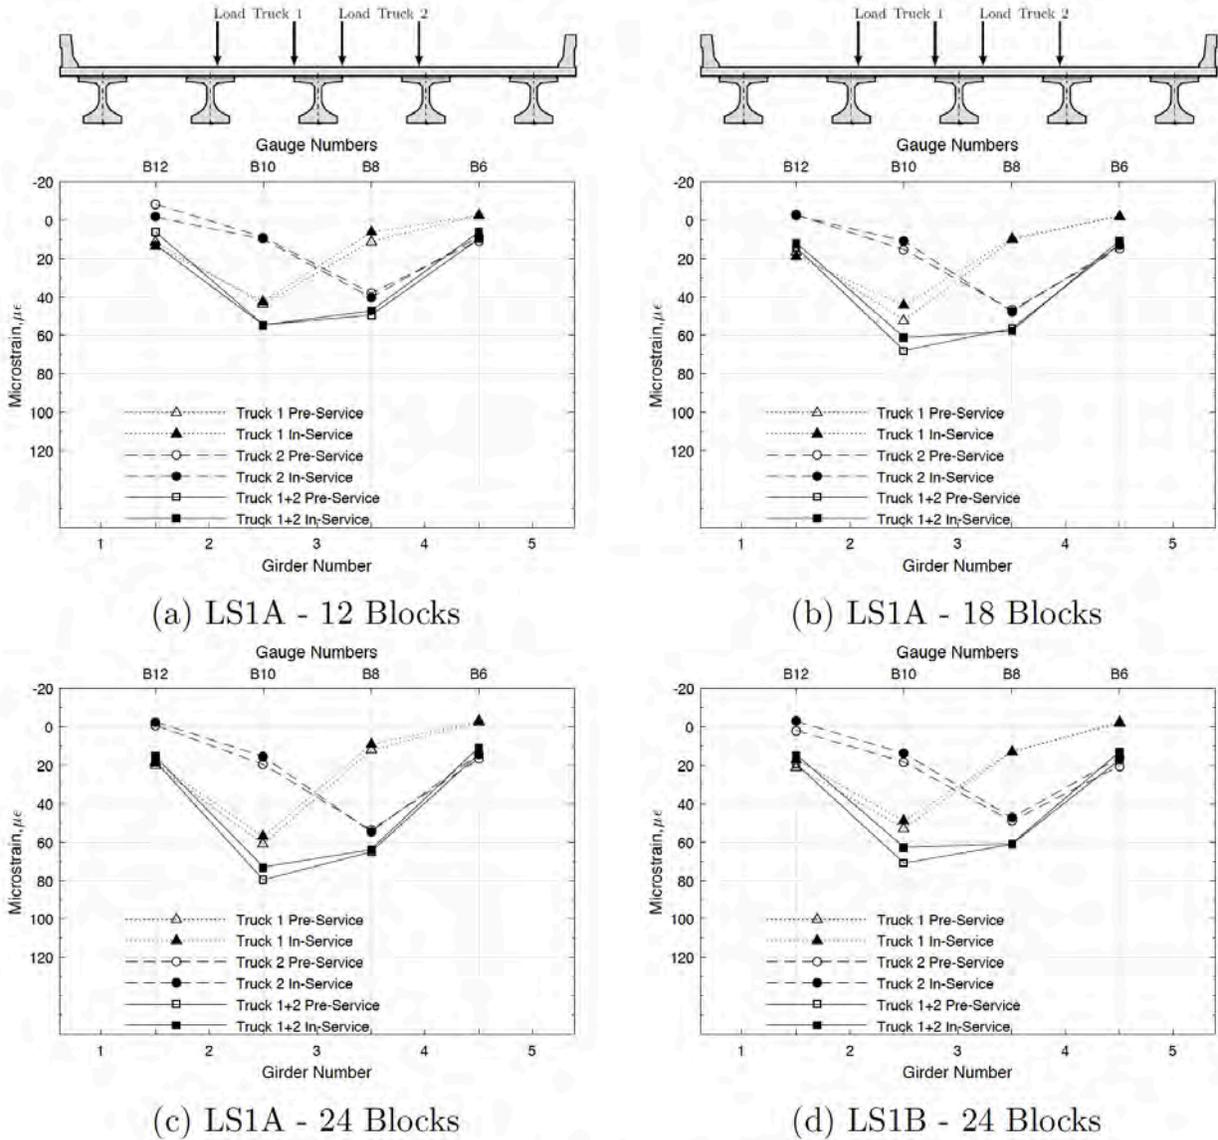
Fig. 5-22. Transverse Strain – Section C – HCWB – LS1A/1B

Figure 5-22 shows transverse strain results at section C for HCWB load position 1A/1B. Here, the pre-service results show similar trends to in-service strain results. However, pre-service strains are slightly more than strains recorded for the in-service results. The trend shows that B10 (between FIB2 and FIB3) had maximum strains for both the pre-service and the in-service tests at section C for HCWB.

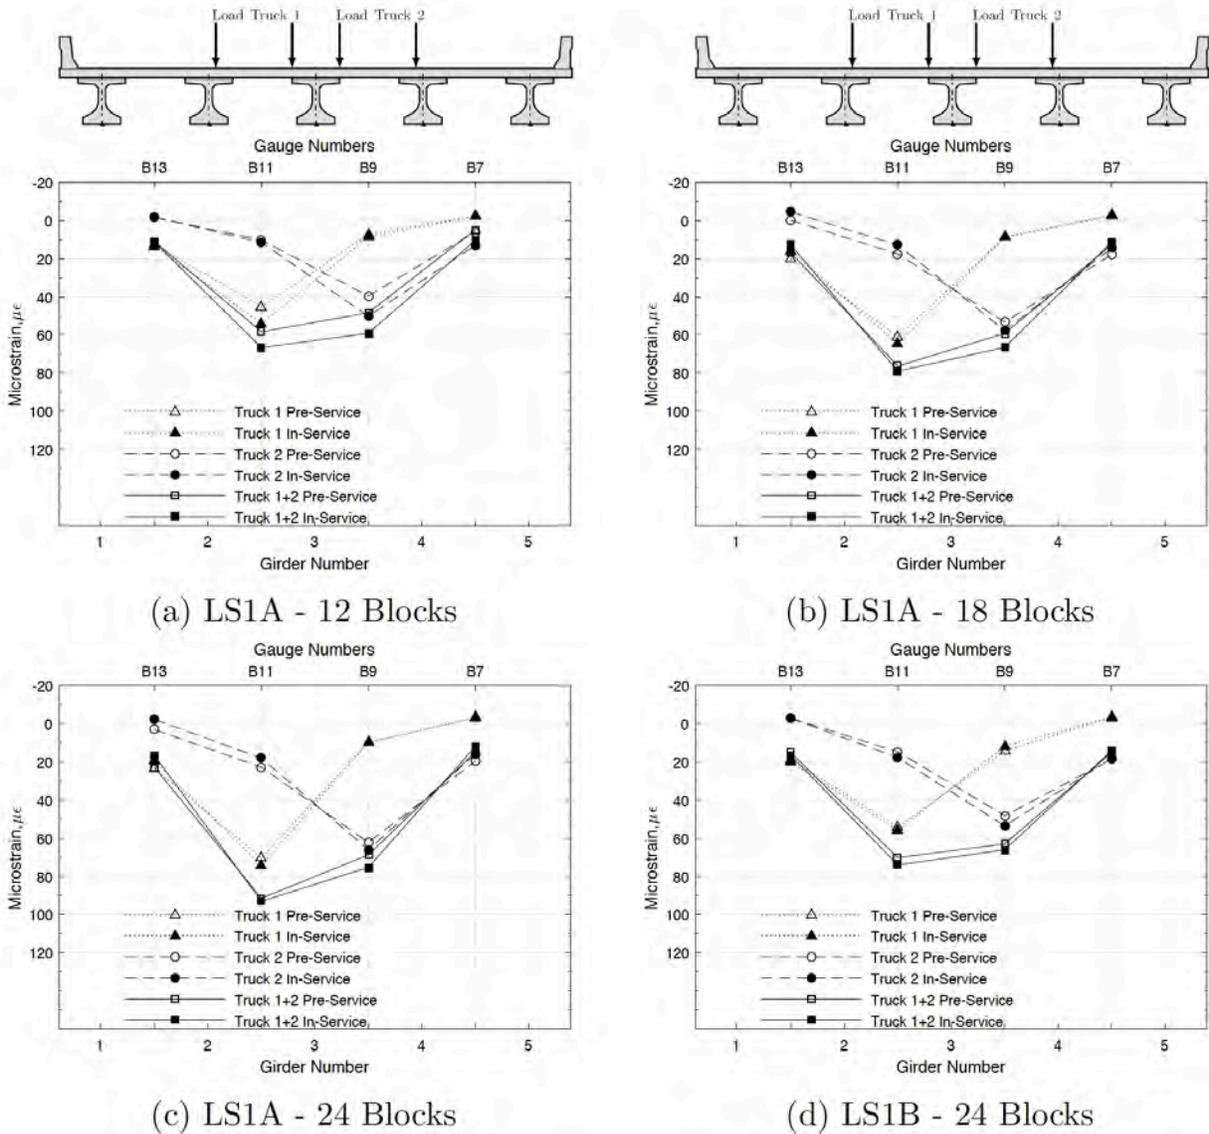
Fig. 5-23. Transverse Strain – Section B – LRWB – LS1A/1B

Figure 5-23 shows transverse strain results at Section B for LRWB load position 1A/1B. As shown, the pre-service results are similar to in-service strain results, although the 12 blocks load case exhibited the most change. The trend also shows that B11 (between FIB2 and FIB3) recorded the maximum strains for the pre-service and the in-service tests.
