Precast Element Evaluation for the US 90 Bridges over Little River and Hurricane Creek

Contract Number BDV30-307-01
FSU Project ID 032819

July 2019
FINAL REPORT

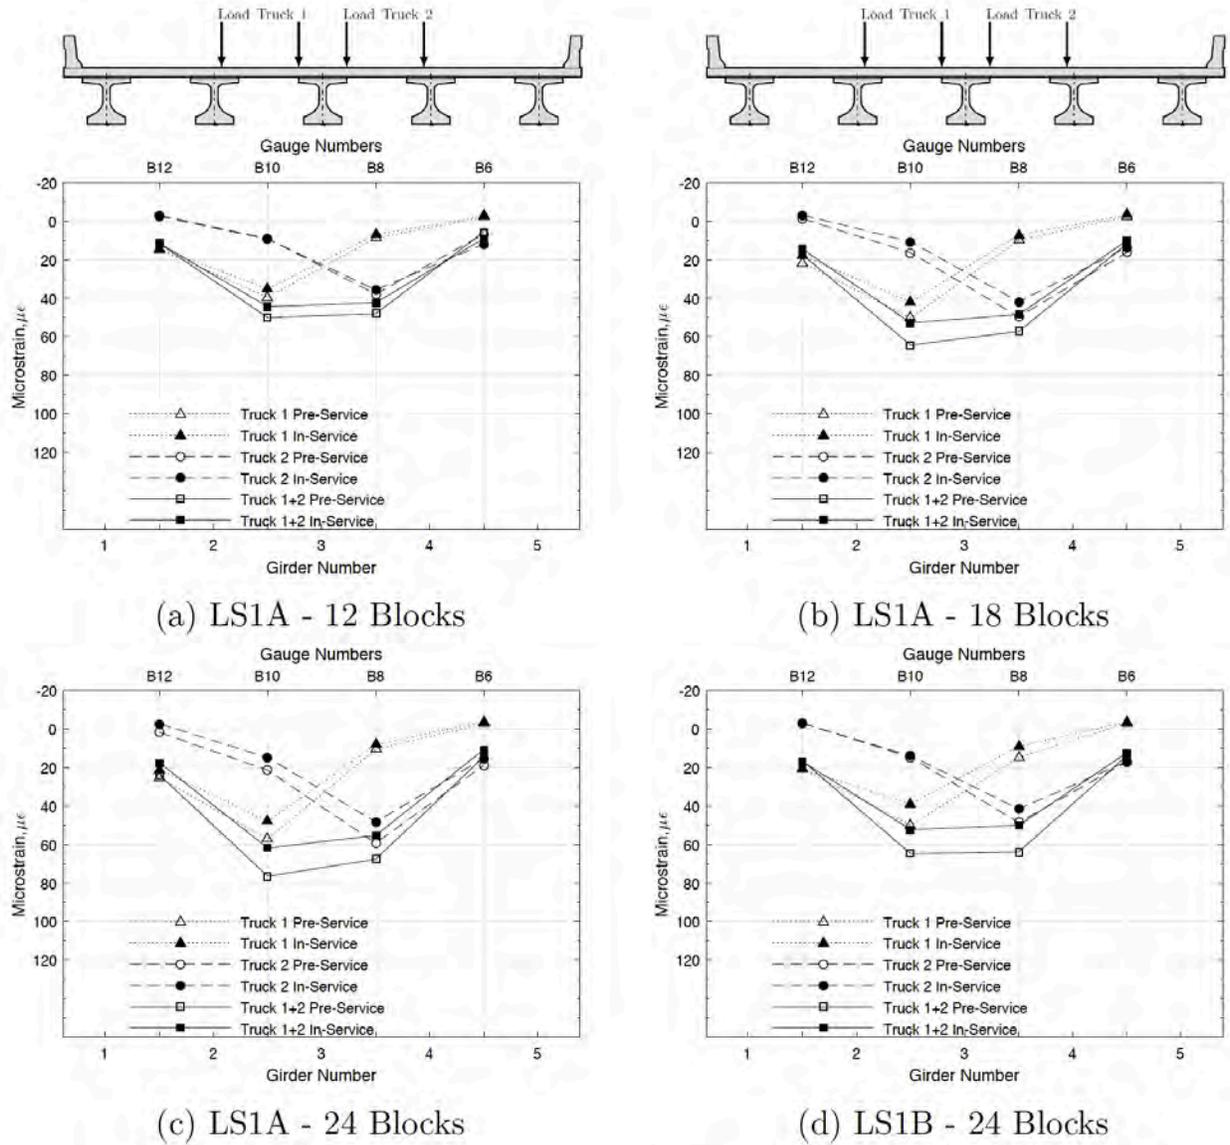
Fig. 5-24. Transverse Strain – Section C – LRWB – LS1A/1B

Figure 5-24 shows transverse strain results at section C for LRWB load position 1A/1B. Gauges at section C measured strains in the closure joints, as stated previously. Again, the pre-service results show similar trends to in-service strain results. The trend shows that

B10 (between FIB2 and FIB3) had the maximum strains for both the pre-service and the in-service tests. Pre-service strains generally exceeded in-service strains at this section.

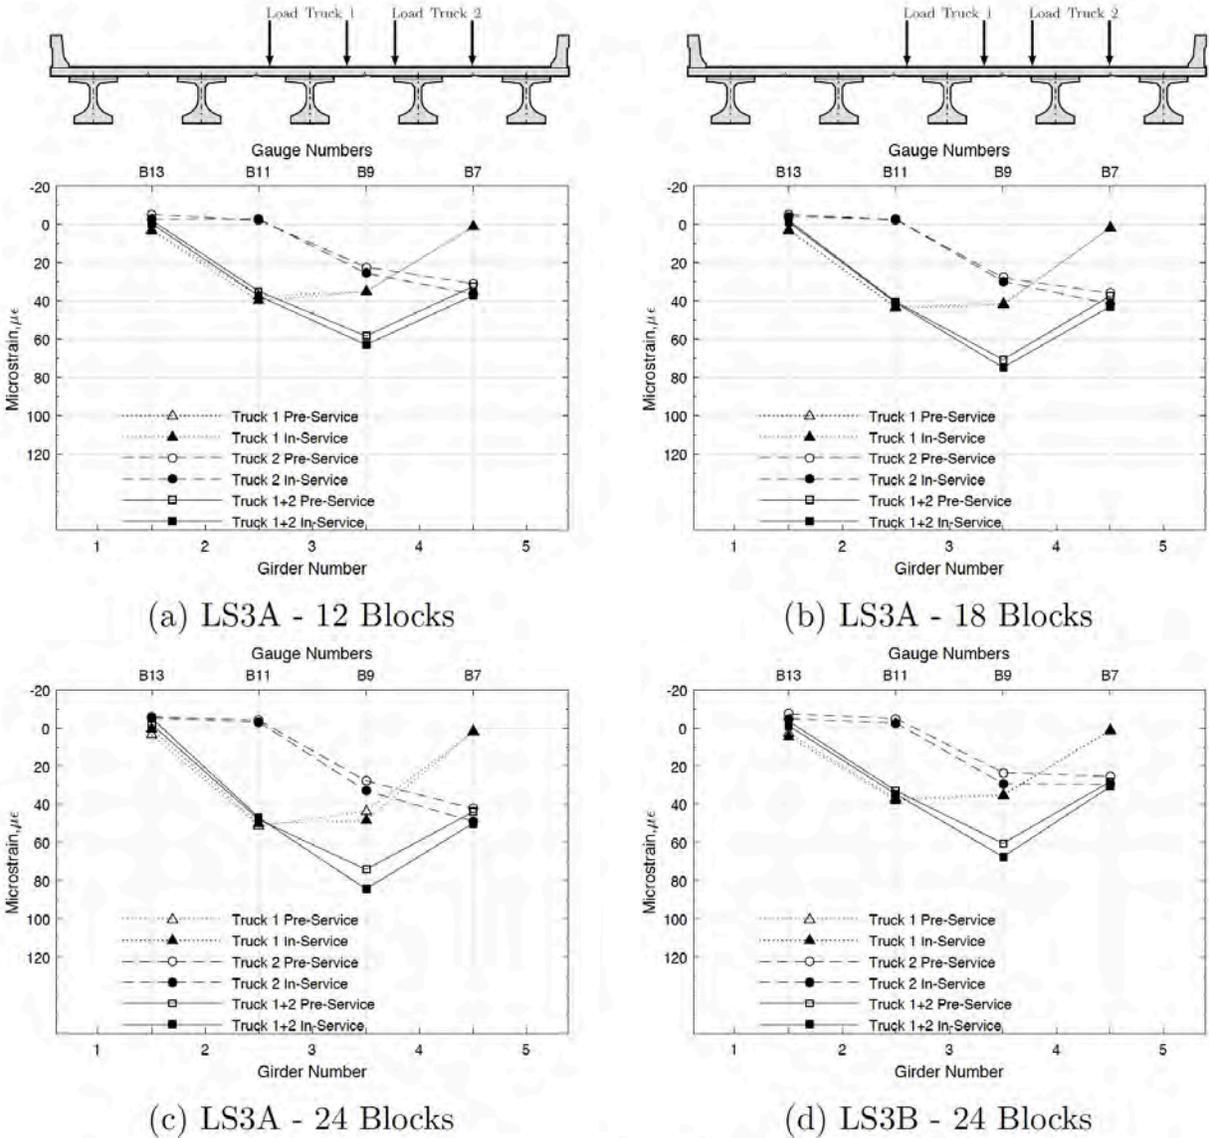
Fig. 5-25. Transverse Strain – Section B – HCWB – LS3A/3B

Figure 5-25 shows transverse strain results at Section B for HCWB, for load position 3A/3B. The trends for the pre-service and in-service strain results are similar. In-service strains slightly exceeded pre-service strains.

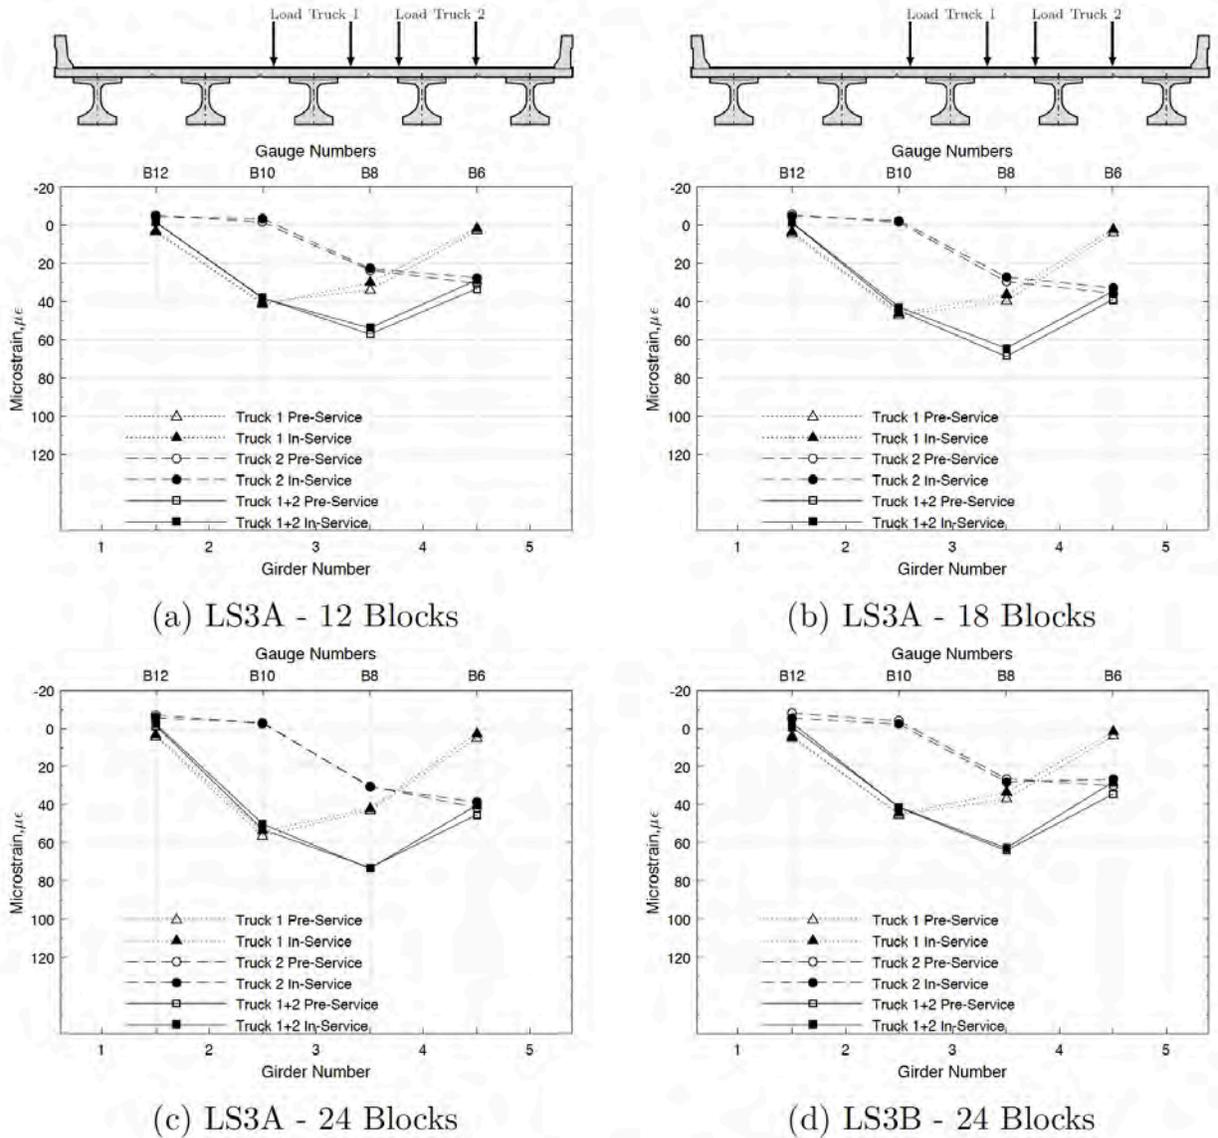
Fig. 5-26. Transverse Strain – Section C – HCWB – LS3A/3B

Figure 5-26 shows transverse strain results at section C for HCWB load position 3A/3B. Again, the pre-service results show similar trends to in-service strain results. Maximum strains were recorded at gauge B8 as expected. The pre-service strains are slightly more than the in-service strains.

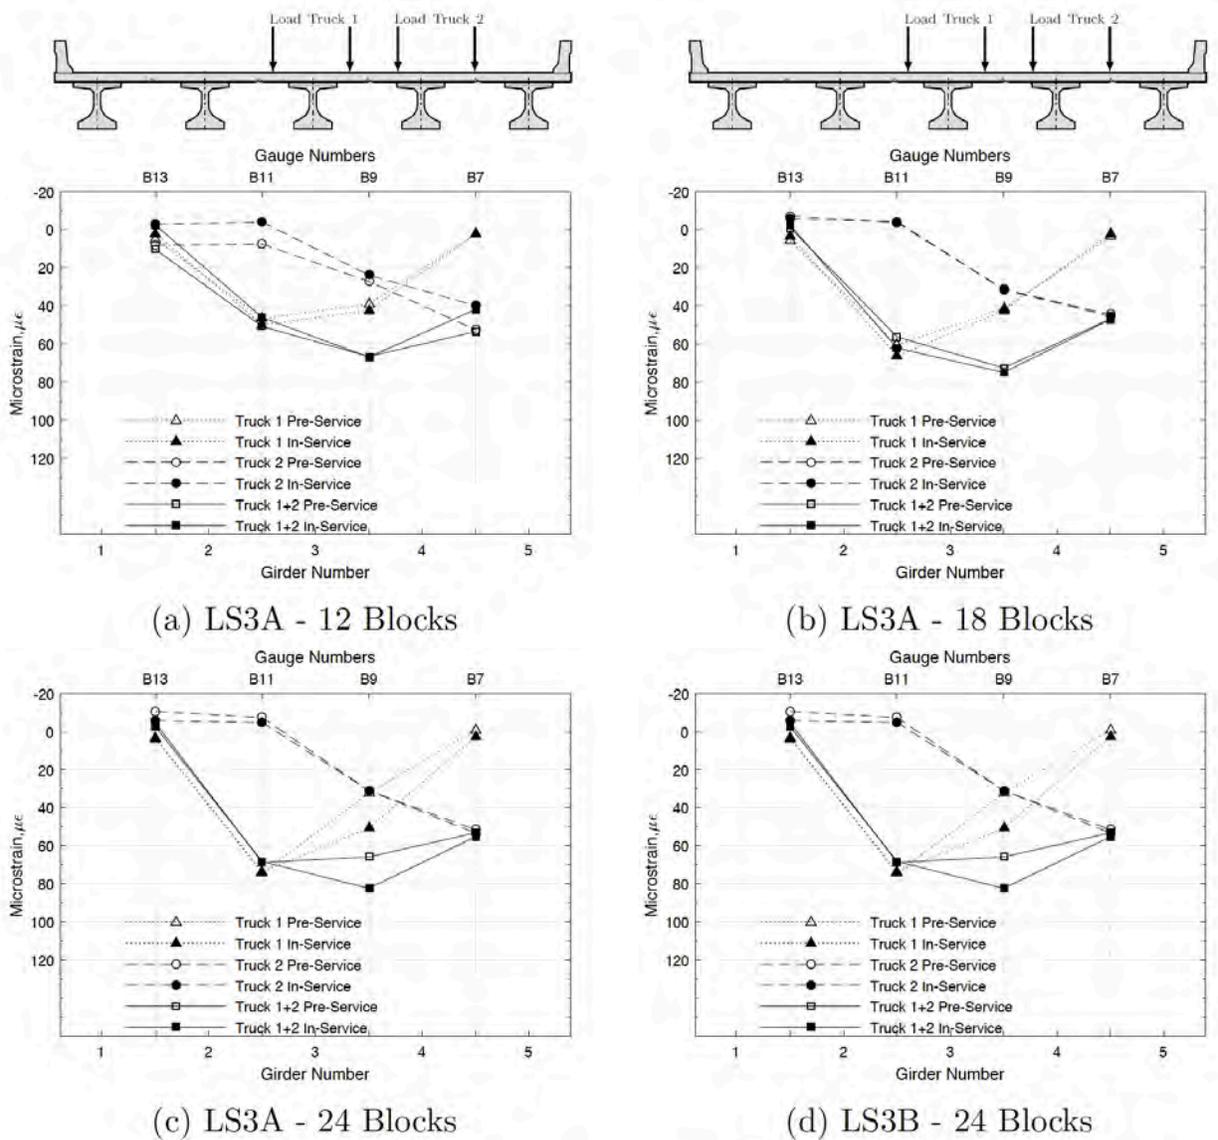
Fig. 5-27. Transverse Strain – Section B – LRWB – LS3A/3B

Figure 5-27 shows transverse strain results at Section B for LRWB load position 3A/3B. The trends for the pre-service and in-service strain results are similar for the 12 and 18 block cases. The 24 block case shows an unexpected trend for gauge B9 (between FIB3 and FIB4), especially in the pre-service results. This could be a result of gauge drift that was observed in B9. In-service strains generally slightly exceeded pre-service strains, except at gauge B9 for the 24 block cases as discussed.

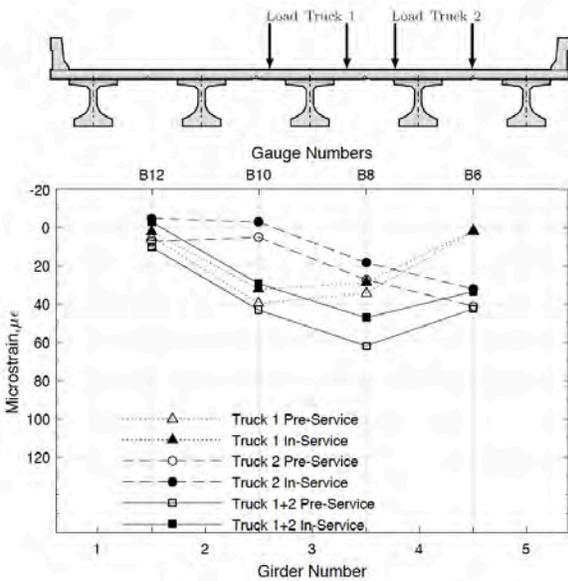
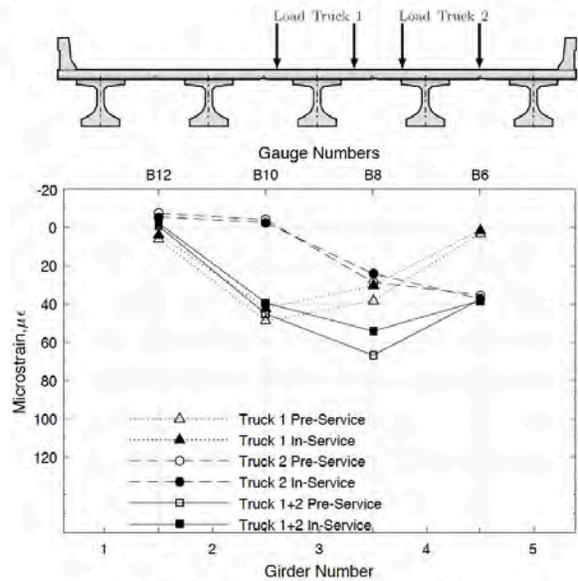
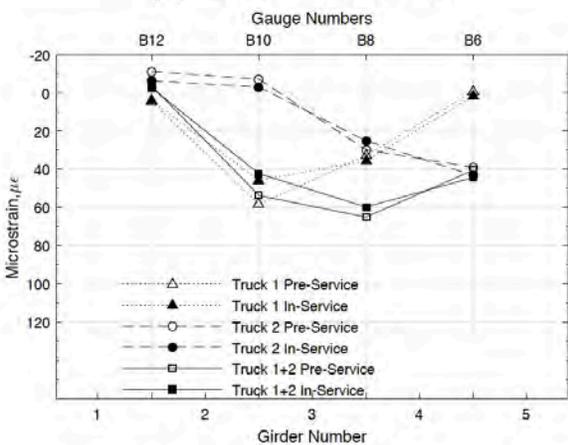
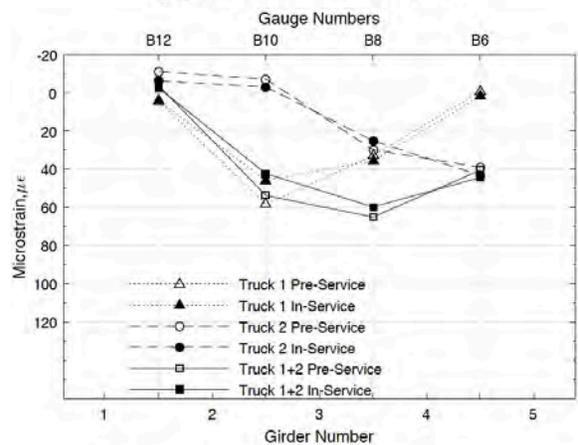
Fig. 5-28. Transverse Strain – Section C – LRWB – LS3A/3B

Figure 5-28 shows transverse strain results at section C for LRWB load position 3A/3B. The trends are similar for both the pre-service and the in-service tests. Maximum strain was recorded at gauge B8 as expected. The pre-service strains were more than the in-service strains.

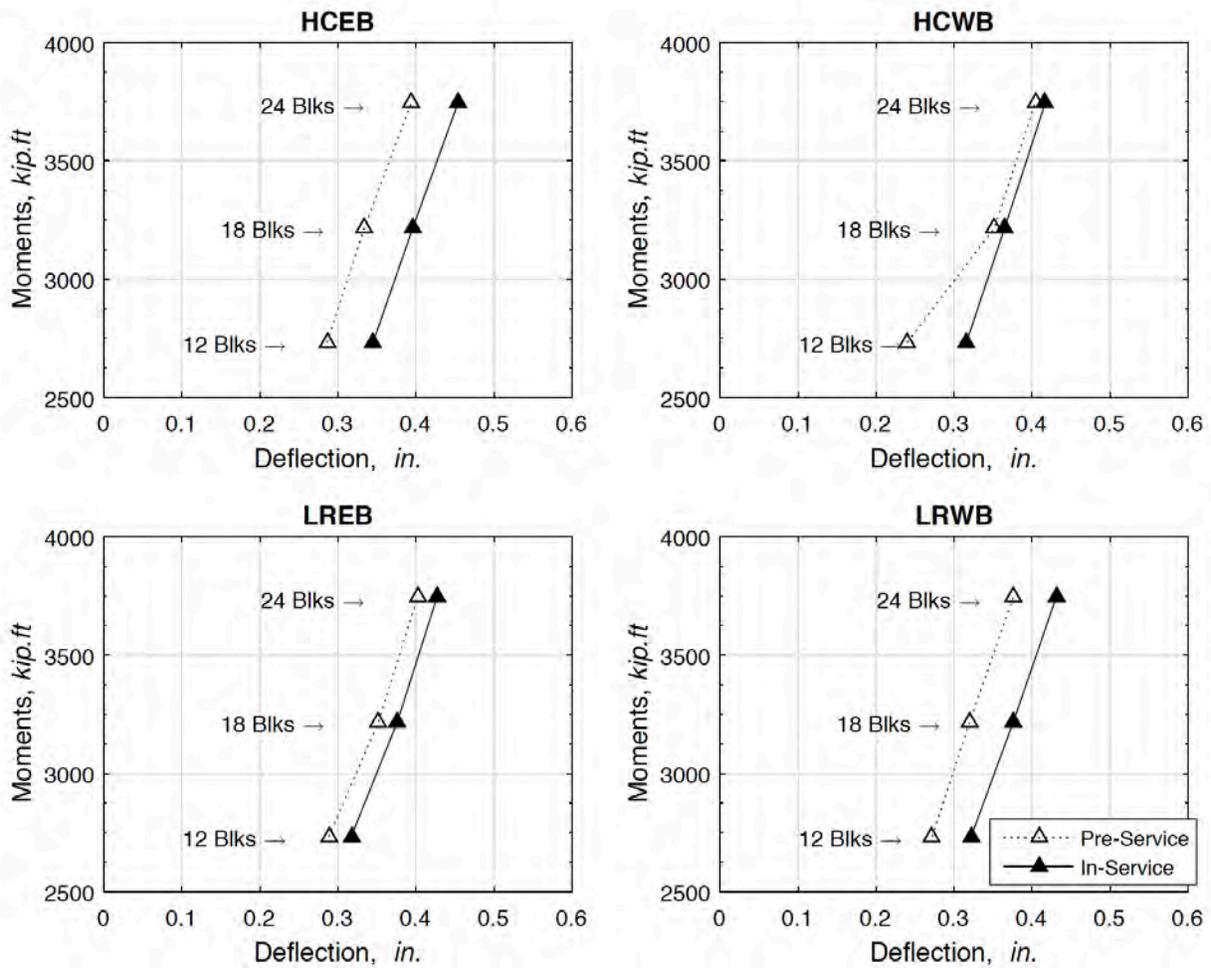
Fig. 5-29. Moment-Deflection Response – FIB3 – LS1/1A – Truck 1+2

Figure 5-29 shows a linear moment - deflection relationship for FIB3 at load position 1/1A, for the tested span of each bridge. The response of the girder remained within the linear elastic limit. However, FIB3 on HCEB appears to have lost the most stiffness over time, compared to FIB3 on LRWB, HCWB, and LREB. The measured deflection on the girders increased by 18.1%, 16.8%, 13.8%, and 7.7%, respectively. Loss of stiffness is often attributed to cracking of members, in which case, one would expect HCEB and LREB bridge to lose more stiffness than HCWB and LRWB. (In the separate report, Report 4, Monitoring of Cracks in Precast Panels, where results of crack mapping of the precast deck panels are

presented, it was concluded that the deck panels on the EB bridges cracked significantly more over time than the panels on the WB bridges.) However, LREB experienced the least stiffness loss of the four bridges. There also seems to be no correlation between stiffness loss and time in service: HCEB and LREB bridges were constructed before, and were in service longer, than the WB bridges. Nonetheless, the pre-service load tests were performed before the bridges were subjected to any traffic – i.e., the bridges were new – and therefore some “shakedown” was likely to occur once opened to traffic, which could cause an increase in deflections.

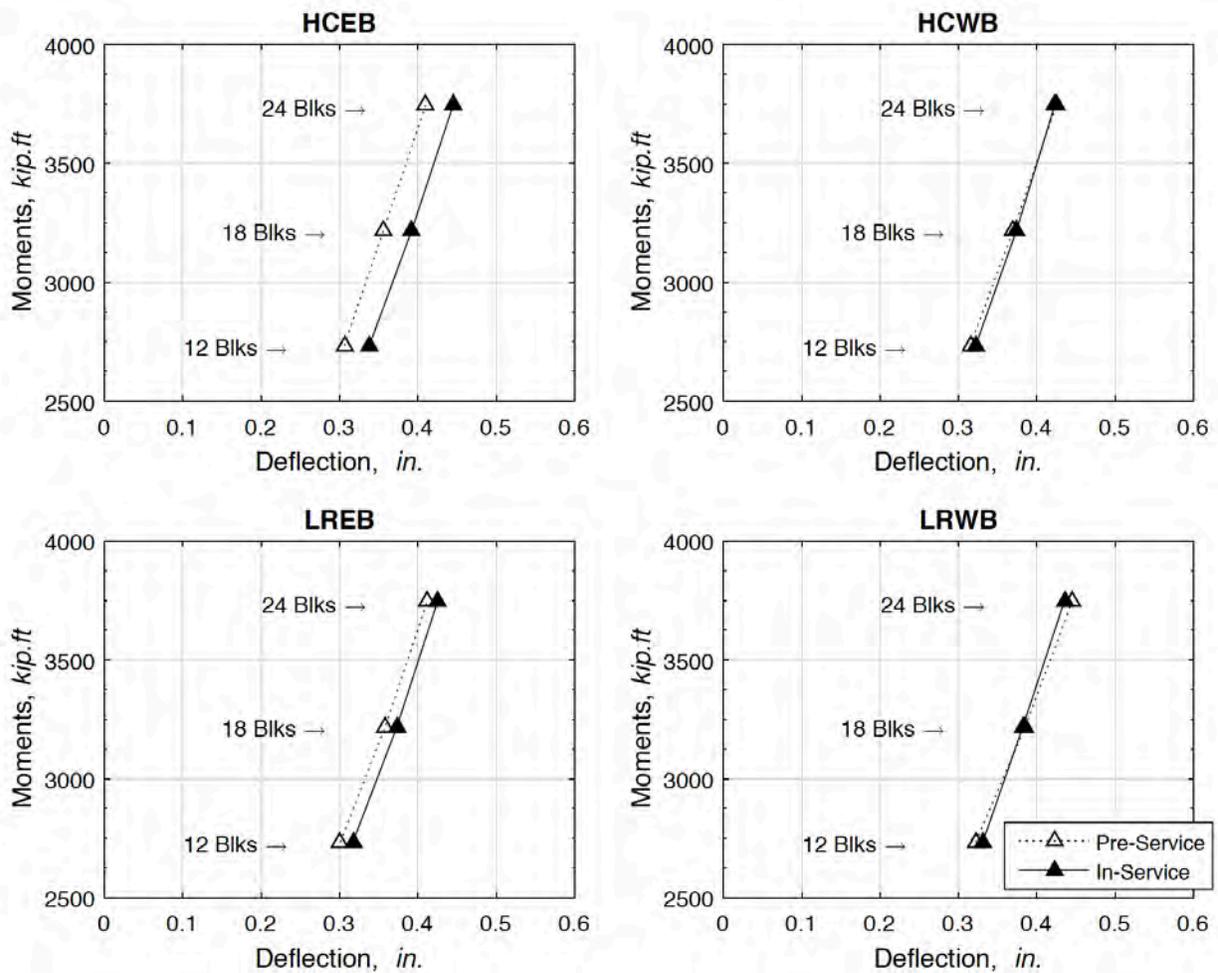
Fig. 5-30. Moment-Deflection Response – FIB4 – LS2 – Truck 1+2

The response of FIB4 for load position 2 remained within the linear elastic limit (Figure 5-30) for each bridge. The change in deflection over time was less than 10% for all FIB girders in the tested spans, perhaps signifying a small change in stiffness.

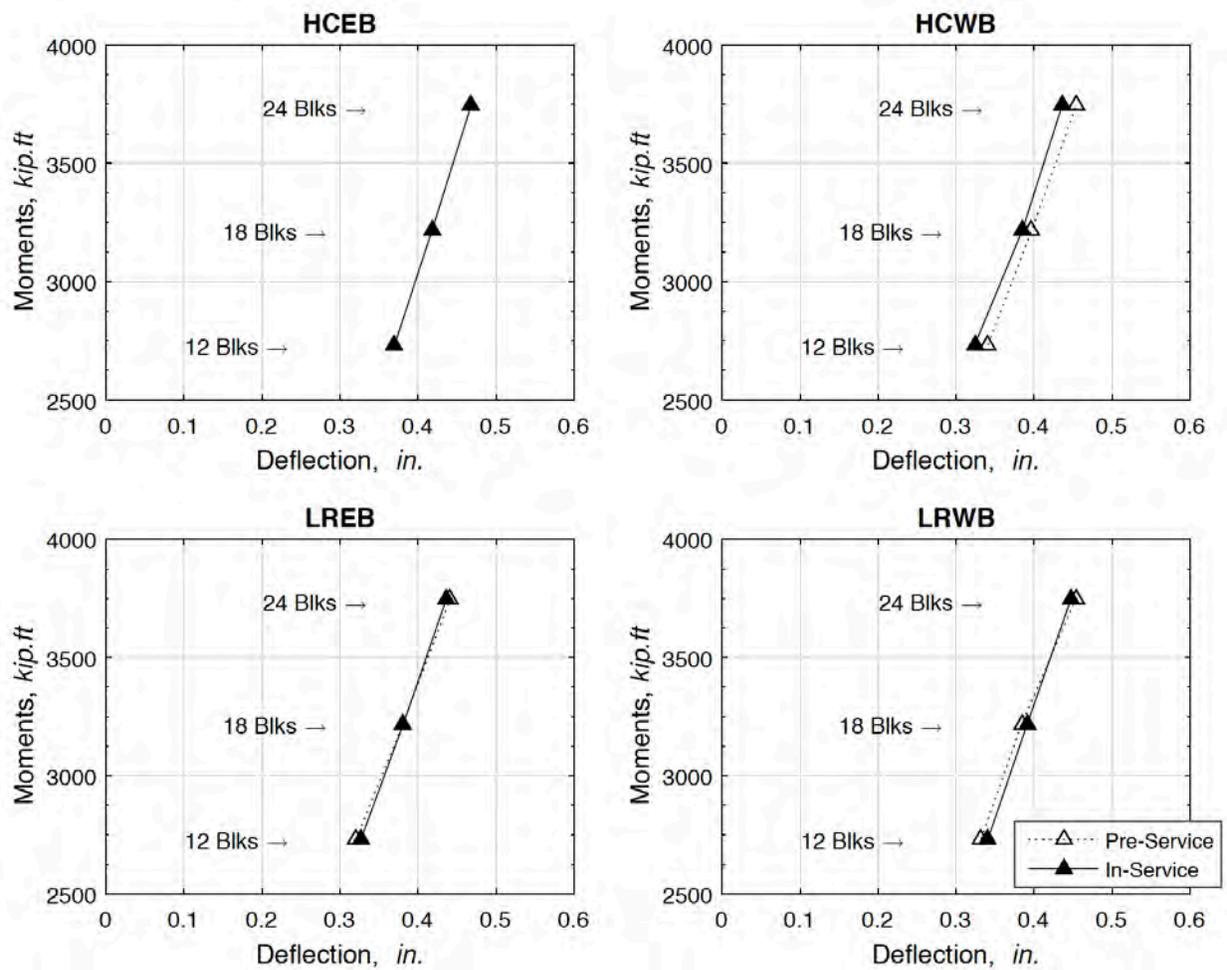
Fig. 5-31. Moment-Deflection Response – FIB5 – LS2 – Truck 1+2

Figure 5-31 shows a linear moment - deflection relationship for FIB5 for load position 2. Gauge readings for HCEB (pre-service) were omitted because gauge D11 was faulty. The change in deflection for HCWB, LREB, and LRWB was less than 5%.

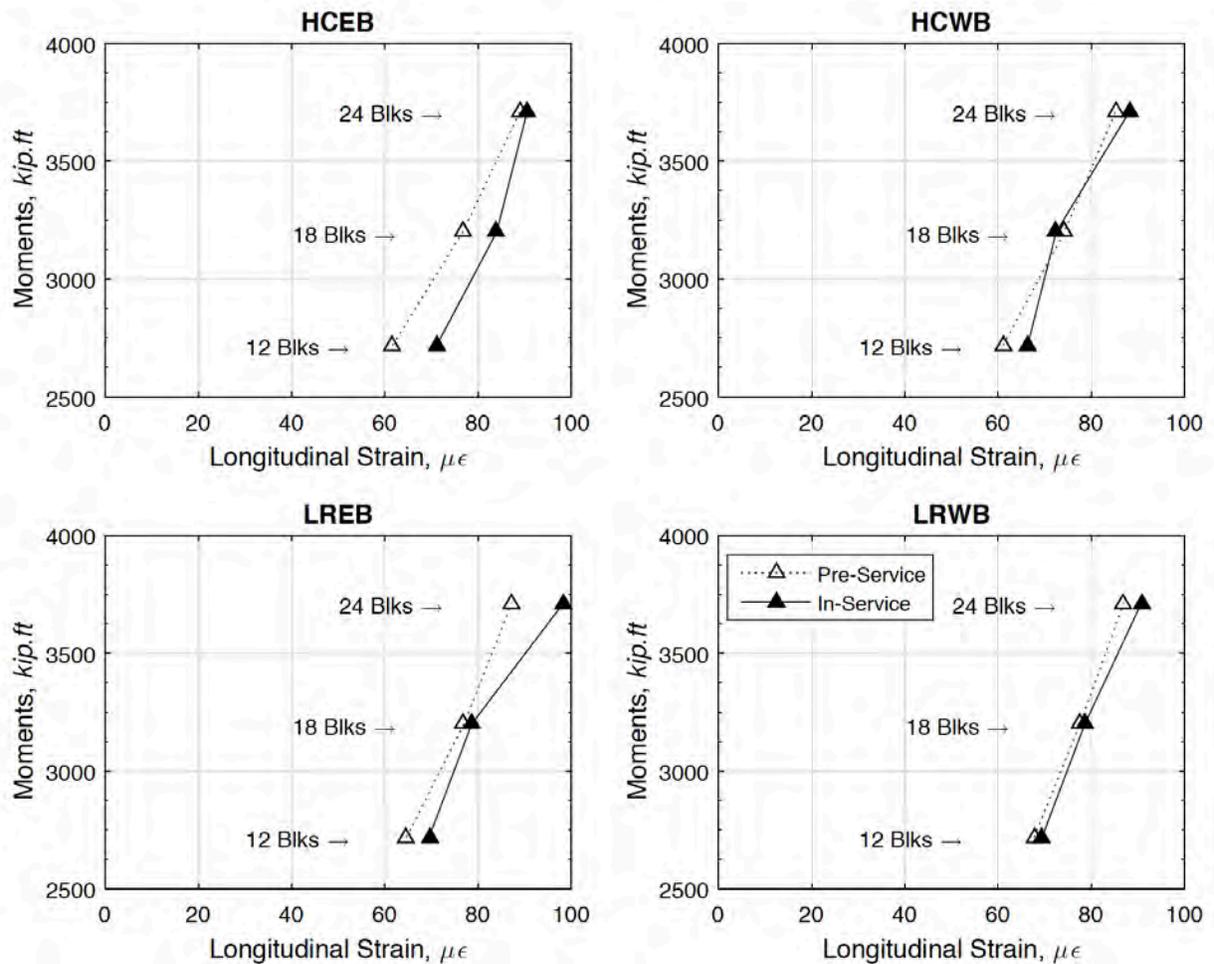
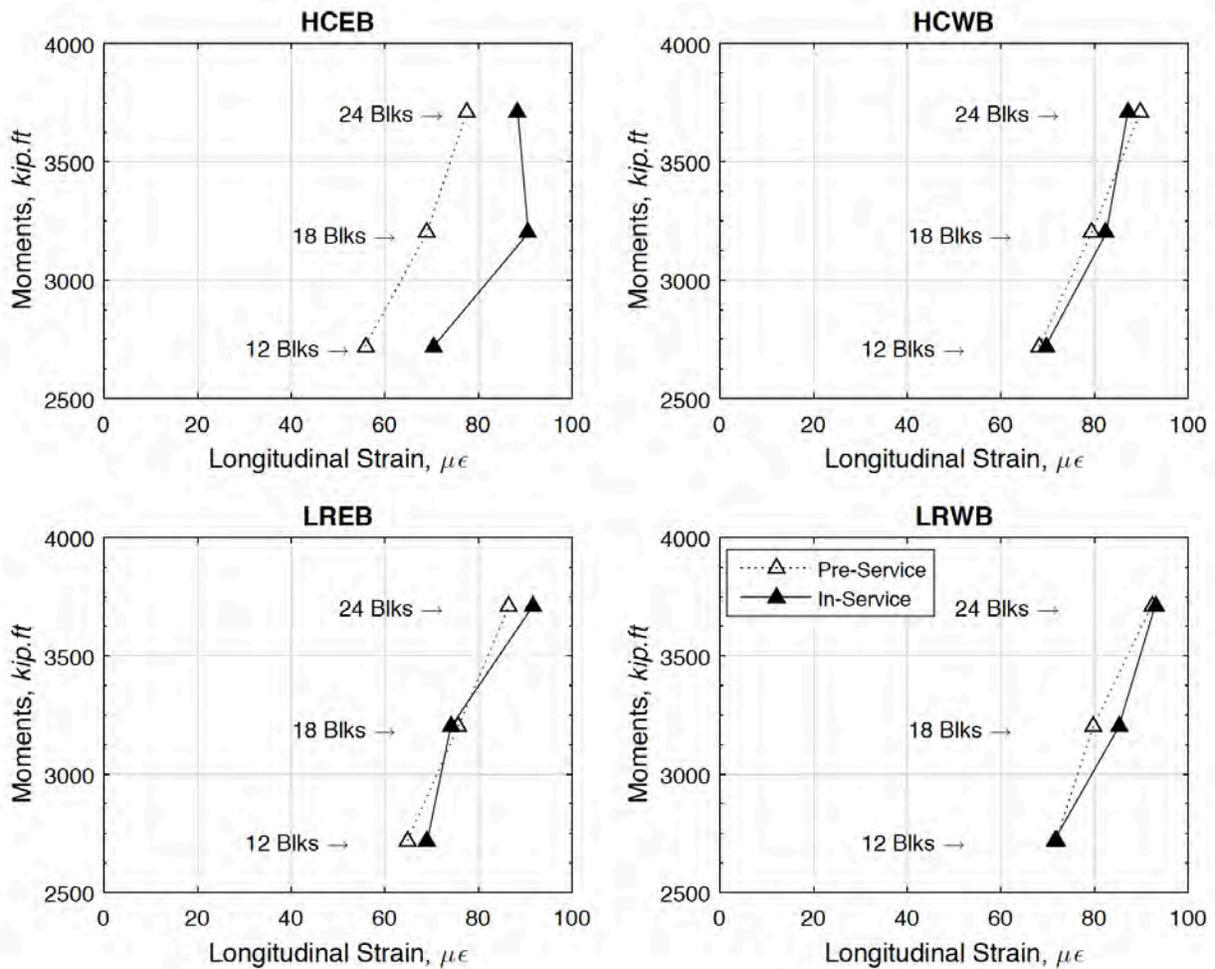
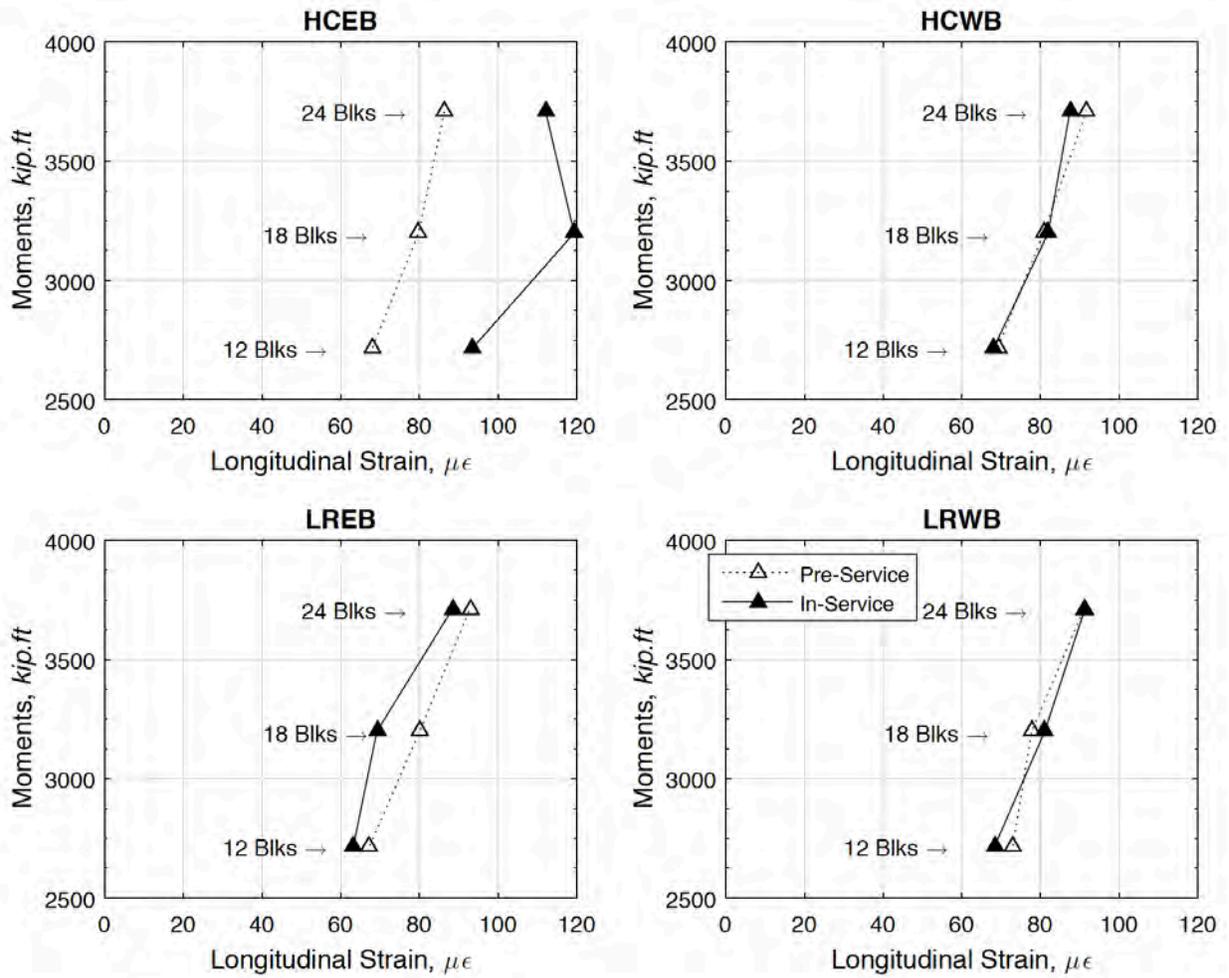
This section presents the moment vs strain responses of critical girders measured at load positions 1/1A and 2. Strains were measured by gauge pairs at the bottom flange of each girder at section B. Average values from the gauge pairs were then used for the plots. From **Figures 5-32 to 5-34**, moment – strain responses were approximately linear. **Figure 5-32** shows the response of FIB3 for load position 1/1A, **Figure 5-33** shows the response of FIB4 for load position 2, and **Figure 5-34** shows the response of FIB5 for load position 2 for each of the bridges. For HCWB, LREB, and LRWB the responses from the pre-service tests were relatively close to the responses from the in-service tests. However, HCEB shows more

variation in the moment – strain response. The 18 block case for HCEB produced more strains than expected on FIB3, FIB4, and FIB5.

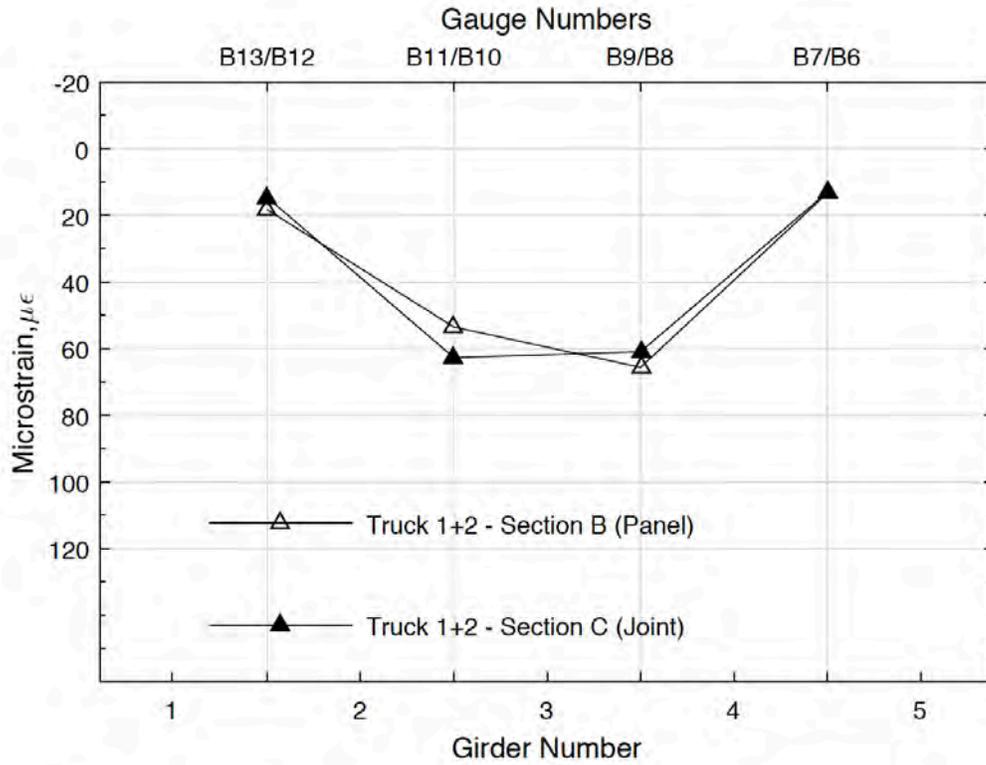
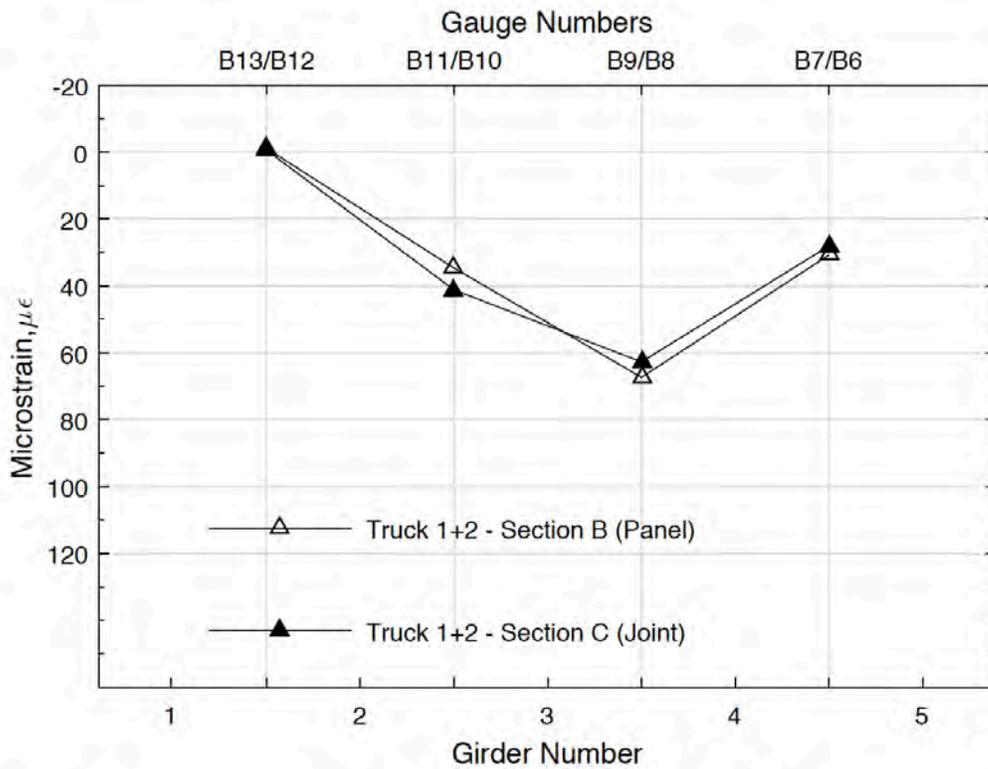
Figures 5-35 and 5-36 compare transverse strains in the panel and joint, for HCWB, for load positions 1B and 3B. The panel and closure joint responses to live load are similar. However, on LRWB, as shown in **Figures 5-37 and 5-38**, higher strains were observed in the panel than in the closure joint. This variation was as much as 29.5% for load position 1B and 22% at load position 3B. Some differences could be due to the precast panel and cast-in-place joint having different material properties – although, one would expect the panels to have lower strains than the joints because of the high strength of the concrete used in the panels. There could have been some slightly inconsistent sharing or transfer of load between the panels and joints, or there could have been a localized effect such that the strains were sensitive to the wheel load locations. The wheel loads were in relatively close proximity to the transverse strain gages, and the wheel loads may not have been exactly placed.
