Final Report for Research Project

**LONG-TERM MAINTENANCE MONITORING
DEMONSTRATION ON A MOVABLE BRIDGE**

**Mustafa Gul, H. Burak Gokce
and
F. Necati Catbas***

September 2011

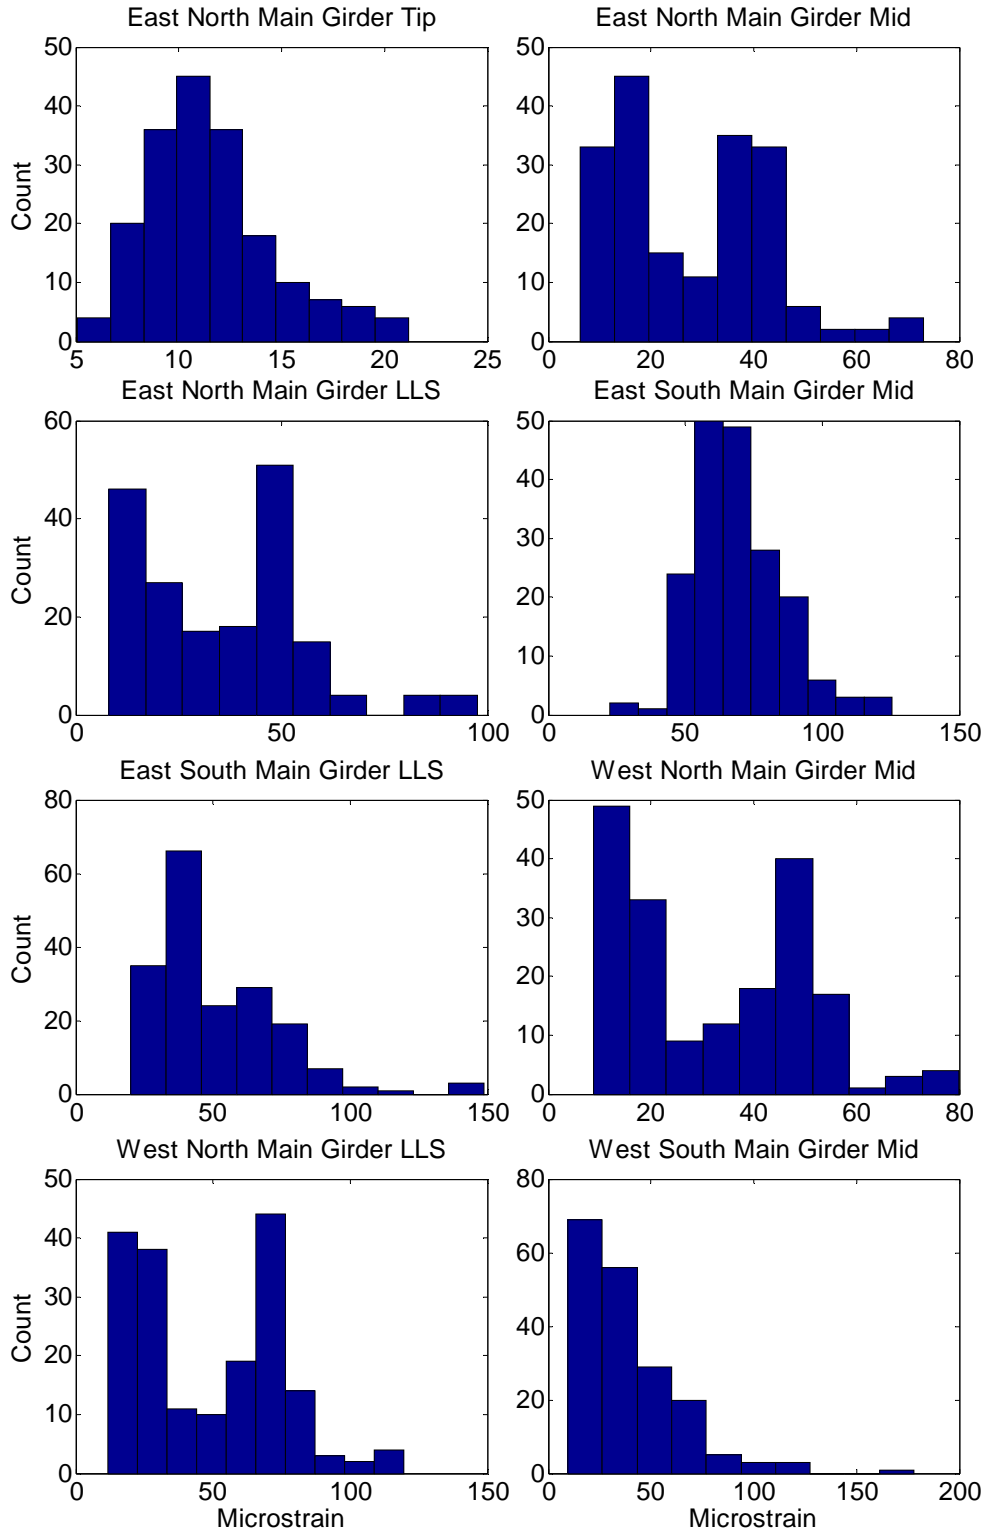
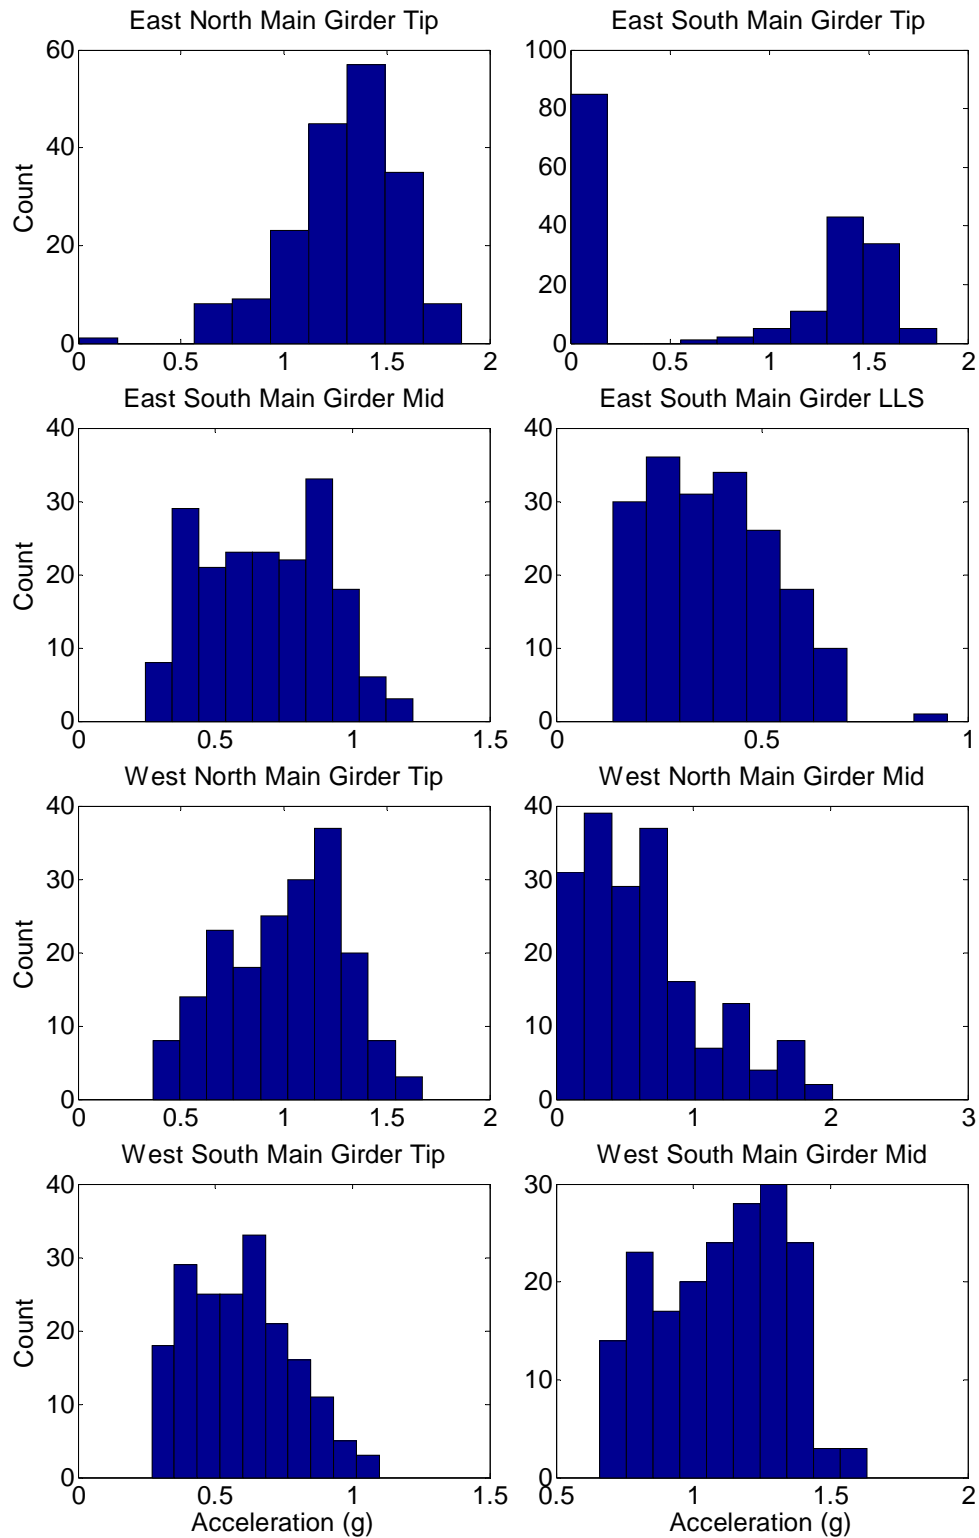
These histograms are generated from the maximum observed values from the collected data during the pre-defined rush hours. For strains, it is seen that the critical locations are LLS areas, but for accelerometers, tip and mid areas of the main girders have the highest vibrations.

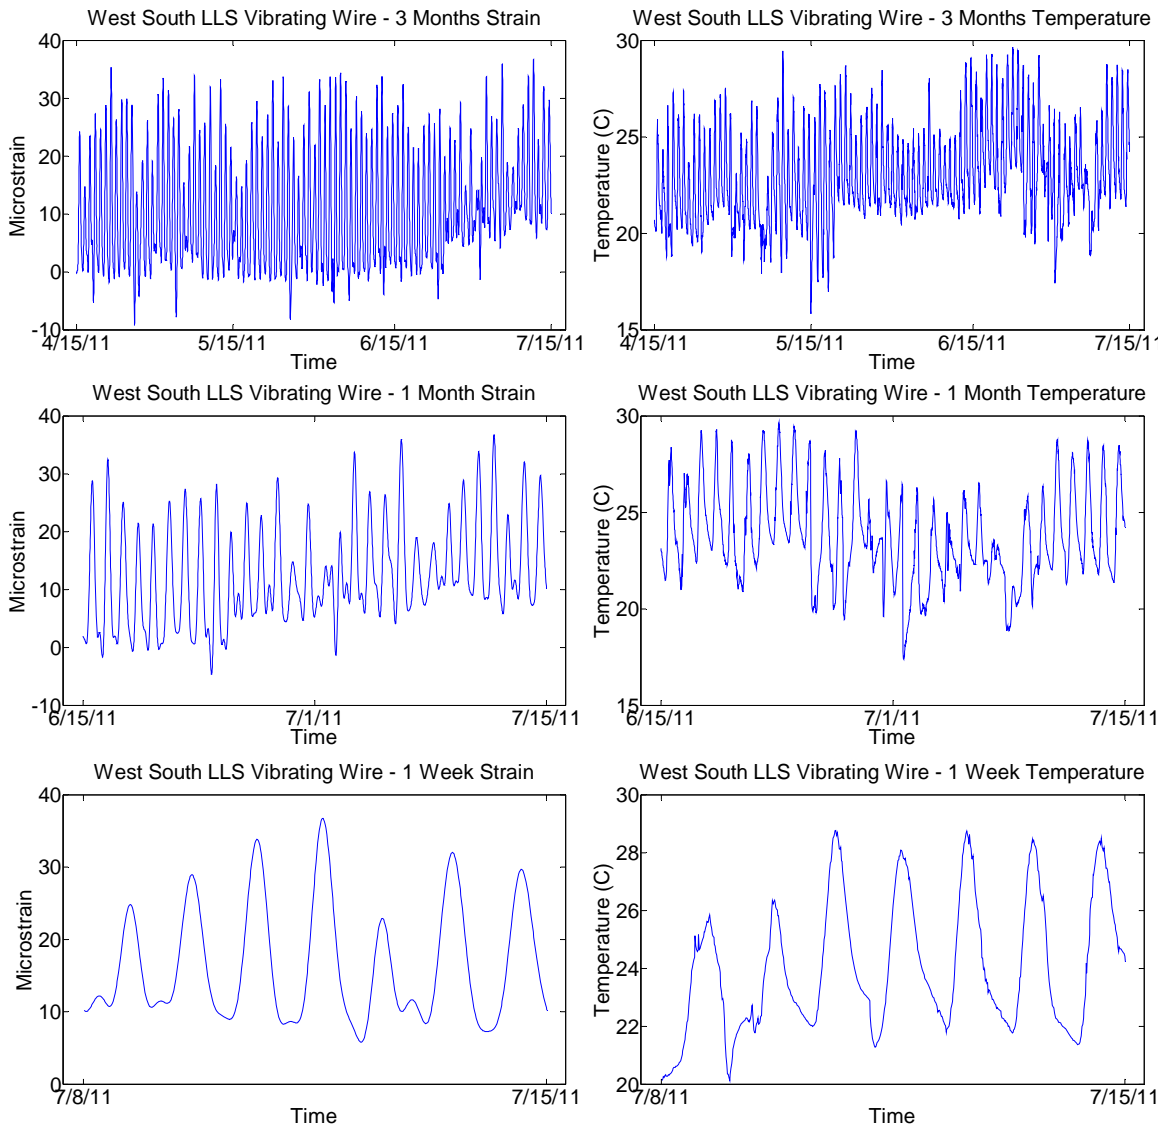
Figure 37: WS3 vibrating wire 3-months, 1-month and 1-week strain and temperature readings

For the west leaf representative data West South LLS area is selected and the data for different periods of this location is presented in Figure 37. It is seen that the strain cycle level is higher at LLS regions. For West South LLS region the strain cycles are around 50 microstrains whereas the temperature cycles are around 15 degrees.

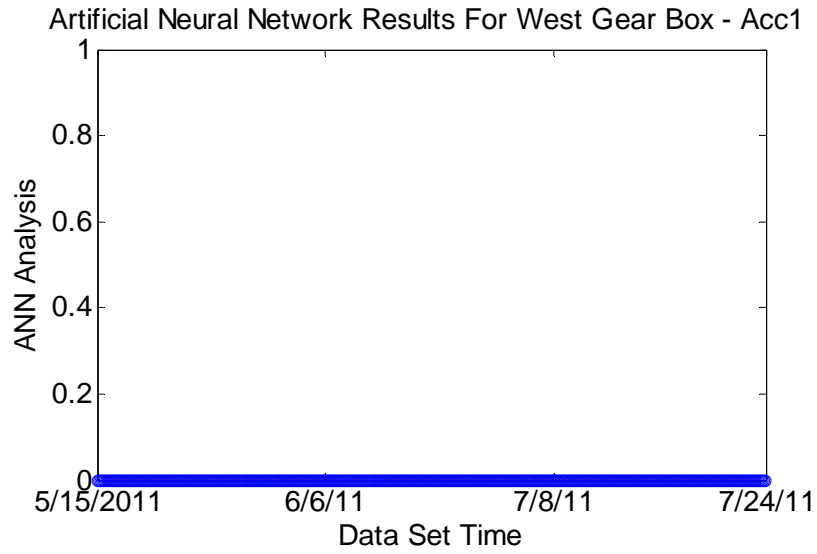
Figure 41: ANN results for gearbox oil level

ANN results for gearbox oil level and open gear grease level are illustrated in Figure 41 and Figure 42, respectively. It is seen that ANN produces zero values for the openings between 5/15/11-7/24/11 which concludes both components have healthy levels of oil and grease.

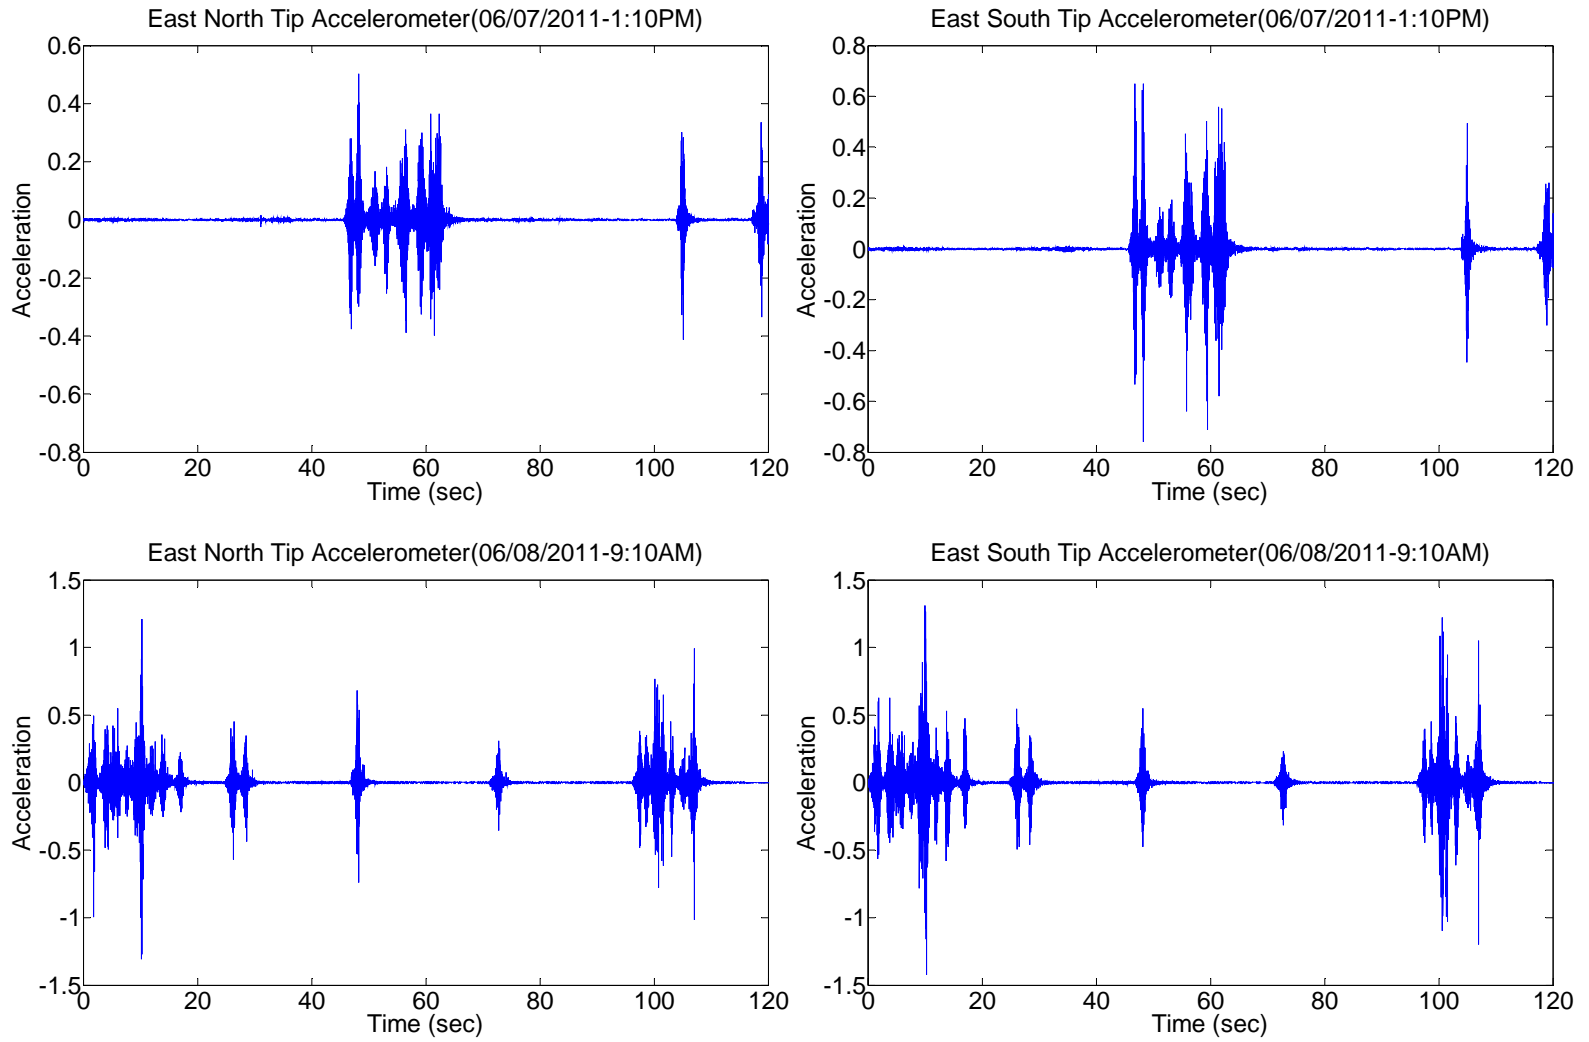
Figure 45: Vibration recorded at the tips of the main girders

In addition to pressure data, changes in the acceleration and rosette strains during this period are also investigated. The accelerometers at the tip at North and South tip near the span lock are evaluated. After 6/7/2011, higher levels of vibrations are observed at both (Figure 45). It should be noted that while the increase in acceleration and strain

levels corroborate with the changes observed at the span lock pressure gages, these are also affected by the traffic on the bridge.
