# DISPUTE REVIEW BOARD RECOMMENDATION

RE: SR 5A (Nova Rd) from Flomich Avenue to SR 5 (US 1)  
FIN No.: 240758-1-52-01  
Contract No: 21266  
County: Volusia  
District 5  
Disputes Review Board

DISPUTE: Request for Equitable Adjustment due to encountering coquina rock boulders in pipe trench.

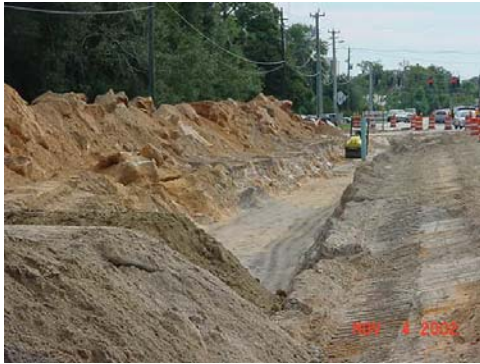
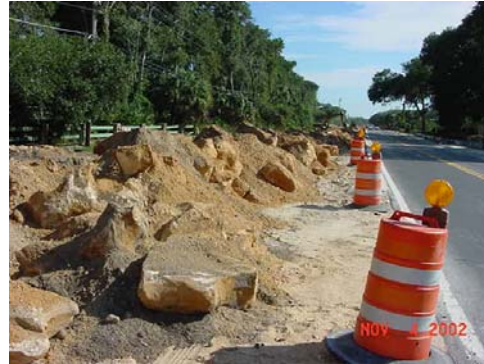
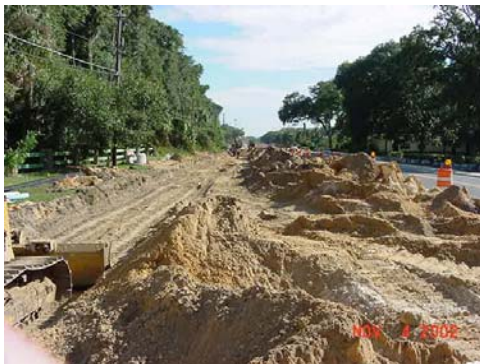
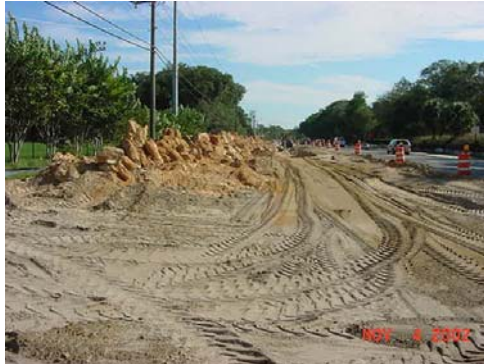
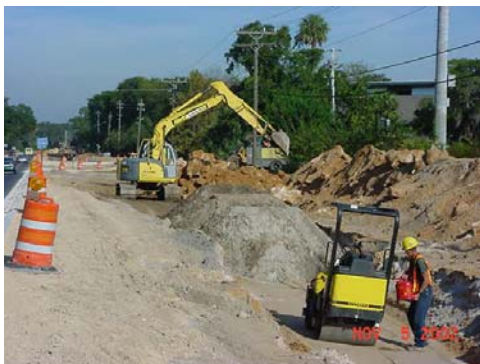
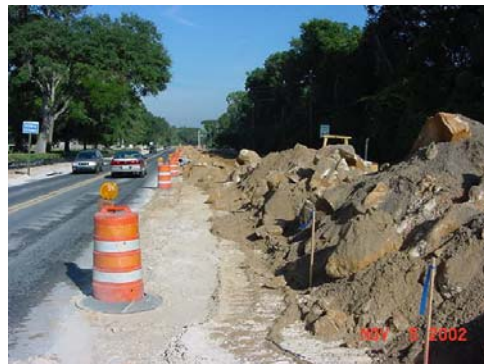
### PHOTOGRAPHS SHOWING CONDITIONS

*TYPICAL TRENCH VS: TRENCH WHERE COQUINA WAS ENCOUNTERED<sup>1</sup>*

*The coquina rock required larger equipment, backhoe and loader, than would have been necessary with normal earth, as well as separation, complete offhaul and replacement for backfill of trench.*

*The coquina rock also caused the ditch excavation to be considerably wider than required and precluded using trench boxes.*
