# PIPE INSPECTION AND REPAIR

**2022 CONSTRUCTION ACADEMY**  
**Jason Russell, FDOT**

- The Standard Specifications for pipe installation and inspection requirements.
- Information on the components of a pipe inspection.
- CPAM Chapter 8.13 guidance on some of the common issues associated with pipe installation.
- CPAM Chapter 8.13 guidance and the Pipe Repair Matrix for acceptable repair methods.

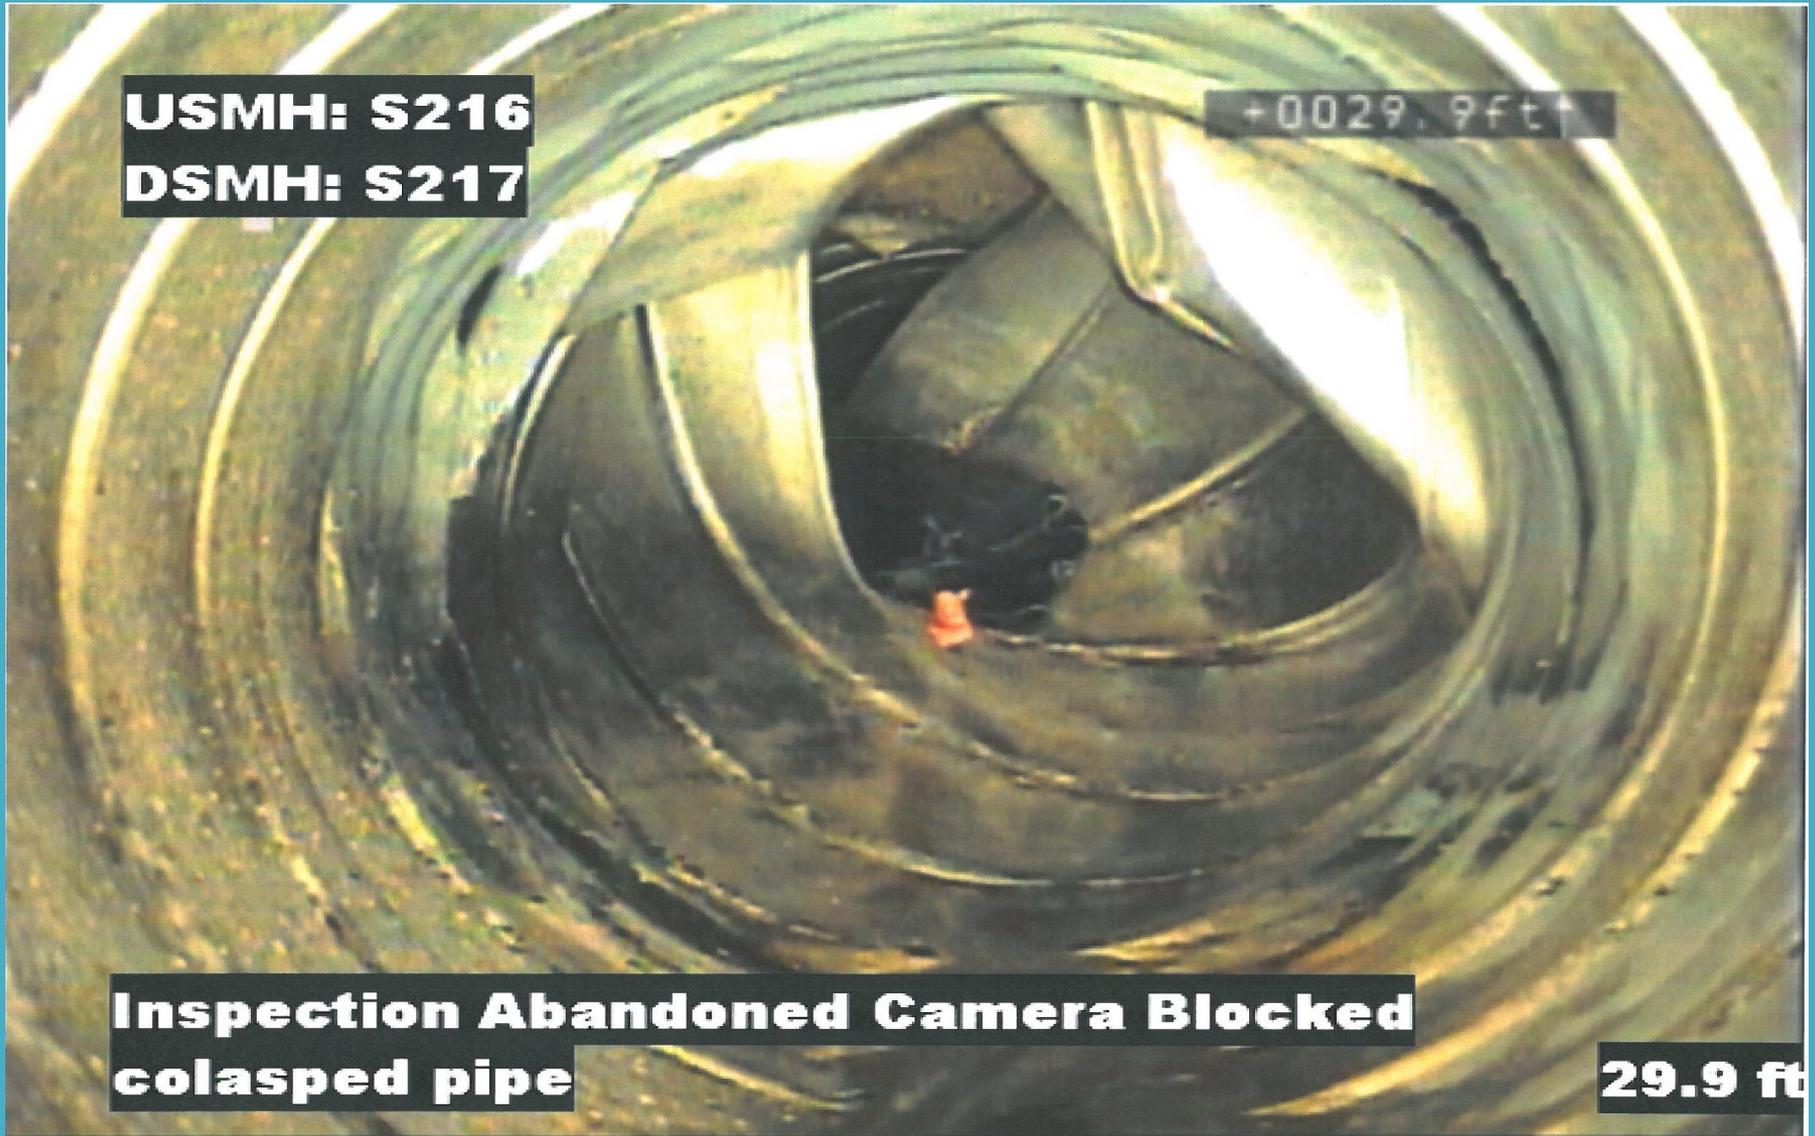
**USMH: S216**  
**DSMH: S217**

**+0029.9ft**

**Inspection Abandoned Camera Blocked  
colapsed pipe**

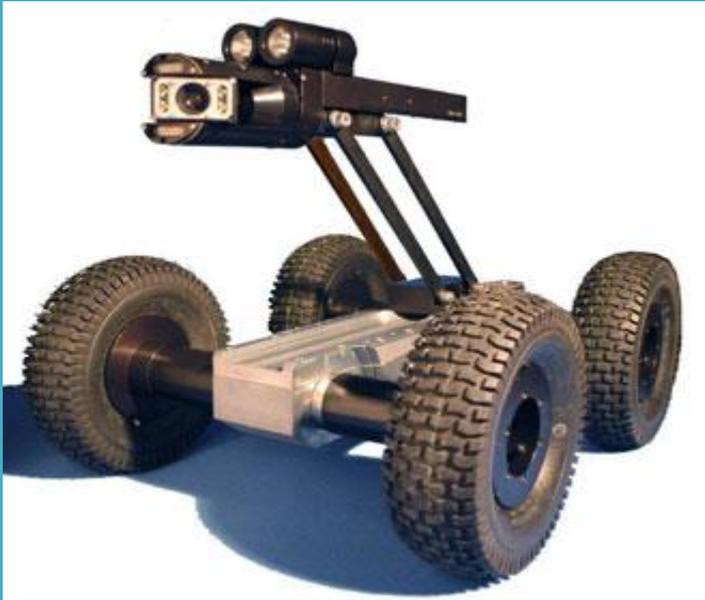
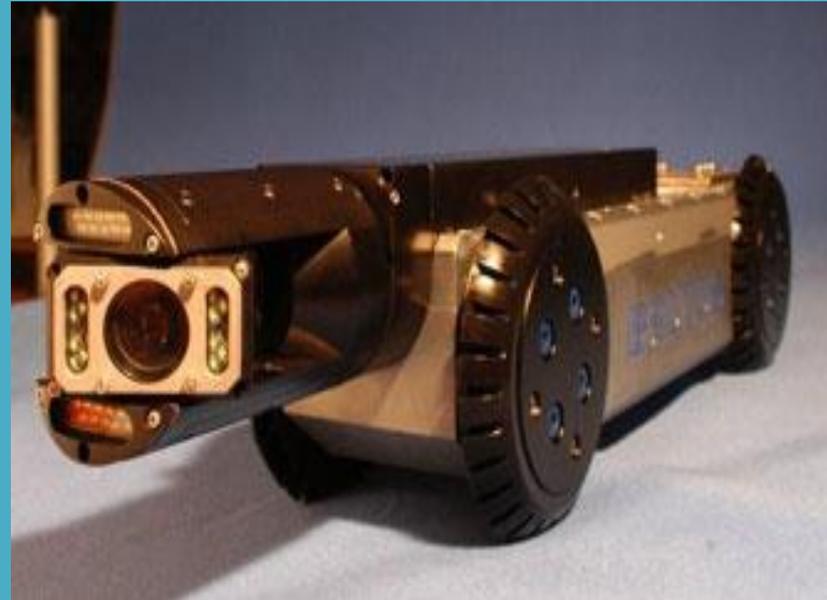
# CRAWLER

- These machines come with several different wheel sets or tracks that must be changed out to accommodate the size and type of pipe being inspected.

1. **Crawler** – moves the equipment through the pipeline.
2. **Closed Circuit TV camera** – records images and sends data back to a computer.
3. **Laser Profiler** – provides numerous measurements of a pipe's internal surface.
4. **Software** – interprets data and generates an inspection report.

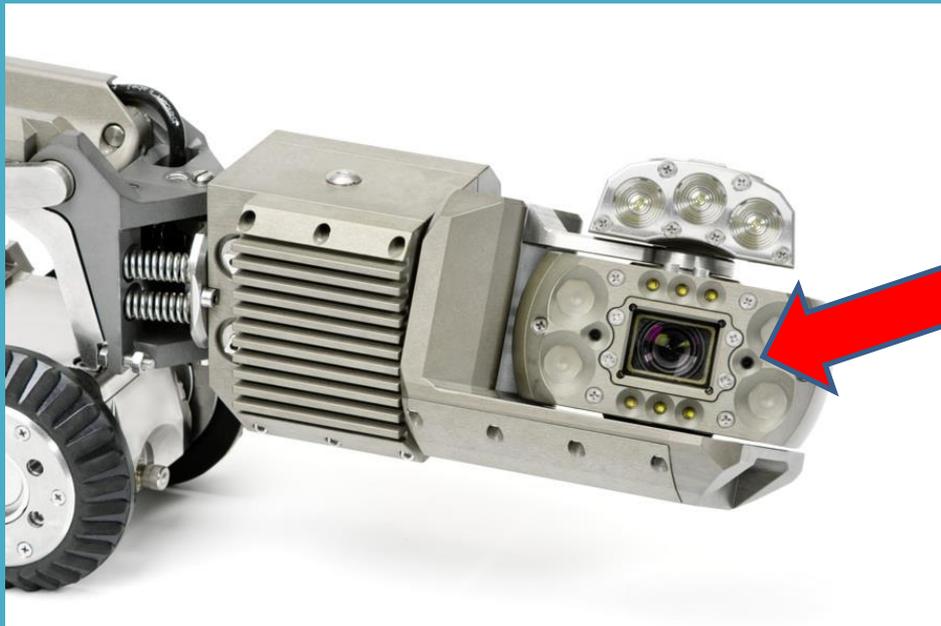
# ROTATING PROFILER

- The rotating head profiler has two laser diodes built into the CCTV camera head. The diodes take continual measurements while the camera head rotates 360° at a set speed while the crawler is pulled back through the pipe.

**DIODES**

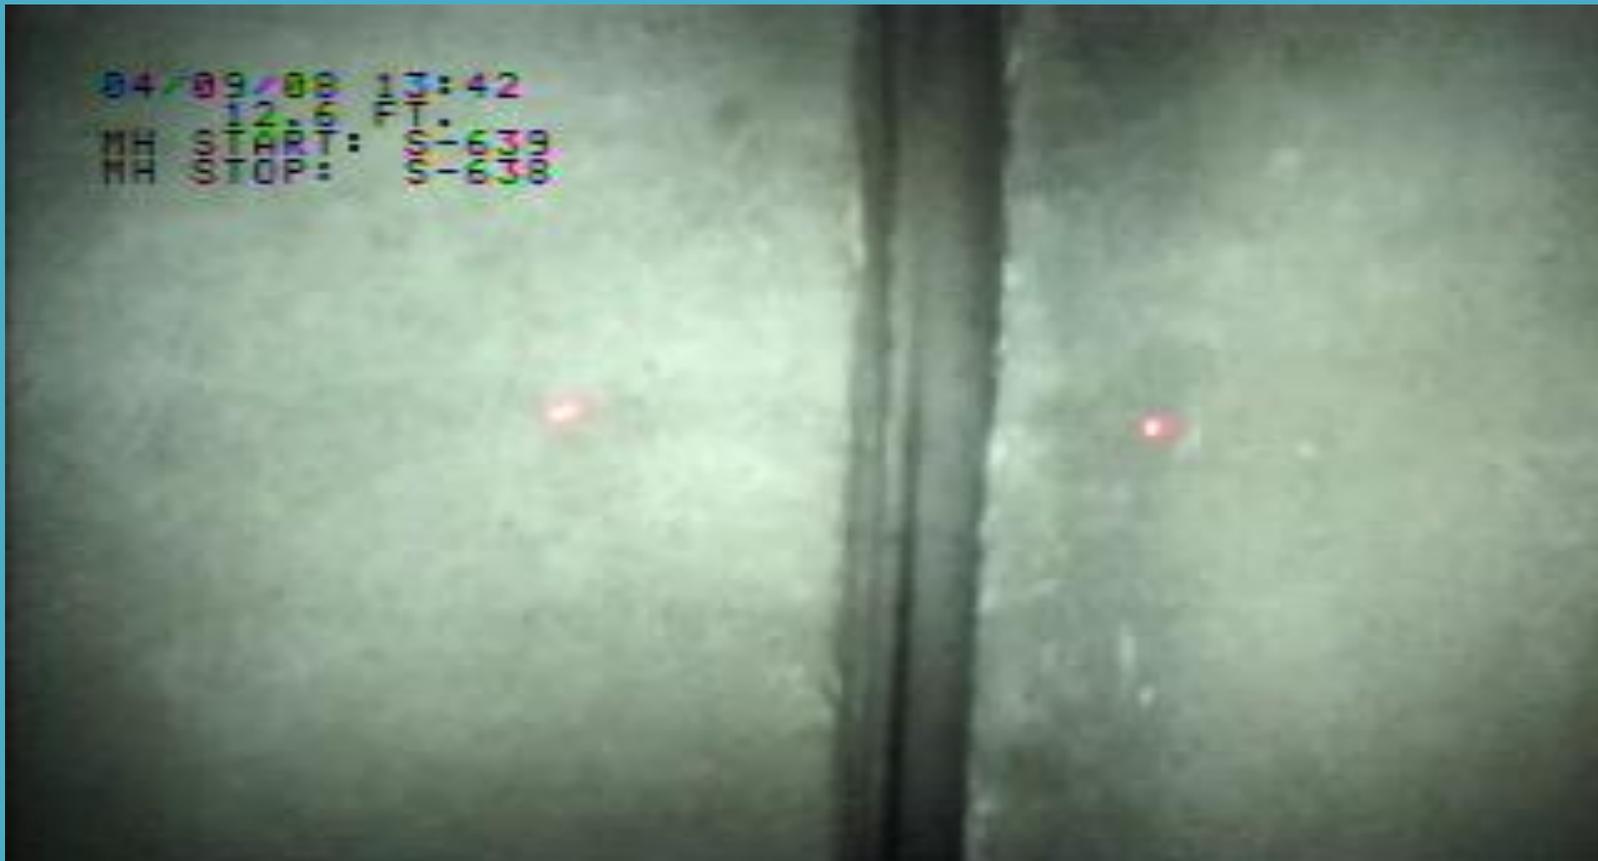
# CAMERA SPEED

- Move the camera through the pipe at a speed no greater than 30 feet per minute.

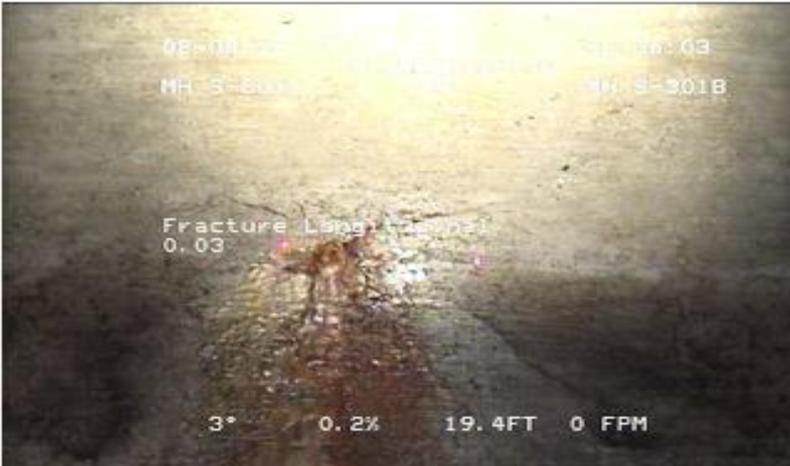
# PIPE OBSERVATIONS

<p>19.4</p>	<p><b>Fracture Longitudinal</b> <b>Position: 3</b> <b>Severity: None</b> <b>Size: 0.03</b> <b>Remarks: with infill weeper</b> <b>Struct Weight: 3</b></p>	<p>05:00</p>

<p>08-08-2017 11:00:00 AM MR 3-301B Fracture Longitudinal 0.03 3° 0.2% 19.4FT 0 FPM</p>
-------------	---	--------------	---

- Observation Reports typically include crack and joint gap measurements, joint misalignment, ovality issues and any other type of damage sustained by the pipe.
- The defects noted in the report should be compared with the video to verify the location of defects in the pipe run and to ensure no defects were missed during the inspection.

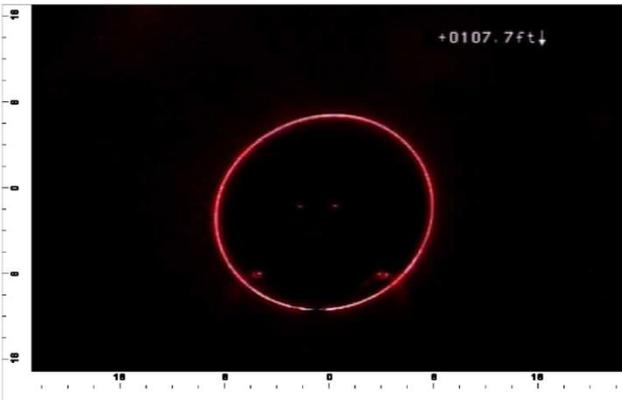
OVALITY = 5.4%

Date 1/5/2014  
Material PVC  
Pipeline Length 298.2 ft  
Internal Diameter (Expected) 17.6 in

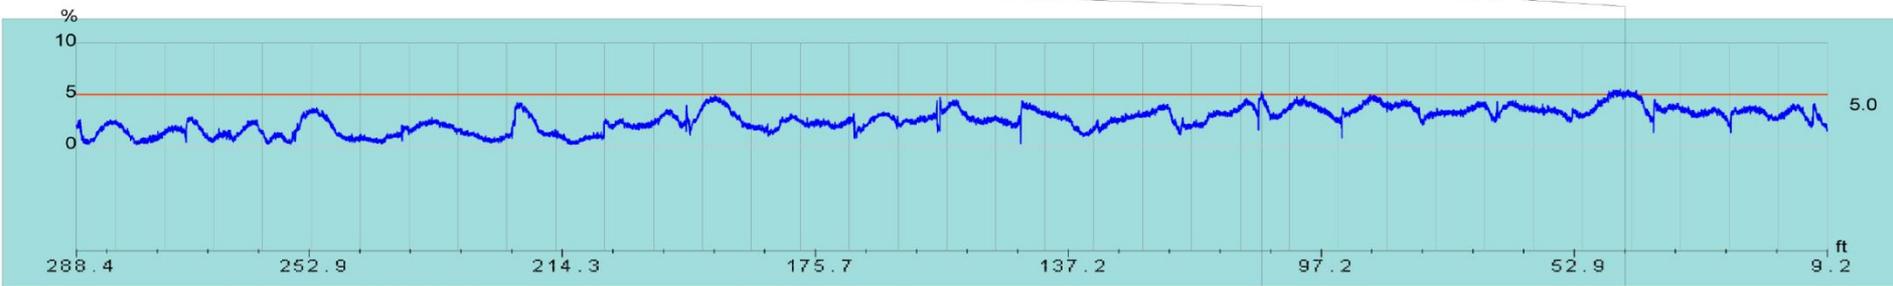
90% - Fractile: 4.0%

Ovality 'q' (as per ASTM F 1216 Standard Practice) as a percentage of original pipe versus distance

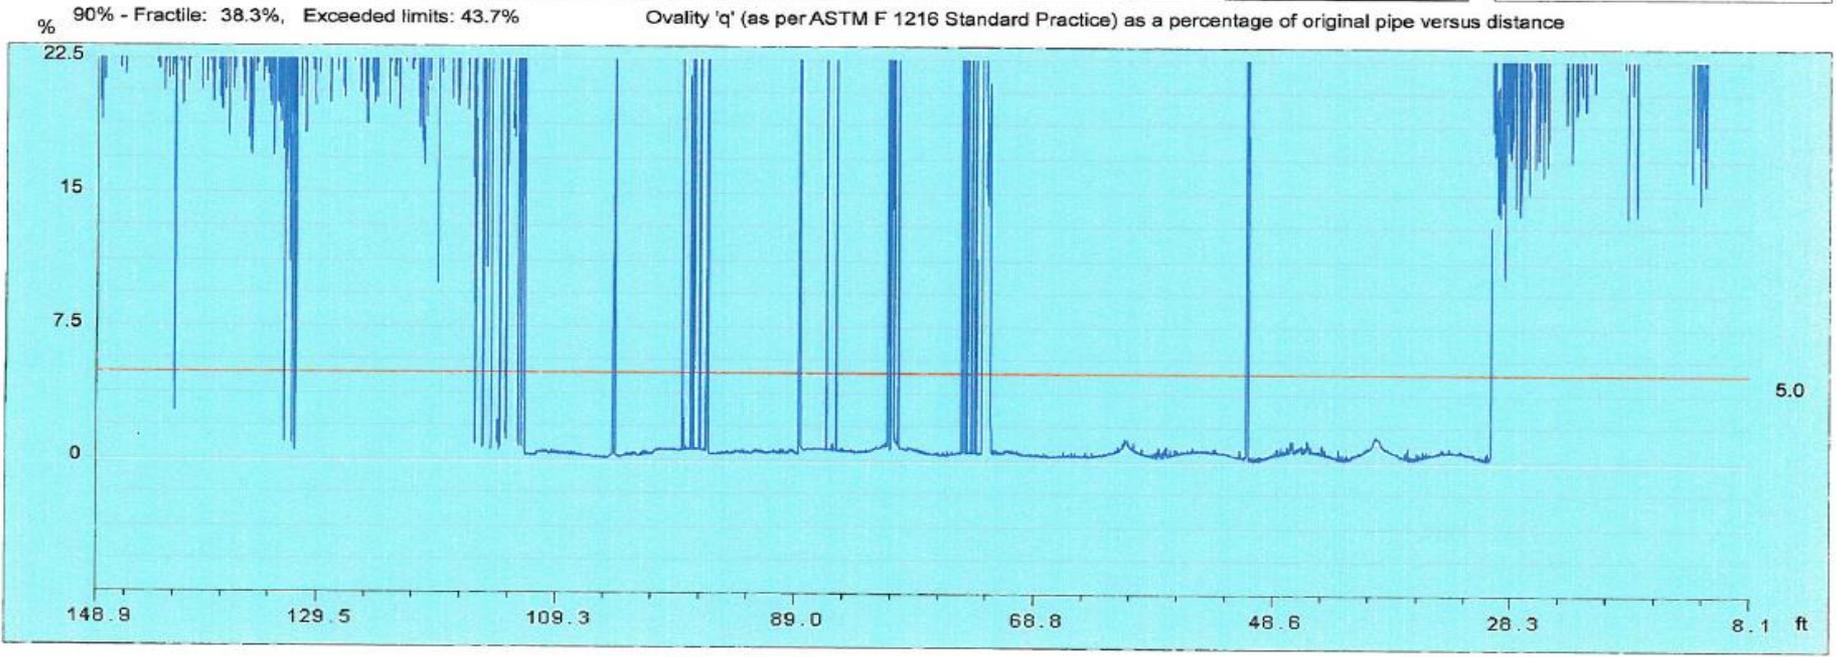
# BAD OVALITY REPORT

Site ID	Asset No.	Date	8/28/2013
City		Material	
Start No	Finish No	Pipeline Length	164 ft
Location	Location	Internal Diameter	36 in
Comments			
		Limit Lines	Upper limit = 5 Lower Limit = 5
