# PIPE INSPECTION AND REPAIR

**2022 CONSTRUCTION ACADEMY**  
**Jason Russell, FDOT**

# PIPE INSPECTION

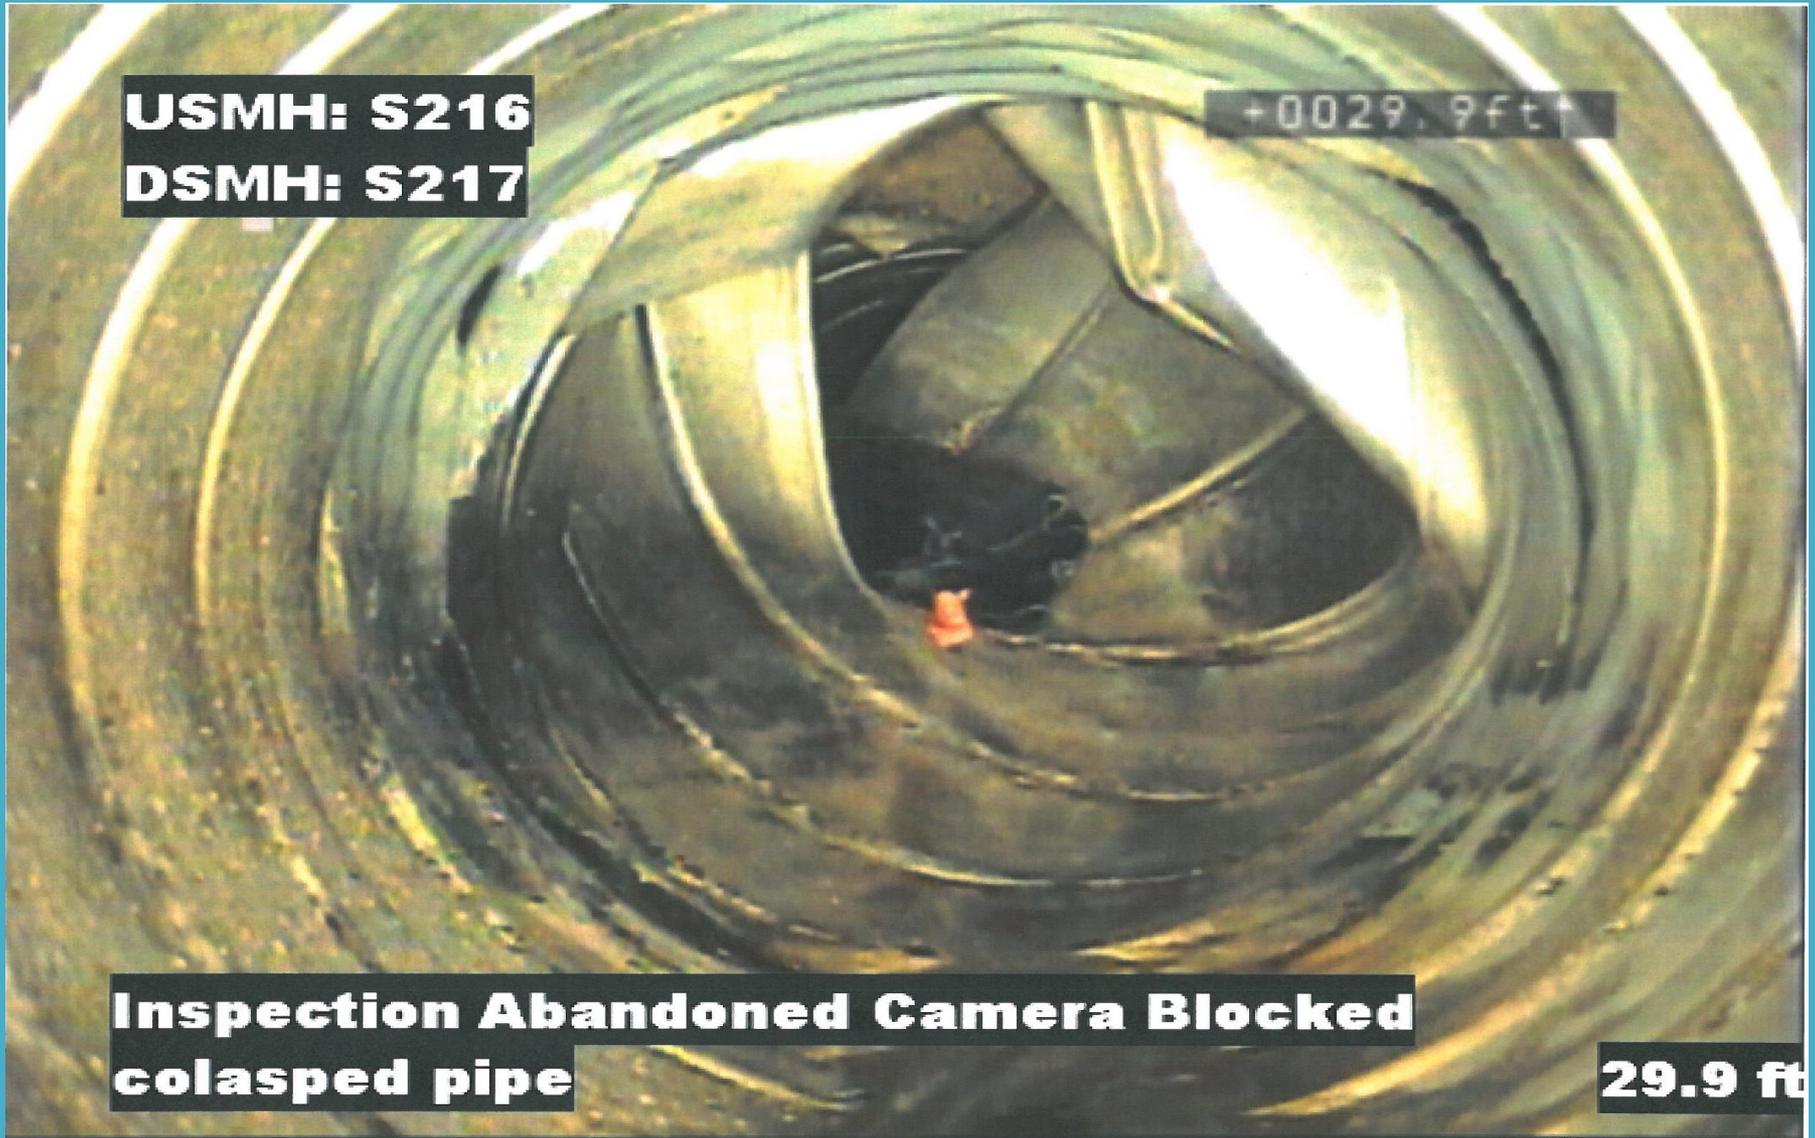
**USMH: S216**  
**DSMH: S217**

**+0029.9ft**

**Inspection Abandoned Camera Blocked  
colapsed pipe**

**29.9 ft**

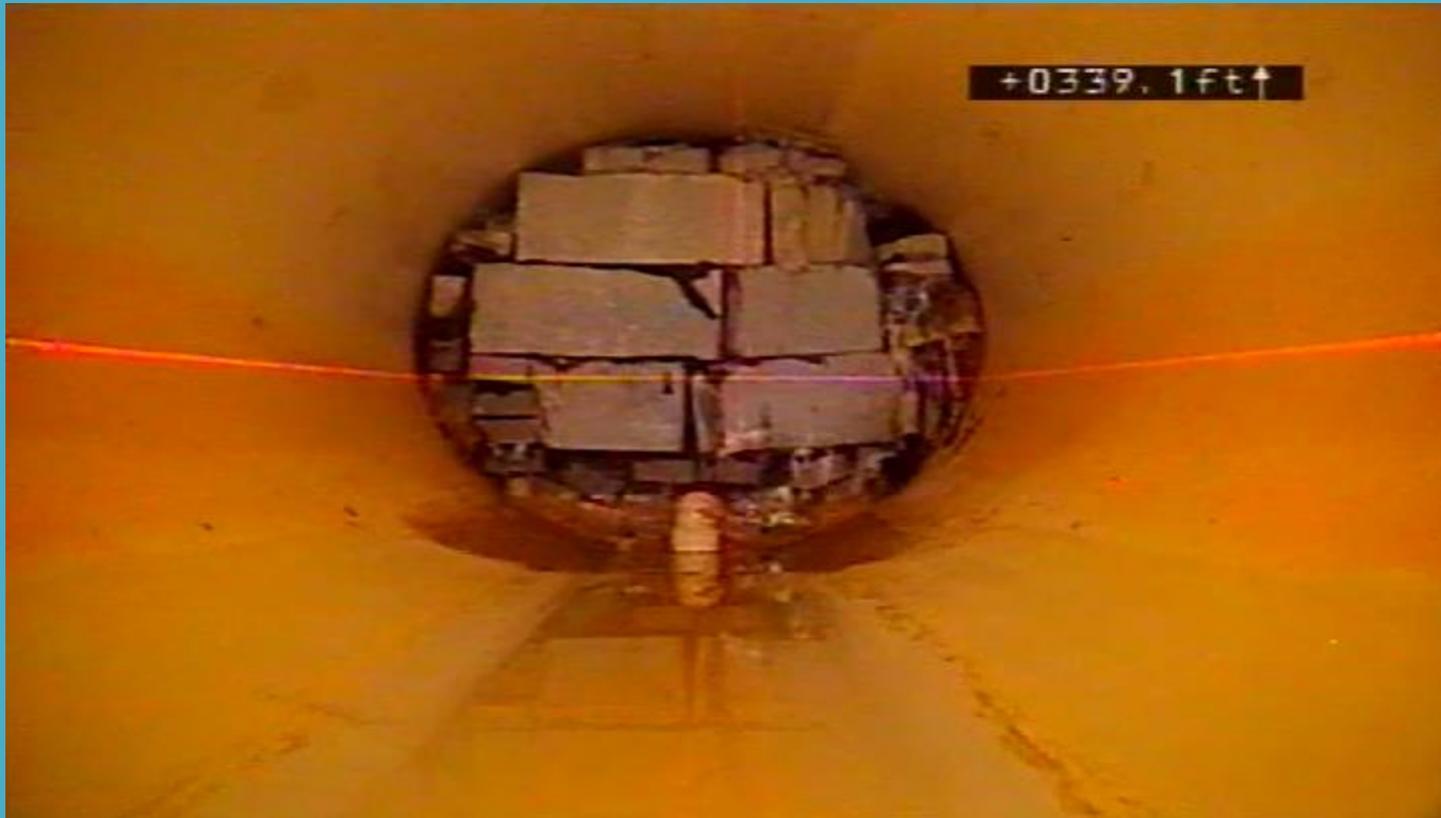
- Prior to inspection, dewater the pipe and remove all silt, debris, and obstructions.

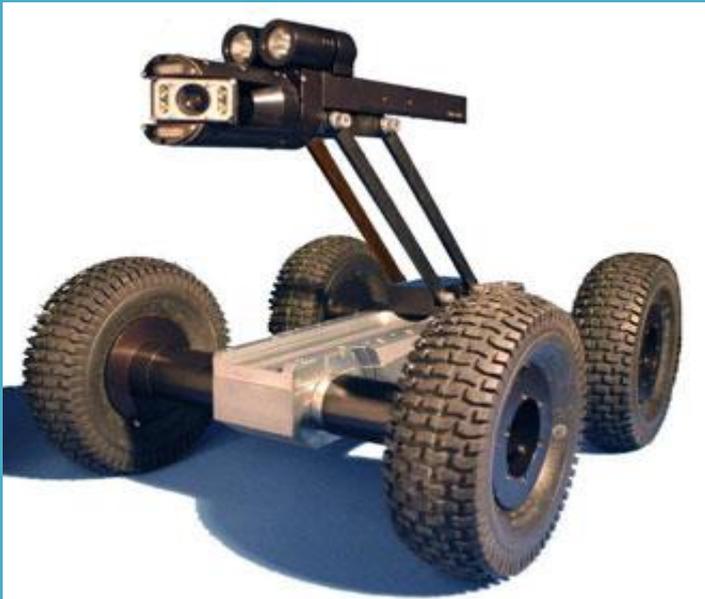
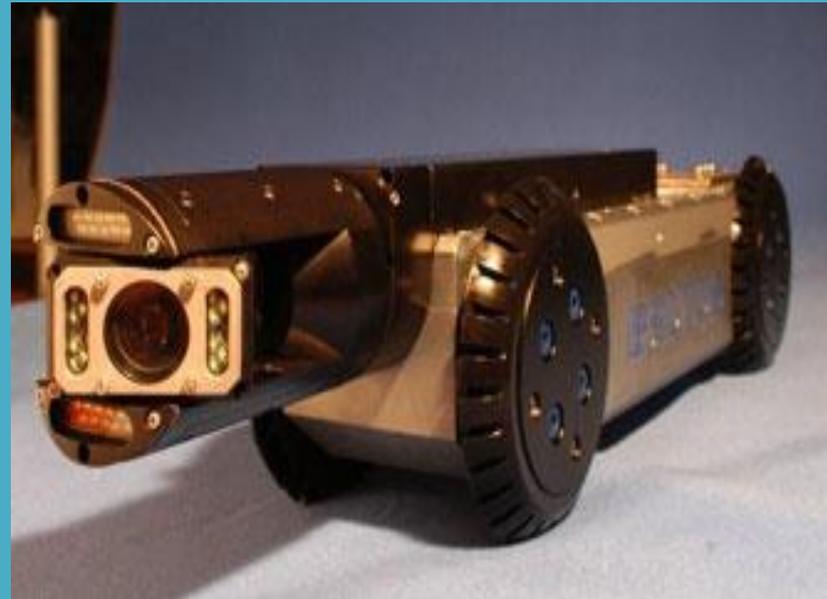
- These machines come with several different wheel sets or tracks that must be changed out to accommodate the size and type of pipe being inspected.

1. **Crawler** – moves the equipment through the pipeline.
2. **Closed Circuit TV camera** – records images and sends data back to a computer.
3. **Laser Profiler** – provides numerous measurements of a pipe's internal surface.
4. **Software** – interprets data and generates an inspection report.

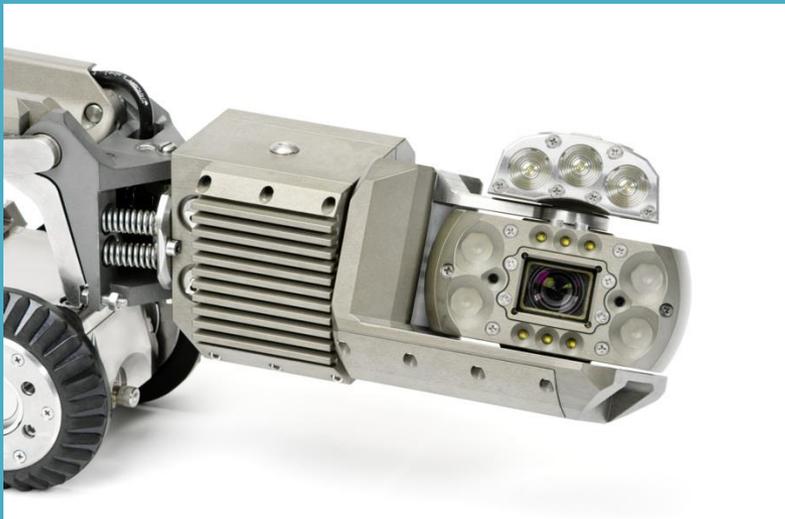
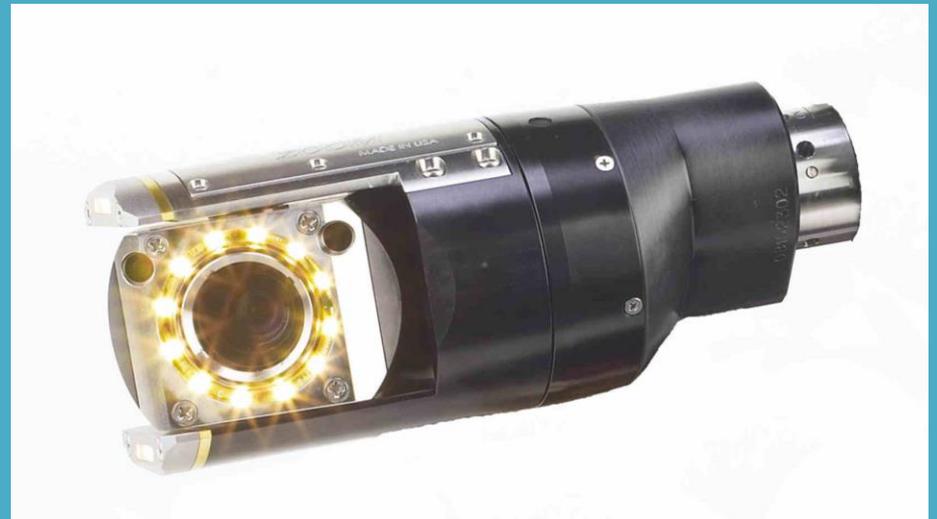
- The Closed Circuit Television (CCTV) camera records all the images for the pipe inspections. This is the equipment that pans and tilts around the inside of a pipe for observations and measurements.

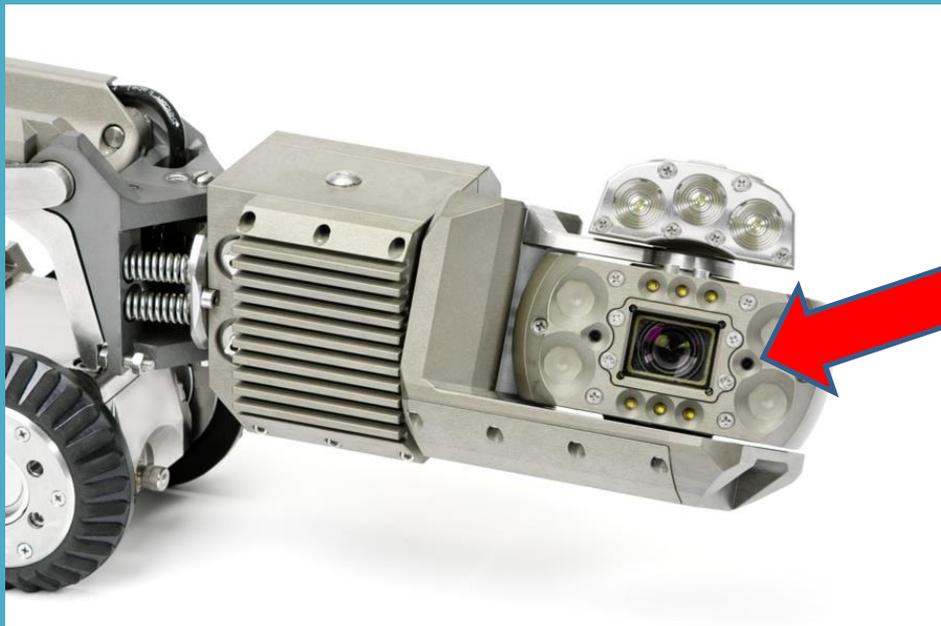
- The rotating head profiler has two laser diodes built into the CCTV camera head. The diodes take continual measurements while the camera head rotates 360° at a set speed while the crawler is pulled back through the pipe.

**DIODES**

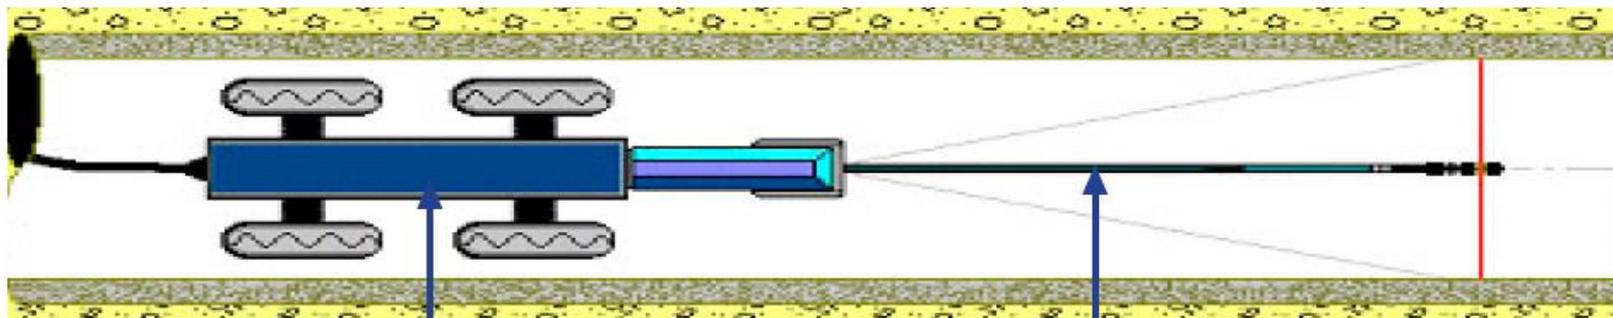
- The continuous ring profiler projects a visible laser beam onto the internal surface of the pipe. The beam is centered in the field of view of the CCTV camera and the camera records the image of the beam as it is pulled back through the pipe.

CCTV INSPECTION CAMERA

LASER PROFILER

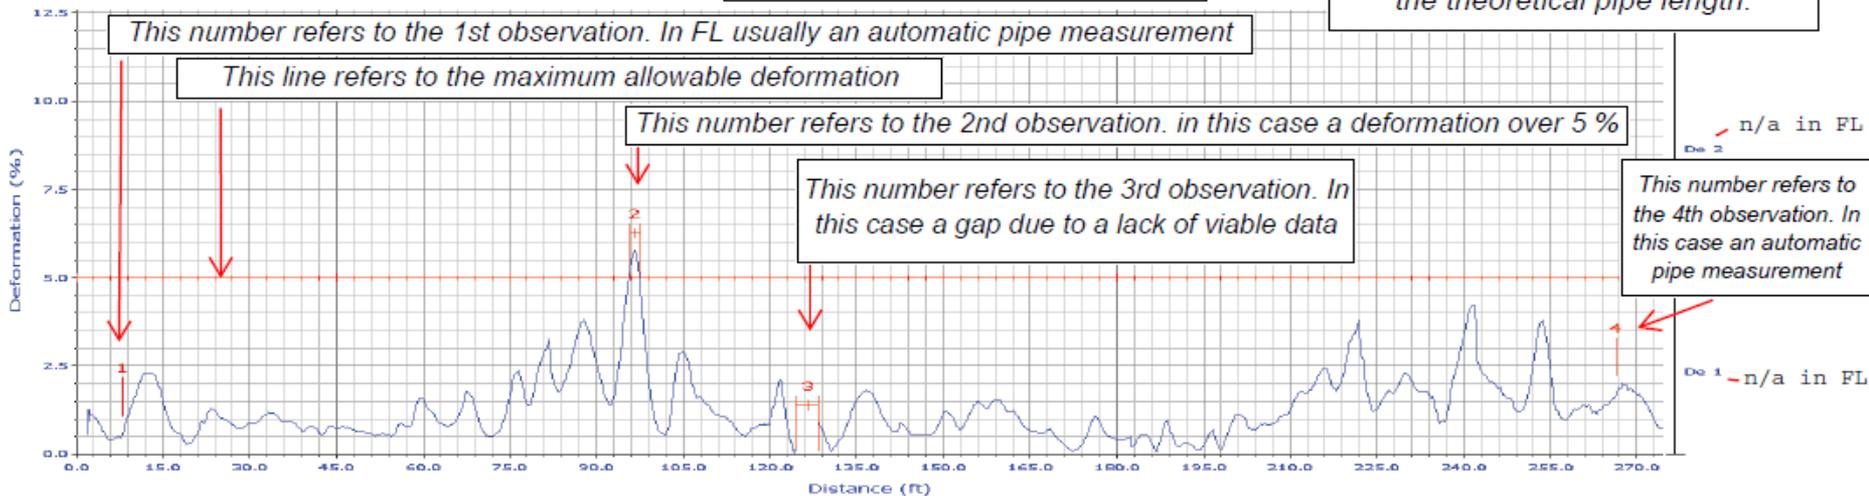
## Deformation analysis

Dimensions of pipeline

1st number refers to the length processes. 2nd number refers to the theoretical pipe length.

S-66 ←

This graph is always displayed from the start of the inspection to the end of the inspection

→ S71

**Note, observations are numbered on this graph and an explanation of what the observations are is given on the following table.**

These Observation IDs refer to the observation numbers on the previous graph and provide an explanation as to what the observation is and its location in the pipeline.

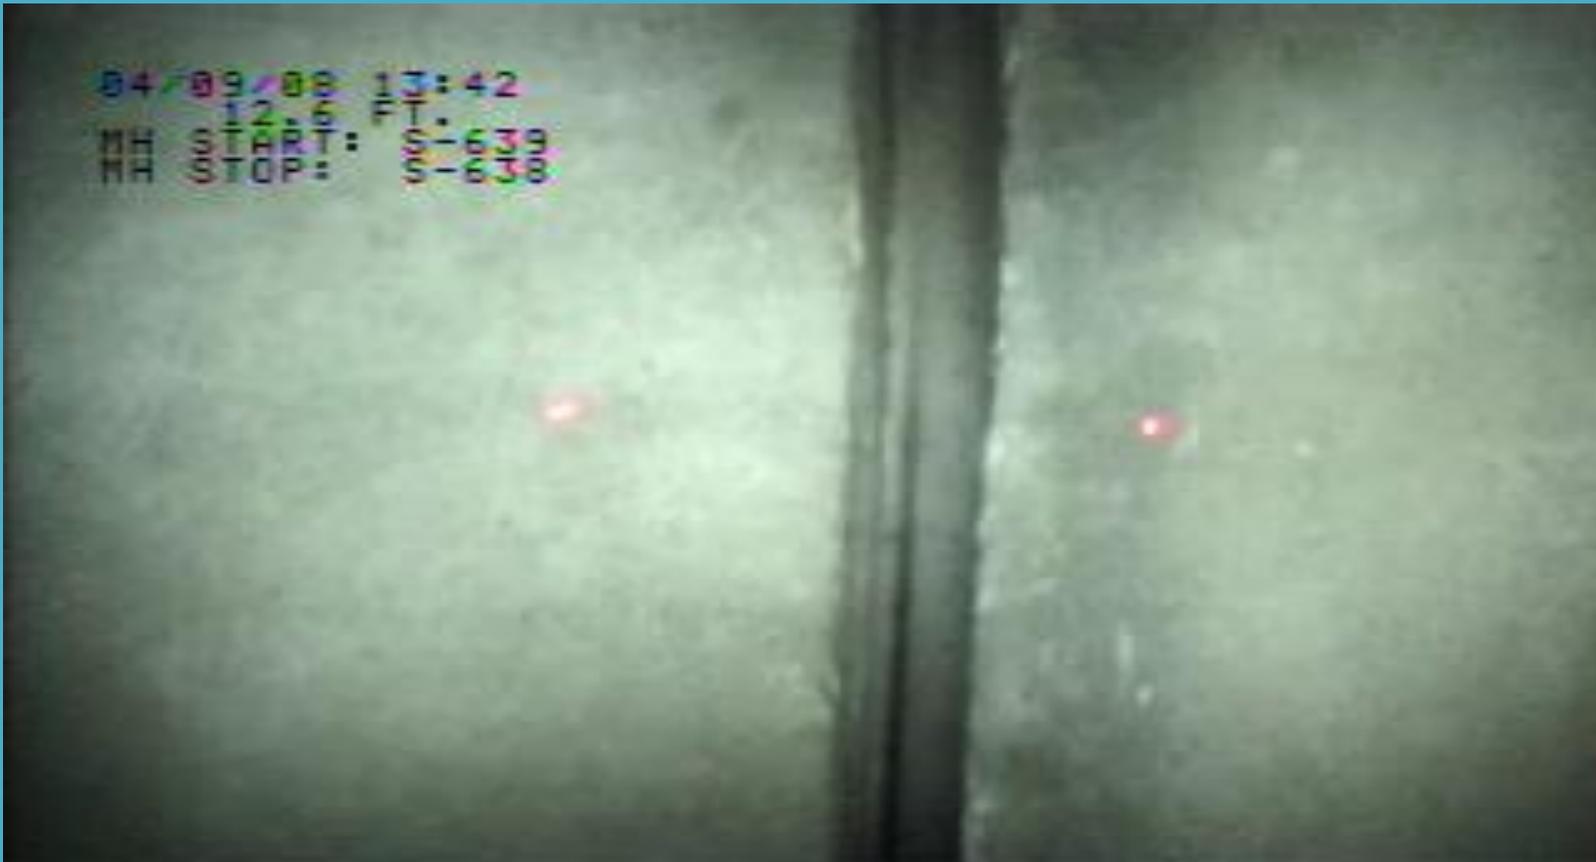
- Move the camera through the pipe at a speed no greater than 30 feet per minute.

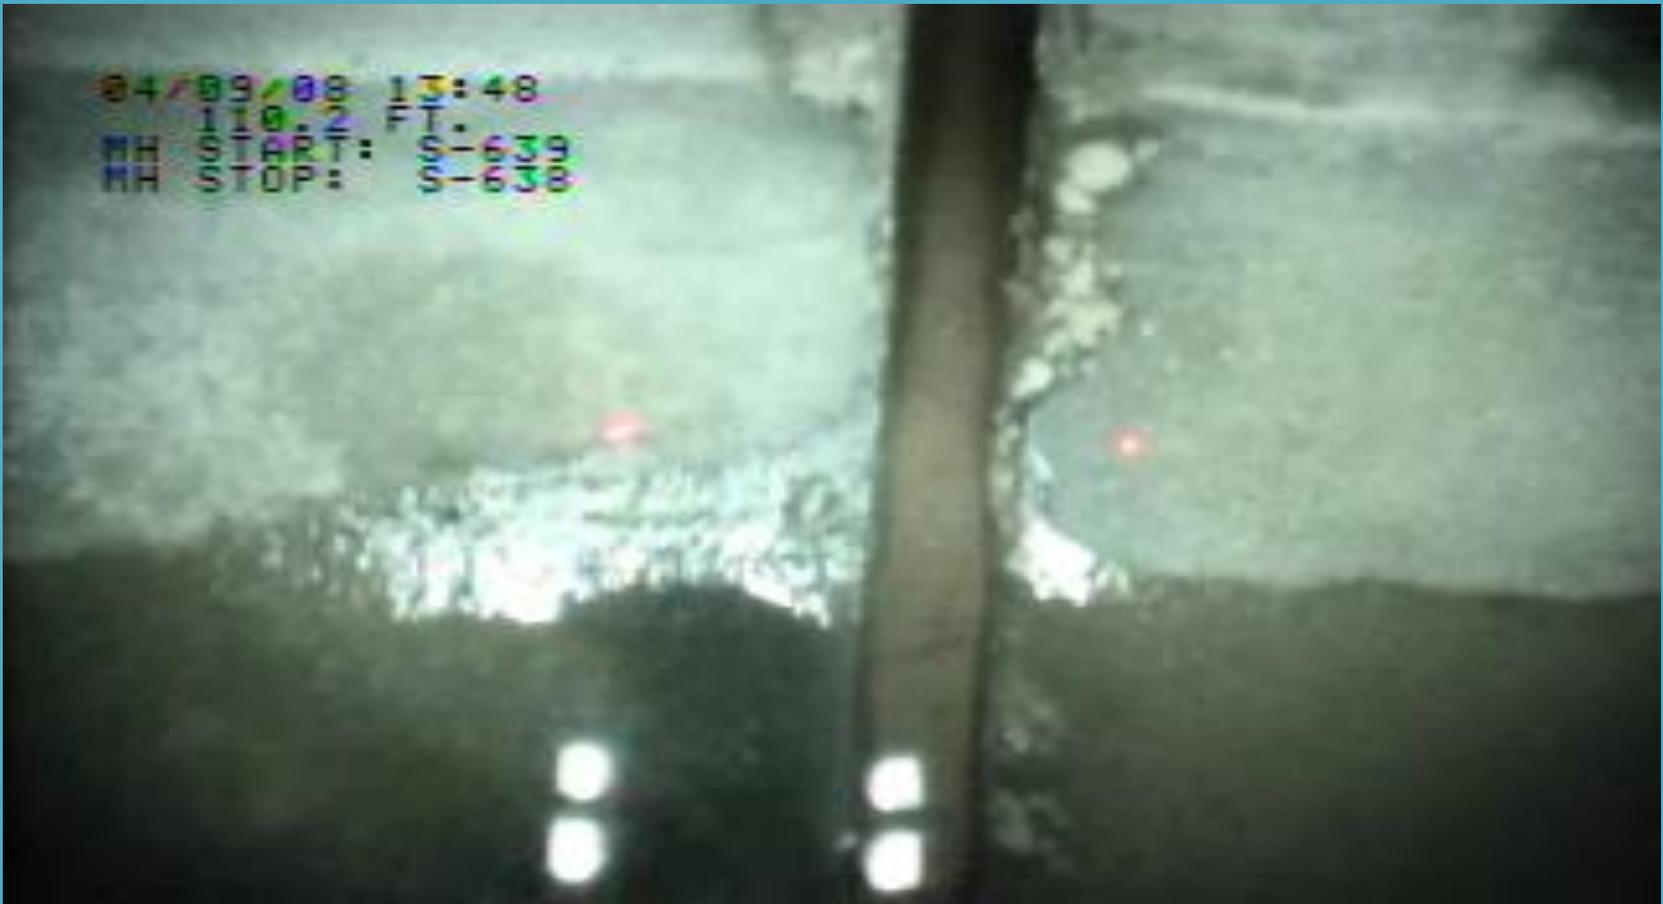
- Stop the camera and pan when necessary to document defects.

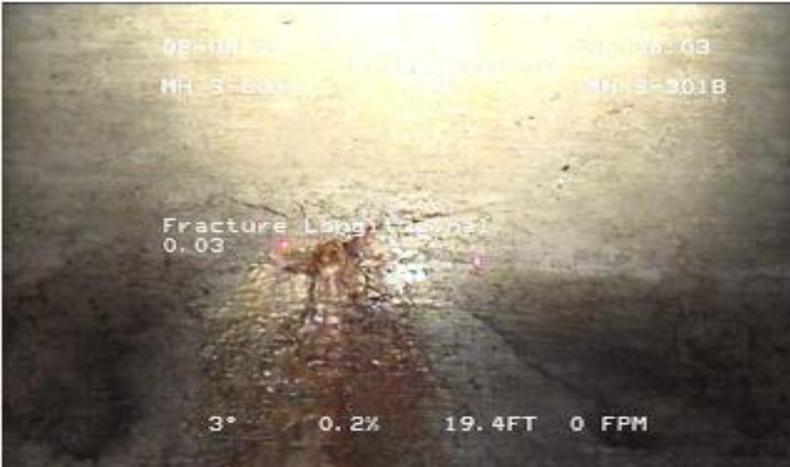
<p>19.4</p>	<p><b>Fracture Longitudinal</b> <b>Position: 3</b> <b>Severity: None</b> <b>Size: 0.03</b> <b>Remarks: with infill weeper</b> <b>Struct Weight: 3</b></p>	<p>05:00</p>

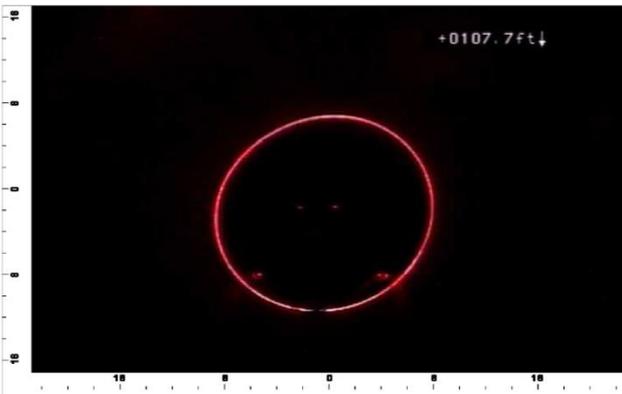
OVALITY = 5.4%

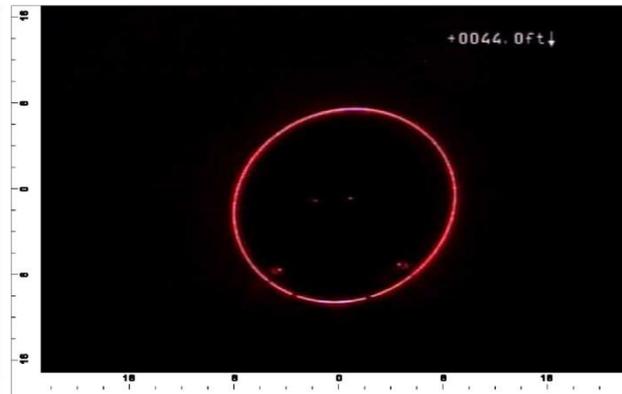
OVALITY = 5.1%

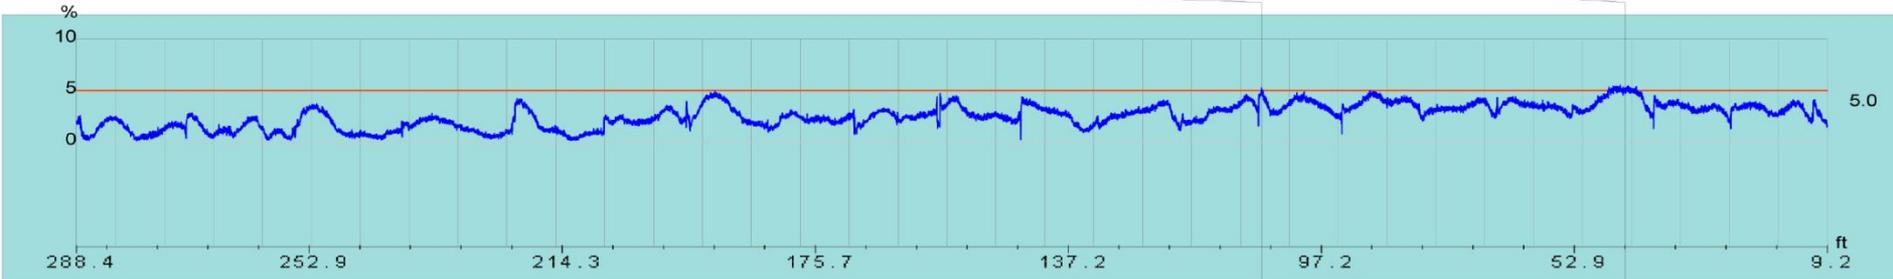
90% - Fractile: 4.0%

Ovality 'q' (as per ASTM F 1216 Standard Practice) as a percentage of original pipe versus distance

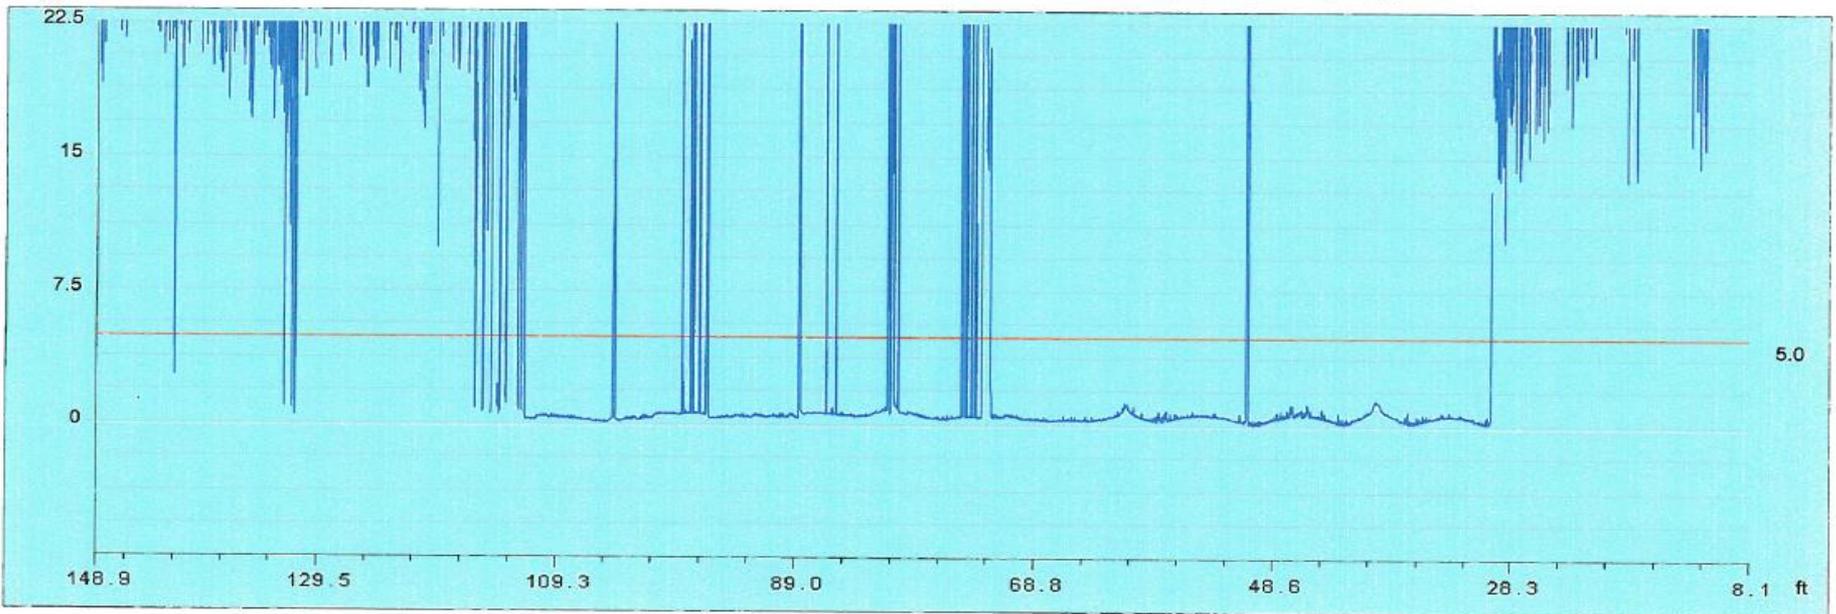
Limit Lines  
Upper limit = 5  
Lower Limit = 5

90% - Fractile: 38.3%, Exceeded limits: 43.7%      Ovality 'q' (as per ASTM F 1216 Standard Practice) as a percentage of original pipe versus distance

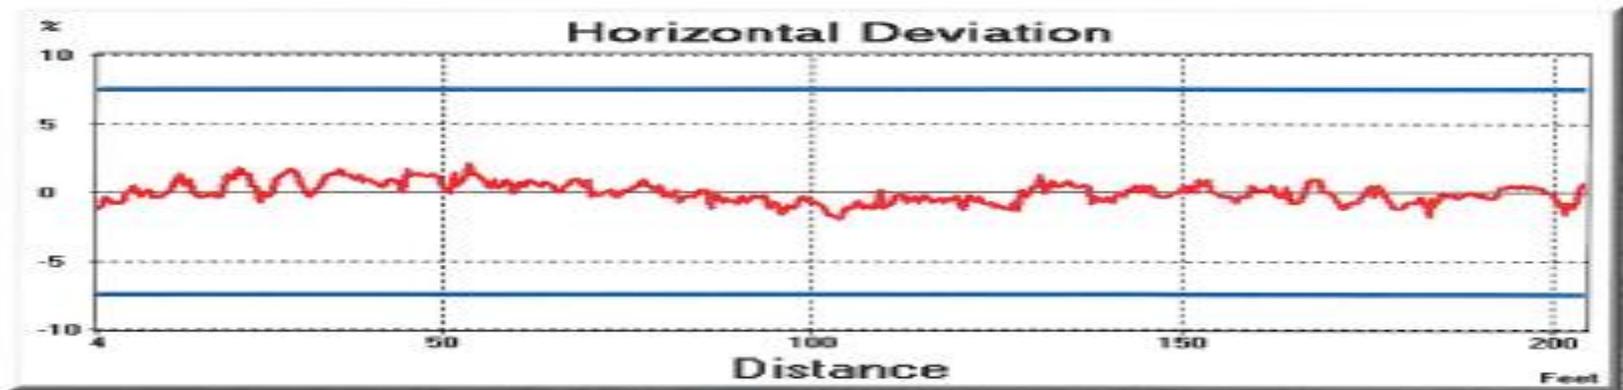
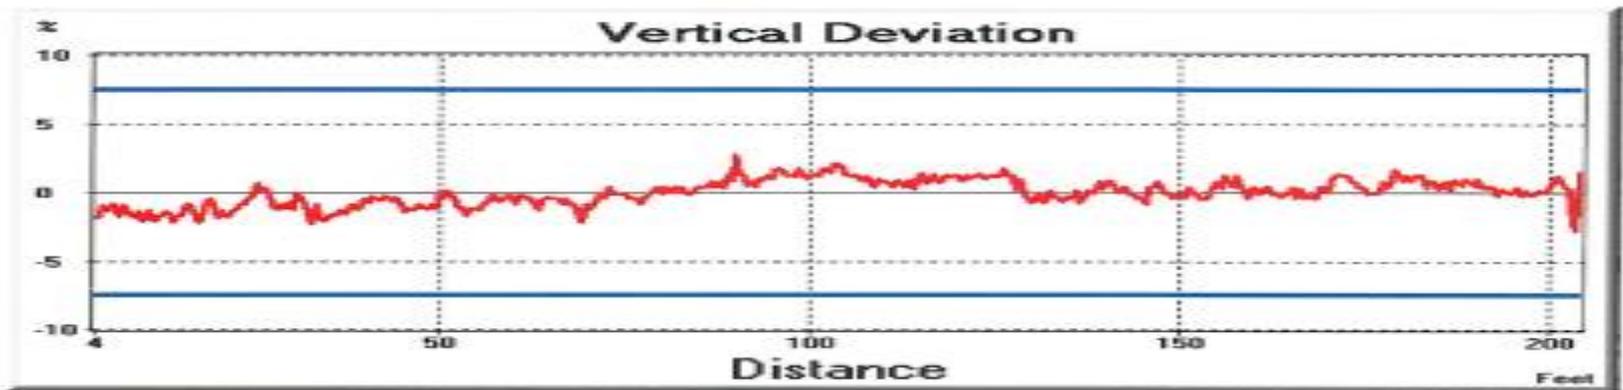
## Project Name: I10

Date: 4/22/2009 9:23:00 AM  
Location: Leon County  
Length Surveyed: 205.5  
Run Number:  
Pipe Size: 18"

Asset ID:  
Upstream MH Number: S330Demo  
Downstream MH Number: S331Demo  
Direction Of Survey: Upstream  
Pipe Material: Polyvinyl Chloride

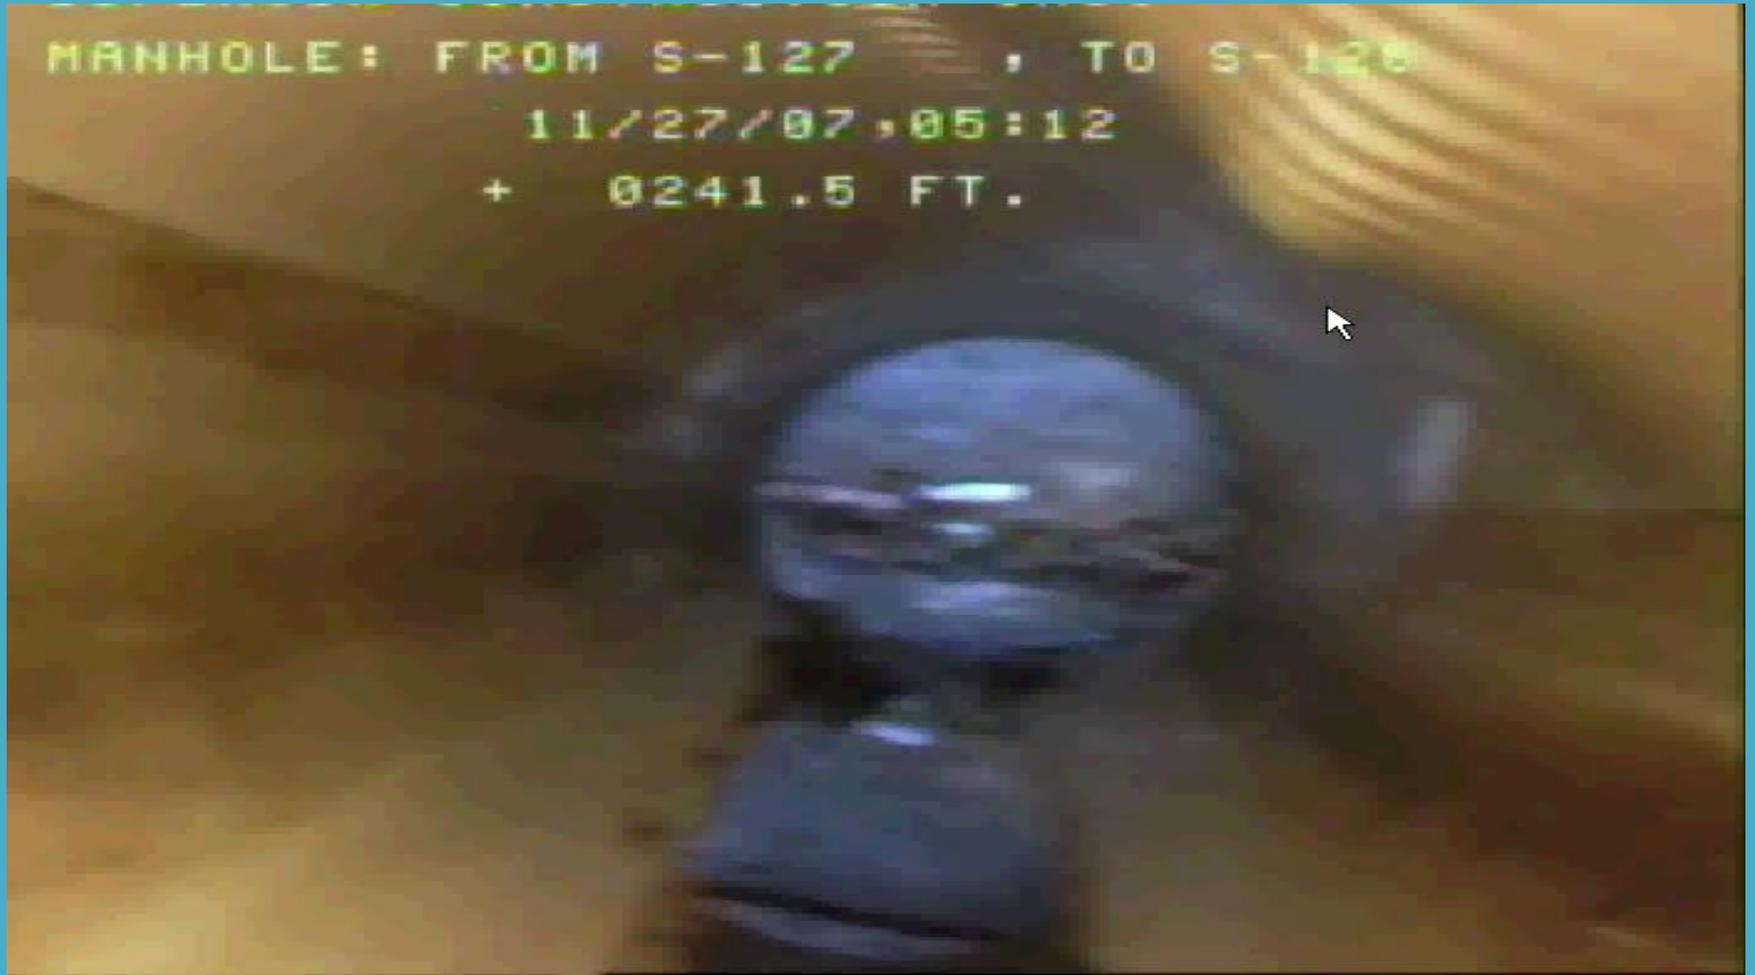
MANHOLE: FROM S-127 , TO S-128  
11/27/07, 05:12  
+ 0241.5 FT.

- All flexible pipe types must meet the Department's deflection criteria in Section 430.
- Pipe deflected 5% or more of the certified actual mean diameter of the pipe at final inspection shall be replaced at no cost to the Department.

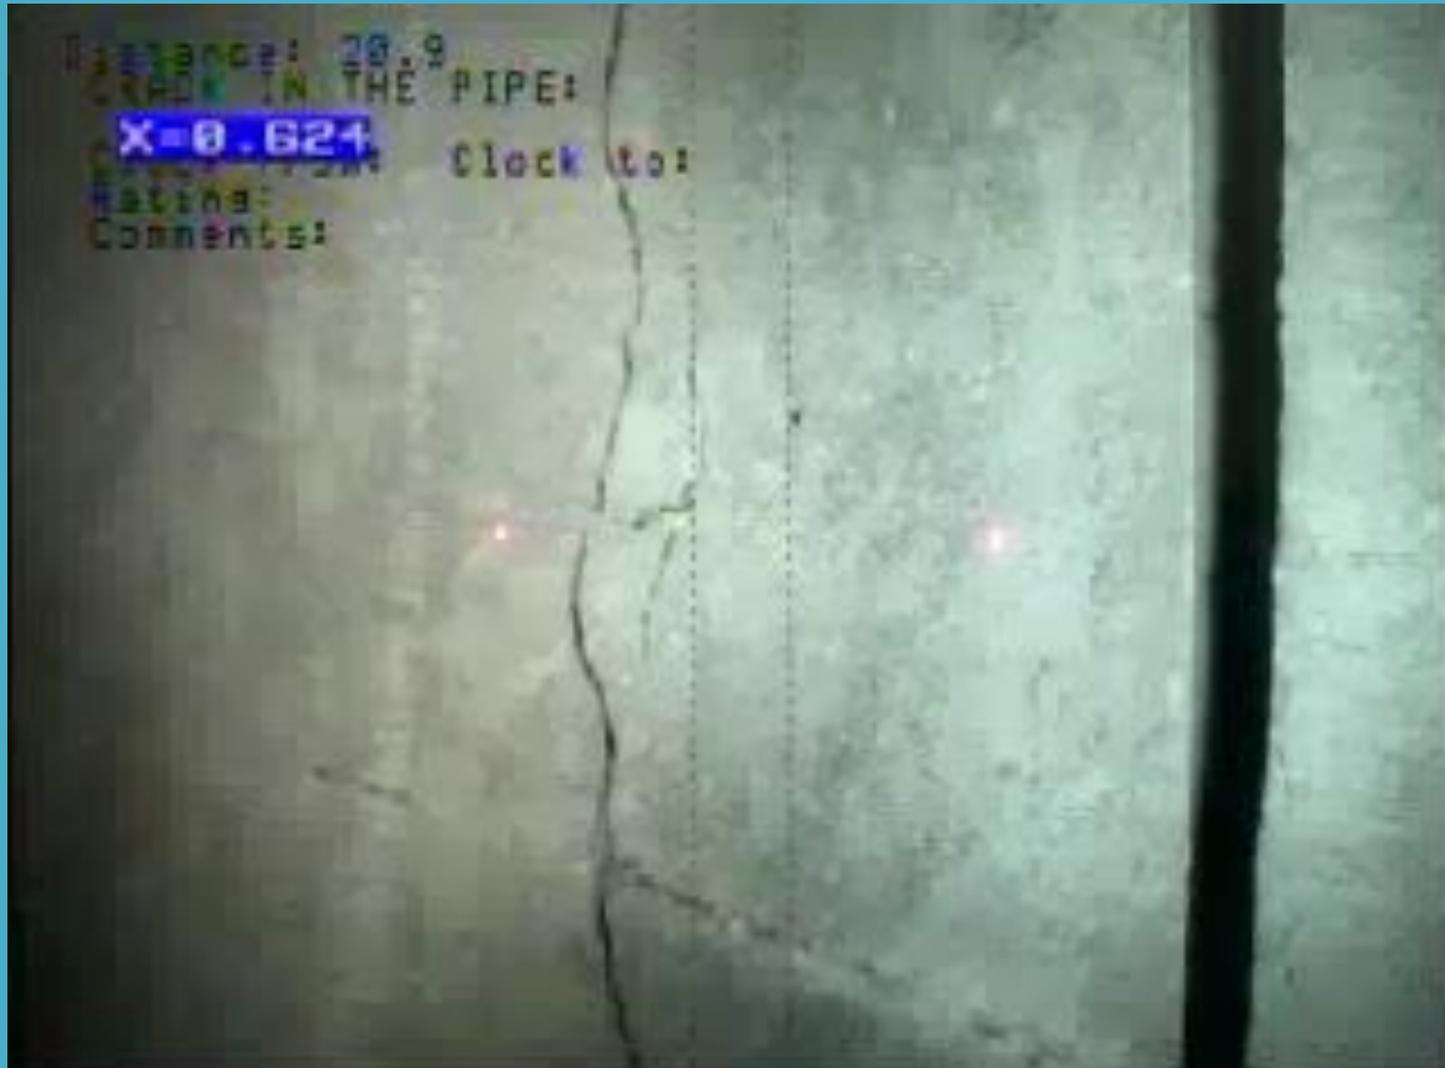
- Cracking can occur in all pipe types.
- If the pipe is cracked during installation, it is usually due to the pipe being overloaded or not backfilled properly.
- Cracking can affect the structural integrity of the pipe.
