# PIPE INSPECTION AND REPAIR

**2022 CONSTRUCTION ACADEMY**  
**Jason Russell, FDOT**

- The Standard Specifications for pipe installation and inspection requirements.
- Information on the components of a pipe inspection.
- CPAM Chapter 8.13 guidance on some of the common issues associated with pipe installation.
- CPAM Chapter 8.13 guidance and the Pipe Repair Matrix for acceptable repair methods.

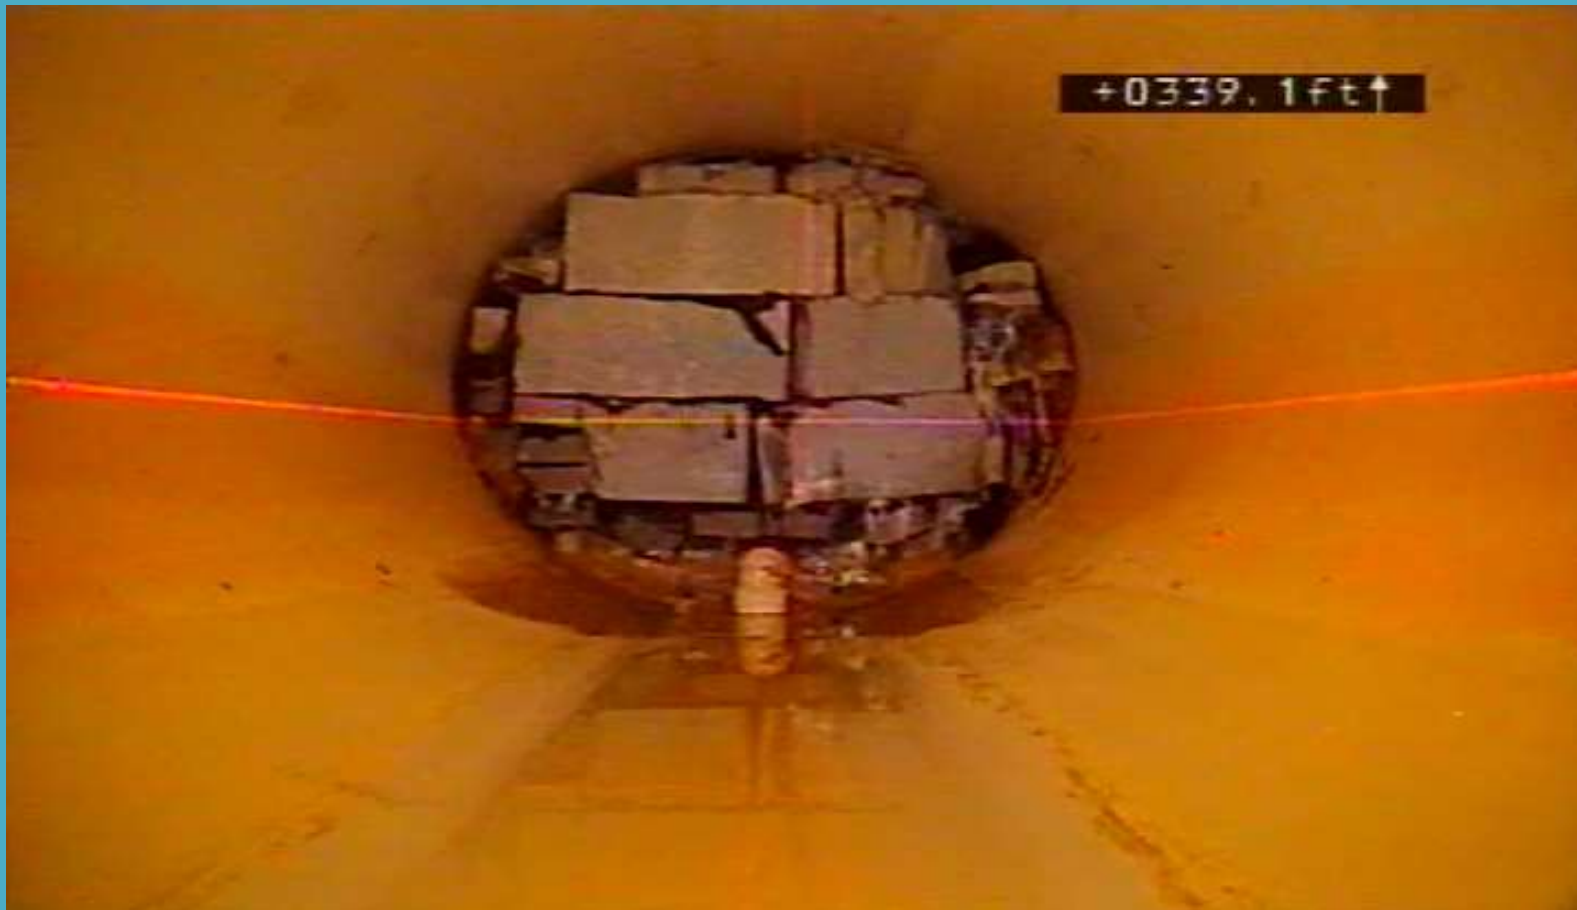
- Prior to inspection, dewater the pipe and remove all silt, debris, and obstructions.

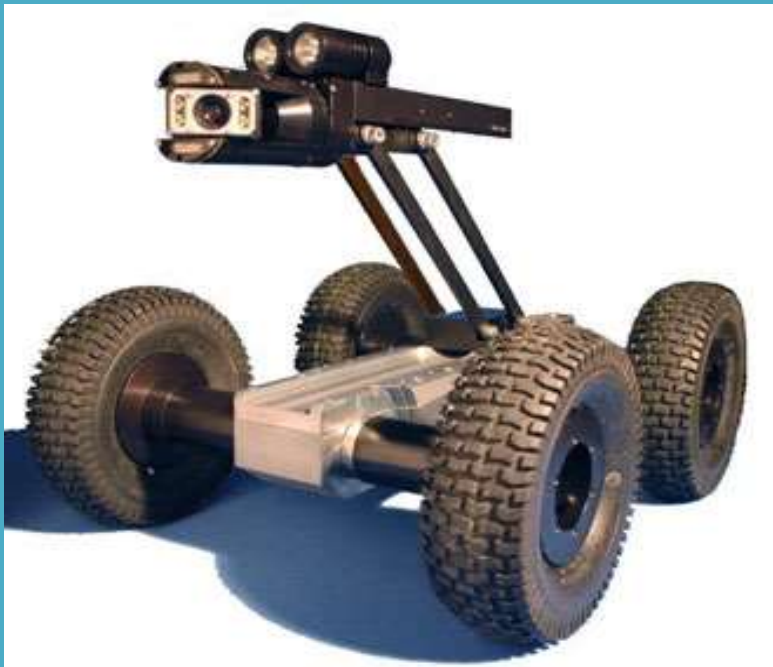
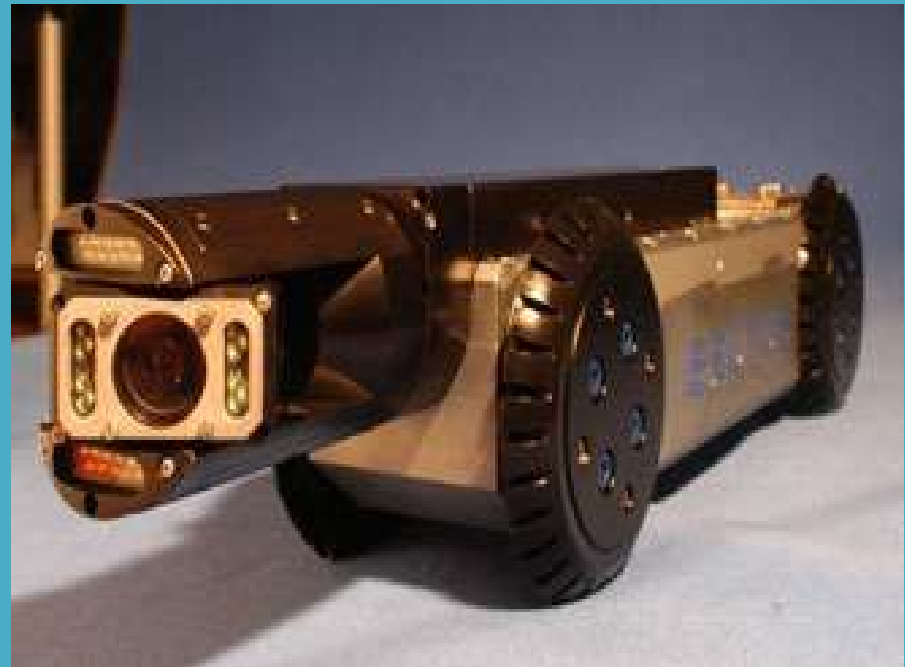
# CRAWLER

- These machines come with several different wheel sets or tracks that must be changed out to accommodate the size and type of pipe being inspected.

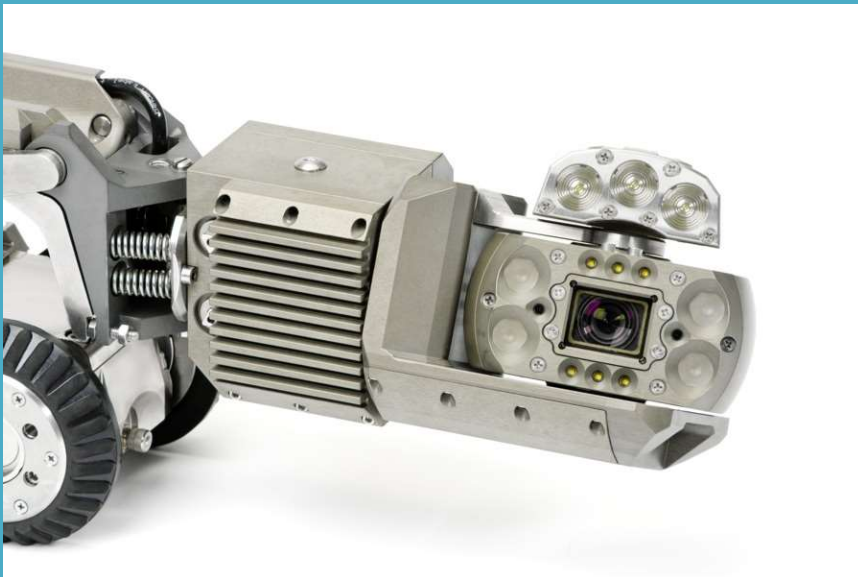
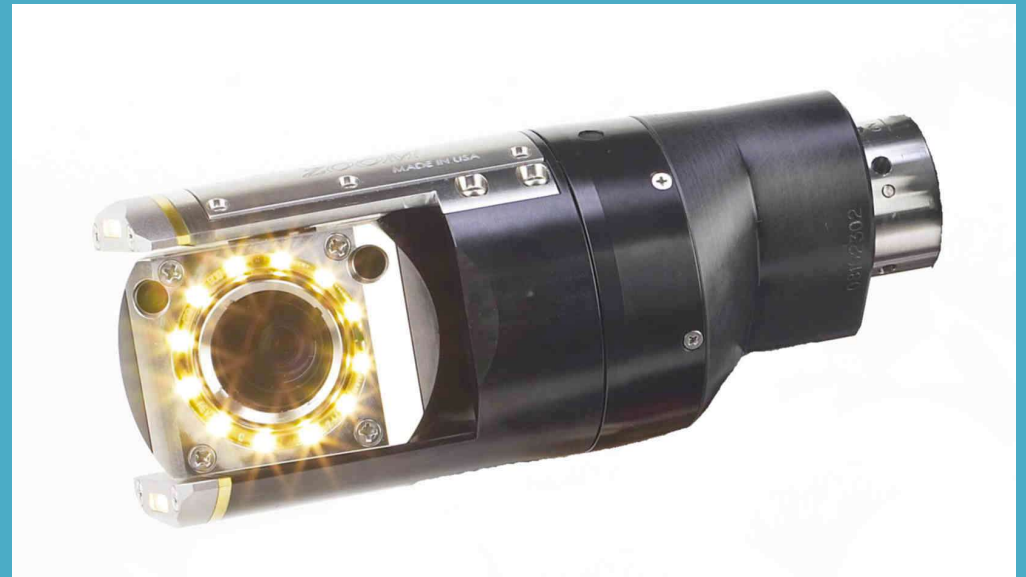
# CCTV

- The Closed Circuit Television (CCTV) camera records all the images for the pipe inspections. This is the equipment that pans and tilts around the inside of a pipe for observations and measurements.

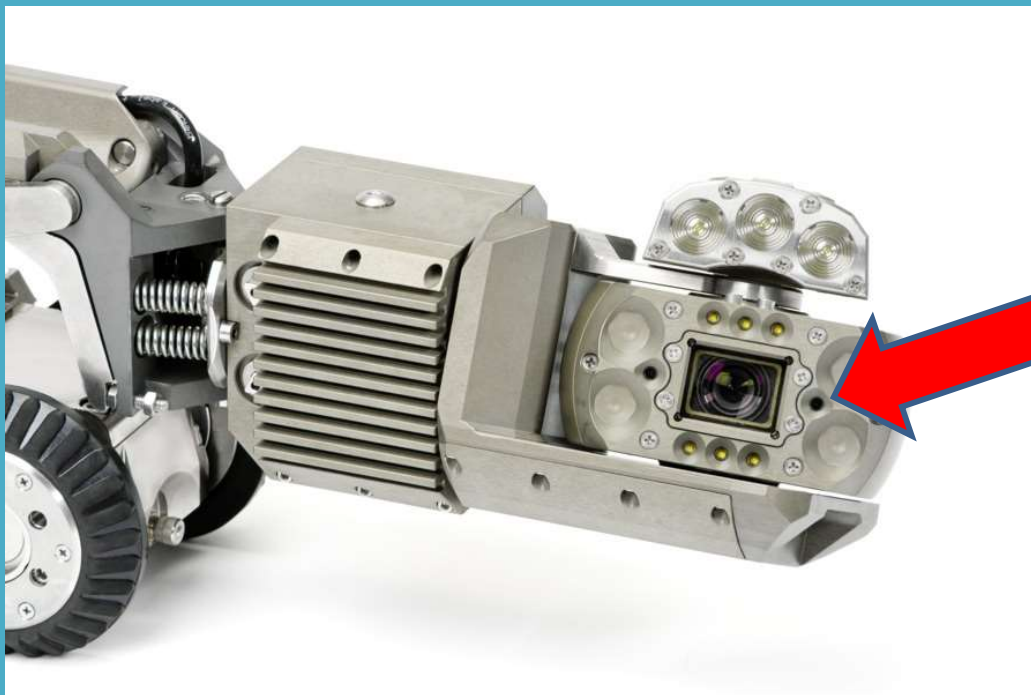
**DIODES**

- The rotating head profiler has two laser diodes built into the CCTV camera head. The diodes take continual measurements while the camera head rotates 360° at a set speed while the crawler is pulled back through the pipe.

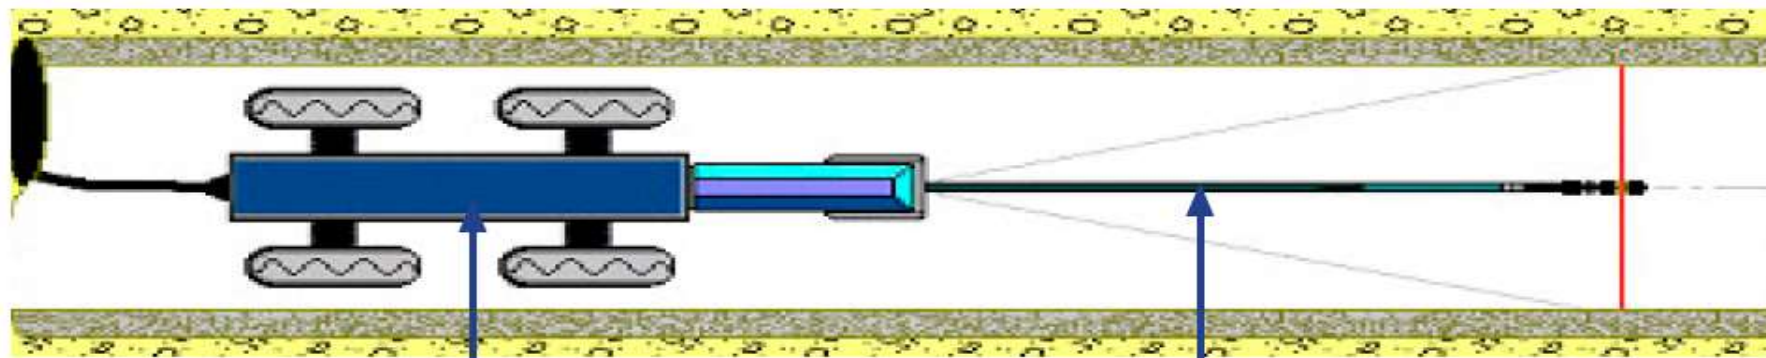
- The continuous ring profiler projects a visible laser beam onto the internal surface of the pipe. The beam is centered in the field of view of the CCTV camera and the camera records the image of the beam as it is pulled back through the pipe.

CCTV INSPECTION CAMERA

LASER PROFILER

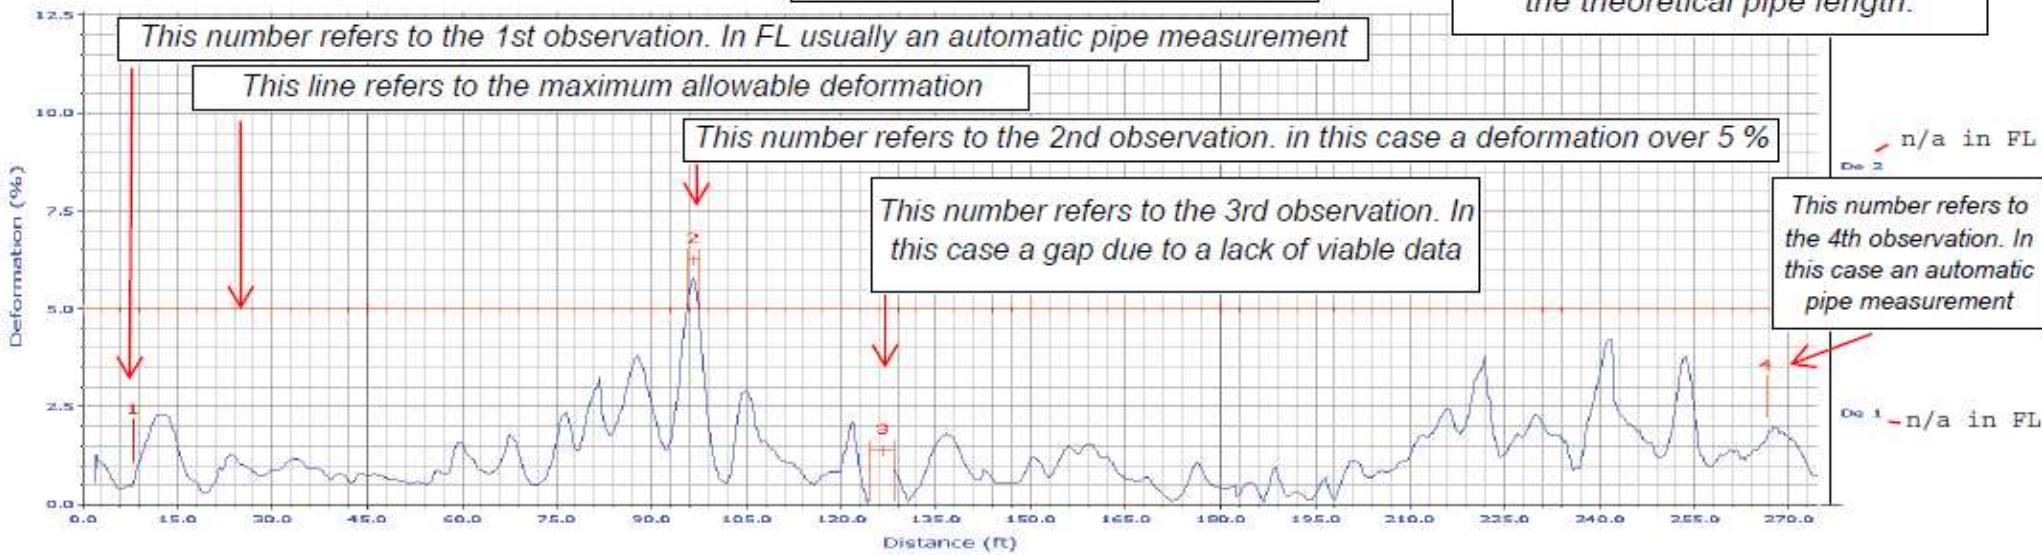
## Deformation analysis

Dimensions of pipeline

1st number refers to the length processes. 2nd number refers to the theoretical pipe length.

This graph is always displayed from the start of the inspection to the end of the inspection

**Note, observations are numbered on this graph and an explanation of what the observations are is given on the following table.**

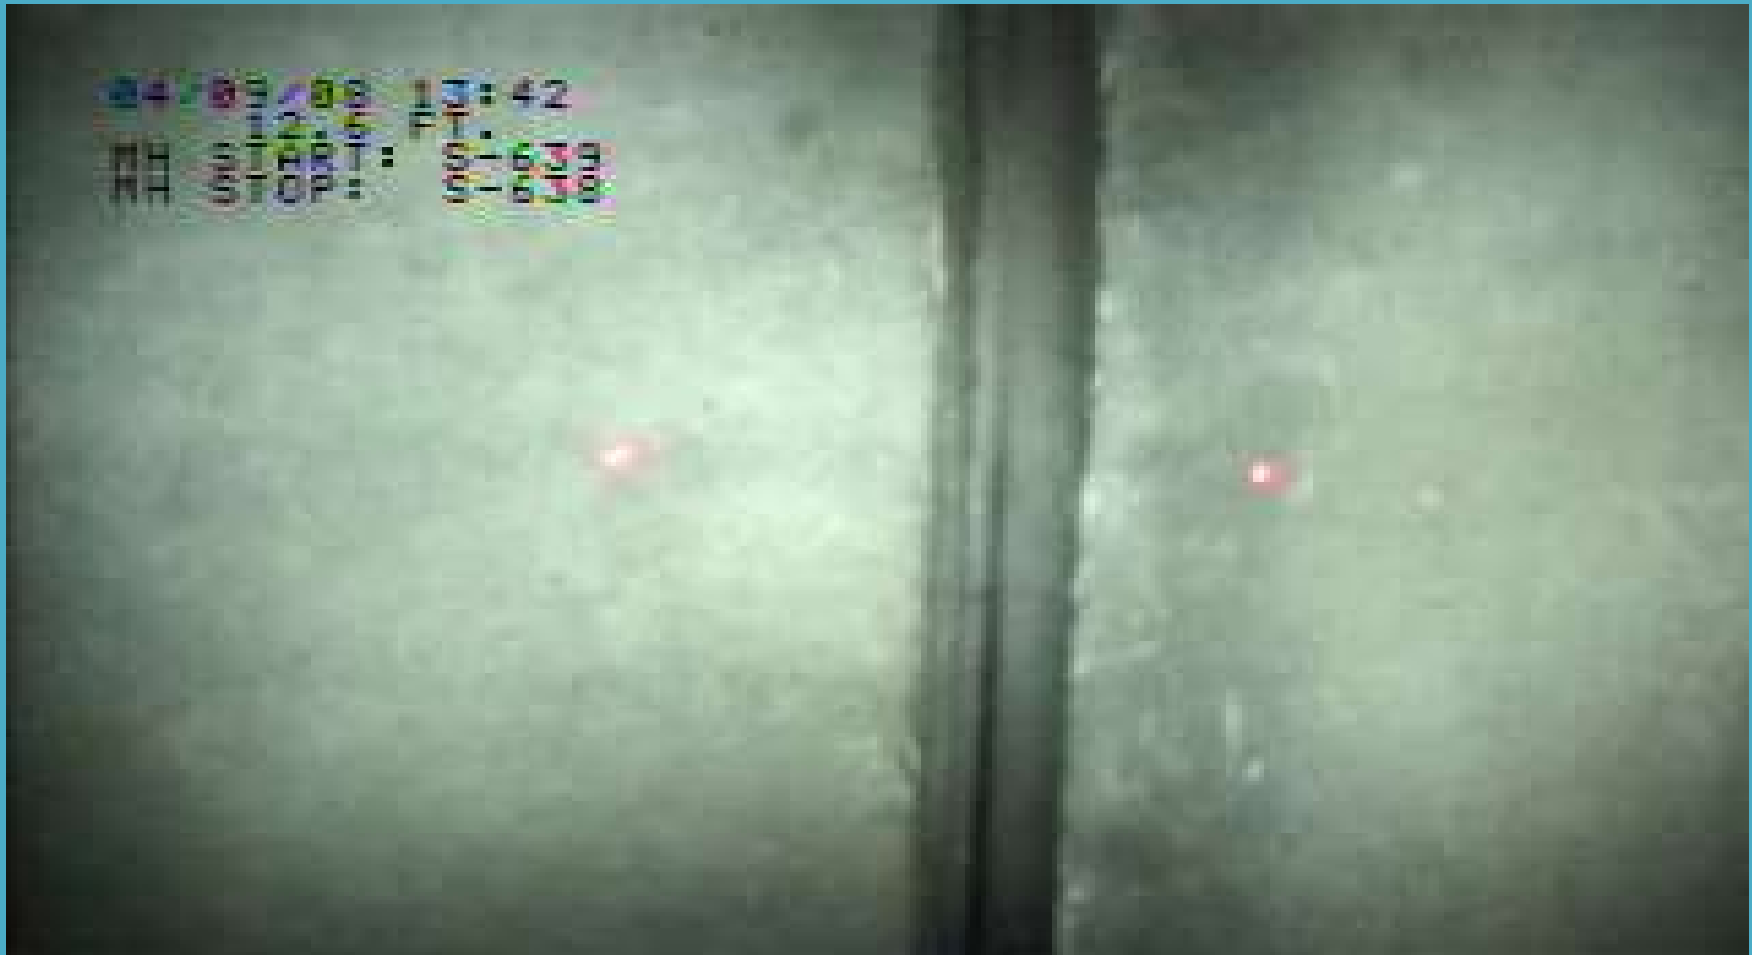
# CAMERA SPEED

- Move the camera through the pipe at a speed no greater than 30 feet per minute.

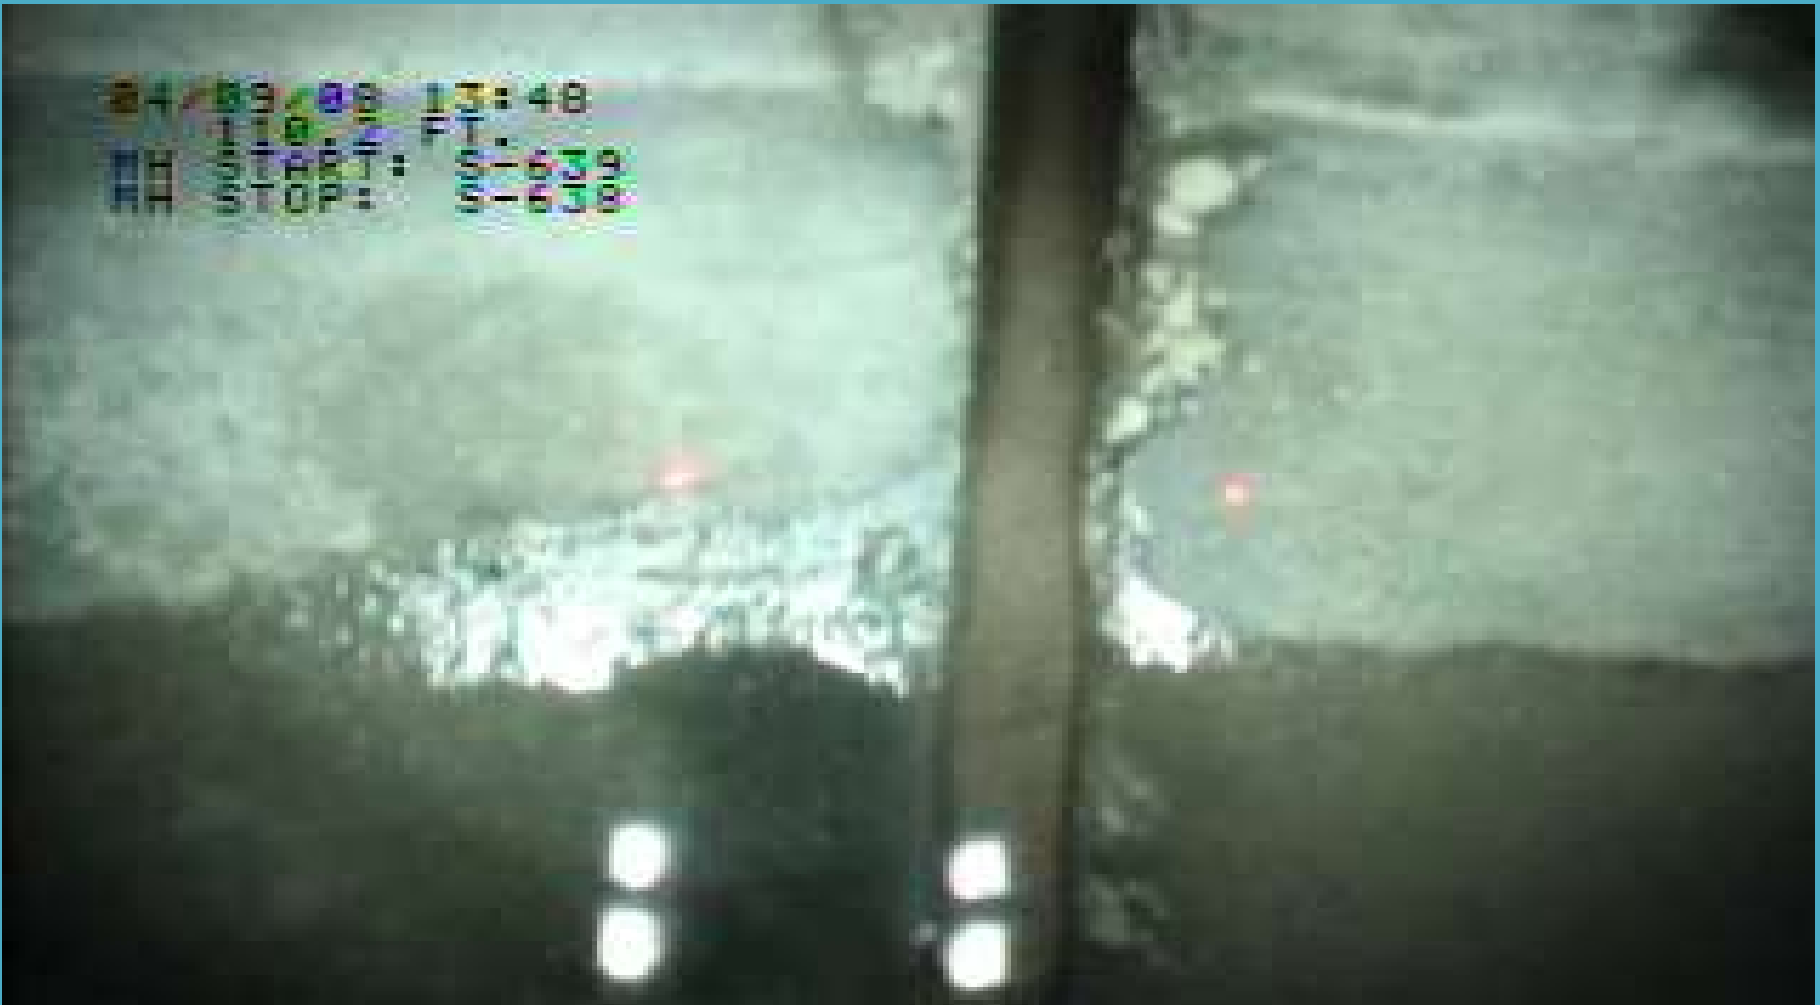
# DOCUMENT DEFECTS

- Stop the camera and pan when necessary to document defects.

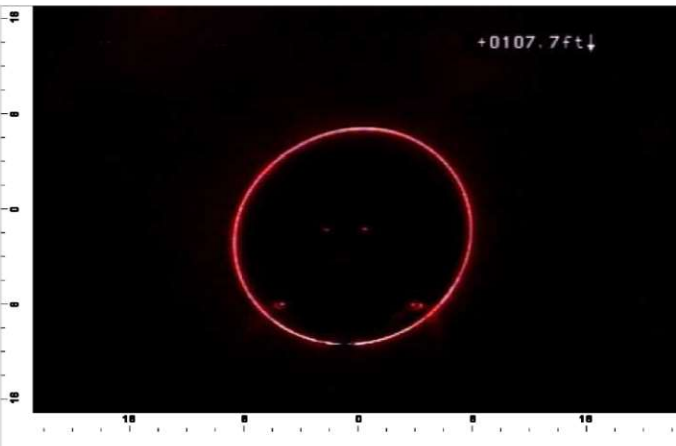
OVALITY = 5.4%

Date 1/5/2014  
Material PVC  
Pipeline Length 298.2 ft  
Internal Diameter (Expected) 17.6 in

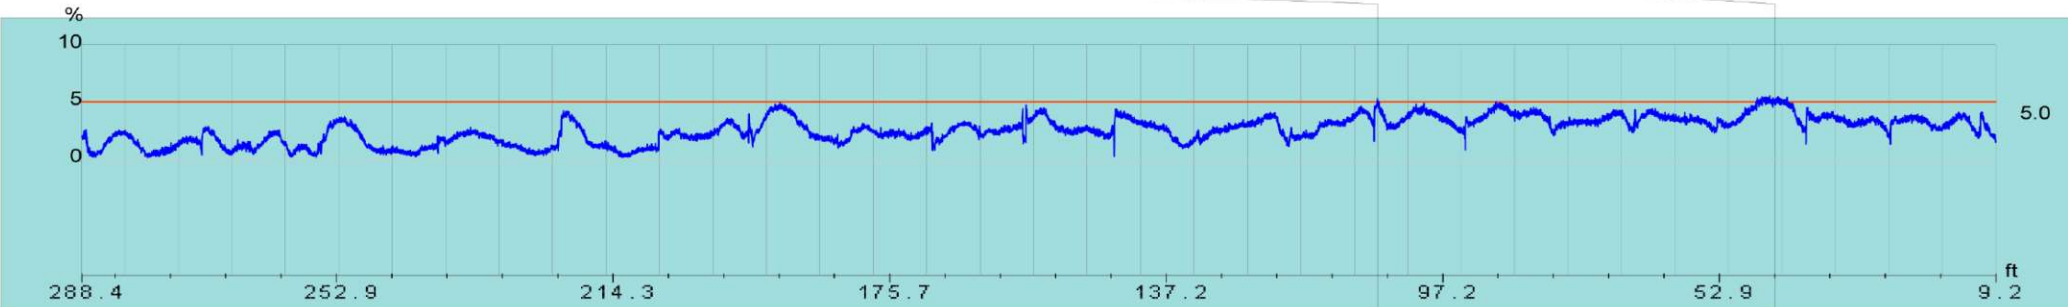
90% - Fractile: 4.0%

Ovality 'q' (as per ASTM F 1216 Standard Practice) as a percentage of original pipe versus distance

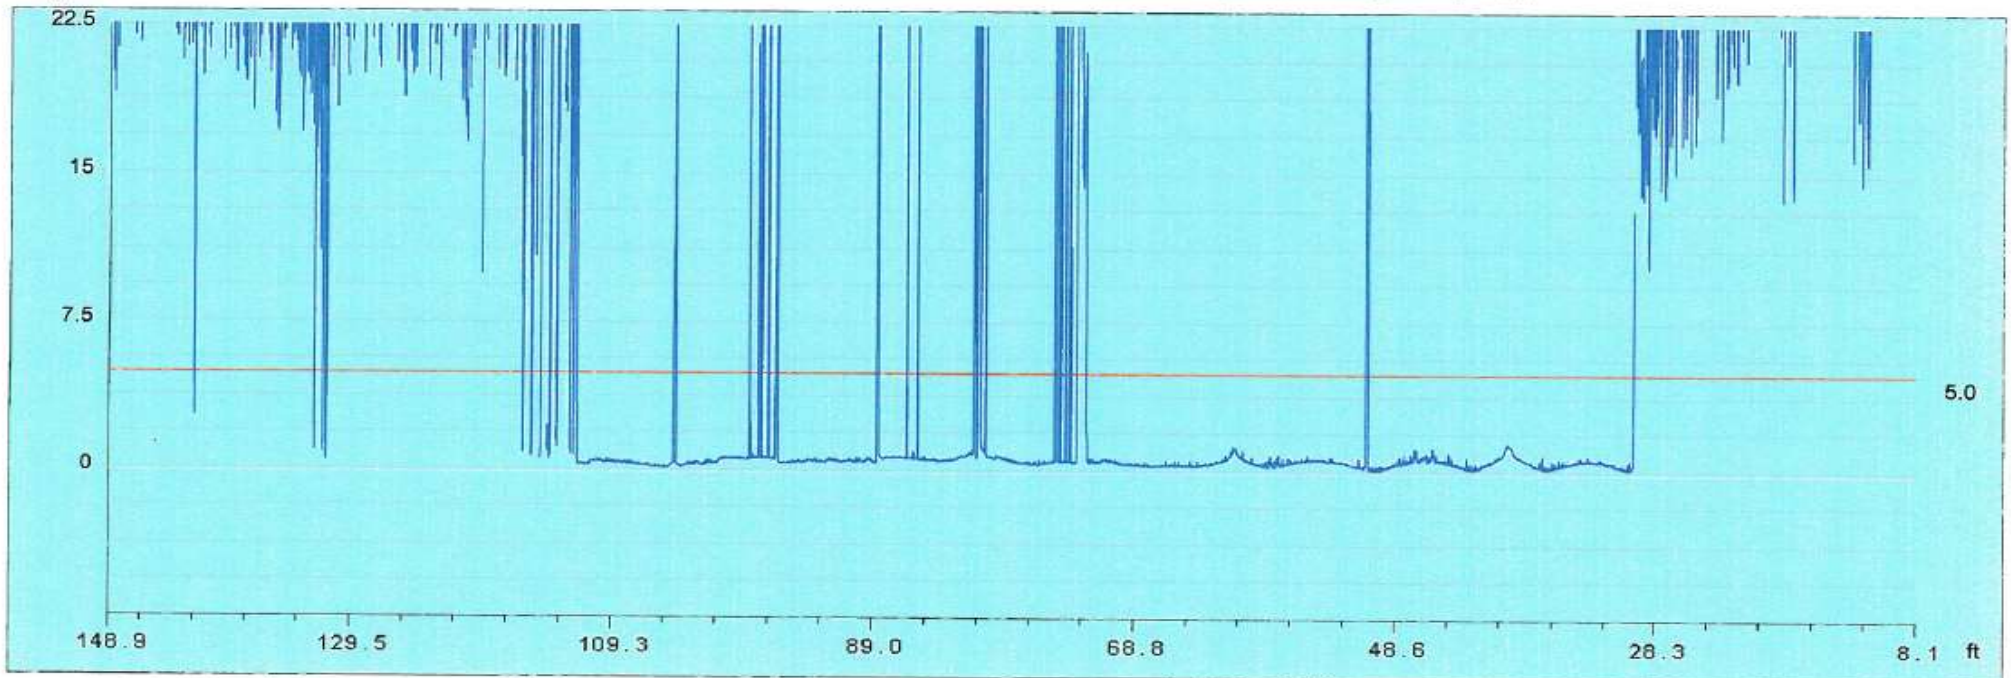
# BAD OVALITY REPORT

Date 8/28/2013  
Material  
Pipeline Length 164 ft  
Internal Diameter 36 in

Upper limit = 5  
Lower Limit = 5

% 90% - Fractile: 38.3%, Exceeded limits: 43.7%

Ovality 'q' (as per ASTM F 1216 Standard Practice) as a percentage of original pipe versus distance

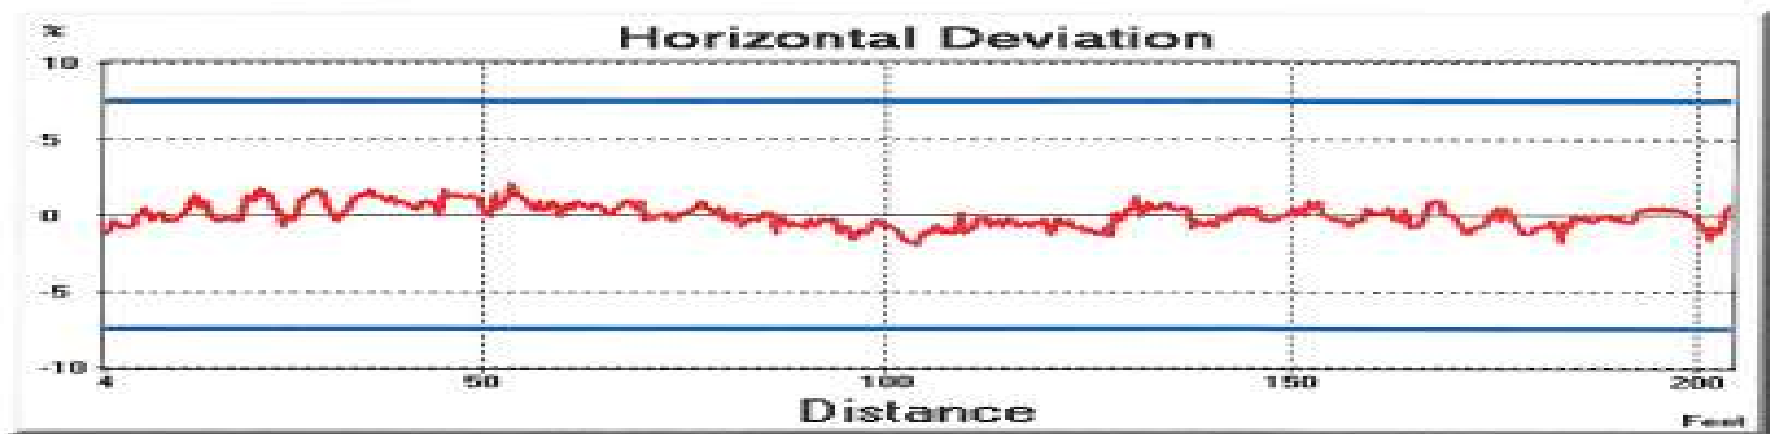
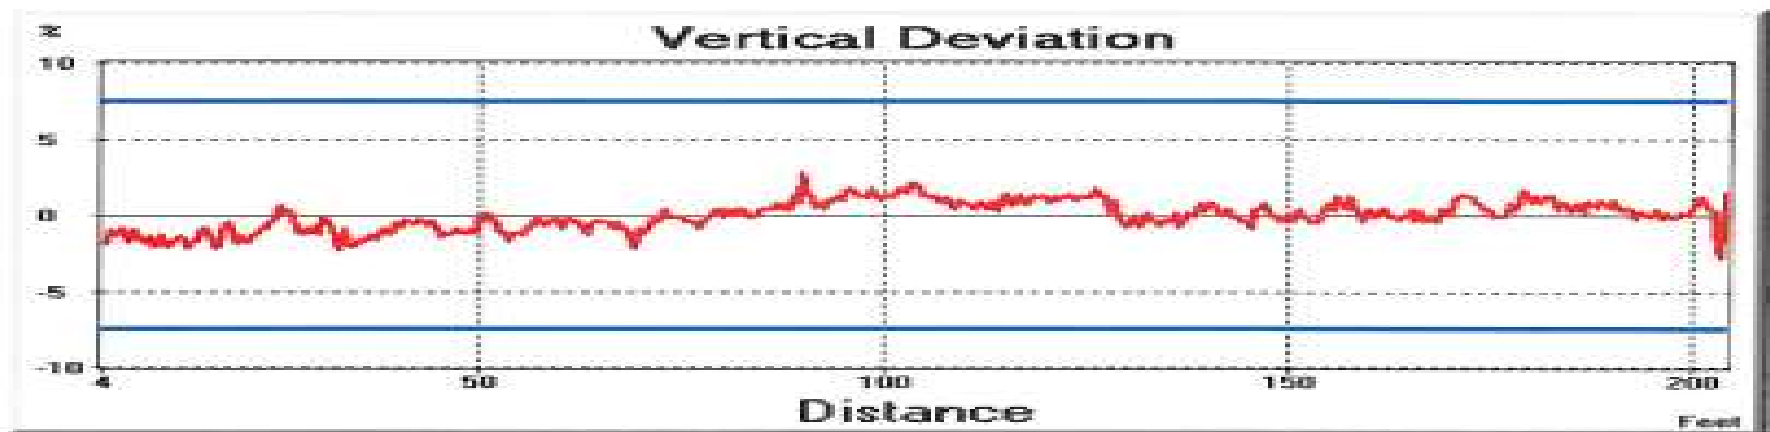
# OVALITY REPORT

Date: 4/22/2009 9:23:00 AM  
Location: Leon County  
Length Surveyed: 205.5  
Run Number:  
Pipe Size: 18"

Asset ID:  
Upstream MH Number: S330Demo  
Downstream MH Number: S331Demo  
Direction Of Survey: Upstream  
Pipe Material: Polyvinyl Chloride

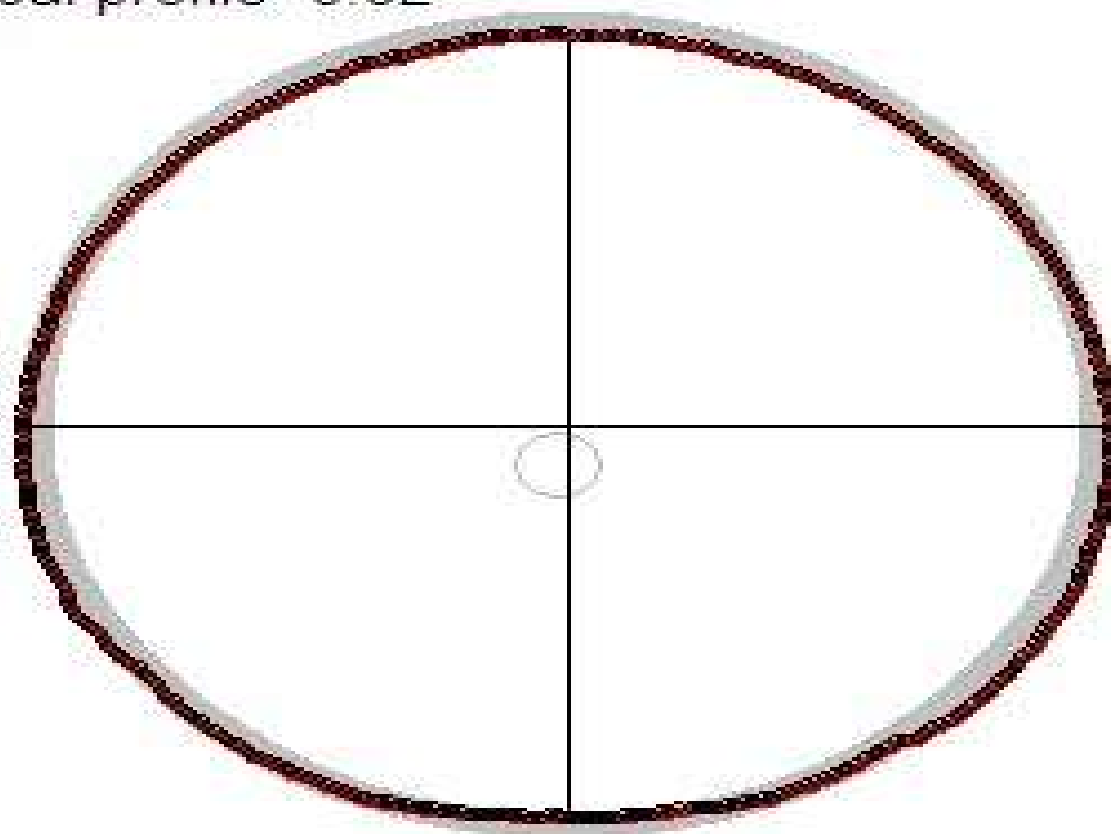
# REPRESENTATIVE DIAMETER OF THE PIPE

Horizontal profile 0.01"  
Vertical profile -0.02"

nom. dia 18

meas. dia 18.00
