# PIPE INSPECTION AND REPAIR

**2023 CONSTRUCTION ACADEMY**  
**Jason Russell, FDOT**

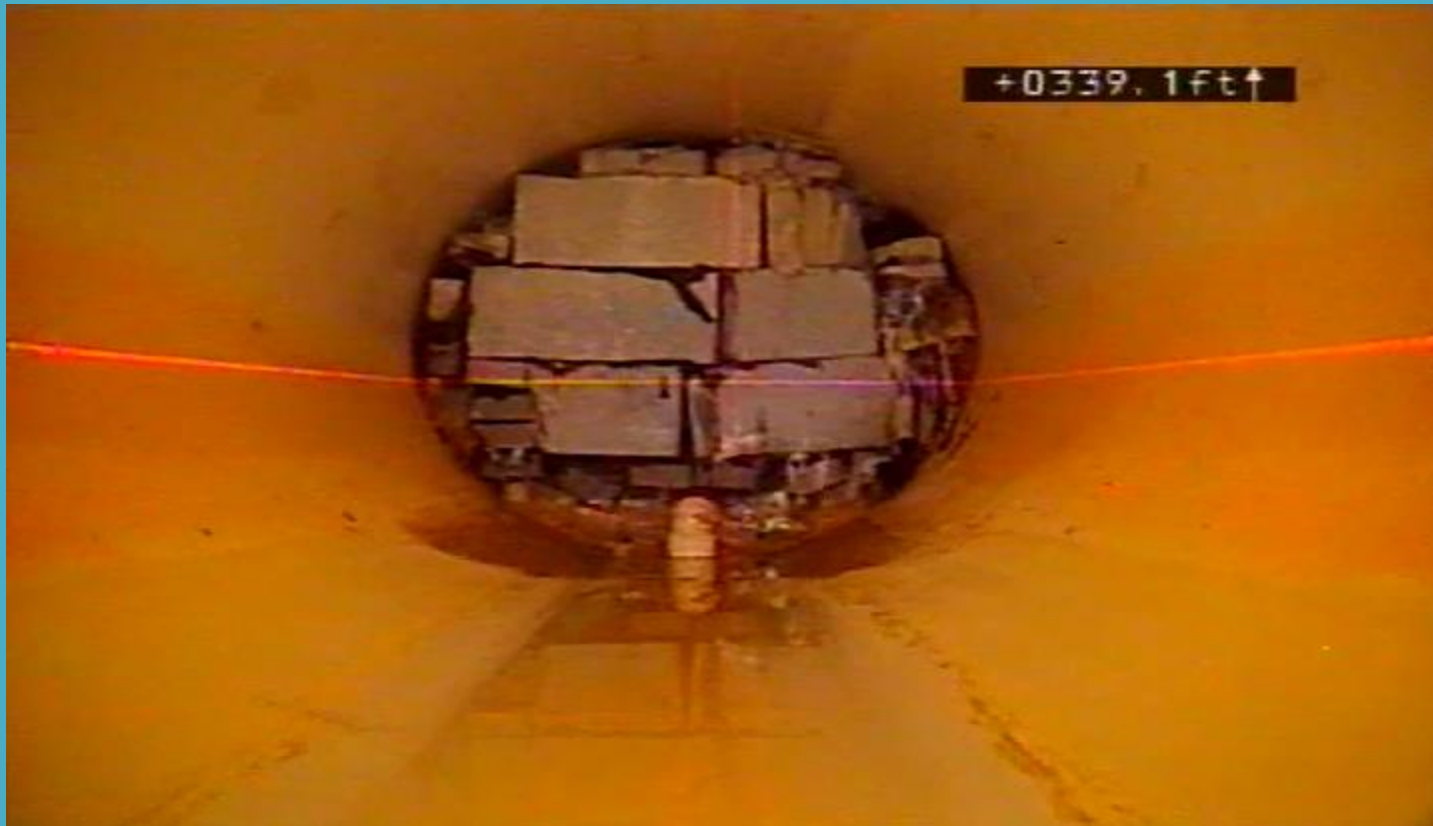
- Prior to inspection, dewater the pipe and remove all silt, debris, and obstructions.

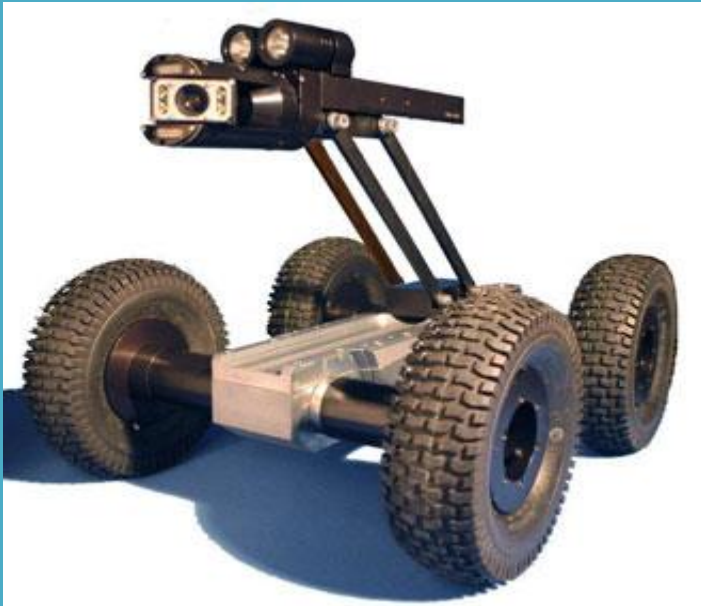
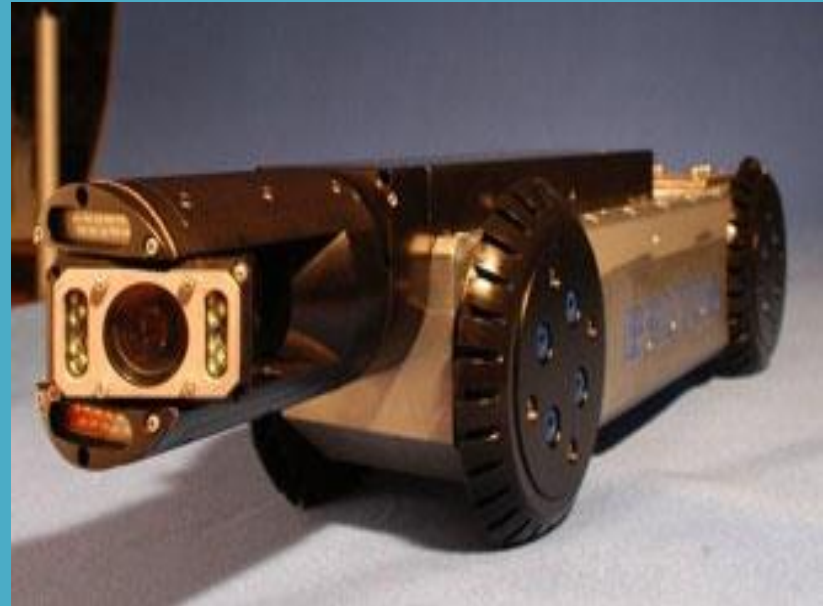
# CRAWLER

- These machines come with several different wheel sets or tracks that must be changed out to accommodate the size and type of pipe being inspected.

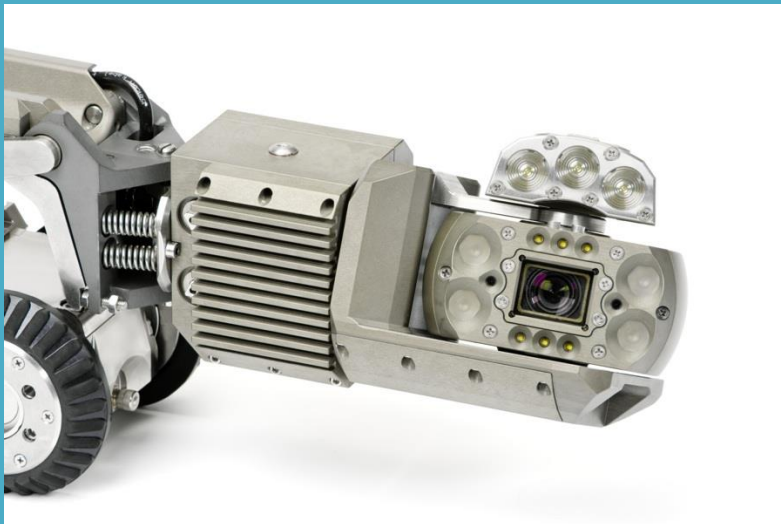
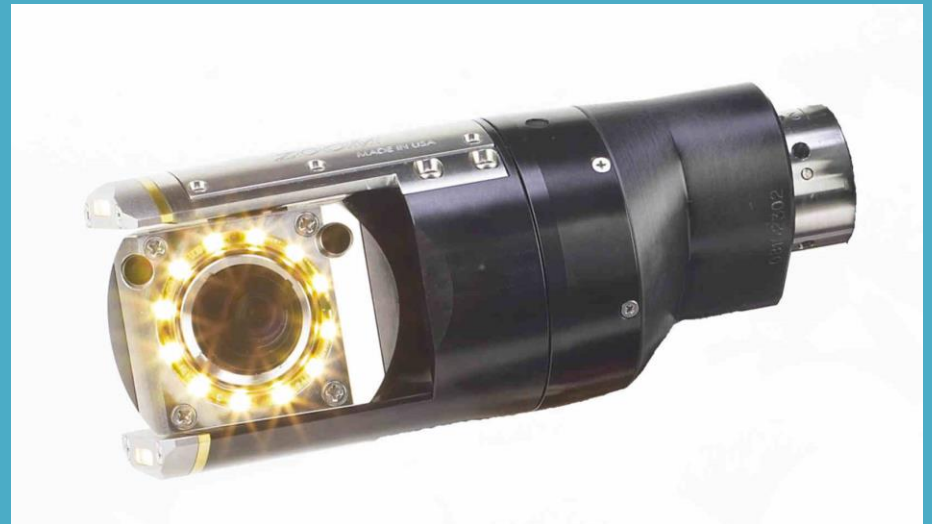
# CCTV

- The Closed Circuit Television (CCTV) camera records all the images for the pipe inspections. This is the equipment that pans and tilts around the inside of a pipe for observations and measurements.

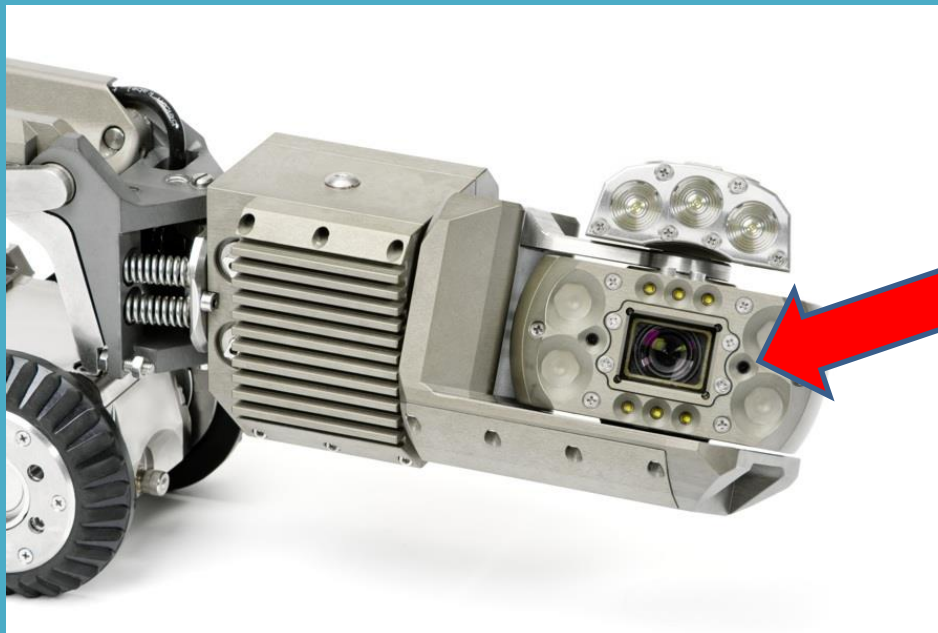
**DIODES**

- The rotating head profiler has two laser diodes built into the CCTV camera head. The diodes take continual measurements while the camera head rotates 360° at a set speed while the crawler is pulled back through the pipe.

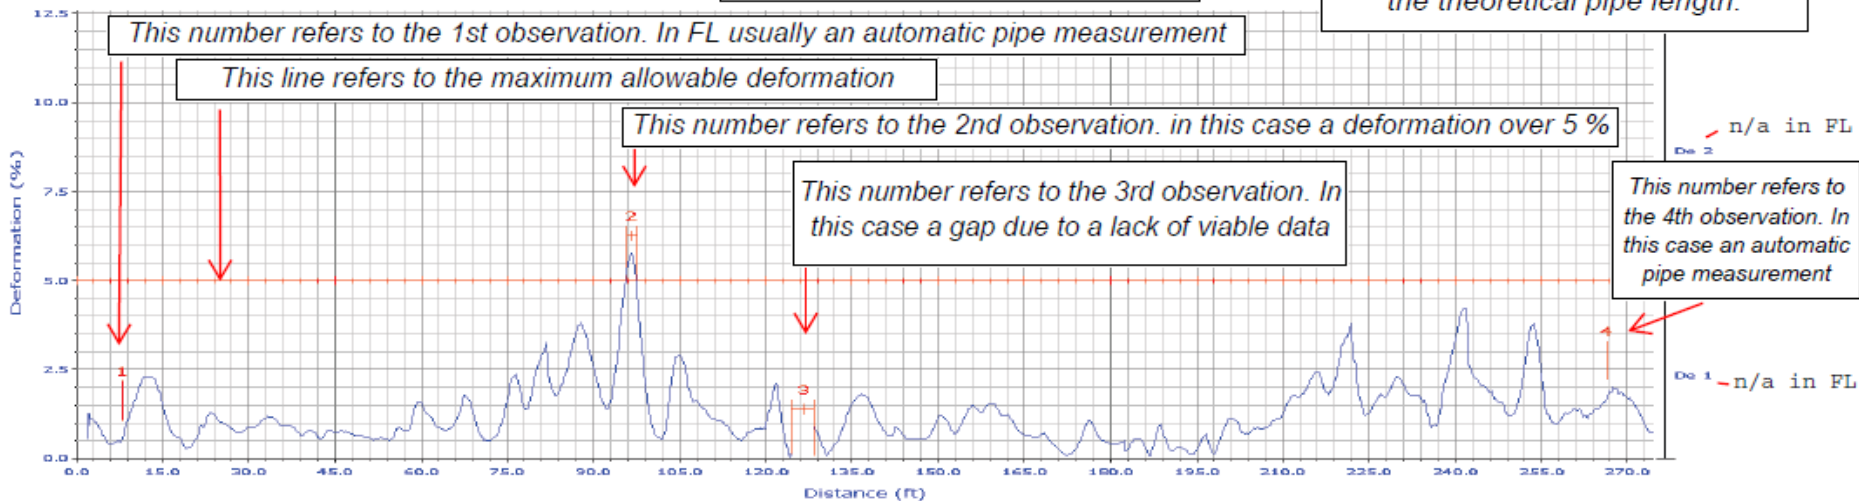
Pipe section information				
Inspection Date	Street name	Upstream Manhole	Inspection Direction	Downstream Manhole
July 31, 2008	123	S71	<<<	S-66
Network Type	Material	Nominal Diameter(in)	Inspected/Theoretical Length(ft)	
Surface water	PVC	18	272.3 / 273.4

1st number refers to the length processes. 2nd number refers to the theoretical pipe length.

This graph is always displayed from the start of the inspection to the end of the inspection

**Note, observations are numbered on this graph and an explanation of what the observations are is given on the following table.**

These Observation IDs refer to the observation numbers on the previous graph and provide an explanation as to what the observation is and its location in the pipeline.

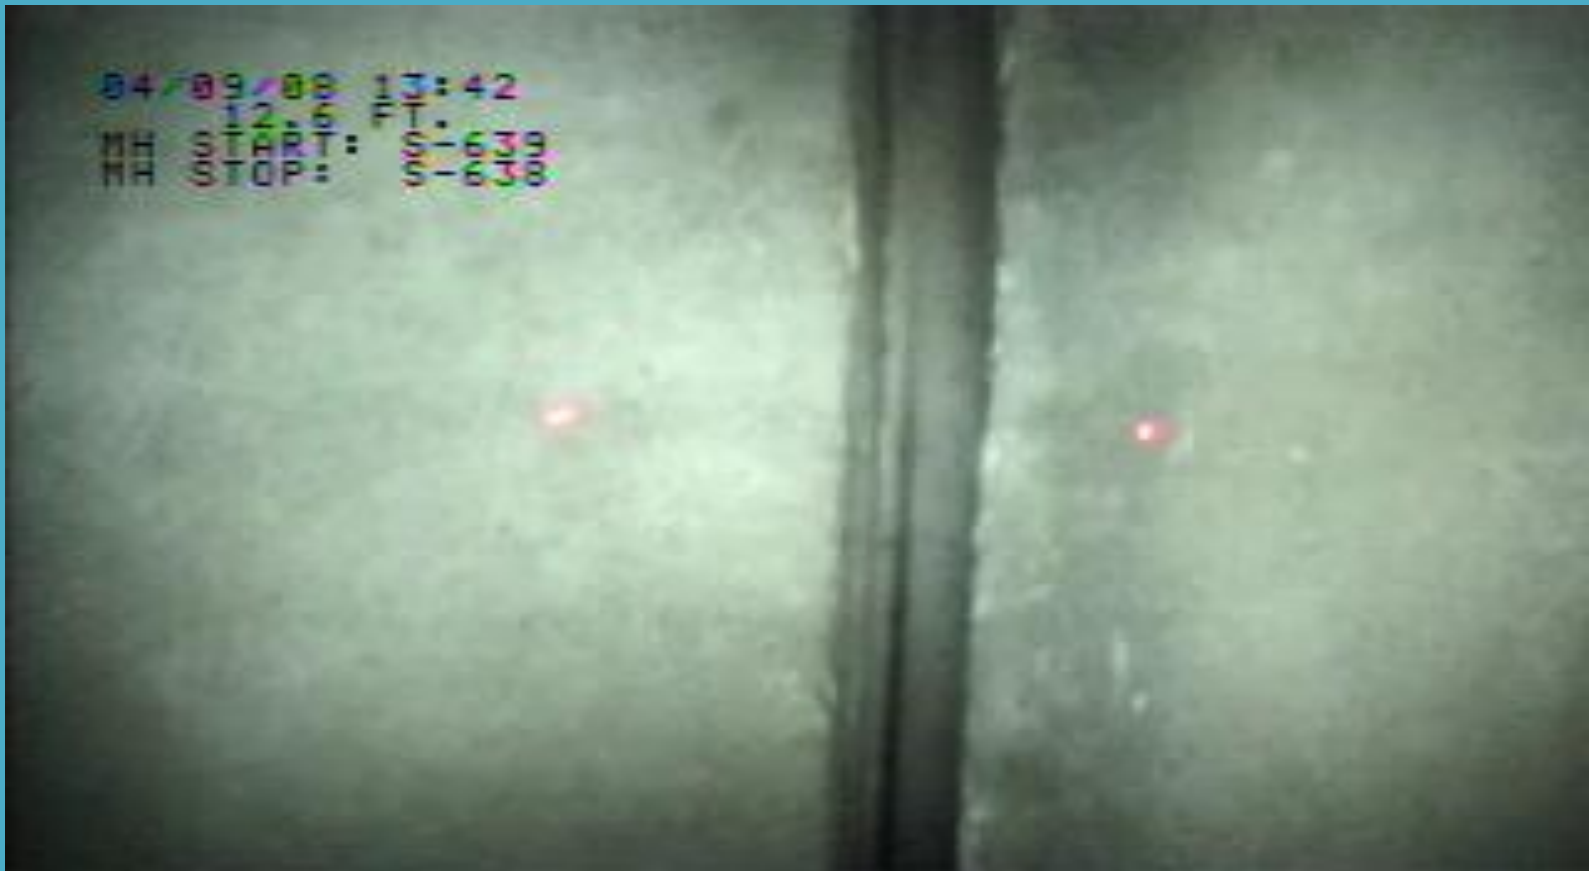
# CAMERA SPEED

- Move the camera through the pipe at a speed no greater than 30 feet per minute.

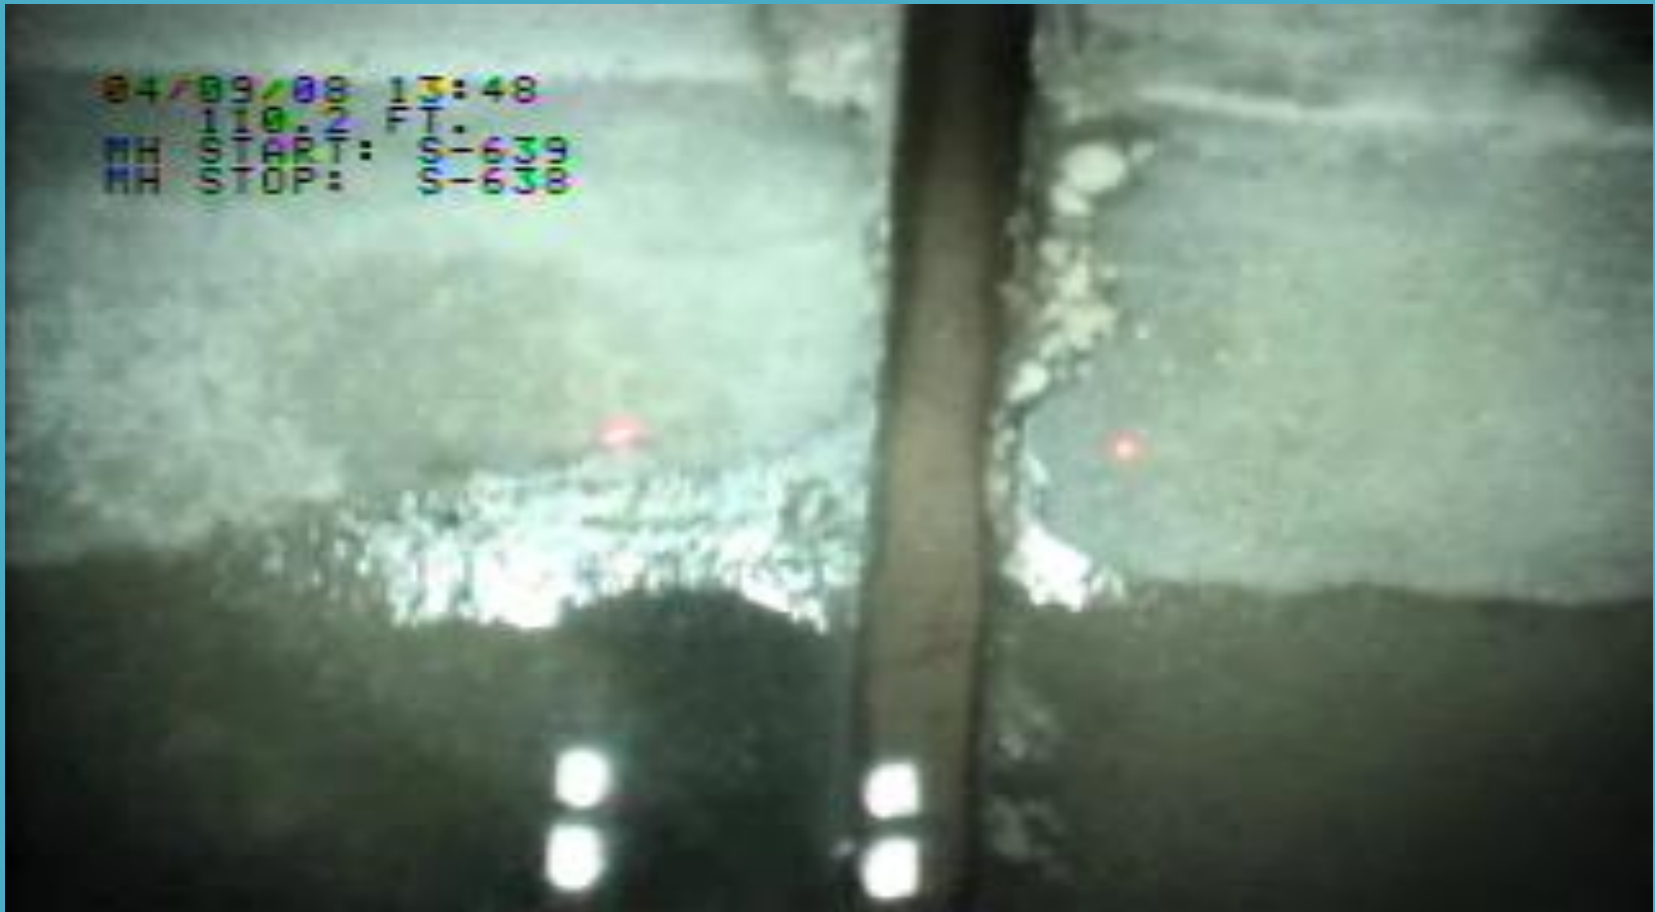
# DOCUMENT DEFECTS

- Stop the camera and pan when necessary to document defects.

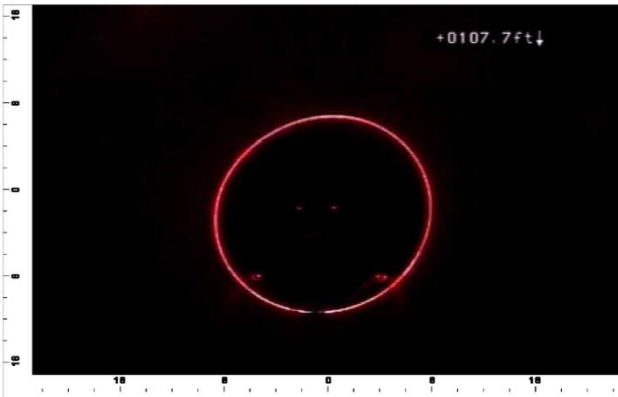
OVALITY = 5.4%

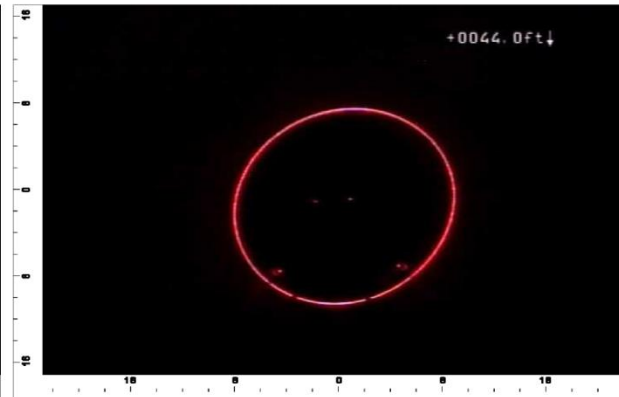
OVALITY = 5.1%

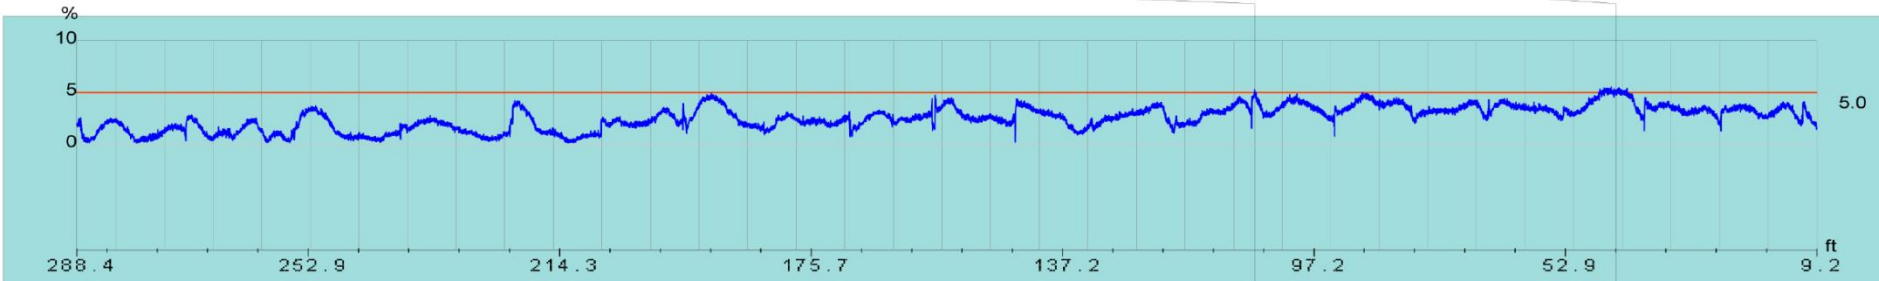
90% - Fractile: 4.0%

Ovality 'q' (as per ASTM F 1216 Standard Practice) as a percentage of original pipe versus distance

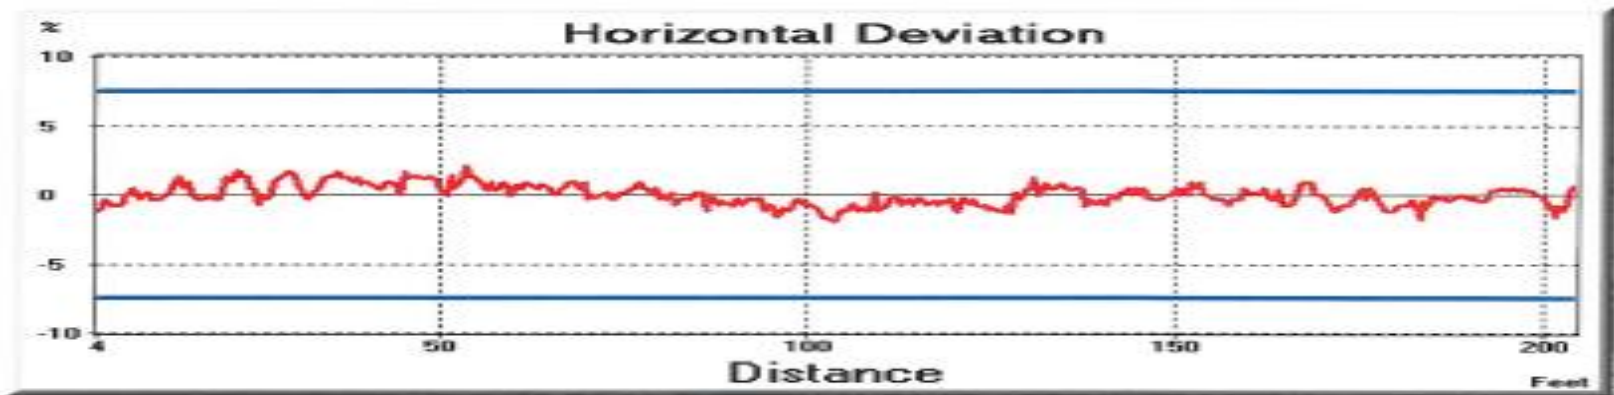
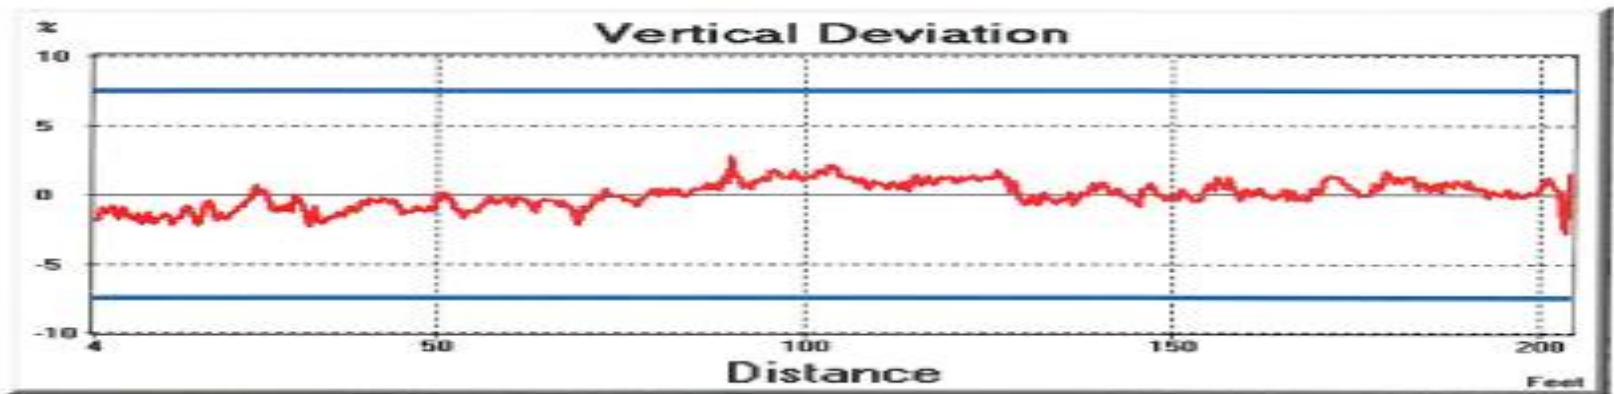
Date: 4/22/2009 9:23:00 AM  
Location: Leon County  
Length Surveyed: 205.5  
Run Number:  
Pipe Size: 18"

Asset ID:  
Upstream MH Number: S330Demo  
Downstream MH Number: S331Demo  
Direction Of Survey: Upstream  
Pipe Material: Polyvinyl Chloride

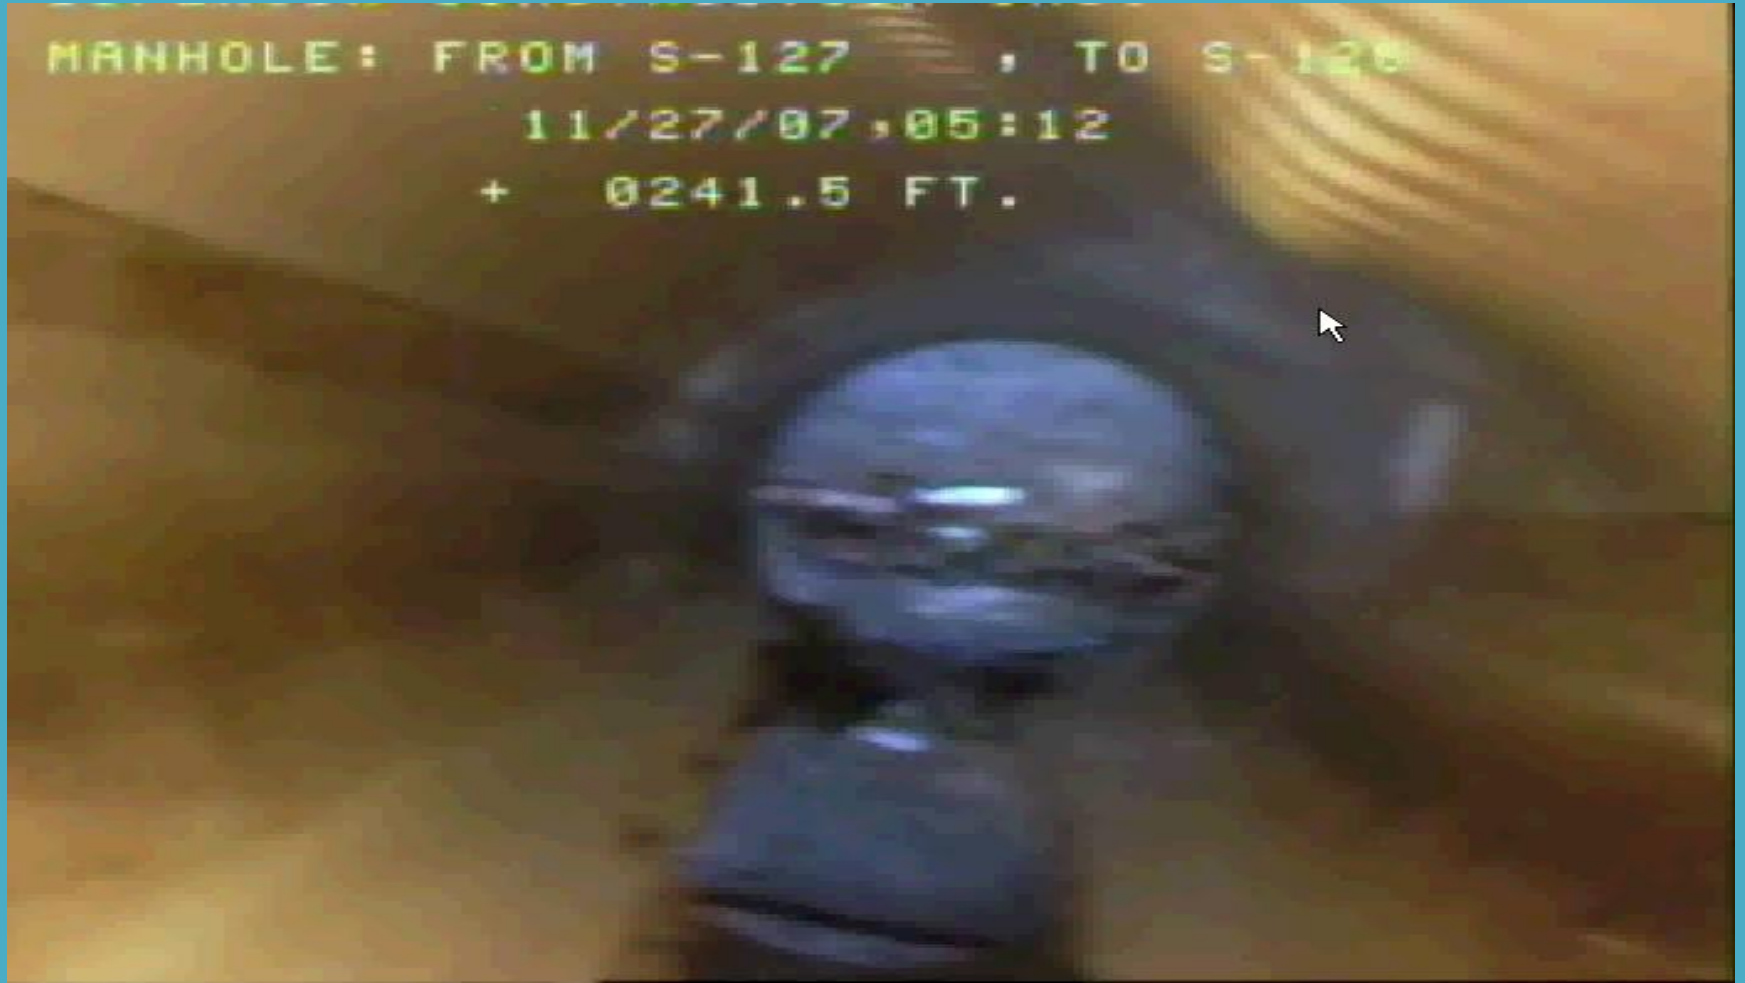
MANHOLE: FROM S-127 , TO S-128  
11/27/07, 05:12  
+ 0241.5 FT.

- All flexible pipe types must meet the Department's deflection criteria in Section 430.
- Pipe deflected 5% or more of the certified actual mean diameter of the pipe at final inspection shall be replaced at no cost to the Department.
