# PIPE INSPECTION AND REPAIR

**2025 CONSTRUCTION ACADEMY**  
**Jason Russell, FDOT**

# PIPE INSPECTION

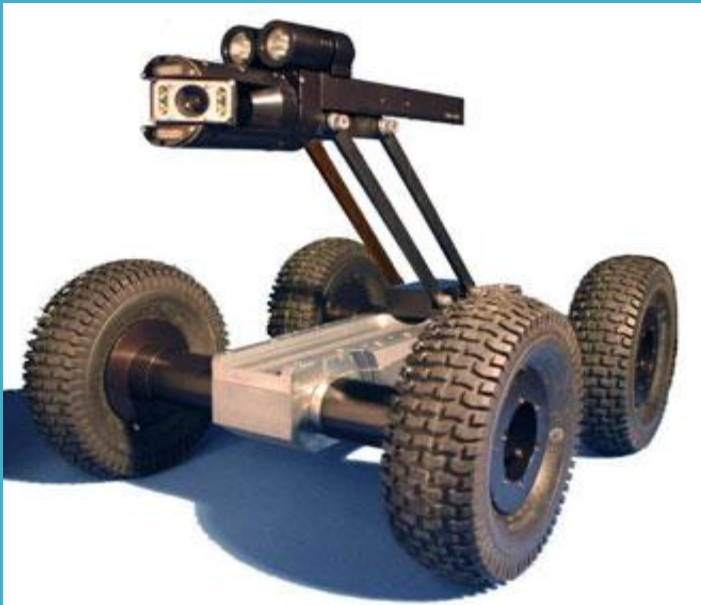
# CRAWLER

- These machines come with several different wheel sets or tracks that must be changed out to accommodate the size and type of pipe being inspected.

1. **Crawler** – moves the equipment through the pipeline.
2. **Closed Circuit TV camera** – records images and sends data back to a computer.
3. **Laser Profiler** – provides numerous measurements of a pipe's internal surface.
4. **Software** – interprets data and generates an inspection report.

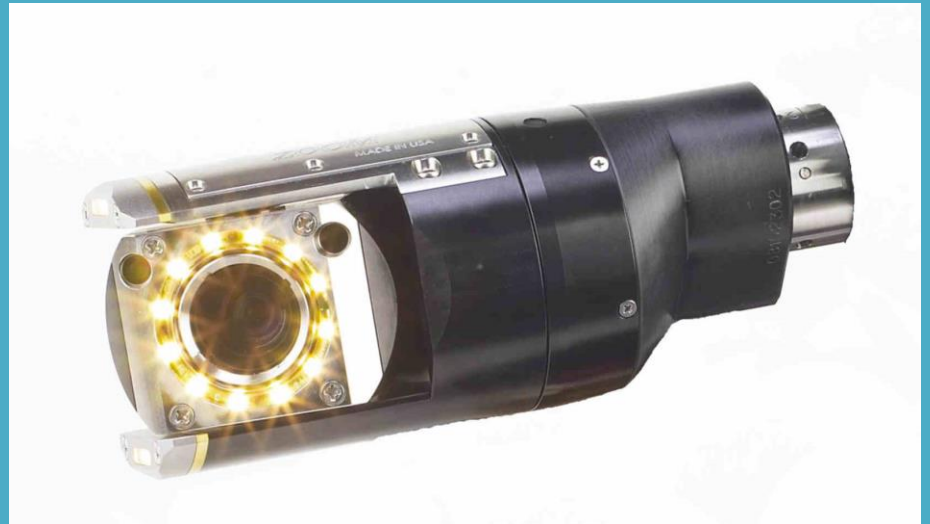
# CCTV

- The Closed Circuit Television (CCTV) camera records all the images for the pipe inspections. This is the equipment that pans and tilts around the inside of a pipe for observations and measurements.

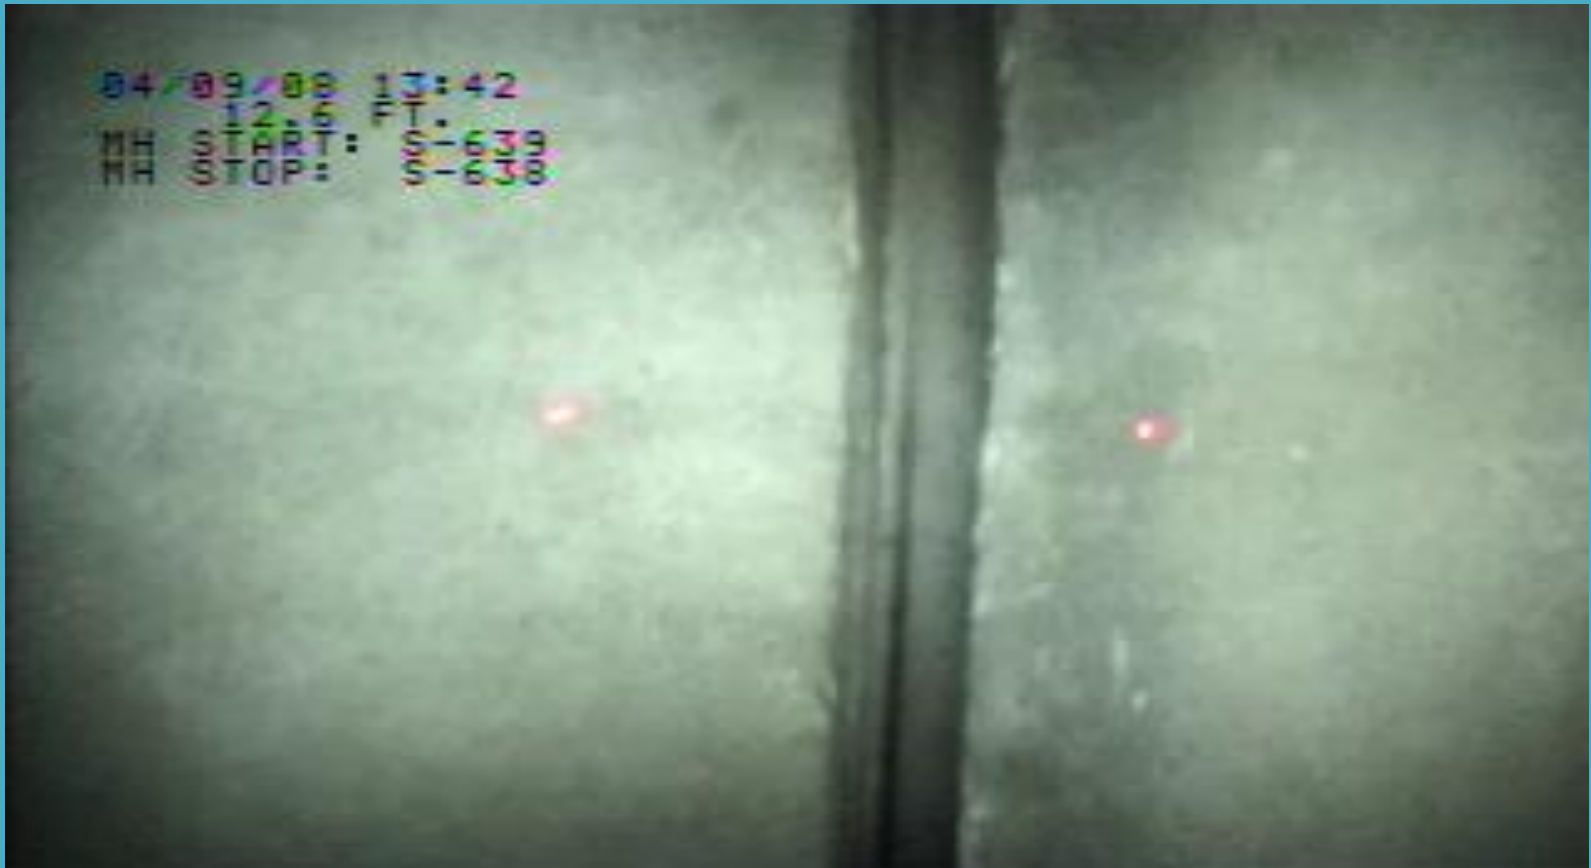
# CAMERA SPEED

- Move the camera through the pipe at a speed no greater than 30 feet per minute.

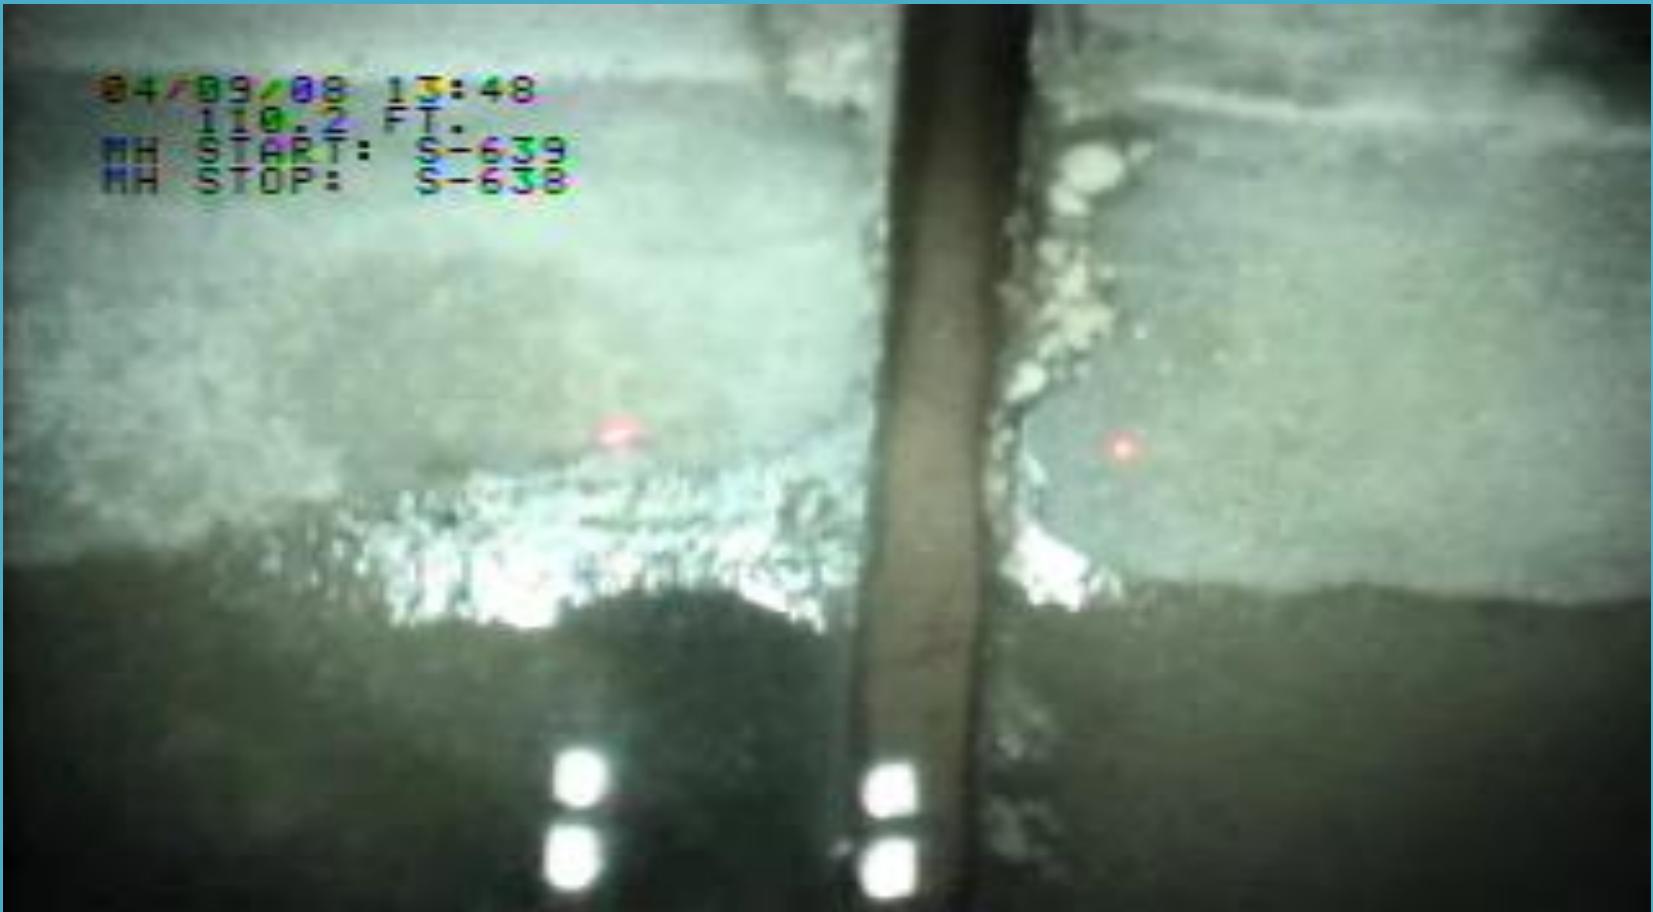
# DOCUMENT DEFECTS

- Stop the camera and pan when necessary to document defects.

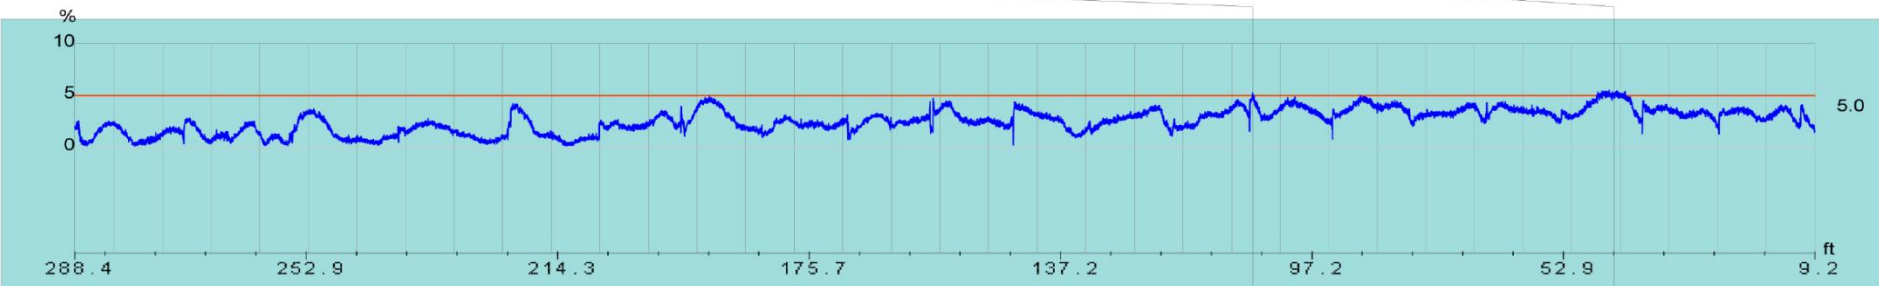
## Ovality Observations Report

Owner FDOT  
Project ID SR 93/I-75 408459-4-52-01  
Start No S-104  
Location

Contractor BETTER ROADS  
Finish No S-100  
Location

Date 1/5/2014  
Material PVC  
Pipeline Length 298.2 ft  
Internal Diameter (Expected) 17.6 in

90% - Fractile: 4.0%

Ovality 'q' (as per ASTM F 1216 Standard Practice) as a percentage of original pipe versus distance
