PIPE INSPECTION AND REPAIR

2026 CONSTRUCTION ACADEMY
Jason Russell, FDOT

PIPE INSPECTION

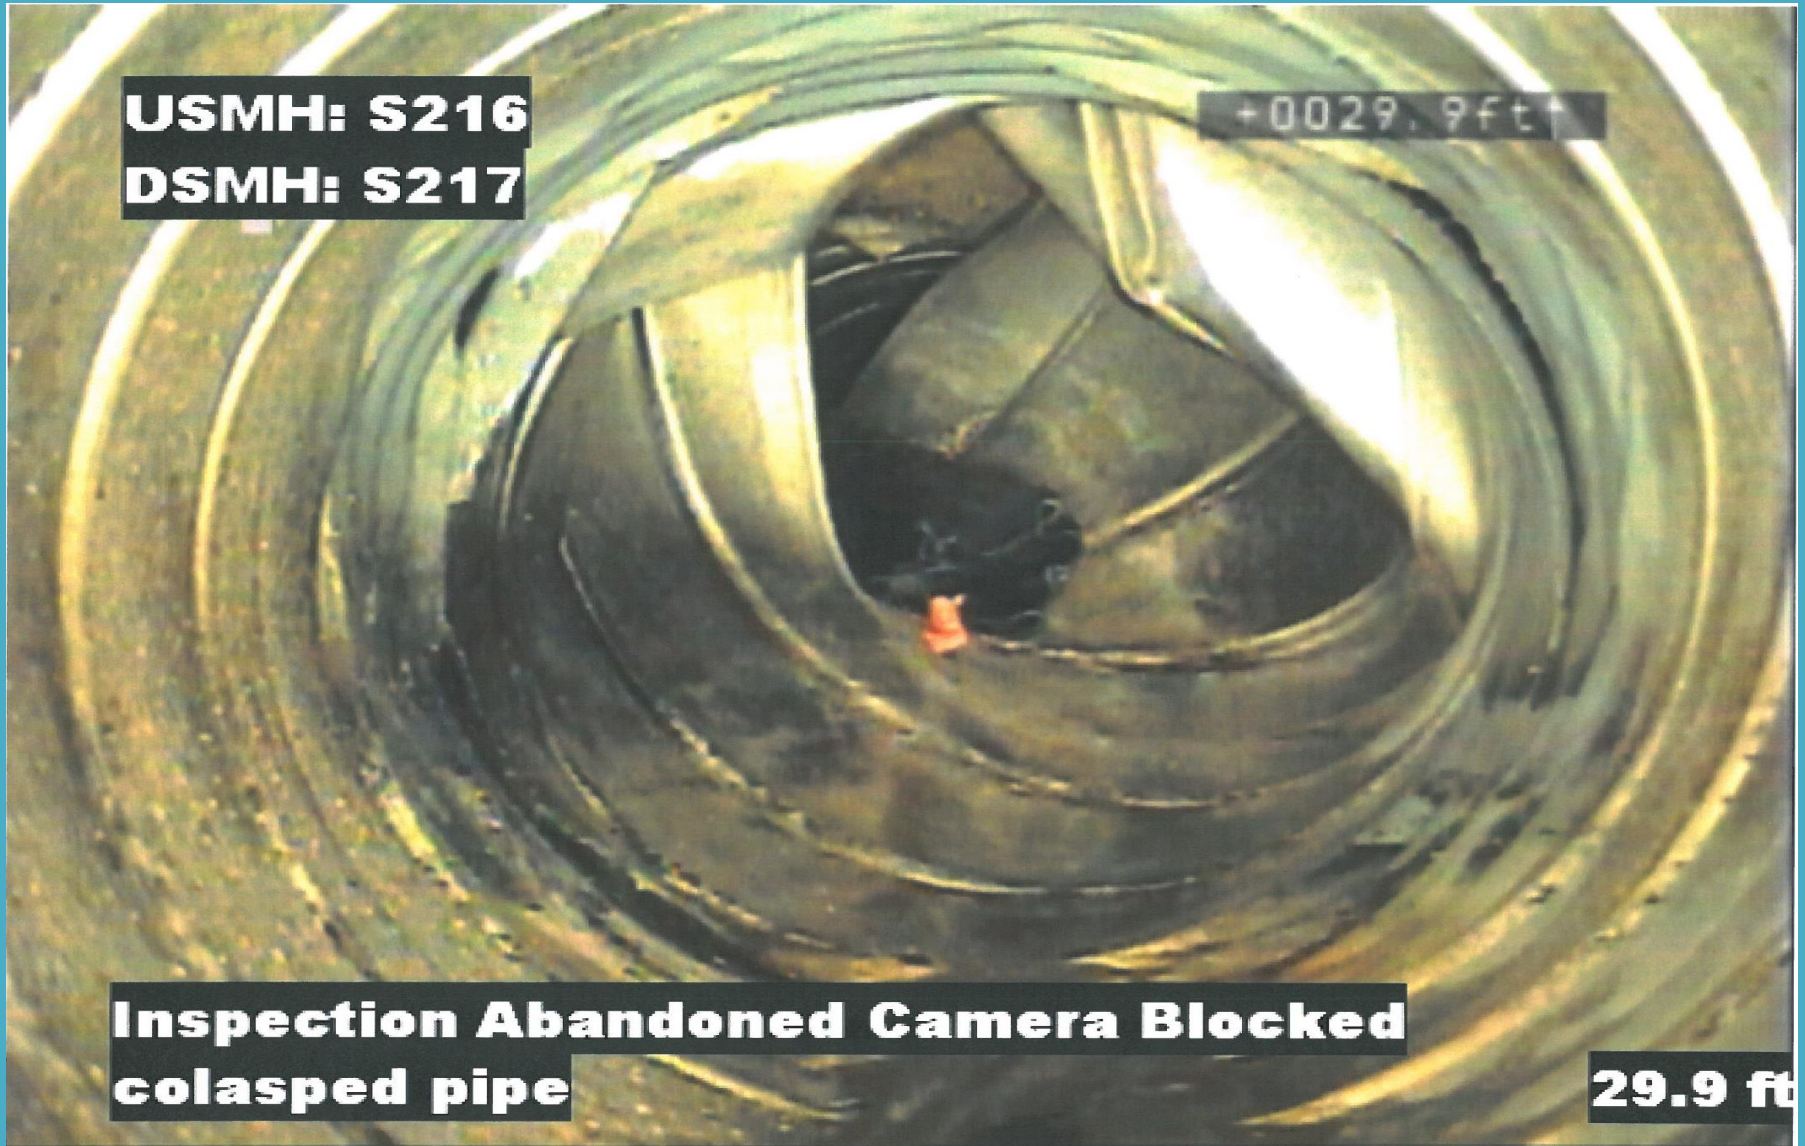
USMH: S216
DSMH: S217

**Inspection Abandoned Camera Blocked
colapsed pipe**

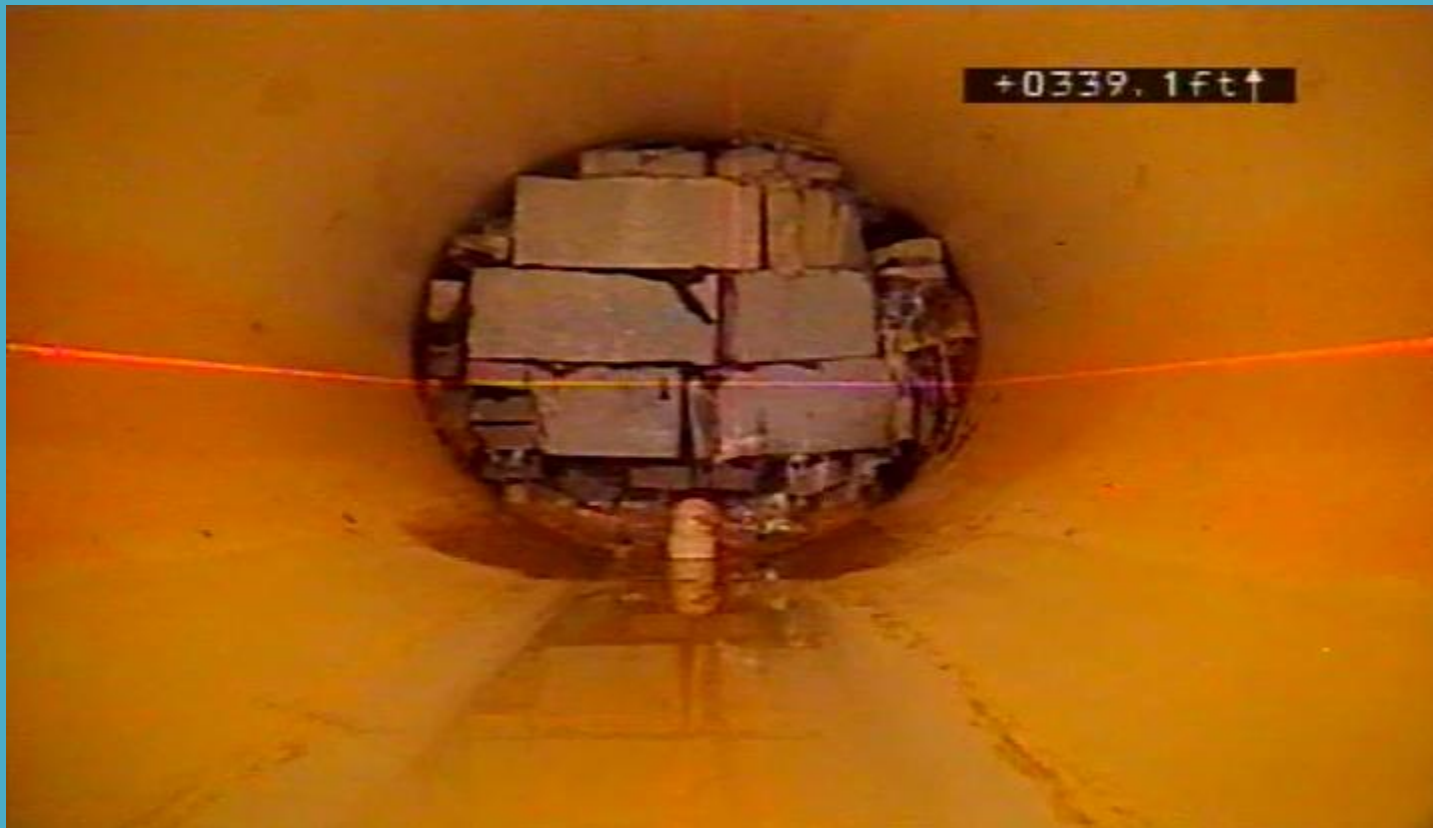
- Prior to inspection, dewater the pipe and remove all silt, debris, and obstructions.

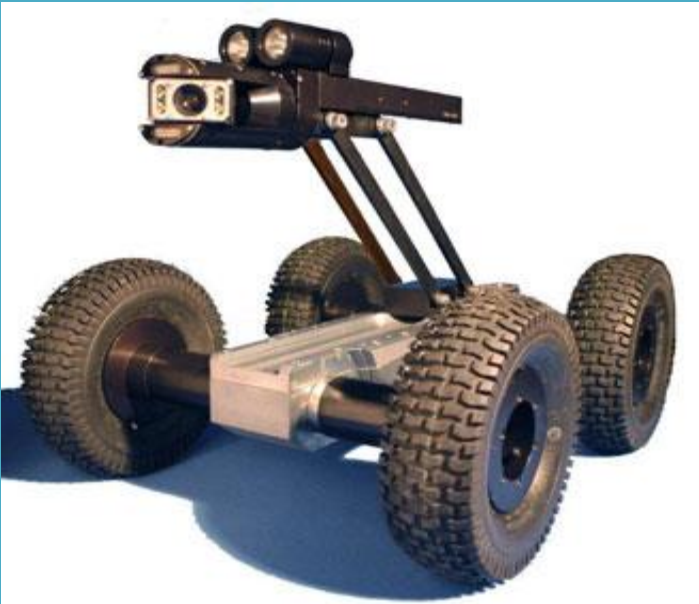
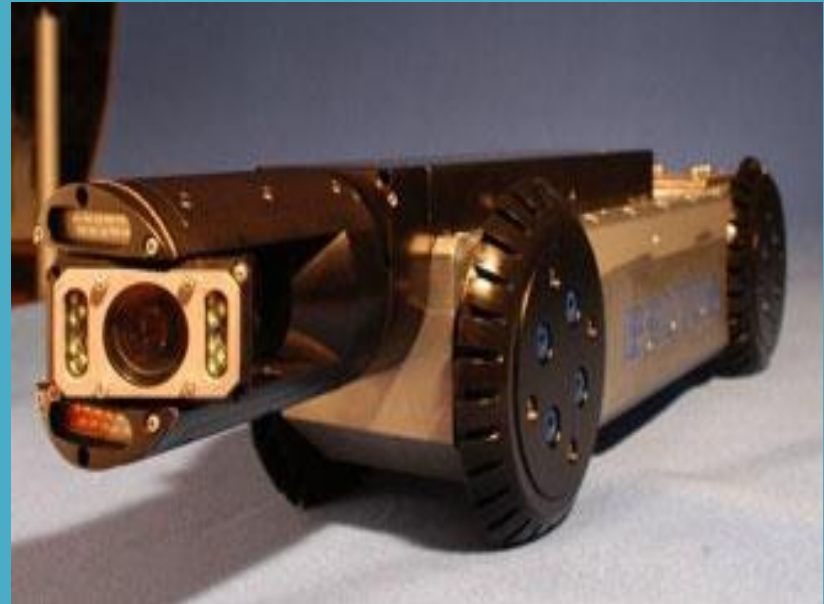
CRAWLER

- These machines come with several different wheel sets or tracks that must be changed out to accommodate the size and type of pipe being inspected.

1. **Crawler** – moves the equipment through the pipeline.
2. **Closed Circuit TV camera** – records images and sends data back to a computer.
3. **Laser Profiler** – provides numerous measurements of a pipe's internal surface.
4. **Software** – interprets data and generates an inspection report.

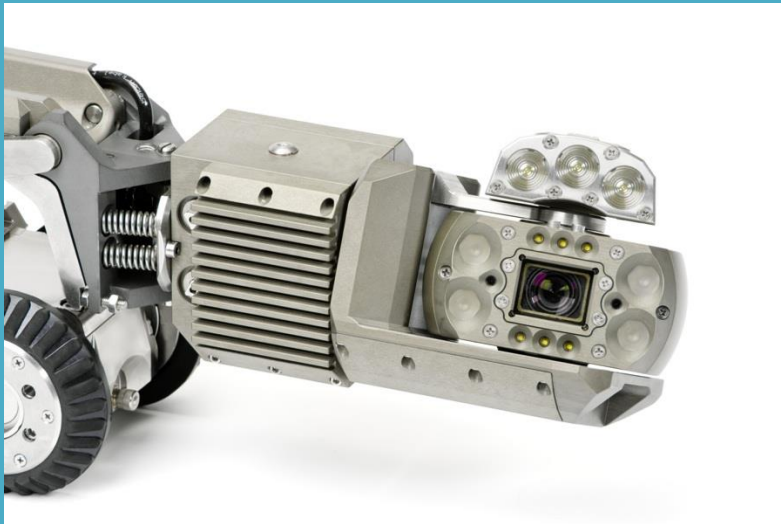
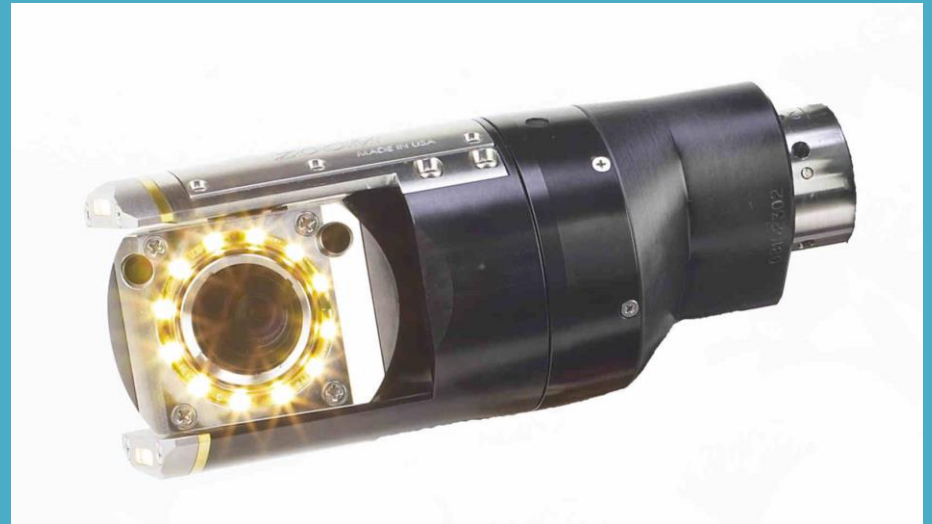
CCTV

- The Closed Circuit Television (CCTV) camera records all the images for the pipe inspections. This is the equipment that pans and tilts around the inside of a pipe for observations and measurements.

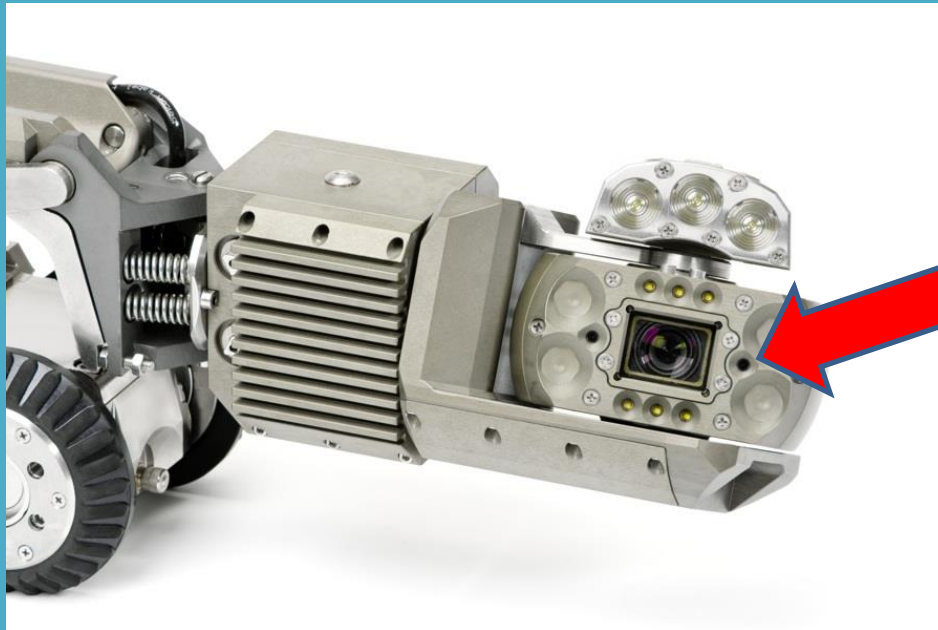
ROTATING PROFILER

- The rotating head profiler has two laser diodes built into the CCTV camera head. The diodes take continual measurements while the camera head rotates 360° at a set speed while the crawler is pulled back through the pipe.

DIODES

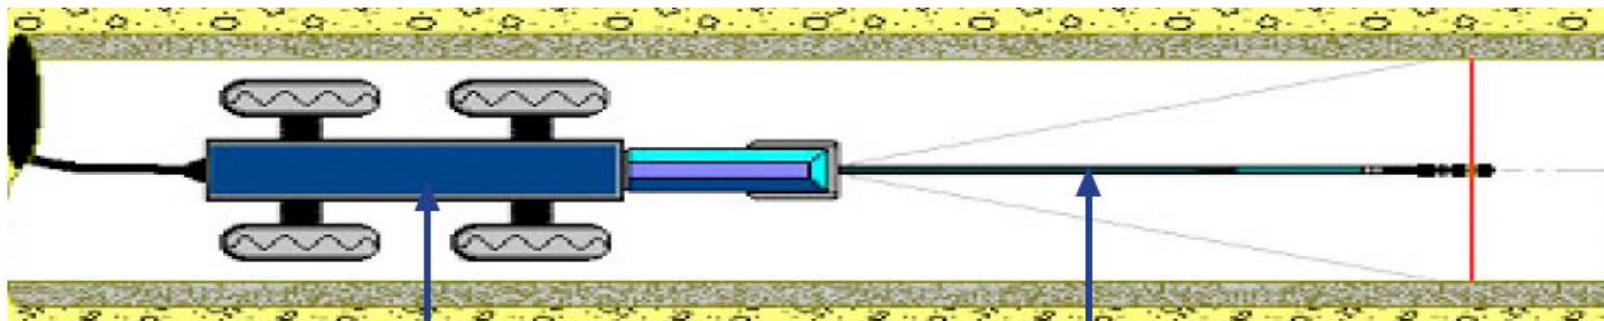
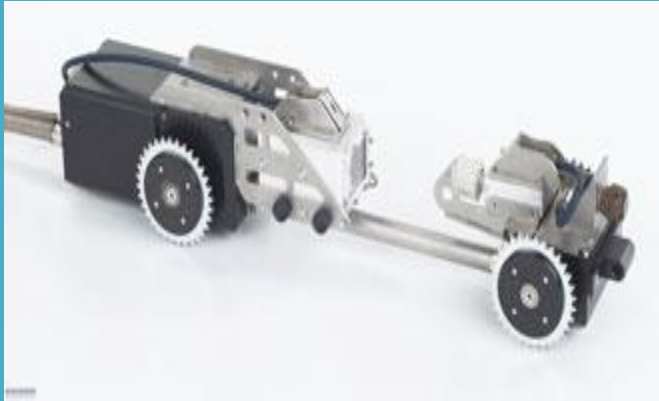
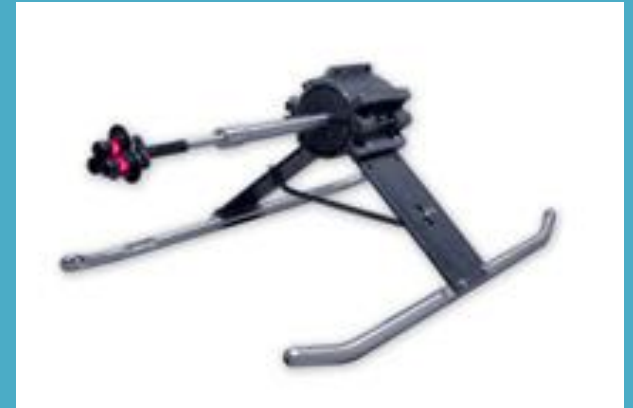
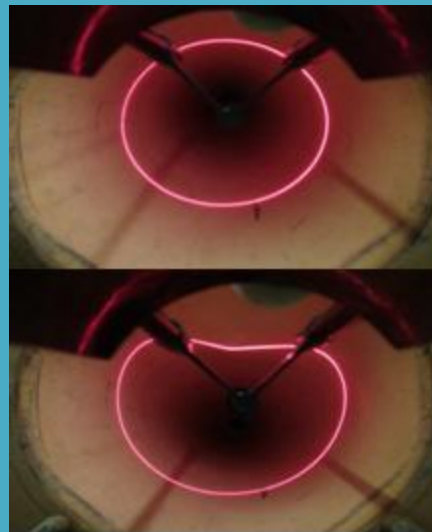
- The continuous ring profiler projects a visible laser beam onto the internal surface of the pipe. The beam is centered in the field of view of the CCTV camera and the camera records the image of the beam as it is pulled back through the pipe.

CCTV INSPECTION CAMERA

LASER PROFILER

CONTINUOUS RING PROFILER

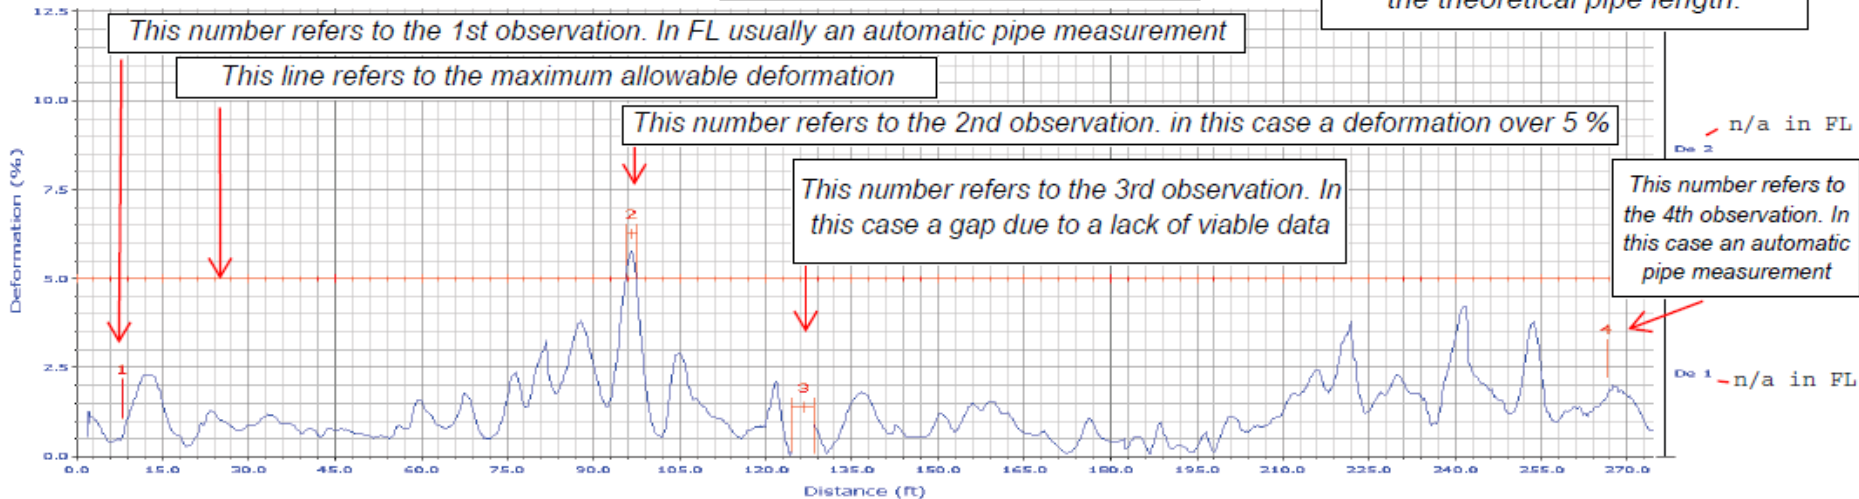
Pipe section information				
Inspection Date	Street name	Upstream Manhole	Inspection Direction	Downstream Manhole
July 31, 2008	123	S71	<<<	S-66
Network Type	Material	Nominal Diameter(in)	Inspected/Theoretical Length(ft)	
Surface water	PVC	18	272.3 / 273.4

1st number refers to the length processes. 2nd number refers to the theoretical pipe length.

This graph is always displayed from the start of the inspection to the end of the inspection

Note, observations are numbered on this graph and an explanation of what the observations are is given on the following table.

These Observation IDs refer to the observation numbers on the previous graph and provide an explanation as to what the observation is and its location in the pipeline.

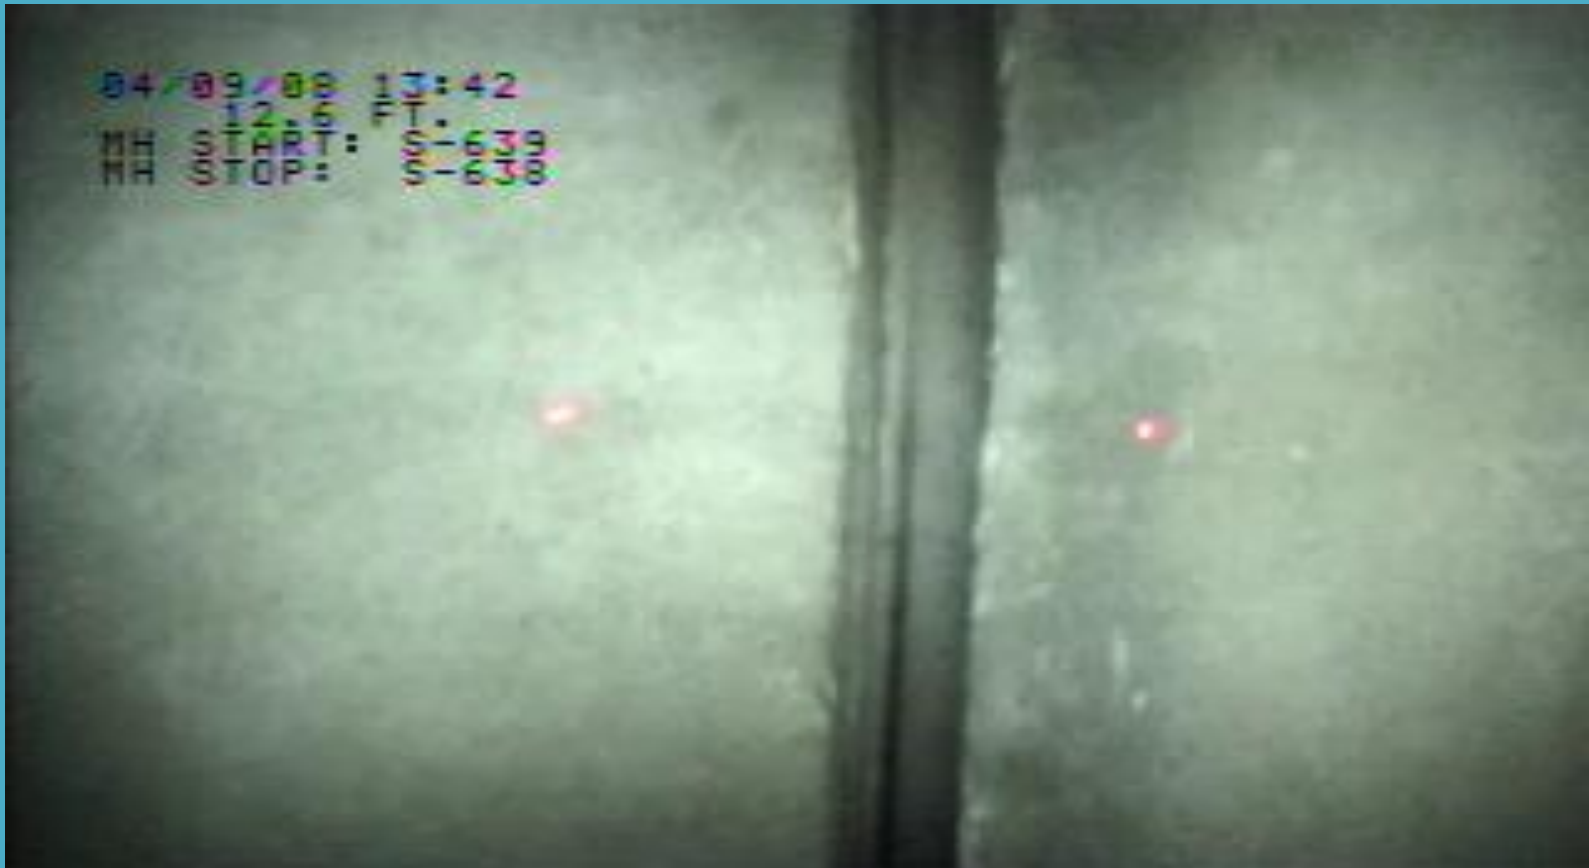
CAMERA SPEED

- Move the camera through the pipe at a speed no greater than 30 feet per minute.

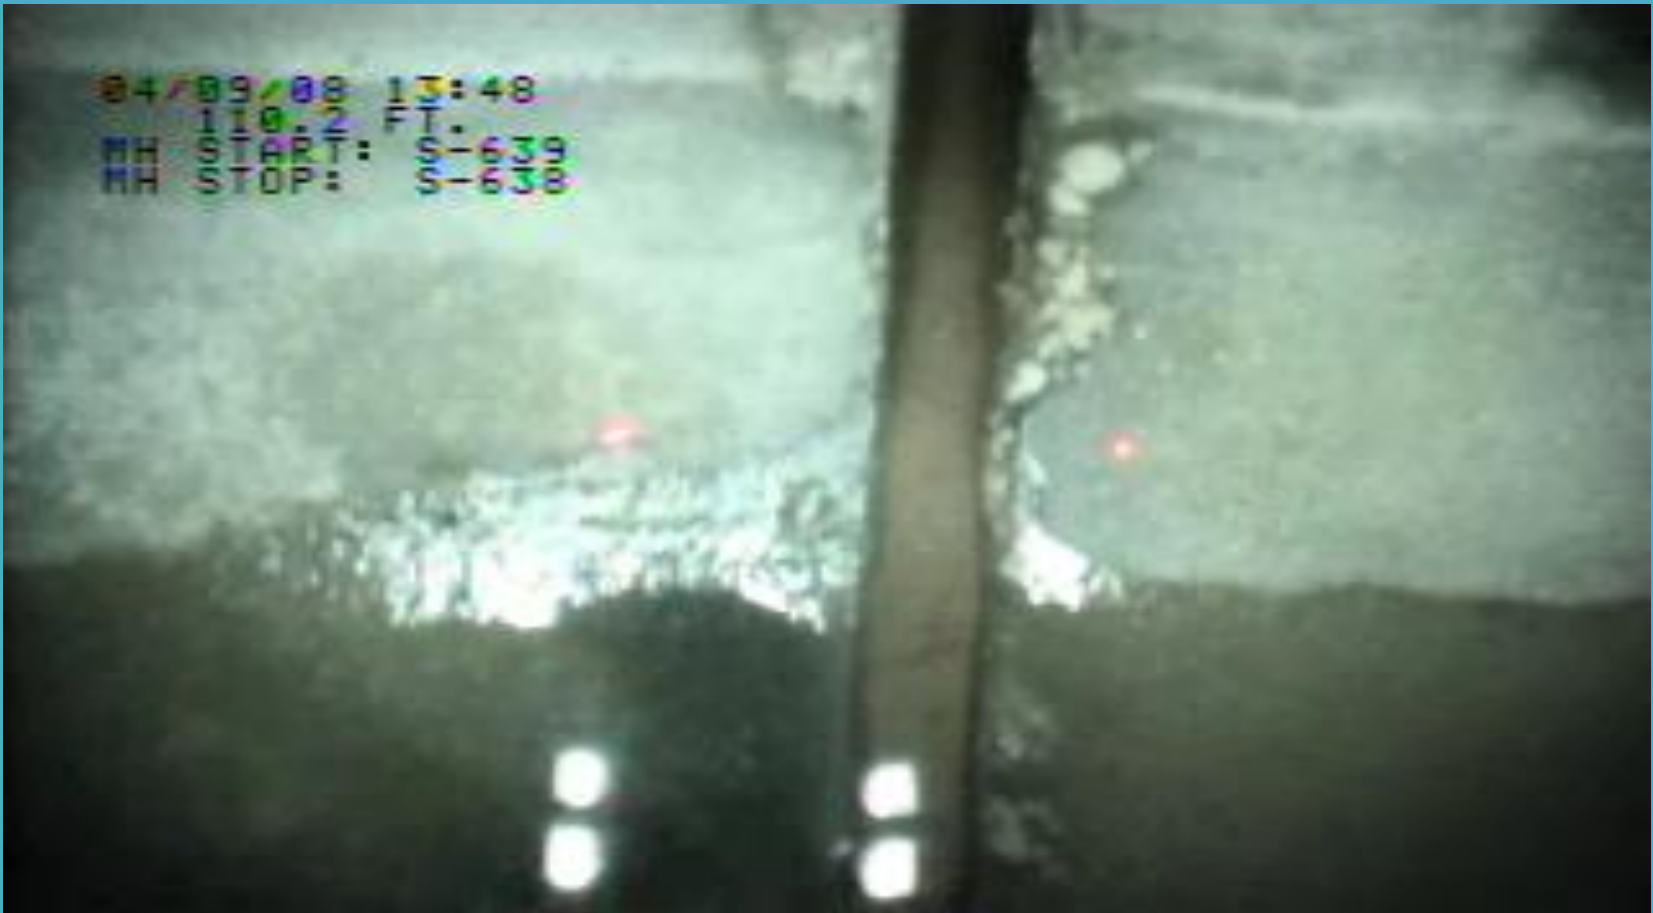
DOCUMENT DEFECTS

- Stop the camera and pan when necessary to document defects.

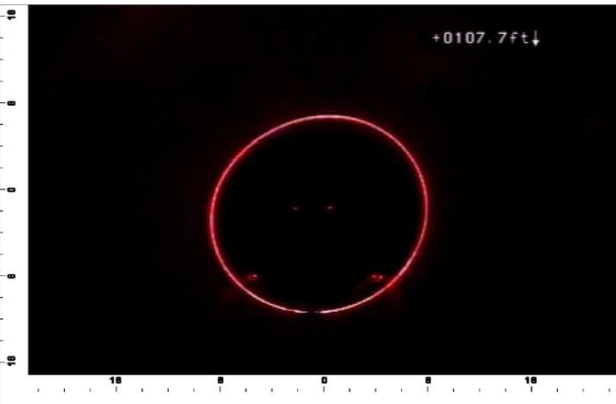
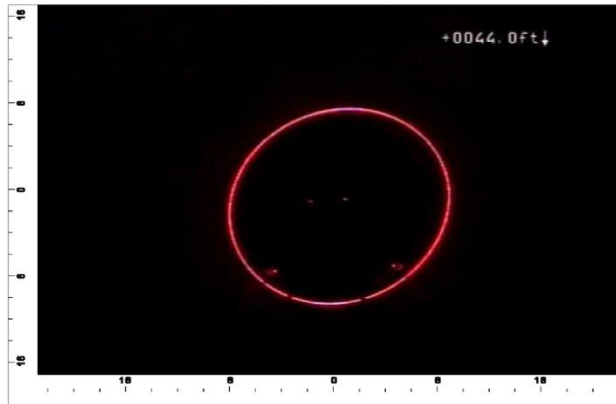
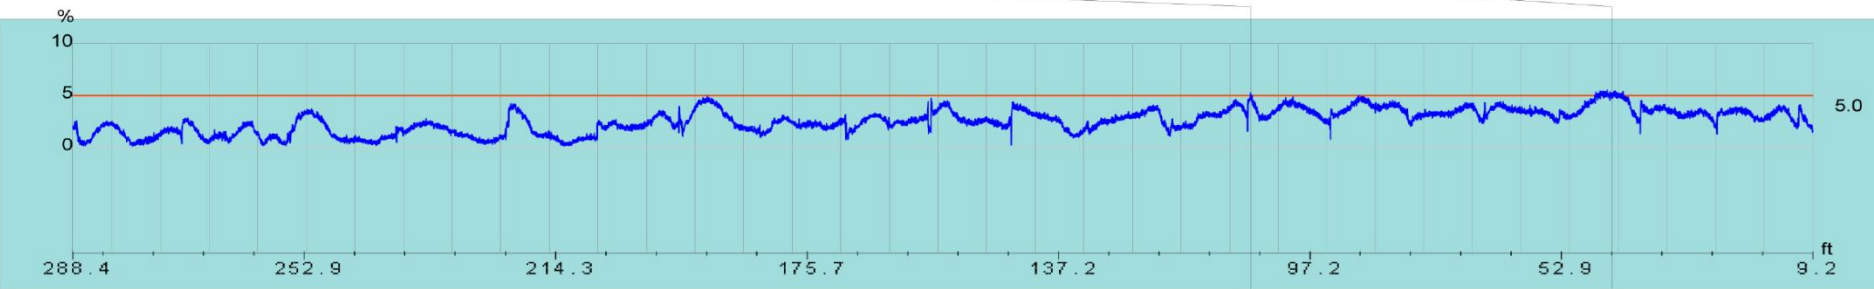
OVALITY REPORT

Date 1/5/2014
Material PVC
Pipeline Length 298.2 ft
Internal Diameter (Expected) 17.6 in

OVALITY = 5.4%

OVALITY = 5.1%

Ovality 'q' (as per ASTM F 1216 Standard Practice) as a percentage of original pipe versus distance

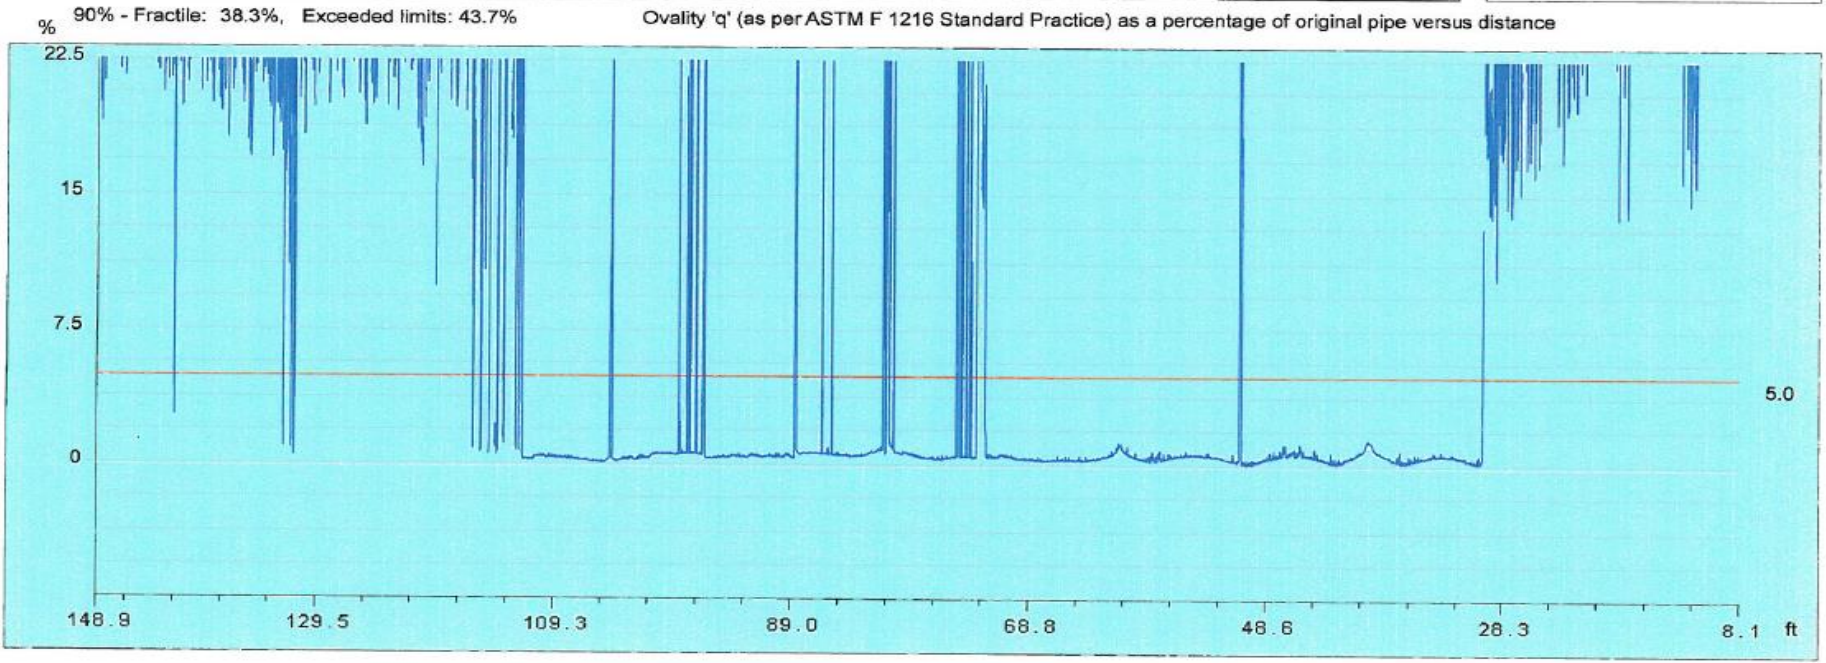
BAD OVALITY REPORT

Site ID	Asset No.	Date	8/28/2013
City		Material	
Start No	Finish No	Pipeline Length	164 ft
Location	Location	Internal Diameter	36 in
Comments		Limit Lines	Upper limit = 5 Lower Limit = 5

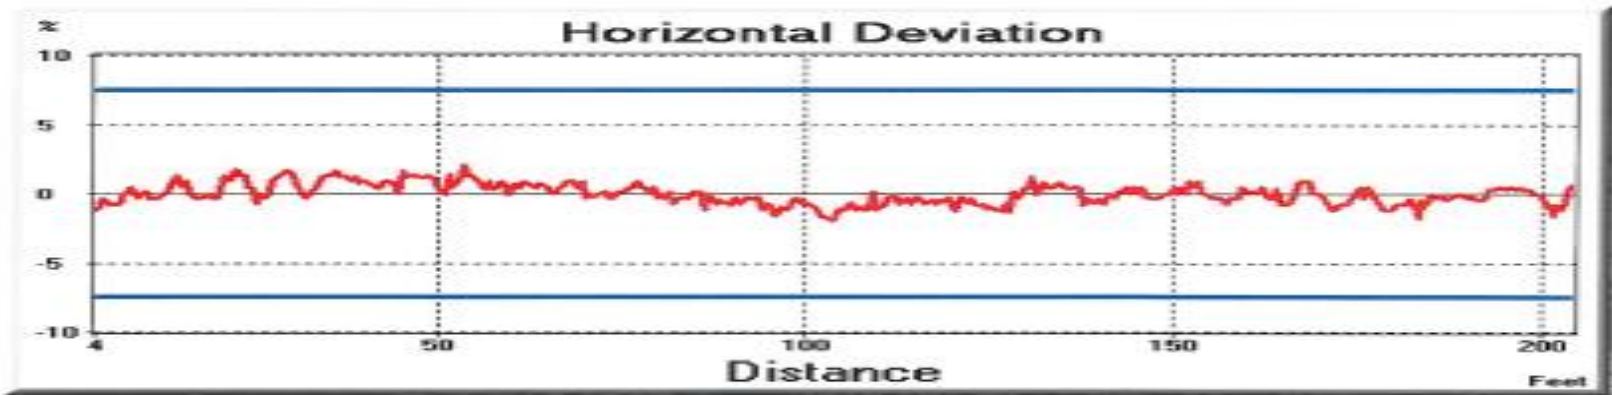
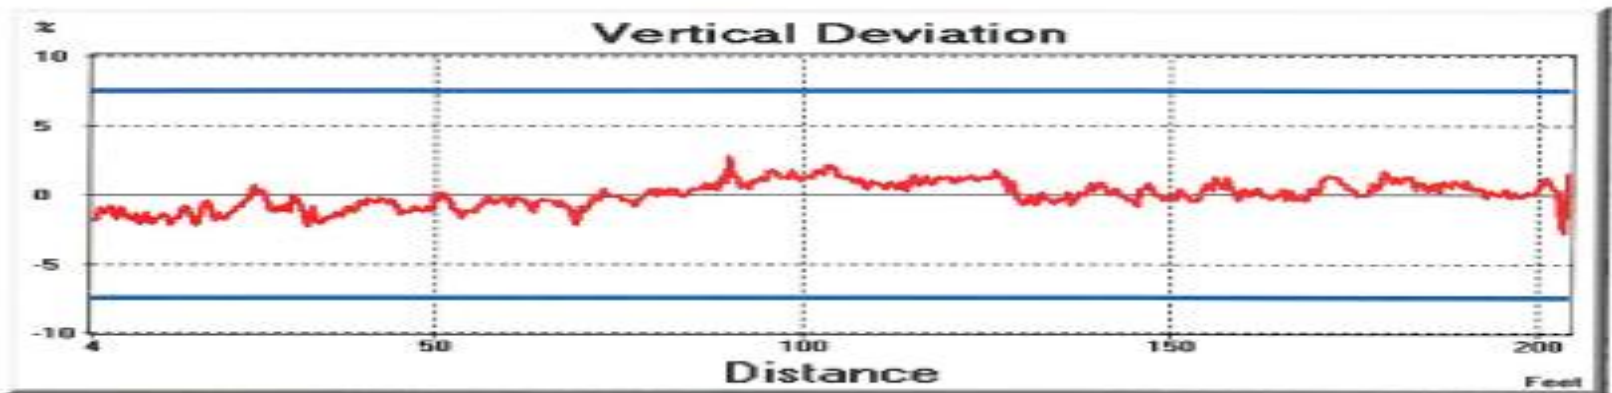
OVALITY REPORT

Date: 4/22/2009 9:23:00 AM
Location: Leon County
Length Surveyed: 205.5
Run Number:
Pipe Size: 18"

Asset ID:
Upstream MH Number: S330Demo
Downstream MH Number: S331Demo
Direction Of Survey: Upstream
Pipe Material: Polyvinyl Chloride

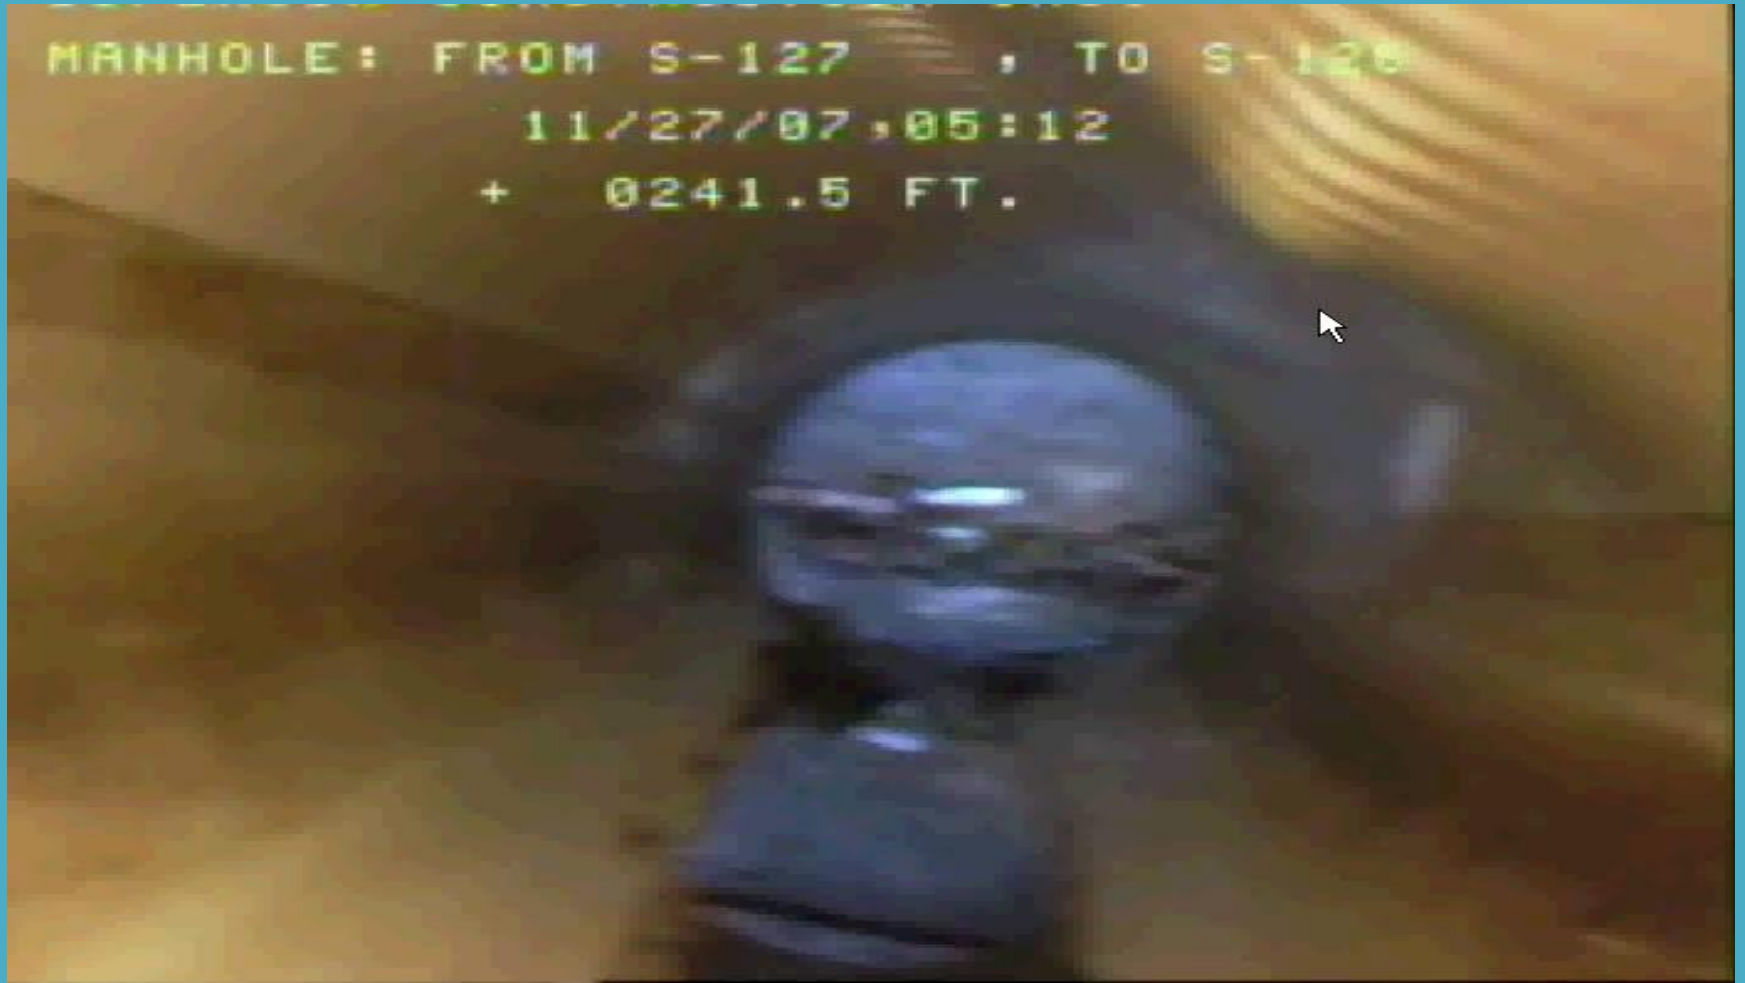
MANHOLE: FROM S-127 , TO S-128
11/27/07, 05:12
+ 0241.5 FT.

- All flexible pipe types must meet the Department's deflection criteria in Section 430.
- Pipe deflected 5% or more of the certified actual mean diameter of the pipe at final inspection shall be replaced at no cost to the Department.
