External Post-Tensioning Anchorage

University of Central Florida

Florida Department of Transportation

Final REPORT

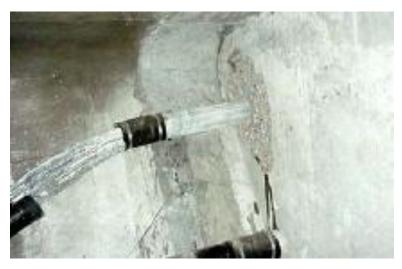
Figure 1. Mid-Bay Slipped Pipe

On August 28, 2000, a routine inspection of the Mid-Bay Bridge, a 19,265 ft precast segmental bridge located over the Choctawhatchee Bay in Okaloosa County, Florida, revealed that the polyethylene duct of one of the bridge's 19-strand tendons was cracked. It was also observed within the cracked housing that several tendon strands had fractured. The discovery of the de-stressed tendon led to an immediate walk-though inspection of the bridge's remaining spans to confirm if other tendons were displaying similar signs of de-stress. The resulting walk-through led to the discovery of a tendon found to completely slacked between the pier expansion joint diaphragm and the mid-span deviator. Slacking was caused by a substantial level of slip that occurred between the embedded steel pipe tendon duct (Figure 1), located within the expansion joint pier segment, and the surrounding concrete. An inspection of the slacked tendon anchorage device revealed that a substantial level of corrosion had led to the brittle fracture of numerous strands within the anchorage (Figure 2). Failure of the anchorage caused all post-tensioning (PT) force to transfer to the steel duct located within the pier segment. The force transfer resulted in the significant slippage of the steel pipe and resulted in the complete tendon slacking (FDOT 2001).

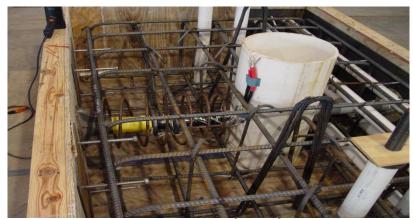
(d) Hollow section for shorter bond length - 2nd and 3rd 7 and 12 strand specimen Figure 10. First Set of Specimen Blocks Prior to Casting

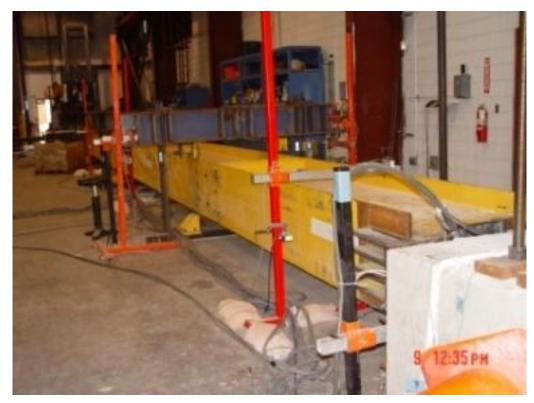
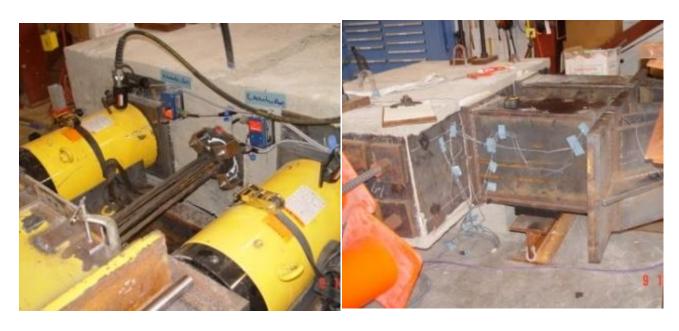
Figure 13. Test set-up photos

(a) Sliding reaction frame

(b) Stressing Jacks

(c) Dead-end reaction fixture

The configuration of the specimen and reaction fixtures used during all portions of the large-scale experimental investigation can be found in Figure 12. Both reaction fixtures were secured from translating out of axis by tie-down beams (Figure 13-a and -c). Both hydraulic jack locations i.e. stressing and active loading, can been identified. The jacks can be seen in Figure 13-b in the stressing position. The specimen block was mounted on three grout pads cast on the strong floor and was tied down to the strong floor using four 100kip capacity threaded rods.

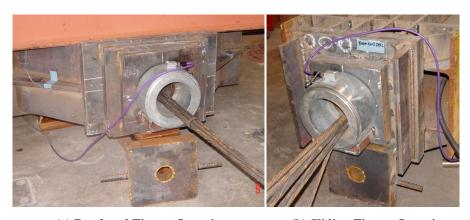
Figure 14. Load Cell Locations

Two Geokon 3000 Series 1,500 kip hollow-core load cells were used to measure the applied load at the anchor points of the multi-strand tendons. As recommended by the manufacturer, 3" thick bearing plates were used on either side of the cells to minimized error due to eccentric loading. The load cells and respective locations can be seen in Figure 14.

(a) Dead-end Fixture Location

(b) Sliding Fixture Location

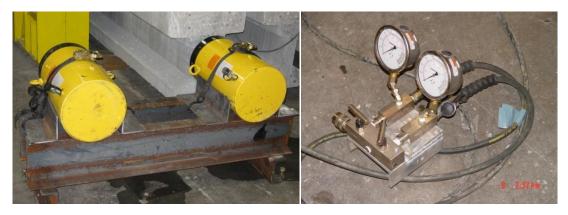
Figure 17. Enerpac Jacks

Two 600kip Enerpac CLL series hydraulic jacks (Figure 17) with lock nut cylinders, located between the sliding frame and specimen, were used for all major loading procedures. A manual flow value coupler (Figure 18) was used to operate the two jacks simultaneously during stressing. Since the Enerpac CLL series jacks only had single action hydraulic flow, the value coupler was also used during the de-stressing procedure to control the rate of return.

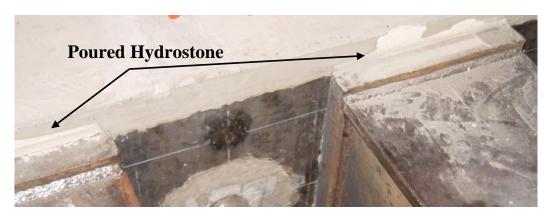
Figure 19. Hydrostone Joint

During preparation for stressing of the 7-strand specimen, it was noticed that the deadend reaction fixture did not sit plumb against the specimen block. Prior to proceeding with tendon stressing, it was decided to pour hydrostone gypsum cement between the specimen block and reaction fixture to ensure a flush bearing surface. This can be seen in Figure 19.

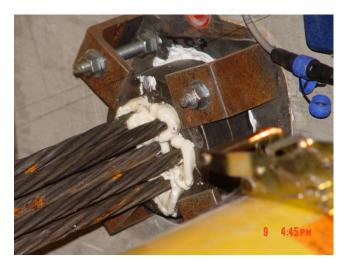
Figure 32. Grout Blocker at Free End

Upon completing active loading, instrumentation, hydraulic jacks, and reaction fixtures were removed such that the specimen could be inspected. There was no visual indication of slippage between the embedded steel pipe and concrete or between the steel pipe and PT grout. Although, once the grout blocker (Figure 32) was removed from the free end of the specimen, a significant amount of radial cracking was observed within the anchor bearing plate (Figure 33), which is a sign of the significant role the Hoyer Effect had played in the anchorage of the tendon. No cracking was seen to have occurred in the specimen block due to the active loading procedure.

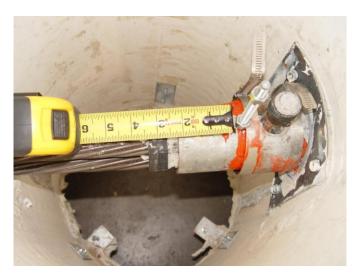
Figure 45. 7-strand - Second Specimen - Grout Slip Photo

After active loading, the hydraulic jacks, and reaction fixtures were removed and DSI bars were de-stressed and the specimen was inspected. There was visual indication of slippage between the steel pipe and PT grout from the active loading end (Figure 45). Once the grout blocker was removed from the free end of the specimen, slippage between the tendon and the grout was observed as well as a significant amount of radial cracking within the anchor bearing plate (Figure 46). No cracking was seen to have occurred in the specimen block due to the active loading procedure.

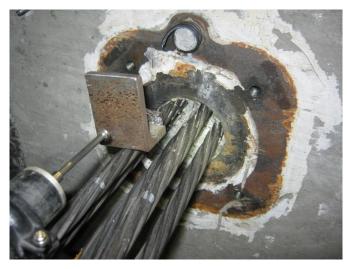
Figure 59. 7-strand - Third Specimen - Tendon Slip at Free face

After active loading, the hydraulic jacks, and reaction fixtures were removed and DSI bars were de-stressed allowing the visual inspection of the specimen. There was visual indication of slippage between the tendons and PT grout as well as slip between the grout and the pipe from the active loading end (Figure 58). Once the grout blocker was removed from the free end of the specimen, slippage between the tendon and the grout was observed (Figure 59). No cracking was seen to have occurred in the specimen block due to the active loading procedure.

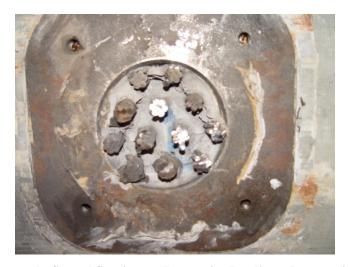
Figure 86. 12-strand - Second Specimen - Post-active Loading - De-stressing End Photo

After active loading, the hydraulic jacks, and reaction fixtures were removed and DSI bars were de-stressed allowing the visual inspection of the specimen. The same post-active-loading observations that were recorded in the 2nd and 3rd 7-strand specimens were observed in the 2nd 12 strand specimen. There was visual indication of slippage between the tendons and PT grout from the active loading end (Figure 85). Once the grout blocker was removed from the free end of the specimen, slippage between the tendon and the grout was observed (Figure 86). No cracking was observed in the specimen block due to the active loading procedure.

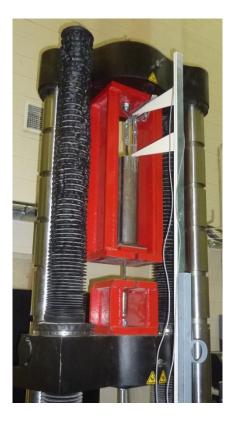
Figure 173. Photos From the NASP Setup

(b) Chuck Location

To determine the bond performance between the VSL 0.6" diameter strand used and the PT grout, it was decided to perform a standard NASP PT strand bond test as described in Appendix H of NCHRP Technical Report 603. Six pullout samples were prepared and tested at the University of Central Florida Structural Analysis Laboratory. Pictures from the experimental setup are shown in Figure 173.

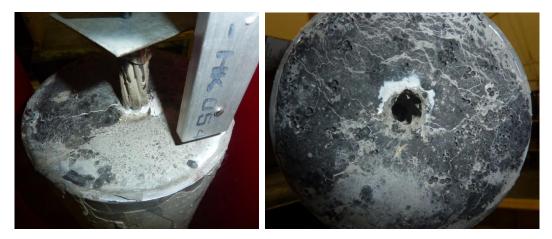
Figure 180. Specimen before (left) and after (right) testing

All the specimens were tested until the strand slipped at least 2 inches. When the first specimen was re-tested, sudden failure occurred at 31 kips with a popping sound. The same failure happened when testing the third specimen. The latter failed at 35 kips. The tendon from the rest of the specimens was pulled out gradually, with no sudden failures. Surface cracks

developed during curing that radiate from the strand but no new cracks developed after the testing Figure 180.
