Maintenance and Repair

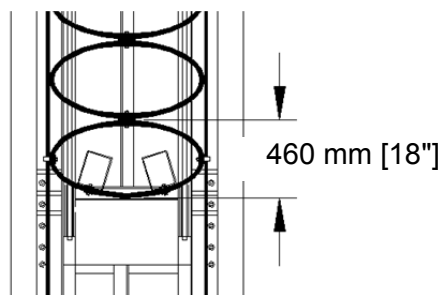
Figure 30 - Measure Minor Axis

The REACT 350[®] system must be inspected after each impact. Depending on the impact, components may get damaged and need replacement. A cylinder requires replacement when the minor axis of the cylinder stays permanently at 460 mm [18"] or less (see Figure 30) or the system does not reach 90% of the original length. It is critical that all cables and anchoring be checked and returned to original assembly conditions. Any parts used in the repair of the system must be original Trinity Highway parts (see p. 3).
