## **Resetting SMART CUSHION® after Impact**

### **Re-Extension and Inspection after Frontal Impact**

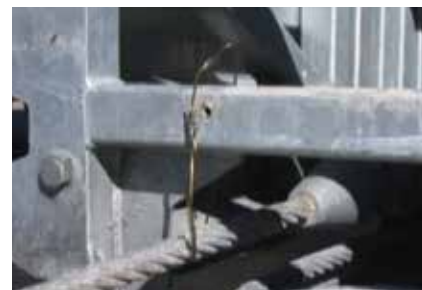
**Fig. 1**

1. Remove the front delineator panel and attach pulling means to the **bottom brace** of the front sled.
2. Use wire or strap on the bottom brace at the front of the sled to hold the spelter socket up in the air while pulling out or it will catch on the base frame cross braces. (See Fig. 1)
3. Remove the front cable bracket that is located on the front sheave at the front of the attenuator. (See Fig. 2)
4. Attach a ½" Grade 100 chain to the bottom brace of the front sled.
5. Pull the sled forward one to two feet to give you slack on the cable.
6. If necessary, use Work Area Protection Corp's cable release tool to break cable loose from the sheave at the front of the attenuator if the zinc coating has attached the cable to the sheave. (See Fig. 3)

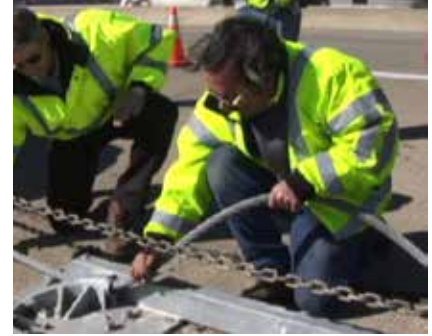
Fig. 4

7. Pull out in two foot increments while helping the cable feed out of the front of the unit. (See Fig. 4)

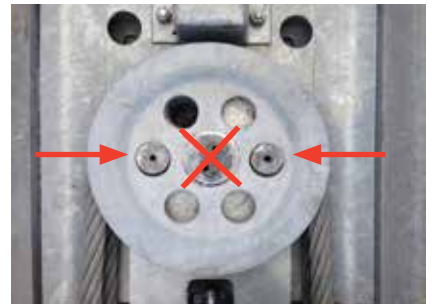
Fig. 5

11. Remove the anti-rotation pins, which are the two outer pins, inserted through the holes in the sheaves from both the front and back sheaves. This will be easily done with Work Area Protection Corp's anti-rotation pin removal tool.  
**Caution: Do not remove the center pin. The rear pins are longer than the front sheave pins and cannot be intermixed so leave them by their locations.**

(See Fig. 5)

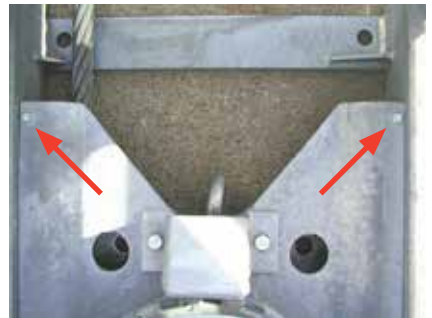
Fig. 6

12. Remove shear bolt remnants in the holes on both sides of the mobile sheaves. These are grade 8 bolts so they can be difficult to remove without a 90 degree pry bar with a claw to pry out. (See Fig. 6)

13. Attach a pulling means to the shackle on the mobile sheave assembly. (See Fig. 6)

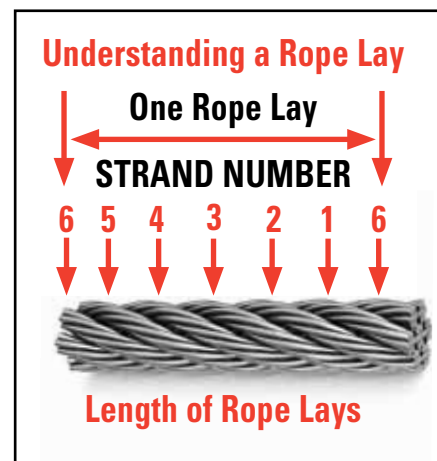
**Fig. 7**

The cable should be visually inspected for damage. The most common sign of rope deterioration is broken wires. The wire must be clean and not under tension to perform a visual inspection. The visual inspection should include looking for broken wire strands, localized wear or crowns. A sharp awl or marlin spike can be used to separate wires to check if internal damage is present, indicated by loose wires or crowns. If internal inspection shows any damage to any core wires, the cable should be replaced. If there are more than six random broken wires in one rope lay or three broken wires in one strand in one rope lay, the wire rope should be replaced. A rope lay is the length along the rope in which one strand makes a complete revolution around the rope. (See Fig. 7)
