## Chapter 14 – Table of Contents

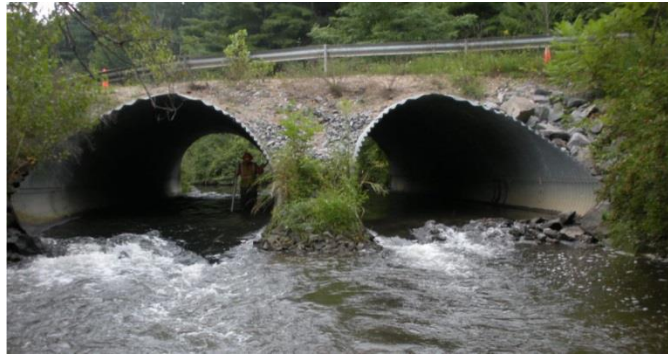
Corrugated metal plate pipes/arches are composed of individual corrugated metal plates that are bolted together in the field to construct the culvert. These corrugated plates are often of heavier gauge metal than the pre-formed pipes, and are delivered in smaller sized pieces. Because each plate typically has multiple bolts fastening it to adjacent plates, the joints between aren't typically misaligned, and so leak less frequently. An example of a twin corrugated metal plate pipe arch culvert is shown in Figure 14.1.

*Figure 14.1 Twin Corrugated Metal Plate Pipe Arches*

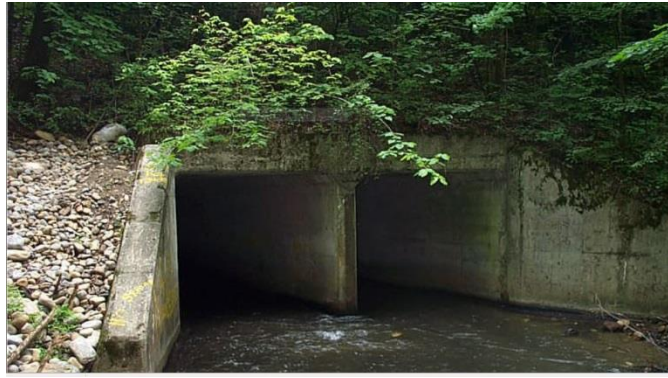
Because cast in place box culverts and arches are not limited by the transportation constraints that limit precast culverts, they may have longer spans or different configurations. It is not uncommon for cast in place boxes to have multiple barrels to provide additional span or waterway openings, as shown in Figure 14.2. Cast-in-place concrete culverts and arches can be designed and constructed to meet specific site conditions.

*Figure 14.2 Twin Barrel Cast-in-Place Concrete Box Culvert*

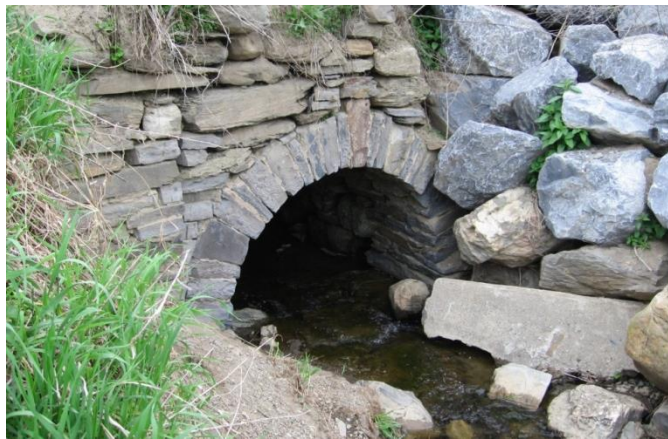
Masonry culverts are typically constructed of stone, brick or concrete block, an example of which is shown in Figure 14.3. This type of culvert was commonly built prior to the 1920's because these relatively durable materials were readily available for construction. The masonry units may be held together with mortar, or they may be dry (no mortar). Dry masonry relies on the friction/compression of well fit masonry units to hold the culvert together. Since the 1920's, the use of masonry in culvert applications has largely been limited to headwalls.

*Figure 14.3 Masonry Culvert*

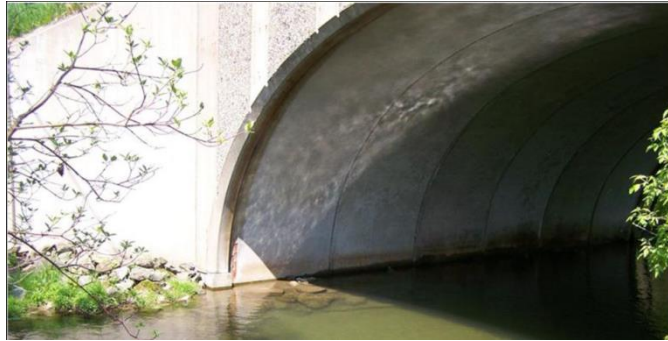
Precast 3-sided concrete culverts or arches can be designed for various depths of cover and live loads. Unlike other culverts, the natural stream bottom serves as the invert, and the legs of the box or arch are founded on concrete footings. Spans can be up to 100 feet for arches. As with the other precast culverts, size and weight for transportation will often govern the size of the

precast pieces and the number of joints. An example of a bottomless pre-cast arch is shown in Figure 14.4.

*Figure 14.4 Bottomless Precast Concrete Arch*

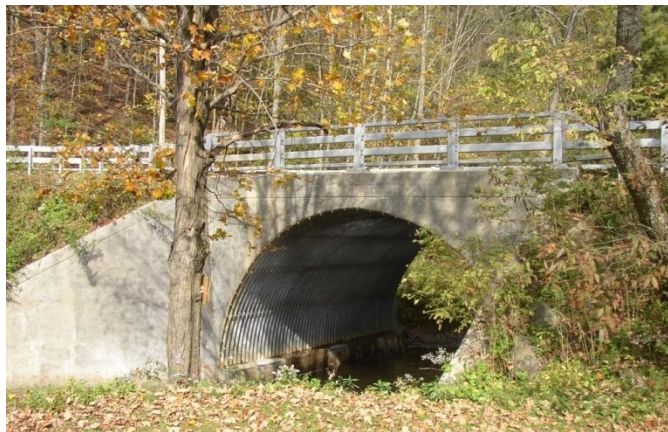
Bottomless corrugated metal box culverts and arches may be constructed of either galvanized steel or aluminum and typically range in span up to 40 feet. Unlike the corrugated metal structures with a bottom, the legs of a bottomless corrugated metal box or arch are founded on concrete footings, and the invert is the natural stream bed. They are usually constructed of corrugated structural plate, with the corrugation size depending on the span and configuration of the box. An example of a bottomless corrugated metal arch culvert is shown in Figure 14.5.

*Figure 14.5 Bottomless Corrugated Metal Arch Culvert*

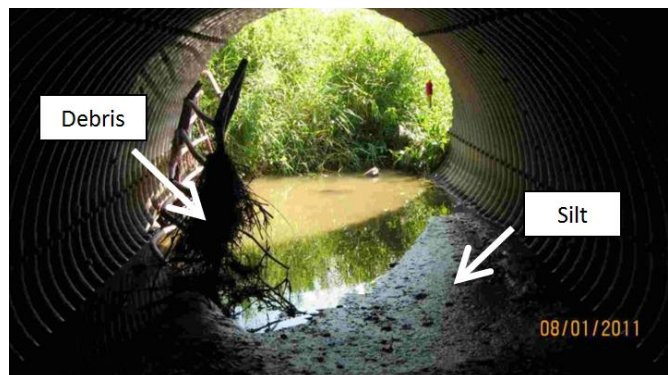
Debris inside culverts, as well as at inlet and outlet ends, can degrade the hydraulic capacity and performance of culverts. An example of debris and silt buildup in a corrugated culvert is shown in Figure 14.6. Accumulations of debris can re-direct the flow of water causing scour of the stream banks, road embankment, or stream bed. Debris can also cause standing water in culverts, or conditions where material stays in contact with the culvert keeping it wet, and accelerating deterioration of the culvert materials. This is of particular concern in applications with galvanized steel. The debris may be large such as trees, limbs, woody vegetation, tires, shopping carts, or naturally occurring objects such as cobbles and boulders that have been washed down stream into or around the culvert. The debris may also be smaller grained soils, such as gravel, sand or silt. Vegetation growing at the inlet may also restrict the waterway opening.

*Figure 14.6 Debris and Silt in Corrugated Culvert*

Similar to debris, siltation inside culverts, as well as at inlet and outlet ends, can degrade the hydraulic capacity and performance of culverts, as shown in the examples in Figure 14.6 and Figure 14.7. Accumulations of silt can re-direct the flow of water causing scour of the stream banks, road embankment, or stream bed. Silt can also cause standing water in culverts or conditions where material stays in contact with the culvert keeping it wet. These situations can accelerate deterioration of the culvert materials. This is of particular concern in applications with galvanized steel. The siltation may be caused, or at least exacerbated, by larger debris, such as trees, limbs, cobbles and boulders, or vegetation. Removal of larger debris should be done in conjunction with siltation removal to reduce the potential for deposition of more silt.

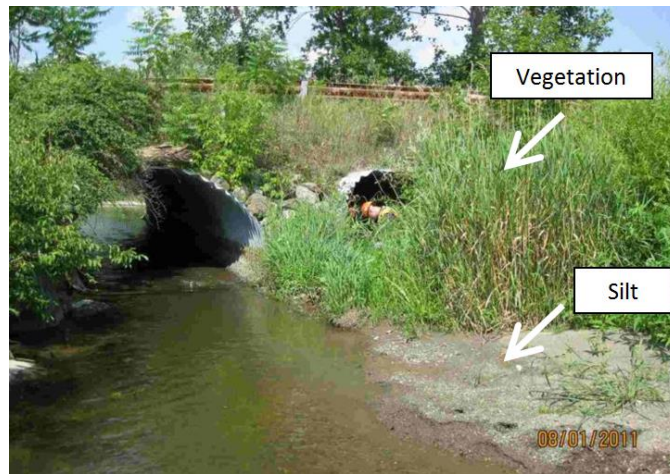
**Figure 14.7 Silt and Vegetation Blocking Corrugated Metal Culvert**

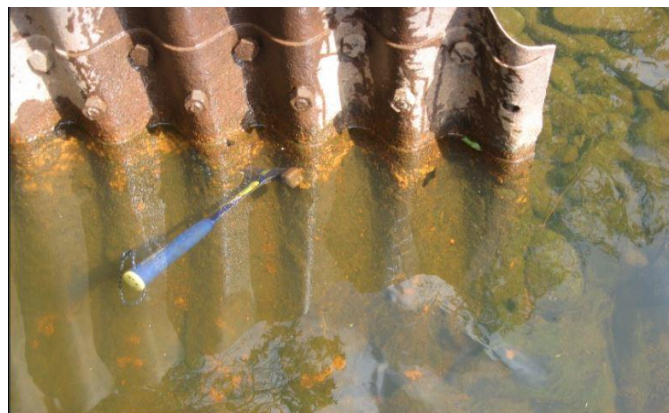
Corrosion occurs in soils or waters that have corrosive properties (high or low pH) or an abrasive environment (where abrasion removes the protective coatings on the culvert increasing vulnerability to corrosion). Acidity or Alkalinity can occur from pollutants, such as acid rain, but more typically it is due to the underlying geology of the area. Corrosion can lead to section loss, perforation, and ultimately structural failure. Some agencies may choose to utilize culvert materials of heavier gauge, or with additional coatings to obtain the necessary design life given a more corrosive environment. However, when corrosion progresses to the point where the culvert is failing (leaks, perforations, structural deformations) repairs, rehabilitation, or replacement options should be explored. During selection of the repair option, the pH of the environment should be considered. Examples of culvert corrosion are shown in Figure 14.8 and Figure 14.9.

**Figure 14.8 Corrosion in Plate Arch**

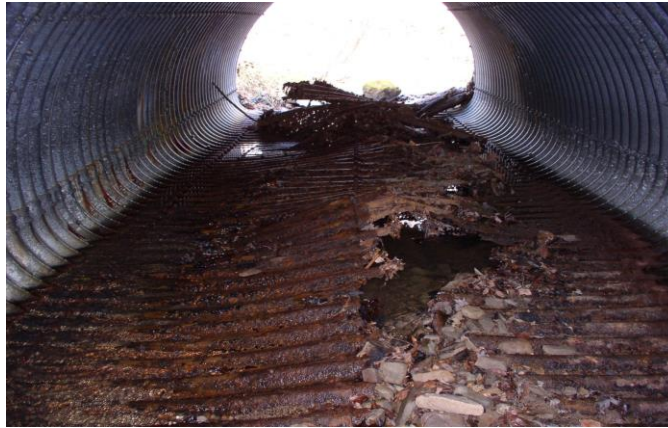
**Figure 14.9 Corrosion Failure of Culvert Invert**

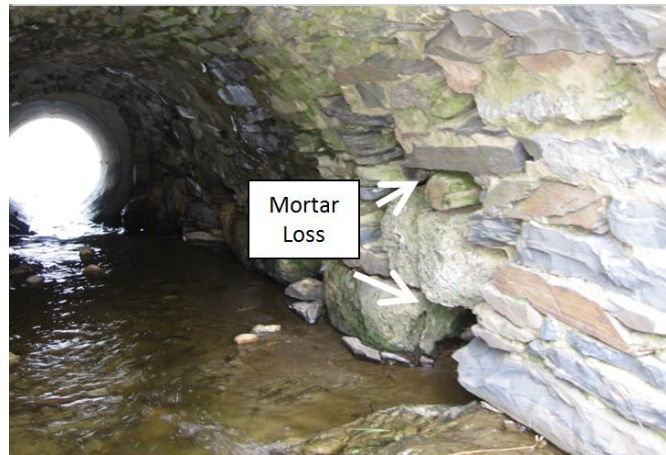
In most masonry construction, mortar is used to cement the masonry units together. Loss of mortar may lead to displacement or loss of masonry units which can compromise the structural integrity of the culvert (Figure 14.11). Loss of mortar may be caused by moisture, thermal expansion and contraction, or loss of soil support. Loss of mortar may lead to water and soil infiltration.

**Figure 14.11 Mortar Loss in Bottomless Masonry Arch**

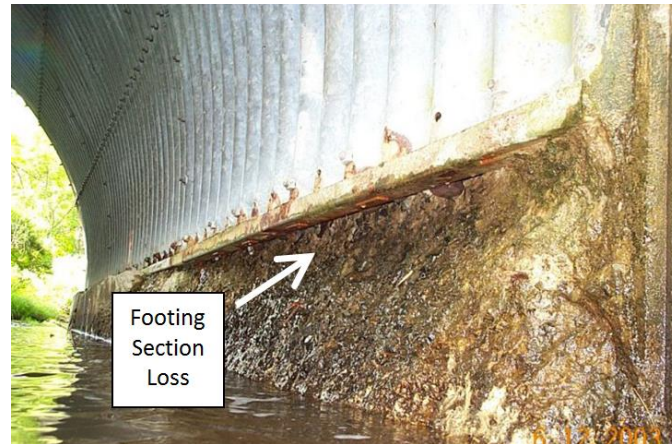
Loss of section in the footings of bottomless culverts can lead to loss of support for the structural elements of the culverts. An example of footing section loss in a bottomless culvert is presented in Figure 14.12.

**Figure 14.12 Footing Section Loss in Bottomless Culvert**

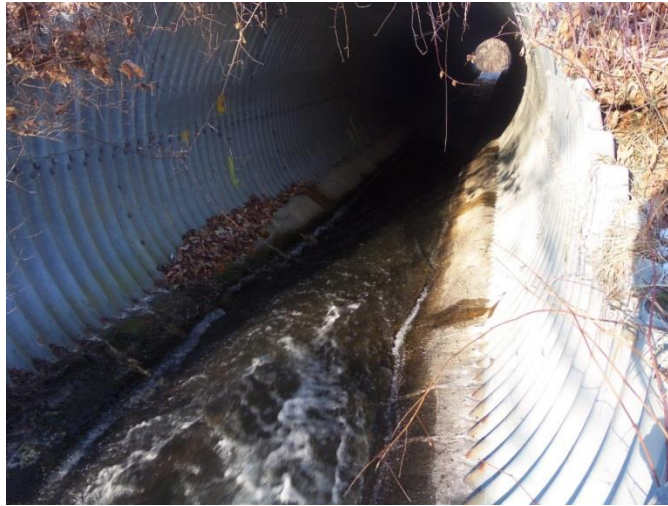
When the invert of a culvert has deteriorated, and the culvert is large enough for workers to enter the culvert, a new concrete invert may be cast in the culvert. Prior to relining, or as part of the new invert installation, any voids beneath the invert should be filled with concrete. An example of a repair of a damaged invert by using a concrete paved invert is shown in Figure 14.15.

*Figure 14.15 Concrete Paved Invert*

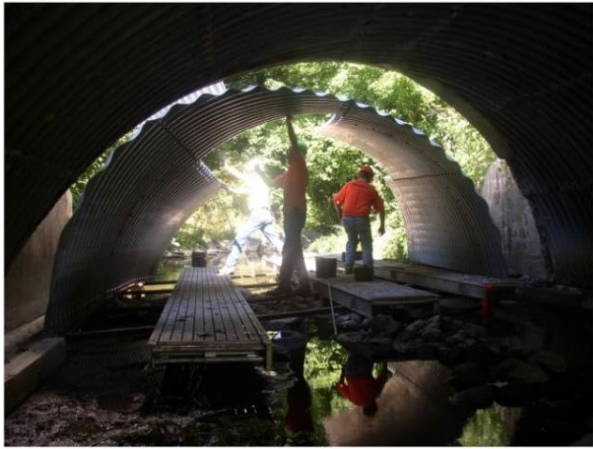
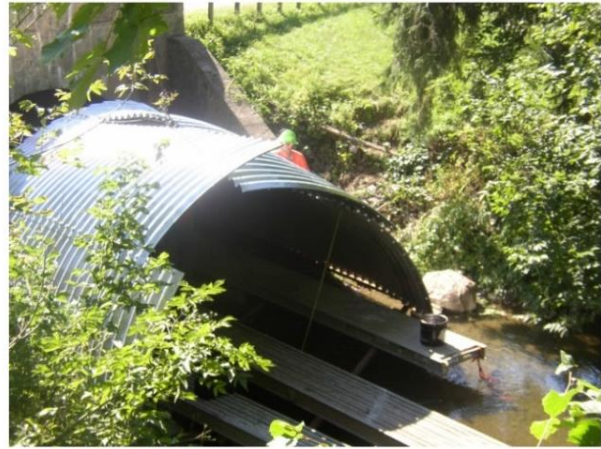
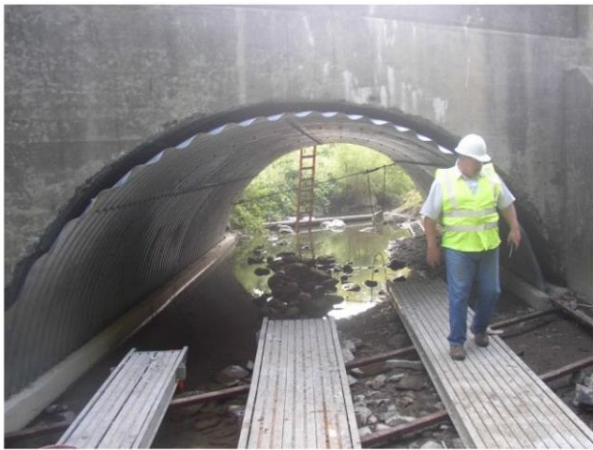
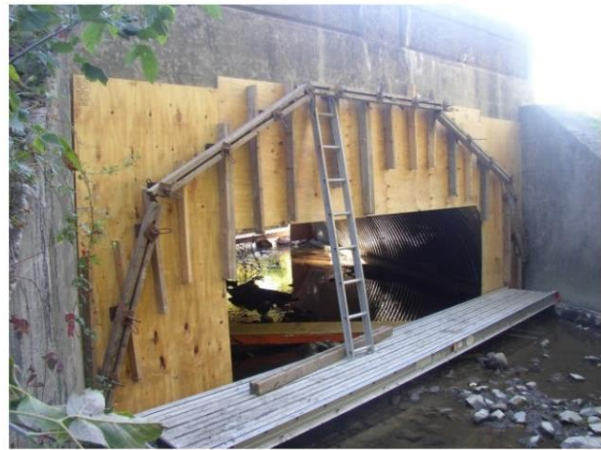
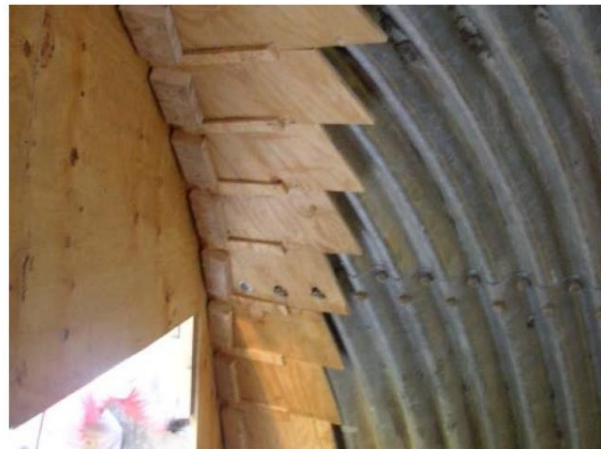
A sequence of photos showing replacement of an existing corrugated metal arch with a new corrugated metal arch is shown in Figure 14.16. The figure shows several steps, including (a) Assembly of plate arch outside existing culvert from interior of existing culvert, (b) Assembly of plate arch liner from outside existing culvert, (c) Plate arch liner in place prior to forming and grouting, (d) Exterior formwork for placing grout between liner and existing arches, (e) Formwork for grouting annular space between existing arch and liner from interior of liner, and (f) Interior close up showing how skewed end of corrugated arch was formed. For the installation shown in Figure 14.16, the grout was placed from the roadway surface by excavating to the top of the existing corrugated arch and cutting holes for grout placement (see Figure 14.17). Specifically in Figure 14.17, the liner arch and hole cut in existing arch visible in bottom of hole is shown (left) and placement of grout is shown (right). The completed lined arch is shown in Figure 14.18.

**Figure 14.16 Sequence of Culvert Lining Replacement in Corrugated Metal Arch  
(Courtesy of Washington County NY DPW)**

Figure 14.16 shows the steps involved to line a corrugated metal plate pipe arch. If the existing footing is adequate, it can be used as the footing for the liner arch. If not, repairs to the existing footing will be necessary as described in Section 14.6.6 Footing Repair of Bottomless Culverts. In the case of a round pipe, perforations in the invert and voids below it must be filled, and blocking beneath the invert of the liner pipe is typically provided to maintain an annular space between the existing pipe and the liner pipe.

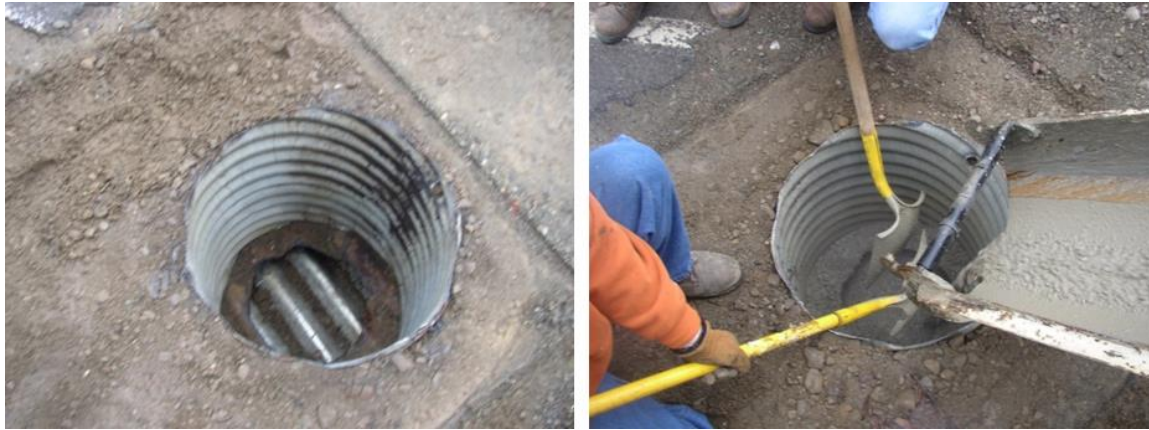
**Figure 14.17 Grout Placement Hole Excavated in Road Surface  
(Courtesy of Washington County NY DPW)**

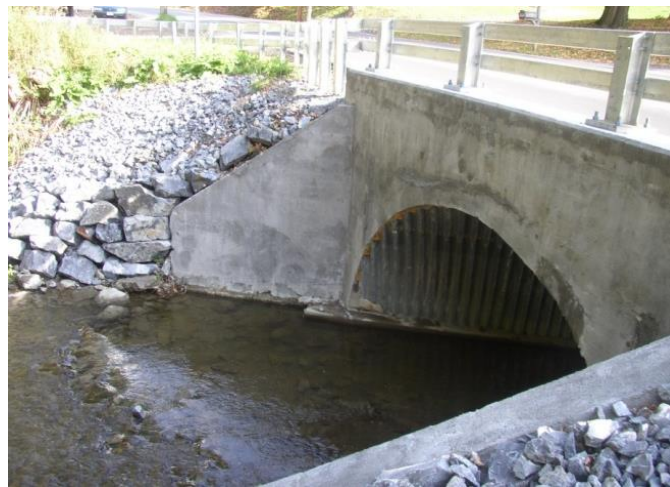
**Figure 14.18 Completed Lined Arch (Courtesy of Washington County NY DPW)**

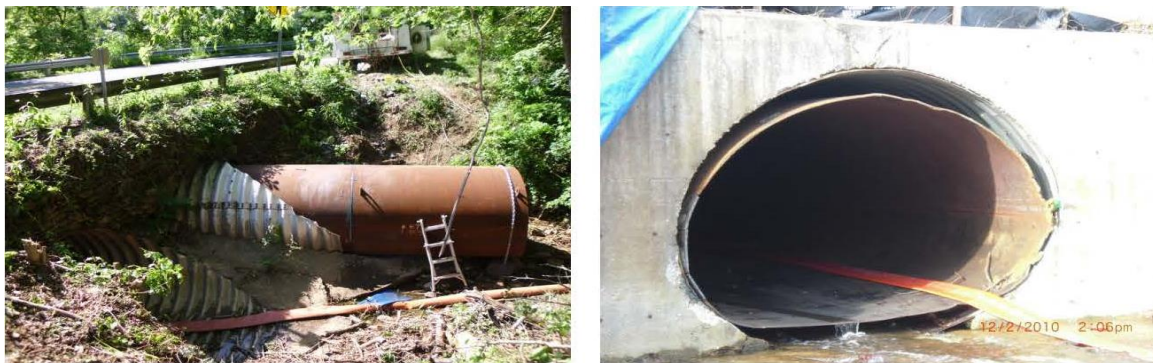
Figure 14.19 and Figure 14.20 show slip lining installations using smooth interior metal pipe. In Figure 14.19, the external view is shown (left) and internal view showing grout ports is shown (right). While the pipe in Figure 14.19 does have ribs, they are flat enough that the pipe is considered smooth for hydraulic purposes. In the installation of the metal pipe shown in Figure 14.20, grouting occurred from the interior using the grout ports shown in the photo. Following curing of the grout, the forms were removed and the stream was restored.

**Figure 14.20. Smooth Wall Steel Culvert Liners** (Courtesy of Virginia DOT)

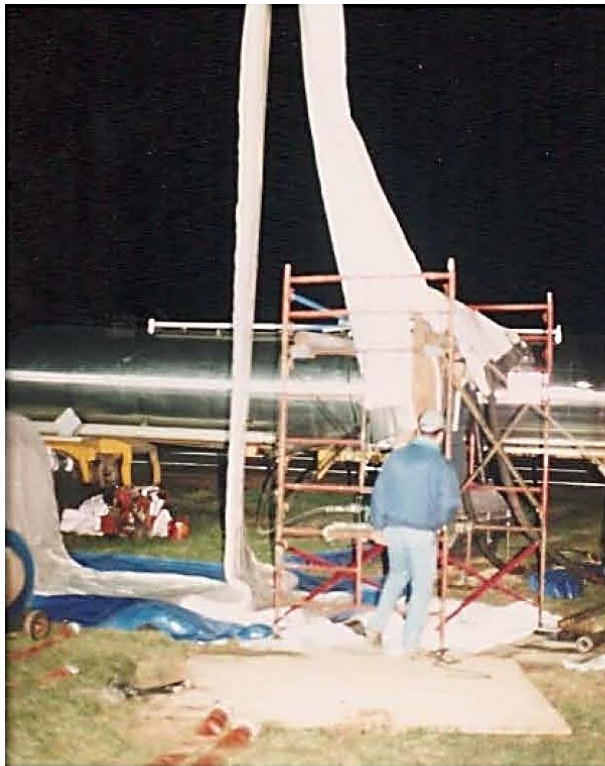
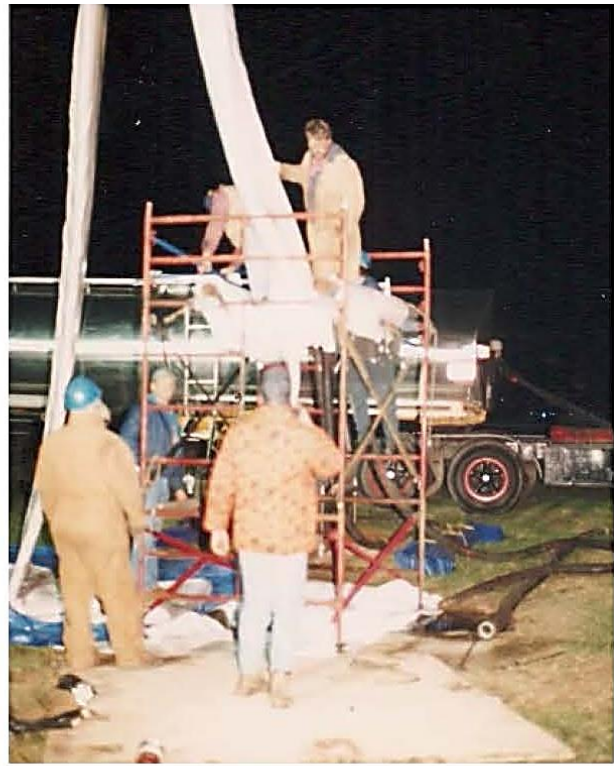
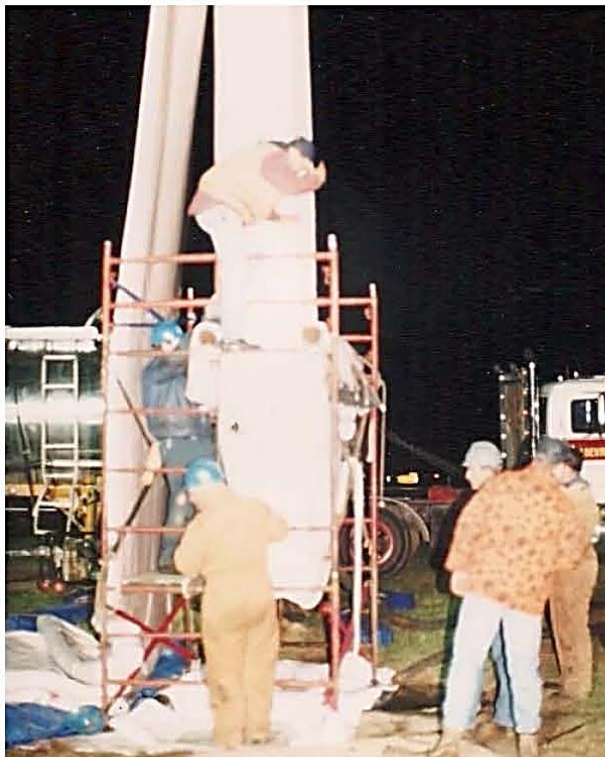
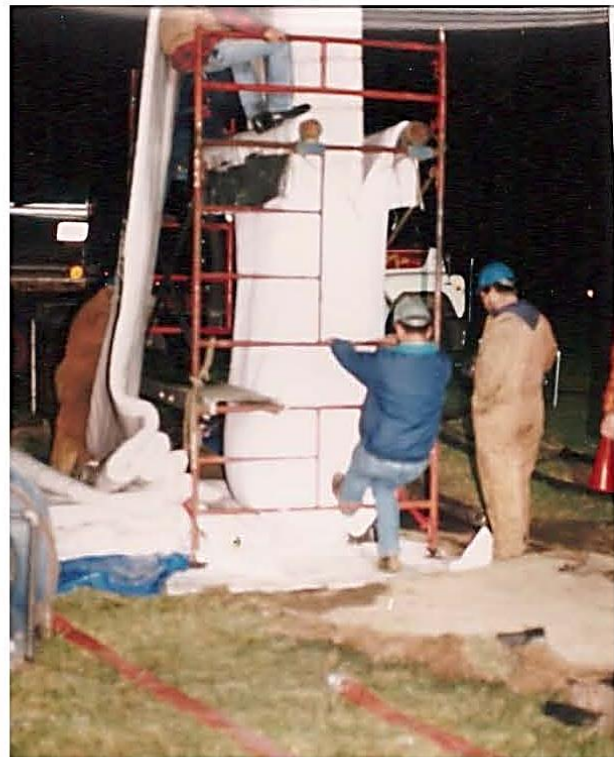
An example of the steps for installation of an inversion liner is shown in Figure 14.21, showing (a) Incisions are cut in sides of liner to facilitate inversion, (b) Sides of liner fastened to installation scaffolding, while first portion of liner is inverted, (c) Water is added to inverted liner to advance it toward installation manhole (d) Inverted liner being lined up and advanced into the installation manhole.

**Figure 14.21 Inversion Liner Installation**

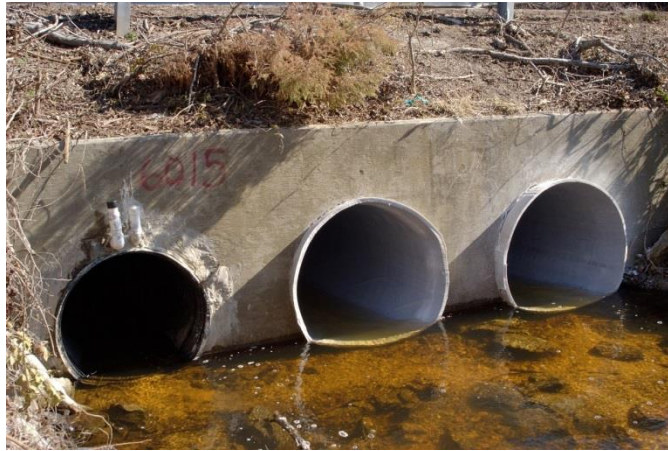
A completed installation of cured in place pipe is shown in Figure 14.22.

*Figure 14.22 A Completed Installation of Cured in Place Pipe (Courtesy of Insituform USA)*

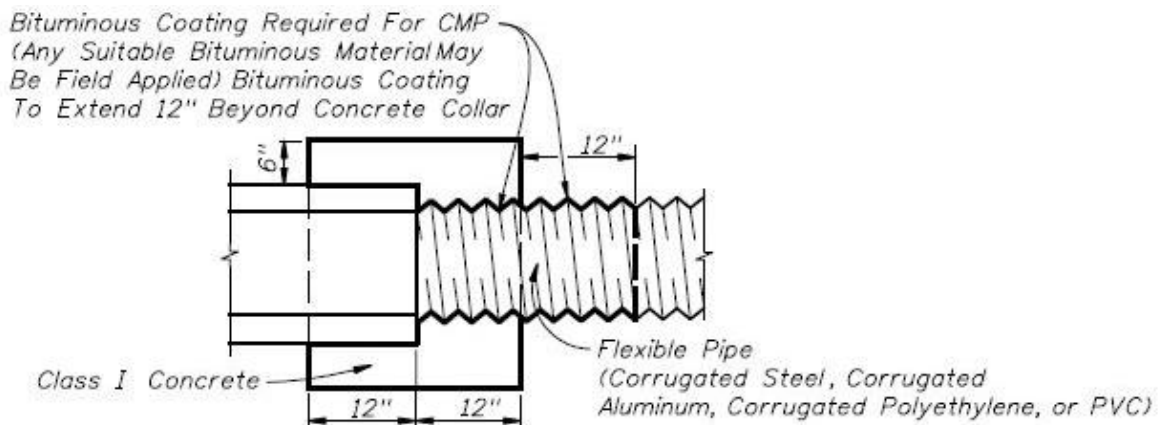
1. Excavate bedding from under and around the existing pipe to a width at least 12 inches from either side of the joint.
2. Encase the damaged joint with a concrete collar a minimum of 24 inches wide and at least 6 inches thick around the culvert.
3. Carefully replace and compact bedding.
4. Then backfill to provide proper support for pipe and collar.

An example of a concrete installation procedure is shown in Figure 14.23.

**Figure 14.23 Concrete Collar Detail (Courtesy of Florida DOT)**

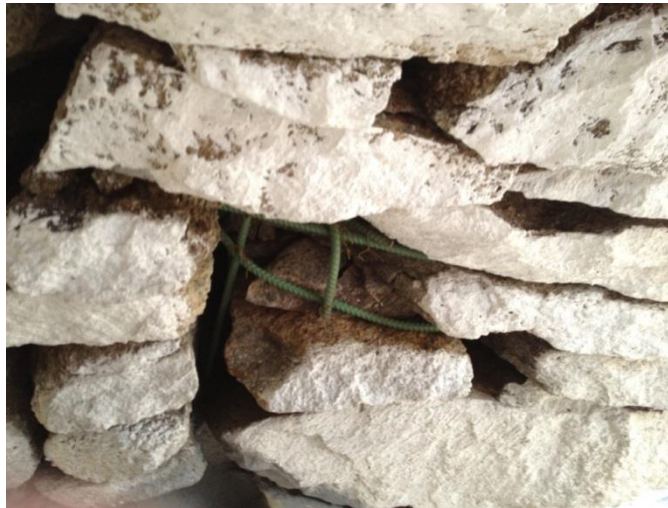
*Figure 14.26 Reinforcing Steel Installed Prior to Grouting Stone Masonry*

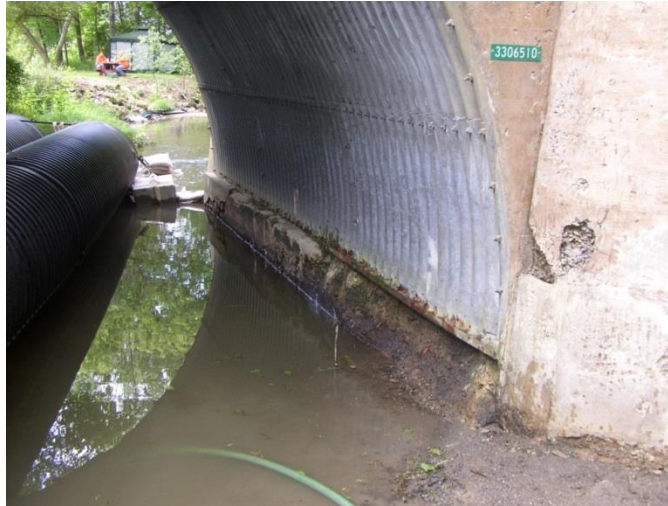
To excavate, form, and pour in dry conditions the stream will need to be diverted. In Figure 14.27, the owner is using twin HDPE culverts to divert flow during a low flow period. Other diversion methods could include sandbagging, bypass pumping, cofferdams or Aqua dams.

**Figure 14.27 Preparation for Footing Repair on Corrugated Plate Arch**

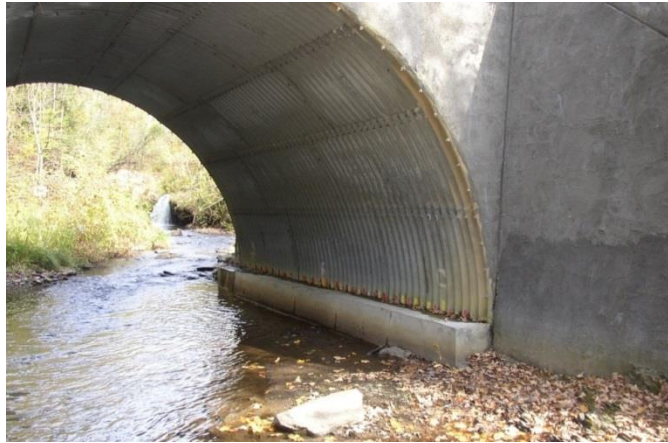
**Figure 14.28** Repaired Footing for Corrugated Plate Arch

The concrete is placed and cured, forms removed, and the stream restored to its original course. The completed repaired footing is shown in Figure 14.28.

Once the water has been diverted, the existing footing surface should be removed to sound concrete, and the soil at the toe of the footing should be excavated to the design repair depth.

As part of the forming process, provision should be made for adequately connecting the repair concrete to the existing footing. Typically, reinforcing bar is drilled and grouted into the existing concrete. Some agencies will treat the face of the existing concrete with epoxy or another bonding agent to strengthen the bond between the new concrete and the old concrete.
