## Florida Department of Transportation Research Damage Detection and Repair Methods for GFRP Bridge Decks BDK75 977-17

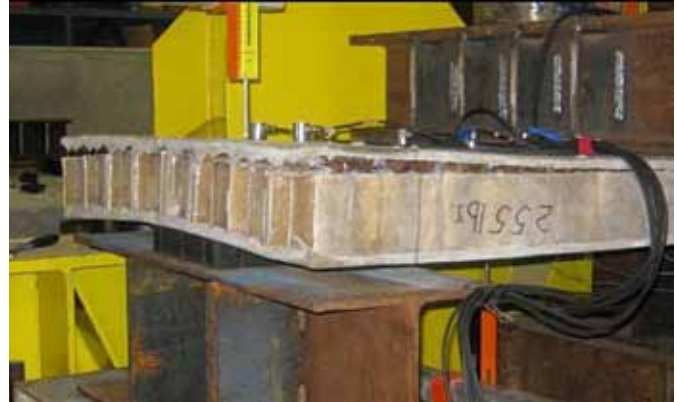
*A section of GFRP deck is loaded to failure in a laboratory setup.*

Three commercial GFRP bridge decks were tested in both positive and negative bending in a three-point loading setup. Each specimen was subjected to sequential load tests consisting of service, ultimate, then service. Load steps were separated by a brief load reduction to allow observation of Kaiser and felicity effects during reloading. Two AE analysis methods, intensity analysis and relative ratio analysis, were used to evaluate the data. Intensity analysis did not provide sufficient discrimination between damaged and undamaged states, but relative ratio analysis provided sufficient discrimination to allow development of criteria for laboratory testing. A modified form of relative ratio analysis was also used to analyze selected AE data from a bridge load test.
