## Florida Department of Transportation Research

### Damage Detection and Repair Methods for GFRP Bridge Decks

BDK75 977-17

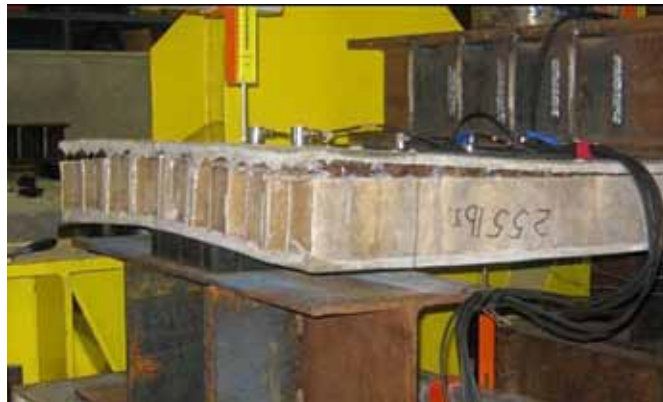
*A section of GFRP deck is loaded to failure in a laboratory setup.*

Three commercial GFRP bridge decks were tested in both positive and negative bending in a three-point loading setup. Each specimen was subjected to sequential load tests consisting of service, ultimate, then service. Load steps were separated by a brief load reduction to allow observation of Kaiser and felicity effects during reloading. Two AE analysis methods, intensity analysis and relative ratio analysis, were used to evaluate the data. Intensity analysis did not provide sufficient discrimination between damaged and undamaged states, but relative ratio analysis provided sufficient discrimination to allow development of criteria for laboratory testing. A modified form of relative ratio analysis was also used to analyze selected AE data from a bridge load test.
