**FINAL REPORT**

**BEST PRACTICES FOR QUALITY MANAGEMENT OF STORMWATER PIPE  
CONSTRUCTION**

FDOT Contract Number BDK75-977-56

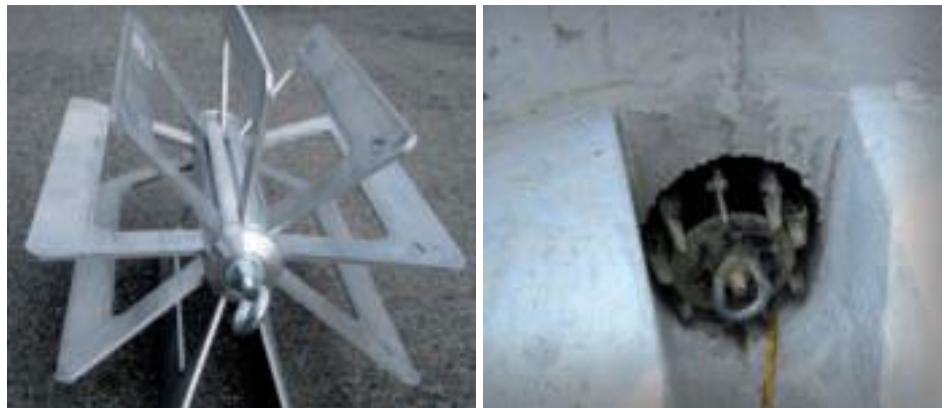
As a precursor to laser profiling, mandrels provided a much more primitive method for verifying ovality and locating deflections along a pipeline. A mandrel is a round apparatus that is driven through the interior of a pipe in order to verify that the pipe meets the minimum size requirements and contains no major obstructions to flow (RedZone 2011). The mandrel is slightly smaller than the required internal diameter of the pipe, and this difference in size corresponds to a proportional percent variance that is acceptable in the pipe size. If a mandrel does not successfully pass through the inner workings of a pipeline, the inspection is unsuccessful. A picture of a mandrel by itself, and in operation, is shown in Figure 2-3.

**Figure 2-2: Image of Pipe Mandrel by Itself and within a Pipeline**  
*(from the Ontario Concrete Pipe Association)*

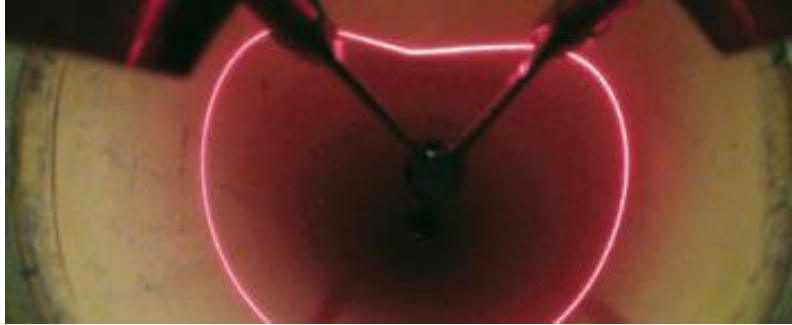
With respect to the laser profiling systems, the process can be performed in one of three ways: by laser ring, by point cloud, or by rotating laser. As the name implies, the laser ring method entails projecting a laser ring along the interior of the pipe culvert, just ahead of the CCTV camera. As the mechanism travels along the pipe invert, a laser ring is projected perpendicular to the longitudinal axis and any defects in the overall shape of the pipe are recorded both visually and digitally. A picture of a laser ring projected onto the interior wall of a pipe is shown in Figure 2-5 – note the inverted curve of the ring at the top of the pipe.

**Figure 2-4: Laser Ring Profiler**  
(from *Maverick Inspection Ltd.*)

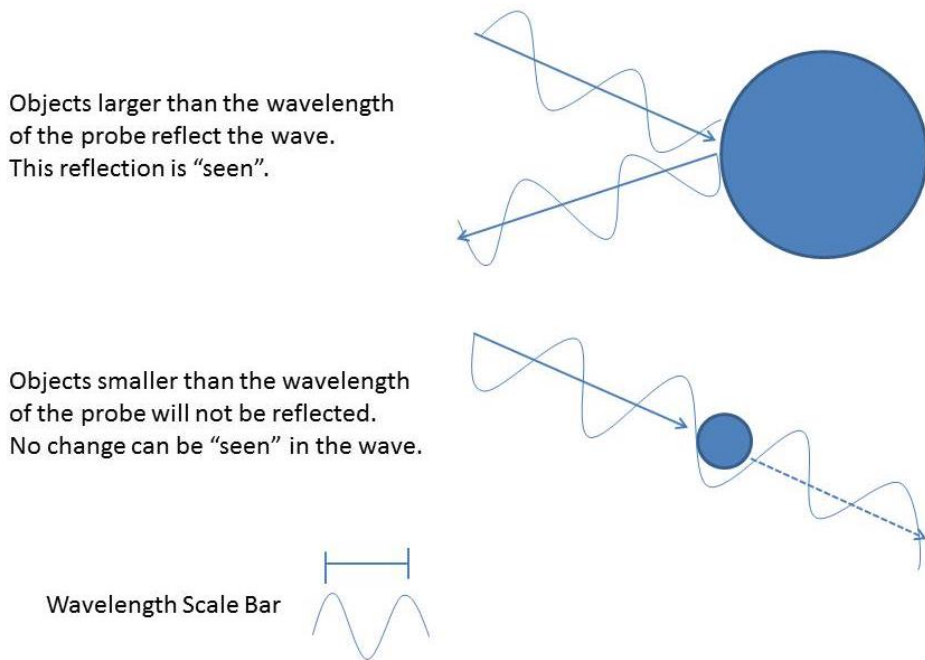
The type of pipe to be examined should also be taken into account as different materials can absorb, reflect, or refract the probe laser in different ways, altering the perceived resolution (Hummel 2001). Even the roughness of the surface of the pipes can have an effect on laser reflection. The resolution will determine the minimal size crack that can be detected at a given distance under nominal conditions (Chu and Butler 1998). This information should be available from the manufacturers' literature in the form of a "Distance versus Resolution" graph, or even as an equation. Figure 2-7 presents an overly simplified depiction of how an object's detection is related to the size of the wavelength.

**Figure 2-6: Object Detection in Relation to Wavelength**

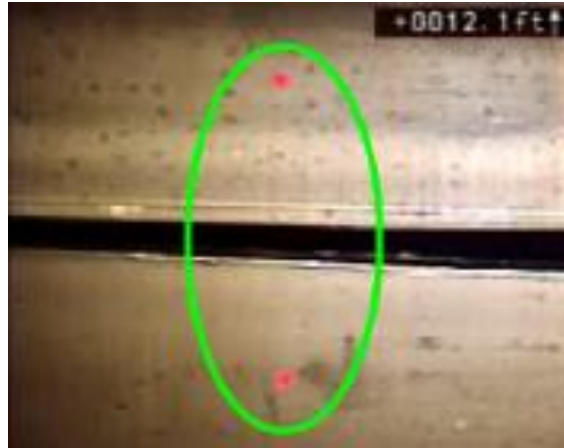
A video micrometer, typically attached or built into a laser profiling setup, consists of two parallel lasers. These lasers are spaced apart at a known distance, and they function as a reference point when measuring the required defect. Proper measurement of a pipe defect necessitates proper alignment of the CCTV mechanism. Using the image as a guide, an operator must maneuver the recording device so that the image and respective laser beams are perpendicular to the longitudinal axis of the pipe. When an image of the defect and the two laser points is properly captured on the screen, a ratio can be established between the screen image pixilation and the known reference distance between the two lasers. With this corresponding value, the profiling software can then calculate the corresponding defect measurement.

It is imperative that the two lasers form a  $90^\circ$  angle with the pipe to ensure there is no skewing of the laser lines. If the lasers are not exactly perpendicular to the defect surface, the corresponding defect measurement will be incorrect. Accounting for this likelihood of operator error, some video micrometer manufacturers offer an H-beam laser. As the name implies, the image produced by an H-beam laser resembles the letter H. The purpose of this particular shape is to verify on video if the laser is truly perpendicular to the defect – as a slight angle difference will cause an obvious visible distortion of the H-beam. Looking at Figures 2-9 and 2-10, one can compare the images of a two-point laser system with that of an H-beam laser system.

**Figure 2-8: Measurement of a Joint Gap with a Video-Micrometer – Using Two Laser Beams**  
*(from C-Tec Presentation)*

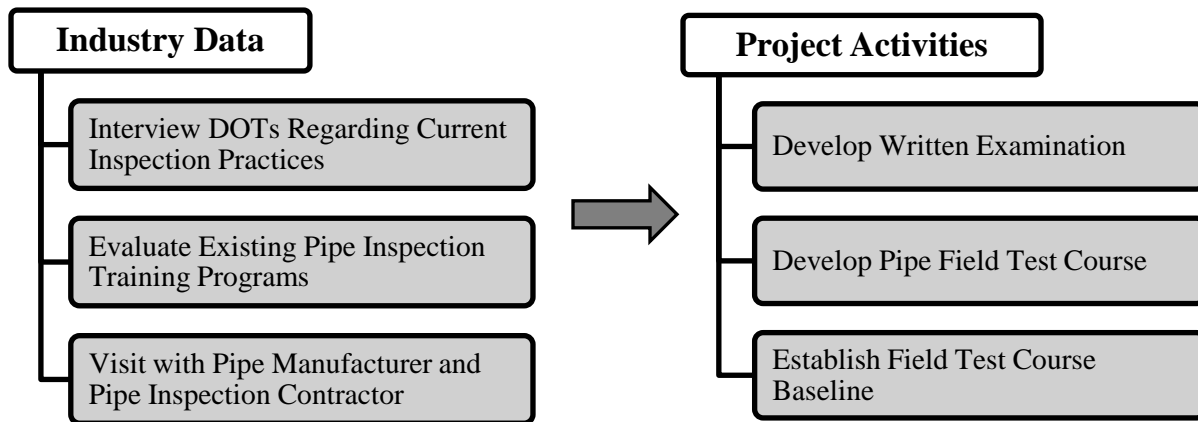
A synthesis of the industry was necessary to establish Florida’s standing in the use of laser profiling equipment for the inspection of post-installation pipe culverts. Moreover, an evaluation of the current practice in pipe culvert inspection was deemed essential in gauging the overall industry culture. As illustrated in Figure 3-1, input from all levels of the pipe inspection industry were essential in establishing key project activities. Regulating agencies, existing certifying organizations, pipe manufacturers and inspection contractors alike would provide the data in which to frame the basis for the written exam, field test course and baseline.

**Figure 3-1: Influence of Industry Data on Project Activities**

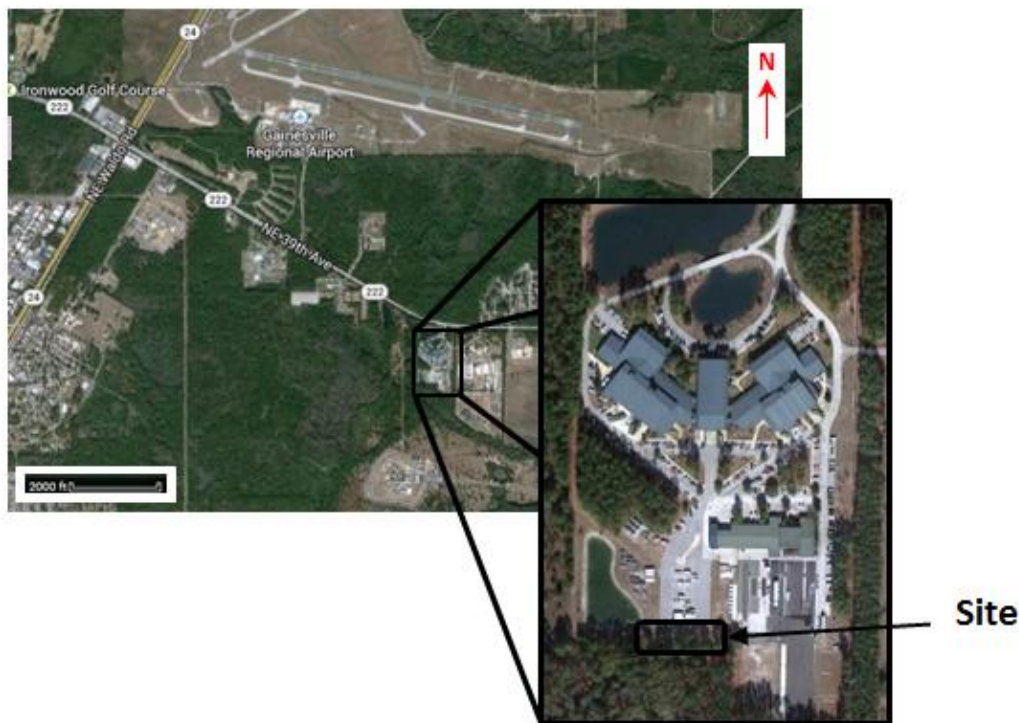
The research team met with key individuals from the FDOT State Materials Office (SMO) to establish an ideal location for the pipeline field test course. After discussing potential sites available to the research team, it was decided that setting up on the southernmost part of the SMO site was most convenient for accessibility. Figure 3-2 shows the designated area set aside by the SMO for the development of the field test course – located far enough away from existing testing facilities to prevent disturbance and still within access to the road for material delivery.

**Figure 3-2: SMO Site Map for Pipeline Field Test Course**

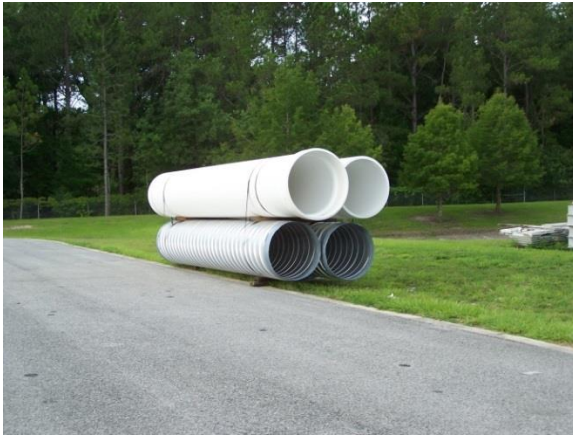
Once delivered onsite, pipe segments were positioned into place with the use of a 4-ton capacity forklift. Individual pipe segments rested on 4-foot pieces of 4"x4" lumber, with chocks to keep them in place. Figures 3-3 to 3-9 illustrate the positioning of pipe material.

**Figure 3-3: Delivery of PVC and CMP**

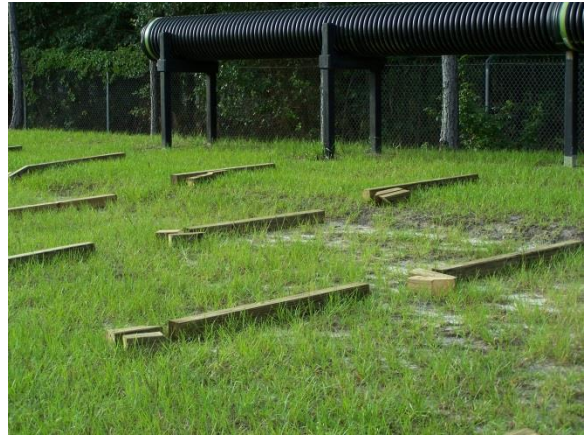
**Figure 3-4: Lumber Supports and Chocks**

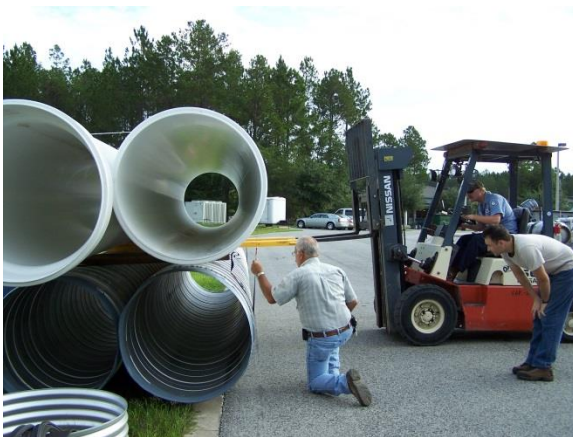
**Figure 3-5: Forklift Loading PVC Pipe**

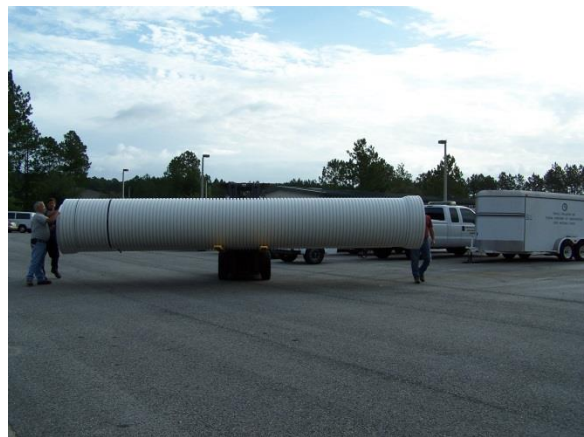
**Figure 3-6: Forklift Moving PVC Pipe**

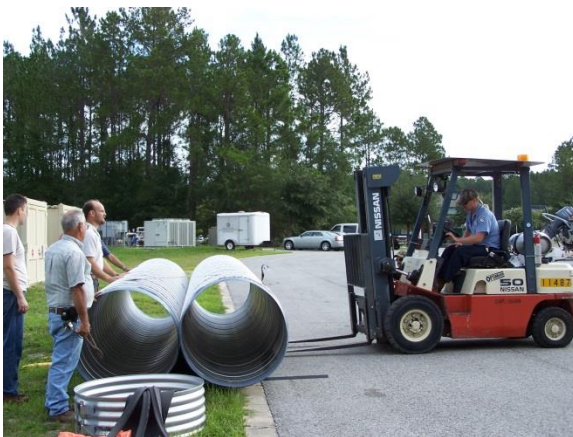
**Figure 3-7: Forklift Loading CMP**

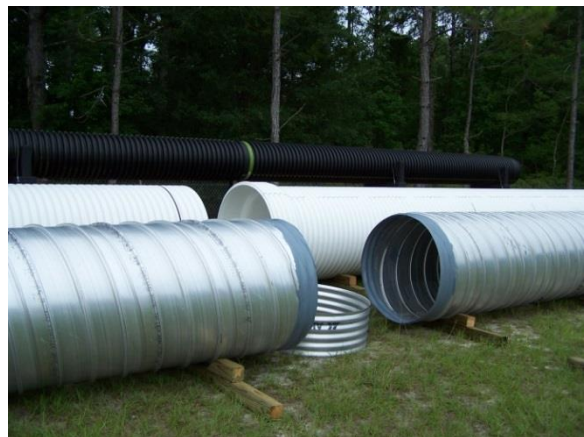
**Figure 3-8: Positioned PVC and CMP**

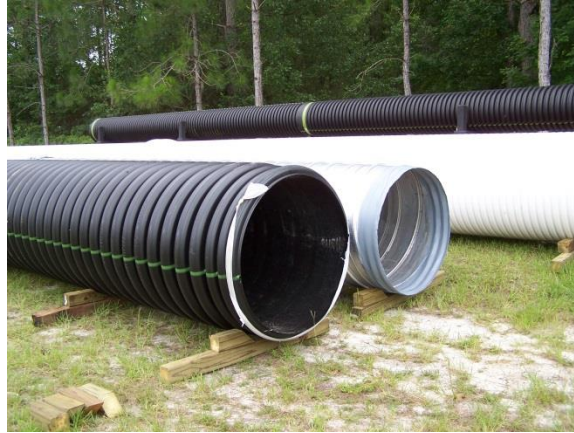
**Figure 3-9: Positioned PVC, CMP, and HDPE Pipes**

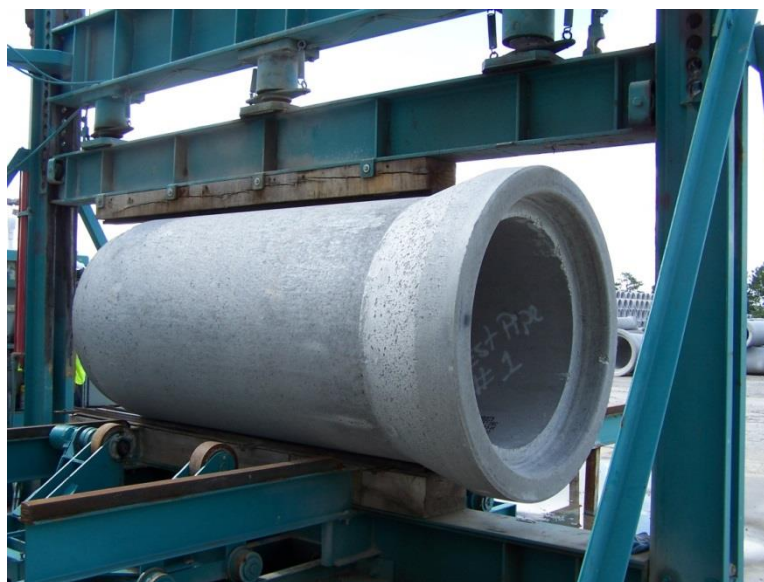
Prior to delivery of the RCP segments, suppliers introduced crack defects on four of the five segments by means of a three-edge bearing test device (Figure 3-10). The pipe segments were loaded until the development of hairline fractures was observed, and in some cases until failure occurred. This ensured a distribution of both “negligible” and “more substantial” cracks (Figures 3-11 and 3-12), illustrating situations that were both common-place and extreme for pipe culvert installation inspection.

**Figure 3-10: Introduction of Cracks on RCP by Means of Three-Edge Bearing Test Device**

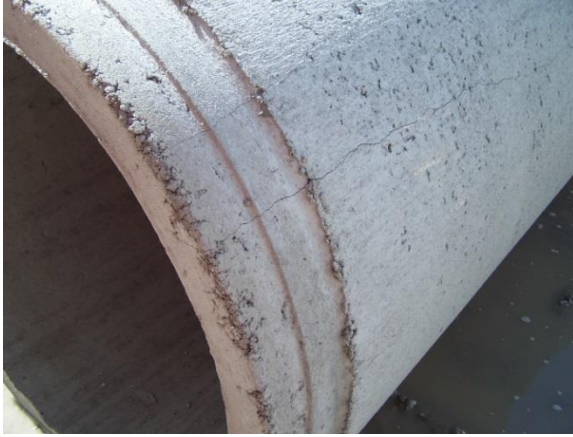
**Figure 3-11: Hairline Crack on RCP**

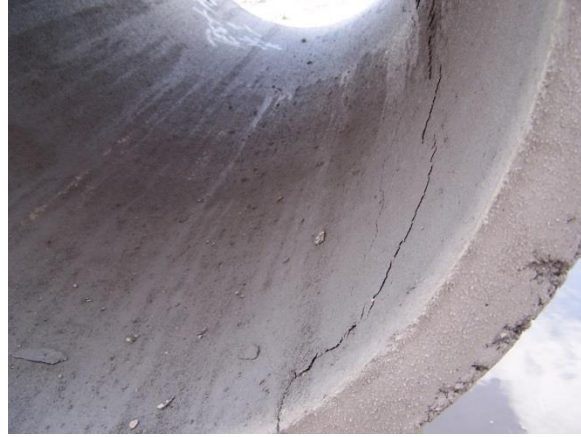
**Figure 3-12: Larger Crack on RCP**

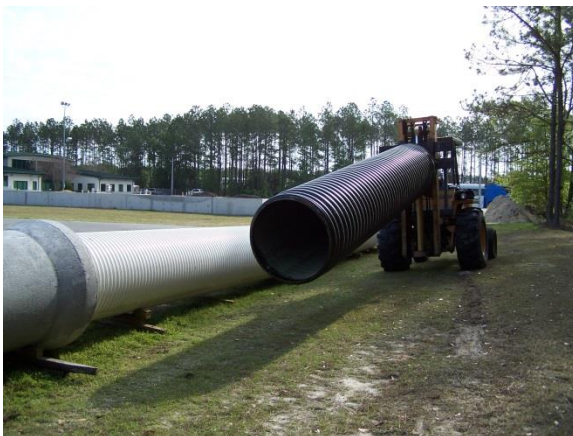
Because of this problem, the preliminary layout of four individual runs was changed a single 164-foot continuous run composed of varying pipe material. Relocation of the entire course, however, was now limited by the inability to move the installed concrete pipe run. Instead, the remaining three pipe runs (PVC, HDPE, and CMP) were relocated to either side of the RCP (Figure 3-13). In moving the pipe segments it was discovered that the terrain to the east of the RCP was at a lower elevation. Sandbags were used to raise individual pipe segments in order to provide a continuous line (Figure 3-14).

**Figure 3-13: Relocating Pipe Segments**

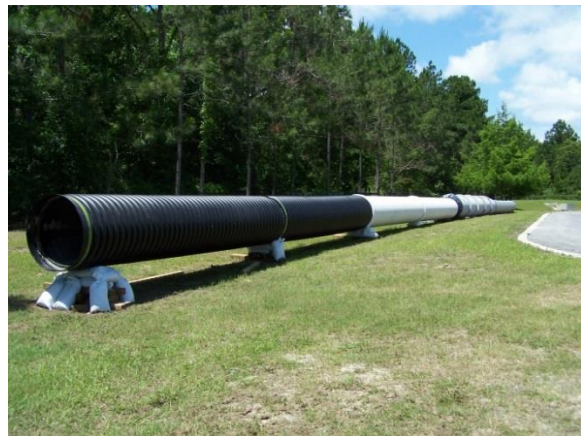
**Figure 3-14: Elevated Pipe Course Run**

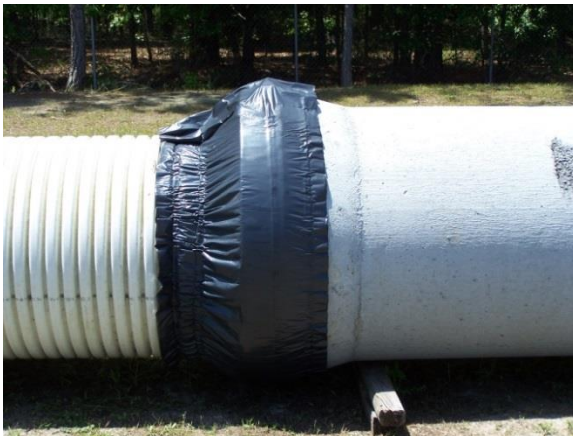
Figures 3-15 and 3-16 show the use of dissimilar pipe coupling material to seal the joints for the PVC-to-RCP and CMP-to-RCP runs. It should be noted that the use of these couplers for the specific dissimilar pipe junctions is not recommended by the coupling material supplier. Because of the extreme difference in outside pipe diameters, these couplers would probably not be used in proper pipe culvert installations.

**Figure 3-15: Dissimilar Pipe Coupler at PVC-to-RCP Junction**

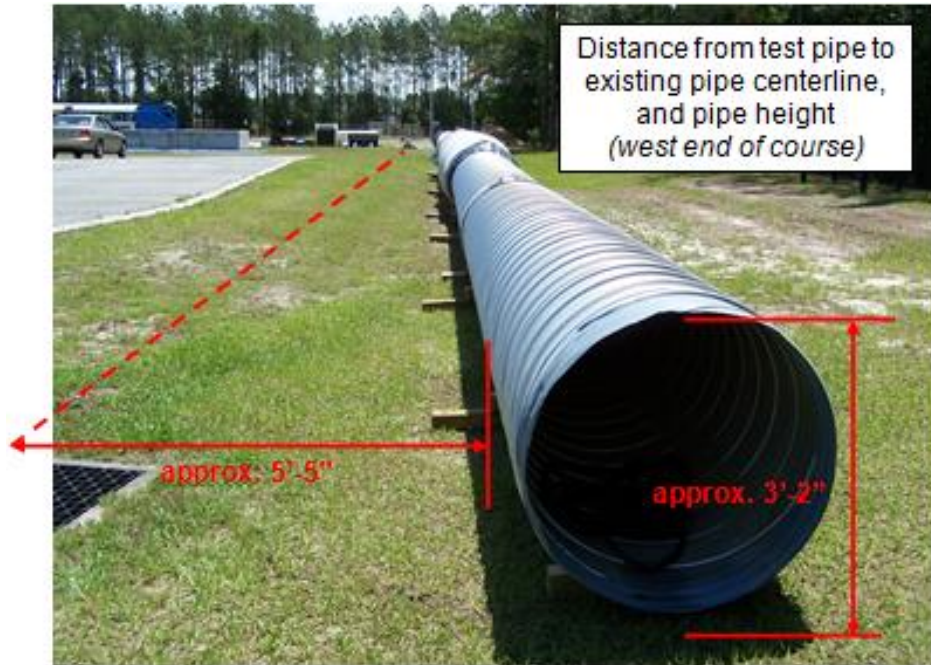
**Figure 3-17: Distance to Existing Drainage Pipe (West End)**

Inability to relocate the RCP also hindered construction of the tarp structure; the continuous run was in close proximity to an existing buried drainage pipe. Support posts would have to be carefully located and in some cases could not be fully inserted into the ground for fear of damaging the existing drainage pipe. Figures 3-17 to 3-21 illustrate the approximated distances between the pipe run and the drainage pipe that were taken into consideration when designing the tarp cover.

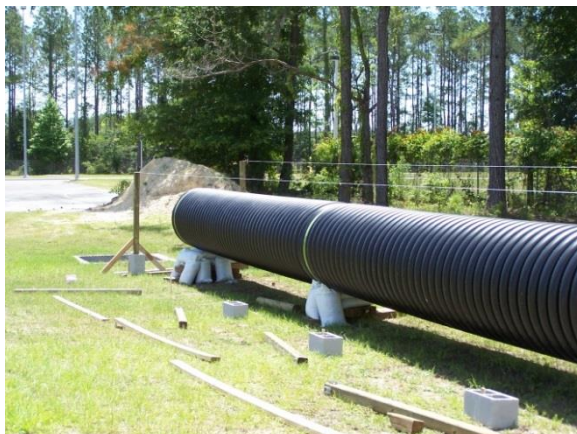
**Figure 3-22: Corner Posts (East End)**

The four corners of the framing structure were located; post locations were staked out; four corner and two mid-point posts were set up; and a line was strung up between the posts. The remainder of the post holes were dug, posts erected, and framing was set up.

Posts that were located directly above, or within close proximity to, the existing drainage pipe were not buried completely underground but instead were supported by cinder blocks filled with concrete. All other posts were buried at a maximum depth of 3 feet. Figures 3-22 to 3-31 illustrate the construction process of the framing structure.

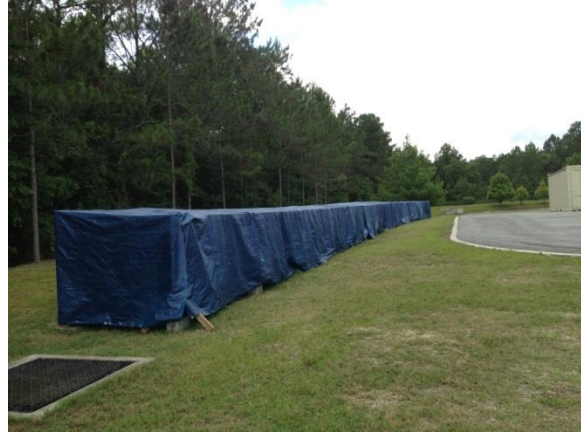
**Figure 3-31: Completed Structure with Tarp**

The course was covered by tarp for two reasons: (1) to prevent the influence of thermal expansion on pipe defects, potentially influencing operator crack measurements; and (2) to conceal the location of pipe defects, potentially influencing operator defect locations.

Final dimensions for the tarp framing structure were approximately 6 feet wide by 170 feet long, with maximum and minimum heights of about 5 feet and 7 feet, respectively. Room was provided for easy access alongside the pipe.

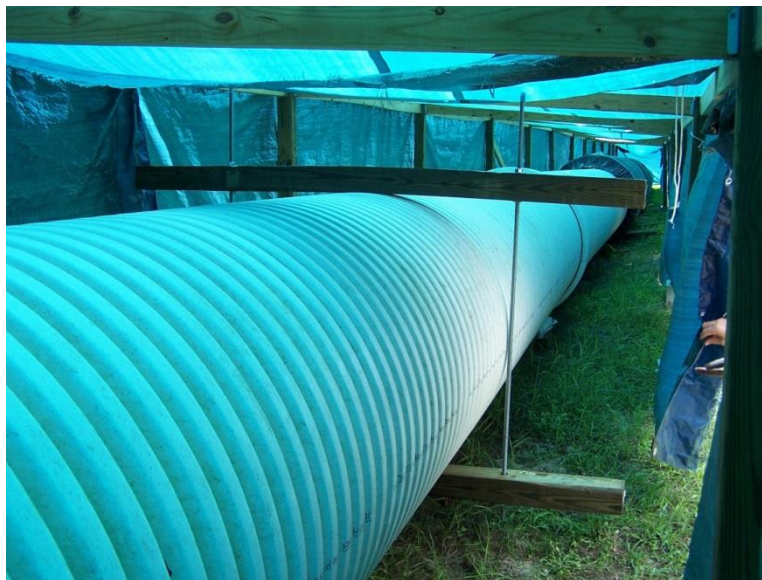
**Figure 3-32: Deflection Vice on PVC Pipe**

Besides the defects introduced during the assembly process, ovality issues were introduced once the entire course run and framing structure were completed. Deflection vices were created from 4x4 lumber pieces, threaded rods, galvanized hex nuts and washers as shown in Figure 3-32.

The devices were tightened in order to produce observable defects within the interior of the pipe.

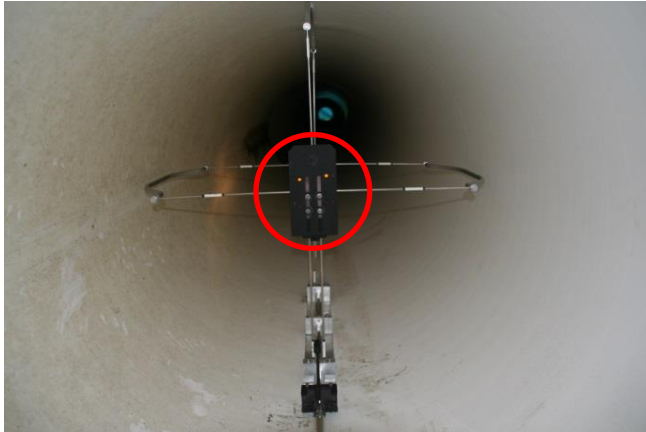
**Figure 3-33: Location before the Deflection Vice**

A pipe deflectometer was used to verify the presence and severity of pipe ovality as a result of the deflection vices. The deflectometer fits inside the pipe and is guided through with the use of attachable extension rods. The deflectometer can be adjusted to fit within different pipe sizes, and as such, spring-loaded mechanisms on the end arms of the device will rest flush with the inner walls of the pipe. As the deflectometer travels the length of the pipe, any variations in the inner diameter of the pipe (exclusively in either the X- or Y-direction) will be displayed by the presence of reflective dots on the faceplate, and the number of dots revealed correlates to the percentage of pipe ovality exceeding the 5% allowed per FDOT specifications – each reflective dot denotes a decrease in the pipe inner diameter by approximately  $\frac{1}{4}$  inch. Figures 3-33 to 3-35 illustrate the process by which the device was used to confirm deflection in the pipe.

To ensure the device was “snug” within the confines of the pipe, the end arms were extended to fit a larger sized pipe, thus explaining the presence of two orange reflective dots (circled) at the onset of the test.

These two dots were regarded as a “baseline” and the intent was to observe changes in the number of reflective dots.

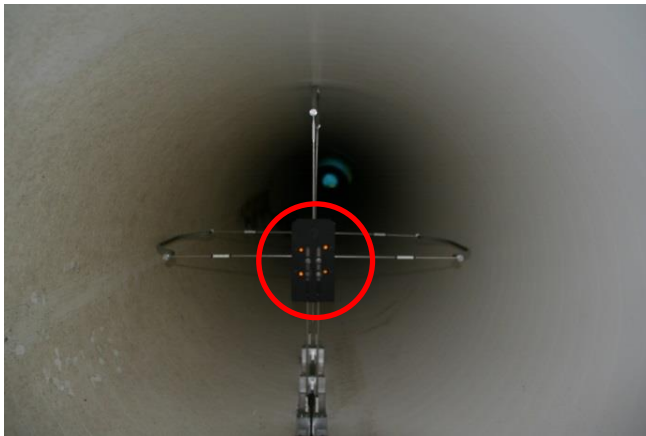
**Figure 3-34: Location at the Deflection Vice**

At the location of the deflection vice there is an observable increase in the number of reflective dots.

Two additional dots were seen for a total of four reflective dots (circled).

The net increase in reflective dots at the location of the deflection vice confirms a total deflection ranging between  $\frac{1}{4}$  to  $\frac{1}{2}$  inch, with each dot at the site of the defect representing approximately  $\frac{1}{4}$  inch change in inner pipe diameter.

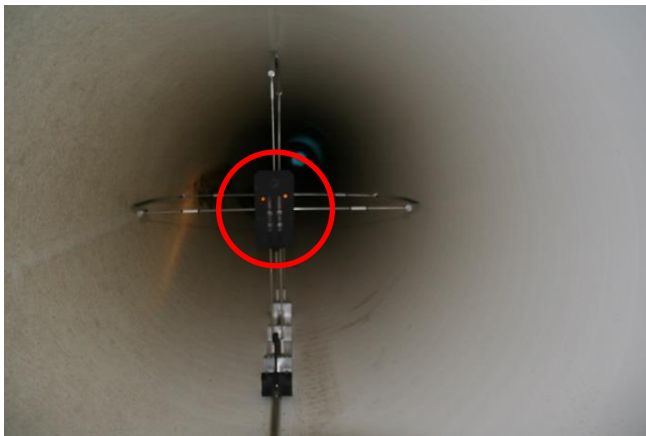
**Figure 3-35: Location after the Deflection Vice**

The additional reflective dots are no longer observed. The faceplate returned to its “baseline” of two dots (circled).

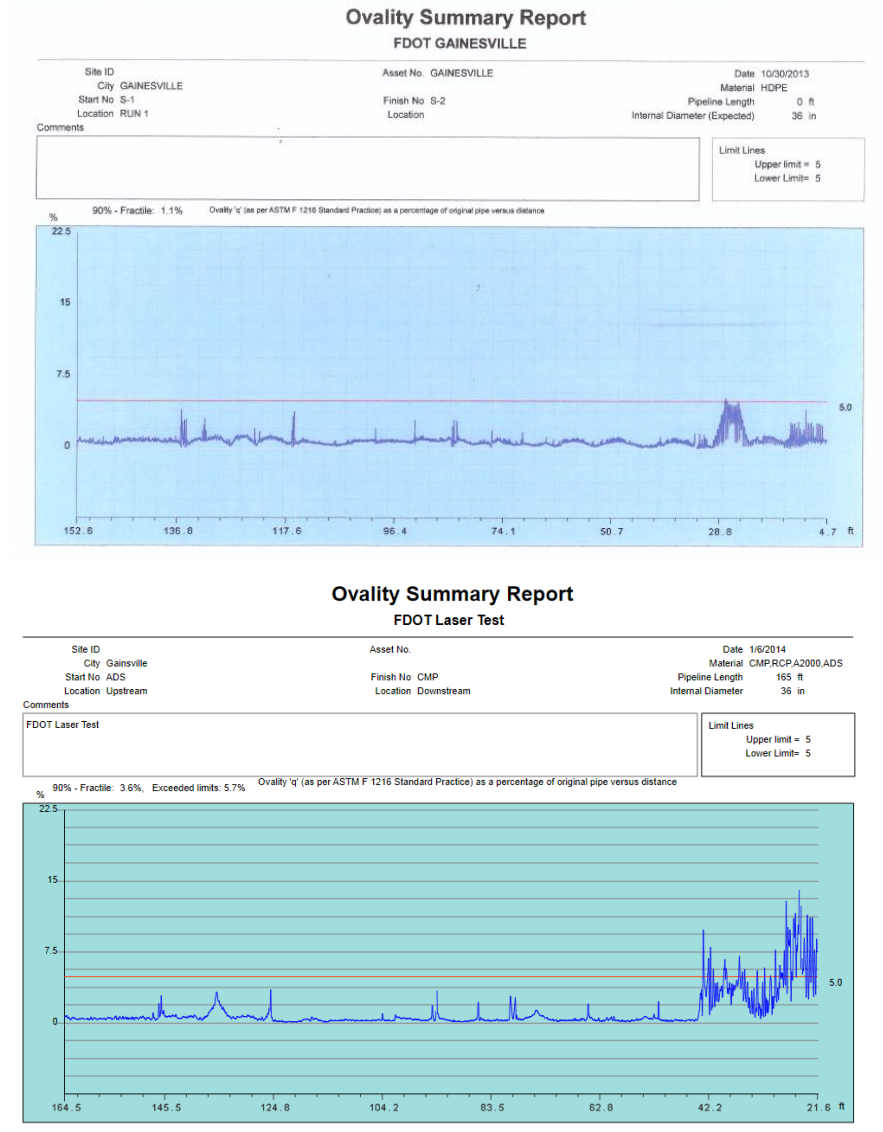
**Figure 4-12: Comparison of Ovality Reports between American In-Line (top) and Granite Technologies (bottom)**

Comparing the content between reports was also revealing. Figure 4-12 shows ovality reports for both American In-Line and Granite Technologies and although the two graphs appear similar (and both use ring-based laser profiling systems) there are a few differences between the graphs. Both graphs appear to show the greatest variance in ovality for the last segment of pipe measured (HDPE). However, there is a notable difference in the magnitude of the values. American In-Line shows the data, on average, falling below the 5% line; however, Granite shows the data, on average, surpassing the 5% line. Since the two graphs present identical scales for the y-axis, there is a possibility that other settings have influenced the output. Profiler settings or software analysis

information could have potentially skewed the results, but without knowing what values were established prior to data processing for the two graphs, we cannot properly assess the reason for the disparity. Attempts to confirm the actual deflection by means of the SMO's pipe deflectometer device were unsuccessful. On two separate occasions, the deflectometer registered pipe deflections exceeding 10%, but when confirmed profiler measurements were taken, the readings came in at under 5%. Faulty design of the deflectometer was suggested but unconfirmed.

Attempting to compare horizontal and vertical deviations Figure 4-13 to the ovality reports in Figure 4-12 illustrates the need for standardization between laser-based system output graphs. While the deviation values are not quite equivalent to pipe ovality,
