## Florida Department of Transportation Research

### The Repair of Damaged Bridge Girders with Carbon Fiber Reinforced Polymer “CFRP” Laminates

BDK82 977-03

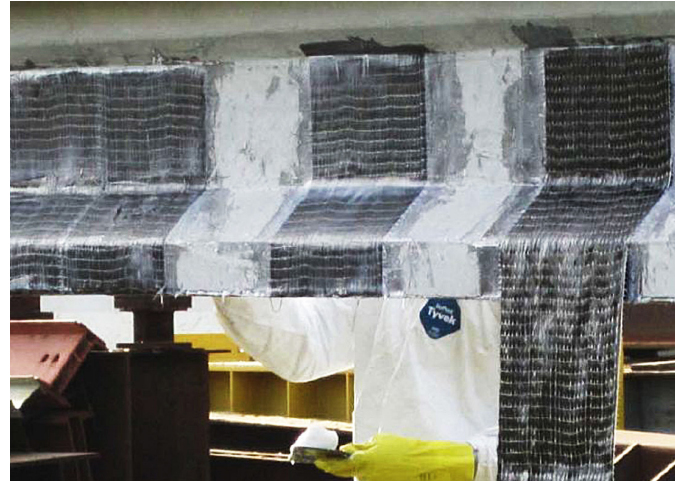
*A technician works on wet layup application of CFRP fabric laminate on a prestressed concrete girder.*
