## Florida Department of Transportation Research

### The Repair of Damaged Bridge Girders with Carbon Fiber Reinforced Polymer “CFRP” Laminates

BDK82 977-03

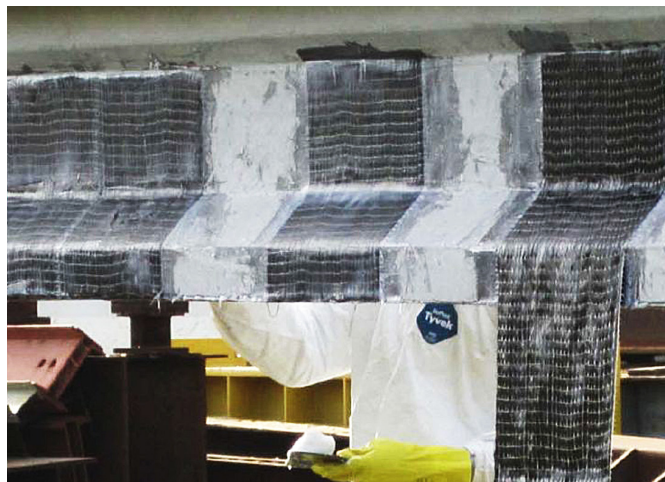
*A technician works on wet layup application of CFRP fabric laminate on a prestressed concrete girder.*

to the girder soffit along with U-wrapping anchored with a longitudinal CFRP strip at the top ends of U-wraps. This configuration restored and increased girders’ load-carrying capacity. Details for optimum application were also described. Evenly spaced transverse U-wrappings provided an efficient configuration to mitigate debonding.
