## **FINAL REPORT**

### **CORROSION CHARACTERISTICS OF UNPROTECTED POST-TENSIONING STRANDS UNDER STRESS**

**Contract No. BDK84-977-22  
Final Report to Florida Department of Transportation**

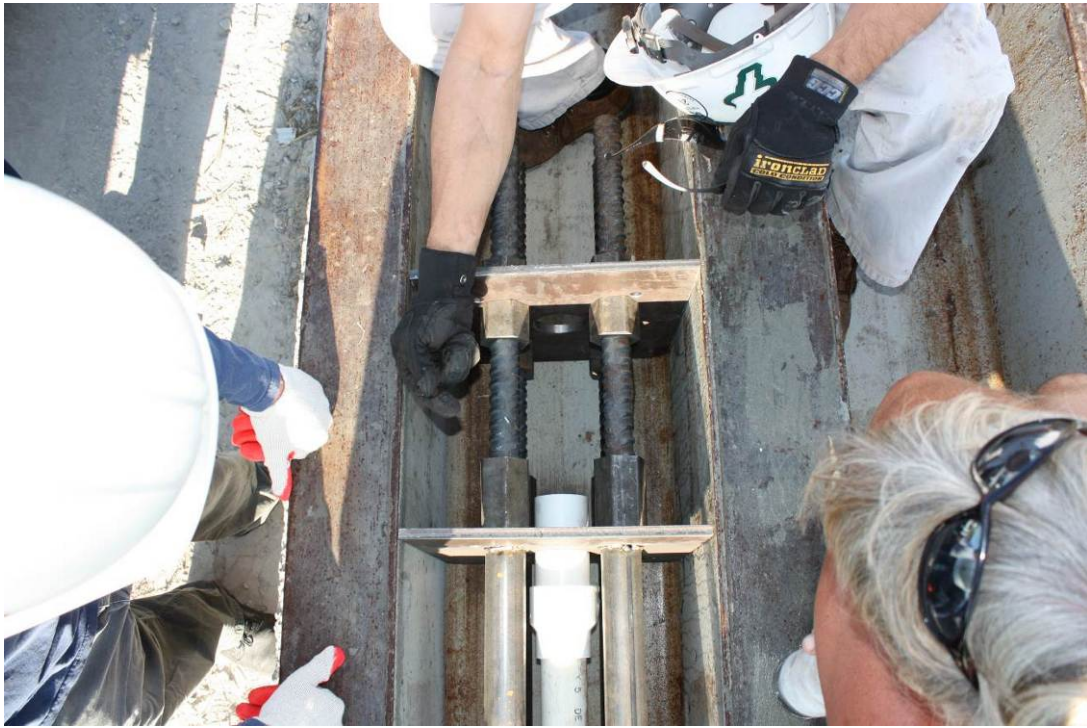
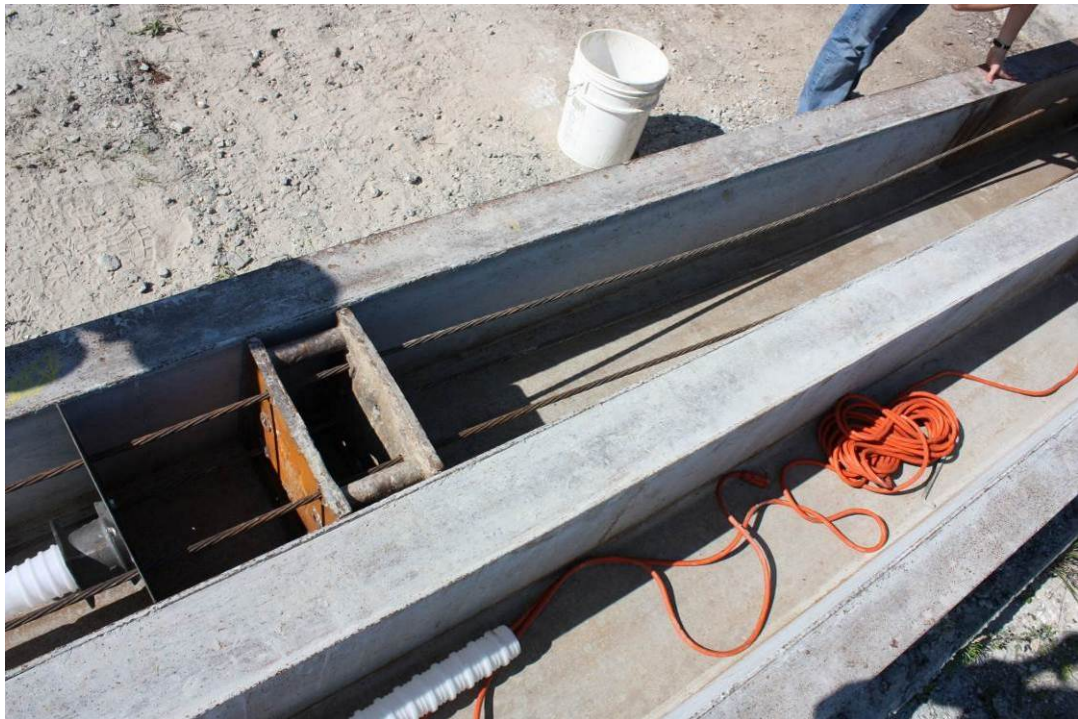
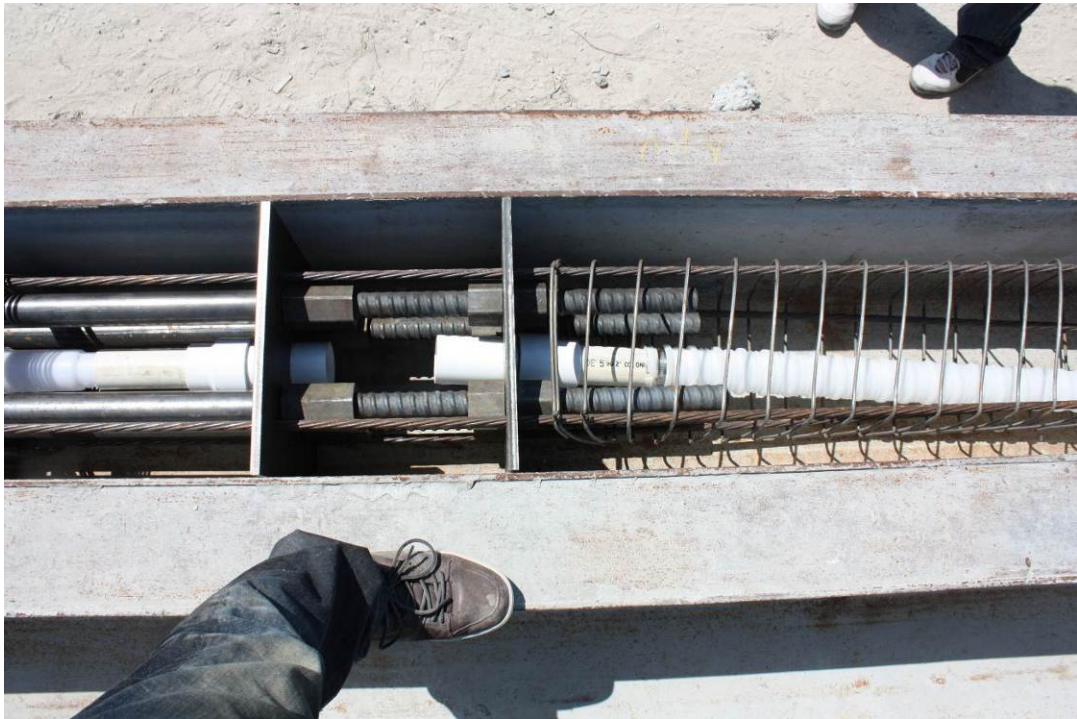
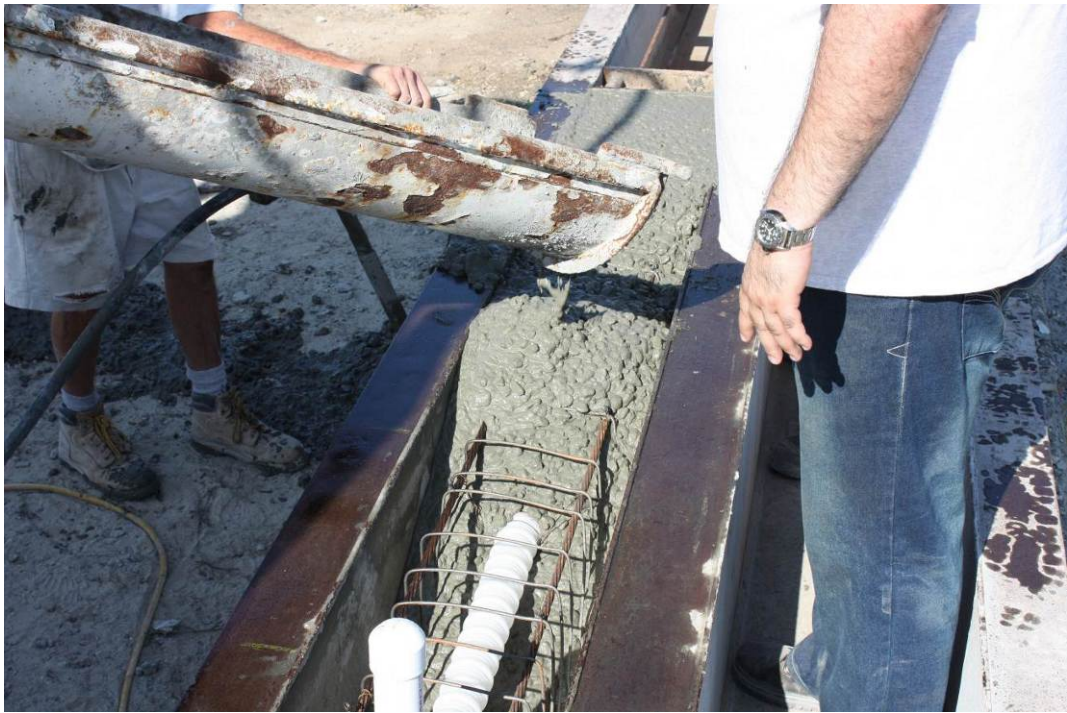
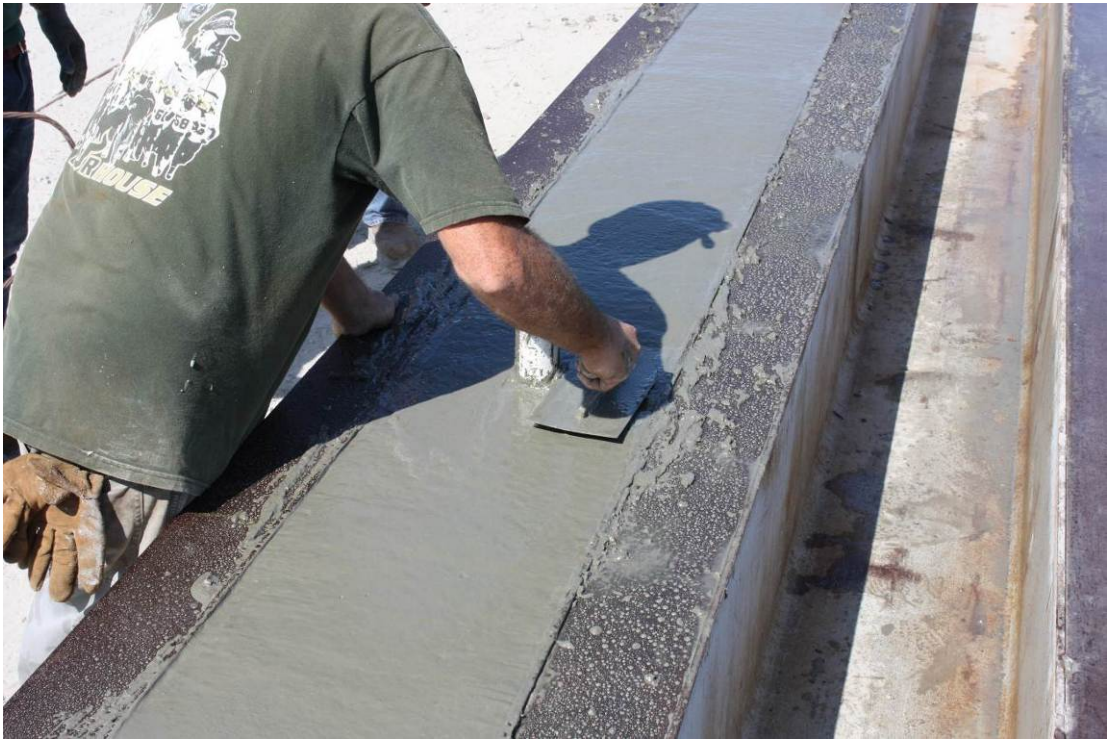
The casting of the piles was performed at Henderson Prestress in Tarpon Springs, FL (Figures 2 through 6). Henderson Prestress provided access to a 14-inch casting bed to the University of South Florida as well as materials and labor for pile construction. After one week, the piles were removed from the casts and transported to both the inland location (USF) and the marine location (SSK). Piles were arranged in an alternating pattern to allow better access to the de-tensioning mechanism. Piles were placed on two dunnage piles provided by Henderson Prestress to allow the small portion of the pile to move per the design, and the piles were made level using concrete blocks.

**Figure 2 Setup for Casting of De-Tensioning Piles**

**Figure 3 Prestressing Strand for Casting of De-Tensioning Piles**

**Figure 4 Spiral Wire for Casting of De-Tensioning Piles**

**Figure 5 Concrete Pouring for Casting of De-Tensioning Piles**

**Figure 6 Smoothing of Poured Concrete De-Tensioning Piles**

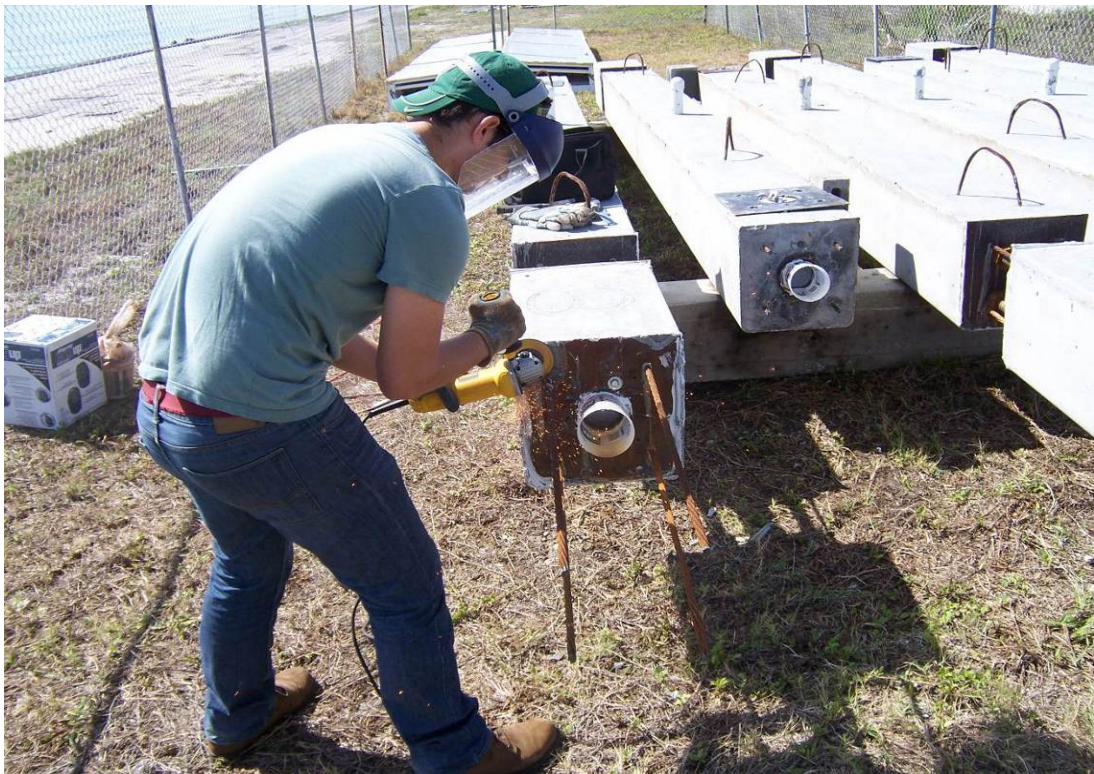
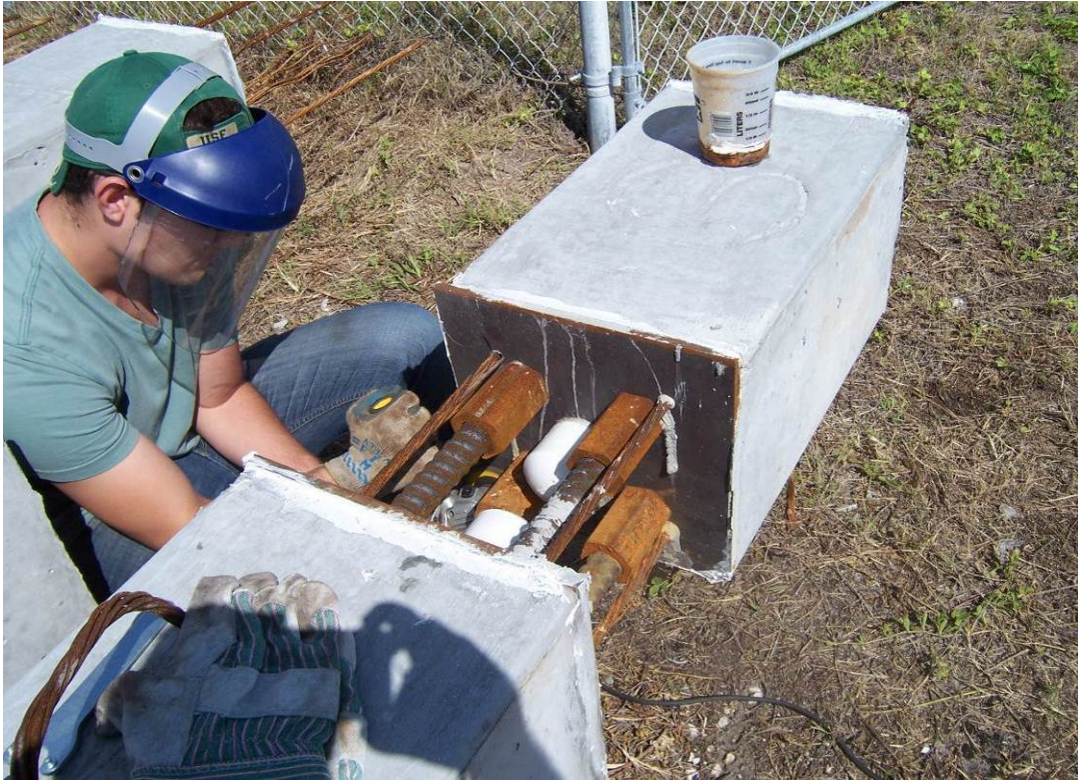
Once the piles were in place, a series of maintenance and cleanup steps were done (Figures 7 and 8). First, the extra prestressing strand material for the strengthening of the piles was removed. Then, the steel plates used to hold the anchor assemblies were removed from the ends where possible. The ducts were cleared out by blowing air through them to remove any water or dirt that may have entered into the ducts. The open points on the ducts were closed with plastic caps and sealed with weatherproof silicon. Rust inhibitor was applied to the exposed metal. Weatherproof silicon was applied to any joints of metal to concrete to prevent crevice corrosion. The layout of the piles at USF location is shown in Figures 9 and 10. The layout of the piles at SSK location is shown in Figures 11 and 12.

**Figure 7 Cutting of Excess Strand Material**

**Figure 8 Cutting of Excess Strand Material**

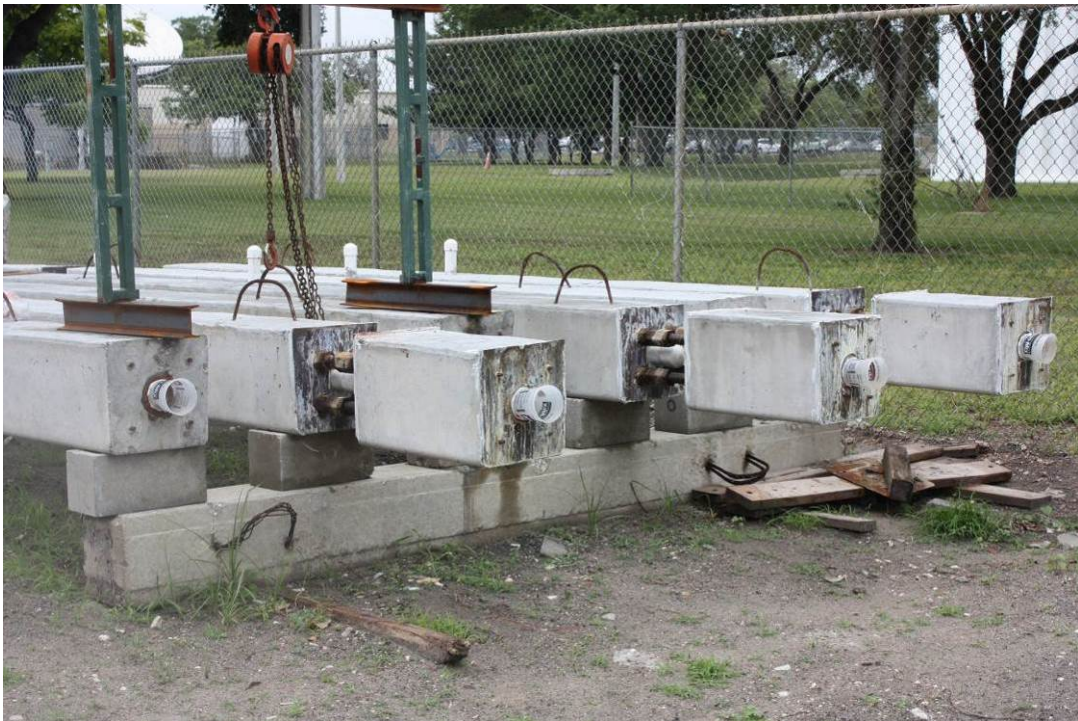
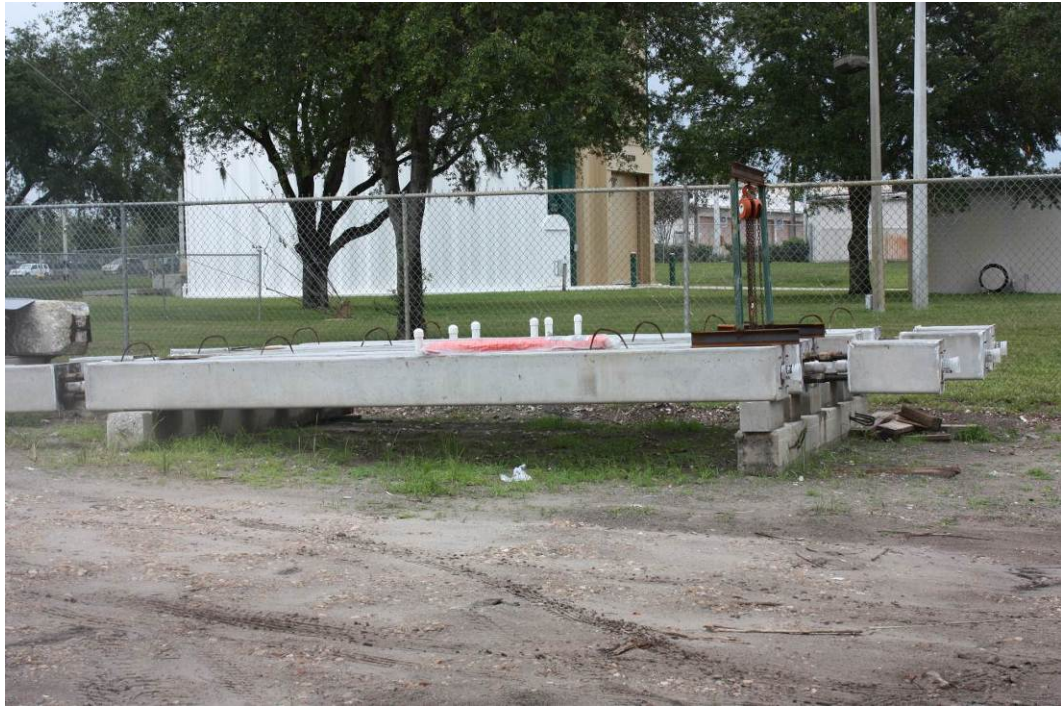
**Figure 9 De-Tensioning Pile System at Inland Location (USF)**

**Figure 10 De-Tensioning Pile System at Inland Location (USF)**

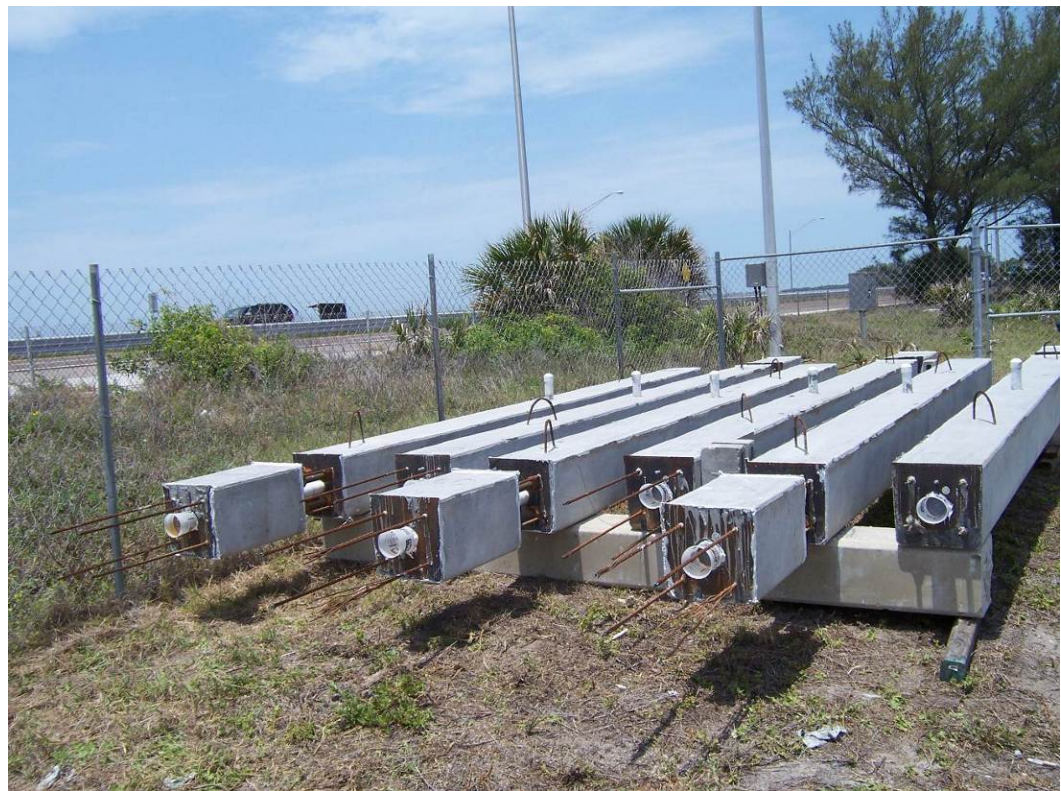
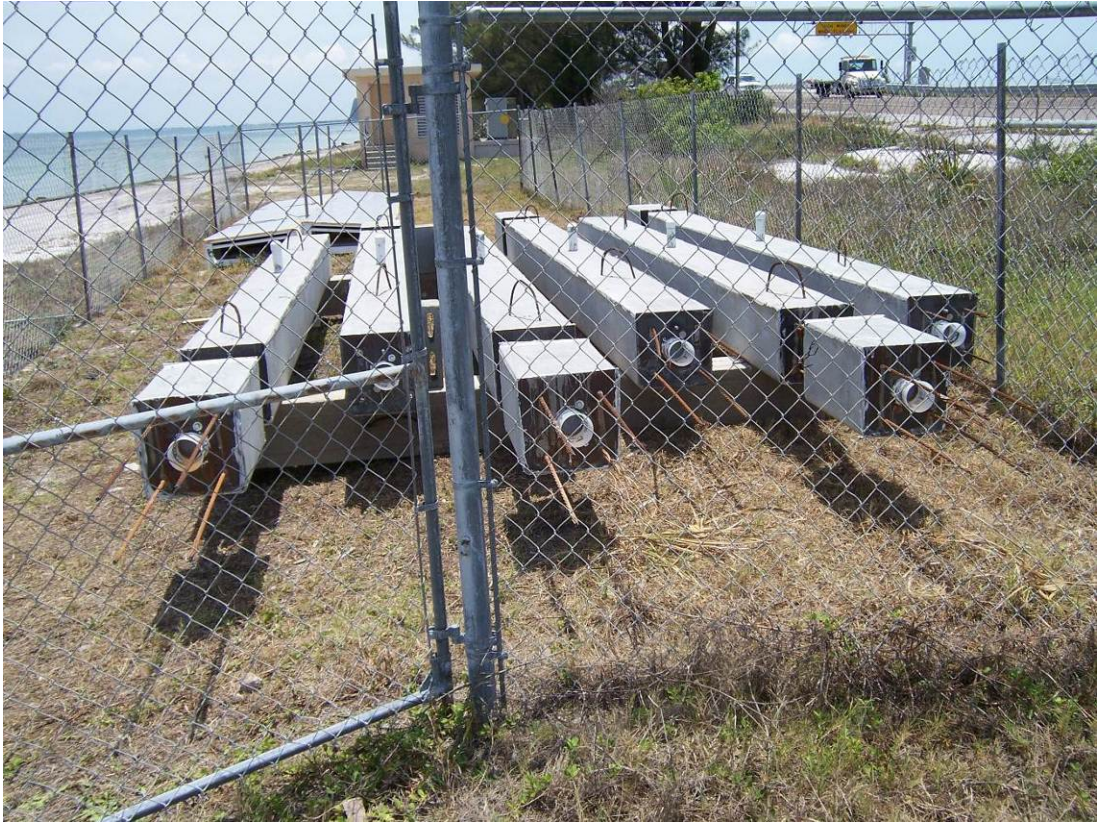
**Figure 11 De-tensioning Pile System at Marine Location (SSK)**

**Figure 12 De-tensioning Pile System at Marine Location (SSK)**

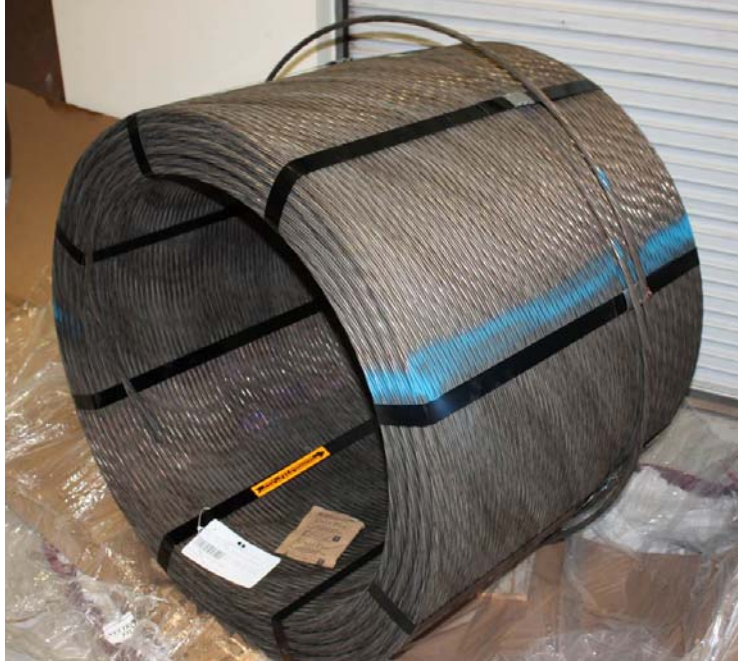
The material used was ASTM A416 7-wire steel strand. The diameter of the strand is nominally ~0.5 inches and has estimated yield strength of 270,000 psi. Steel strand was delivered on 07/18/12 rolled as shown Figure 13.

**Figure 13 ASTM A416 270 Kilo-Pounds per Square Inch (ksi) Yield Strength Prestressing Steel Strand**

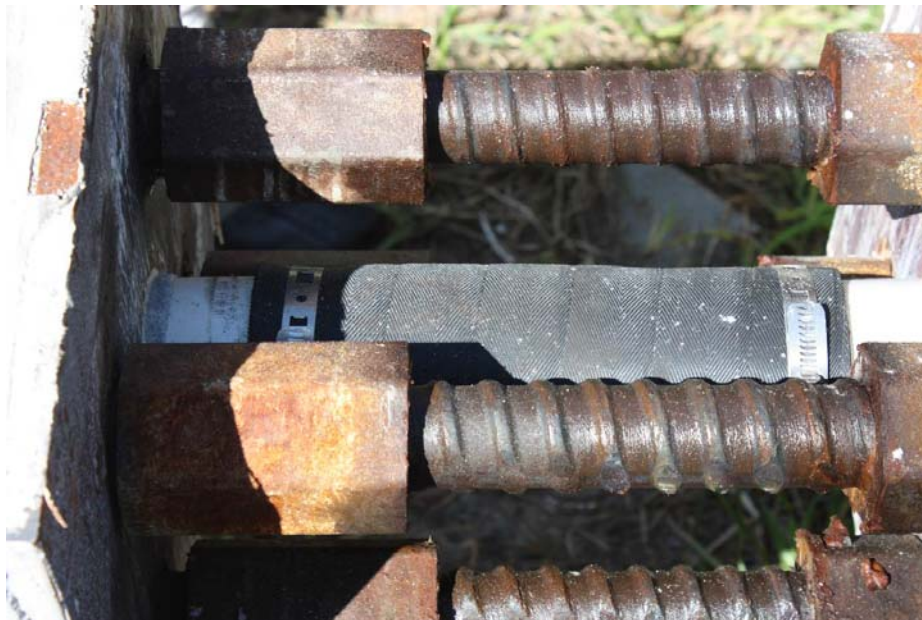
The temporary PVC slip-cap connections were replaced with a flexible bellows connection as shown in Figure 14. Furthermore, the slip-cap connection for the RH access port was deemed inadequate for proper sealing of the ducts, and was replaced with a threaded cap, shown below in Figure 15.

**Figure 14 Installed "Bellows" Connection for Pile Segment Break**

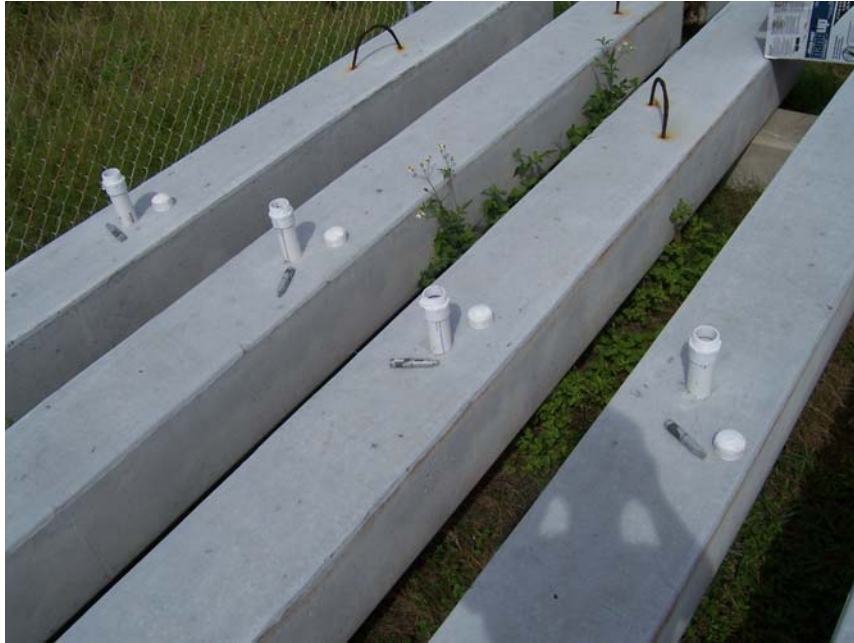
**Figure 15 Threaded Caps for Relative Humidity Probes Access Port**

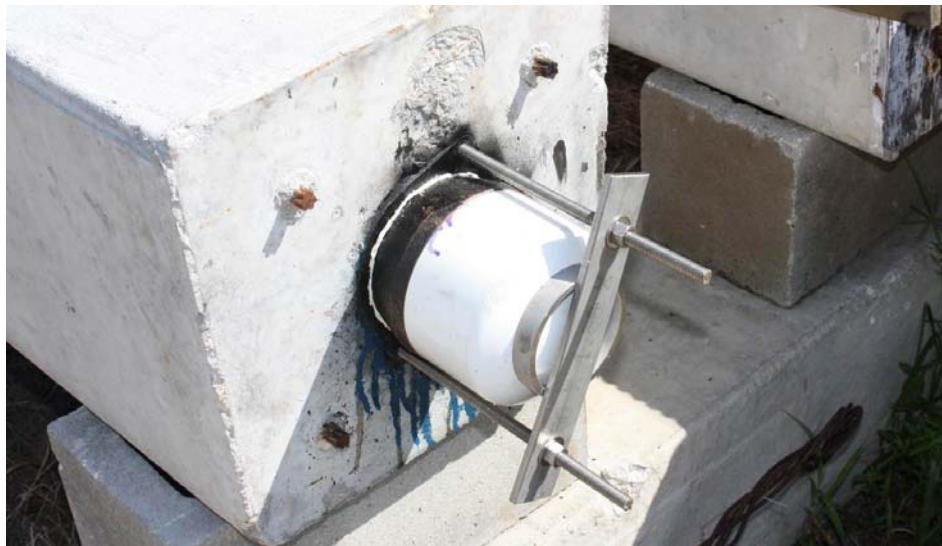
End-caps from the PT anchor body manufacturer were not compliant with FDOT specifications in terms of corrosion resistance. A custom end-cap design was proposed to provide both adequate seal and corrosion protection in lieu of employing the manufacturer's cap. The design includes a standard 4-in PVC slip cap held by a retaining bar and ring which are secured by threaded rods to the anchor body. All metallic elements of the end-cap are stainless steel. A rubber O-ring seal is machined between the PVC cap and the cast-iron wedge plate. The End Cap assembly is shown in Figure 16.

**Figure 16 Custom End Cap installed on East End of Duct 6 at USF Facility**

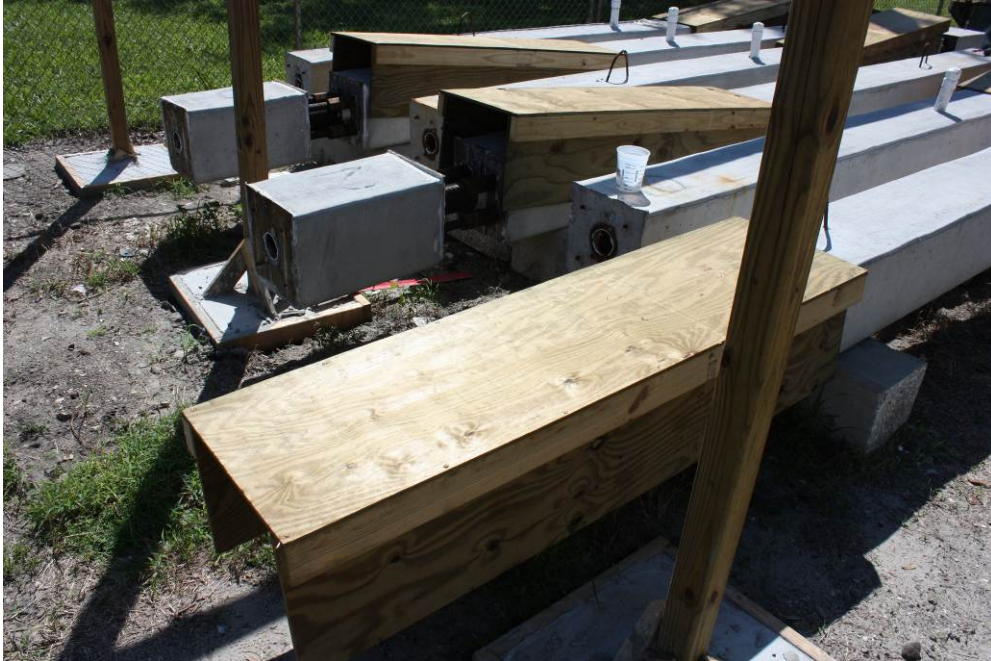
To protect the end caps and pile break steel bars/nuts from undue environmental exposure, wooden cowls fitting over the pile ends were designed, produced, and installed. Figure 17 illustrates the cowls both installed and partially removed.

**Figure 17 Wooden End Cowls at USF Facility**

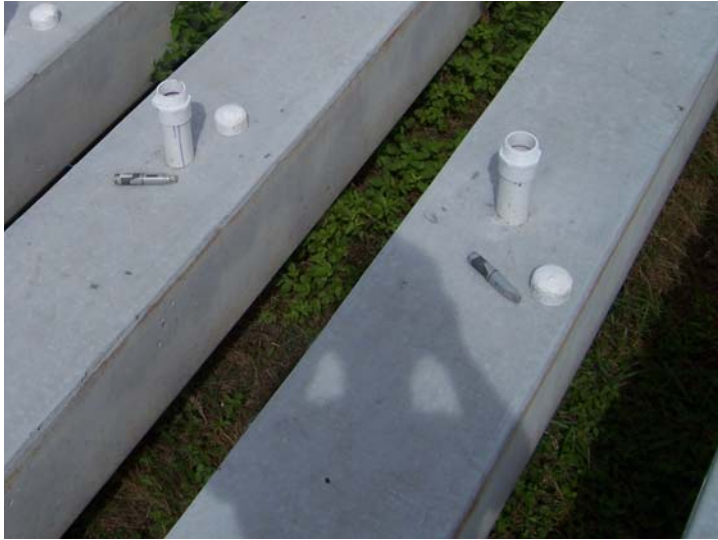
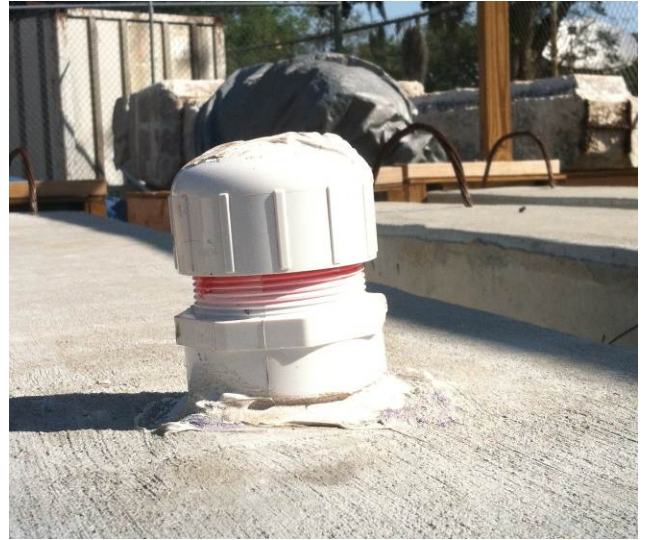
The relative humidity (RH) probe access port was cut to a shorter height (Figures 18 & 19) to reduce the possible reflux in the ducts from the convection of air on the surface of the access port PVC tube.

**Figure 18 RH Probe Access Port Tube before Height Reduction**

**Figure 19 RH Probe Access Port Tube after Height Reduction**

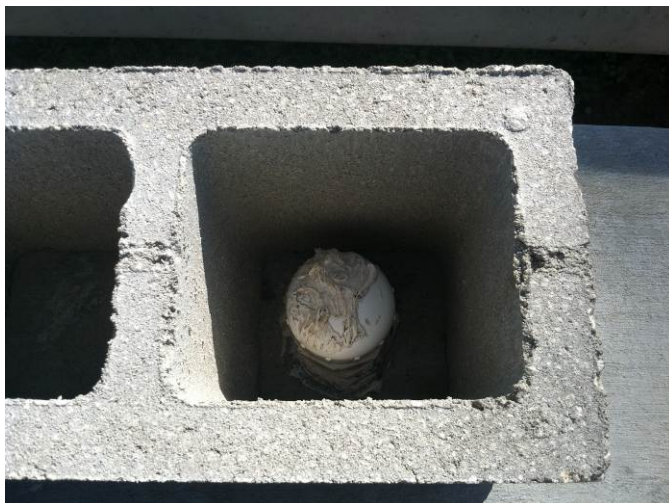
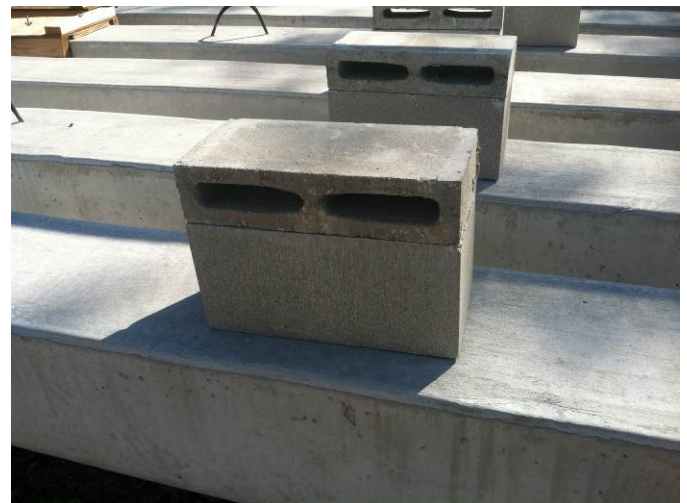
In an effort to further reduce the local environment disparity between the internal duct embedded within the concrete and the portion of duct at the RH probe access port, concrete cinder blocks (Figures 20 and 21) were used to cover the access port thus relieving them from direct exposure to the external environment. At this point, no further alterations were done to the piles, and stressing of the strand commenced.

**Figure 20 RH Access Port Cinder Block Covers, without Lid**

**Figure 21 RH Access Port Cinder Block Covers, with Lid**

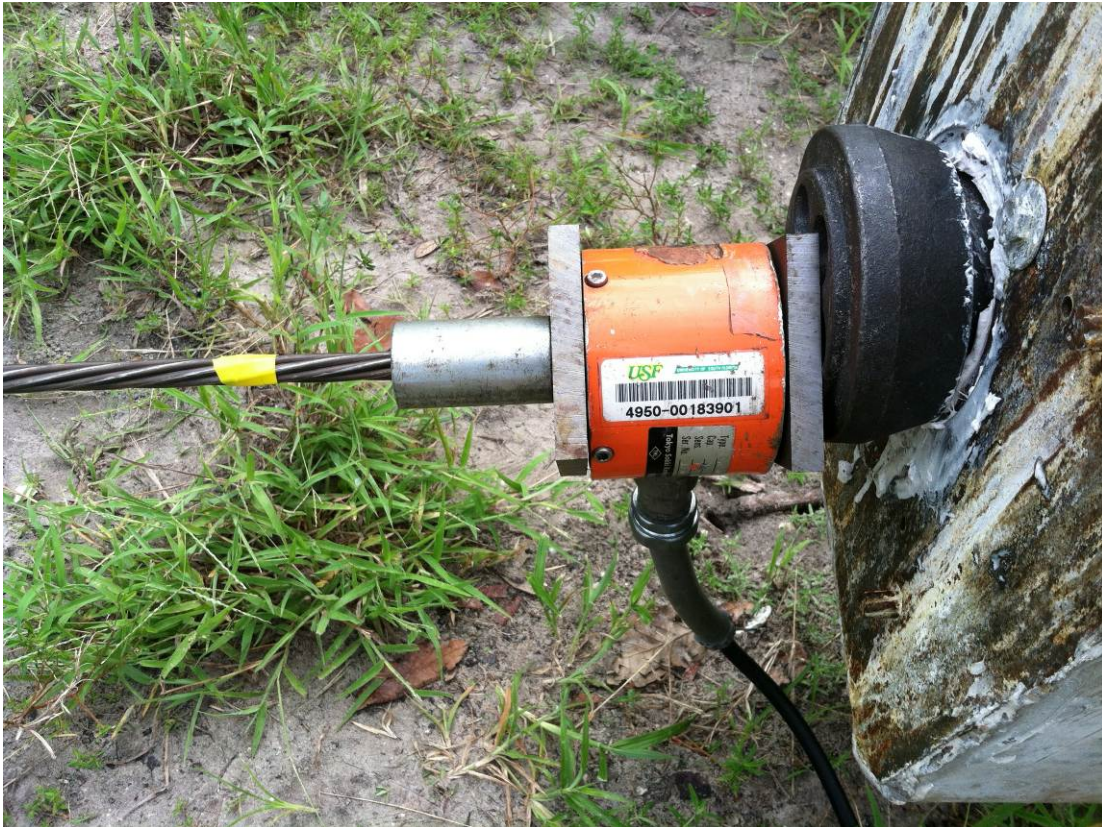
Evaluation of the jack pressure required for appropriate strand stressing and determination of stressing procedure was performed on 07/25/12. A strand sample was paid out from the delivered spool and stressed to various levels. The load cell and jack used, as well as the testing setup are illustrated below in Figures 22, 23 & 24.

**Figure 22 Load Cell Setup for Stressing Operation Test**

Colored electrical tape (yellow – see Figure 22) was used to measure slippage of the strand. The load cell was placed at the dead end and used to measure the force applied to the strand so as to calibrate the hydraulic system. The calibration consisted of measuring the force on the strand as function of the hydraulic system pressure. The force on the strand was divided by the nominal cross-sectional area of the strand (0.144 inches<sup>2</sup>) to obtain the stress on the strand, and plotted as function of the pressure from the hydraulic system. The plot was found to be highly linear as expected. The ratio of the stress on the strand to pressure in the hydraulic pump was found to be 0.0304 ksi/psi. Elongation measurements were in general agreement with the stress levels thus estimated. The jack was fitted with a custom collar to ensure adequate wedge set. Applying pressure to obtain a strand stress of 229.2 ksi and removing jack pressure resulted in a final stress of 220.8 ksi or 0.82  $f_{pu}$ . It was decided to use for the regular stressing procedures an initial pressurization of 1,000 psi to remove any slack from the strand, and then increase the pressure to 8,000 psi (a nominal stress of 243.9 ksi, or 0.90  $f_{pu}$ ) so that upon removal of the pressure and subsequent wedge set a final stress level of about 0.87  $f_{pu}$  would exist. While the code recommended jacking load should not exceed 0.94  $f_{py}$  or 0.8  $f_{pu}$ , (which should then result in a final stress of 0.7  $f_{pu}$ ), all specimens were jacked to a level high enough to overcome large wedge seating losses (due to short strands) and to leave the strand at a higher than normal stress during the exposure ( $>0.8f_{pu}$  instead of  $0.7f_{pu}$ ). This resulted in a more aggravated stress state that offered a greater opportunity of revealing any adverse effect of stress-corrosion interactions during the ungrouted period.

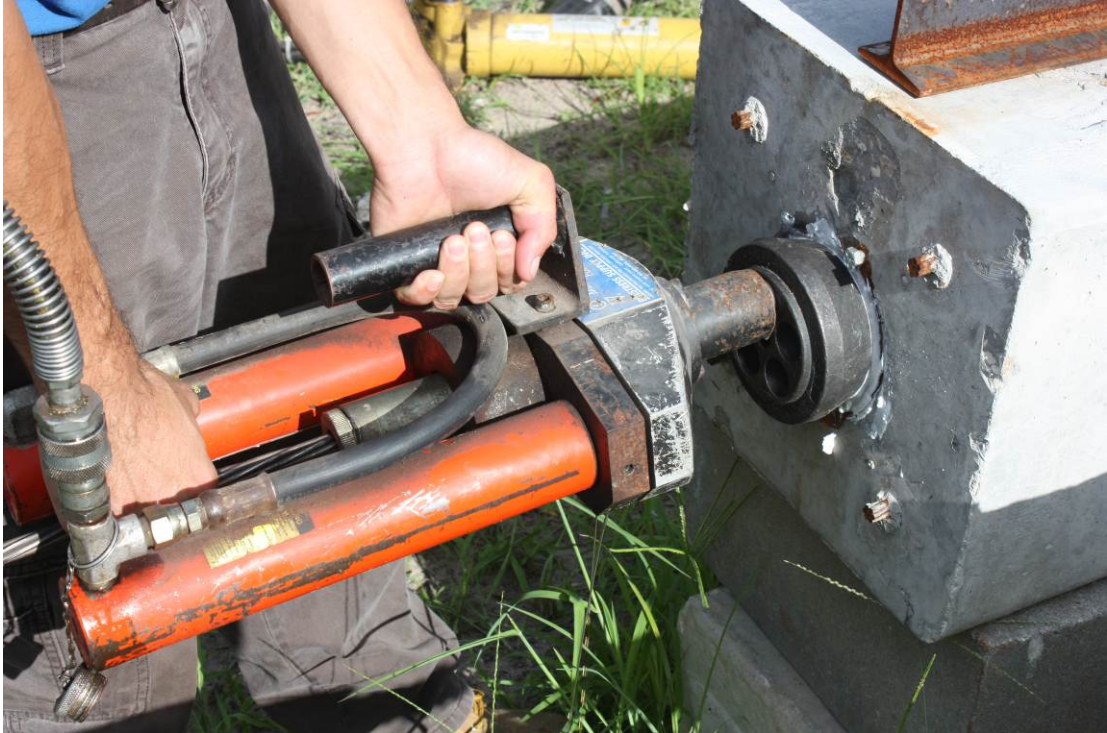
**Figure 23 Hydraulic Jack Setup for Stressing Operation Test**

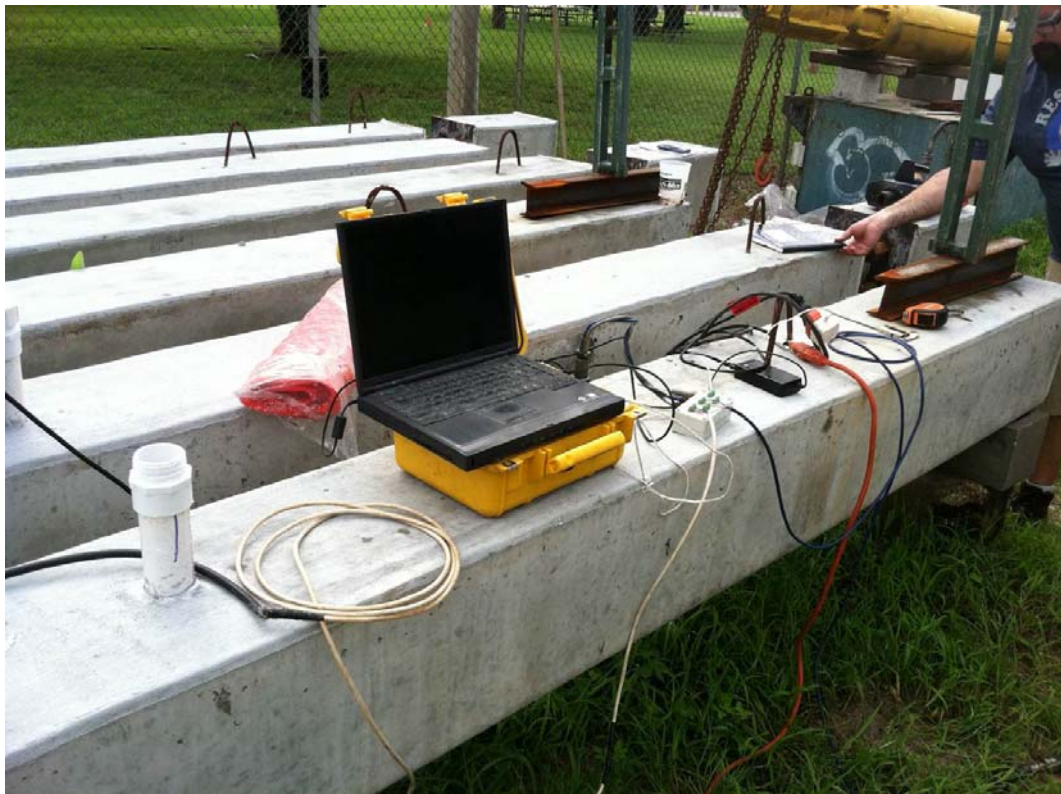
**Figure 24 On-Site Testing Evaluation Setup for Stressing Operation Test**

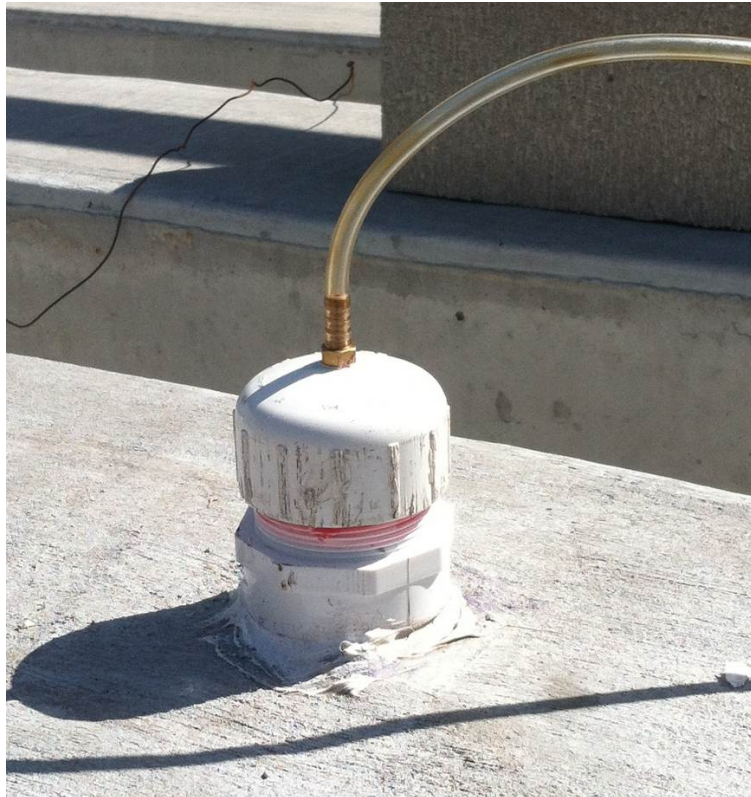
In order to verify the validity of the seal offered by the end caps and flexible bellows connections, a vacuum test was performed on Duct 6 at the USF facility. A threaded cap with a small hole was placed over the RH access port, and a vacuum hose was attached to the cap at the hole, then vacuumed down to 15 inches Hg, and the vacuum level was subsequently measured (see Figure 25). The results of the test showed that the duct can hold vacuum pressure, indicating a sealed system with the bellows and custom end caps.

**Figure 25 Vacuum Hose Attached to RH Access Port for Vacuum Pressure Testing**

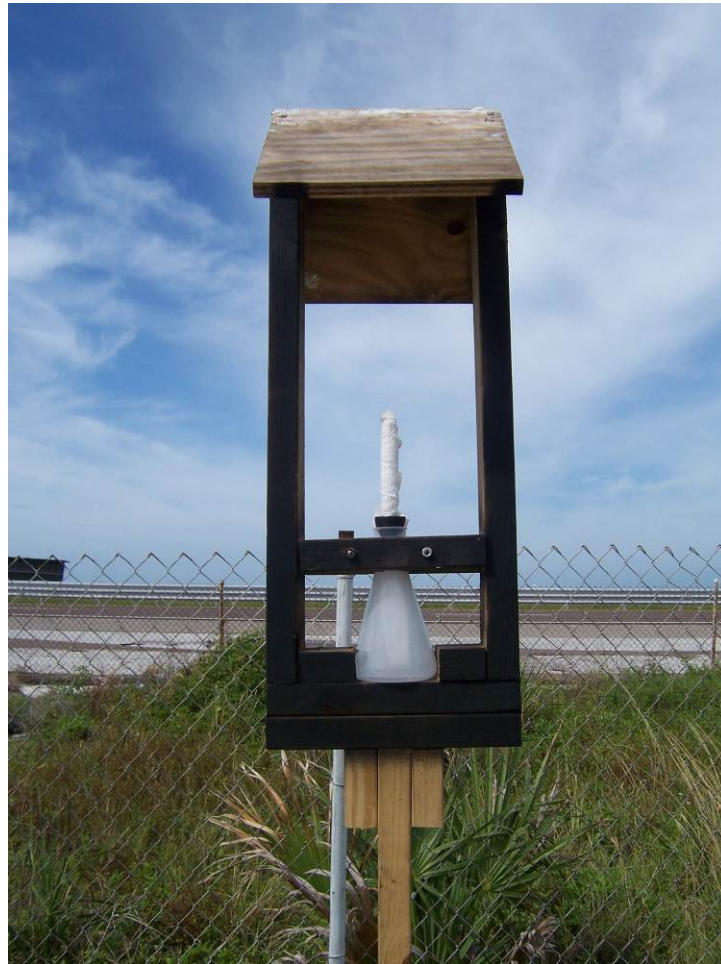
In lieu of an external strand exposure to the environment, the ‘exposed to the environment’ strands were subjected to a controlled laboratory salt spray delivery, thus eliminating the need to circumvent rainfall events in an external environmental exposure. The atmospheric chloride deposition rate was measured at both facilities using a wet candle method conforming to ASTM G140 specifications; the SSK facility wet candle setup is shown in Figure 26.

**Figure 26 Wet Candle Setup for Determining Atmospheric Cl<sup>-</sup> Deposition Rate at SSK Facility**

Duplicate wet candles were exposed for 7 to 8 periods of ~30 days over about 1 year at both facilities. Following exposure, chloride content was determined via ASTM testing method D4458. Chloride content was determined and the atmospheric chloride deposition was estimated. The average, highest and lowest results measured are listed below in Table 3. As expected, exposure at the inland USF location was minimal. The values for the SSK facility were much larger in comparison, but not as severe as encountered at other Florida near-shore locations (Montgomery, 2012). The range of values found in the (Montgomery, 2012) document varied from 75 to 2550 mg Cl<sup>-</sup> m<sup>-2</sup> day<sup>-1</sup> and another analysis from (Echevarria, 2012) showed a range from 100 to 400 mg Cl<sup>-</sup> m<sup>-2</sup> day<sup>-1</sup>. However, both of the measurements from these sources were performed on the Atlantic side of Florida, which may differ from conditions in the Gulf of Mexico side. Also, (Echevarria, 2012) values for sites away from the ocean but near a water way, 100 to 200 mg Cl<sup>-</sup> m<sup>-2</sup> day<sup>-1</sup> were closer to our measured values. Based on those results and to create a somewhat more conservative effect, the salt spray mixture and exposure for the laboratory spray was formulated to simulate a somewhat larger precipitation of 100 mg Cl<sup>-</sup> m<sup>-2</sup> day<sup>-1</sup> (chosen as a lower end value which may be more realistic for the Gulf region). The mixture was prepared by mixing distilled

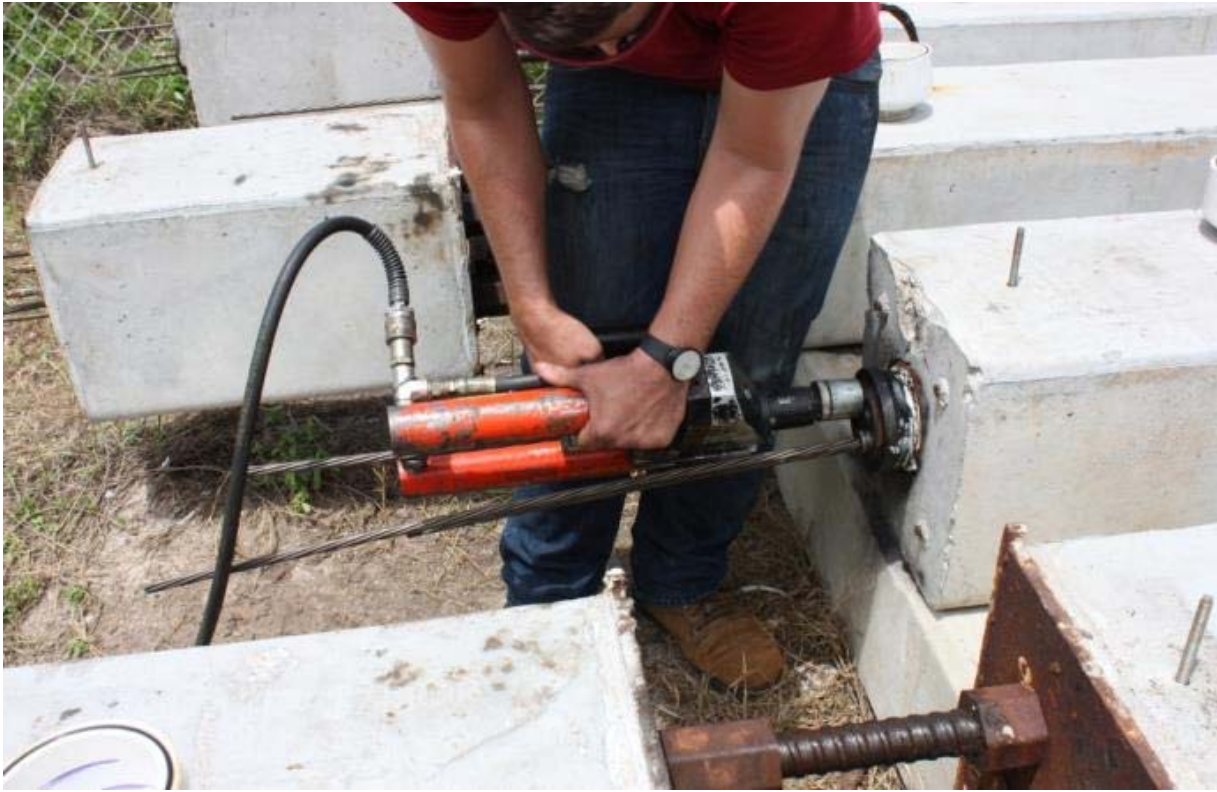
**Figure 31 Mono-Strand Jack Used to Stress Strand**

For placement in the piles the strands were removed from their storage container pushed through the ducts, crossing the two stressed strands by appropriate placement in the wedge plates at opposite ends. Thus, a crossover overlap contact was created somewhere near the center of the pile, that contact was introduced to increase the chances of crevice effects or adverse condensation of moisture in the area of contact. The wedge pieces were then placed on both ends of the strands to be stressed and tightened down by hand. The unstressed control strand was placed in the duct, through the wedge plate holes, but no wedge pieces were placed on them. The stressing of the strands was performed one strand at a time using the mono-strand jack as shown in Figure 31 for the two stressed strand in each pile. Stressing was performed by placing the jack at the end of the pile furthest away from the pile segment break and once stressed the excess strand length was cut away. Examples of the stressed and capped piles are shown in Figures 32 and 33 for the USF and SSK facilities, respectively. Detailed stressing procedures are given in Appendix B.

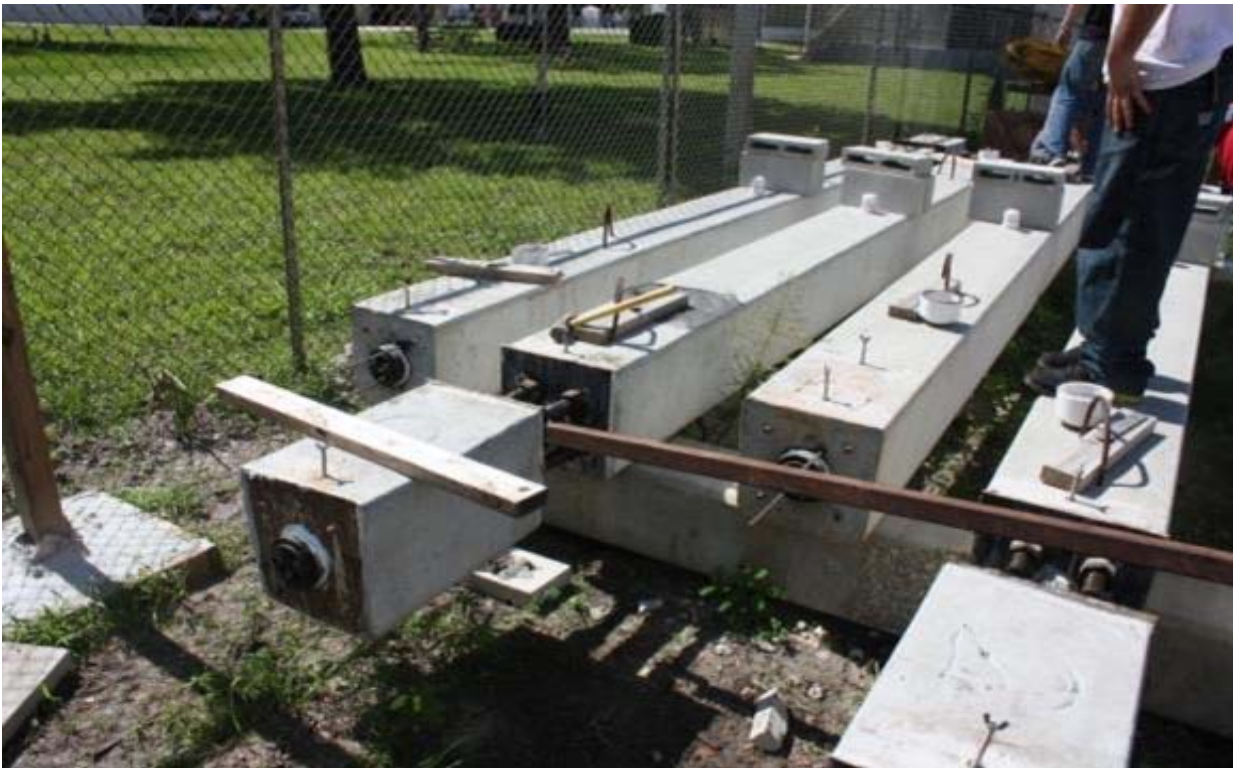
**Figure 32 Stressing Strand at USF**

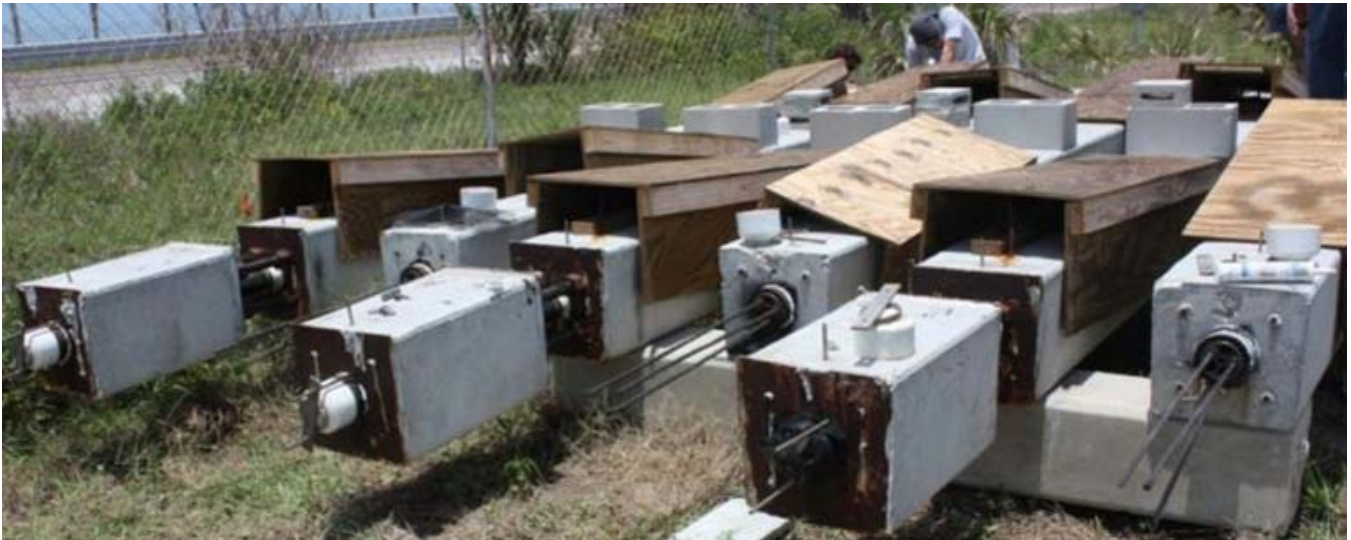
**Figure 33 Stressing Strand at SSK**
