## **FINAL REPORT**

### **CORROSION CHARACTERISTICS OF UNPROTECTED POST-TENSIONING STRANDS UNDER STRESS**

**Contract No. BDK84-977-22  
Final Report to Florida Department of Transportation**

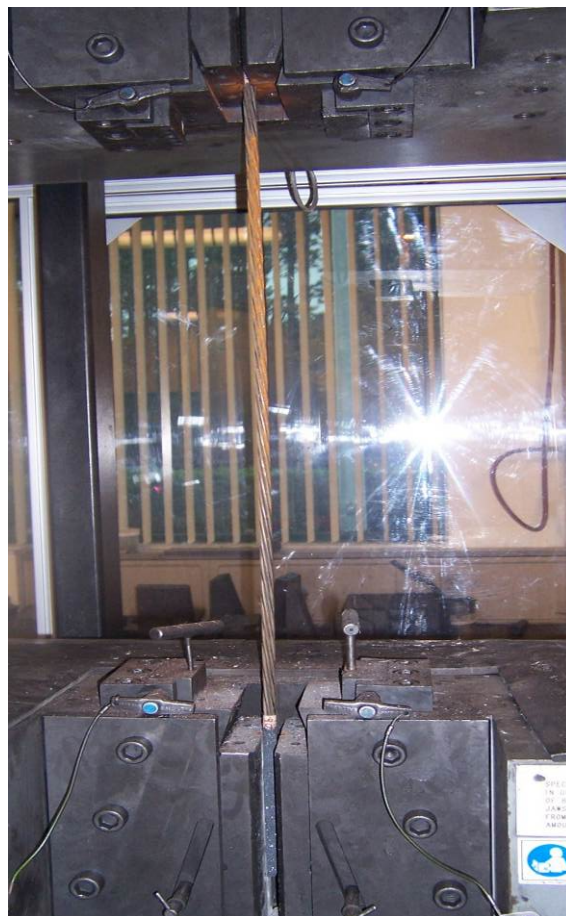
**Figure 35 Typical Strand Placements in Tensile Testing Machine at the FDOT SMO**

The strand tested in this project (7-wire strand A416 270 ksi) was specified to pass the tensile testing method detailed in ASTM A1061/A1061M in terms of yield strength, elongation, and breaking strength. The testing performed here was to determine to what extent strand in the post-exposure condition would satisfy that specification. Removing the de-stressed strands from the piles involved cutting them from the wedge plates, and relabeling them on site. The strands were then brought to the laboratory at USF, where they were then photographed and cut into segments for mechanical testing. A 50" segment was cut from the center of each strand specimen for tensile testing. To improve gripping silicon carbide powder was glued 8" from the ends of the 50" specimen using diluted Elmer's™ glue as detailed in Figure 34. These specimens were then transported to the FDOT State Material Office for tensile testing using the pull testing machine and setup shown in Figure 35. Once the tensile test was complete (the specimen normally broke at the center point between the grips shown in Figure 35), the two separate specimen pieces (as represented in Figure 36) were secured together and transported back to USF for analysis and storage.

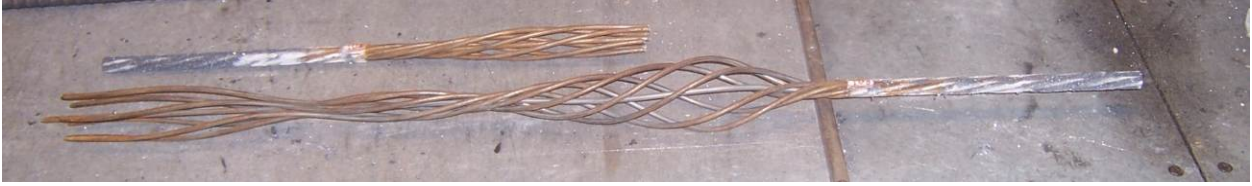
**Figure 36 Typical Strand after Tensile Testing**

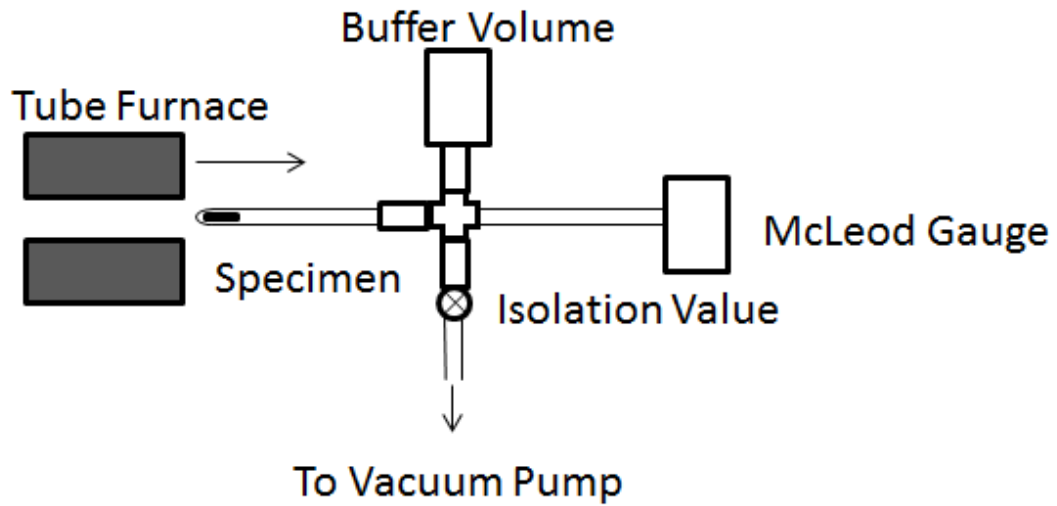
The procedure for the measurement of the hydrogen concentration consisted of outgassing in a vacuum system. Figure 37a and 37b shows a diagram and a photograph of the vacuum system setup respectively. Specimens for this test consisted of a set of four 2" pieces from the outer wires for each strand. Each piece was glass-bead blasted to ensure that there was no surface rust which during outgassing can produce water vapor and falsely increase the hydrogen concentration reading. Then the pieces were placed together in a 0.5 inch internal diameter quartz tube, sealed at the end closest to the specimens and with the other end connected to the vacuum system. The vacuum system was then sealed and pumped down to about 0.05 Torr with a mechanical vacuum pump. A valve was closed isolating the pump from the rest of the sealed vacuum system, which had a total volume of 824 cm<sup>3</sup>. Measurements of the system pressure were taken using a McLeod gauge every minute to establish the value of the leaking rate. After five minutes, a tube furnace set at a temperature of 480 °C was slid over the quartz tube end containing the specimen; the rest of the system remaining at room temperature. Measurements of the system pressure were taken every minute for at least another 35 minutes. The pressure gauge data was corrected for parallax and point of view errors using electronic camera photos taken at each measurement. A photo pixel counting program was used to accurately conduct those corrections.

**Figure 37a Diagram of Hydrogen Concentration Measurement Setup**

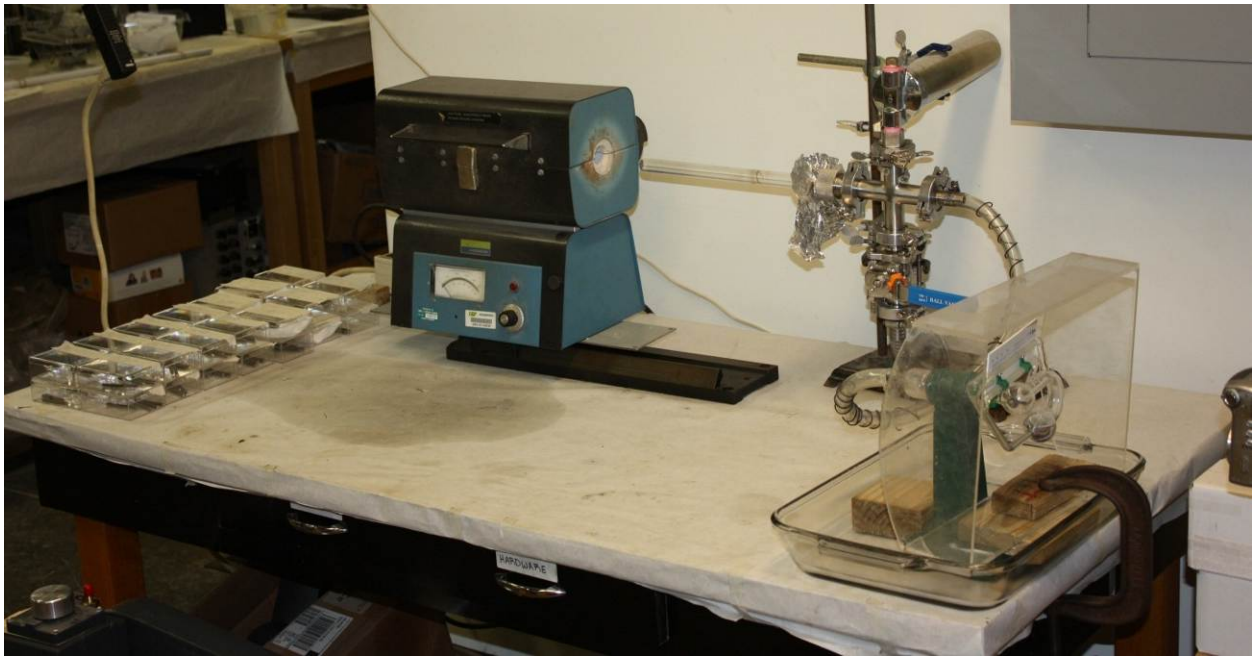
**Figure 37b Hydrogen Concentration Measurement Setup**

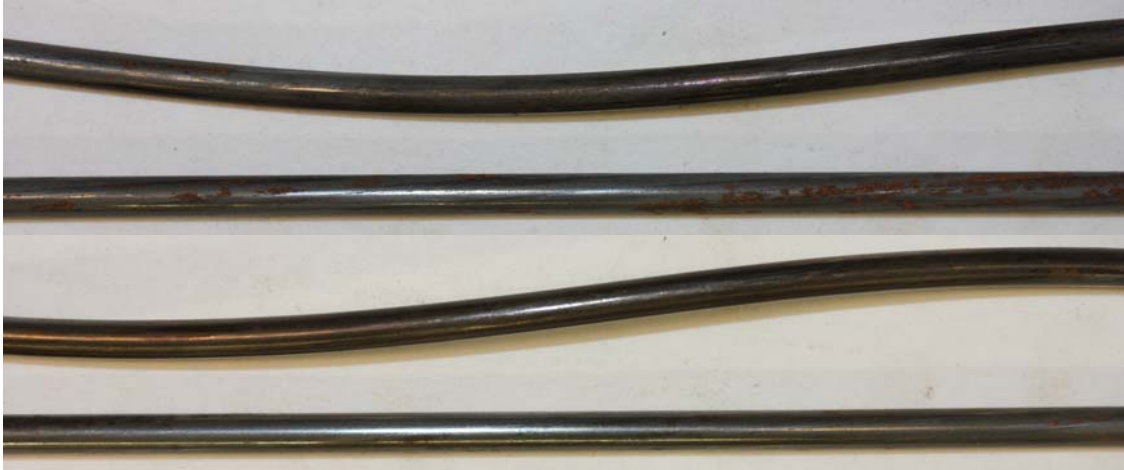
Figures 61 and 62 exemplify wire appearances before and after light surface cleaning, resulting in ratings of 2 and 4 respectively. The picture scale used is given in (Sason, 1992). The summary of all results are shown previously in Table 5.

**Figure 61 Specimen 97a 4 Week not Salted but Wet Exposed (Top) and after Cleaning (Bottom)**

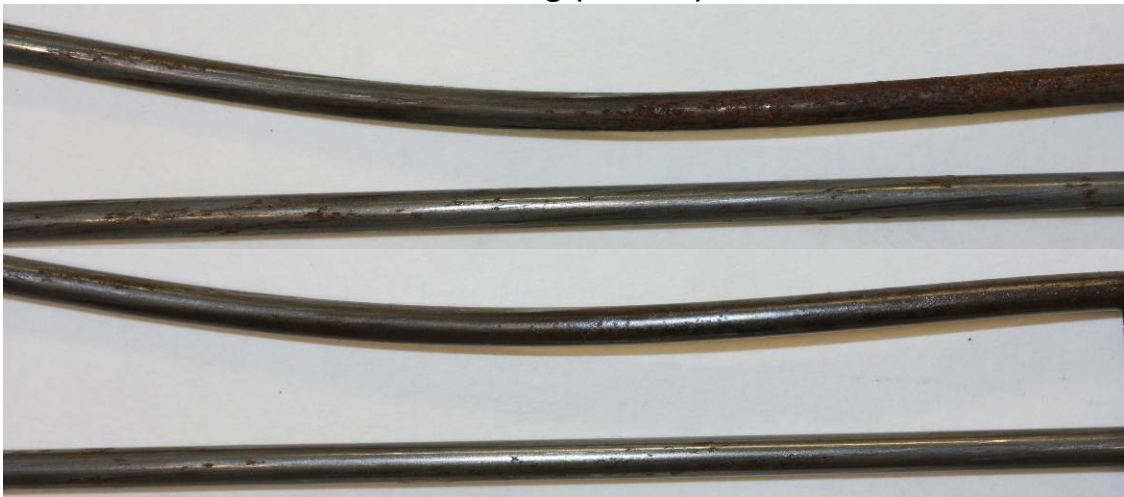
**Figure 62 Specimen 106a 4 Week Salted and Wet Exposed (Top) and after Cleaning (Bottom)**

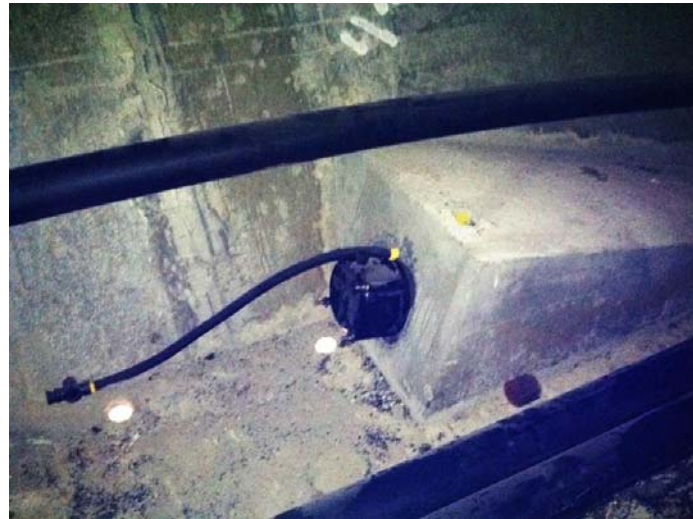
Figure A3 Permanent plastic end cap and grouting port in span 10-8

Two probes, placed in span 10-8, were placed together next to each other in a completed duct with permanent plastic caps and awaiting strand placement. Probes installed were PT 0, and PT 7. Figure A3 shows the end cap inside of which the probes were placed. Figure A4 shows the labeling of the segment within the span, which was already placed at its service elevation.

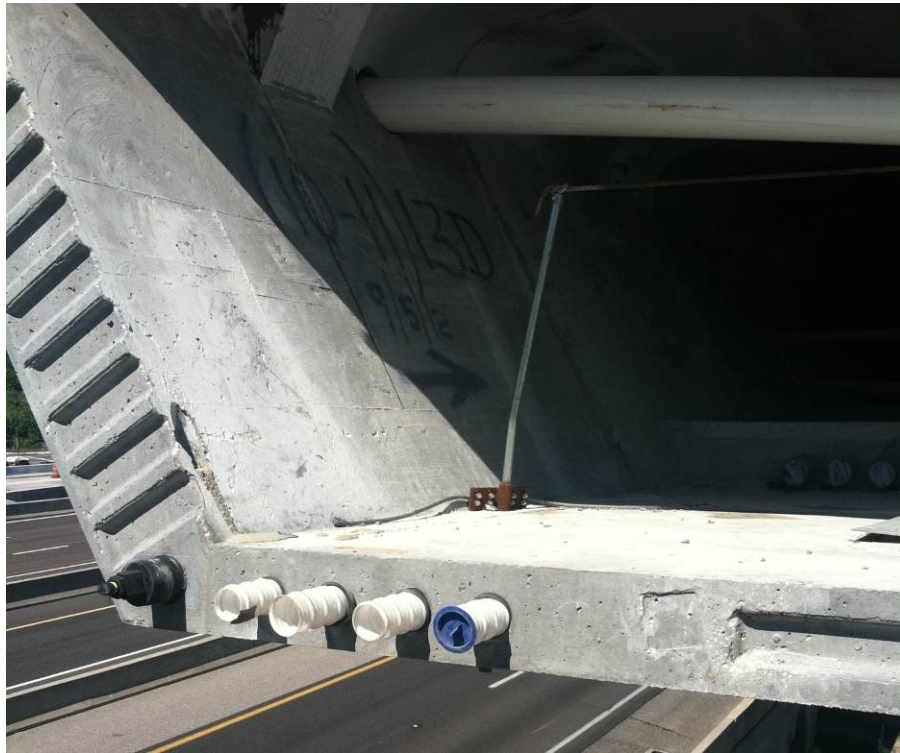
Ducts monitored in span (10-11) were from the upper row of a cantilevered section in segment 12U, already at service elevation. The probes used in this area were: PT 6A, 8, 5 11, 4, & 1. The probes were placed in the interior section of the duct that would become coupled to a nearby segment later during construction. Ducts were sealed with temporary plastic caps. Figure A5 shows the bottom portion of an adjacent cantilevered section. The caps used to seal the cantilevered ducts were identical to the one seen in Figure A5.

**Figure A5 Uncapped PT strand ducts in partially constructed span (10-11).  
Probes not placed in this segment**

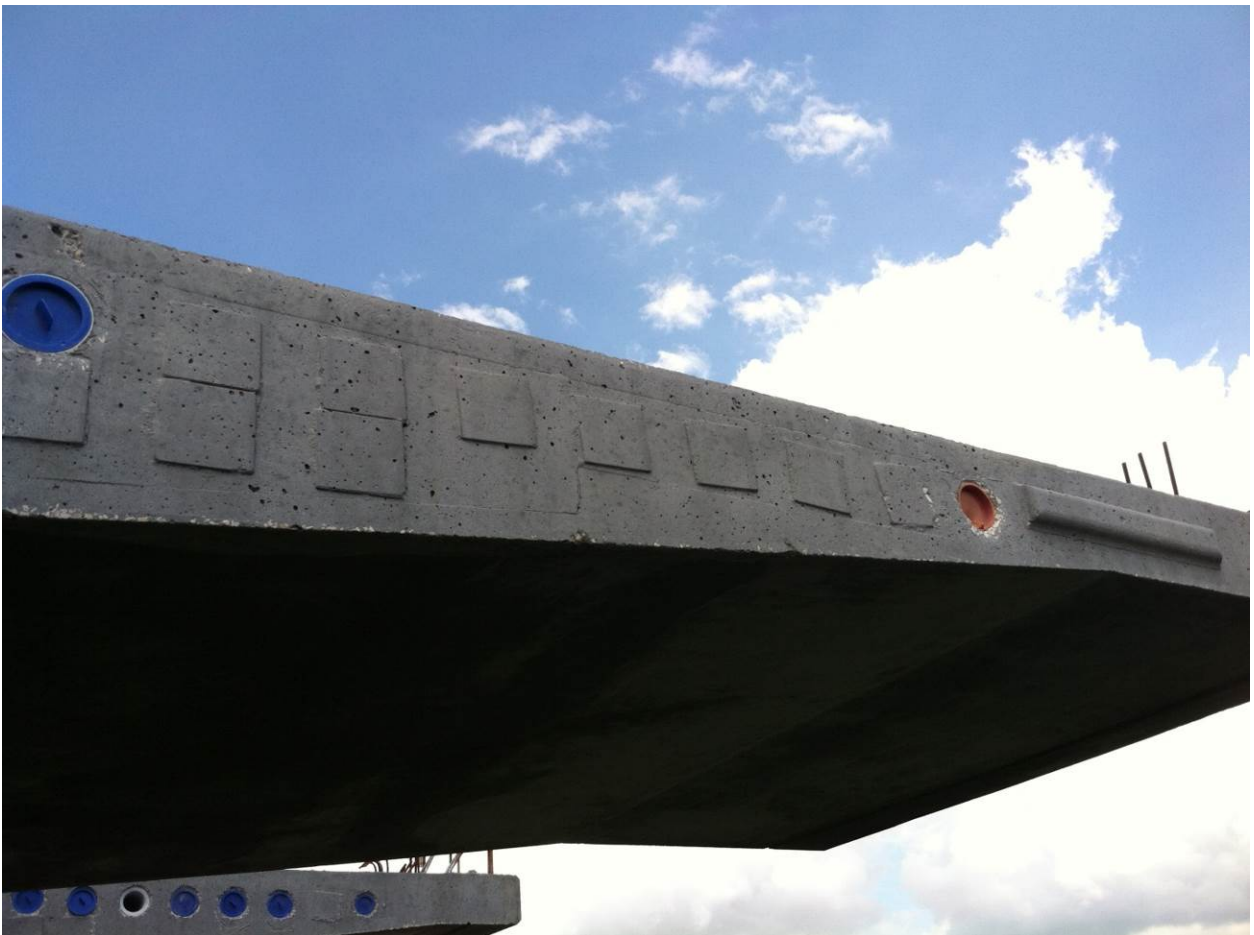
Two (2) box girder segments from the casting yard, both to be installed in span (10-11), were chosen for probe insertion. These segments were still on the ground. During span erection, these segments were to sequentially follow the cantilevered segment mentioned previously. The upper ducts near the inside of the segment wings (left side in Figure A6) had probes positioned within to emulate similar concrete cover as in experiments that are part of an ongoing investigation at USF. Segment 13U (PT 2 & 9) had probes placed within PT strand ducts, where segment 14U had probes placed in PT bar ducts (PT 3 & 10). Some ducts were found to have the caps open upon inspections (Figure A7).

**Figure A6 PT strand (left) and PT bar ducts (right) with temporary end caps in casting yard (14U, used for PT bar duct RH record). Note uncapped duct in nearby segment. No picture for 13U**

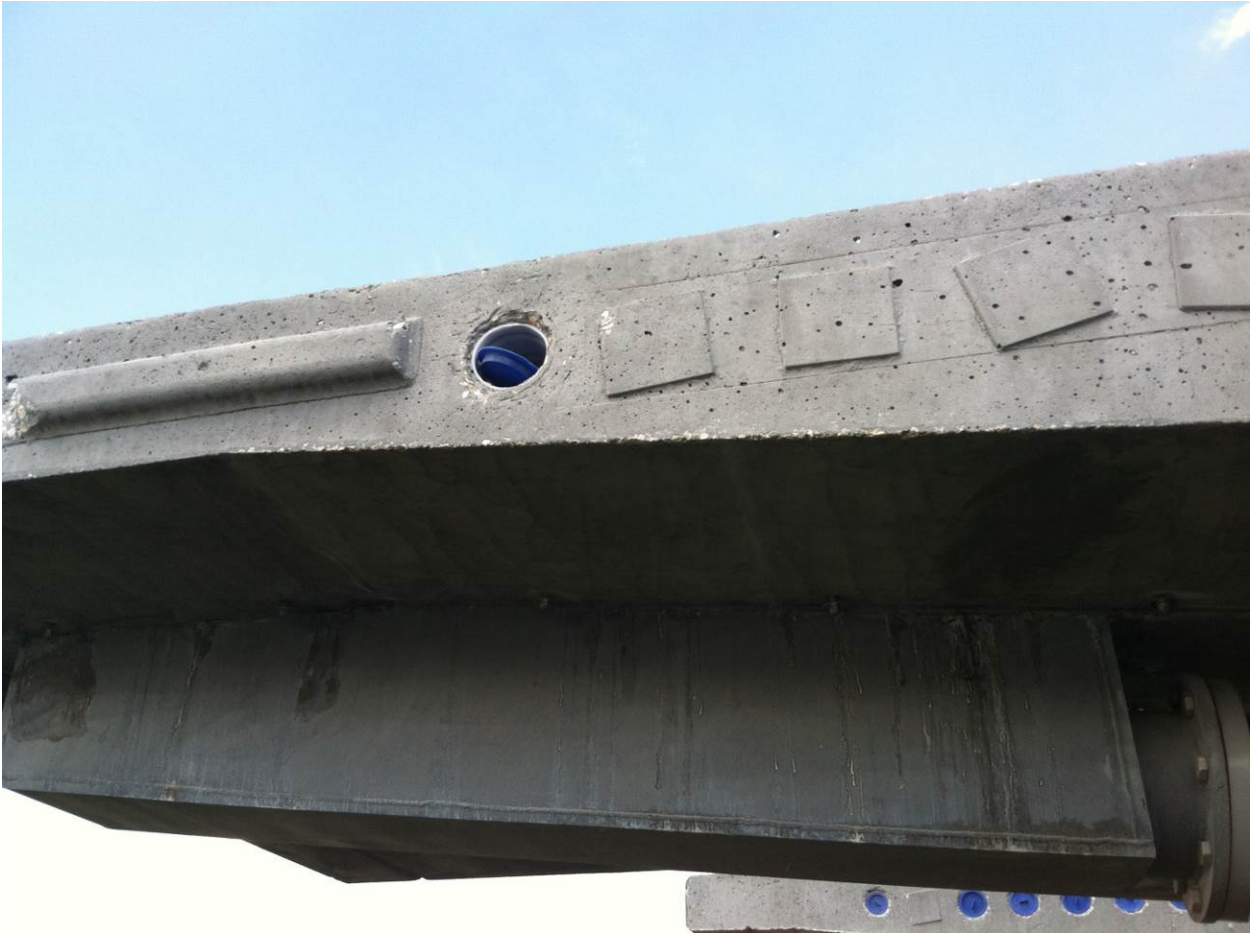
**Figure A7 Uncapped PT strand duct in casting yard segment (14U, no probes placed in this duct)**

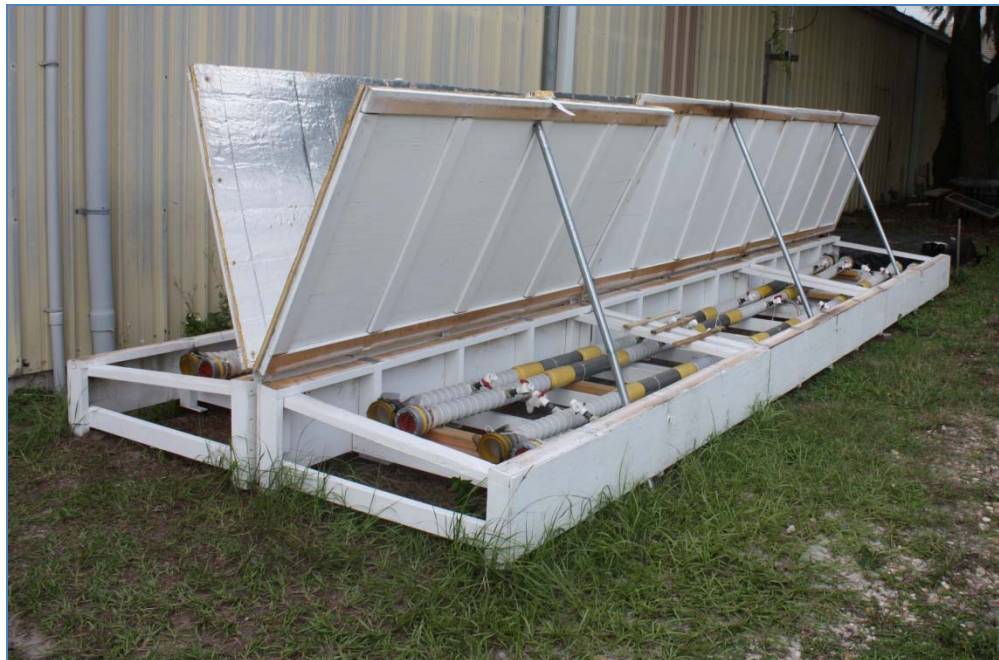
Figure C1 USF Duct Facility in the Open Position

Two facilities were available from the previous investigation (Sagüés et al., 2011) and used for the present unstressed strand study. The facilities were designed to house eight (8) full sized ducts currently used in practice albeit shorter in length than PT duct used in actual bridges. Each facility consists of a hinged roofing enclosure which house eight (8) ducts each. The ducts were sheltered from direct rain on the top and sides, but open to the outside at the ends. The duct segments consisted of polypropylene corrugated sections (PPEX3 3-in internal diameter, 3.6-in external diameter) and transparent polyvinyl chloride (PVC) sections (3-in Sch-40 Harvel™ Clear PVC). The transparent portions were added for in situ visual inspection. Ducts were approximately 20 feet in length and the roof enclosure extended two feet on each side, Figure C1 and Figure C2 display the facility design. Duct sections contained a sag in the center to reproduce conditions used in external PT tendons which have intentional sags secured by deviator blocks. Four vent ports (used in construction for grouting purposes) for each duct was installed at fifth points. One of these central vent ports for each duct housed a relative humidity and temperature probe (Omega OM-EL-USB-2-LCD) as shown in Figure C3.

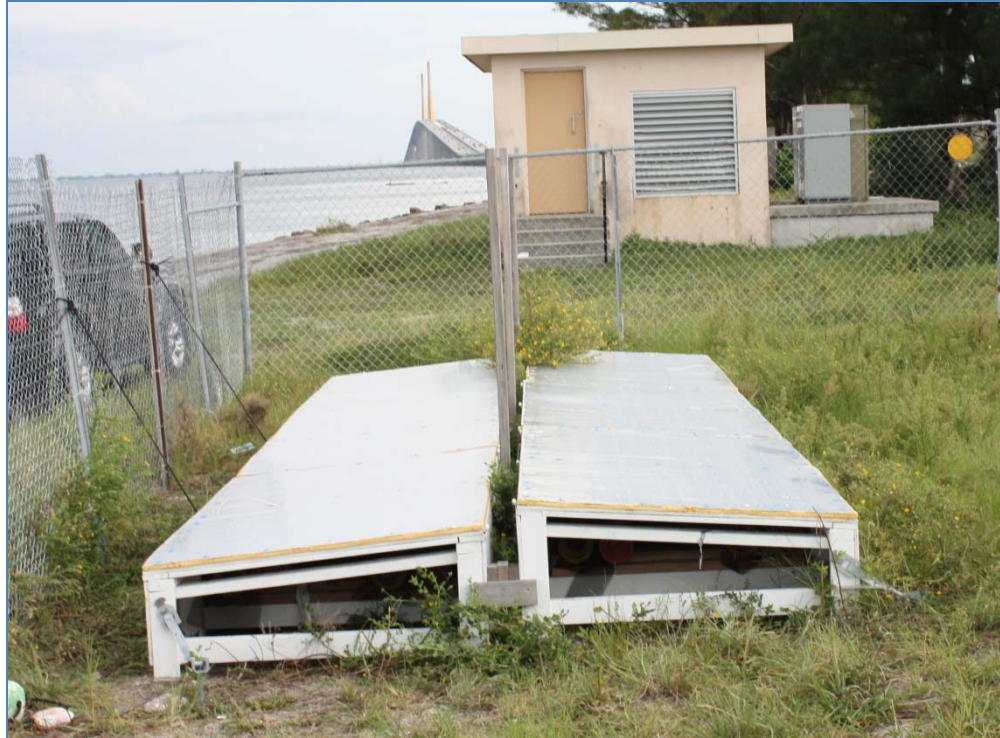
**Figure C2 SSK Duct Facility in the Closed Position - Sunshine Skyway Bridge Main Span and Generator Control Room in the Background**

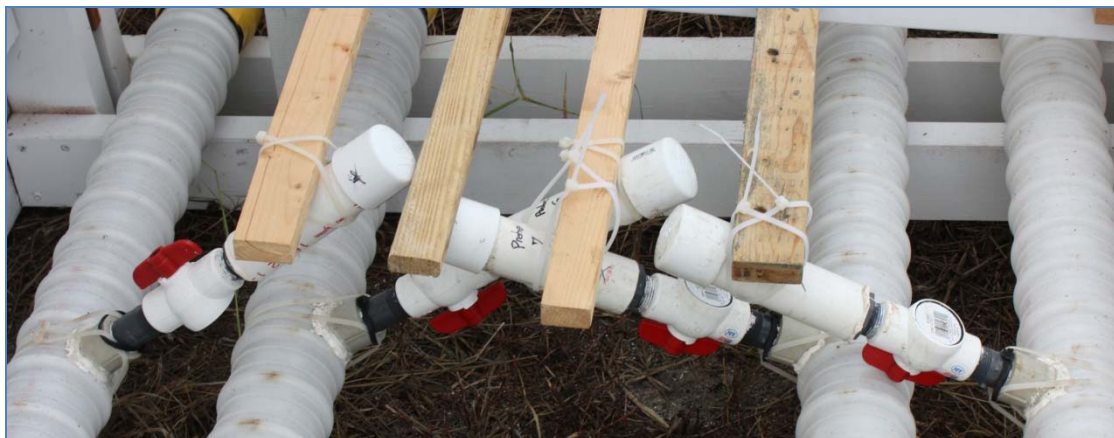
**Figure C3 Relative Humidity & Temperature Probe Housings Attached to Ducts via Vent Port and Secured with Wood Boards and Zip-Ties**

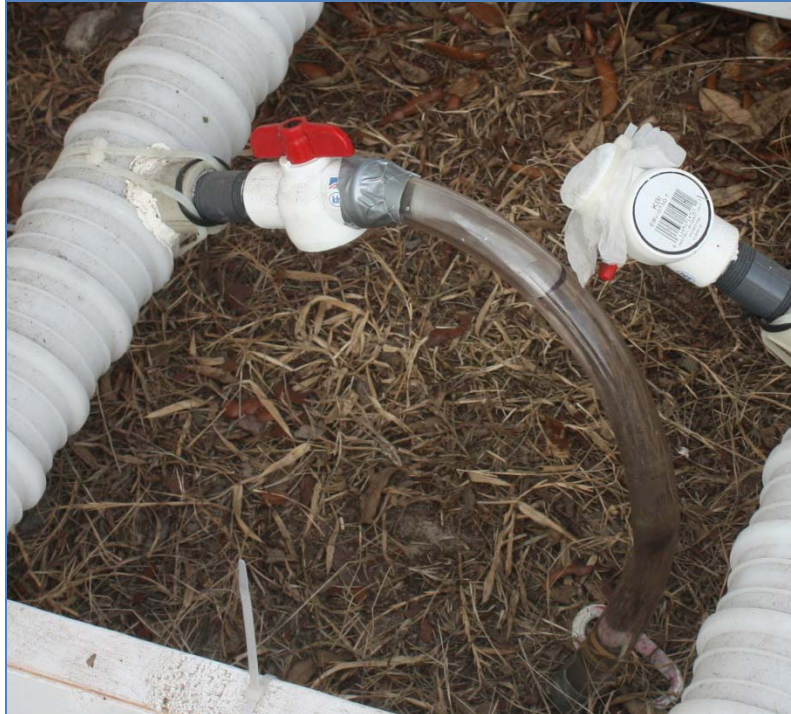
The other would house a separate water reservoir for the ducts which required it. Water level was marked and refilled as needed, as seen in Figure C4.

**Figure C4 Water Reservoir Attached via Vent Port (left) and Closed Vent Port Covered with Bug Shield (Right)**

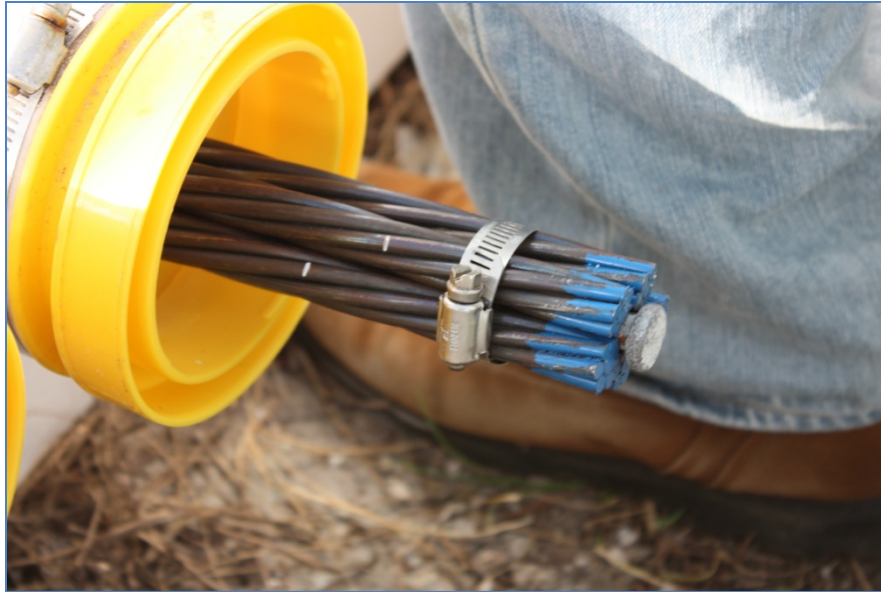
A galvanized nail was attached via a stainless steel hose clamp (Figure C5) to simulate the effects (if any) of a galvanized anchorage system on the corrosion propagation of the strands.

**Figure C5 Strand Group Ready for Duct Insertion with Galvanized Spike Secured with Stainless Steel Hose Clamp**

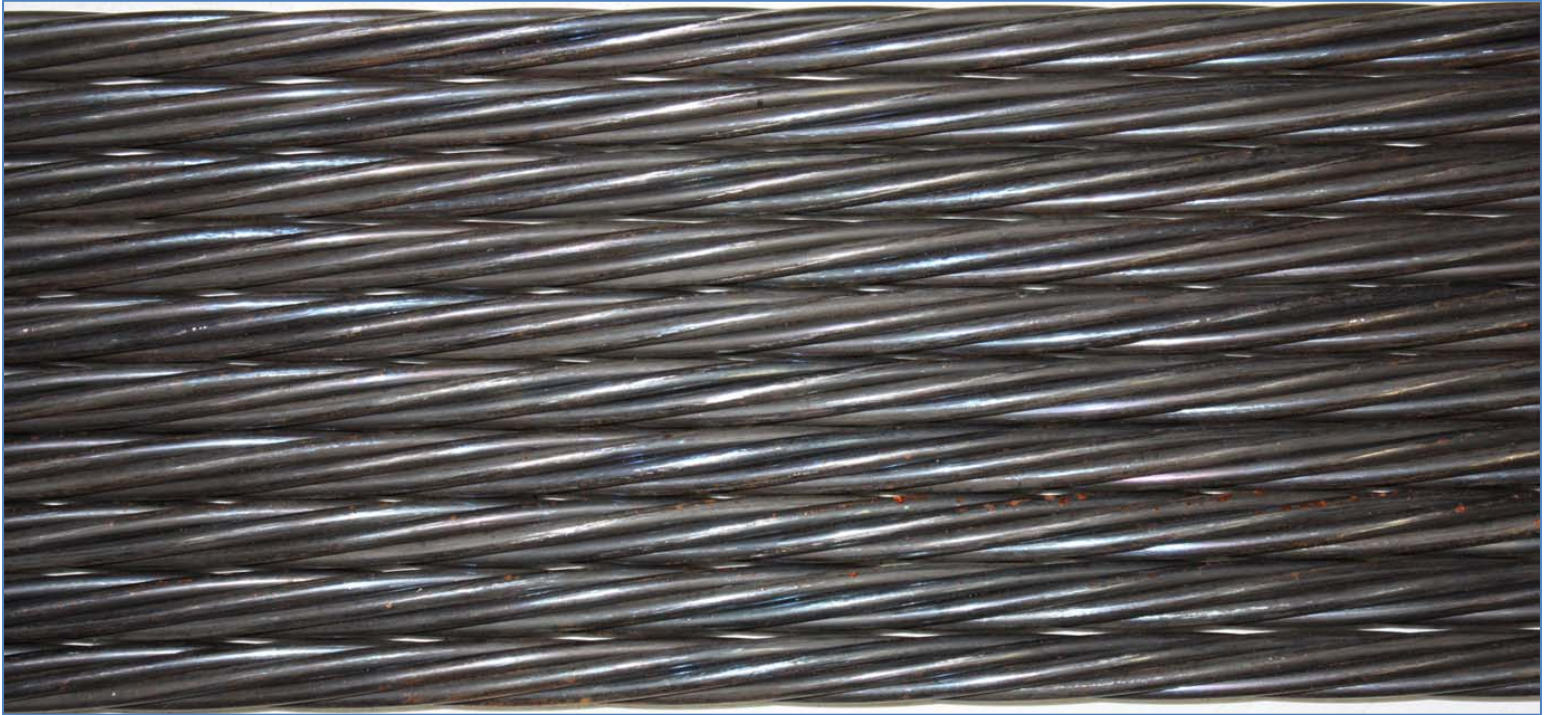
**Figure C6 Typical As Received Condition of Strands Prior to Exposure**

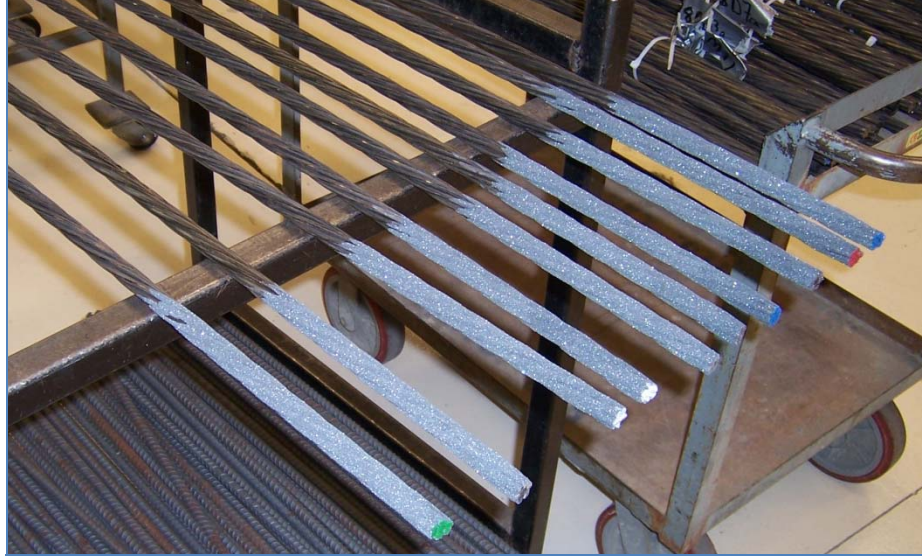
**Figure C13 Sample Strands' Ends Coated in Grit Material Awaiting Tensile Testing**

Three performance descriptors were evaluated from the results of the tensile pull test: total load at failure, total elongation, and load at 1% elongation. These values were then compared to the mechanical performance criteria as specified by ASTM A416 (ASTM International, 2006). The graphs in Figure C15 through Figure C26 show the cumulative fractions of each respective category. The vertical red lines indicate the ASTM specified requirement for satisfactory performance. Major slippage occurred when testing some strands. The cause was loss of gripping due to either improper application of the silicon carbide (SiC) at the ends, or failure to suitably clean the jack grips before each sample was tested. Samples which displayed obvious grip slippage are not represented in the following data. Figure C13 shows the samples ready for testing with SiC coated ends. Figure C14 shows a sample break and the fully engaged grips used for testing.

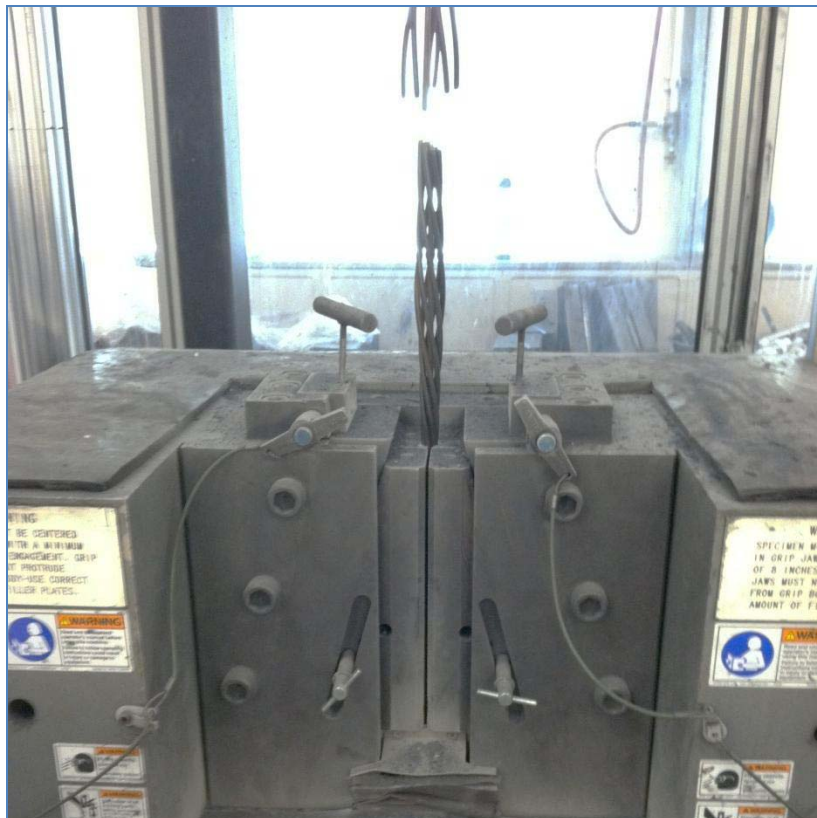
**Figure C14 Sample Strand Break and Fully Engaged Grip**

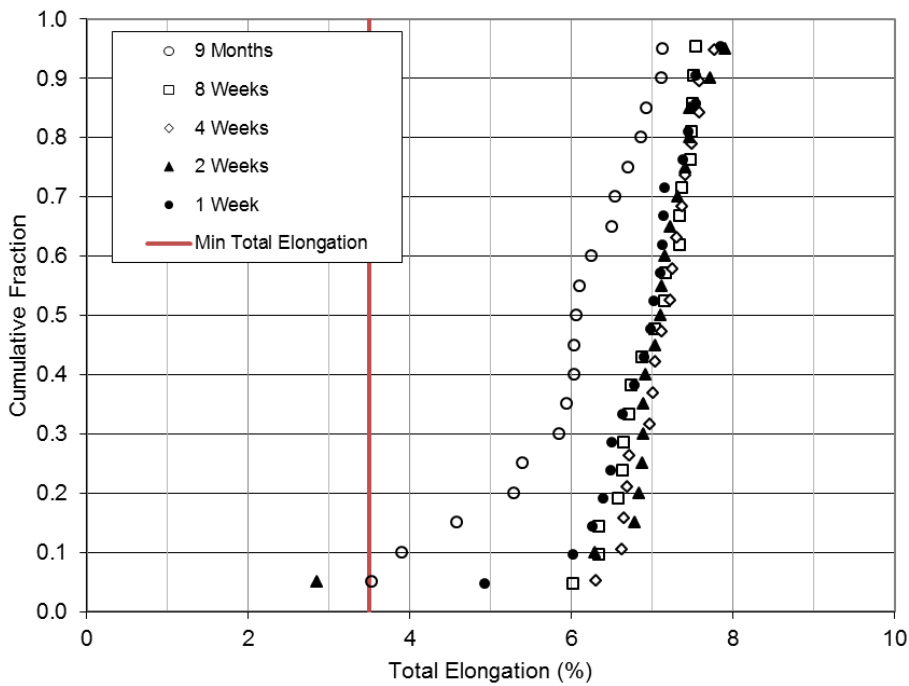
**Figure 5 Cumulative Fraction of Total Elongation at Failure - Exposure Length Comparison**

Elongation values showed no clear differentiation with respect to duct condition or internal environment. Duration of exposure of tests also did not appear to have an effect on ductility values, with the exception of the supplemental 9-month exposure samples which showed as a group a marginal reduction (~1%) in median total

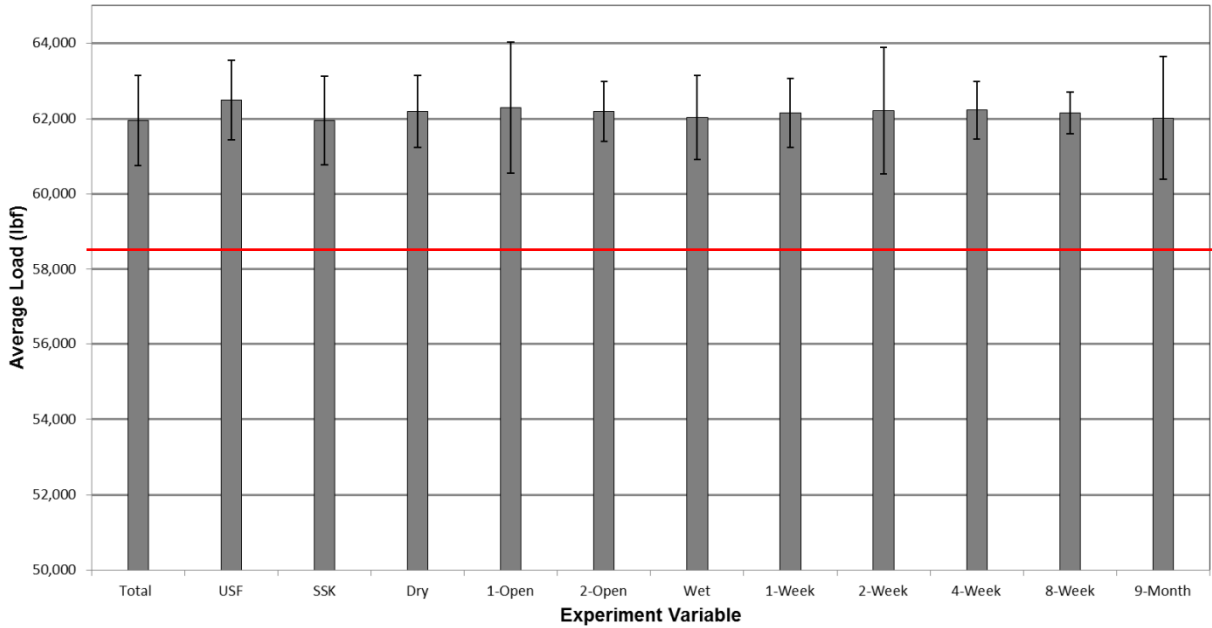
**Figure C27 Average Load at Failure by Experiment Variable - Error Bars are 2 Standard Deviations Tall (Red Line Indicates ASTM A416 Minimum Requirement)**
