Final Report

Corrosion Prevention of Bridge Tendons Using Flexible Filler Materials
BDV27-977-10

Submitted to
Florida Department of Transportation Research Center
605 Suwannee Street
Tallahassee, Florida 32399

November 2018

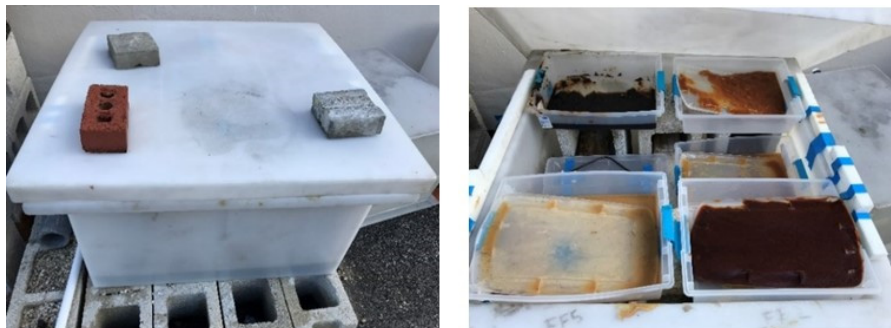
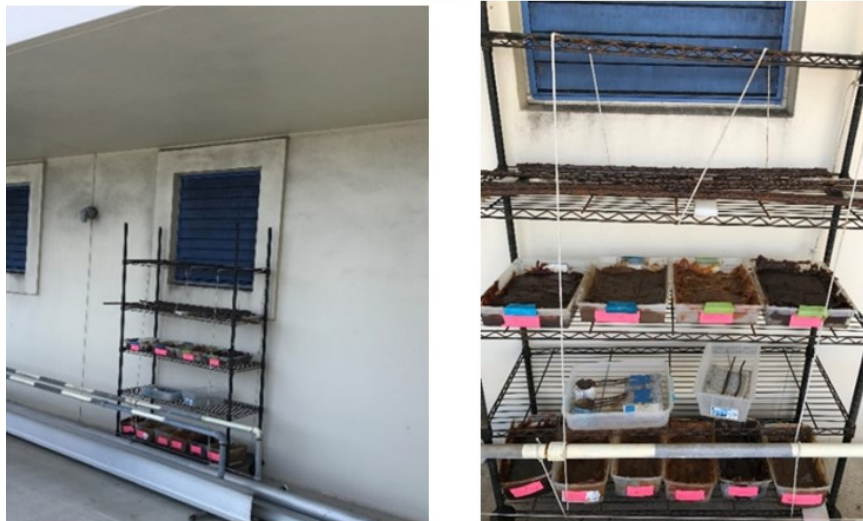
Figure 3. (a) Containers outdoors, (b) Metallic shelf outdoors.

- 1) A pair of large partially closed containers (one is 29 inches \times 30 inches \times 17 inches) stored the small containers with the flexible fillers. The humidity was kept high inside the partially closed container by adding water to the bottom of the container. The large bin was not hermetically sealed and particulates were able to enter during inspection and if the day was very windy; (see pictures in Figure 3.(a))
- 2) A second set of small bins containing the different fillers was placed on a metallic shelf on the second floor at a partially sheltered location. This type of set-up was developed in order to see how long it takes the samples to get contaminated by airborne particulates. Continuous visual inspection was performed regarding the contamination (determined by appearance). (see Figure 3.(b))

A set of strands with a length of approx. 4 feet coated with three flexible fillers (Civetea, Nontribos, and Trenton) were provided by SRC-FDOT. The coated strands were exposed to two different environmental conditions, both of which are located outdoors at Sea Tech: 1. Coated strands were placed in an enclosed container (samples were exposed to this condition for 353 days); 2. Coated strands were placed outdoors, at a partially sheltered (see Figure 3(b)) location.

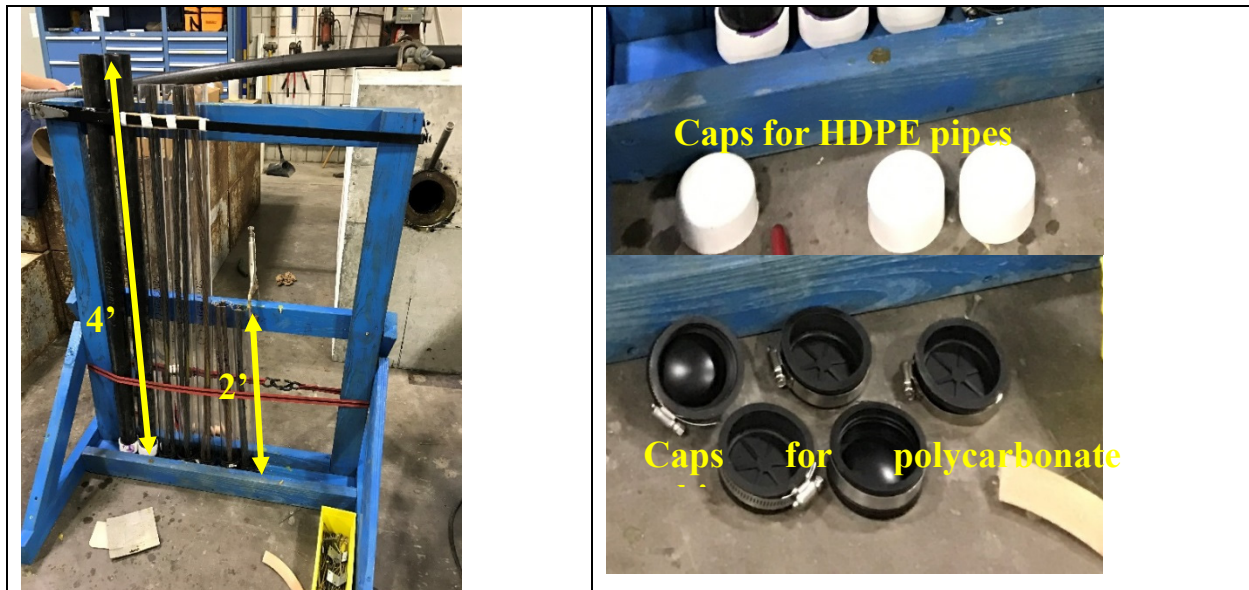
Figure 5. Left: Stand used with tubing ready to be injected; Right: Caps used.

A wood stand was used to hold the tubing. The stand was made by SRC-FDOT staff and it is shown in Figure 5. A similar stand was later prepared at FAU-SeadTech. The stand was made of 2 by 4 wood pieces and painted blue. The height of the stand is about 4 feet and it has an incline that allows it to hold the 4 foot long tubing. Two types of tubing were used to prepare the samples: transparent polycarbonate tubing and HDPE pipes. The internal diameter of these pipes is 2 inches. To have a good sealing at each end, two type of caps were used. For HDPE pipes, white PVC caps were used. PVC glue was used to secure the white PVC-cap to the HDPE duct. Whereas for the polycarbonate tubing, black rubber-caps were used. The clamp surrounding the cap was adjusted to provide a good seal. Two lengths were cut and injected with the flexible filler for polycarbonate tubing segments. Some polycarbonate tubes were 4 feet long, and the other polycarbonate tube segments were cut to 2 feet long. The HDPE segments were a little longer than 4 feet long. Once the tubing was placed in the wood stand, steel strands were inserted into the pipes. Two strands (in a few cases three strands) were inserted for each pipe sample. The strand segments were 2 feet or 4 feet long depending on the tube length. Figure 6 shows the tubing materials and some of the seven-wire steel strand segments used. The flexible fillers were heated and injected to each sample.

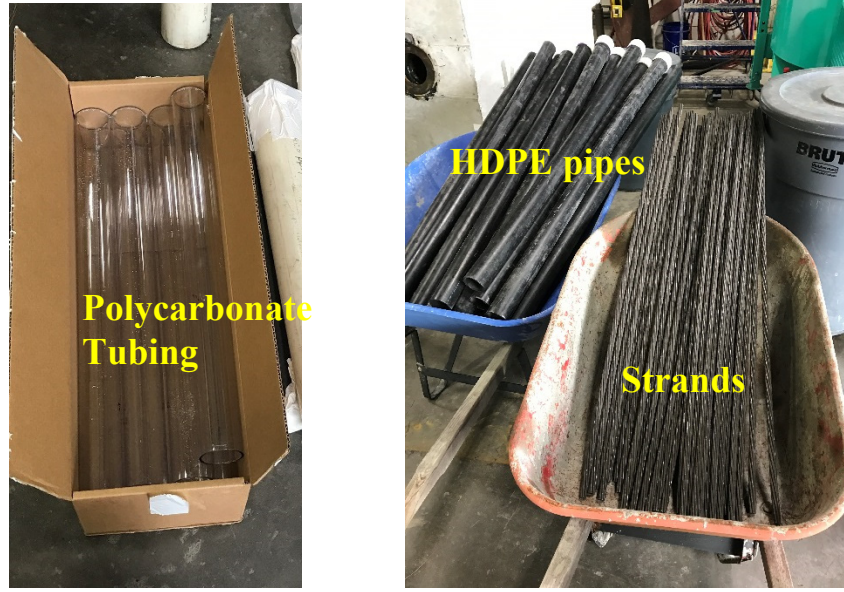
Figure 6. Polycarbonate tubing, HDPE tubing, and steel strands used

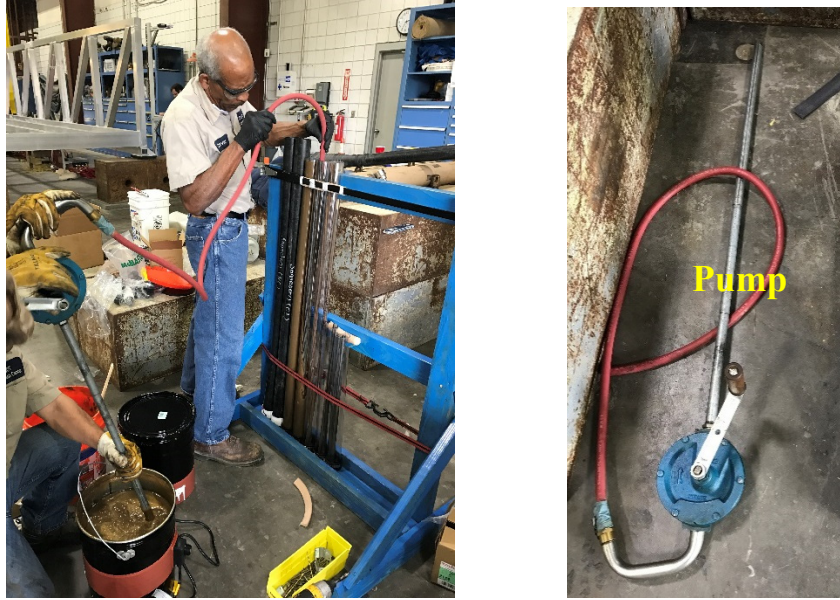
Figure 8. Flexible filler injection and a picture of the pump used.

The injection was made using a manual pump as shown in Figure 8. During the wax injection, the strands were separated to make good contact of wax with each strand. The wax was injected to a level that completely covered the strands in each tube. The manual pump was cleaned before each injection using mineral spirits (paint thinner).

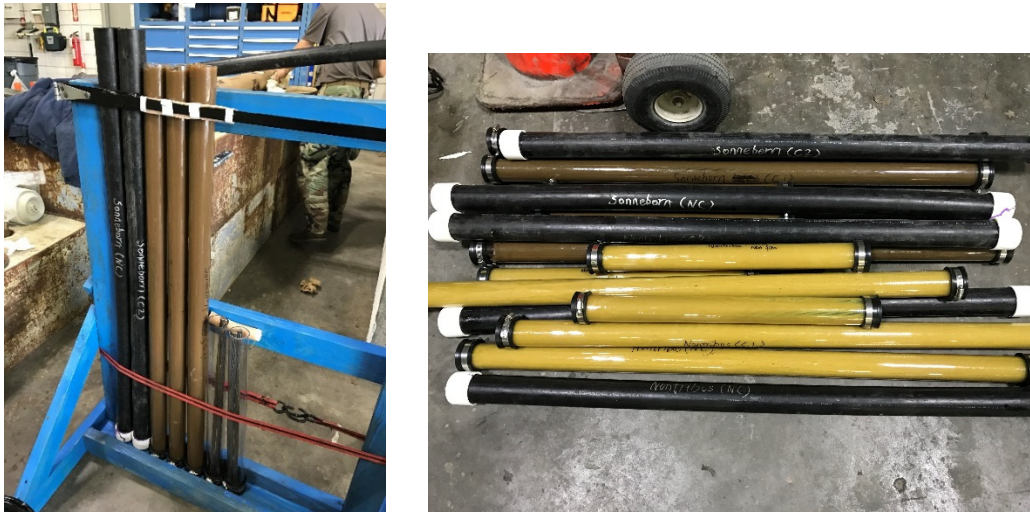
Figure 9. Left: Cooling down of 4-foot samples; Right: After top cap had been placed.

After injection, the pipes were kept open to cool down the smelting fillers for about 2 hours before placing the top cap. Figure 9 shows on the left some samples while waiting for cooling down and on the right a picture after the samples have cooled down with both caps. Figure 10 shows a top view after completing filler injection, prior to placing the top cap.

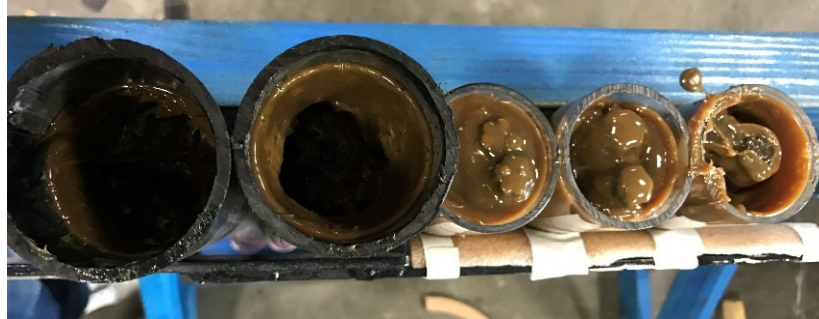
Figure 10. Top view of flexible filler cooling down prior to capping.

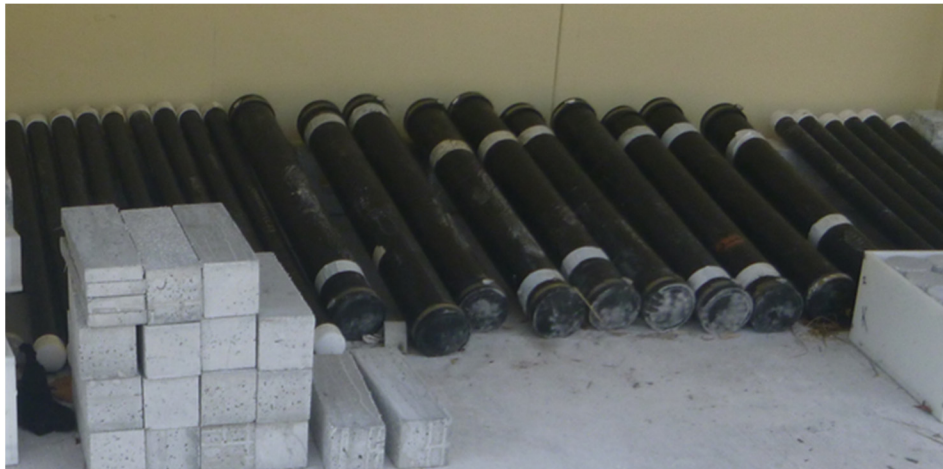
Figure 11. Four-inch and 2-inch diameter samples injected with flexible filler.

The paragraphs that follow list the samples by exposure location grouped per sample type. Each subsection that follow contains pictures of the exposure setup and describes the type of sample, whether the sample was sprayed, what type of solution was used, and how much was used initially. It also indicates if additional wetting took place and with what solution. The results section presents pictures with the caps removed from both sides. On each sample, only one side was sprayed with solution. Figure 11, Figure 12, and Figure 13 show pictures of the samples placed outdoors under the stairs on the west side of Sea Tech. It can be observed that the tubing is made of high density polyethylene. There are samples that are 4 inches in diameter and others that are 2 inches in diameter.

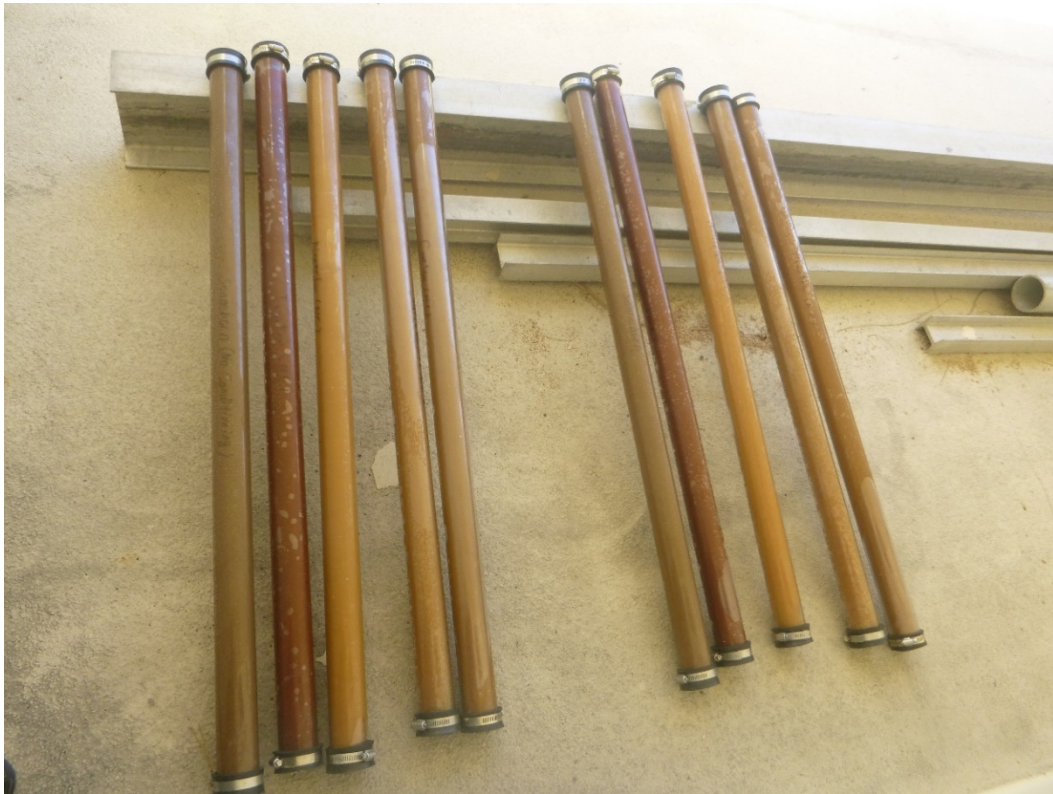
Figure 14. Two-inch diameter samples injected with various flexible fillers.

Table 13 lists the samples that were sprayed either with fungi mix or water. Figure 14 shows that two of the three samples per filler type were supported by an aluminum I-beam. The third sample per set was placed on a shelf. Figure 15 shows three samples exposed at the partially sheltered site located upstairs (terrace) that were injected with Trenton. The sample from the shelf was momentarily moved next to the other two samples injected with Trenton.

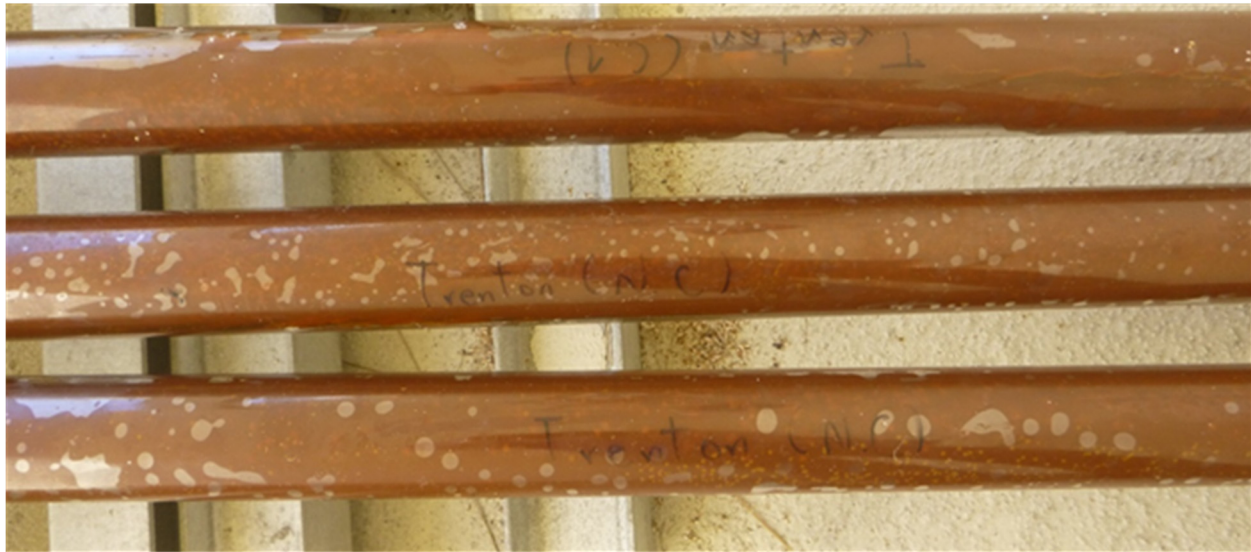
Figure 15. Two-inch diameter 4-foot long samples injected with Trenton (two NC and one C1 conditions)

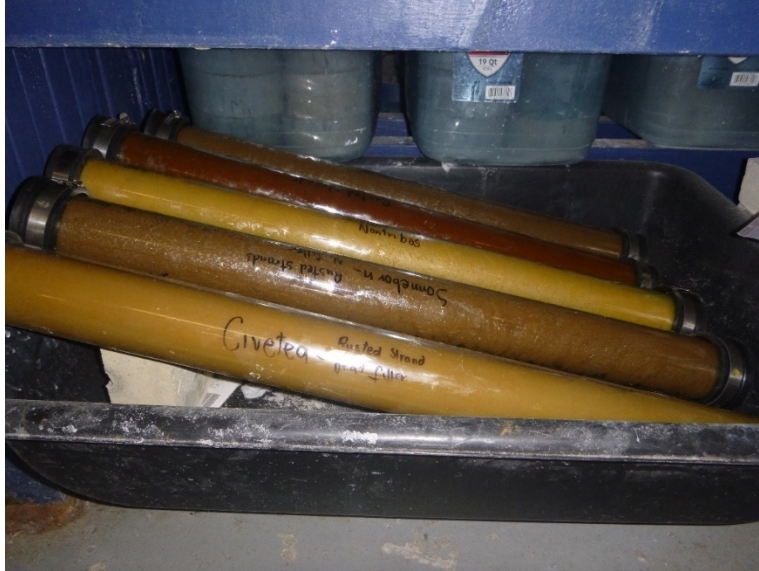
Figure 16. Two-inch diameter, 2-foot long samples stored in the laboratory

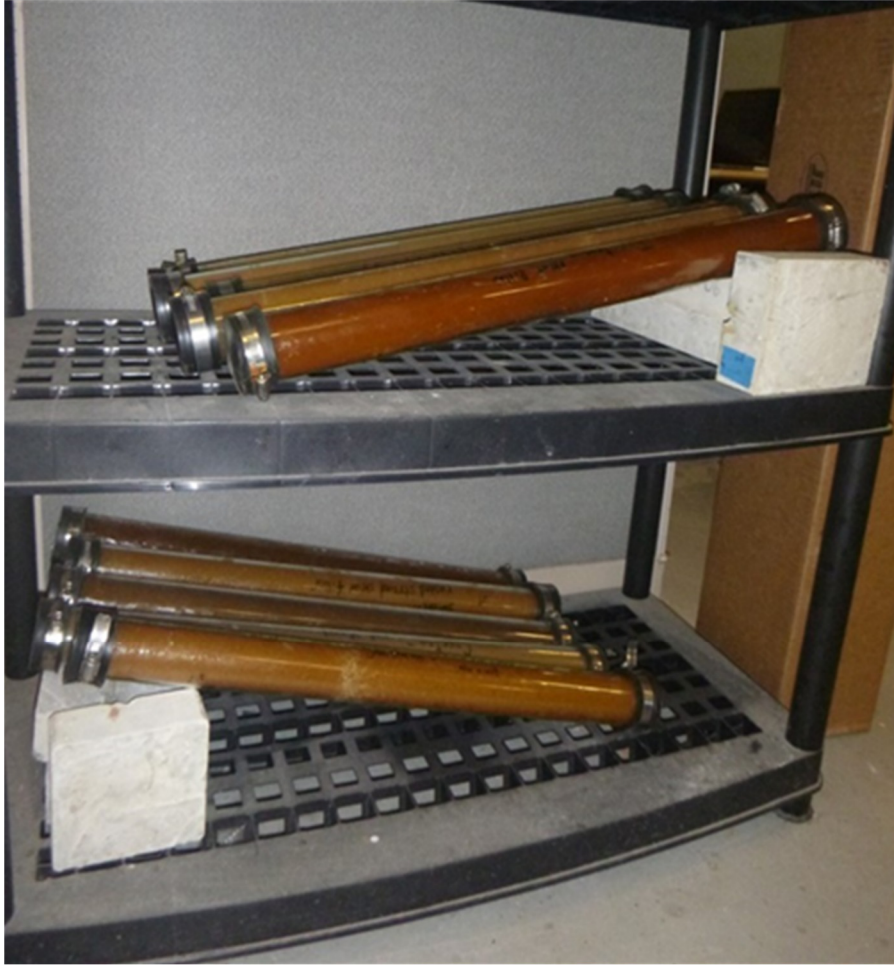
Figure 17. Two-inch diameter, 2 foot long samples stored in the laboratory at a shelf

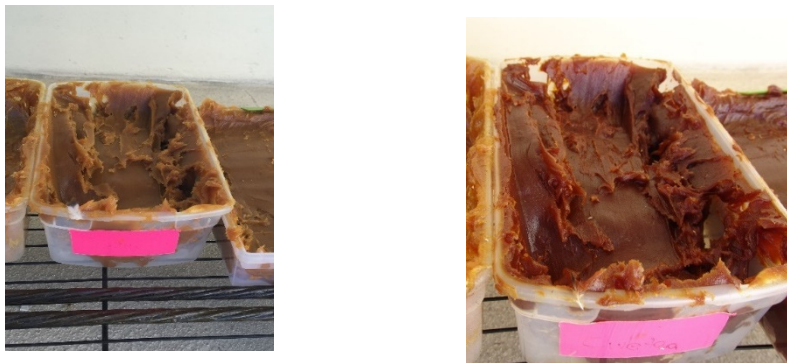
Figure 19. (a) Civetea original color (April 11 2016); (b) Civetea after 60 days of exposure.

After approximately a year of exposure the color of the Civetea filler remains as the one shown in figure 19.b (i.e., darker than the original color). With respect to the other flexible fillers, none of the samples presented a change of texture or color as Civetea did. Some of the filler samples at the semi-sheltered location presented contamination by bugs, particulates, dust pieces, or palm fronds, even small amounts of water drops were observed (likely due to heavy rain and wind, or even dew) at the corners or spaces of the containers where the filler wasn't applied uniformly. The contaminated outdoor fillers were removed from exposure and used as injection material for selected samples. Some of the 2 foot long samples used these fillers.

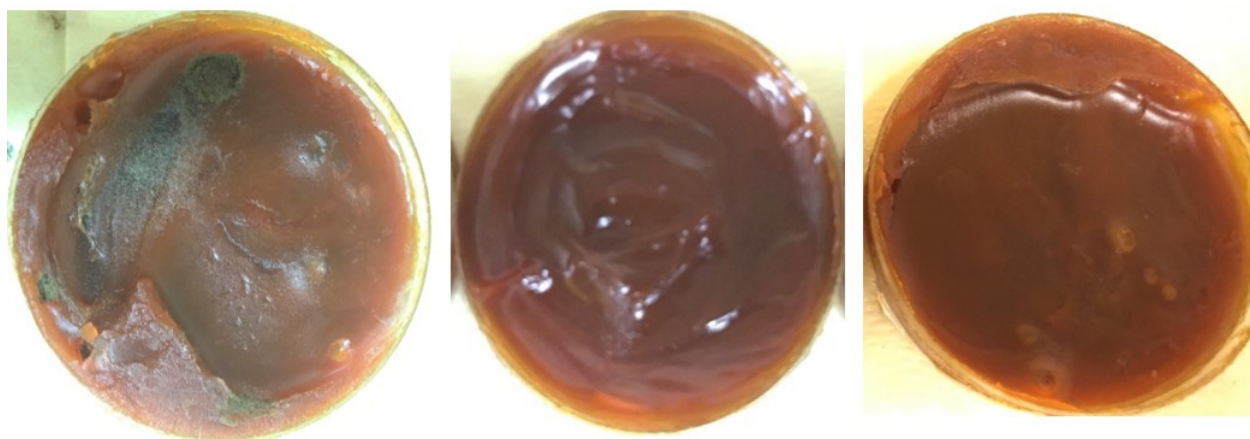
Figure 20. Left: Trenton with *Aspergillus flavus*; Middle: Trenton not inoculated; Right: Trenton with *Fusarium oxysporum* (April 2017)

None of the samples left in the elevated temperature (40°C) room presented visual presence of the fungi, i.e., they did not spread (June 2017). Nevertheless, the samples placed in the laboratory at 21°C showed presence of two out of three of the fungi species. The first visual sign of fungi was observed in the Petri dish with Trenton sprayed with *Aspergillus flavus*, after 25 days, followed by Civetea sprayed with *Aspergillus flavus* and Sonneborn sprayed with *Fusarium oxysporum* after 34 days of exposure. After 60 days of exposure, it was possible to observe that *Fusarium oxysporum* was able to propagate in Trenton (Figure 20), Sonneborn, and Nontribos (Figure 22). The species *Aspergillus flavus* was able to use the five fillers as carbon source in order to grow. Figure 20 and Figure 22 shows additional fillers sprayed with fungi as of April 2017. The samples were inspected during June/July of 2017 and remained the same, with no additional presence of fungi species in the microcrystalline waxes.

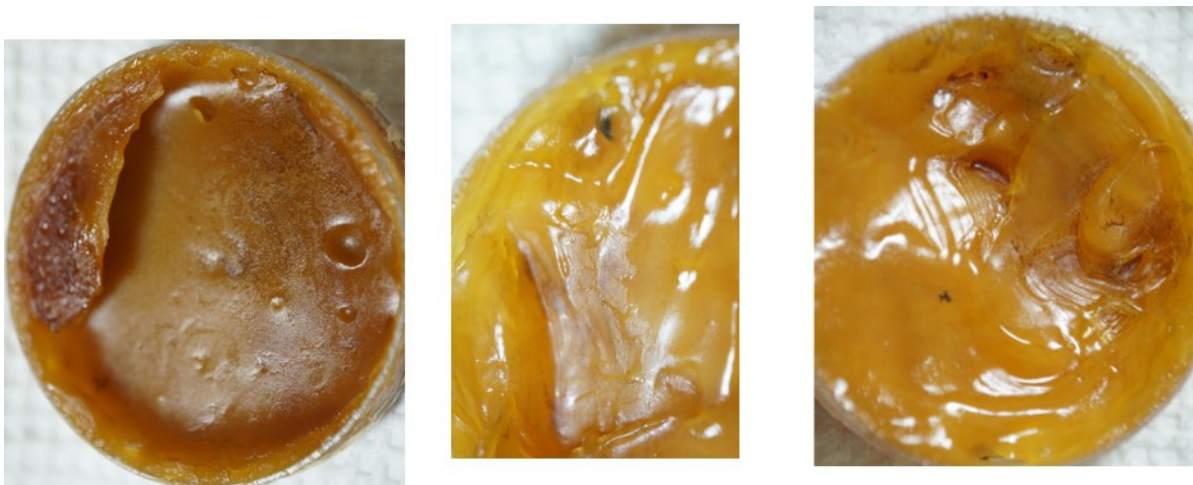
Figure 23 Left: Civetea with *Aspergillus flavus*; Middle: Nontribos with *Fusarium oxysporum*; right: Nontribos with *Aspergillus flavus* (July 2018)

Figure 21 and Figure 23 show the same samples, but the pictures were taken during July 10, 2018. Figure 24 shows a picture taken July 10, 2018, on Sonneborn with *Aspergillus flavus*. A visual inspection took place during July 2018, and it appears that fungi did not propagate any further. Moreover, in some cases, it appears that the region with fungi was covered by a smaller area compared to that observed in June 2017. Some of the images taken in 2018 used flash, and thus, the filler appear to be a lighter color.

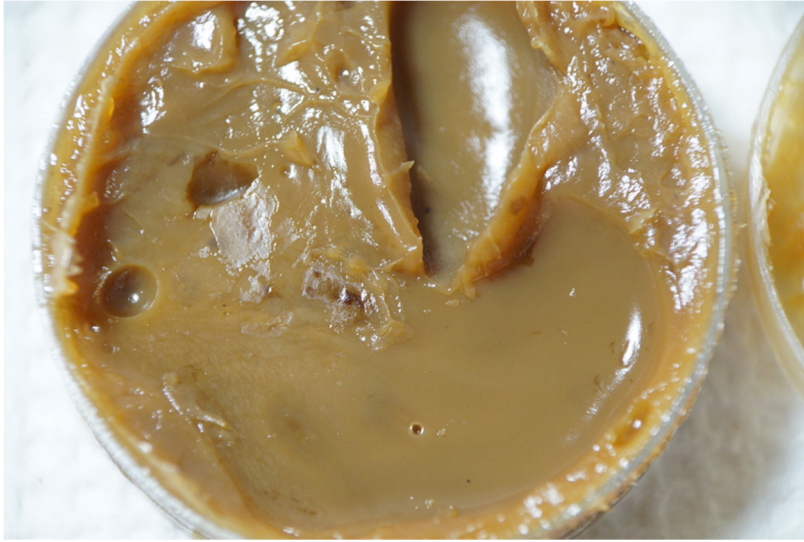
Figure 24. Sonneborn with *Aspergillus flavus* (July 2018)

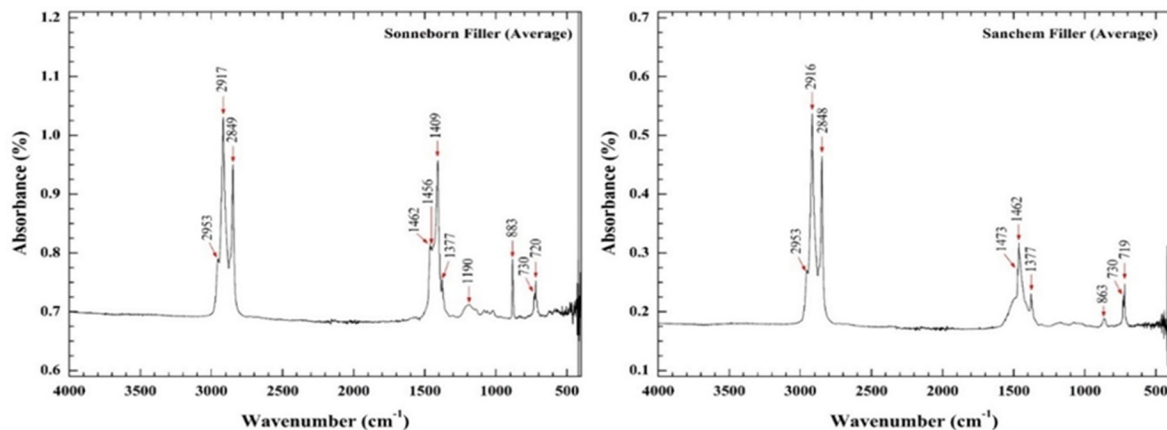
Figure 25. FTIR neat: Sonneborn and Sanchem

Fourier transform infrared spectroscopy (FTIR) of each of the microcrystalline waxes has been obtained (neat condition only) (Figure 25 and Figure 26).

Table 16 lists the number of peaks and the wave number location at which the peaks were observed on the different microcrystalline waxes. All fillers had three peaks between 2,800 and 3,000 (cm⁻¹), the number of peaks at the other ranges varied depending on the filler.

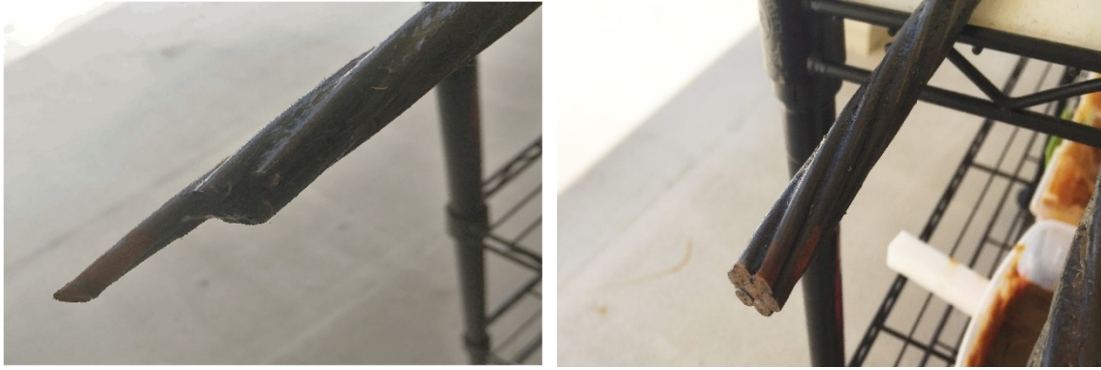
Figure 27. Samples coated with Nontribos, April 25, 2016

Strand samples coated with Nontribos and Civetea segments were exposed on April 11, 2016 at both outdoor environmental conditions. None of the samples in the enclosed container presented rust by day 353 (when these strands were moved to the partially sheltered area or used to be inoculated and placed inside a PVC tube). With respect to the samples exposed outside at the semi-sheltered location, the strand coated with Nontribos started presenting rust spots on April 25, 2016 (14 days after exposure started). See Figure 27 that shows the rust spots starting to appear at the corners. By May 13, 2016 (34 days of exposure), rust spots were present in other areas of the strand as well (see Figure 28).

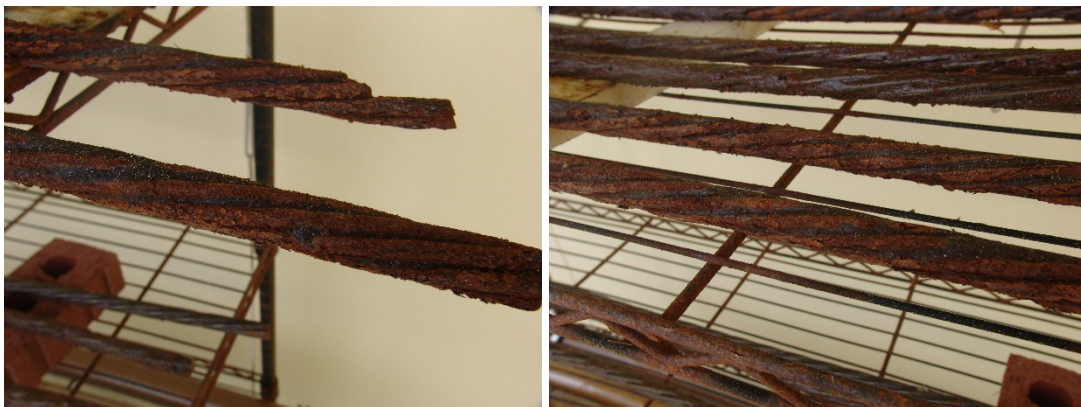
Figure 29. Samples coated with Nontribos, April 18, 2017

By April 18, 2017 it was possible to appreciate that rust had covered a large part of the surface of the strands (see Figure 29) coated with Nontribos. Figure 30 shows how the strands look by the end of June 2017. Figure 31 shows a couple of pictures of the strands coated with Nontribos taken in July 2018. Corrosion propagated and it appears that some wires suffered cross-section loss. Figure 32 shows a close-up picture for a section that showed corrosion. This picture is brighter because it was taken with a macro lens and flash.

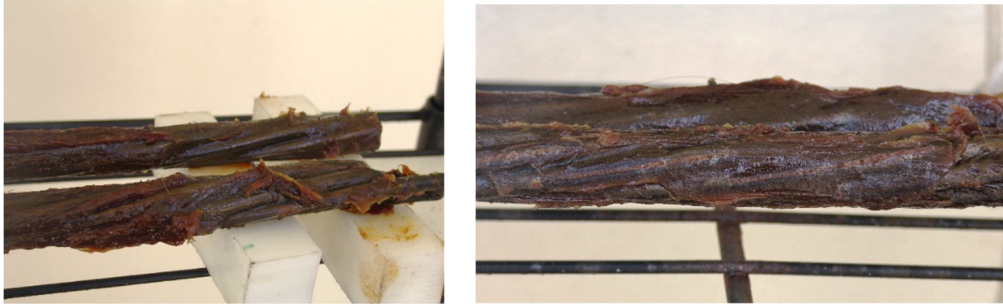
Figure 33. Samples coated with Civetea. Left: July 12, 2016; Right: Nov 4, 2016.

Strands coated with Civetea at the semi-sheltered location started presenting rust spots on July 12, 2016 (92 days after exposure started). This can be seen in Figure 33. The picture on the right shows the surface condition in November 2016.

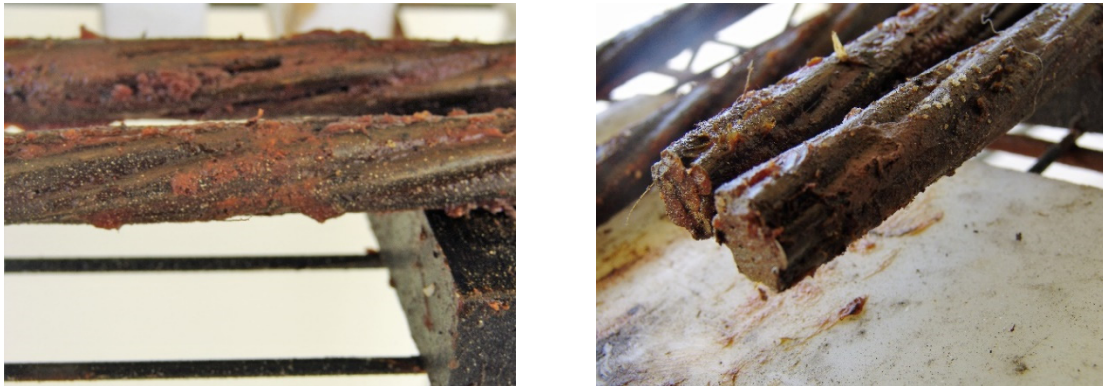
Figure 38. Samples coated with Trenton, April 18, 2017

Strands coated with Trenton were exposed at both sites on December 12, 2016. The strands exposed in the enclosed container did not show corrosion spots. These strands were then moved to the semi-sheltered area during early April 2017. Nevertheless, the filler-coated strand specimens exposed at the semi-sheltered location started presenting signs of corrosion on April 11, 2017 (120 days after initial exposure) (Figure 38). Figure 39 shows pictures taken during July 11 2017 and illustrate the condition of the coated strand at that time and that additional corrosion spots are visible: Figure 40 shows the state of the strands on July 10, 2018 and Figure 41 shows a close-up of the coated segment on the front.

From Figure 38 to Figure 43, it can be observed that signs of corrosion were present even on some of the central wires after outdoor exposure (Trenton and Civetea); the corrosion extent was not as large as that observed on the outside wires. It is important to clarify that the pictures shown here were selected from the worst sites to show the most corroded parts. From the above observations, it can be deduced that corrosion initiated (via visual evidence) even on areas where there was a layer of the flexible filler. Sodium chloride or other types of particulates in the environment likely penetrated through the flexible filler to reach the metal surface and corrosion initiated in the steel wires. It is likely that moisture in the environment also played a role (due to high humidity, dew or rain). Appendix A shows additional detail.

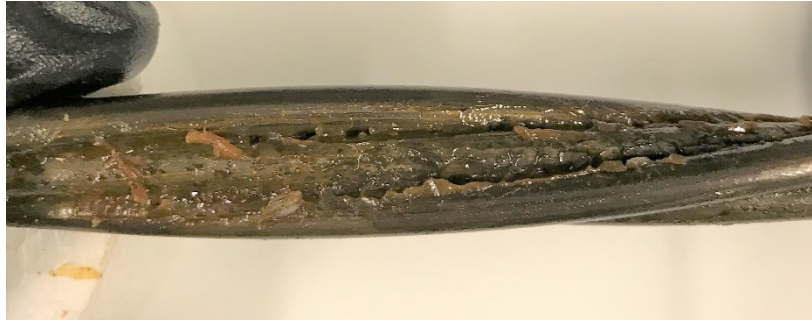
Figure 43. Strand coated with Trenton (182 days after Exposure).

For the specimens coated with Trenton, two 13 centimeter long pieces were cut off after 182 days of exposure. As expected, the inner side of the wires and the central wire still had some of the flexible filler (Figure 43).

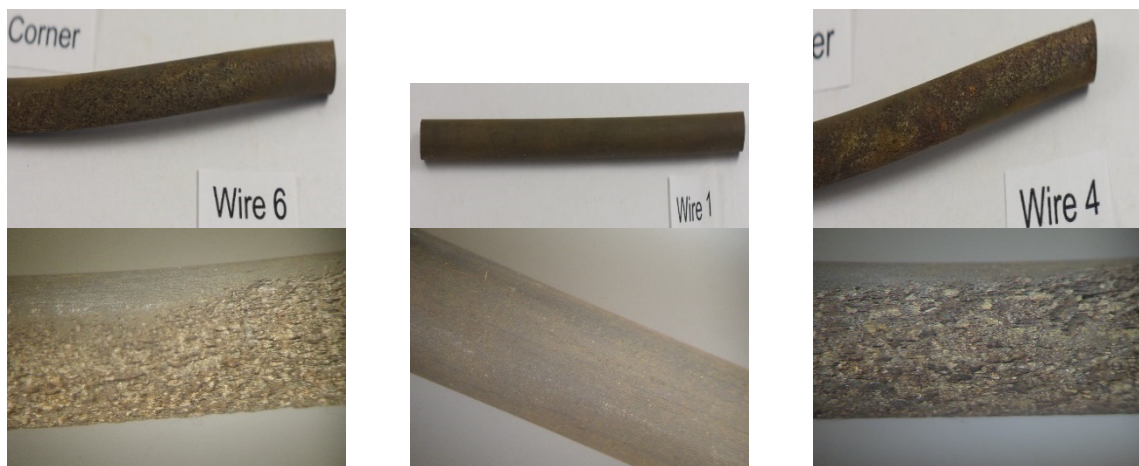
Figure 44. Wires from the strand coated with Nontribos, (a) Wire 6; (b) Central wire; (c) Wire 4.

Specimens coated with Nontribos showed that corrosion covered approximately 40% of the wire surface of the external wires and very low corrosion extent on the central wire (less than 5%) for both the edge segment (Figure 44) and the following segment (Figure 45).

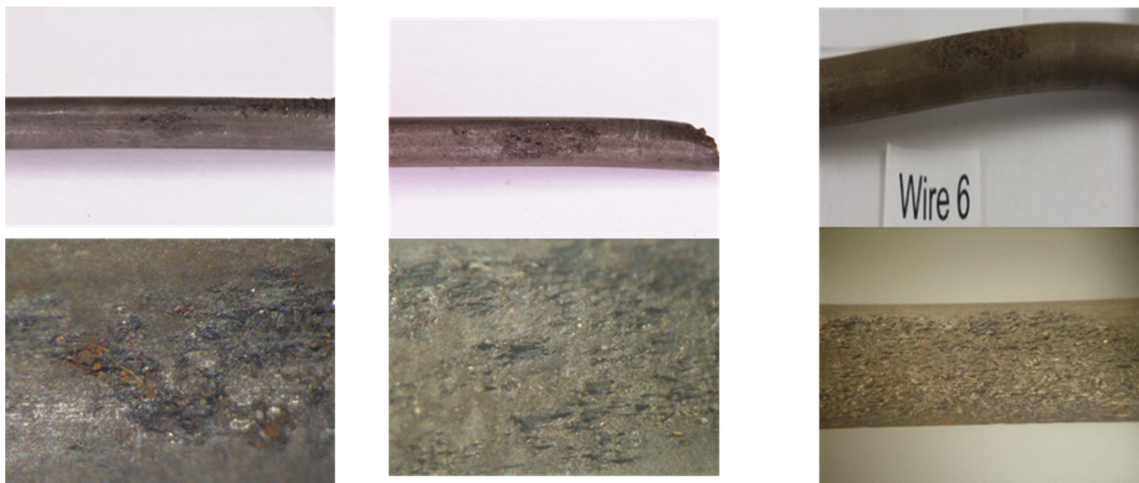
Figure 48. Wires from the strand coated with Civetea (edge): (a) Wire 3; (b) Central wire; (c) Wire 6.

For the specimen coated with Civetea, the following figures (Figure 48 and Figure 49) show that the central wire presented significantly more rust than that observed on specimens coated with Sanchem or Trenton. Specimens coated with Civetea presented corrosion on approximately 30% of the area on the external wires. The central wires showed corrosion on approx. 10% of the area

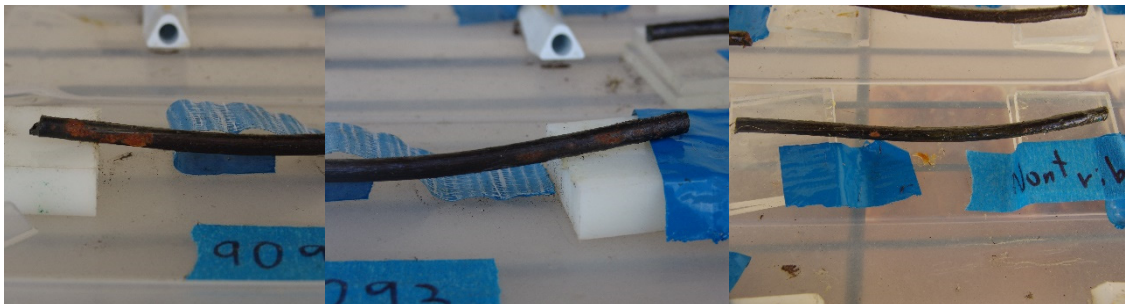
Figure 50. Wires coated and presence of rust. Left and Middle: Sanchem; Right: Nontribos, June 14, 2016.

Coated single-wire samples were exposed on May 5, 2016 (at the closed container and at the partially sheltered site on a shelf). Coated wires exposed at the partially sheltered site started to show rust on May 25, 2016 (Sanchem), (after 20 days). All other samples also started showing corrosion spots after longer exposure periods: Nontribos (43 days), Civetea (49 days), Trenton (114 days) and Sonneborn (126 days) (Figure 50 and Figure 51).

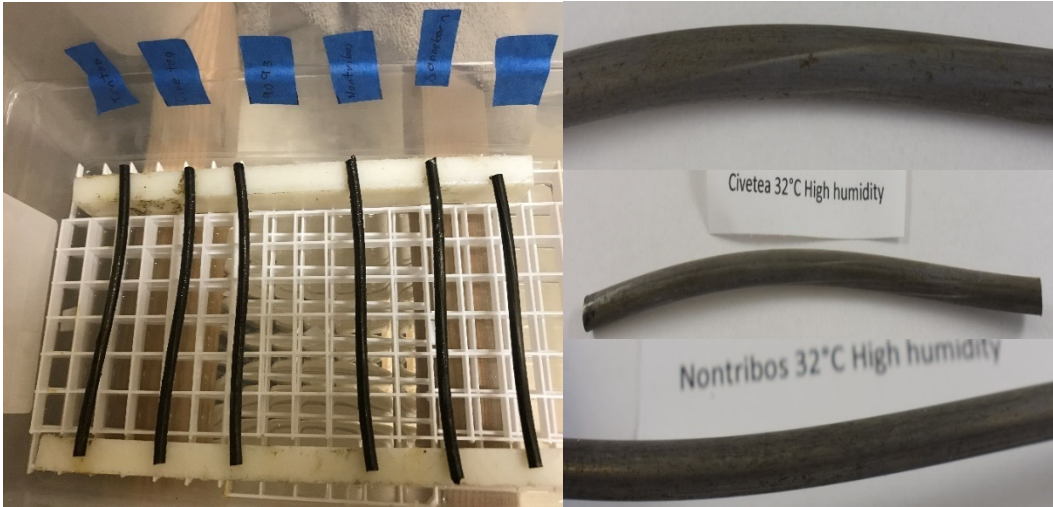
Figure 57. Wires coated at elevated temperature room.

Samples exposed in high humidity at 32°C started exposure on November 16, 2016. The uncoated specimen presented rust after 16 days of exposure. Coated samples started presenting rust spots after 58 days (Civetea). By June 26, 2017, all the samples had corrosion spots visible at the site supporting the wire. Additional corrosion spots were observed in other areas only on the wires coated with Civetea and Sanchem. This set of wires were cleaned after 222 days of exposure. Figure 57 shows the wires before cleaning (left) and the blank wire, wire coated with Civetea, and wire coated with Nontribos after cleaning (right). Figure 58 and Figure 59 show close-ups after cleaning for each of the wires exposed in the elevated temperature condition.

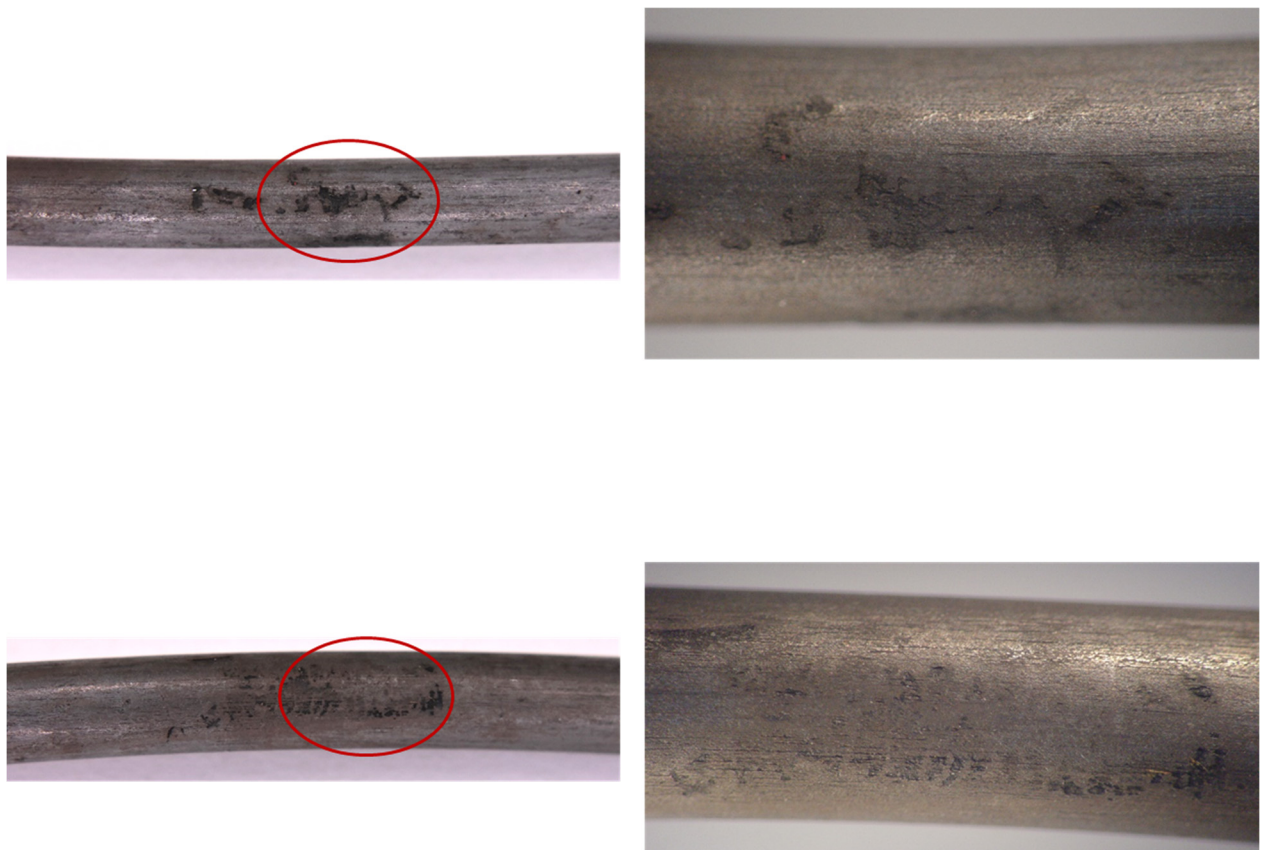
Figure 68 shows the wire coated with Trenton and sprayed with fungi *Penicillium chrysogenum*. The pictures show the wire after cleaning. Upon rotating the wire, there were other corrosion spots observed. Figure 69 shows two close-ups and two pictures taken with the stereo microscope from two sites on the same wire shown in Figure 68. A modest amount of cross-section loss is observed.

Figure 69. Close-ups – wire coated with Trenton and sprayed with *Penicillium chrysogenum*.

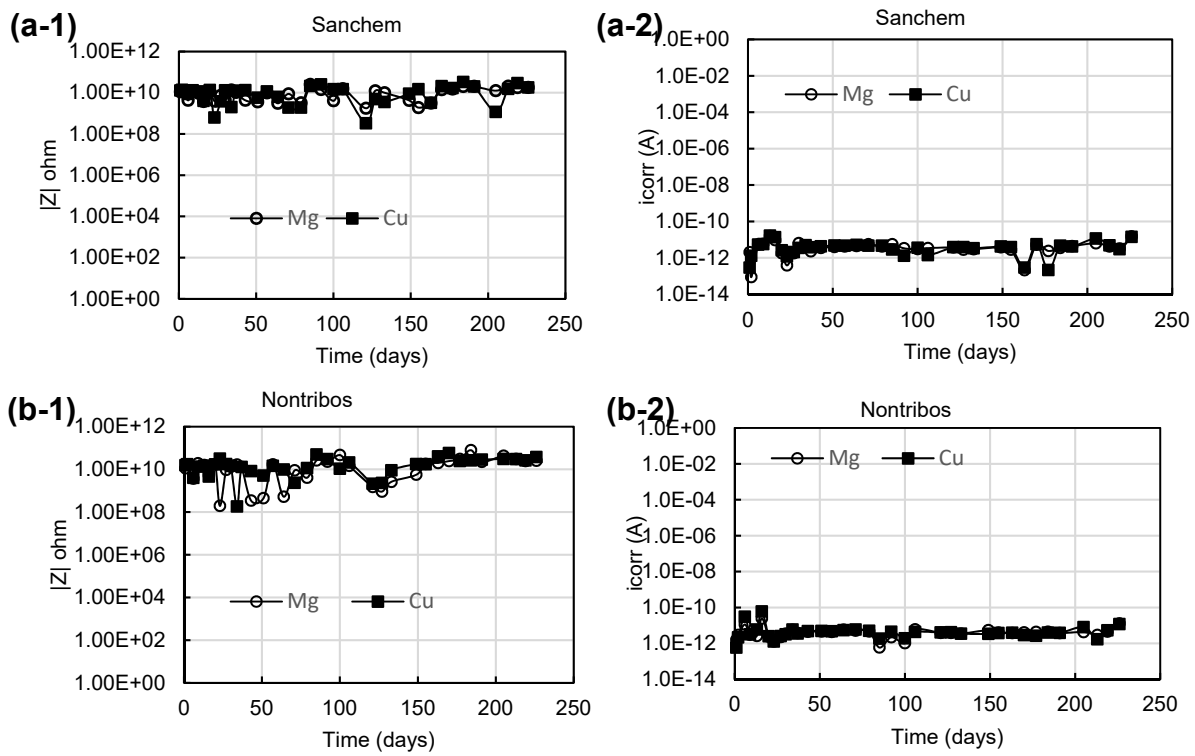
Figure 77 shows the change of impedance magnitude and galvanic corrosion current for steel strand electrodes coated with Sanchem (type 1) and Nontribos (type 2) fillers as a function of time in a 4.4 pH solution. These were different from the other three fillers. There was no change in both the impedance magnitude and galvanic current over time for the electrochemical cells with electrodes coated with Type 1 and Type 2 fillers. The impedance magnitude remained around $10\text{ G}\Omega$ and the galvanic corrosion current was around 1.0 pA . The high impedance magnitude and the low galvanic corrosion current indicate that both type 1 and type 2 fillers have better corrosion protection compared with the other three fillers.

Figure 77: Evolution of (1) impedance magnitude and (2) galvanic current for steel strand electrodes coated with (a) type 1 (Sanchem) and (b) type 2 (Nontribos) in pH=4.4 solution over time.

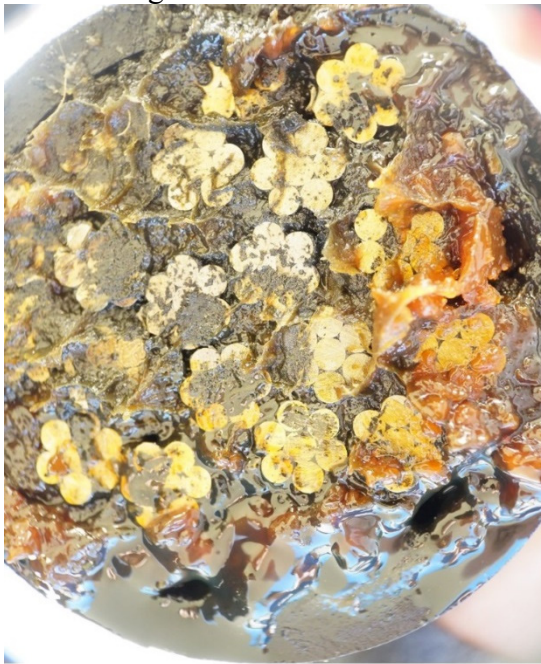
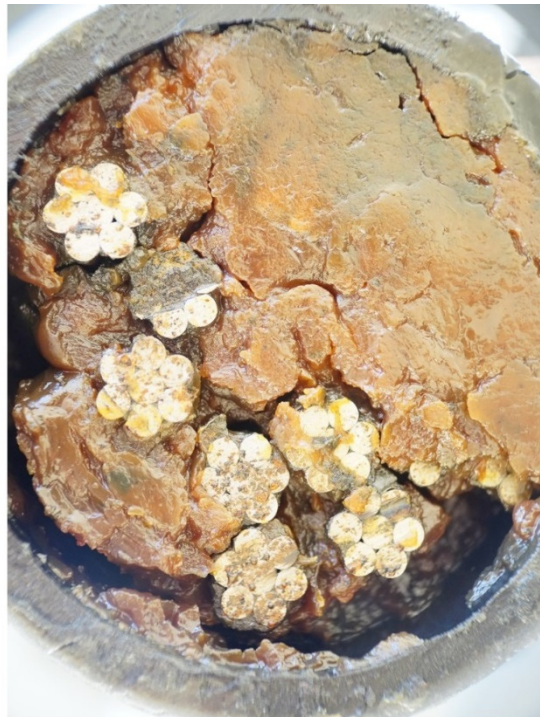
Not Sprayed – Bottom Side

Sprayed with Water

Figure 78. Four-inch diameter sample sprayed with water (December 2017).

No changes based in sample appearance were identified on the samples that were not sprayed. Figure 78 shows pictures of both ends for a sample sprayed with water (the picture on the right shows the end sprayed with water) for the inspection that took place during December 2017. Figure 79 shows a picture of the side sprayed with water during the inspection that took place during June 2018. No significant changes were observed when comparing the pictures from December 2017 and May/June 2018. It appears that some corrosion (as suggested by rust spots) has taken place on a few wires on the side sprayed with water. These wires might have had a thin layer of the filler, whereas a number of strands were protected because they were covered with a thicker layer of the Trenton filler. Figure 80 shows the surface condition for the Sample Sprayed with fungi mix during the visual inspection that took place on December 2017. Figure 81 shows the surface sprayed with fungi mix during the inspection taken May 2018. Droplets of solution are visible in the picture on the right side of Figure 80, but not in Figure 81. The difference could be the time of the inspection with respect to the time the sample was sprayed and/or also that the temperature during May/June are significantly higher and it is likely the solution evaporated faster. It is not clear if the dark green surface is due to the cut, the fungi reacting with the filler or if it is a combination of both the cut and the fungi.

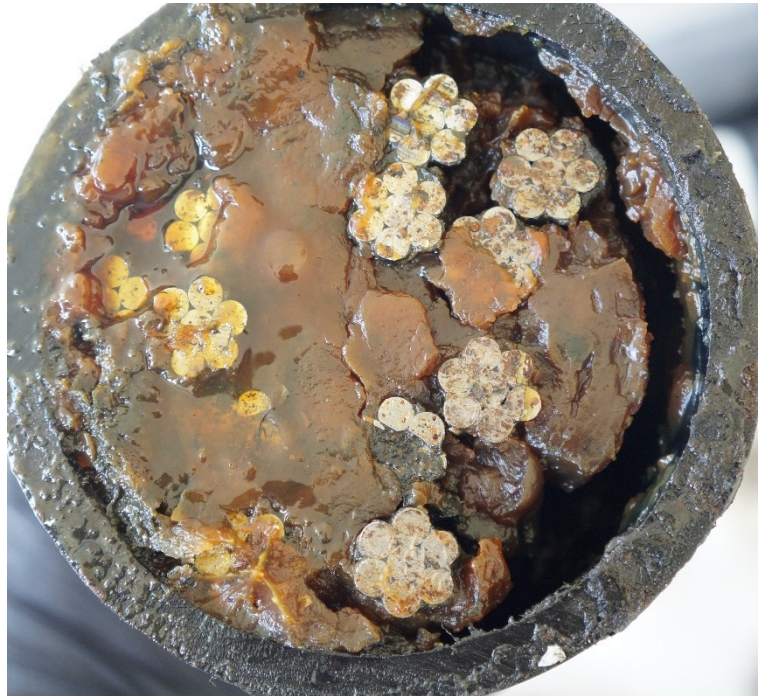
Figure 79. Four-inch diameter sample, side sprayed with Water (June 2018).

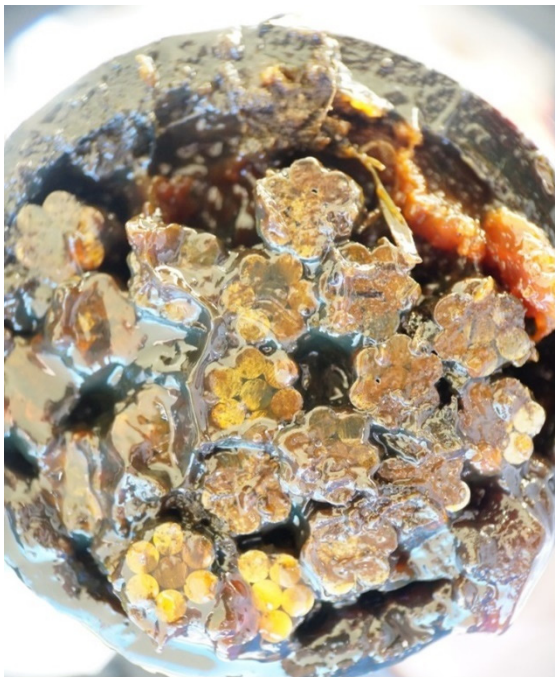
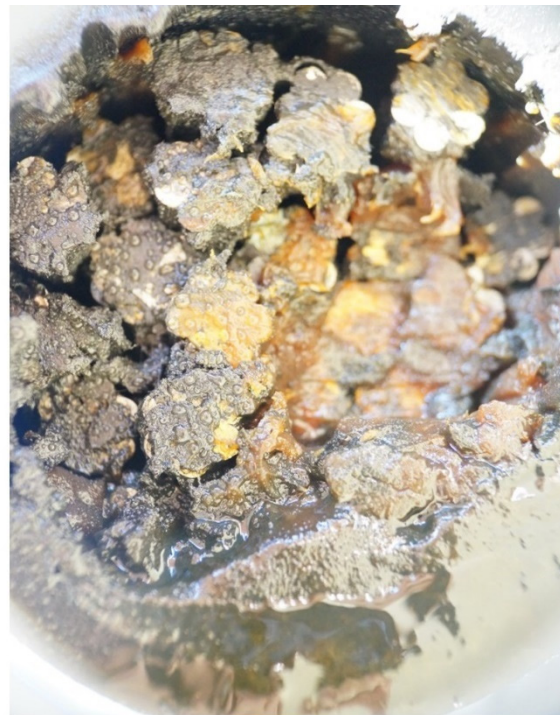
Not Sprayed – Bottom Side

Sprayed with Fungi Mix

Figure 80. Four-inch diameter sample sprayed with fungi mix (December 2017).

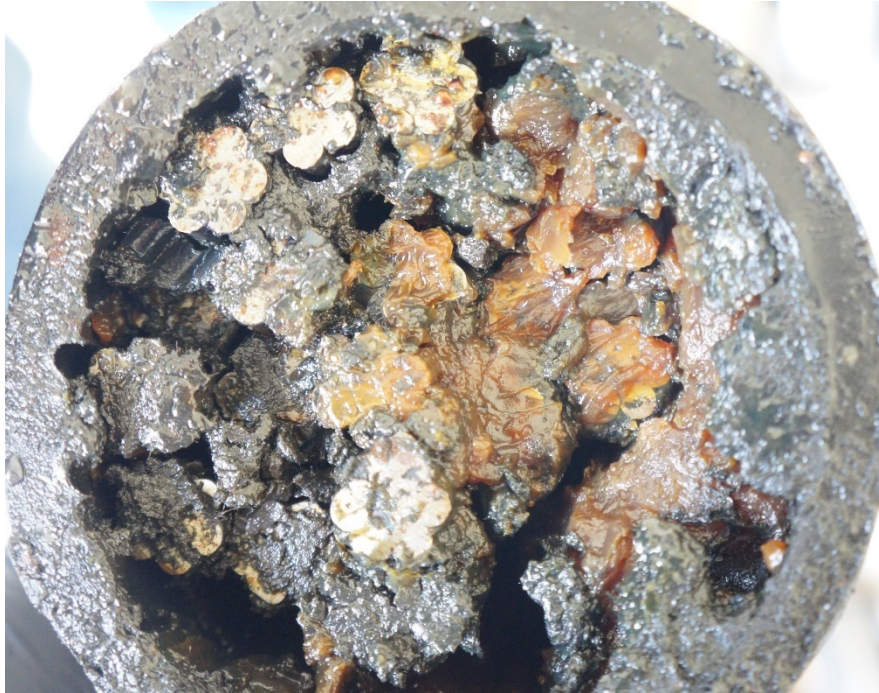
Figure 81. Four-inch diameter sample, side sprayed with fungi mix. June 2018.
