Final Report

Corrosion Prevention of Bridge Tendons Using Flexible Filler Materials
BDV27-977-10

Submitted to
Florida Department of Transportation Research Center
605 Suwannee Street
Tallahassee, Florida 32399

November 2018

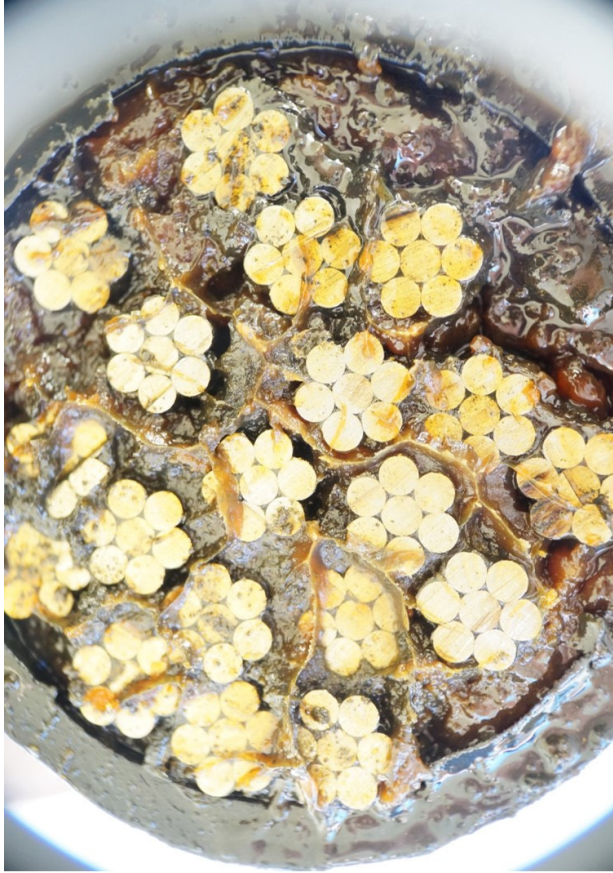
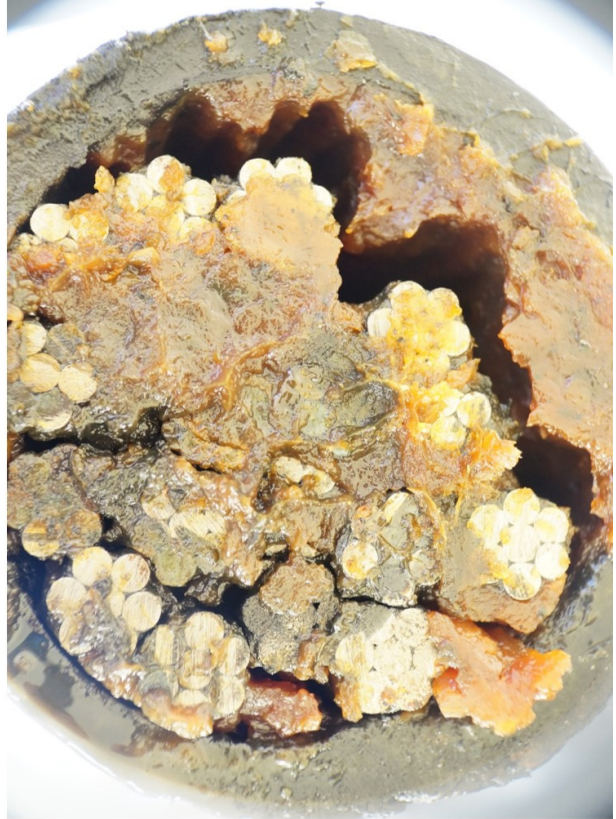
Not Sprayed – Bottom Side

Sprayed with F.O.

Figure 82. Four-inch diameter sample sprayed with FO (December 2017).

Figure 82 to Figure 87 show the surface condition for the samples initially sprayed with FO, PC and AF, respectively. The spraying that took place at a later time was done with water. Figure 82, 84, and 86 show a picture of the surface on the right that was initially sprayed with the fungi solution. Figure 82, Figure 84 and Figure 86 show pictures taken during December 2017, and Figure 83, Figure 85 and Figure 87 show pictures taken during May/June 2018. Based on what the pictures showed. It is not clear if the fungi has spread or if corrosion has initiated. There are a few strands that have one or two wires that appear to be corroding, as indicated by rust stains. In most of the pictures showing the sprayed sides; there are gaps/separation between the filler and the strands. It is possible that some of the filler leaked-out during the cuts done to obtain shorter segments. It is also possible that during exposure some of the filler flowed downwards. The sample that appears to have the most corrosion is the specimen initially sprayed with AF (Figure 87).

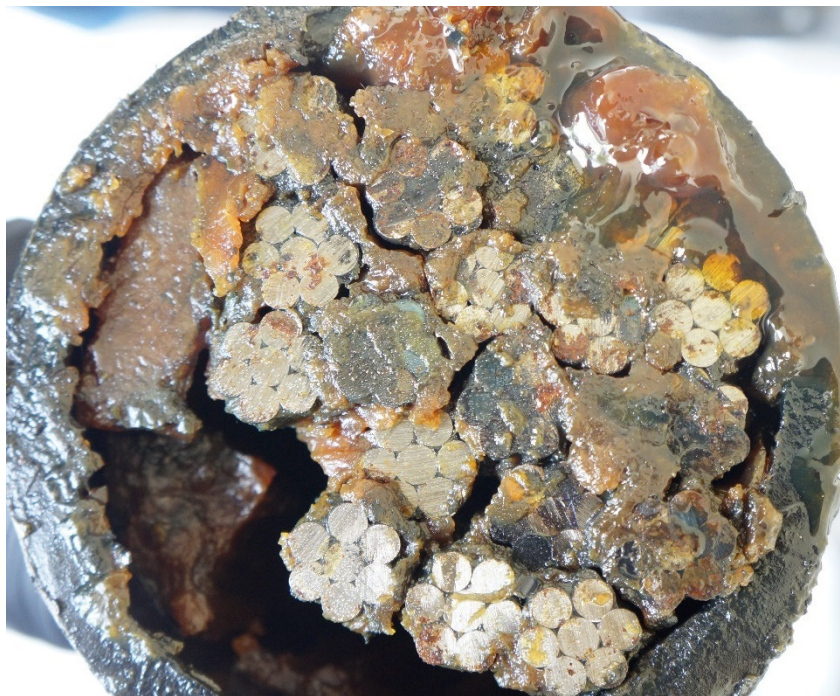
Figure 83. Four-inch diameter sample initially sprayed with FO, side sprayed with water. (May 2018).

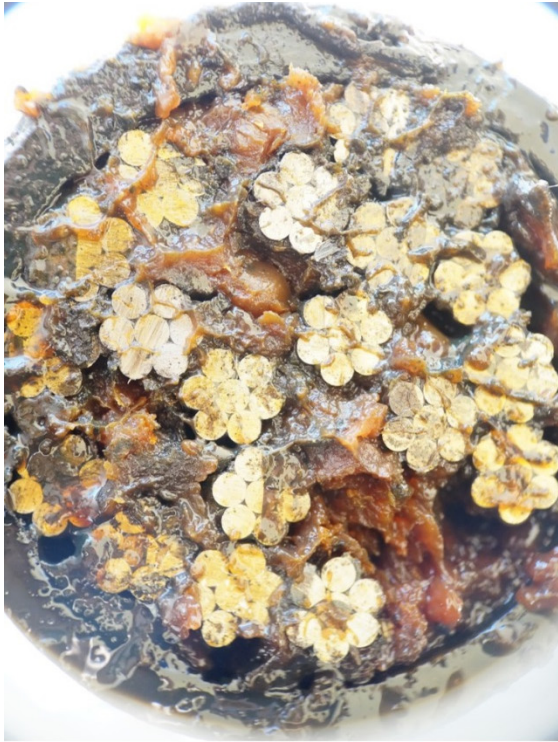
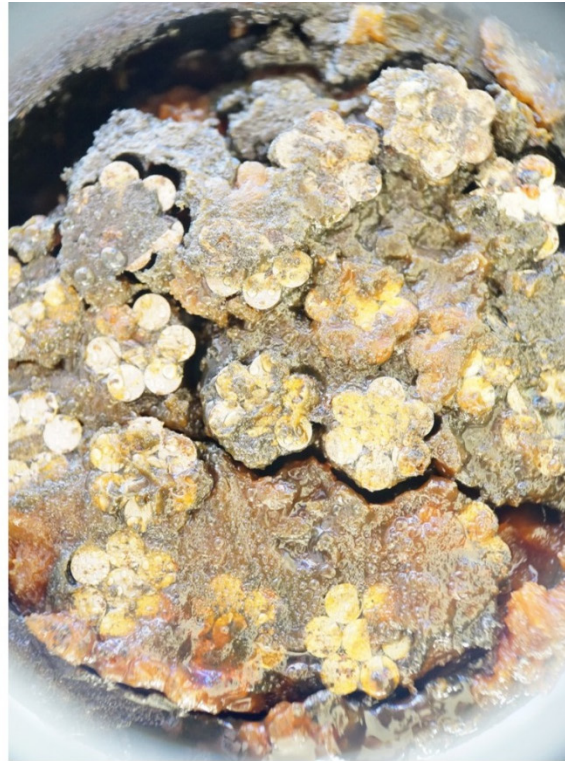
Not Sprayed – Bottom Side

Sprayed with P.C.

Figure 84. Four-inch diameter sample injected with Trenton and initially sprayed with PC. (December 2017)

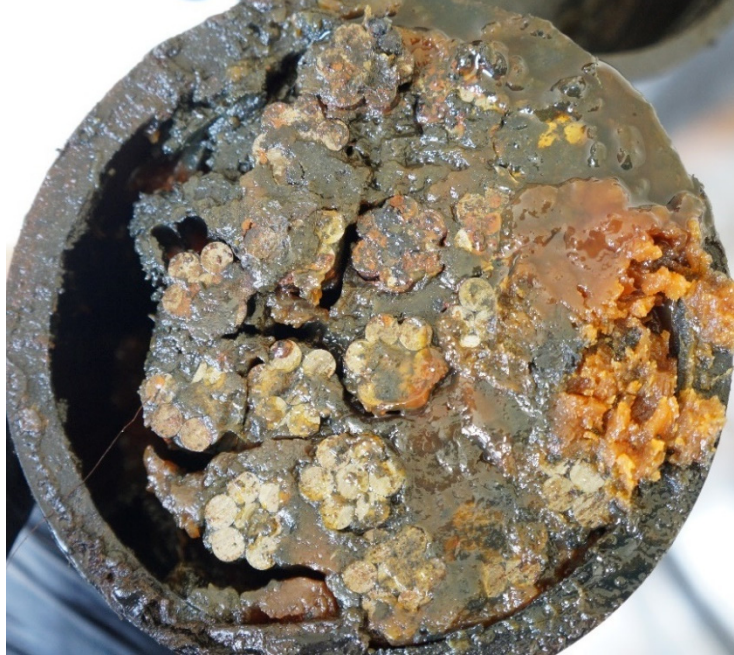
Figure 85. Four-inch diameter sample Trenton and initially sprayed with PC, side sprayed with water. (June 2018).

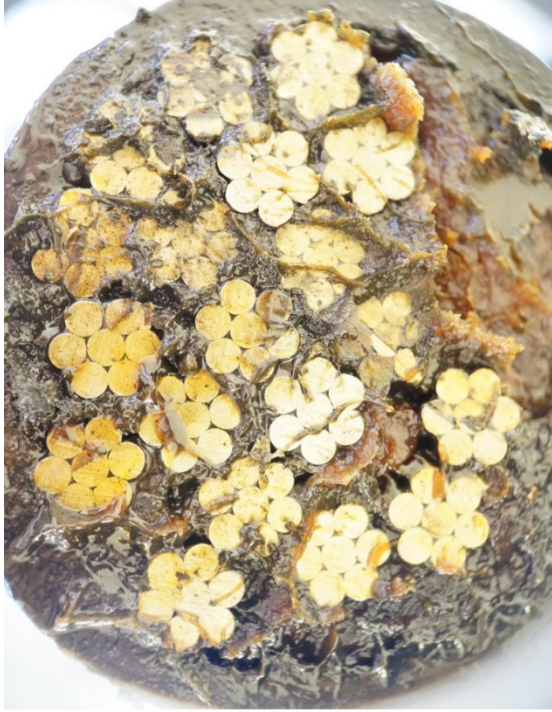
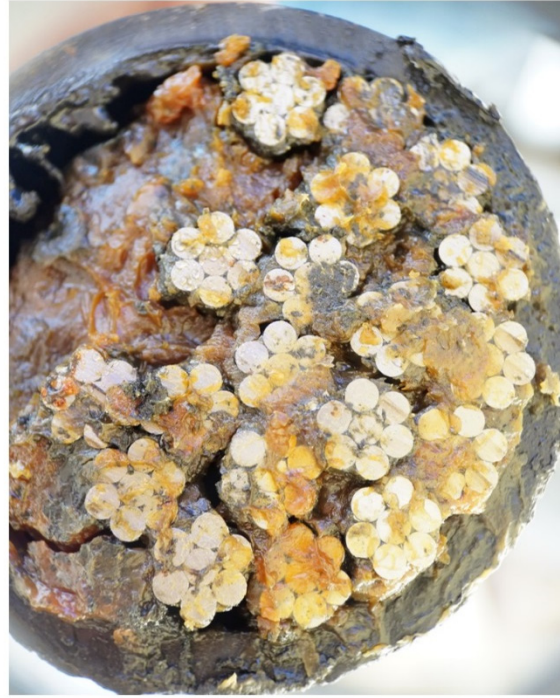
Not Sprayed – Bottom Side

Sprayed with AF

Figure 86. Four-inch diameter sample injected with Trenton and sprayed with AF (December 2017).

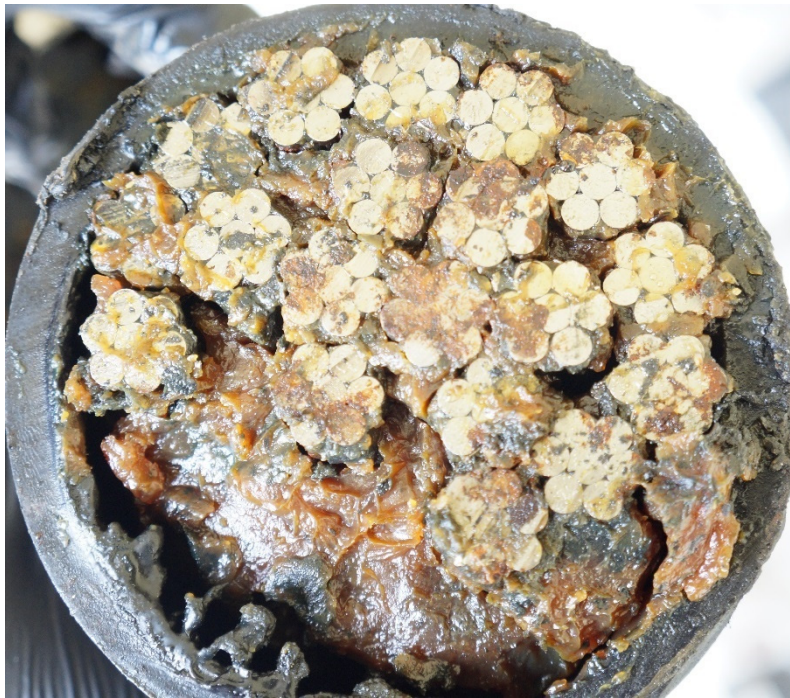
Figure 87. Four-inch diameter sample injected with Trenton and initially sprayed with AF, side sprayed with water. (May 2018).

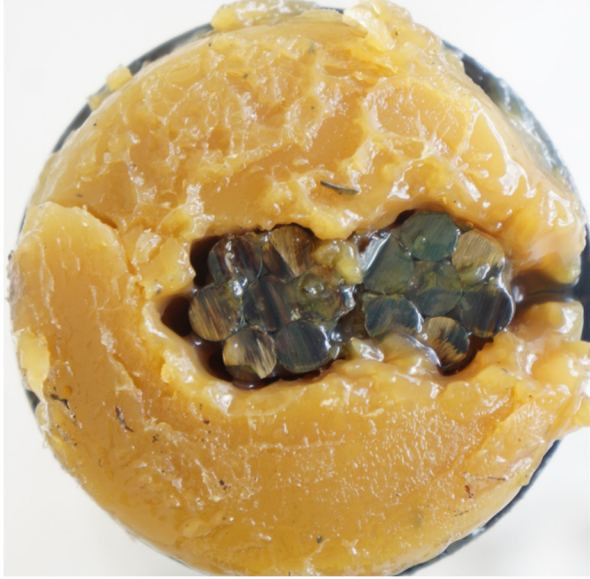
Figure 89. Civetea NC sample sprayed with fungi mix (one side) (June 2018).

Figure 88 shows the surface condition after removing the caps on both ends of the NC samples injected with Civetea and sprayed with fungi mix (picture on the right) during December 2017. A slight change in color appears to have taken place, but it might be due to a camera and/or light effect. The strand that is visible does not appear to be corroding. Figure 89 shows similar pictures for the sample injected with Civetea and sprayed with fungi mix during an inspection that took place during June 2018. Two strands are visible in the picture on the left and one strand is visible in the picture on the right. No corrosion is visible in the pictures shown in Figure 89.

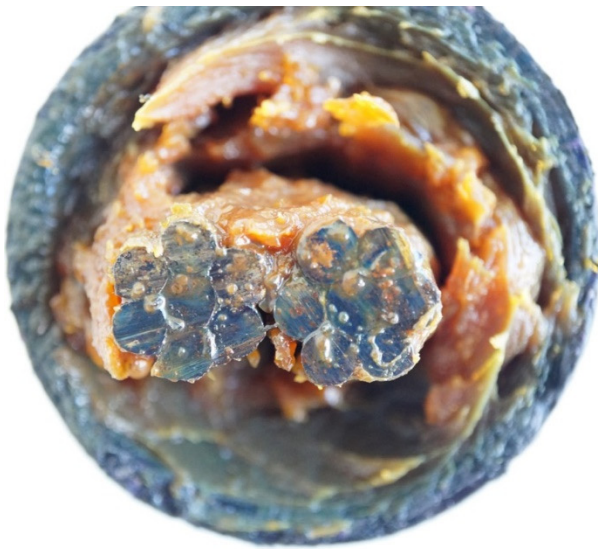
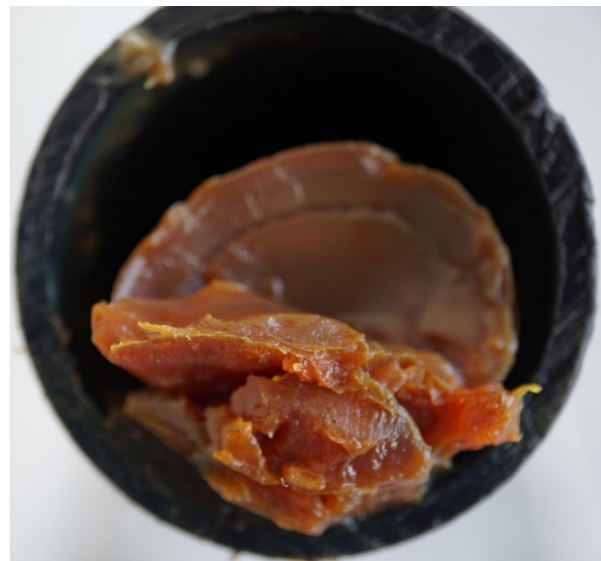
Figure 90 shows pictures of the Trenton injected NC sample and sprayed with fungi mix, for the inspection that took place December 2017. For this sample two strands are visible in the left picture with partial coverage of the filler. The picture on the right (side sprayed) only shows Trenton filler and no strand is visible. No color change is apparent. Figure 91 shows similar picture for the inspection performed during June 2018. The picture on the left shows two strands with good filler coverage and there is a thicker layer.

Figure 90. Trenton NC sample sprayed with fungi mix (one side) (December 2017).

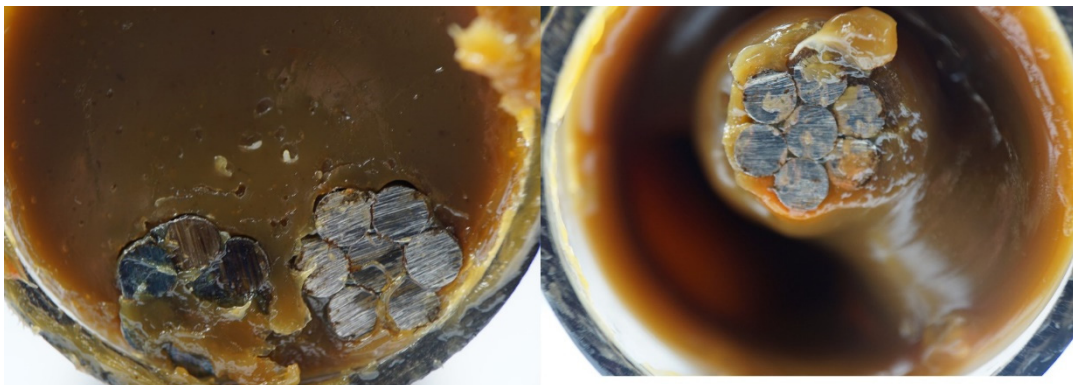
Figure 92 shows the Sonneborn injected NC sample sprayed with fungi mix (December 2017). One of the strands shows corrosion on both ends, and not just the side sprayed (picture on the right). The corroding sites appear small. Figure 93 shows similar picture for the same sample during the visual inspection performed June 2018. The picture on the left now shows that the two strands have a thick flexible filler layer. The two pictures show that the filler has shifted positions on both sides of the sample. Figure 94 shows the Sanchem injected NC sample sprayed with fungi mix. No strand is visible on the side sprayed with the fungi mix due to a thick layer of the filler. The strands visible on the opposite side (picture on the left) do not show corrosion. Figure 95 shows the view observed during June 2018. No significant change occurred, except for a thicker filler layer covering the strands on the left. The change in the color of the filler was due to the use of flash in June 2018.

Figure 92. Sonneborn NC sample sprayed with fungi mix (one side) (December 2017).

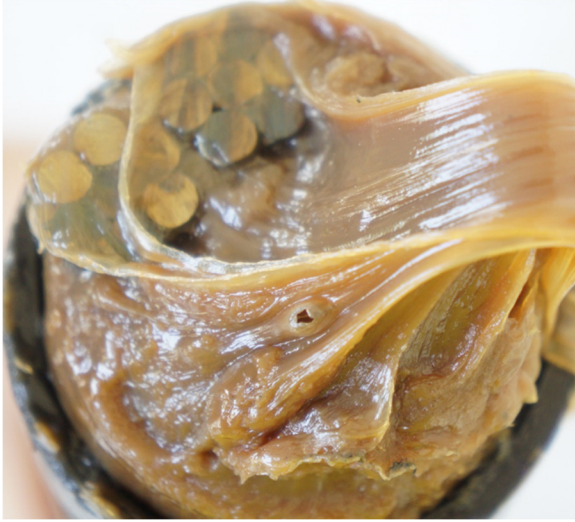
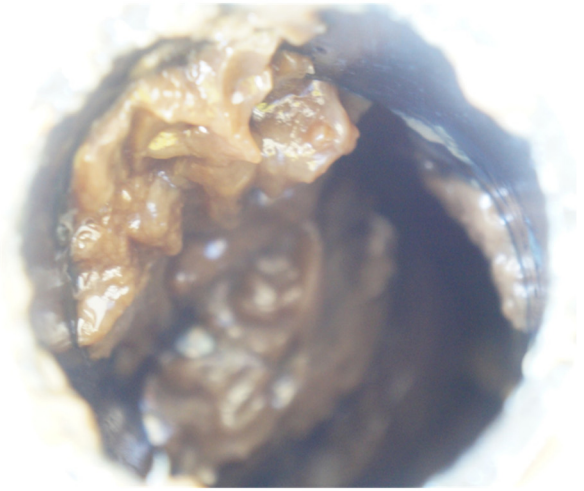
Figure 93. Sonneborn NC sample sprayed with fungi mix (one side) (June 2018).

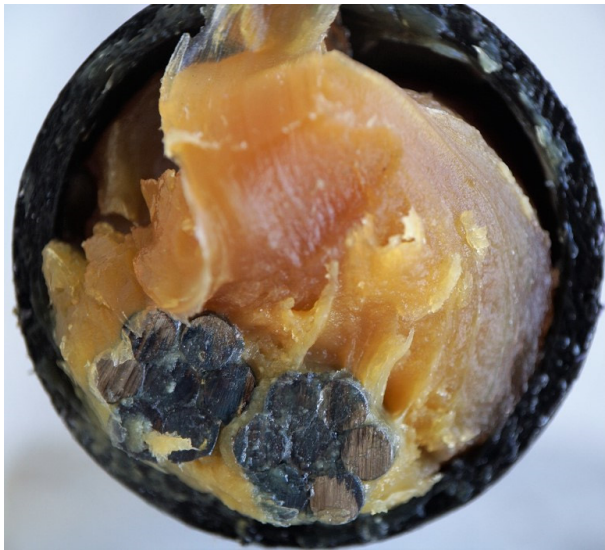
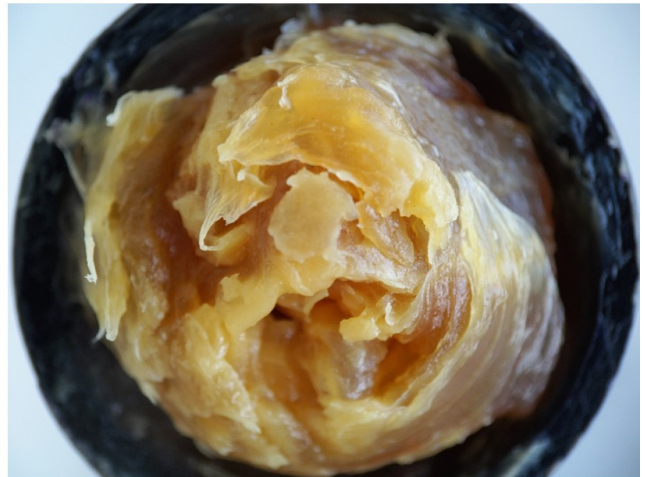
Figure 94. Sanchem NC sample sprayed with fungi mix (one side) (December 2017).

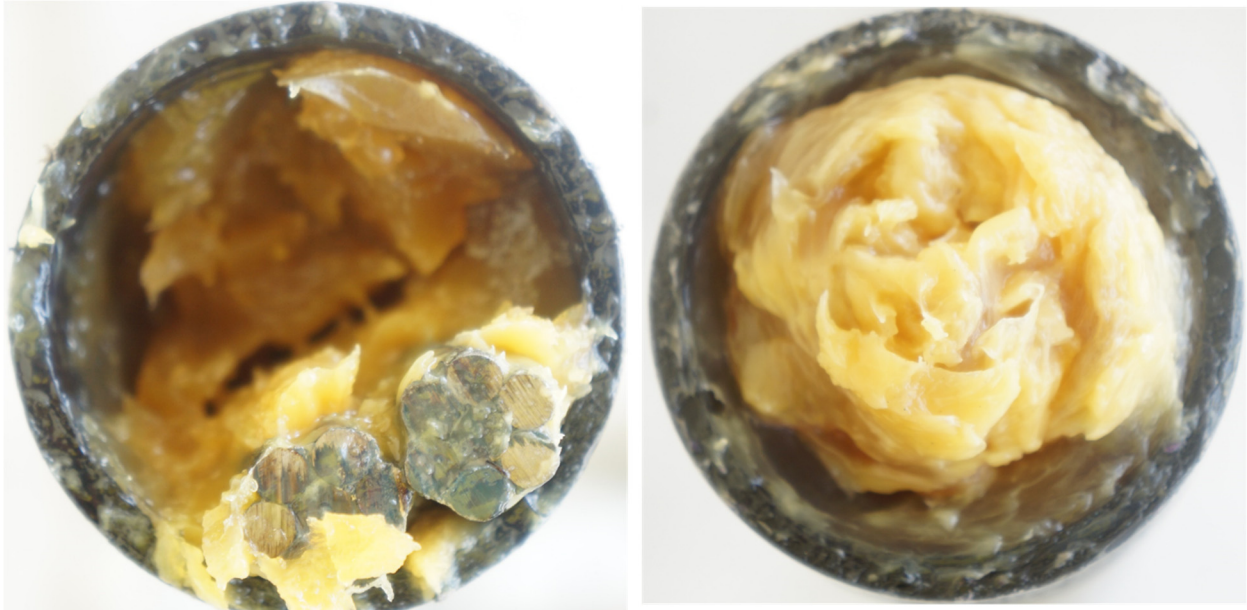
Figure 95. Sanchem NC sample sprayed with fungi mix (one side) (June 2018).

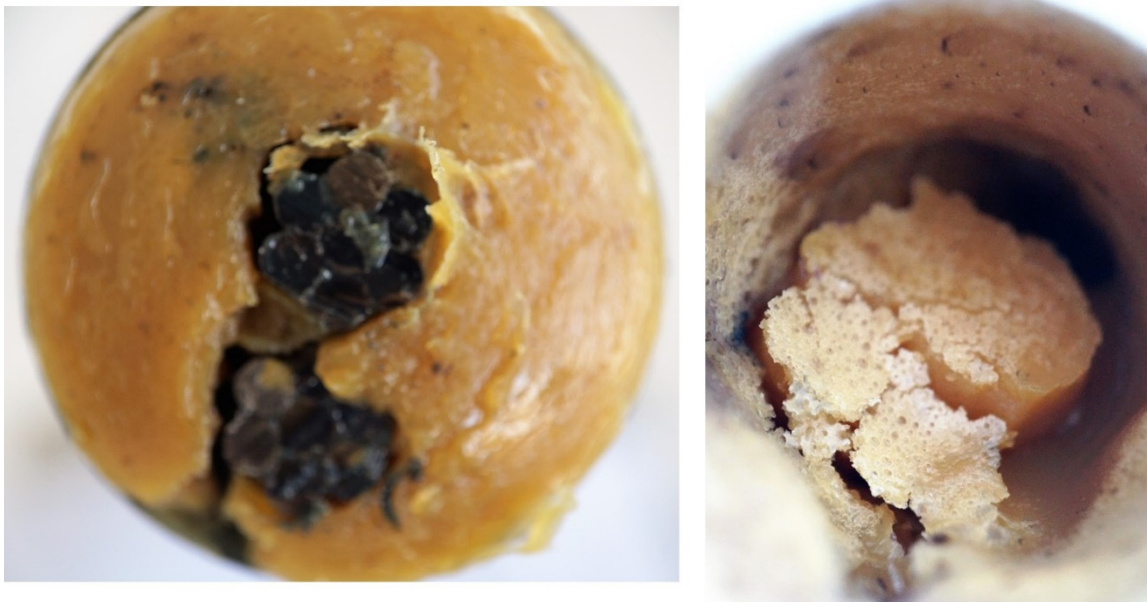
Figure 96. Nontribos NC sample sprayed with fungi mix (December 2017).

Similarly, Figure 96 shows pictures taken in December 2017 for the Nontribos injected NC sample that was sprayed with fungi mix. The picture on the right shows the side that was sprayed with fungi mix and no strand is visible. It is interesting to note that the filler shown in the picture on the right appears to have reacted at the surface (different color and texture). Figure 97 shows pictures taken in June 2018 for the samples injected with Nontribos and sprayed with fungi mix. The picture on the left shows that the strands are not corroding, and that additional filler has flowed down. The change in color seen is due to the use of flash for the pictures taken in June 2018.

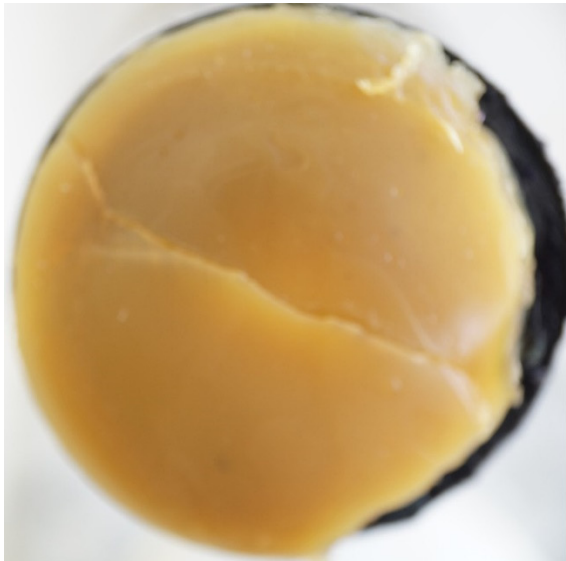
Figure 100. Civetea overheated sample sprayed with fungi mix (one side) (December 2017).

Figure 98 and Figure 100 show pictures taken in December 2017 of the overheated, injected samples for Trenton and Civetia, respectively. No strands were included in these samples. The sprayed side appears to have experienced a color change, but similar color change occurred on the sample sprayed with water. The color change might be due to overheating, and not a result of spraying with fungi mix solution. This applies to the pictures taken during December 2017. In June 2018, Figure 99 shows in the picture on the right that Trenton sample sprayed with fungi mix has a gold color stain on half of the surface that might be due to fungal interaction with the overheated Trenton filler. No such change was observed on the Civetia sample (Figure 101) during the inspection performed in June 2018.

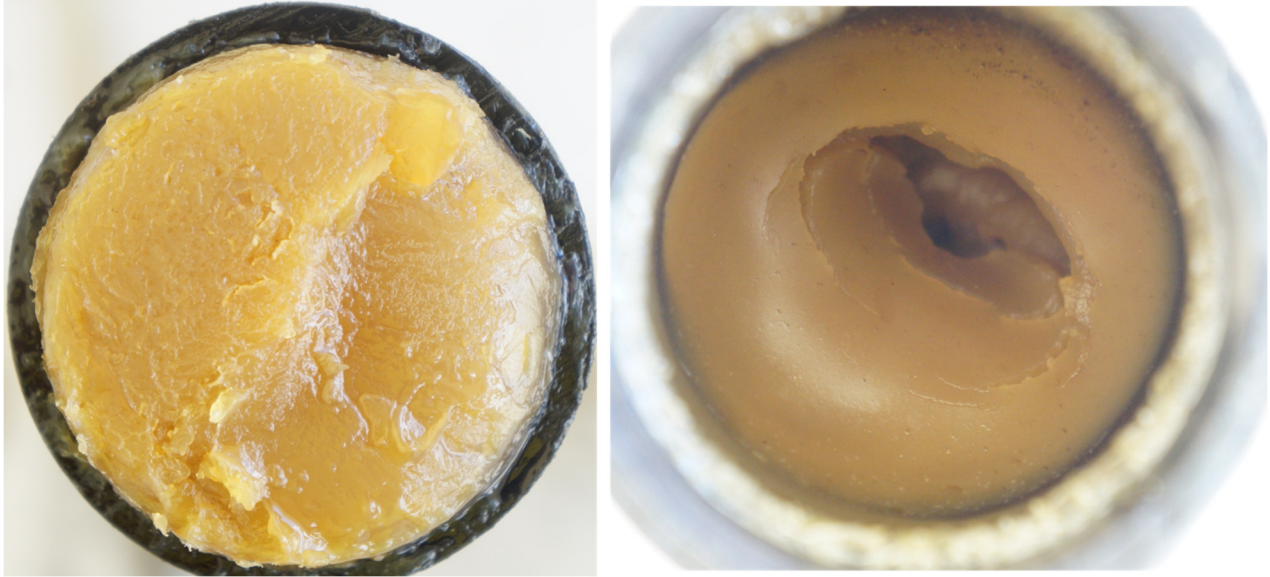
Figure 101. Civetea overheated sample sprayed with fungi mix (one side) (June 2018).

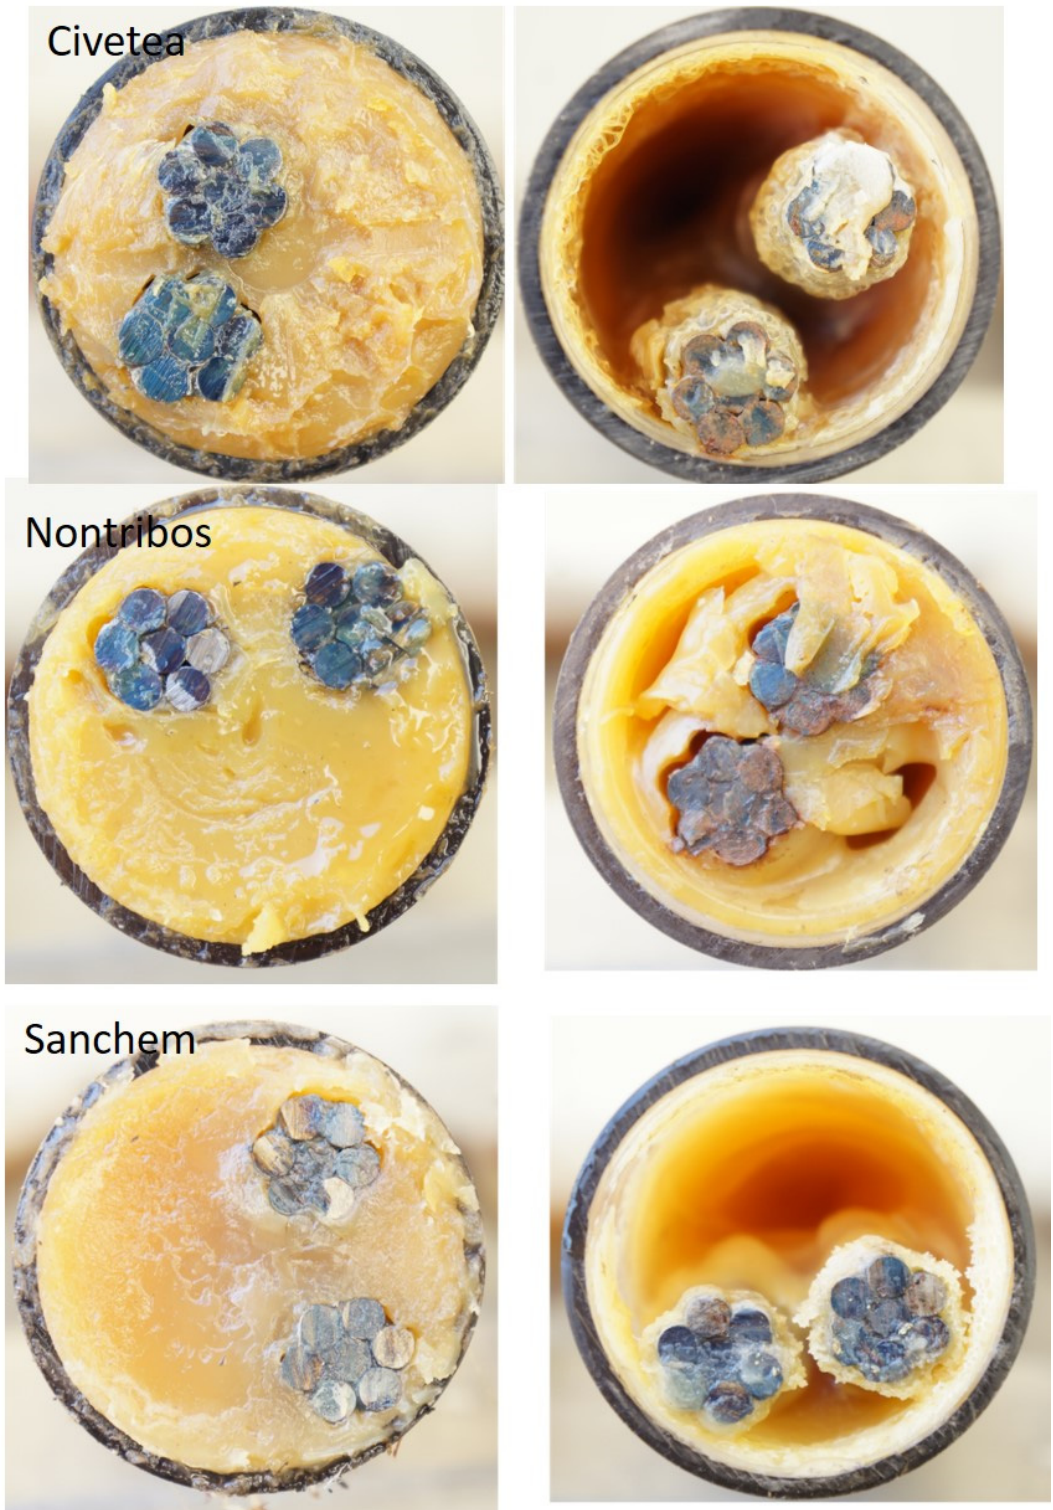
Figure 103. Samples injected with flexible fillers (polycarbonate tubing) and sprayed with fungi mix (May 2018).

Pictures of the samples sprayed with water and pictures of the samples sprayed with fungi mix will be presented in this section. In the figures that follow, the picture on the right shows the side that was sprayed. The samples that used NC strands were selected. A third sample with strands subjected to Conditioning Type 1 (C1) were placed on the shelf at this exposure location, but were not sprayed. The caps of C1 samples were periodically removed, similar to what was done for NC sprayed samples. No changes were observed on the C1 samples, because neither moisture nor fungi mix solution was sprayed. Figure 102 shows the NC samples sprayed with fungi mix, for specimens injected with Civetea, Nontribos, and Sanchem for the inspection performed in December 2017. Figure 103 shows NC samples sprayed with fungi mix, for specimen injected with Civetea, Nontribos, and Sanchem for the inspection done in May 2018. The samples on the right show modest amounts of corrosion on the samples injected with Civetea and Nontribos, but not on the sample injected with Sanchem. The opposite side did not show corrosion on any of these samples. The corrosion appears to have progressed on the Civetea sample. Also a change in the coloring of the flexible filler took place. A lesser amount of drops/moisture were observed during May 2018.

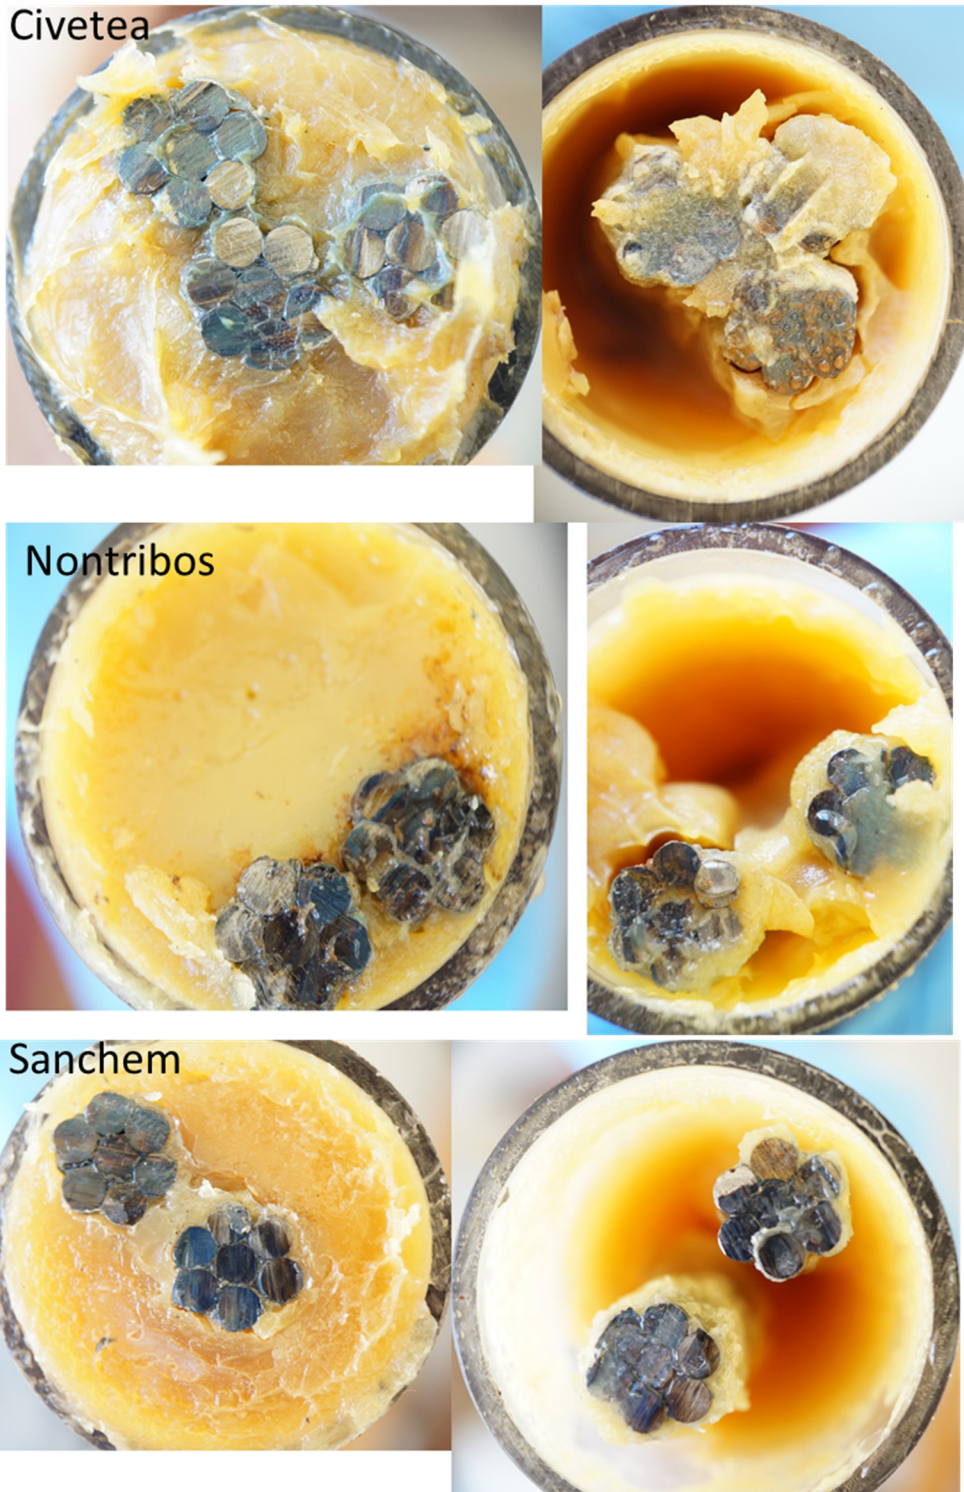
Figure 106. Samples injected with flexible fillers (polycarbonate tubing) and sprayed with water. (December 2017)

Figure 106 shows the surface condition for samples sprayed with water and injected with Civetea, Nontribos and Sanchem during the December 2017 inspection. Minor amounts of rust are visible on one strand of the sample injected with Civetea (top right picture). A couple of wires on one strand show corrosion spots on the sample injected with Nontribos, but no corrosion spots are distinguishable on the sample injected with Sanchem. Figure 107 shows pictures taken in May 2018 of samples sprayed with water and injected with Civetea, Nontribos and Sanchem. The corrosion spots appear to be at the same locations, and at some there is a thicker red rust-like coloring. Figure 108 shows pictures of the surface condition for specimens injected with Sonneborn and Trenton, and sprayed with water during December 2017. No corrosion is visible on these samples. Figure 109 shows pictures of the surface condition for specimens injected with Sonneborn and Trenton, and sprayed with water during May 2018. No corrosion is visible on wires

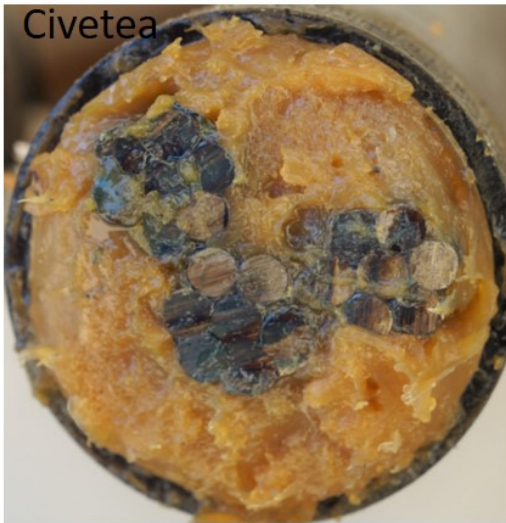
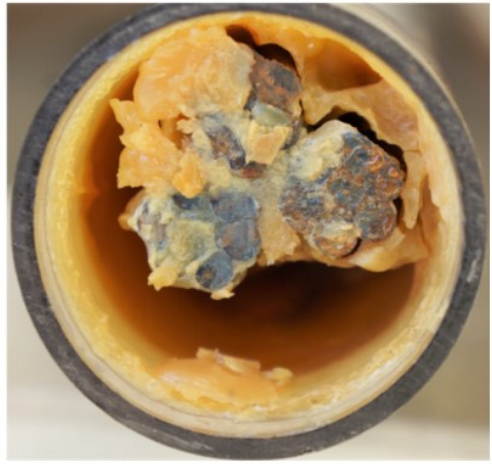
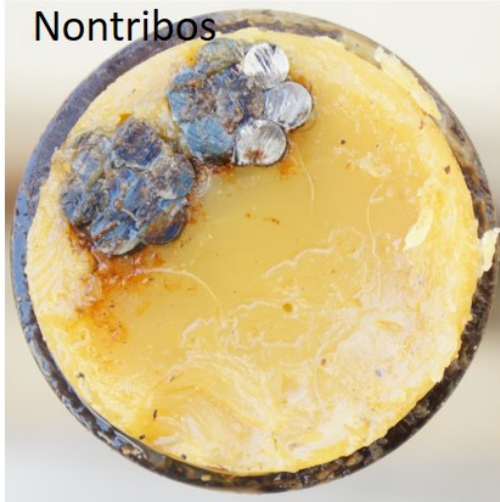
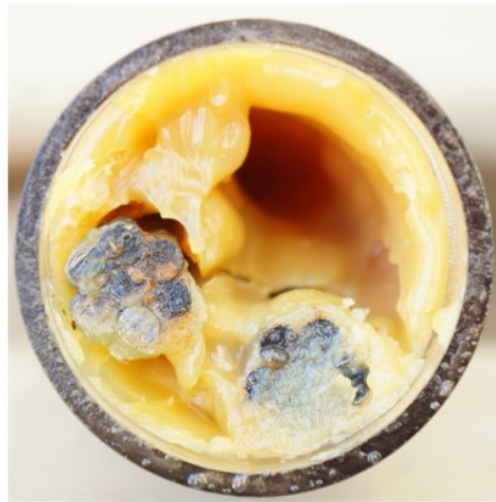
Figure 107. Samples injected with flex fillers (polycarbonate tubing) and sprayed with water (May 2018).

of the strands coated with Sonneborn. The picture on the right shows some red rust-like coloring on the wires of one of the strands for the sample injected with Trenton and sprayed with water.

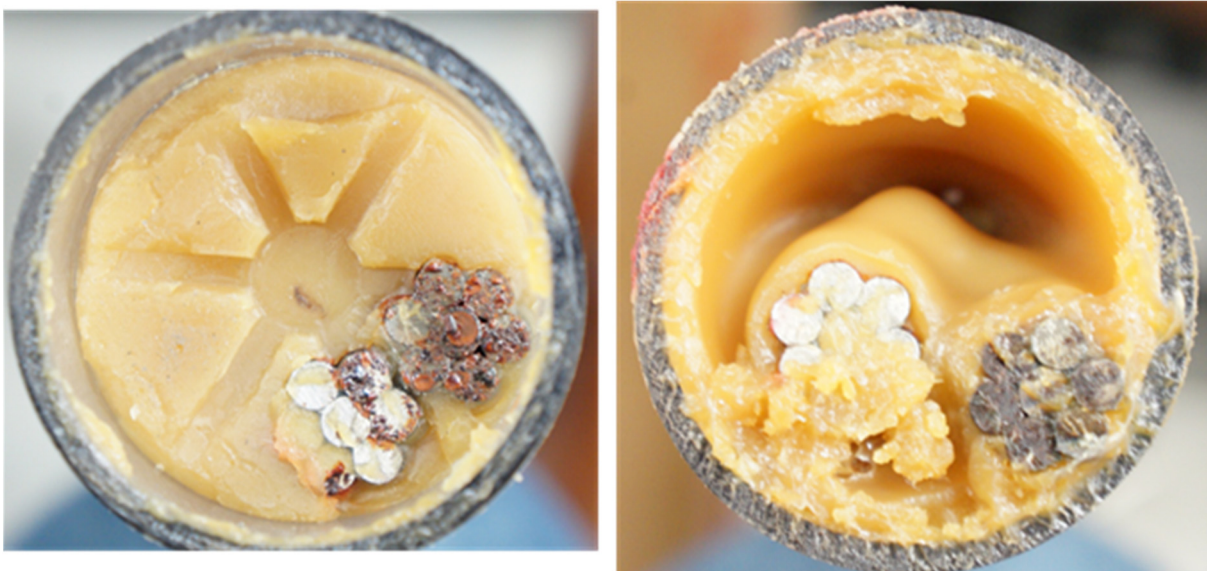
Figure 111. Two-foot long samples injected with Civetea filler (polycarbonate tubing) sprayed with fungi mix (June 2018).

exposure to the lab environment while inspecting the sample. Figure 111 shows the same sample during the inspection performed in June 2018. No corrosion was observed on the side sprayed with fungi mix (the picture on the right). The picture on the left shows larger coverage by corrosion products (red rust). It is possible that some of the solution wicked with time and reached the strand that has little or no flexible filler. Figure 112 shows both ends of the samples injected with Trenton and sprayed with fungi mix, during the inspection that took place in December 2017. No corrosion is observed. The side sprayed with fungi mix appears to have a layer of the filler. Figure 113 shows in the picture on the right that both strands have a few wires with red rust-like stains.

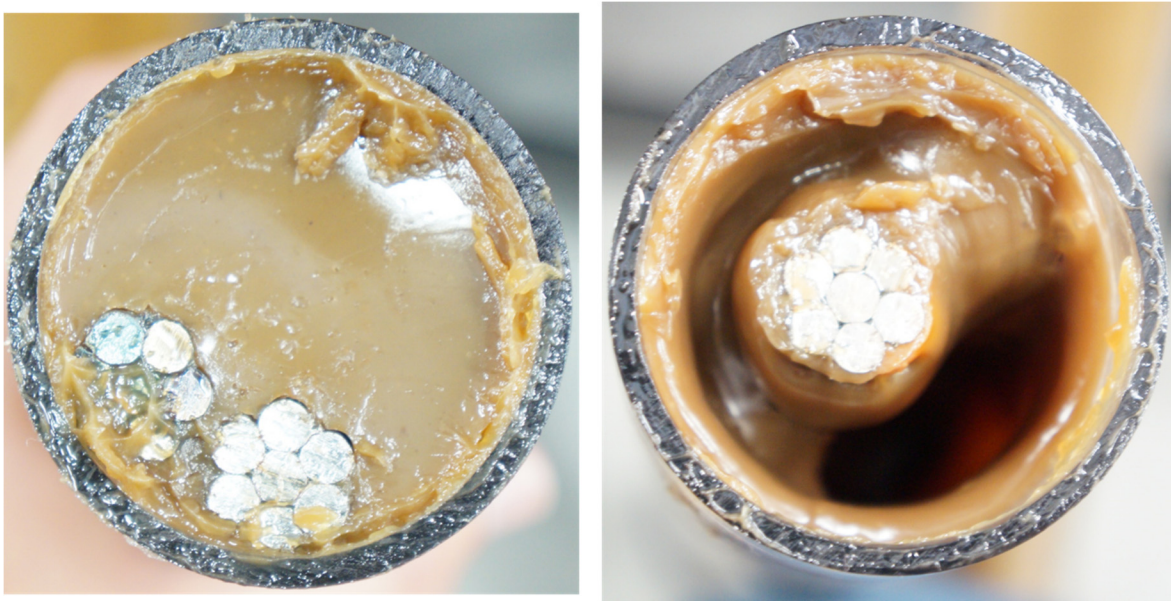
Figure 115. Two-foot long samples injected with Sonneborn filler (polycarbonate tubing) sprayed with fungi mix (June 2018).

Figure 114 shows the samples injected with Sonneborn and sprayed with fungi mix. The picture on the right (the side sprayed with fungi) illustrates that only one strand is visible, and that the other is fully covered with filler. No corrosion is observed. The picture on the left shows no corrosion on the wires. Figure 115 shows pictures taken in June 2018 for the sample injected with Sonneborn and sprayed with fungi mix. No corrosion is visible. The recent pictures were taken with the flash on and that caused the filler to look lighter and some of the wires to appear quite bright.

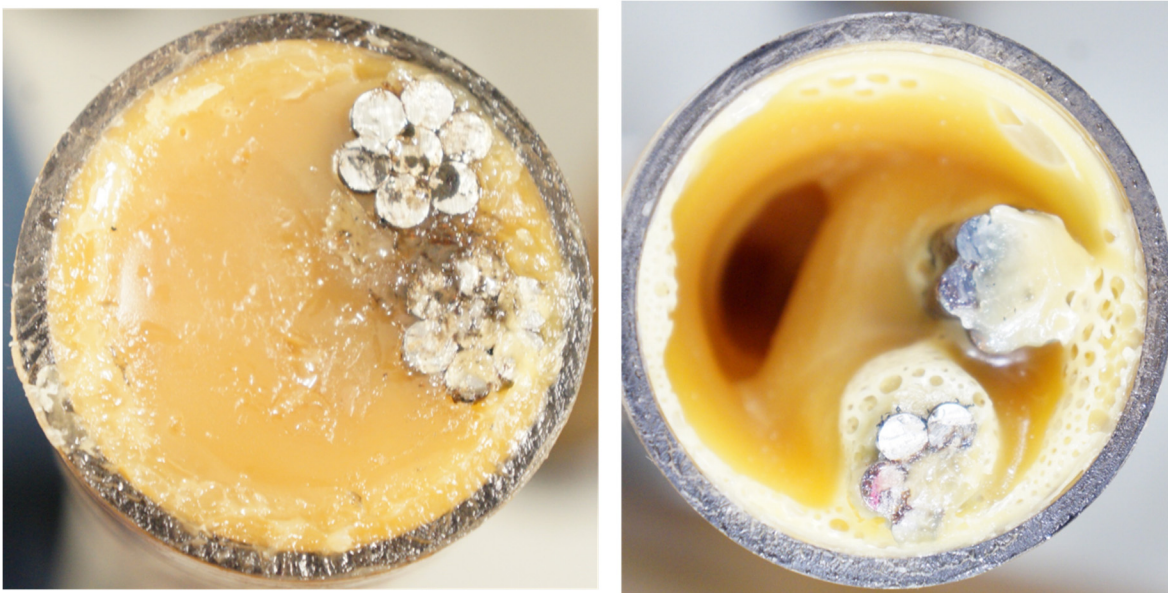
Figure 117. Two-foot long samples injected with Sanchem filler (polycarbonate tubing) sprayed with fungi mix (June 2018).

Figure 116 shows the sample injected with Sanchem sprayed with fungi mix during the inspection that took place in December 2017. In the picture on the right (the side sprayed with fungi mix), both strands are visible and both appear to be covered with filler. No corrosion is observed. The picture on the left shows black spots. Figure 117 shows pictures taken in June 2018 on the same sample. Flash was used and resulted in a lighter coloring of the flexible filler in the picture. The picture on the left shows that most of the black stains observed in December 2017 are no longer visible, but there are still some areas covered in black. The picture on the right shows that two wires have reddish stains.

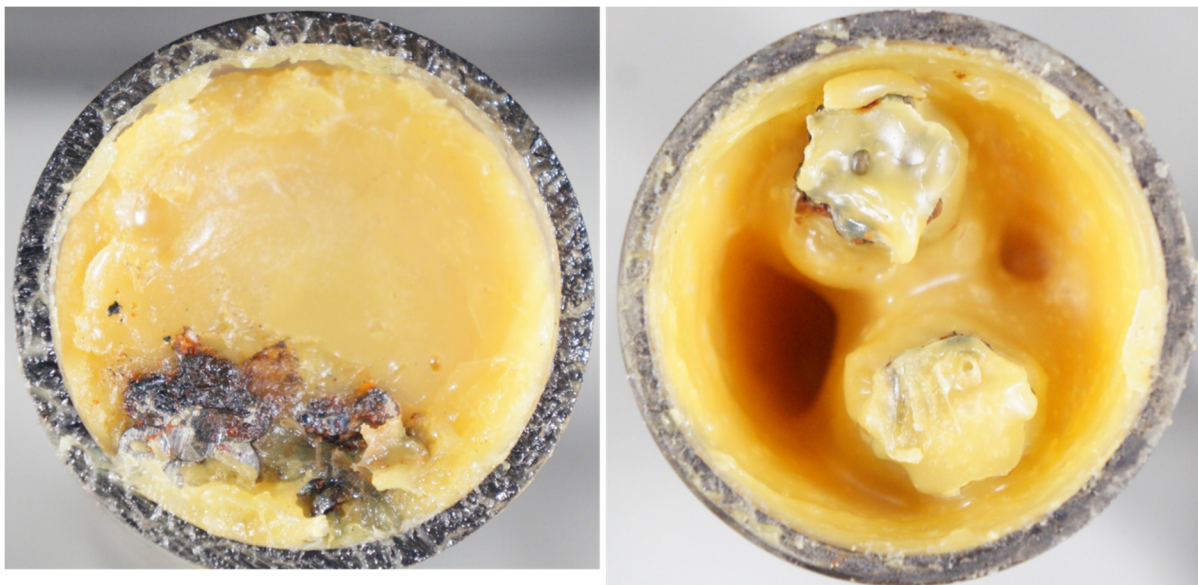
Figure 119. Two-foot long samples injected with Nontribos filler (polycarbonate tubing) sprayed with fungi mix (June 2018)

Finally, Figure 118 shows the sample injected with Nontribos and sprayed with fungi mix during the visual inspection that took place in December 2017. The side sprayed with fungi (picture on the right) shows good coverage of the filler over the strands. The picture on the left shows a couple of rust-colored spots on a couple of wires, but most other wires appear to be covered with the filler. Figure 119 shows the pictures taken in June 2018 on the Nontribos Sample Sprayed with fungi mix. The picture on the right shows that all wires still have good layer of the filler, but on the side there might be a couple of spots showing red rust stains. The figure on the left shows that corrosion has progressed on the wires of the strand shown on the left.

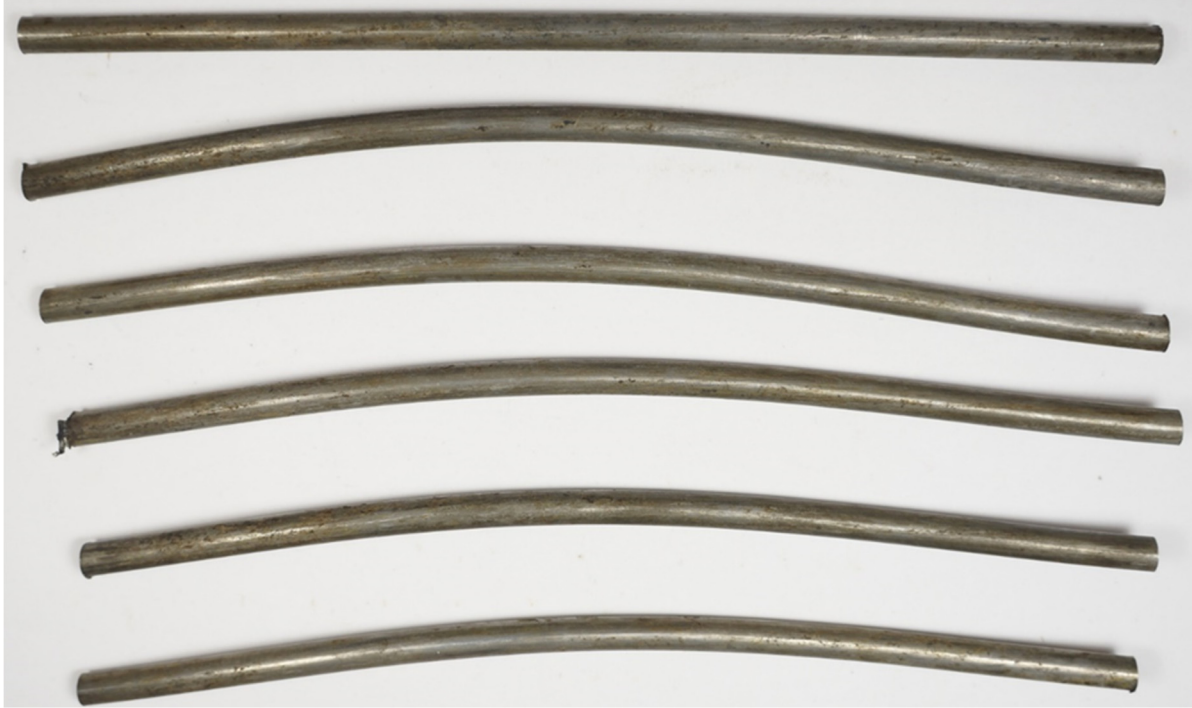
Figure 120. Section of Trenton coated strand (fungi mix), after cleaning

Figure 120 shows after cleaning wires coated with Trenton. This picture shows six of the seven wires. At least four of the wires were chemically cleaned. Figure 121 shows selected close-ups of the locations that appear to have the worst corrosion. One of these wire sections was selected for further analysis by taking images with the SEM. A smaller section that fits within the SEM holder was obtained. Figure 122 shows the images obtained with the SEM. The image taken with 26X magnification suggests that corrosion took place at various locations. The location close to the center was selected for images at 150X, 300X, and 1,000X. The pictures obtained at 150X and 300X shows that on the left side of the images there are striations and on the center there is a region that had more depth (indicating larger cross-section loss).

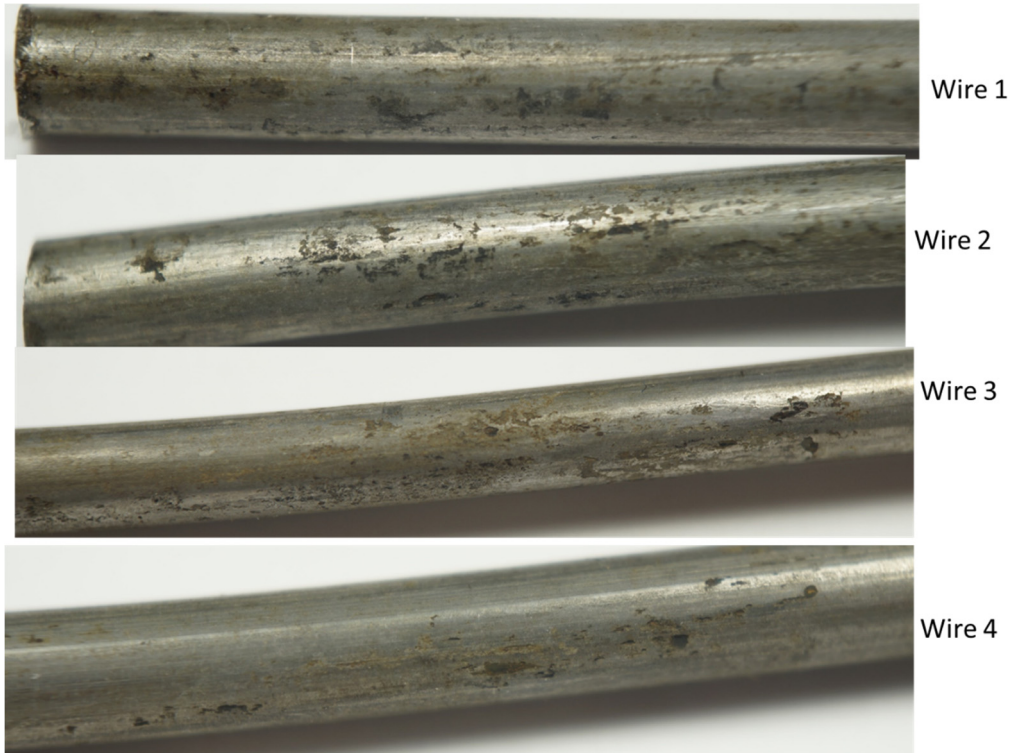
Figure 121. Close-up selected wires, after cleaning. (Trenton – fungi mix)

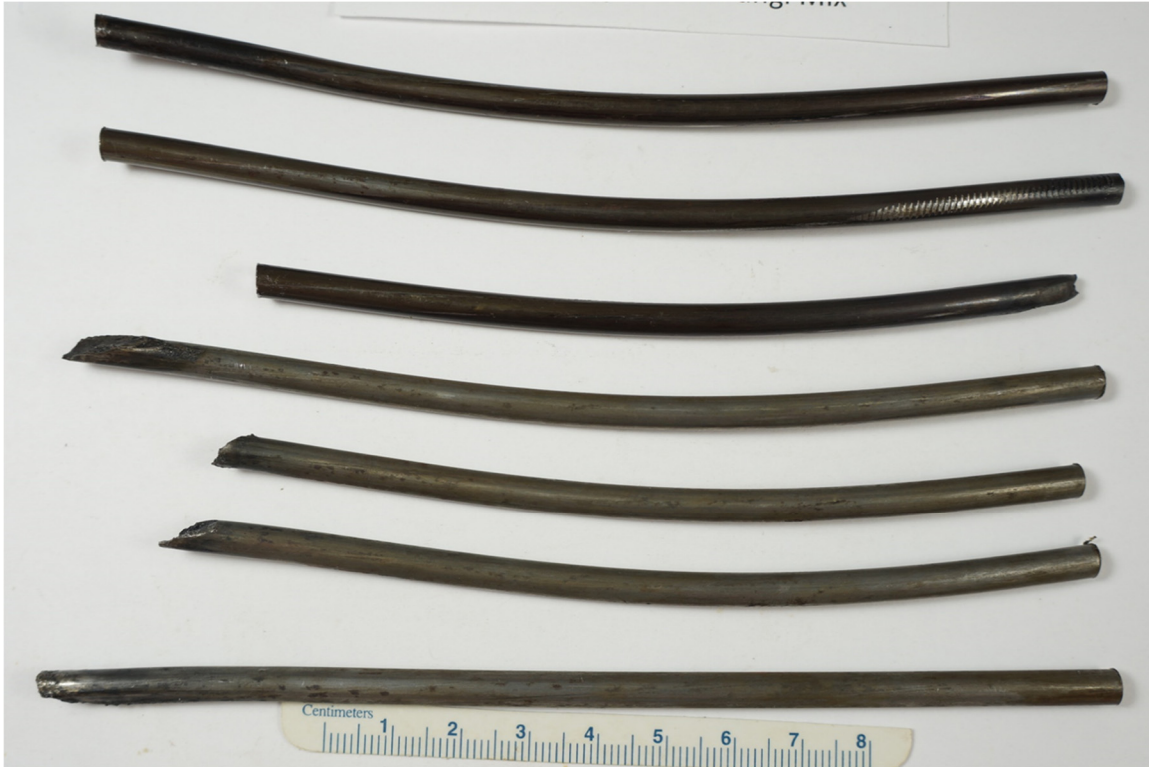
Figure 123. Section of Civetea coated strand, after cleaning (fungi mix).

Figure 123 shows the wires after cleaning for the section of the strand that was cut off from the sample coated with Civetea and sprayed with fungi mix. All wire sections were cleaned with mineral spirits, but only four were subjected to chemical cleaning (bottom four). The center wire (straight wire) appears to have the larger number of corroding sites. Corrosion spots are observed on the other three wires cleaned. Figure 124 shows close-ups for three of the wires. Figure 125 shows a picture taken with a stereo microscope and five pictures taken with the SEM. The SEM images show striations at the different magnifications and are more easy to identify on images taken at $\geq 300X$.
