Final Report

Corrosion Prevention of Bridge Tendons Using Flexible Filler Materials
BDV27-977-10

Submitted to
Florida Department of Transportation Research Center
605 Suwannee Street
Tallahassee, Florida 32399

November 2018

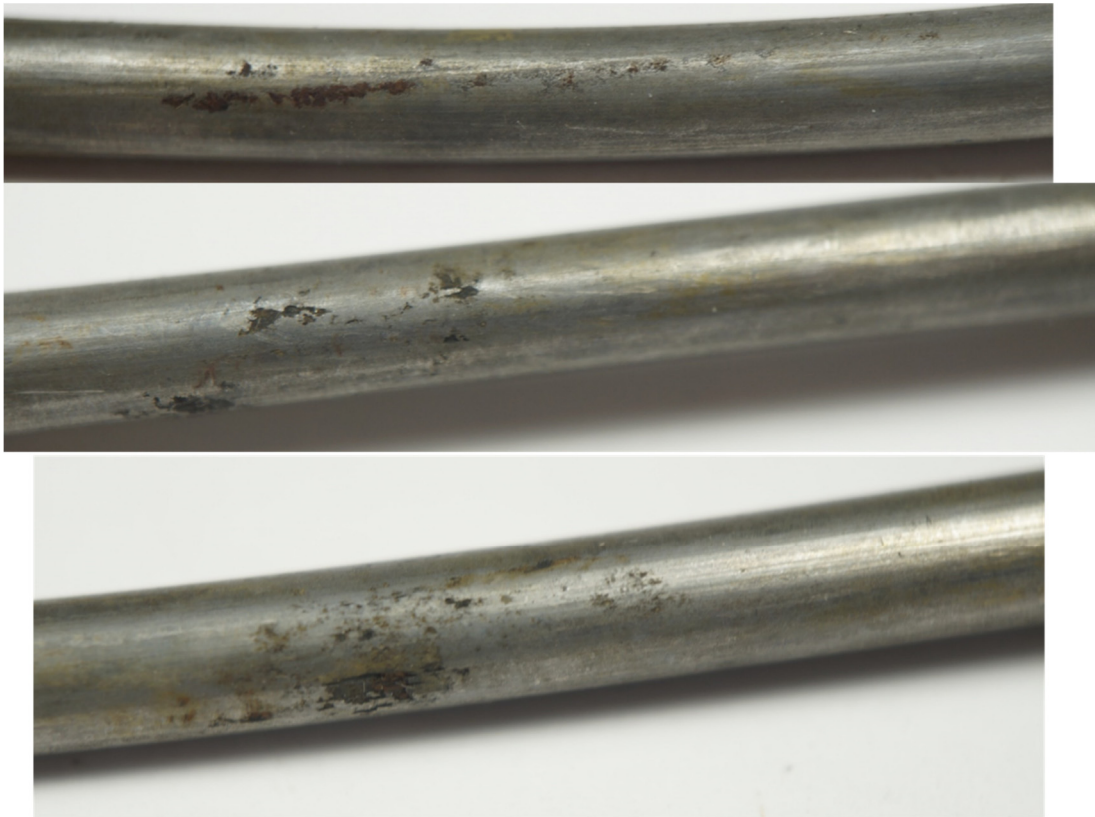
Figure 124. Close-up selected wires, after cleaning (Civetea – fungi mix)

Figure 123 shows the wires after cleaning for the section of the strand that was cut off from the sample coated with Civetea and sprayed with fungi mix. All wire sections were cleaned with mineral spirits, but only four were subjected to chemical cleaning (bottom four). The center wire (straight wire) appears to have the larger number of corroding sites. Corrosion spots are observed on the other three wires cleaned. Figure 124 shows close-ups for three of the wires. Figure 125 shows a picture taken with a stereo microscope and five pictures taken with the SEM. The SEM images show striations at the different magnifications and are more easy to identify on images taken at $\geq 300X$.

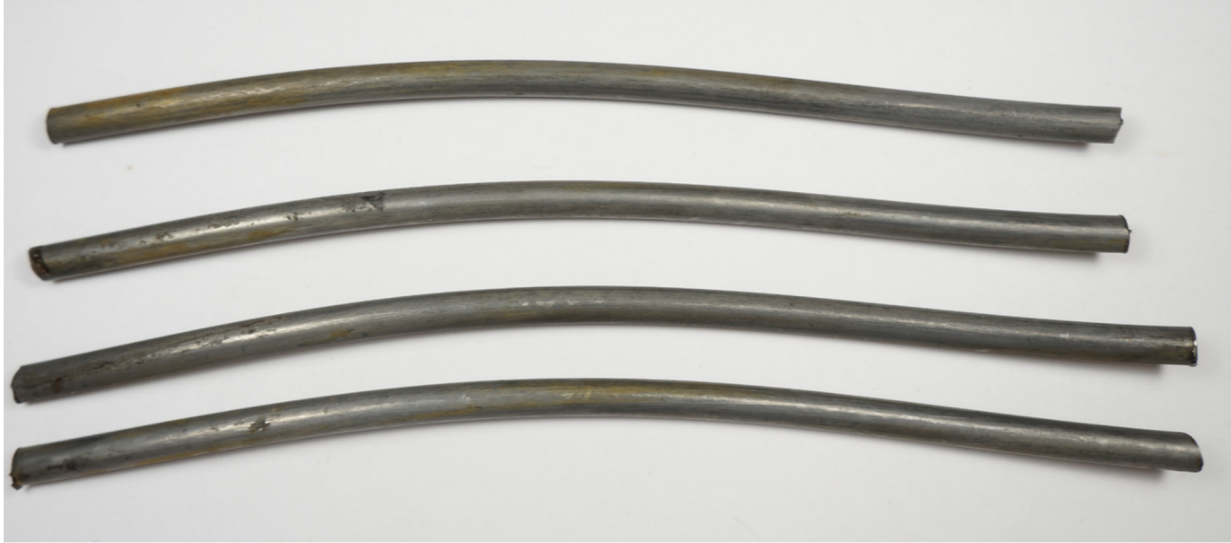
Figure 126. Section of Nontribos coated strand, after cleaning (Nontribos - fungi mix)

Figure 126 shows a picture of four cleaned wires taken from the cut off strand section for the sample coated with Nontribos and sprayed with fungi mix. Three of the wires show corrosion spots. Figure 127 shows close-ups for three wires. The corrosion sites are more clearly seen in the close-up images. The images suggest minor cross-section took place on the spots where corrosion occurred. Two sections were cut off from one of the cleaned wires to be able to observe them via the scanning microscope. Figure 128 and Figure 129 show on each a stereo micrograph and five images taken with the SEM. Figure 128 shows images with the following magnifications: 26X, 54X, 150X, 1,000X, and 5,000X. The images with the three larger magnifications show striations pattern that are likely due to corrosion. The image taken at 5,000X shows needle like structures. Figure 129 shows a stereo microscope image and five images taken with the SEM. The regions chosen had a corrosion site with a different shape. Particles appear to be present at the deeper corrosion site and higher magnification (1,000X), there are regions that show striations at two different levels (150X and 300X images). Figure 130 shows that some regions of this wire had minor corrosion damage. Figure 131 shows a 2,000X magnification picture of a different site where the corrosion developed an interesting feature. The picture shows the remaining steel for a section that had corrosion cross-section loss.

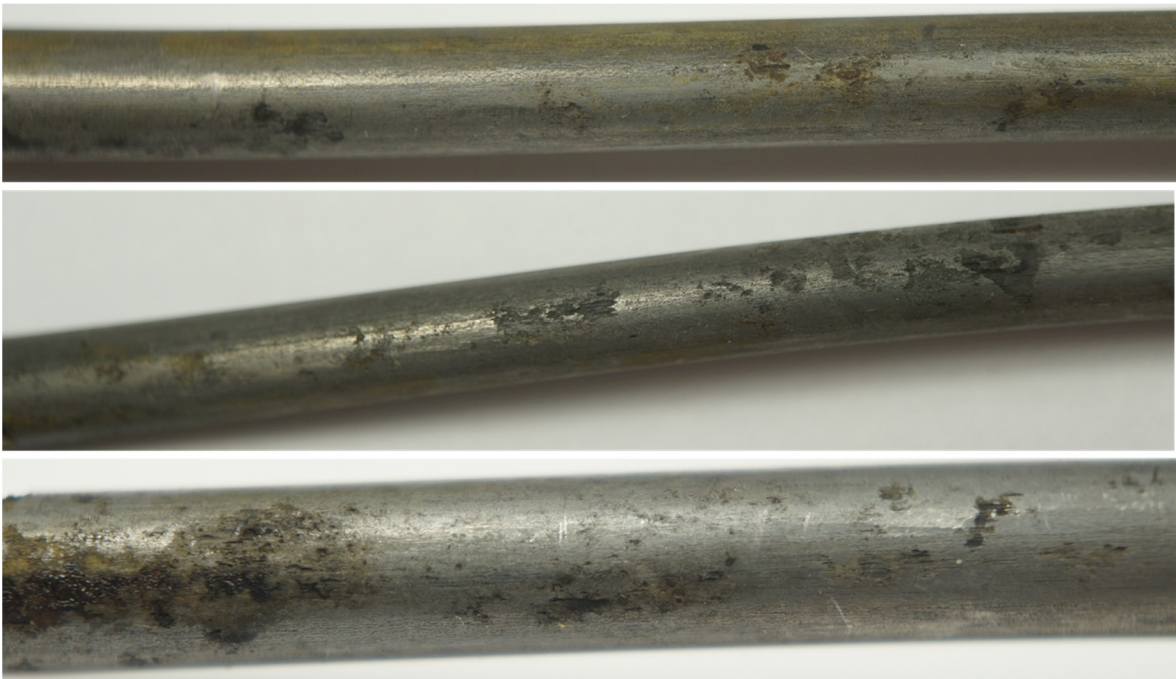
Figure 127. Close-up selected wires, after cleaning (Nontribos fungi mix)

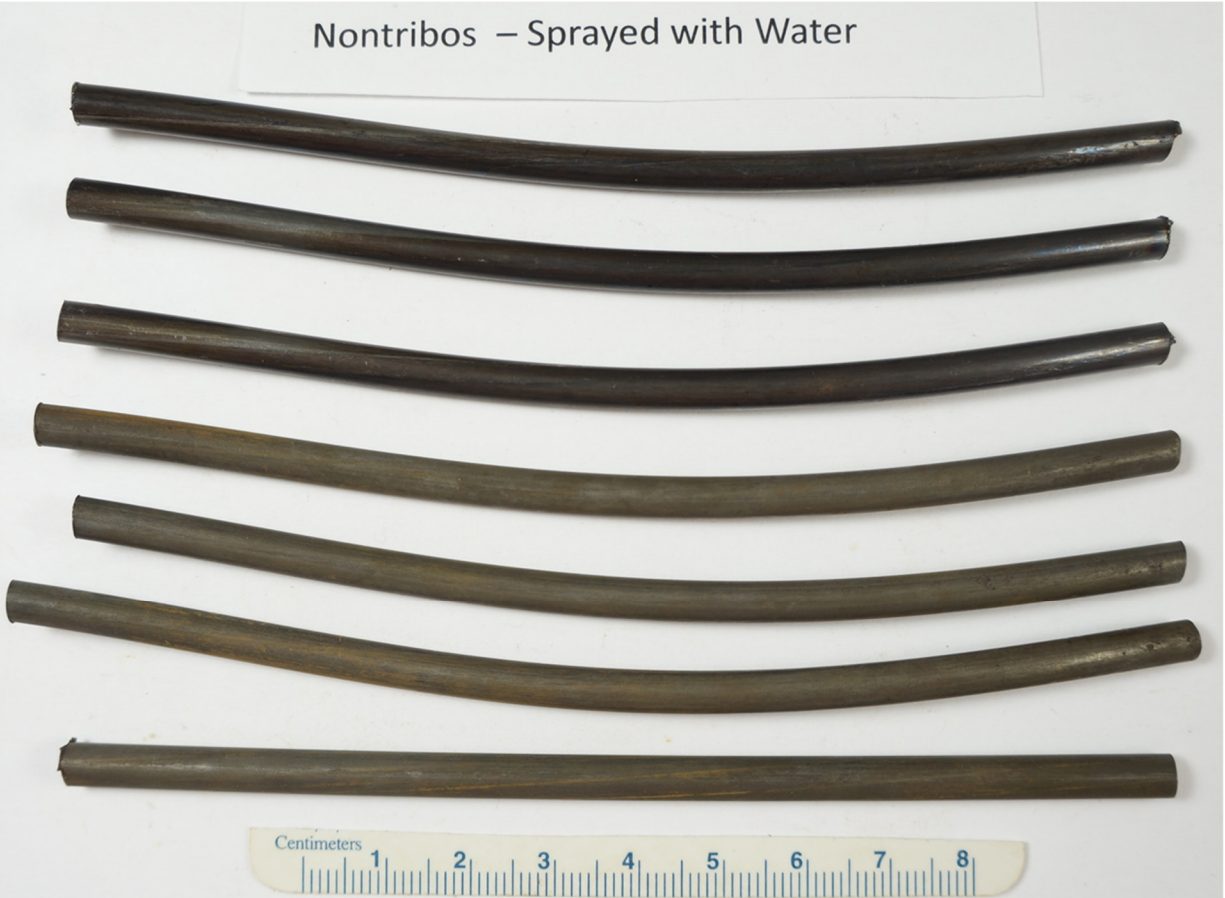
Figure 133. . Section of Nontribos coated strand, after cleaning – (water)

A strand was coated with Nontribos and sprayed with water, it was stored in a PVC pipe and placed outdoors. Figure 133 shows cleaned wires (top three still with mineral spirits) for the section of the strand cut off. No significant amount of corrosion was observed from this view. A section was cut off from one of these wires that appeared to have some corrosion. Images were taken with the SEM and are shown in Figure 134. The low magnification image (26X) shows that there are large areas with no corrosion and a few small spots with corrosion. The 300X image shows that corrosion took place and it displays striation like patterns. The higher magnification images show additional detail.

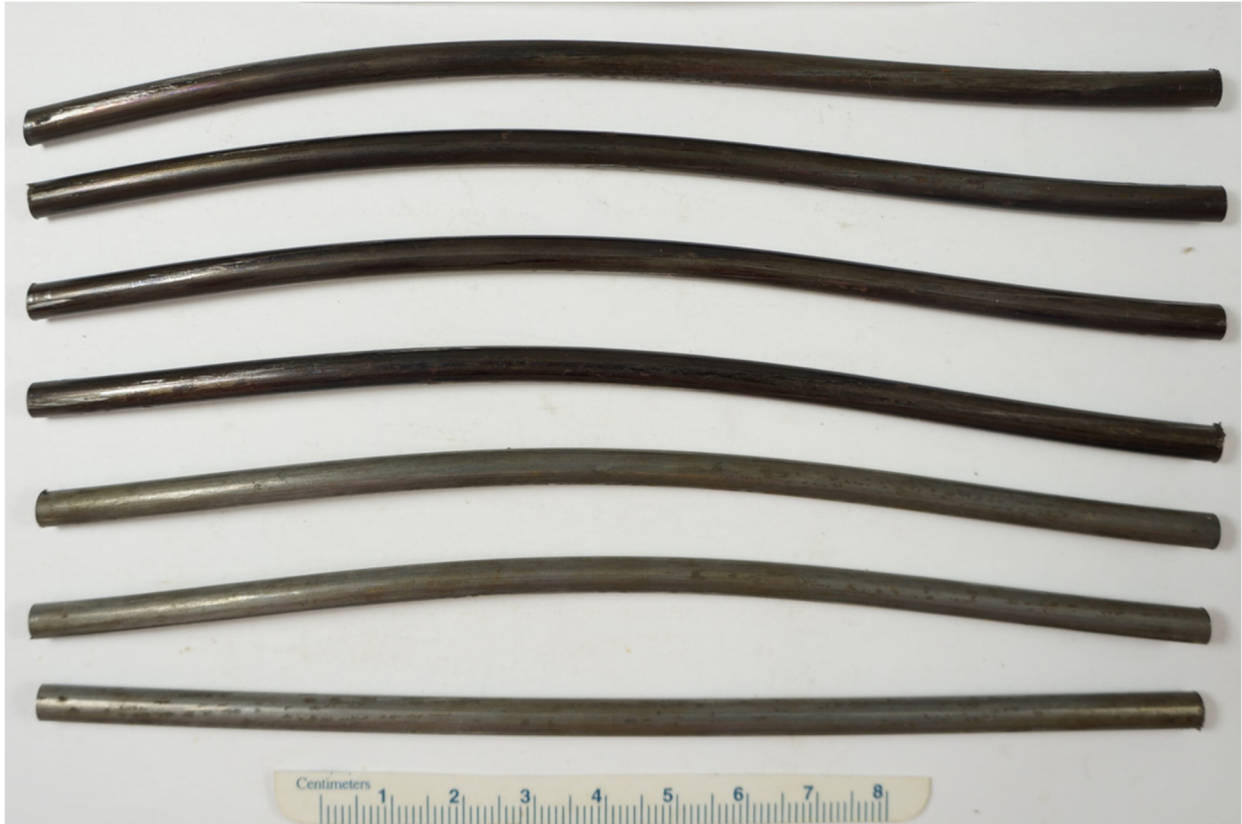
Figure 135. Section of Civetea coated strand, after cleaning (water)

Three wires from the cut off section were cleaned for the strand coated with Civetea and later sprayed with water. No SEM images were taken. Figure 135 shows the seven wires, three of which were chemically cleaned. Figure 136 shows a picture of a section with a corroding site on the top row. The bottom row shows three pictures taken with the stereo microscope. The 3X images indicate that pitting like corrosion took place in some areas.

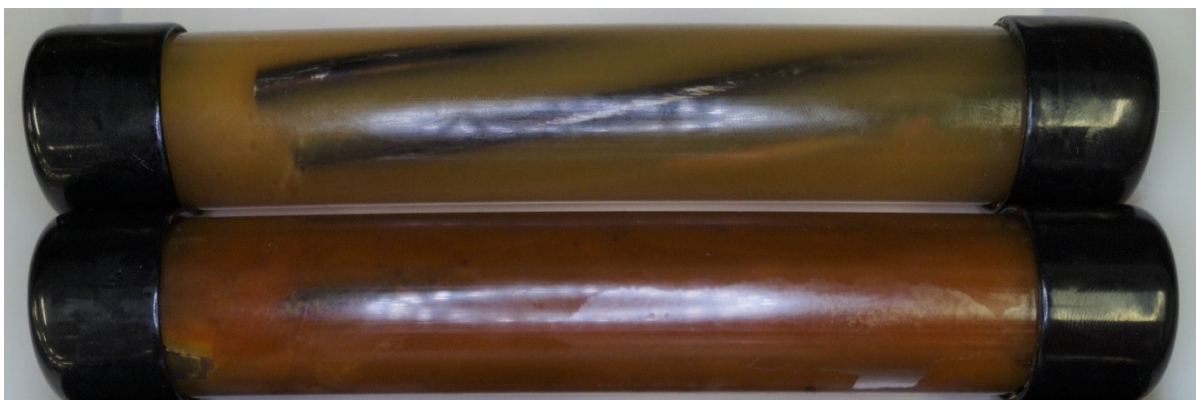
Figure 137. Pictures showing two of the 6-inch long samples.

Polycarbonate tubing with 0.75 inch ID (inner diameter) and 1 inch OD (outside diameter) and six to eight inches in length were injected with each of the available flexible fillers. Two or three wires were inserted on each tube prior to injecting the filler. Black caps fitting the tube were placed on both ends. Figure 137 shows a picture for a couple of samples. Figure 138 shows a top view section for three of the samples with the cap removed. As indicated in the experimental section different solutions (water/control, water with fungi mix, *Aspergillus flavus* (AF), *Fusarium oxysporum* (FO), *Penicillium chrysogenum* (PC)) were sprayed from one end of the samples.

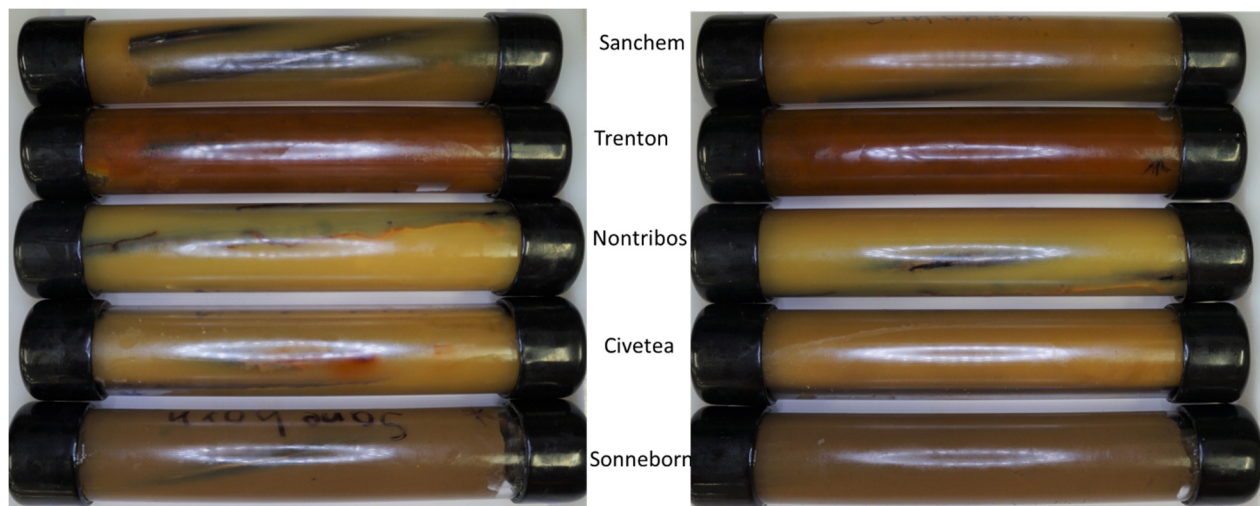
Figure 140. Two views of the five samples sprayed with *Aspergillus flavus*.

The following pages will show the samples grouped per solution sprayed. Pictures were taken from two different views, showing that not all samples showed rust spots. The wires were not always close to the surface. Figure 140 shows the samples sprayed with solutions containing *Aspergillus flavus* (AF). Figure 141 shows the samples sprayed with solutions containing *Fusarium oxysporum* (FO). Figure 142, Figure 143, and Figure 144 show the samples sprayed with solutions containing *Penicillium chrysogenum* (PC), fungi mix, and water respectively.

Figure 140 to Figure 144 show the corrosion spots visible on wires close to the surface on samples injected with Civetea and Nontribos and sprayed with a specific fungi or with fungi mix, but no corrosion spots were visible on those sprayed only with water. Recall that samples sprayed with *Aspergillus flavus*, *Fusarium oxysporum*, *Penicillium chrysogenum* were done only on the initial spray and later sprays were done using water. For the samples sprayed with fungi mix, the same solution was used during later sprays. Corrosion spots were not visible through the polycarbonate tube on the samples injected with Sanchem, Trenton or Sonneborn.

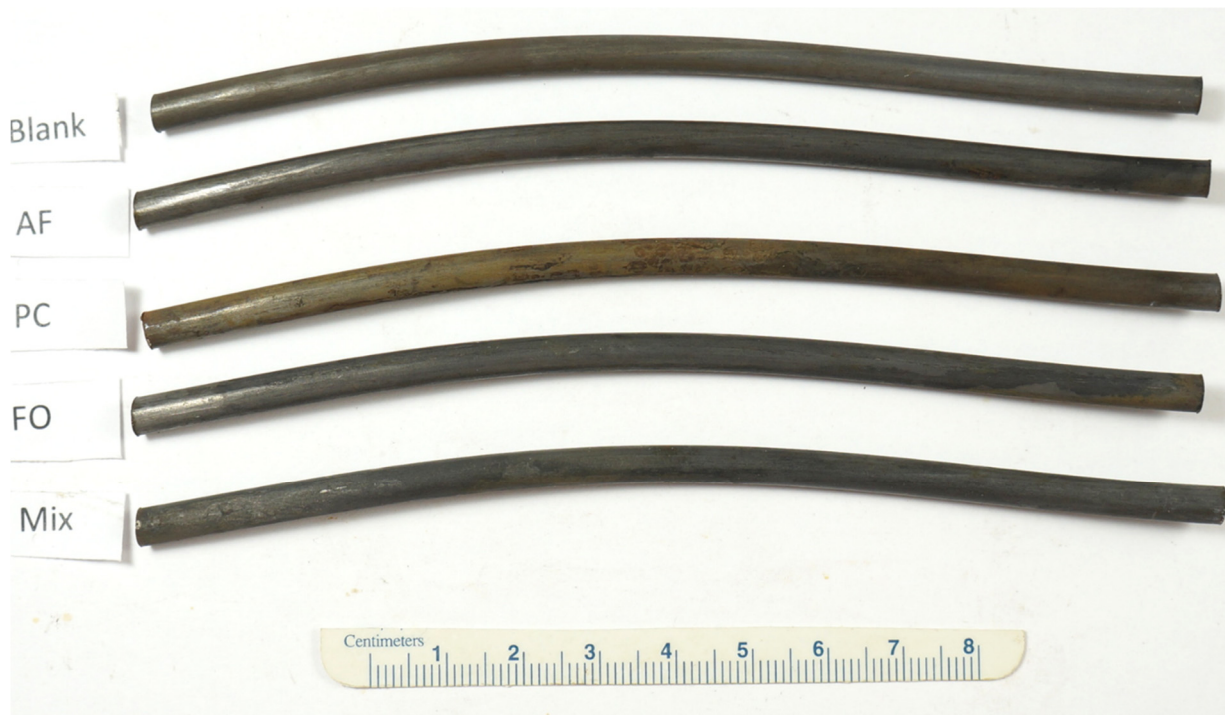
Figure 145. Wires after cleaning removed from samples injected with Civetea.

Figure 145 shows the wires removed from samples injected with Civetea. Very modest amounts of corrosion were observed upon removing the flexible filler and then cleaning the wires. Figure 146 shows close-ups images after cleaning of the wire covered with Civetea and sprayed with water. The SEM photographs show that a modest amount of corrosion took place. The SEM pictures were taken a few weeks after cleaning. The 10,000X image shows a number of small crystals, that are likely due to corrosion products that developed after cleaning. Figure 147 shows close-ups images of the wire covered with Civetea and sprayed with FO and later sprayed with water (after cleaning). The low magnification image shows a large corrosion spot, the intermediate magnification (150X and 300X) shows striations due to corrosion. More detail of the striations are visible on the images taken at 600X and 1,000X. Figure 148 shows close-up images of the wire covered with Civetea and sprayed with fungi mix. The corrosion extent observed on the wire sprayed with fungi mix is intermediate of that observed on the other two wires just described. The higher magnification images show that striations are present but not as many. The 10,000X image shows needle like particles at the bottom of the striations.

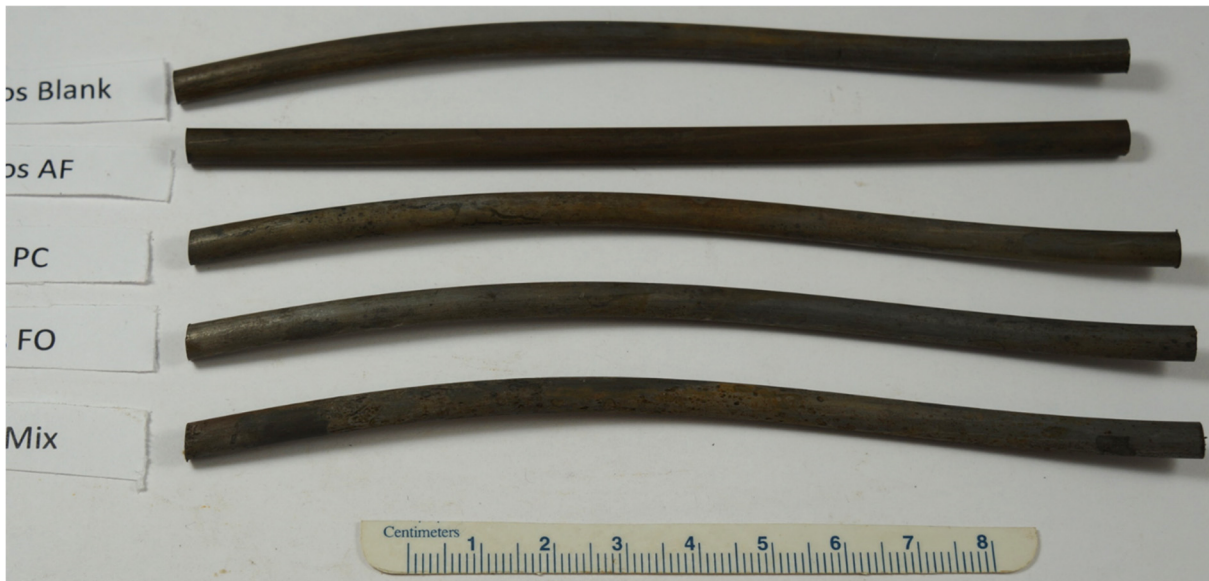
Figure 149. Wires after cleaning removed from samples injected with Nontribos.

Figure 149 shows the wires removed from samples injected with Nontribos. Very modest amounts of corrosion were observed upon removing the flexible filler and then cleaning the wires. Figure 150 shows close-up images after cleaning the wire covered with Nontribos and sprayed with water. The top left image shows a stereo microscope picture. The other images on this figure were taken with the SEM at various magnifications ranging from 26X to 10,000X. The SEM photographs show that a modest amount of corrosion took place. A crystalline structure appears to have developed at the surface of the sample (10,000X magnification). Figure 151 shows close-up images after cleaning of the wire covered with Nontribos and sprayed initially with FO and later sprayed with water. The low magnification image shows a shallow corrosion spot, the intermediate magnification (150X and 300X) shows that striations due to corrosion are visible, and more detail of the striations are visible on the images taken at 600X and 1,000X. Figure 152 and Figure 153 show close-up images of the wire covered with Nontribos and sprayed with fungi mix for two different sites. Figure 152 shows site 1 and there are several spots where corrosion took place. The higher magnification images show striations within the corroding spots. Figure 153 shows site 2 and that there were two depths on the corrosion products. Both depths are observable up to 300X. At higher magnifications the striations are observed and they are somewhat different than that observed on the wires injected with Civetea and sprayed with fungi mix.

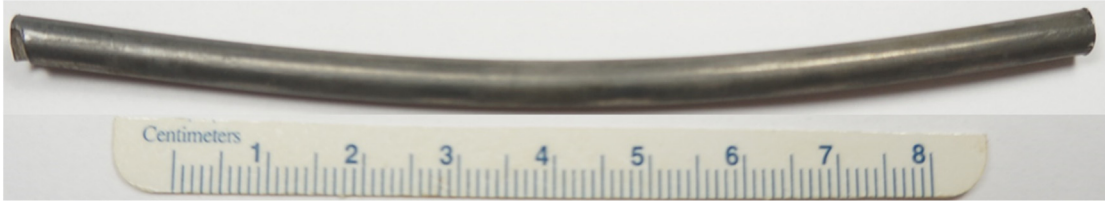
Figure 154. Wire after cleaning removed from samples injected with Sanchem – sprayed with fungi mix

Figure 154 shows an image after cleaning of the wire coated with Sanchem, Figure 155 show images taken with the SEM. The images of the selected location show a different pattern than previously. The low magnification suggests no corrosion. The higher magnification images suggest that corrosion might have taken place, but no significant penetration occurred.

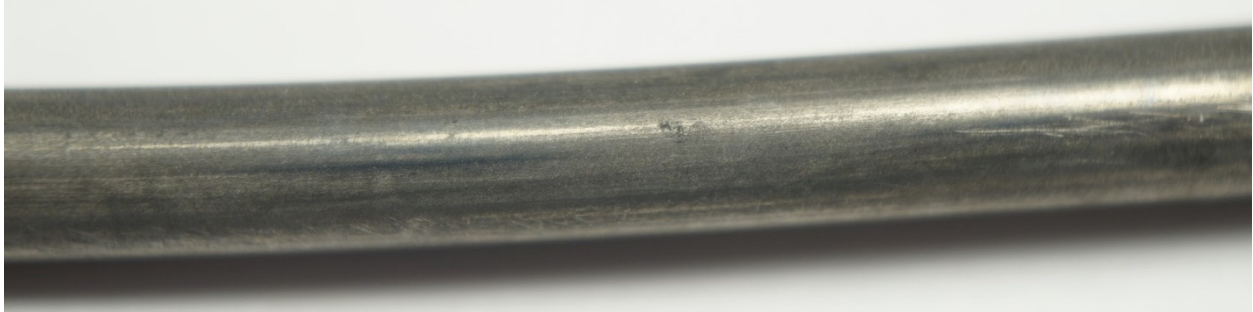
Figure 158. Wire section after cleaning for wire removed from samples injected with Trenton – sprayed with fungi mix.

Figure 158 shows a section of the wire removed from the sample injected with Trento and sprayed with fungi mix. Very few corrosion sites are observed. Figure 159 shows a picture taken with a stereo microscope and four pictures taken with the SEM. The low magnification (26X and 150X) shows a small pit on the assessed area. The higher magnification images show striations. Similar small corroding sites were observed at other locations within the piece placed on the scanning electron microscope.

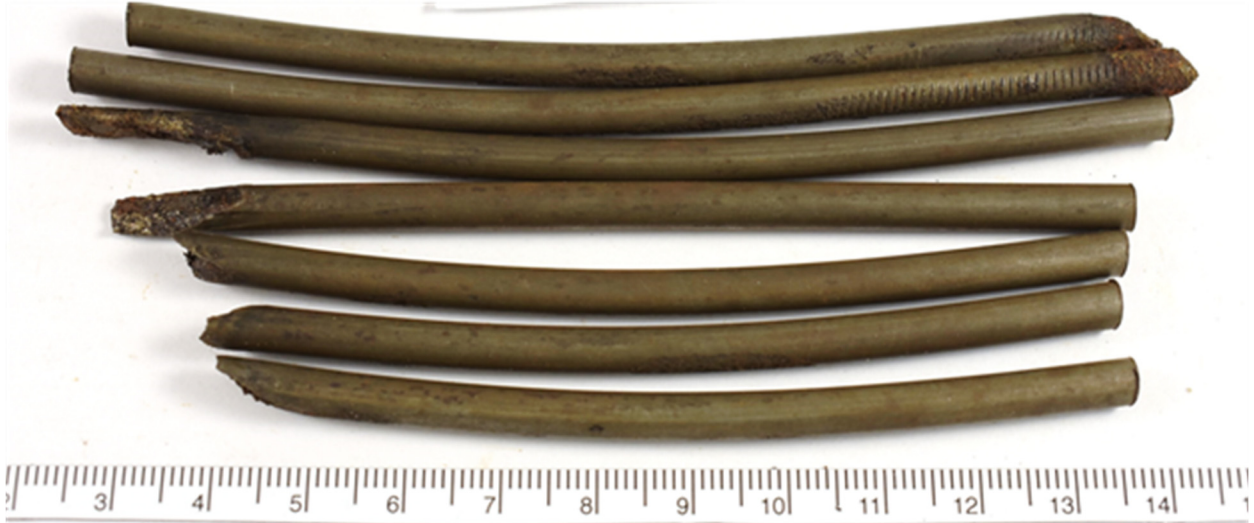
Civetea edge

Figure 160. View of strand wires coated with Civetea after removing filler and cleaning

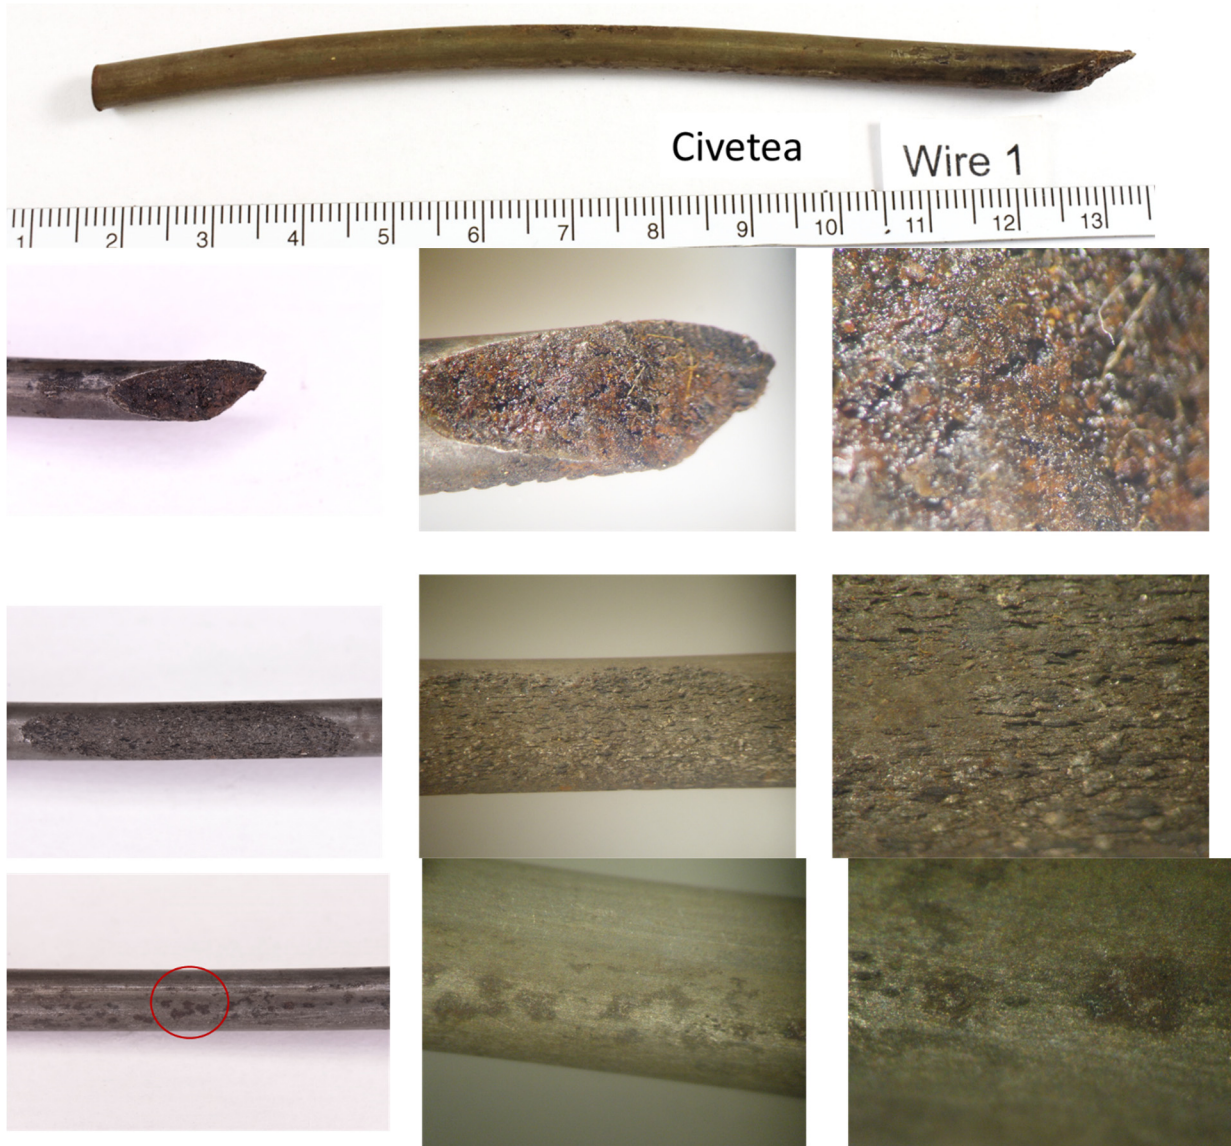
Figure 161. View of wire 1 after removing filler and cleaning

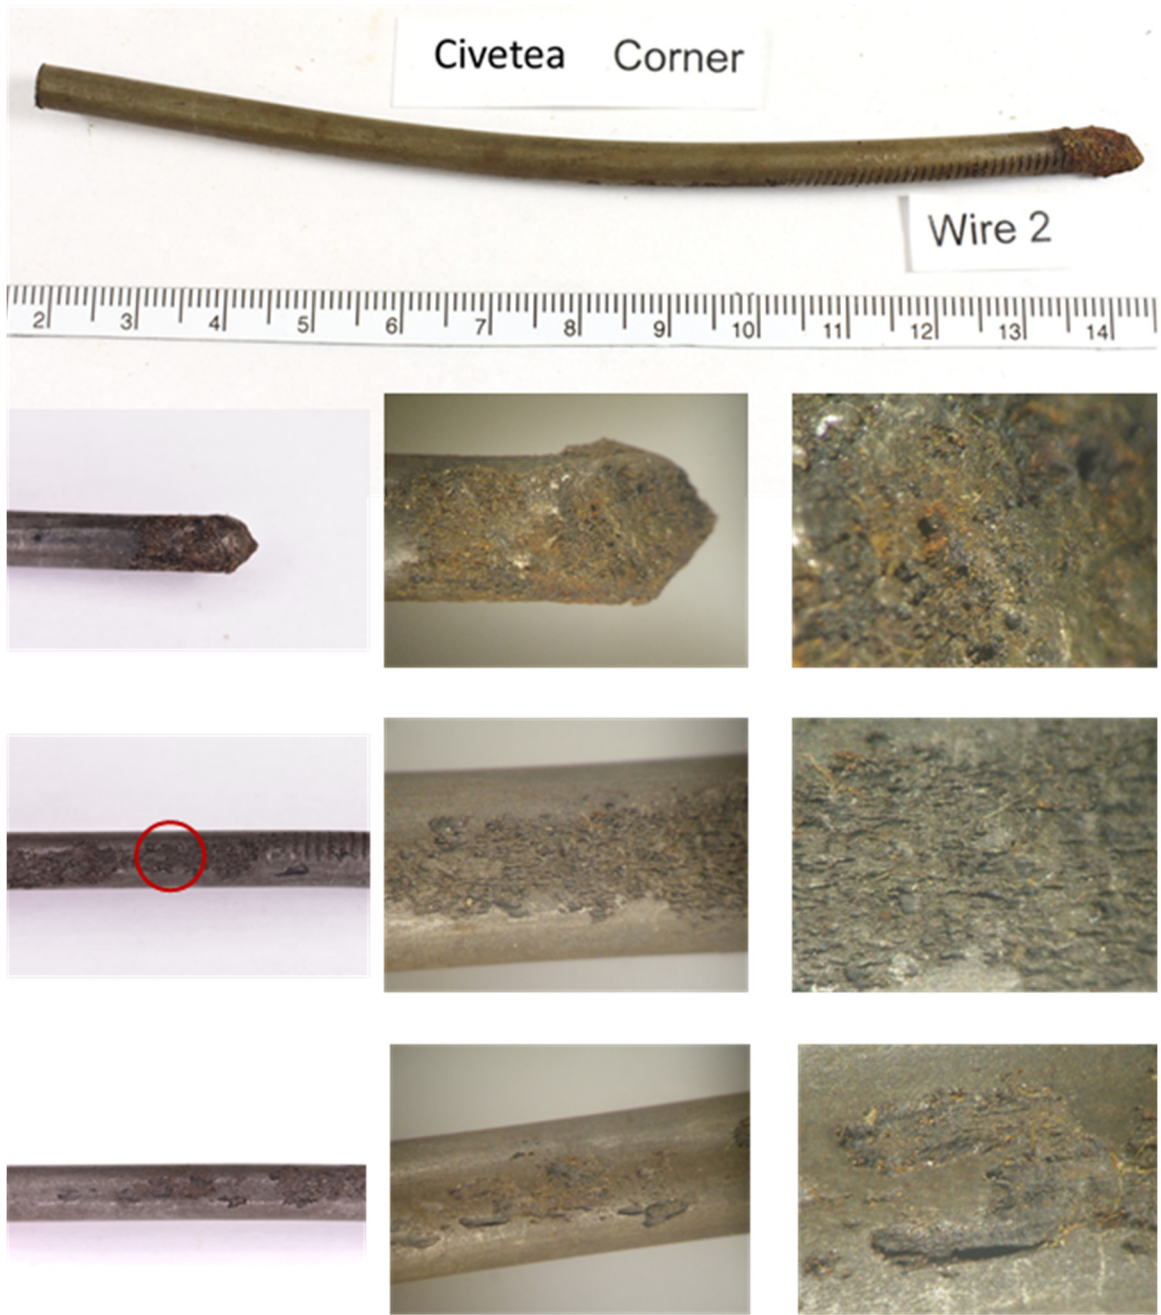
Figure 162. View of wire 2 after removing filler and cleaning (full view).

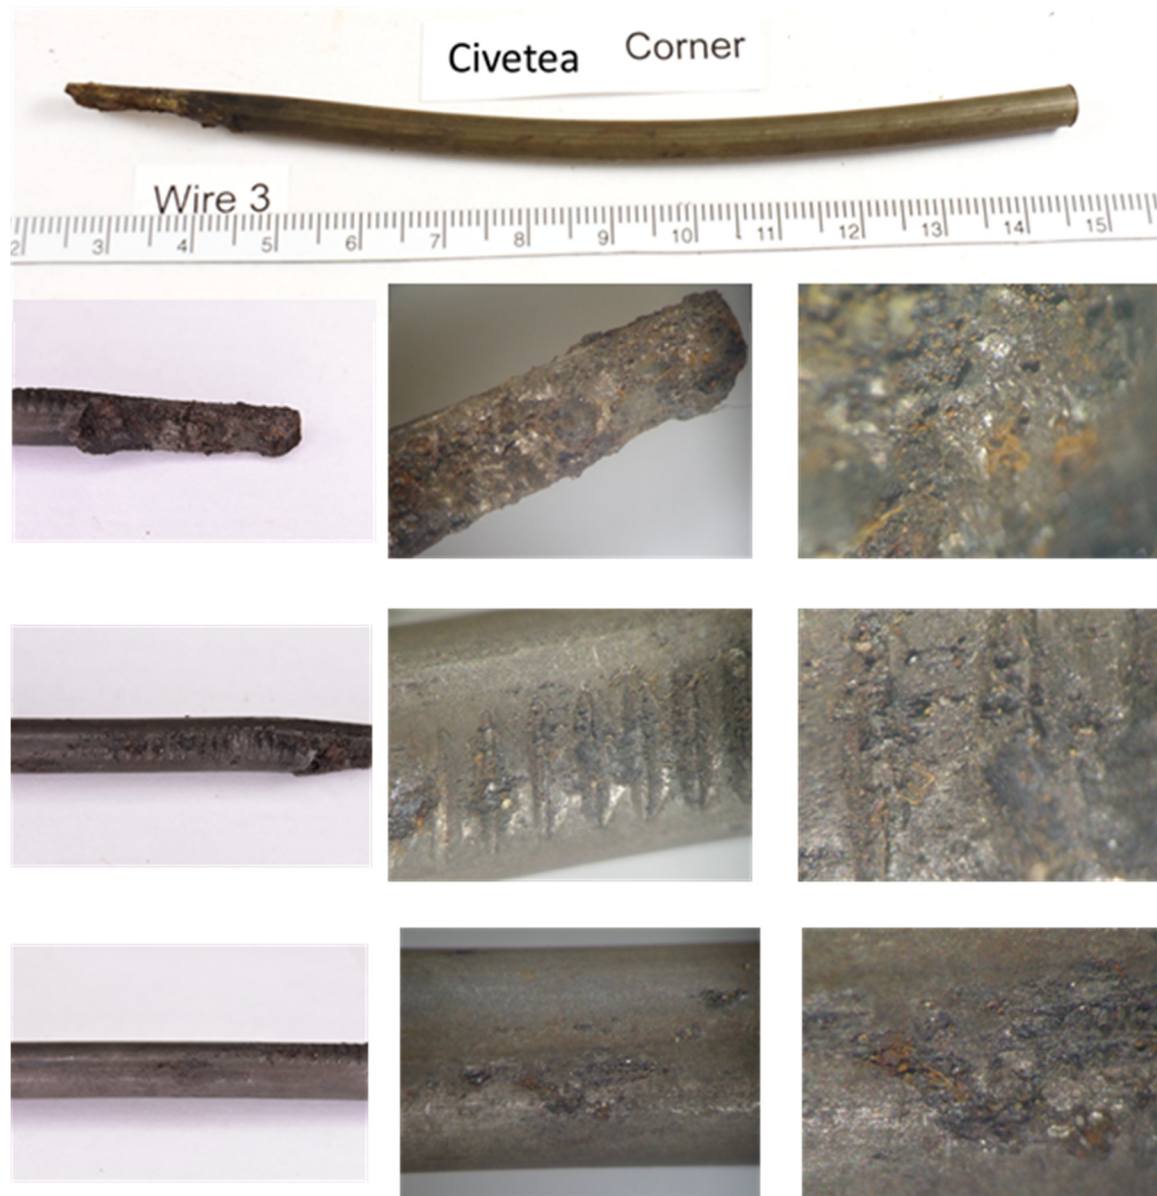
Figure 163. View of wire 3 after removing filler and cleaning (full view).

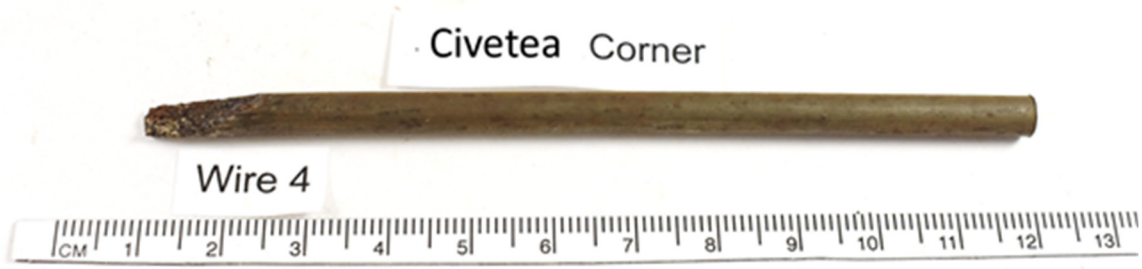
Figure 164. Close-up of wire 4 after removing filler and cleaning (view 1)

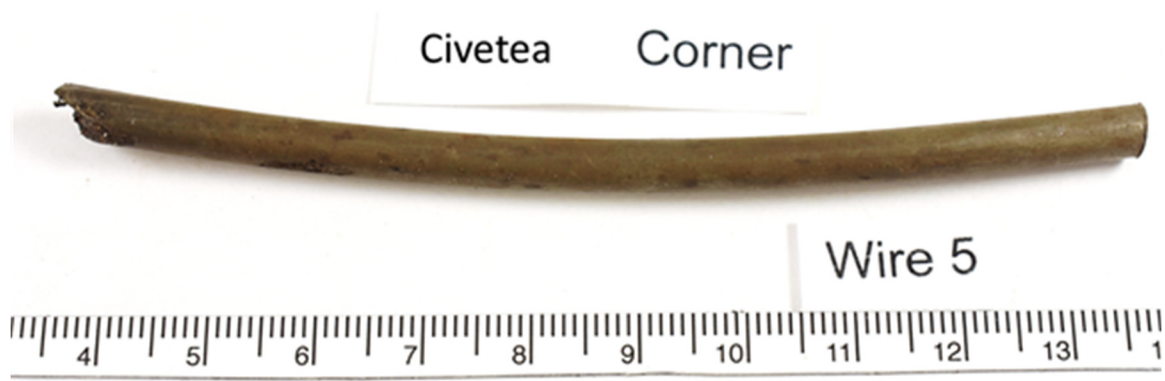
Figure 165. Close-up of wire 5 after removing filler and cleaning (view 2).

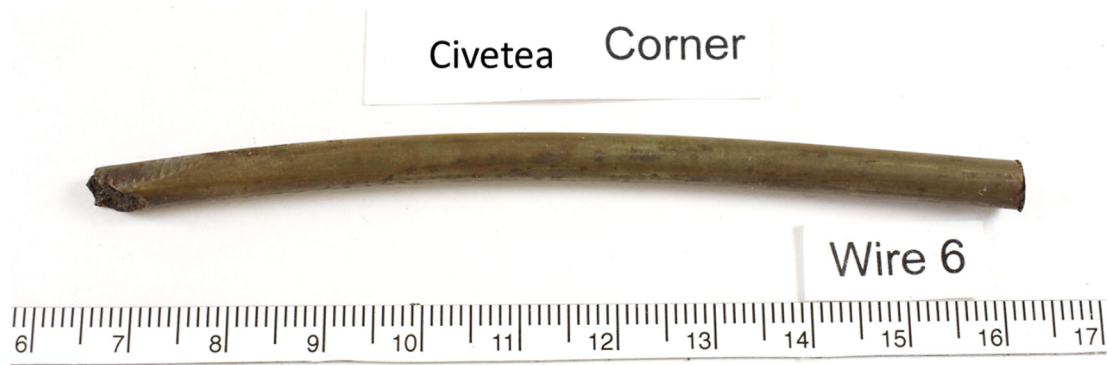
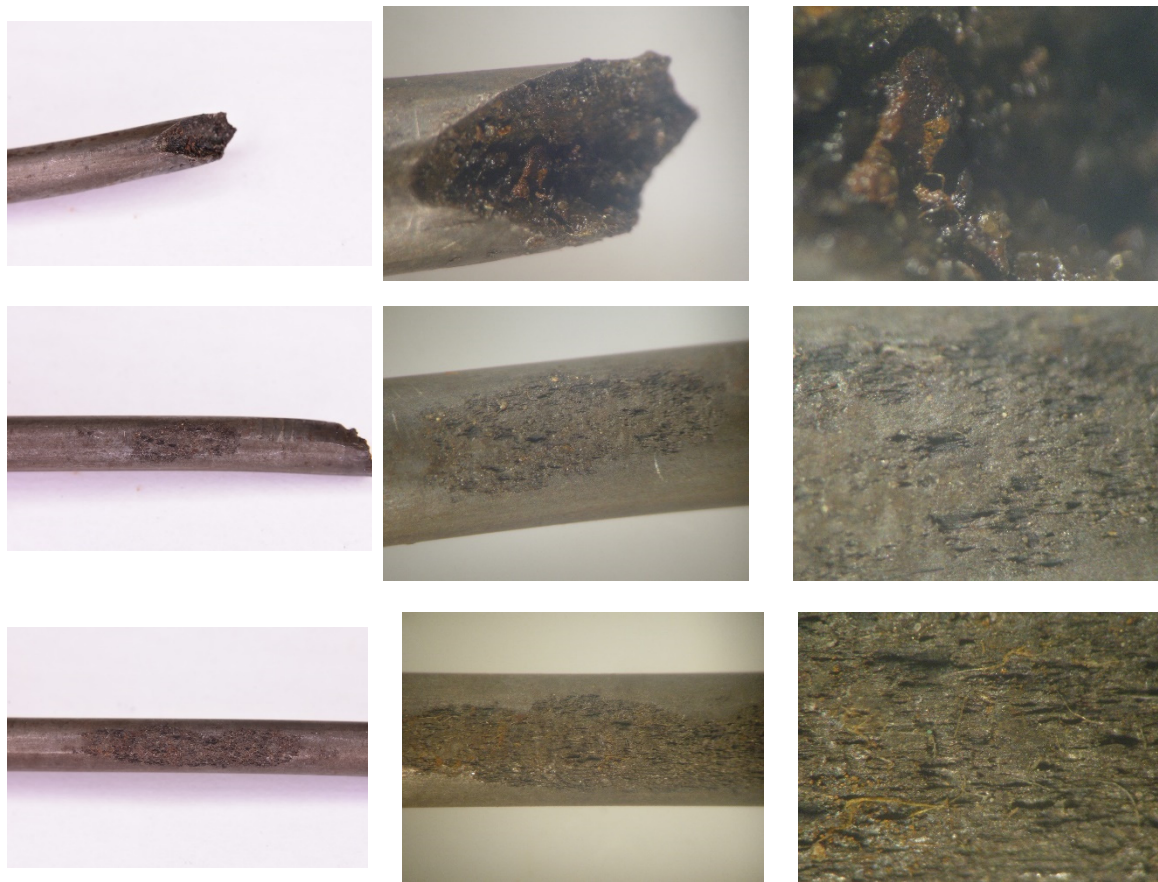
Figure 166. Close-up of wire 6 after removing filler and cleaning (view 2)

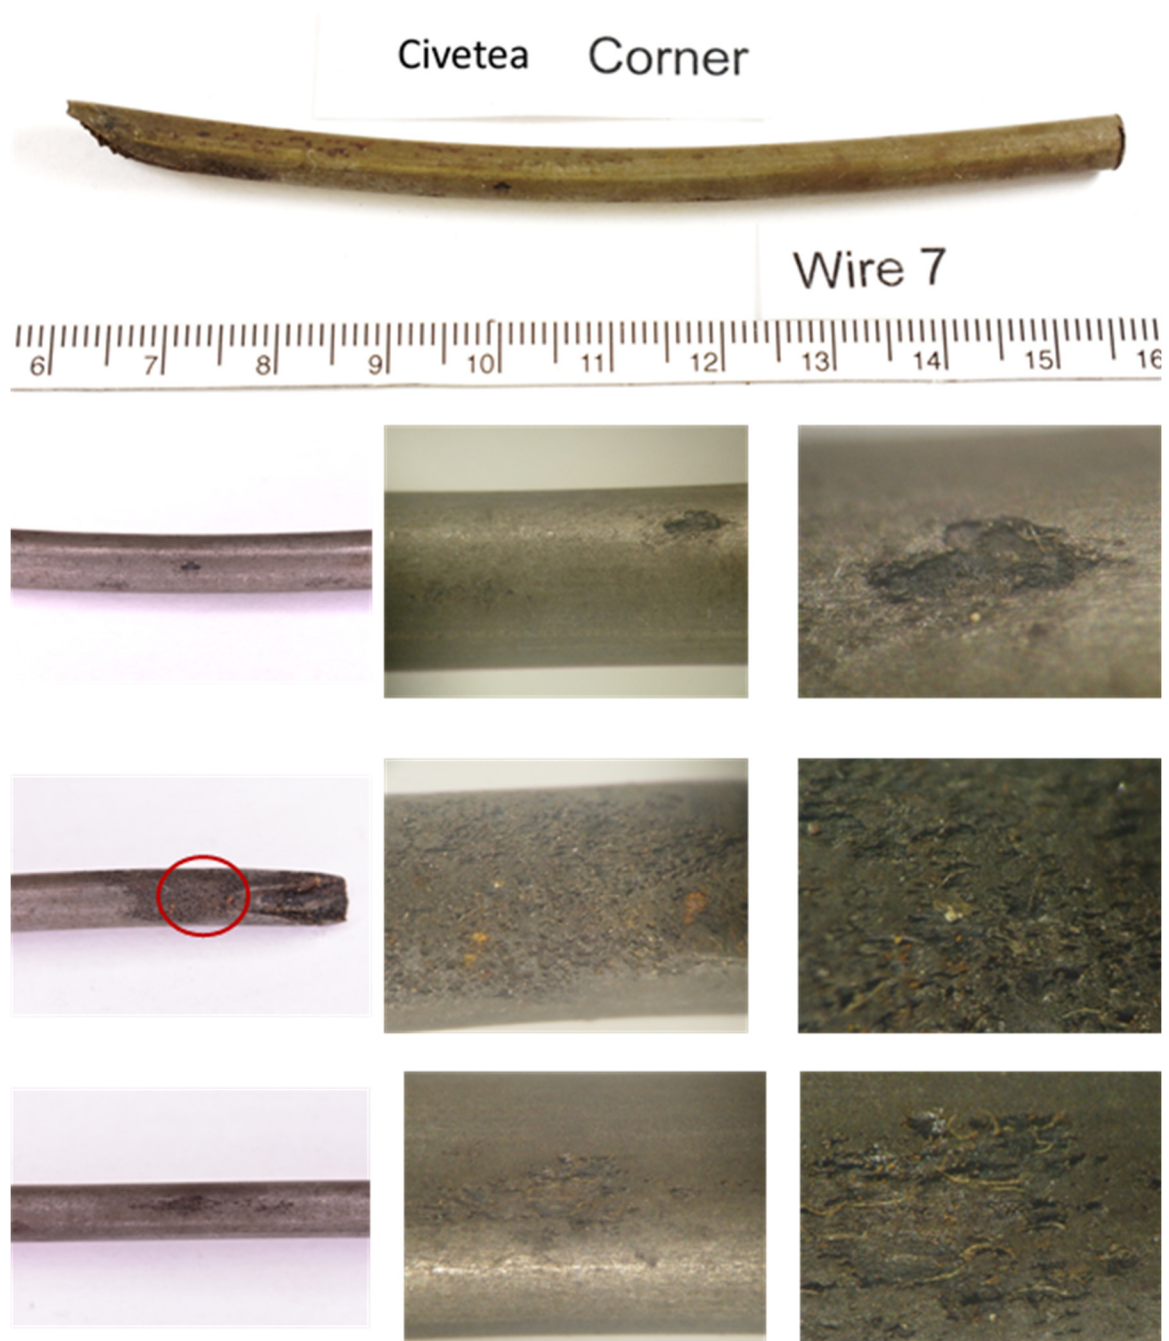
Figure 167. Close-up of wire 7 after removing filler and cleaning

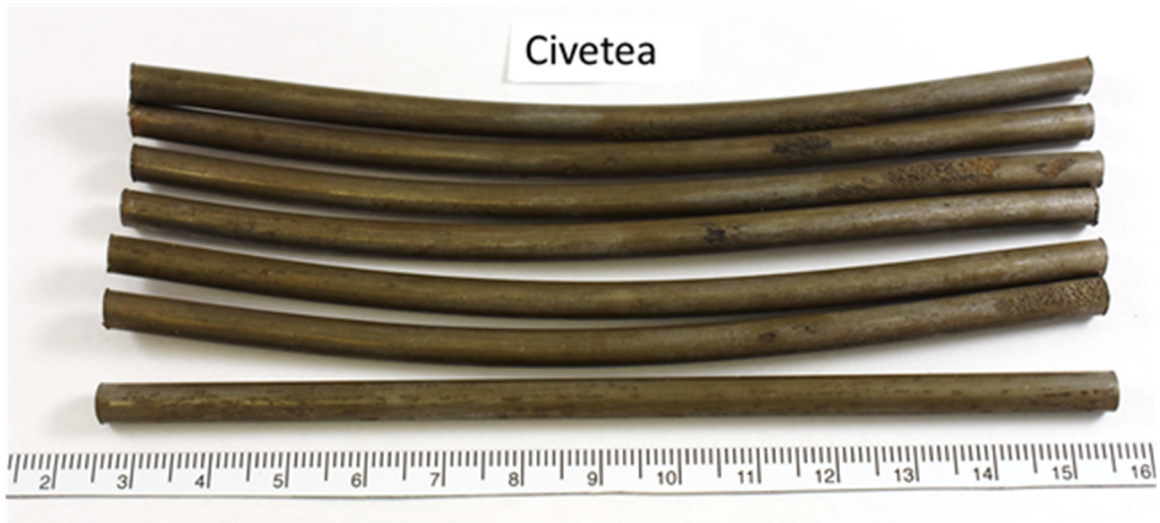
Figure 168. View of second strand segment: wires after removing filler and cleaning

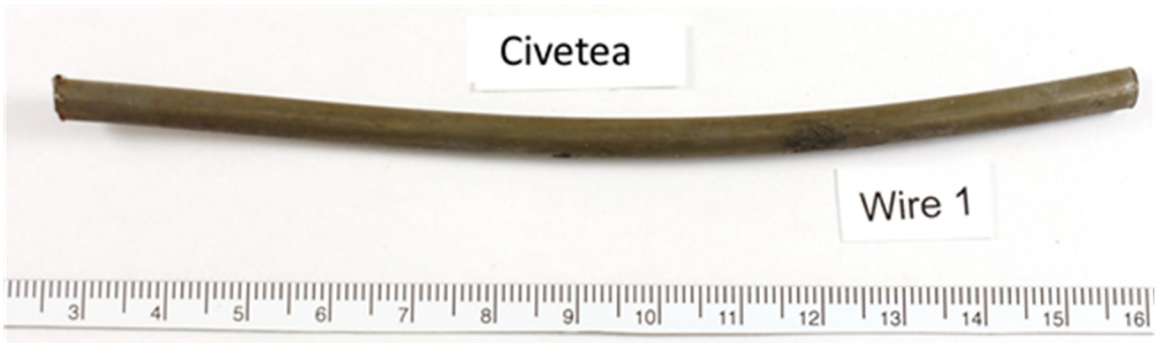
Figure 169. View of 2nd strand segment, wire 1 after removing filler and cleaning

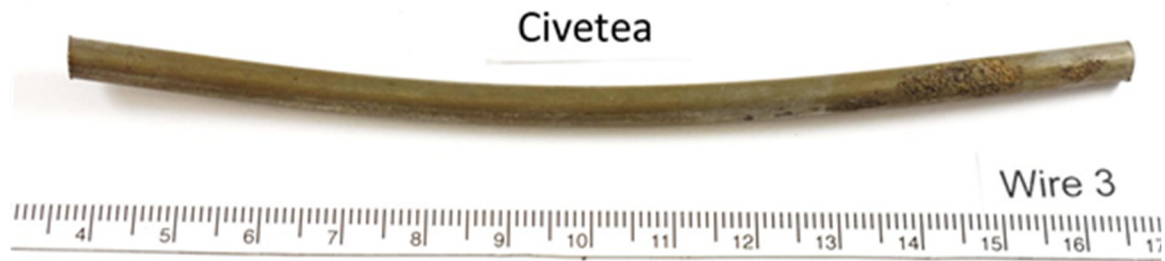
Figure 171. View of 2nd strand segment, wire 3 after removing filler and cleaning

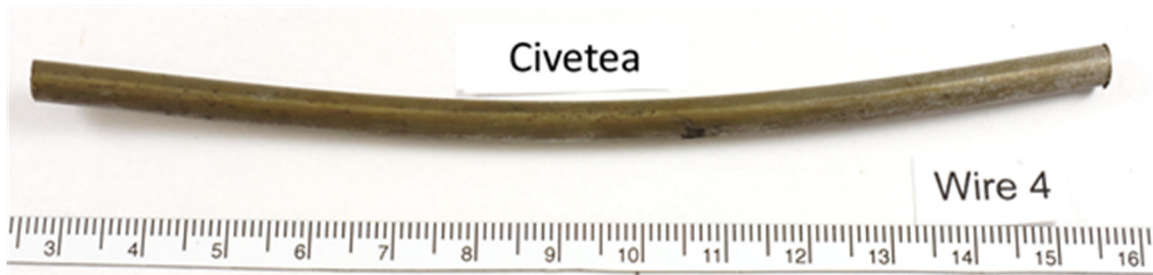
Figure 172. View of 2nd strand segment, wire 4 after removing filler and cleaning

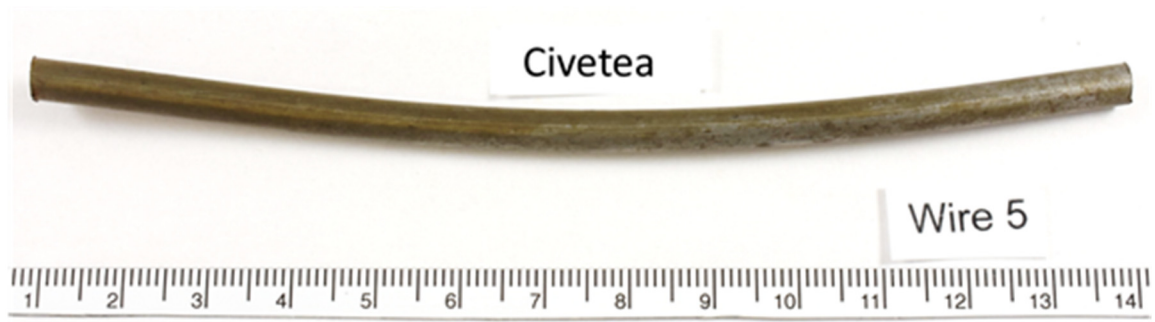
Figure 173. View of 2nd strand segment, wire 5 after removing filler and cleaning

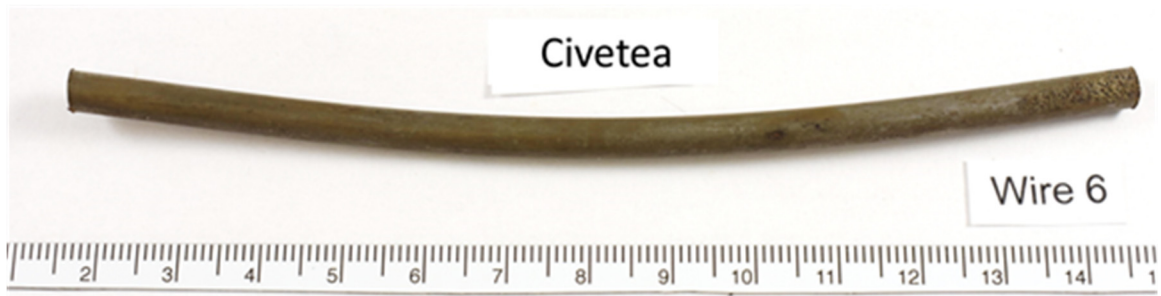
Figure 174. View of 2nd strand segment, wire 6 after removing filler and cleaning

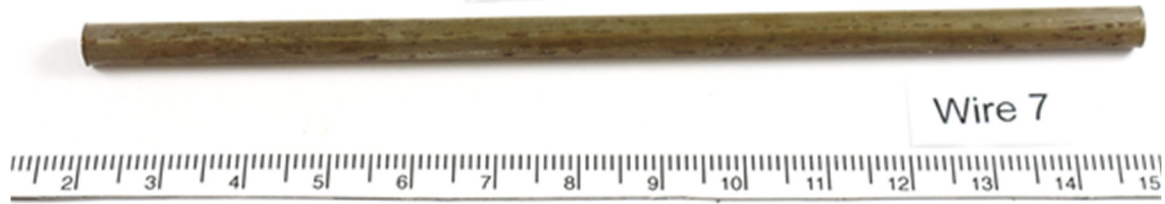
Wire 7

Figure 175. View of 2nd strand segment, wire 7 after removing filler and cleaning
