Final Report

Corrosion Prevention of Bridge Tendons Using Flexible Filler Materials
BDV27-977-10

Submitted to
Florida Department of Transportation Research Center
605 Suwannee Street
Tallahassee, Florida 32399

November 2018

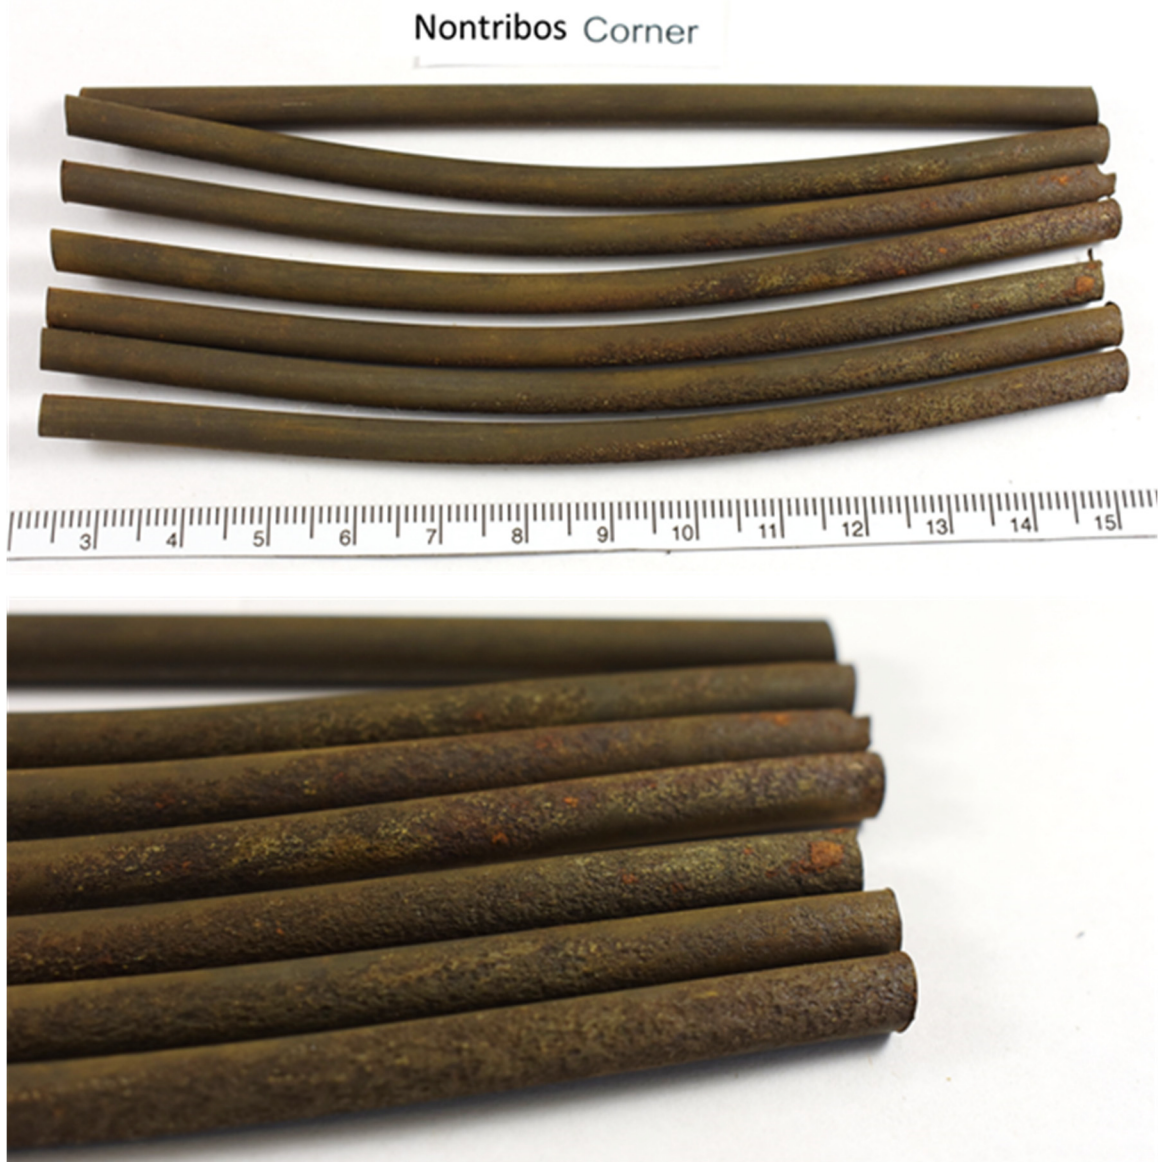
Nontribos Corner

Figure 176. View of strand wires after removing Nontribos filler and cleaning (edge piece)

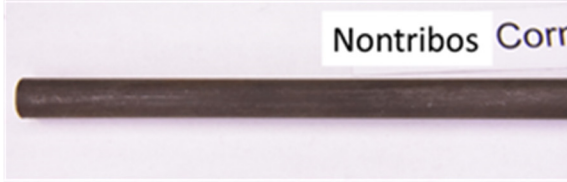
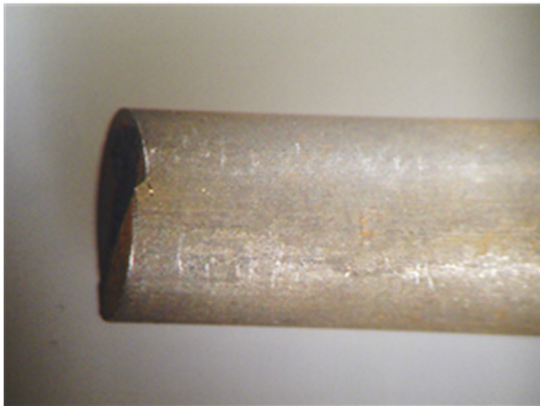
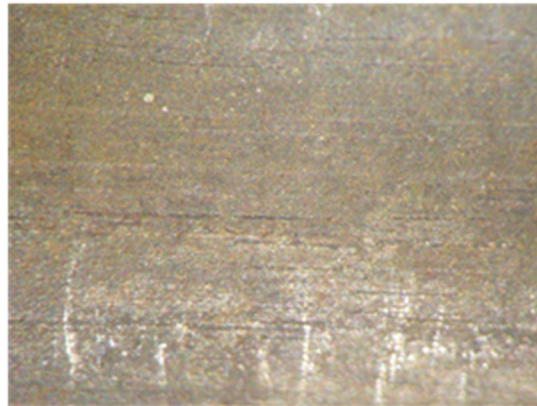
Wire 1

Figure 177. View of 1st strand segment, wire 1 after removing filler and cleaning (close-up 2)

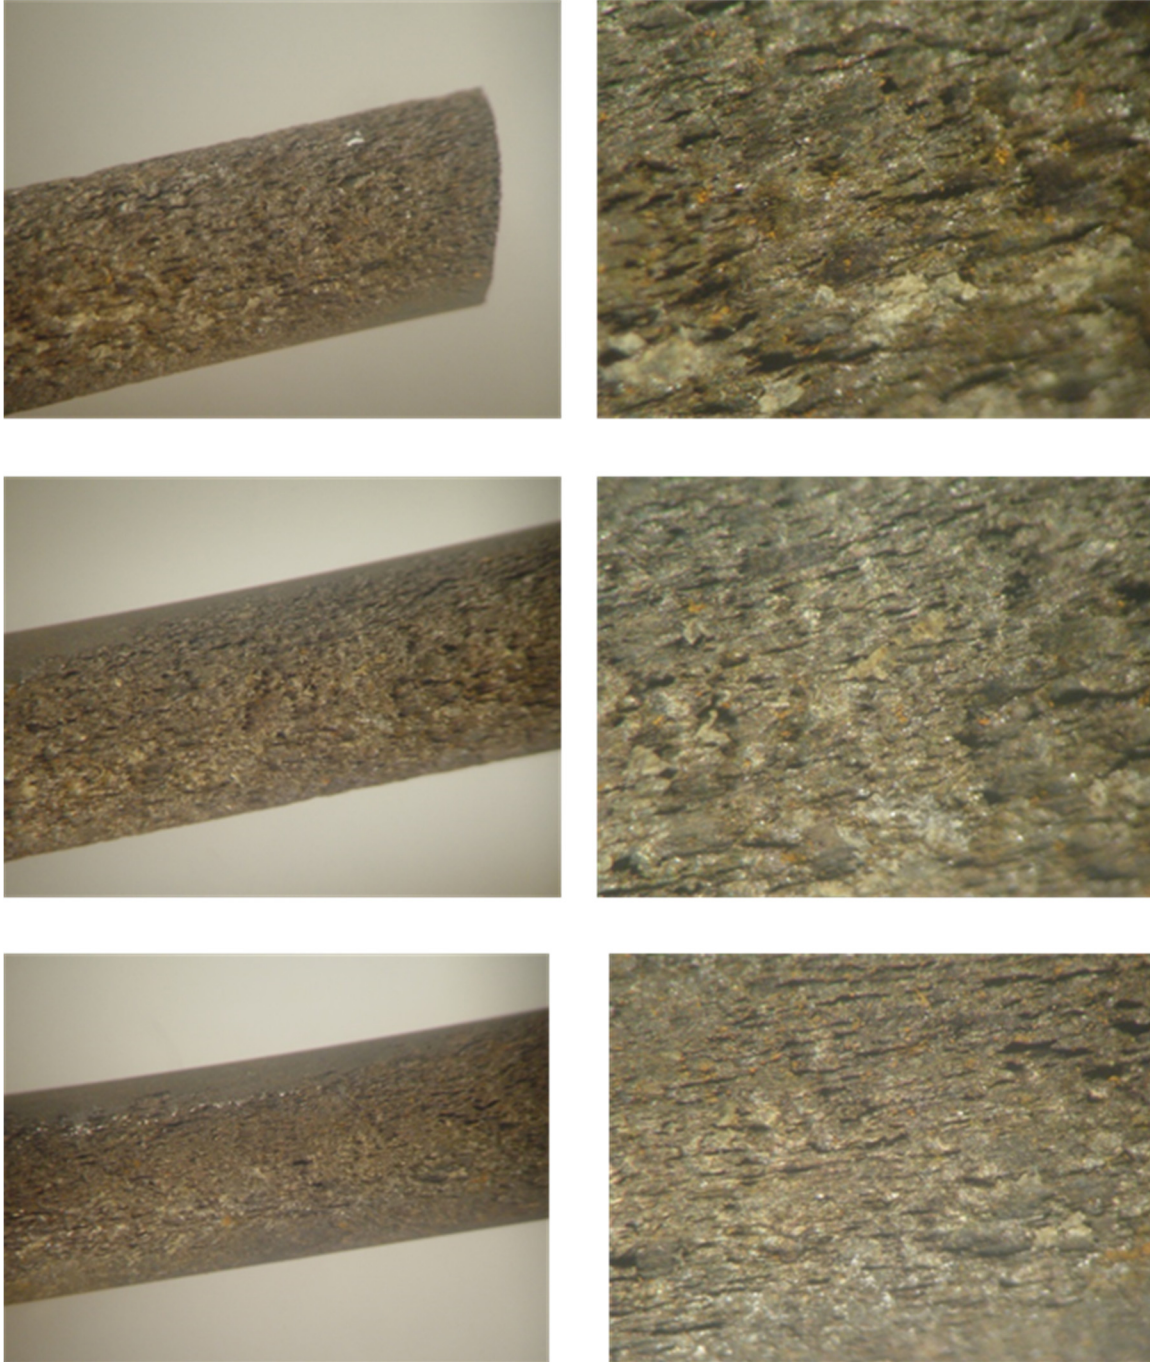
Figure 179. View of 1st strand segment, wire 2 after removing filler and cleaning (close-up 3)

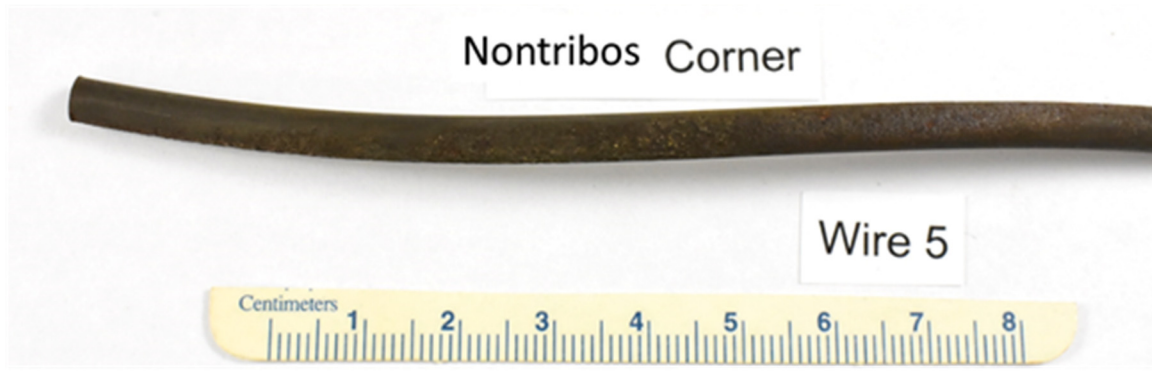
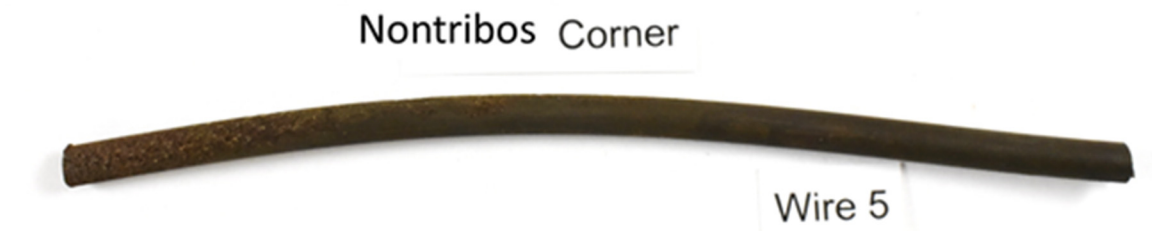
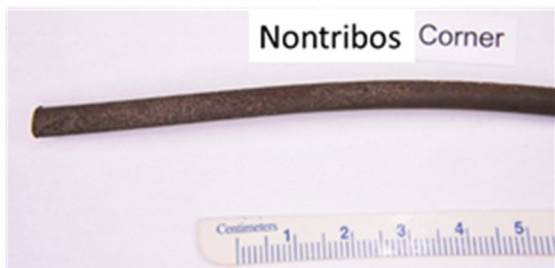
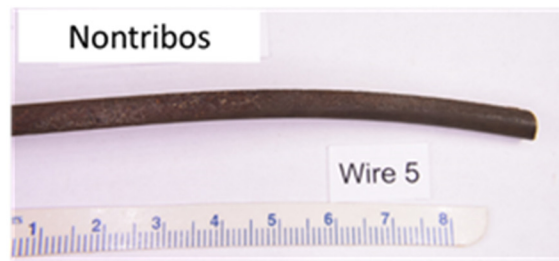
Figure 182. View of 1st strand segment, wire 5 after removing filler and cleaning

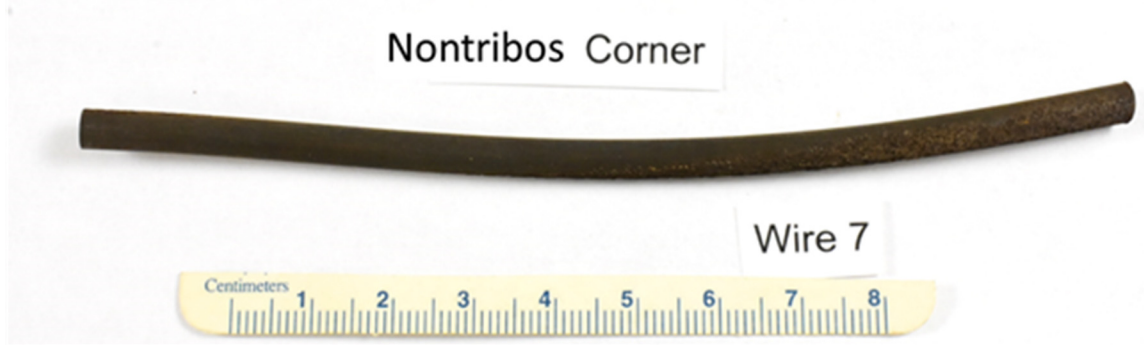
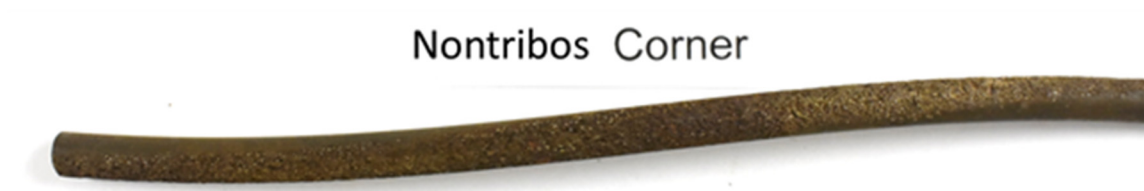
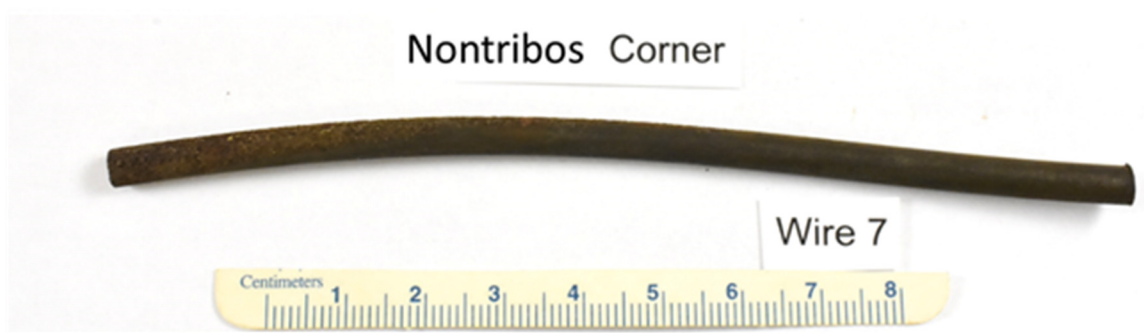
Figure 185. View of 1st strand segment, wire 7 after removing filler and cleaning. (close-up)

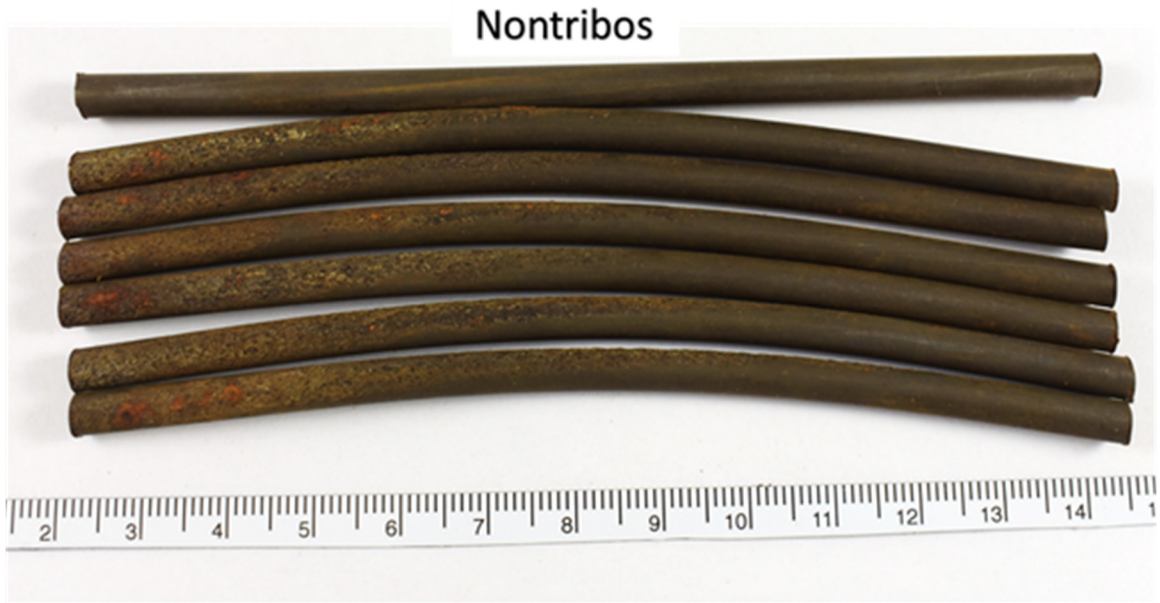
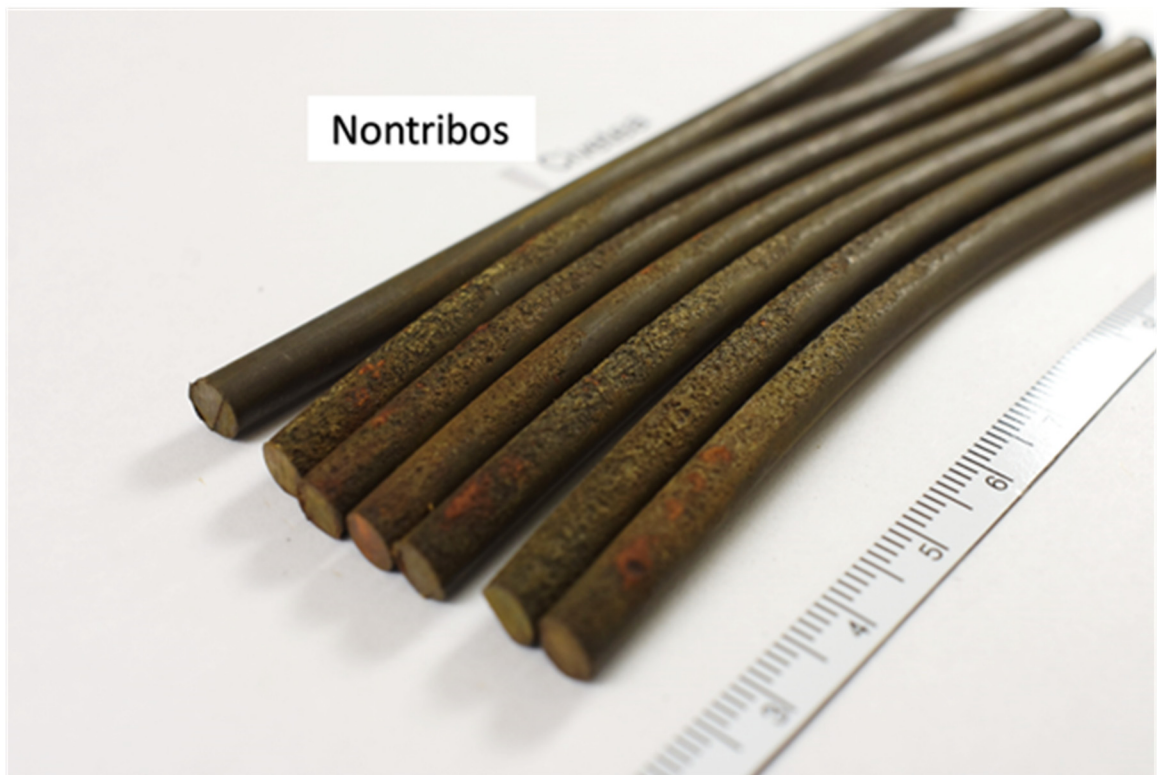
Figure 186. View of strand wires after removing Nontribos filler and cleaning

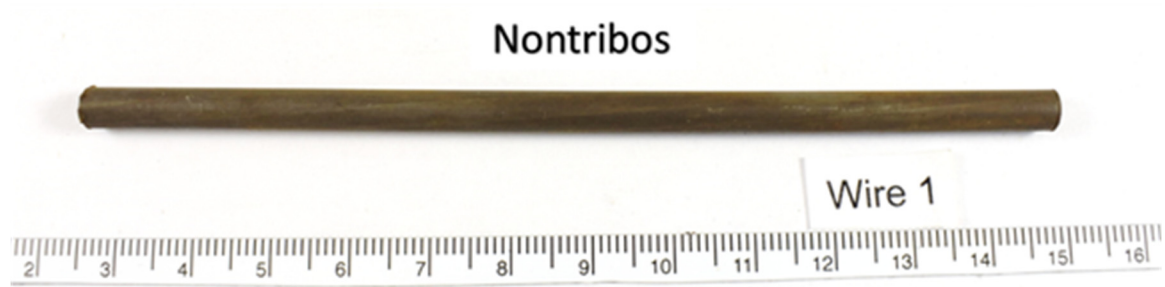
Figure 187. View of 2nd strand segment, wire 1 after removing filler and cleaning

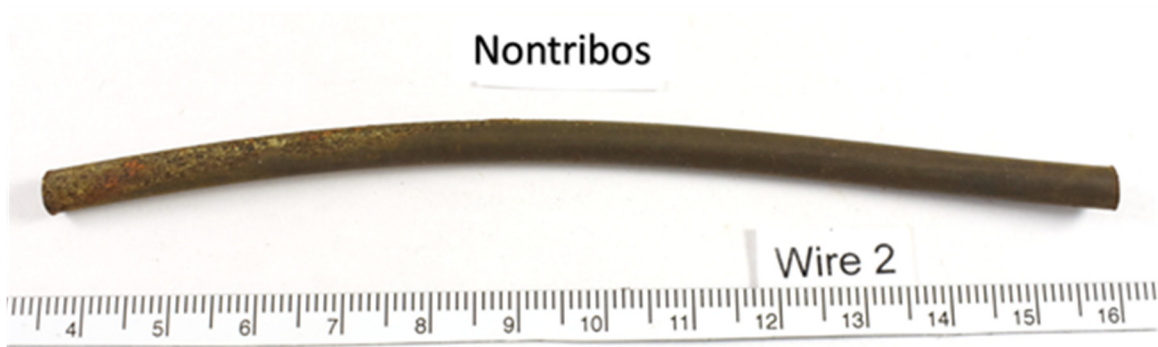
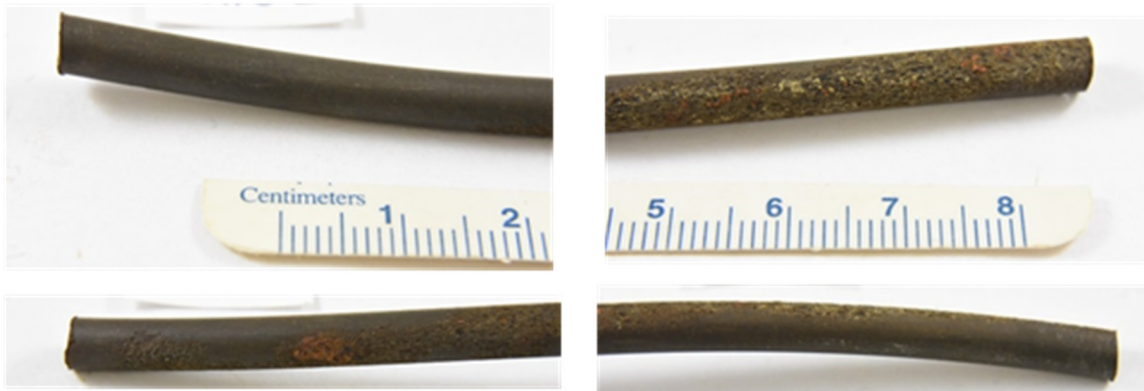
Figure 188. View of 2nd strand segment, wire 2 after removing filler and cleaning (close-up)

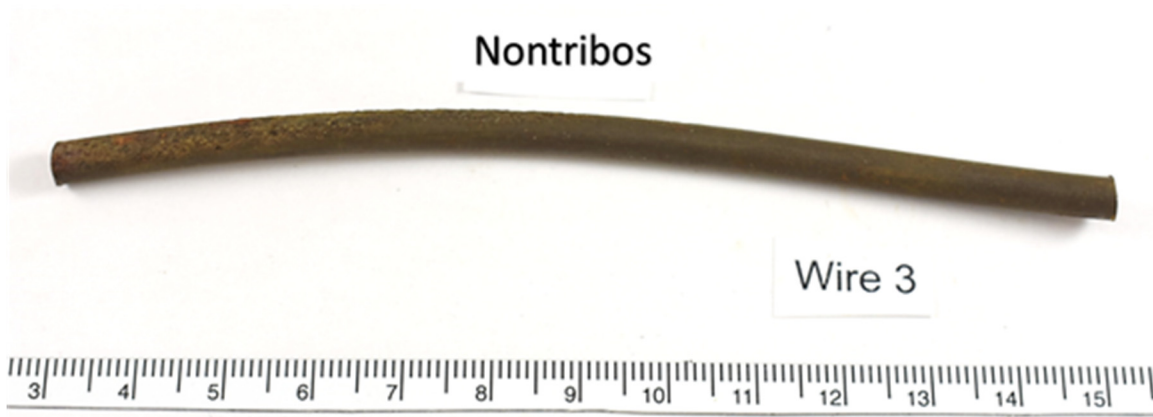
Figure 189. View of 2nd strand segment, wire 3 after removing filler and cleaning (close-up)

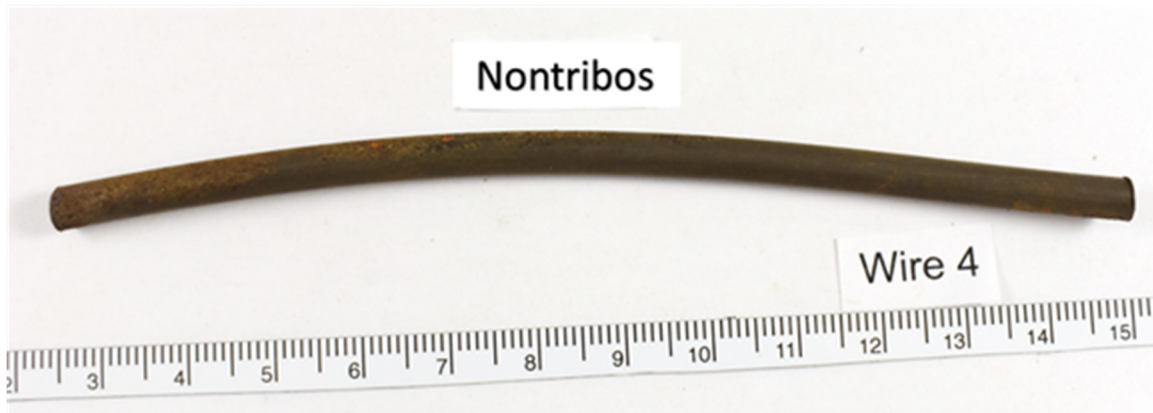
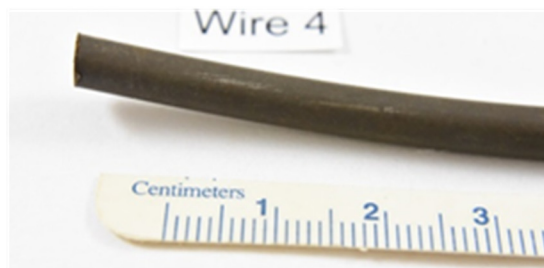
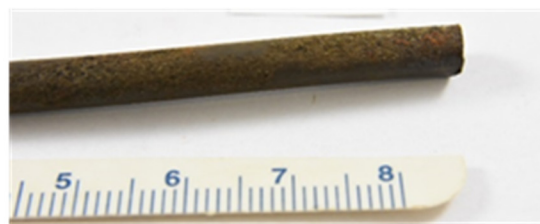
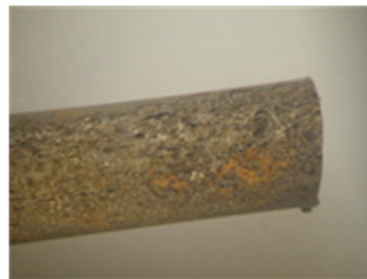
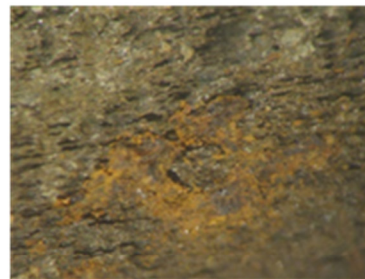
Figure 190. View of 2nd strand segment, wire 4 after removing filler and cleaning (close-up)

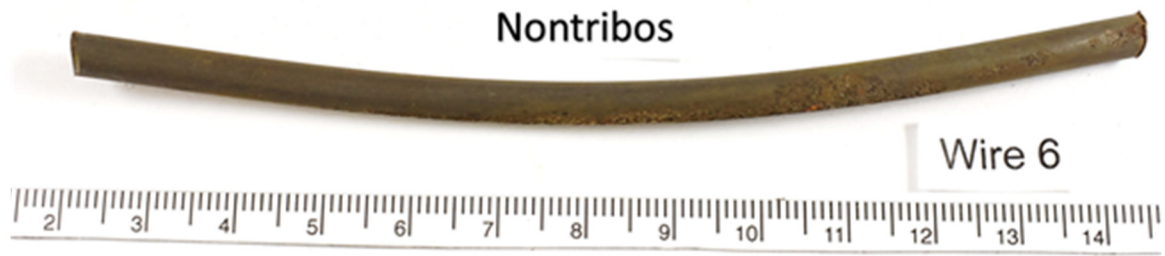
Figure 192. View of 2nd strand segment, wire 6 after removing filler and cleaning (close-up 1)

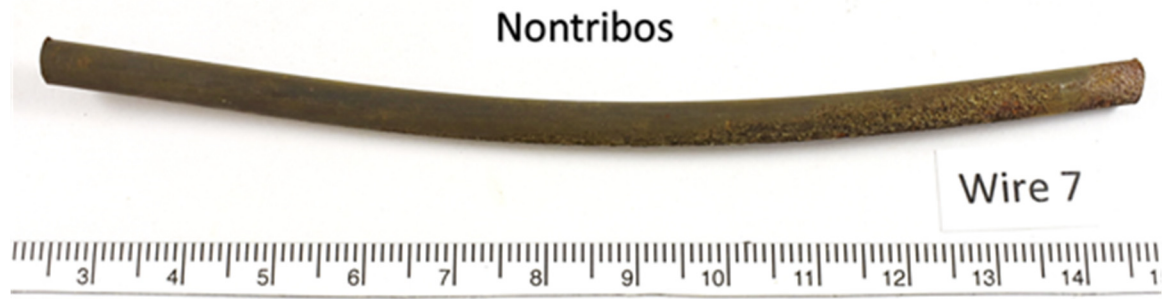
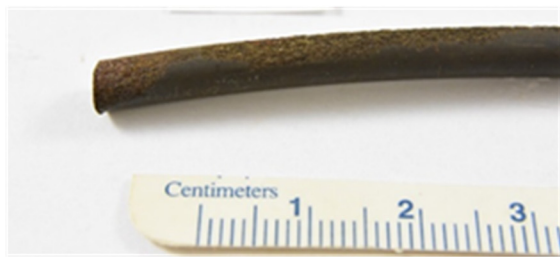
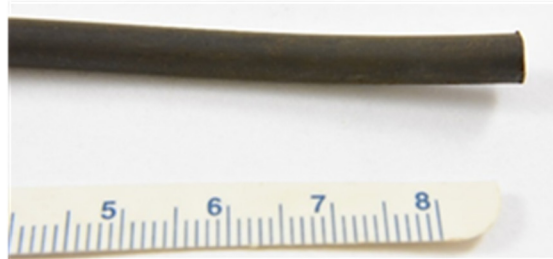
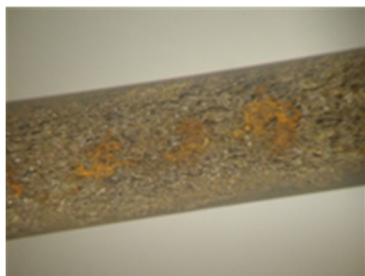
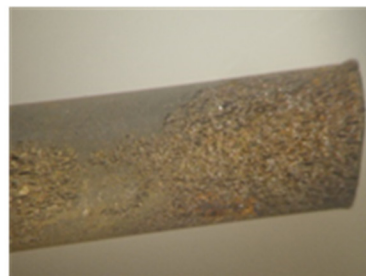
Figure 193. View of 2nd strand segment, wire 7 after removing filler and cleaning (close-up 1)

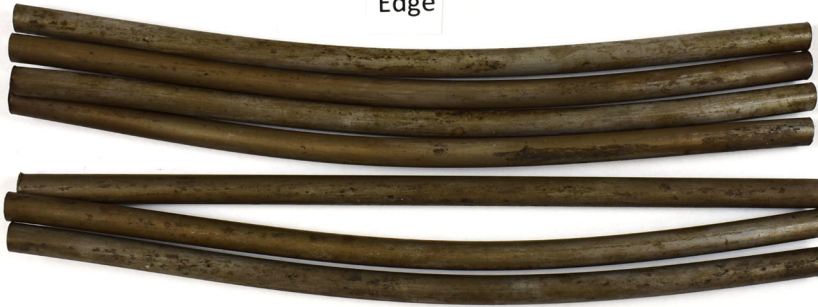
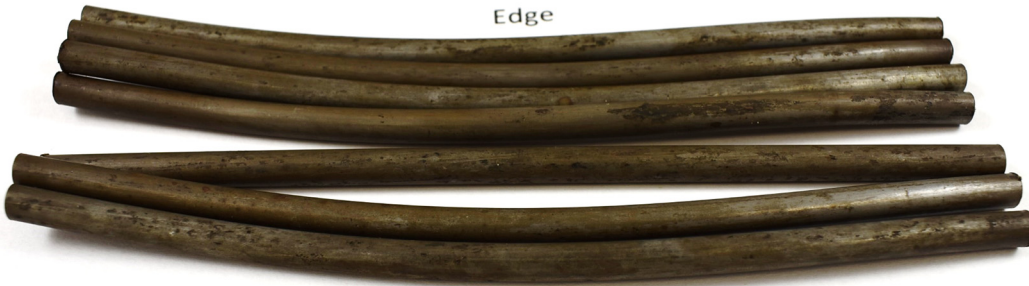
Coated Strand with Trenton (Outside)

Figure 194. View of coated strand with Trenton (outside) edge (view 1).

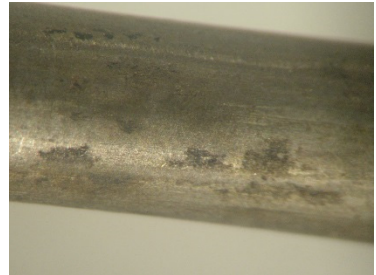
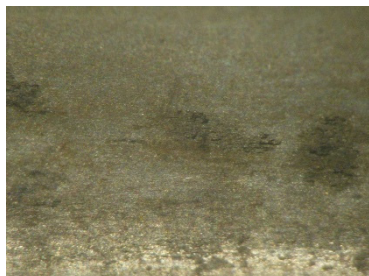
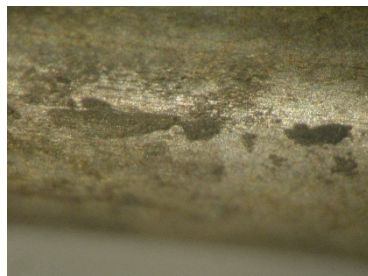
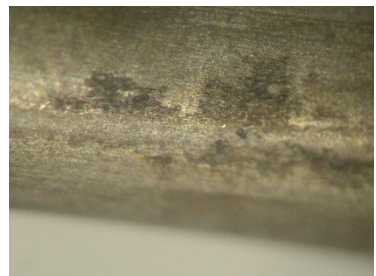
Figure 195. View of coated strand with Trenton (outside) edge, wire 1 after removing filler and cleaning (close-up)

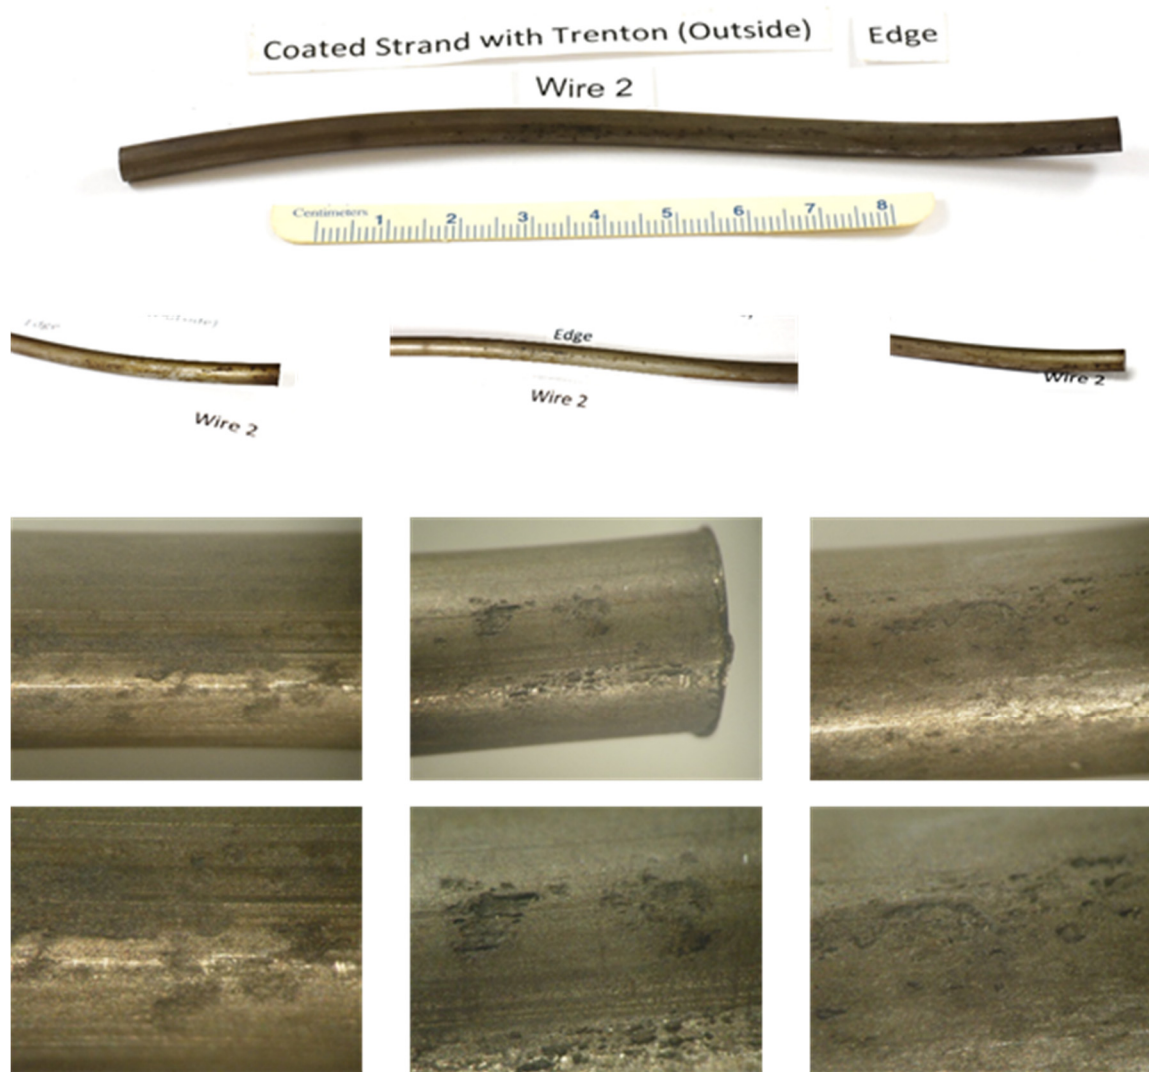
Figure 196. View of coated strand with Trenton (outside) edge, wire 2 after removing filler and cleaning (close-up 2)

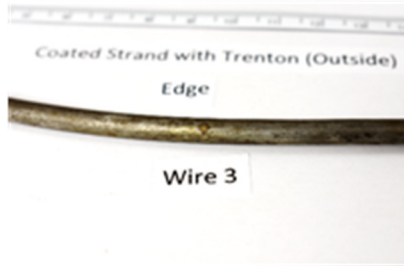
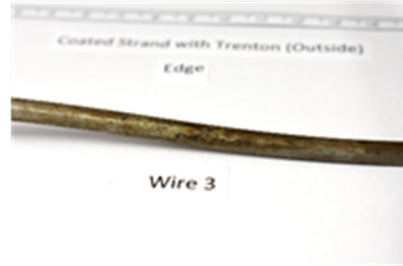
Figure 197. View of coated strand with Trenton (outside) edge, wire 3 after removing filler and cleaning (close-up 2)

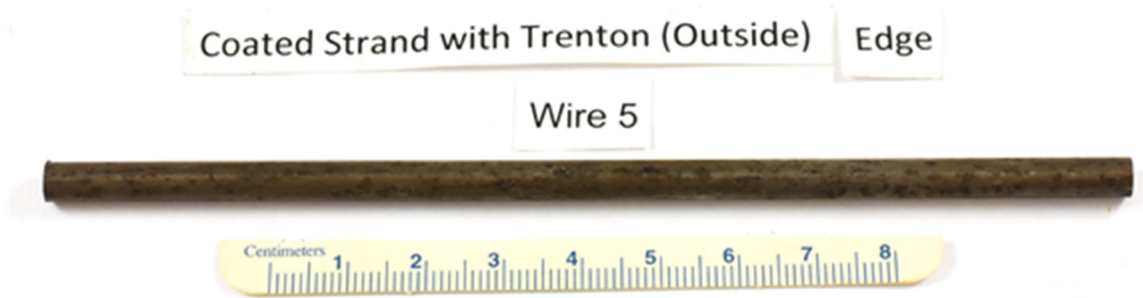
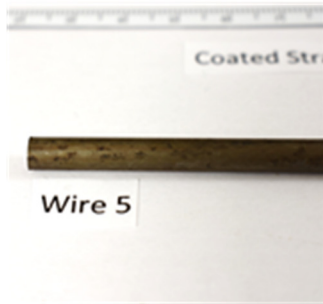
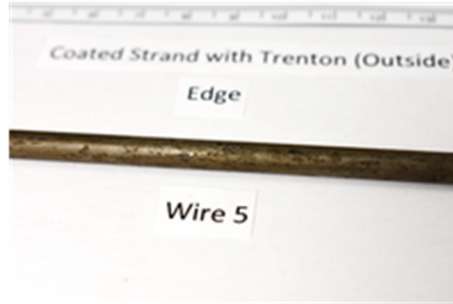
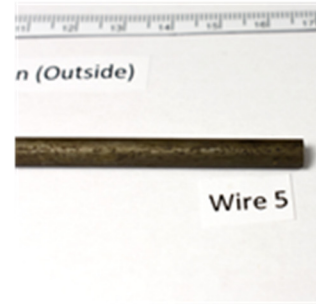
Figure 199. View of coated strand with Trenton (outside) edge, wire 5 after removing filler and cleaning (close-up 2)

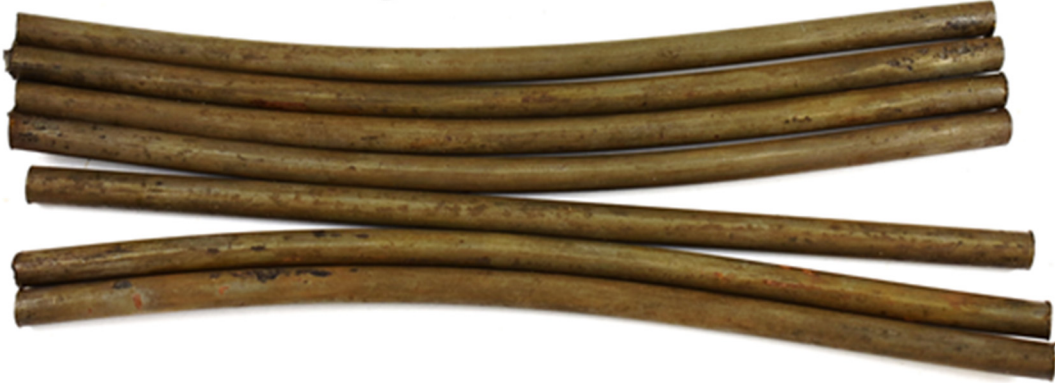
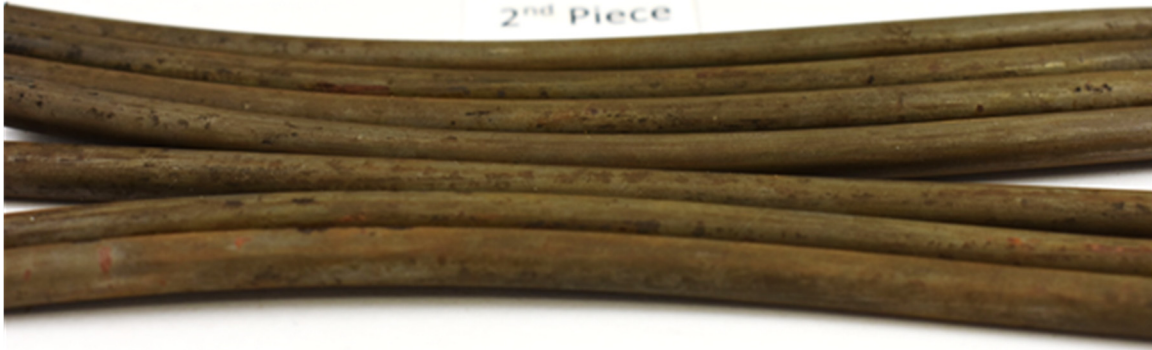
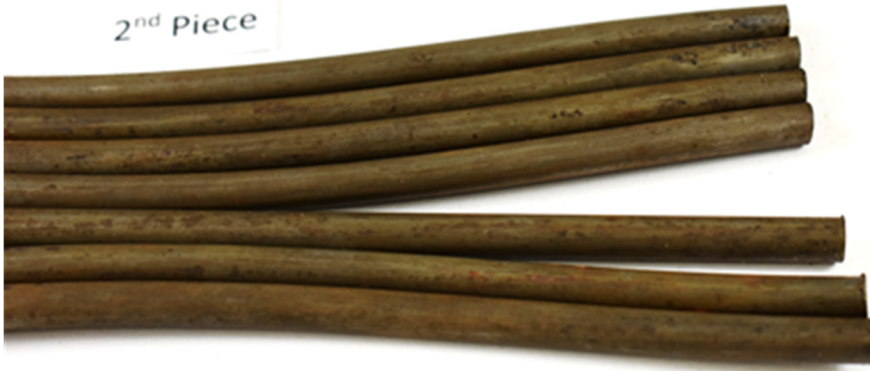
Figure 202. View of coated strand with Trenton (outside) 2nd piece

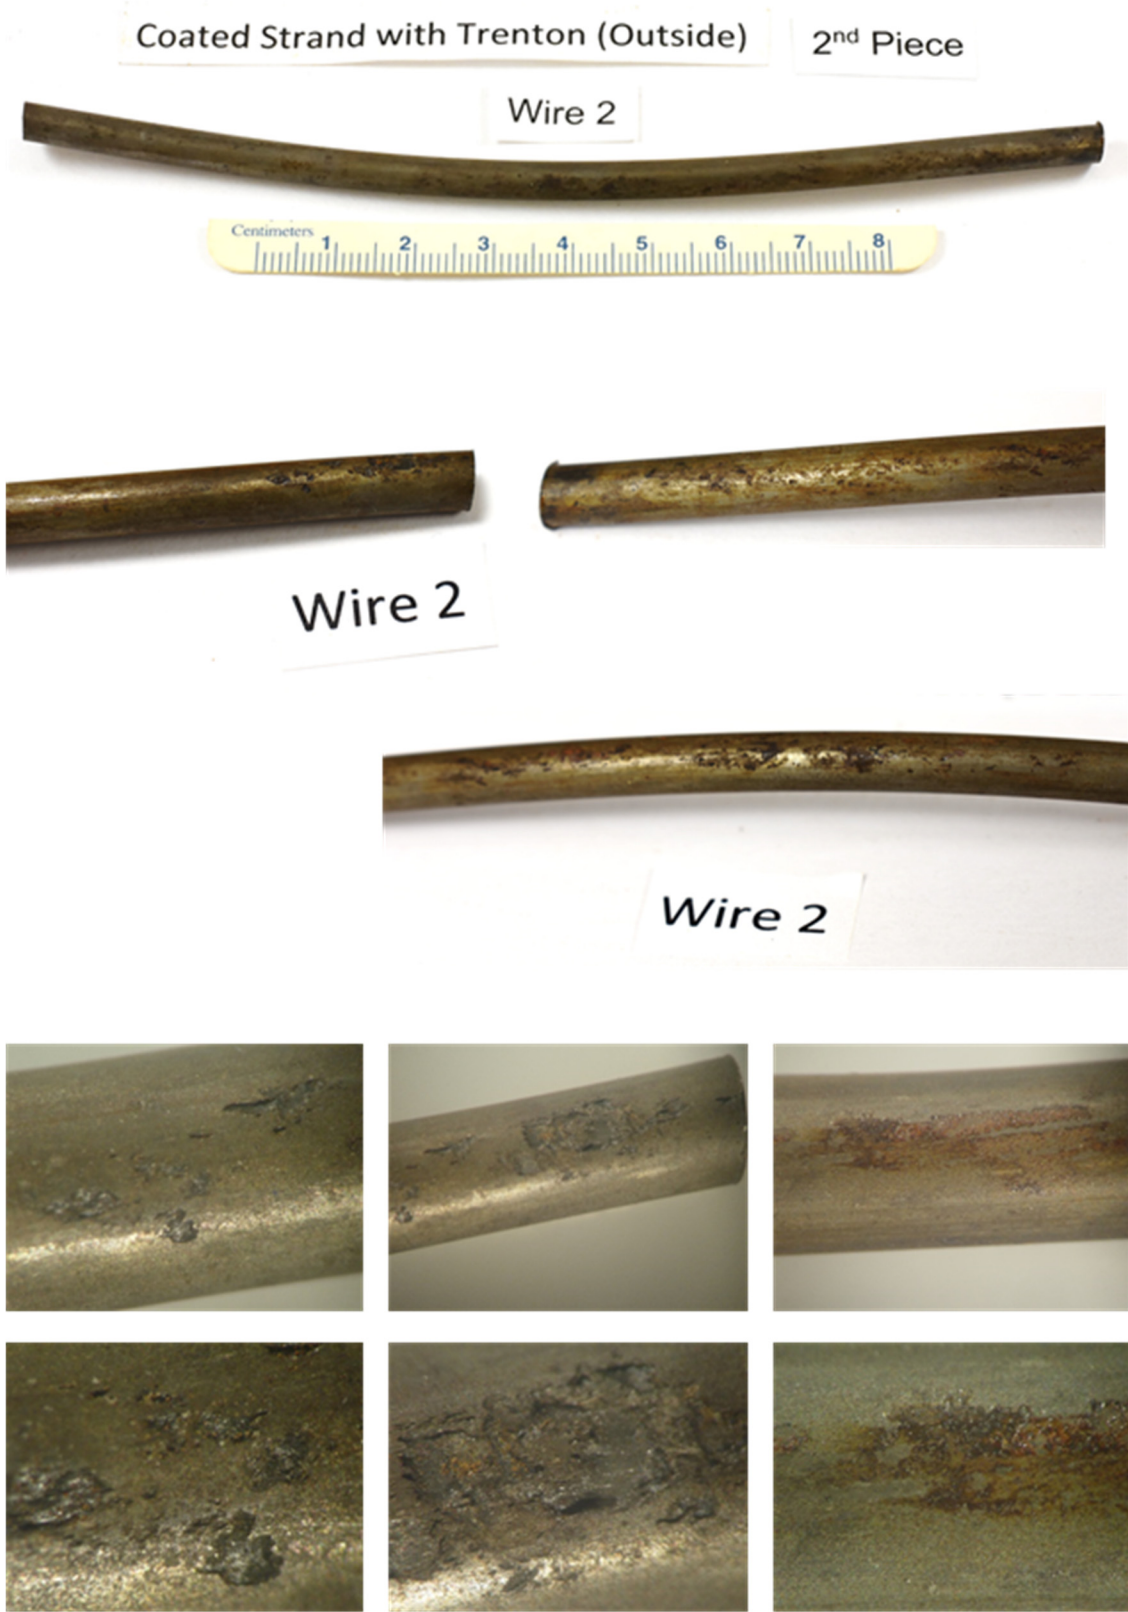
Figure 204. View of coated strand with Trenton (outside) 2nd piece, wire 2 after cleaning

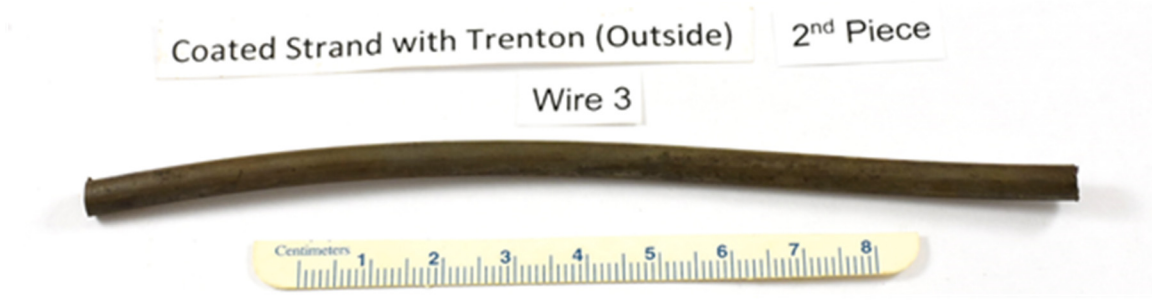
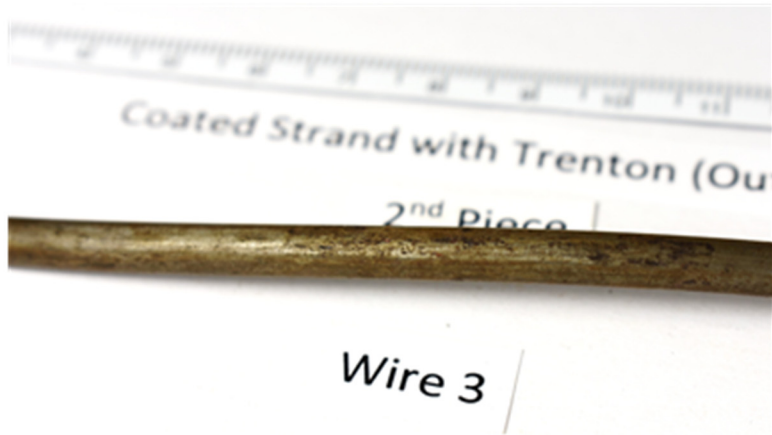
Figure 205. View of coated strand with Trenton (outside) 2nd piece, wire 3 after cleaning.

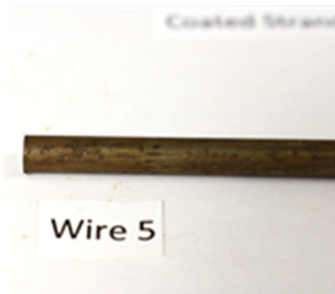
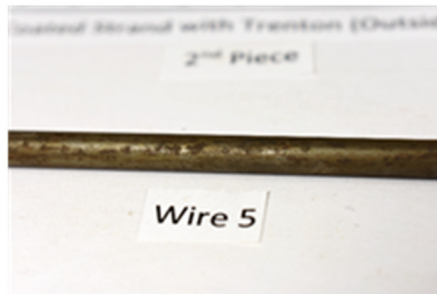
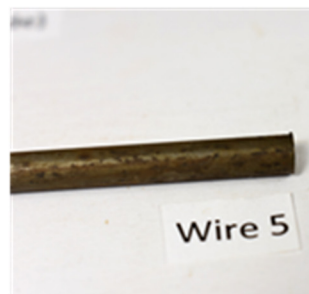
Figure 207. View of coated strand with Trenton (outside) 2nd piece , wire 5 after removing filler and cleaning (close-up).

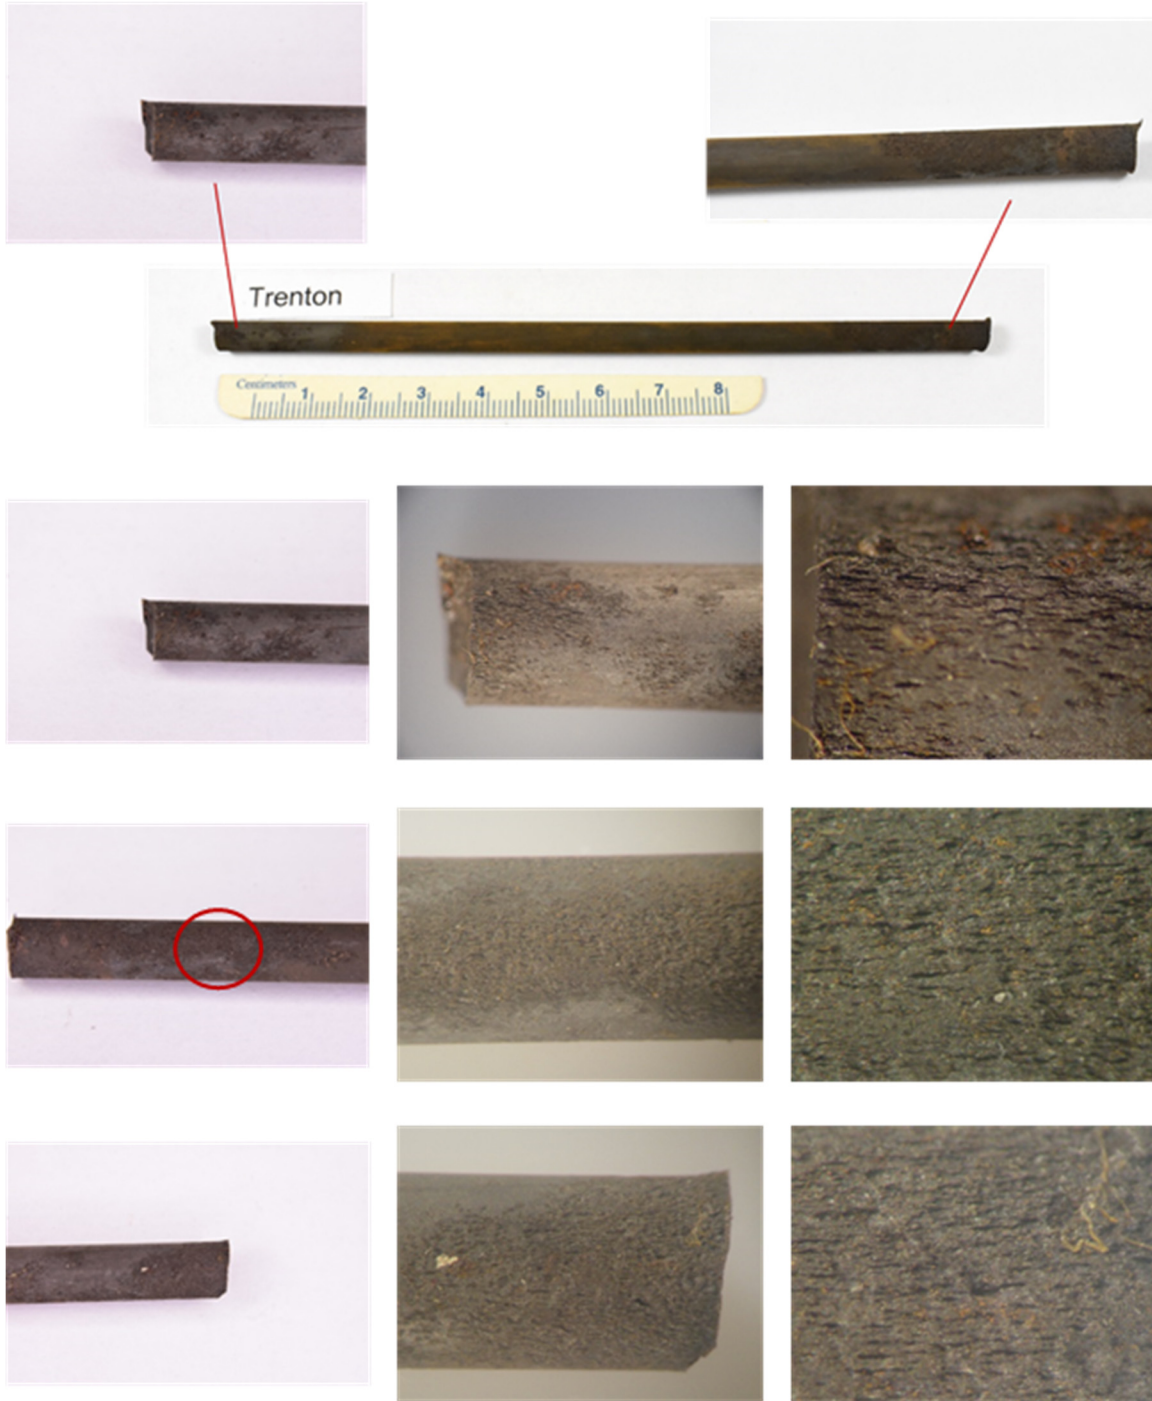
Figure 211. Single wire coated with Trenton exposed outside semi-sheltered area.

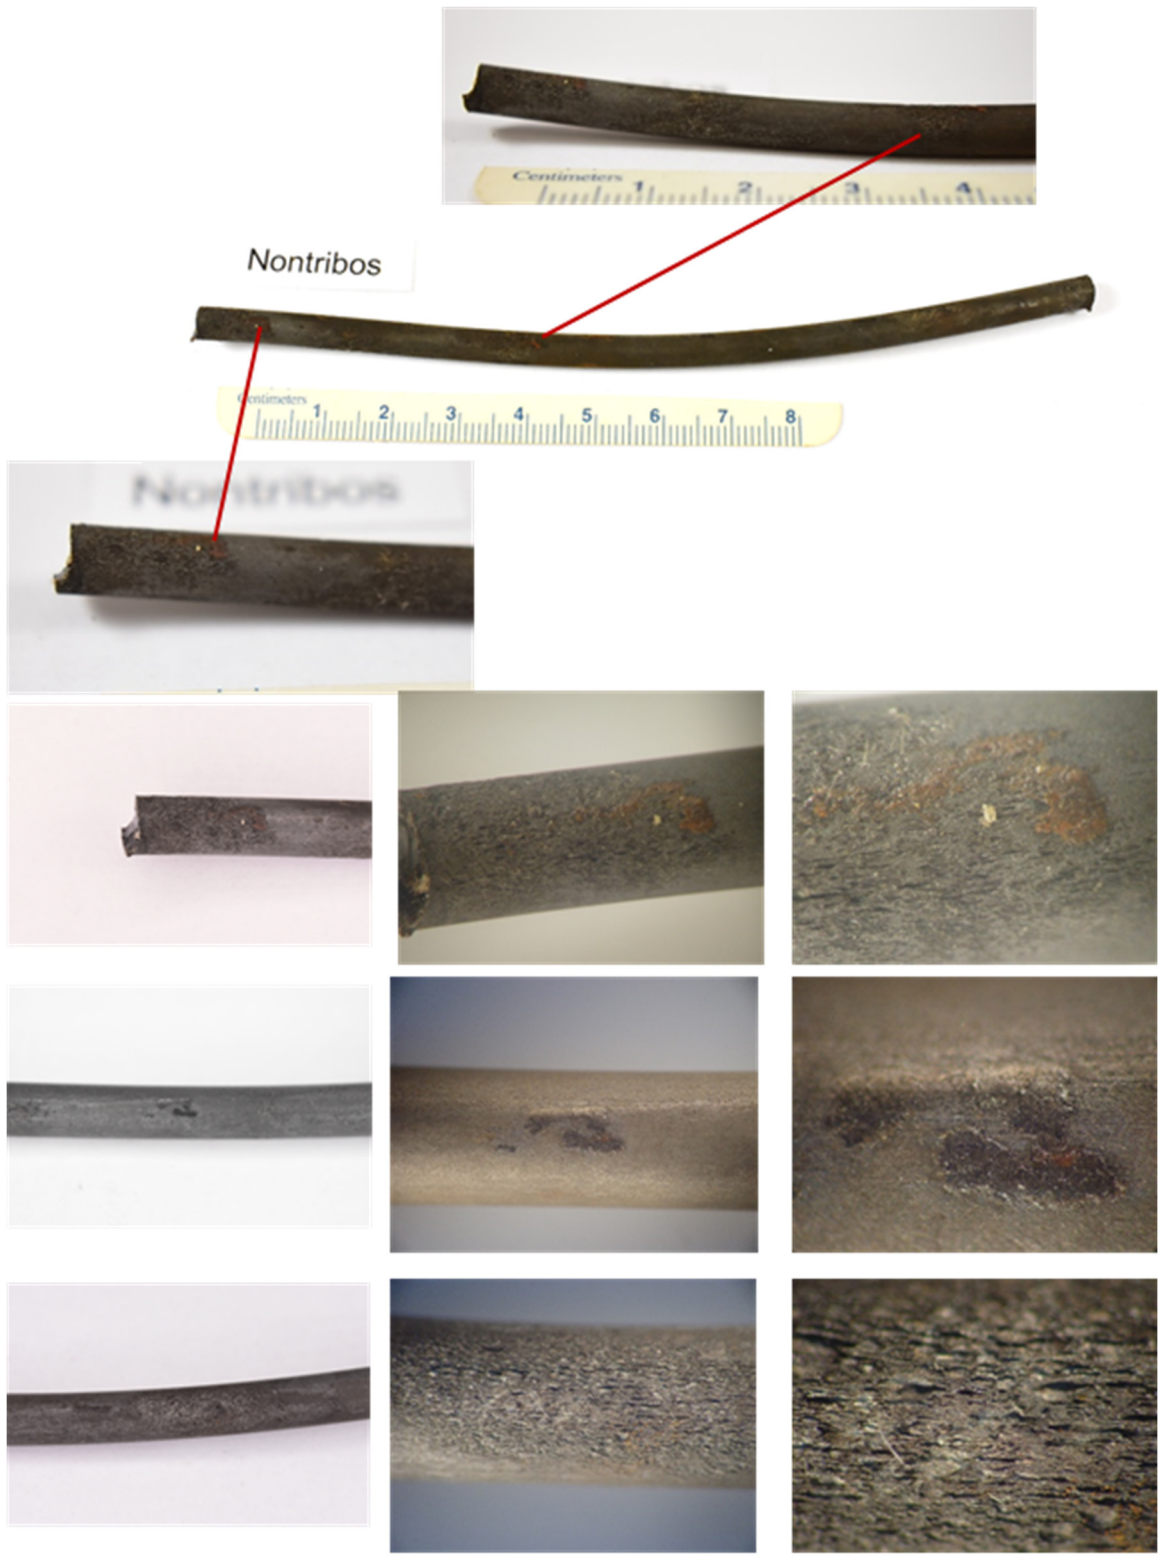
Figure 212. Single wire coated with Nontribos exposed outside semi-sheltered area
