Final Report

Corrosion Prevention of Bridge Tendons Using Flexible Filler Materials
BDV27-977-10

Submitted to
Florida Department of Transportation Research Center
605 Suwannee Street
Tallahassee, Florida 32399

November 2018

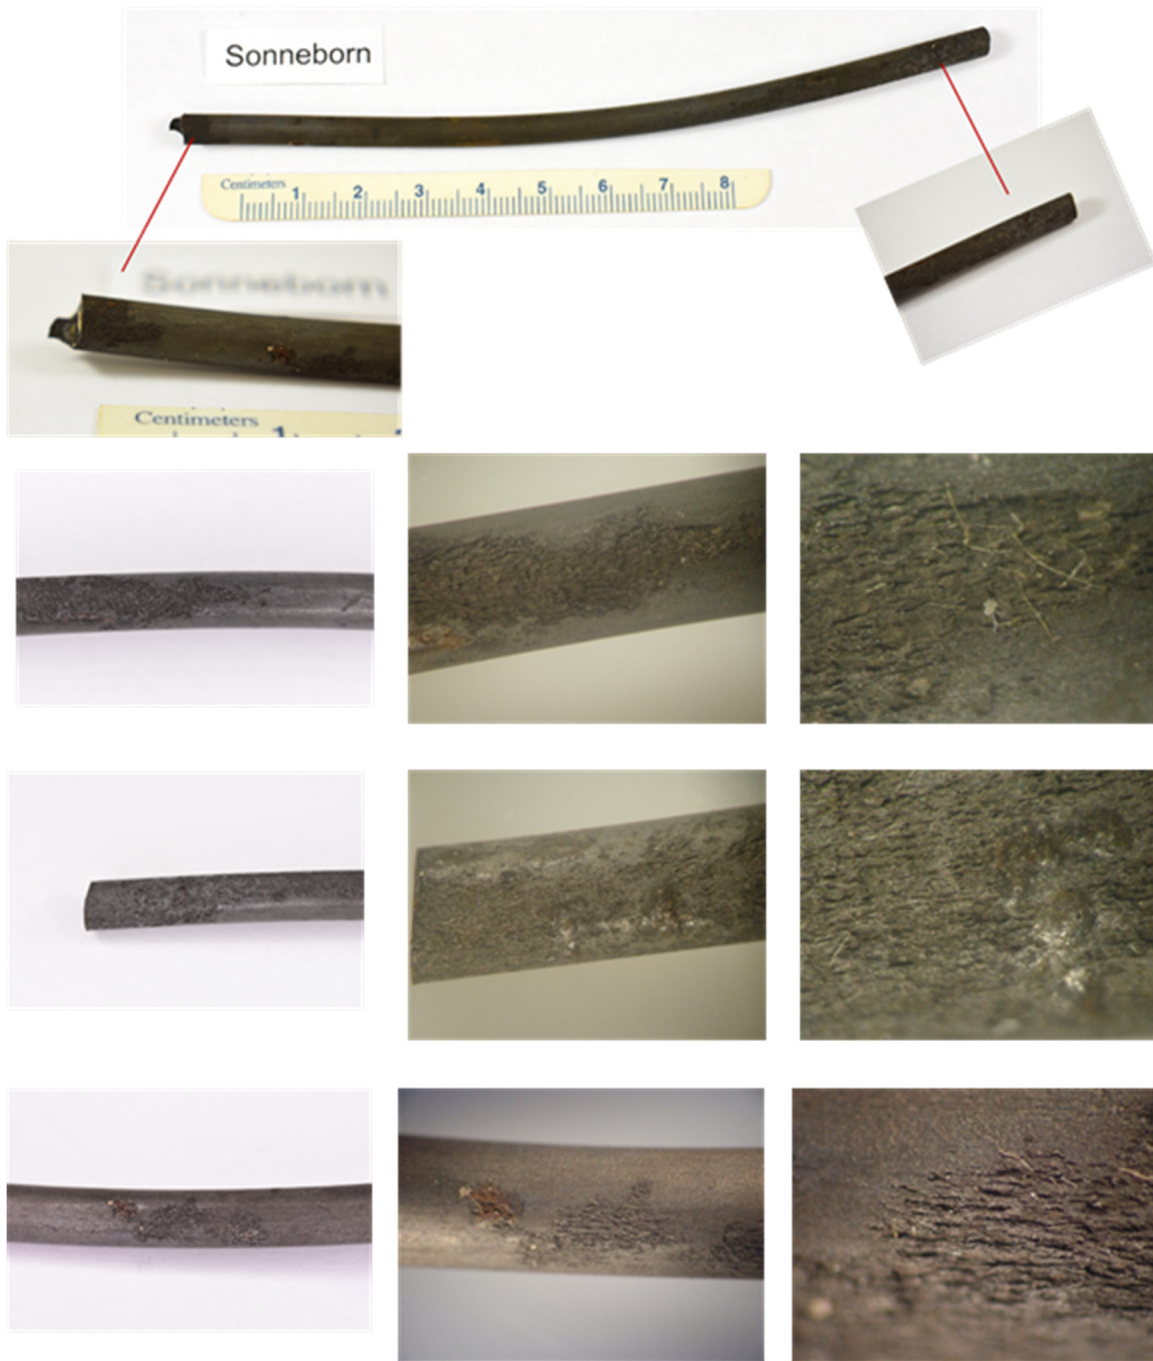
Figure 213. Single wire coated with Sonneborn exposed outside semi-sheltered area

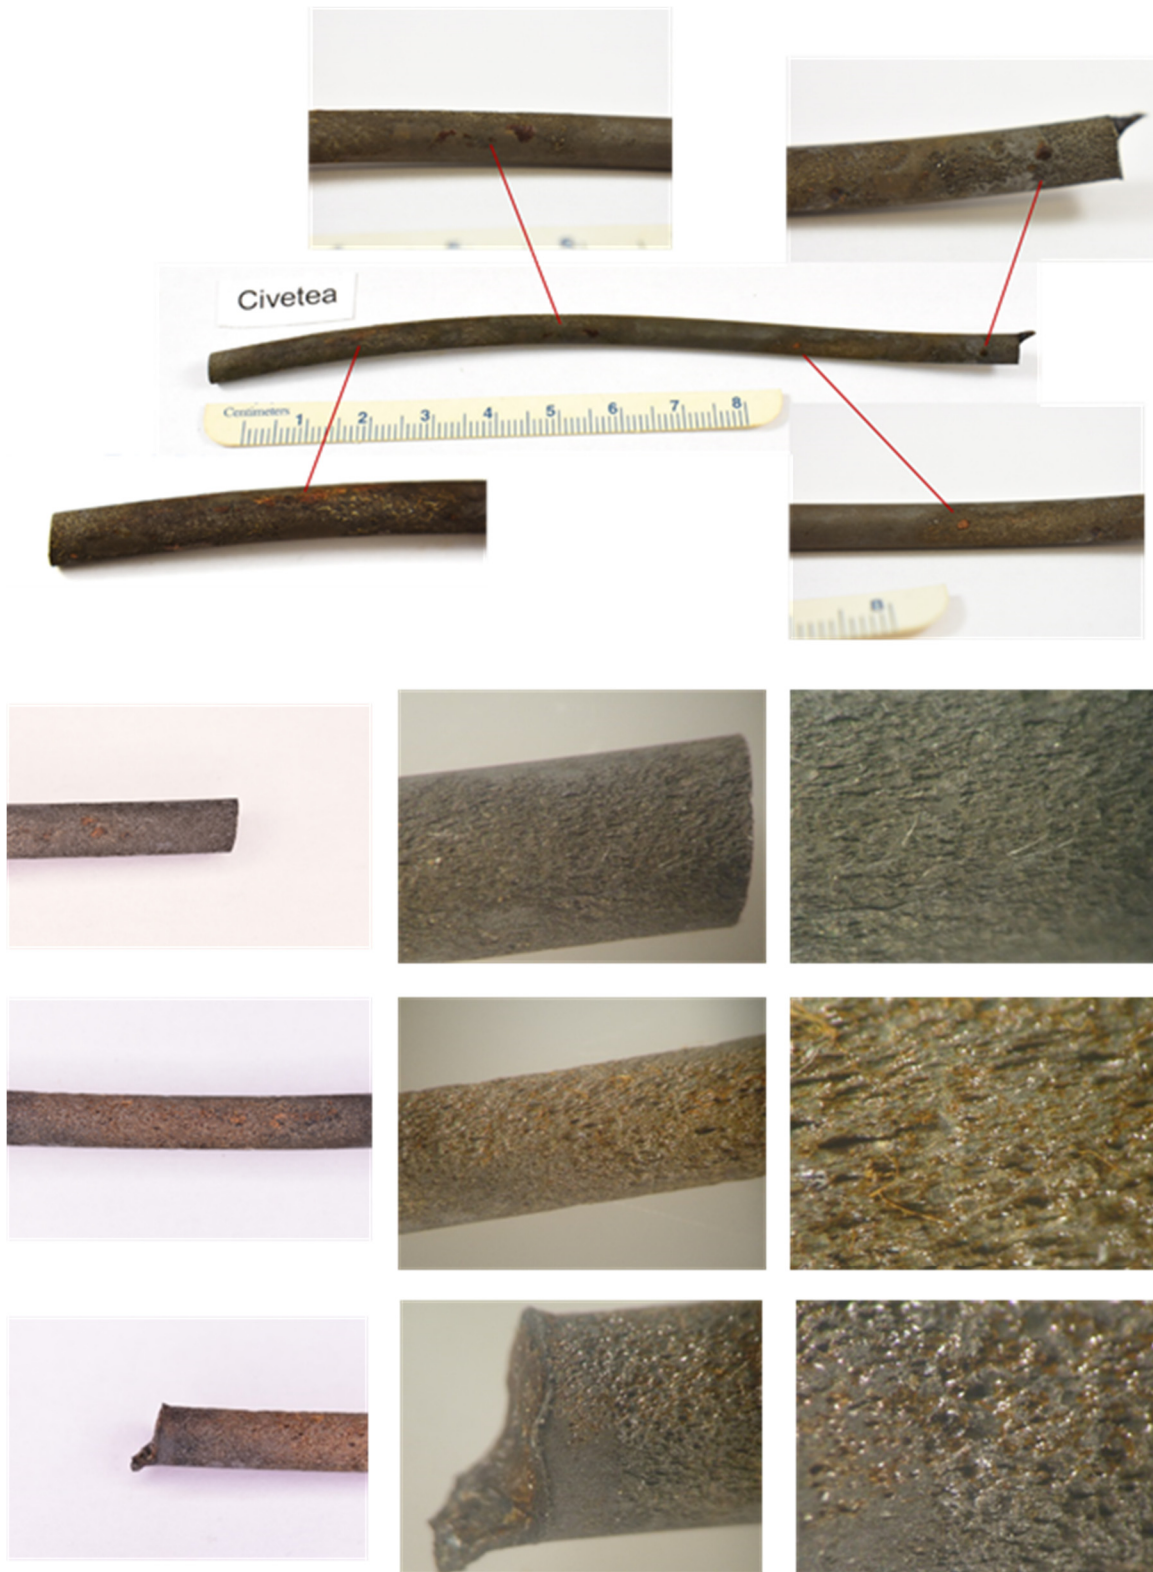
Figure 214. Single wire coated with Civetea exposed outside semi-sheltered area

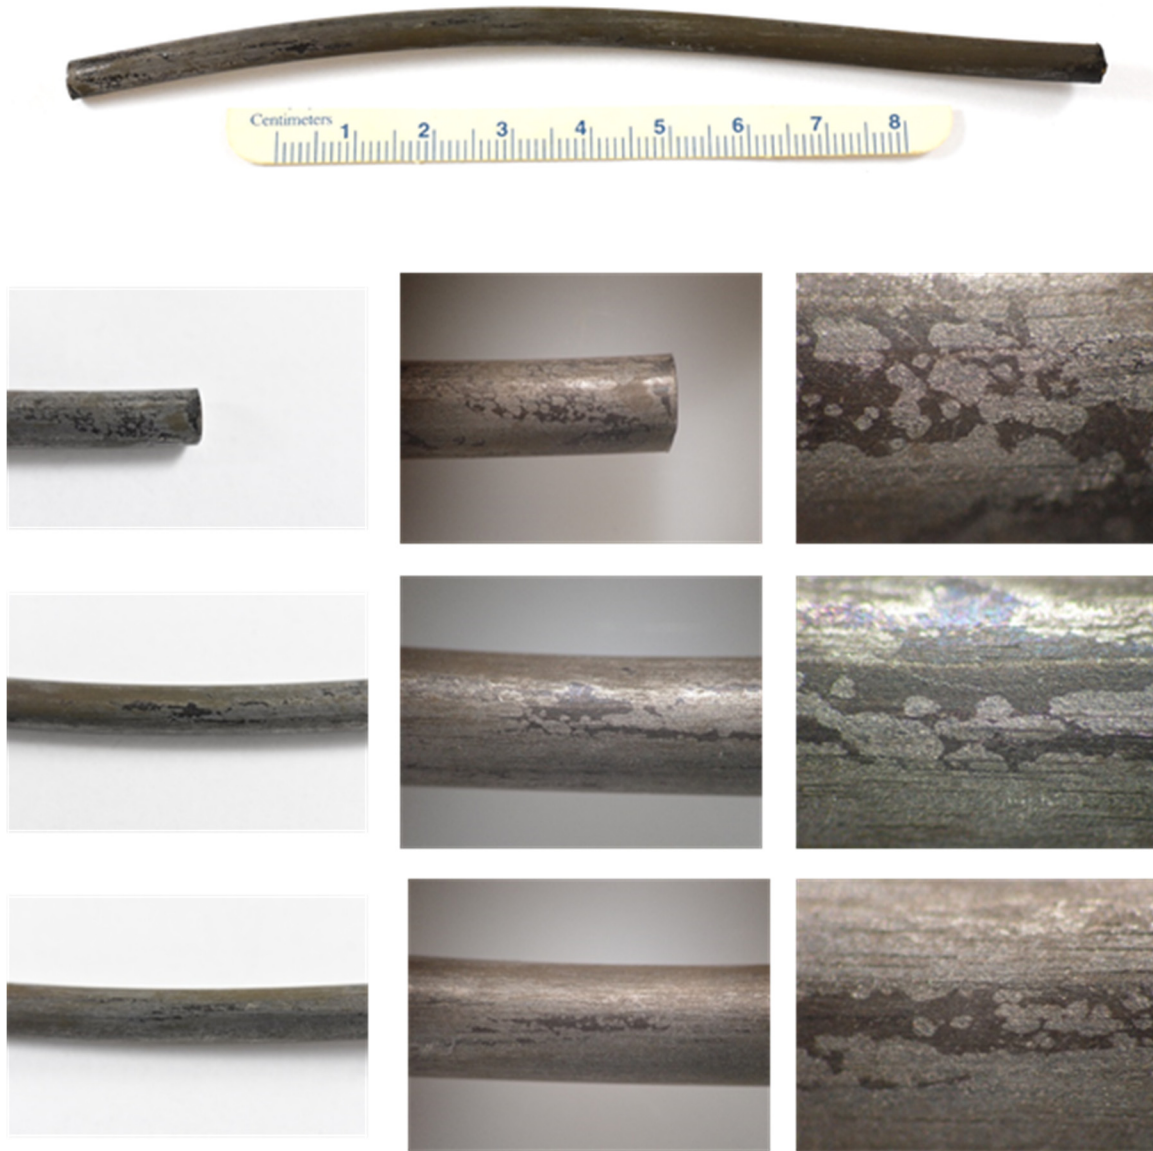
Trenton (Outside/Enclosed)

Figure 215. Single wire coated with Trenton exposed outdoors inside partially closed container

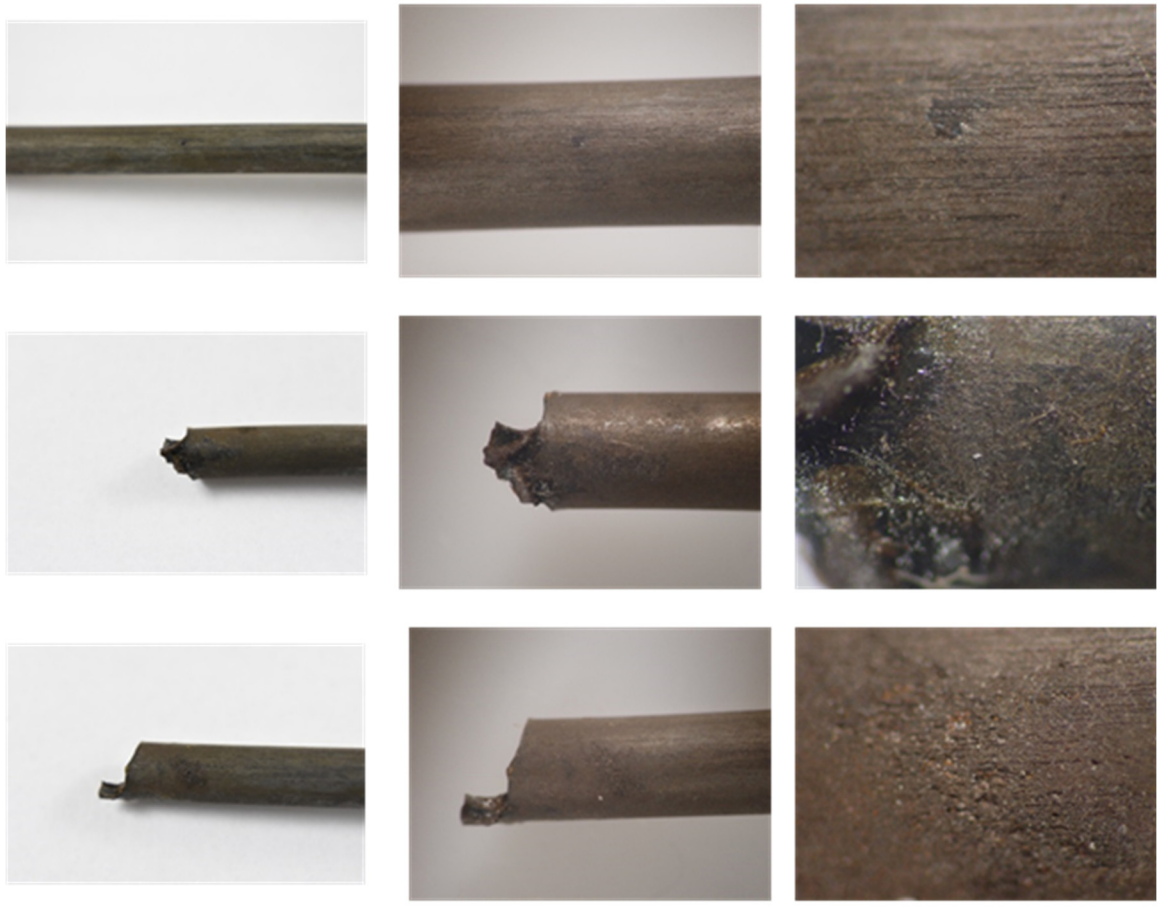
Figure 216. Single wire coated with Nontribos exposed outdoors inside partially closed container

Figure 216. Single wire coated with Nontribos exposed outdoors inside partially closed container	192
Figure 217. Single wire coated with Sonneborn exposed outdoors inside partially closed container (close-up 2)	193
Figure 218. Single wire coated with Civetea exposed outdoors inside partially closed container.	194
Figure 219. Single wire coated with Sanchem exposed outdoors inside partially closed container.	195
Figure 220. Single wire coated with Trenton at 20°C at high humidity.	196
Figure 221. Single wire coated with Nontribos at 20°C at high humidity.....	197
Figure 222. Single wire coated with Sonneborn at 20°C at high humidity	198
Figure 223. Single wire coated with Civetea at 20°C at high humidity	199
Figure 224. Single wire coated with Sanchem at 20°C at high humidity	200
Figure 225. Single wire blank at 20°C at high humidity	201
Figure 226. Single wire coated with Trenton at 32°C at high humidity (close-up 1).....	202

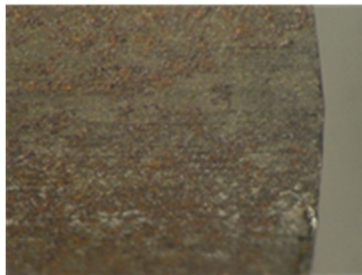
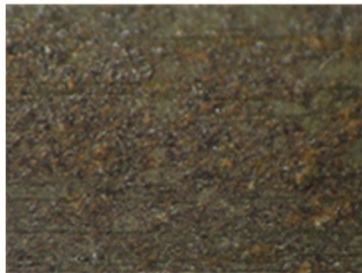
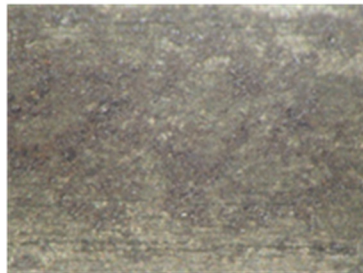
Sonneborn (Outside/Enclosed)

Figure 217. Single wire coated with Sonneborn exposed outdoors inside partially closed container (close-up 2)

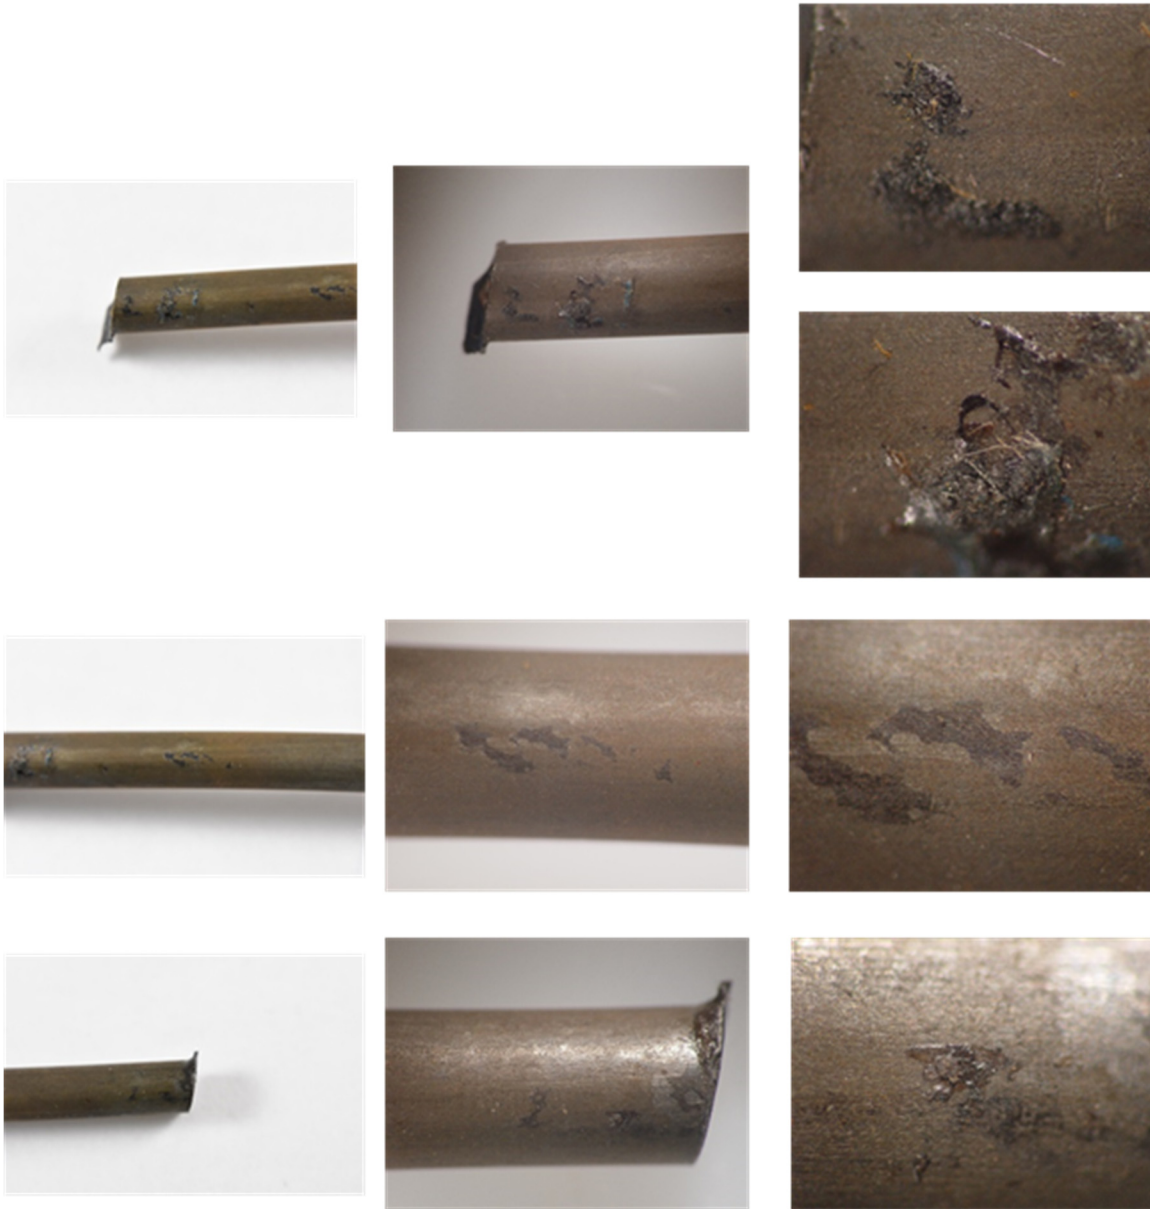
Figure 218. Single wire coated with Civetex exposed outdoors inside partially closed container.

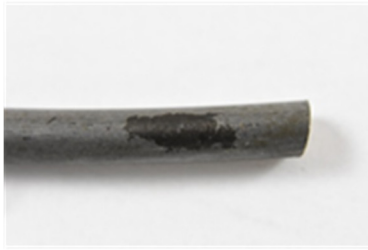
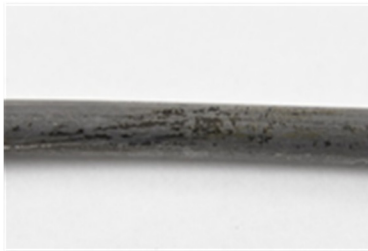
Sanchem (Outside/Enclosed)

Figure 219. Single wire coated with Sanchem exposed outdoors inside partially closed container.

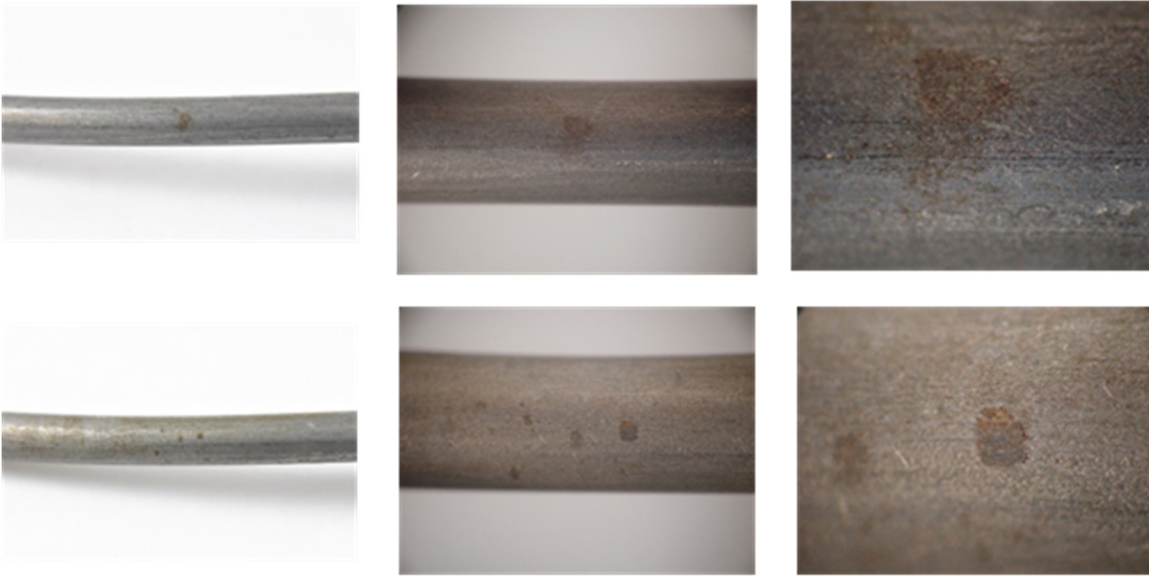
Figure 220. Single wire coated with Trenton at 20°C at high humidity.

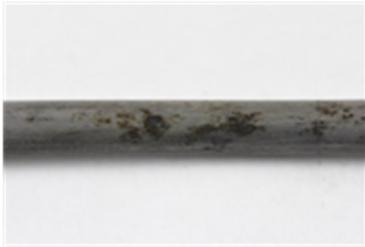
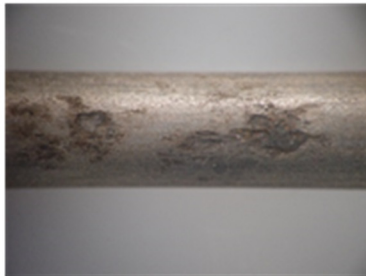
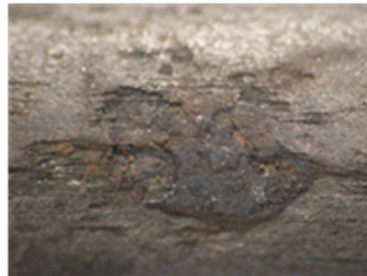
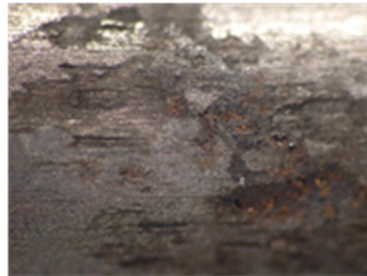
Figure 221. Single wire coated with Nontribos at 20°C at high humidity

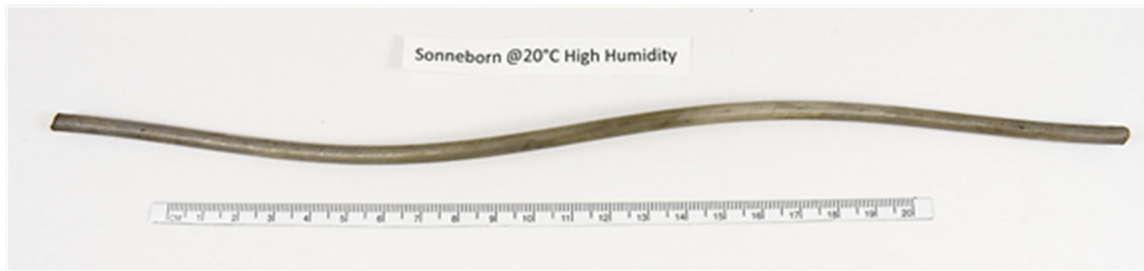
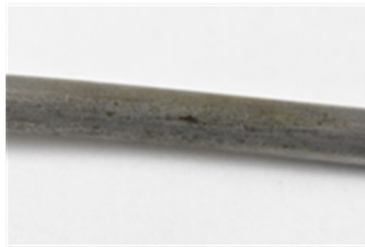
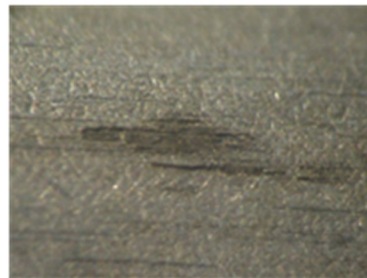
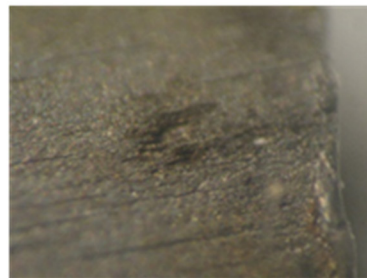
Figure 222. Single wire coated with Sonneborn at 20°C at high humidity

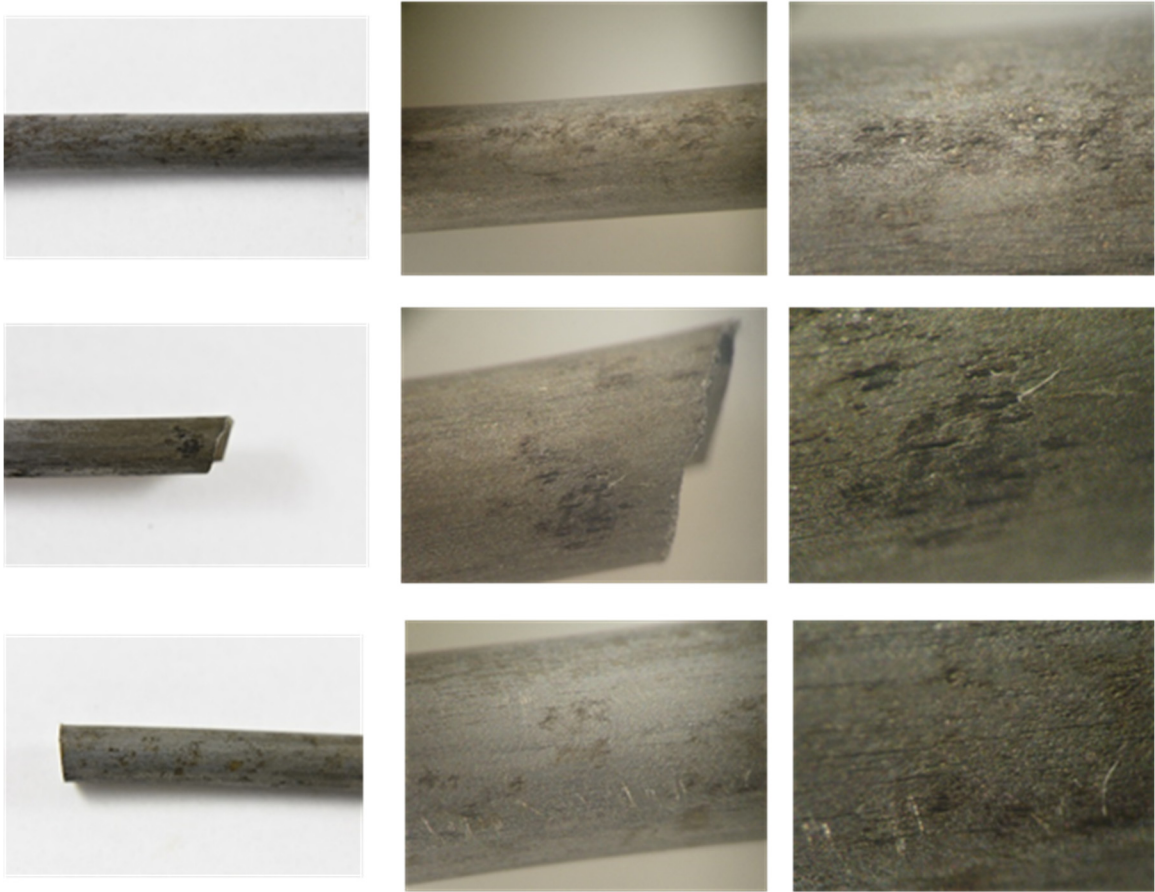
Figure 223. Single wire coated with Civetia at 20°C at high humidity

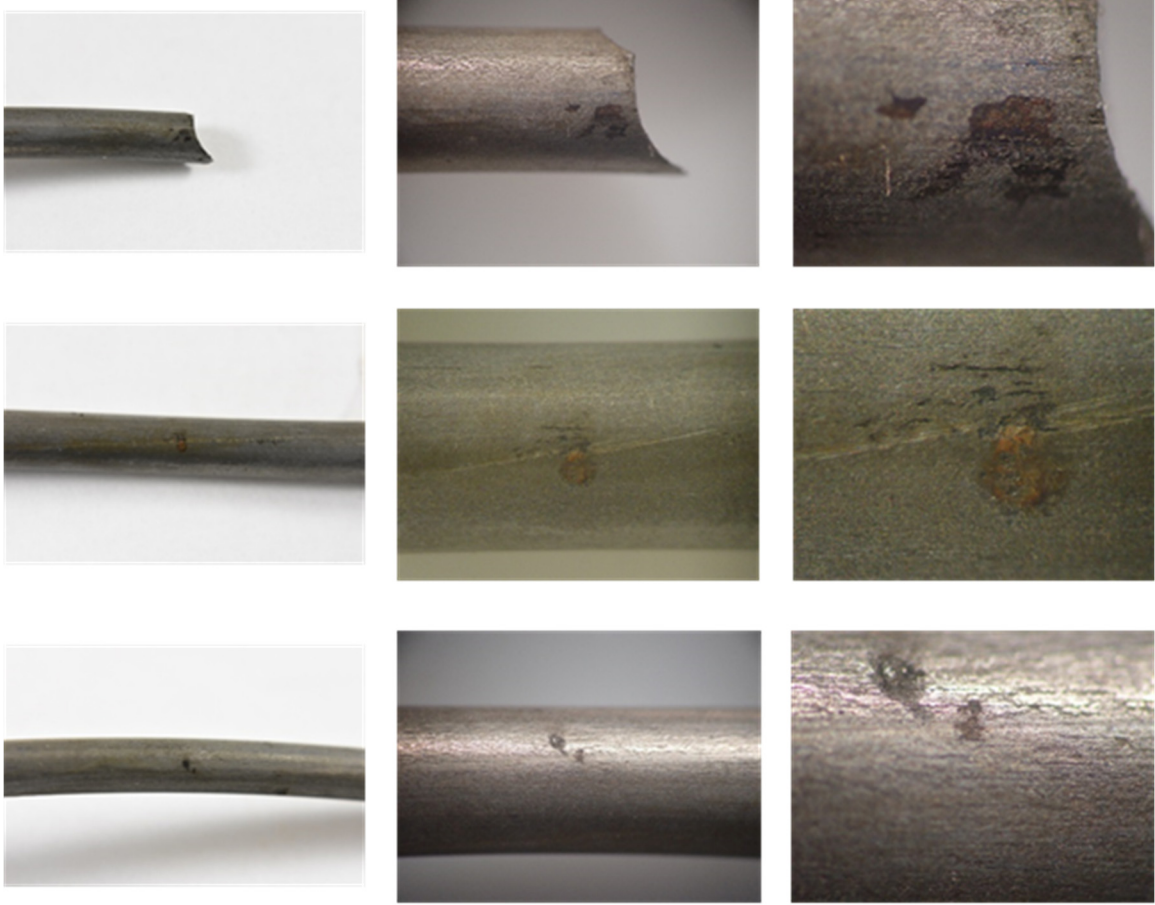
Figure 224. Single wire coated with Sanchem at 20°C at high humidity

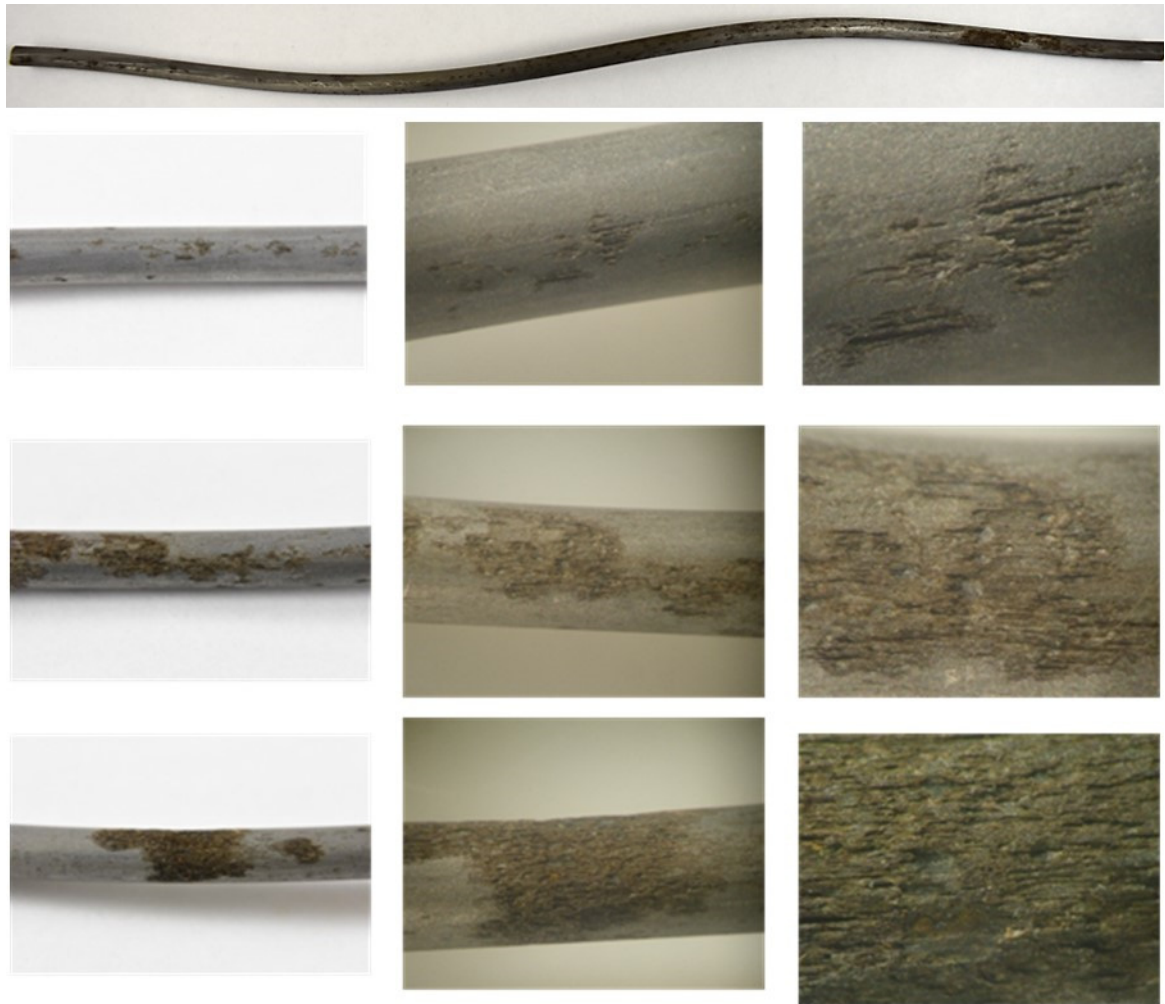
Figure 225. Single wire blank at 20°C at high humidity

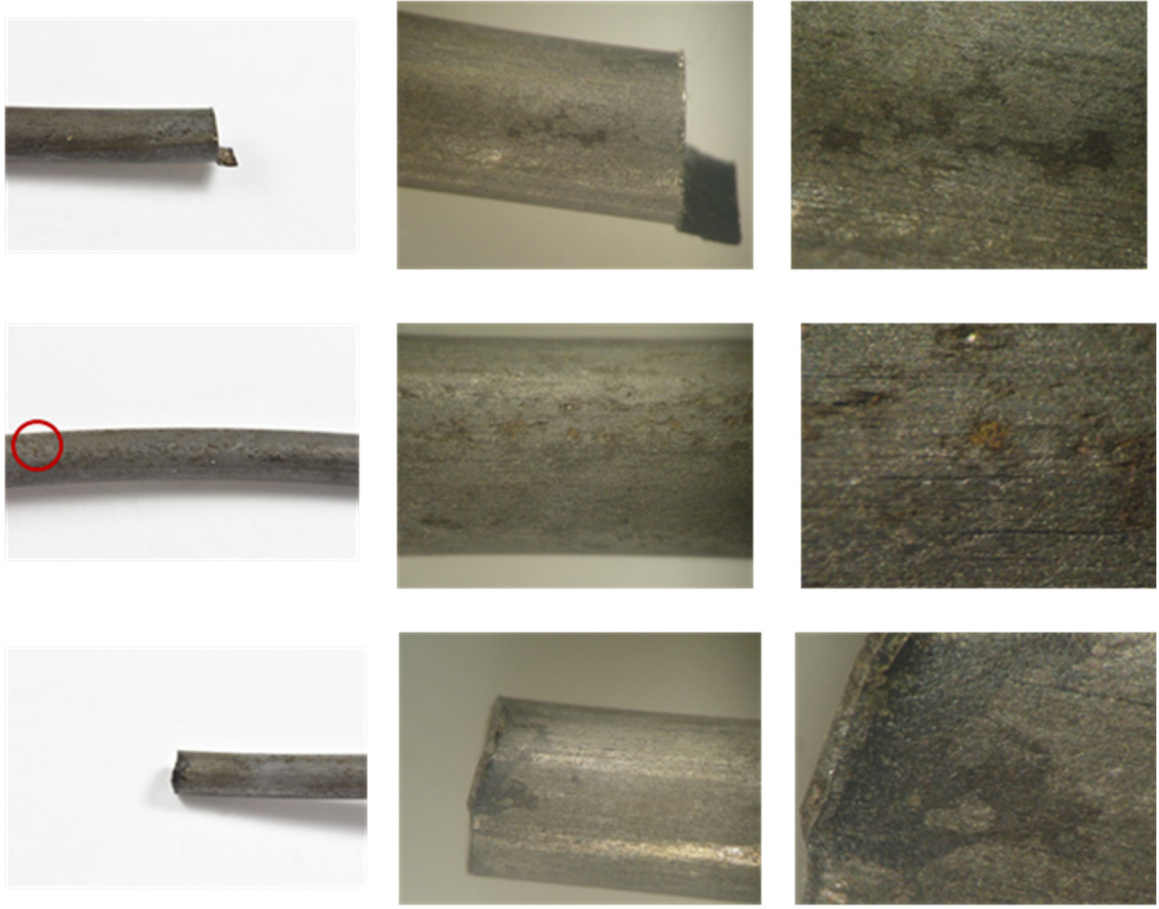
Figure 227. Single wire coated with Nontribos at 32°C at high humidity

Figure 227. Single wire coated with Nontribos at 32°C at high humidity.....	203
Figure 228. Single wire coated with Sonneborn at 32°C at high humidity	204
Figure 229. Single wire coated with Civetea at 32°C at high humidity.	205
Figure 230. Single wire coated with Sanchem at 32°C at high humidity	206
Figure 231. Single wire blank at 32°C at high humidity	207
Figure 232. Coated with filler and sprayed with 1.5 milliliter of solution containing fungus AF	208
Figure 233. Coated with filler Trenton and sprayed with 1.5 milliliter of solution containing fungus AF	209
Figure 234. Coated with filler Trenton and sprayed with 1.5 milliliter of solution containing fungus AF	210

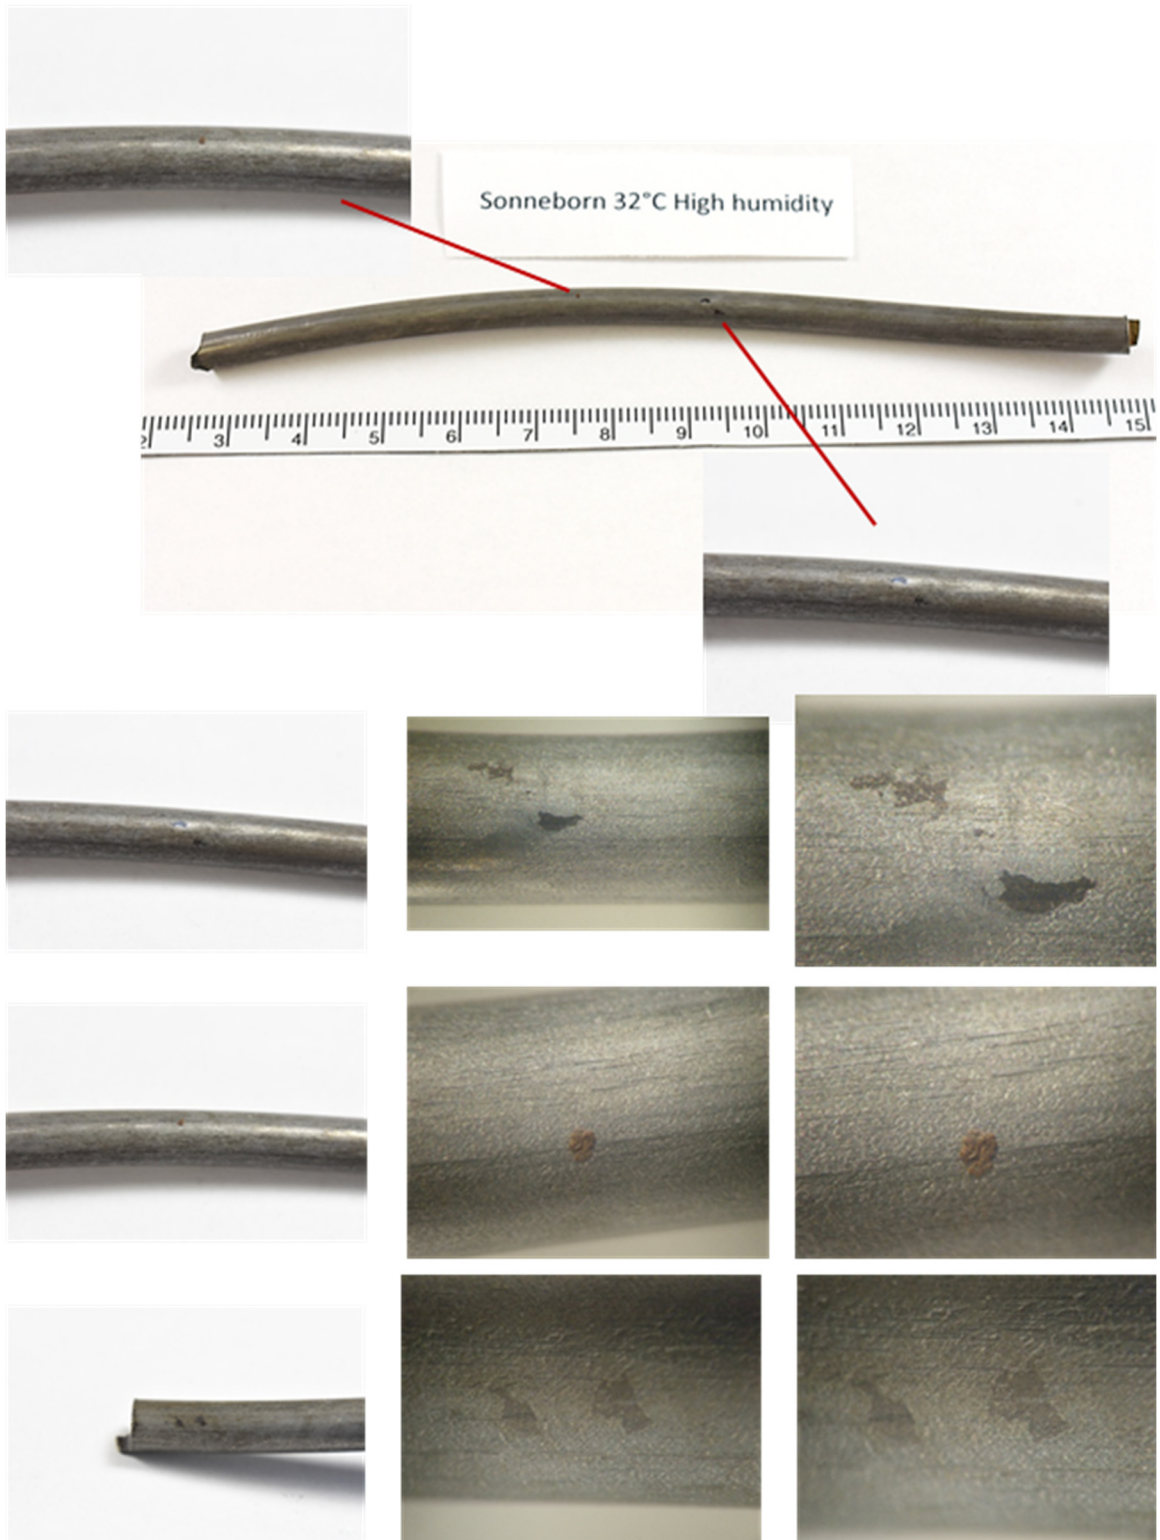
Figure 228. Single wire coated with Sonneborn at 32°C at high humidity

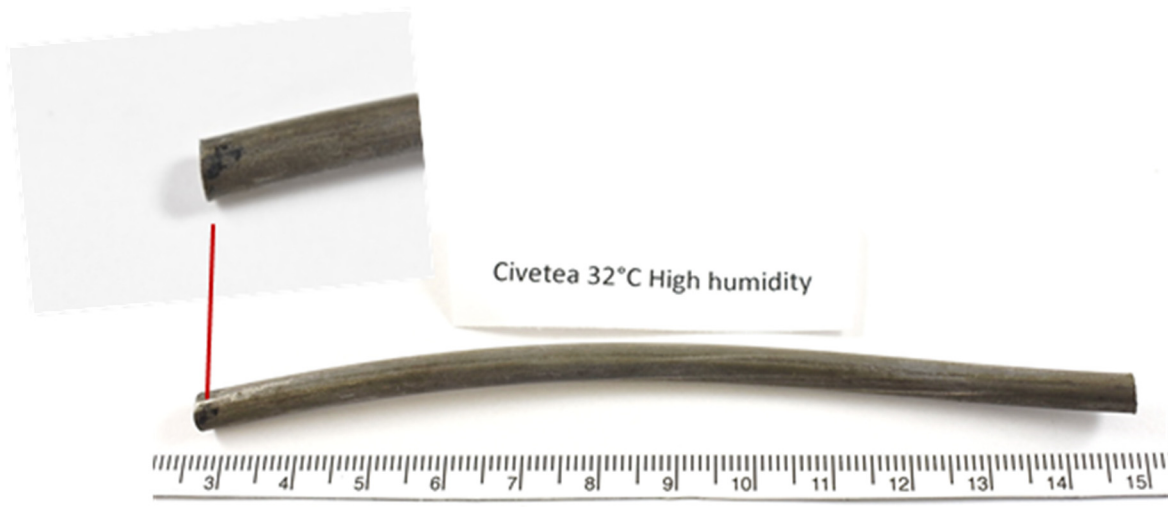
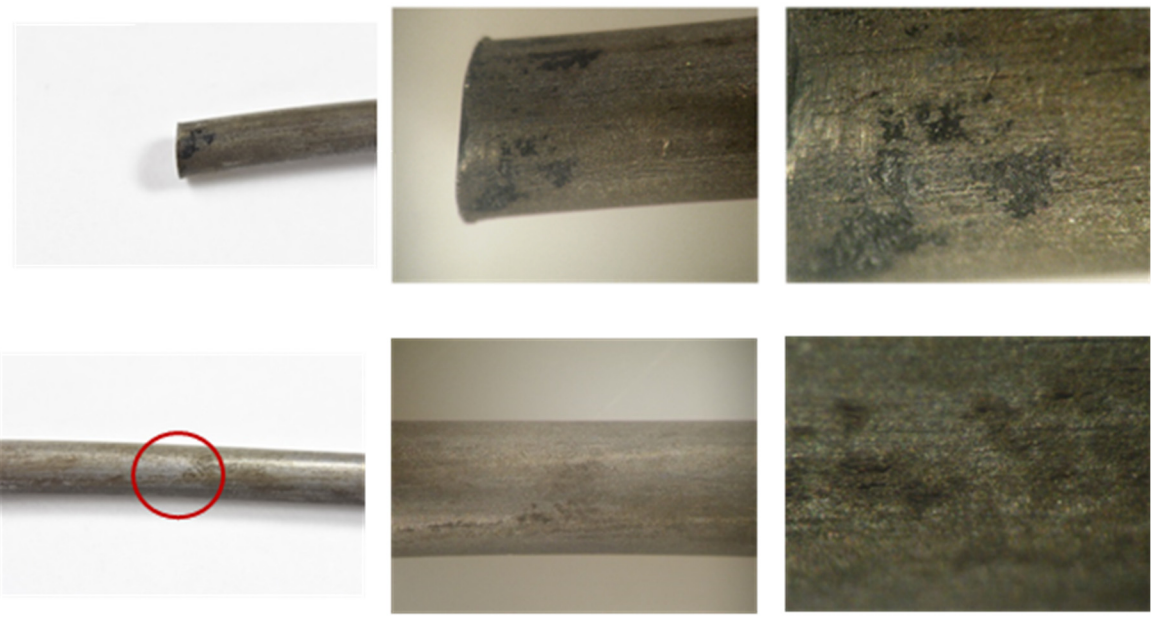
Figure 229. Single wire coated with Civetea at 32°C at high humidity.

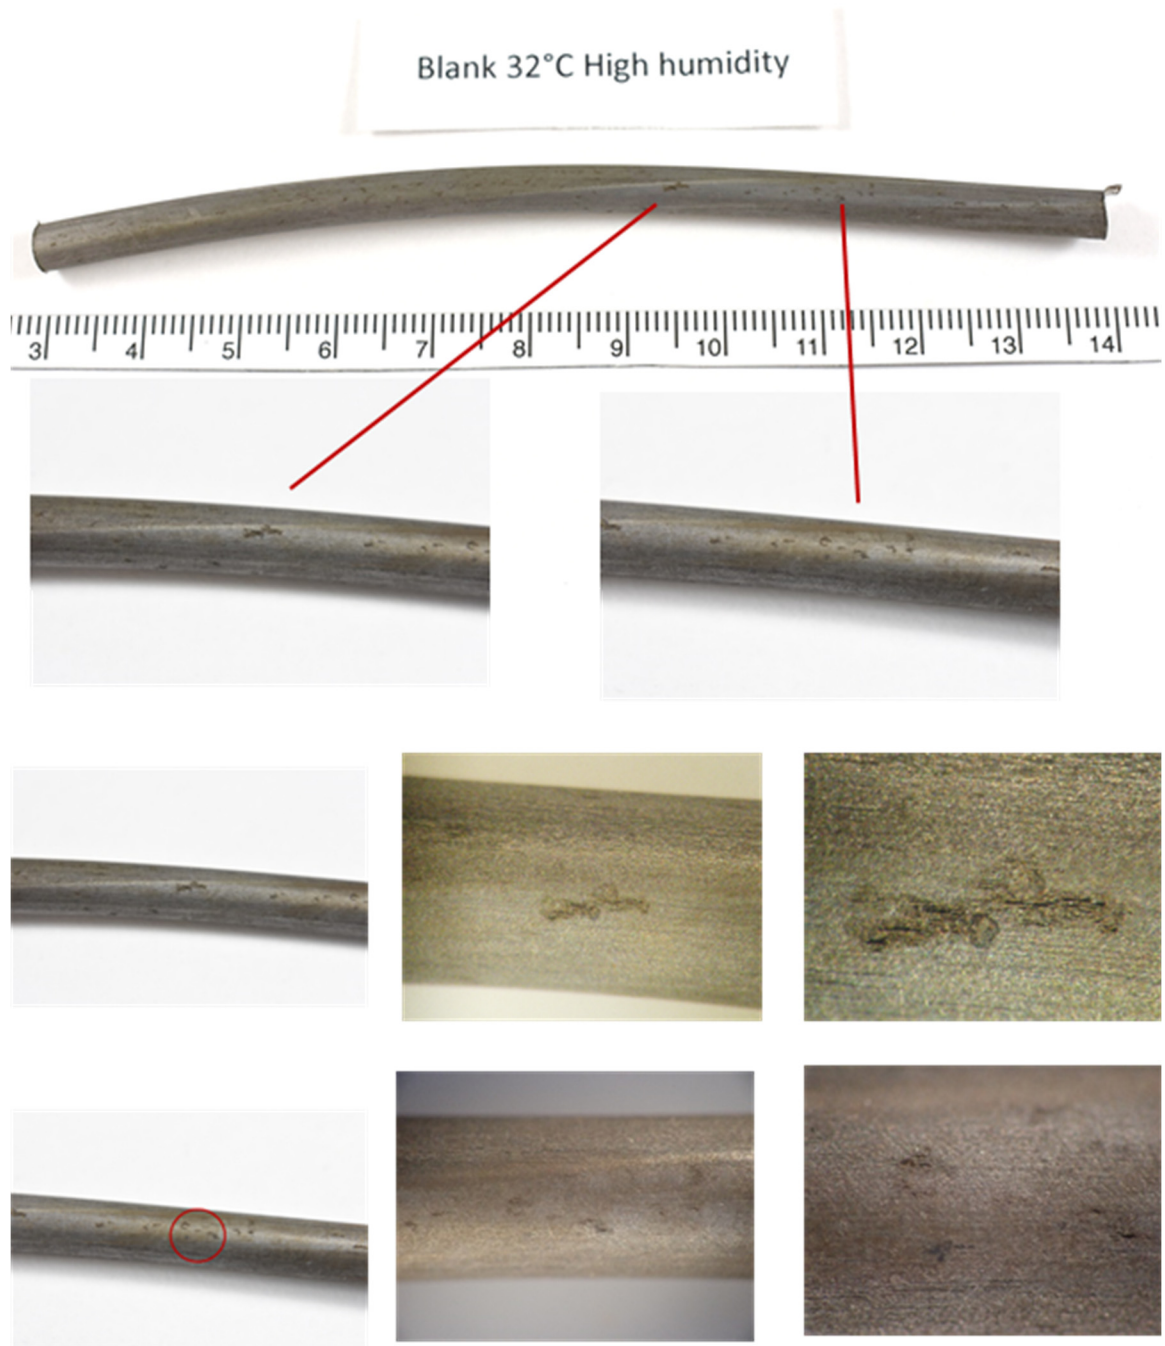
Figure 231. Single wire blank at 32°C at high humidity

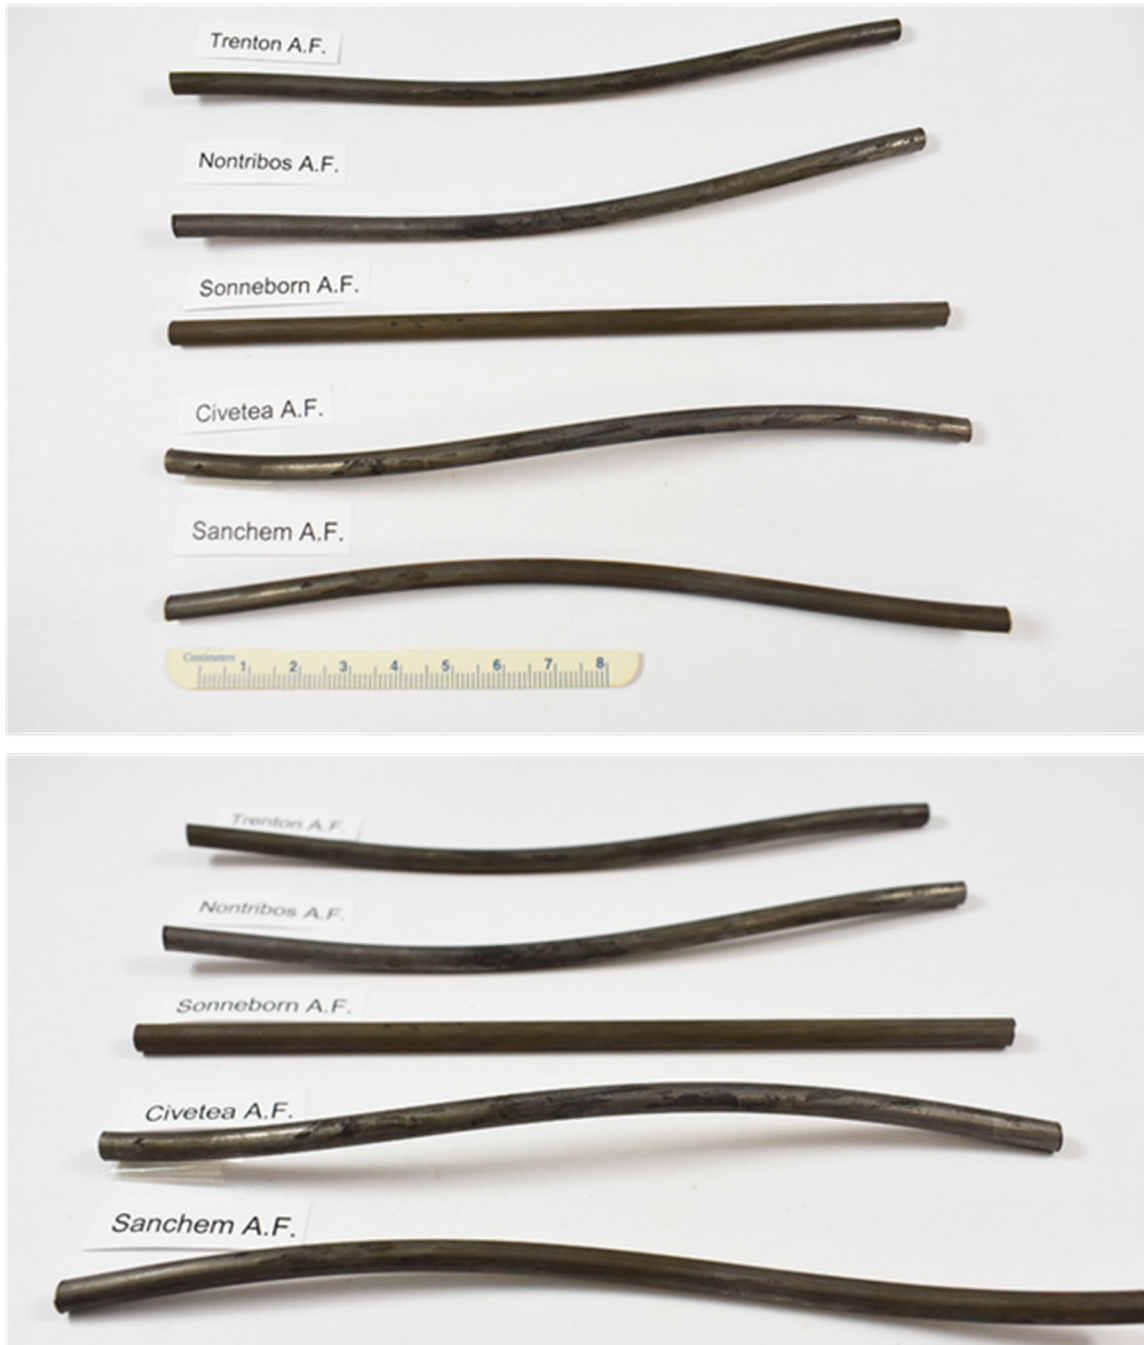
Figure 232. Coated with filler and sprayed with 1.5 milliliter of solution containing fungus AF

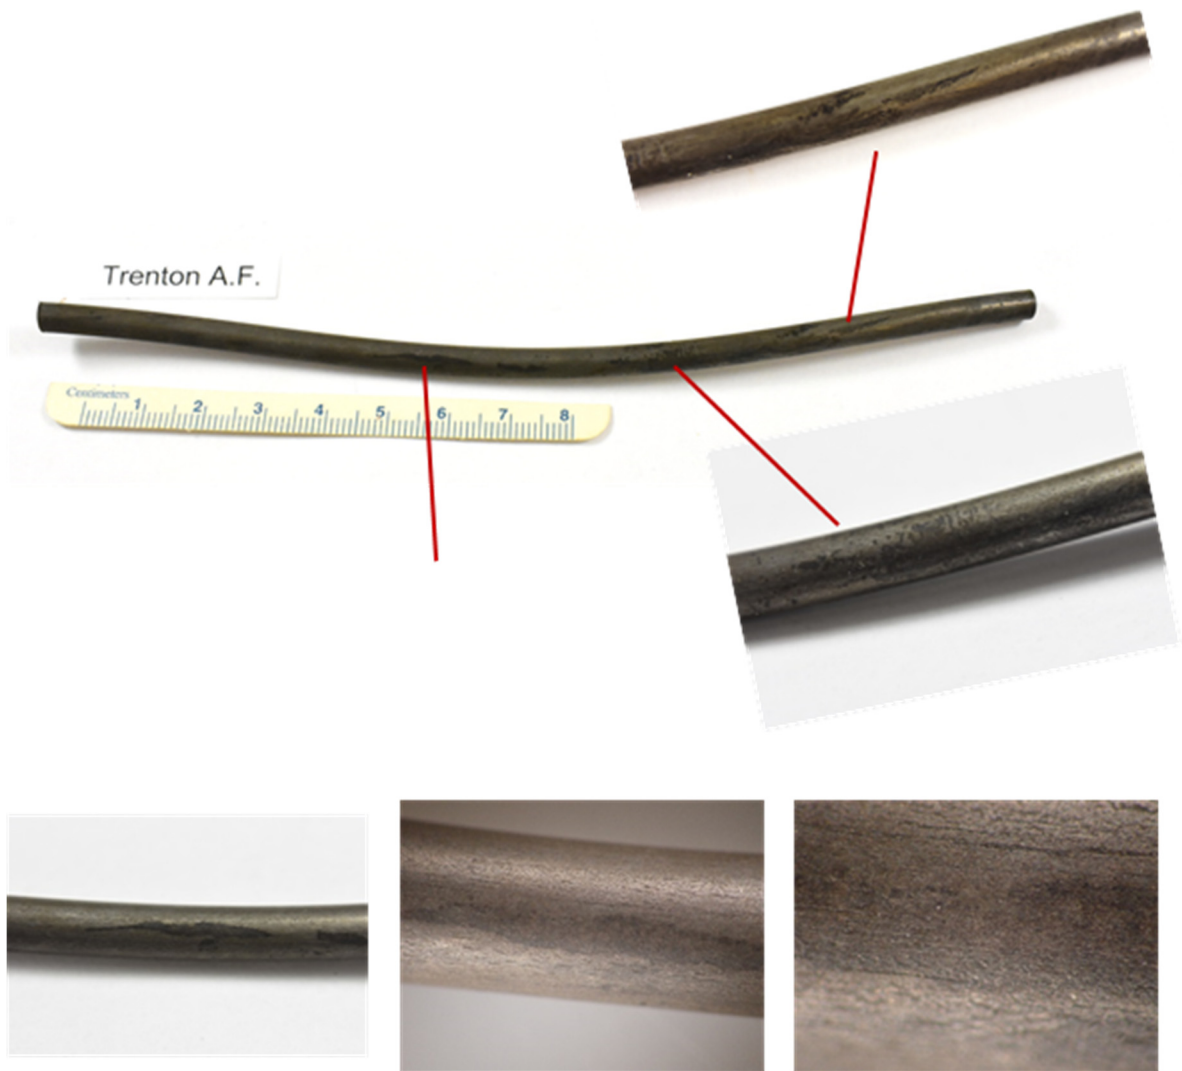
Figure 233. Coated with filler Trenton and sprayed with 1.5 milliliter of solution containing fungus AF
