Final Report

Corrosion Prevention of Bridge Tendons Using Flexible Filler Materials
BDV27-977-10

Submitted to
Florida Department of Transportation Research Center
605 Suwannee Street
Tallahassee, Florida 32399

November 2018

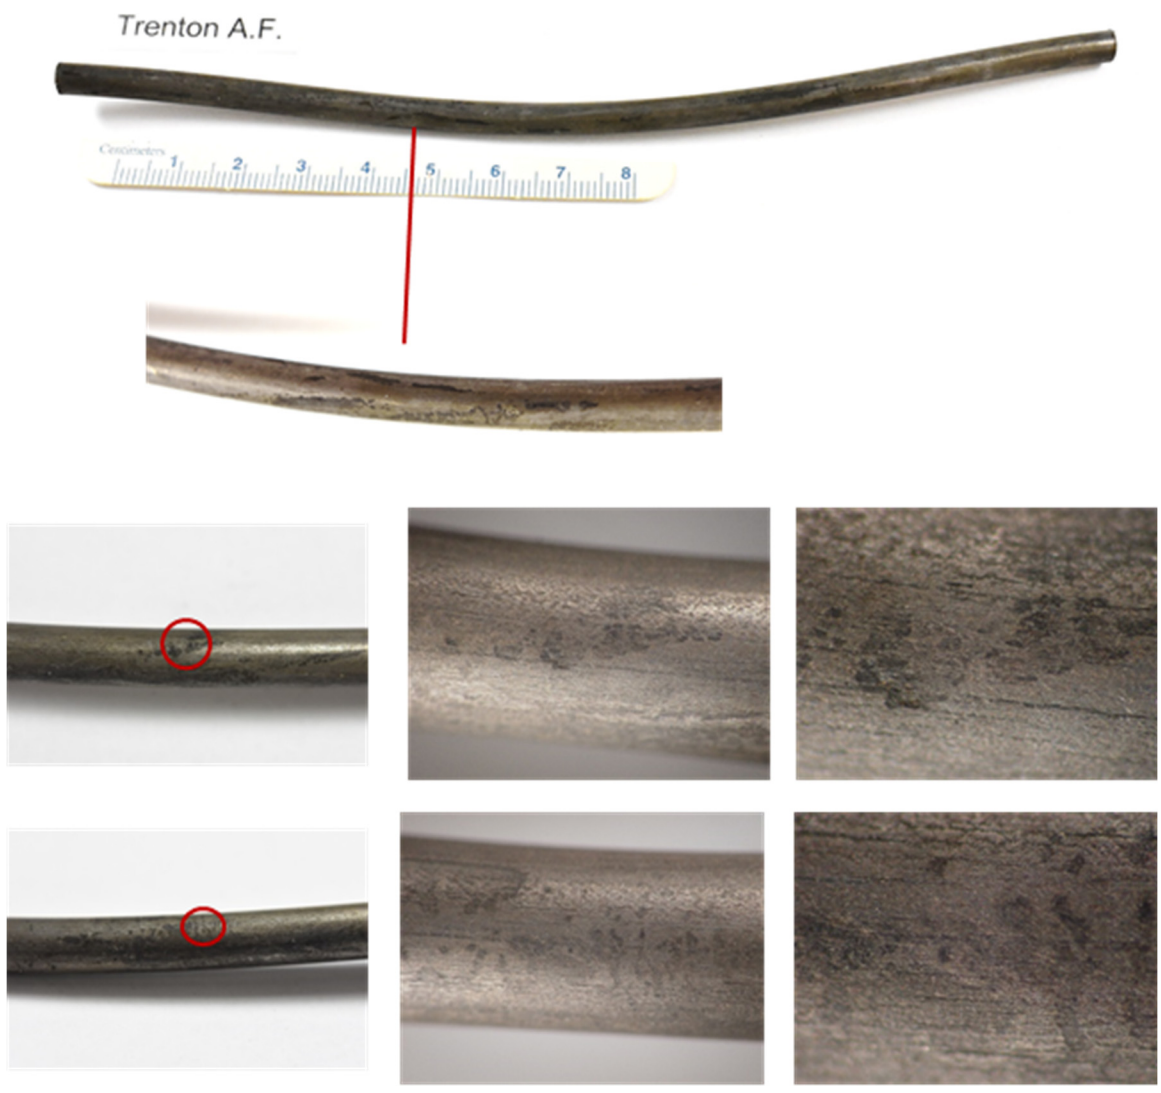
Figure 234. Coated with filler Trenton and sprayed with 1.5 milliliter of solution containing fungus AF

Figure 227. Single wire coated with Nontribos at 32°C at high humidity.....	203
Figure 228. Single wire coated with Sonneborn at 32°C at high humidity	204
Figure 229. Single wire coated with Civetea at 32°C at high humidity.	205
Figure 230. Single wire coated with Sanchem at 32°C at high humidity	206
Figure 231. Single wire blank at 32°C at high humidity	207
Figure 232. Coated with filler and sprayed with 1.5 milliliter of solution containing fungus AF	208
Figure 233. Coated with filler Trenton and sprayed with 1.5 milliliter of solution containing fungus AF	209
Figure 234. Coated with filler Trenton and sprayed with 1.5 milliliter of solution containing fungus AF	210

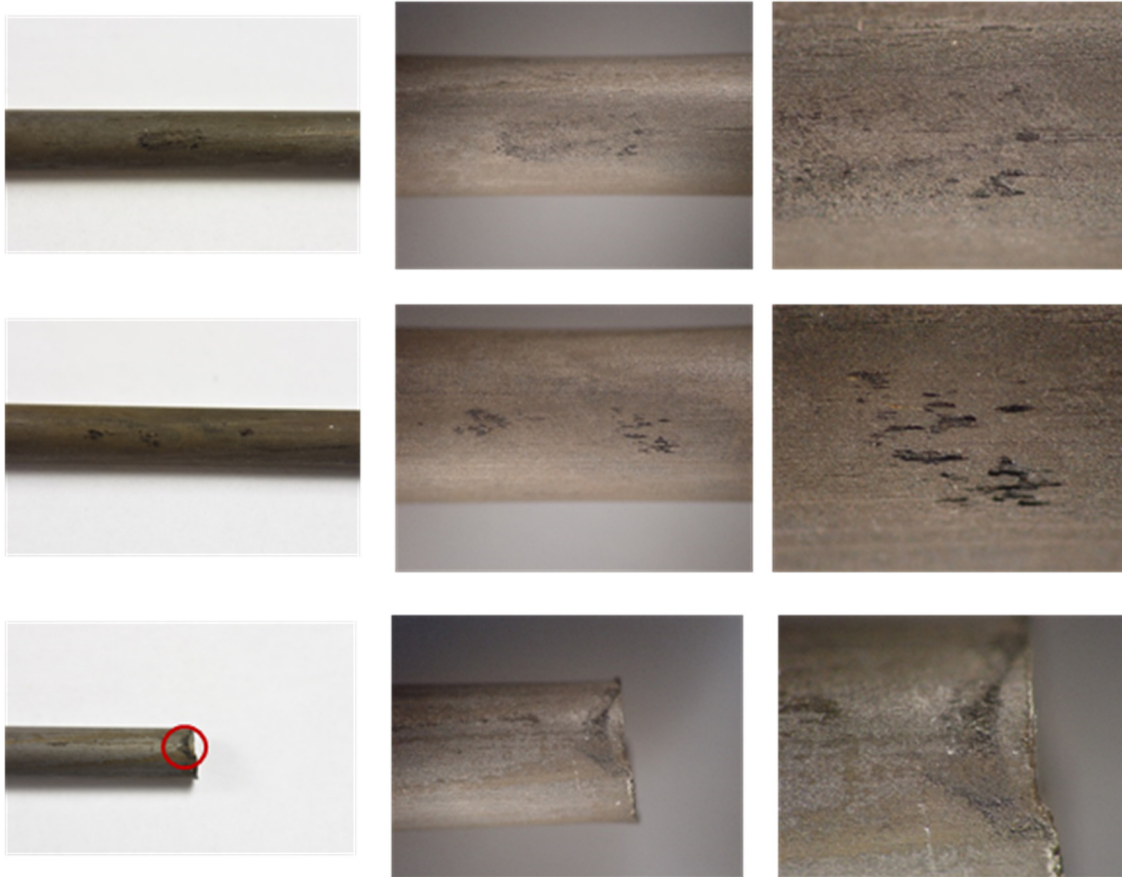
Figure 236. Coated with filler Sonneborn and sprayed with 1.5 milliliter of solution containing

Figure 235. Coated with filler Nontribos and sprayed with 1.5 milliliter of solution containing fungus AF.....	211
Figure 236. Coated with filler Sonneborn and sprayed with 1.5 milliliter of solution containing fungus AF.....	212
Figure 237. Coated with filler Sanchem and sprayed with 1.5 milliliter of solution containing fungus AF (close-up 3).	213
Figure 238. Coated with filler and sprayed with 1.5 milliliter of solution containing fungus FO	214
Figure 239. Coated with filler Trenton and sprayed with 1.5 milliliter of solution containing fungus FO (close-up 1).....	215
Figure 240. Coated with filler Trenton and sprayed with 1.5 milliliter of solution containing fungus FO (close-up 2).....	216
Figure 241. Coated with filler Nontribos and sprayed with 1.5 milliliter of solution containing fungus FO (close-up 3)	217
Figure 242. Coated with filler Sonneborn and sprayed with 1.5 milliliter of solution containing fungus FO (close-up)	218

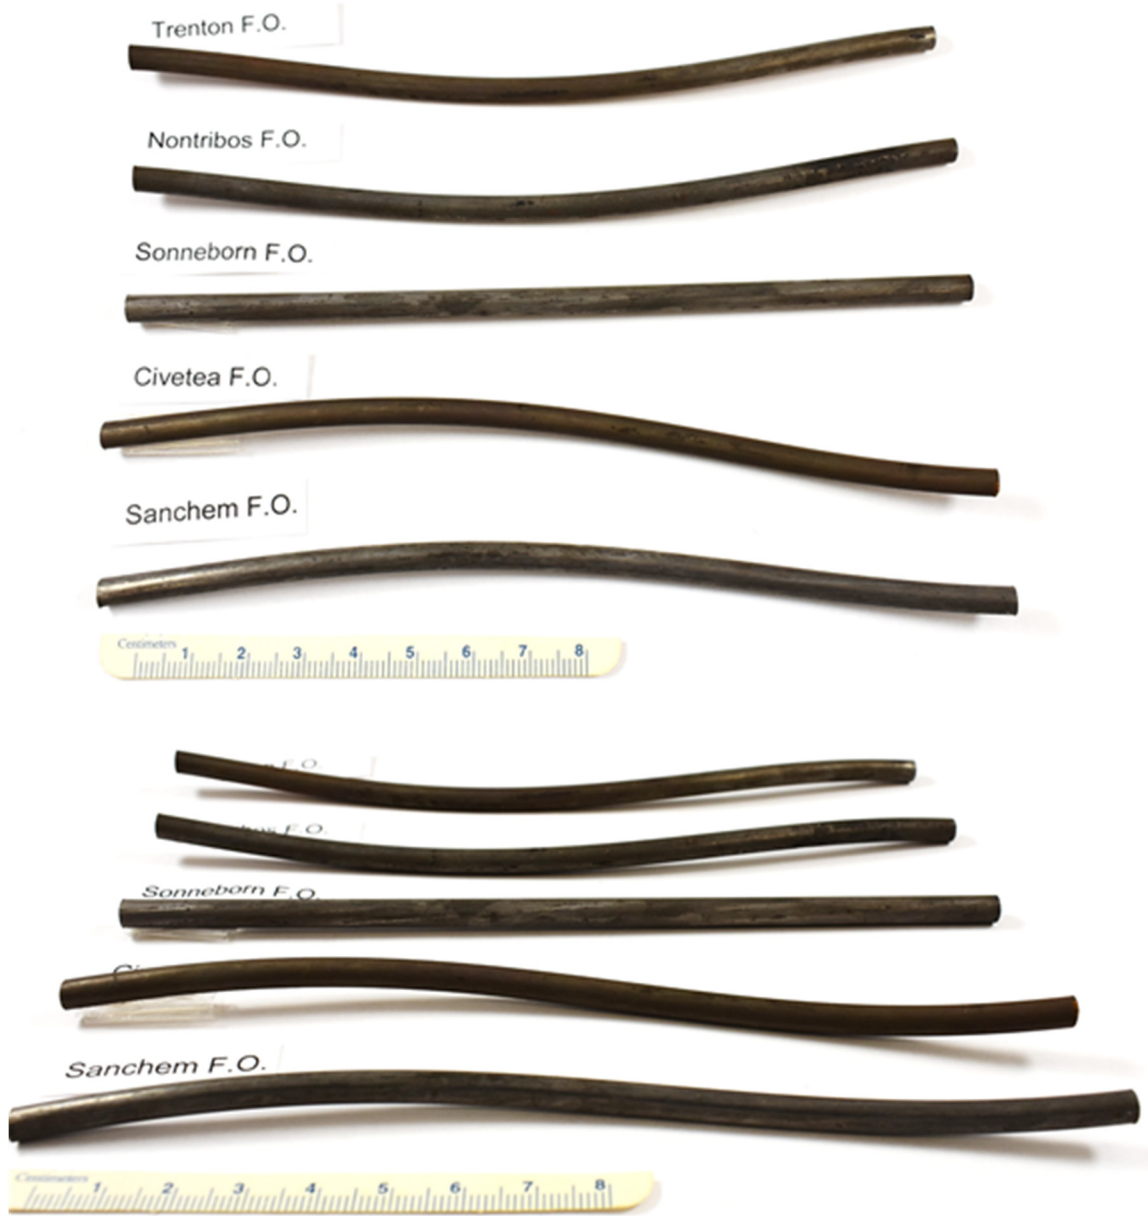
Figure 238. Coated with filler and sprayed with 1.5 milliliter of solution containing fungus FO

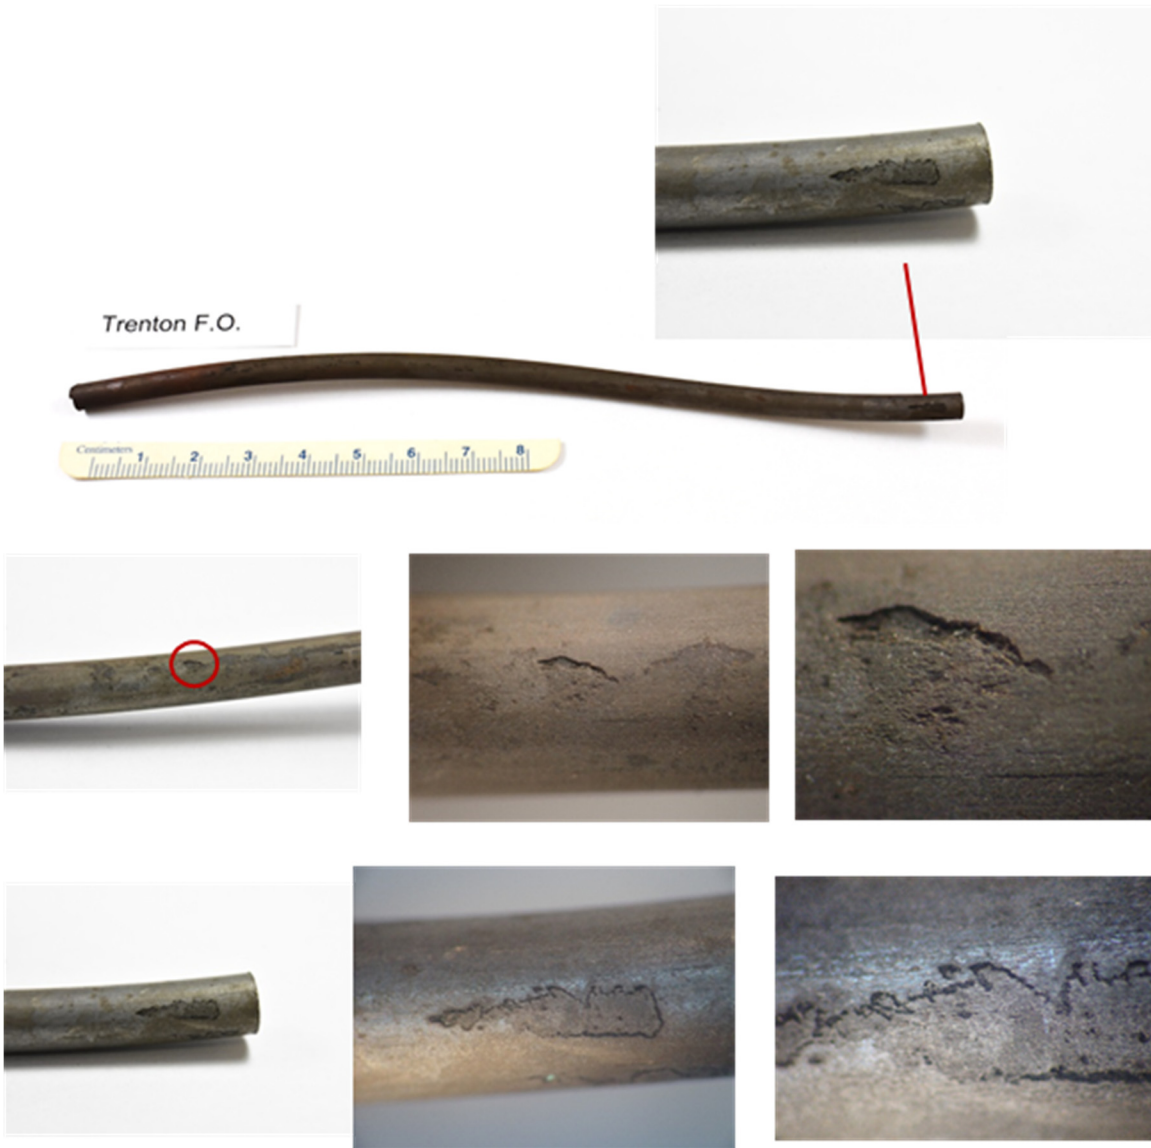
Figure 240. Coated with filler Trenton and sprayed with 1.5 milliliter of solution containing fungus FO (close-up 2)

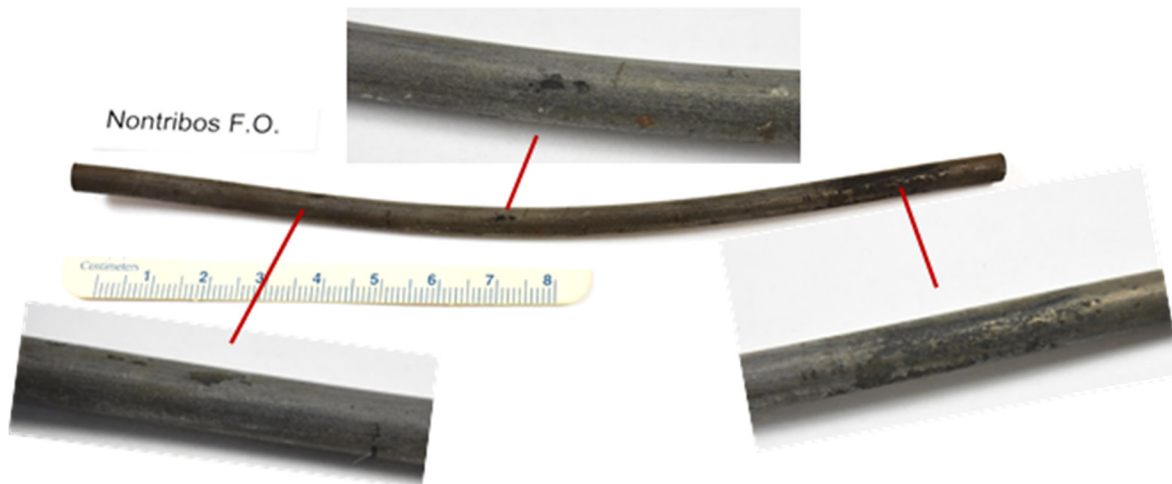
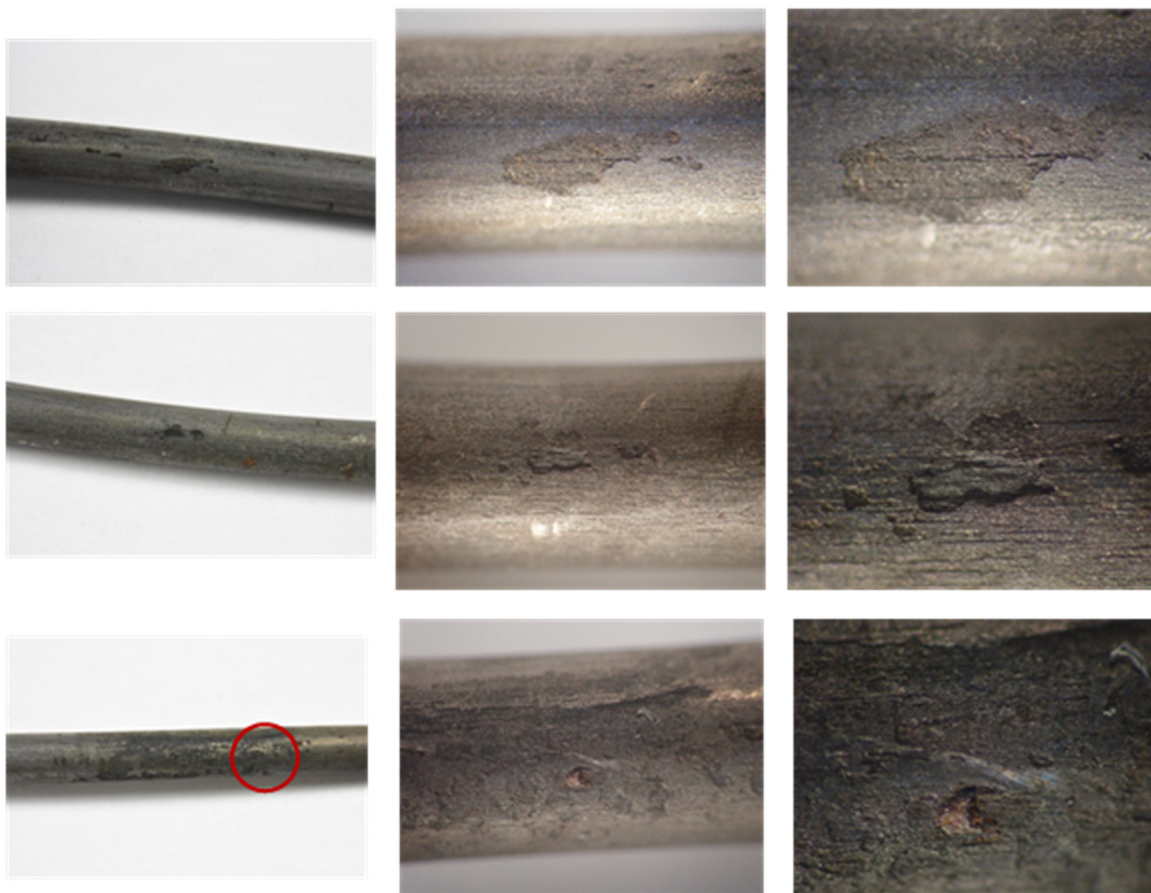
Figure 241. Coated with filler Nontribos and sprayed with 1.5 milliliter of solution containing fungus FO (close-up 3)

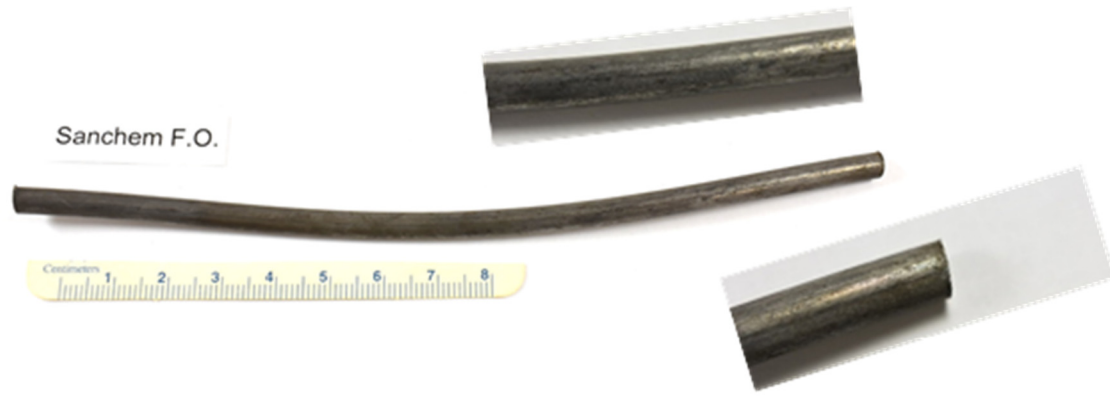
Figure 244. Coated with filler Sanchem and sprayed with 1.5 milliliter of solution containing fungus FO (close-up).

Figure 243. Coated with filler Civetea and sprayed with 1.5 milliliter of solution containing fungus FO (close-up).....	219
Figure 244. Coated with filler Sanchem and sprayed with 1.5 milliliter of solution containing fungus FO (close-up).	220
Figure 245. Coated with filler Sanchem and sprayed with 1.5 milliliter of solution containing fungus FO (close-up 2).	221
Figure 246. Coated with filler and sprayed with 1.5 milliliter of solution containing fungi mix.	222
Figure 247. Coated with filler Trenton and sprayed with 1.5 milliliter of solution containing fungi mix (close-up).	223
Figure 248. Coated with filler Nontribos and sprayed with 1.5 milliliter of solution containing fungi mix (close-up).....	224
Figure 249. Coated with filler Sonneborn and sprayed with 1.5 milliliter of solution containing fungi mix (close-up).....	225
Figure 250. Coated with filler Civetea and sprayed with 1.5 milliliter of solution containing fungi mix (close-up 1).	226

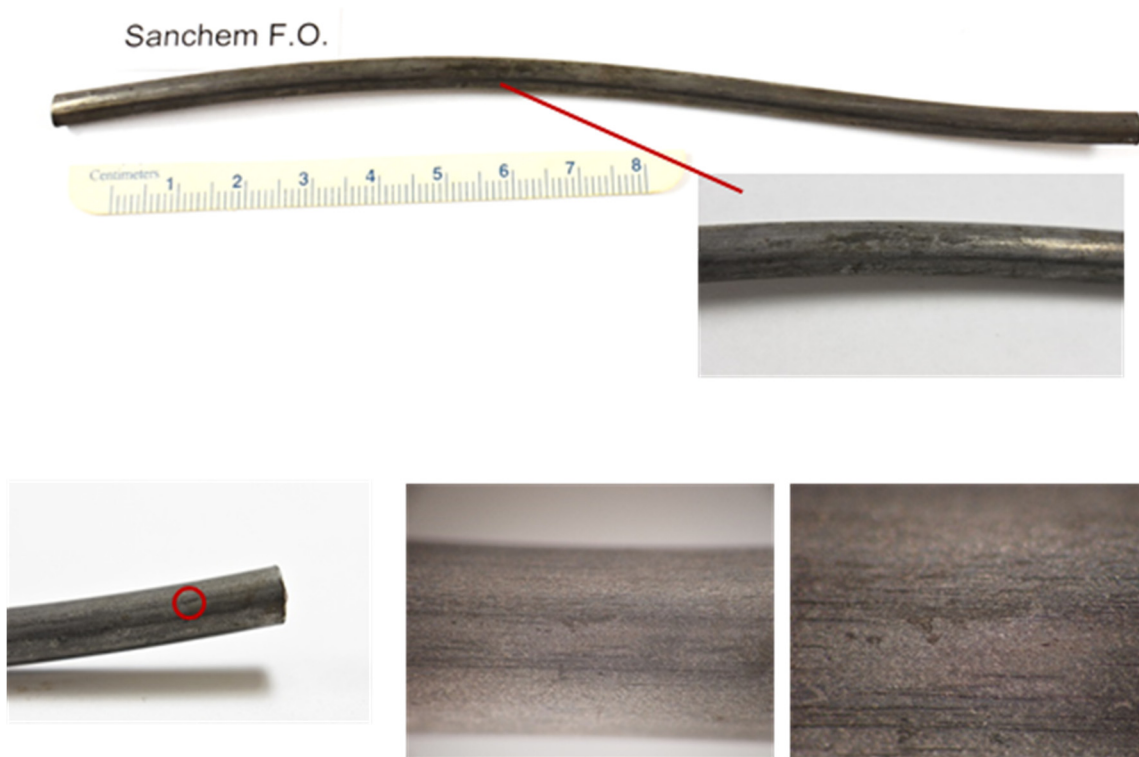
Figure 245. Coated with filler Sanchem and sprayed with 1.5 milliliter of solution containing fungus FO (close-up 2).

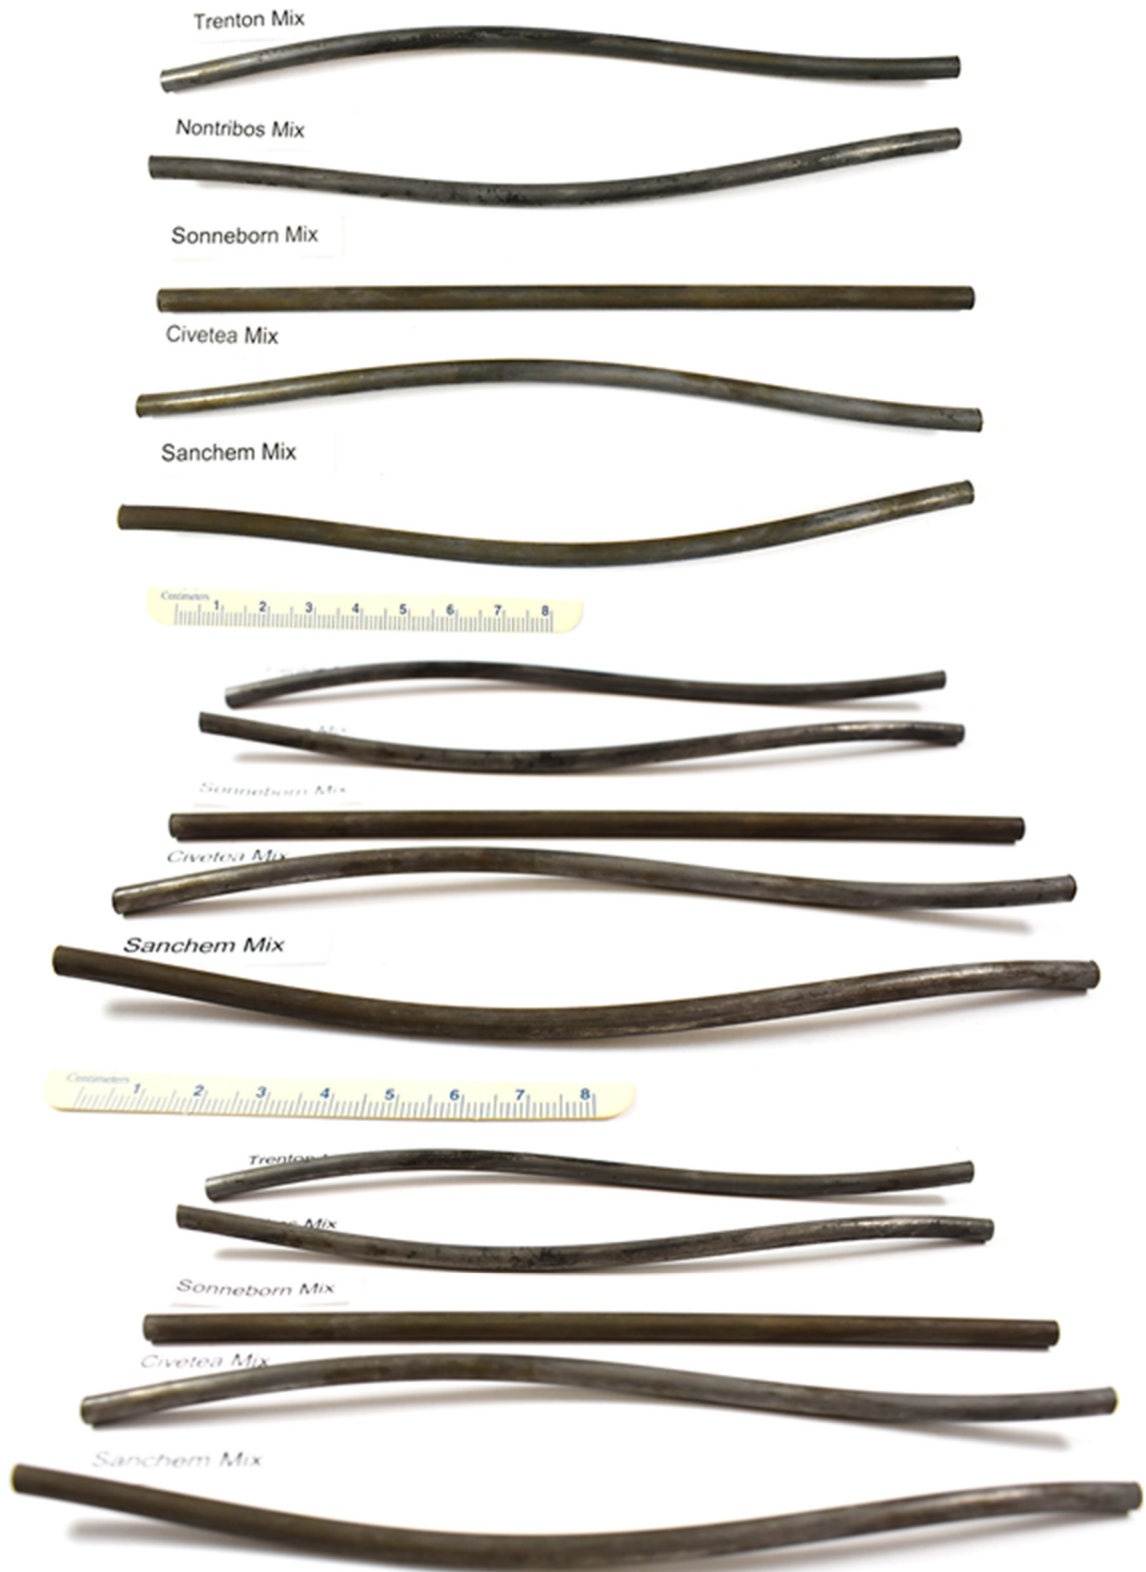
Figure 246. Coated with filler and sprayed with 1.5 milliliter of solution containing fungi mix.

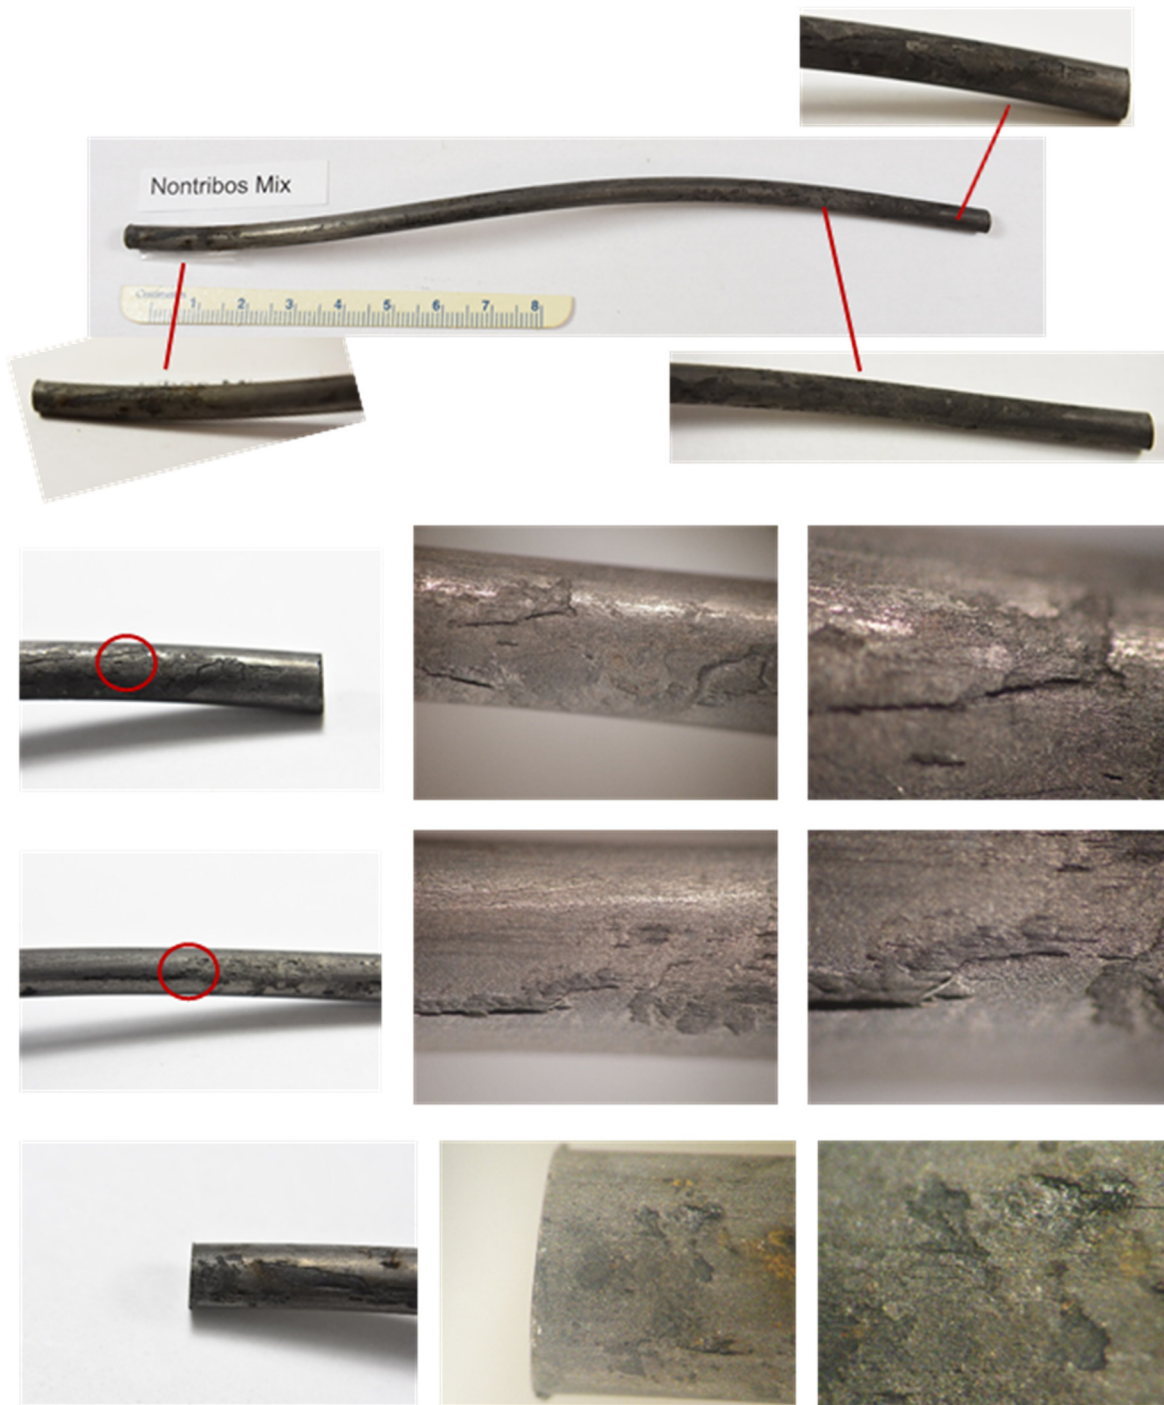
Figure 248. Coated with filler Nontribos and sprayed with 1.5 milliliter of solution containing fungi mix (close-up).

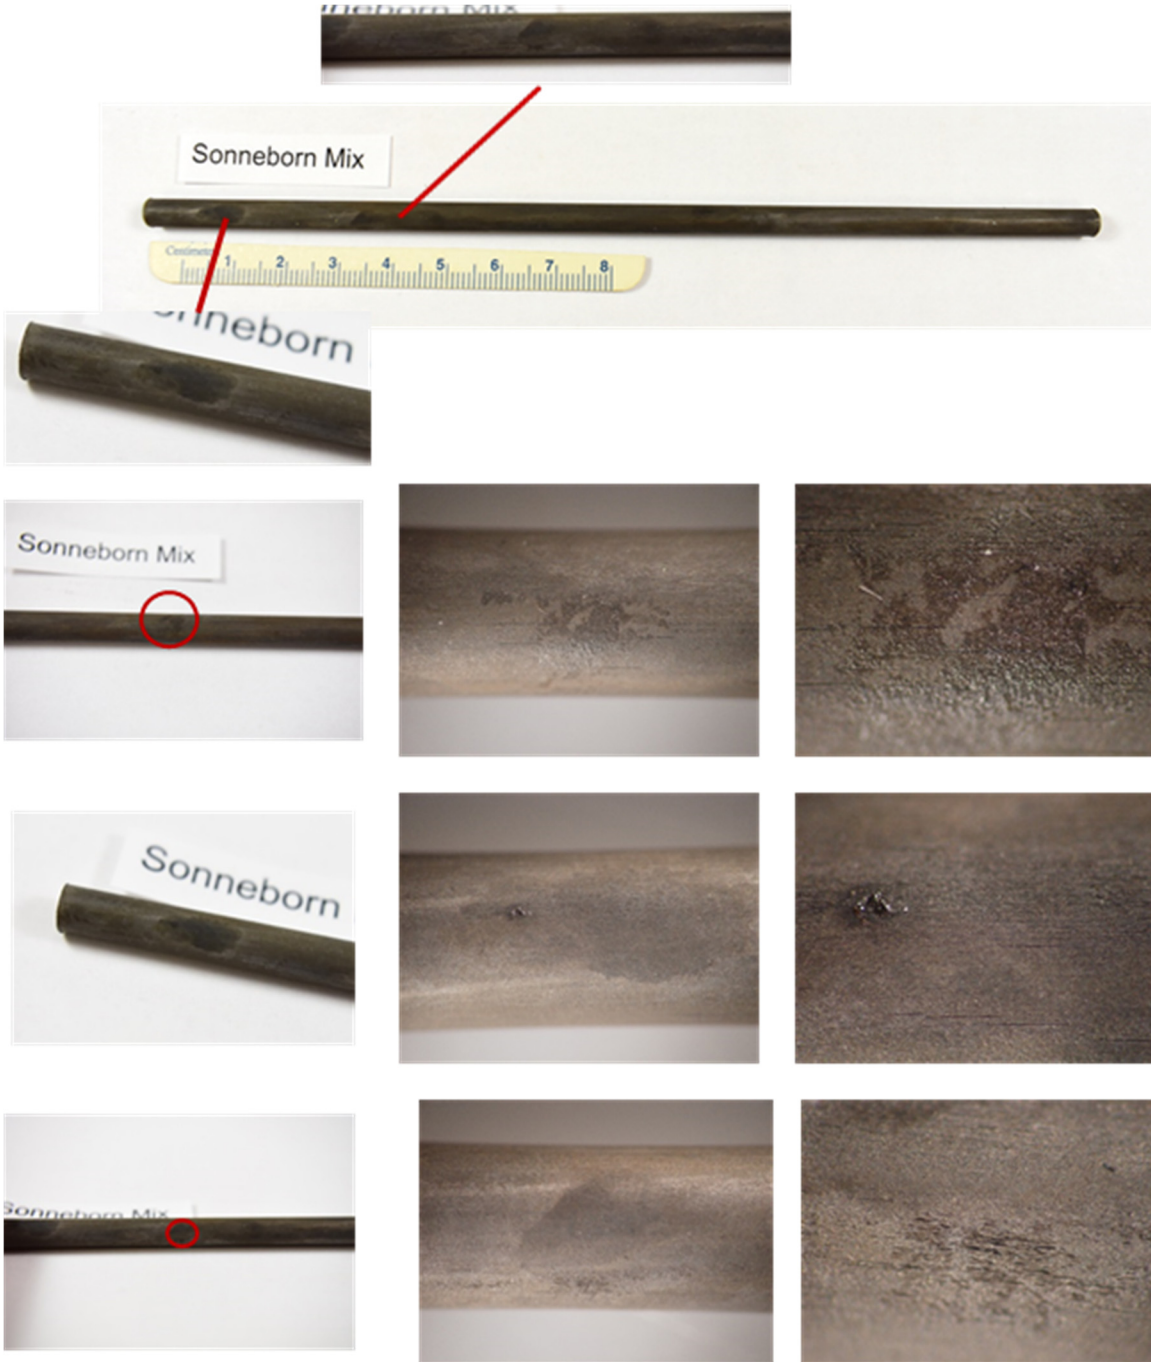
Figure 249. Coated with filler Sonneborn and sprayed with 1.5 milliliter of solution containing fungi mix (close-up).

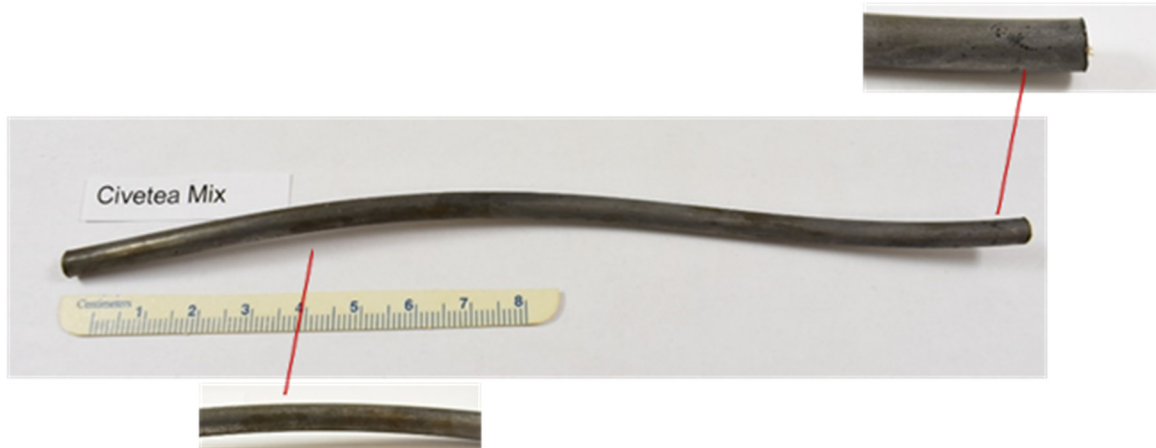
Figure 251. Coated with filler Civetea and sprayed with 1.5 milliliter of solution containing fungi mix (close-up 2).

Figure 251. Coated with filler Civetea and sprayed with 1.5 milliliter of solution containing fungi mix (close-up 2).	227
Figure 252. Coated with filler Sanchem and sprayed with 1.5 milliliter of solution containing fungi mix (close-up).	228
Figure 253. Coated with filler and sprayed with 1.5 milliliter of solution containing fungus PC	229
Figure 254. Coated with filler Trenton and sprayed with 1.5 milliliter of solution containing fungus PC (close-up).	230

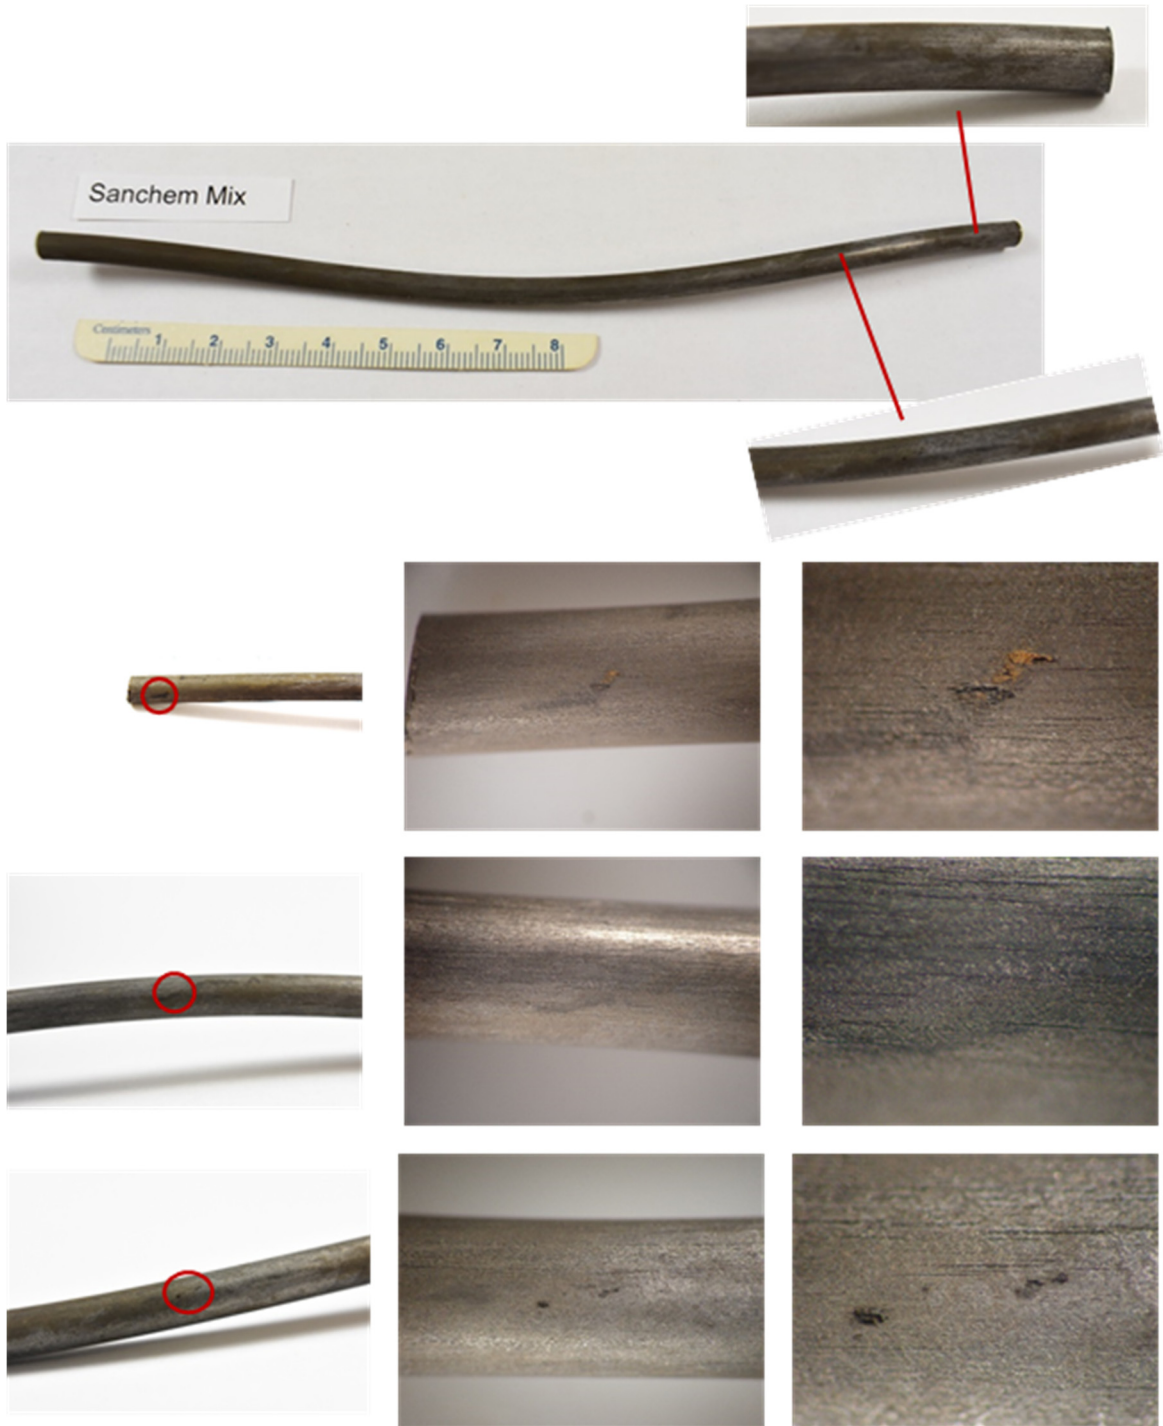
Figure 252. Coated with filler Sanchem and sprayed with 1.5 milliliter of solution containing fungi mix (close-up).

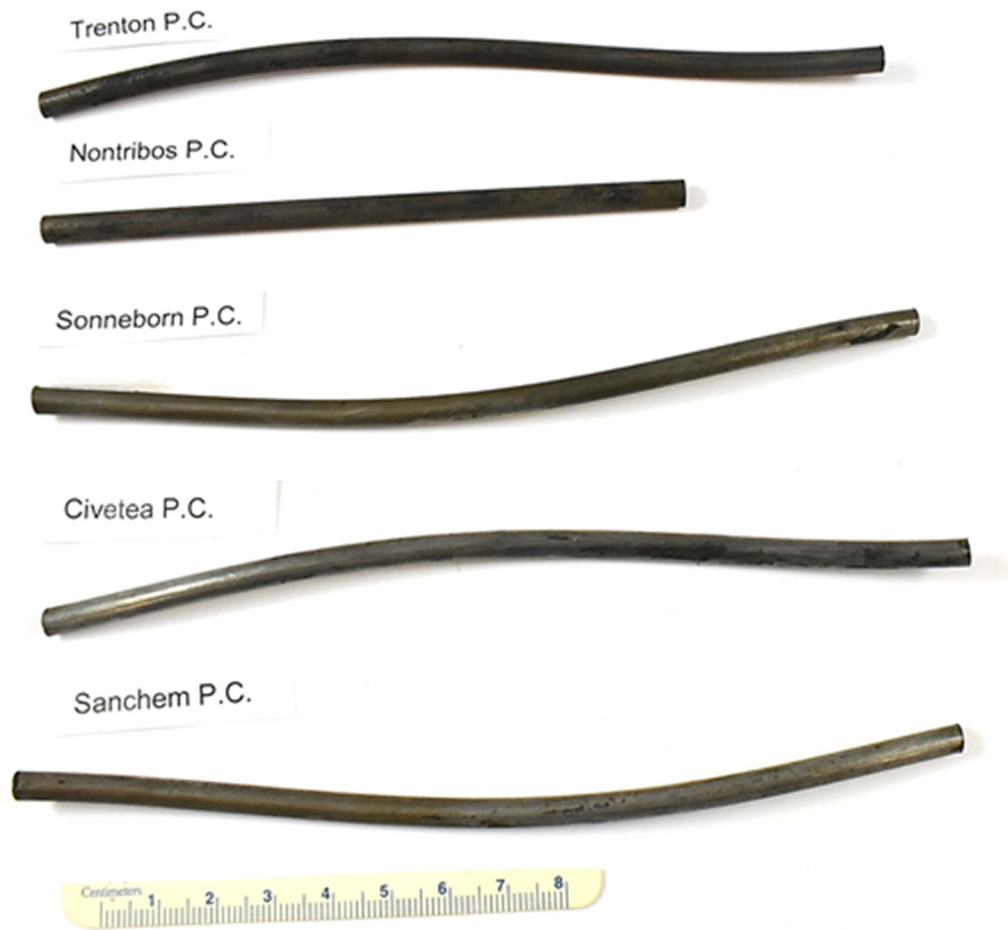
Figure 253. Coated with filler and sprayed with 1.5 milliliter of solution containing fungus PC

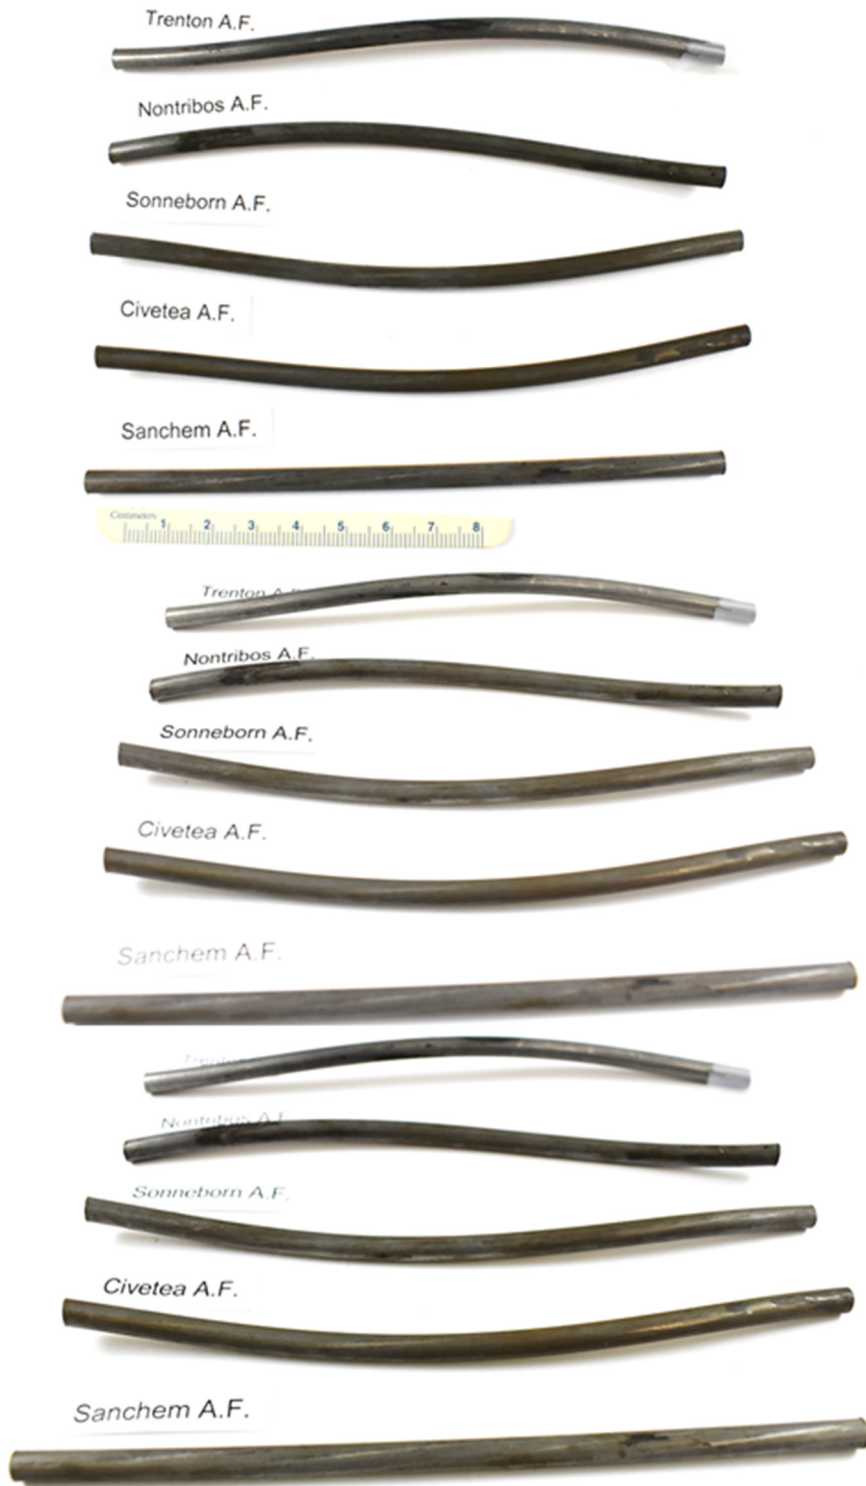
Figure 259. Coated with filler and sprayed with 0.6 milliliter of solution containing fungus AF

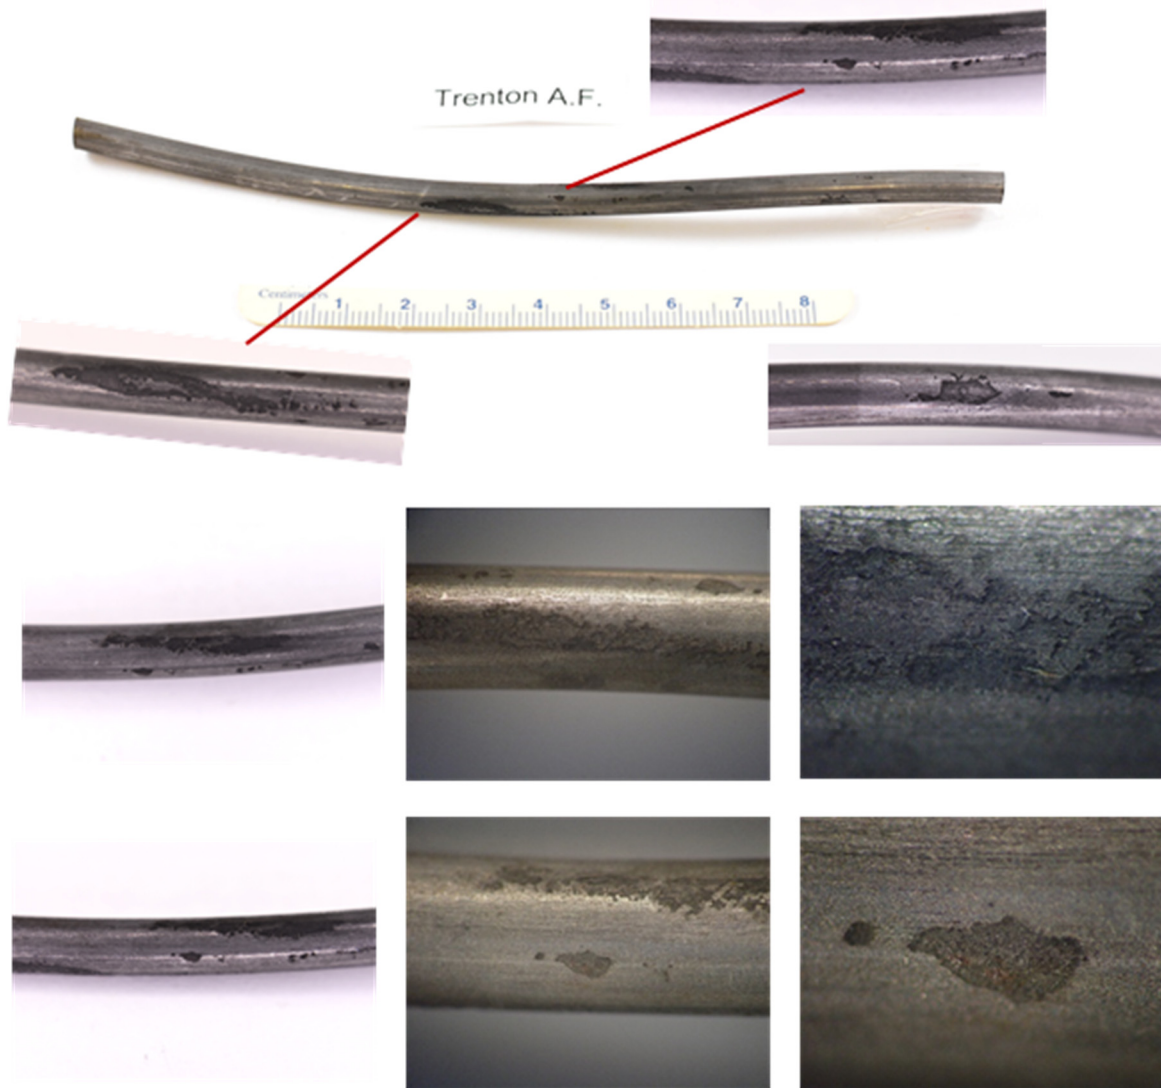
Figure 260. Coated with filler Trenton and sprayed with 0.6 milliliter of solution containing fungus AF (close-up 1).

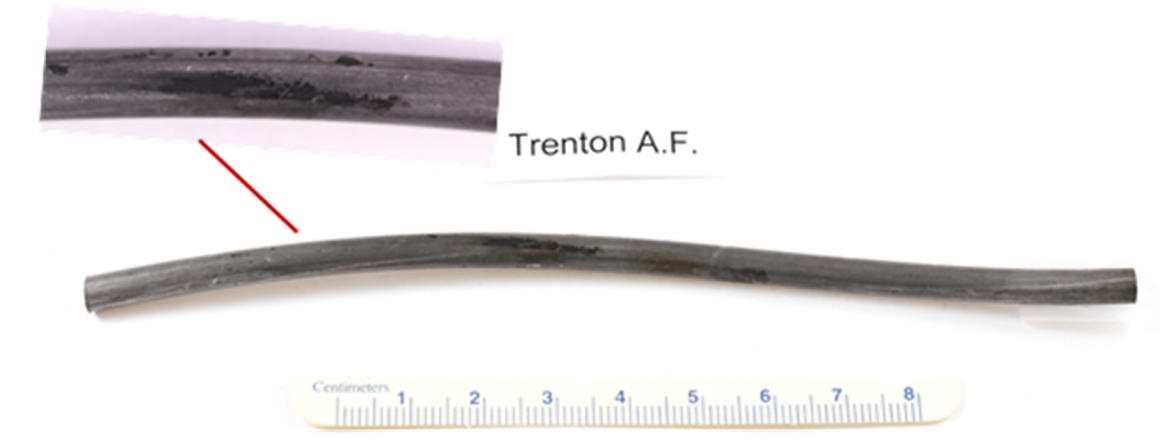
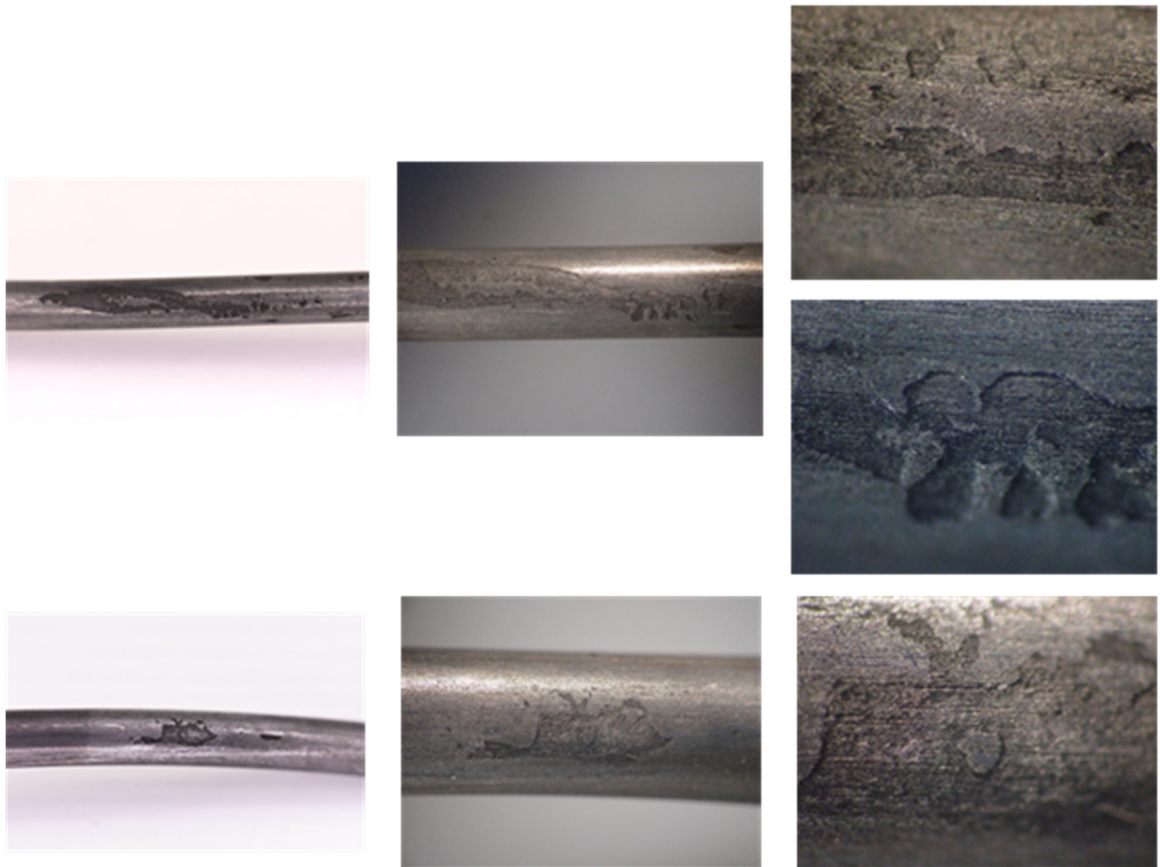
Figure 261. Coated with filler Trenton and sprayed with 0.6 milliliter of solution containing fungus AF (close-up 2).

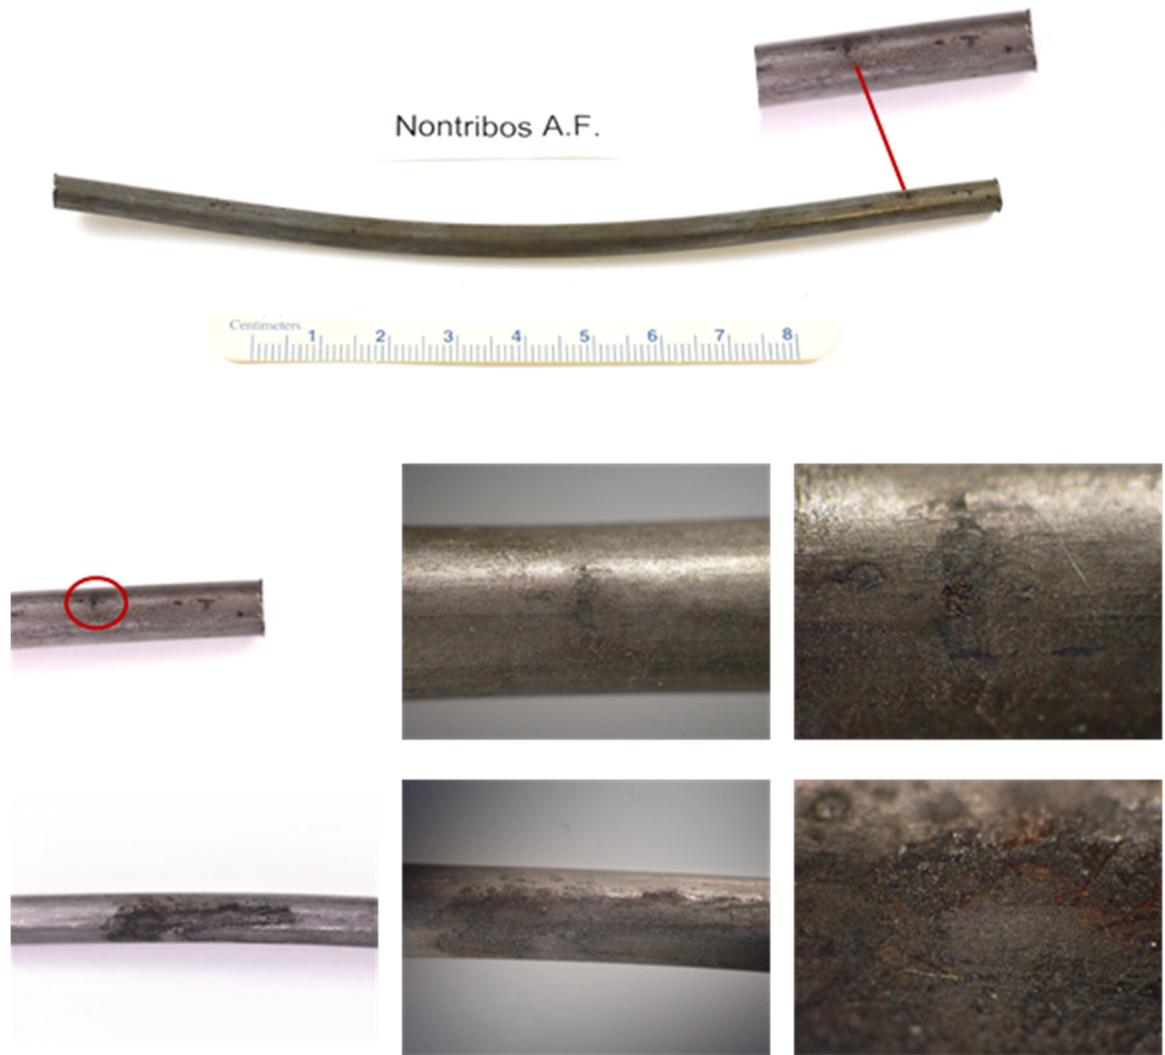
Figure 262. Coated with filler Nontribos and sprayed with 0.6 milliliter of solution containing fungus AF (close-up 1).

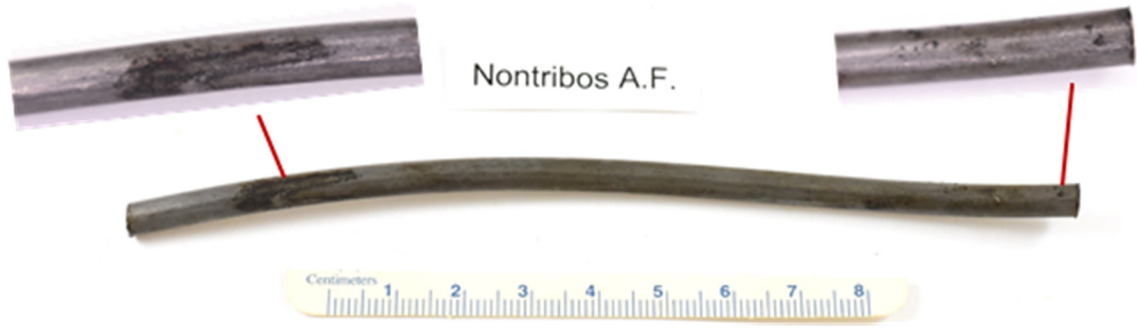
Figure 263. Coated with filler Nontribos and sprayed with 0.6 milliliter of solution containing fungus AF (close-up 2).
